**Cell 1 Regional Coastal Monitoring Programme
Walkover Inspection Surveys 2016**

Hartlepool Borough Council

Walkover Inspection Surveys 2016

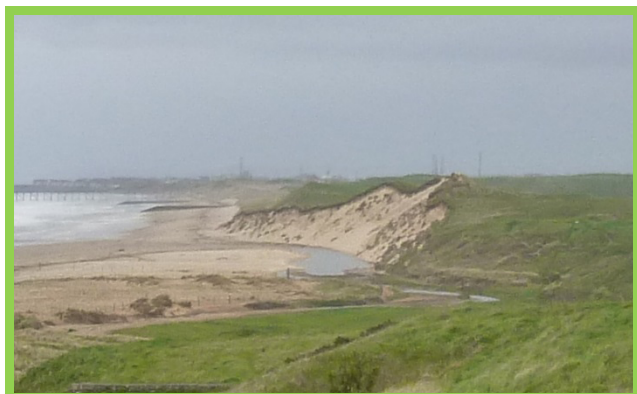
The dunes fronting Hartlepool Golf Course remained high and steep with sparse vegetation coverage at the northern extent and increasing vegetation coverage towards the south. The profiles of the dunes remained similar to that of 2014 suggesting these remain relatively inactive with evidence of small-scale local erosion, particularly evident at the toe of the slope adjacent to Crimdon Dene. A wide sandy beach was present along North Sands.

View on dunes looking south (/C0301C01)

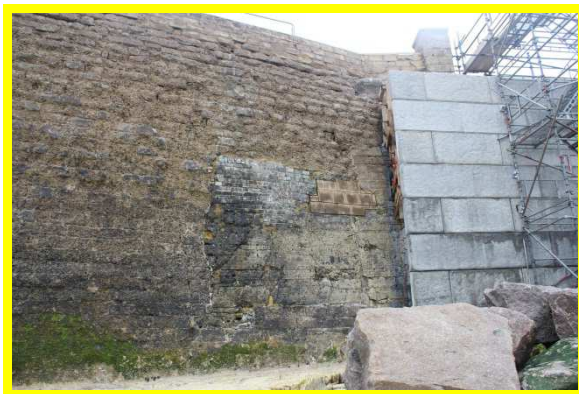
To the south of the apex of the headland, it appeared that further work was to take place to tie-in the newly constructed defences into the existing seawall (temporary works were still in place).

Southern extent of ongoing construction works. (/C0303C02)

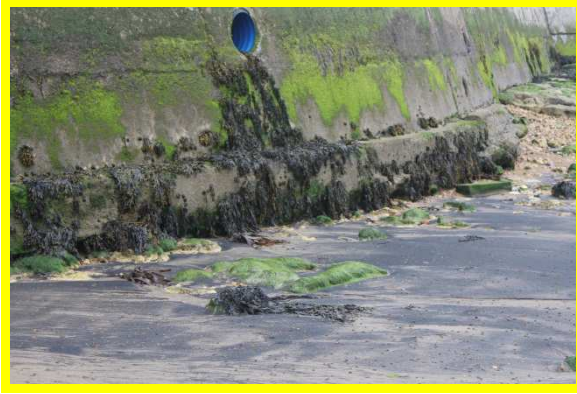
Undercutting – partially obscured by vegetation (/C0401C04)

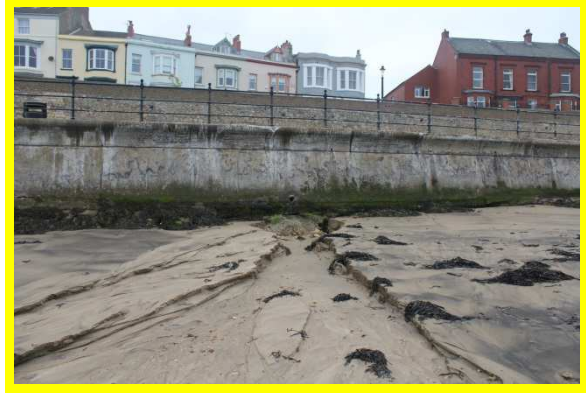
Local scour in front of outfall (/C0401C05)

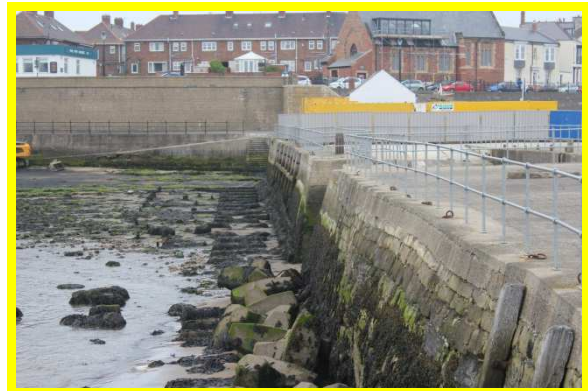
Inner face of North Pier – note potential settlement of masonry blocks (/C0401C06)

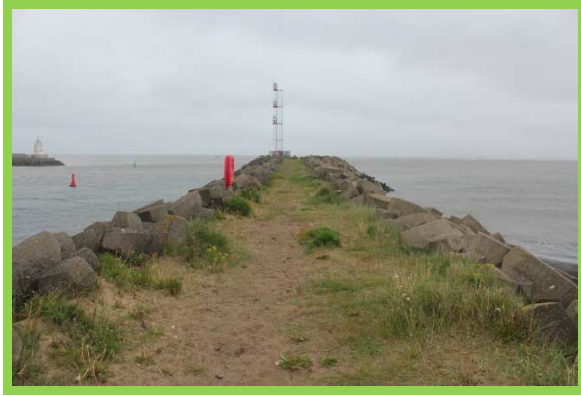
It was not possible to inspect the toe of the jetty structure as this was submerged at low tide. The concrete accropode armour units displayed good interlock with a consistent slope/profile throughout and there was no evidence on the crest to suggest global movement or distress. Wind-blown sand had accumulated at the landward end, with vegetation growth.

Middleton Jetty north aspect (/C0401C16)

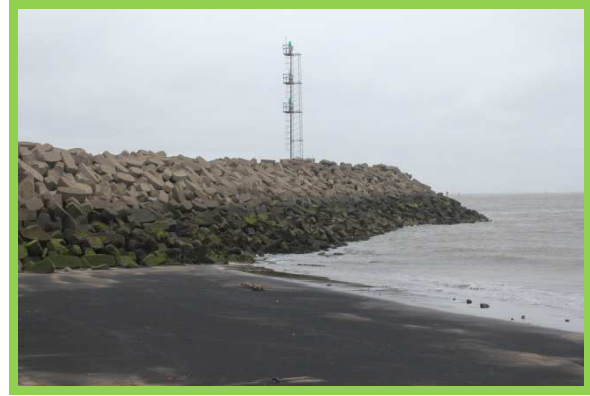
Middleton Jetty south aspect (/C0401C16)

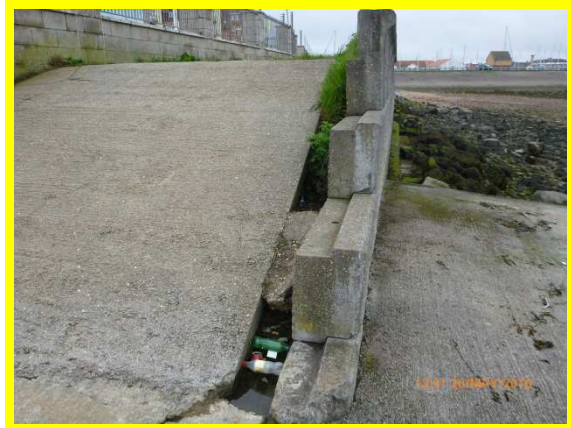
Void behind concrete wall units and beneath concrete ramp (/C0401C27)

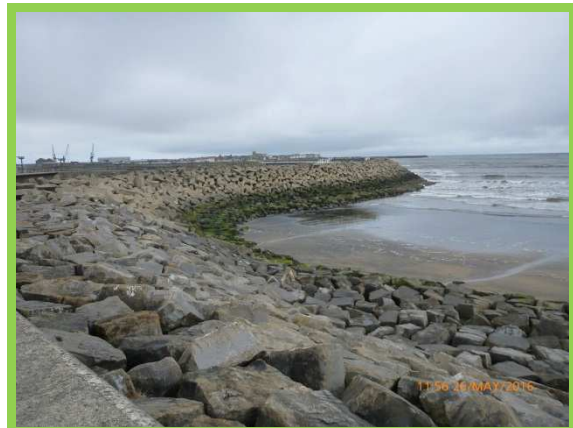
Outer face of South Pier (/C0401C32)

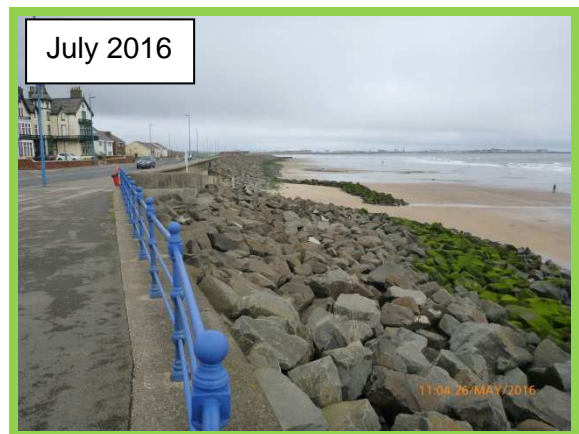
Little Scar access ramp (/C0401C33)

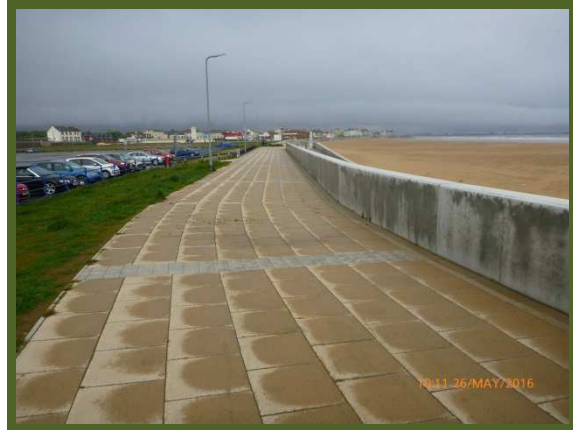
Promenade at pumping station (/C0501C02)

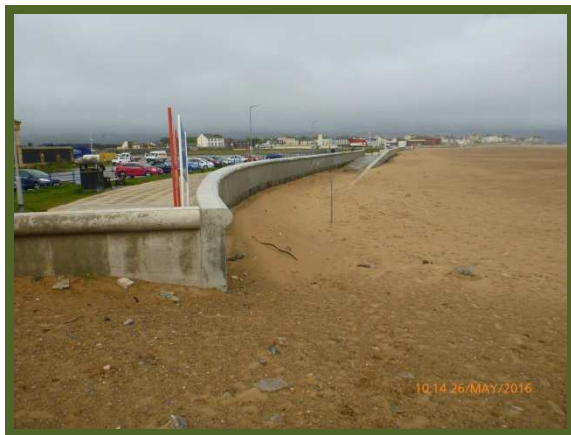
Southern extent of seawall (/C0501C02)

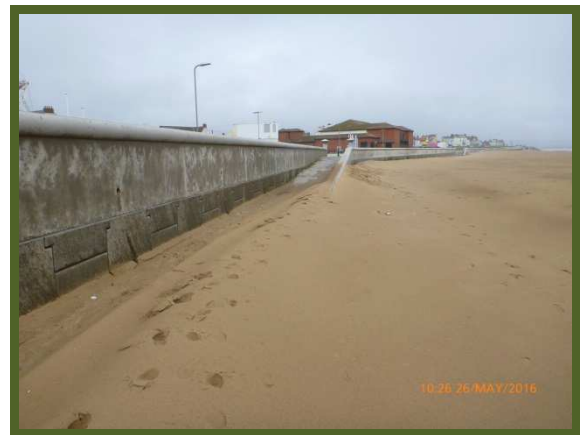
Ridge of wind-blown sand. Note partially buried access ramp (/C0501C03)

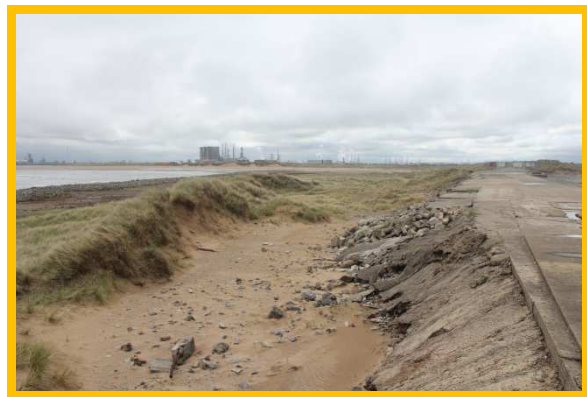
*South face of North Gare Breakwater. Dune field in lee of structure
(/C0503C01)*
