Cell 1 Regional Coastal Monitoring Programme Walkover Inspection Surveys 2020

Hartlepool Borough Council

Walkover Inspection Surveys 2020

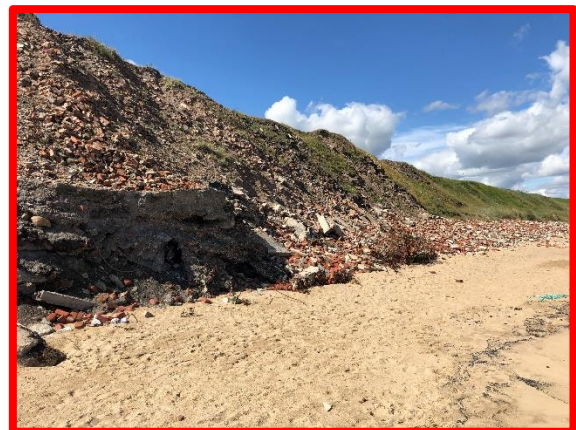
The coastal slope to the rear appeared to be largely comprised of made ground/bricks/rubble with evidence of ongoing erosion/instability. An outlet pipe has been exposed through ongoing erosion. In light of the property development in the vicinity, it is recommended a formal coastal defence is considered in this area.

Erosion of made ground slope and collapsed former gabion structure (C0302C02)

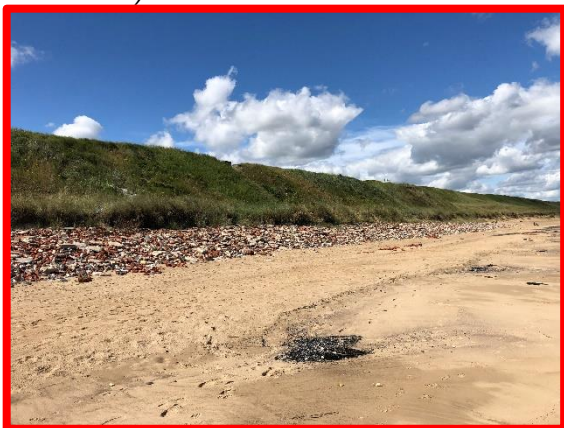
The section of made slope that is now undefended due to the failure of the brick gabion (reported in previous surveys) now fronts an ongoing residential development on the former industrial site to the south of Spion Kop cemetery. The proximity of the residential development and the ongoing erosion activity observed along this section means it is recommended that a formal coastal defence should be considered.

Burst brick gabions spread along foreshore to the north (C0302C02)

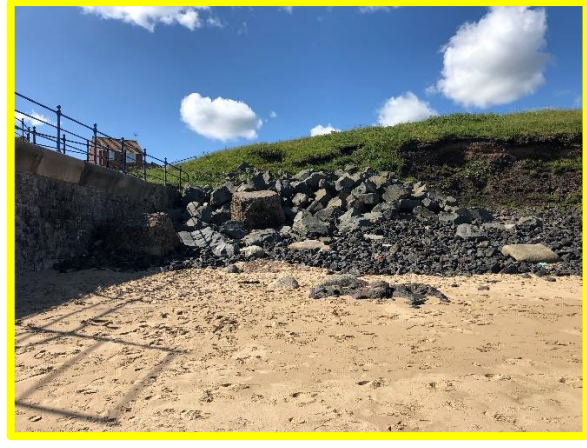
Large pieces of slag material previously poured to form a protective apron had continued to break up although the material is likely to remain *in situ*. Rock armour revetment (also incorporating several concrete tank blocks) at the interface with Marine Drive sea wall appeared in fair condition.

Rock armour revetment at Marine Drive seawall (/C0302C03)

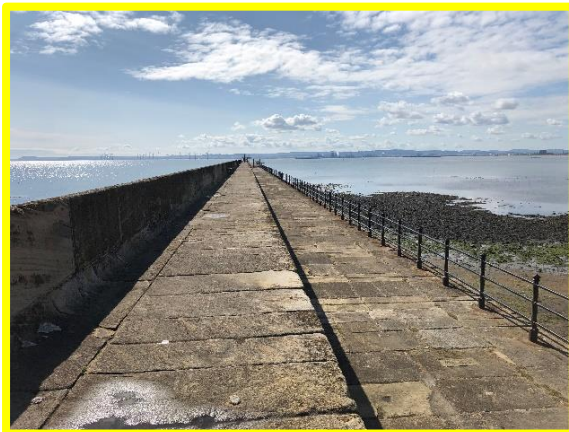
Heugh Breakwater – Deck slab (/C0401C01)

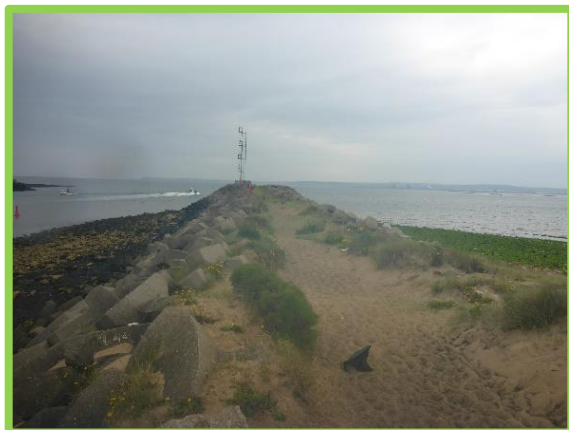
Middleton Jetty north aspect (/C0401C16)

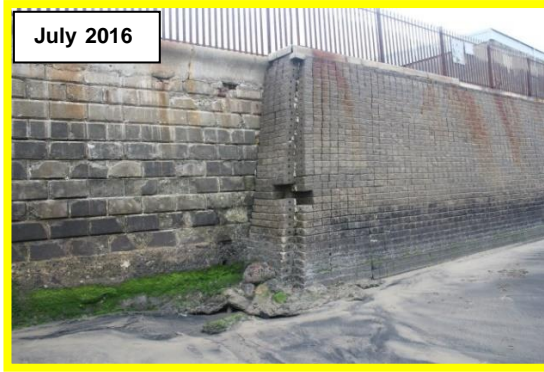
Missing blocks at interface between two walls. Local scour at toe (2016) (/C0401C19)

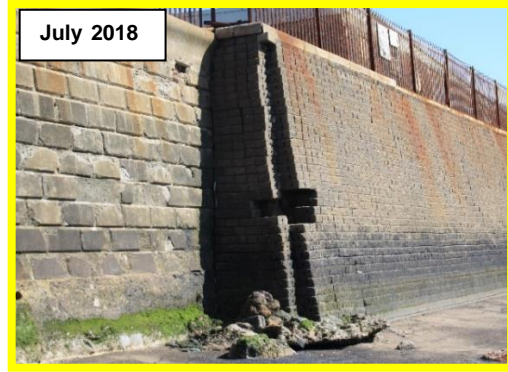
Progressive loss of blocks at interface between two walls. Local scour at toe (2018) (/C0401C19)

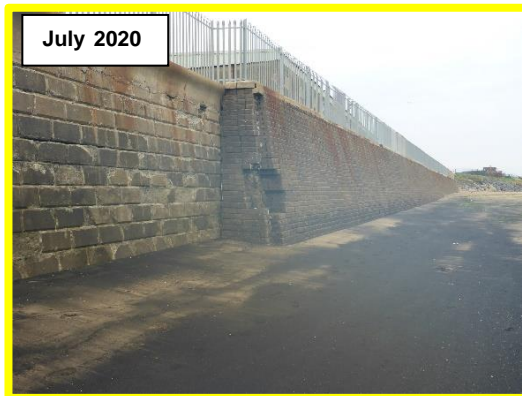
The retaining blockwork wall fronting the warehouse structure remains in poor condition with the area of block loss, at the interface with the adjacent asset, doubling in size since 2018. The wall has an inconsistent profile with various bulges. It is recommended that a detailed structural survey of this asset is carried out.

Loss of blocks doubled in size since 2018. High beach levels concealing scour. (/C0401C19)

As observed in previous surveys, the profile of the concrete blockwork wall was not consistent, with bulges of various sizes visible along the full length. The majority of concrete coping units were missing. Opening joints were evident, suggesting global movement of the structure. The missing blocks at the interface between the two walls has more than doubled in size since 2018. Significantly higher beach levels concealed the minor scour observed in previous surveys. It is recommended that a detailed structural survey is carried out of the retaining blockwork wall.

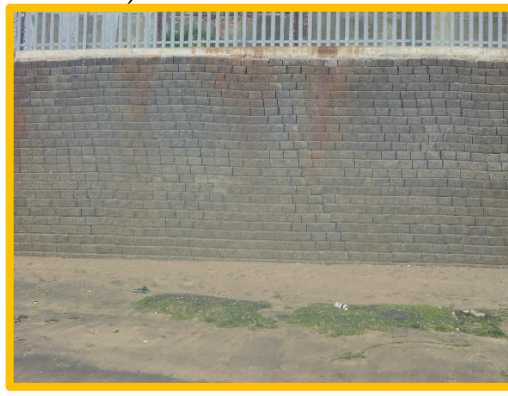
Inconsistent profile, missing copes, open joints (/C0401C19)

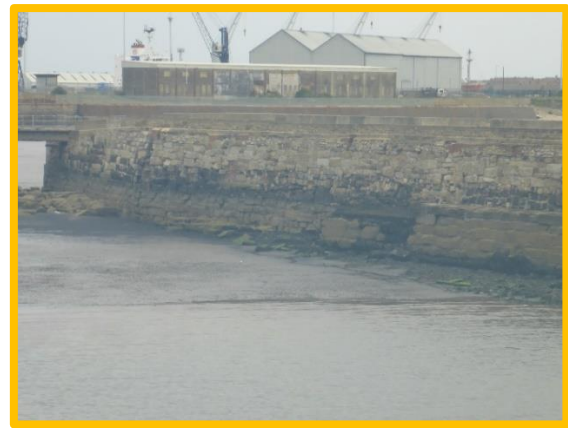
South face of North Pier (C0401C22)

The seaward ends of the inner and outer arms of the North Pier were inspected from a distance (Middle Pier and South Pier). The structure appeared in fair to poor condition overall with defects including missing mortar, open joints, missing masonry, significant areas of damaged masonry and concrete. During the 2020 inspection, voids were observed in the south face of the pier head.

Consideration should be given to undertaking a more detailed survey of the structure, including a boat/dive survey to inspect the permanently submerged seaward ends. It is recommended that repair works are carried out urgently to prevent further deterioration of the structure.

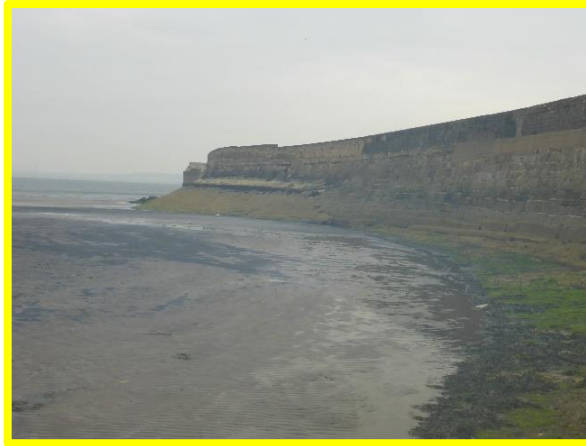
North face of North Pier (C0401C22)

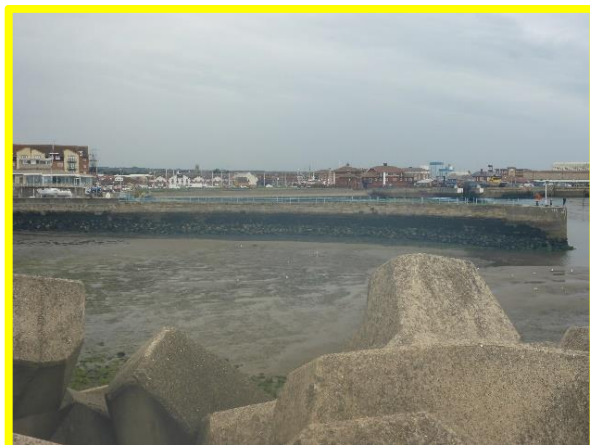
The masonry structure to the west of the Yacht Club remains greatly obscured by marine vegetation. Generally, the Middle Pier appeared in fair condition with minor mortar loss locally. As noted in the 2016 report, significant vegetation growth was evident in the construction joints on the deck which should be removed and joints repointed. The rock armour placed around western face of the Middle Pier remains in good condition, however at the seaward end of the structure the coverage became increasingly sparse. It is recommended that rock armour is re-profiled, to ensure efficient and effective coverage around the structure.

Outer face of Middle Pier (/C0401C28)

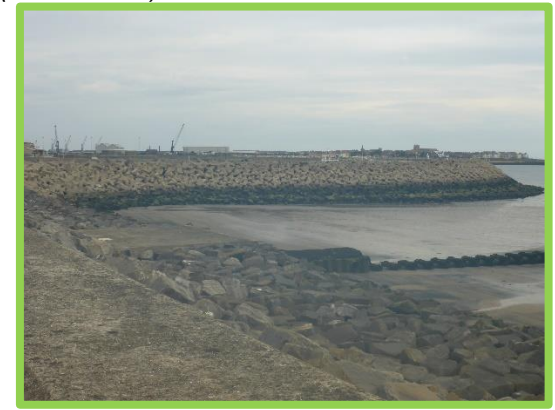
Outer face of South Pier (/C0401C32)

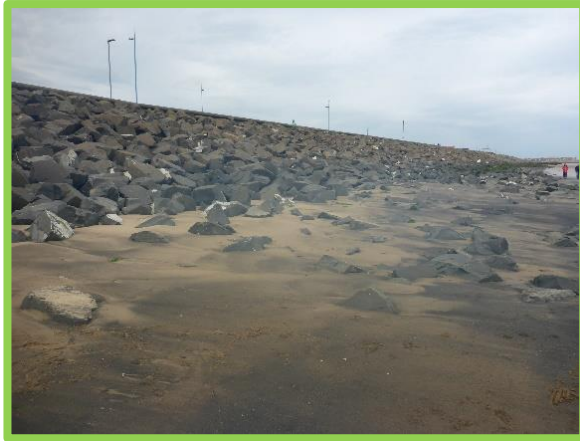
Other noticeable defects included hardened and missing flexible sealant in construction joints of the concrete seawall, minor local spalling and cracking of the concrete access steps and corroded handrails on access steps. Despite this, the seawall and various access steps remain generally in fair to good condition. A number of historic repairs, particularly to the missing or damaged flexible sealant were noted as being effective. Surface water drainage holes on the landward side of the seawall were generally found to be clear and working effectively, however some buildup of litter and sand was observed, these should be cleaned to prevent attenuation of flood water (pluvial, fluvial or coastal) on the landward side of the wall.

Rock armour revetment and concrete seawall (/C0401C33)

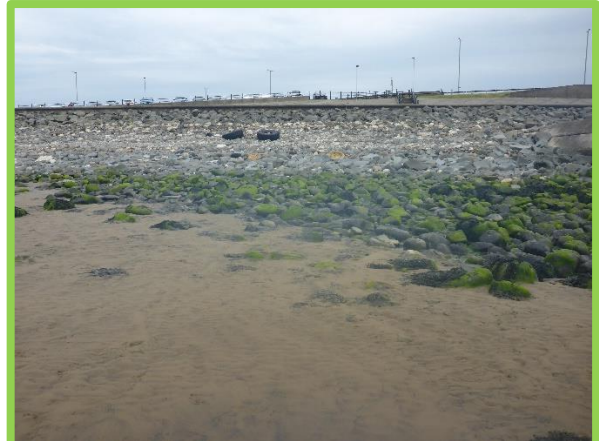
At Newburn Bridge towards the northernmost end of Carr House Sands, as noted in previous surveys there has been some local displacement of rock armour units. This is evidenced by an obvious encroachment of the revetment toe onto the foreshore north of the Newburn Bridge outfall structure. The damaged slip way handrails have been repaired since 2018.

Displaced rock at toe north of Newburn Bridge outfall structure. (/C0401C33)

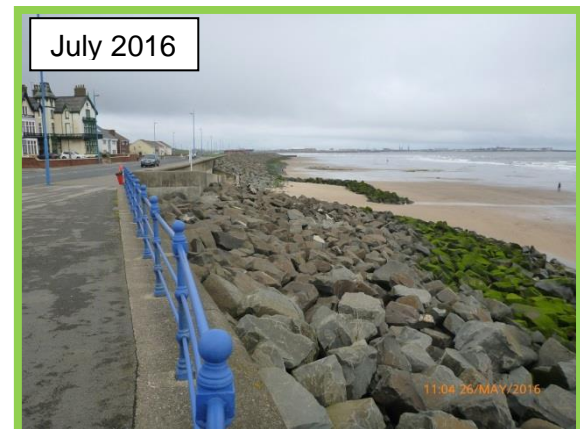
Little Scar access ramp in 2016 (/C0401C33)

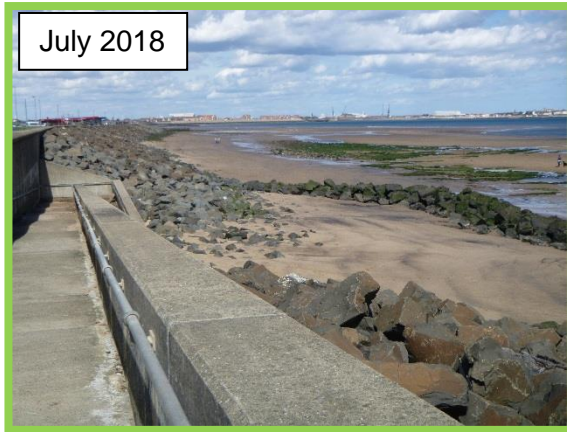
Little Scar access ramp in 2018 (/C0401C33)

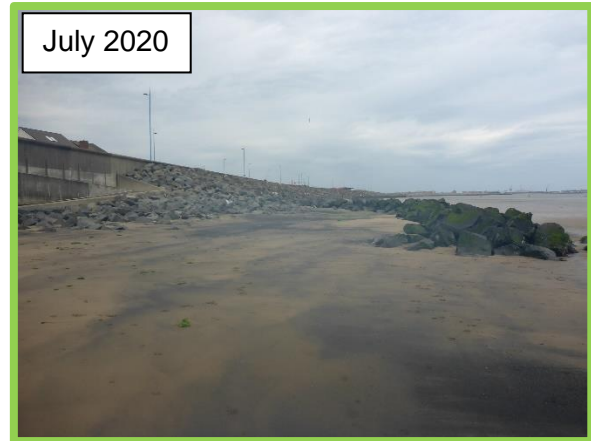
Little Scar access ramp in 2020 (/C0401C33)

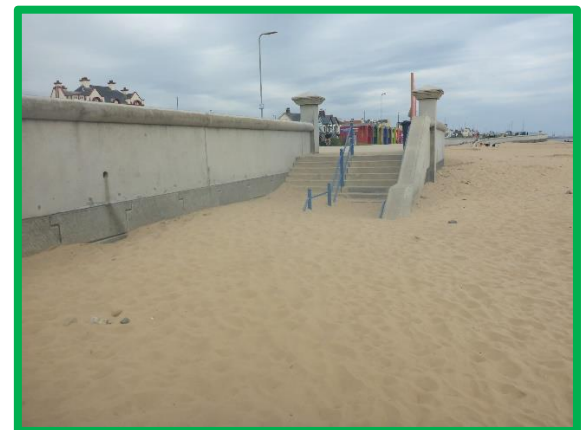
High beach levels at access steps (/C0501C04)

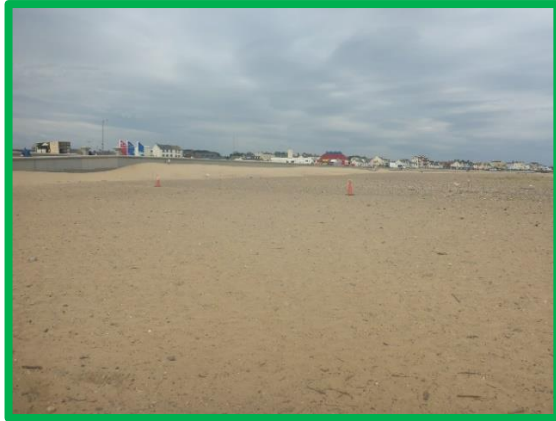
Cordoned off section of frontage for nesting Little Terns. Build up off sediment against seawall (/C0501C02)

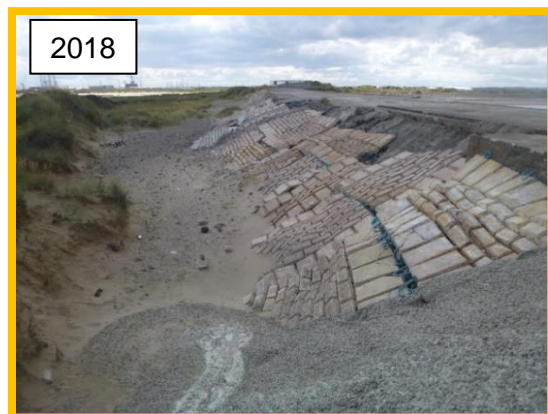
South face of North Gare Breakwater. Dune field in lee of structure (/C0503C01)

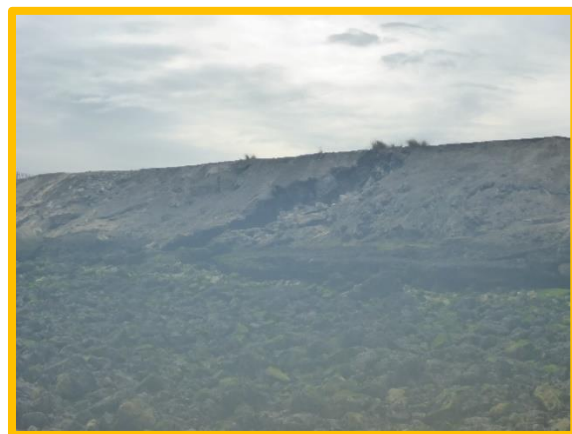
Significant voiding along north face of North Gare Breakwater (/C0503C01)
