NECAG Coast Protection Assets and Coastal Slope Condition Analysis

To this end, Scarborough Borough Council, acting as the 'lead authority' for NECAG, commissioned a team from Royal Haskoning and Halcrow to undertake the '*NECAG Coastal Protection Assets and Coastal Slope Condition Analysis*' between August 2008 and January 2009. Fieldwork was undertaken in the summer to autumn of 2008.

This section presents the approach taken by the slope and asset inspectors respectively for the East Riding of Yorkshire Council coastal frontage.

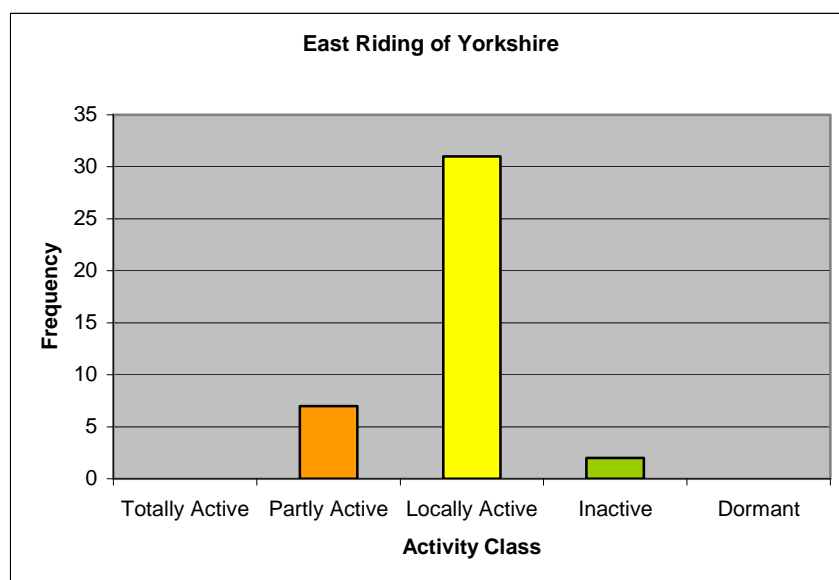
Figure 1. Frequency of cliff activity along the ERYC frontage

The majority of CBUs within this region are classified as Locally Active and pose little risk to the listed assets. The exceptions are the Partly Active areas around Thornwick Nab and Stottle Bank Nook. At both locations diversion of the cliff top footpath has been necessary due to cliff top retreat with the latter involving loss of land at the golf course. Continued monitoring of all units is recommended with more frequent inspection of the more active units at Thornwick Nab and especially Stottle Bank Nook required.
