Cell 1 Regional Coastal Monitoring Programme Walkover Inspection Surveys 2018

**Scarborough
Borough Council**

October 2018

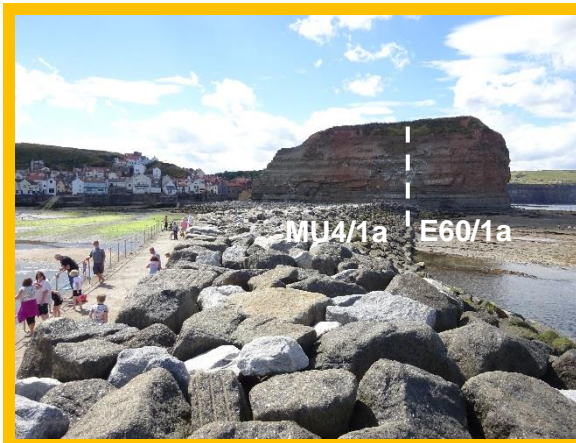
*East-facing Cowbar Nab. **E60/1a** (right) and MU4/1a (left). Partly Active in July 2018*

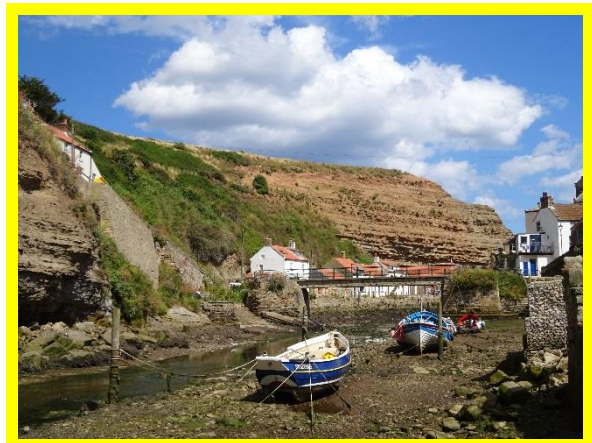
Unit MU4/1b is the south facing side of Cowbar Nab which runs adjacent to the north bank of Staithes Beck. This sandstone unit is sheltered from wave action behind the harbour walls. The cliff fails occasionally and is therefore classified as Locally Active, unchanged from 2016.

*South-facing Cowbar Nab along Staithes Beck **MU4/1b** (Locally Active in July 2018)*

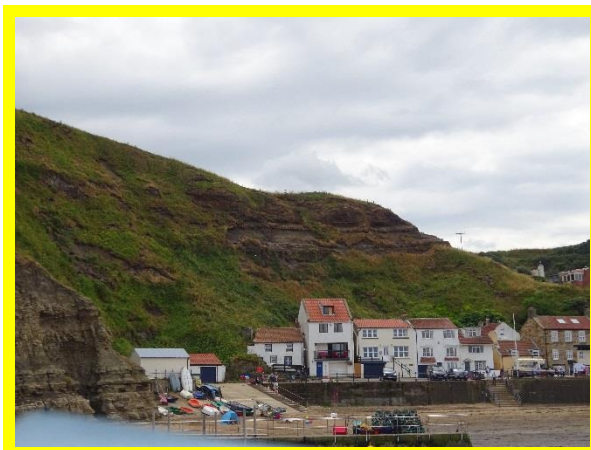
Unit MU4/2 is located behind Staithes Harbour. This sandstone cliff is well vegetated with small localised slumps and is classified as Locally Active, unchanged from 2016.

***MU4/2** Locally Active in July 2018*

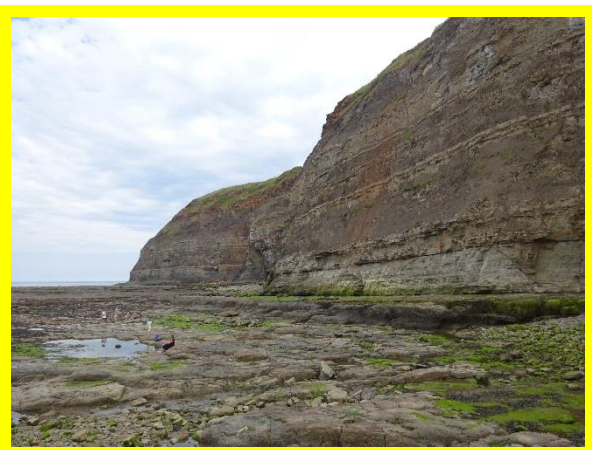
Further east, beyond the extent of Staithes Harbour is unit MU4/3. The cliffs are steep and the unvegetated sandstone is exposed to wave action at the toe. The unit is classified as Locally Active.

***MU4/3** Locally Active in July 2018*

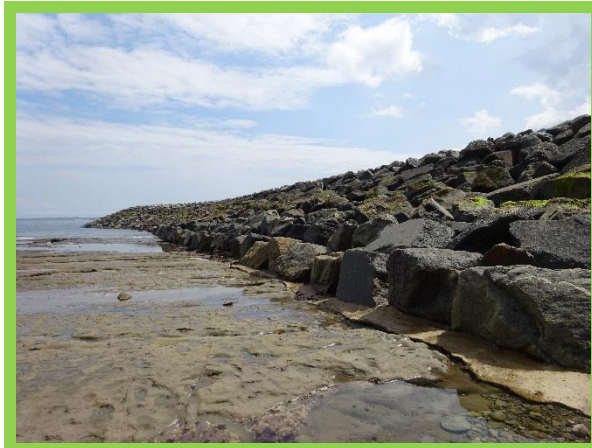
The North Breakwater (0402C01) is in fair condition overall, but certain elements are poor. The rock armour added in 2002 to the seaward face and extending around the seaward end of the breakwater mostly remains in Good condition, tightly packed and maintaining a consistent profile, however two crest blocks are missing (approx. 30m from landward end and approx. 10m from seaward end). There appears to have been some historic movement of rock armour at the eastern extent of the structure where a gap/low spot in the armour at crest level appears to coincide with high block(s) at

Rock armour revetment on seaward face of North Breakwater (/0402C01)

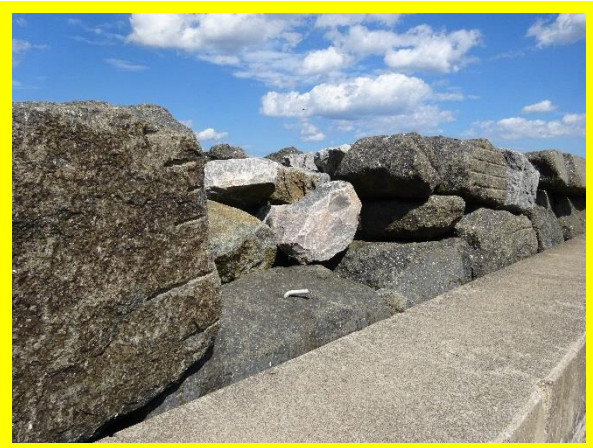
Missing crest block (30m from landward end) (/0402C01)

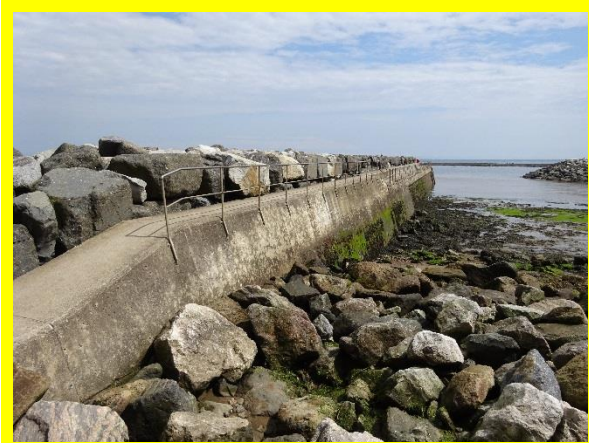
Thirty metres from the landward extent of the structure, the deck splits into two levels, with the lower level having cracking and abrasion in places. There is also abrasion, significant in localised patches, and rust-staining along parts of the inner-facing edge of the North Breakwater's deck and wall. The eastern-most sixty metres, (beyond the first elbow) is more significantly affected.

Inside face of North Breakwater (/0402C01)

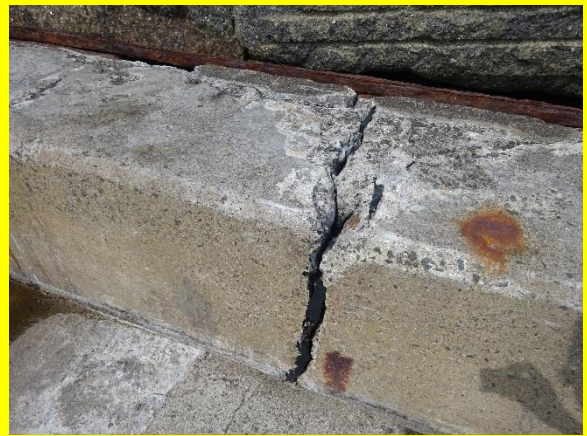
Twenty metres from the eastern end of the breakwater there is a crack which runs the full width of the deck and the full thickness of the crest wall suggesting a previous global movement. The crack has previously been filled with sealant, however this is now largely been washed-out/lost.

Crack in deck and crest wall of North Breakwater (/0402C01)

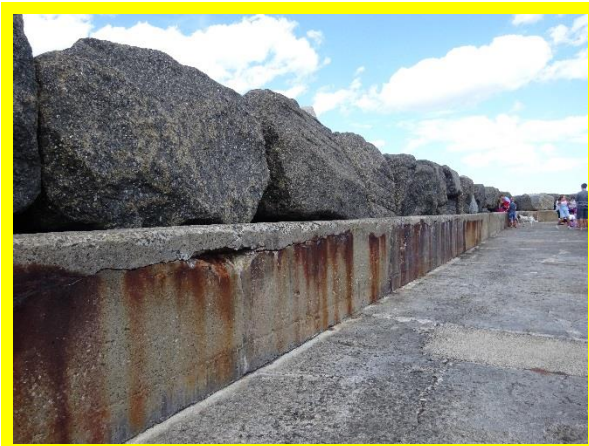
Rust staining and spalling to crest wall (/0402C01)

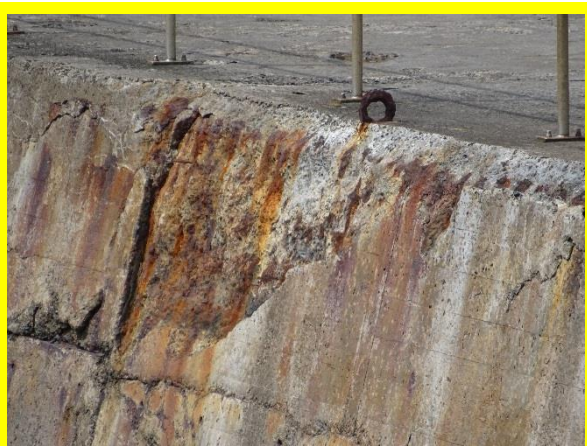
Abrasion and rust-staining on inner-facing edge of North Breakwater (/0402C01)

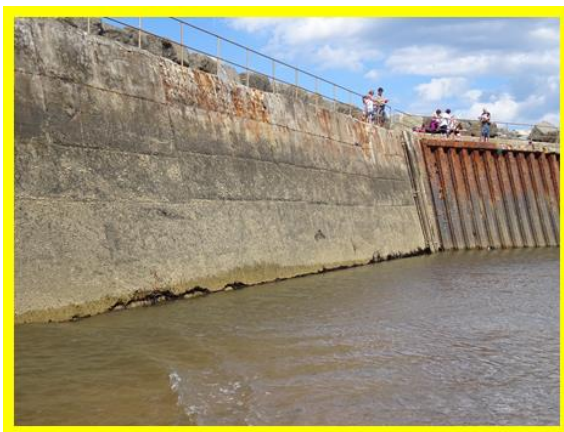
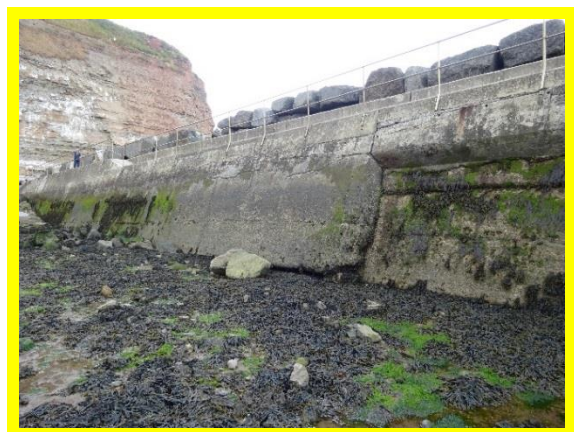
The sheet piling on the inner face of the east end of the breakwater is heavily corroded with significant loss of section in the uppermost 2m. Undercutting to the inner-facing side of the North Breakwater wall was previously reported in 2016 inspection and this was still evident, however even at low tide the toe of the structure remained submerged to prevent detailed inspection. Similar undercutting was also evident towards the landward end of the structure.

Undercutting of the inner-facing wall of North Breakwater. Seaward end (left) and landward end (right) (/0402C01)

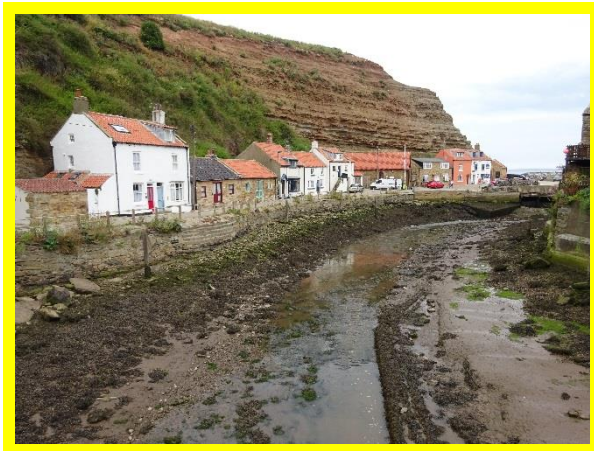
The walls between the RNLI slipway and the footbridge over Staithes Beck (/0402C06) comprise a variety of masonry and concrete blockwork structures and are generally in a fair condition, reduced to poor condition locally with missing mortar, settlement of blockwork and exposure of the toe (previous small boulder sized rock appears to have been largely washed away). The more recently constructed wall immediately in front of the RNLI building is in good condition, but there is a gap in the older stone blockworks wall at its interface with the newer wall which could compromise overall stability if voiding occurs behind. Reported in 2016, the external dimensions of this void do not appear to have increased.

Wall on northern side of beck (missing blocks, open joints and voids) (/0402C06)

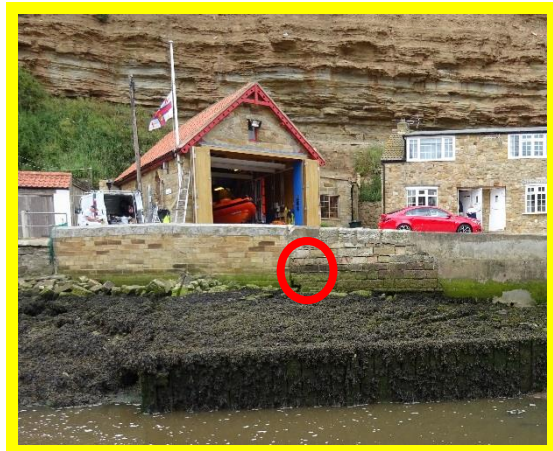
Gap at base of interface between new and older walls in front of RNLI station (/0402C06)

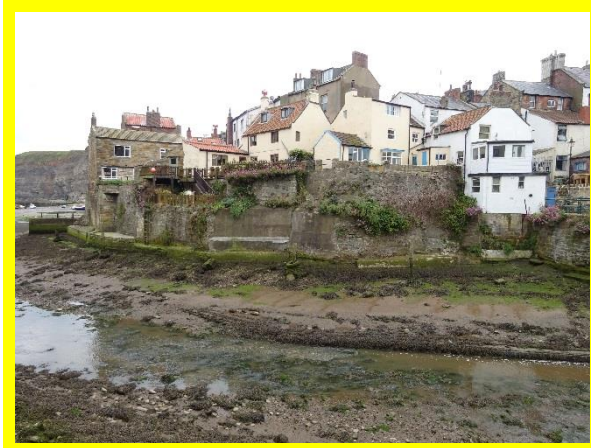
On the south side of the beck a variety of wall details extends from the footbridge over Staithes Beck (/0402C04). There is evidence of previous repairs, with the overall condition of the asset generally fair, locally this reduces to poor, with sections of open joints, loose blockwork, abrasion, cracking and vegetation growth.

Variety of masonry and concrete walls. Vegetation growth locally (/0402C04)

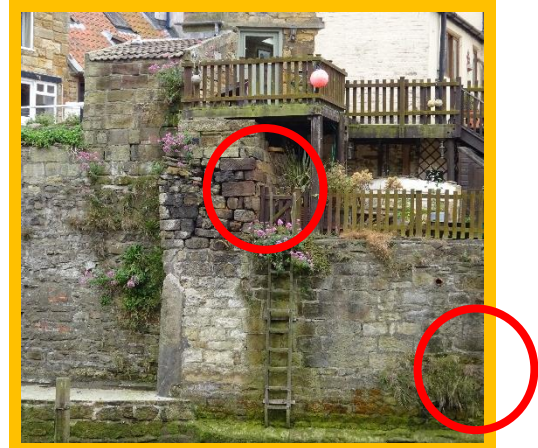
Open joints and loose masonry blocks locally (/0402C04)

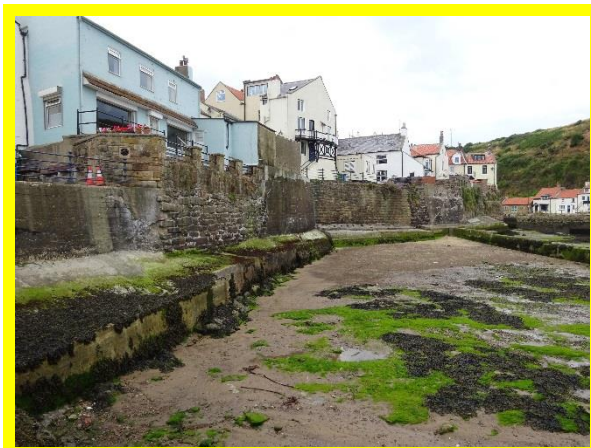
The walls continue as a series of masonry blockwork walls, often exterior walls of private properties (/0402C22), which continue to display visible loss of mortar causing open joints and missing blocks. It is recognised that some previous repairs have been undertaken, but deterioration continues. Although undercutting of the toe has previously been reported in several locations, exposing timber piling, this was not observed during the 2018 inspections.

Cracking and open joints locally (/0402C22)

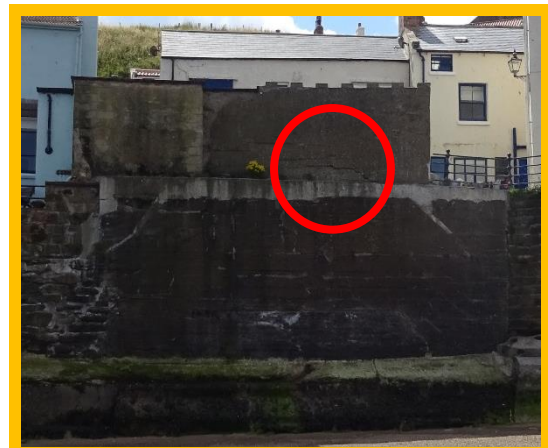
Previous repairs in lower wall. Significant crack at base of upper wall. (/0402C22)

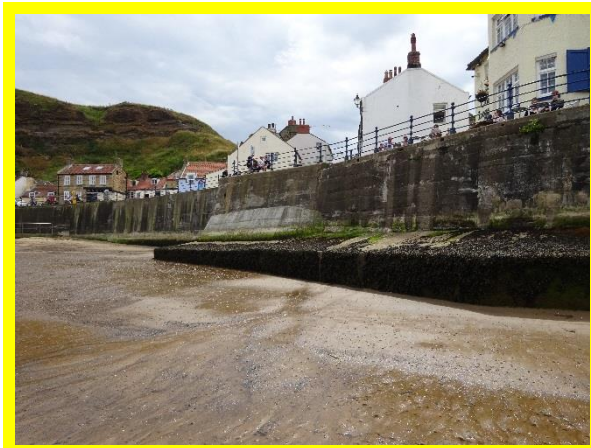
Whilst repairs and improvements have previously been undertaken to the sea wall west of the Cod & Lobster (/0403C05), the wall remains heavily abraded and cracked in places, although in fair overall condition. There is notable cracking and loss of render at the interface between adjacent seawall sections. The concrete groyne (/0403C07) limiting sediment movement within the harbour is in fair condition.

Recent toe berm addition to wall west of Cod & Lobster in Good condition, original wall in Fair condition (/0403C05)

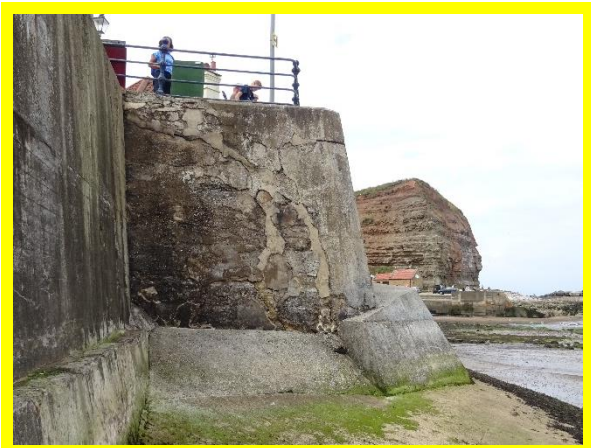
Abrasion and cracking to seawall face and crest at interface between different wall sections (/0403C05)

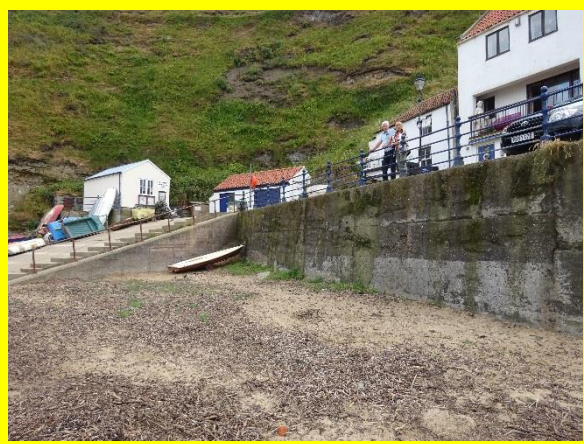
The seawalls extending to the Staithes Harbour Office (/0403C01 and /0403C02) are in fair condition, with previous repairs to cracks holding well. However, there is one full height vertical crack at the interface of adjacent wall sections which needs filling. The slipway and adjacent boat storage area at Staithes Harbour Office remain in good condition.

Full height vertical crack (/0403C01)

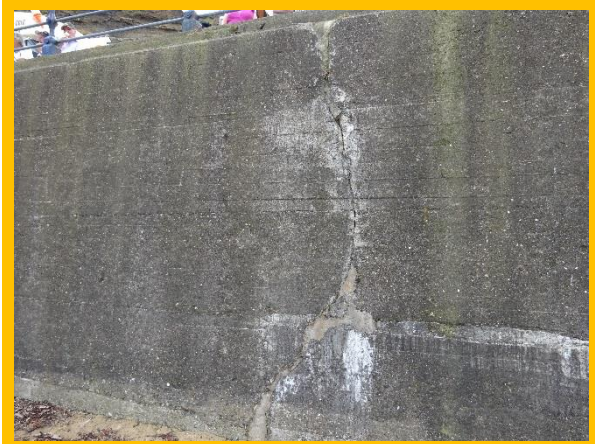
Previous repair to vertical crack washed out (/0403C01)

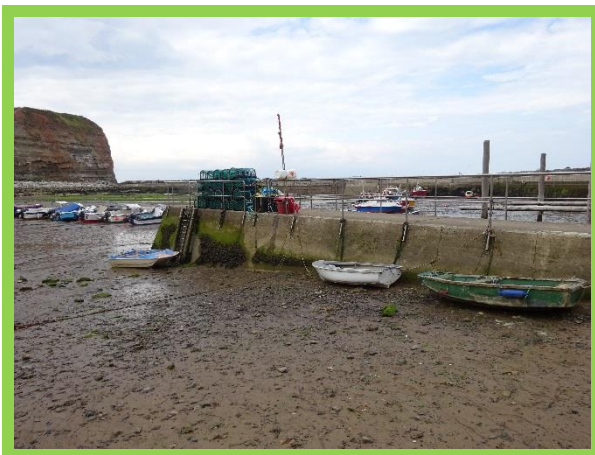
The inner harbour concrete breakwater (/0403C04) remains in good condition. A crack was observed at the crest on the inside/south face. At approximately mid-length, a crack extends the full width of the in-situ deck and aligns with vertical cracks in the walls however these appear to be historic and do not suggest continued global movement/displacement. Steel guardrails appeared to be in good condition.

Inner harbour concrete breakwater (/0403C04)

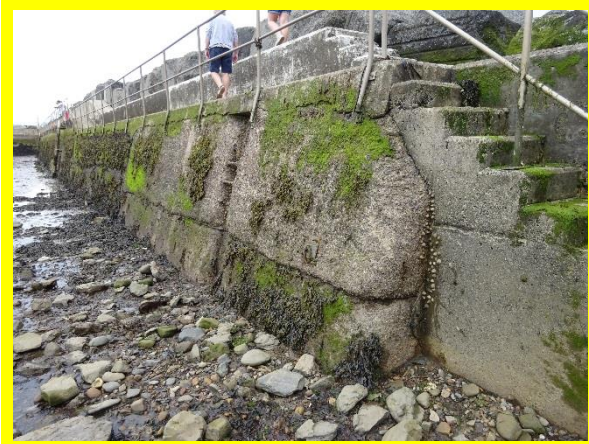
The main South Breakwater of Staithes harbour (/0403C03) is also in good overall condition, although there is minor abrasion and spalling at the access steps and around construction joints and one local area of cracking at the edge of the deck and wall on the lower (inner-most) deck of the structure. This may have been caused by an impact from a vessel (noting local deformation of guardrail tube). Steel guardrails generally appeared to be in good condition.

Local abrasion, cracking and spalling inside face of South Breakwater (/0403C03)

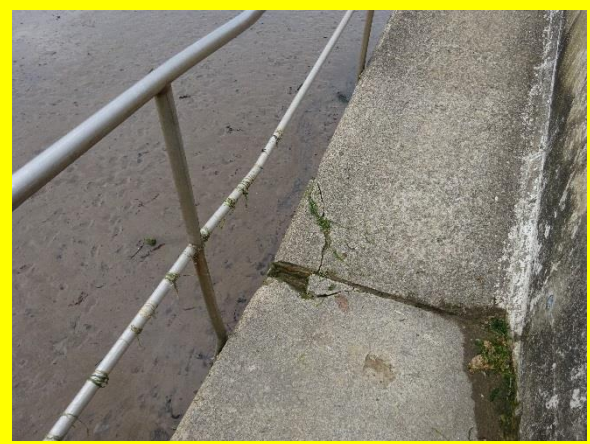
Local damage. Cracking and loose concrete to crest of South Breakwater. (/0403C03)

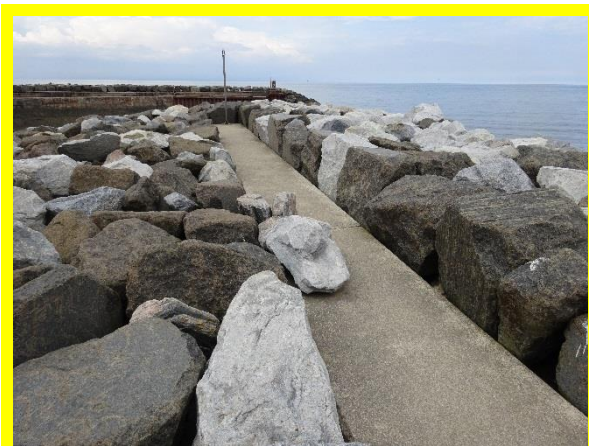
The rock armour revetment appears to be in good condition with generally consistent crest level and slope profiles. Several smaller rock armour pieces appear to have been lifted/displaced and are sitting on top of the larger armour. Four small rock armour pieces were laying on the concrete crest (outer limb of the structure) having been displaced from the rock armour crest. The rock armour fillet between the two breakwaters has several blocks displaced locally and sitting slightly seaward of the majority of the rock but the defence is generally in good condition.

Displaced rock armour on concrete crest (/0403C03)

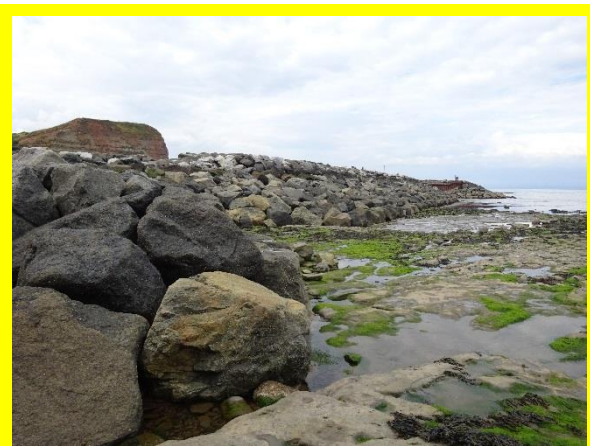
Rock armour on East face of breakwater (/0403C03)

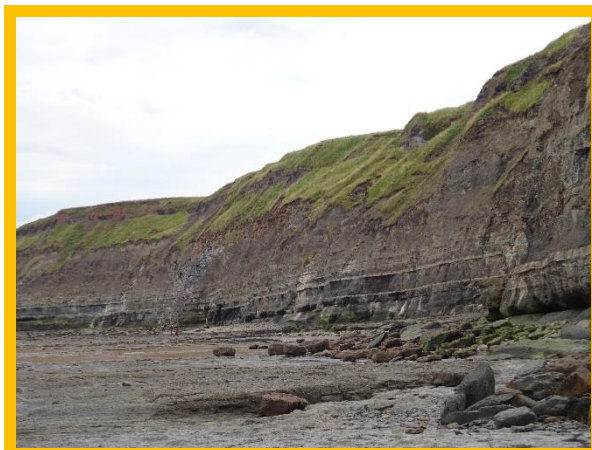
Jet Wyke forms the embayment between Penny Steel and Old Nab and consists of unit MU5/1, which remains classified as Partly Active in 2016. The lower slopes of the cliff are very steep, unvegetated and subject to gradual marine erosion. The upper cliff is composed of softer material and supports some vegetation cover, with evidence of local slumps.

MU5/1 Partly Active in July 2018.

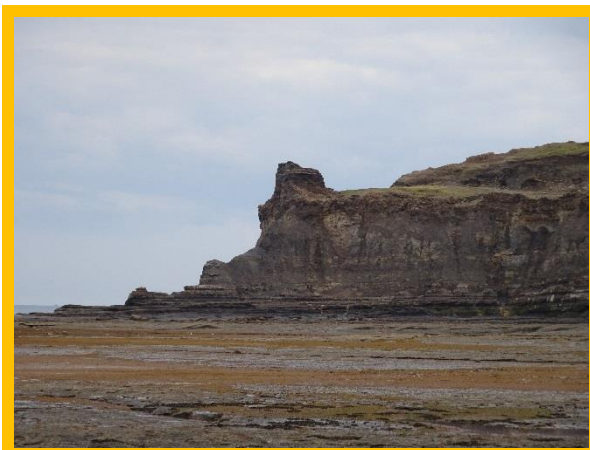
At the eastern extent of the unit is the western side of Old Nab, a headland composed of highly weathered shales. This unit has not changed activity status and remains as Partly Active in 2016.

*Extensively weathered headland at Old Nab
MU5/1 Partly Active in July 2018.*

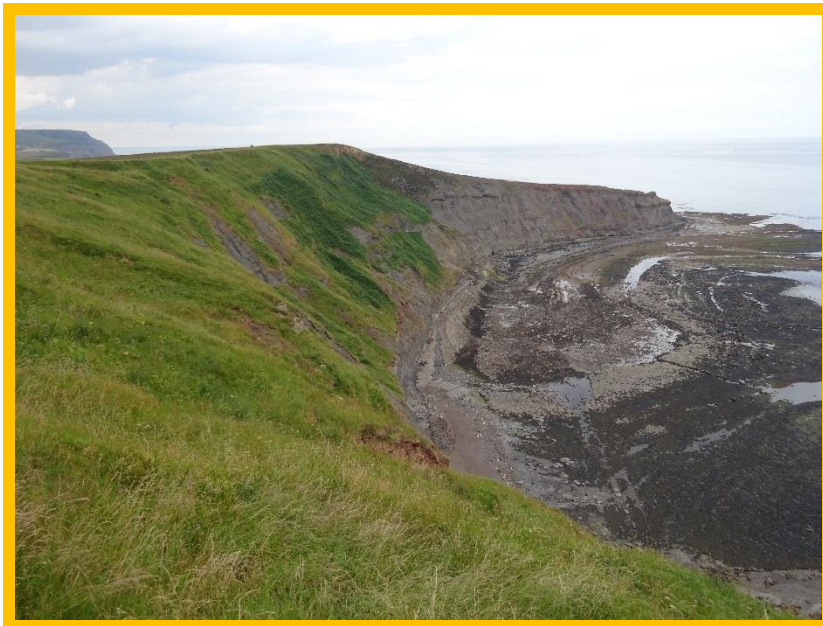
This section of cliff line remains classified as Partly Active in 2018, unchanged since 2012. The northern extent of MU6/1 forms the eastern side of Old Nab, characterised by steep slopes with no vegetation cover. Further south in the bay, some vegetation is supported on the upper slopes with exposed shales lower down showing evidence of on-going erosion. Marine erosion is cutting into the stratified rock at the base of the cliffs.

*Looking northwest across Brackenberry Wyke. **MU6/1** Partly Active in July 2018.*

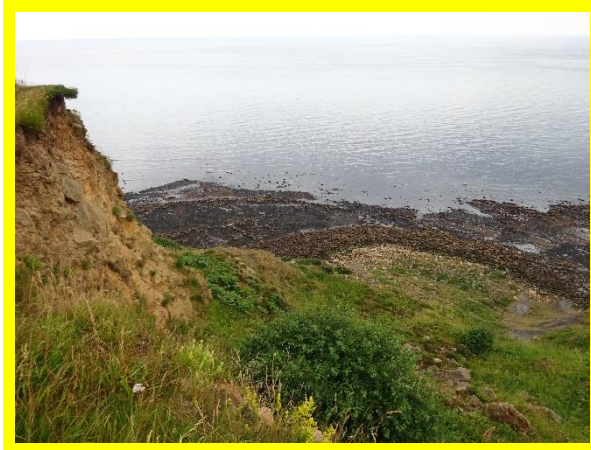
Units MU6/2 (debris lobe), MU6/3 and MU6/4 (coastal slopes) all show evidence of localised instability but also are substantively vegetated and therefore remain classified as Locally Active in 2018.

MU6/2 Locally Active in July 2018.

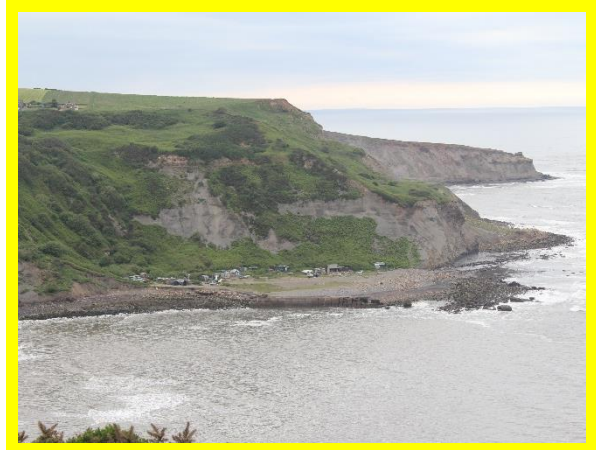
Steepest slopes with no vegetation cover and evidence of minor local activity. **MU6/3** Locally Active in July 2018.

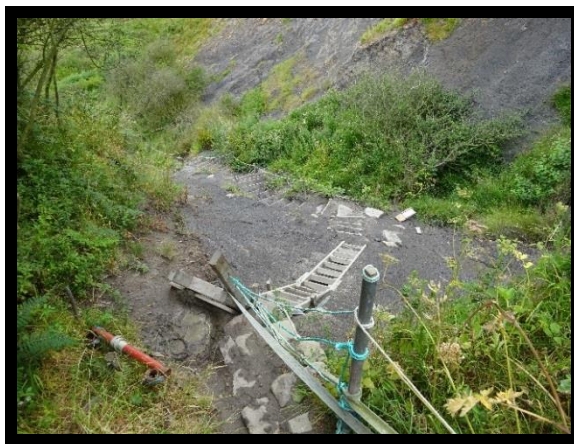
There are “unauthorised” access routes down to the Port Mulgrave foreshore which is still regularly used by anglers. The routes comprise timber steps with timber fence posts and roped handrails. Signposts are present stating;

“Unauthorised” access route to foreshore within MU6/4.

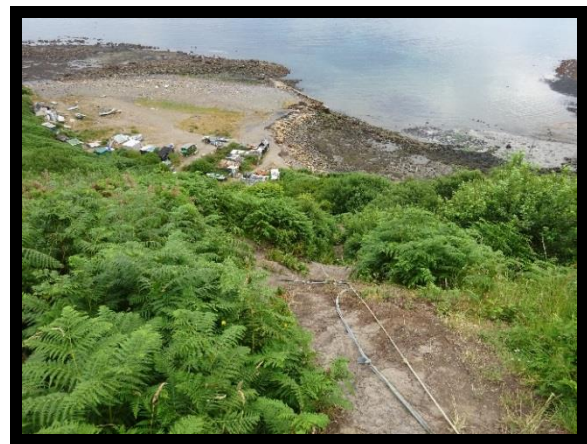
“Unauthorised” access route within MU6/4. Failed jetty structure in background (D0502C01)

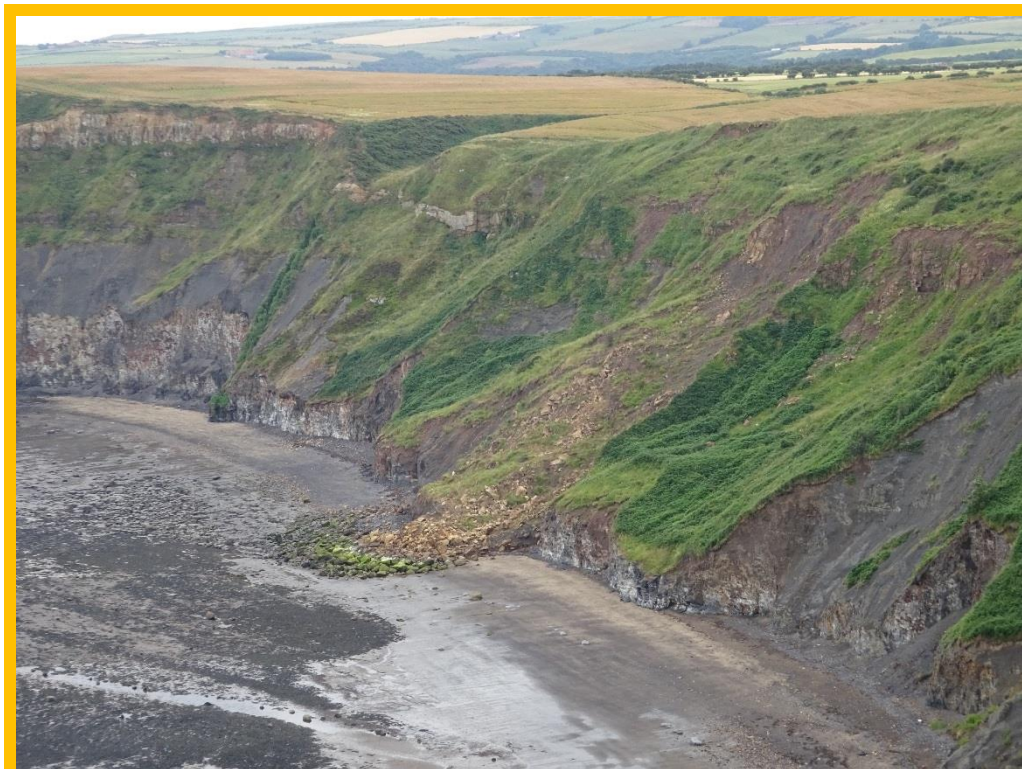
Downgraded to Partly Active in 2018, as there is a lack of evidence of significant continued activity following the large landslide which occurred in 2016 other than a reduction in the size of debris fan and a reprofiling of the toe section of the failure.

MU6/5 – View of the landslide looking across Port Mulgrave from west to east (Partly Active in July 2018).

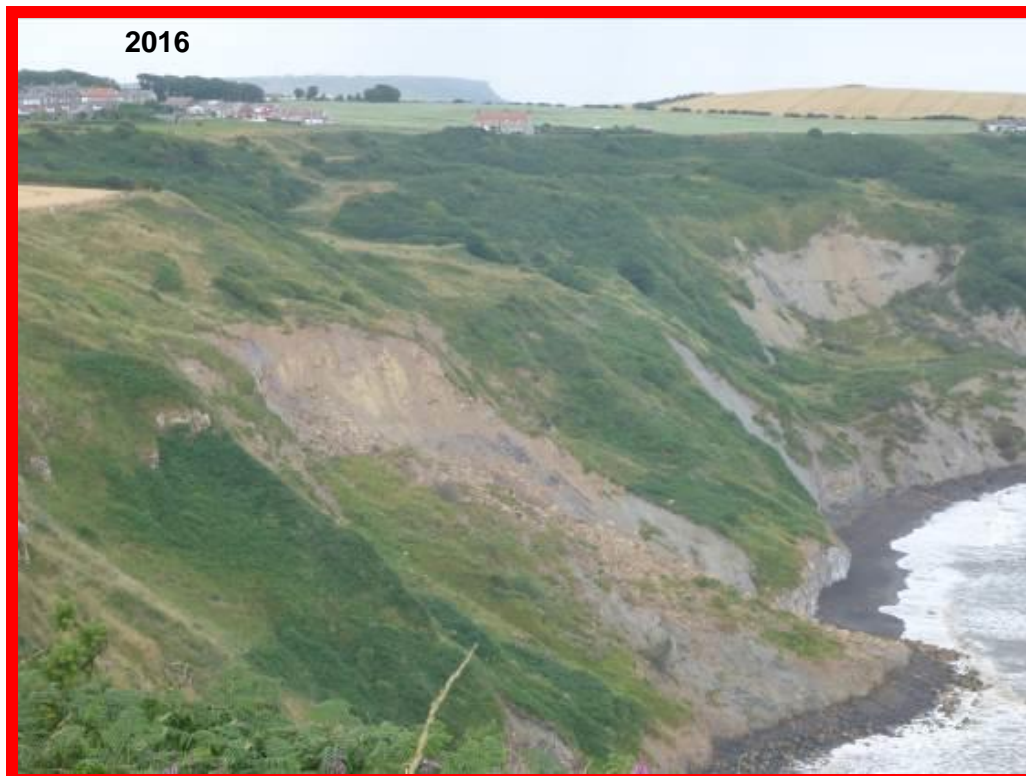
MU6/5 – View of the landslide looking across Port Mulgrave from east to west (*Totally Active in August 2016*)

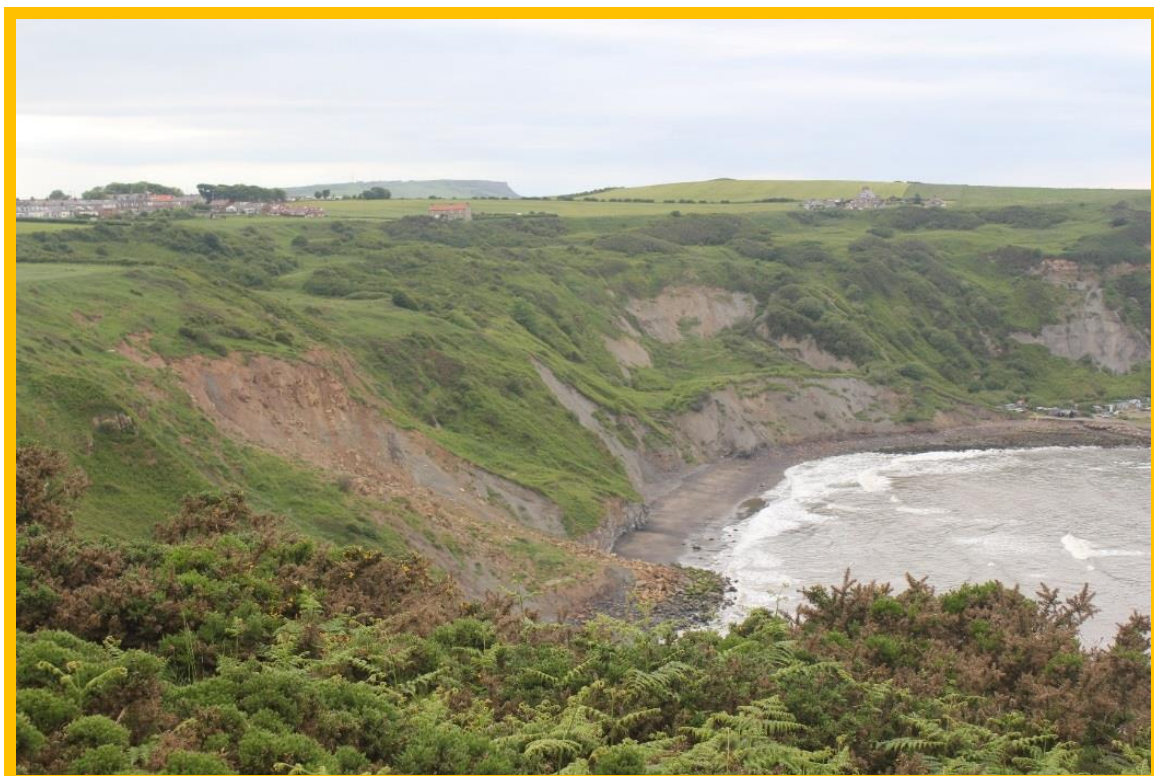
MU6/5 – View of the landslide looking across Port Mulgrave from east to west (*Partly Active in July 2018*).

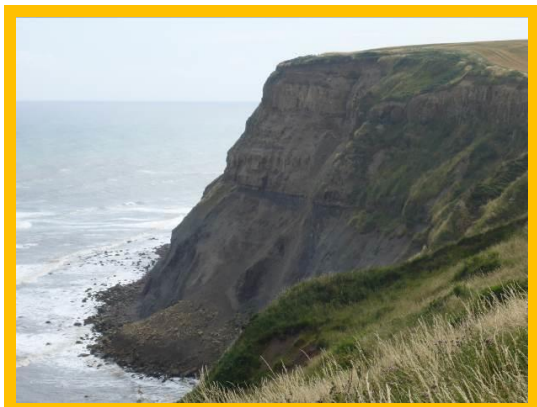
Unit MU6/6 forms the northern part of the Lingrow Cliffs. The upper slopes support some vegetation cover while lower slopes are actively eroding. The unit continues to be classified as Partly Active in 2018 due to evidence of rock falls.

MU6/6 – Debris fan, Partly Active in 2018

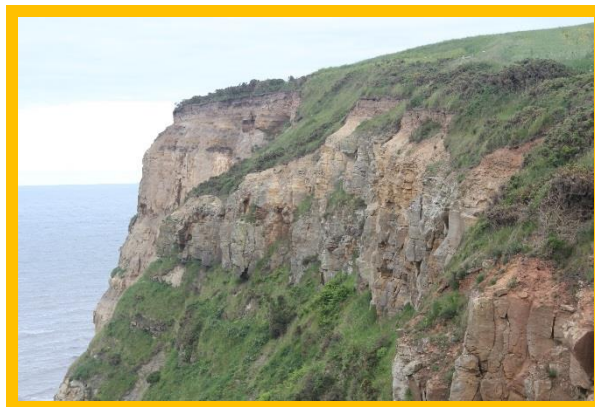
Significant cracking and local rockfalls MU6/6 Partly Active in 2018

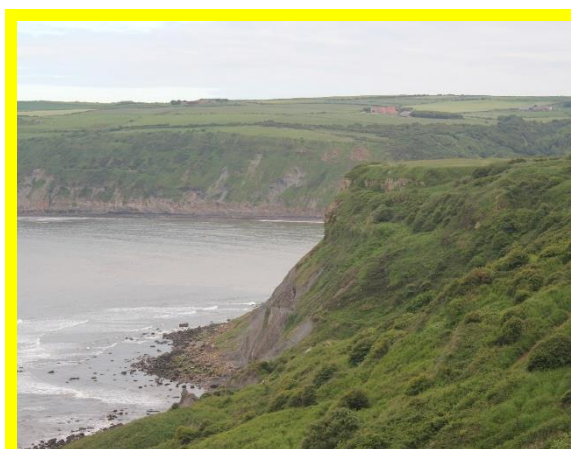
Unit MU6/7 forms the central part of this Sub-management unit and consists of a large relict debris run-out lobe. The cliff is well-vegetated with only localised activity at the toe. It remains classified as Locally Active in 2018, unchanged since 2002.

MU6/7 Locally Active in 2018

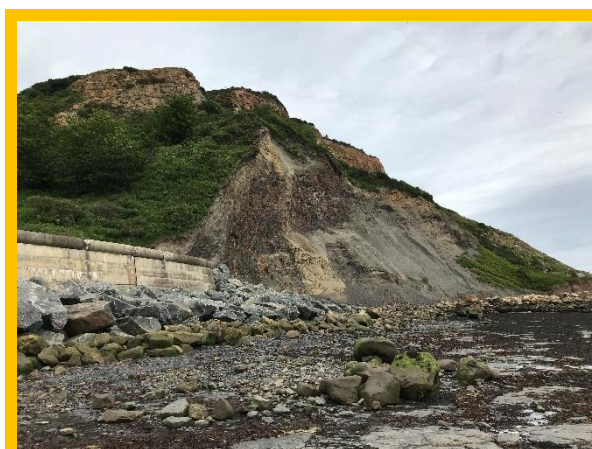
Unit MU6/8 is located north of the northern end of Runswick Bay seawall. The main bulk of the cliff is mudstone capped by sandstone. The main mudstone part of the cliff is vegetated in its upper part and is eroding in its lower part with debris fans splayed across the toe and occasional rock falls at the base. The sandstone top is a vertical unvegetated cliff. The activity in the mudstone cliff means the unit is classified as Partly Active in 2018, the same as 2016.

Debris fans at toe of MU6/8, Partly Active in July 2018

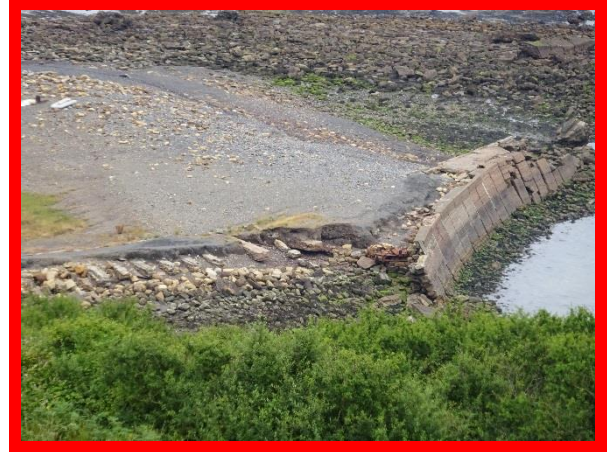
The jetty of the former port and ironstone mine at Port Mulgrave has been derelict for many years and is considered to be redundant. Virtually all coastal defences have been lost to the sea. What is left of the southern breakwater is undergoing large scale cracking, deformation, undercutting and outflanking and failure of more recently added gabions. It is estimated that more than half of its original length has now been eroded. The rate of deterioration appears to have slowed as the remains of the structure appeared very similar to observed in 2016. (0502C01).

Dilapidated asset in 2018 (0502C01)

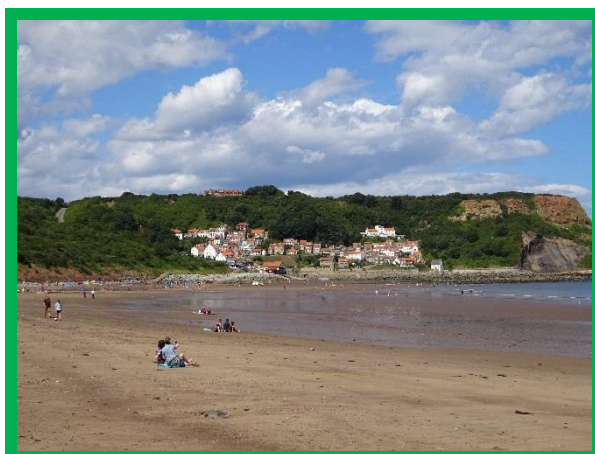
Unit MU7/1 includes Runswick Bay village and the adjacent glacial till slopes. It is well vegetated and defended at the toe by seawalls and rock armour. This unit is classified as Dormant in 2018, unchanged since 2016.

Slopes of Runswick Bay village. MU7/1 Dormant in July 2018

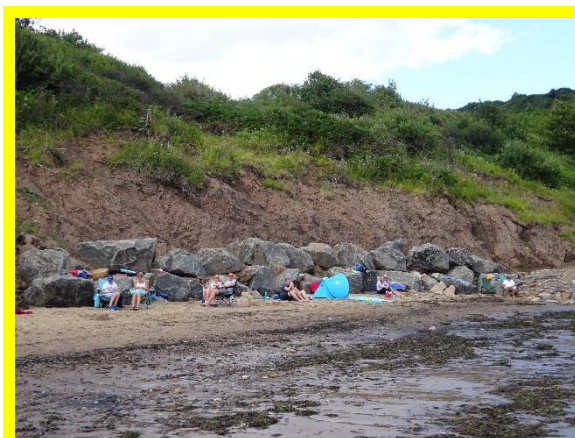
Unit MU7/2 occupies the area adjacent to and south of Runswick Bay village. It is well vegetated glacial till and defended at the toe by rock armour. The southern extent of the existing revetment was strengthened in July 2018 using surplus rock armour from the Coastal Protection works. A rock armour fillet was extended for approx. 30m to the south along the toe of the coastal slopes. There is evidence of minor shallow slumps to the southern extent of Unit MU7/2 and therefore it is classified as Locally Active in 2018, unchanged from 2016.

MU7/2 Locally Active behind new rock armour fillet in July 2018)

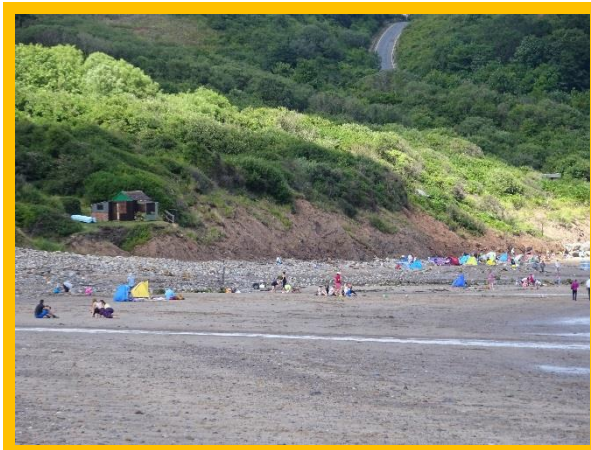
Active toe of till cliffs in Runswick Bay. **MU7/3N**
Partly Active in July 2018.

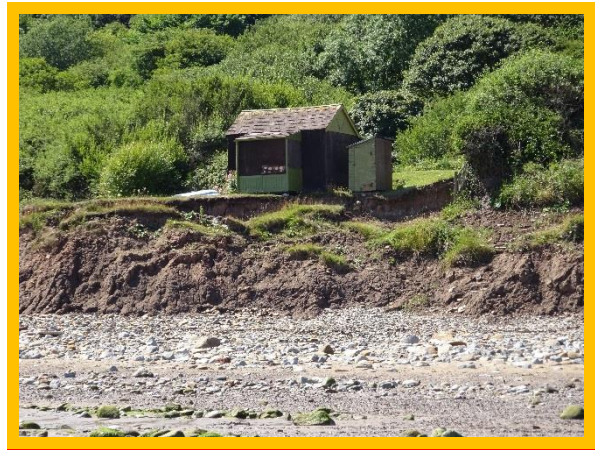
Slips are threatening the stability of timber buildings/sheds (use unknown) **MU7/3N** Partly Active in July 2018.

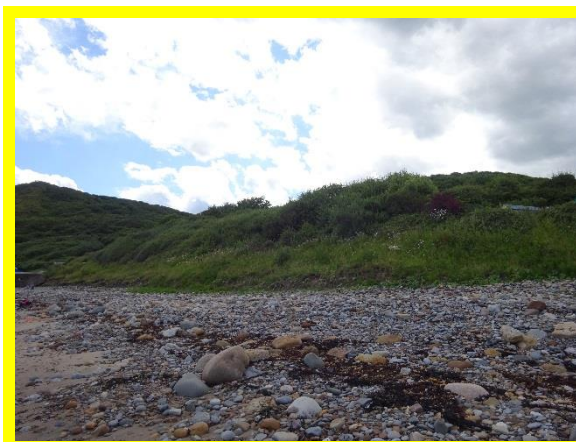
Well vegetated till in Runswick Bay. **MU7/3S**
Locally Active in July 2018.

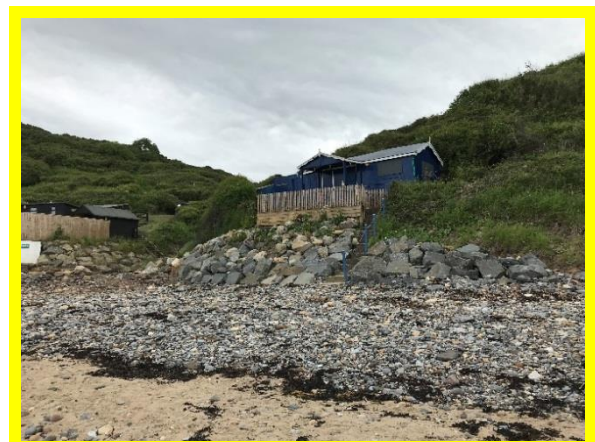
layer of rock armour (<500kg) used to protect slope at mouth of river. Smaller cobbles/beach material also appears to have been used but has been displaced. There is little evidence of significant activity at the toe, and so is classified as Locally Active, the same as 2016.

Rock armour slope protection at southern extent of **MU7/3S**, Locally Active in July 2018.

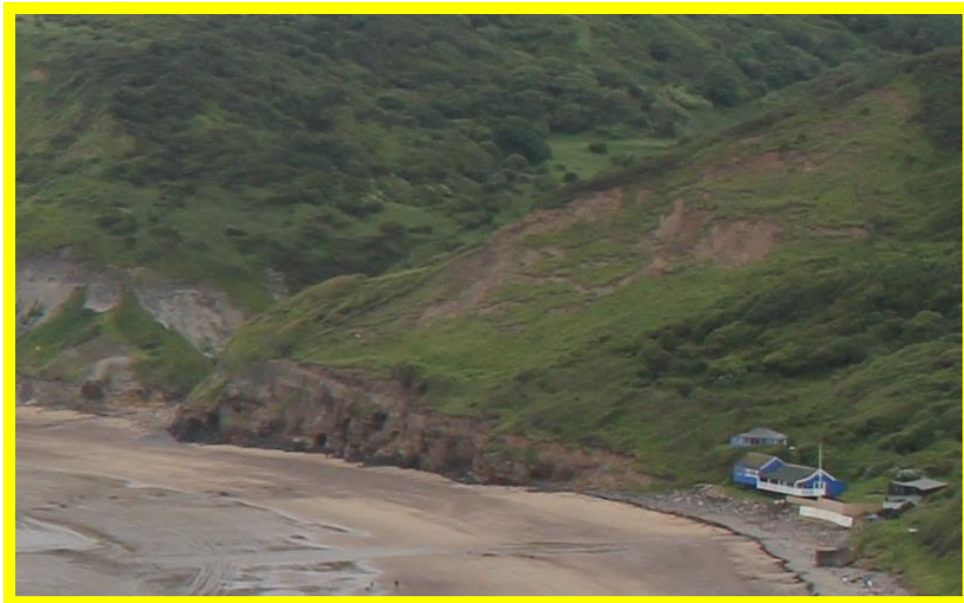
MU7/4 consists of a steep unvegetated cliff toe composed of mudstone behind which are shallower well-vegetated mid to upper slopes of till with local slumping. The cliff toe is generally steep and several small caves are evident but there is little evidence of recent activity, and so the unit is classified as Locally Active, unchanged since 2016

Steep mudstone cliffs with overlying shallower sloping till with local slumps.
MU7/4 Locally Active in July 2018.

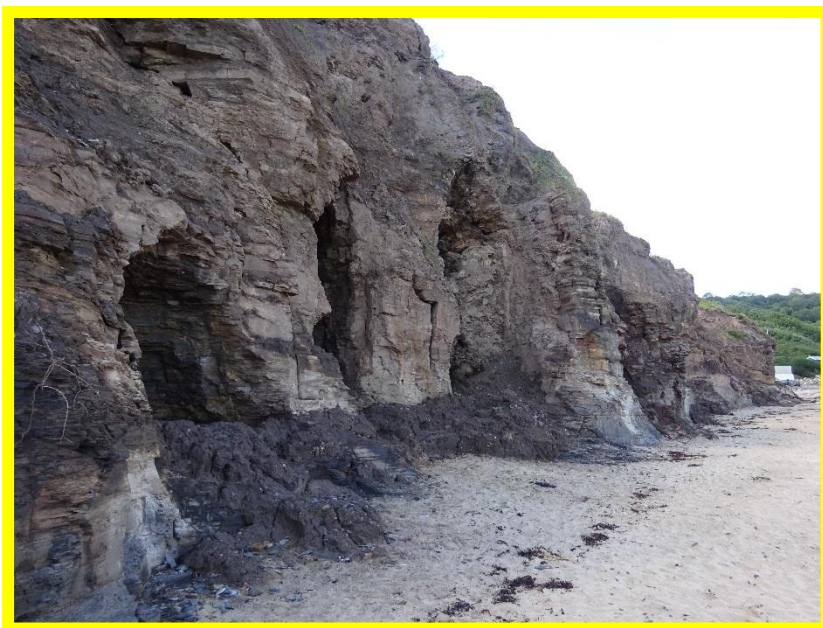
Caves in mudstone cliffs. **MU7/4** Locally Active in July 2018

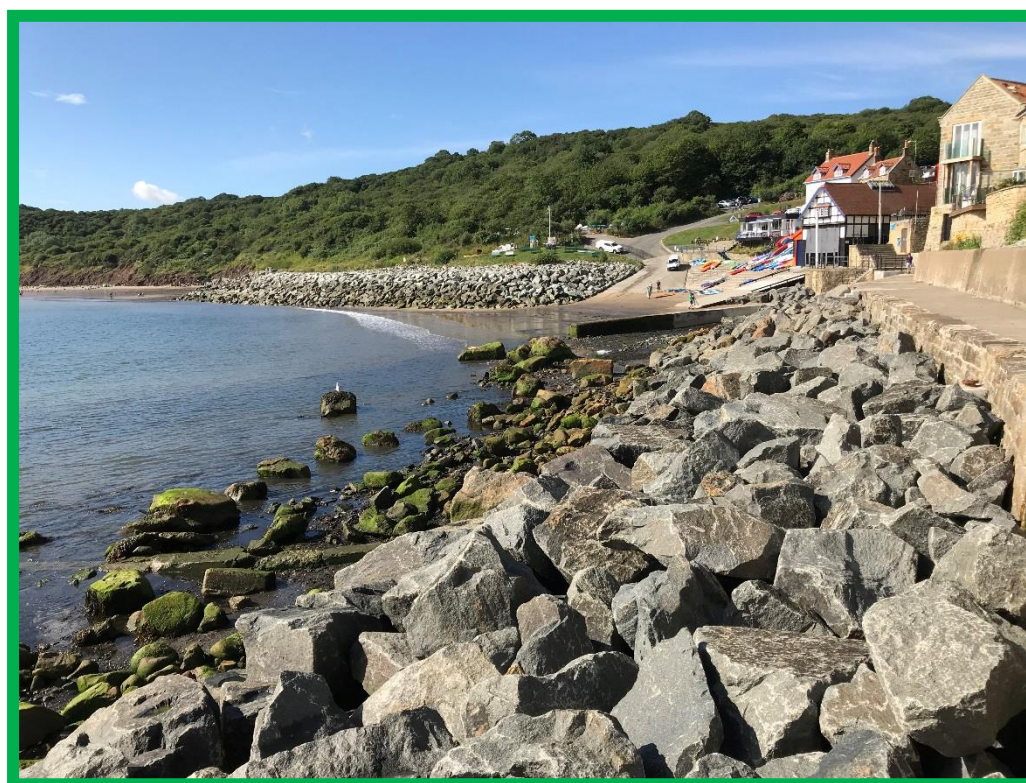
Rock armour fillet at toe of existing seawall

The rock armour revetment is in Very Good condition. The typical detail is a minimum 3.5m wide crest and a 1:3 slope profile to toe rocks which are placed in a trench excavated 0.5m into the bedrock. As the works were completed shortly before the present inspection, the foreshore still showed evidence of recent activity such as plant movement, but this is expected to recover a more natural appearance over time.

The Coastal Protection Scheme comprised installation of concrete toe protection and local repairs to the existing masonry seawalls and prior to the construction of a rock armour fillet at the toe to protect the seawall over approximately 250m length of frontage (from the Yorkshire Water pumping station to approximately 15m North of the Upgarth Hill / Cauldron Cliff seawall with breaks for public access and the Runswick Beck). The scheme incorporated a new set of reinforced concrete access steps through the rock armour.

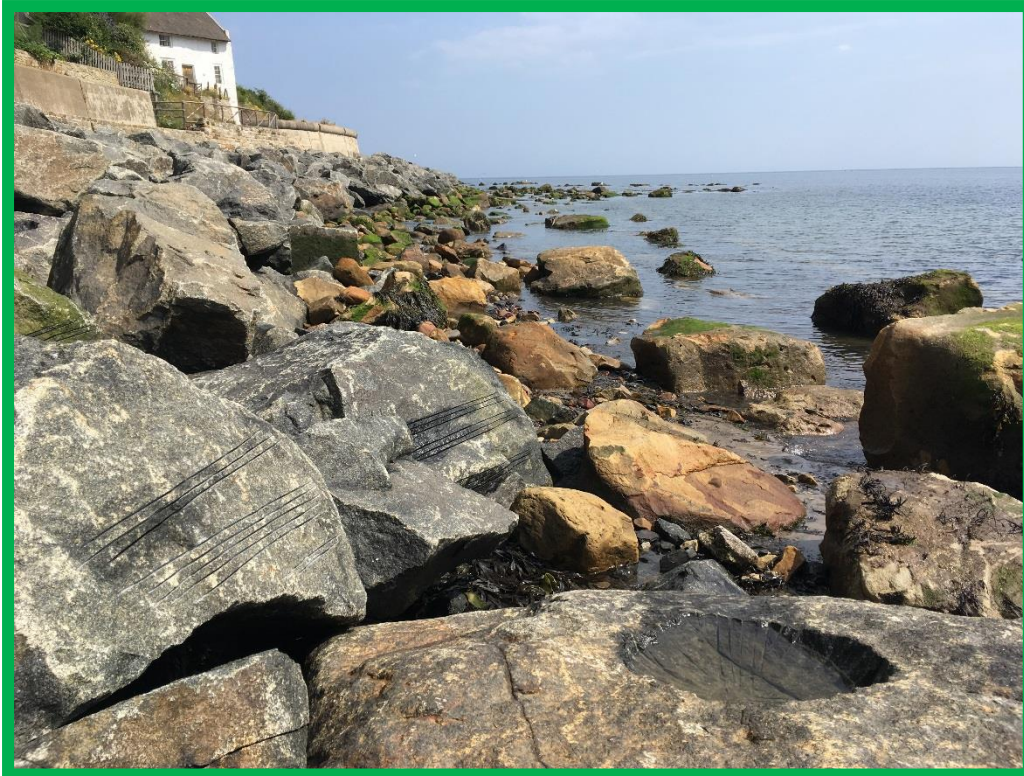
Artificial rock pool, surface scoring and natural seed rocks – ecological enhancement at the toe of the new rock armour fillet.

Existing foreshore rocks were placed against the toe rocks of the new structure to allow seeding of the new rock armour and to encourage fast colonisation of vegetation/fauna. Environmental enhancement was provided through increasing the textural complexity of the granite rock armour blocks by cutting artificial rock pools and grooves into selected rocks to encourage the colonisation and survival of intertidal species.

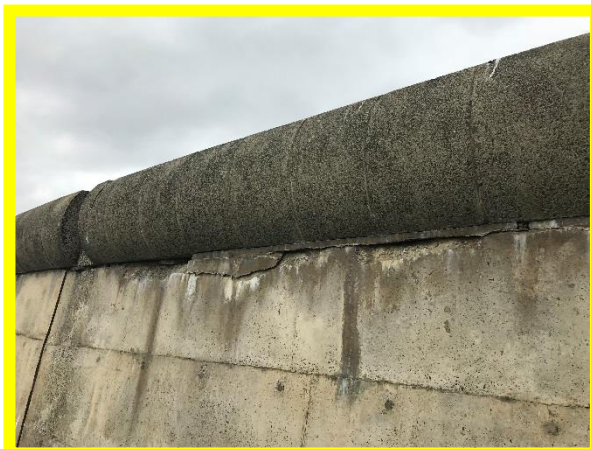
Above the rock armour fillet, the northernmost sea wall (/0601C01) is suffering from heavy surface abrasion on its facing, cracking and spalling to the concrete coping and wash-out of the joints under the coping along most of its length.

Loss / wash-out of mortar beneath coping. Local abrasion (/0601C01)

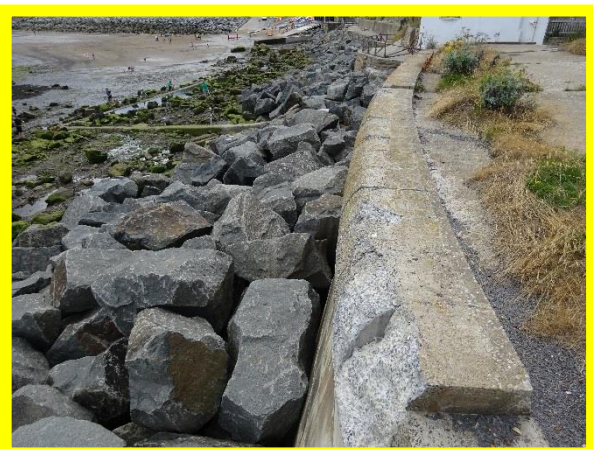
Abrasion and cracking of concrete coping (/0601C01)

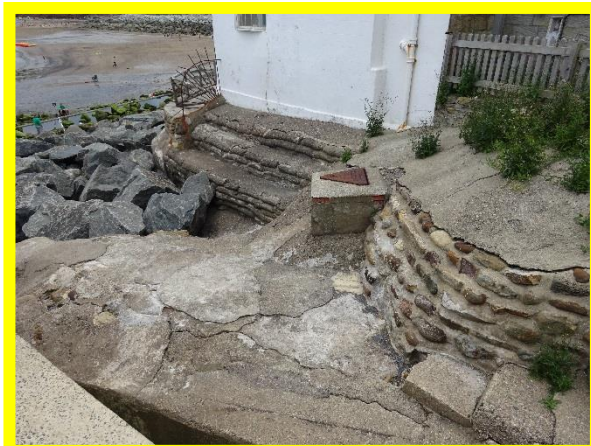
Cracks in the upper masonry seawall were filled and the wall repointed locally with marine mortar. The bagwork and mass concrete structures to the rear of the rock armour and moving up the Runswick Beck are generally in Fair to Poor condition with cracking and open joints. The Thatched Cottage has significant cracks running the full height of the gable end.

Variety of concrete structures/repairs at Runswick Beck (/0601C06)
