Cell 1 Regional Coastal Monitoring Programme Walkover Inspection Surveys 2018

**Scarborough
Borough Council**

October 2018

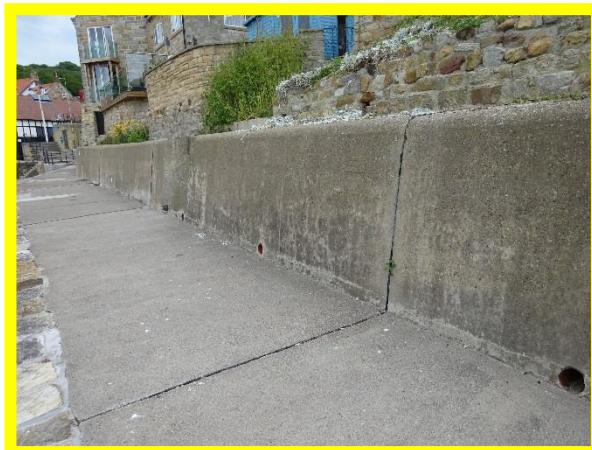
The concrete deck and crest wall are generally in fair condition with evidence of previous repairs locally which are holding up reasonably well. The filler in the expansion joints is brittle and missing in places. The structures at the foot of the slope comprise masonry retaining walls/property walls which vary from Good to Fair condition. Minor cracking, open joints and recessed mortar were observed locally.

Concrete deck and crest wall (retaining wall and property walls) (/0601C03)

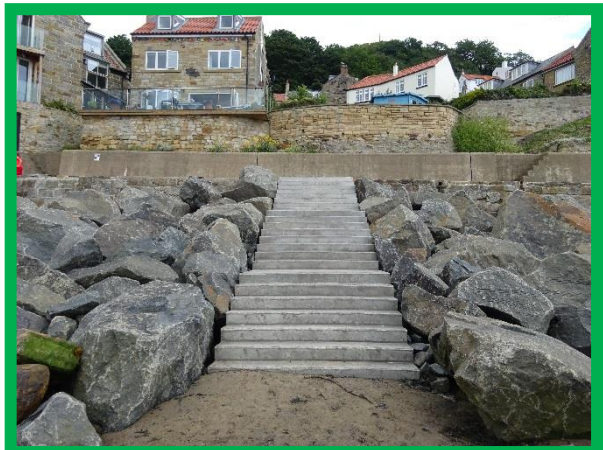
Reinforced Concrete access steps (/060C03)

A set of 2.5m wide reinforced concrete access steps (three flights and two landings) was installed, centred on the location of the previous narrow access steps which were backfilled with mass concrete. SBC were to install handrails to the steps in August 2018. The rock armour detail is modified locally to tie into the steps (higher crest, rocks down profile above step tread level).

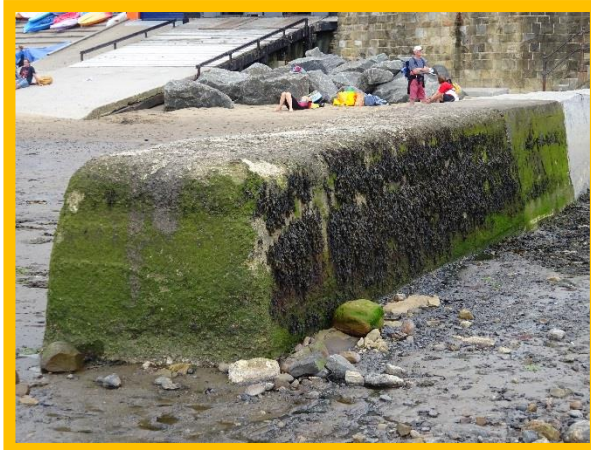
Whilst the new concrete is in Good condition and local repairs/filling of cracks and voids were also carried out in the original concrete at the tie-ins, overall the structure remains in Poor condition due to significant abrasion of concrete, opening of joint between wall and crest concrete and potential undermining of the seaward end beginning to be revealed by low beach levels.

Significant abrasion of concrete. Opening of joint between wall and crest concrete – largely obscured by vegetation (/0601C02)

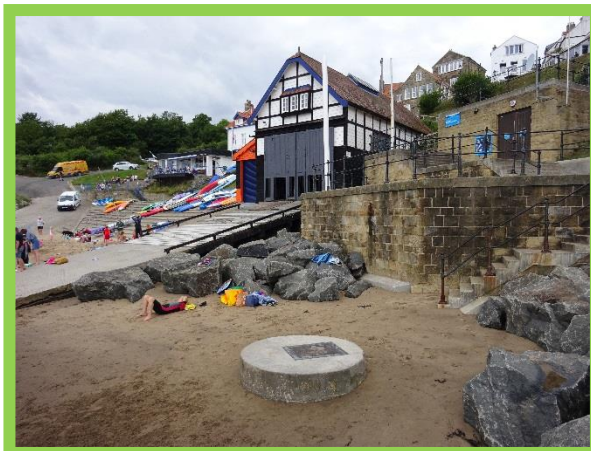
The sea wall around the Yorkshire Water pumping station comprises masonry cladding to a reinforced concrete structure with concrete toe protection and is in Good condition (/0601C07). Immediately to the north of the pumping station, Yorkshire Water raised the existing manhole chamber to match the crest height of the seawall to ensure the chamber was accessible after the construction of the rock armour fillet. The mass concrete surround (to precast concrete manhole rings) is in very good condition as is the new edge protection/handrailing installed at the crest. The rock armour fillet incorporates a break to allow access to the existing steps and then runs to its easternmost extent at which point it ties into the former lifeboat slipway.

Break in rock armour fillet at pumping station (/0601C07)

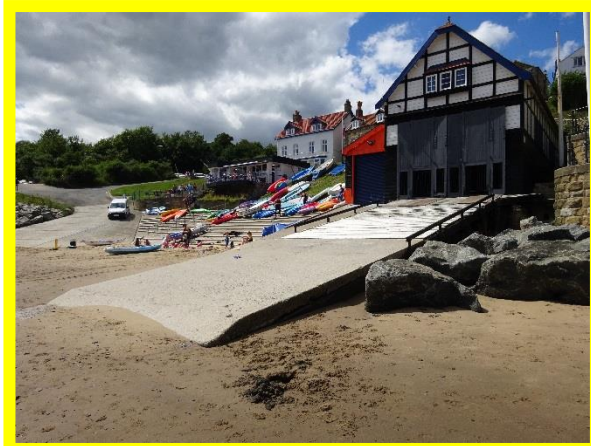
South of the pumping station, the defences comprise the slipway of the former lifeboat station which is generally in Fair presented abraded concrete piers and severely corroded steel edge protection. The timber decking was generally in good condition. The Runswick Rescue slipway features open joints and cracks in the concrete to the exposed face but overall the structure appeared in Fair condition. The concrete forming the boat storage area and the access ramp in front of the café is in Good condition with only minor local defects such as abrasion on exposed edges at construction joints, minor cracking and loose timbers/steps.

Former lifeboat slipway. Low beach levels expose previous repairs/concrete pours at the toe (/1003C04)

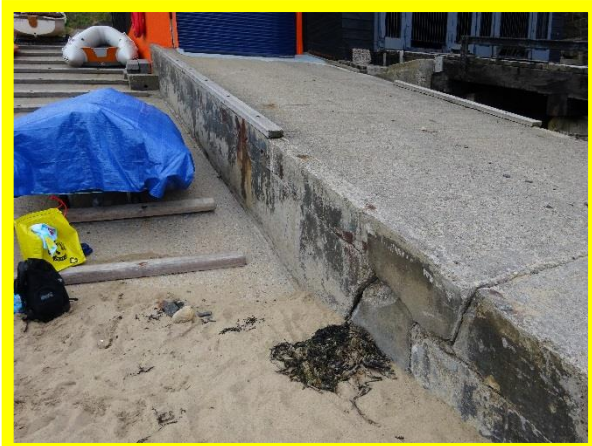
Open joints / cracks in Runswick Rescue slipway (/1003C04)

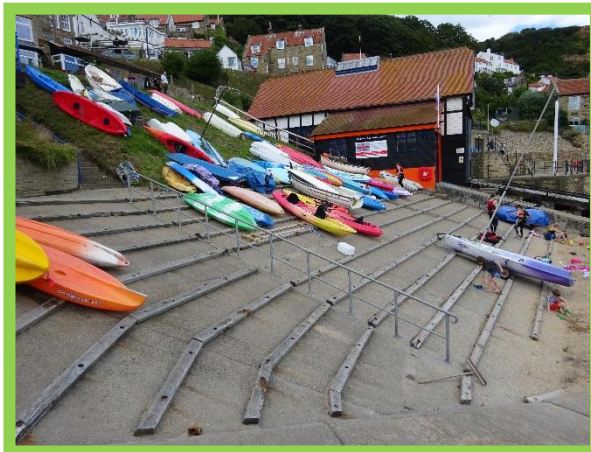
Boat storage area (/1003C04)

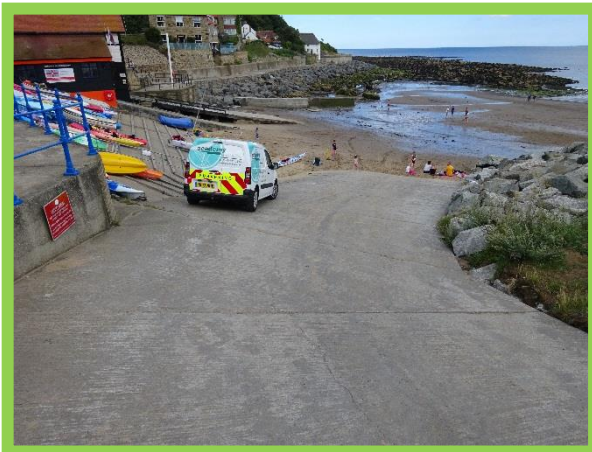
Concrete access ramp (/1003C04)

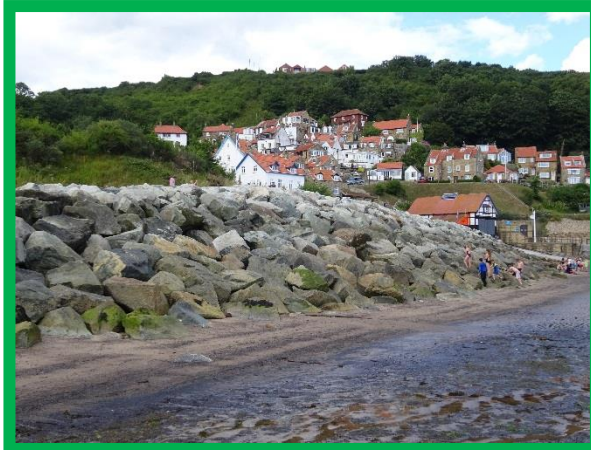
The rock armour revetment (/0602C01) remains generally in Very Good condition, with the rocks tightly packed with no significant voids and consistent crest level and seaward slope profile.

Rock armour revetment (/0602C01)

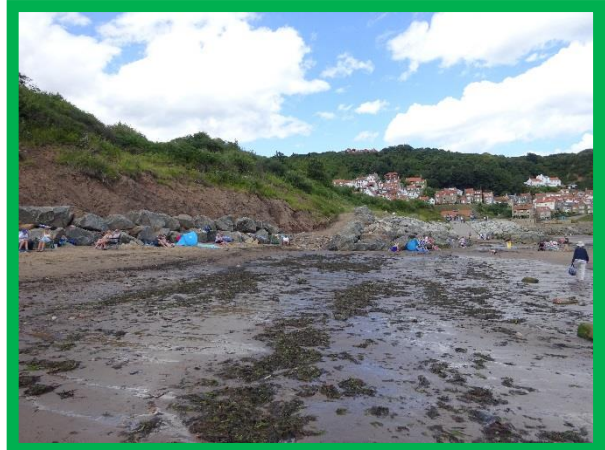
However, there is ongoing erosion of the undefended cliff at the southern end of the defence which should continue to be monitored for signs of outflanking of the revetment.

Active cliffs near southern end of revetment (/0602C01)

The high-level beach access ramp (facilitating access during high tides which cut off the main concrete slipway) was refurbished in July 2018. Surplus rock armour from the CPS works was placed along the seaward edge of the ramp and forming a fillet at the toe of the previously undefended cliffs to the south over a length of approximately 30m with the aim of mitigating the risk of outflanking.

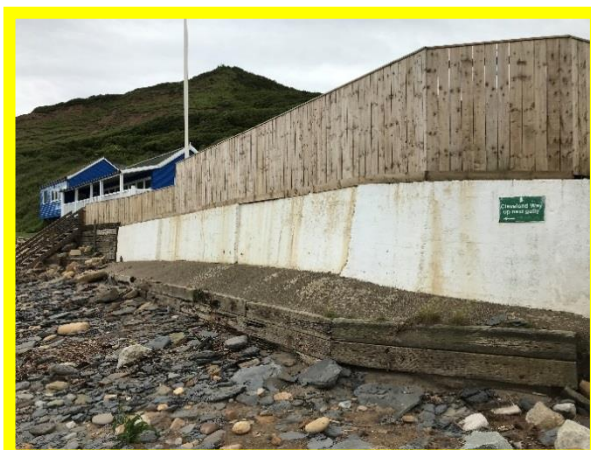
A number of boulders and concrete blocks are present in front of a timber sleeper retaining wall defences. This defence, and the backing white-washed concrete wall to the north, are both in fair condition.

Lower beach levels than the 2016 inspection expose more of the retaining wall structure. Timber sleepers are exposed and damaged locally, however the concrete behind appears in fair condition. (appears to be permanent formwork for in situ concrete pour).

The southern extent of the asset comprises concrete cubes/tank blocks and rock armour. This is not of formal construction detail, however appears to be offering some protection to the slope and building behind.

Sailing Club defences (/0602C05)

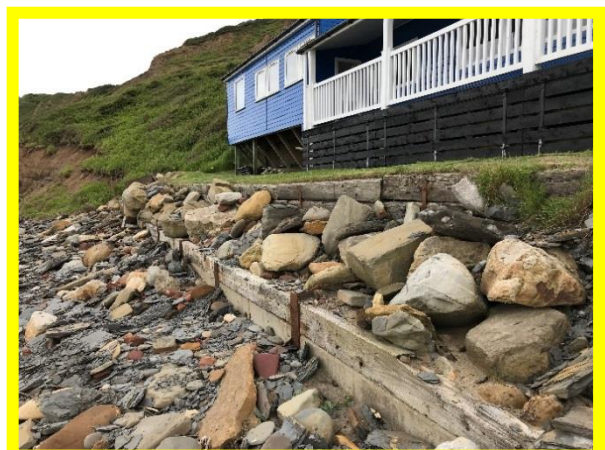
Sailing Club defences (/0602C05)

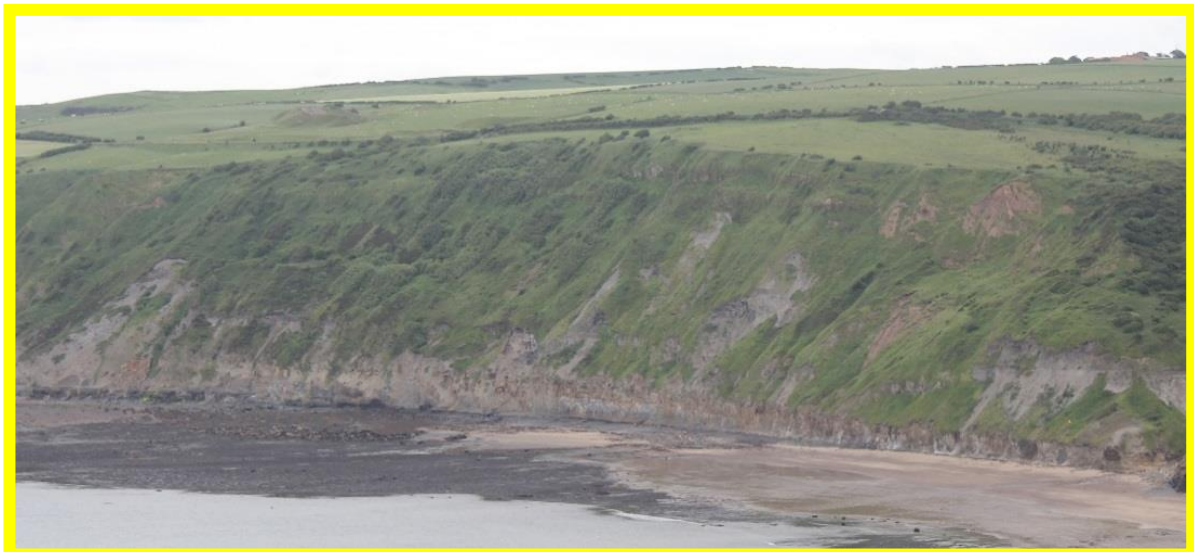
*Steep mudstone cliffs with overlying shallower sloping till with local slumps. **MU8/1** Locally Active in July 2018.*

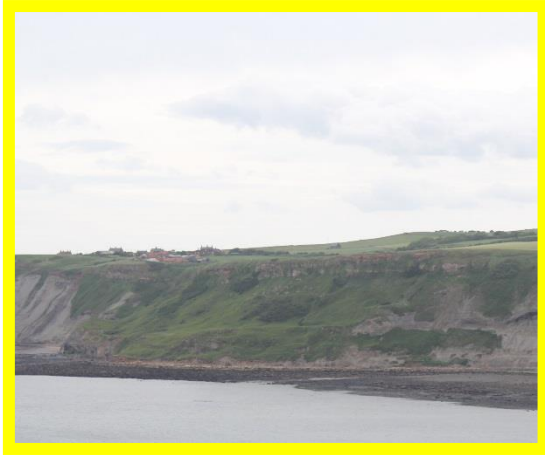
Relict debris run-out lobe. **MU8/2** Locally Active in July 2018.

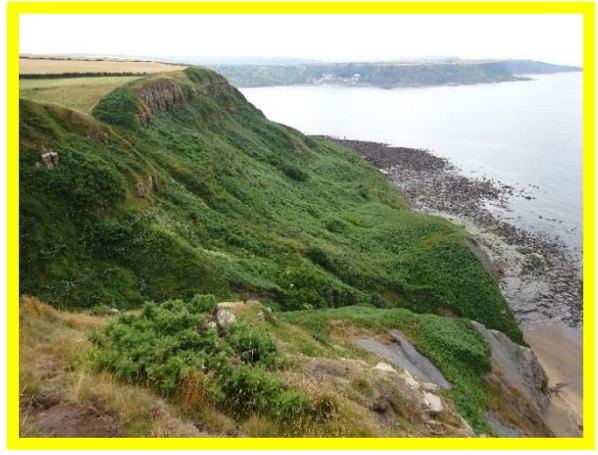
Relict debris run-out lobe. **MU8/2** Locally Active in July 2018.

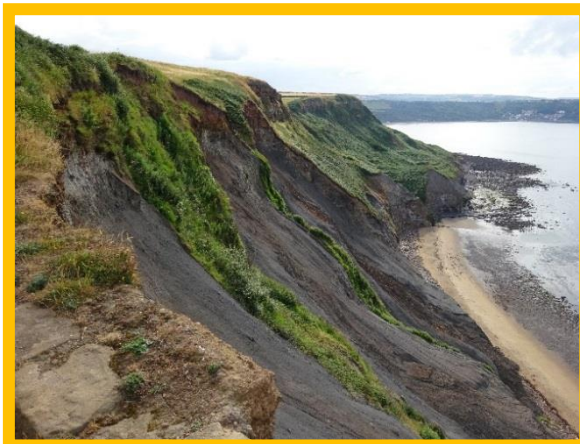
MU8/3 is located in front of the village of Kettleness. The cliff is high and steep with only the very top part covered in vegetation. The cliff slope comprises large debris flows, which extend as fans from near the cliff top to the toe, and slumps. This level of activity means this unit is classified as Partly Active, the same as 2016.

Steep cliff with debris flows. **MU8/3** Partly Active in July 2018

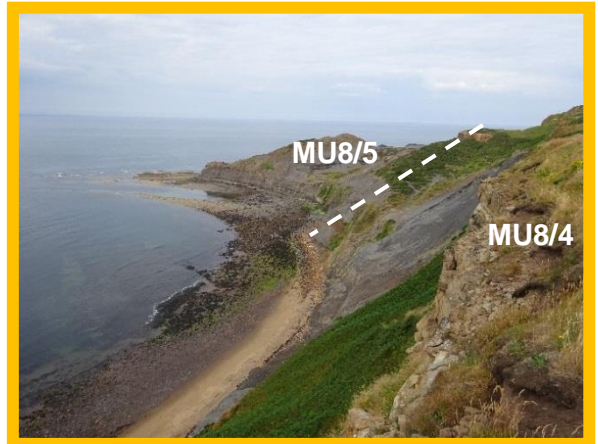
MU8/4 is immediately west of Kettle Ness headland. This unit is classified as Partly Active in 2016, unchanged since 2014.

MU8/4 (foreground) and west side of **MU8/5** (background) (both Partly Active in July 2018)

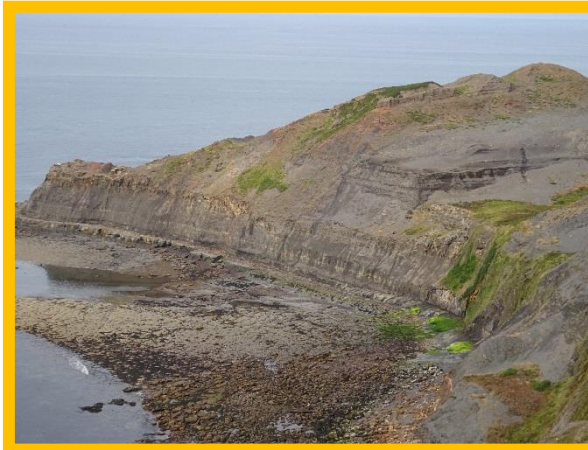
Unit MU8/5 forms the headland of Kettle Ness. This area has historically been extensively quarried for alum and as a result is now subject to ongoing erosion of the exposed weak bedrock. It remains classified as Partly Active in 2018, unchanged since 2016.

West side of Kettleness headland. MU8/5 Partly Active in July 2018

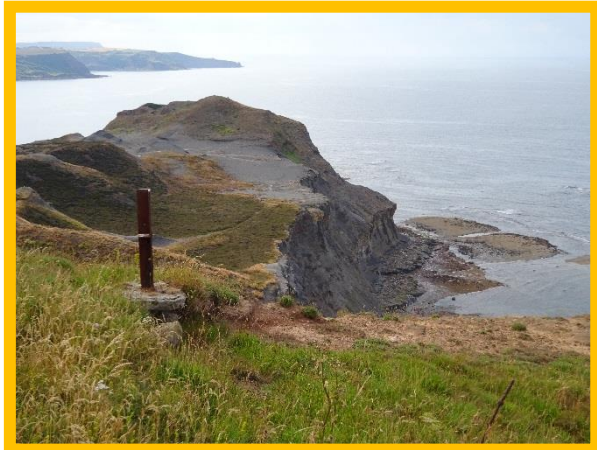
East side of Kettleness headland. MU8/5 Partly Active in July 2018

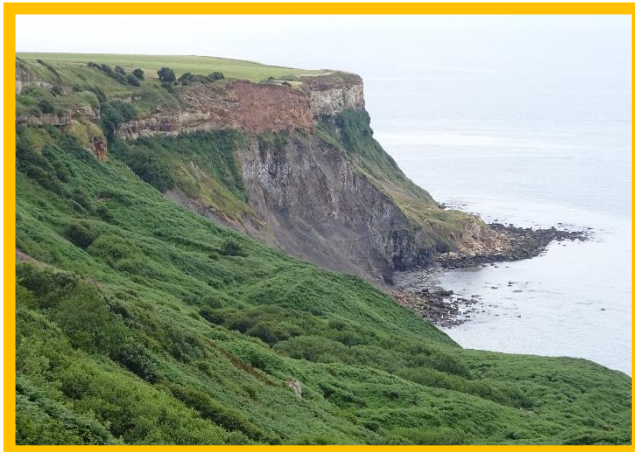
Unit MU8/6 is located to the east of the Kettle Ness headland and remains classified as Partly Active in 2018. Along most of its length this unit is steep with little vegetation cover. Evidence of recent erosion/slips in the headscarp.

MU8/6 Partly Active in July 2018.

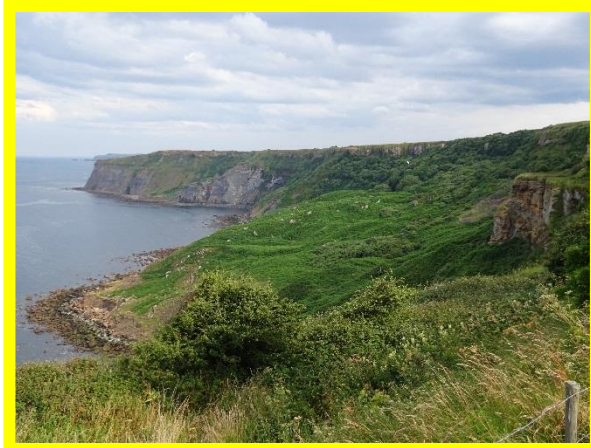
Units MU8/7 and MU8/8 comprise the relict debris run out lobes of Seaveybog Hill and Ovalgate Cliff. They are generally well-vegetated, but localised activity at the toe and headscarp mean the units are classified as Locally Active in 2018.

MU8/8 (foreground) Locally Active in July 2018

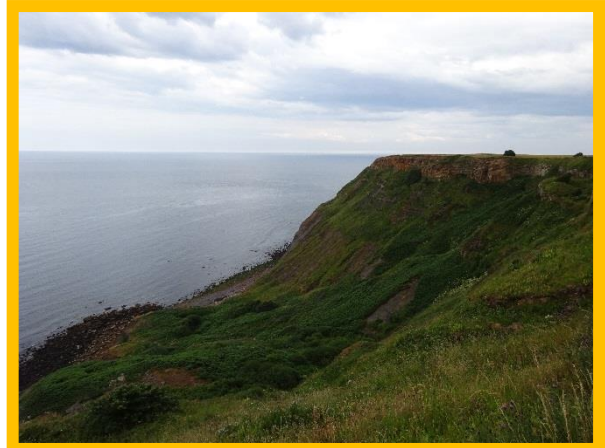
Unit MU8/9 is located at Loop Wyke and is classified as Partly Active in 2018. The upper slopes support some vegetation cover, but the lower slopes are steeper, free of vegetation and subject to on-going toe erosion the headscarp comprises exposed rock which is steep and heavily weathered.

MU8/9 Partly Active in July 2018

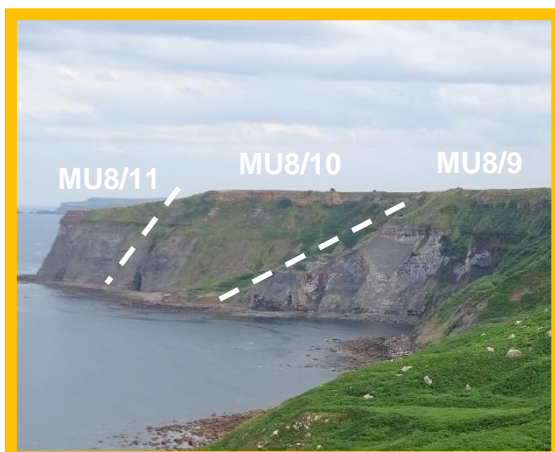
Unit MU8/10 forms a relict debris slide lobe. The unit is well-vegetated with localised erosion at the headscarp and the toe. This unit is classified as Locally Active in 2018.

MU8/9 and **MU8/11** are Partly Active sea cliffs. **MU8/10** is a debris slide deposit classified as Partly Active in July 2018.

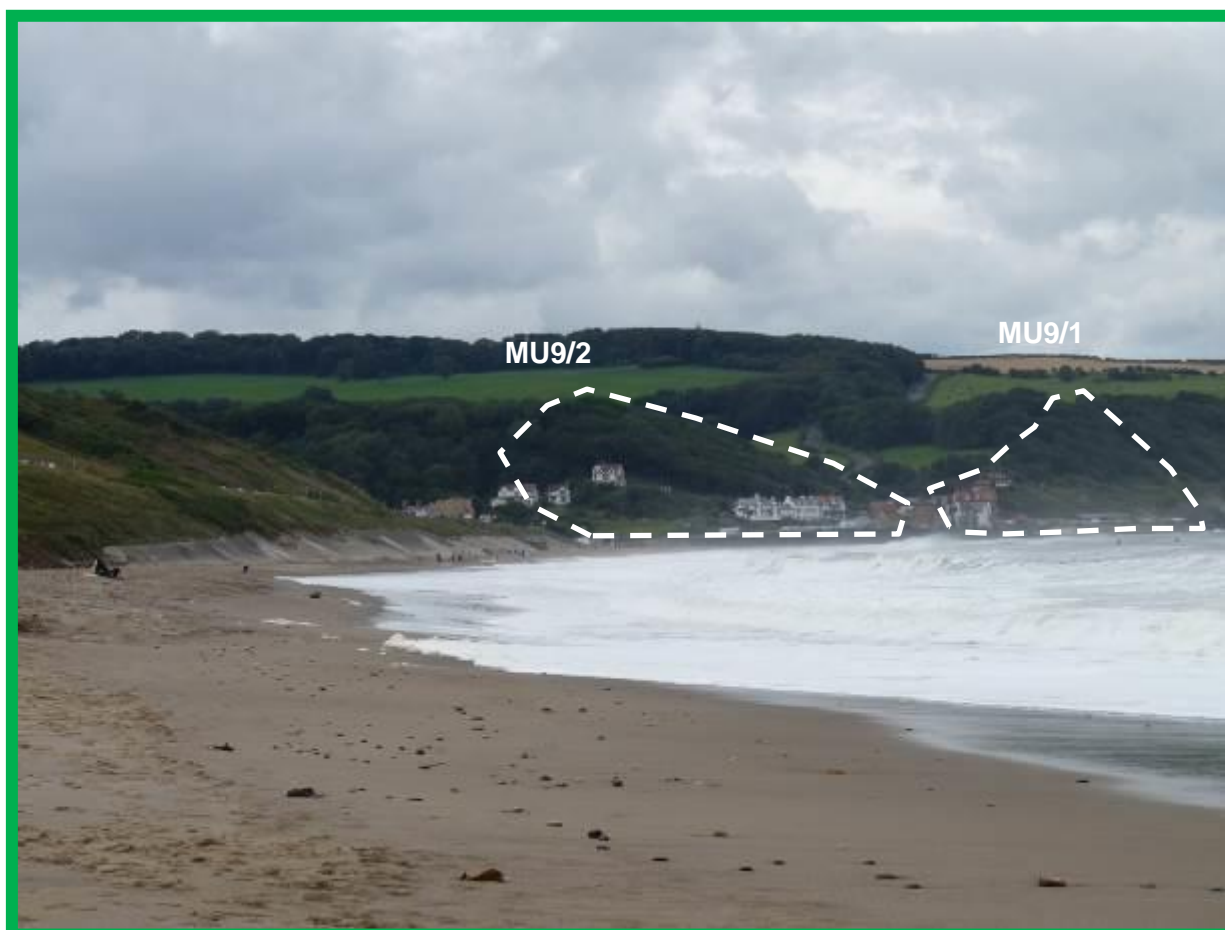
Management units MU9/1 and MU9/2 are Dormant cliffs behind Sandsend village. They are defended at the toe by a sea wall, groynes and rock armour. No evidence of activity was seen in 2016.

MU9/1 and MU9/2 are located close to Sandsend and show no signs of activity (Dormant).
(Figure reproduced from August 2014)

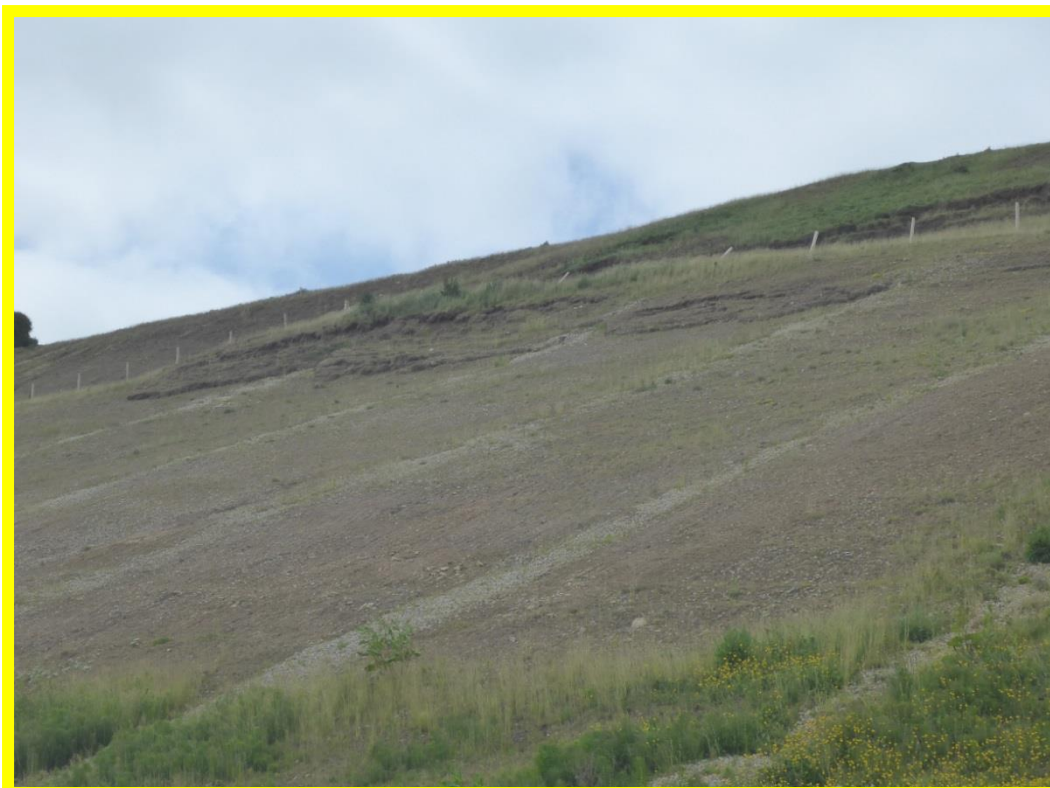
MU9/3 One area of locally active cliffs in the recently stabilized area. This shallow slip is to be remediated imminently.

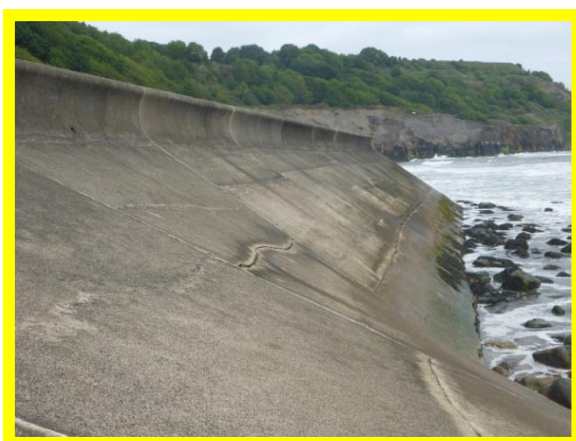
The most northerly defence is located at Sandsend car park. It is a sloping concrete revetment with a recurve crest wall (D0701C02). The concrete wall remains in fair condition with minimal damage to the surface, however the revetment has lost thickness of concrete at the base through abrasion, with exposure of reinforcement bars. Encasement of this reinforcement is advised from a structural perspective, as well as preventing any Health & Safety incidents occurring due to sharp edges of the exposed bars on this popular amenity beach. At the northern end of the structure is a tie-in section, comprised of steel sheet piling which is heavily corroded. At the southern end is a slipway adjacent to Sandsend Beck. The slipway is undermined in places, despite previous repairs at this location.

Sendsend car park sea wall (D0701C02)

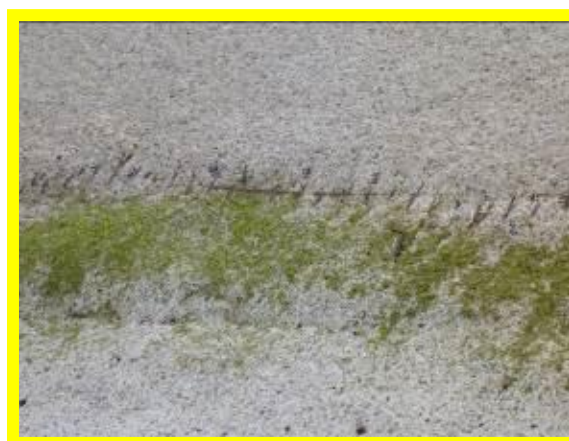
Exposed rebar (D0701C02)

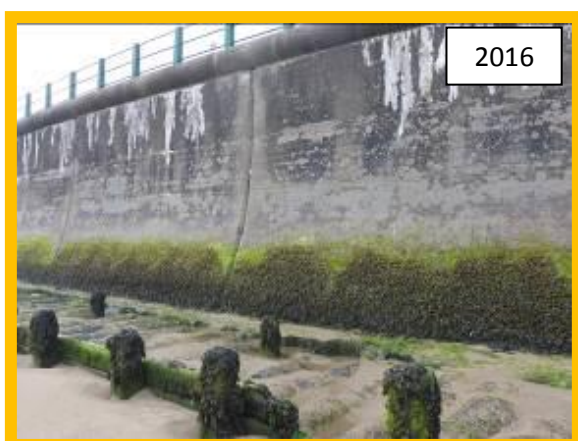
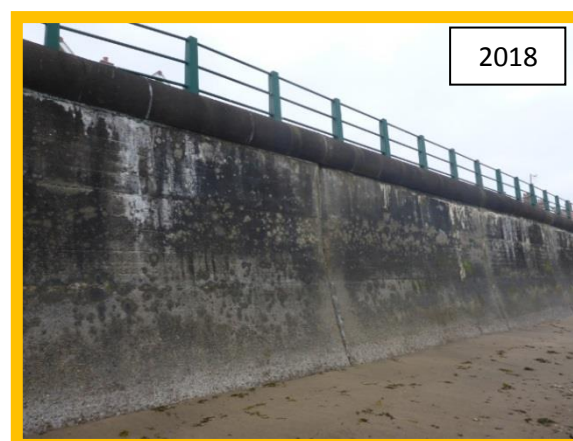
A concrete seawall (D0702C01) extends from Sandsend Beck towards the east. The groyne field fronting the seawall is derelict and the remains have no significant impact on sand movement. The wall is heavily abraded. Whilst timber breastwork was exposed at the toe in the 2009 survey and has been observed to have progressively deteriorated since to 2016, it was covered by beach sand at the time of the 2018 inspections. There are occasional cracks in the wall and significant abrasion at the steps. Also at most steps there are missing or heavily corroded sections hand rails.

Poor condition sea wall (D0702C01)

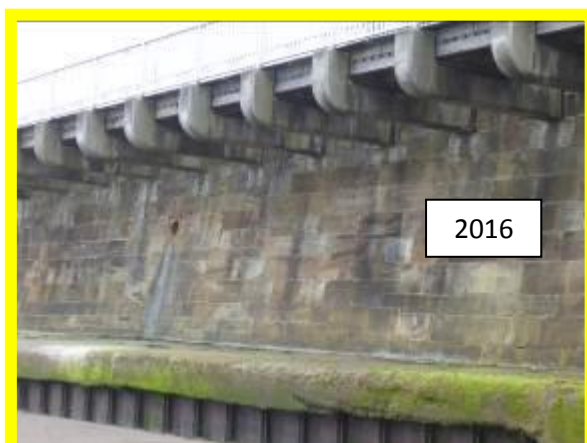
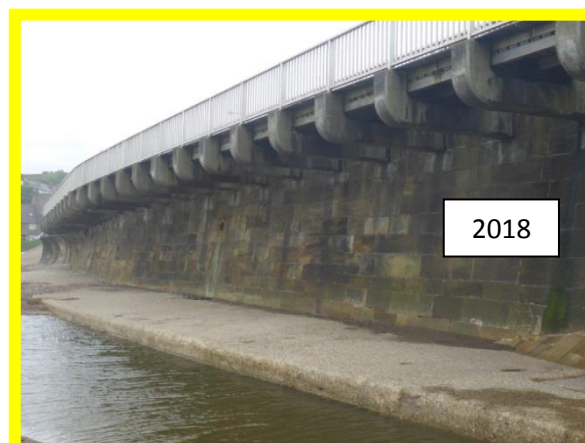
The newer short section of masonry blockwork sea wall (D0702C04) that supports a cantilevered promenade just north of East Row Beck is in fair condition. Although the steel toe piling was observed in 2016 to be corroded and abraded, it was covered by beach sand at the time of the 2018 inspections. At the eastern end, there are voids and undermining of a concrete apron which should

be further investigated. The timber decking of the cantilever footway was destroyed during the December 2013 surge and repairs were made late 2014.

Masonry blockwork sea wall with cantilevered footway (D0702C04)

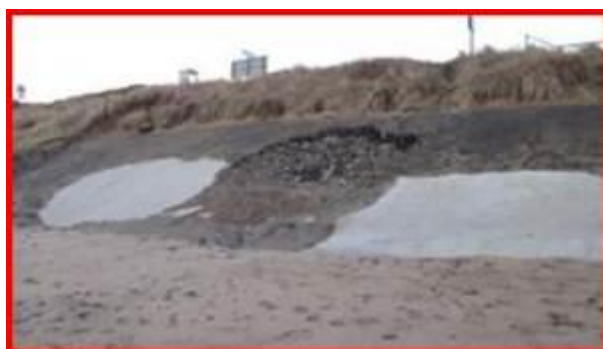
The sloping concrete revetment (D0702C02) which used to provide the main coastal defence to the A174 Sandsend Road against erosion and overtopping was in a poor and deteriorating condition for many years and became further damage by the December 2013 storm surge, resulting in a previous grading of very poor condition in 2014, despite post-storm repairs.

Previous storm damage and very poor condition of sloping revetment at Sandsend Road

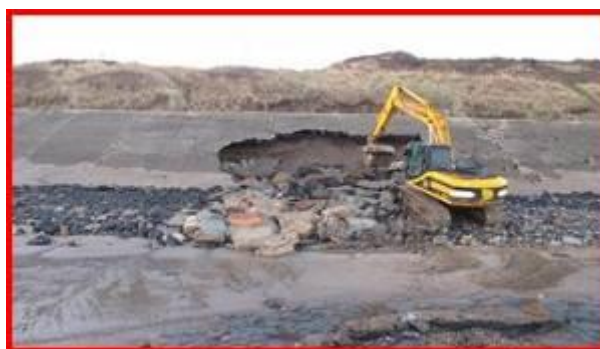
Previous temporary repairs to sloping revetment at Sandsend Road (D0702C02)

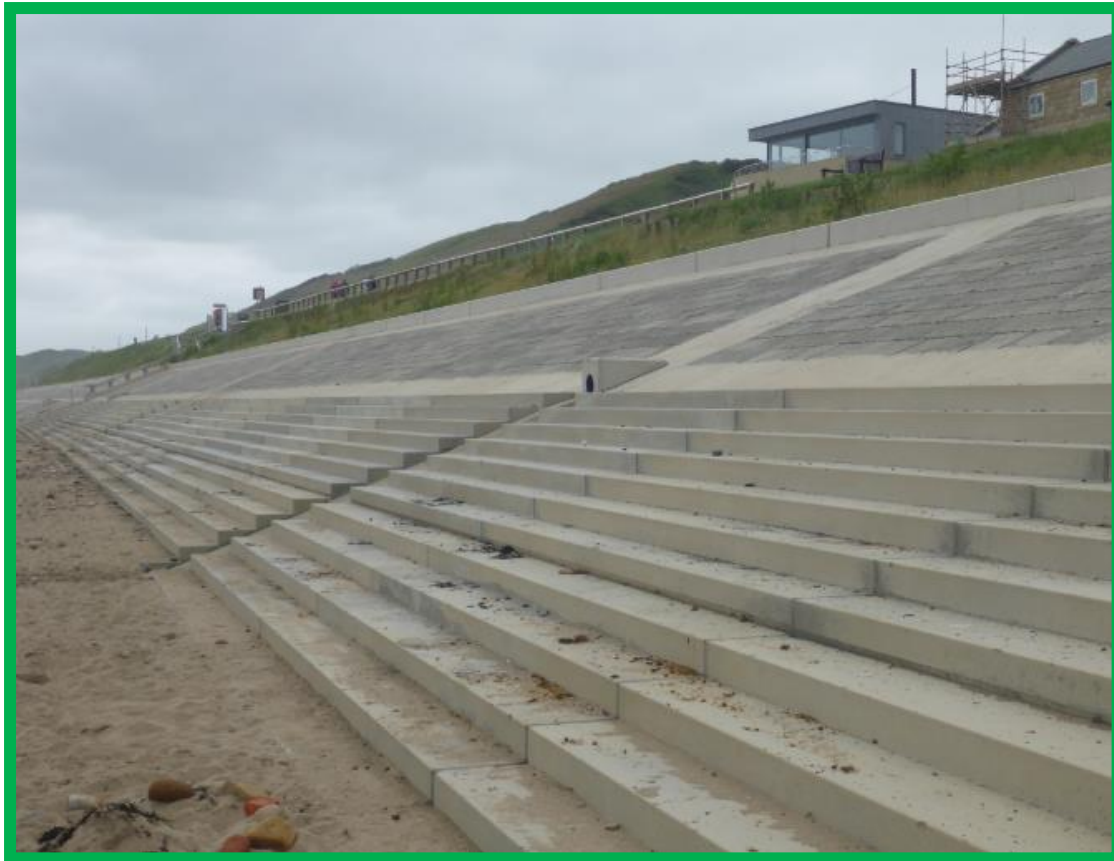
Cross section of coastal defences at Sandsend Road in 'as built' condition showing stepped pre-cast apron and upper Dycel units (D0702C02)

- Outfall drains are freely running (despite one lower outfall being partly blocked by cobbles)
- Toe beam are covered with beach sand
- Some chipping damage has occurred to the edge of the steps (confined to lower steps at the western end but becoming more frequent and higher up the structure to its central and southern sections).
- Outflanking at the eastern end is being addressed by large beach boulders

With construction of the scheme having been completed in August 2016, the new defences are in very good (as built) condition with some minor chipping to the step edges.

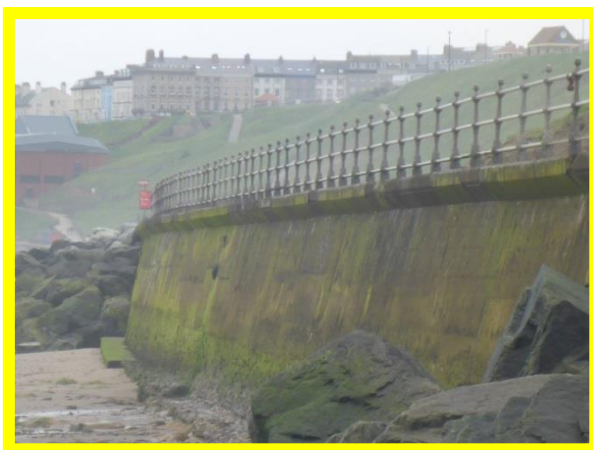
There are two sections of seawall along the frontage with no protective rock armour. One occupies a short gap between the two areas of rock armour, whilst the other is to the east, backed by beach chalets on the promenade. Both sections have experienced considerable abrasion damage to the face. Due to the absence of rock armour, the toe at both sections has also been subject to undercutting. Recent repairs (prior to the 2016 inspection) appear to have cast a new concrete toe over much of the affected sections, but their overall condition remains poor and there are short lengths adjacent to where the new toe ends where boulders and rock outcrops are present and the original toe is still being undercut. There is also local damage (cracking and abrasion) to the wall coping beam and at each set of access steps along these lengths with no protective rock armour.

Seawall at gap in rock armour revetment (D0802C01)

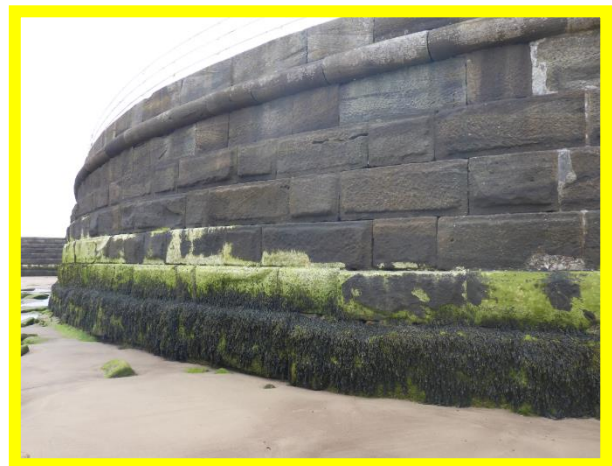
The Battery Wall, just west of Whitby West Pier, is formed of large sandstone blocks. Although repairs to some gaps between blocks are evident, further repairs are deemed necessary in numerous areas, especially at the wing wall of the access steps to the beach. Despite this, the asset remains in overall fair condition.

Battery Wall, with some open joints between blocks
(\D0802C12)

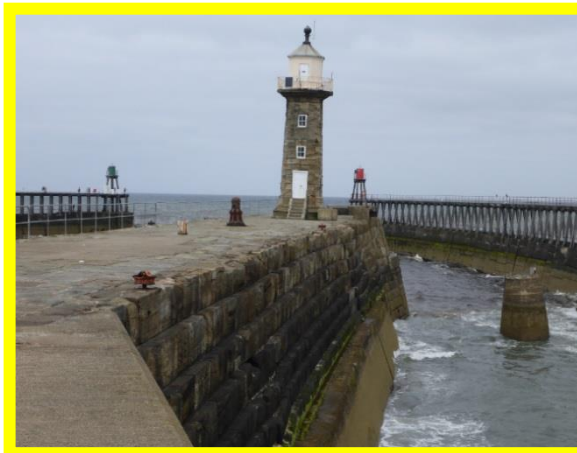
The piers have each been classified as generally fair, but the West Pier is locally poor in condition and the East Pier locally very poor in condition.

East Pier, generally in fair condition but locally very poor (\803C03)

Both main harbour piers have loose and cracked blocks and vertical movement (settlement) in at least one location on each arm. This potentially is indicative of wash-out of backing fill material and voiding. It is recommended that the proposed capital works to the main piers are implemented as soon as practically possible. Loose blocks could potentially become displaced or missing during a storm and there may be a significant quantity of wash-out of material from the core, leading to the consequent weakening and collapse of the structure. The situation is particularly bad on the inner face of the East Pier.

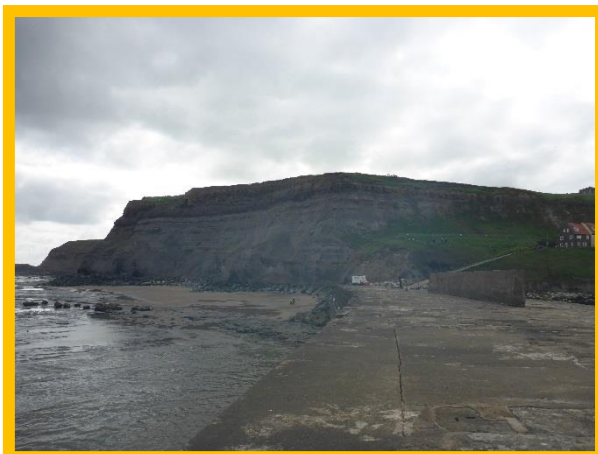
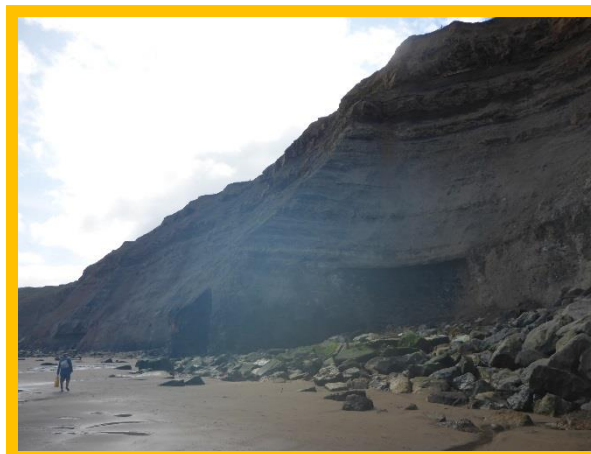
Unit **MU12/2** comprises high cliffs protected by rock armour. There is evidence of a past rockfalls from the upper part of the cliff in the form of debris slopes and almost the entire cliff face is exposed, with very little vegetation cover. The cliffs therefore remain classified as Partly Active.

MU12/2 Cliffs east of Whitby (Partly Active)

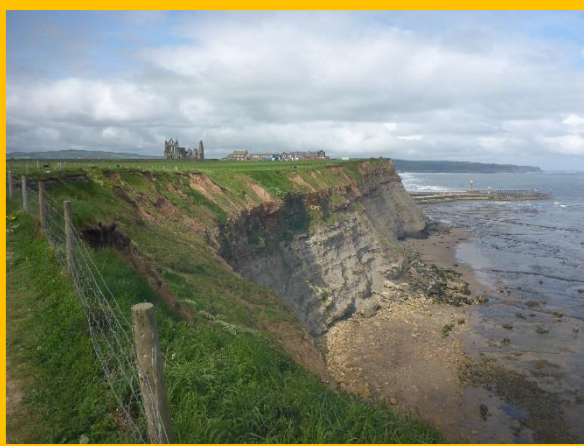
MU13/1 Cliffs east of Whitby (Partly Active)

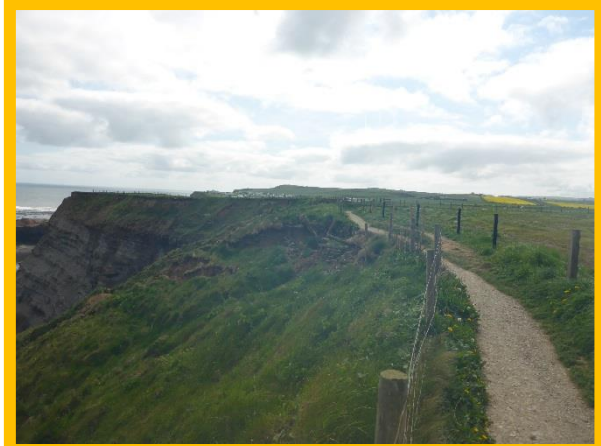
MU13/1 Recent slump encroaching coastal path (Partly Active)

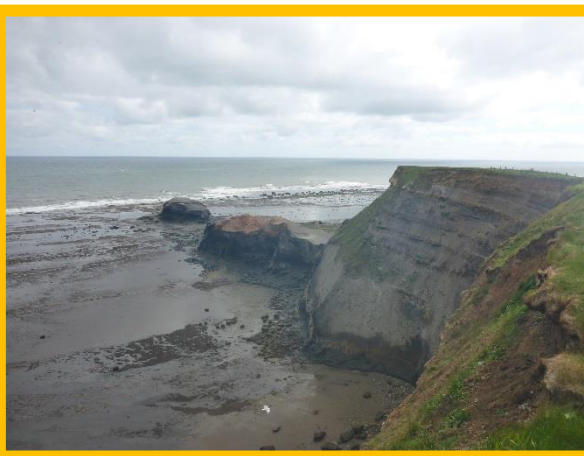
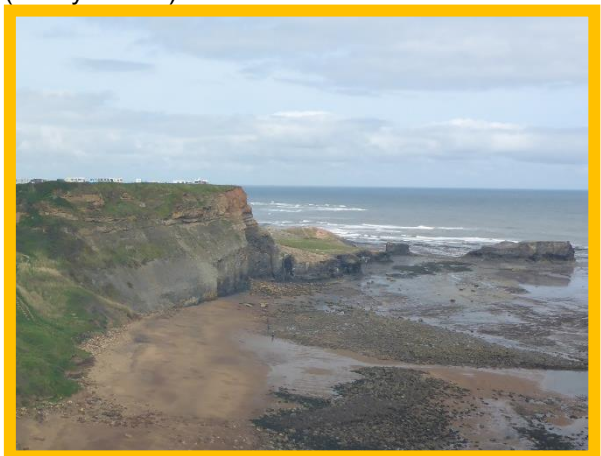
Unit MU13/2 comprises the eroded headland of Saltwick Nab. This unit is continuing to actively erode and supports little vegetation cover. Rilling and gulying is evident on the exposed faces. As a result, this unit remains classified as Partly Active in 2016.

MU13/2 Saltwick Nab (Partly Active)

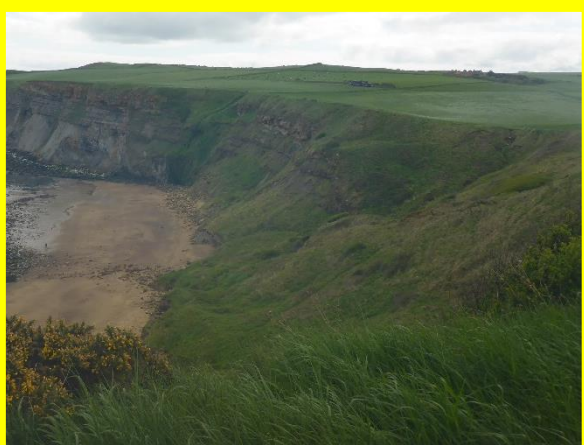
The cliffs within **unit MU13/3** are located within Saltwick Bay. The cliffs of this embayment are protected to some extent from marine action by the high stable beach. As a result, the unit is generally less active and well vegetated and was classified as Locally Active in 2014. This remains a valid classification, despite the occurrence of a local rockfall since that time.

MU 13/3 Saltwick Bay (Locally Active)

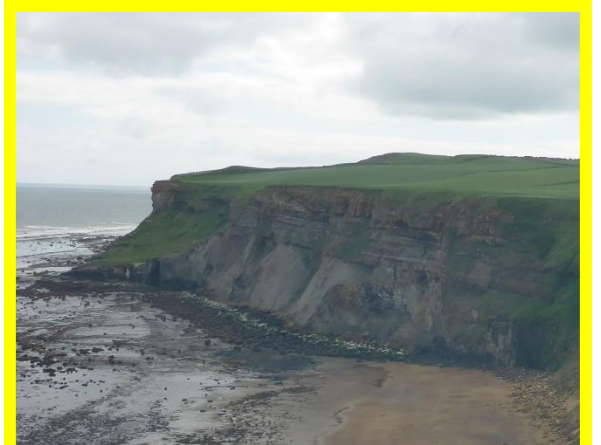
MU13/4 East of Saltwick Bay (Locally Active)

Unit MU13/4 is located just east of Saltwick Bay and is fronted by a narrower beach than adjacent unit MU13/3. Consequently, it is subject to more regular wave attack at the toe and much of the slopes are active and exposed. There is evidence of small slumps of debris and rockfall activity and there is ongoing localised and minor recession of the headscarp. This unit remains classified as Locally Active in 2018.

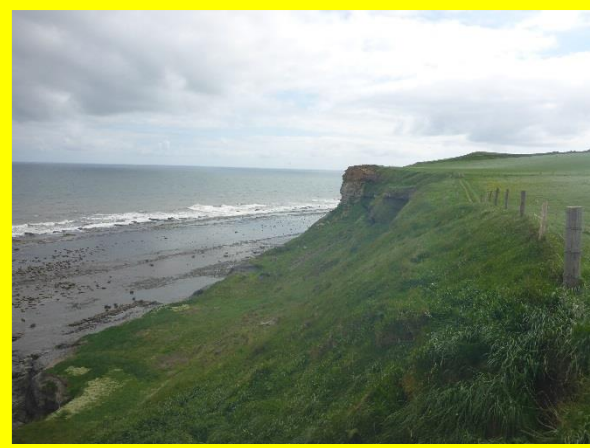
MU 13/5 Vegetation covering majority of debris lobe at Black Nab (Locally Active)

Unit MU13/5 is formed by the shallow, relict debris flow lobe at Black Nab. The slopes of this unit are well vegetated, with localised activity evident at the toe and headscarp. Activity noted at the headscarp and toe meant it was classified as Partly Active in 2012, this appeared to have reduced by 2014 resulting in re-classification as Locally Active and this status remains valid in 2018.

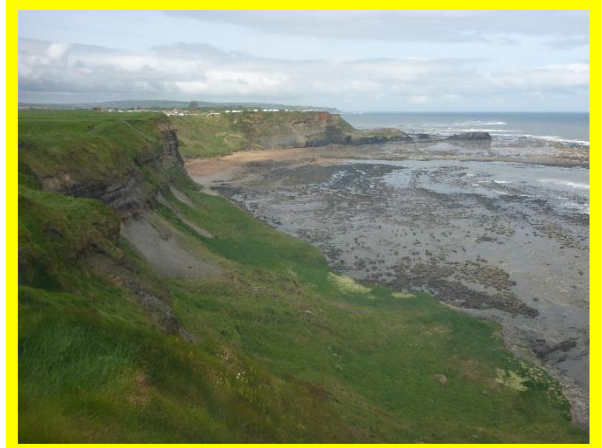
MU13/5 Debris lobe in foreground (Locally Active)

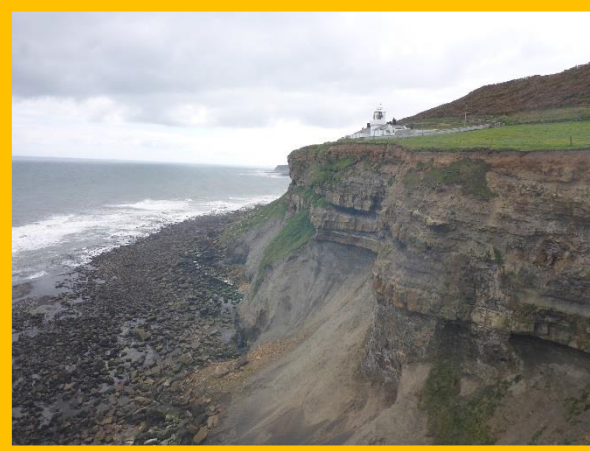
MU 13/6 Unvegetated eroding cliffs at Whitby Lighthouse (Partly Active)

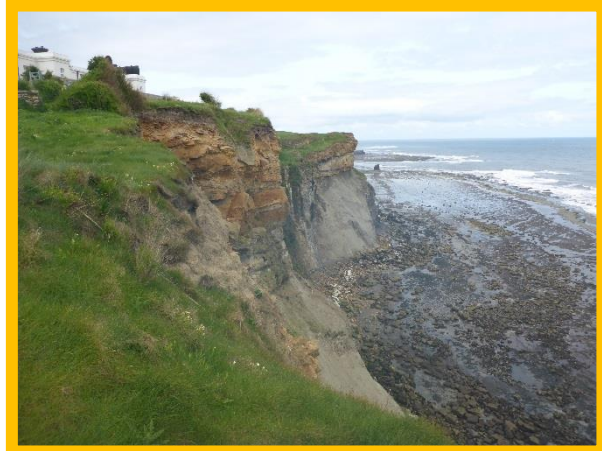
MU13/6 Steep overhanging cliffs at Whitby Fog Signal (Partly Active)

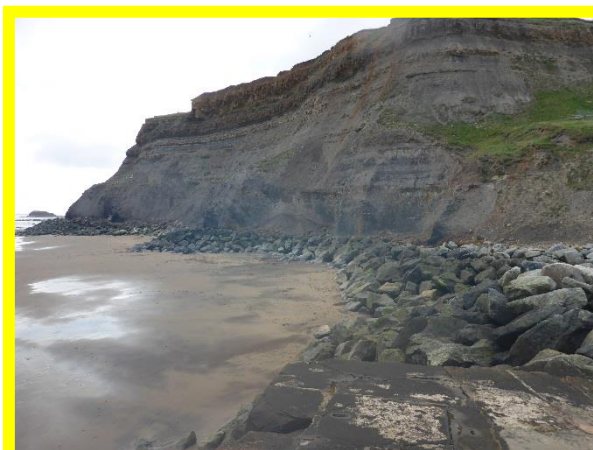
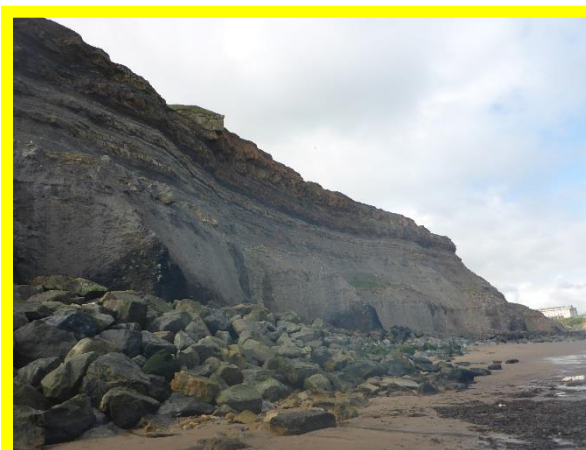
There is a section of rock armour giving protection to the toe of Abbey Cliff directly to the east of Whitby Harbour's East Pier. The rock armour varies in size from 1-4 tonnes to 5-8 tonnes and is in fair overall condition.

Rock armour protection to toe of Abbey Cliff
(\803C06)

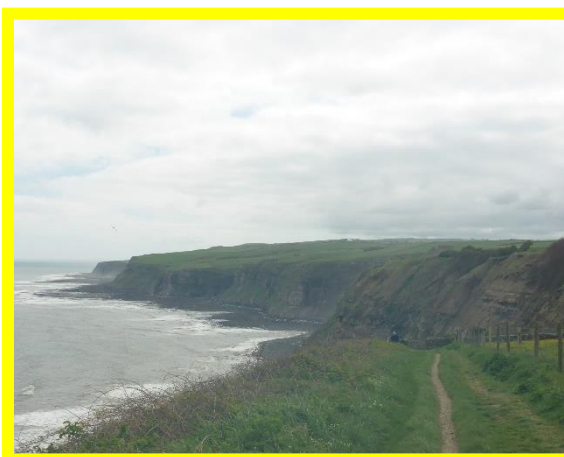
MU 14/1 Stable cliffs, upper slopes and debris aprons generally vegetated (Locally Active)

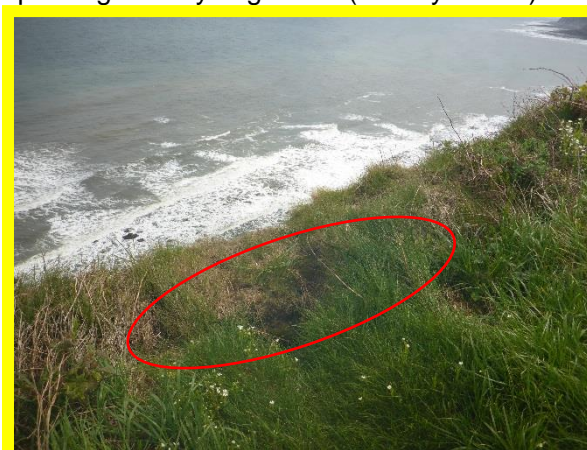
The only unit within this Management Unit is **MU14/1**. The cliffs within this unit remain classified as Locally Active in 2018 because whilst the slopes are partly vegetated, there remain small areas of erosion evident. An incipient tension crack was noted in the crest of the cliffs at the foot of timber steps south of Whitby Lighthouse. Installation of timber fencing on seaward side of path should be considered.

MU 14/1 Tension crack in crest of cliffs adjacent foot of steps

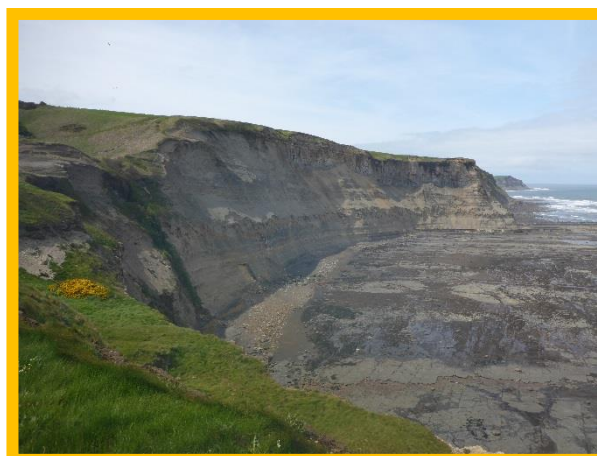
Unit MU15/2 is located at Far Jetticks. This cliff has widespread activity, with ongoing marine erosion evident at the toe and localised activity on the cliff face. It remains classified as Partly Active in 2018. Note: A series of arcuate tension cracks were observed during the 2014 inspections (and seen during the 2018 inspections) on the cliff top at grid reference 495076 507274, indicating an incipient failure that poses a hazard to walkers on the Cleveland Way. The site has been brought to the attention of Scarborough Borough Council who have informed the North York Moors National Park Authority.

MU15/2 Ongoing erosion at Far Jetticks (Partly Active)

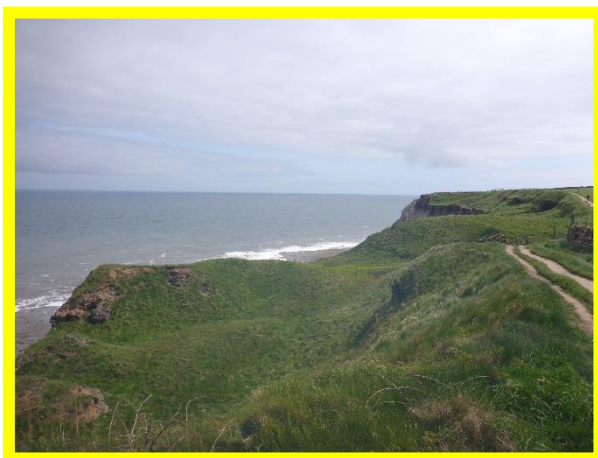
MU15/3 Vegetated slopes at cliff top (Locally Active)

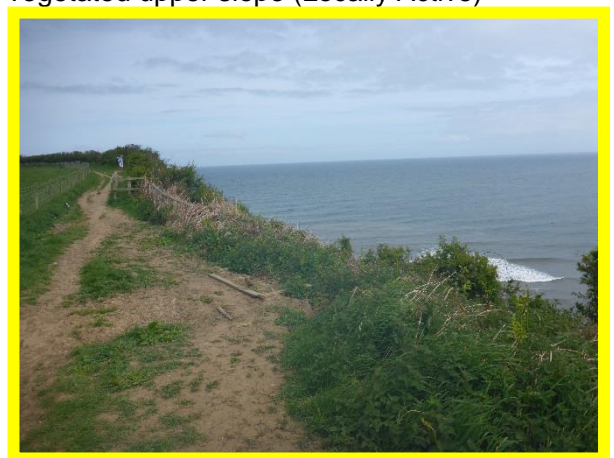
MU15/3 Local slumping of headscarp adjacent coastal path (Locally Active)

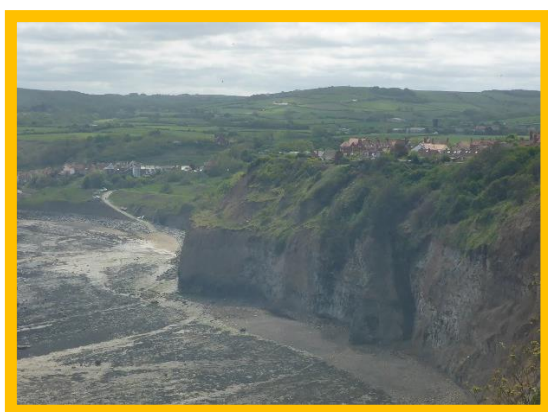
Unit MU16/1 is the composite cliff complex fronting the northern part of Robin Hood’s Bay village and is classified as Partly Active in 2018, no change from 2014. The cliff comprises a near-vertical lower cliff of mainly sandstone overlain by shallower sloping heavily vegetated glacial till with evidence of slumping and recession of the head scarp.

MU16/1 Sandstone cliff overlain by shallow till (Partly Active)

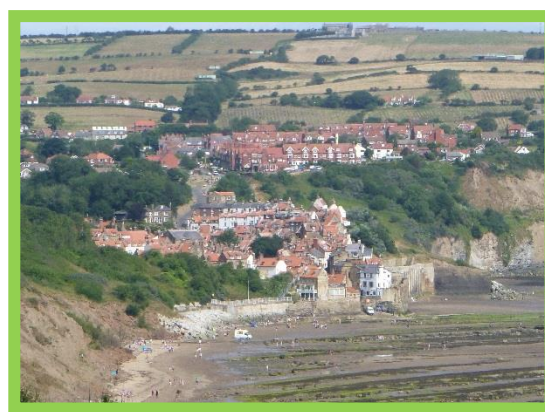
Units MU16/2 is a stabilised landslide that forms the southern part of Robin Hood’s Bay village. There is little evidence of any activity and so it remains classified as Inactive in 2018. MU16/3 protected by sea defences retains its Dormant status in 2018, as in 2016.

MU16/2 Stabilised landslide (Inactive)
