Cell 1 Regional Coastal Monitoring Programme Walkover Inspection Surveys 2018

**Scarborough
Borough Council**

October 2018

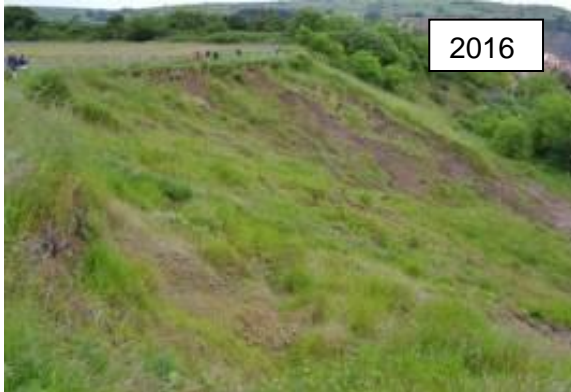
Unit MU17/2 comprises glacial till cliffs to beach level protected by rock armour at their toe. The slopes are vegetated however the area of exposed cliff has increased since the 2016 survey. Generally, the flatter mid-slope is well vegetated whilst the headscarp and toe are exposed with extensive evidence of recent slumping. This unit remains classified as Partly Active in 2018, due to widespread evidence of instability. During the 2018 survey it was noted that the Cleveland Way footpath has been severely undermined along the headscarp of the management unit. This has led to a section of the footpath being lost through landslip. A temporary diversion has been put in place with flexible jointed plastic matting replacing the stone flagstones which have fallen down the face of the cliff.

Head scarp of MU17/2 (Partly Active in June 2016)

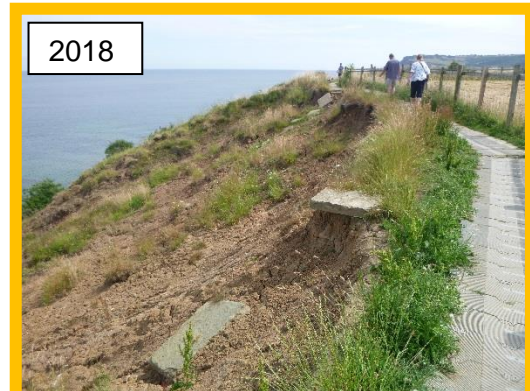
MU17/2 Undermined Cleveland Way footpath route and temporary diversion (Partly Active).

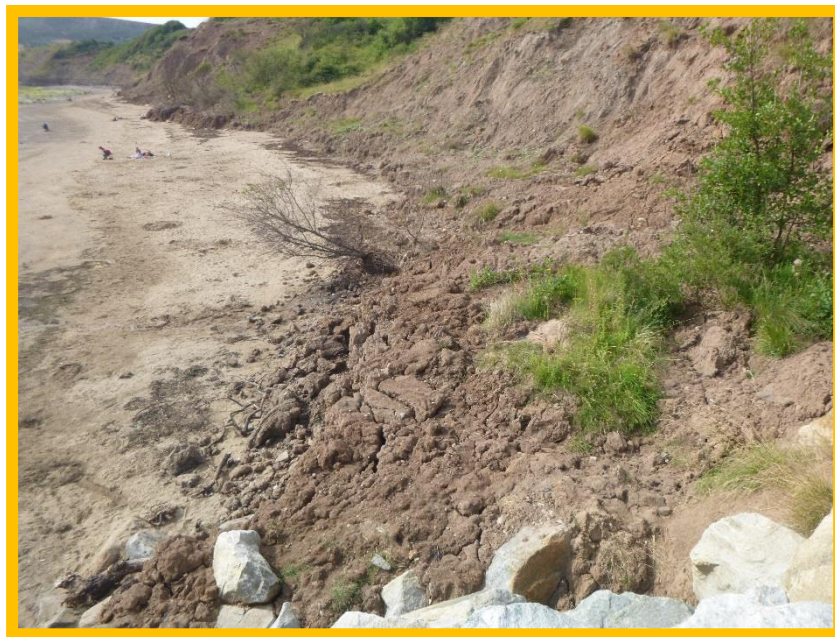
Toe of MU17/2 showing extensive activity (Partly Active).

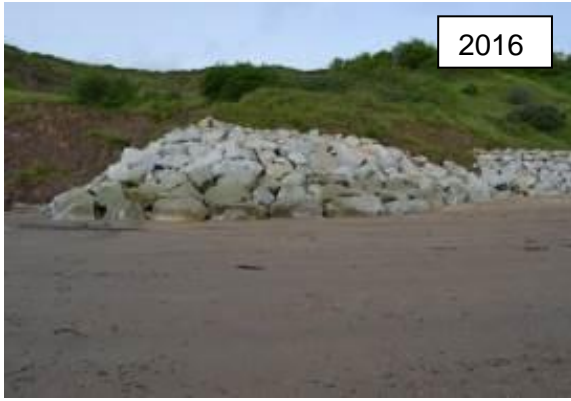
Protected toe of till cliffs in Robin Hood's Bay.
MU17/2 (Partly Active in June 2016)

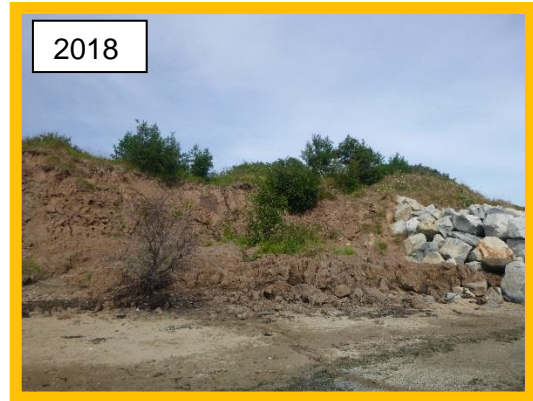
Slumped toe of till cliffs adjacent revetment.
MU17/2 (Partly Active)

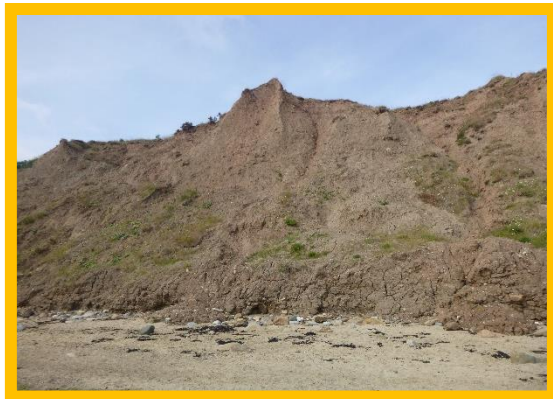
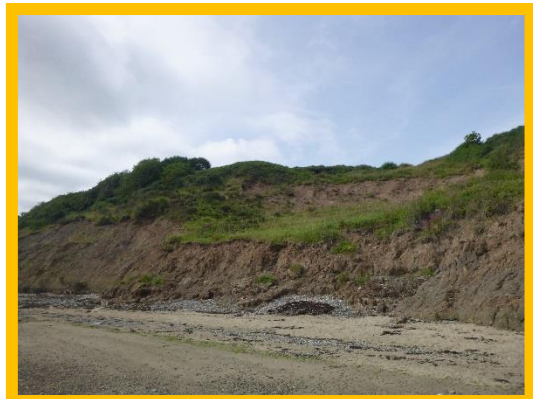
Further south, within unit MU17/3, defences are absent and the cliffs are active. There is massive slumping at beach level and in the mid to upper slopes. This unit is classified as Partly Active in 2016, no change from 2014.

Active toe of till cliffs in Robin Hood's Bay.
MU17/3 (Partly Active)

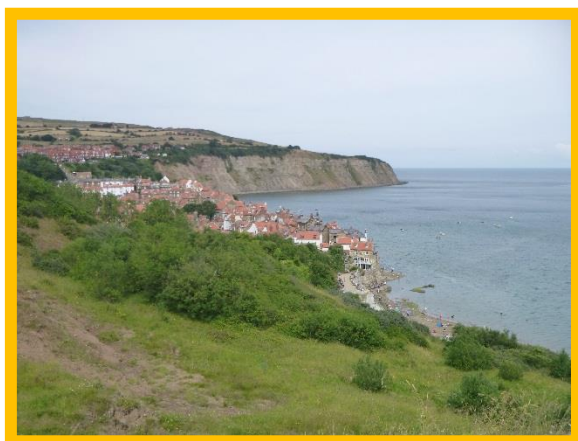
Vegetated mid-slope of MU17/3 (Partly Active)

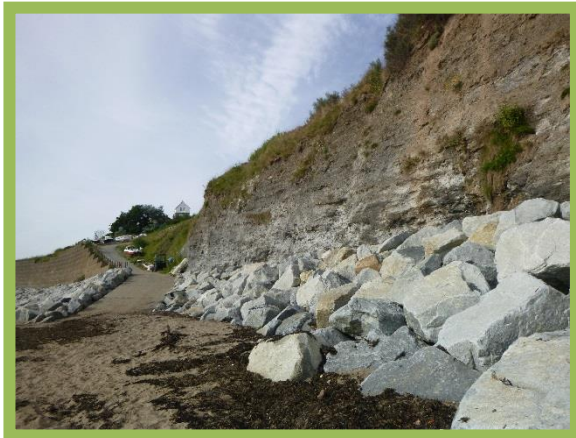
The most northern defence is a section of rock armour that gives some limited protection to the cliff toe to the north of the northern slipway / beach access ramp (/1002C02). This rock armour was constructed as part of the 2001 scheme and remains in good condition. As the rock armour extends south (/1002C01) it fronts the wingwall of a slipway / ramp from the boatyard and then a large blockwork sea wall that was built in 2001. Overall, both the wall and the revetment are in good condition. Cliffs to the rear of the slipway have rock netting which remains in good condition. It was noted during the 2018 inspection that there had been a small rockfall above the slipway just north of the rock netting. It is recommended that this netting is extended to prevent further activity.

Rock revetment fronting sea cliffs (/1002C02)

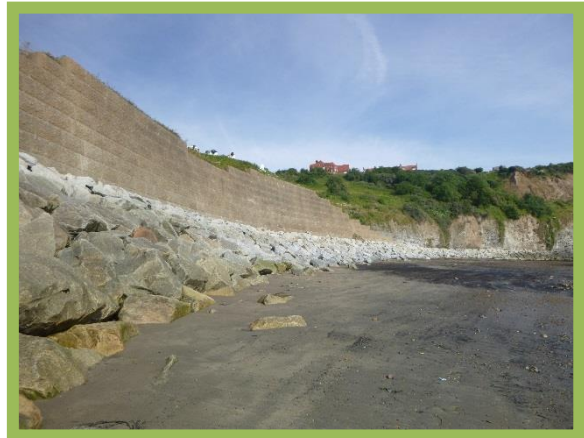
Rock revetment fronting large sea wall (/1003C01)

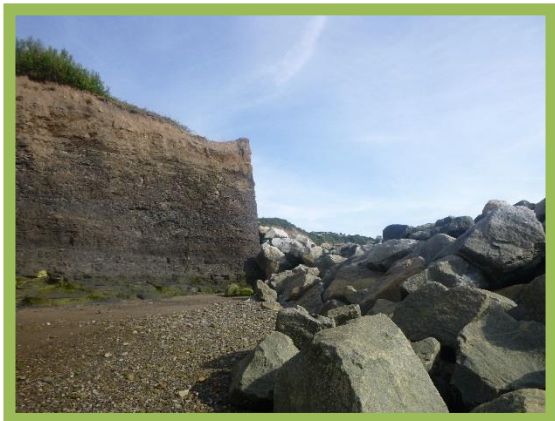
Rock revetment protruding beyond undefended cliffs (/1003C01)

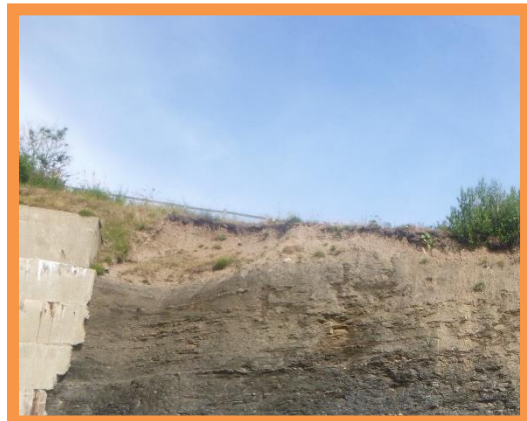
The rock armour extends south of the end of the wall, remaining in good condition, to protrude beyond the toe of the short length (~25m) of adjacent undefended shale cliffs. The cliffs (/1003C03) are generally eroding at slow rates, except for in one location at the cliff top near the interface with the southern large sea wall where a local slippage has occurred in the overlaying till. The minor outflanking noted in 2016 at this location has worsened slightly as predicted.

Erosion of cliffs immediately adjacent to large northern end of large sea wall (/1003C03)

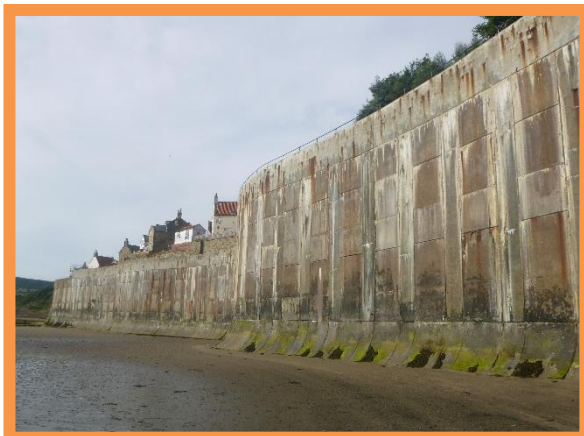
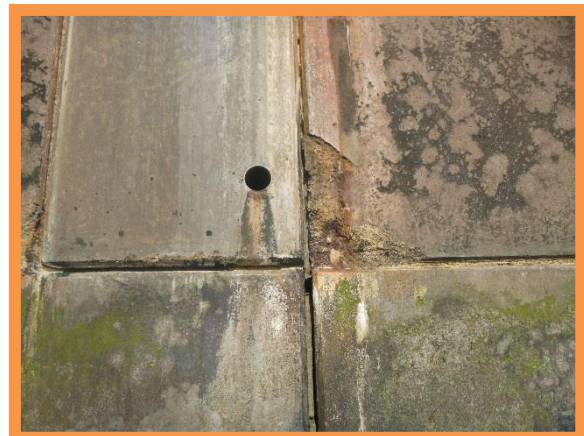
The large vertical pre-cast concrete panel wall that was constructed in 1975 (1003C02) remains in poor condition, showing evidence of surface cracking, rust marks indicating corrosion of the reinforcement steel, mineral encrustation, seepage, frequent open joints, and extensive cracking and repair work to the crest of the wall. Generally, the wall appeared in similar condition to 2016, however it was noted during the 2018 survey that there was further damage and outflanking of the transition to the shale cliffs at the north end of the wall.

Whilst previous inspections noted some evidence of undercutting of the toe this was not visible in 2016. During the 2018 survey beach levels were noted as being significantly lower than 2016. However, minor undercutting was only noted at the southern end of the asset. In order to fully determine the extent of undercutting of the wall it is recommended that a detailed structural survey is undertaken whilst beach levels remain at their current level. A recently developed Project Appraisal Report has proposed a capital scheme to repair and refurbish this wall.

Large sea wall in poor condition will benefit from future planned capital scheme (/1003C02)

Typical defects on large sea wall (/1003C02)

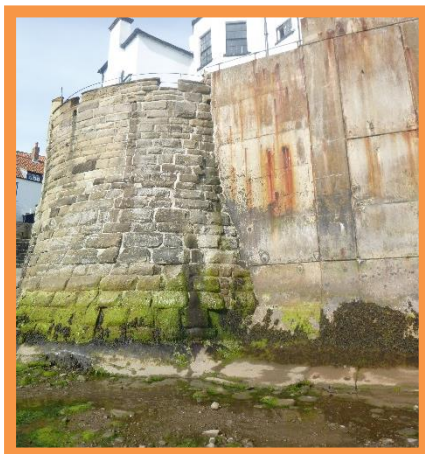
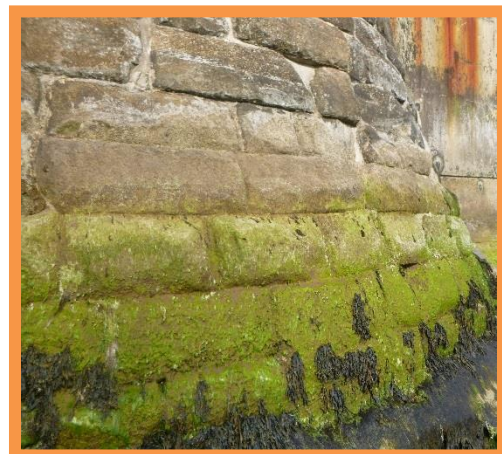
Immediately south of the large concrete sea wall, a private blockwork wall fronts the Bay Hotel (/1003C04). This wall extends south to the central slipway and is in overall poor condition. Some repairs have been undertaken since the 2016 inspection. These include grouting of open joints and sealing the open interface with the precast concrete seawall to the north. Generally, the repairs appear to be working effectively, however there are still a number of open joints visible in the wall face. Additionally, the low beach levels exposed voids in the concrete toe at beach level.

Blockwork wall in poor condition fronting the Bay Hotel (/1003C04)

Typical defects on blockwork wall (/1003C04)

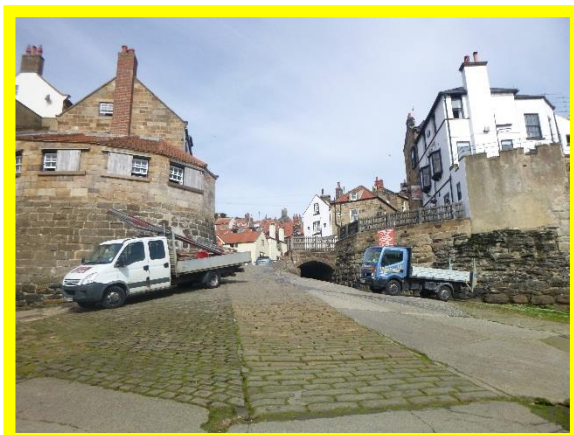
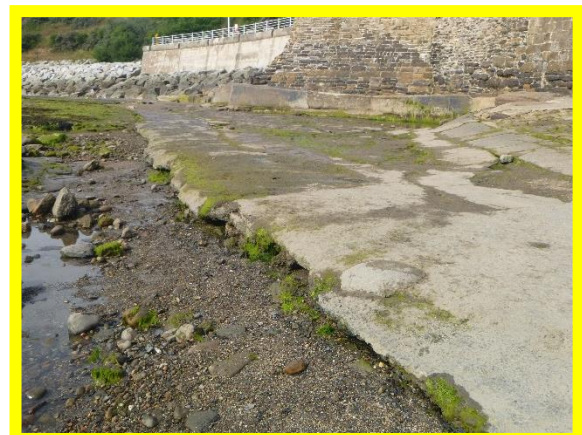
The adjacent central slipway (/1003C05) is in an overall fair condition, with minor damage to an area of previous concrete repairs near one corner. It was noted that a historic access chamber which has previously been filled in, is now reopening with some apparent washout of fill material. This open void presents a trip hazard and enables the ingress of water into the structure. It is recommended that this void is repaired and capped effectively. The concrete apron at the seaward end of the slipway is presently being undercut and generally is in poor condition.

Slipway in fair condition (/1003C05)

Undercutting of slipway toe and damage to previous repairs. (/1003C05)

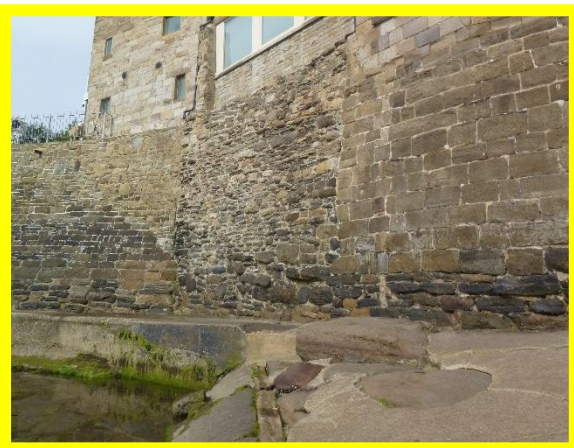
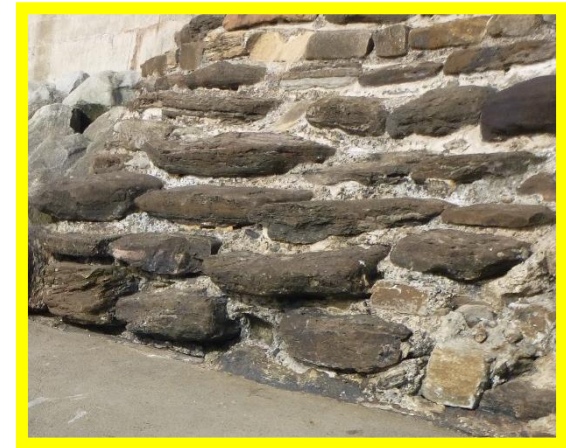
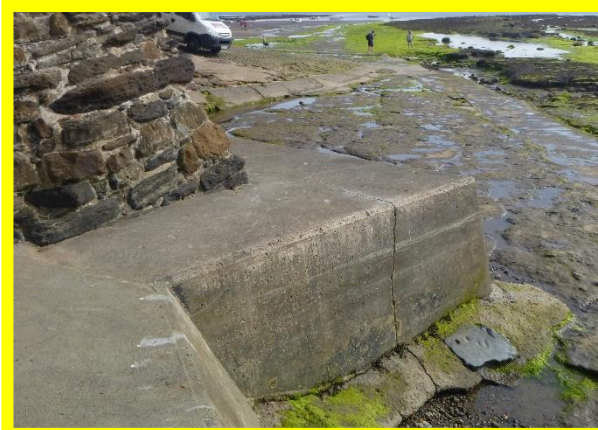
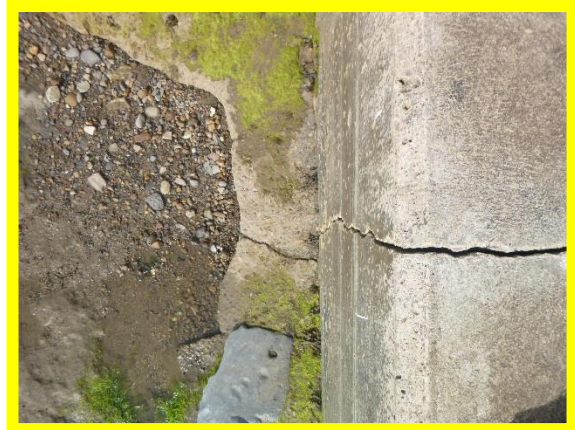
The mixed construction defence (/1003C06) on the south side of the slipway has mass concrete toe at the base with a variety of stone and blockwork above. The defence has a patchwork of previous repairs and repointing throughout but despite this a small number of open joints remain (mostly in areas of previous repairs) and there is one area of cracking in the concrete at the apron. This appears to have worsened since the 2016 inspection and it is highly recommended that this is repaired to prevent further damage to the structure. Overall the structure remains in fair condition, but it would benefit from some minor maintenance.

Blockwork wall (/1003C06)

Typical defects (gaps) on blockwork wall (/1003C06)

Typical defects (cracking) on toe apron (/1003C06)

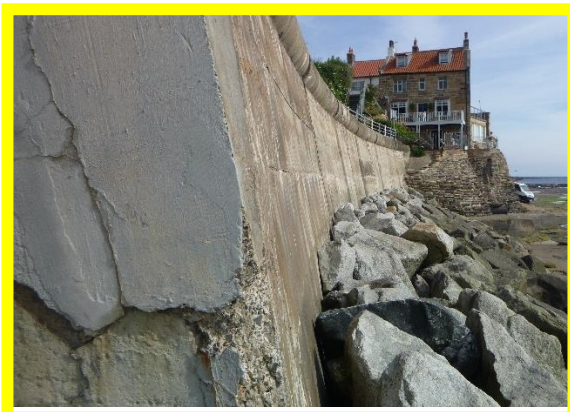
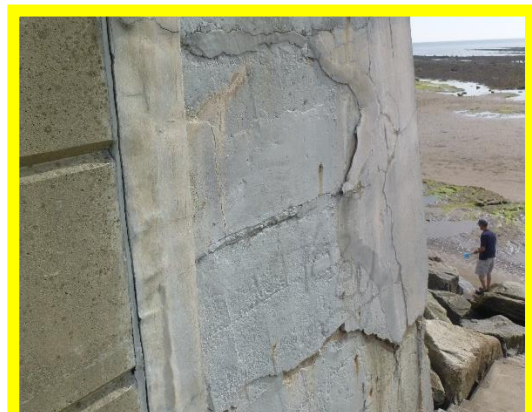
At the south of the village is the concrete sea wall at the Quarter Deck (/1003C10). This structure was given rock armour toe protection as part of the 2001 scheme. The rock armour remains in good condition with the sea wall in fair condition. There are some notable defects at the access steps at the southern end of the wall, with render cracking and falling away and abrasion of the concrete beneath. There is also some local abrasion and spalling at the coping and around joints. There has been some localised loss of joint sealant, however generally the sealant remains in good condition.

Concrete sea wall generally in fair condition (/1003C10)

Defects at access steps (/1003C10)

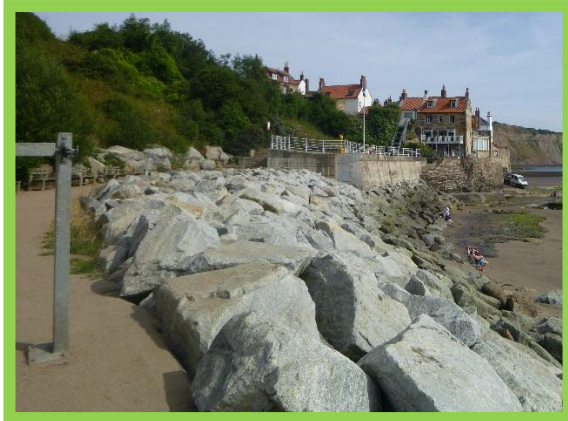
South of the Quarter Deck there is a length of rock armour defence with a slipway / ramp, both of which were constructed in 2001 and remain in good condition in 2018 (/1003C09). One or two displaced armourstones from the revetment are now almost fully buried below beach level.

Rock revetment and slipway remain in good condition (/1003C09)

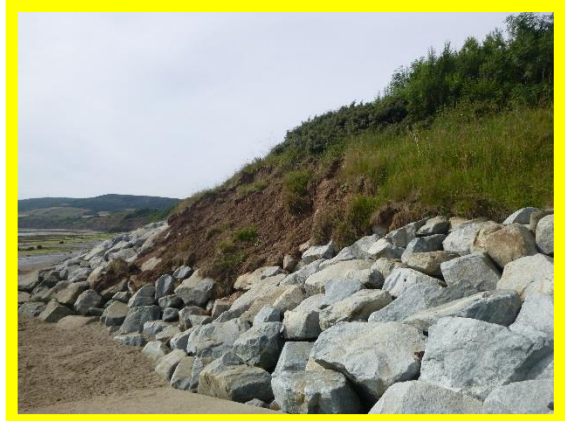
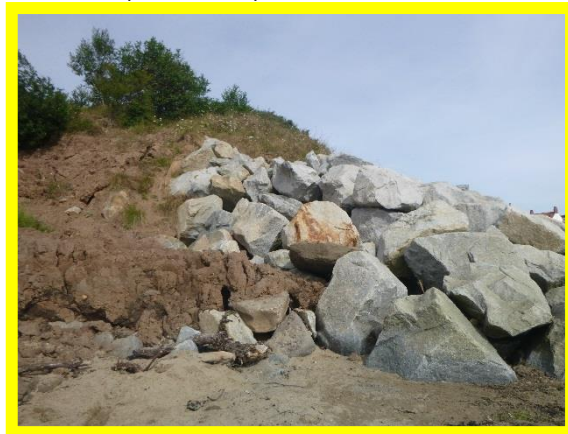
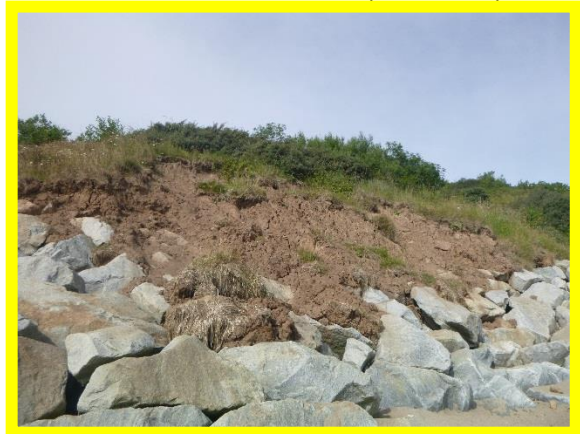
To the immediate south of the ramp is a short section of rock armour built in 2001 to stabilise the cliff (/1003C07). Since 2016 there has been further significant slumping behind the revetment and in one place, just south of the snout of the slipway, the cliff has overtopped the crest. In addition to this, the defence is at risk of being outflanked at its southern end. It is recommended that the situation in this area is monitored and considerations are made for the revetment to be realigned once the cliff has retreated sufficiently.

Slumping of cliffs immediately adjacent to southern end of rock armour (/1003C07)

Outflanking of rock armour (/1003C07)

Slumping of cliffs behind rock armour (/1003C07)

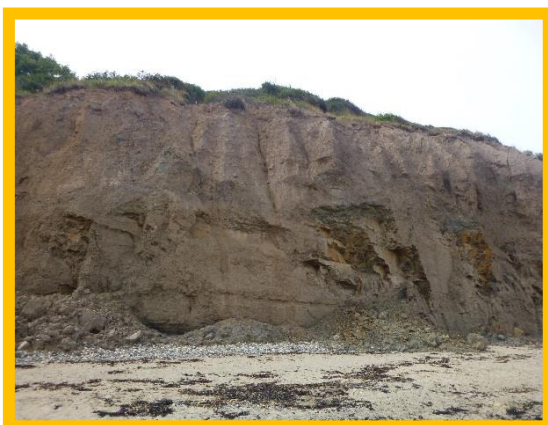
Units MU17/4 is located between Boggle Hole and just west of Stoupe Beck and has a near-vertical lower cliff formed in mudstone and an upper shallower part formed in glacial till. The unit was downgraded from Partly Active in 2014, to Locally Active in 2016, during the 2018 survey it was noted that there appears to have been significant and ongoing activity. As such, the unit has now been upgraded to Partly Active as prior to 2016.

Steep composite cliff of mudstone overlain by till. MU17/4 (Partly Active).

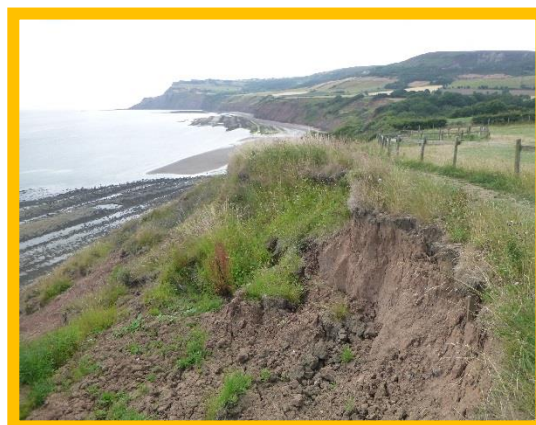
Active retreat of headscarp undermining footpath . MU17/4 (Partly Active).

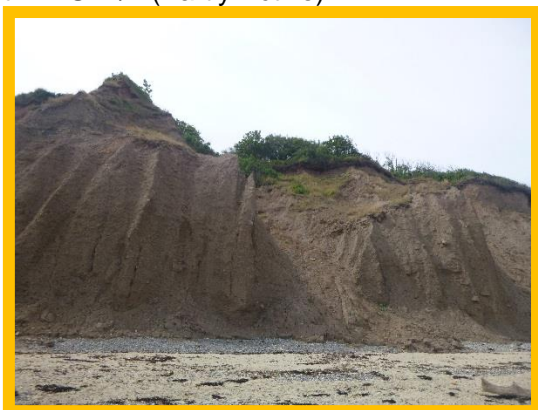
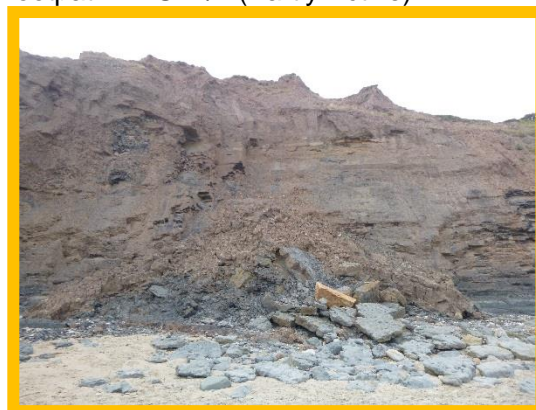
MU17/5 is located south of Stoupe Beck and is classified as Partly Active, no change since 2014. The cliff toe is slumped till at beach level nearer Stoupe Beck becoming bedrock with overlying till to the southeast, which is regularly slumped over the cliff face and on to the beach. The mid and upper slopes of the composite cliff are shallower gradient. There is an ongoing active retreat of the unit headscarp undermining the Cleveland Way footpath, which in parts appears to have been diverted and stabilised since the last inspection.

Active till cliffs down to beach level in Robin Hood's Bay. MU17/5 (Partly Active).

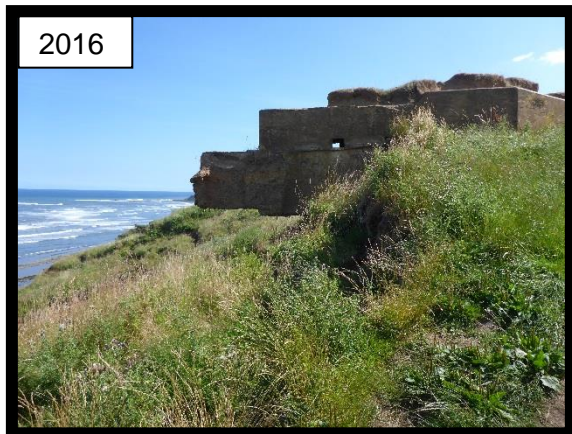
In addition to the cliff activity within MU17/5 it is worth noting that the retreat of the headscarp has undercut a historic WW2 pill box which during the 2016 survey was seen to be at risk of collapse. The structure has now been undercut and is severed in two, with the seaward facing section now lying someway down the cliff face. Due to the highly active nature of the cliff in this location both pieces of the structure are at risk of collapsing onto the beach below, with the fully detached section posing a potentially imminent risk to users of the beach. Due to the difficulties associated with placing signage on the beach, and the inherent risks associated with access to the structure, options to minimize the risk to the public are not straightforward and will require some consideration.

Historic WW2 pillbox in 2016. MU17/5.

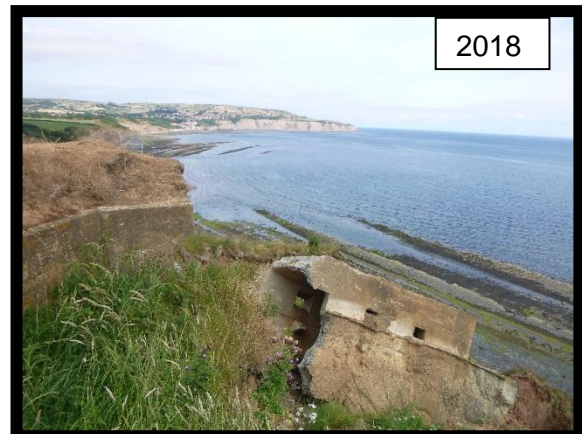
Historic WW2 pill box in 2018. MU17/5.

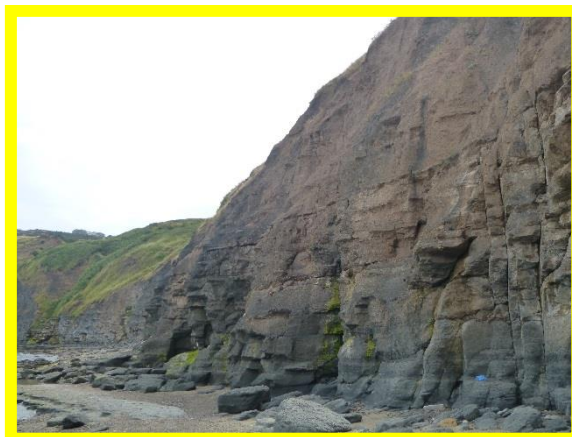
Further southeast, units MU17/6 and MU17/7 remain classified as Locally Active after being downgraded from Partly Active in 2016. The lower slopes are steep cliffs composed of mudstone overlain by shallower sloping till. The cliff face suffers localised rock falls and localised slumping of till from above.

Steep composite cliff of mudstone overlain by till. MU17/6 (right) and MU17/7 (left) (both Locally Active July 2018)

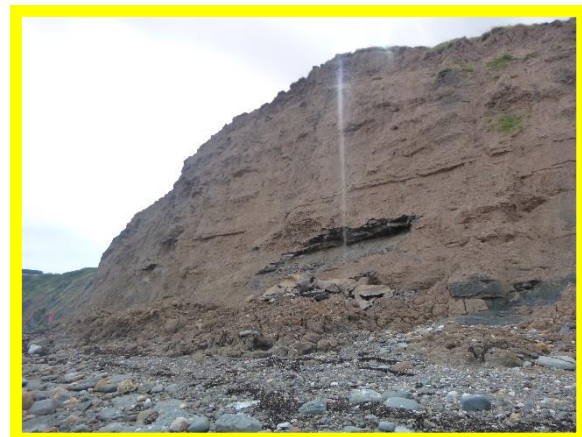
Recent local rock fall in the mudstone cliff. MU17/6 (Locally Active).

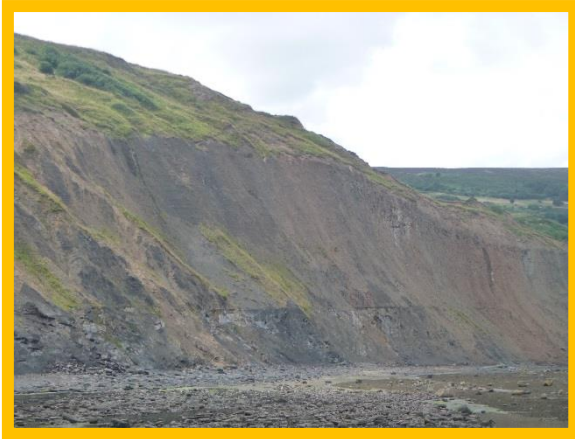
Units MU17/8 and MU17/9 are located immediately west of Peak Steel. **Unit MU17/8** has a steep lower slope which is actively eroding and a shallower upper slope which supports some vegetation cover. **Unit MU17/9** is steep with little vegetation. These units remain classified as Partly Active in 2018, as they have been since 2002.

Some vegetation cover visible along upper slopes of MU17/8 (Partly Active).

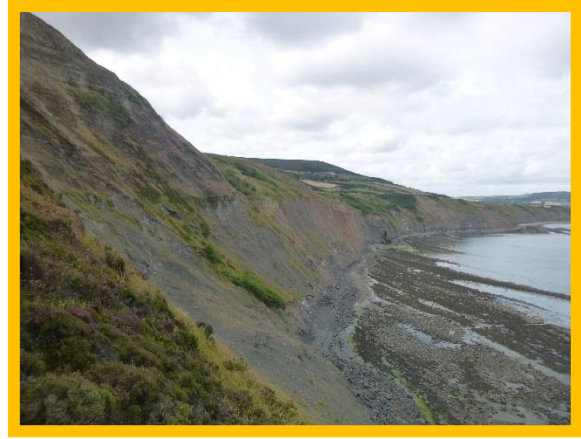
Ongoing erosion of cliff face along MU17/9 (Partly Active)

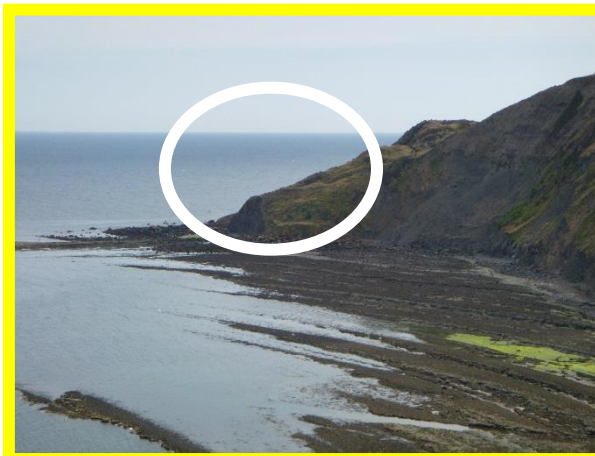
Unit MU18/1 is located at Peak Steel, below Ravenscar. The cliffs in this region have a distinct two-tiered form. Much of the upper headscarp is densely vegetated with little evidence of recent activity. The lower headscarp, exposed to the sea, is more active and subject to episodic slides and falls evident. This unit is classified as Locally Active in 2018

MU18/1 Peak Steel (circled)
(Locally Active)

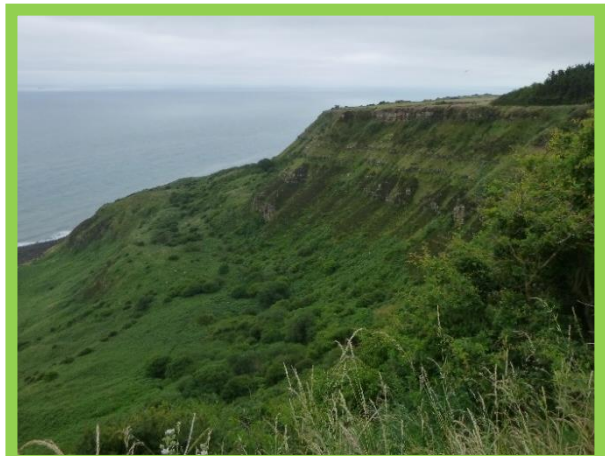
Unit MU18/2 is a well vegetated, relict system with no signs of activity. As a result, it is classified as Inactive.

MU18/2 Distinct two-tiered cliffs
(Inactive)

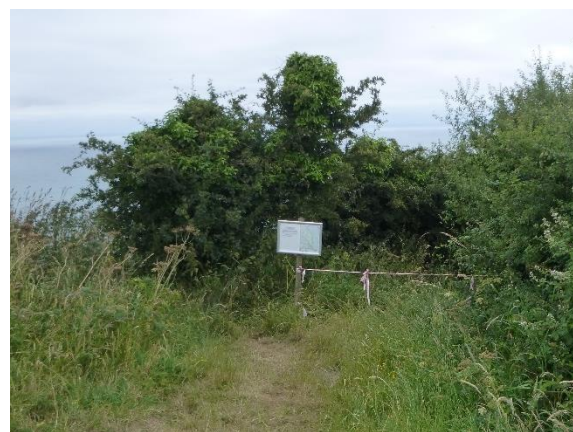
During the 2018 walkover survey it was noted the section of footpath between Petard Point and Hayburn Wkye was temporarily closed due to a landslip. The closure was effective for a period of 6 months, between 6th April 2018 and 18 September 2018. The temporary closure followed a prior closure under Emergency Notice No 56 which commenced on 16th March 2018. A detour route via Plane Tree Farm was recommended. Due to the closure, it was not possible to inspect MU19/1.

North end footpath closure.

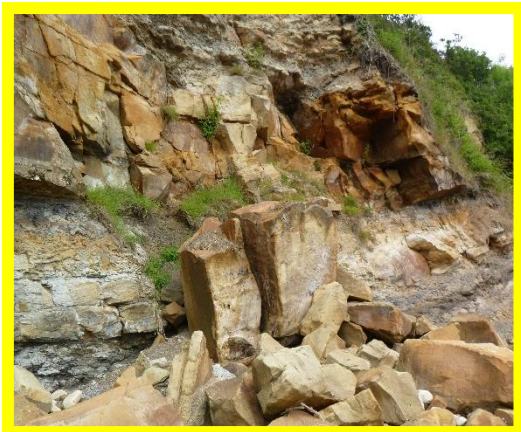
Unit MU19/2 is located on the north side of Hayburn Wyke and remains classified as Locally Active because of minor activity at the headscarp and some evidence of recent rockfalls at the toe. It was noted during the 2018 survey that there had been several large rockfalls near the access to the beach (see images below). Due to the proximity of the rockfalls to the access and the significance of the risk associated with rockfalls of such a magnitude it is recommended that MU19/2 is monitored for further change, particularly following periods of adverse weather where the cliffs may become unstable. However due to the localised nature of the activity the overall condition of the unit remains unchanged.

MU19/2 Rockfall at the toe of cliff.

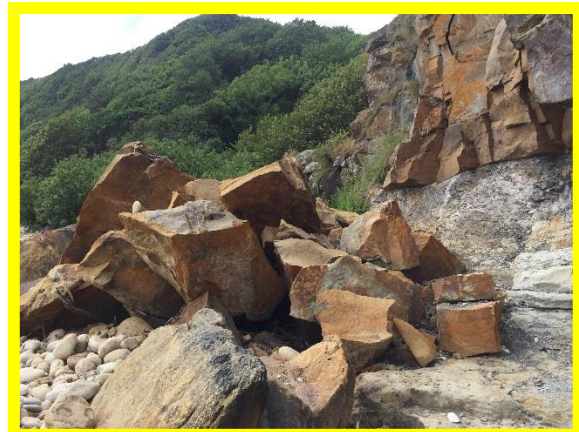
MU19/2 – Rockfall at toe of cliff, adjacent to waterfall.

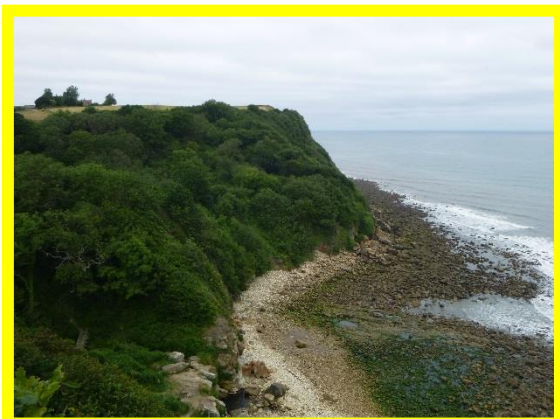
MU19/2 Looking north across Hayburn Wyke at the vegetated cliffs (Locally Active)

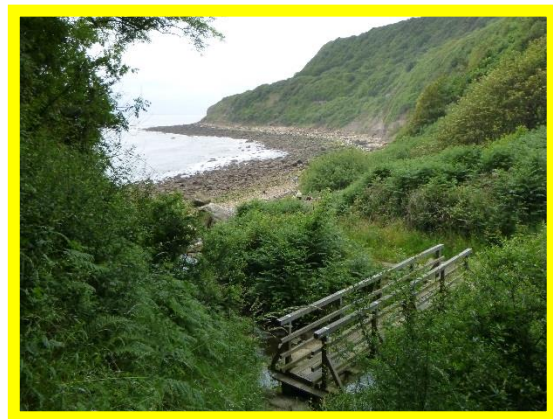
Unit MU19/3 is located around and to the south of Hayburn Wyke. These cliffs are well vegetated, with localised erosion at the toe and headscarp. This unit remains classified as Locally Active.

MU19/3 – Well vegetated undercliff on south side of Hayburn Wyke (Locally Active)

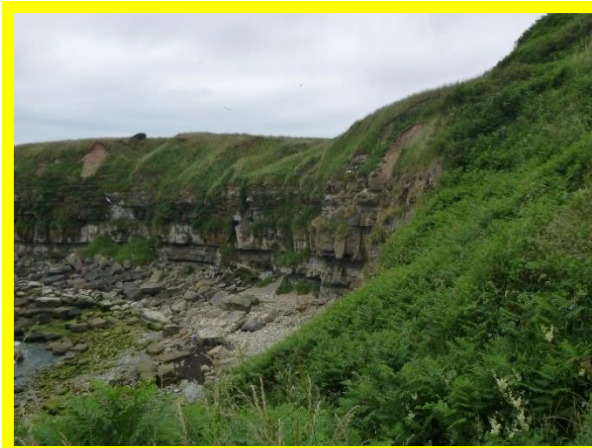
Unit MU19/6 forms the southern part of Cloughton Wyke and extends southwards to Long Nab. The lower cliff is near vertical and actively eroding. There is evidence of rockfall (large, angular boulders) from this part of the cliff onto the shoreline below. The upper part of the cliff is shallower angled and much less active. This unit condition was changed to Locally Active in 2018. Although some evidence of minor rockfall was still visible, the cliff appeared to be in better condition than 2016. The stability of the upper reaches of cliff was evidenced by the increased vegetation coverage.

MU19/6 Rockfall on southern side of Cloughton Wyke (Locally Active)

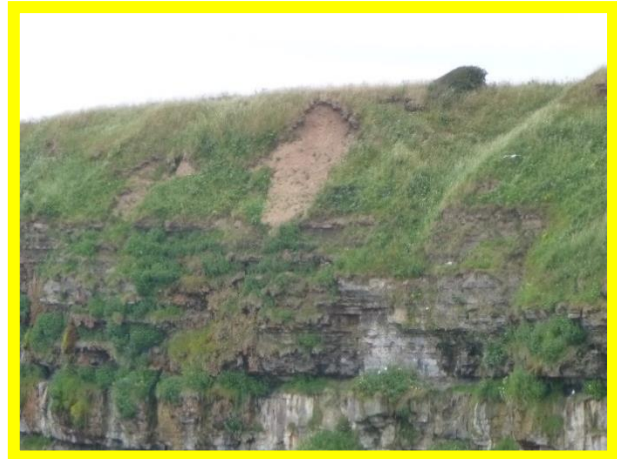
MU19/6 Rockfall on southern side of Cloughton Wyke (Locally Active)

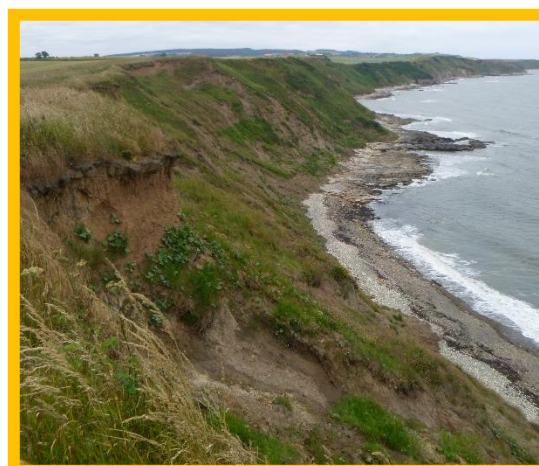
During the 2018 survey it was noted that the headscarp was actively undercutting the footpath and there was a significant risk to users of the path along several sections. This was due to the instability of the ground, evidenced by many minor landslips across the cliffs upper reach.

MU19/9 Landsliding and retreat of headscarp (Partly Active)

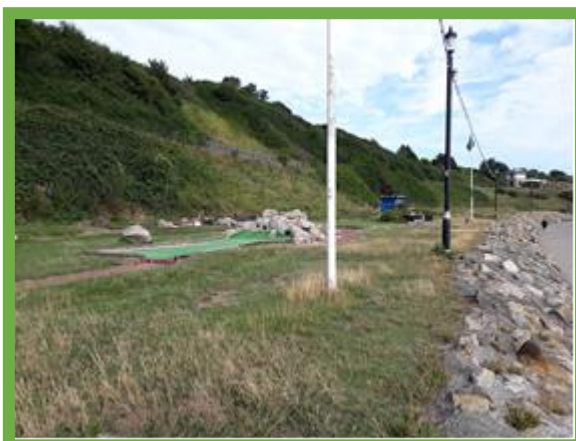
Both units are defended at the toe by the sea wall which runs the entire length of North Bay. The slopes are well vegetated, show no evidence of recent activity and are both classified as Dormant, as they were in previous surveys.

MU20/1 Cliffs in northern North Bay (Dormant)

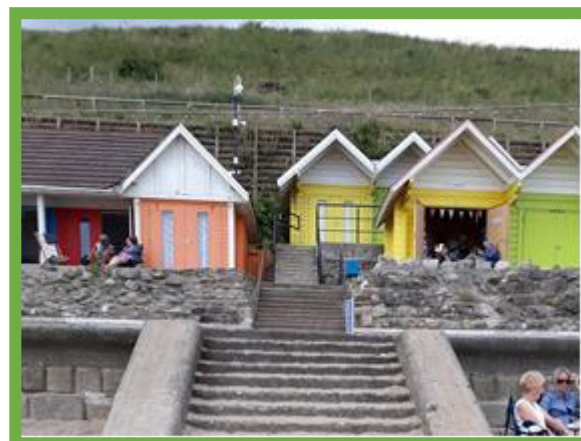
MU20/2 Cliffs in northern North Bay (Dormant)

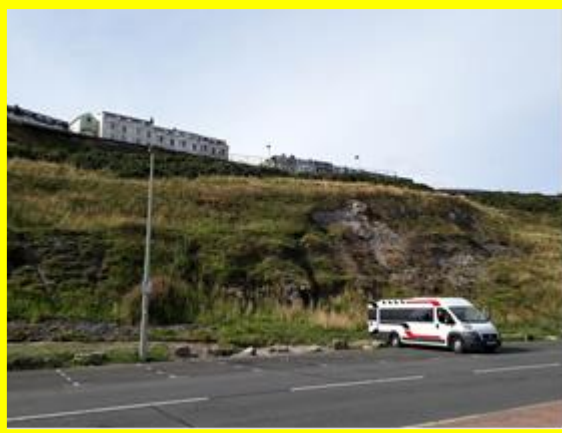
are now well vegetated with exposed rock at the headscarp. This unit was downgraded to Inactive in 2012 and retained this status in 2014. However, because of evidence of some (very) shallow slips in one local area near to parking bays, it was altered to Locally Active in 2016 and the 2018 survey found evidence of further

MU20/4b Cliffs in southern North Bay
(Locally Active)

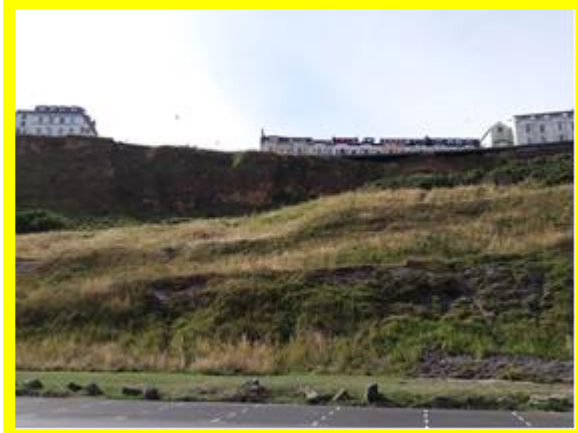
MU20/4b Cliffs in southern North Bay
(Locally Active)

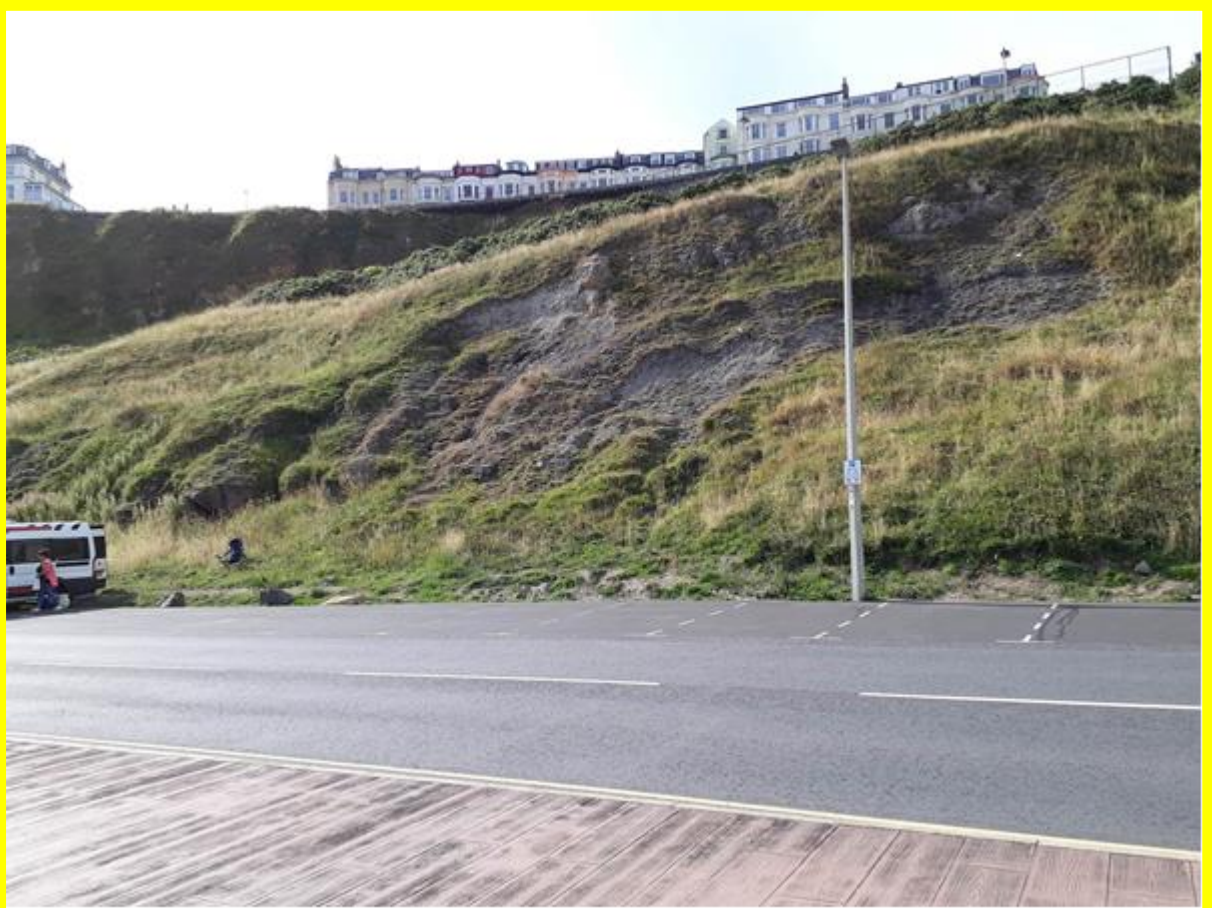
MU20/4b Cliffs in southern North Bay showing some signs of shallow slippage (Locally Active)

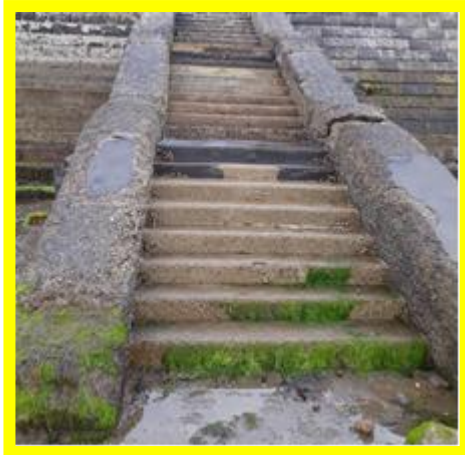
There is considerable abrasion damage to the front face, and spalling of the capping beam along the entire length of this frontage. The beach access steps are particularly heavily abraded and the southernmost set of steps have been subject to substantial repair which, to date, is holding well. However, there is a small crack between the repaired steps and the seawall which should continue to be monitored and beach levels were low at the time of the inspections, exposing the sheet piled foundations below the access steps landing. The concrete repairs extend northwards from the steps along the toe apron and remain effective.

Poor condition access steps with severe corrosion to side wall toe piles (/1201C02)

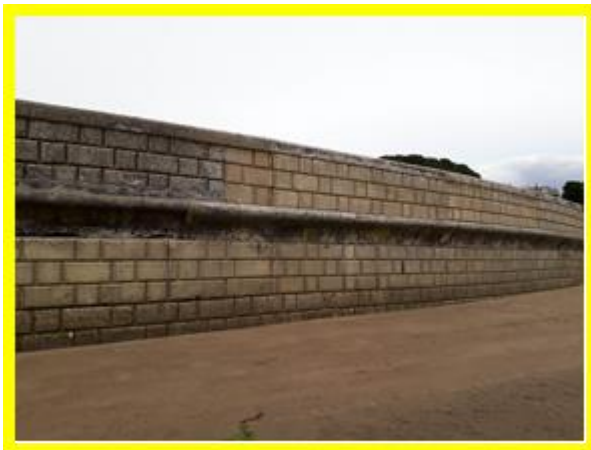
The wall around the promontory (/1201C04) is more exposed and has had relatively recent repairs to both the front face and the low crest wall, although abrasion damage remains heavy in other places (especially on the unrepaired sections of lower wall) and there is damage to the rear crest wall in two places. The new drainage outfall and entry guard are in good condition.

Area of recent repairs to promontory wall (/1201C04)

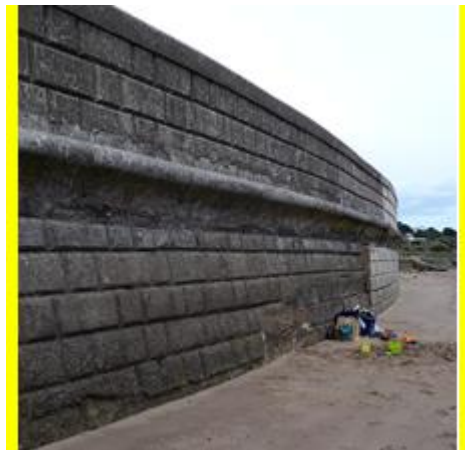
Area of heavy abrasion damage to promontory wall (/1201C04)

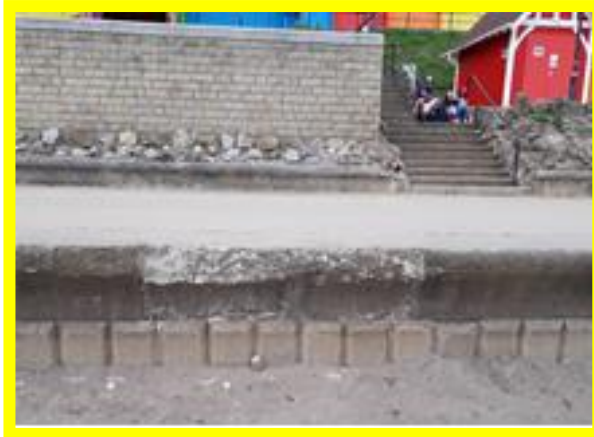
Abrasion of capping beam on front wall (/1201C05)

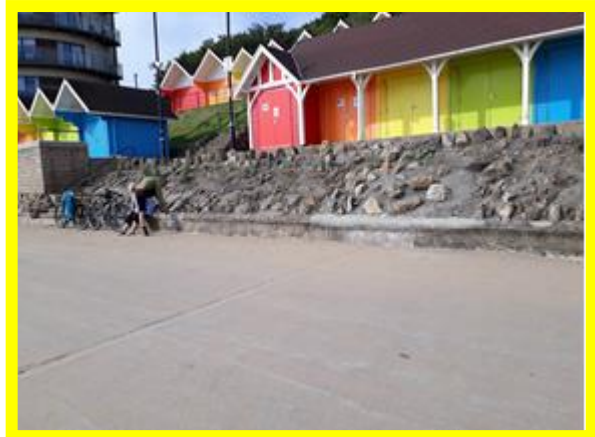
Previous repairs to stone revetment at rear of promenade (/1201C05)

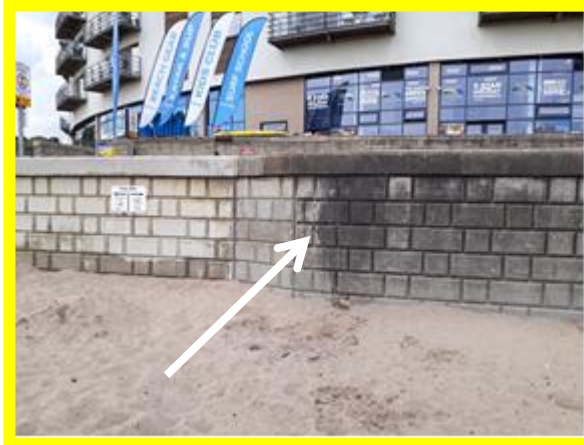
The wall to the north of the ramp at Peasholm Gap (/1201C06) continues to show several (currently minor) vertical cracks in the rear wall protecting the new development behind the wall, as well as one area of notable abrasion damage to the facing.

Vertical cracks in wall protecting recent development (/1201C06)

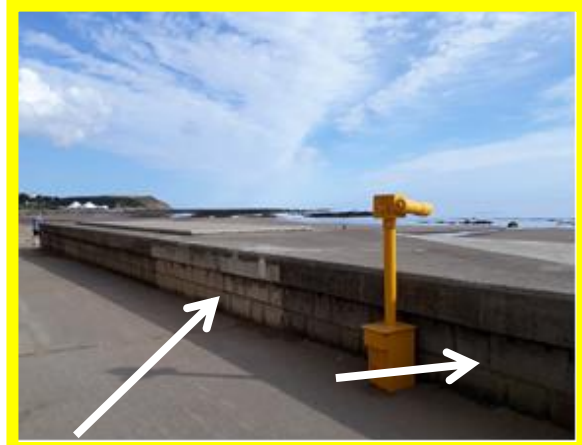
Vertical cracks in wall protecting recent development (/1201C06)

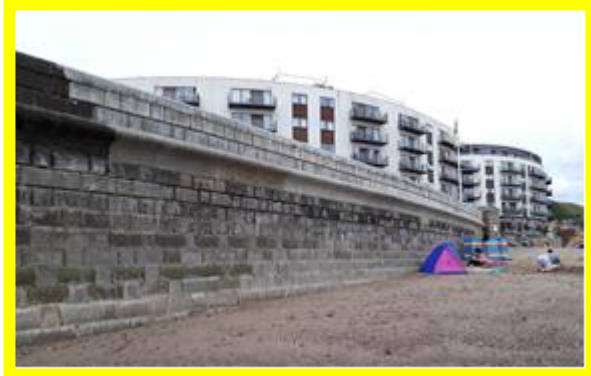
The wall at Peasholm Gap (/1201C19) has had an extensive number of significant repairs in 2014 which are holding well, with sections rebuilt or overlaid. However, there are still some damaged areas of blocks and spalling to the splash beam in areas not yet repaired. Overall, the wall remains in fair condition.

Previous repairs to wall at Peasholm Gap (/1201C19)

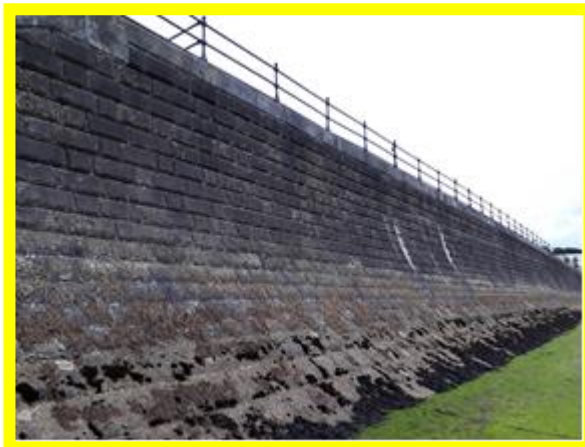
South of Peasholm Gap the beach levels drop and Royal Albert Drive is protected by an increasingly high curve-profiled blockwork wall (/1201C07 and C21) that runs south to the slight promontory at the ramp opposite the recently redeveloped Oasis Café. The previous repairs to joints, damaged wing-walls to beach access steps and entire sections of full height wall are holding well. However, one crack has opened in the wing-wall to the access ramp (which is closed off to the public) and another in the coping above the blockwork. The promenade along part of this section was re-laid in 2012 but remaining poor in other sections. Beach levels were relatively low at the time of the inspections, exposing the concrete apron which seems in fair condition although was subject to extensive algae growth.

High curved-profile seawall (/1201C07)

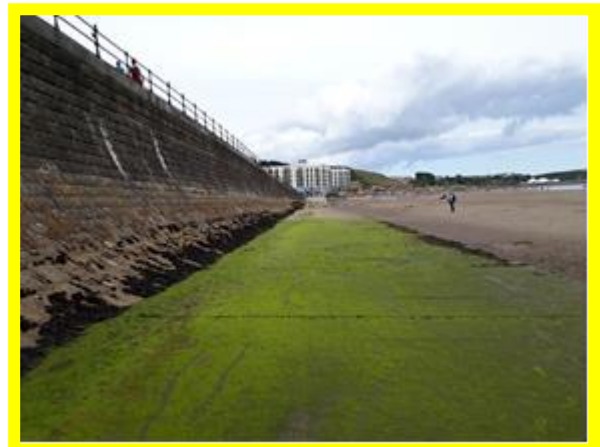
Toe apron with algae growth (/1201C07)

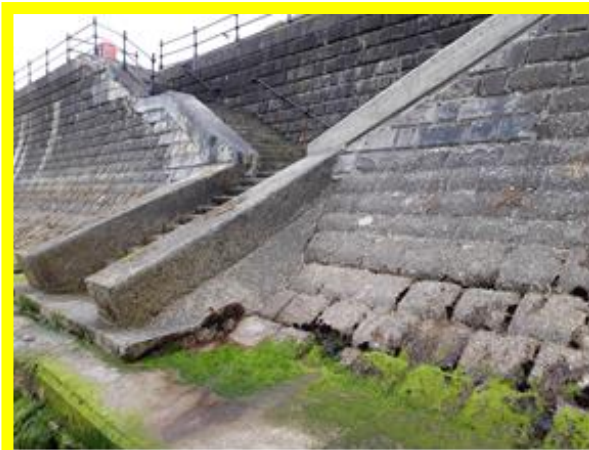
Previous repairs to wing-wall (/1201C07)

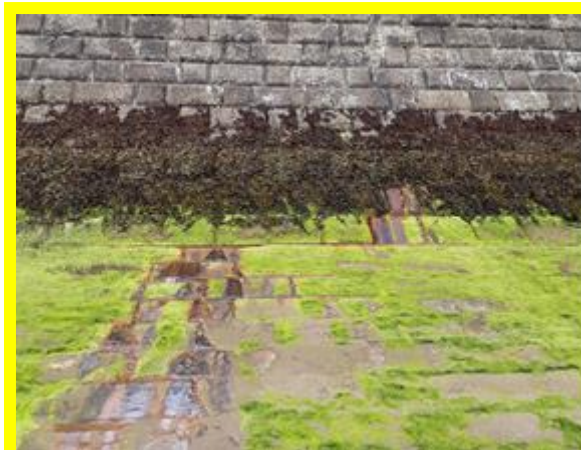
Leak through previous crack repair to seawall (/1201C07)

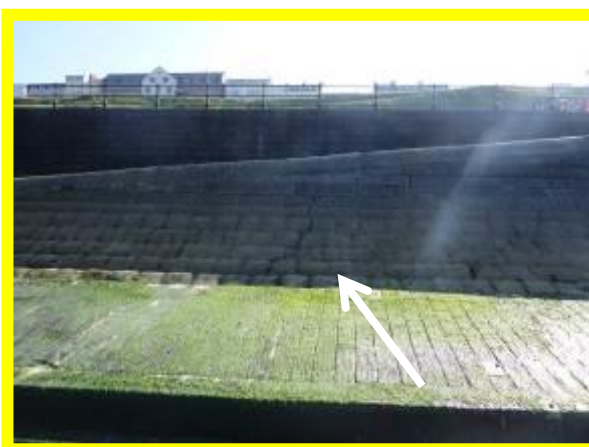
One of two notable cracks visible in wing-wall at access ramp (/1201C21)

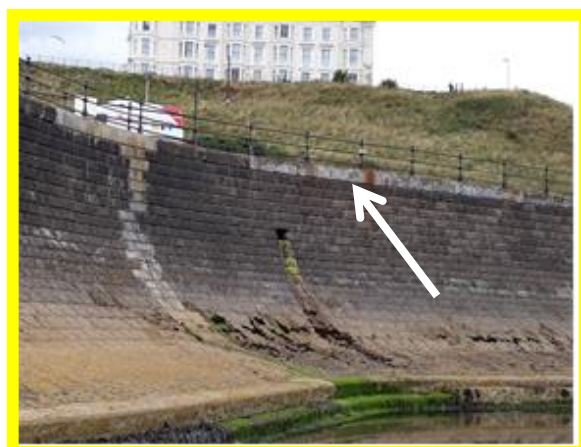
Small cracks in seawall coping adjacent to area of previous seawall repairs (/1201C21)
