Cell 1 Regional Coastal Monitoring Programme Walkover Inspection Surveys 2018

**Scarborough
Borough Council**

October 2018

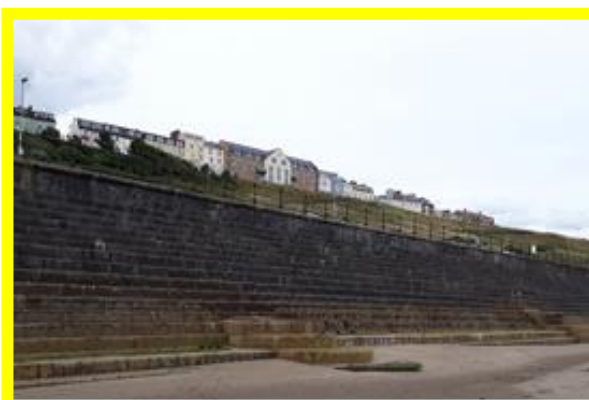
At the southern end of the North Bay, there is a large stepped concrete blockwork sea wall structure (/1201C08) constructed with nine large buttresses/bastions which protrude from the wall out onto the beach. The apron of the structure becomes increasingly exposed with progression north along the wall. There is one longitudinal crack in the blockwork across several adjacent blocks but otherwise the wall is in fair condition, although the promenade surface is poor in places.

Concrete blockwall wall with buttresses (/1201C08)

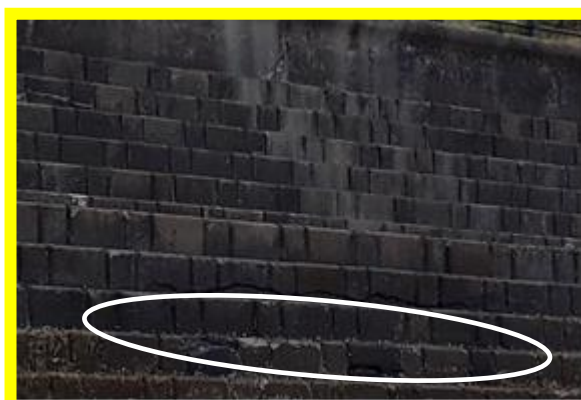
Longitudinal crack in blockwall wall (/1201C08)

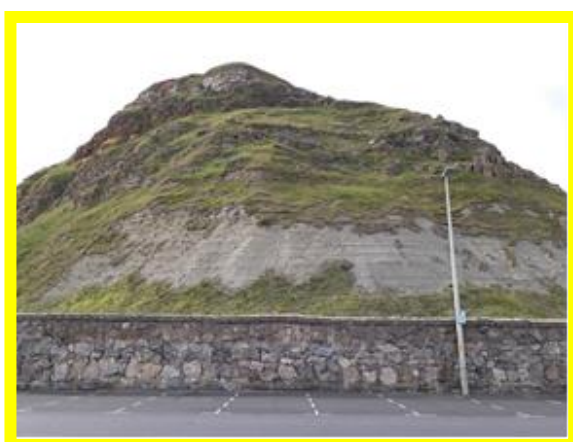
Unit MU21/2 forms the Castle Cliff promontory and continues to be classified as Locally Active, unchanged from recent inspections. The cliffs are steep with extensive toe protection measures. Locally, bedrock is exposed where it is subject to ongoing weathering and erosion from rainfall.

MU21/2 Castle Headland cliff (Locally Active)

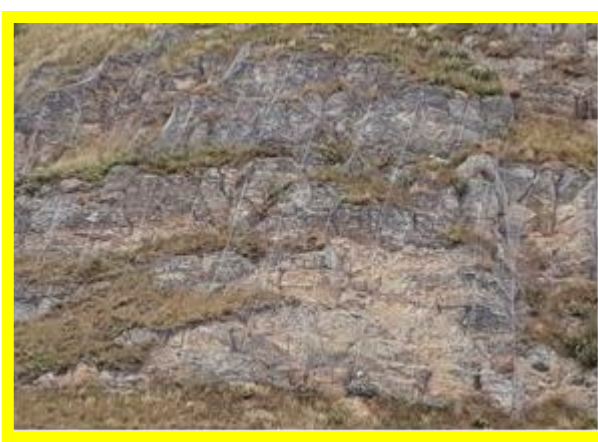
MU21/2 Rock netting on parts of Castle Headland cliff (Locally Active)

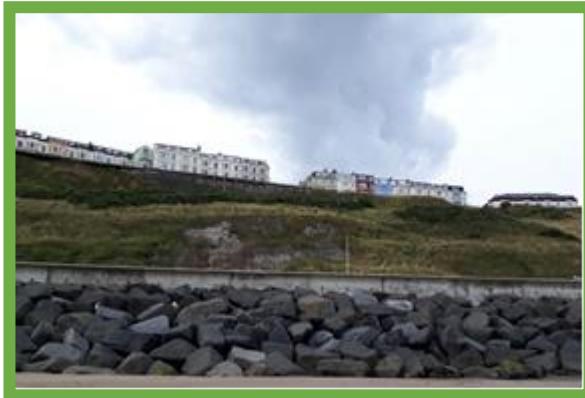
Part of the wider East Pier to the Holms Coast Protection Scheme, constructed between 2003 and 2005, protects this frontage with a rock armour revetment which extends from the southern end of North Bay (/1202C03). This continues through the Holms as rock armour with concrete toe piles to reduce the footprint of the defence, thus limiting encroachment into the foreshore SSSI (/1202C04). There is a continuous wave return wall along the crest of these defences, which remain in good condition along both asset lengths. Where there are beach access steps through the rock armour in the south part of North Bay (/1202C01), there is considerably more abrasion damage to the steps and locally scoured areas of the beach which leave a standing pool of water at low tide, making access to and from the beach difficult, but the structures themselves remain sound.

Rock armour revetment and wave return wall (/1202C03)

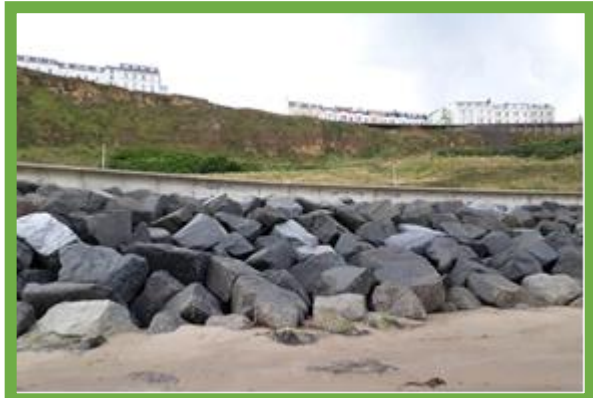
Rock armour revetment and wave return wall (/1202C03)

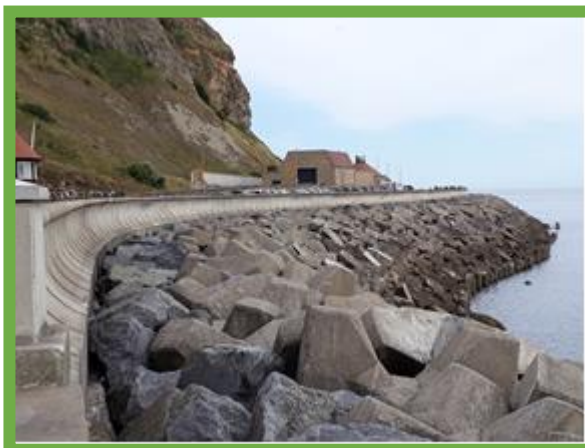
The section of defence continuing around the Castle Headland to the harbour is an Accropode revetment with concrete toe piles and a rock armourstone crest, with a concrete wave return wall (/1202C02). The inspection was limited to views from the crest wall and it was not possible to inspect the toe as along most of the length it is below water in all tide conditions. Overall, these defences remain in good condition with only localised evidence of concrete abrasion and cracks in the Accropodes. The crest wall is generally sound with only minor cracking and good joint seals. The promenade remains in overall good condition.

Accropode revetment with concrete toe piles, rock crest and wave return wall (/1202C02)

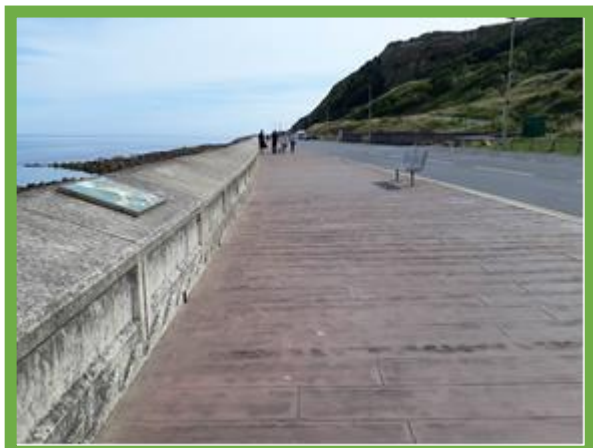
Promenade deck and wave return wall around Castle Headland (/1202C04)

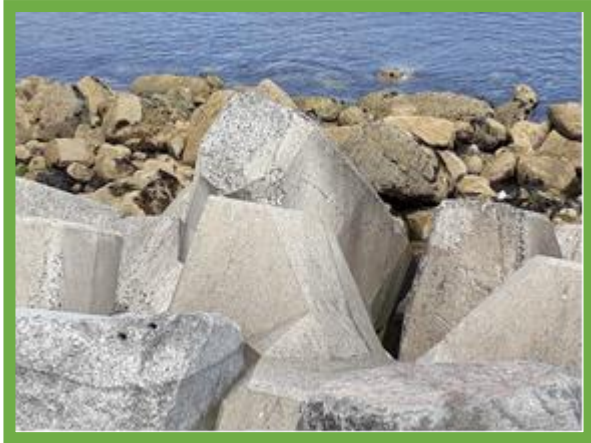
Locally abraded Accropode unit but otherwise good condition revetment (/1202C04)

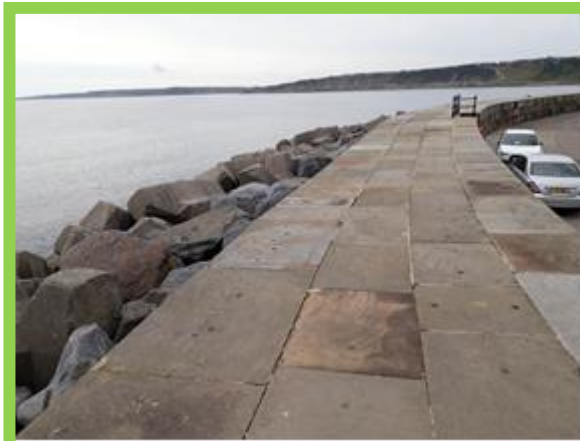
The outer facing pier of East Harbour's outer pier is protected by rock armour and Accropode units (/1301C01) and is in good overall condition. Towards the seaward end of the pier, many of the original wall blocks on the crest of the outer wall are heavily abraded and some are partially cracked.

East Harbour outer pier (/1301C01)

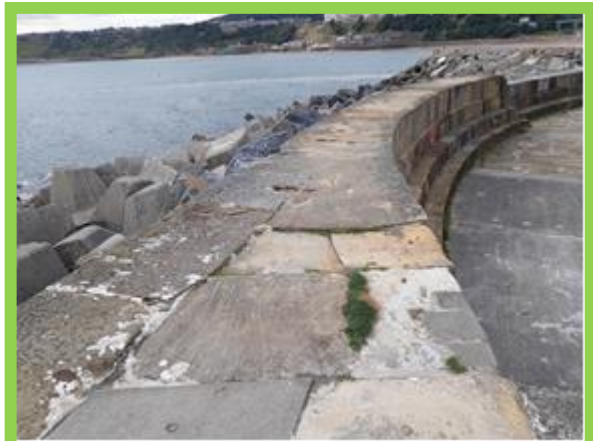
Abrasion towards seaward end of East harbour outer wall (/1301C01)

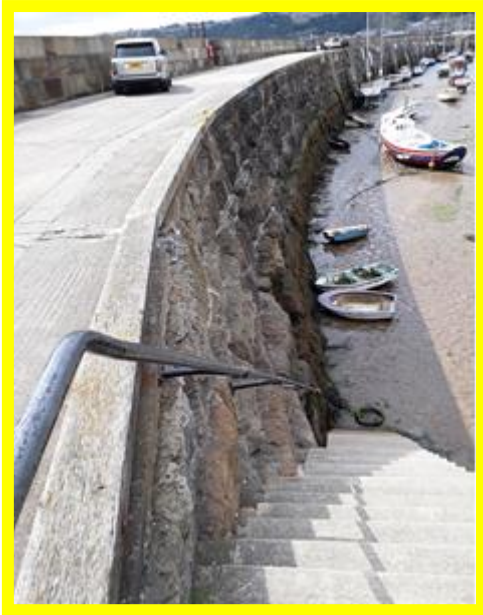
The inner facing wall of East Harbour's outer pier (/1301C16) was refurbished as part of the 2005 scheme, with missing blocks replaced and joints filled. Minor missing joints and cracks appear throughout the harbour masonry walls. The inner face remains in fair condition.

Inner-facing wall of East Harbour outer pier (/1301C16)

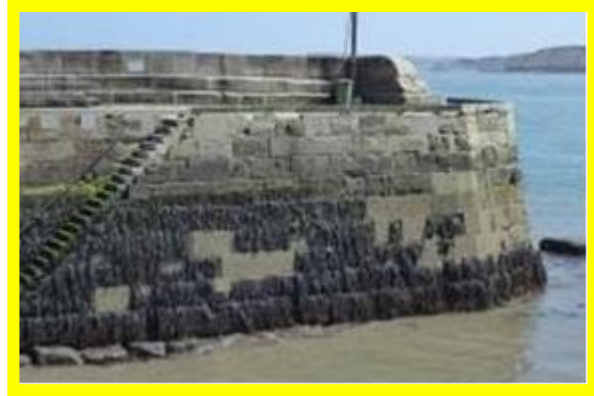
Previous repairs to inner-facing wall of East Harbour outer pier (/1301C16)

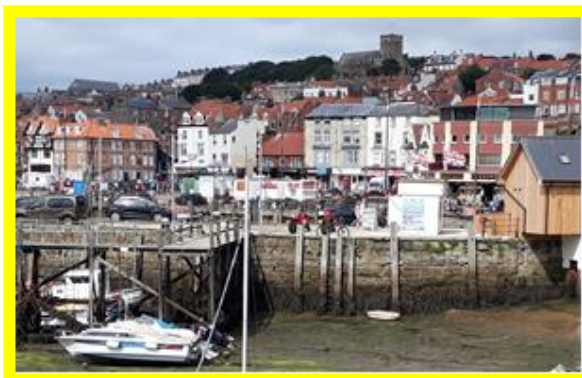
Vincent's Pier (/1301C04) separates East Harbour from Old Harbour and is in overall fair condition. The wall facing East Harbour is largely covered by timber boarding and algae growth, making inspection difficult, but where visible the blockwork and joints are sound. The pier deck is in good condition.

Wall of Vincent Pier facing east (/1301C04)

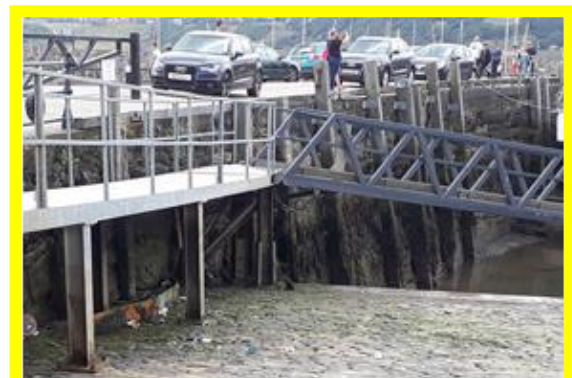
Wall of Vincent's Pier facing west (/1301C04)

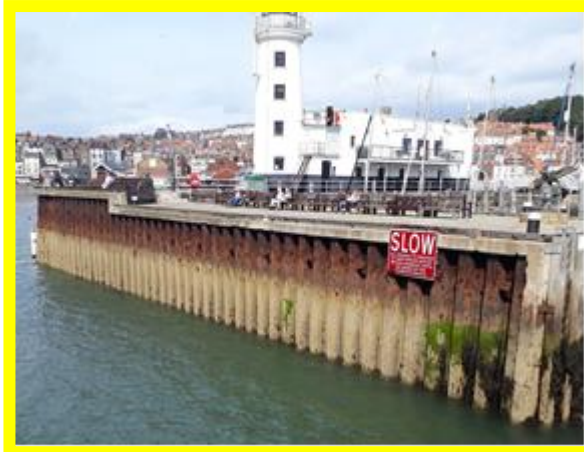
At the harbour arm beyond the Captain Sydney Smith Bridge, near the lighthouse, the steel sheet piling on the outer wall (/1301C17) is corroded but no holes were obviously apparent. However, it is notable that the blockwork walls at the end and inner facing walls (/1301C03) of this pier have open joints, although the overall condition of the pier remains fair.

Corroded steel sheet piling (/1301C17)

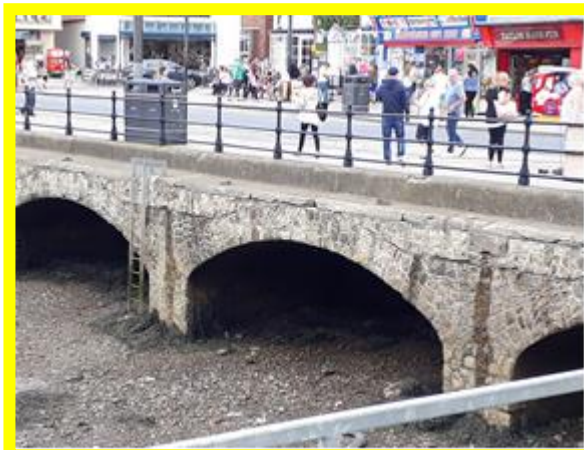
Some Cracking and missing joints to top of capping to wall south of roundabout opposite arcade. (/1301C05)

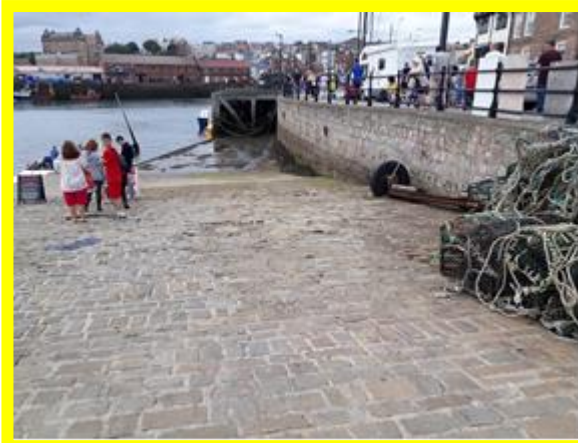
West of the arches, the quay wall leading to the slipway midway along Sandgate is formed by steel sheet piling (1301C12) which is corroded but otherwise appears in fair condition. The slipway (1301C11) is in fair condition, as is the short length of visible blockwork quay wall (1301C06) adjacent to the slipway. Immediately west of here is a concrete jetty which has been constructed to extend a suspended deck seaward of the wall. Previous inspections have reported signs of movement of the jetty and original quay wall, but this was not obviously apparent at the time of the present inspections and there was no sign of cracking in the deck. The slipway and wall at the western end of Sandgate (/1301C14), adjacent to the West Pier, is in fair condition.

Slipway, quay wall and concrete jetty (/1301C11 and C06)

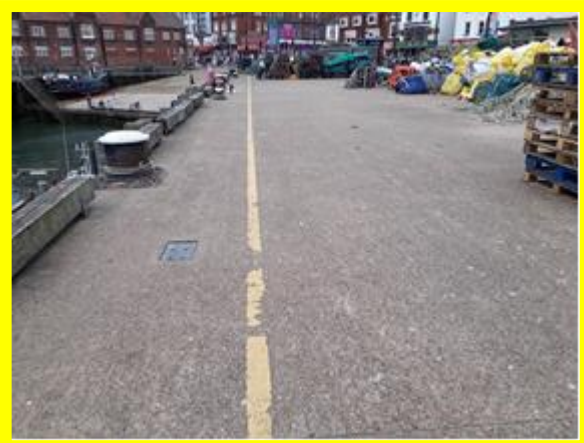
Suspended deck of concrete jetty (/1301C6)

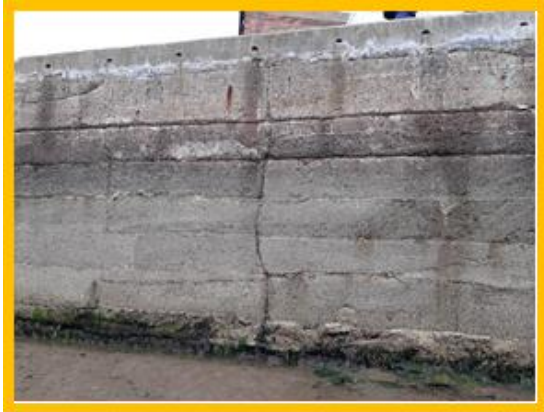
The outer face of West Pier (/1301C07) continues to show several significant defects including numerous longitudinal cold joints, several large full height cracks and exposure of aggregates. Its condition has been recorded as poor since 2009. Some previous repairs are obvious but in places cracks remain partly open. There is one area of voiding near the toe of the wall and spalling and loss of render near the seaward end of this southern face. Repairs are recommended.

Longitudinal cold joints in south face of West Pier wall (/1301C07)

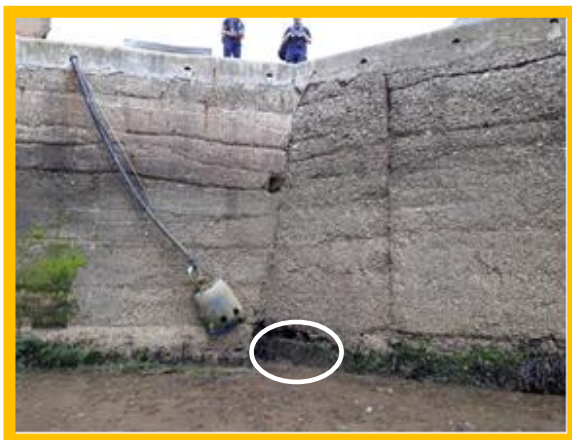
Void at toe in south face of West Pier wall (/1301C07)

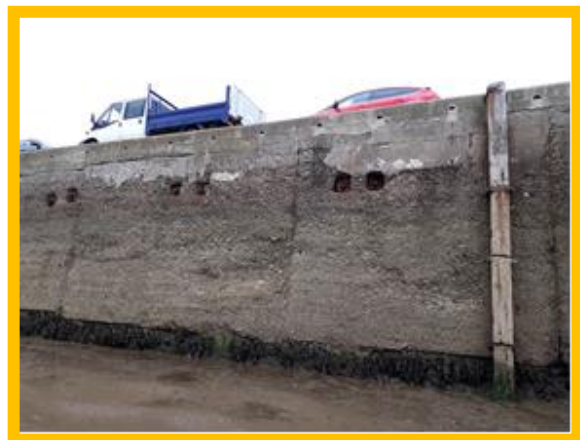
Spalling and loss of render in south face of West Pier wall (/1301C07)

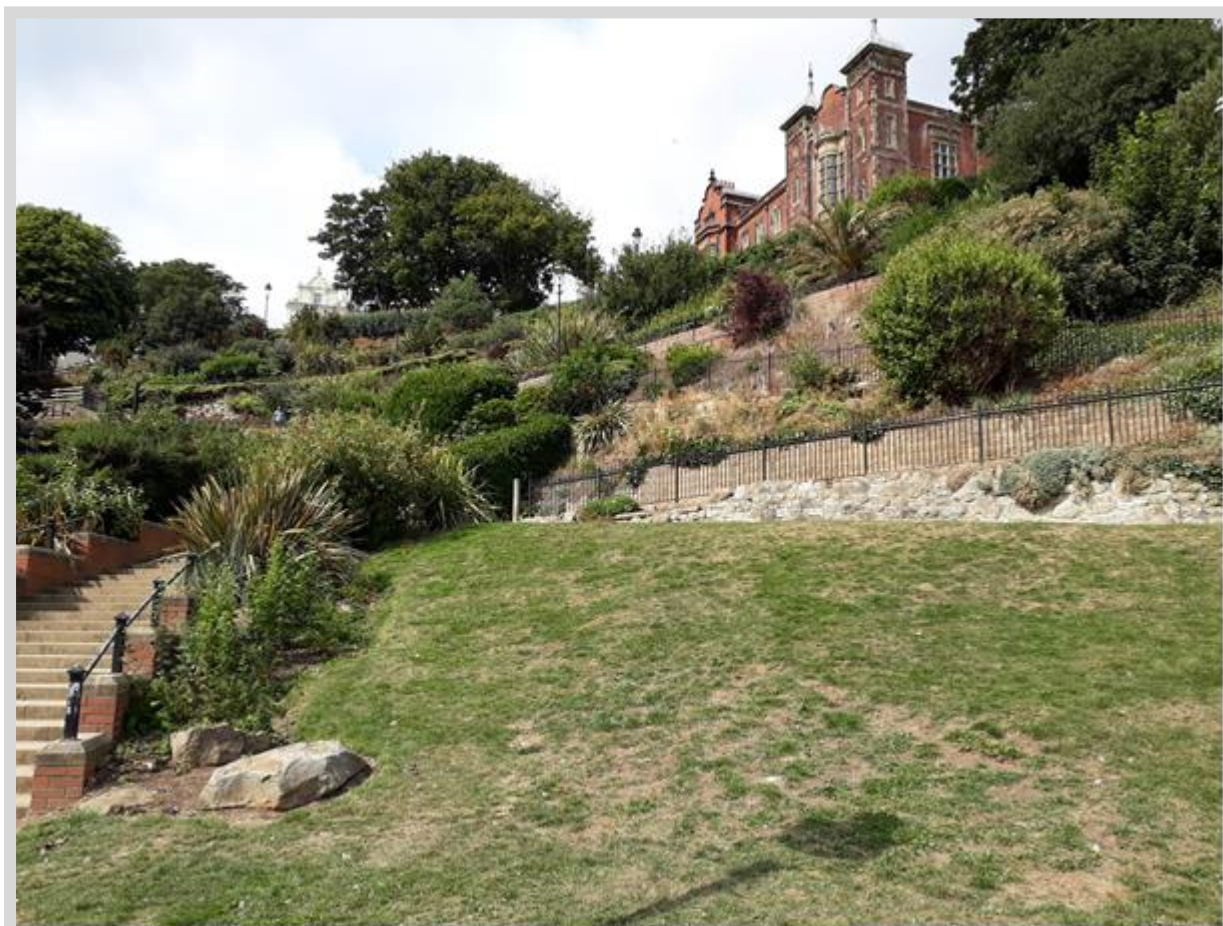
Terraced gardens at St. Nicholas Cliff

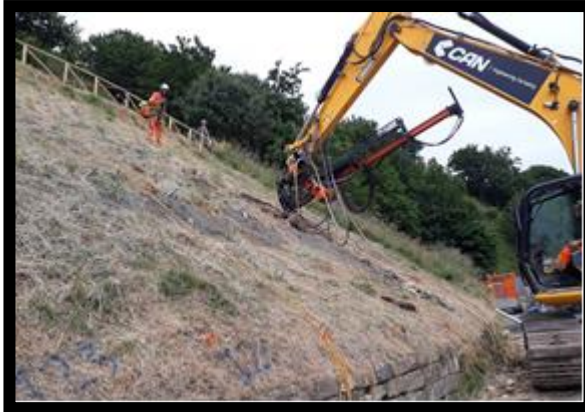
MU22/2 Soil nail installation on coastal slopes near the Spa

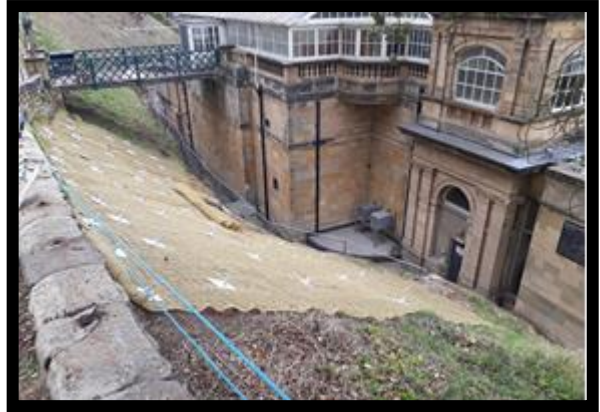
MU22/2 Soil nail and slope mesh installation behind main Spa building

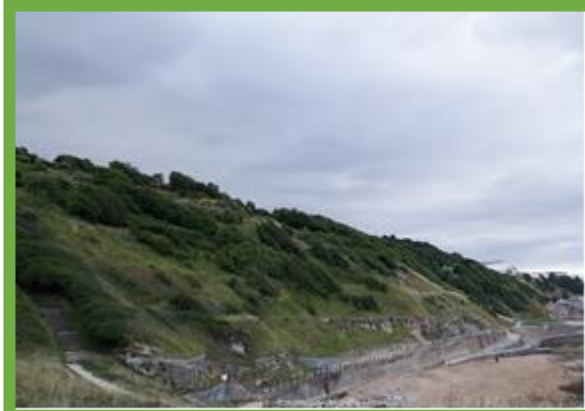
Unit MU22/7 is located at Holbeck Gardens and is classified as Inactive in 2016, unchanged since 2012. A number of footpaths in have previously been closed due to cracking and ongoing instability. Otherwise, the slopes are well vegetated except for an area of exposed bedrock subject to small rockfalls at the cliff toe. The promenade at the base of the cliff is protected by a rockfall catch fence.

MU22/7 Coastal slopes near Holbeck Gardens (Inactive)

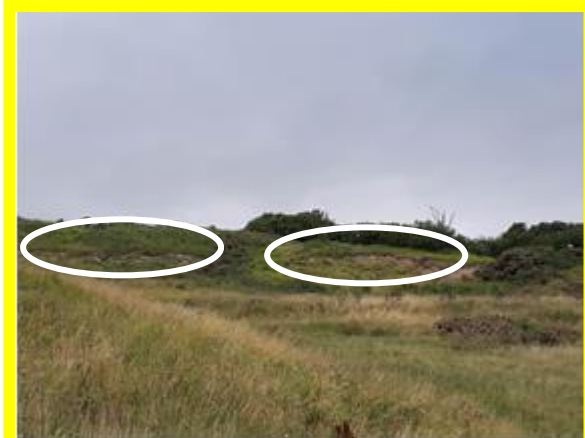
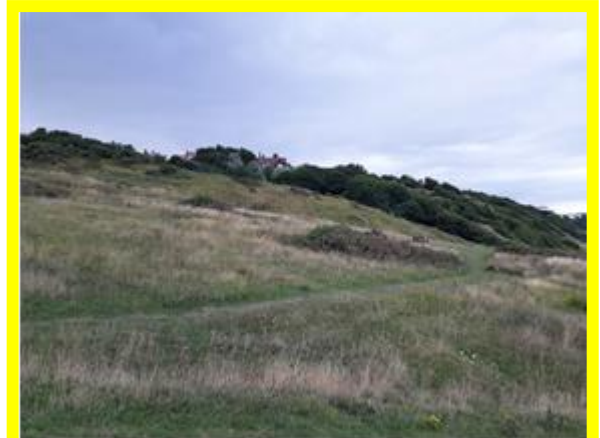
Unit MU22/8 comprises the stabilised Holbeck Hall landslide run-out lobe and is protected at the toe by boulder armour. Localised sections near the headscarp are exposed. This unit is classified as Locally Active in 2018, unchanged.

MU22/8 Coastal slopes at Holbeck Hall landslide (Locally Active)

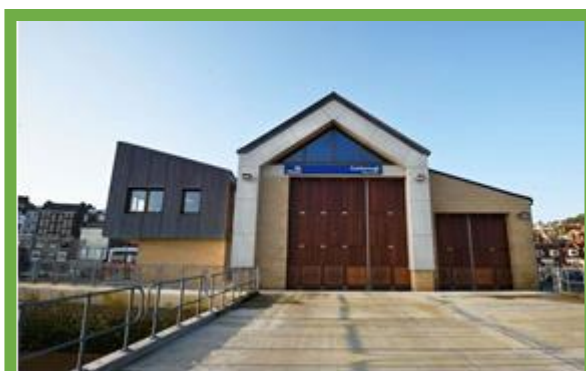
The South Bay defences start at the RNLI lifeboat station, adjacent to West Pier (/1301C08). The construction of the new RNLI Lifeboat Station has been completed since the last inspection. The works were completed in November 2016 and were found to be in As Built condition during the 2018 survey.

New RNLI lifeboat station and slipway (/1301C08)

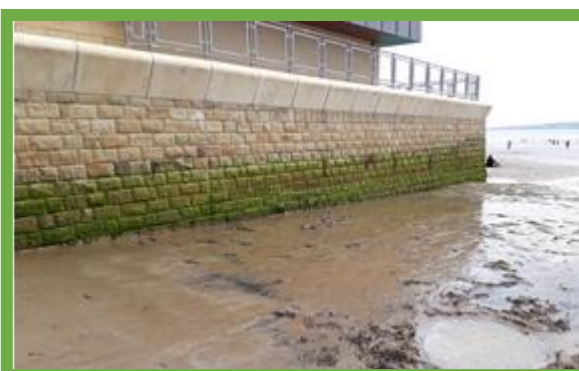
New RNLI lifeboat station wall (/1301C08)

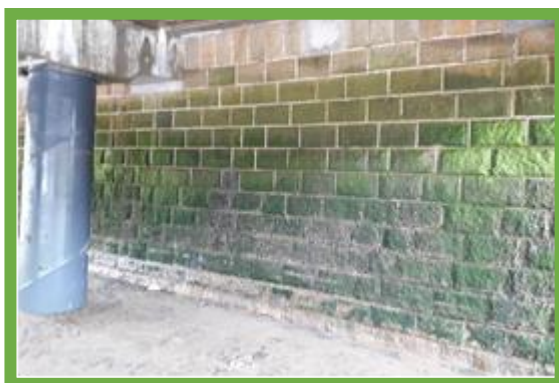
New RNLI lifeboat station wall beneath slipway (/1301C08)

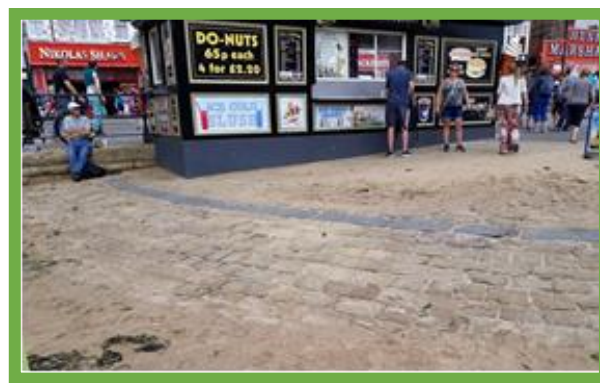
Slipway next to RNLI station (/1301C20)

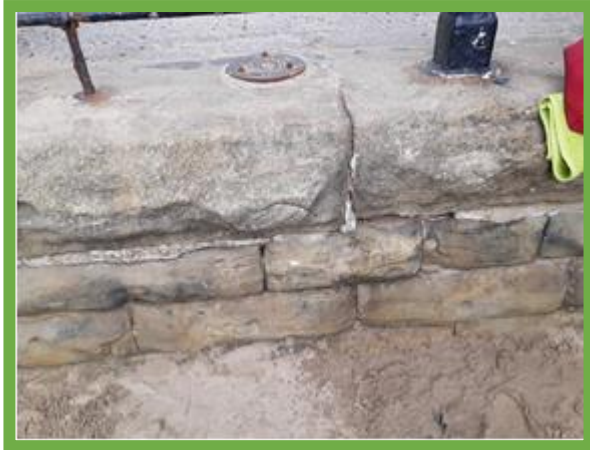
Beach levels flush with promenade at north end of Foreshore Road seawall (/1301C15)

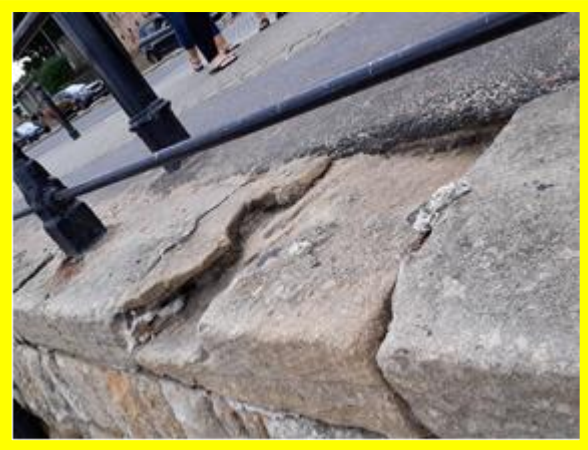
One of the worst areas of abrasion at top of wall (/1301C25)

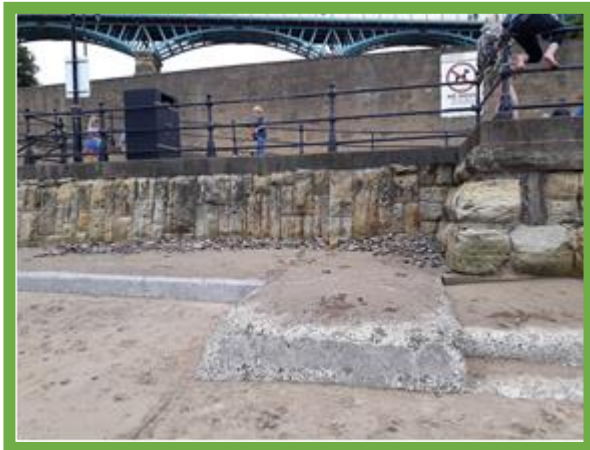
At the subway beach access in the vicinity of the Spa Bridge (1301C09), repairs have previously been made to the northern section of beach landing apron to the access steps and these remain in good condition. However, central and southern sections of the apron remain in fair condition. They are heavily abraded and in need of attention.

Previous repairs remain in good condition locally, but overall asset condition is fair (/1301C09)

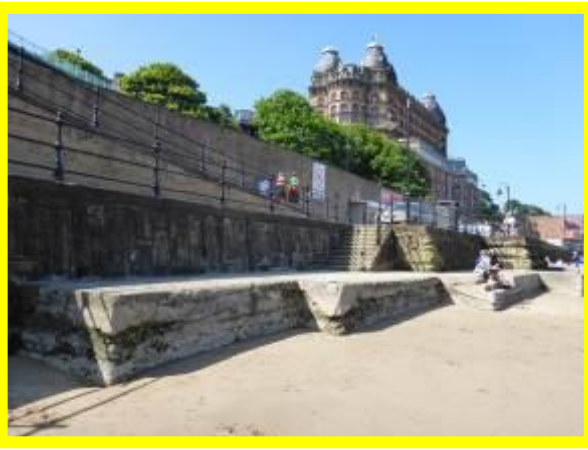
Abrasion of toe apron south of previous repairs (/1301C09)

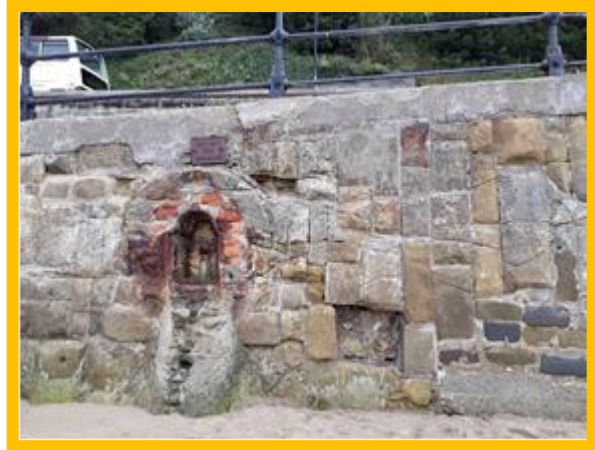
Missing blocks around Spa feature (/1301C10)

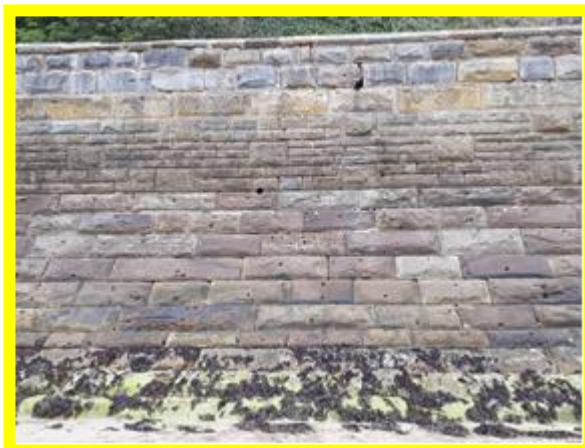
The recurved sea wall between Valley Road and the promontory at the Spa (/1301C26) continues to show occasional defects throughout, such as washout of joints and abrasion to the blockwork surface or coping, and some cracked blocks although they appear stable. It is in overall fair condition, with parts of the upper section having been rebuilt, but ongoing maintenance is needed. In one location, the timber piles at the toe of the structure were exposed and future inspections should check for signs of undercutting.

Occasional minor defects but overall fair condition seawall (/1301C26)

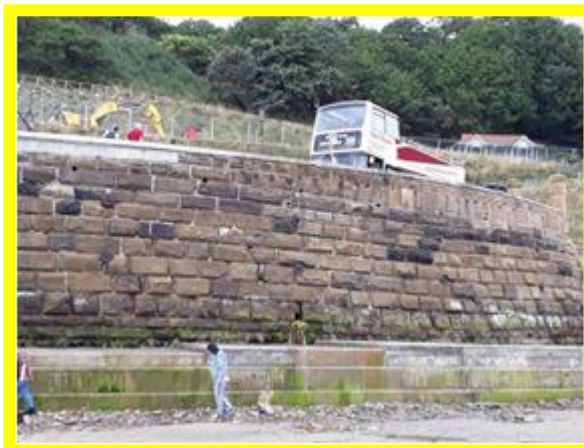
The masonry sea wall at the northern end of the Spa frontage (/1301C27) remains in fair condition following previous repairs, including reinstatement of a section of the masonry/concrete parapet after December 2013 storm damage. Previous repairs to fill joints between blocks in the wall's face also remain effective, but there are other occasional open joints between blocks which would benefit from filling and cracks are evident across the corners or full height of the face of some blocks. In front of the Spa building's entrance, one section of sea wall has longitudinal cracks across three adjacent masonry blocks, which is likely to be an area of potential weakness.

Masonry sea wall at The Spa access steps in fair overall condition (/1301C27)

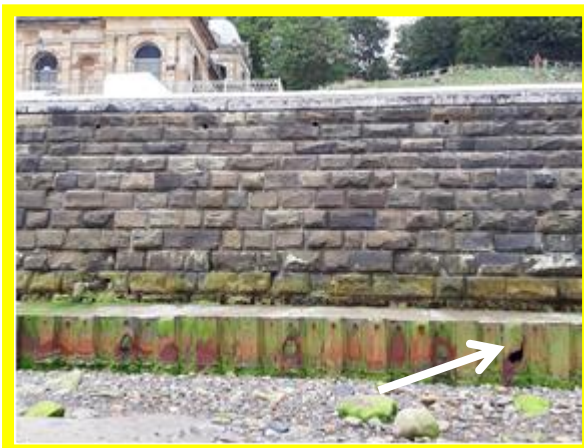
Example of gaps between blocks in sea wall (/1301C27)

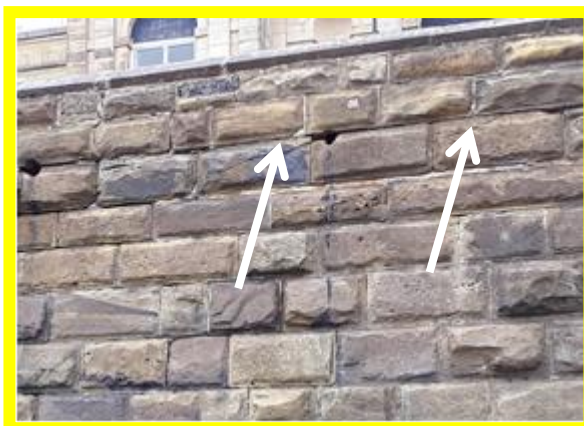
Longitudinal cracks across blocks in sea wall (/1301C27)

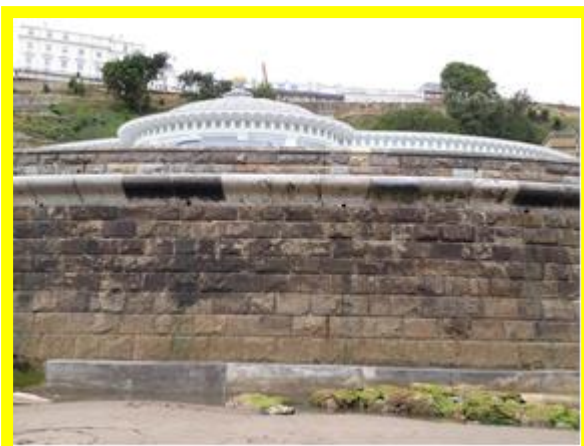
In front of the Sun Court (/1301C28), the wall has a concrete 'nosing' intended to act as a wave deflector below the parapet. Previous repairs to this element remain effective. The concrete toe beam was partially exposed along the length of the Sun Court and visible sections appeared in fair condition.

Previous repairs to wave deflector wall in front of the Sun Court & new concrete toe installed in 2017 (/1301C28)

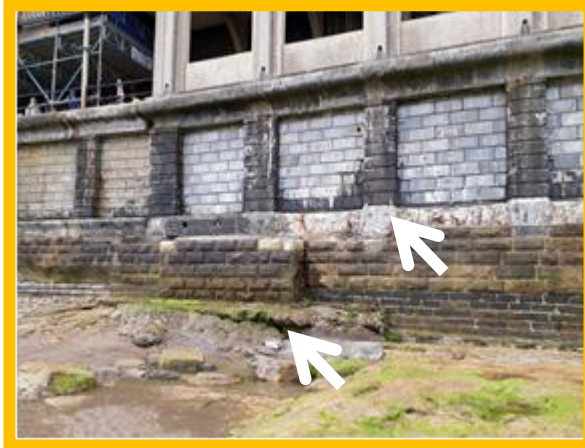
The wall between the Sun Court and the closed colonnade (/1301C29), remains in fair overall condition but has several small open joints. However, the closed colonnade section (/1301C29) has major spalling and loss of concrete to the lower splash beam below in-filled openings, tending towards poor condition. Some repairs have been undertaken since the previous survey to adjacent to the steps. The pillars between adjacent in-filled openings show some minor cracking.

Spalling to the lower splash beam at closed colonnade section and undercutting at toe (/1301C29)

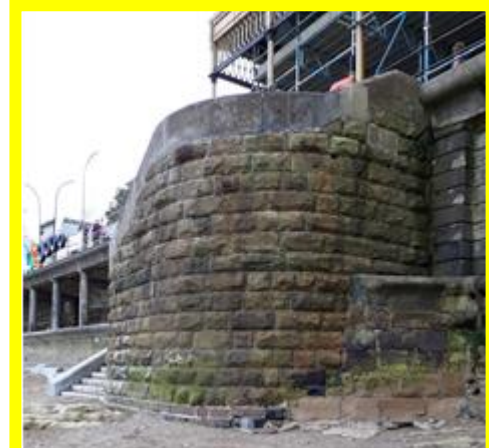
Area of repairs undertaken adjacent to the steps (/1301C29)

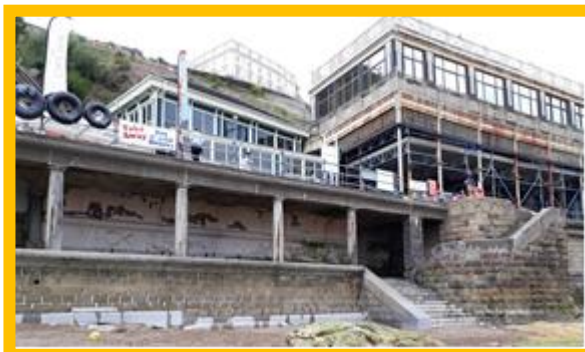
Along the open colonnade section (1302C01) there are three flights of access steps from the low-level promenade to the beach, all of which are heavily abraded. The wall itself is in generally in poor condition despite previous December 2013 repairs remaining effective, with significant areas of open joints in other sections of the lower wall. The support pillars are heavily stained and in places there is some cracking. The access steps to the beach at the southern tie-in have been subjected to extensive repairs following previous damage in December 2013.

Previous repairs (Dec 2013) at the open colonnade remain effective, but extensive open joints remain in lower wall (/1302C01)

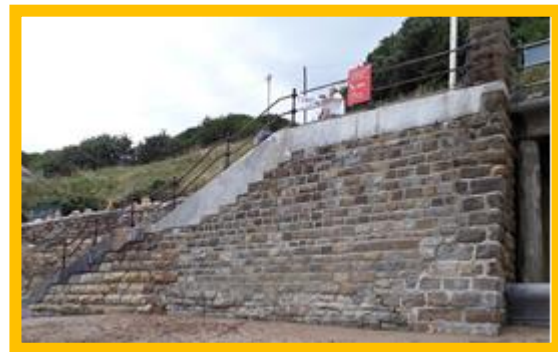
Previous repairs at southern tie-in following December 2013 storm damage (/1302C01)

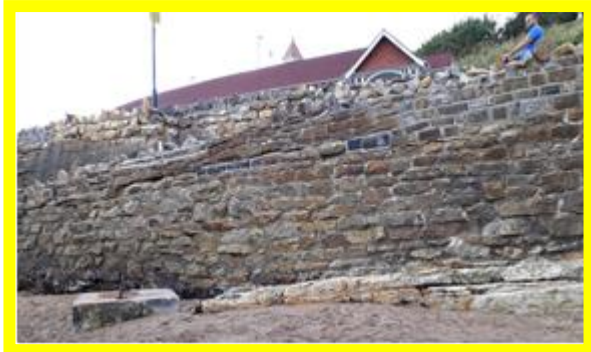
The low stone wall at South Cliff Gardens (/1302C03) has had a considerable number of repairs and rebuilding over the last few years, however notable cracks and gaps remain in need of further attention.

Overall fair condition of low stone wall (/1302C03)

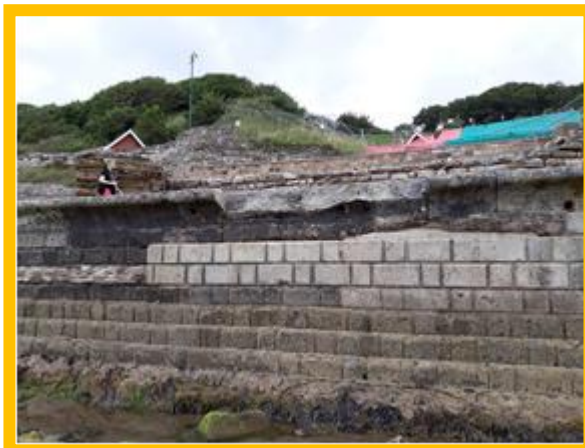
The low stone wall continues at the rear of the promenade around South Cliff Gardens with a seawall in front (/1302C02). The seawall has considerable previous repairs to the blocks and coping, a section of the wave wall is severely damaged in one area. At the southern end of the wall, a short section of concrete bagwork is present at the tie-in to the South Bay Pool seawall to the south. Here one bag has been plucked from the wall, creating a small void which also needs attention. These defences have caused the structure to be regraded to poor.

Overall fair condition of low stone wall with spalling to splash beam (/1302C02)

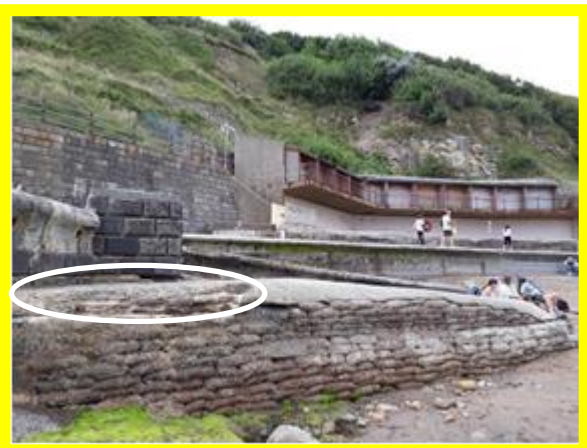
Missing area of bagwork/screed (/1302C02)

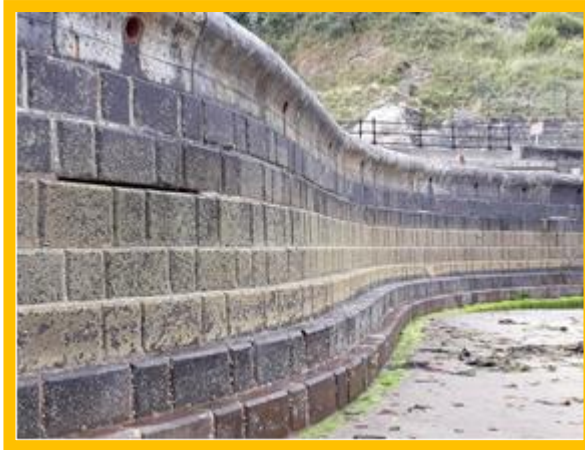
A concrete block wall (/1303C02) extends around the infilled lido pool, which is now used as a Star Disk. This wall has slightly stepped blocks on its face and these blocks and the wave return capping beam show continued signs of considerable abrasion. Some areas of the wall have been subject to beneficial repairs, but there are numerous other areas of open joints. In one location, a failed outfall pipe extends across the foreshore. The wall's condition has previously been classed as poor and ongoing repairs/maintenance would be beneficial.

Concrete block wall with open joints and heavy abrasion (/1303C02)

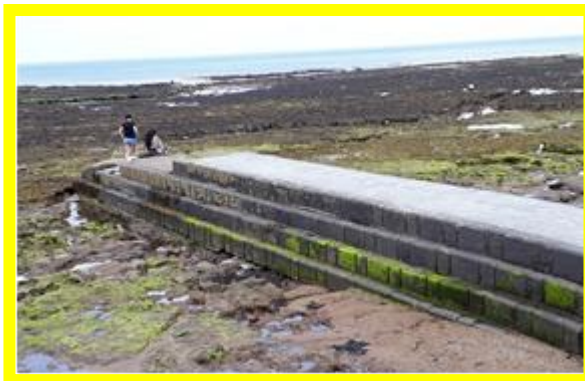
There is a bastion groyne at the north of this frontage (/1304C02) which has trapped sand between here and the rock revetment around the Hoilbeck Hall landslide to the south. The lower sections of the backing seawall have areas of previously repaired and currently heavily abraded coping, with previous repairs also evident on the upper wall. The backing promenade deck has some cracks.

Bastion groyne in overall fair condition (/1304C02)

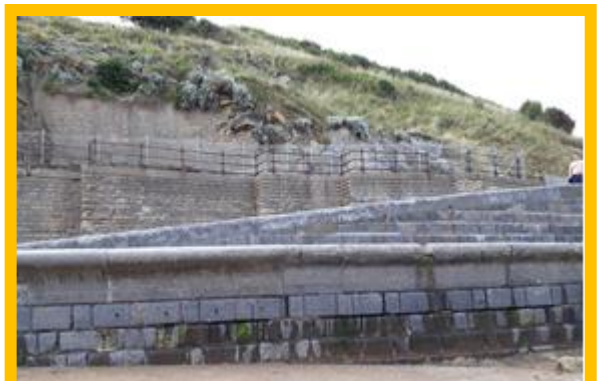
Seawall in overall poor condition Cracks to bastion throughout. Missing pointing / open joints and damaged parts of upper and lower capping beam. Mortar missing between blockwork in lower wall. Corroded handrail with missing sections. Upper prom has been fenced off. Full height cracks through uppermost wall. (/1304C02)

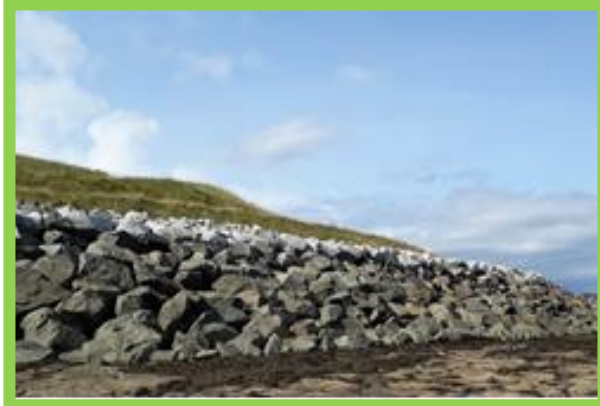
The rock armour revetment (/1304C01) defending the relict debris flow lobe at the site of the Holbeck Hall landslide remains in good condition, with the armour tightly packed and good coverage. At the southern end of the defence the beach access ramp has a short vertical drop to rocks at the end making its use slightly difficult and there a crack in the most seaward concrete section which would benefit from repair.

Rock revetment around debris lobe of Holbeck Hall landslide (/1304C01)

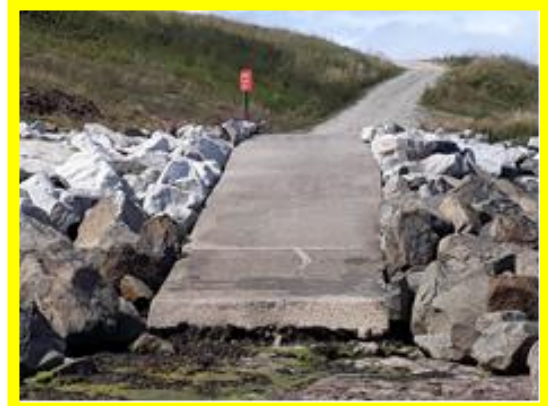
Vertical drop and crack in concrete at end of access ramp at south end of revetment (/1304C01)

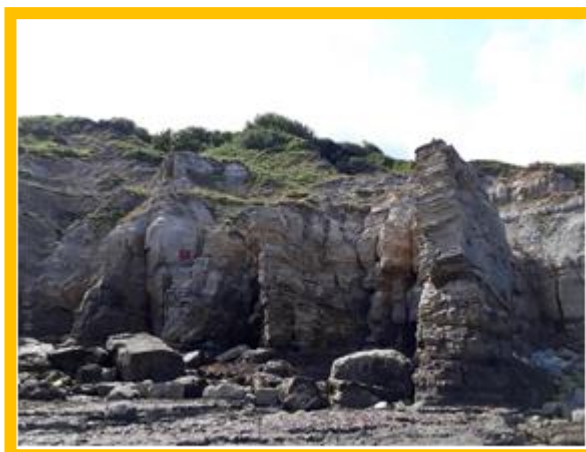
MU23/A Partially active evidence of significant amount of fallen rock at toe of cliff

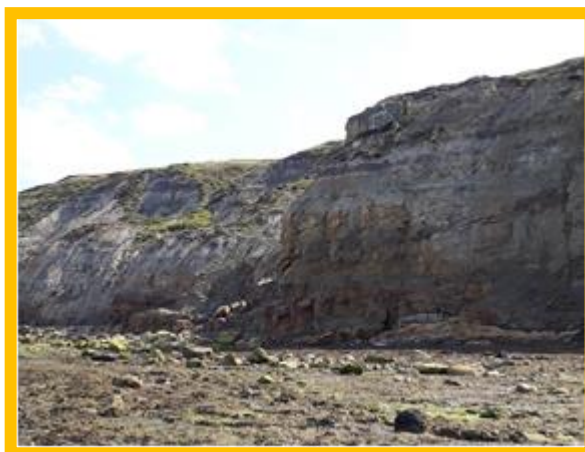
Units MU23/D1, MU23/D2 and MU23/D3 are located at Wheatcroft Cliff above Black Rocks. These units are active down much of their length, with ongoing recession of the headscarp, slumping in the mid-slope and erosion of the toe. They are classified as Partly Active in 2016.

MU23/D Partially active with ongoing recession at the headscarp

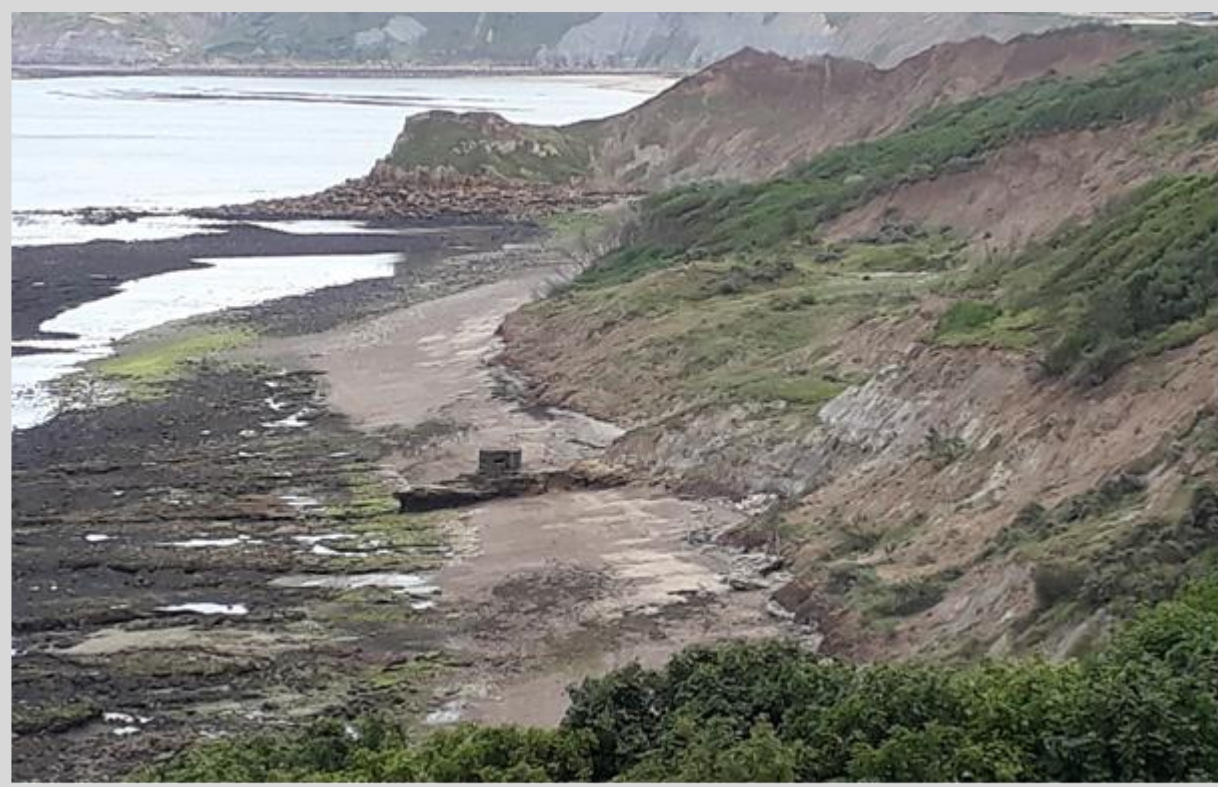
Unit MU23/F is a narrow, thin unit which follows a small valley occupied by an outflow channel for a pipeline and pumping station. The slopes inland are well vegetated and show very little evidence of recent activity. As a result, this unit is classified as Inactive in 2018. Works have been undertaken to repair the Yorkshire Water outfall at this site relatively recently (with a replacement long sea outfall scheduled to be built in the future).

View from **MU23/F** to **MU23/J** (status varies as below)

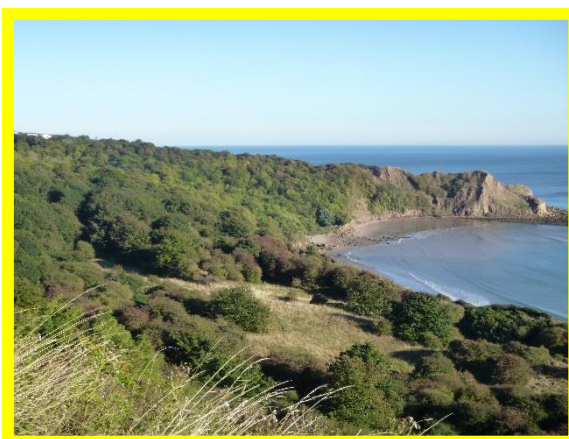
Immediately south of Osgodby Point, unit MU24/A comprises mudstone at beach level of the Cayton Cliff landslide complex. The wide expanse of Cayton Cliff is capped by till which is heavily vegetated. Significant recession of the head scarp occurred during an event in 2008-2009, resulting in the loss of land and properties at Knipe Point Drive. The cliff at the toe of the complex is steep and comprises uplifted debris from deep landslide movement. Only localised activity is evident at the toe and head scarp, with no evidence for movement in the body of the landslide, and so the unit is Locally Active in 2018, unchanged since 2012. The southern face of Knipe Point (sub unit MU24/A7) was found to be Partly Active in 2018, as it has been since 2008.

Heavily vegetated till of Cayton Cliff. MU24/A Locally Active in September 2018

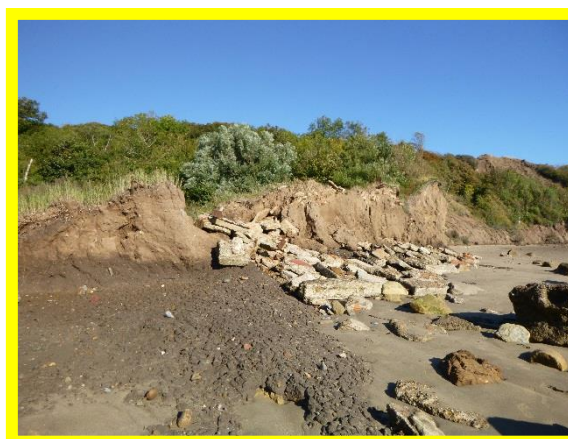
Toe of Cayton Cliff. MU24/A Locally Active in September 2018

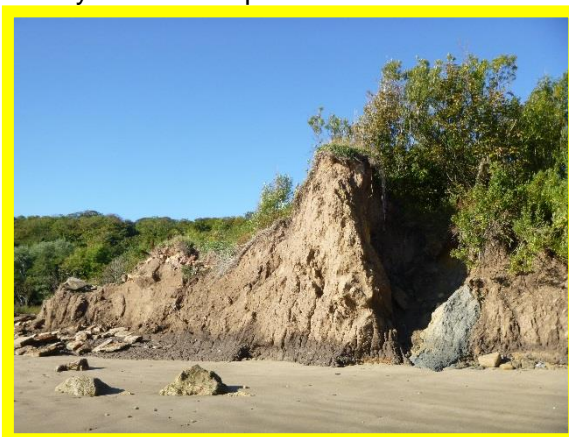
Toe of Cayton Cliff. MU24/A Locally Active in September 2018

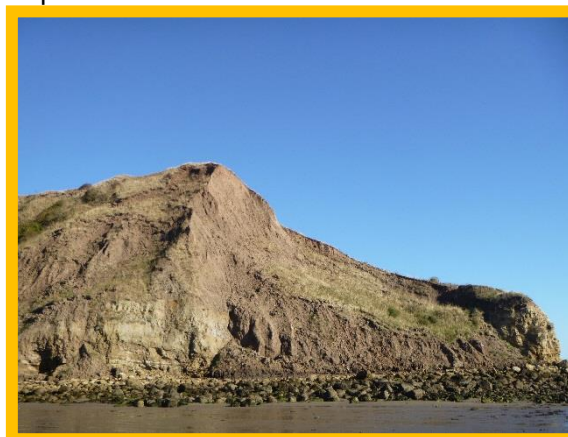
MU24/A7 Partly Active in September 2018

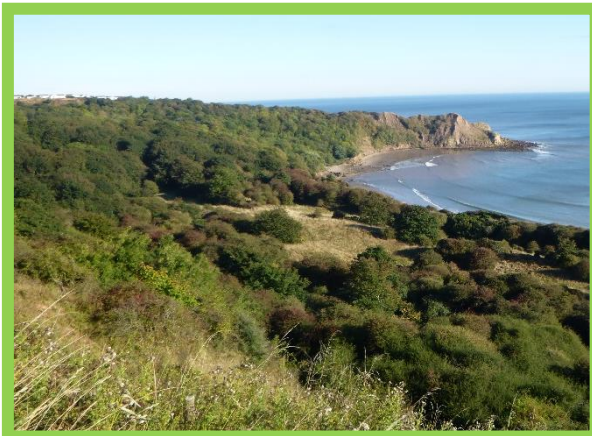
Tenants' Cliff is a complex of terraced landslips in mudstone and sandstone and is divided into 11 units. Unit MU24/B forms the main part of the Tenants' Cliff landslide and is classified as Inactive in 2018, no change from 2016. The toe of Tenants' Cliff is categorised into ten smaller landslide units comprised of massive displaced blocks of sandstone. The more northerly units (MU24/B1 and MU24/B2) are classified as Locally Active. Along the toe of these units there is an ongoing accretion of pebbly material with the beach profile increasing in gradient into MU24/B2. MU24/B3 to MU24/B8 remain classed as Partly Active in 2018. MU24/B9, where there is intense ongoing erosion of the unit toe, is classified as Totally Active. It was also noted that various ad hoc repairs have been made to the walls northern extent to counteract the outflanking caused by the retreat of this unit. All these units are classified the same as they were in 2016. MU24/B10 is protected by the seawall which extends northwards from the pumping station. During the 2016 survey it was completely vegetated and is classified as Inactive.

Heavily vegetated part of Tenants' Cliff complex. MU24/B Inactive in September 2018

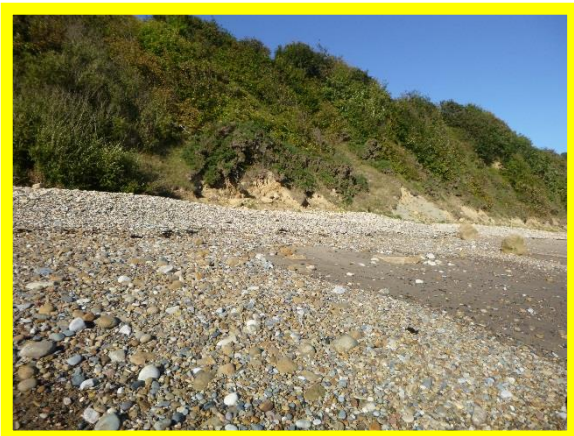
Toe of Tenants' Cliff complex. MU24/B1 Locally Active in September 2018

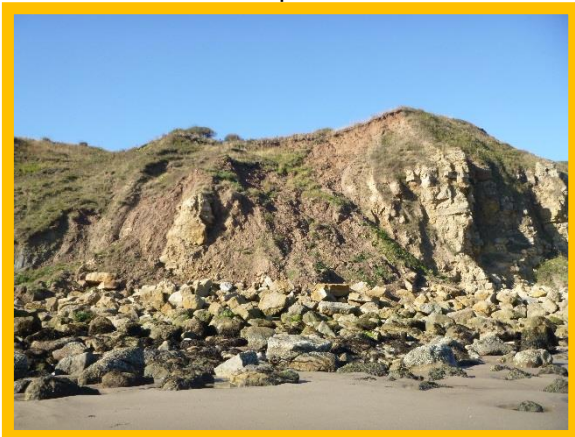
Toe of Tenants' Cliff complex. MU24/B4 (right) to MU24/B6 (left) Partly Active in September 2018

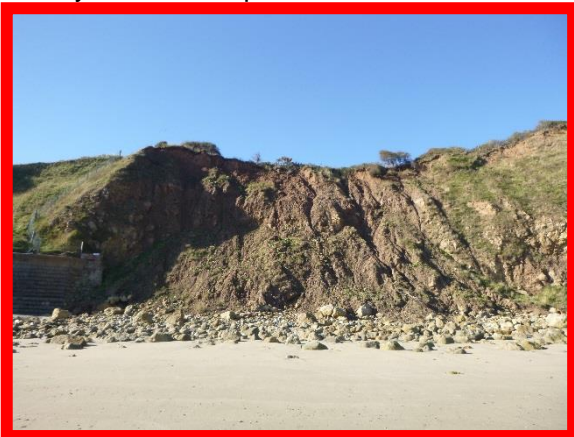
Intense erosion in MU24/B9 (Totally Active in September 2018)
