Cell 1 Regional Coastal Monitoring Programme Walkover Inspection Surveys 2018

**Scarborough
Borough Council**

October 2018

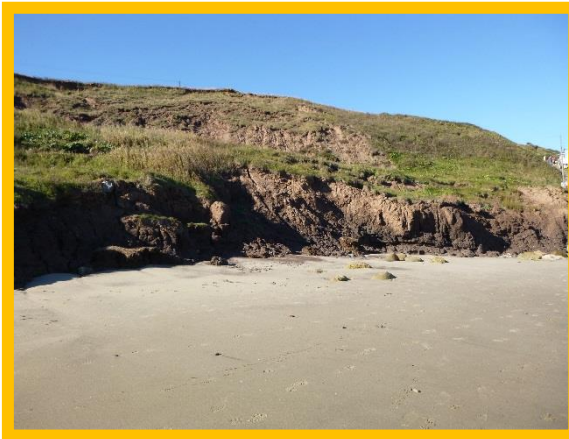
Units MU24/C to MU24/O are composed of glacial till down to beach level and stretch south from the pumping station as Killerby Cliffs. Apart from MU24/F, MU24/G, MU24/H and MU24/J, they are all classified as Partly Active in 2018, unchanged from 2014. The Partly Active units show active recession of the head scarp and slumping in mid and lower slopes. At the cliff toes, there is evidence of instability through slumping and erosion. In the south-central units (MU24/K to MU24/O), the slumped till may be masking bedrock in the lower cliff. An exception to the Partly Active classification is MU24/H which comprises the access route to the beach. The slope of this unit is engineered and well vegetated, with no obvious signs of recent activity, and so is classified as Inactive. The large bowl to the west of the beach access comprising of MU24/F and MU24G was noted as being well vegetated in 2018 with only some minor erosion of the toe, as such these units are classed as Locally Active. Additionally, although there is activity throughout much of the head scarp of MU24/J, there is less than in adjacent units, and so it is classified as Locally Active.

Toe of Killerby Cliffs. MU24/C Partly Active in September 2018

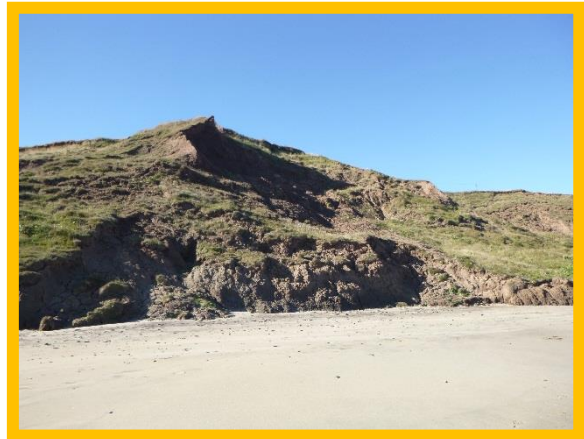
Till of Killerby Cliffs. MU24/D Partly Active in September 2018

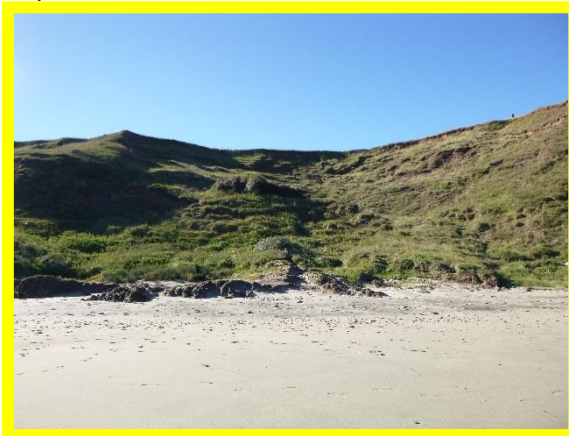
Vegetated till slopes of Killerby Cliffs. MU24/F and G Locally Active in September 2018

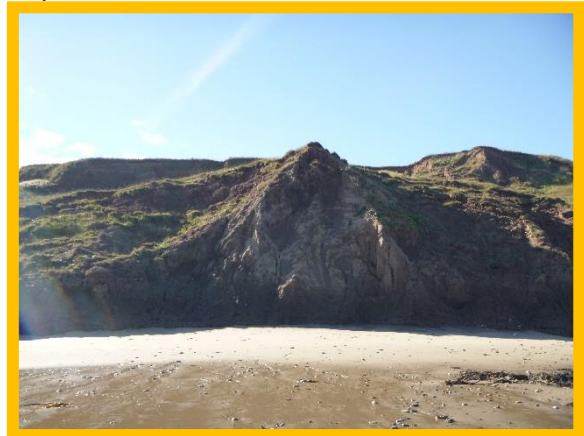
Toe of Killerby Cliffs. MU24/I Partly Active in September 2018

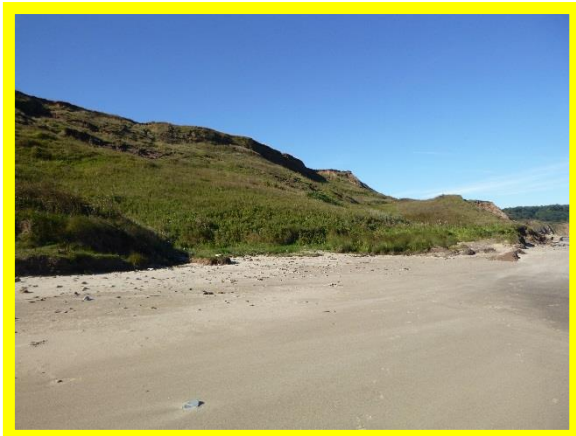
Toe of Killerby Cliffs. MU24/J Locally Active in September

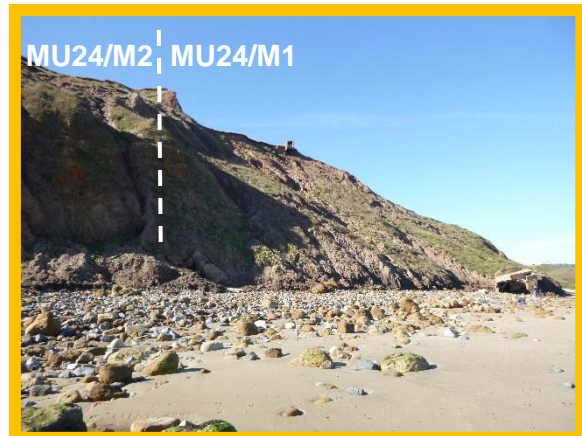
Till of Killerby Cliffs. MU24/M1 (right) and MU24/M2 (left) (both Partly Active in September 2018)

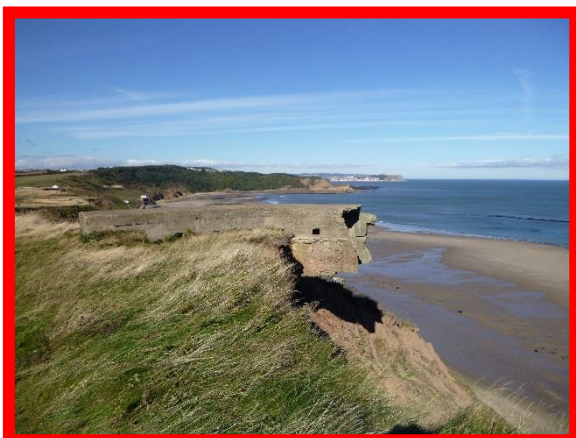
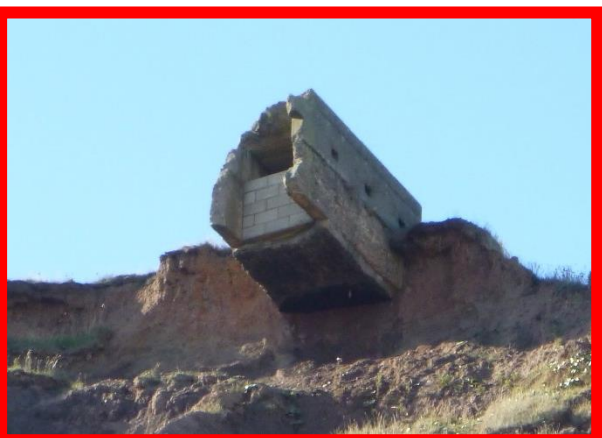
Due to the activity within cliff units MU24/L and MU24/M1 and the retreat of the headscarp at the boundary between the two units a historic WW2 pill box is significantly undercut and at risk of collapse, although there appears to be little change in the condition of the structure on from recent years. Due to the nature of the cliff units the structure poses a significant and potentially imminent risk to beach users. Additionally, the structure is easily accessible from the Cleveland Way path atop the cliff units, and has the potential to become a landmark feature. During the 2018 inspection a member of the public was seen to be standing on the structure, seemingly unaware to the degree it was undercut.

Looking north west towards Scarborough

Looking from up from the beach at the base of MU24/M1

Due to the difficulties associated with placing signage on the beach, and the inherent risks associated with access to the structure, options to minimize the risk to the public are not straightforward and will require some consideration.

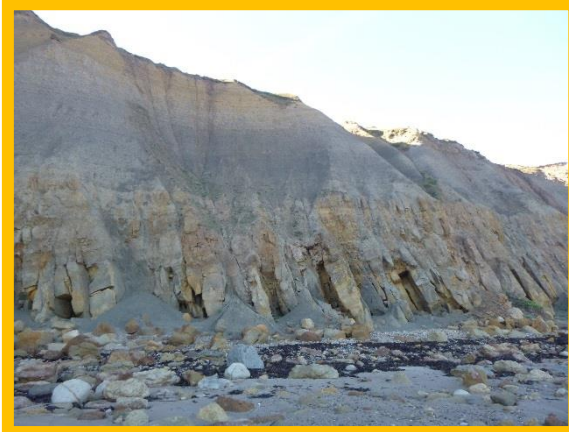
Units MU24/P to MU25/T are predominantly exposed near-vertical sandstone at the toe of a steep cliff overlain by mudstone with a thin capping of till. The sandstone is characterised by local rock falls on to the beach and platform with local small debris cones off the base of the mudstone. In 2016 all units MU24/P to MU25/T were downgraded from Partly Active (in 2014) to Locally Active. In 2018 the westernmost units (MU24/P and MU24/Q) showed signs of ongoing activity evidenced by several large debris cones. Additionally, the eastern headscarp of MU24/T showed further signs of activity and so has regained its Partly Active status. The remaining units within this section remain classed as Locally Active, no change from 2016.

Composite sandstone and mudstone cliffs in south Cayton Bay. MU24/P (right) and MU24/Q (left) (both Partly Active in September 2018)

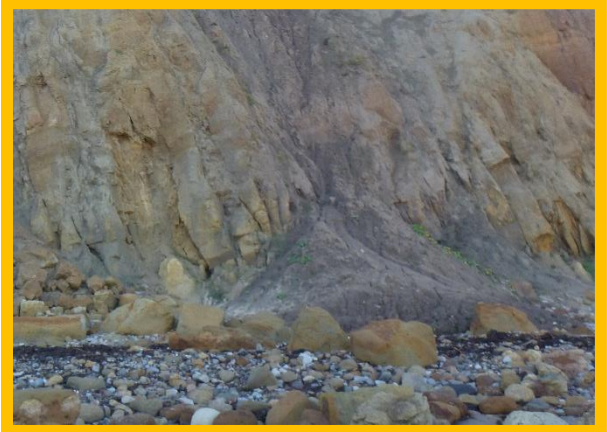
Local rock fall and debris cone in MU24/P (Partly Active in September 2018)

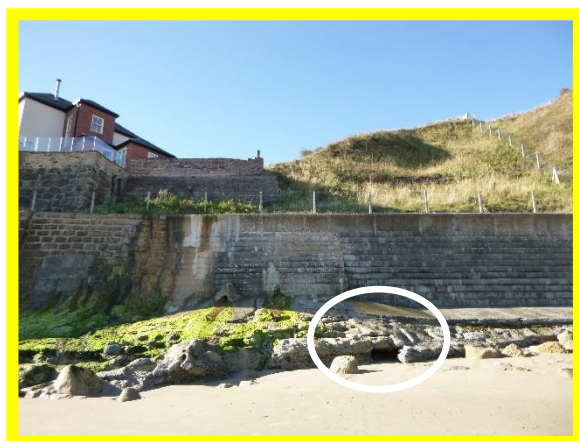
To the north of the pumping station (which is now converted to a private residence) is a private blockwork defence with concrete toe slab (/1402C02), which ties into the eroding cliffs to the north with a mixture of brick, stone blocks and concrete. The wall itself is in fair condition and appears newer than the wall to the south. During the 2018 inspection it was noted that low beach levels had exposed a large void in the apron of 1402C02. The depth of the void is unknown however it appeared to be in the order of 2 metres and may even be encroaching beneath the base of the wall. It is recommended that further investigation of this defect is undertaken determine the risk to the walls stability. The erosion of the undefended cliff immediately to the north of the tie-in appears to have slowed. Between 2012 and 2014, the wall became outflanked but in recent years it does not appear to have worsened. Despite this the northern transition remains at risk of being compromised by rockfall and erosional activity in this cliff unit.

Private sea wall in fair condition. Large void visible in wall apron. (/1402C02)

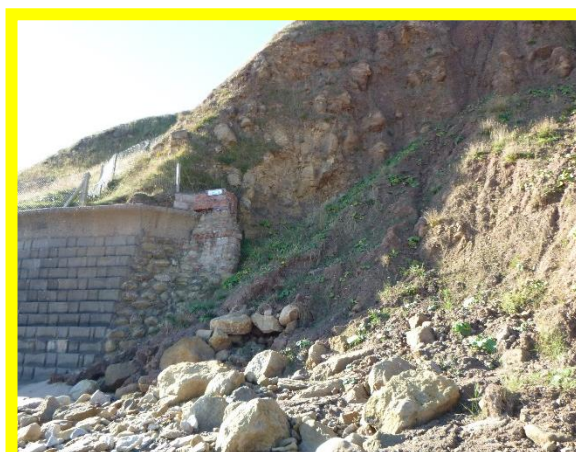
Erosion of undefended cliffs at tie-in of sea wall private sea wall (/1402C02)

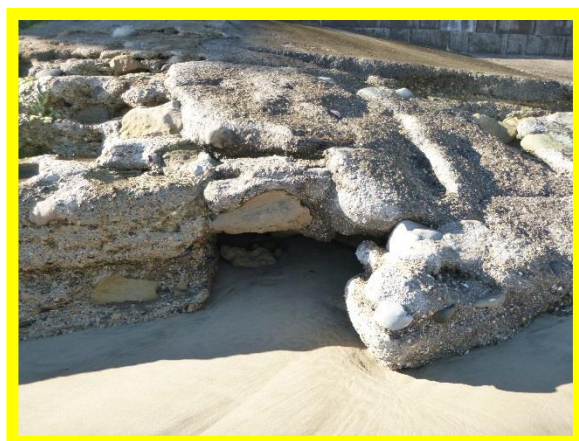
Large void in concrete apron to private sea wall (/1402C02)

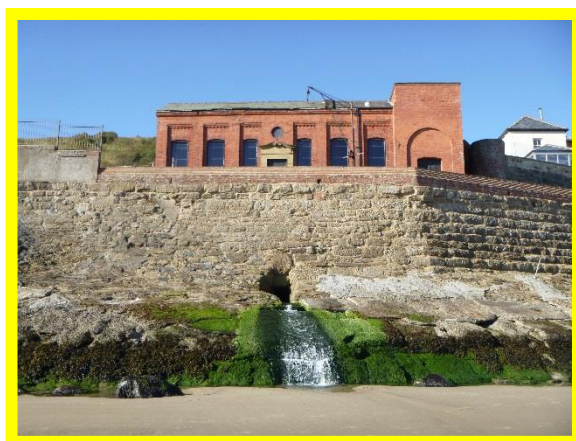
Private sea wall in fair overall condition but with the toe apron subject to ad hoc repairs (/1402C05)

The condition of the defences varies with the higher, red brick walls appearing sound, the lower, concrete and sandstone blockwork remaining in fair condition but the apron at the toe being the worst affected. Numerous ad hoc repairs were noted as being in a variety of conditions with the lower grouted repairs being the worst affected. In some locations undercutting of the concrete apron was visible, and particularly around the apex of the bend in the structure, marine vegetation may have obscured further voiding.

Overall the structure remains in fair condition following the 2018 inspection however, it is suggested that the condition is monitored closely particularly if beach levels continue to recede.

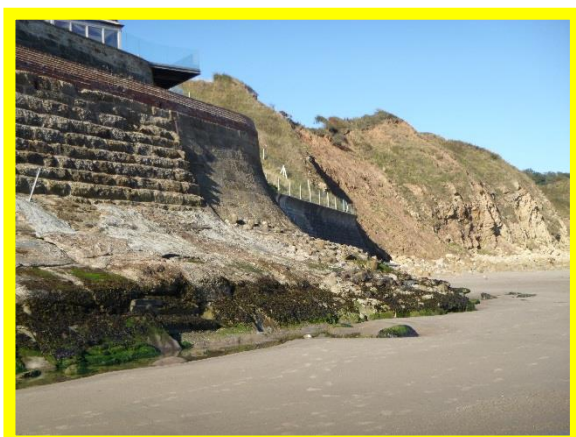
Private sea wall in fair overall condition but with the toe apron subject to ad hoc repairs and localised undermining (/1402C05)

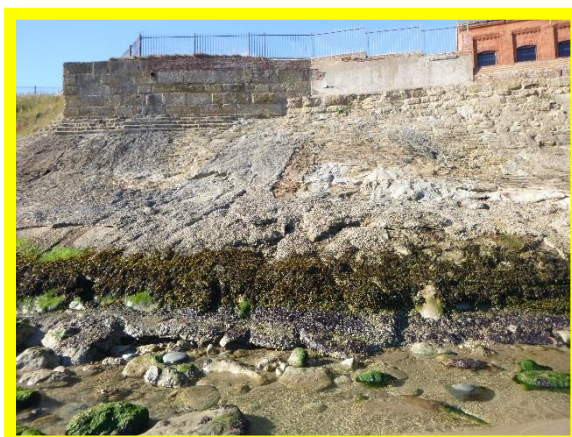
Localised undermining of private seawall (/1402C05)

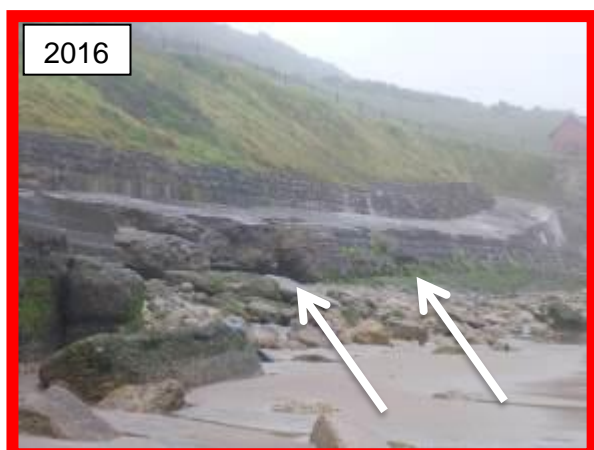
Between the southern end of the pumping station defences and the landing of the beach access steps, there is a length of defence (/1402C04) which exhibited major undercutting and blockwork loss leading to washout of backing material observed during the 2016 inspection. Numerous repairs were made to the defence including a new section of mass concrete wall, repairs to the decking and infilling of the large voids created by washout of fill material. Additionally, due to the loss of beach material the grouted stone toe of the structure is now entirely exposed and shows signs of localised undermining. Despite the repairs made following the damage in 2016 the defence remains in very poor condition and is considered a risk to the public due to potential voids within the structure, the great variation in surface condition of the deckslab and the localised outflanking and undermining of the footpath and upper retaining wall fronting the vegetated slope.

Damage to seawall in June 2016 (/1402C04)

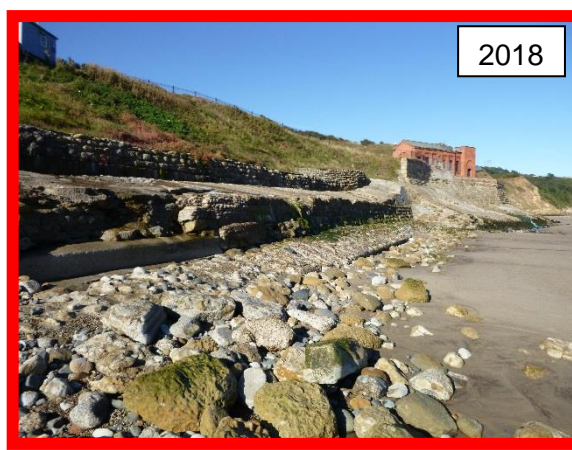
Seawall in September 2018. (/1402C04)

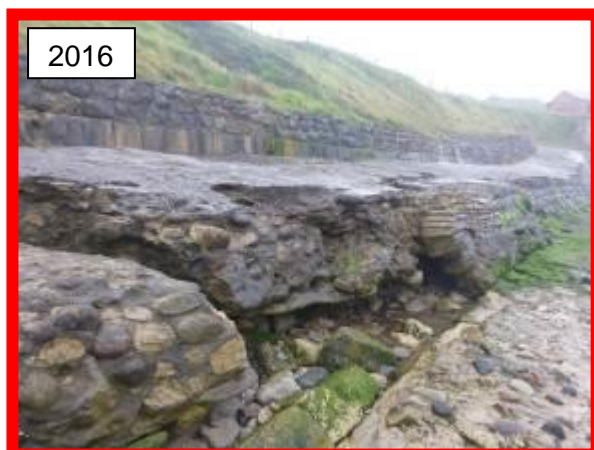
Undercutting at toe leading to voiding behind and break-up of deck (/1402C04)

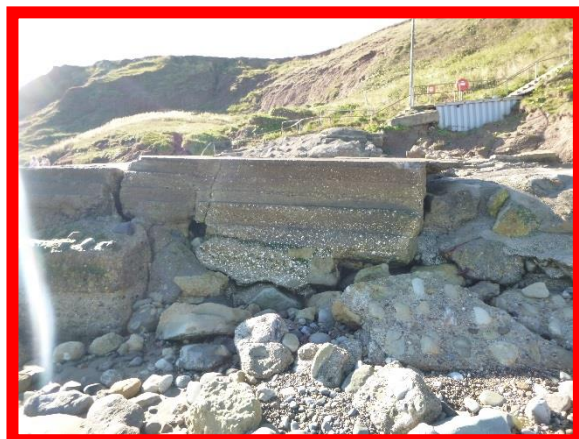
Damage to deckslab and settlement caused by washout from voids in wall face (/1402C04)

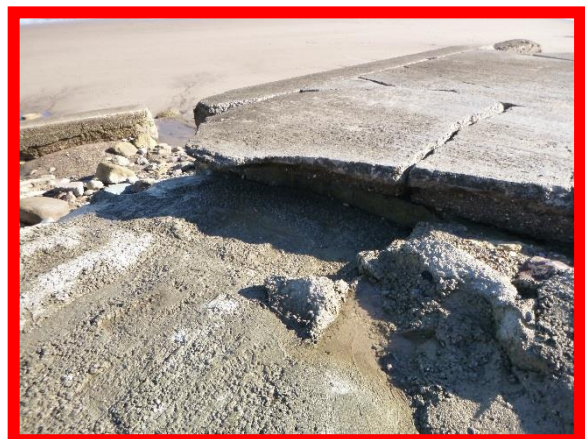
Deckslab showing signs of settlement and is significantly lifted (/1402C04)

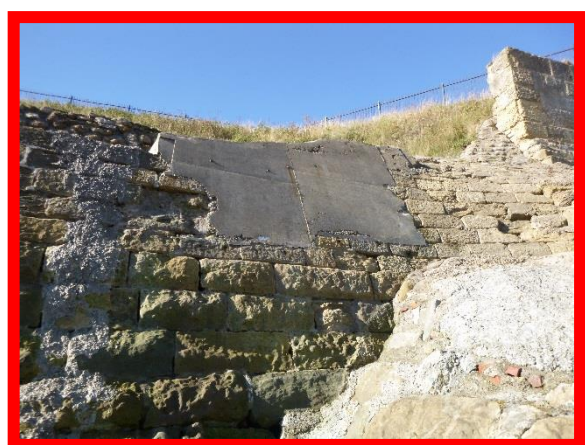
Concrete encasement at western transition (/1402C04)

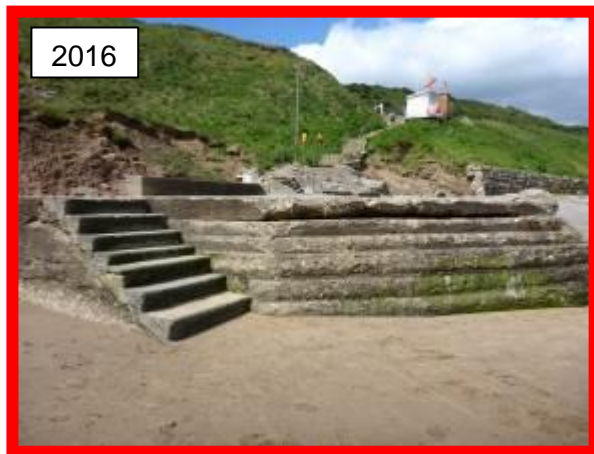
The concrete structure at the beach landing of the public access point remains in a very poor condition with large cracks and voids throughout (/1402C06). Previous poured concrete skim has covered some voids on the deck to make the structure safer for pedestrians but slumps in the cliff

Beach access in 2016 (/1402C06)

behind are continuing to threaten the access. During the 2018 inspection the beach levels across Cayton Bay were found to be significantly lower than in 2016. This is evidenced by an approximately 500mm drop in the level at the beach access steps, seen in the images below. It is recommended that this structure is urgently demolished, removed and replaced with a simple, safer and more adaptable public access.

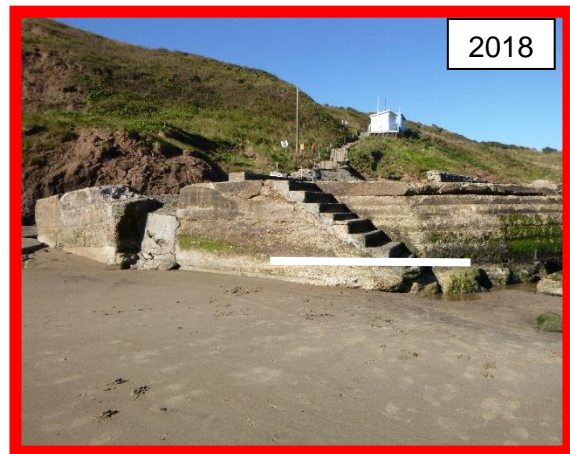
Beach access in 2018 (line showing approximate beach level in 2016) (/1402C06)

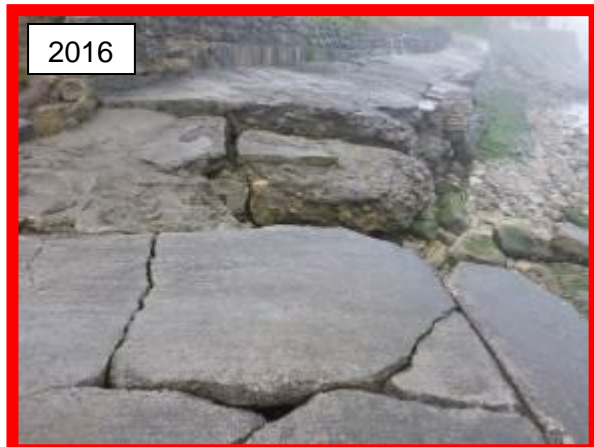
Cracked concrete at landing at beach access (/1402C06)

Despite recent reactive repair work the condition of the defences at the Cayton Bay pump house access remains classified as very poor in 2018. The structures present a significant health and safety risk to the general public. It is recommended that access arrangements to Cayton Bay at this location are re-evaluated at the earliest opportunity in line with the *Filey & Cayton Bay Coastal Strategy*.

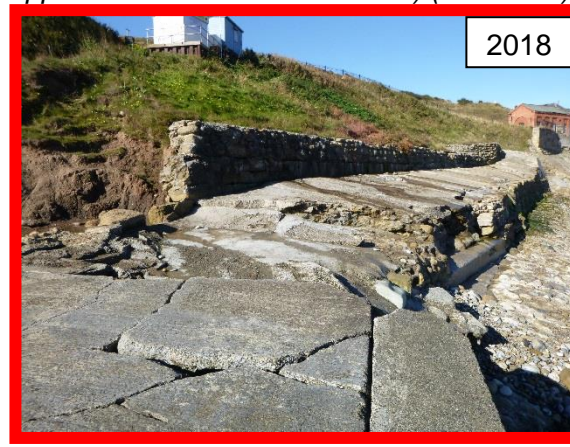
Slumping cliffs adjacent to steps leading to outflanking – southern end (/1402C04)

In addition to the damage sustained to the defence to the north of the beach access steps, the structure is also being undercut and outflanked at its western end and towards its rear. The footpath which runs up the bank towards Lucy's Shack is being undercut. A section of retaining sheet piling was noted during the 2018 inspection, this appears to be effectively supporting the path, however it can only be a temporary solution due to the risk of further outflanking and undermining.

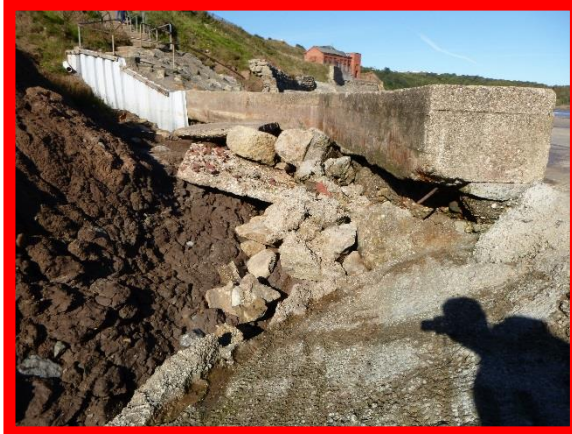
Damage to rear of structure, washout of fill material (/1402C06)

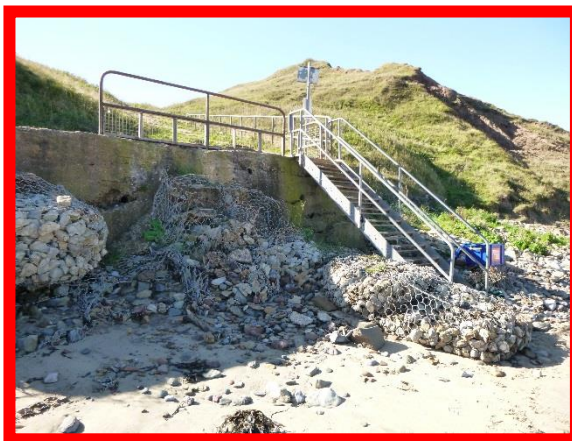
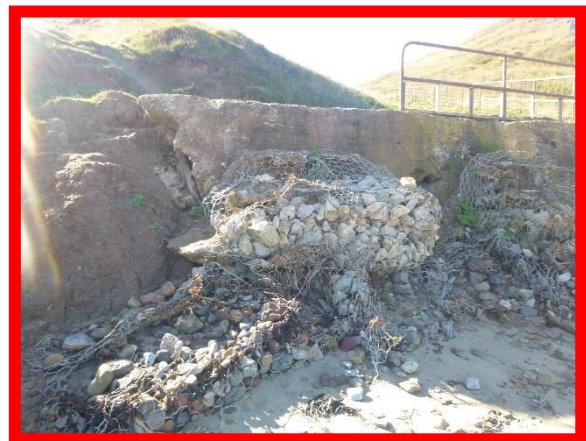
Around 300m south of the pumping station beach access, there is beach access point for the path from the public car park at the surf shop. There are a set of beach access steps that were previously protected by gabion baskets, which have distorted and split under wave action. This is not a formal coastal defence, so has no asset number.

Failed gabion baskets at surf shop car park beach access (no asset reference)

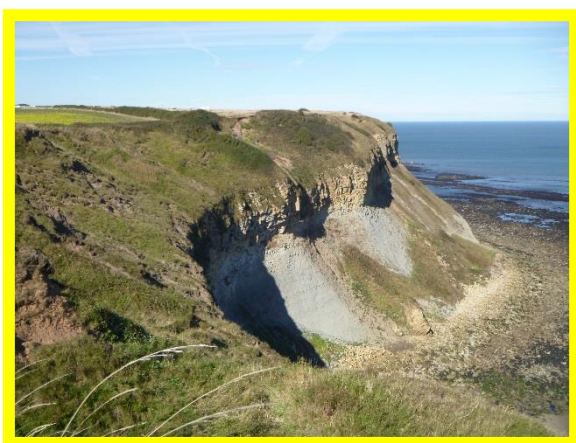
MU26/AF Soft till overlying resistant rock (Locally Active).

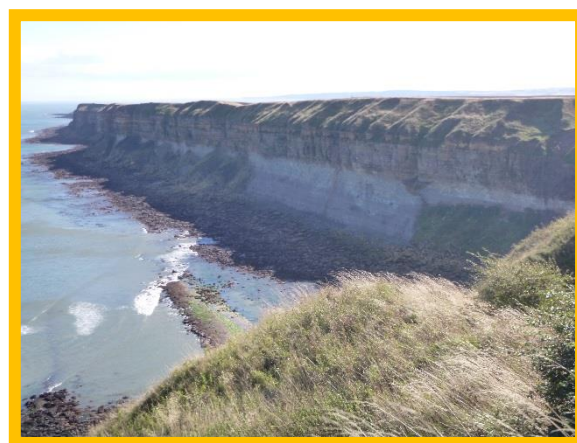
MU26/AK and MU26/AL were changed in grading to Partly Active in 2016, having experienced widespread rockfalls and mudslides along their length. This status has been retained following the 2018 inspection, however it was noted that the debris cones along the base of these units have receded slightly indicating that the cliffs experience some degree of erosion along their toe. This may also indicate that they are not being recharged from activity in the cliff units above.

MU26/AK and MU26/AL Cliffs experiencing rockfalls and mudslides.

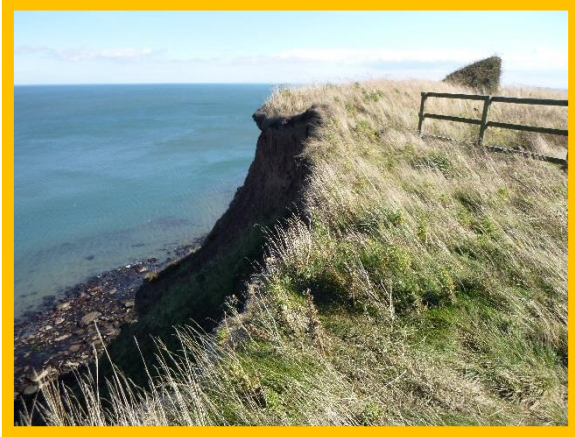
The remaining **Units MU26/AS to MU26/AY** have all been assigned a status of Locally Active in 2018, except for MU26/AT which has been classified as Partly Active, due to intensive erosion activity in the headscarp at the western of the unit. The upper part of the cliffs, comprised of soft glacial sediment is exhibit only localized, rather than widespread, erosion in the form of headscarp recession and mud sliding. There is also localised marine erosion of the toe.

MU26/AT Ongoing recession of the headscarp (Partly Active).

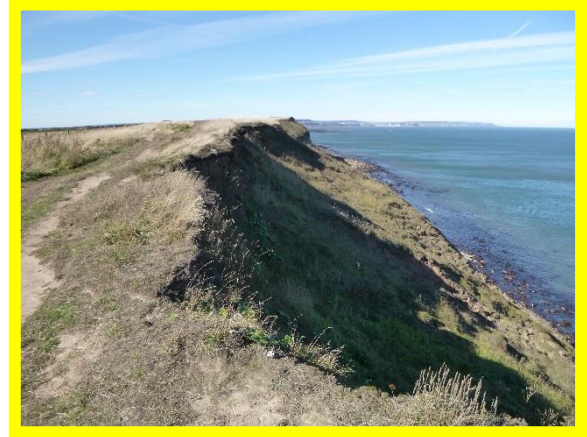
MU26/AZ and MU26/AY Shallower more stable slopes of easternmost assets in **MU26**.

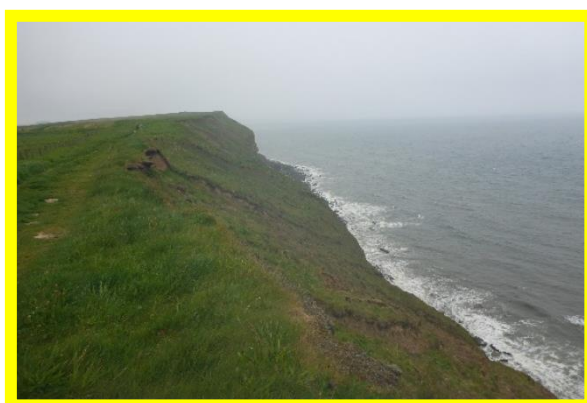
Well vegetated upper slopes.
MU27/AY (Locally Active in May 2018)

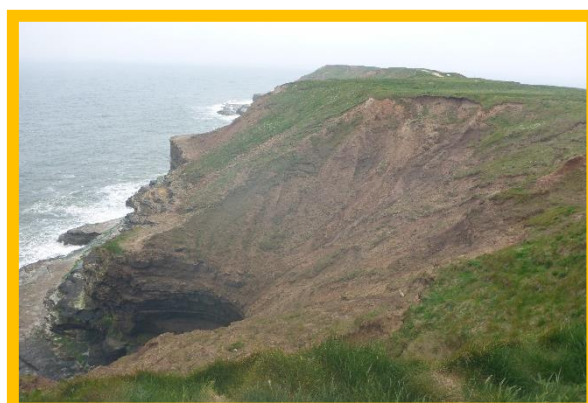
Headscarp recession and mudslides in upper till unit on the north side of Filey Brigg.
MU27/BC (Partly Active in May 2018)

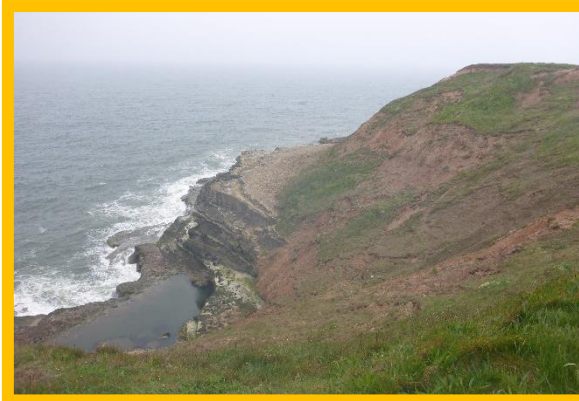
Mainly unvegetated and eroding upper slopes on the north side of Filey Brigg. MU27/BE (Partly Active in May 2018)

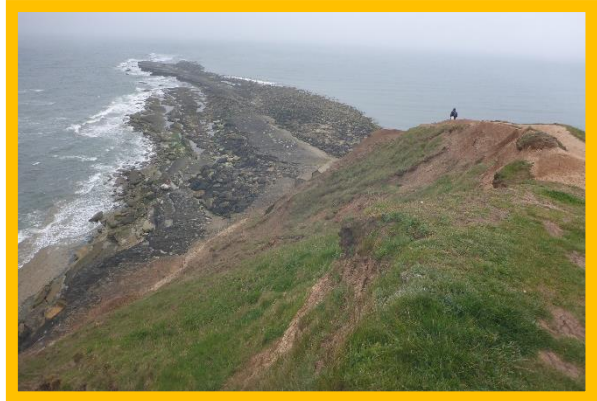
Headscarp recession and mudslides in upper till unit on north side of Filey Brigg. MU27/B (Partly Active in May 2018)

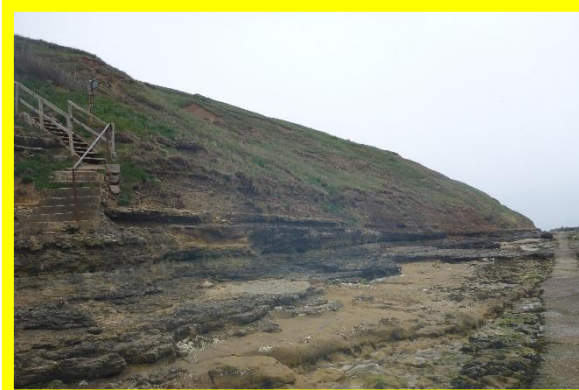
Composite cliffs on the south side of Filey Brigg. MU27/C (right) to MU27/F (left) (all Locally Active in May 2018)

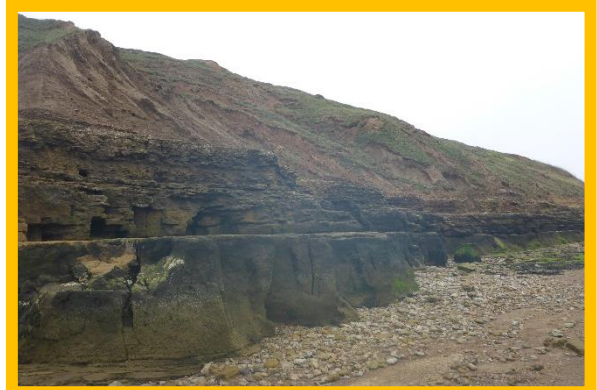
MU27H and MU27/I are in the central part of the south side of Filey Brigg and are variously vegetated and unvegetated. These units comprise simple mudslides, each with an arcuate head scarp and elongate flow tracks. They are classified as **Partly Active** in 2018, the same as 2016.

Composite cliffs on the south side of Filey Brigg. MU27/H (right) to MU27/I (left) (both Partly Active in May 2018)

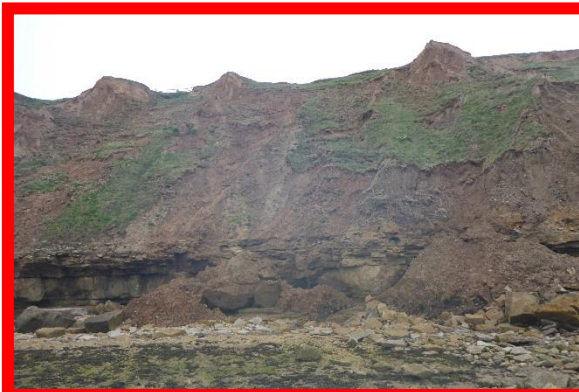
Units MU27/J to MU27/O are also located on the south side of the Brigg at its western end. They are predominantly unvegetated and are undergoing intense erosion and are therefore classified as **Totally Active** in 2018. MU27/J was graded Partly Active in 2016 whereas the MU27/K to MU27/O were classified Totally Active in 2016.

Composite cliffs on the south side of Filey Brigg. MU27/J (Totally Active in May 2018)

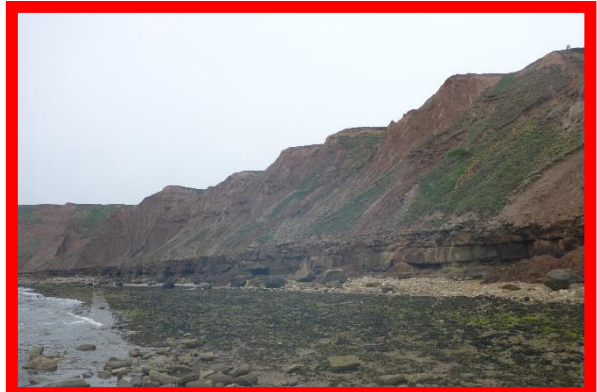
Composite cliffs on the south side of Filey Brigg. MU27/K (right) to MU27/N (left) (all Totally Active in May 2018)

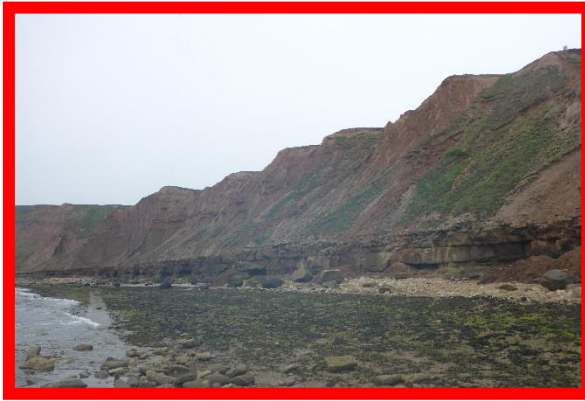
Composite cliffs on the south side of Filey Brigg. MU27/J (right) to MU27/N (left) (all Totally Active in May 2018)

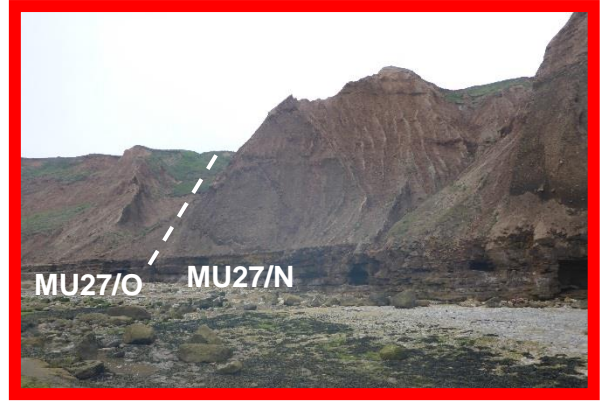
Composite cliffs on the south side of Filey Brigg. MU27/N (right) & MU27/O (left) (both Totally Active in June 2016)

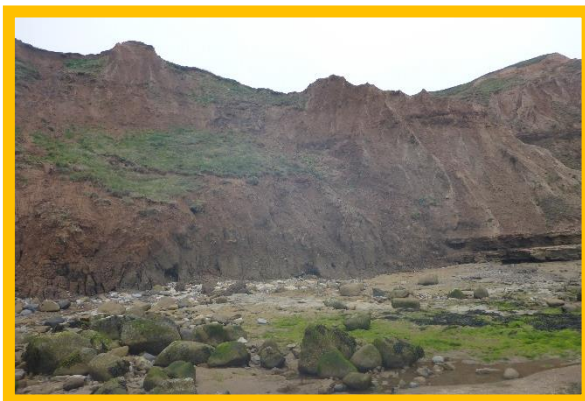
Till cliffs between Filey Brigg and Filey sailing club. MU27/Q Partly Active in May 2018

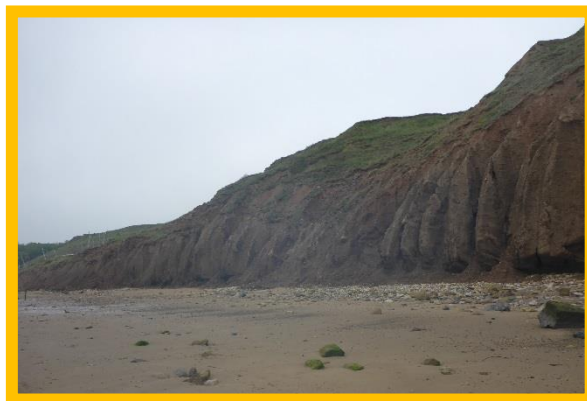
Till cliffs between Filey Brigg and Filey Sailing Club. MU27/R to MU27/S Partly Active in May 2018

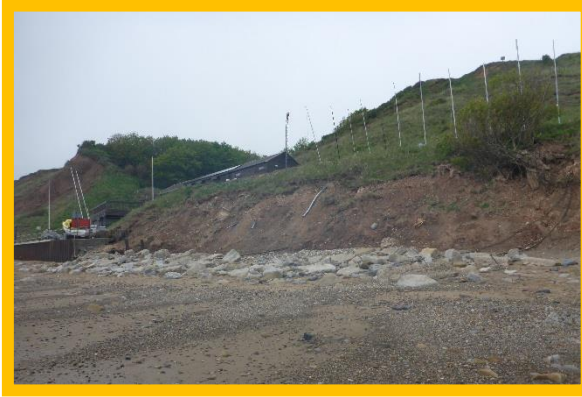
Till cliffs at Filey Sailing Club.
MU27/T Partly Active in May 2018

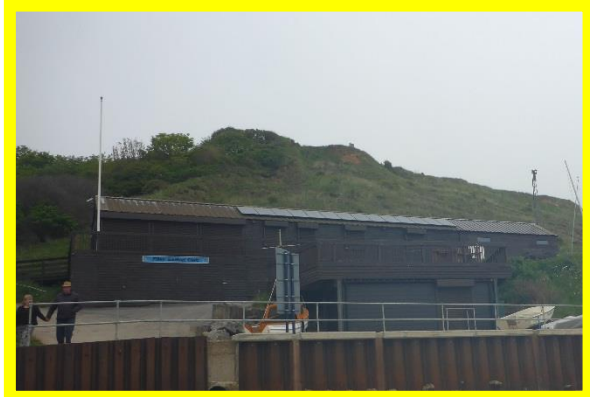
Unit MU27/U is generally well vegetated but local erosion of the headscarp was noted. This unit is classified as **Locally Active**, the same as 2014 and 2016.

Well vegetated slope behind Filey Sailing Club.
MU27/U Locally Active in May 2018

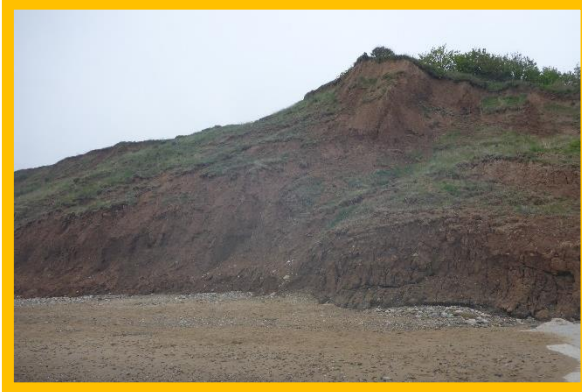
Units MU27/V and MU27/W are located between the sailing club and the north end of Filey seawall. These units are classified as **Partly Active** in 2018 with large-scale head scarp recession, slumping throughout the profile and erosion at the toe.

Till cliffs between Filey Sailing Club and Filey town. MU27/V Partly Active in May 2018

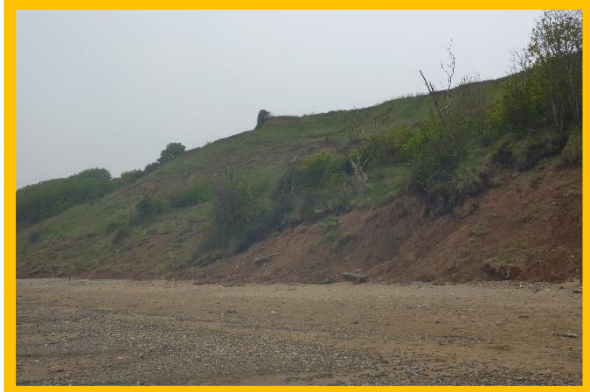
Till cliffs between Filey sailing club and Filey town. MU27/W Partly Active in May 2018

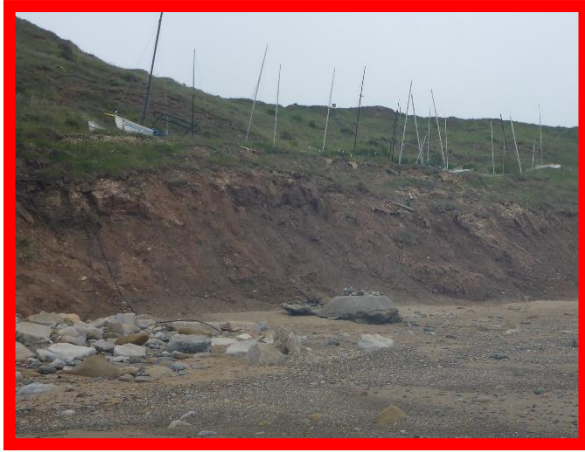
To the north of the town, Filey Sailing Club is located at the back of the beach and is partly protected by some coastal defences. However, the section of cliff below the boat park (which is located on a terrace part way up the cliff) north of the club building is undefended (/1601C01) and suffering active slumping along its length.

Undefended cliffs below boat storage yard (/1601C01)

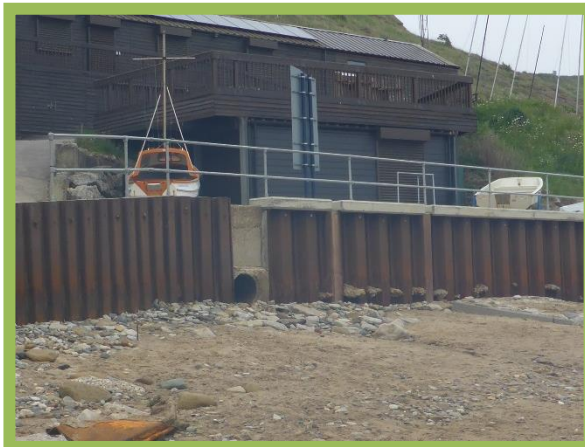
At the club building, there is a section of sheet piling (/1601C03) which showed significant corrosion leading to sizeable holes forming in the steel in the central section and voids behind due to wash out of material in May 2015. At that time, the concrete slipway had been repaired not long before and the southern sections of steel piles had been replaced between 2009 and 2012. However, repairs have been made since May 2015 and the sheet piling is now in good condition with minor surface corrosion noted. A scour hole (approx. 2m depth) was noted at the northern end of the promenade.

Repaired central section of steel sheet piling as observed in May 2018 (/1601C03)

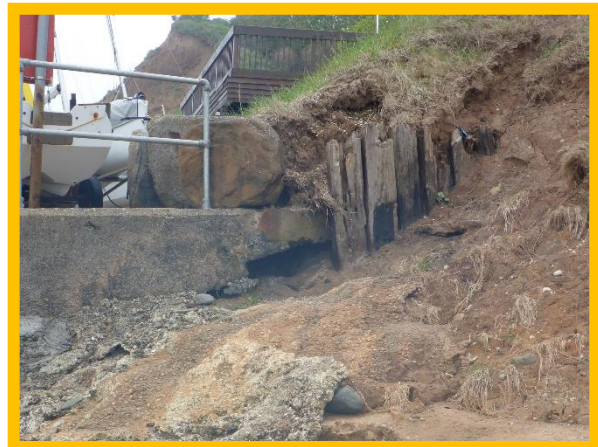
Scour hole at northern end of promenade (/1601C03)

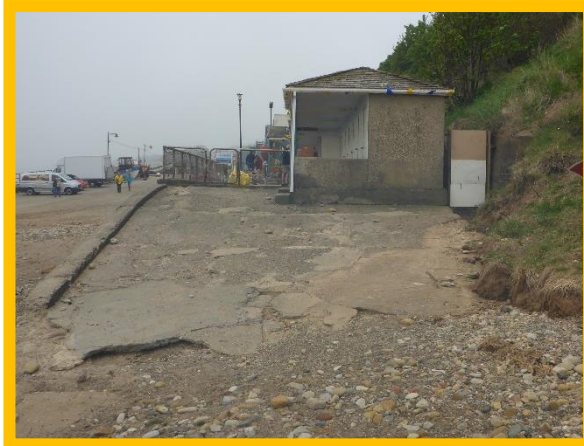
The most northerly asset in the defence system consists of the rear wall and slipway at Coble Landing (/1602C01). The slipway blockwork appeared in fair condition although, as noted during previous inspections, the rear wall below the chalets has several horizontal cracks in the wall and is in fair condition. The concrete rear ramp/wall is in poor condition with heavy abrasion and voids in the deck towards toe of structure.

Voids in deck of rear ramp/wall at Coble Landing (/1602C01)

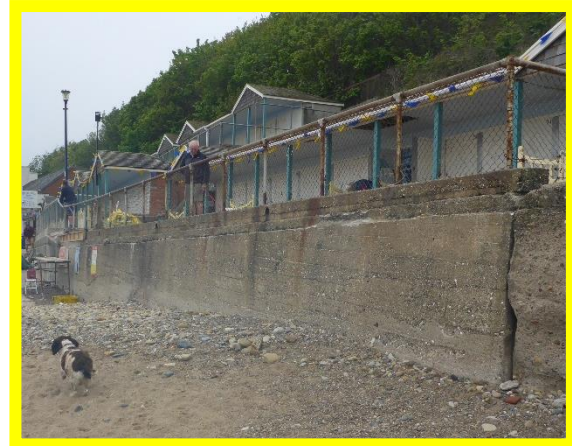
Longitudinal cracks in rear wall, open joint (/1602C01)

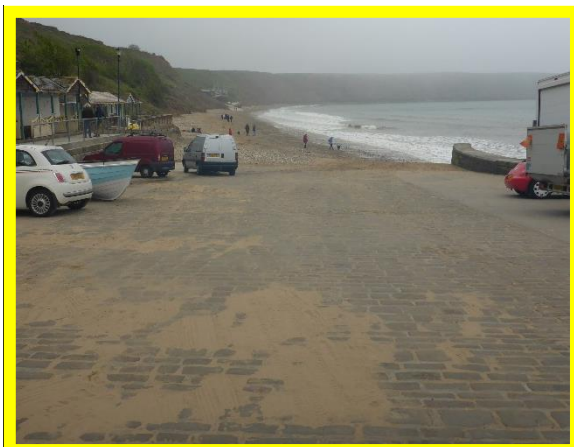
Coble Landing slipway blockwork in fair condition (/1602C01)

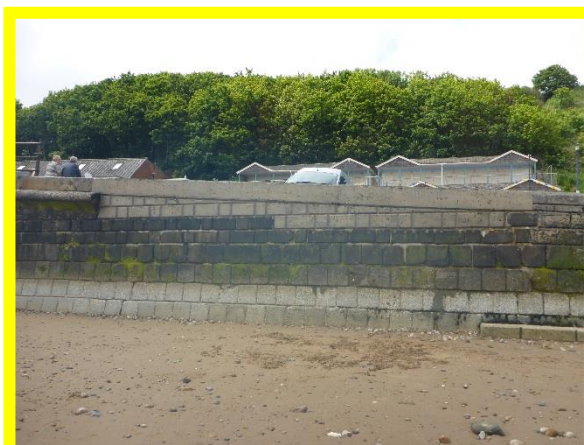
The next asset (/1602C09) is essentially a wing wall protecting the slipway. Repairs to this wall were made between 2012 and 2014 and are holding well and the overall asset condition remains as fair. It appears a new course of blocks has been placed on the toe apron to repair abrasion damage noted in previous inspections. However, the end of the wall has been heavily abraded, and becoming undercut.

Previous repairs to slipway 'wing-wall' (/1602C09)

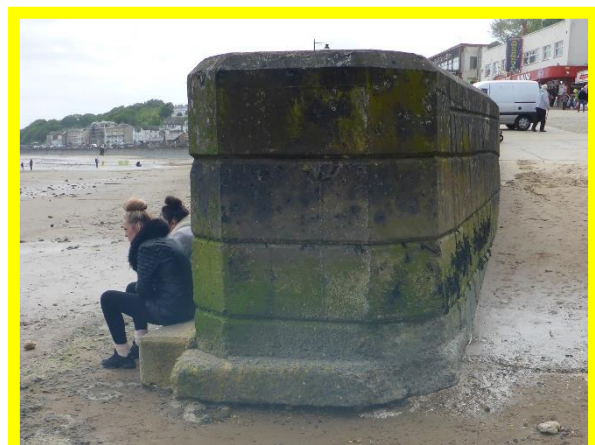
Undercutting at end of 'wing-wall' (/1602C09)

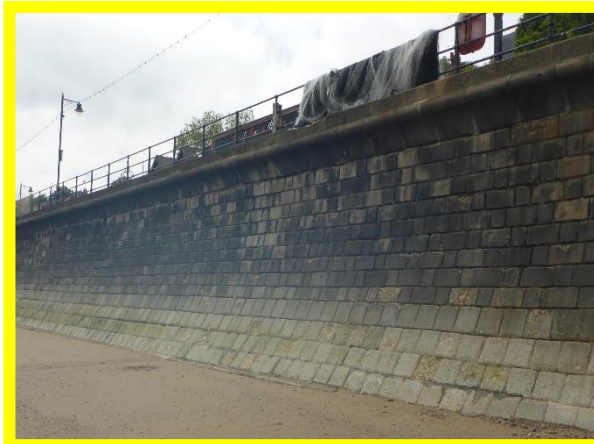
The wall located north of Ravine Road (/1602C06) is in fair overall condition, although there are areas of damage that have been previously repaired. There are cracks / washed out joints / missing mortar between the masonry blocks at several locations.

Sea wall near Ravine Road in fair condition (/1602C06)

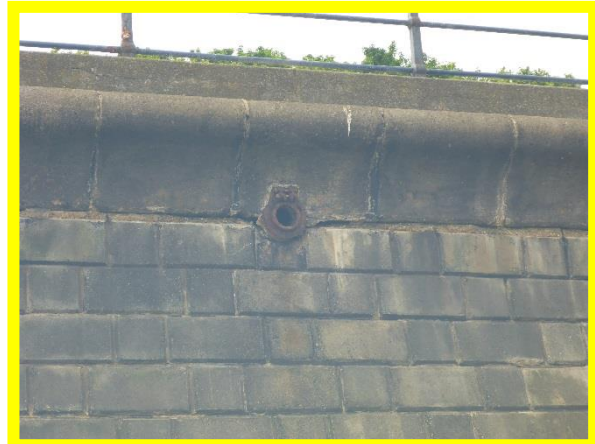
Occasional open joints with missing mortar (/1602C06)

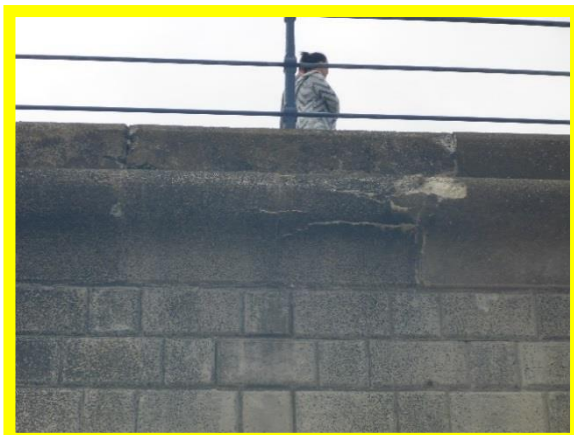
The sections of sea wall between Ravine Road and the access point east of Cargate Hill Road (/1602C08) and between Cargate Hill Road and Crescent Hill (/1602C03) are both in fair overall condition, although in some sections several blocks have abrasion damage to the front face, particularly just above beach level. Many of the splash coping blocks have been replaced along the length of these assets, but others are cracked or damaged. The damage appears to get worse with progression south and is mainly focused around the lower blockwork or upper splash wall / coping.

Damage to coping/wave return on seawall south of Ravine Road (/1602C08)

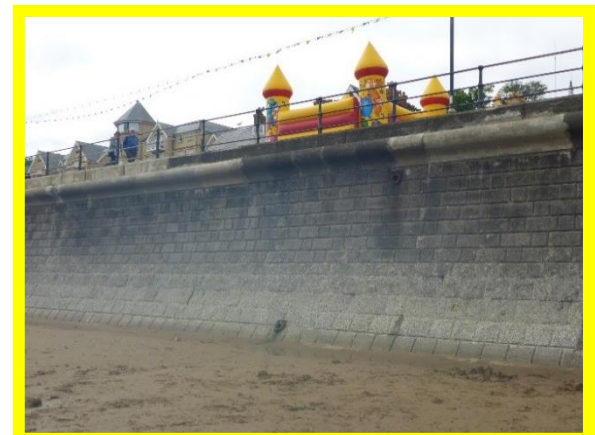
Previous repairs to coping and wave return feature (/1602C08)

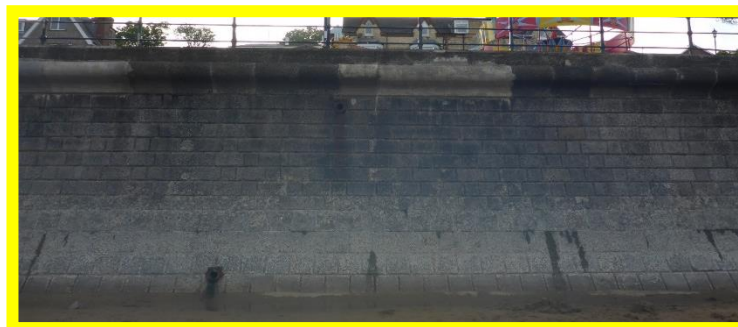
Several open joints in seawall south of Ravine Road leaking water (/1602C08)

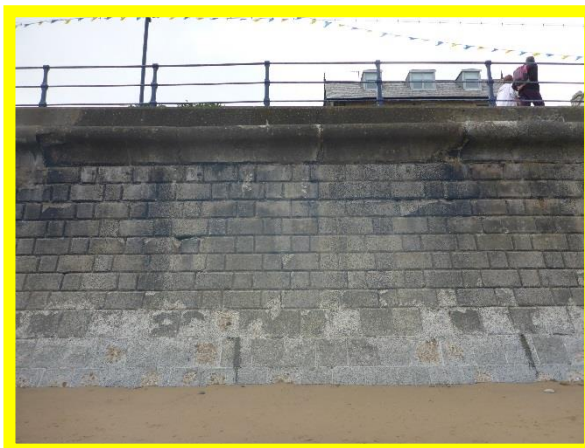
Abrasion damage and open joints in sea wall south of Cargate Hill (/1602C03)

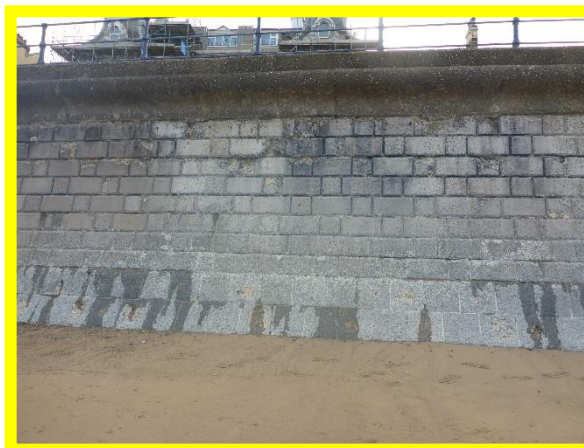
Abrasion damage, several leaking joints (/1602C03)

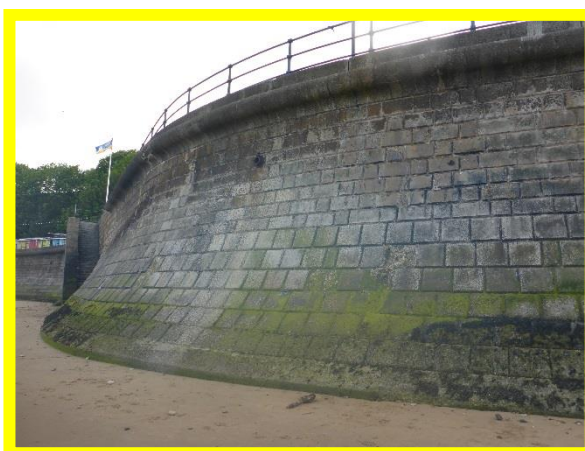
The next defence assets to the south are the wall around the Royal Parade promontory (/1602C04) and the wall between here and the southern-most promontory (/1602C07). These sections of wall are in fair overall condition (including previous repairs to one long vertical gap between adjacent blocks running over half the height of the wall), although there is cracking to the coping and numerous abraded, chipped or damaged blocks. Previous repairs to the lower section of the access steps at Royal Parade are holding well but the cracks and open joints in the southern set of access steps makes it vulnerable to damage during storms.

Royal Parade seawall in fair condition, some blockwork abrasion and open joints (/1602C04)

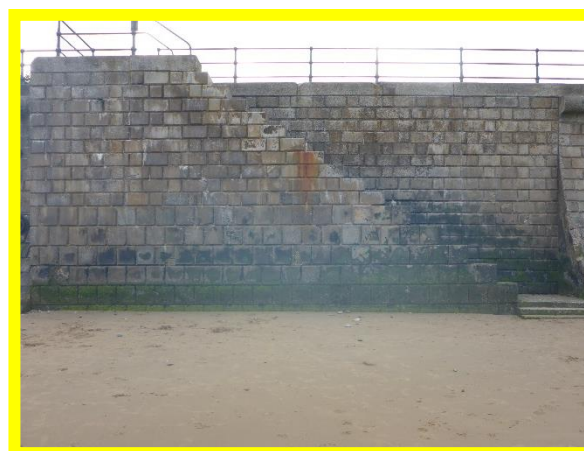
Access steps at Royal Parade sea wall (/1602C04)

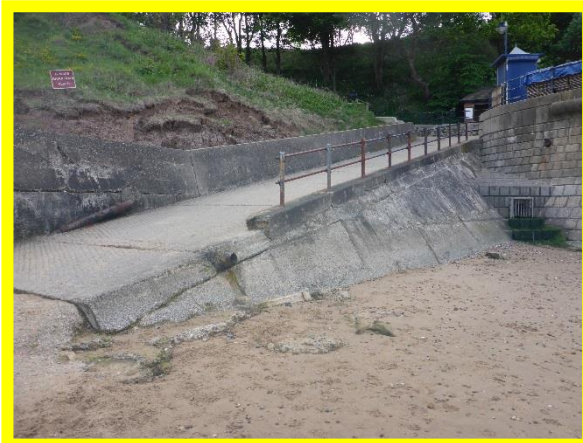
The southernmost section of the main wall includes the southern promontory and the return section to Martin's Gill (/1602C05). This structure is overall in fair condition, although there is chipping and cracking to the coping in small areas throughout length and numerous lower blocks area abraded. Cracks in the side wall to the slipway / access ramp at the southern end of the wall appear to have been filled.

Slipway / access ramp at southern end of Filey Sea Wall (/1602C02)

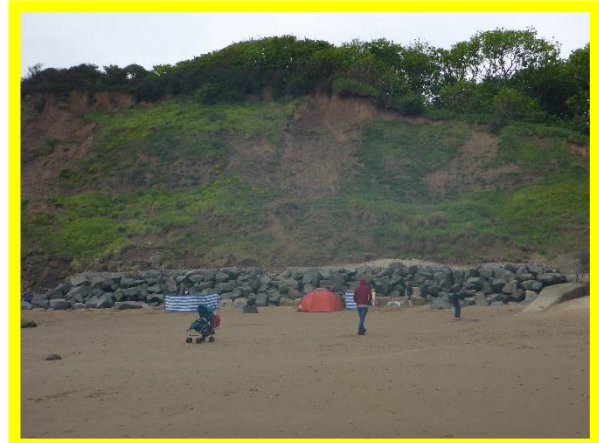
A short section of rock revetment with gabion baskets beneath is located at the southern end of the sea wall near Martin's Gill (/1602C02). This defence extends into Sub-management Unit MU29A and is intended to manage the interface between the hard defences to the north and eroding natural cliff to the south. The rock armour has been re-profiled on occasion after movement of some armourstones during storms. However, at the time of the inspections, the structure was in fair condition. Despite this, the coastal slopes behind the revetment still appear to be active and some form of improved outflanking defence remains necessary in the medium term.

Rock revetment at southern end of Filey Sea Wall (/1602C02) – note active coastal slopes to rear
