Cell 1 Regional Coastal Monitoring Programme Walkover Inspection Surveys 2018

**Scarborough
Borough Council**

October 2018

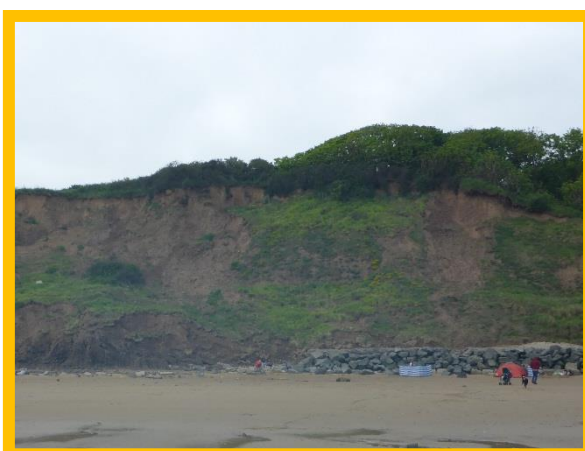
Units MU29/AA and MU29/AI which are composed of glacial till down to beach level and stretch south of Filey town are all classified as Partly Active in 2018, unchanged from 2016. The entire length of cliff is partly vegetated and suffers from head scarp erosion and slumps and slides are causing failure throughout the cliff face. The toes are undergoing various degrees of marine erosion.

Till cliffs adjacent to Filey town.
MU29/AA Partly Active in June 2018

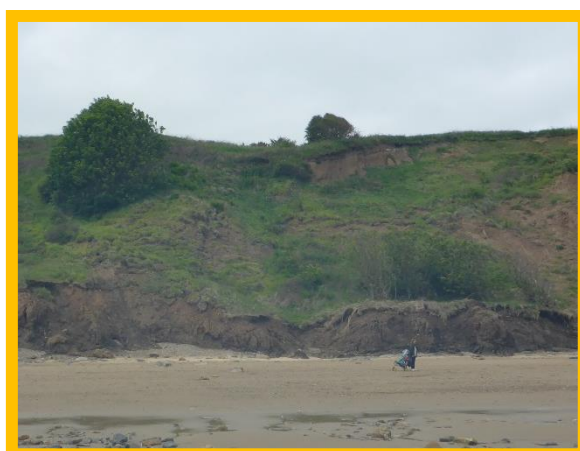
Till cliffs along Muston Sands.
MU29/AB Partly Active in June 2018

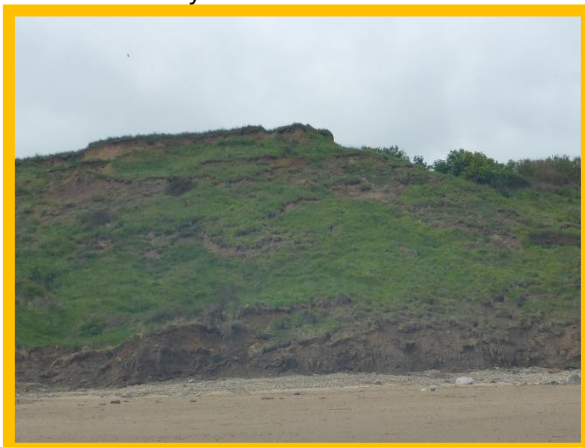
Till cliffs along Muston Sands.
MU29/AC Partly Active in June 2018

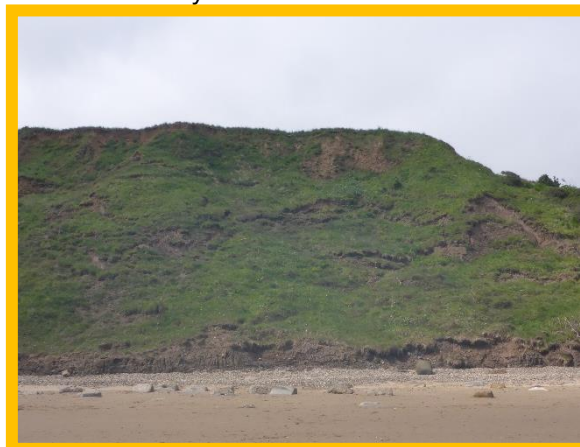
Till cliffs along Muston Sands.
MU29/AD Partly Active in June 2018

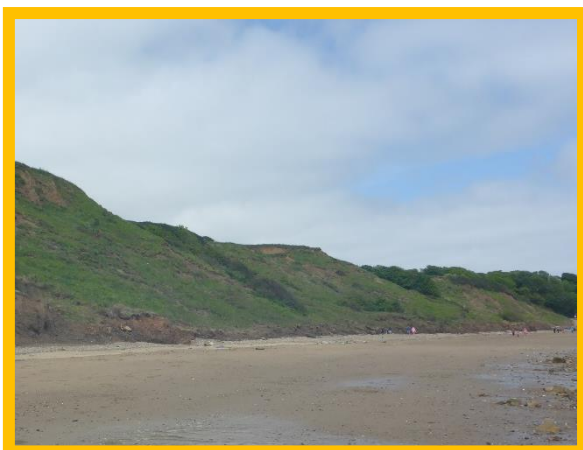
Till cliffs along Muston Sands.
MU29/AA (right) to MU27/AD (left)
(all Partly Active in June 2018)

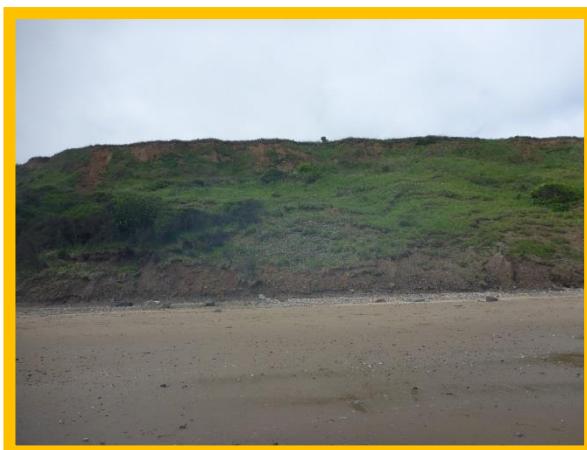
Till cliffs along Muston Sands.
MU29/AE Partly Active in June 2018

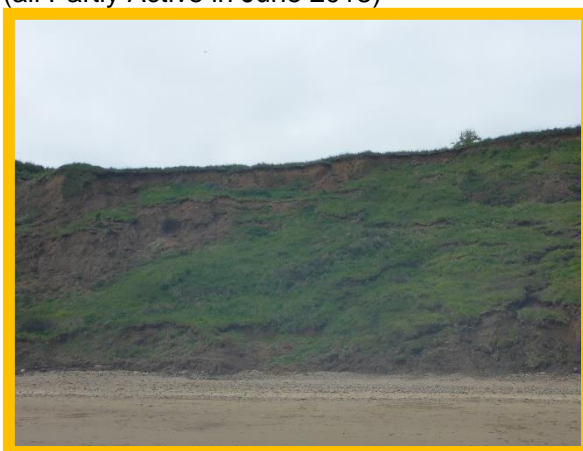
Till cliffs along Muston Sands.
MU29/AF Partly Active in June 2018

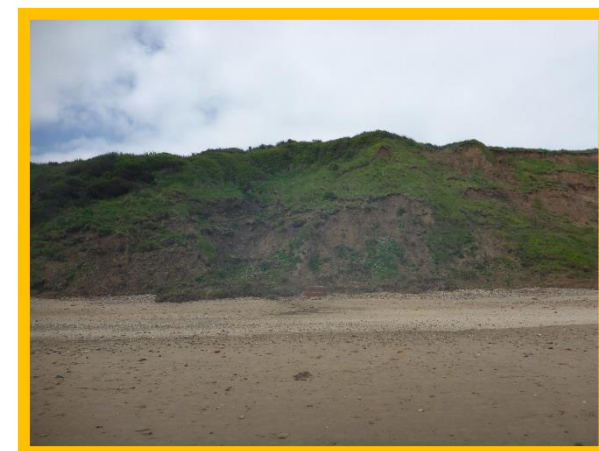
Till cliffs along Muston Sands.
MU29/AG Partly Active in June 2018

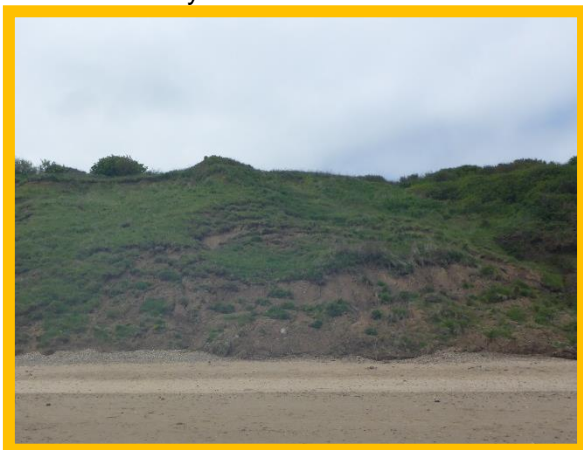
Till cliffs along Muston Sands.
MU29/AH Partly Active in June 2018

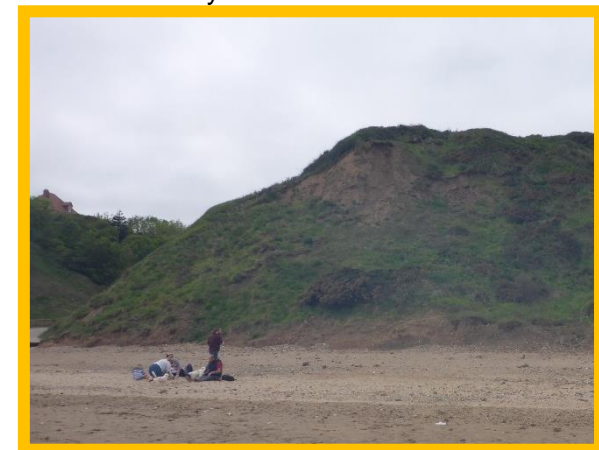
The concrete ramp / outfall structure at the Primrose Valley access MU29/AI and **MU29/AJ** was notably undermined.

Till cliffs along Muston Sands.
MU29/AI Partly Active in June 2018

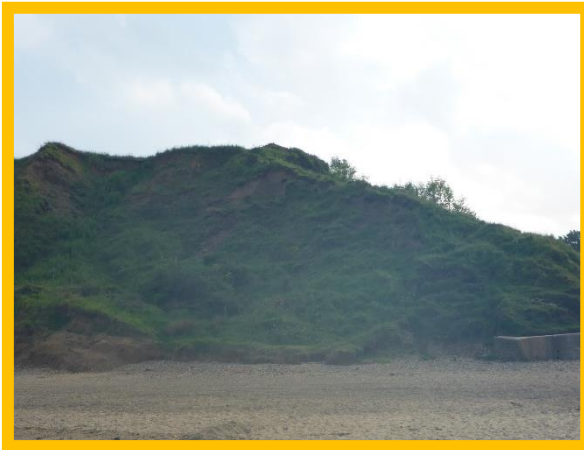
Till cliffs along Hunmanby Sands, outflanking at concrete blocks.
MU29/AJ Partly Active in June 2018

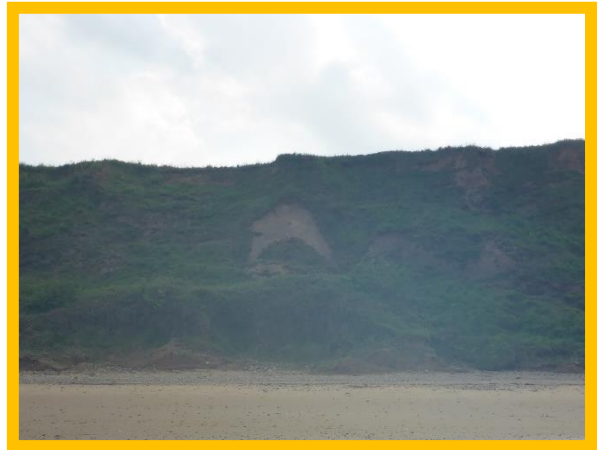
Till cliffs along Hunmanby Sands.
MU29/AK Partly Active in June 2018

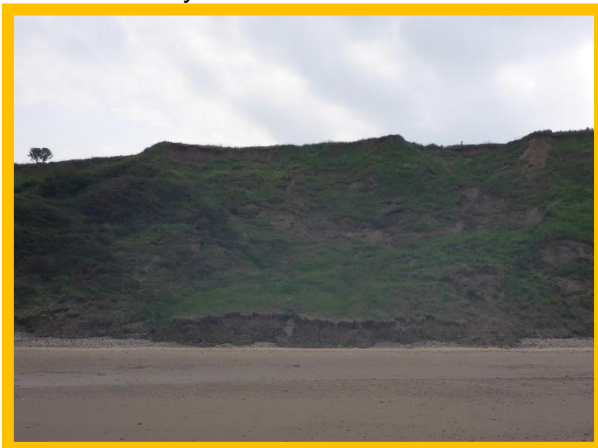
Till cliffs along Hunmanby Sands.
MU29/AP Partly Active in June 2018

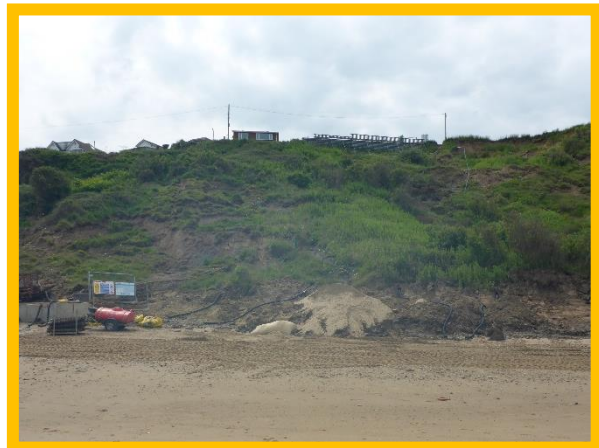
At **MU29/AQ** the Flat Cliffs coastal slope stabilisation project was ongoing which aims to reduce improve the stability of the cliffs at the sole access road into Flat Cliffs hamlet. Works to install inclined sub-horizontal drains and geotextile sand containers at the toe of the cliffs were taking place during the inspection.

Works to install inclined drains at the toe of till cliffs at Flat Cliffs.
MU29/AQ Partly Active in June 2018

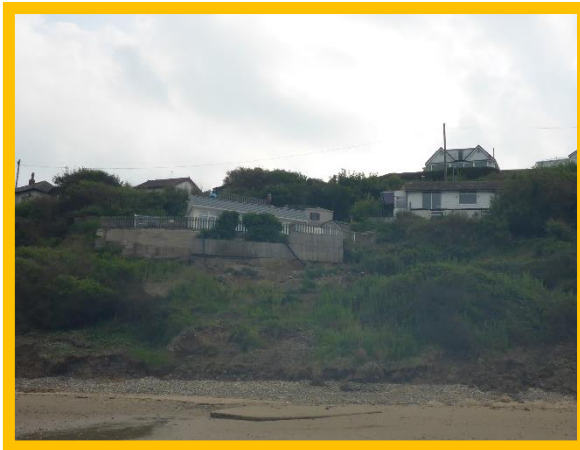
Toe of till cliffs at Flat Cliffs.
MU29/AR Partly Active in June 2018

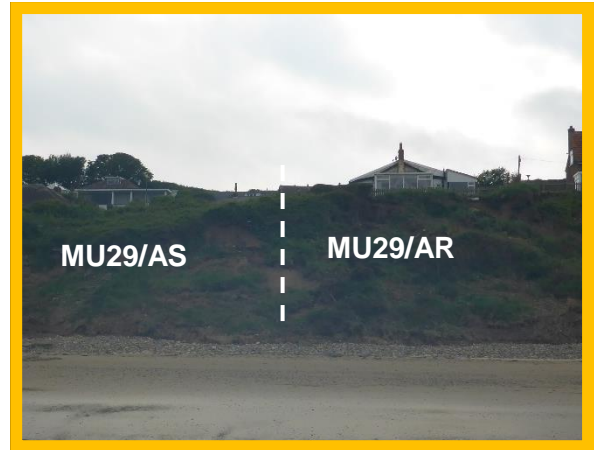
Toe of till cliffs at Flat Cliffs.
MU29/AR & MU29/AS Partly Active in June 2018

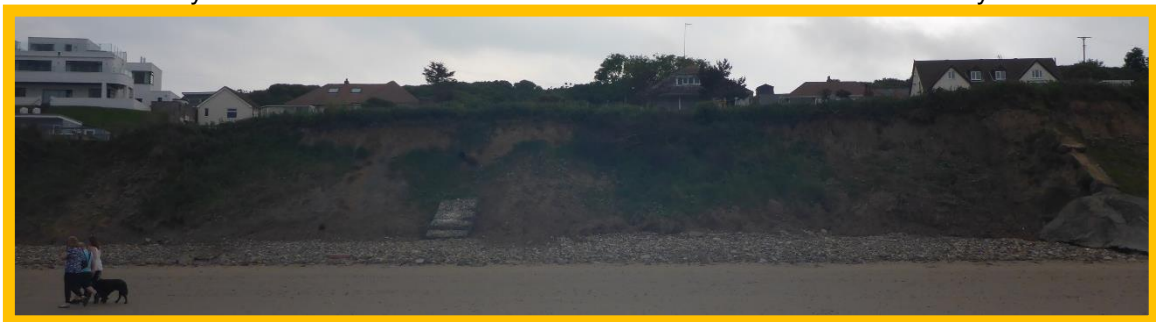
At MU29/AS untreated sewage debris was observed on the gabion baskets below the outfall pipe through the cliffs, and the rising main thrust block at the toe of the cliffs was undermined/outflanked locally.

Toe of till cliffs at Flat Cliffs. MU29/AS Partly Active in June 2018

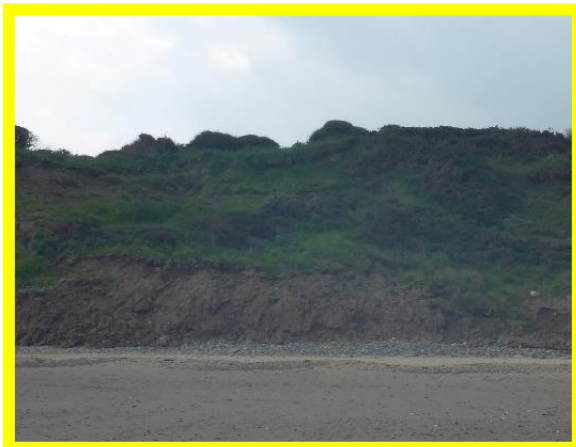
MU29/AT is classified as Locally Active in 2018 (unchanged from 2016) as it is generally well vegetated and there is only local evidence for toe erosion or activity at mid to upper levels. More intense erosion was present along the full height of the cliff adjacent Butcher's Gap.

Well vegetated till cliffs along Hunmanby Sands. MU29/AT Locally Active in June 2018

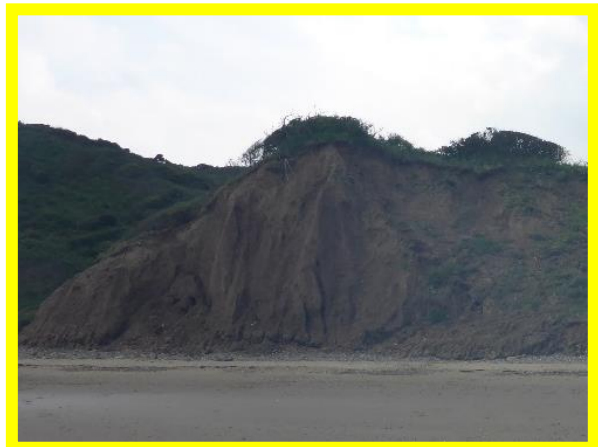
More intense erosion of cliff at Butcher's Gap.
MU29/AT Locally Active in June 2018

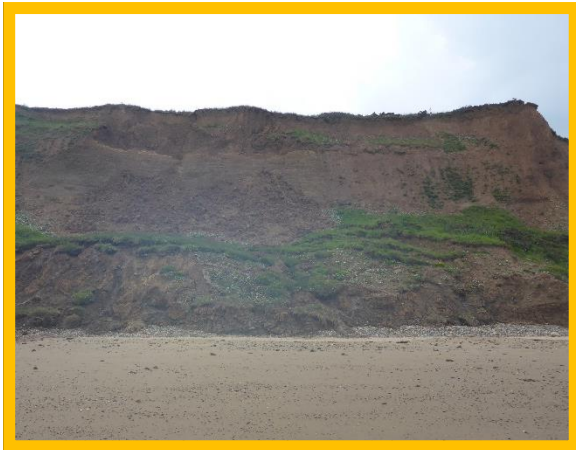
Units MU29/BA to MU29/BE2 are located between Butcher Haven and Hunmanby Gap and are all classified as Partly Active, unchanged from 2016. These cliffs are steeper than further north and are characterised by head scarp erosion and common areas of intense erosion. The toes are active with slumping and sliding on to the beach.

Till cliffs north of Hunmanby Gap.
MU29/BB Partly Active in June 2018

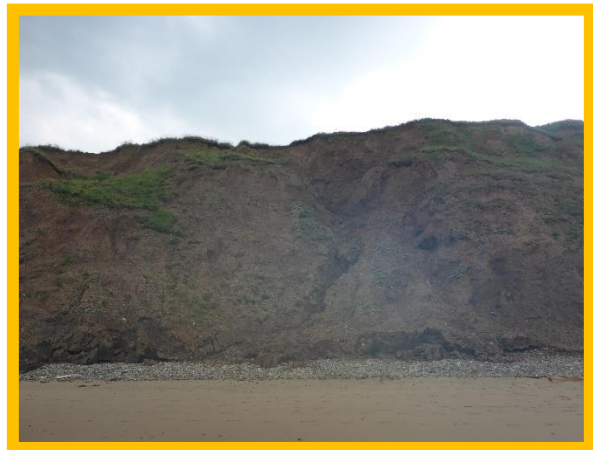
Till cliffs north of Hunmanby Gap.
MU29/BD Partly Active in June 2018

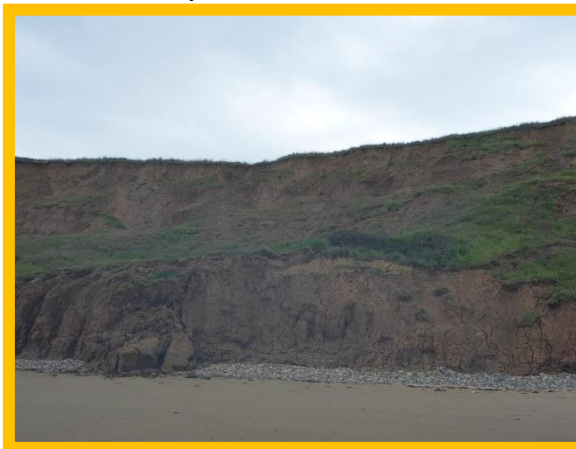
Till cliffs north of Hunmanby Gap.
MU29/BE Partly Active in June 2018

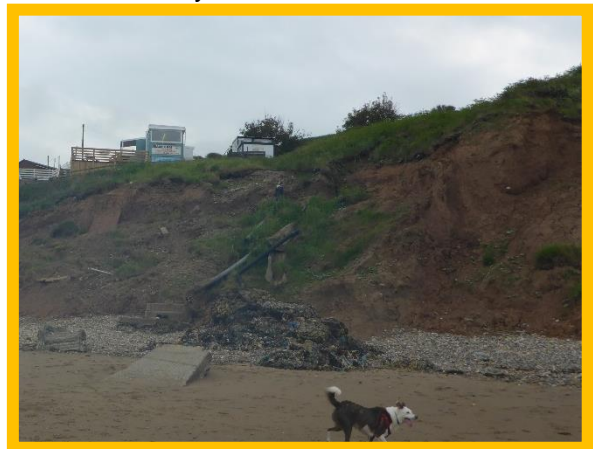
Till cliffs at Hunmanby Gap.
MU29/BE2 Partly Active in June 2018

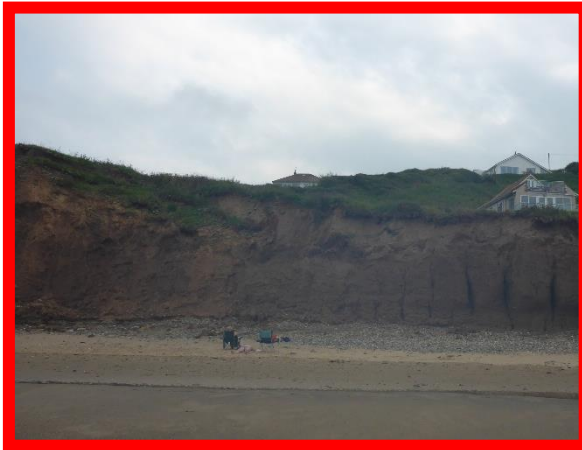
Unit MU29/BF includes Hunmanby Gap itself. This unit is partly shielded from wave erosion by unit MU29/BG and is classified as Locally Active in 2018, unchanged from 2016. MU29/BG to MU29/BJ are located south of Hunmanby Gap. These cliffs are steep and affected by intense erosion throughout most of their height. The head scarp is retreating and there is significant slumping on to the beach. MU29BG to MU29/BJ are classified as Totally Active in 2018, unchanged from 2016.

Intense erosion of till cliffs south of Hunmanby Gap. MU29/BG Totally Active in June 2018

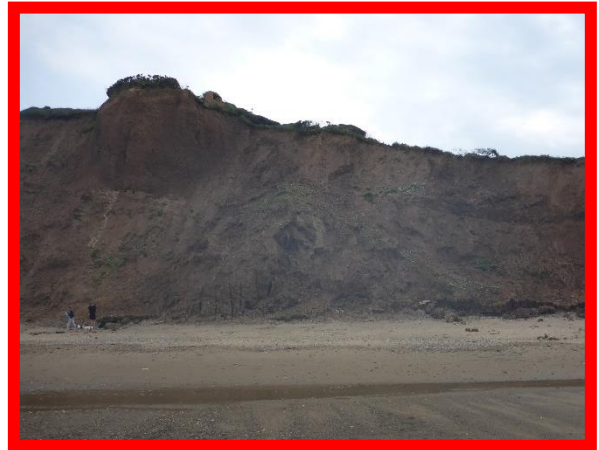
Intense erosion of till cliffs south of Hunmanby Gap. MU29/BH Totally Active in June 2018

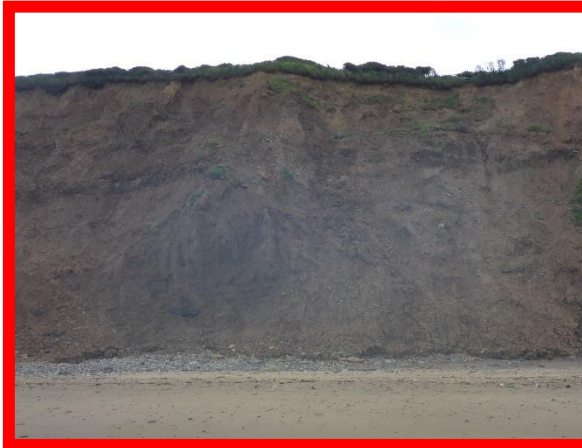
Intense erosion of till cliffs south of Hunmanby Gap. MU29/BI Totally Active in June 2018

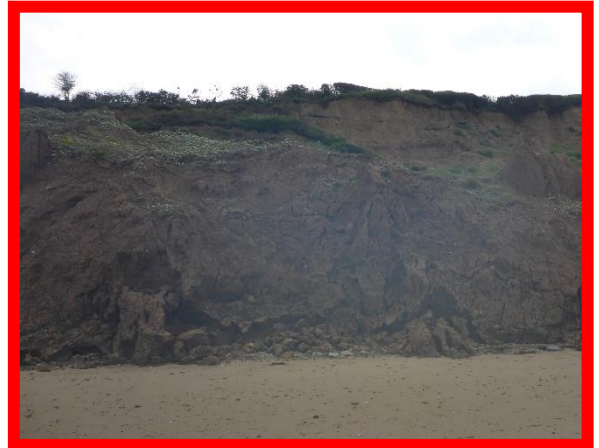
Intense erosion of till cliffs south of Hunmanby Gap. MU29/BJ Totally Active in June 2018

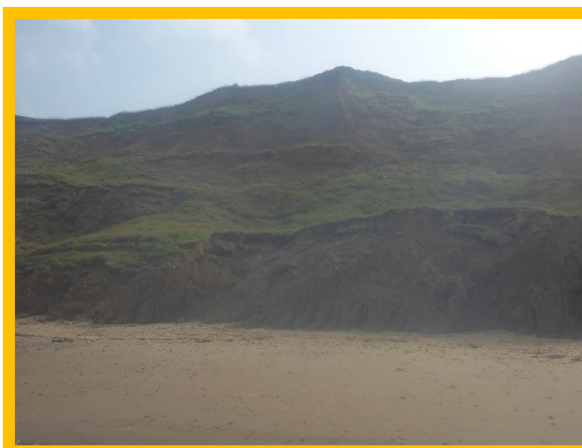
Further south, units MU29/BK to MU29/BQ are located above Reighton Sands. These units are classified as Partly Active in 2018, unchanged from 2016. They are characterised by steep slopes partially covered in vegetation. There is recession of the head scarp, common areas of erosion in the mid-slopes and slumping on to the beach. The toes are steep and eroding.

Till cliffs at Reighton Sands. MU29/BL Partly Active in June 2018

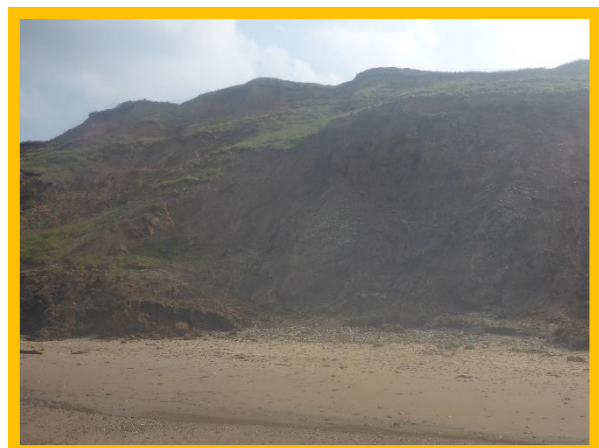
Till cliffs at Reighton Sands. MU29/BM Partly Active in June 2018

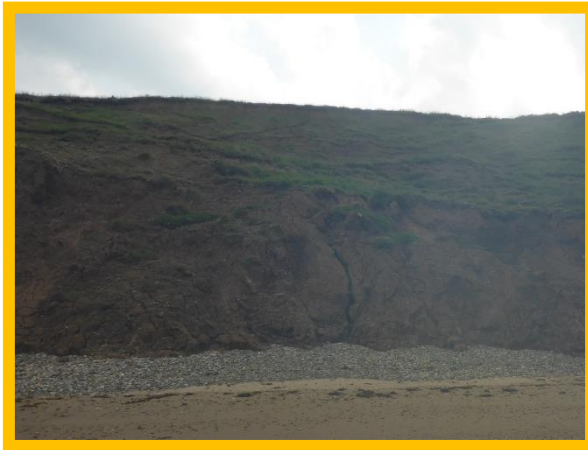
Till cliffs at Reighton Sands. MU29/BO Partly Active in June 2018

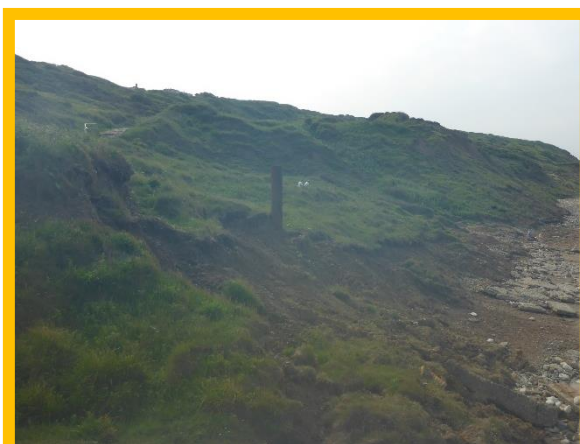
Units MU29/BR, MU29/BS and MU29/CA form the majority of this Sub-management Unit and are classified as Partly Active in 2018, unchanged from 2016. These units are partially vegetated, and contain large slumps and erosion at their head scarps.

Till cliffs beneath Reighton Sands Holiday Village. MU29/BR Partly Active in June 2018

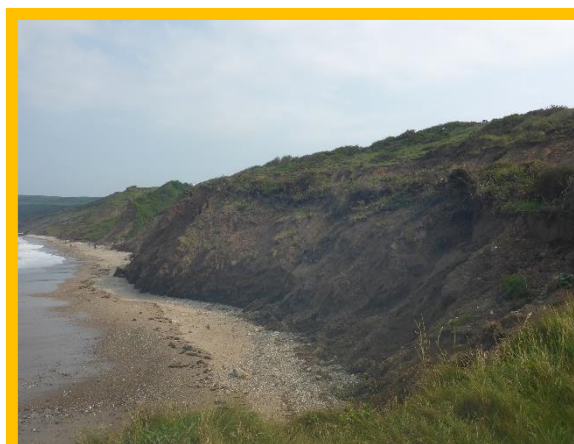
Till cliffs beneath Reighton Sands Holiday Village. MU29/BR Partly Active in June 2018

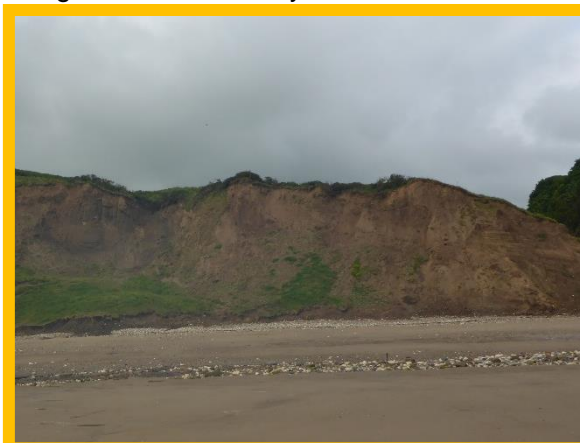
Till cliffs beneath Reighton Sands Holiday Village. MU29/BS Partly Active in June 2018

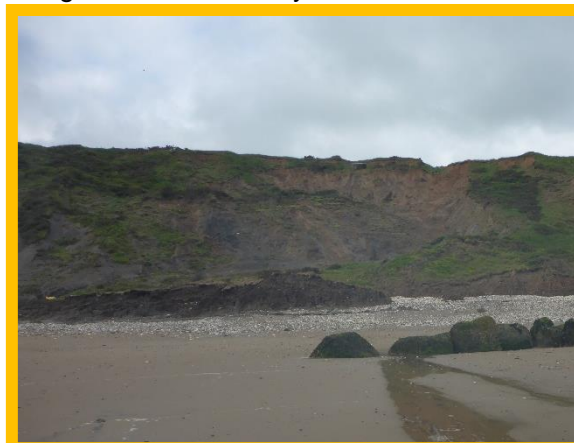
Till cliffs beneath Reighton Sands Holiday Village. MU29/CA Partly Active in June 2018

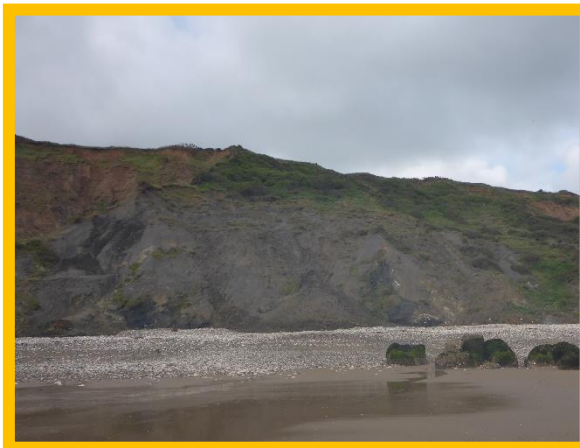
Unit MU29/CB is at the eastern end of the holiday village. The unit exhibits mudslides and an eroding head scarp, and is classified as Partly Active in 2018, the same as 2016. Unit **MU29/CCa** forms a shallow mudslide embayment extending on to the beach. The unit is classified as Partly Active, unchanged from 2016.

Till cliffs in MU29/CB
(Partly Active in June 2018)

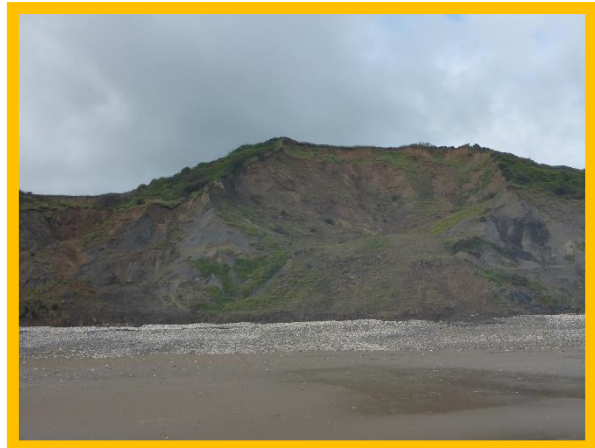
Mudslide embayment of MU29/CCa
(Partly Active in June 2018)

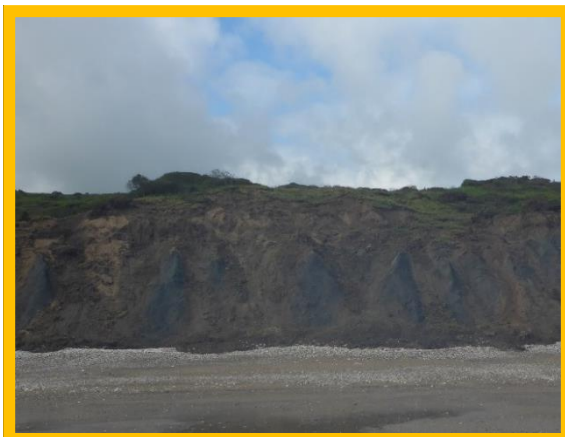
Unit MU29/CC forms a large, shallow, well vegetated embayment known as Middle Cliff with a steep well-defined eroding toe in mud. There is also activity at the unit head and mid slope. The unit is classified as Partly Active in 2018, the same as 2016.

Toe of mud cliff in MU29/CC (Partly Active in 2018)

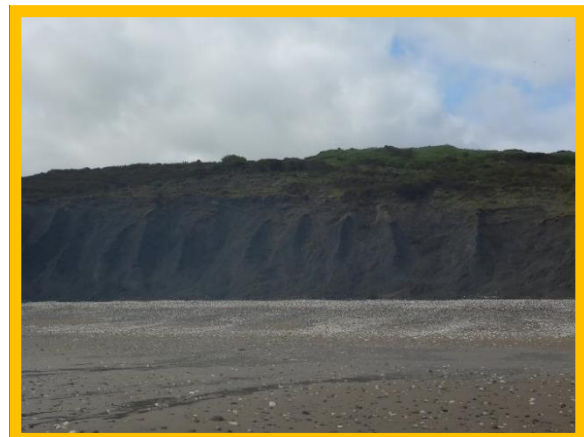
Toe of mud cliff in MU29/CC (Partly Active in 2018)

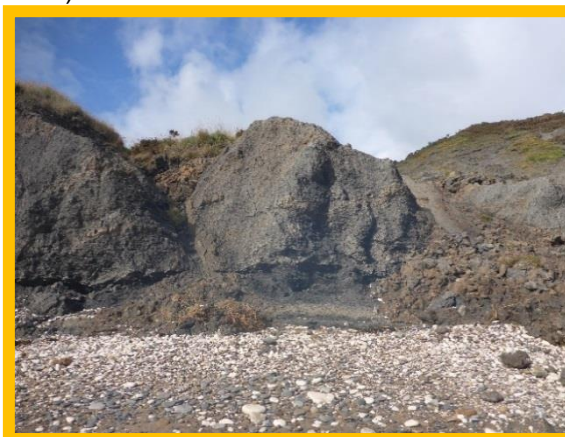
Unit MU29/CD is similar to MU29/CC but with more recent activity in the form of slumps, slides, block failures and mudflows at the toe. As a result, this unit is classified as Partly Active, as it was in 2016.

Toe of mud cliff in MU29/CD
(Partly Active in 2018)

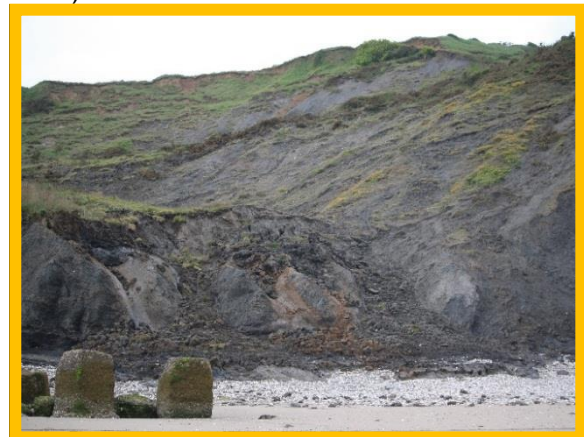
Mudflow from mud cliff in MU29/CD
(Partly Active in 2018)

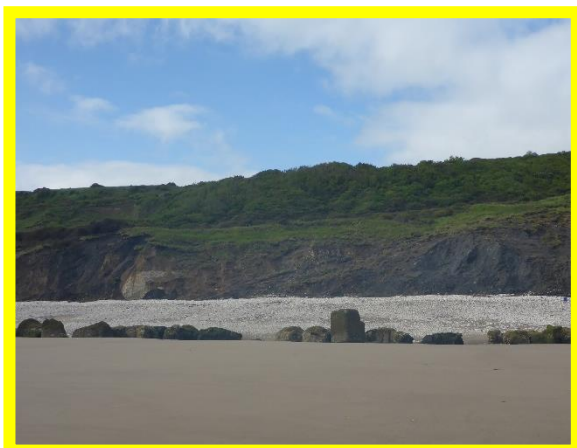
Unit MU29/CE is similar in form to unit MU29/CC but is classified as Locally Active in 2018. The slopes are well vegetated with dense trees and shrubs in places. Erosion at the toe extends relatively high above the beach in places, but the upper slopes are well vegetated.

Well vegetated upper slope above eroding toe
MU29/CE Locally Active in June 2018

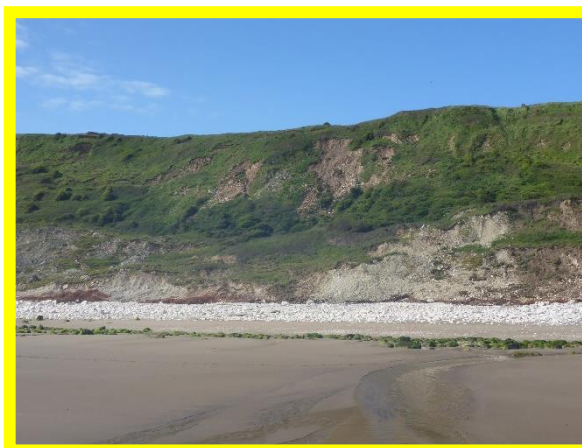
Units MU29/CF to MU29/CI are located at Speeton Cliffs and are all classified as Locally Active in 2018. These units are characterised by outcrops of chalk near the unit toes which are actively eroding onto the beach below. In places, the headscarp is near vertical and exposed.

Eroding chalk outcrop at toe
MU29/CF Locally Active in June 2018

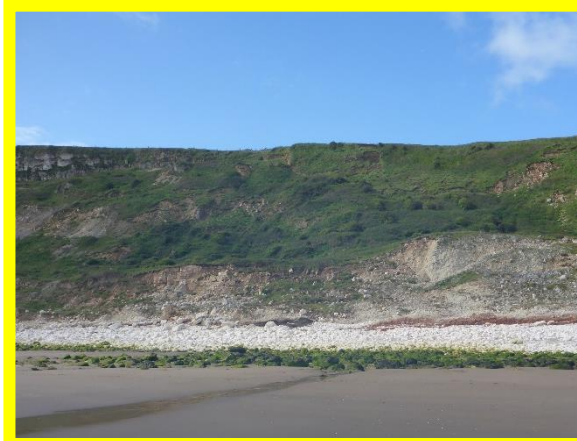
Eroding chalk outcrop at toe
MU29/CG Locally Active in June 2018

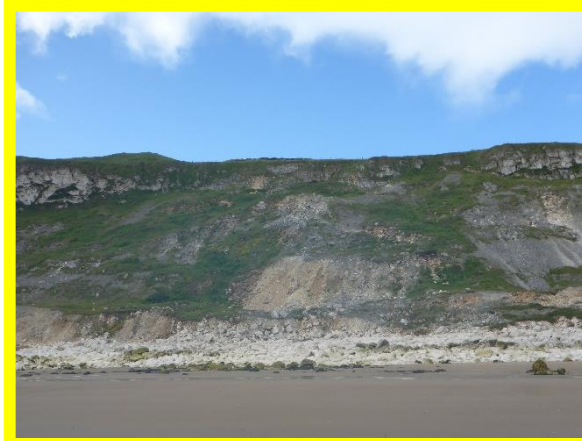
Eroding chalk outcrop at toe
MU29/CH Locally Active in June 2018

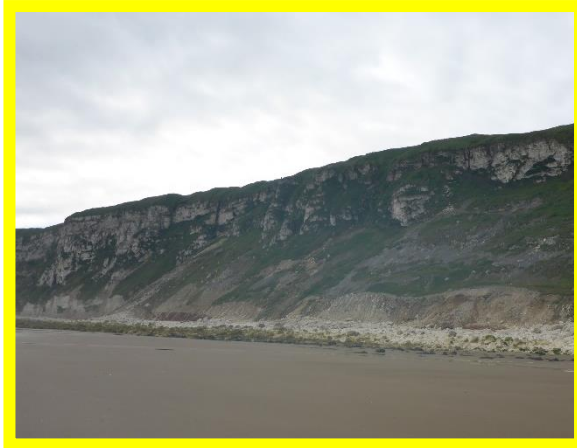
Eroding chalk outcrop at toe
MU29/CI Locally Active in June 2018
