Asset Inspection Document

Walk-over Visual Inspections of Assets

Scarborough Borough Council

NOVEMBER 2022

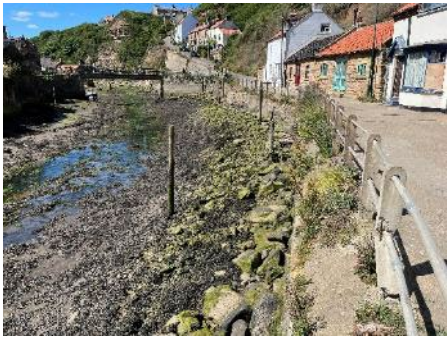
SBC Reference:	N/A		
NFCDD reference:	1221D901D0402C06

Asset Location:	Staithes, LB of River D/S of footbridge.	
	Asset Length:	100.3	
	Condition Assessment		
	Condition	Priority	Risk
	C	3	
	Brief Description		
	Promenade / road in fair condition. Wall has missing blocks and open joints locally. Vegetation growth at top of wall causing damage to concrete render. Small voids in timber and masonry training wall – largely obscured by marine vegetation growth, however no visible signs of global movement or distress of the structure		
	Recommendations		
	Clear vegetation to allow inspection. Replace missing blocks and repoint open joints. Infill / grout voids.

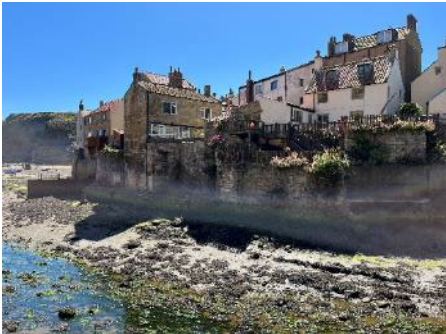
SBC Reference:	N/A		
NFCDD reference:	1221D901D0402C04

Asset Location:	NZ78261889, NZ78301886. South bank from bridge.	
	Asset Length:	117.1	
	Condition Assessment		
	Condition	Priority	Risk
	C	3	
	Brief Description		
	<p>Repair work to parts of wall evident. Vegetation growing in joints/voids locally. Minor cracks evident throughout wall. Open joints and loose masonry blocks locally (two areas in property walls backing onto Staithes Beck in poor condition as a result).</p> <p>Undercutting of toe reported in 2014 partially visible in 2018 not observed in 2020 or 2022 due to higher beach level and marine vegetation growth.</p>		
	Recommendations		
	Clear vegetation. Repair cracks, repoint masonry, fill voids. Continue to monitor.

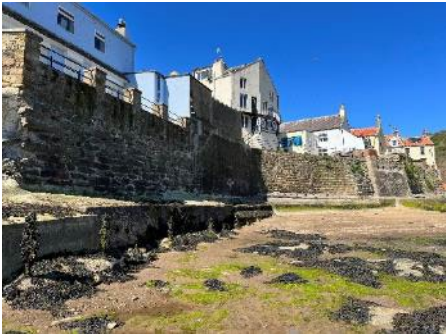
SBC Reference:	02-04-01		
NFCDD reference:	1221D901D0402C22

Asset Location:	Between slipway and groyne on South wall.	
	Asset Length:	47.7	
	Condition Assessment		
	Condition	Priority	Risk
	C	2	
	Brief Description		
	<p>Repairs evident to cracks and missing blocks replaced. Two groynes in good condition (concrete and rock armour sections). Cracking and abrasion locally. Significant horizontal crack at base of structure wall on top of seawall. Vegetation growth throughout. Partially visible in 2022 – approx. 2m long, 100mm tall, 300mm deep void between concrete wall and rock on foreshore. Located approx. mid-point between slipway and groyne structure.</p>		
	Recommendations		
	Clear vegetation. Repairs to walls joints, cracks and infill voids at toe. Consider investigation to expose voids and determine extent/take remedial action in advance of natural beach lowering.

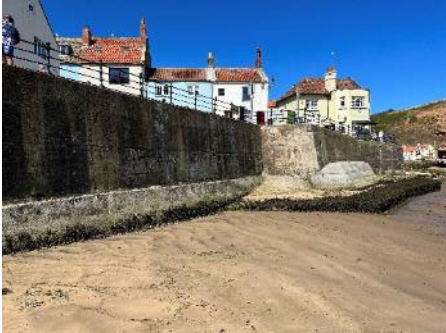
SBC Reference:	03-04-01		
NFCDD reference:	1221D901D0402C05

Asset Location:	NZ78301886, NZ78361882. Between east groyne and slipway.	
	Asset Length:	70.5	
	Condition Assessment		
	Condition	Priority	Risk
	B	3	
	Brief Description		
	Multiple cracks and spalling, but signs of multiple repair works. Some loose blocks to slipway walls. Significant vegetation growth obscuring north face of slipway. Cracks along promenade. Additional toe berm placed along short length since 2012. Cope repair patches holding well.		
	Recommendations		
	Continue to monitor. Clear vegetation, repair cracks and joints.

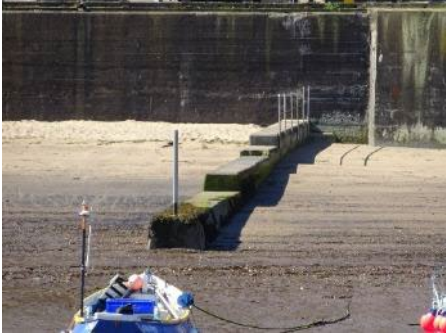
SBC Reference:	N/A		
NFCDD reference:	1221D901D0403C07

Asset Location:	NZ78361882, NZ78381885. In-between South slipways.	
	Asset Length:	32	
	Condition Assessment		
	Condition	Priority	Risk
	B	4	>5
	Brief Description		
	Groyne in good condition. Minor cracking to second "step". Vegetation cover at seaward end. Handrail in good condition.		
	Recommendations		
	Continue to monitor.

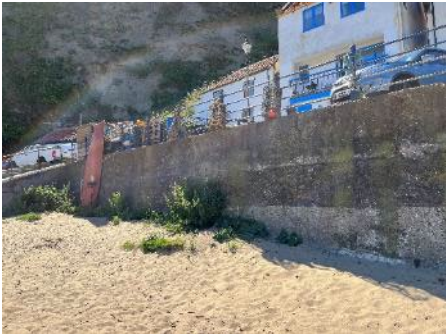
SBC Reference:	04-04-01		
NFCDD reference:	1221D901D0403C01

Asset Location:	NZ78361882, NZ78421880 South wall next to last slipway.	
	Asset Length:	73.1	
	Condition Assessment		
	Condition	Priority	Risk
	B	3	
	Brief Description		
	Vertical full height cracks through the wall between access steps and groyne has been filled although would benefit from further attention due to abrasion at surface. Exposure of aggregate throughout wall. Vegetation growing at top of wall. Cracking to promenade.		
	Recommendations		
	Continue to monitor. Remove vegetation. Re-visit previous infill repair to full-height crack. More general repairs to wall and promenade cracking.

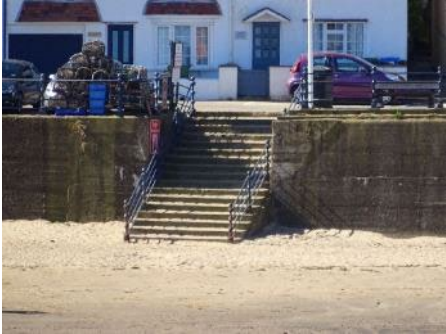
SBC Reference:	N/A		
NFCDD reference:	1221D901D0403C02

Asset Location:		
	Asset Length:	~5	
	Condition Assessment		
	Condition	Priority	Risk
	B	4	>5
	Brief Description		
	Concrete steps in fair condition. Handrails in fair condition.		
	Recommendations		
	Continue to monitor

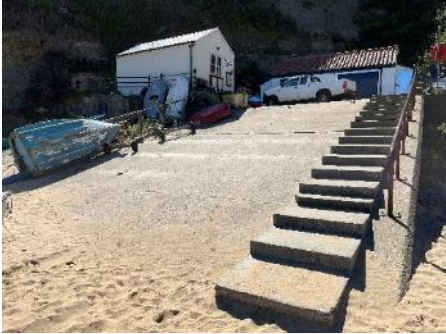
SBC Reference:	N/A		
NFCDD reference:	1221D901D0403C05

Asset Location:	NZ78421881, NZ78441881 Next to cliff.	
	Asset Length:	26.8	
	Condition Assessment		
	Condition	Priority	Risk
	B	4	>5
	Brief Description		
	Concrete ramp and steps in good to fair condition. Loss of joint filler and minor abrasion at exposed edges at construction joints.		
	Recommendations		
Continue to monitor. Replace joint filler.

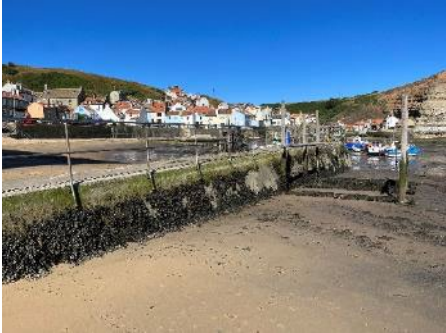
SBC Reference:	N/A		
NFCDD reference:	1221D901D0403C04

Asset Location:	NZ78431886, NZ78461884 Behind South breakwater.	
	Asset Length:	39	
	Condition Assessment		
	Condition	Priority	Risk
	B	3	
	Brief Description		
	Good condition concrete breakwater, some minor cracking in crest. Vegetation growth to vertical faces. Crack in vertical face at seaward end. At mid-length, vertical crack full width of deck and corresponding crack in vertical faces – appeared historic/stable. Handrails in good condition throughout.		
	Recommendations		
Fill cracks. Continue to monitor.

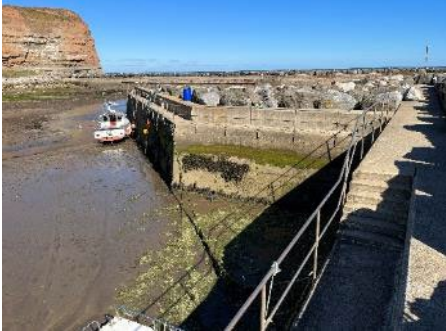
SBC Reference:	N/A		
NFCDD reference:	1221D901D0403C03

Asset Location:	NZ78491884, South Breakwater.	
	Asset Length:	327.5	
	Condition Assessment		
	Condition	Priority	Risk
	B	3	
	Brief Description		
	Concrete crest cracked in the middle of the length. Rock armour mostly tightly packed and maintaining good profile although some smaller rocks displaced and sitting on top of rock armour and four rocks on concrete deck (at seaward end). Opening of construction joints to the old part of the wall (visible on inner face). Notable construction joint between wall concrete and crest concrete look to be widening esp. around historic ladders. Local cracking and loose concrete locally at crest on inside face at approx. Mid-length possibly as a result of vessel impact. Minor deformation of handrails in same location. Local repairs ongoing July 2022.		
	Recommendations		
	Continue to monitor. Move smaller rock armour pieces from concrete crest back into revetment (H&S/access/aesthetic – not critical for performance of structure).

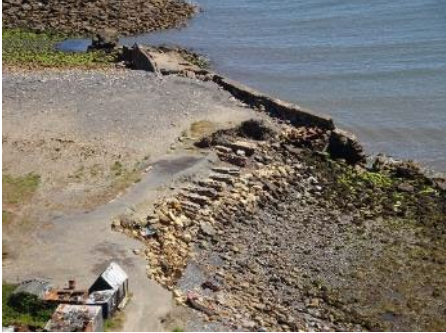
SBC Reference:	N/A		
NFCDD reference:	1221D901D0502C01

Asset Location:	NZ79871763, NZ79941769. Port Mulgrave Pier.	
	Asset Length:	161.4	
	Condition Assessment		
	Condition	Priority	Risk
	D	1	
	Brief Description		
	The structure is considered redundant however still provides limited protection to the fishermen huts and base of the cliff. Continues to deteriorate, however little change between 2020 and 2022 surveys.		
	Recommendations		
Not inspected - redundant

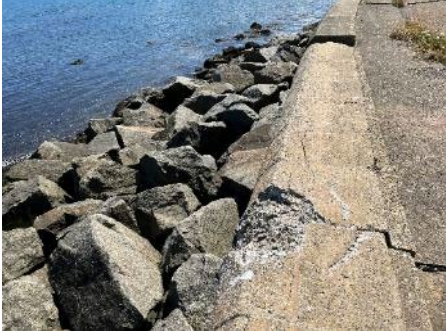
SBC Reference:	07-07A-01		
NFCDD reference:	1221D901D0601C01

Asset Location:	NZ81081614, NZ81111619. Next to Upgarth Hill	
	Asset Length:	72.4	
	Condition Assessment		
	Condition	Priority	Risk
	B	3	
	Brief Description		
	<p>Previously reported defects (erosion/abrasion & undercutting to the wall toe) were repaired via local concrete repairs in advance of construction of rock armour fillet as part of Coastal Protection Scheme (July 2018). Rock armour extends approx. 15m west of seawall to tie-in at Cauldron Cliff.</p> <p>Wash out of the joints under the capping beam. Local cracking and abrasion/spalling of reinforced concrete coping/capping beam continues to worsen. Brittle/missing joint filler on promenade parallel to capping beam (up to 20mm wide joint). Vegetation growth in joints. Route for surface water to enter backfill – increased risk of freeze-thaw action. Differential settlement of promenade slabs. 10-20mm vertically.</p>

Recommendations		
	Local repairs to concrete coping, fill open joints. Remove vegetation. Replace joint filler. Continue to monitor.

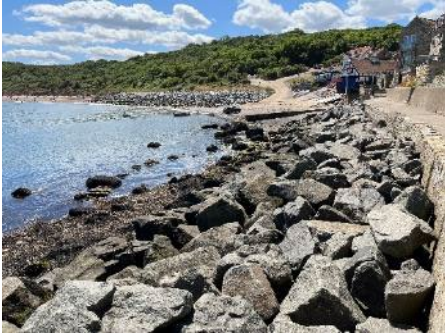
SBC Reference:	08-07A-01		
NFCDD reference:	1221D901D0601C03

Asset Location:	NZ81001604, NZ81081614. North of breakwater.	
	Asset Length:	91.3	
	Condition Assessment		
	Condition	Priority	Risk
	B	4	>5
	Brief Description		
	Rock armour fillet constructed as part of Coastal Protection Scheme (July 2018). Local repointing of masonry sea wall and repairs to coping in advance of rock placement. Minor cracking in concrete of promenade. Recessed mortar in structure and slope protection above seawall, to eastern extent of asset. Brittle/missing joint filler to promenade and concrete retaining wall to rear. Rock armour maintains good interlock and consistent profile throughout. YW rodding eyes remain visible/accessible from promenade.		
	Recommendations		
	Continue to monitor. Repair cracks, replace joint filler, repoint masonry of structures and slope protection.

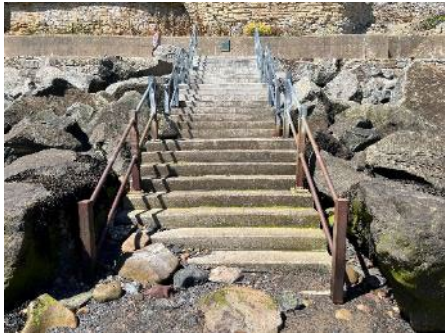
SBC Reference:	08-07A-02		
NFCDD reference:	1221D901D0601C03 ⁰⁰¹

Asset Location:	North of breakwater	
	Asset Length:	~7	
	Condition Assessment		
	Condition	Priority	Risk
	A	4	>5
	Brief Description		
	Reinforced concrete access steps constructed as part of Coastal Protection Scheme (July 2018). Precast RC step and landing units grouted onto mass concrete fill in advance of placing rock armour to both sides. Handrailing installed by SBC in August 2018. Flexible construction joints in good condition.		
	Recommendations		
	Continue to monitor.

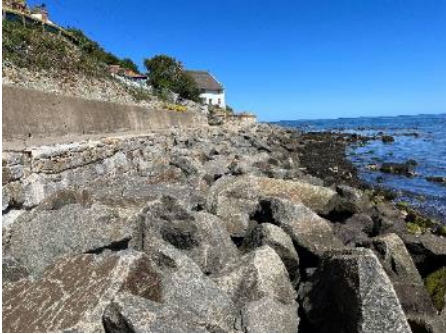
SBC Reference:	08-07A-03		
NFCDD reference:	1221D901D0601C03002

Asset Location:	North of breakwater	
	Asset Length:	~35	
	Condition Assessment		
	Condition	Priority	Risk
	B	4	>5
	Brief Description		
	<p>Cracks, abrasion and voids previously reported in lower concrete seawall repaired through Yorkshire Water realignment work (2017) and local concrete repairs in advance of construction of rock armour fillet (July 2018). Repointing/repairs to masonry wall and coping locally. Minor cracking in concrete of promenade. Recessed mortar in structure and slope protection above seawall, to eastern extent of asset. Brittle/missing joint filler to promenade and concrete retaining wall to rear.</p>		
	Recommendations		
Continue to monitor. Repair cracks, replace joint filler, repoint masonry of structures and slope protection.

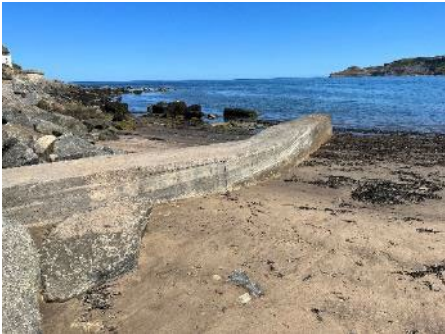
SBC Reference:	08-07A-04		
NFCDD reference:	1221D901D0601C02

Asset Location:	NZ81011606, NZ81031605.	
	Asset Length:	26.1	
	Condition Assessment		
	Condition	Priority	Risk
	C	2	
	Brief Description		
	<p>Breakwater / groyne in poor condition overall. Landward section of structure covered by rock armour fillet (approx. 4m length of crest & 10m length on both faces). Smaller vertical cracks to breakwater at seaward end. Section of breakwater around elbow broken out temporarily to allow access for construction of Coastal Protection Works (this section was previously in very poor condition). Reinstated with 16m³ of in situ cast concrete in July 2018. Crack/displacement of concrete in crest of existing structure at seaward end of infill section.</p> <p>Extensive vegetation coverage. Significant abrasion. Opening of joint between crest and walls. Higher beach levels obscuring potential undercutting reported in 2018.</p>

Recommendations		
	Continue to monitor. Consider removal.

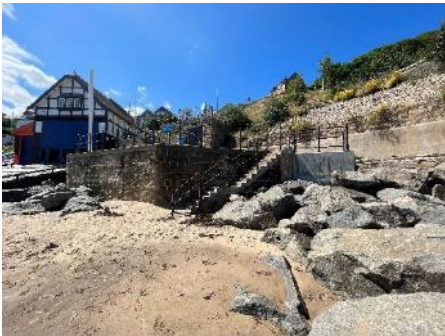
SBC Reference:	08-07A-05		
NFCDD reference:	1221D901D0601C07001

Asset Location:	Runswick Bay Pumping Station	
	Asset Length:	7	
	Condition Assessment		
	Condition	Priority	Risk
	B	4	>5
	Brief Description		
	<p>Yorkshire Water constructed concrete manhole chamber immediately to north in advance of Coastal Protection Scheme (July 2018). Remains in good condition as are handrails.</p> <p>Minor local damage/abrasion to surface and edges of concrete access steps. Several steps buried beneath sand. Minor loss of mortar locally. Small flap valve no longer operational and in need of replacement. Rock fillet in good condition – no evidence of global displacement. Gap remains for access to foot of steps.</p>		
	Recommendations		
	Continue to monitor. Replace flap valve.

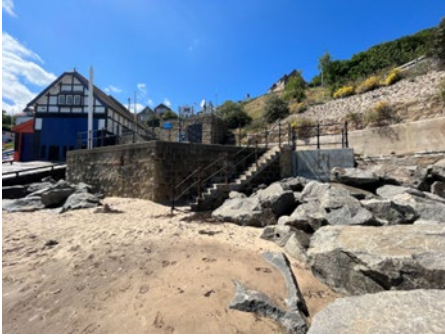
SBC Reference:	08-07A-06		
NFCDD reference:	1221D901D0601C07

Asset Location:	Runswick Bay. Pumping station.	
	Asset Length:	33.3	
	Condition Assessment		
	Condition	Priority	Risk
	B	4	>5
	Brief Description		
	Pumping station with masonry cladding in good condition. Rock armour fillet constructed as part of Runswick Bay Coastal Protection Scheme completed July 2018. Minor loss of mortar locally. Small flap valve no longer operational and in need of replacement. Rock fillet in good condition – no evidence of global displacement. Beach levels higher than 2020 survey, now burying significant proportion of rock armour.		
	Recommendations		
Continue to monitor. Replace flap valve.

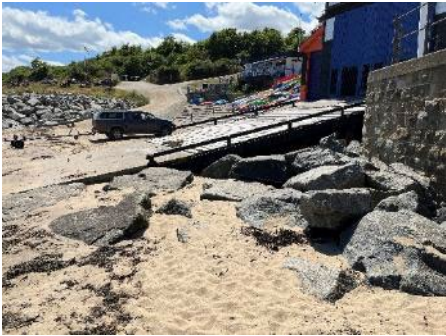
SBC Reference:	09-07A-01		
NFCDD reference:	1221D901D0601C04

Asset Location:	NZ81011601. Lifeboat slipway.	
	Asset Length:	43.8	
	Condition Assessment		
	Condition	Priority	Risk
	B	3	
	Brief Description		
	Rotting timber supports to historic lifeboat slipway. Deck timbers in good condition. Cracks/open joints to side walls of Runswick Rescue slipway. Southern slipway / beach access ramp concrete in good condition with local abrasion at construction joints and minor longitudinal crack in top two panels. Concrete revetment including timber steps in good condition.		
	Recommendations		
Repair cracks to slipway, replace rotten/missing timbers. Continue to monitor.

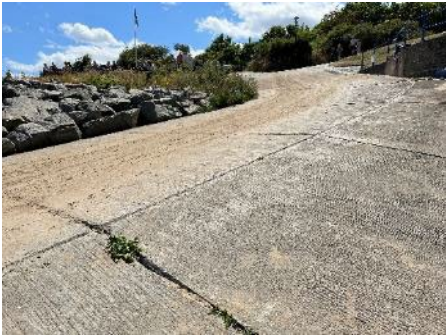
SBC Reference:	09-07A-02		
NFCDD reference:	1221D901D0601C04 001

Asset Location:		
	Asset Length:	~30	
	Condition Assessment		
	Condition	Priority	Risk
	B	4	>5
	Brief Description		
	Concrete ramp in good condition. Minor damage / abrasion locally at concrete edges at construction joints. Minor longitudinal crack in centre of top two panels.		
	Recommendations		
Continue to monitor.

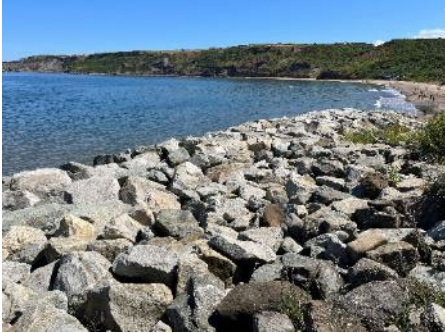
SBC Reference:	10-07A-01		
NFCDD reference:	1221D901D0602C01

Asset Location:	NZ81051591, NZ81011601	
	Asset Length:	290	
	Condition Assessment		
	Condition	Priority	Risk
	B	4	>5
	Brief Description		
	<p>Rock armour generally in good condition. Consistent crest and slope profile. No evidence of significant global movement / displacement. Toe rocks well buried in sand. High level access ramp (Cleveland Way) well protected – armour stone “edging” remains in place. Backfill/surfacing in fair condition (smaller rocks and sand placed by SBC).</p>		
	Recommendations		
Continue to monitor.

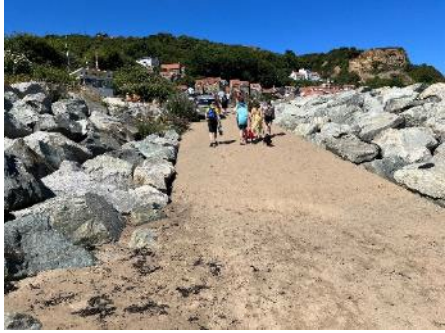
SBC Reference:	10-07B-01		
NFCDD reference:	1221D901D0602C01 001

Asset Location:	NZ81051591, NZ81011601	
	Asset Length:	~50	
	Condition Assessment		
	Condition	Priority	Risk
	B	4	>5
	Brief Description		
	<p>Concrete slipway in good condition. Vegetation growth associated with Nettle Beck which outfalls through the rock armour and over the ramp surface in high flows.</p>		
	Recommendations		
Continue to monitor.

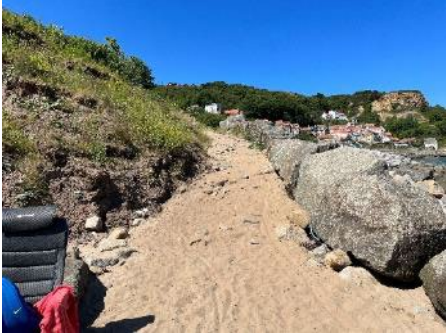
SBC Reference:	10-07B-02		
NFCDD reference:	1221D901D0602C01002

Asset Location:		
	Asset Length:	~48	
	Condition Assessment		
	Condition	Priority	Risk
	B	3	
	Brief Description		
	<p>Southern extent of revetment refurbished in June 2018 using surplus rock armour from CPS. Rock is generally 8-10t. Seaward edge of high-tide access ramp lined with single row of rock armour and revetment bolstered with rock armour (previously smaller armour and beach-won boulders were used). Rock armour extends approx. 30m to the south to form fillet at toe of active coastal slopes. High level access ramp (Cleveland Way) well protected – armour stone “edging” remains in place. Backfill/surfacing in fair condition (smaller rocks and sand placed by SBC).</p>		
	Recommendations		
Continue to monitor. Replace smaller backfill as required.

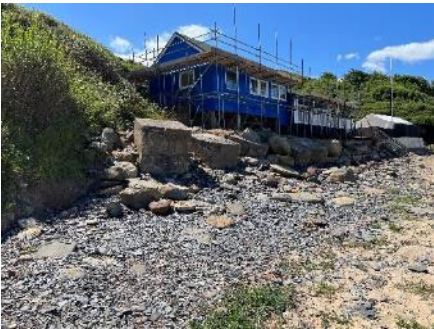
SBC Reference:	N/A		
NFCDD reference:	1221D901D0602C05

Asset Location:	South end of bay.	
	Asset Length:	56.2	
	Condition Assessment		
	Condition	Priority	Risk
	B	3	
	Brief Description		
	<p>North: Rock armour slope protection at mouth of stream. Concrete seawall and apron above timber toe beams (likely permanent formwork). South: Boulders and concrete blocks placed informally on/in front of retaining wall formed from timber sleepers fixed between vertical steel columns. Boulders and large concrete tank blocks to tie into coastal slope.</p>		
	Recommendations		
Continue to monitor. Replace/reprofile rock to protect timber retaining wall.

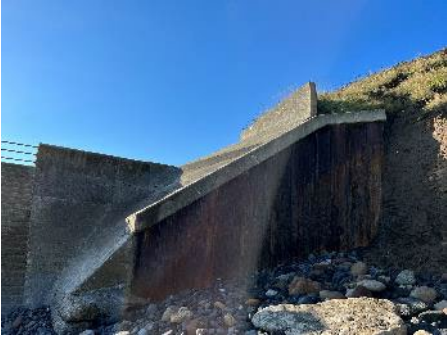
SBC Reference:	13-09A-01		
NFCDD reference:	1221D901D0701C02001

Asset Location:	NZ86061286, NZ85981297. Wall protecting car park.	
	Asset Length:	~5	
	Condition Assessment		
	Condition	Priority	Risk
	C	3	
	Brief Description		
	Heavily corroded sheet pile retaining wall tied into the unprotected cliff. No deflection / movement of the pile noticeable. Concrete capping appears in good condition. It has previously been observed that minor abrasion at toe has caused some exposed reinforcement, but this was covered by beach sand.		
	Recommendations		
Continue to monitor corrosion of piles and erosion of undefended cliff at tie-in.

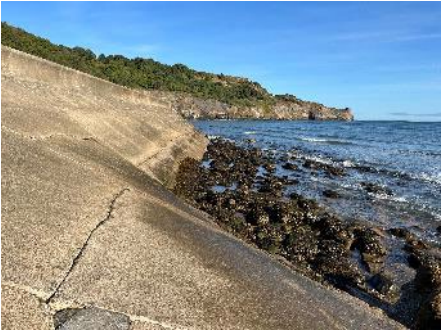
SBC Reference:	13-09A-02		
NFCDD reference:	1221D901D0701C02

Asset Location:	NZ86061286, NZ85981297. Wall protecting car park.	
	Asset Length:	174.5	
	Condition Assessment		
	Condition	Priority	Risk
	B	3	
	Brief Description		
	Sloping concrete revetment with a recurve crest wall. The concrete wall remains in fair condition with minimal damage to the surface, however the revetment has lost thickness of concrete at the base through abrasion, with exposure of reinforcement bars previously reported.		
	Recommendations		
Encasement of this reinforcement is advised from a structural perspective, as well as preventing any Health & Safety incidents occurring due to sharp edges of the exposed bars on this popular amenity beach. Cracks towards southern end (near slipway) need filling.

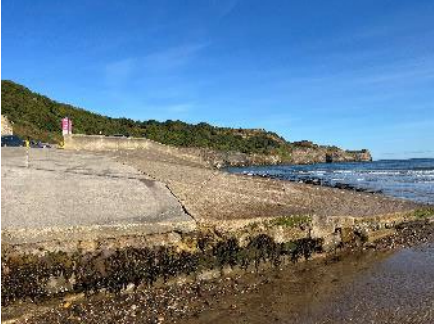
SBC Reference:	13-09A-03		
NFCDD reference:	1221D901D0701C02002

Asset Location:		
	Asset Length:	~15	
	Condition Assessment		
	Condition	Priority	Risk
	B	3	
	Brief Description		
	Missing filler in joints to slipway's blockwork wing-wall. Toe at interface of slipway and adjacent seawall previously reported as being locally poor, but covered during inspections due to high beach levels.		
	Recommendations		
	Continue to monitor toe and fill gaps in joints on wing-wall.

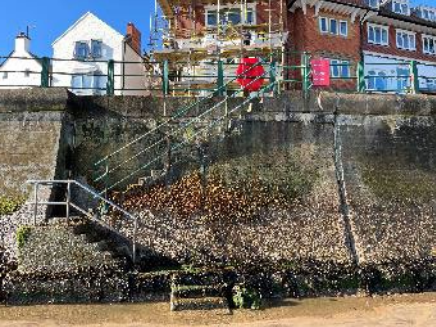
SBC Reference:	14-09B-02		
NFCDD reference:	1221D901D0702C01001

Asset Length:	~4	
	Condition Assessment		
	Condition	Priority	Risk
	B	3	
	Brief Description		
	Steps abraded on lower sections. Lower section of handrail replaced since last inspection.		
	Recommendations		
	Continue to monitor.

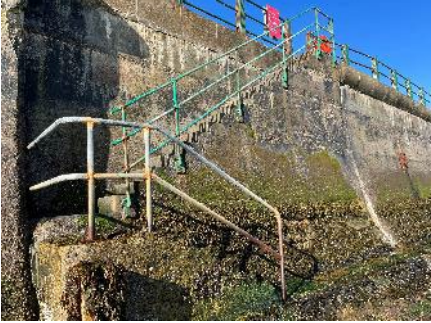
SBC Reference:	14-09B-04		
NFCDD reference:	1221D901D0702C01003

Asset Location:		
	Asset Length:	~4	
	Condition Assessment		
	Condition	Priority	Risk
	B	3	
	Brief Description		
	Steps abraded on lower sections. Handrail replaced or painted since 2018, with lowest section corroded.		
	Recommendations		
	Continue to monitor.

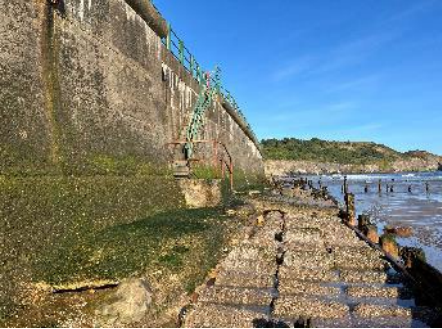
SBC Reference:	14-09B-05		
NFCDD reference:	1221D901D0702C01004

Asset Location:	Same as 14-09B-01	
	Asset Length:	Incl. in 14-09B-01	
	Condition Assessment		
	Condition	Priority	Risk
	C	2	
	Brief Description		
	Groynes derelict. Apron substantially exposed. Very poor with adjacent timber planks and stakes missing and rotten. Concrete-filled barrel toe structure exposed, with significant displacement of some elements Missing joint filler under capping beam. Some sections of missing sealant in most joints in wall, with minor abrasion around joints.		
	Recommendations		
Re-seal joints where missing between poured sections of sea wall, and replace/encase apron. Whilst not yet 'urgent' the structure would benefit from works within a few years.

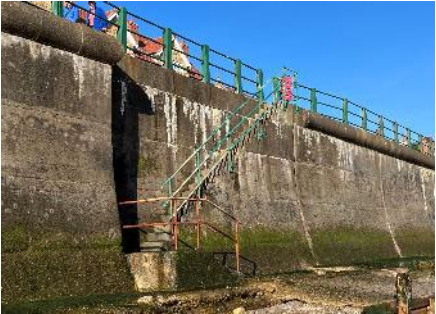
SBC Reference:	14-09B-06		
NFCDD reference:	1221D901D0702C01005

Asset Location:		
	Asset Length:	~4	
	Condition Assessment		
	Condition	Priority	Risk
	B	3	
	Brief Description		
	Steps abraded on lower sections. Handrail replaced or painted since 2018, with lowest section corroded.		
	Recommendations		
Continue to monitor.

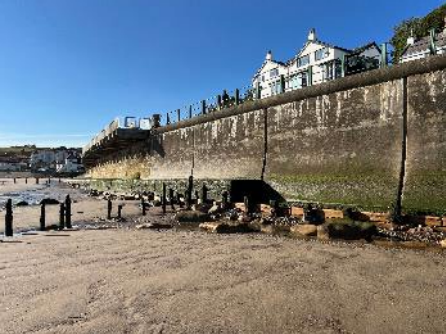
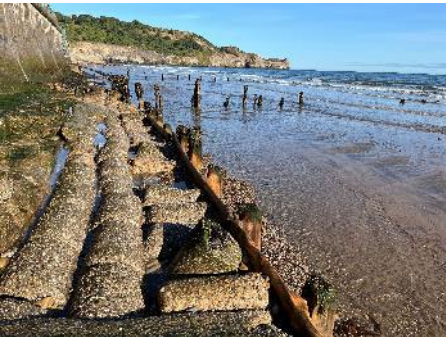
SBC Reference:	14-09B-07		
NFCDD reference:	1221D901D0702C01006

Asset Location:	Same as 14-09B-01	
	Asset Length:	Incl. in 14-09B-01	
	Condition Assessment		
	Condition	Priority	Risk
	C	2	
	Brief Description		
	Groynes derelict. Apron substantially exposed. Very poor with adjacent timber planks and stakes missing and rotten. Concrete-filled barrel toe structure exposed, with significant displacement of some elements Missing joint filler under capping beam. Some sections of missing sealant in most joints in wall, with minor abrasion around joints.		
	Recommendations		
	Re-seal joints where missing between poured sections of sea wall, and replace/encase apron. Whilst not yet 'urgent' the structure would benefit from works within a few years.

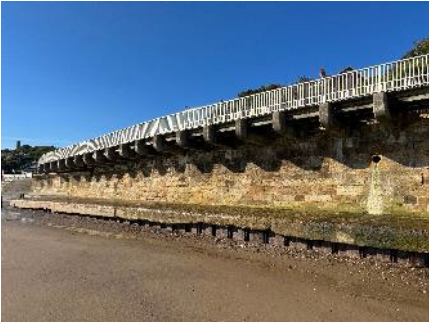
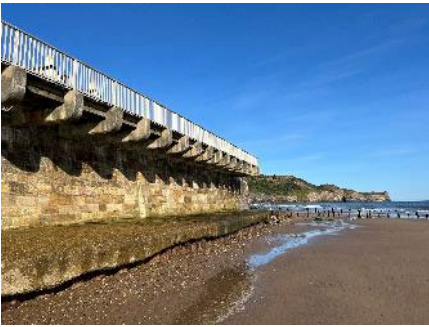
SBC Reference:	15-09B-01		
NFCDD reference:	1221D901D0702C04

Asset Location:	NZ86251264, NZ86241268. NE of East Row Bridge.	
	Asset Length:	42.1	
	Condition Assessment		
	Condition	Priority	Risk
	B	3	
	Brief Description		
	Steel toe piles exposed during the 2022 survey, as in 2016, with substantial voids under the toe apron. Buried/submerged by ponded water in 2018 and only one small section exposed in 2020. Groynes derelict. Vertical crack to masonry wall near pipe at centre of wall. Some mortar missing in some joints in masonry wall. Timber walkway in good condition.		
	Recommendations		
	Expose and repair voids under toe apron.

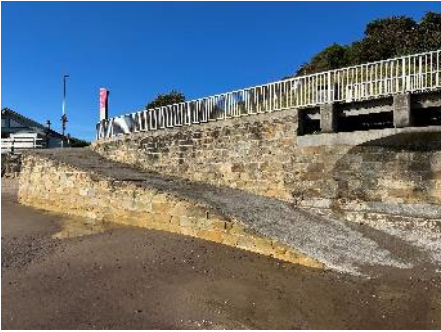
SBC Reference:	15-09B-02		
NFCDD reference:	1221D901D0702C03

Asset Location:		
	Asset Length:	~10	
	Condition Assessment		
	Condition	Priority	Risk
	B	3	
	Brief Description		
	Slipway in good condition overall. One or two gaps in the blockwork wing wall recorded in 2018 have now been infilled.		
	Recommendations		
Continue to monitor.

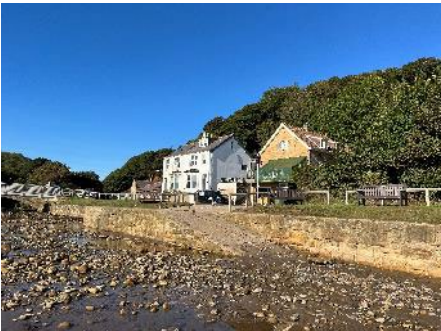
SBC Reference:	15-09B-04		
NFCDD reference:	1221D901D0702C03 002

Asset Location:		
	Asset Length:	~4	
	Condition Assessment		
	Condition	Priority	Risk
	B	3	
	Brief Description		
	Fair overall condition. Edge capping stone missing. Toe below beach level.		
	Recommendations		
Repair capping edge. Continue to monitor.

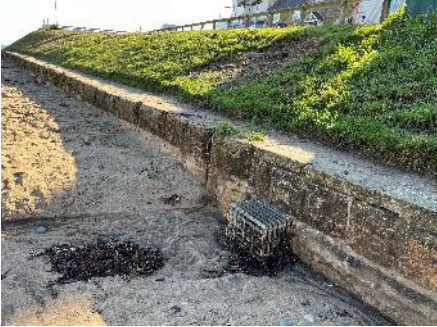
SBC Reference:	15-09B-05		
NFCDD reference:	1221D901D0702C03 003

Asset Location:		
	Asset Length:	232.4 total (15-09b-03 to 15-09b-05)	
	Condition Assessment		
	Condition	Priority	Risk
	B	3	
	Brief Description		
	Masonry blockwork wall to channel sides in fair to good condition.		
	Recommendations		
Continue to monitor.

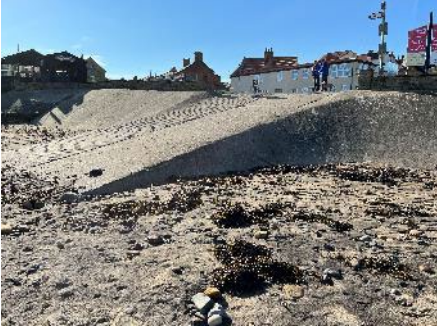
SBC Reference:	15-09B-07		
NFCDD reference:	1221D901D0702C02 001

Asset Location:		
	Asset Length:	774.5 total (15-09b-06 to 17-10-02)	
	Condition Assessment		
	Condition	Priority	Risk
	B	4	>5
	Brief Description		
	Slipway in good condition with toe below beach level. Adjacent concrete tie-ins to either side of slipway in good condition.		
	Recommendations		
Continue to monitor

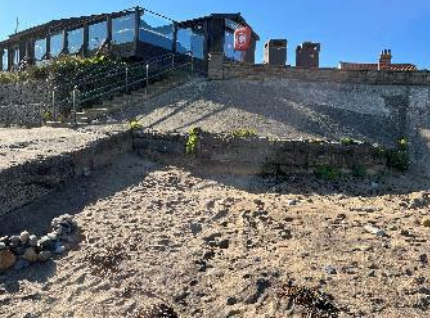
Good overall condition. Sloping revetment with blockwork wall. Toe of wall below beach level but some open joints in exposed sections.	
	Recommendations	
	Repoint joints in blockwork wall below revetment.

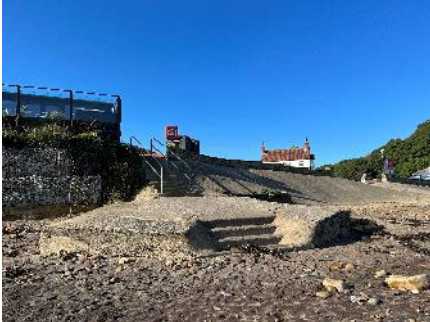
SBC Reference:	16-09C-02		
NFCDD reference:	1221D901D0702C02003

Asset Location:		
	Asset Length:	774.5 total (15-09b-06 to 17-10-02)	
	Condition Assessment		
	Condition	Priority	Risk
	B	3	
	Brief Description		
	Steps in fair overall condition. Concrete revetment on the landing is abraded in places.		
	Recommendations		
Continue to monitor.

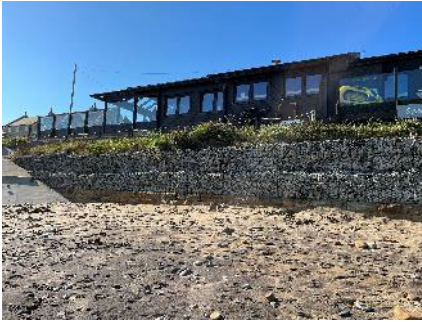
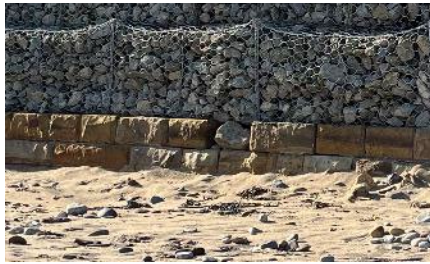
SBC Reference:	16-09C-04 to 17-10-02		
NFCDD reference:

Asset Location:		
	Asset Length:		
	Condition Assessment		
	Condition	Priority	Risk
	B	2	
	Brief Description		
	The gabion baskets have not filled completely with visible sagging on the bottom row. The top row has remained vertical. No significant deterioration since 2020. Upper courses of stone blocks exposed, showing 1 block still missing and still plugged with a beach boulder and large cobbles as was the case during the 2016 survey when it was last exposed.		
	Recommendations		
Continue to monitor.

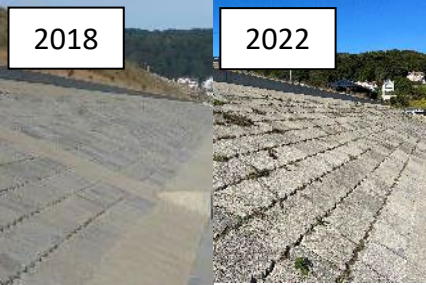
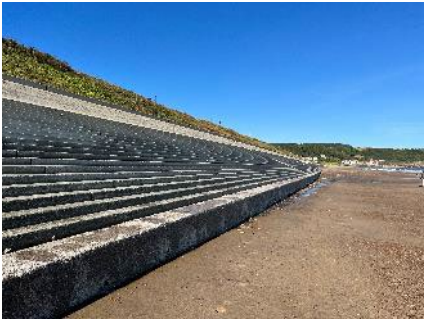
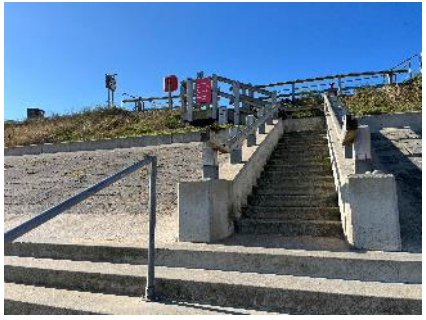
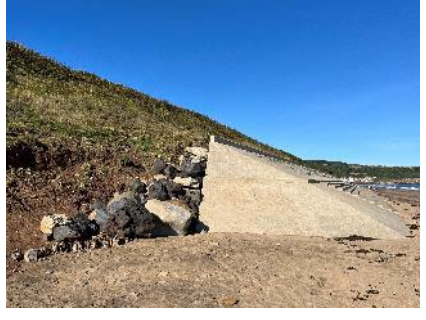
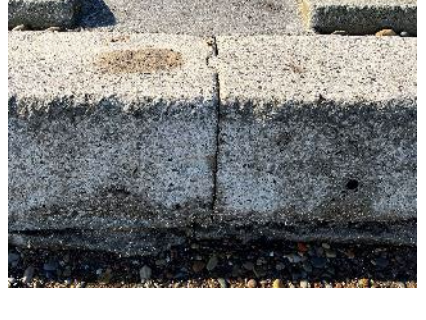
SBC Reference:	15-09B-06 and 16-09C-04 to 17-10-02		
NFCDD reference:

<p>Coastal defences constructed between early 2015 and summer 2016. The new defences comprise a lower section with a stepped revetment built from pre-cast concrete units and a buried concrete toe beam that was cast in situ, with an upper section of interlocking pre-cast Dycel units.</p> <p>Natural coastal slope extends above the upper units to the plateau upon which the highway and footpaths sit, with re-graded and stabilised high coastal slopes to landward of the road.</p>

<p>Sloping concrete tie-in revetments exist at either end of the structure.</p> <ul style="list-style-type: none"> • Outfall drains are freely running • Vegetation is being established between the Dycel blocks • A significant length of the upper section of the toe beam, and all the lower steps are were exposed. The section of toe beam recently repaired following displacement was not however visible

<ul style="list-style-type: none"> • Evidence of loss of foam strips used as packing between the structural elements was observed, though with not obvious impact upon structural integrity. • Abrasion of the in situ concrete toe beam has exposed some of the plastic fibre reinforcement • Some chipping damage has occurred to the edge of the steps (confined to lower steps at the western end but becoming more frequent and higher up the structure to its central and southern sections).

<ul style="list-style-type: none"> • Outflanking at the eastern end is being adequately addressed by large beach boulders, more of which appear to have been placed since the previous inspection

Recommendations
	Continue to monitor.

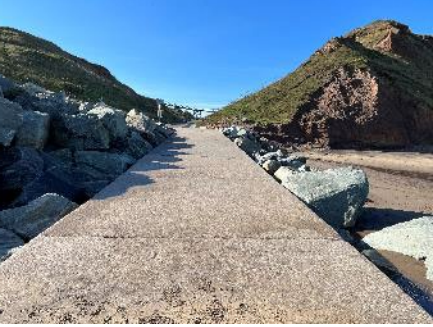
SBC Reference:	18-11A-01		
NFCDD reference:	1221D901D0801C01 001

Asset Location:	NZ88161194, NZ88541185	
	Asset Length:	~10	
	Condition Assessment		
	Condition	Priority	Risk
	B	4	>5
	Brief Description		
	Concrete edge of slipway chipped at construction joint. Overall good condition. Toe below beach level. Rock armour both sides tightly packed.		
	Recommendations		
Continue to monitor.

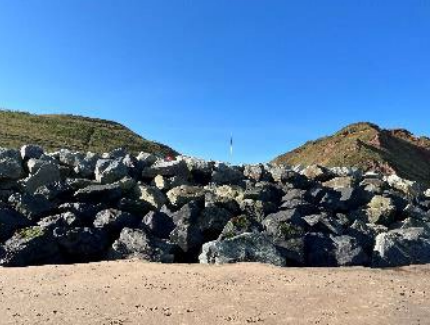
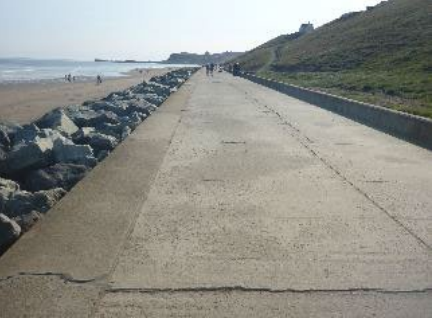
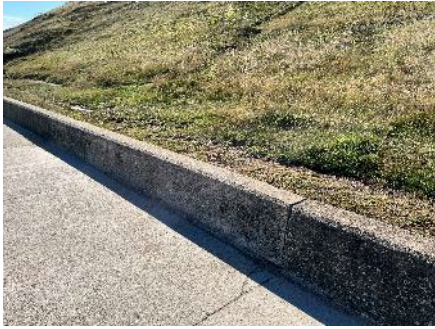
SBC Reference:	18-11A-02		
NFCDD reference:	1221D901D0801C01

Asset Location:	NZ88161194, NZ88541185	
	Asset Length:	439.3	
	Condition Assessment		
	Condition	Priority	Risk
	B	3	
	Brief Description		
	Rock armour generally good, well packed but movement in several local areas. Some smaller armour loosely packed on crest.		
	Promenade has occasional minor open joints / cracks / missing sealant but nothing appears to have worsened since previous inspections.		
Localised damages to rear 'splash' wall observed.

Continue to monitor surface cracking in promenade and reactive repairs on an 'as needs' basis.

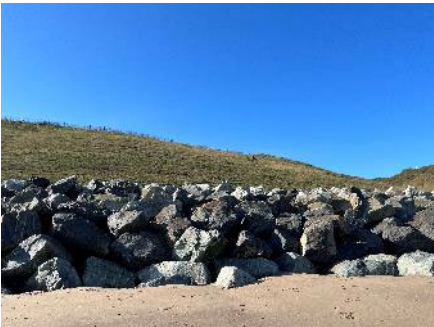
SBC Reference:	18-11A-04		
NFCDD reference:	1221D901D0801C01003

Asset Location:	Part of 18-11A-02	
	Asset Length:		
	Condition Assessment		
	Condition	Priority	Risk
	B	3	
	Brief Description		
	Rock revetment – remainder of 18-11A-02 - appears in generally good condition.		
	Recommendations		
	Continue to monitor.

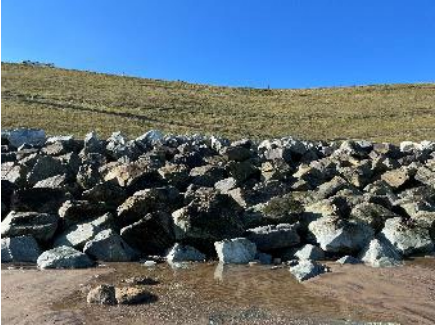
SBC Reference:	70-11A-01		
NFCDD reference:	1221D901D0802C02

Asset Location:	NZ88671180, NZ88861170	
	Asset Length:	216.1 (inc 70-11a-01 to 70-11a-04)	
	Condition Assessment		
	Condition	Priority	Risk
	B	3	
	Brief Description		
	Rock armour in good condition, closely packed, and good coverage. Some smaller rocks on crest lost interlock. Promenade surface showing some signs of cracking and sealant loss between concrete sections.		
	Recommendations		
	Continue to monitor.

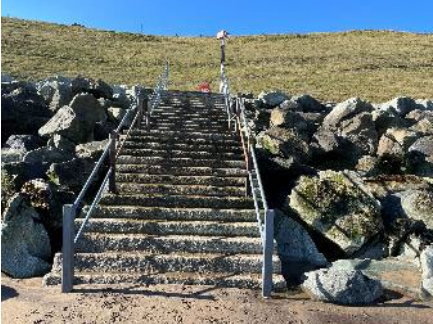
SBC Reference:	70-11A-02		
NFCDD reference:	1221D901D0802C02001

Asset Location:	Western promenade, Whitby	
	Asset Length:	216.1 (inc 70-11a-01 to 70-11a-04)	
	Condition Assessment		
	Condition	Priority	Risk
	B	3	
	Brief Description		
	Steps with algae on lower courses. Heavy abrasion on lower sections of steps.		
	Recommendations		
Continue to monitor

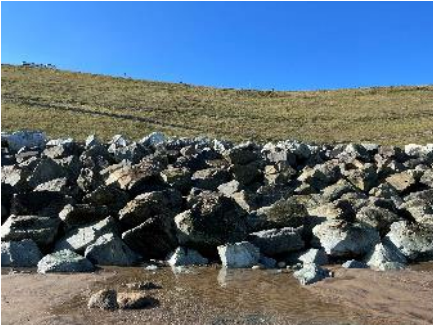
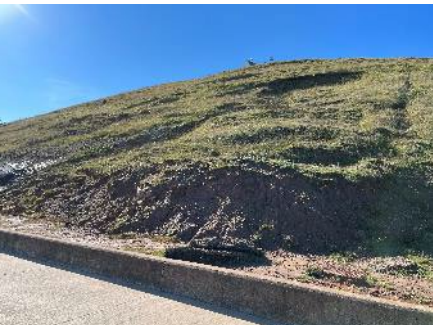
SBC Reference:	70-11A-03		
NFCDD reference:	1221D901D0802C02002

Asset Location:	Western promenade, Whitby	
	Asset Length:	216.1 (inc 70-11a-01 to 70-11a-04)	
	Condition Assessment		
	Condition	Priority	Risk
	B	3	
	Brief Description		
	Rock armour in good condition, closely packed, and good coverage. Some smaller rocks on crest lost interlock. Promenade surface showing some signs of cracking and sealant loss between concrete sections.		
	Cliff behind the defences showing evidence of minor slumps and failure of local drainage assets.		
Recommendations			
Continue to monitor.

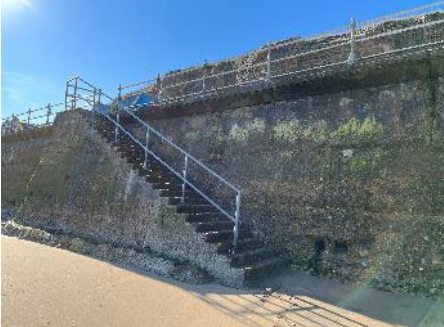
SBC Reference:	70-11A-04		
NFCDD reference:	1221D901D0802C02003

Asset Location:	Western promenade, Whitby	
	Asset Length:	216.1 (inc 70-11a-01 to 70-11a-04)	
	Condition Assessment		
	Condition	Priority	Risk
	C	3	
	Brief Description		
	<p>Tread of steps in fair condition. Side wall corner is heavily abraded. Handrail replaced since last inspection. Heavy abrasion on lower sections of steps.</p>		
	Recommendations		
Treat or replace handrails.

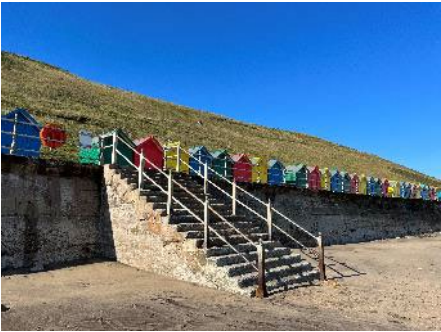
SBC Reference:	71-11A-02		
NFCDD reference:	1221D901D0802C13 001

Asset Location:	Western promenade, Whitby	
	Asset Length:	~ 4	
	Condition Assessment		
	Condition	Priority	Risk
	B	3	
	Brief Description		
	<p>The steel rise 'facing' on the bottom step was exposed in the previous inspections and had moved seaward and was coming away on 'corner' (but was covered by beach levels in 2022 inspections). Handrail in generally good condition. Heavy abrasion on lower sections of steps.</p>		
	Recommendations		
Continue to monitor

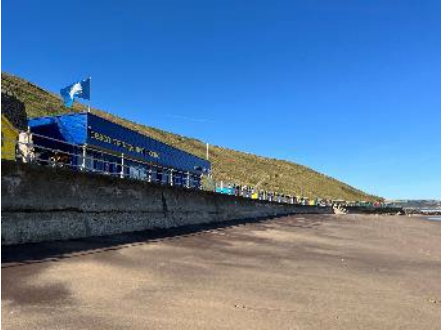
SBC Reference:	71-11A-03		
NFCDD reference:	1221D901D0802C13

Asset Location:	NZ88861170, NZ89231154	
	Asset Length:	158.4	
	Condition Assessment		
	Condition	Priority	Risk
	C	2	
	Brief Description		
	<p>Horizontal cracks to wall visible near slipway, east of Beach Management Centre and North Beach cafe. Beach level high and wall's toe not exposed. Handrail is relatively new. Some anchor bolts showing signs of corrosion. Concrete facing weathered/abraded.</p>		
	Recommendations		
Repair cracks (likely cold joints) to wall near slipway.

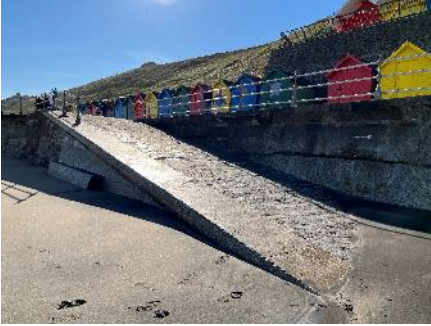
SBC Reference:	71-11A-04		
NFCDD reference:	1221D901D0802C13002

Asset Location:	Western promenade, Whitby	
	Asset Length:	~12	
	Condition Assessment		
	Condition	Priority	Risk
	C	2	
	Brief Description		
	Lower section of slipway repairs in good order but wing wall abrasion still evident.		
	Recommendations		
Continue to monitor

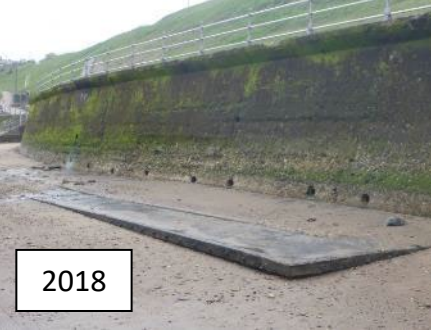
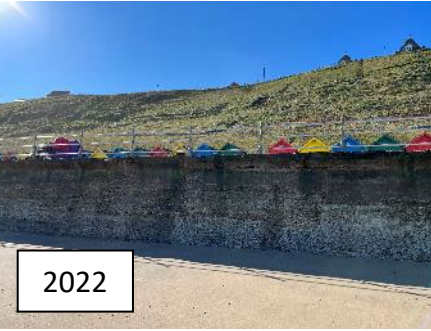
SBC Reference:	71-11A-05		
NFCDD reference:	1221D901D0802C14

<p>2022</p>	Asset Location:	NZ88861170, NZ89231154	
	Asset Length:	86.2	
	Condition Assessment		
	Condition	Priority	Risk
	C	2	
	Brief Description		
	Erosion/abrasion to lower half of wall. Minor damage throughout. Apron buried (was partly exposed in 2018). Substantial renovation of the promenade carried out in 2022 to repair/replace panels. Areas of chipping/cracking along top edge remain. Handrails replaced following 2013 storm surge remain in good order relatively recently.		
	Recommendations		
Repair chipped areas approx. 0.5m from edge throughout.

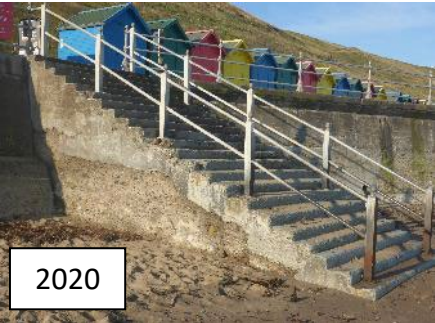
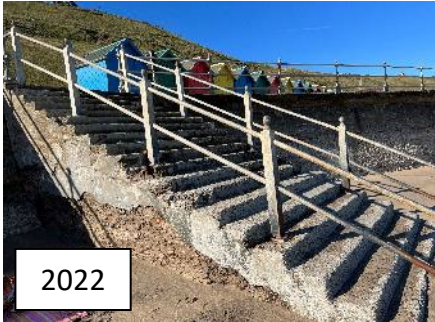
SBC Reference:	20-11A-01		
NFCDD reference:	1221D901D0802C04001

<p>2022</p>	Asset Location:	Western promenade, Whitby	
	Asset Length:	~7	
	Condition Assessment		
	Condition	Priority	Risk
	C	3	
	Brief Description		
	<p>Steps. Weathered concrete with exposed aggregates. Abraded side walls with large cracks. Handrail in fair condition. Heavy abrasion on lower sections of steps.</p> <p>Render on side wall has deteriorated significantly since the last inspection.</p>		
Recommendations			
<p>Replace render on side wall and repair cracks. Continue to monitor.</p>

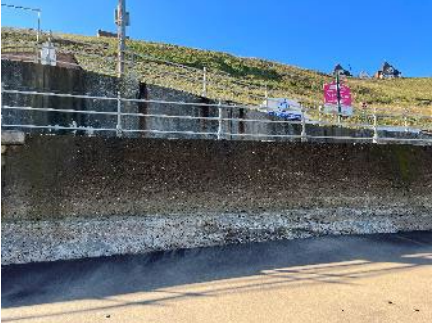
SBC Reference:	20-11A-02		
NFCDD reference:	1221D901D0802C04

Asset Location:	NZ89231154, NZ89291153	
	Asset Length:	65.4	
	Condition Assessment		
	Condition	Priority	Risk
	C	3	
	Brief Description		
	<p>Some minor vertical cracking at a joint in eastern third of wall. Concrete coping replaced at western end.</p> <p>Erosion/abrasion to lower half of wall, including exposed sections of apron.</p> <p>Lower handrails replaced following the 2013 storm surge remain in good condition. Minor cracking to promenade.</p>		
	Recommendations		
Repair abraded front face. Infill crack.

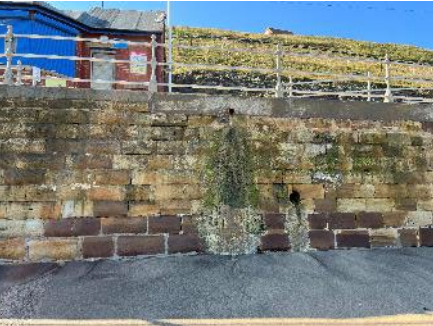
SBC Reference:	21-11A-01		
NFCDD reference:	1221D901D0802C07

Asset Location:	NZ89291153, NZ89361152	
	Asset Length:	71.9	
	Condition Assessment		
	Condition	Priority	Risk
	C	3	
	Brief Description		
	<p>Blockwork wall - cracking/loss of mortar and abraded blocks in places. Joints missing locally. Generally stable although these points of weakness could cause failure. Higher concrete wall in a fair condition. Minor cracking in promenade. New coping replaced in 2014 remains in good condition.</p>		
	Recommendations		
Repair/replace damaged blocks and grout joints.

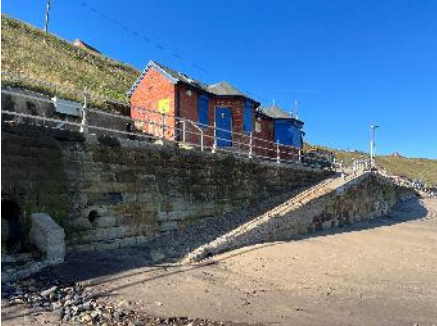
SBC Reference:	21-11A-02		
NFCDD reference:	1221D901D0802C07001

Asset Location:		
	Asset Length:	~30	
	Condition Assessment		
	Condition	Priority	Risk
	C	3	
	Brief Description		
	Slipway. Concrete deck replaced on the top half of the structure - bottom half abraded.		
	Recommendations		
Continue to monitor.

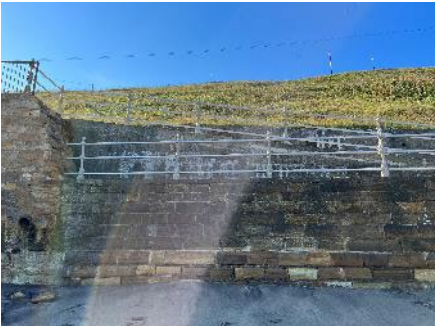
SBC Reference:	22-11A-01		
NFCDD reference:	1221D901D0802C06

Asset Location:	NZ89361152, NZ89401152	
	Asset Length:	37.5	
	Condition Assessment		
	Condition	Priority	Risk
	C	3	
	Brief Description		
	Blockwork wall with many previously open joints now repointed. High beach levels covered previously reported abrasion and loss of blocks and mortar in lower section and under ramp. No water seen seeping through wall as observed in 2012 and 2016. Cracks in coping of upper wall behind sea wall.		
	Recommendations		
Repair or encase toe. Repair cracking in masonry wall.

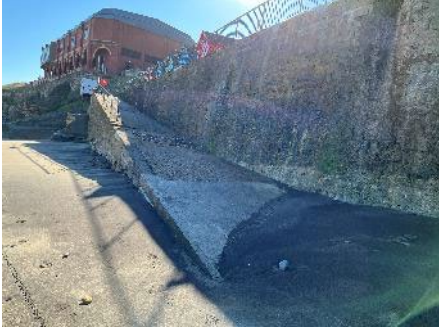
SBC Reference:	22-11A-02		
NFCDD reference:	1221D901D0802C06001		
	Asset Location:		
	Asset Length:	30	
	Condition Assessment		
	Condition	Priority	Risk
	C	3	
	Brief Description

Slipway. Mixed construction. Settlement of toe remediated with concrete transition slope. Open joints between blocks revetment and occasional cracks and voids. Toe previously reported as being heavily abraded has been repaired since last observed. Wing walls in fair condition.

Repair joints, cracks and voids. Continue to monitor.

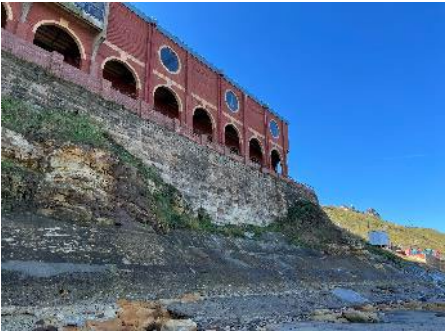
SBC Reference:	22-11A-03		
NFCDD reference:	1221D901D0802C15

Asset Location:	Beneath red brick building (Whitby Pavilion).	
	Asset Length:	71.8	
	Condition Assessment		
	Condition	Priority	Risk
	C	3	
	Brief Description		
	Concrete toe showing signs of cracking, abrasion and loss of concrete and undercutting. Evidence of previous repairs. Blockwork walls below Pavilion appear sound but some loss of mortar. Minor slips in cliff between upper wall and toe structure.		
	Recommendations		
	Stabilise and repair cliff. Repair toe.

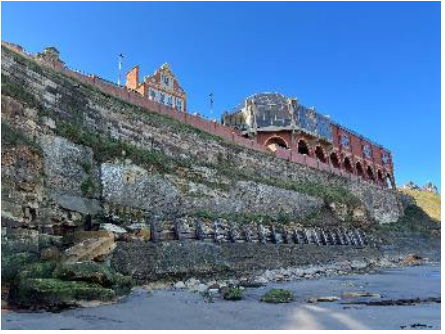
SBC Reference:	N/A		
NFCDD reference:	1221D901D0802C05

Asset Location:	NZ89401152, NZ89511152	
	Asset Length:	43.1	
	Condition Assessment		
	Condition	Priority	Risk
	C	3	
	Brief Description		
	Concrete apron seaward of timber breastwork exposed by low beach levels when the 2022 inspection was carried out, highlighting significant undercutting with large voids beneath and part of the lower section of apron breaking up. Blockwork walls below Pavilion and its access road appear sound but slips / falls in cliff below and some loss of mortar.		
	Recommendations		
	Repairs to toe.

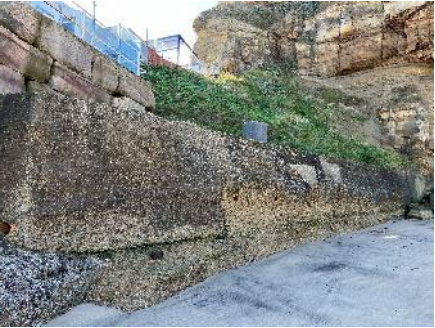
SBC Reference:	25-11B-01		
NFCDD reference:	1221D901D0802C10

Asset Location:	NZ89771147, NZ89781150. West side of West Pier.	
	Asset Length:	26.8	
	Condition Assessment		
	Condition	Priority	Risk
	B	3	
	Brief Description		
	In situ concrete retaining wall. Abrasion has led to areas of exposed aggregates. Lower beach levels in 2022 exposing toe revealing similarly abraded concrete with exposed aggregates. Fair condition overall despite abraded face. Minor slip in cliff above wall has not worsened since previous inspections.		
	Recommendations		
	Continue to monitor.

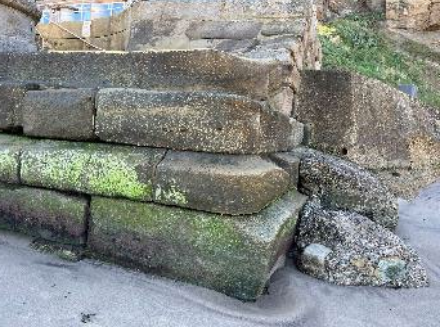
SBC Reference:	25-11B-02		
NFCDD reference:	1221D901D0802C12002

Asset Location:	NZ89781150, NZ89861150	
	Asset Length:	~7	
	Condition Assessment		
	Condition	Priority	Risk
	B	3	
	Brief Description		
	Sloped stonework area has evidence of repairs and repointing to upper blocks. Open gaps between blocks on wing wall (north and west faces).		
	Recommendations		
	Continue to monitor.

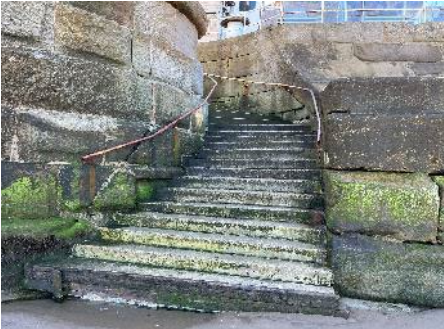
SBC Reference:	25-11B-03		
NFCDD reference:	1221D901D0802C12 003

Asset Location:	NZ89781150, NZ89861150	
	Asset Length:	~7	
	Condition Assessment		
	Condition	Priority	Risk
	B	3	
	Brief Description		
	Toe and lower steps exposed, revealing wooden toe in reasonable condition. Steps in fair condition, with abrasion on lower courses.		
	Recommendations		
Continue to monitor.

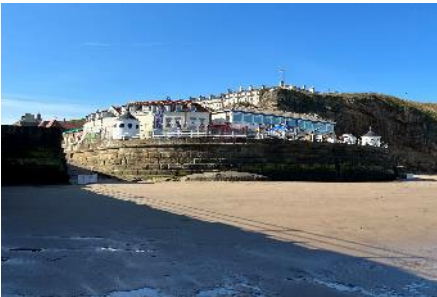
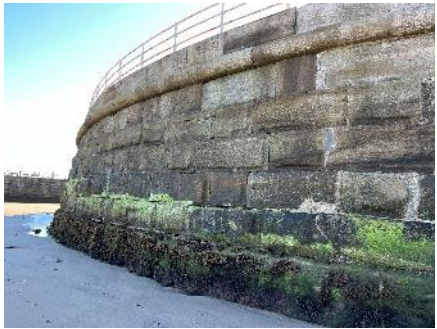
SBC Reference:	26-11B-01		
NFCDD reference:	1221D901D0802C12

Asset Location:	NZ89781150, NZ89861150 Start of west pier at slipway.	
	Asset Length:	87.7	
	Condition Assessment		
	Condition	Priority	Risk
	B	2	
	Brief Description		
	Battery wall. Deep voids between blockwork, with a few blocks vertically cracked. Voids between corners of blocks. Slipway wall capping beam and wall to west is abraded, with a displaced block. Damaged apron. Promenade in fair condition.		
	Recommendations		
Continue to monitor and repair deep voids and cracks.

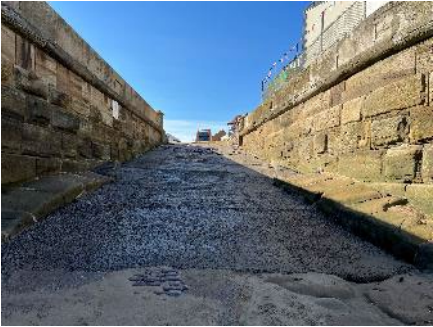
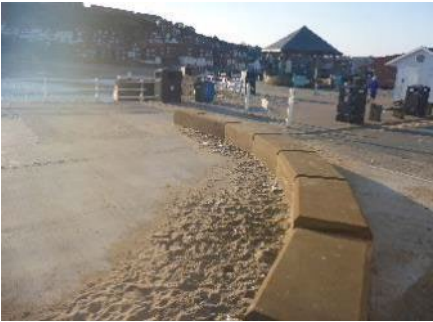
SBC Reference:	26-11B-02	
NFCDD reference:	1221D901D0802C12001

Asset Location:	NZ89781150, NZ89861150
	Asset Length:	~12
Condition Assessment		
Condition	Priority	Risk
B	3	
Brief Description		
<p>Slipway in fair condition. Toe exposed during 2022 survey, revealing the junction with the bedrock and earlier cobbled sections. Uneven, but in overall fair condition.</p>

<p>Wall built at top of slipway as part of capital scheme in 2019 to deflect wave run-up back into the harbour. Some sand accumulating on seaward side of wall should be periodically cleared.</p>	
	Recommendations	
<p>Continue to monitor condition of slipway and start to record the performance of the wave deflector wall during surge and storm events.</p>

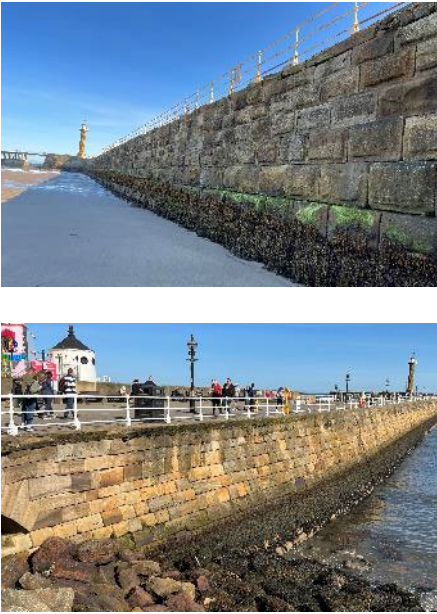
SBC Reference:	27-11B-01		
NFCDD reference:	1221D901D0803C02

Asset Location:	NZ89861145, NZ89931173 West pier.	
	Asset Length:	639.7	
	Condition Assessment		
	Condition	Priority	Risk
	A	4	
	Brief Description		
	No visible defects following capital works.		
Recommendations			
Major refurbishment undertaken in 2018/19.
