Asset Inspection Document

Walk-over Visual Inspections of Assets

Scarborough Borough Council

NOVEMBER 2022

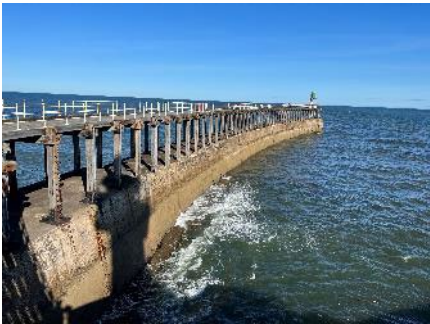
SBC Reference:	N/A		
NFCDD reference:	1221D901D0803C01

Asset Location:	NZ89921172, NZ89921187 West breakwater arm.	
	Asset Length:	315.5	
	Condition Assessment		
	Condition	Priority	Risk
	B	3	
	Brief Description		
	2022 Survey from boat (inner side only) showed overall fair condition but limited inspection as toe is covered in water even at low tide. Abrasion to edges of concrete structure and exposure of aggregate. Timber supporting structure weathered. Some planks on the timber deck replaced since previous inspection.		
Recommendations			
Continue to monitor and replace planks in promenade deck as necessary. Detailed low water inspection from vessel recommended every 10 years.

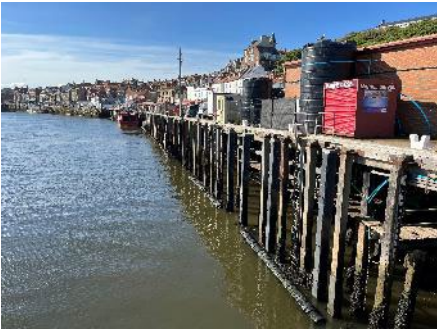
SBC Reference:	N/A		
NFCDD reference:	1221D901D0803C06

Asset Location:	West bank, Whitby Harbour	
	Asset Length:	215.4	
	Condition Assessment		
	Condition	Priority	Risk
	B	4	5
	Brief Description		
	Timber edge beam and fenders remain in good condition following recent replacement/refurbishment. Metal deck support piles to suspended quay deck are corroding. Original sandstone blockwork wall viewed from ends only, but looks fair. Some voids to blockwork.		
	Recommendations		
	Detailed inspection of supporting piles to deck required

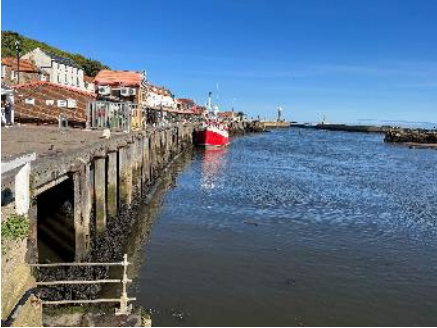
SBC Reference:	N/A		
NFCDD reference:	1221D901D0803C07

Asset Location:	West bank, Whitby Harbour	
	Asset Length:	157.4	
	Condition Assessment		
	Condition	Priority	Risk
	C	3	
	Brief Description		
	Timber fenders along length, vegetation to upper part of wall. Promenade in good condition. Lower wall obscured by seaweed. Steps cracked and open joints at mid-length. Concrete steps repaired but cracking and abrasion still evident. No handrail.		
	Recommendations		
	Repair and repoint joints at steps.

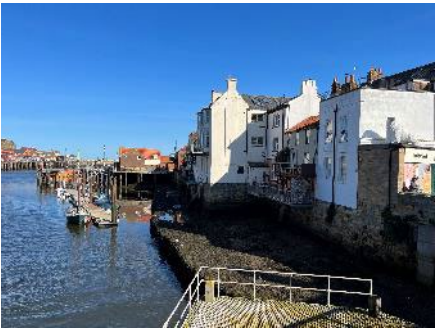
SBC Reference:	N/A		
NFCDD reference:	1221D901D0803C10

Asset Location:	East bank, D/S of Whitby Bridge	
	Asset Length:	135.2	
	Condition Assessment		
	Condition	Priority	Risk
	B	3	
	Brief Description		
	No direct access but appears in fair condition when viewed from distance (limited access, visual inspection from RNLI, bridge and boat survey). Some joint washout to riparian walls. Area of damage to blocks 20m downstream of bridge. Concrete apron near to the bridge appears in fair condition including the sheet pile toe.		
	Recommendations		
Continue to monitor – repair washed out joints to wall

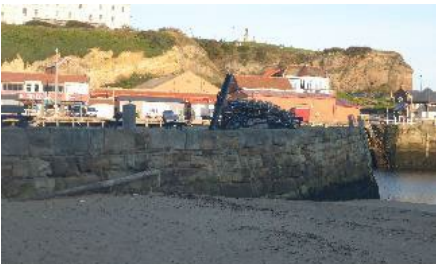
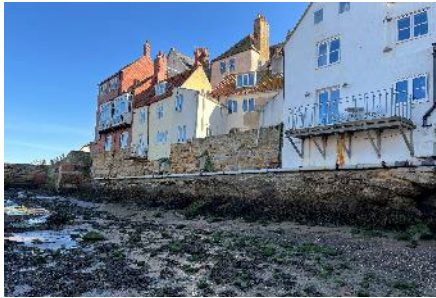
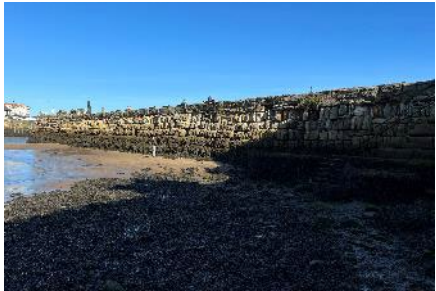
SBC Reference:	N/A		
NFCDD reference:	1221D901D0803C08

Asset Location:	West bank, Whitby Harbour RNLI Station and Pier.	
	Asset Length:	391.3	
	Condition Assessment		
	Condition	Priority	Risk
	B	3	
	Brief Description		
	Very weathered blocks with gaps on east side of old RNLI pier but overall fair. High levels of abrasion, marine growth and steel sheet pile corrosion to old Boathouse 'block'.		
	Coping damage on the slipway but fair overall condition. Walls between piers of mixed construction, fair to poor condition.		
	Beach levels at the toe of the riparian foundation walls very low. Missing mortar between blocks and cracked blocks.		
	Tate Hill Pier has deep joints and block eroding. Steps weathered with corroding handrail at bottom section.		
Top revetment in fair condition. Healthy beach sand on north side of pier, but very low on south side.			
Recommendations			
Fill voids, cracks and open joints.

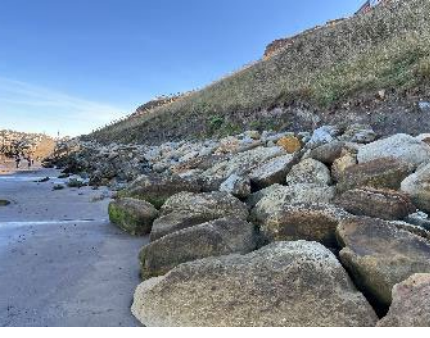
SBC Reference:	N/A		
NFCDD reference:	1221D901D0803C05

Asset Location:	NZ90171146, NZ90421143. East side of pier.	
	Asset Length:	420.7	
	Condition Assessment		
	Condition	Priority	Risk
	B	3	
	Brief Description		
	A relatively low bank of Rock armour is generally in fair condition. There is some exposed erosion-control matting on the cliff above.		
	Recommendations		
	Continue to monitor.

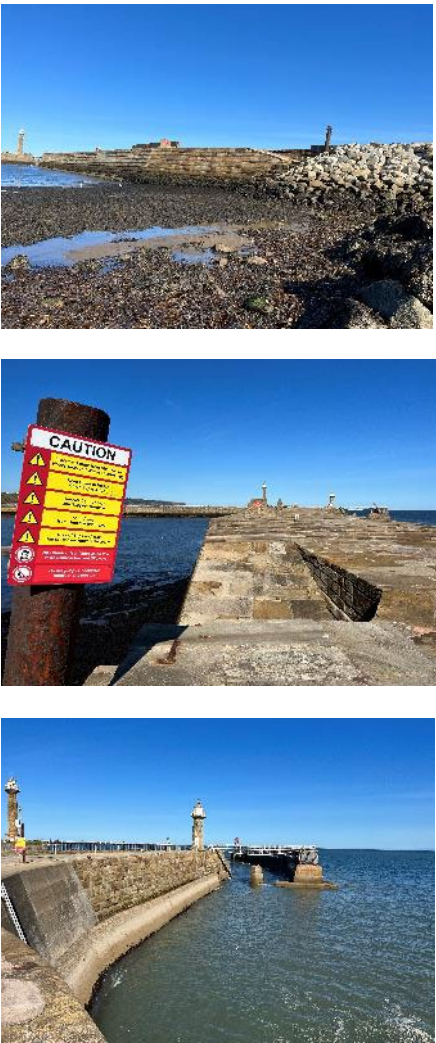
SBC Reference:	N/A		
NFCDD reference:	1221D901D0803C04

Asset Location:	NZ90161146, NZ90001174. East Pier.	
	Asset Length:	637	
	Condition Assessment		
	Condition	Priority	Risk
	A	4	
	Brief Description		
	No visible defects following capital works to walls, toe, deck. Signs erected warning users of winds, wave overtopping, trips, edges.		
Recommendations			
Major refurbishment undertaken in 2018/19.

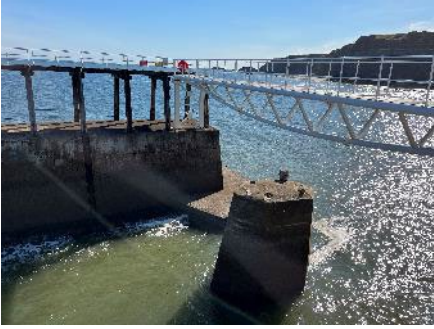
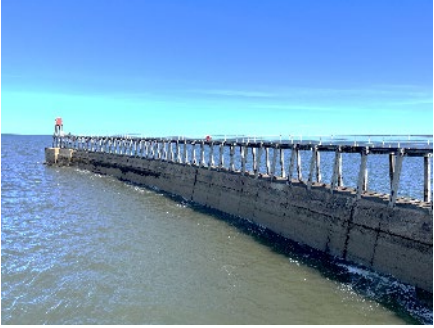
Asset Location:	NZ90041172, NZ89971186. East breakwater.	
	Asset Length:	330.9	
	Condition Assessment		
	Condition	Priority	Risk
	B	3	
	Brief Description		
	Access now possible due to replacement bridge erected in 2019. Survey from boat (inner side only) indicates generally fair condition but limited inspection as toe is covered in water even at low tide.		
	Recommendations		
	Continue to monitor and replace planks in promenade deck as necessary. Detailed low water inspection from vessel recommended every 10 years.

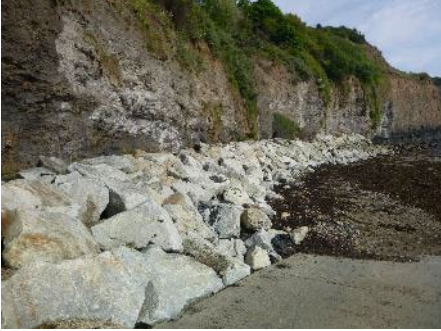
SBC Reference:	32-16A-01		
NFCDD reference:	1221D901D1002C02

Asset Location:	Robin Hood's Bay.	
	Asset Length:	59.4	
	Condition Assessment		
	Condition	Priority	Risk
	B	4	>5
	Brief Description		
	Rock armour remains tightly packed and in good condition. Installed in 2001.		
	Recommendations		
Continue to monitor.

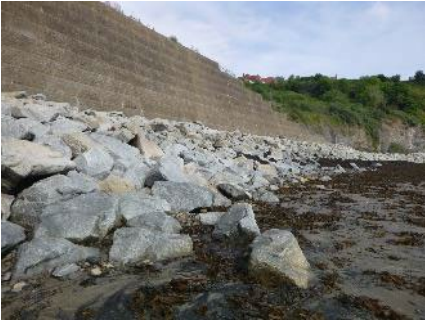
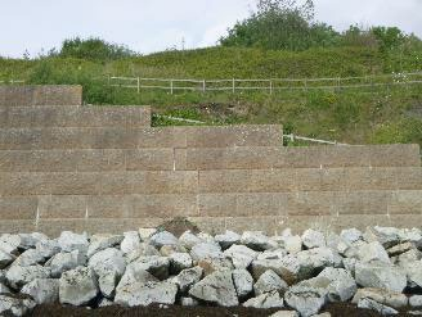
SBC Reference:	33-16A-01		
NFCDD reference:	1221D901D1003C01

Asset Location:	NZ95340504, NZ95270520	
	Asset Length:	183.4	
	Condition Assessment		
	Condition	Priority	Risk
	B	4	>5
	Brief Description		
	<p>Wall was built in 2001. Rock armour in good condition with good coverage, profile and interlock. Slipway ramp in good condition, some abrasion to slab and joints near toe. Loss of fence / edge protection as indicated above.</p> <p>Precast concrete sea wall in good condition. Short section of blocks missing from along the crest of the wall. This is assumed to be a historic defect. There has been a small amount of material overtop the wall and collect on the crest of the revetment.</p>		
	Recommendations		
Continue to monitor.

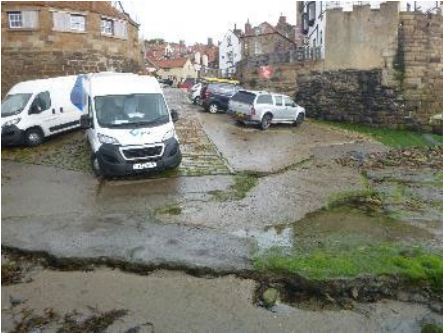
SBC Reference:	35-16B-01		
NFCDD reference:	1221D901D1003C05

Asset Location:	NZ95310485, NZ95320486	
	Asset Length:	15.6	
	Condition Assessment		
	Condition	Priority	Risk
	B	3	
	Brief Description		
	Slipway generally in fair condition. Some cracking but appears stable at present. Washout at toe.		
	Recommendations		
Continue to monitor, investigate and fill voids, repoint as necessary.

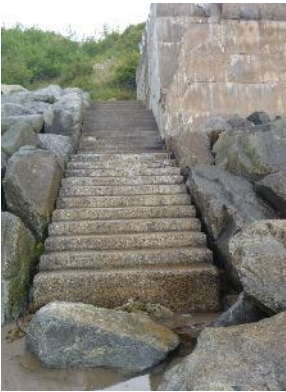
SBC Reference:	36-16B-03		
NFCDD reference:	1221D901D1003C09001

Asset Location:	NZ95320468, NZ95310481	
	Asset Length:	~10	
	Condition Assessment		
	Condition	Priority	Risk
	B	4	5
	Brief Description		
	Steps in good overall condition. No handrail.		
	Recommendations		
Continue to monitor

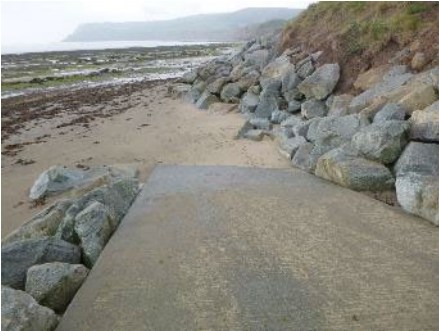
SBC Reference:	37-16C-02		
NFCDD reference:	1221D901D1003C07 001

Asset Location:	NZ95320468, NZ95310481	
	Asset Length:	~20	
	Condition Assessment		
	Condition	Priority	Risk
	B	4	>5
	Brief Description		
	Slipway in good condition.		
Recommendations			
Continue to monitor

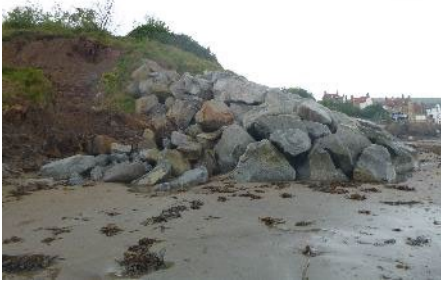
SBC Reference:	37-16C-03		
NFCDD reference:	1221D901D1003C07

Asset Location:	NZ95320468, NZ95310481	
	Asset Length:	54.3	
	Condition Assessment		
	Condition	Priority	Risk
	C	2	
	Brief Description		
	Rock armour mostly well packed, but cliffs slumping from rear over top of revetment has damaged and displaced rock, particular just South of slipway / ramp and at the southern end of revetment (see photo).		
Recommendations			
Continue to monitor rock armour and cliff. Considerations should be made for the revetment to be realigned when the cliff has retreated sufficiently.

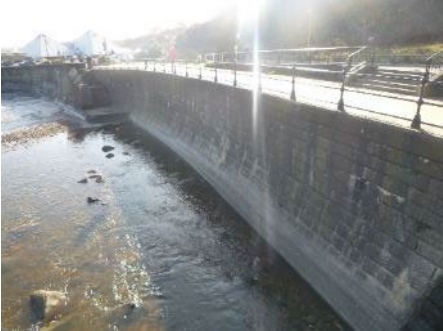
SBC Reference:	39-20A-01		
NFCDD reference:	1221D901D1201C01

Asset Location:	TA03569082, TA03569085 North of the Sea Life Centre.	
	Asset Length:	37.4	
	Condition Assessment		
	Condition	Priority	Risk
	B	4	>5
	Brief Description		
	Promenade in good condition. Wall in fair condition. No change identified in 2022.		
	Recommendations		
Continue to monitor

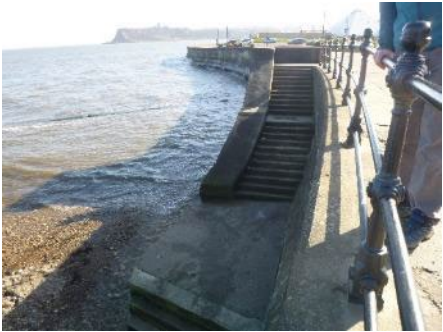
SBC Reference:	39-20A-01		
NFCDD reference:	1221D901D1201C02001

Asset Location:	TA03549057, TA03569082 next to Sea Life Centre.	
	Asset Length:	~10	
	Condition Assessment		
	Condition	Priority	Risk
	B	4	>5
	Brief Description		
	Steps. Localised concrete abrasion with chipped tread but overall remains in fair condition in 2022.		
	Recommendations		
Continue to monitor.

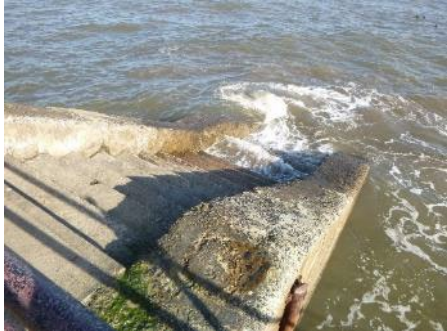
SBC Reference:	40-20A-01		
NFCDD reference:	1221D901D1201C02004

Asset Location:		
	Asset Length:	~5	
	Condition Assessment		
	Condition	Priority	Risk
	C	3	
	Brief Description		
	Repairs undertaken in 2016. Steps themselves are in poor condition cracks remain through older steps. Abrasion to capping and side walls with cracks through side walls between various repairs. Piles at toe of side walls severely corroded with water seeping out at low tide.		
	Recommendations		
Continue to monitor. Repair cracks and pile toes.

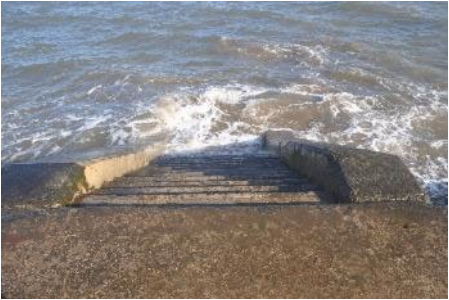
SBC Reference:	40-20A-03		
NFCDD reference:	1221D901D1201C03 001

Asset Location:	TA03589031, South of Sea Life Centre.	
	Asset Length:	~5	
	Condition Assessment		
	Condition	Priority	Risk
	B	4	
	Brief Description		
	As reported in 2020, the capping to north and south abutment walls have both been repaired. The capping to the lower half (that was not repaired) is showing signs of abrasion. Treads in fair condition although some rounding has occurred. Beach levels lower in 2022 were high meaning the final tread of steps was covered.		
	Recommendations		
	Continue to monitor

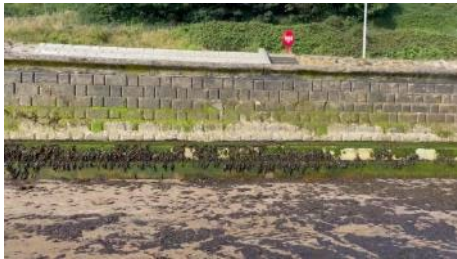
SBC Reference:	40-20A-04		
NFCDD reference:	1221D901D1201C24

Asset Location:	TA03589031, TA03549057	
	Asset Length:	65	
	Condition Assessment		
	Condition	Priority	Risk
	C	3	
	Brief Description		
	Exposed aggregate and abrasion / spalling to capping beam and facing blockwork. Cracks throughout promenade. Two sections of the grouted revetment have been replaced with a concrete block effect revetment; these are in good condition. Elsewhere, the grouted revetment is in poor condition and historic repairs are now failing. Recent repairs to toe beam to the south remain in good condition.		
	Recommendations		
	Continue to monitor. Repair damaged capping beam and cracks in promenade.

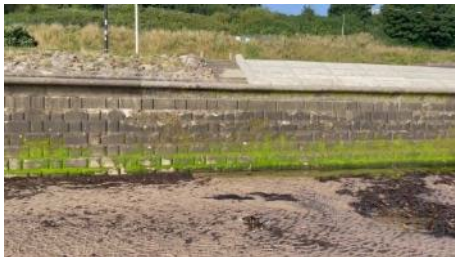
SBC Reference:	40-20A-06		
NFCDD reference:	1221D901D1201C25

Asset Location:	TA0357690349 North of slipway and beach huts.	
	Asset Length:	73.8	
	Condition Assessment		
	Condition	Priority	Risk
	C	3	
	Brief Description		
	Face loss with exposed aggregates – Repairs to section of blockwork in centre remains in good condition. Cracking to deck slab on promenade, some historic repairs in poor condition. Revetment to rear of prom generally appears in fair condition, with recently repaired sections in good condition.		
	Recommendations		
Continue to monitor and repair cracks.

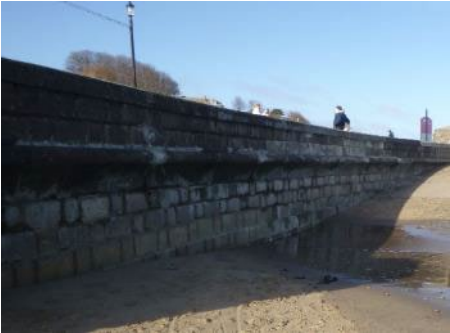
SBC Reference:	41-20A-04		
NFCDD reference:	1221D901D1201C10

Asset Location:	TA03599020, TA03589031	
	Asset Length:	13	
	Condition Assessment		
	Condition	Priority	Risk
	B	3	
	Brief Description		
	No significant change observed in 2022. As reported previously there are cracks in the capping beam, adjacent to slipway at north end of the asset. Some mortar has been lost from between blocks.. Cracking and spalling to bullnose / recurve.. Promenade in good condition.		
	Recommendations		
Repoint missing mortar to sea wall.

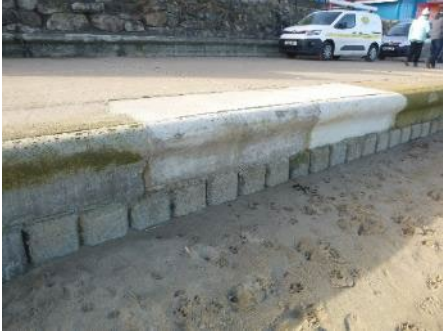
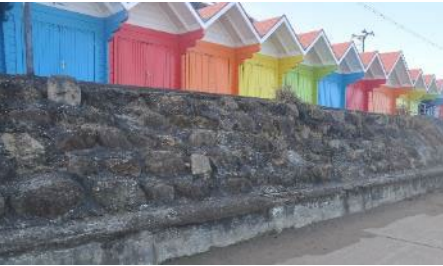
SBC Reference:	42-20A-06		
NFCDD reference:	1221D901D1201C12

Asset Location:	TA03758981, TA03599020	
	Asset Length:	58.4	
	Condition Assessment		
	Condition	Priority	Risk
	B	4	5
	Brief Description		
	Beach levels slightly lower than in 2020, exposing first course of block wall. Blocks are abraded and with some open joints. The repaired sections of coping are in good condition, elsewhere the coping is in fair condition. Promenade in good condition with some localised spalling adjacent to coping. Rear revetment in fair condition, although mature vegetation growth was noted, some spalling to splash wall beneath revetment.		
	Recommendations		
Continue to monitor. Remove mature vegetation.

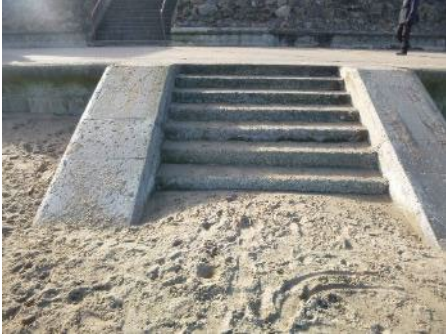
SBC Reference:	42-20A-07		
NFCDD reference:	1221D901D1201C12001

Asset Location:	TA03758981,TA03599020	
	Asset Length:	~3	
	Condition Assessment		
	Condition	Priority	Risk
	B	4	5
	Brief Description		
	Beach levels remained high during the 2022 inspection. The step abutments (rebuilt in 2015) remain in good condition. Steps show minor signs of abrasion which is causing rounding of the treads.		
	Recommendations		
	Continue to monitor.

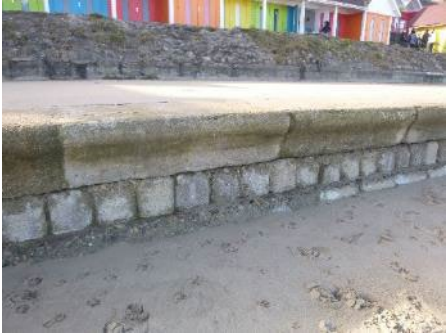
SBC Reference:	42-20A-08		
NFCDD reference:	1221D901D1201C13

Asset Location:	TA03758981,TA03599020	
	Asset Length:	58.2	
	Condition Assessment		
	Condition	Priority	Risk
	B	4	>5
	Brief Description		
	Beach levels remained high during the 2022 inspection. However, unlike in 2020 the first course and part of the second course of blockwork was visible. The facing block work shows signs of abrasion with significant rounding of the block edges. There is further abrasion to the coping and several of the joints are open. Vegetation growth in grouted stone revetment.		
	Recommendations		
	Repair cracks to coping and replace mortar in joints of facing blockwork. Inspect toe when beach levels allow. Remove mature vegetation from revetment.

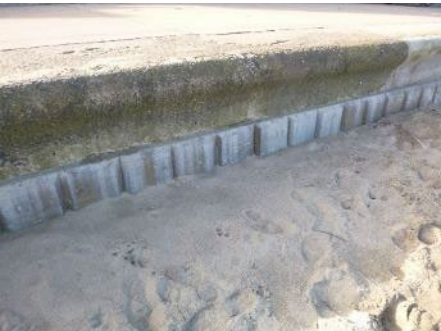
SBC Reference:	42-20A-10		
NFCDD reference:	1221D901D1201C14

Asset Location:	TA03758981, TA03599020	
	Asset Length:	58.4	
	Condition Assessment		
	Condition	Priority	Risk
	B	4	5
	Brief Description		
	Beach levels remained high during the 2022 inspection, however they were lower than in 2020 resulting in the upper course of blockwork being visible. Generally the coping is in fair condition with some localised abrasion. Rear revetment fair condition with recent repairs – although mature vegetation growth noted in crest.		
	Recommendations		
	Monitor and repair spalling to wall capping.

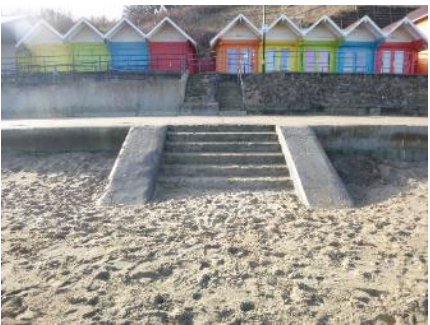
SBC Reference:	42-20A-11		
NFCDD reference:	1221D901D1201C14001

Asset Location:	TA03758981, TA03599020	
	Asset Length:	~3	
	Condition Assessment		
	Condition	Priority	Risk
	B	4	>5
	Brief Description		
	Steps generally in fair condition, some abrasion and chipping to step treads. Abutment walls in good condition		
Recommendations			
Continue to monitor.

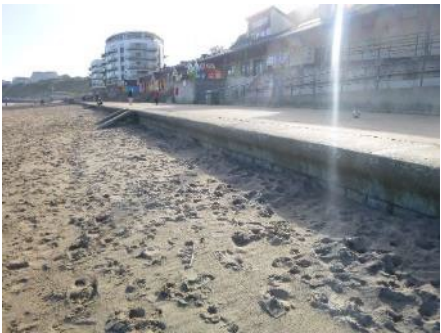
SBC Reference:	42-20A-12		
NFCDD reference:	1221D901D1201C15

Asset Location:	TA03758981, TA03599020	
	Asset Length:	31.9	
	Condition Assessment		
	Condition	Priority	Risk
	B	4	>5
	Brief Description		
	Beach levels are lower in 2022 than in 2020 however much of the wall remained covered with beach material. The wall coping and promenade remain in fair condition. There are some open joints between coping and the promenade slab. Some signs of abrasion to blockwork wall face.		
Recommendations			
Continue to monitor.

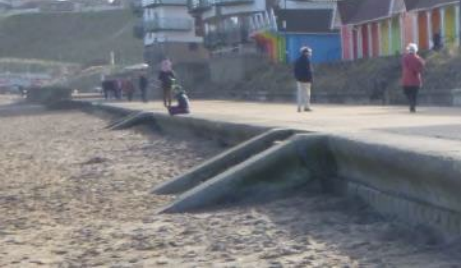
SBC Reference:	42-20A-13		
NFCDD reference:	1221D901D1201C15001

Asset Location:	TA03758981, TA03599020	
	Asset Length:	~3	
	Condition Assessment		
	Condition	Priority	Risk
	B	3	
	Brief Description		
	Beach levels high during the. Steps generally in fair condition, with some abrasion causing rounding of steps. Abutment walls replaced in 2015. Signs of spalling on southern abutment wall at joint with capping noted in 2022.		
	Recommendations		
Repair southern abutment wall. Continue to monitor

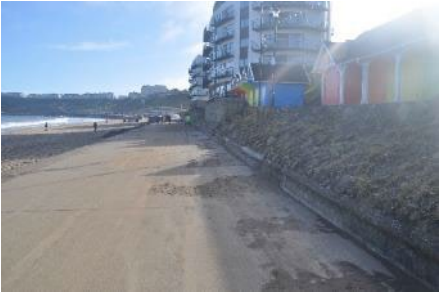
SBC Reference:	42-20A-14		
NFCDD reference:	1221D901D1201C16

Asset Location:	TA03758981, TA03599020. In front of Beach Management Centre.	
	Asset Length:	32	
	Condition Assessment		
	Condition	Priority	Risk
	B	4	5
	Brief Description		
	Beach levels high during the 2022 inspection. Promenade in good condition, although it is clear that sand from the beach is washed onto the promenade frequently, this appears to locally increase abrasion of the deckslab. The coping is in fair condition although some cracking and open joints were observed. Only the upper course of the blockwork facing on the seawall was visible, it has been previously reported that there is missing mortar to blockwork.		
	Recommendations		
Repair cracks to capping and repoint blockwork. Inspect when toe of wall visible.

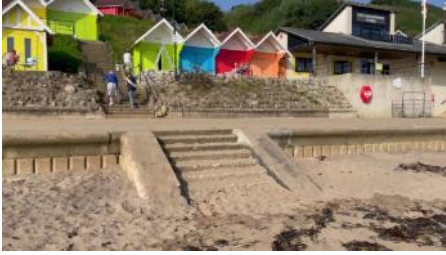
SBC Reference:	42-20A-15		
NFCDD reference:	1221D901D1201C16001

Asset Location:	TA03758981, TA03599020.	
	Asset Length:	~3	
	Condition Assessment		
	Condition	Priority	Risk
	B	4	5
	Brief Description		
	Beach levels high during the inspection. Steps generally in fair condition with some rounding of the step tread observed. Southern abutment spalling at joint with promenade, again noted in 2022.		
	Recommendations		
Repair southern abutment. Continue to monitor.

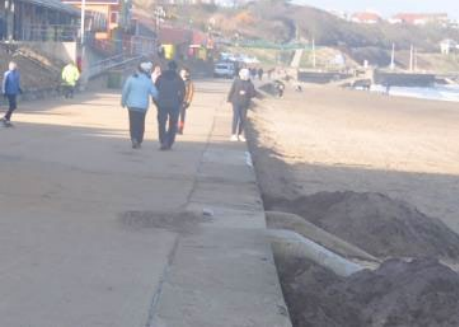
SBC Reference:	42-20A-17		
NFCDD reference:	1221D901D1201C05001

Asset Location:	TA03758981, TA03599020	
	Asset Length:	~3	
	Condition Assessment		
	Condition	Priority	Risk
	A	4	5
	Brief Description		
	<p>High beach levels covered most of the steps. Steps remain in fair condition overall. Some spalling on lower section of northern abutment and some damage at the joint with the adjacent wall coping stone.. Steps show signs of abrasion, and the visible treads were becoming rounded. Damaged abutment at joint on northern side.</p>		
	Recommendations		
Repair northern abutment. Continue to monitor

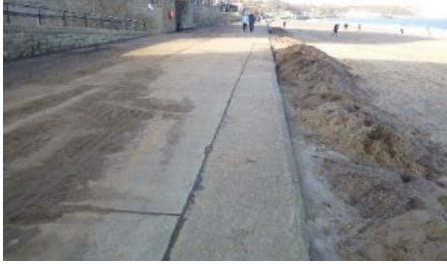
SBC Reference:	42-20A-20		
NFCDD reference:	1221D901D1201C18

Asset Location:	In front of new apartments.	
	Asset Length:	43	
	Condition Assessment		
	Condition	Priority	Risk
	B	4	5
	Brief Description		
	<p>Condition remains unchanged from 2020. High beach levels covered the wall face. The coping stone and promenade deck remain in fair condition with some signs of abrasion and cracking. During the inspection beach material was being removed from the promenade and deposited in piles on the upper beach. Splash wall to the rear of the promenade is in fair condition.</p>		
	Recommendations		
	Continue to repair damaged coping beams.

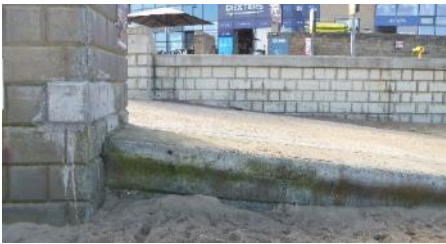
SBC Reference:	43-20B-02		
NFCDD reference:	1221D901D1201C06 001

Asset Location:		
	Asset Length:		
	Condition Assessment		
	Condition	Priority	Risk
	B	3	
	Brief Description		
	<p>Slipway in good condition. It was reported in 2018 that the slipway was fenced off to prevent access – This had been removed in 2020. Cracking and abrasion to seaward abutment.</p>		
Recommendations			
Repair seaward abutment. Monitor

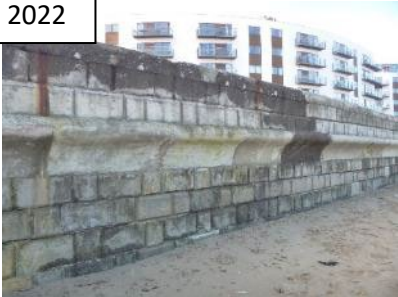
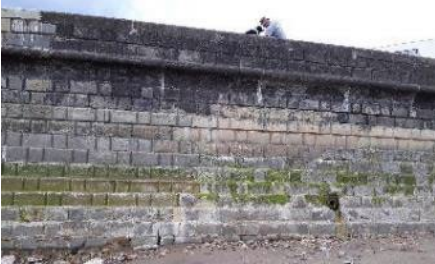
SBC Reference:	43-20B-04		
NFCDD reference:	1221D901D1201C20001		
<div style="border: 1px solid black; padding: 2px; display: inline-block; margin-bottom: 5px;">2022</div>

Asset Location:	TA03818971, TA03758981. In front of new development.	
	Asset Length:	~10	
	Condition Assessment		
	Condition	Priority	Risk
	B	3	
	Brief Description		
	Beach levels approx. 1.5m higher than 2018 concealing toe and outlets. Previously reported that missing mortar between blockwork at toe Broken edge to construction joints. Missing sealant. Overall Fair condition. Cracks in upper wall.		
	Recommendations		
Replace sealant in joints and mortar between blockwork. Repair cracks in upper wall. Continue to monitor.

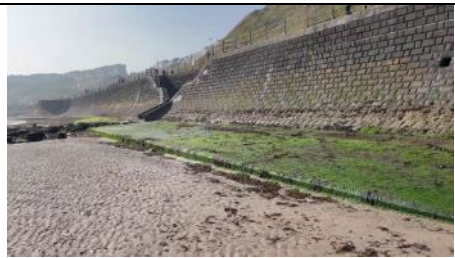
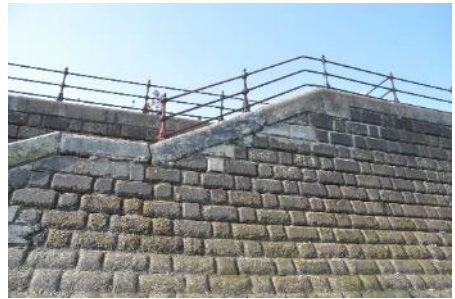
SBC Reference:	44-20B-02		
NFCDD reference:	1221D901D1201C07

Asset Location:	TA03818971, TA04078946 east of Alexandra Gardens.	
	Asset Length:	158.9	
	Condition Assessment		
	Condition	Priority	Risk
	C	2	
	Brief Description		
	Overall, the wall appears in fair condition. However, the lower course of blockwork is abraded. As are sections of cope stone. Handrails heavily corroded. As reported since 2018, leaking evident through previous crack repairs with oily residue, likely from road runoff. Prom re-laid in concrete in 2012 generally in good condition although there is now evidence of localised abrasion on the deck slab. Two blocks missing in seawall adjacent to southern access steps exposing reinforcement.		
	Recommendations		
Cracks need repointing throughout sea wall. Repair damage to coping and toe. Repair missing blocks.

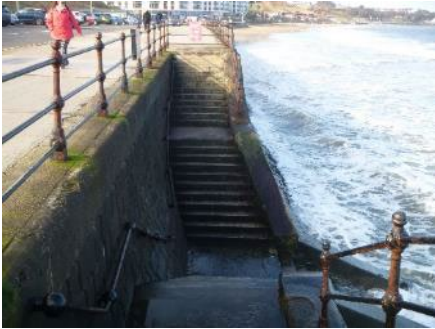
SBC Reference:	44-20B-03		
NFCDD reference:	1221D901D1201C07001

Asset Location:		
	Asset Length:	~7	
	Condition Assessment		
	Condition	Priority	Risk
	B	3	
	Brief Description		
	<p>Lower steps in fair condition with some rounding. Toe visible and now showing some signs of undercutting. Large full height crack from middle platform to prom level. Upper steps (north) in fair condition. Repairs carried out to step treads and abutments. The handrail is corroded and in poor condition. Evidence of abrasion to the blockwork on the backwall of the steps.</p>		
	Recommendations		
<p>Treat corroded handrail. Continue to monitor cracking and undercutting.</p>

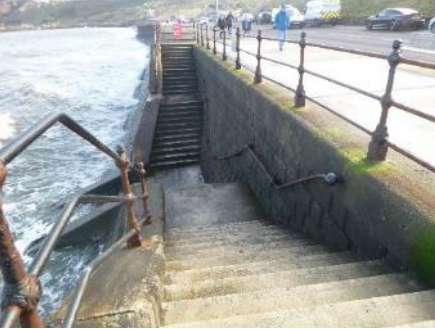
SBC Reference:	44-20B-04		
NFCDD reference:	1221D901D1201C07002

Asset Location:		
	Asset Length:	~7	
	Condition Assessment		
	Condition	Priority	Risk
	B	3	
	Brief Description		
	<p>Overall the upper steps (south) remain in fair condition with no significant change since 2020. The handrail throughout the asset is corroded. Evidence of abrasion to the blockwork on the backwall of the steps</p>		
	Recommendations		
<p>Treat corroded handrail. Continue to monitor</p>

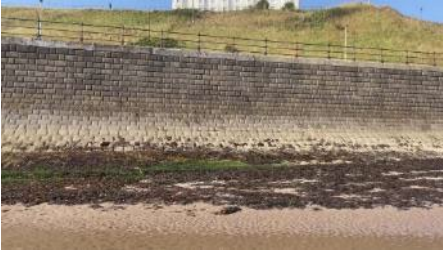
SBC Reference:	44-20B-05		
NFCDD reference:	1221D901D1201C21

Asset Location:	TA03818971, TA04078946 East of Alexandra Gardens.	
	Asset Length:	211.1	
	Condition Assessment		
	Condition	Priority	Risk
	B	3	
	Brief Description		
	<p>No significant change since 2020. Prom surface replaced in 2012 at North and South ends. Repaired sections in fair condition, elsewhere the prom is in poor condition with various patch repairs, some of which present a trip hazard. . The coping stone shows extensive signs of abrasion and has been locally repaired with tarmac and in-situ concrete.</p>		
	Recommendations		
	Repair promenade deck and continue to monitor wall and coping.

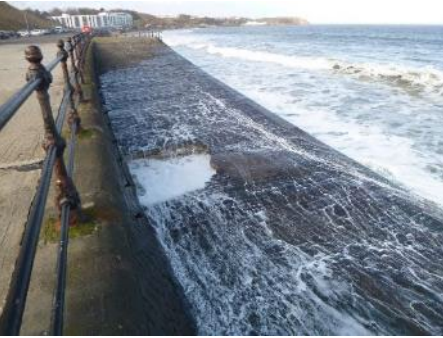
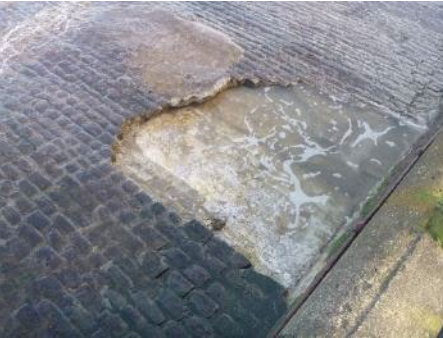
SBC Reference:	45-20B-01		
NFCDD reference:	1221D901D1201C08001

Asset Location:	Part of 45-20B-02	
	Asset Length:	25	
	Condition Assessment		
	Condition	Priority	Risk
	D	1	
	Brief Description		
	<p>The slipway has been fenced off and closed to the public since before 2008. The slipway experiences periodic settlement and instances of damage. The public are known to still use the slipway by climbing over the fence. During the 2022 inspection a large void was noticed within the deck of slipway and the tide was observed washing into the void. Due to the significant risk posed to the structure this was reported immediately to SBC and Engineers were dispatched to attend to the defect the same day (01/03/2022).</p> <p>Additionally there are large vertical cracks on the wingwall face with missing coping stones. Recently repaired (pre 2018) concrete slabs at top of slipway where tarmac had previously settled in good condition. New concrete slabs behind slipway on promenade.</p>

Recommendations		
	Repair void in slipway deck. Carry out repairs to make slipway safe or fence off at bottom as well as top

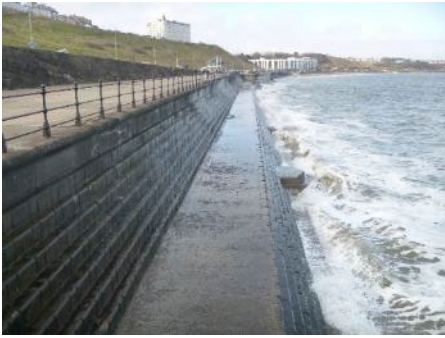
SBC Reference:	45-20B-02		
NFCDD reference:	1221D901D1201C08

Asset Location:	TA04078945, TA04288930	
	Asset Length:	206.9	
	Condition Assessment		
	Condition	Priority	Risk
	B	3	
	Brief Description		
	No significant change since 2020. There is ad hoc maintenance to address persistent abrasion of the surface of the promenade.. Repair / replacement work on some of the steps / toe in 2011/2013, but some horizontal cracks in original blocks remain.		
	Recommendations		
	Continue to monitor and repair cracks and resurface rest of prom.

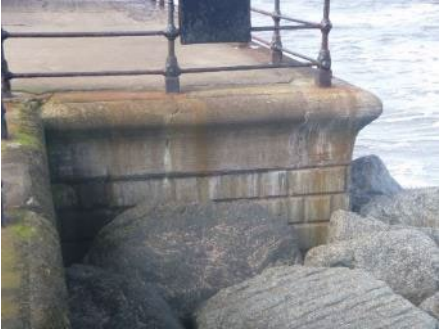
SBC Reference:	45-20B-03		
NFCDD reference:	1221D901D1202C23

Asset Location:	North of Albert Road.	
	Asset Length:	31.5	
	Condition Assessment		
	Condition	Priority	Risk
	C	3	
	Brief Description		
	Wall generally in fair condition, repaired blockwork at southern end in good condition. Lower courses remain heavily abraded. Full height crack through wall at back of prom to south of steps. Cracks through prom slabs and coping to abutments either side of steps.		
	Recommendations		
	Undertake repairs and continue to monitor.

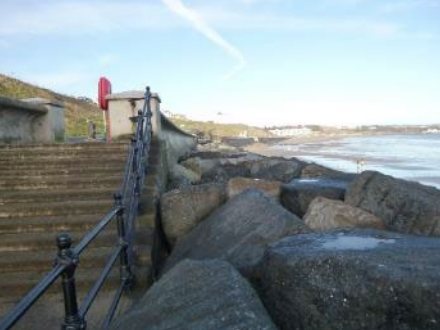
SBC Reference:	46-20B-01		
NFCDD reference:	1221D901D1202C01

Asset Location:	TA04288929, TA0493895. East of Albert Road.	
	Asset Length:	124.8	
	Condition Assessment		
	Condition	Priority	Risk
	B	4	>5
	Brief Description		
	No significant change since 2020. Original wall mostly hidden by rock armour; splash wall seems to be in good condition. Tightly packed rock armour with good coverage. . Missing mortar to wall at rear of prom. Prom slab abraded where not replaced.		
	Recommendations		
	Replace mortar to wall at rear of prom. Continue to monitor. Look to replace remaining sections of prom.

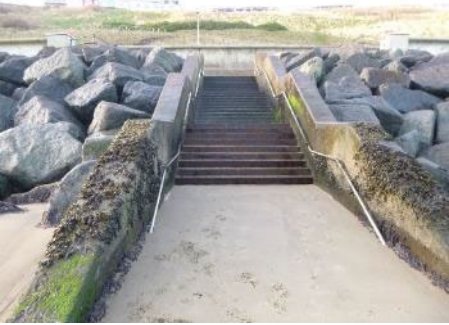
SBC Reference:	46-20B-02		
NFCDD reference:	1221D901D1202C01001

Asset Location:		
	Asset Length:	~5	
	Condition Assessment		
	Condition	Priority	Risk
	B	3	
	Brief Description		
	Fair condition overall. Beach levels high during 2022 inspection meaning previously reported scour pool at the toe of steps was infilled and the lower steps were covered. It has been previously reported that the lower steps are abraded, with rounded treads and that in places the aggregate is exposed. . Upper Steps (north) in good condition		
	Recommendations		
	Continue to monitor.

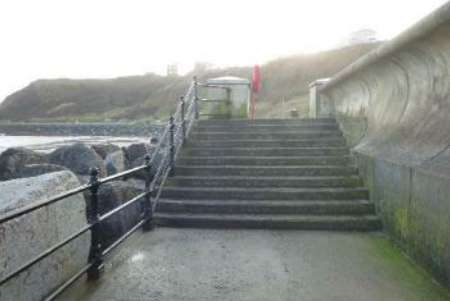
SBC Reference:	46-20B-03		
NFCDD reference:	1221D901D1202C03003

Asset Location:	Part of 46-20b-04	
	Asset Length:	~3	
	Condition Assessment		
	Condition	Priority	Risk
	B	4	>5
	Brief Description		
	Steps and handrail in good condition throughout. Steps combine with the lower flight of SBC Ref: 46-20B-02 to form an access onto the beach.		
	Recommendations		
	Continue to monitor

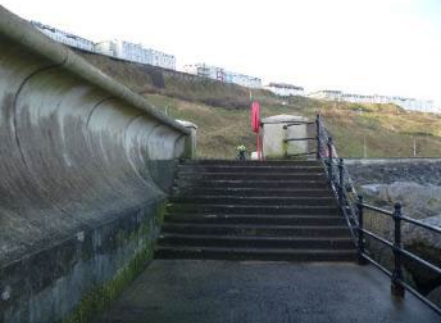
SBC Reference:	46-20B-05		
NFCDD reference:	1221D901D1202C03002

Asset Location:	Part of 46-20B-04	
	Asset Length:	~4	
	Condition Assessment		
	Condition	Priority	Risk
	A	4	
	Brief Description		
	Upper flight of steps and hand rail in good condition. There is some localised abrasion and small degree of rounding of the step treads.		
	Recommendations		
Continue to monitor.

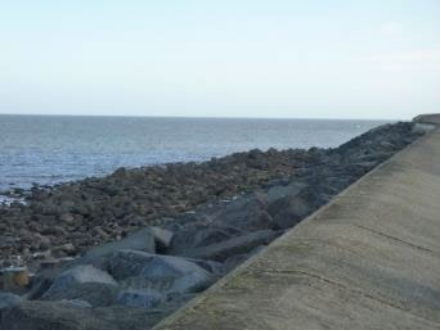
SBC Reference:	46-20B-07		
NFCDD reference:	1221D901D1202C04

Asset Location:		
	Asset Length:	219.9	
	Condition Assessment		
	Condition	Priority	Risk
	B	4	>5
	Brief Description		
	Original wall hidden by armour; splash wall remains in good condition. Tightly packed rock armour appears stable, no loose rocks. Toe piling appears to be working well, although could only be inspected from the promenade. Healthy levels of natural rock against piling offering further protection. Prom good condition.		
	Recommendations		
Continue to monitor.

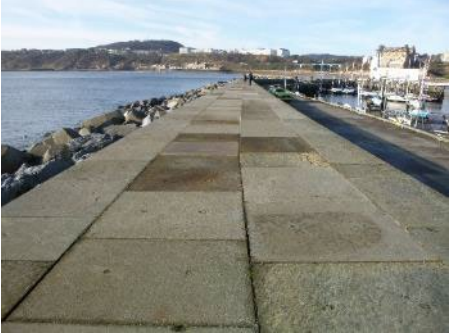
SBC Reference:	N/A		
NFCDD reference:	1221D901D1301C01

Asset Location:	TA04958849, TA05178883 North Harbour Breakwater.	
	Asset Length:	444.9	
	Condition Assessment		
	Condition	Priority	Risk
	B	3	
	Brief Description		
	Crest wall generally in good condition, some cracking and abrasion of the deck on top of the crest wall. Rock armour & accropodes units generally well packed and in good condition. Condition deteriorates at the southern end of the defence as some units are less tightly packed and locally there are missing armour units. Evidence of lateral voids at seaward end of breakwater visible at the low water mark during inspection from the beach to the south.		
	Recommendations		
	Continue to monitor. Inspection of seaward end of structure required from boat.

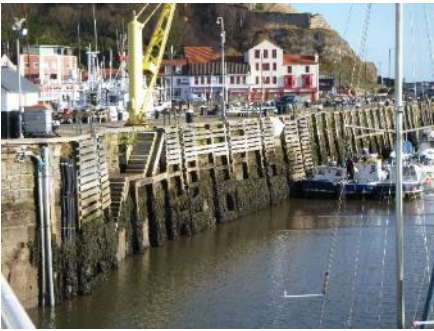
SBC Reference:	N/A		
NFCDD reference:	1221D901D1301C04

Asset Location:	TA05108874, TA05148874. Next to and under fairground.	
	Asset Length:	77.9	
	Condition Assessment		
	Condition	Priority	Risk
	C	3	
	Brief Description		
	<p>Slipway in poor condition, with missing cobbles on the upper reach and extensive abrasion across lower reach. Wall unable to be inspected in great detail due presence of overhanging timber balcony. Wall appeared generally to be in fair condition with some missing mortar. The timber structure appeared in fair condition, with no obvious areas of concern. However, as this is not a coastal defence asset it was not inspected in detail.</p>		
	Recommendations		
Report missing joints to spillway wall and repair slipway surfacing.

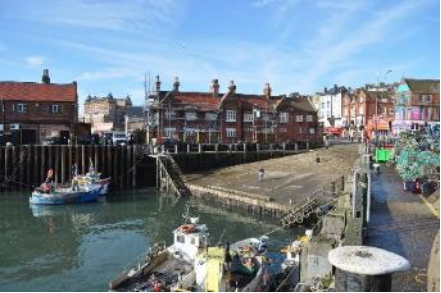
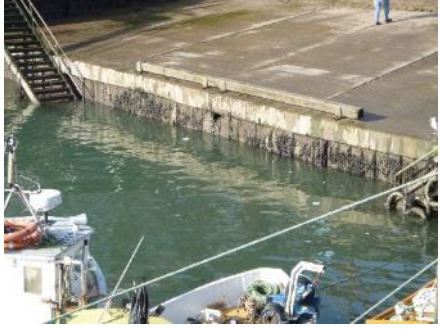
SBC Reference:	N/A		
NFCDD reference:	1221D901D1301C14

Asset Location:	TA04768876, TA04958876. Opposite Information centre.	
	Asset Length:	195.8	
	Condition Assessment		
	Condition	Priority	Risk
	B	3	
	Brief Description		
	Wall in fair condition overall. Some lateral and vertical cracks and missing mortar between blockwork in places. Suspended quay appears to be fair condition, some cracks in protective coating. Timber fenders in fair condition. Promenade deck in good condition. Timber edging rail decaying.		
	Recommendations		
Monitor cracks to wall.

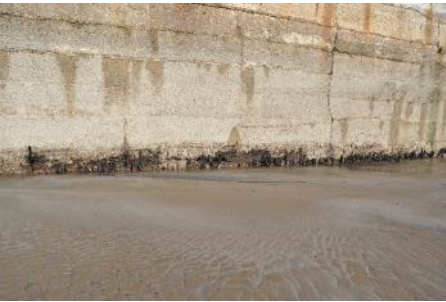
SBC Reference:	49-21B-04		
NFCDD reference:	1221D901D1301C07

Asset Location:	West Pier, Scarborough South Bay.	
	Asset Length:	~5	
	Condition Assessment		
	Condition	Priority	Risk
	C	2	
	Brief Description		
	Steps in poor condition, cracking and missing render around steps. Treads not inspected. Back wall heavily abraded with exposed aggregates and missing capping block in places. Heavily corroded handrail. Large lateral void above toe of side wall on seaward side.		
	Recommendations		
Treat or replace handrail. Replace missing capping block and concrete skim the back wall. Repair cracks in seaward wall.

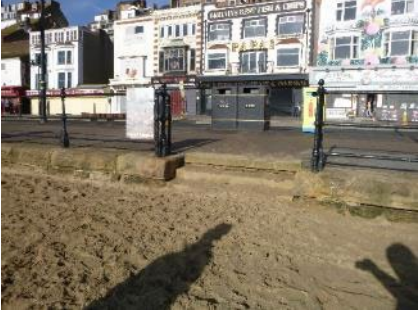
SBC Reference:	51-22A-03		
NFCDD reference:	1221D901D1301C15001

Asset Location:	TA04538856, TA04698873	
	Asset Length:	40.3	
	Condition Assessment		
	Condition	Priority	Risk
	B	3	
	Brief Description		
	High beach levels in 2022 mean only the coping and upper course of blockwork was visible.. Some missing mortar between joints in the coping and localised corrosion to handrails, notably at base.		
	Recommendations		
	Repair joints between blocks. Treat handrails and re-affix when bases become loose.

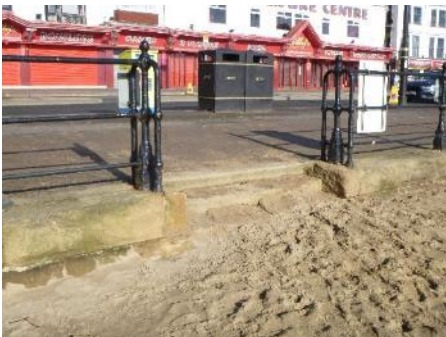
SBC Reference:	51-22A-05		
NFCDD reference:	1221D901D1301C21001

Asset Location:	TA04538856, TA04698873	
	Asset Length:	57.8	
	Condition Assessment		
	Condition	Priority	Risk
	B	3	
	Brief Description		
	<p>High beach levels in 2022 mean only the coping and upper course of blockwork was visible. Missing mortar between joints in the coping and localised corrosion to handrails, notably at base.</p>		
	Recommendations		
Repoint when necessary.

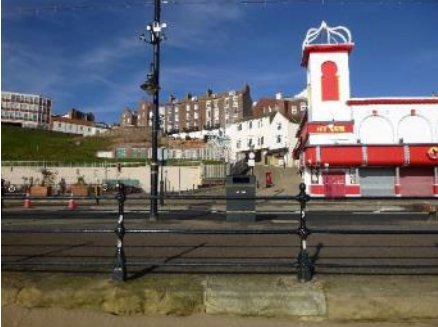
SBC Reference:	51-22A-06		
NFCDD reference:	1221D901D1301C22

Asset Location:	TA04538856, TA04698873	
	Asset Length:	~3	
	Condition Assessment		
	Condition	Priority	Risk
	B	4	5
	Brief Description		
	<p>High beach levels in 2022 meant only the upper steps were visible. Overall steps in fair condition with some minor abrasion and chipping causing rounding of the tread.</p>		
	Recommendations		
Continue to monitor

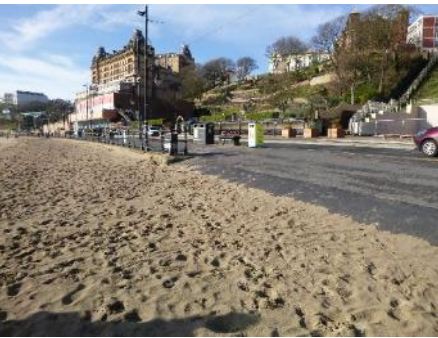
SBC Reference:	51-22A-07		
NFCDD reference:	1221D901D1301C22001

Asset Location:	TA04538856, TA04698873	
	Asset Length:	114.9	
	Condition Assessment		
	Condition	Priority	Risk
	B	3	
	Brief Description		
	High beach levels in 2022 mean only the coping was visible. Missing mortar between joints in the coping and localised corrosion to handrails, notably at base.		
	Recommendations		
Repair handrails. Repoint blocks.

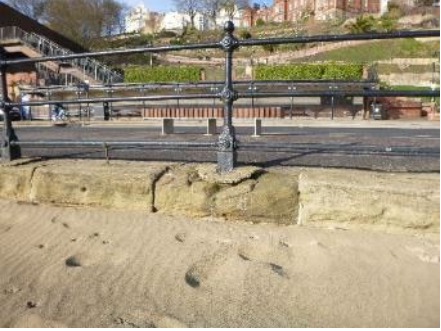
SBC Reference:	51-22A-08		
NFCDD reference:	1221D901D1301C23

Asset Location:	TA04538856, TA04698873	
	Asset Length:	~10	
	Condition Assessment		
	Condition	Priority	Risk
	B	3	
	Brief Description		
	High beach levels in 2022 mean only a small section of the access ramp was visible. Section which was visible appeared in fair condition.		
	Recommendations		
Continue to monitor.

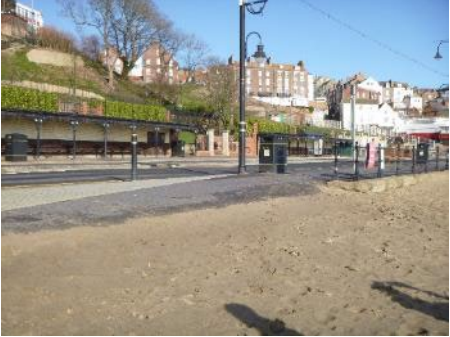
SBC Reference:	51-22A-09		
NFCDD reference:	1221D901D1301C23 ⁰⁰¹

Asset Location:	TA04538856, TA04698873	
	Asset Length:	101.8	
	Condition Assessment		
	Condition	Priority	Risk
	B	3	
	Brief Description		
	High beach levels in 2022 mean only the coping was visible. Missing mortar between joints in the coping and localised corrosion to handrails, notably at base. fair condition missing joints in places with some failing repairs around bases of railing posts.		
	Recommendations		
Repoint as required. Ensure historic repairs to posts are still effective.

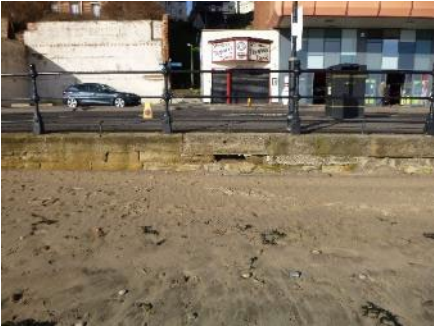
SBC Reference:	51-22A-10		
NFCDD reference:	1221D901D1301C24

Asset Location:	TA04538856, TA04698873	
	Asset Length:	~10	
	Condition Assessment		
	Condition	Priority	Risk
	B	4	5
	Brief Description		
	High beach levels in 2022 mean only a small section of the access ramp was visible. Section which was visible appeared in fair condition. Some missing mortar between blocks.		
	Recommendations		
Repoint as required and continue to monitor.

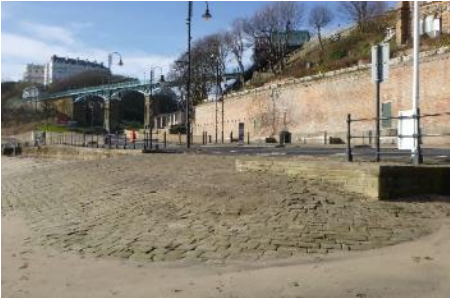
SBC Reference:	51-22A-11		
NFCDD reference:	1221D901D1301C24001

Asset Location:	TA04538856, TA04698873	
	Asset Length:	109.7	
	Condition Assessment		
	Condition	Priority	Risk
	B	3	
	Brief Description		
	Overall fair condition, some missing mortar between blocks, some blocks cracked occasional missing blocks with previous repairs. Promenade in good condition.		
	Recommendations		
	Monitor, replace blocks, seal cracks and repoint when necessary.

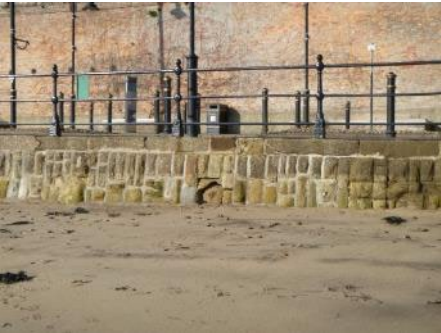
SBC Reference:	51-22A-12		
NFCDD reference:	1221D901D1301C25

Asset Location:		
	Asset Length:	~10	
	Condition Assessment		
	Condition	Priority	Risk
	B	3	
	Brief Description		
	Slipway in fair overall condition. Frequent open joints between blocks due to loss of mortar.		
	Recommendations		
	Fill gaps between blocks. Continue to monitor.

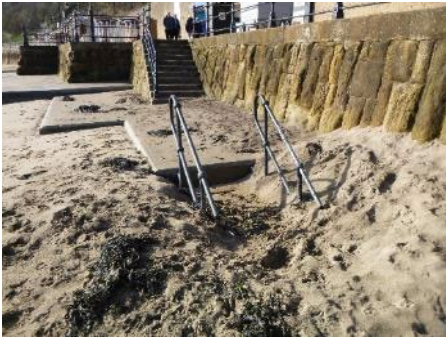
SBC Reference:	52-22A-01		
NFCDD reference:	1221D901D1301C09 001

Asset Location:	TA04538856, TA04698873. In front of Hotel.	
	Asset Length:	99.1	
	Condition Assessment		
	Condition	Priority	Risk
	B	2	
	Brief Description		
	Overall wall in fair condition. Several open joints due to loss of mortar. Signs of abrasion to blocks and coping stones.		
	Recommendations		
	Continue to monitor and repair joints, inspect at low beach level.

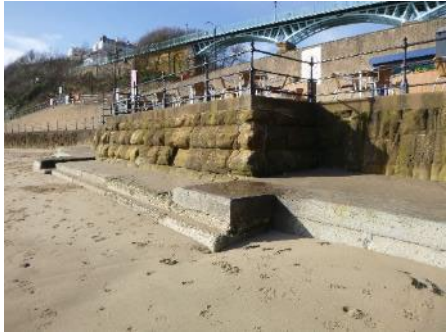
SBC Reference:	52-22A-02		
NFCDD reference:	1221D901D1301C09

Asset Location:		
	Asset Length:	~4	
	Condition Assessment		
	Condition	Priority	Risk
	B	4	5
	Brief Description		
	Steps in fair condition, newer concrete apron in good condition. A new handrail has been installed on the lower steps since the previous inspection, this appeared in good condition. Lower steps not visible due to beach levels.		
	Recommendations		
Continue to monitor.

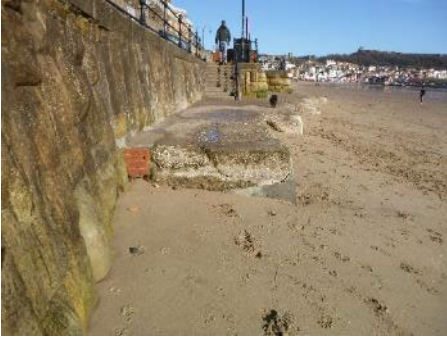
SBC Reference:	52-22A-03		
NFCDD reference:	1221D901D1301C09002

Asset Location:	TA04428822, TA04438827. Wall at underground tunnel entrance.	
	Asset Length:	41.5	
	Condition Assessment		
	Condition	Priority	Risk
	B	3	3
	Brief Description		
	Toe apron has been repaired / overlaid repairs in good condition. Elsewhere, localised missing mortar in joints of seawall. Signs of abrasion and cracking to unrepaired sections of original apron. Several full height vertical cracks to upper road wall. Promenade in good condition.		
	Recommendations		
Continue to monitor and repair joints and cracks.

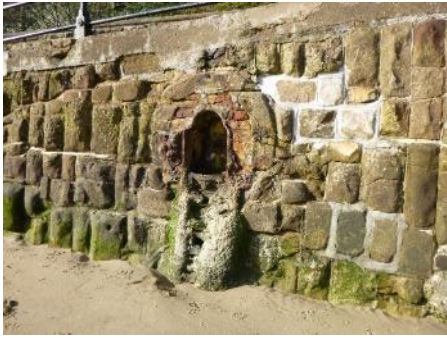
SBC Reference:	52-22A-04		
NFCDD reference:	1221D901D1301C10

Asset Location:	TA04508772, TA04428822. North of slipway.	
	Asset Length:	100.7	
	Condition Assessment		
	Condition	Priority	Risk
	C	3	
	Brief Description		
	Recent repairs to the wall have improved the overall condition to fair. However there are still some open joints due to ongoing loss of mortar and occasional cracked blockwork. Cracking in upper retaining wall between prom and slipway. Recent repairs to slipway coping and toe are in good condition.		
	Recommendations		
Continue to monitor, repair cracks, replace blocks and joints.

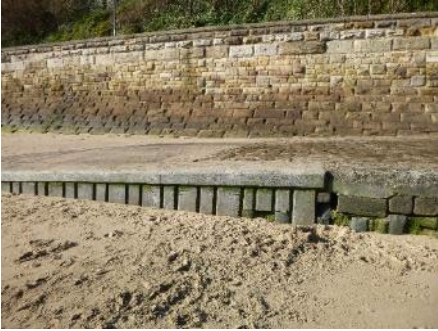
SBC Reference:	53-22B-01		
NFCDD reference:	1221D901D1301C10001

Asset Location:	South of 52-22A-04	
	Asset Length:	~12	
	Condition Assessment		
	Condition	Priority	Risk
	B	3	
	Brief Description		
	Repairs to slipway toe generally in good condition. One area of concern is a small void which has opened between a recently repaired section of the toe edge and the adjacent blockwork wall. Generally the slipway is in fair condition, some open joints to blockwork on upper section.		
	Recommendations		
	Continue monitoring, repair joints and void as required.

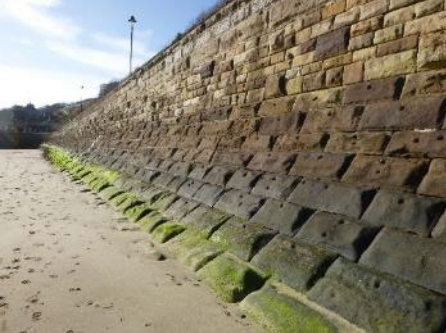
SBC Reference:	53-22B-02		
NFCDD reference:	1221D901D1301C26

Asset Location:	TA04508772, TA04428822. South of slipway.	
	Asset Length:	162.1	
	Condition Assessment		
	Condition	Priority	Risk
	B	3	
	Brief Description		
	Overall the wall is in fair condition. Some cracked blocks but seem stable. Sporadic instances of open joints due to loss of mortar. Crest wall in poor condition with numerous repairs evident. Several sections of coping have been replaced or repaired, elsewhere the coping is heavily abraded		
	Recommendations		
	Grout joints. Continue to monitor.

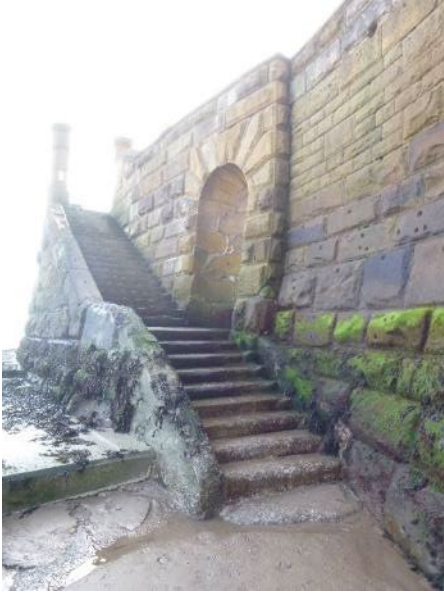
SBC Reference:	53-22B-04		
NFCDD reference:	1221D901D1301C26001

Asset Location:	Part of 53-22b-02	
	Asset Length:	~5	
	Condition Assessment		
	Condition	Priority	Risk
	B	3	
	Brief Description		
	Fair overall condition with bottom steps damaged, due to abrasion and chipping which has caused some rounding of the treads..		
	New concrete toe constructed to seaward side wall in fair condition although partially covered with vegetation growth.		
	Recommendations		
	Continue to monitor.

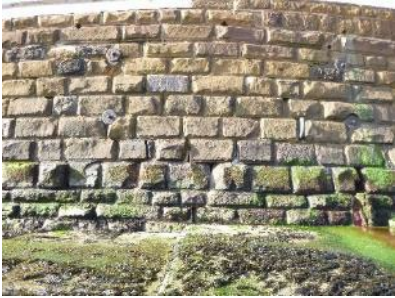
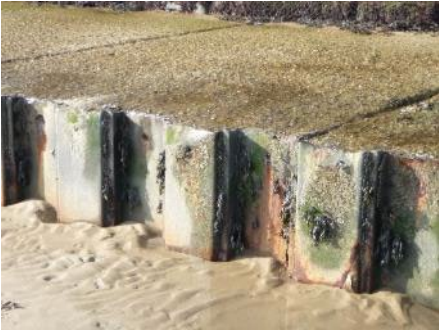
SBC Reference:	53-22B-05		
NFCDD reference:	1221D901D1301C27

Asset Location:	TA04508772, TA04428822. North of The Spa.	
	Asset Length:	158.1	
	Condition Assessment		
	Condition	Priority	Risk
	C	2	
	Brief Description		
	<p>The wall and its concrete apron have undergone multiple repairs in recent years. The repaired section of crest wall rebuilt after Dec 13 storm, in fair condition. Wall remains in poor condition elsewhere. Many cracks, open joints and displaced blocks in main wall. New toe constructed to northern section of wall in 2018 remains in good condition. Sheet piles at edge of concrete apron are severely corroded in places, with extensive voids beneath concrete toe.</p>		
	Recommendations		
Repair cracks, joints and sheet pile toe.

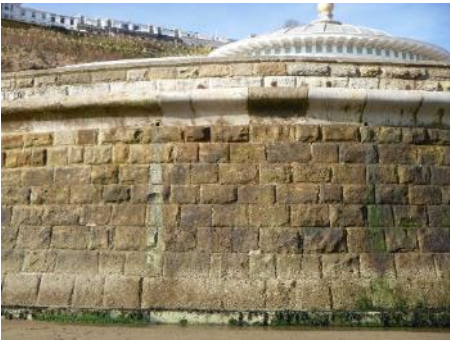
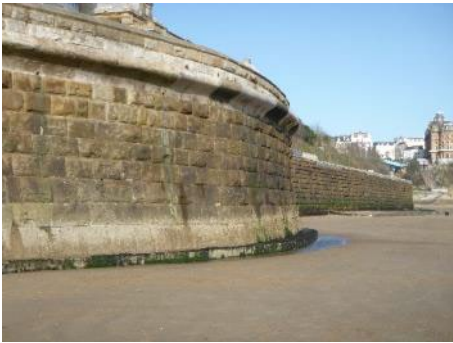
SBC Reference:	53-22B-06		
NFCDD reference:	1221D901D1301C28

Asset Location:	TA04508772, TA04428822 Opposite The Spa	
	Asset Length:	76.4	
	Condition Assessment		
	Condition	Priority	Risk
	B	3	
	Brief Description		
	<p>Repairs undertaken in 2017 to install new concrete toe. Concrete toe only partially visible, appears in fair condition. Bullnose wave return feature has had numerous repairs since the previous inspection is generally in good condition. Elsewhere the wall is in fair condition, some evidence of loss of mortar and movement of blockwork.</p>		
	Recommendations		
Continue to monitor, repoint as necessary, repair damaged section of bullnose.

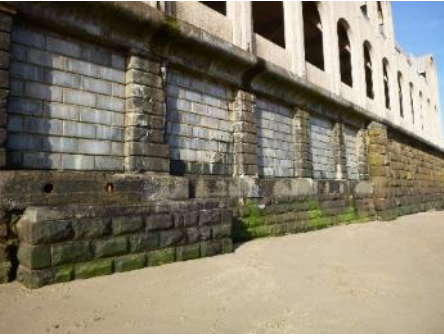
SBC Reference:	53-22B-07		
NFCDD reference:	1221D901D1301C29

Asset Location:	TA04508772, TA04428822. South of The Spa.	
	Asset Length:	57.4	
	Condition Assessment		
	Condition	Priority	Risk
	C	2	
	Brief Description		
	Overall condition of wall is Poor. There are open joints in the main wall and the repairs to lower splash beam are in fair condition. Beach levels in 2022 are high meaning the stepped section of wall could not be inspected. Promenade in fair condition.		
	Recommendations		
	Continue to repair joints and monitor.
