Asset Inspection Document

Walk-over Visual Inspections of Assets

Scarborough Borough Council

NOVEMBER 2022

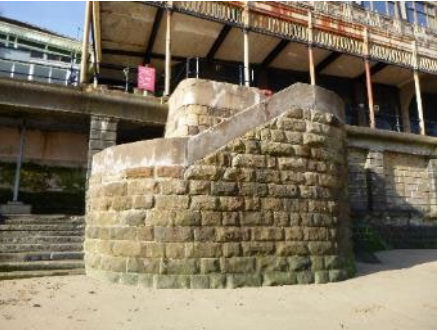
SBC Reference:	53-22B-08		
NFCDD reference:	1221D901D1302C01001

Asset Location:		
	Asset Length:	~4	
	Condition Assessment		
	Condition	Priority	Risk
	B	3	
	Brief Description		
	Steps in fair condition, some abrasion and rounding of tread edge. Repairs to the parapet wall coping stone are in good condition. Blockwork wall generally fair, one diagonal crack identified below parapet coping on seaward face. Elsewhere evidence of missing mortar and open joints.		
	Recommendations		
	Continue to monitor. Repair crack below parapet on seaward face of wall.

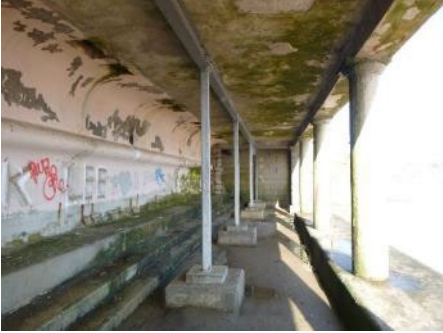
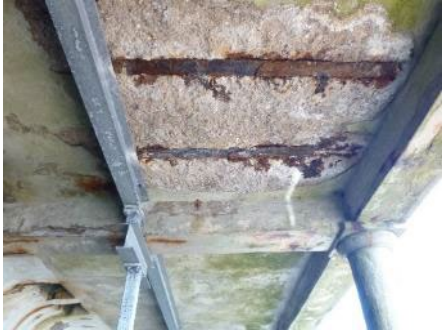
SBC Reference:	54-22B-01		
NFCDD reference:	1221D901D1302C01

Asset Location:	TA04538765, TA04508772. Next to cliff railway.	
	Asset Length:	77.5	
	Condition Assessment		
	Condition	Priority	Risk
	C	2	
	Brief Description		
	<p>The asset remains in poor condition in 2022. The framework of steel supports and horizontal I-section support beam beneath upper prom is in fair condition. The condition of the promenade remains unchanged in a poor state of repair, with extensive cracking and spalling leading to exposed reinforcement on the underside of the deck. There are numerous cracks and extensive corrosion/rust staining to beams supporting upper prom near stairs. Cracking & rust staining to cols. Major weathering loss of stone blocks in rear splash wall. The lower wall at beach level is generally in fair condition, two areas of historic repair are in fair condition.</p>		
	Recommendations

<p>Monitor steel support structure. Capitol scheme to improve long term resilience of the asset.</p>

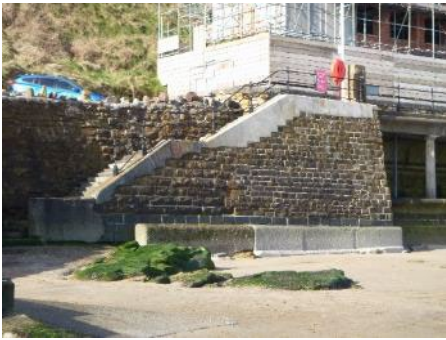
SBC Reference:	54-22B-02		
NFCDD reference:	1221D901D1302C01002

Asset Location:		
	Asset Length:	~4	
	Condition Assessment		
	Condition	Priority	Risk
	C	2	
	Brief Description		
	Overall the steps are in poor condition, with evidence of abrasion and rounding of the tread. The repairs to the parapet are generally in fair condition, as is the blockwork wall and toe. The handrail is corroded in places.		
	Recommendations		
Repair steps. Treat handrail. Continue to monitor.

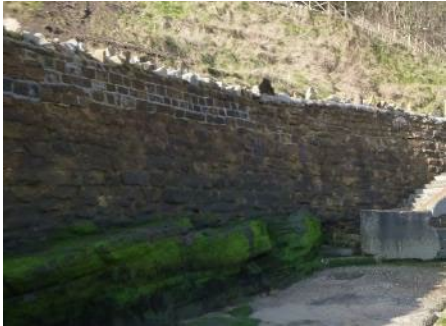
SBC Reference:	54-22B-03		
NFCDD reference:	1221D901D1302C03

Asset Location:	TA04628752, TA04538765. South of cliff railway.	
	Asset Length:	19.2	
	Condition Assessment		
	Condition	Priority	Risk
	B	3	
	Brief Description		
	Wall in fair Condition, numerous patch repairs and repointing have been undertaken. Some evidence of missing mortar and open joints remaining.		
	Recommendations		
Regular repair to joints, particularly on steps.

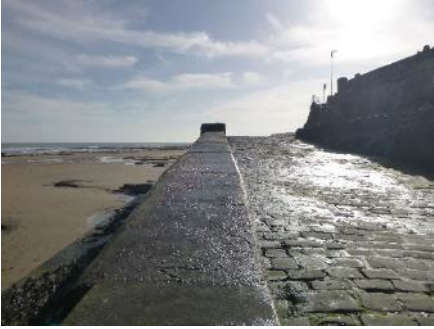
SBC Reference:	56-22B-04		
NFCDD reference:	1221D901D1302C02 001

Asset Location:		
	Asset Length:	~10	
	Condition Assessment		
	Condition	Priority	Risk
	B	3	
	Brief Description		
	Slipway in fair overall condition. Uneven cobbles with some missing mortar requiring repointing in places. No change from 2022.		
	Recommendations		
Repoint joints. Continue to monitor

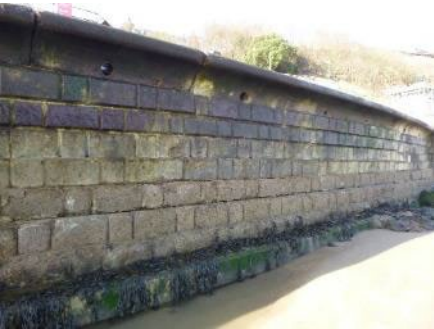
SBC Reference:	55-22B-01		
NFCDD reference:	1221D901D1302C02

Asset Location:	TA04628752, TA04538765. In front of Beach Chalets.	
	Asset Length:	231.8	
	Condition Assessment		
	Condition	Priority	Risk
	C	2	
	Brief Description		
	Numerous historic and recent repairs in varying conditions Generally the condition of the asset is fair with recent repairs to the main wall, coping and wave wall in good condition. Some evidence of spalling and open joints throughout structure. Notably there are several long lateral open joints around the apex of the structure.		
	Recommendations		
Replace missing filler in joints in wall and on promenade.

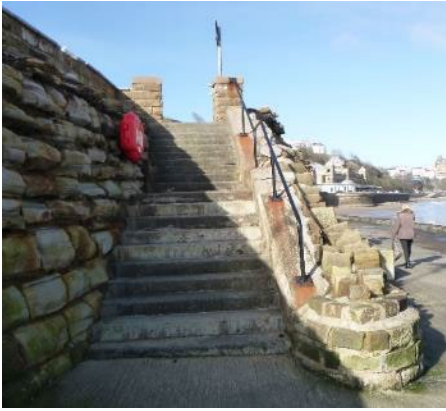
SBC Reference:	56-22B-02		
NFCDD reference:	1221D901D1302C02 002

Asset Location:		
	Asset Length:	~4	
	Condition Assessment		
	Condition	Priority	Risk
	B	3	
	Brief Description		
	Cracks between the capping beam and the steps. Some steps have been refurbished. Fixings to handrail corroded. Overall fair condition no change since 2020.		
	Recommendations		
Treat handrail fixings. Continue to monitor.

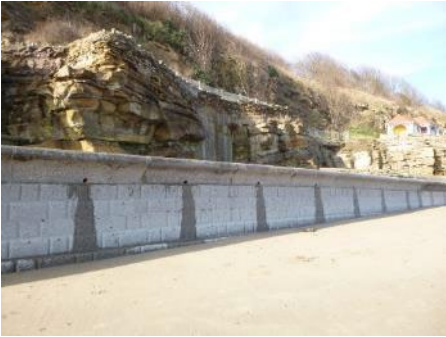
SBC Reference:	56-22B-03		
NFCDD reference:	1221D901D1302C02 003

Asset Location:	Wall south of steps	
	Asset Length:	231.8 (with 55-22b-01)	
	Condition Assessment		
	Condition	Priority	Risk
	C	2	
	Brief Description		
	Overall condition is poor, there are numerous repairs evident. Several sections of the wall have been rebuilt and several prom slabs have been replaced. However, there are frequent open joints in the prom slabs particularly at north end. Previously reported scour of at the toe Was not visible due to beach levels. Open joints in lower wall.		
	Recommendations		
Repoint blockwork, replace joints in slabs and on lower wall. Continue with any outstanding repair work

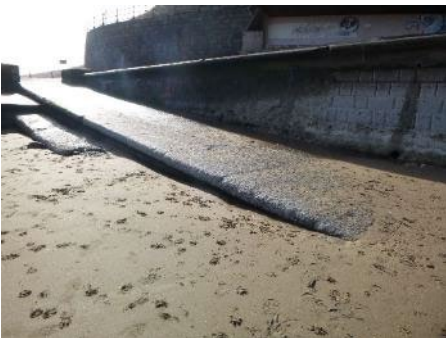
SBC Reference:	56-22B-04		
NFCDD reference:	1221D901D1302C02004

Asset Location:		
	Asset Length:	~5	
	Condition Assessment		
	Condition	Priority	Risk
	B	3	
	Brief Description		
	Top section behind defence wall has been re-built although cracks have started to appear. Overall condition fair. Slipway leading to beach has several- large cracks and damaged side walls (especially the concrete bagwork and mass concrete screed).		
	Recommendations		
	Repair cracks and screed.

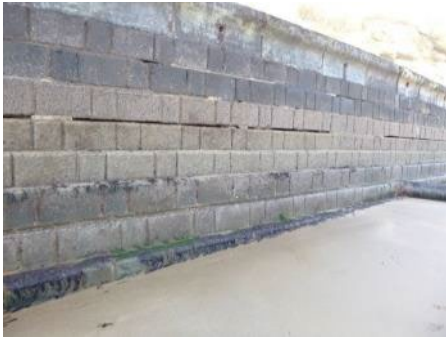
SBC Reference:	56-22B-05		
NFCDD reference:	1221D901D1303C02

Asset Location:	TA04828723, TA04668746.Wall at Dickinson's Point.	
	Asset Length:	308.2	
	Condition Assessment		
	Condition	Priority	Risk
	B	2	
	Brief Description		
	Wall generally in fair condition, although there are locally some areas where the condition is poor. There are several open lateral joints, most notably around the apex of the defence alignment and there are several damaged blocks within the wall face. There is a general deterioration facing to the splash wall and there are frequent cracks and open joints to the promenade deck.		
	Recommendations		
	Repair missing joints in lower blockwork wall and open joints in lower prom. Continue to monitor.

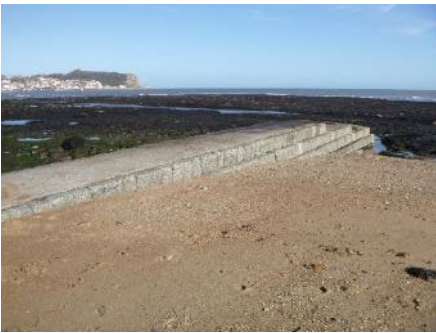
SBC Reference:	56-22B-06		
NFCDD reference:	1221D901D1303C02 001

Asset Location:		
	Asset Length:	~12	
	Condition Assessment		
	Condition	Priority	Risk
	B	3	
	Brief Description		
	<p>Groyne in fair condition, locally there is some undercutting of the toe on the northern aspect of the asset. The ramp behind the groyne is in fair condition with some visible repairs. The concrete slab revetment has failed repairs which need replacing.</p>		
	Recommendations		
Replace asphalt filler.

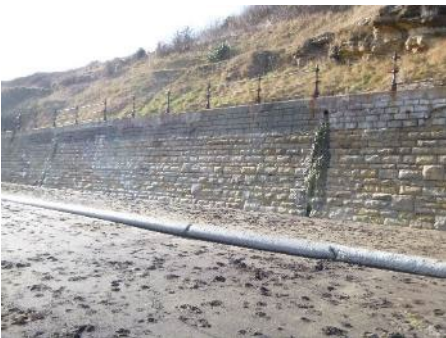
SBC Reference:	56-22B-07		
NFCDD reference:	1221D901D1304C02

Asset Location:	TA04868713, TA04828723. East of Holbeck Gardens.	
	Asset Length:	112.5	
	Condition Assessment		
	Condition	Priority	Risk
	C	3	
	Brief Description		
	<p>Overall condition of the wall is poor. There are frequent open joints in the blockwork wall and extensive abrasion and damage to the coping stone. Concrete apron was partly visible during the 2022 inspection this appeared in fair condition. The promenade is closed to the public and the handrail is heavily corroded with several missing sections.</p>		
	Recommendations		
Repair facing and copings. Replace mortar. Seal cracks. Replace broken handrails.

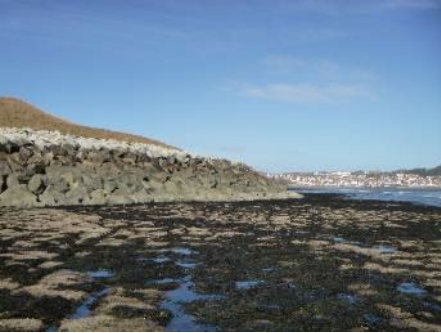
SBC Reference:	56-22B-08		
NFCDD reference:	1221D901D1304C01

Asset Location:	TA05038695, TA04868713. Land slip.	
	Asset Length:	294.7	
	Condition Assessment		
	Condition	Priority	Risk
	B	4	>5
	Brief Description		
	Rock armour tightly packed, good cover and looks in good condition. Toe in good condition, rock socketed into wave cut platform of soft rock. Top of sheet piles just visible at toe of revetment with concrete behind. No change since 2020.		
	Recommendations		
Continue to monitor, monitor stability of cliffs.

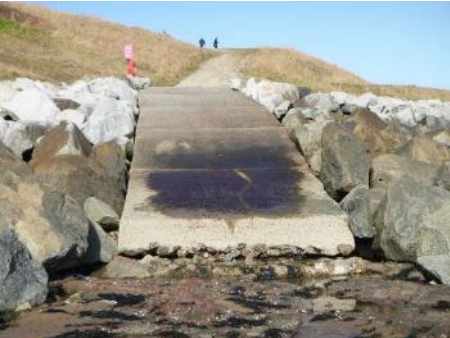
SBC Reference:	56-22B-09		
NFCDD reference:	1221D901D1304C01 001

Asset Location:	Part of 56-22b-08	
	Asset Length:	~10	
	Condition Assessment		
	Condition	Priority	Risk
	C	2	
	Brief Description		
	The ramp is in poor condition. At its seaward end the ramp is undercut and there is a large, near vertical, drop onto the foreshore. There are open joints and locally some cracking to the slabs. The ramp is used informally as a beach access but due to marine growth is extremely slippery.		
	Recommendations		
Erect signage to warn public of the risks of using the structure. Repair cracks. Seal joints. Provide safe access from base of ramp

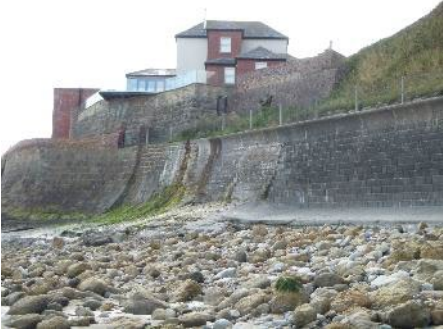
SBC Reference:	58-24B-01		
NFCDD reference:	1221D901D1402C02

Asset Location:	TA06618455, TA06648454	
	Asset Length:	34	
	Condition Assessment		
	Condition	Priority	Risk
	C	3	
	Brief Description		
	<p>North of old PS. Poured concrete and concrete blockwork toe below a stepped seawall with curved coping stone. More recent construction than adjacent walls. Cliff cutting back adjacent to North. Wall generally fair, but toe undercut at South. A large void beneath the apron of the structure remains partially concealed by higher beach levels in 2022. Evidence of leaching and moisture seemingly draining from the cliff unit above.</p>		
	Recommendations		
	<p>Repair voids at toe of wall. Investigate source of moisture at the southern end of the defence. Continue to monitor recession of beach level along toe of structure. Monitor for outflanking at northern end.</p>

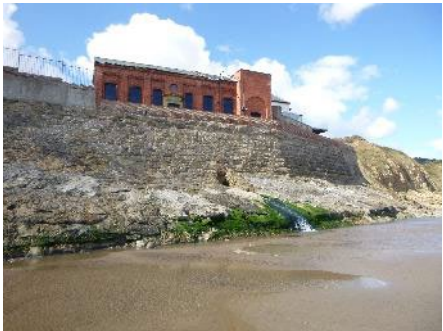
SBC Reference:	59-24B-01		
NFCDD reference:	1221D901D1402C05

Asset Location:	TA06698449, TA06658454	
	Asset Length:	67.3	
	Condition Assessment		
	Condition	Priority	Risk
	C	3	
	Brief Description		
	<p>Private wall to old PS in poor condition. Lower apron has multiple patch repairs with poured concrete but has cracks. Recent re-pointing to main wall joints. Upper wall slightly better than lower. High beach levels in 2022 have in part concealed localised undercutting of the toe of the lower wall apron. Numerous voids visible in concrete apron.</p>		
	Recommendations		
	<p>Private maintenance.</p>

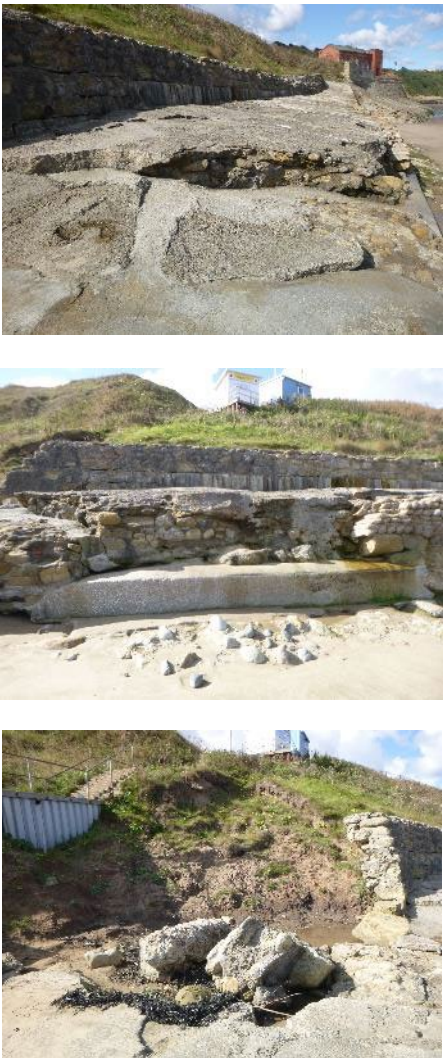
SBC Reference:	60-24B-01		
NFCDD reference:	1221D901D1402C04

Asset Location:	TA06698449, TA06758445	
	Asset Length:	32.6	
	Condition Assessment		
	Condition	Priority	Risk
	D	1	
	Brief Description		
	<p>Southern section of apron is missing, lower sea wall has been undercut and failed. Blockwork missing and displaced. Some repairs to deck with concrete. Upper wall missing southern section. Toe undermined. Crest breaking up.</p> <p>Ongoing localised activity in cliff unit behind higher wall with access steps consolidated with trench sheets. Loss of material from behind upper wall caused by slip failure. Large voids in the lower wall at beach level. Further undermining of the footpath. Defence is at significant risk of washout in the event of rainfall event coupled with tidal surge /wave action. Runoff from slope to the rear of upper wall could lead to instability of the structure and cause collapse of access footpath. Repairs performed following 2016 inspection appear in fair condition however the mass concrete toe repair was noted in 2020 as being undercut undermined from its southern end. Due to high beach levels in 2022 the undercutting was buried.</p>

Recommendations		
	<p>Repair or remove/make safe. Adapt long term strategic approach as defined in Filey and Cayton Bay Coastal Strategy.</p>

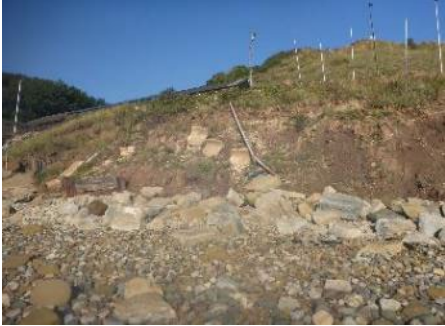
SBC Reference:	N/A		
NFCDD reference:	1221D901D1601C02

Asset Location:	TA12248126, TA12278130	
	Asset Length:	18.3m	
	Condition Assessment		
	Condition	Priority	Risk
	D	4	
	Brief Description		
	Rock armour scattered and totally ineffective. Timber breastwork no longer evident. Coastal slope appears to be actively eroding. Rock armour originally placed in failed breastwork. No significant change in 2020.		
	Recommendations		
	Consider reprofiling rock to slow erosion at boat club.

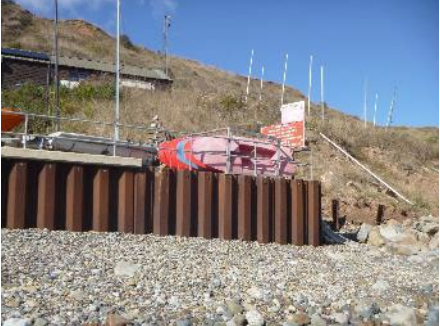
SBC Reference:	64-28A-02		
NFCDD reference:	1221D901D1601C03

Asset Location:	TA12228121, TA12248126	
	Asset Length:	55.8m	
	Condition Assessment		
	Condition	Priority	Risk
	C	2	
	Brief Description		
	Sheet piling remains in good condition although surface corrosion present. High beach levels concealed much of the lower sheet piles, including outlet. Scour hole at north end of promenade identified in 2018 was repaired prior to 2020. Missing section of coping at northern end of sheet pile wall.		
	Recommendations		
	Replace damaged section of coping stone. Monitor for risk of outflanking, continue to inspect.

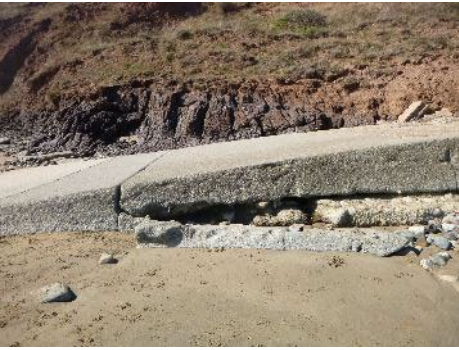
SBC Reference:	64-28A-01		
NFCDD reference:	1221D901D1601C03 001

Asset Location:	TA12228121, TA12248126	
	Asset Length:	~15m	
	Condition Assessment		
	Condition	Priority	Risk
	C	3	
	Brief Description		
	<p>Fair to poor condition overall, concrete encasement abraded, open joints, cracks in the middle part with patch repairs carried out. Significant undercutting of slipway toe on the seaward side. Drainage outlet on seaward side not observed but reported previously to be blocked.</p> <p>In 2022 there was evidence of localised earth movement and slumping onto the slipway.</p>		
	Recommendations		
Repair undercutting slipway.

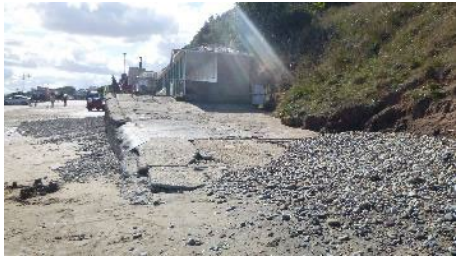
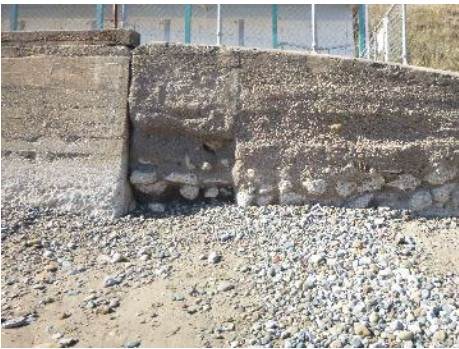
SBC Reference:	N/A		
NFCDD reference:	1221D901D1602C09 002

Asset Location:	TA12118095, TA12128100	
	Asset Length:	~10m	
	Condition Assessment		
	Condition	Priority	Risk
	D	2	
	Brief Description		
	<p>Concrete rear ramp/wing wall in poor condition. Seaward side is heavily abraded with several missing sections of capping beam. Several holes in deck towards toe. A large scour hole has developed since 2018 at the wall joint exposing reinforcement. Asset remains in poor condition.</p> <p>–</p>		
	Recommendations		
Repair scour hole

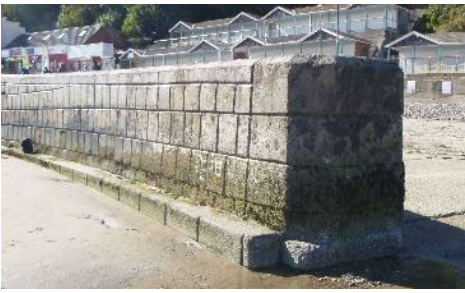
SBC Reference:	N/A		
NFCDD reference:	1221D901D1602C09

Asset Location:	North of promenade, Filey.	
	Asset Length:	38.8m	
	Condition Assessment		
	Condition	Priority	Risk
	C	2	
	Brief Description		
	Horizontal cracks and open joints throughout structure. Degradation of front faces of blocks and capping. Crest section repaired locally. Toe of wall abraded/undermined at bottom of slipway. Large crack through wingwall approx. 7m from extremity of wall possibly due to settlement. No significant change in 2022.		
	Recommendations		
Repair undermining at slipway, monitor and repair damage.

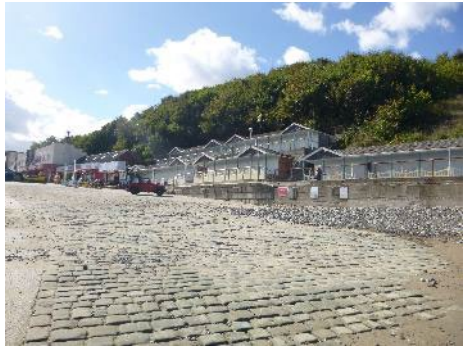
SBC Reference:	N/A		
NFCDD reference:	1221D901D1602C09001

Asset Location:	North of promenade, Filey.	
	Asset Length:	10m	
	Condition Assessment		
	Condition	Priority	Risk
	B	4	
	Brief Description		
	Slipway blockwork remains in fair to good condition. Beach sediment levels on slipway lower than in 2022. Exposed blockwork instances of missing mortar particularly on lower reaches of the slipway.		
	Recommendations		
Continue to monitor

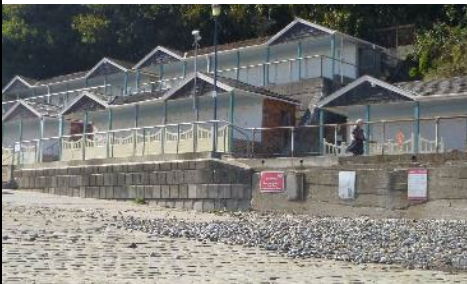
SBC Reference:	N/A		
NFCDD reference:	1221D901D1602C01

Asset Location:	TA12118095, TA12128100	
	Asset Length:	49.6m	
	Condition Assessment		
	Condition	Priority	Risk
	C	2	
	Brief Description		
	The concrete cope beam, replaced prior to 2018, remains in good condition. Abrasion of wall. Concrete block wall adjacent in poor condition – leans seaward, open joints, damaged blocks.		
	Recommendations		
Repair damaged wall. Monitor leaning wall.

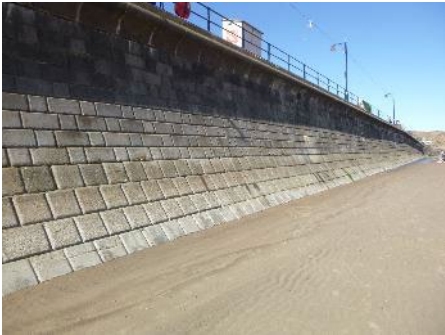
SBC Reference:	67-28B-01		
NFCDD reference:	1221D901D1602C06

Asset Location:	North of promenade	
	Asset Length:	109.8m	
	Condition Assessment		
	Condition	Priority	Risk
	B	2	
	Brief Description		
	No significant change in 2022. Missing pointing between blocks on wall. Damage to front face of several blocks. Concrete toe apron exposed locally. In 2022, beach levels varied with some drainage outlets buried and some exposed.		
	Recommendations		
Repointing. reseal cracks below coping.

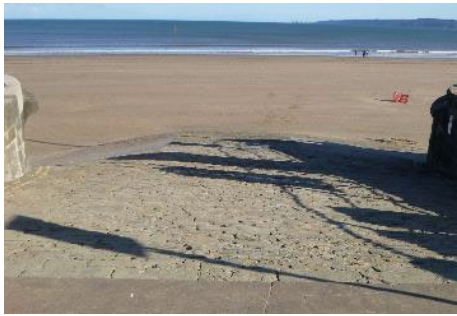
SBC Reference:	67-28B-02		
NFCDD reference:	1221D901D1602C08 001

Asset Location:		
	Asset Length:	~6m	
	Condition Assessment		
	Condition	Priority	Risk
	B	3	
	Brief Description		
	Mixed construction from blockwork and mass concrete. Recent blockwork repair towards toe. Several open joints between blockwork, cracked concrete. High Beach levels concealed concrete toe apron previously reported to be undermined.		
	Recommendations		
Repair/reseal joints and repair cracks. Continue to monitor.

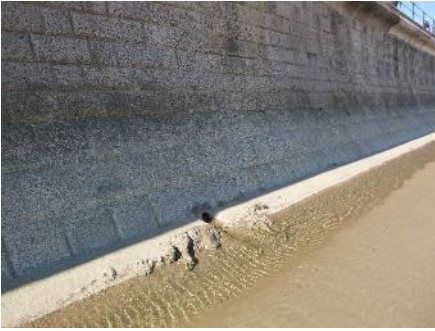
SBC Reference:	67-28B-03		
NFCDD reference:	1221D901D1602C08

Asset Location:	TA11978020, TA12068082	
	Asset Length:	301.6m	
	Condition Assessment		
	Condition	Priority	Risk
	B	2	
	Brief Description		
	Abrasion to front face, particularly just above beach level appearsto have worsened slightly. As reported in 2022, many of the bullnose coping blocks have been repaired, but others are cracked/damaged. Several open joints leaking water. Lower beach levels exposed several drainage outlets, some of which appeared to be blocked. Previously observed bubbling water on beach approx. 1m off toe of wall was not observed in 2022, it is believed this is due to a buried outfall pipe. Handrails corroded.		
	Recommendations		
Replace/repair cracked coping and repair damaged blocks. Repair handrails. Confirm “bubbling” is due to buried outlet.

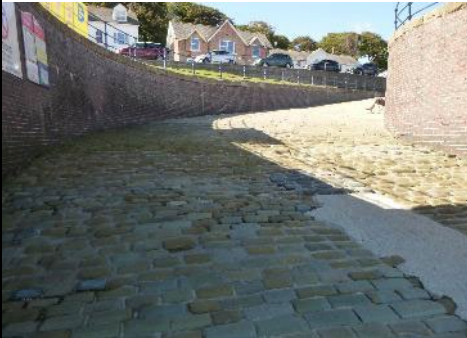
SBC Reference:	67-28B-04		
NFCDD reference:	1221D901D1602C03 002

Asset Location:		
	Asset Length:	12m	
	Condition Assessment		
	Condition	Priority	Risk
	B	3	
	Brief Description		
	Several open/missing joints in slipway, occasional settled blocks although none noted missing. Missing blocks and mortar joints on abutment walls. Handrails corroded. No change in 2022.		
	Recommendations		
Repair/replace missing blocks and joints. Treat/replace handrail.

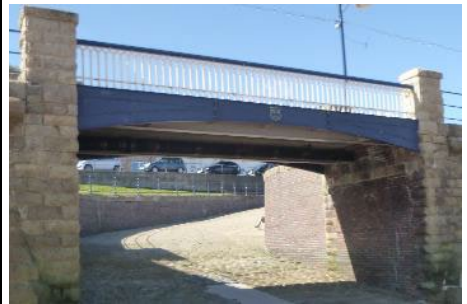
SBC Reference:	67-28B-04		
NFCDD reference:	1221D901D1602C03 003

Asset Location:		
	Asset Length:	6m	
	Condition Assessment		
	Condition	Priority	Risk
	B	3	
	Brief Description		
	No significant change in 2022. Painted steel bridge in good condition overall. No issues noted to slabs on underside of deck, surface corrosion noted to pipework. Several cracks/open joints in both abutments and brickwork in need of localised repointing.		
	Recommendations		
Repair cracks in abutment walls.

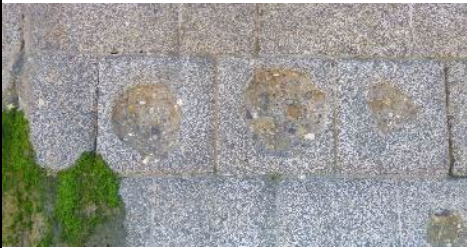
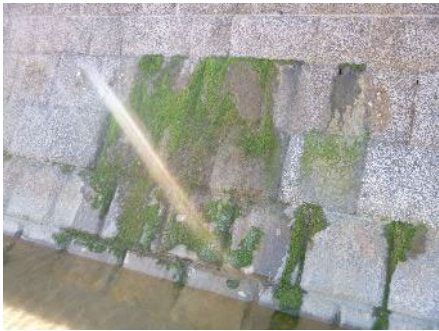
SBC Reference:	67-28B-05		
NFCDD reference:	1221D901D1602C03

Asset Location:	TA11978020, TA12068082	
	Asset Length:	318.8m	
	Condition Assessment		
	Condition	Priority	Risk
	C	3	
	Brief Description

Abraded blockwork continues to deteriorate. Loss of face to many blocks throughout, particularly at lower levels at South end. Water observed seeping from between abraded blocks in area. Several new / repaired coping blocks. Handrails corroding at many joints. Cracked coping beam with missing joint sealant in several places. Some drainage outlets were visible due to lower beach levels.		
	Recommendations		
	Monitor abrasion and reface in blocks. Repair/replace handrails. Repair missing joints.

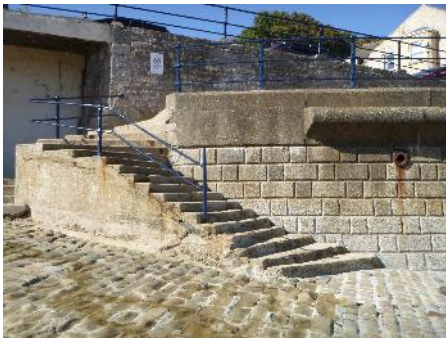
SBC Reference:	N/A		
NFCDD reference:	1221D901D1602C03 001

Asset Location:		
	Asset Length:	5m	
	Condition Assessment		
	Condition	Priority	Risk
	B	3	
	Brief Description		
No significant change in 2022. Corroded handrail and cracking joints below treads on side wall. Step nosing lightly			
Recommendations			
Repair joints. Treat handrails. Continue to monitor.

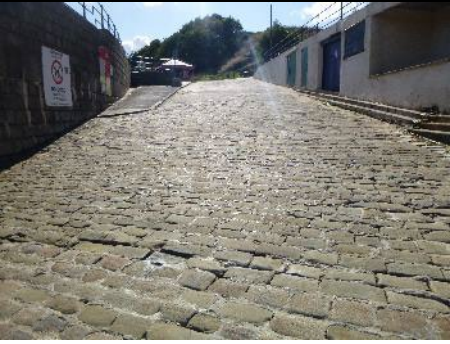
SBC Reference:	67-28B-06		
NFCDD reference:	1221D901D1602C04 002		
	Asset Location:	TA11968012, TA11978020	
	Asset Length:	20m	
	Condition Assessment		
	Condition	Priority	Risk
	B	3

Brief Description	
	Shingle levels at toe of slipway were lower than in 2020. A previously reported scour hole was not observed, however there were many open joints where mortar has been lost from between the stone blocks.	
	Recommendations	
Replace/repair missing joints. Continue to monitor.

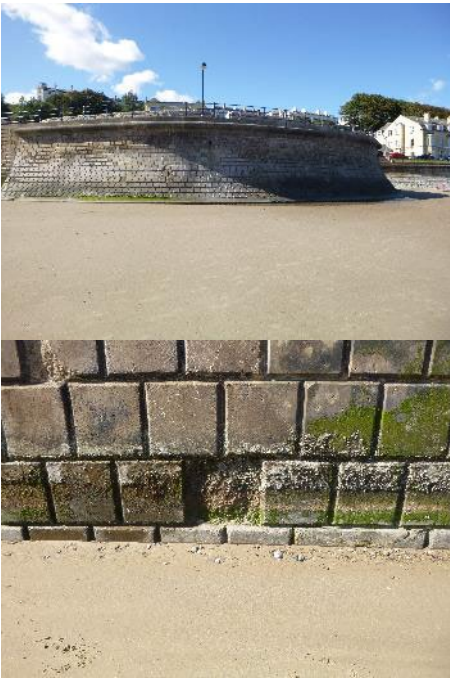
SBC Reference:	67-28B-07		
NFCDD reference:	1221D901D1602C04

Asset Location:	TA11968012, TA11978020	
	Asset Length:	91.8m	
	Condition Assessment		
	Condition	Priority	Risk
	B	3	
	Brief Description		
	Overall fair condition, some abrasion to facing of blocks, open/missing joints between a few blocks. No change in 2022.		
Recommendations			
Seal open joints, repair abrasion damage to facing of blocks.

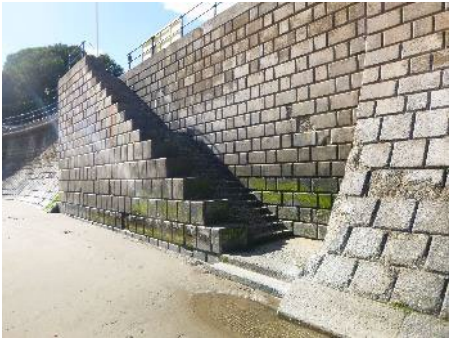
SBC Reference:	67-28B-08		
NFCDD reference:	1221D901D1602C04 001

Asset Location:		
	Asset Length:	~6m	
	Condition Assessment		
	Condition	Priority	Risk
	B	3	
	Brief Description		
	Abrasion/ chipping to steps, coping cracked locally. Localised scour of beach sediment adjacent to landing step can makes access at low tide difficult due to pooling water.		
Recommendations			
Repair chipped steps and cracked coping, continue to monitor.

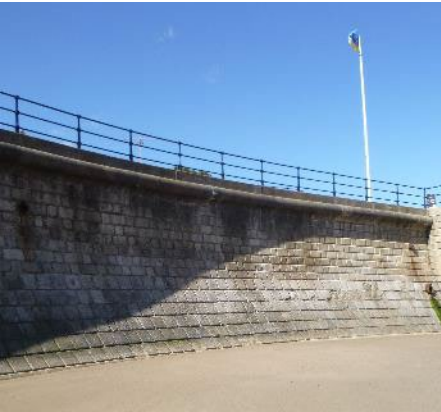
SBC Reference:	67-28B-09		
NFCDD reference:	1221D901D1602C07

Asset Location:		
	Asset Length:	98m	
	Condition Assessment		
	Condition	Priority	Risk
	B	3	
	Brief Description		
	Cracking to bullnose coping stone in a few places, with evidence of historic repairs. Numerous chipped / damaged facing blocks, but overall condition remains fair. Cracks and open joints in blockwork of southern steps buttress. Promenade fair to good. Potholes in asphalt reported in 2018.		
	Recommendations		
Repair cracks and loose blocks. Fill joints. Continue to monitor.

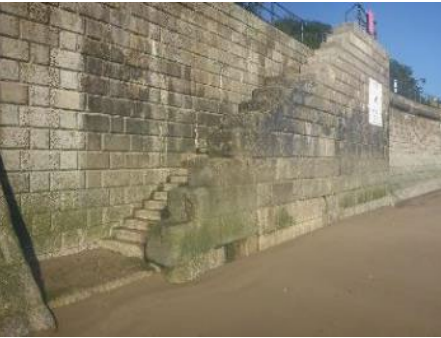
SBC Reference:	67-28B-10		
NFCDD reference:	1221D901D1602C05001

Asset Location:		
	Asset Length:	10m	
	Condition Assessment		
	Condition	Priority	Risk
	B	3	
	Brief Description		
	Spalling and abrasion of concrete blocks on seaward side with missing joints in places. Steps abraded and beginning to round although in fair condition.		
	Recommendations		
Replace missing joints, repoint steps. Continue to monitor

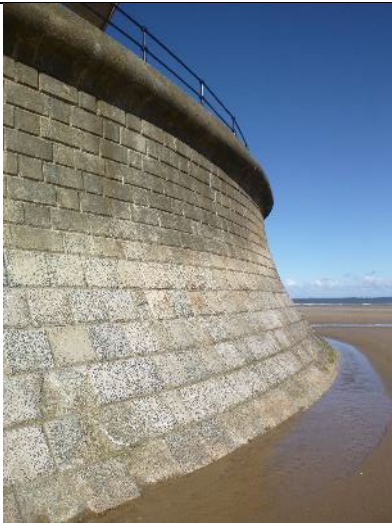
SBC Reference:	67-28B-11		
NFCDD reference:	1221D901D1602C05

Asset Location:	TA11957997, TA11968012	
	Asset Length:	103.9m	
	Condition Assessment		
	Condition	Priority	Risk
	B	3	
	Brief Description		
	Some damage to seaward edge of prom. Repairs to splash beam by outfall holding (reported in 2018). Numerous lower blocks damaged on front face between beach level and 2m height not significantly worsened. Horizontal crack on seaward section as 2012. Cracks in retaining wall to slipway. Only a small flow discharging from outfall on day of inspection. Outfall grate corroded.		
	Recommendations

Monitor damage to blocks and repair where necessary. Treat/replace handrailing.
--	------------------------------------------------------------------------------------

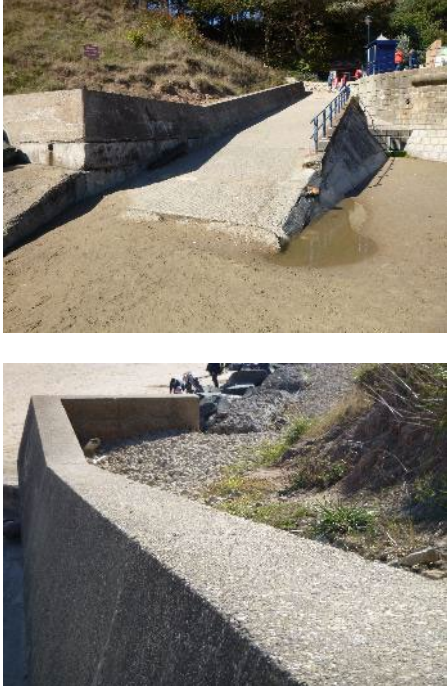
SBC Reference:	67-28B-12		
NFCDD reference:	1221D901D1602C02001

Asset Location:	TA12248126, TA12278130	
	Asset Length:	15m	
	Condition Assessment		
	Condition	Priority	Risk
	B	3	
	Brief Description		
	Spalling of concrete near base. Crack on side wall at mid-section. Fair condition overall. Handrail corroded. Toe of slipway abraded causing open joints between concrete sections. Washout of material behind slipway has caused outlet pipe to break.		
	Recommendations		
Repair spalling and cracking. Repaint/replace handrailing. Repair outlet pipe behind structure.

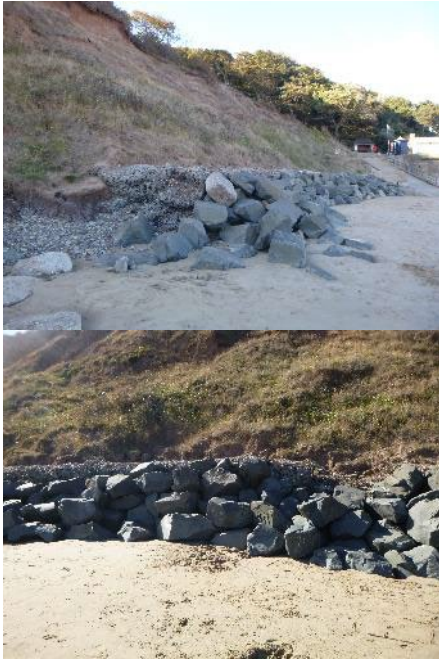
SBC Reference:	67-28B-13		
NFCDD reference:	1221D901D1602C02

Asset Location:	TA12068082, TA12118035	
	Asset Length:	18.3m	
	Condition Assessment		
	Condition	Priority	Risk
	C	2	
	Brief Description		
	Gabion baskets fronted by rock armour and concrete blocks, with gravel/stone infill to rear. Slumping cliffs behind may be pushing rock onto beach highlighted by the depression in the crest of the gabion baskets and rock armour. Noted in 2022 that at least two of the gabion baskets at the southern end of the revetment have split. Revetment at risk of unravelling if outflanking continues.		
	Recommendations		
Continue to monitor and reposition rocks as required. Consider placement of larger rock armour. Repair / replace broken gabion baskets

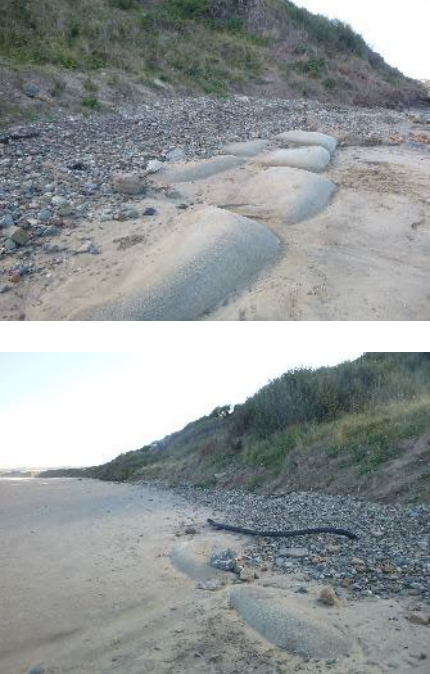
SBC Reference:	To be allocated by SBC to this new defence length		
NFCDD reference:	To be allocated by SBC to this new defence length

Asset Location:		
	Asset Length:	75m	
	Condition Assessment		
	Condition	Priority	Risk
	C	3	
	Brief Description		
	<p>Flat cliffs stabilisation scheme was complete in 2018 to provide temporary (20 year design life) protection to the hamlet access road. The works involved installing sand filled geotextile bags along the toe of the till cliffs, kerb drainage units along the access road at the crest of the cliffs and sub-horizontal slope drainage installed at the base of the cliff.</p> <p>The geotextile bags at the toe of the cliff were partly buried by beach sediment. The toe of the cliff has continued to retreat, exposing drainage pipes along the full length which in many places have come separated at their terminal end. It was noteworthy that several of the drainage pipes were discharging water at the time of inspection suggesting they are still operating as expected</p>

Recommendations		
	<p>It is recommended that the pipes are not reconnected due to the ongoing erosion of the toe making it highly likely for the issues rearise. Remove any unused pipework from foreshore.</p> <p>As the works are designed as a temporary measure, it is recommended that an alternative access arrangement into the hamlet is made [Urgent].</p> <p>Monitor performance of drainage units, ensuring outfalls behave as designed.</p> <p>In the longer term, it is recommended that the Council, residents and other local stakeholders start planning for 'adaptation to coastal change' in the medium to longer term. This may involve relocating inland.</p>
