Scarborough Borough Council
Strategic Coastal Monitoring Programme
2001 – 2006

Condition Analysis of Coast Protection Assets,
Cliffs and Beaches from Staithes to Speeton

November 2006

Halcrow Group Limited

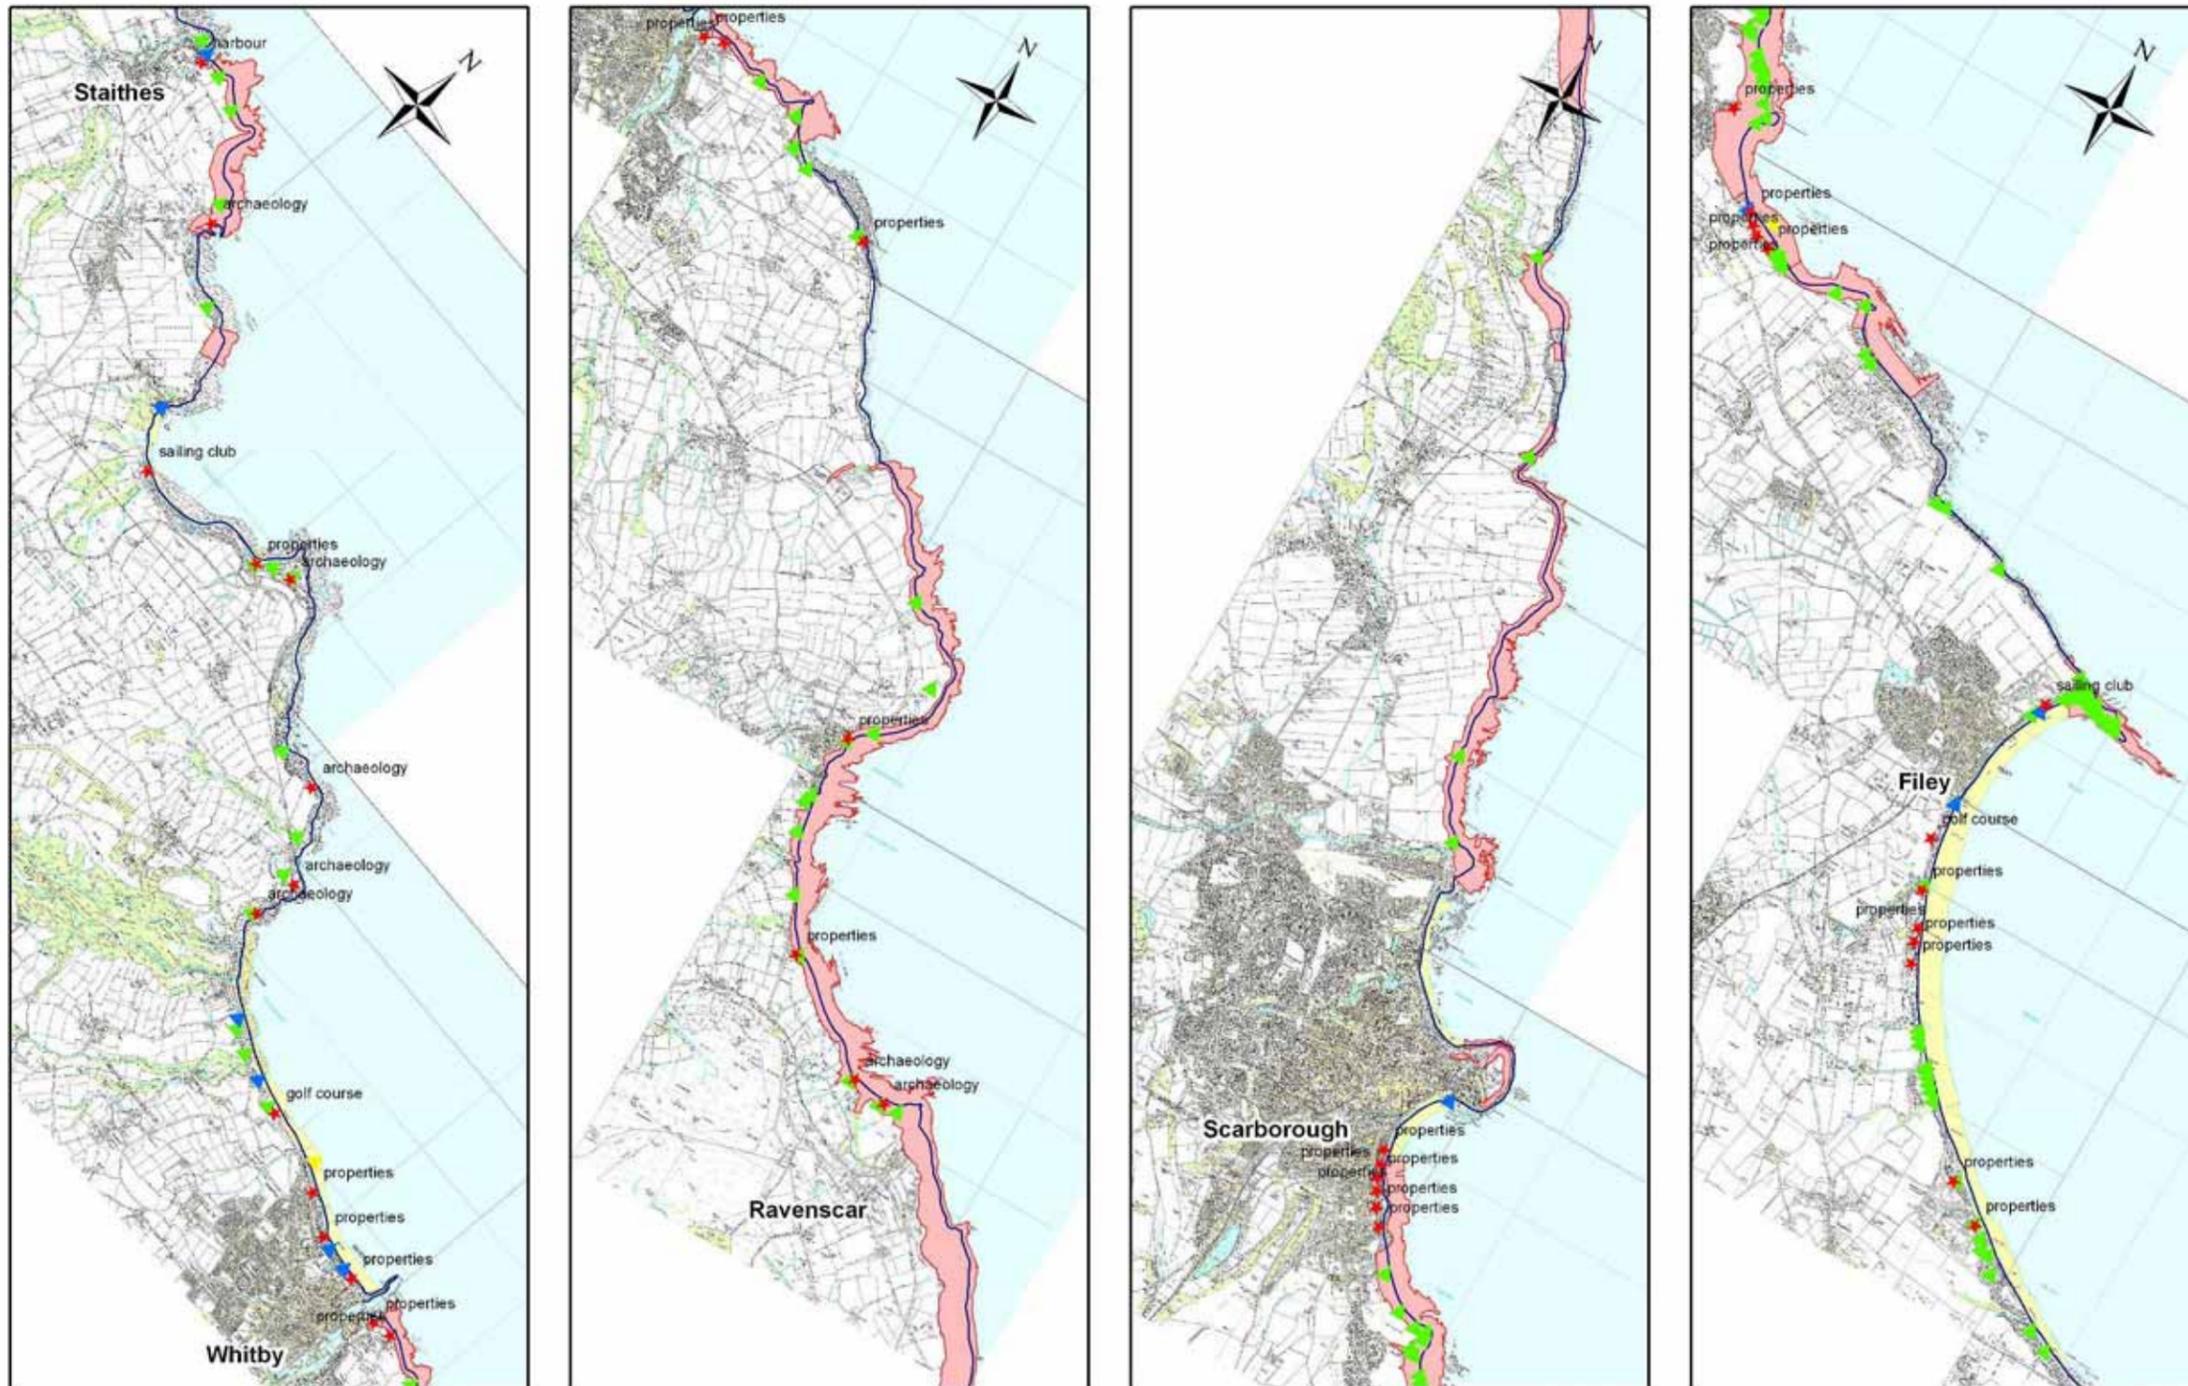
Scarborough Borough Council
**Strategic Cliff Monitoring,
 May to June 2005**
Figure 5.1. Hotspots

A summary of the results of the analysis of cliff activity, structural assets and beach profiles is shown in Figure 5.1. This figure shows the key hotspots identified in each of the surveys and also shows the key assets at risk from coastal **erosion** and the environmental designations which may be affected. With relation to the cliffs, particular hotspots are seen at Kettlethess, Sandsend, Saltwick Nab, Rain Dale, Robin Hood's Bay, White Nab, Cornelian Bay, Killerby Cliff, Filey Brigg, Hunmanby Gap and Speeton Sands. Of these areas, White Nab, Cornelian Bay and Speeton Cliffs are of particular concern, having increased significantly in landslide activity between 2002 and 2005.

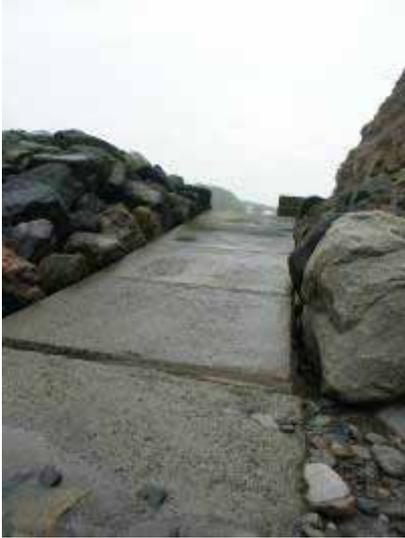
Photograph 3.2 Staithes Northern Breakwater.
Slipway to Seaward side

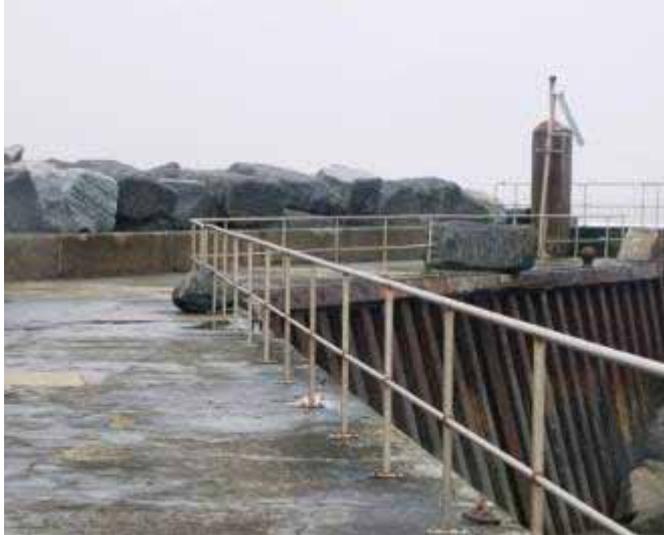
Photograph 3.3 Staithes Northern Breakwater. Displaced rock armour.

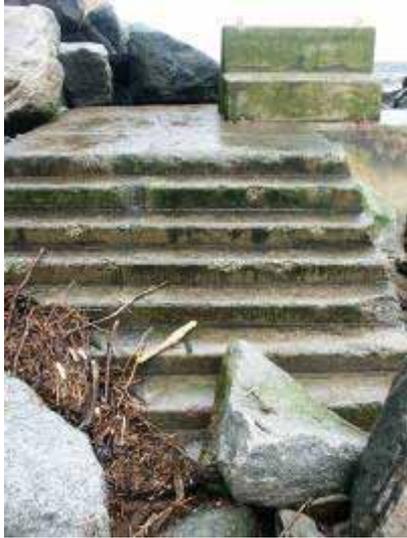
Photograph 3.7 Staithe Northern Breakwater. Steps at root of Northern Breakwater

Moving eastwards, there are the remnants of a concrete promenade or apron. The coping and hand rails remain and are severely undermined. The function of these assets is not known for sure, but they are possibly there to keep people away from the cliff. However, their condition is such that they could potentially present a Health and Safety Hazard. These will continue to deteriorate and should be removed.

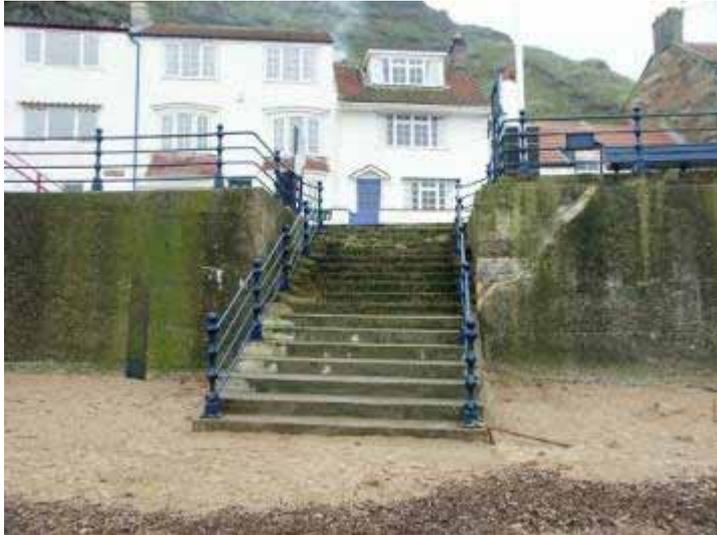
Photograph 3.16 Staithes 04-04-01.
Steps and hand railing

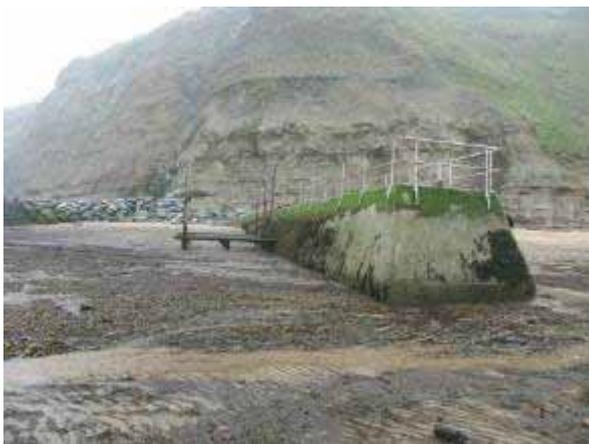
Continuing eastwards, there is a slipway, a concrete pier structure and the eastern breakwater. The slipway and the concrete pier appear to be in fair condition.

Photograph 3.18 Staithes.
Concrete Pier / groyne at south-eastern corner of harbour.

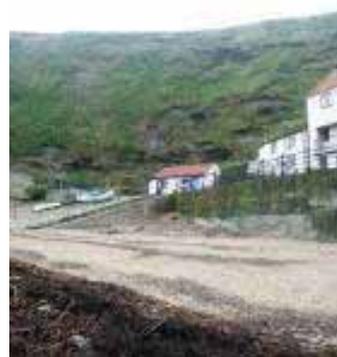
Photograph 3.19 Staithes
Slipway at SE corner of harbour.

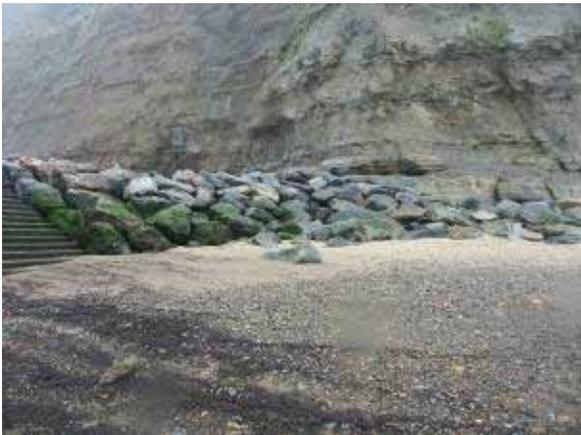
The eastern side of Staithes Harbour is protected by a breakwater. This comprises a concrete pier structure with a rock armour revetment at its seaward (eastern)

Photograph 3.20 Staithes Eastern Breakwater
Root of rock armour breakwater

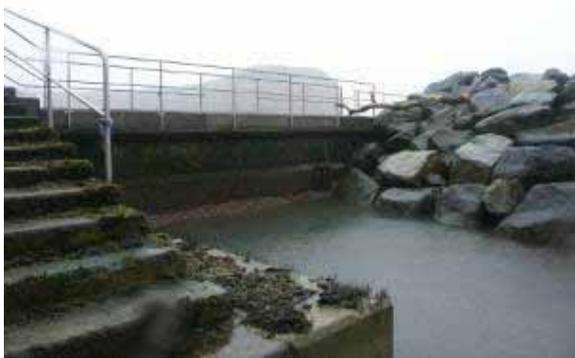
side. Generally, this structure is in a good condition. However, there is a set of steps that terminates with a drop of 2 m into ponded water (at low water.) Signage should be considered to warn users. Some of the rocks have been placed in a stacked fashion, but it is unlikely that this will affect the performance of the breakwater. Units 02-04-01, 03-04-01 and 04-04-01 are not currently on the database. However, these have been inspected and the survey sheets appended to this report.

Photograph 3.21 Staithes Eastern Breakwater.
Steps on eastern side.

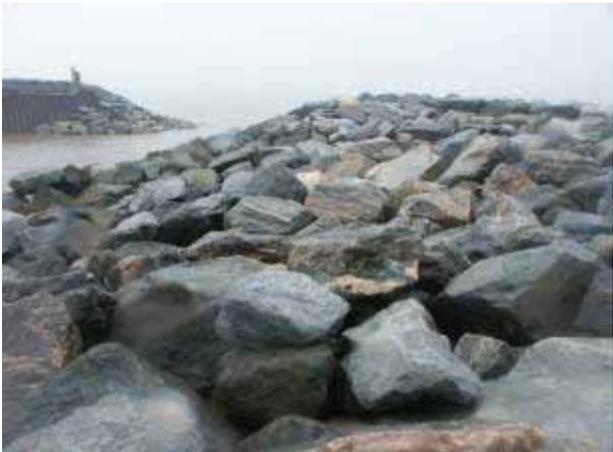
Photograph 3.22 Staithes Eastern Breakwater
Rock armour revetment

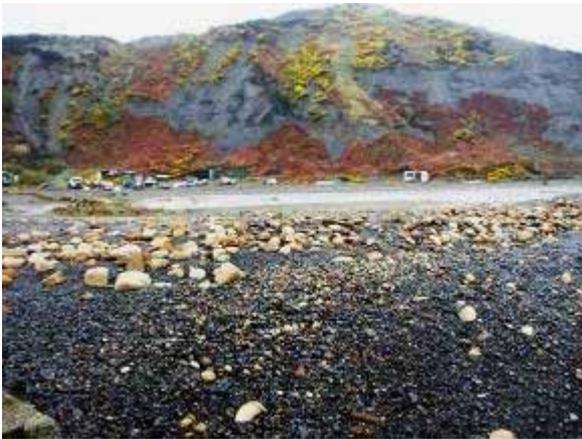
Photograph 3.26 Port Mulgrave.
Harbour basin with boats

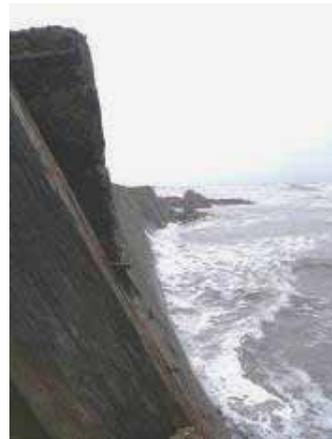
Photograph 3.27 Port Mulgrave.
Seaward facing wall of south breakwater

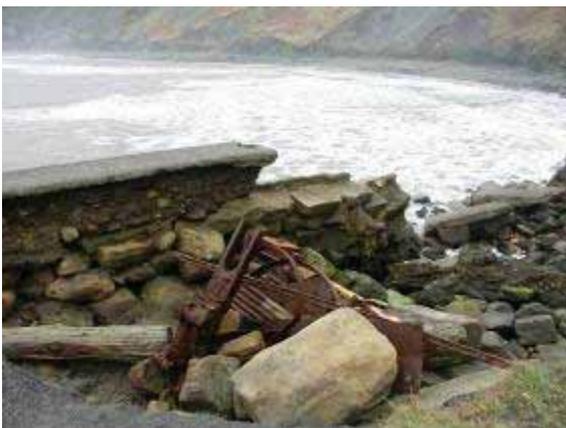
Only remnants indicate the former existences of a north breakwater and rock armour. Broken sections of this structure remain along the frontage.

Photograph 3.28 Port Mulgrave. Collapsed surface of south breakwater

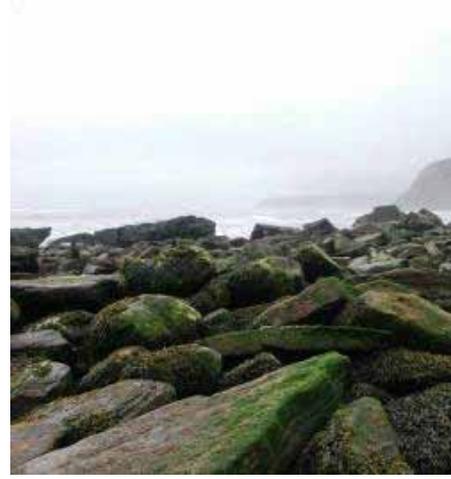
Photograph 3.30 Port Mulgrave.
Remains of north breakwater and rock armour

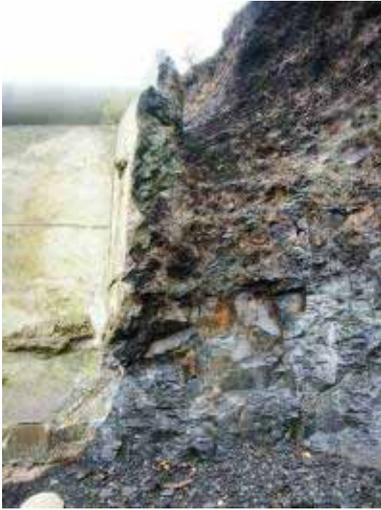
At the northern end of the unit, the asset no 07-07A-01 has failed. Part of the seawall is missing and the frontage is subject to direct wave attack, increasing the risk of outflanking of the defences. The adjacent asset no 07-07A-02 is also in a poor condition, with several patch repairs and an *ad hoc* extension with concrete bag-work forming a protective wall to a private property. The structural integrity and effectiveness of this extension is questionable. The access to the beach is very steep and slippery at this point and may present a hazard to pedestrians. Furthermore, the foundations of the steps leading past the private property onto a path to the main road, are being undermined by a small stream.

Photograph 3.31 Runswick Bay 07-07A-01
Failed seawall section

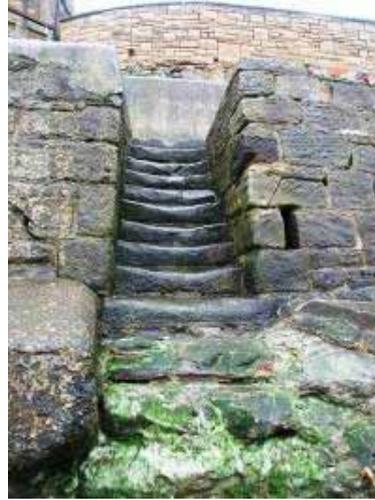
Photograph 3.34 Runswick Bay 08-07A-02.
Very rounded, slippery steps

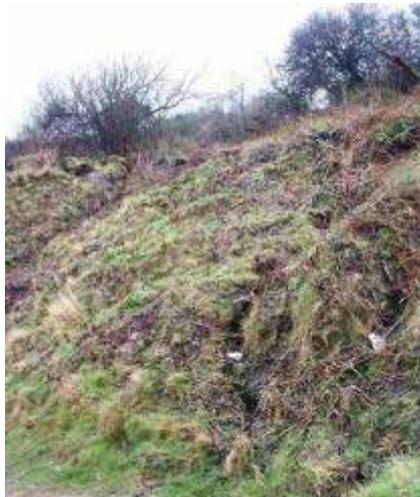
The remaining assets along this unit are in a fair to good condition. The recently built defences are in a good condition. It should be noted, however, that the slope behind these is locally active and should be monitored annually.

Photograph 3.36 Runswick Bay 10-07B-02.
Shallow localised slope failure above the rock revetment.

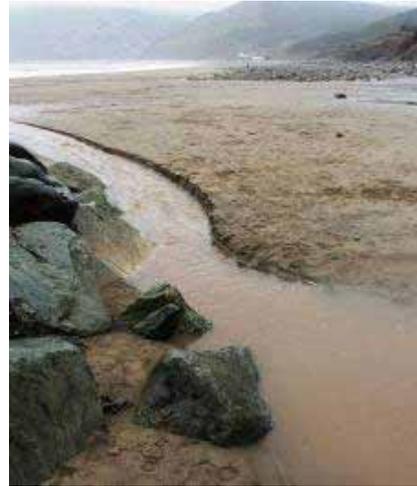
A drain on the landward side of the coastal asset no 10-07B-01 is routed through the rock armour and over the slipway onto the beach. The amount of water

Photograph 3.38 Runswick Bay 10-07B-01
Access to beach – public at times must negotiate the ponded water

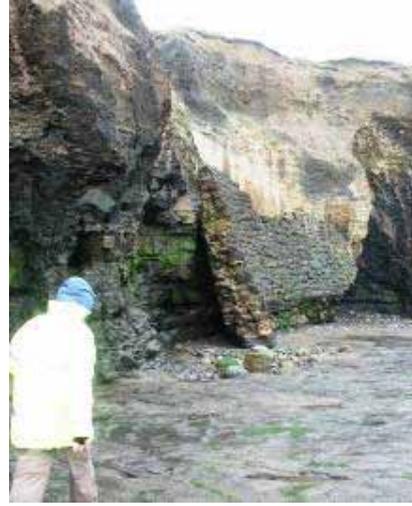
Photograph 3.42 Gouldsbrough 12-08B-01.
Wash-out behind remnant seawall

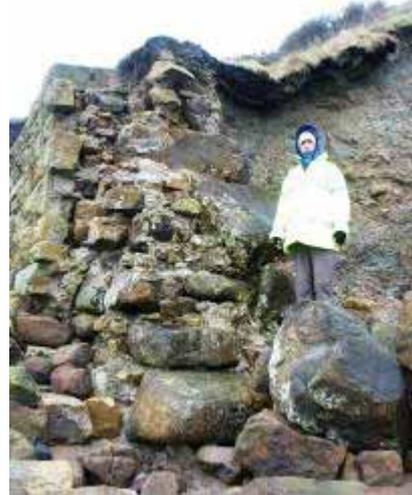
The final section of the remaining sea defences is a wall with rock armour in front. This wall looks newer than the other sections. Nevertheless, the partly active slopes have caused the failure of the defence on both sides of the remaining wall. The rock armour in front of the defence appears to be too small for the impacting waves, as several rocks have been displaced and/or cracked.

Photograph 3.44 Gouldsbrough 12-08B-01. Failed defence

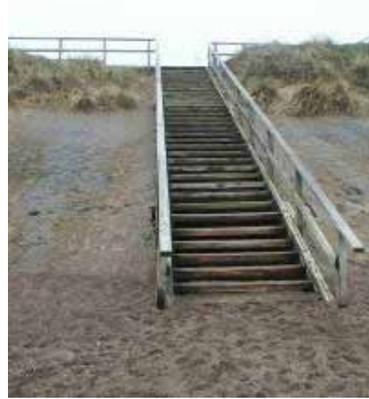
Photograph 3.46 Sandsend 16-09C-05
Staircase

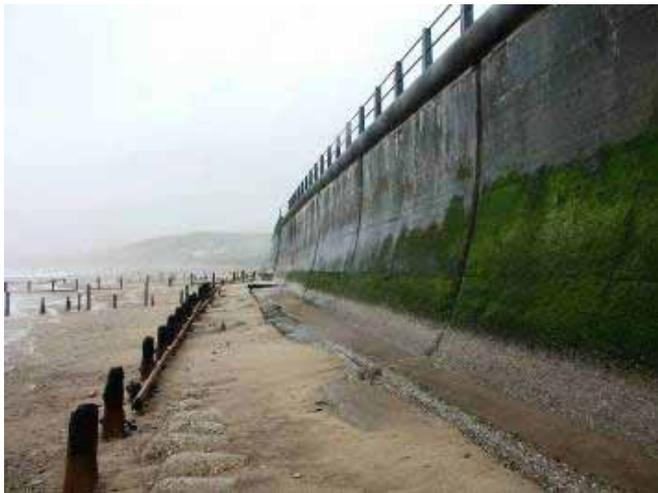
Photograph 3.47 Sandsend 14-09B-05.
Light scour at toe and dilapidated groyne

The defences in the village are in a fair to good condition with some scour at the toe. However, the groynes in front of the defences are in a very poor condition, with exposed metal ties presenting a safety hazard to beach users. They appear to be ineffective as groynes. Minor defects are present in the seawall, with some abrasion damage and fill missing in places.

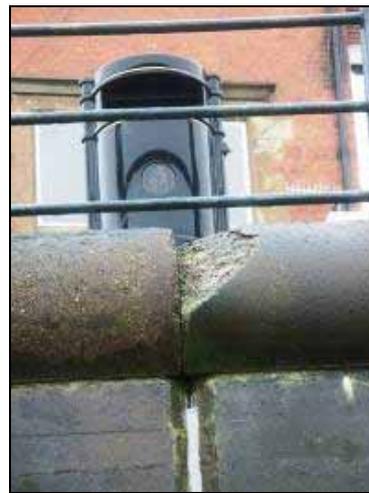
Photograph 3.48 Sandsend 14-09B-01.
Minor damage to wave return feature of wall

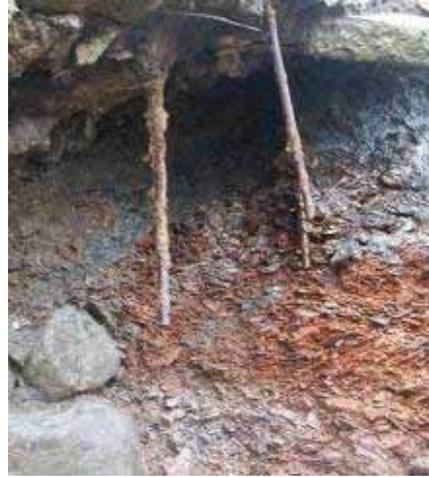
Photograph 3.50 Sandsend 13-09A-01
Weak, washed-out foundation

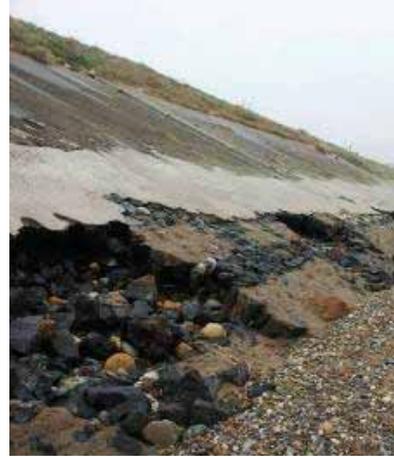
Photograph 3.52 Sandsend Wyke 17-10-01
Abrasion and scour at toe of defence

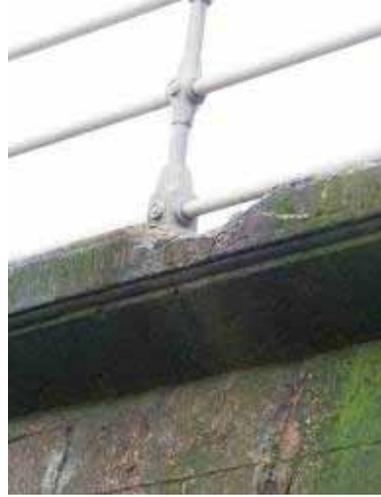
Photograph 3.56 Whitby West Cliff 19-11A-01. Damaged coping

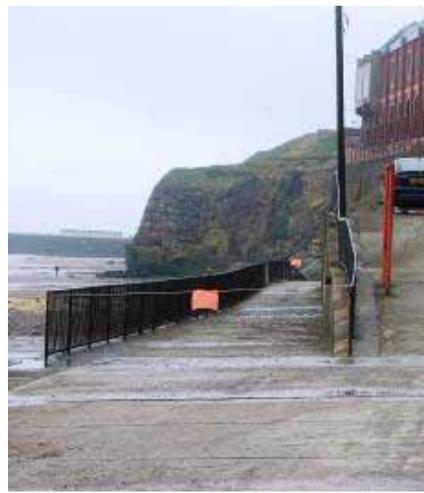
The coastal defence asset no 20-11A-02 has failed and should be repaired urgently to ensure the overall integrity of the structure. Several masonry blocks are missing below the promenade: the access to this part of the promenade has been informally blocked off.

Photograph 3.58 Whitby West Cliff 20-11A-02. Informally blocked promenade

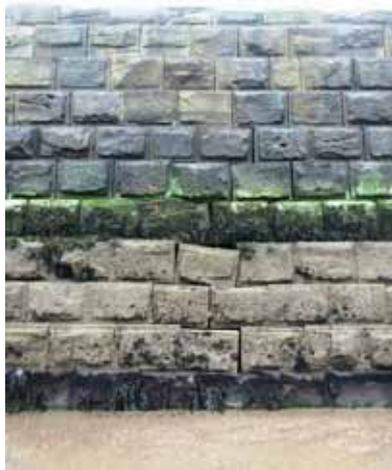
Photograph 3.63 Whitby West Pier 27-11B-01. Blocks displaced due to movement.

There are vertical cracks evident in the north face of the west pier (unit 27-11B-01). In addition, displacement of masonry blocks has occurred. Cracks and voids can be seen in several locations along the harbour wall. (See photograph 3.63). It is not possible to comment on the development of these cracks as these frontages do not appear in the *KeyShore* database and no previous assessments appear to have been made.

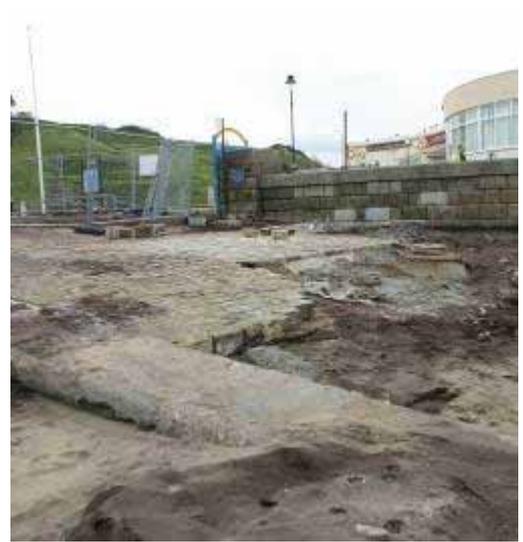
Photograph 3.71 SNB 43-20B-02. Works in progress

Some works to the defence structures were already taking place during the survey in May 2005, which on occasion obstructed the assets, making a full visual inspection not possible. However, a reasonable estimate of the structures condition could be made for all the coastal assets in this coastal unit.

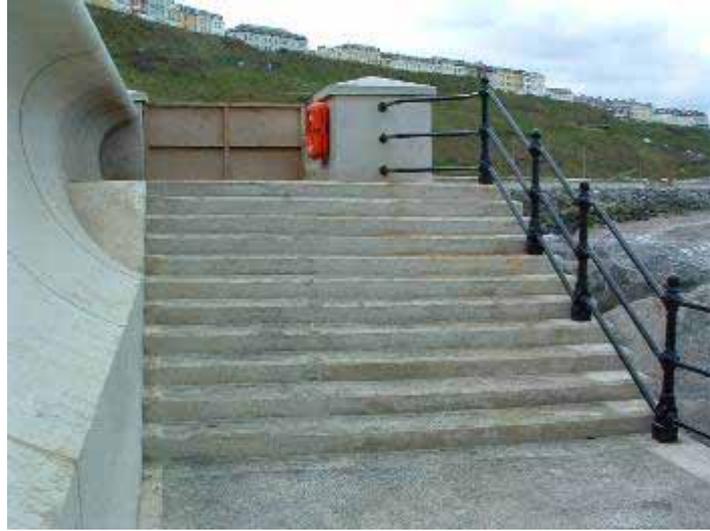
Photograph 3.75 SNB 46-20B-05. New defences have been constructed

The defences below Chain Hill, asset location 46-20B, are currently being replaced by new defences. Since this construction is still ongoing a detailed assessment should be made after the completion of construction.

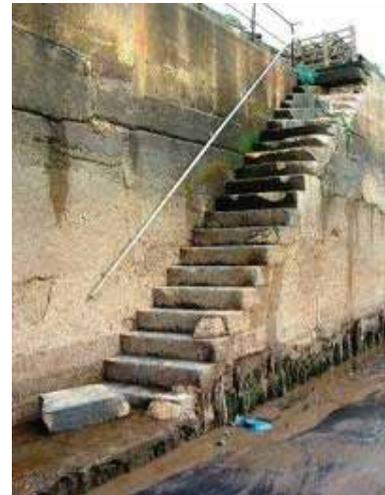
Photograph 3.77 SWP 49-21B-03
Damaged staircase

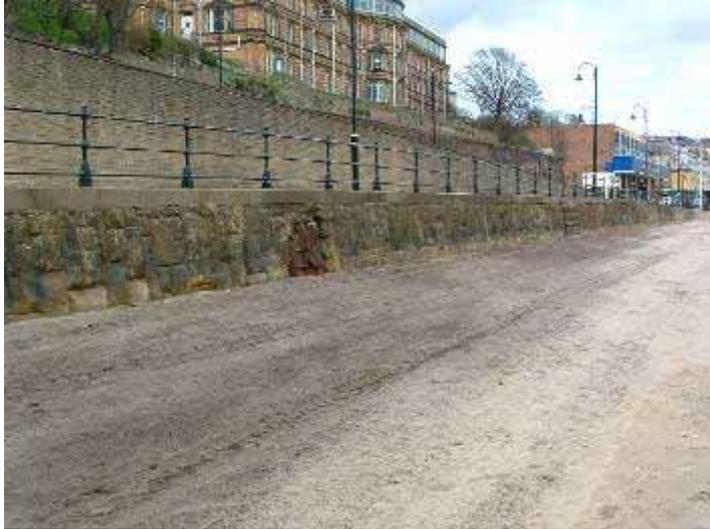
It should be noted that the defence crest level for asset 51-22A-01 to 51-22A-12 appear to be lower than the other defences along the frontage. The crest height changes over the frontage.

Photograph 3.78 Scarborough South Bay (SSB) 51-22A-12.
Seawall with promenade.

The standard of defence is possibly maintained by higher beach levels. An assessment of the beach levels and wave overtopping should be carried out separately from the asset condition to ensure the required standard of protection is maintained by the coast protection asset.

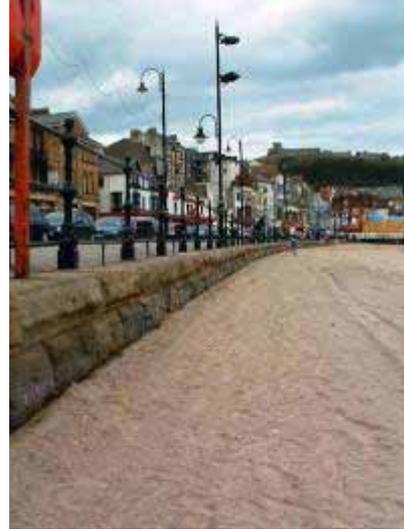
Photograph 3.79 SSB 51-22A-12
Seawall with promenade

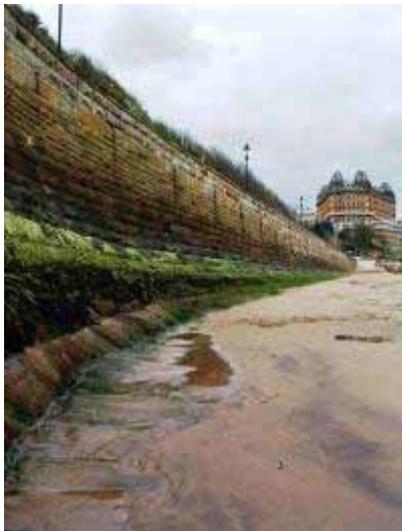
Photograph 3.80 SSB 51-22A-06
Seawall with promenade

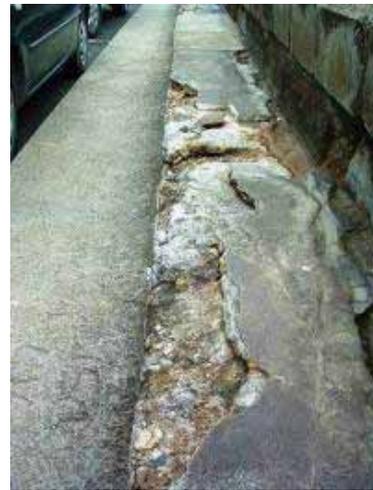
Photograph 3.83 SSB 53-22B-05.
Damaged promenade kerb

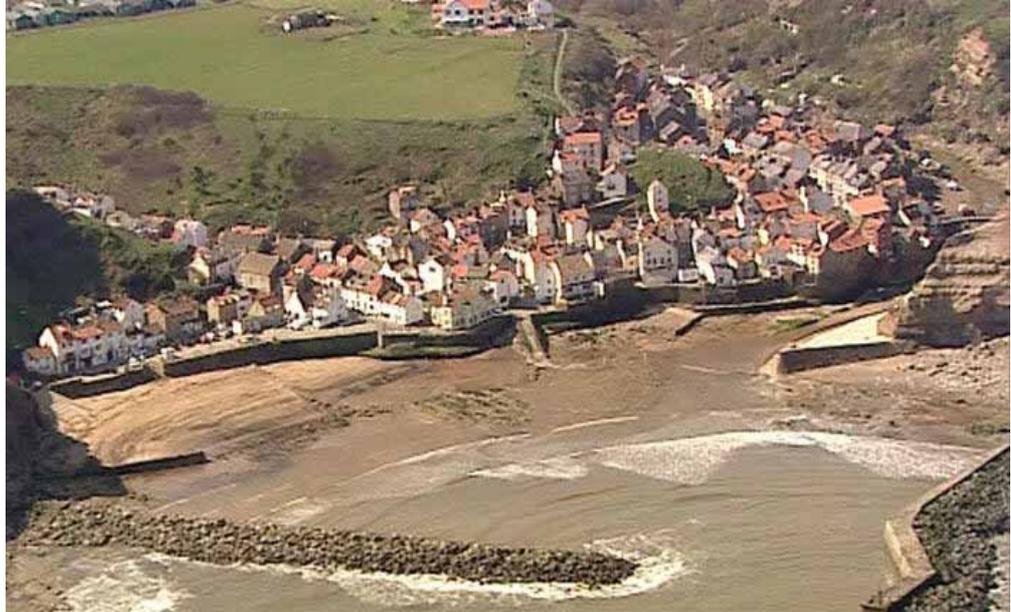
- A variety of coastal defence structures are located at Staithes, including seawalls and rock groynes. Two breakwaters in the north and east provide shelter to the harbour (Photograph 4.1). A river also flows into the northwest of the harbour. As such, it is likely that beach change will be the result of a combination of natural fluvial processes and as a result of the defence structures.

- Overall vertical **erosion** of 7,432m³ has occurred in the harbour between March 02 and October 02. However **accretion** appears to be more dominant where the river flows into the harbour.

Photograph 4.1. Defended Staithes Harbour coastline (taken at Profiles 1 and 2 on 21/04/01 at low water +3 hours).

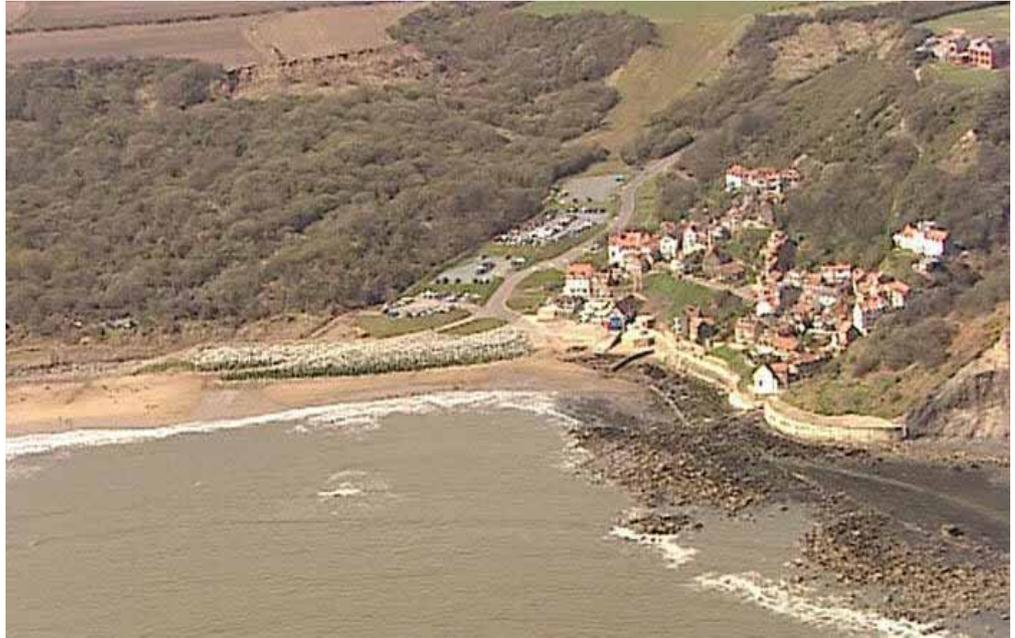
- This length of coastline is predominantly undefended, with the only form of protection being a small length of rock revetment, located landwards of profile 1 (Photograph 4.2). As such, it is likely that beach change will be the result of natural process and not the result of defence structures.
- Beach volume analysis was not carried out at this location as the co-ordinates for the March 2002 survey were incorrect and could not be overlaid with the March 2003 survey. It was only possible to analyse beach change generally using profile analysis for profiles 2, 3 and 4. Results

Photograph 4.2.: Defended Runswick Bay coastline (taken at Profile 1 on 21/04/01 at low water +3 hours).

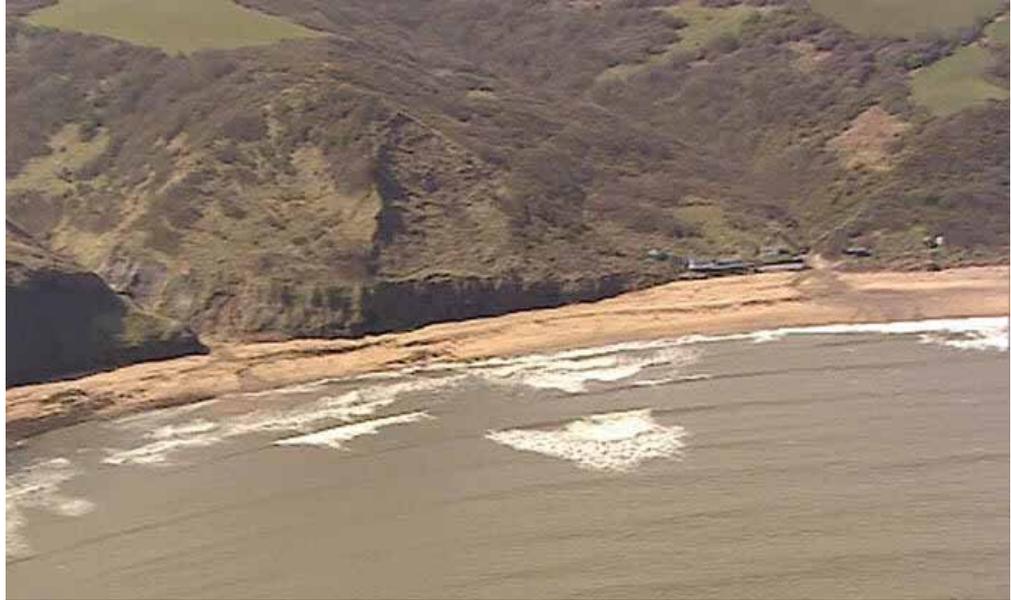
Photograph 4.3. Undefended Runswick Bay coastline (taken at Profile 3 on 21/04/01 at low water +3 hours)

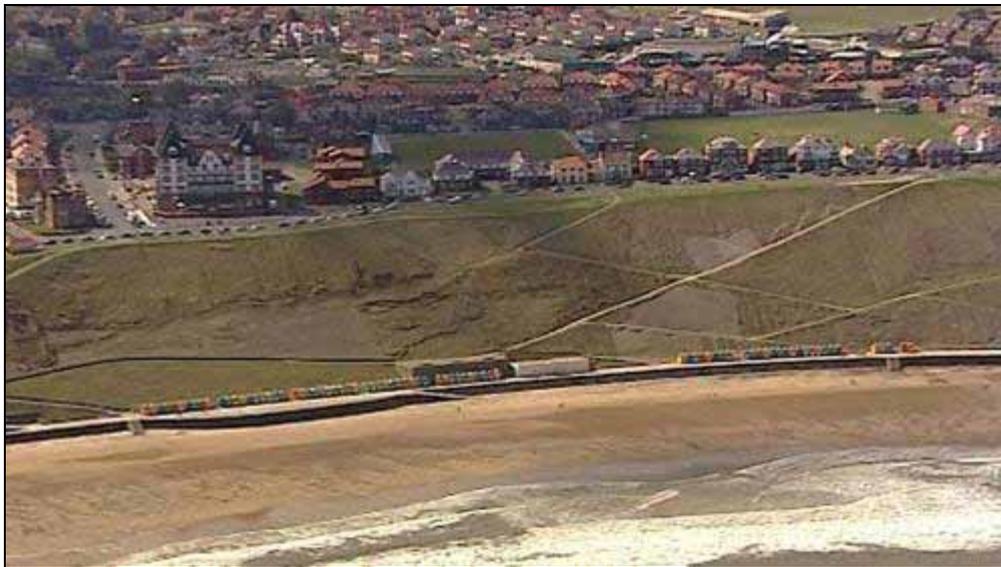
- Seawalls and revetments extend for much of the Whitby coastline, with only the central section (between profiles 4 and 6) remaining undefended (see Photographs 4.4 and 4.5 respectively). Groynes are also present at Sandsend and Whitby;
- Profiles with defences (1, 2, 3, 7, 8, 9, 10) generally have lower volumes of sediment, possibly due to the lack of supply from cliff sources;
- Profiles without defences (4, 5, 6) generally have greater volumes of sediment, possibly supplied from the unprotected backing cliffs or as a result of increased longshore drift supply;
- Overall vertical **erosion** of $-244,833\text{m}^3$ from March 02 – April 04. Whilst this is experienced along the entire length, there are isolated areas that have been consistently accreting throughout the study period (their size fluctuating over time).

Photograph 4.4. Defended cliffs, Whitby West Cliff (profile 8 on 21/04/01 at low water +3 hrs)

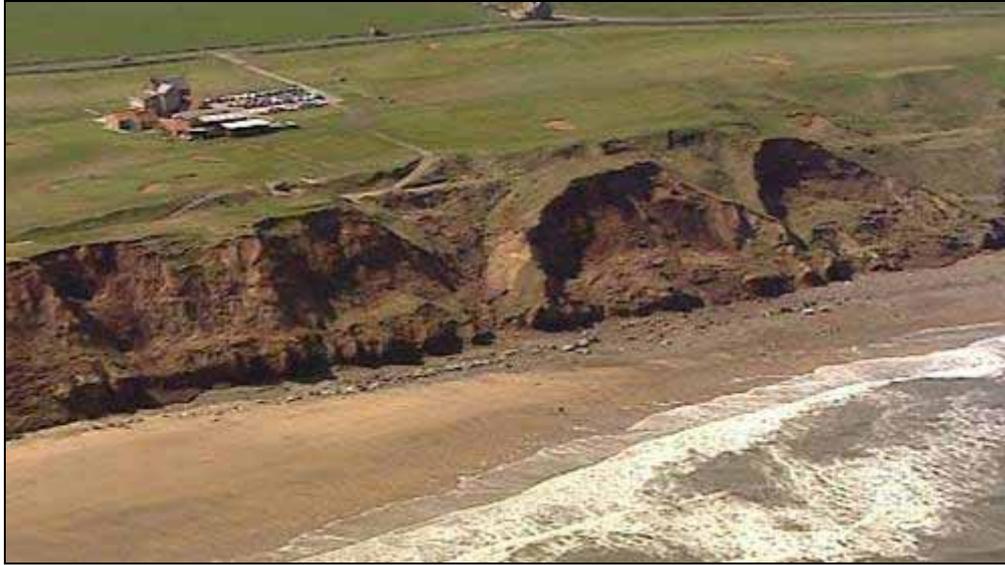
Photograph 4.5.. Undefended cliffs, Uppang Beach (profile 5 on 21/04/01 at low water +3 hrs)

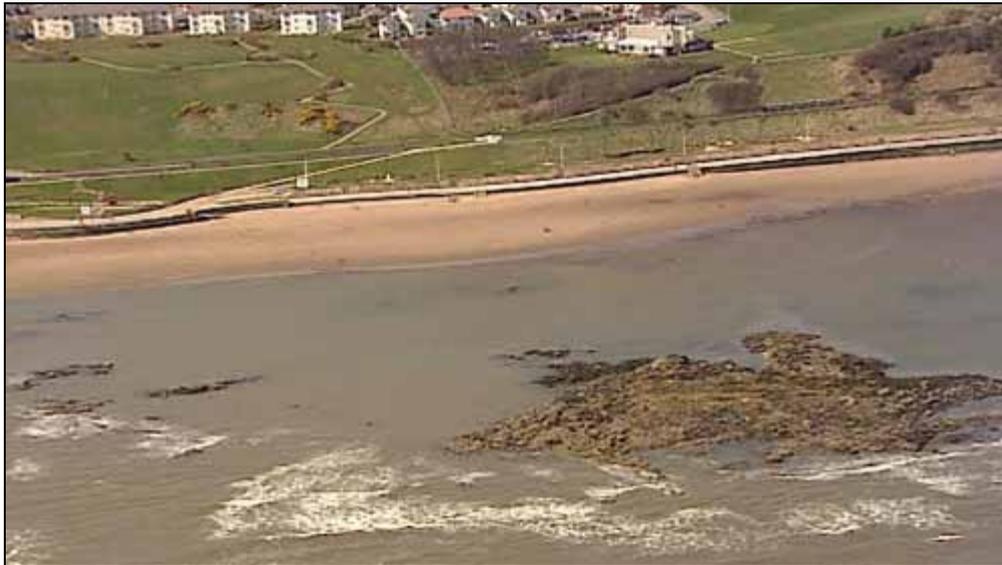
- Jan 04 – Apr 04: upper foreshore **accretion**, lower foreshore **erosion** (steep upper/shallower lower profile maintained);
 - Beach profile fluctuations are minimal. This is possibly due to protection from wave action being provided by offshore rocks (see Photograph 4.6). The profile variations therefore suggest the beach is **relatively stable** (being in, or near to, equilibrium). Given the increased natural sheltering at this location, larger changes in beach volume or profile gradient are likely to result from significant storm activity.

Photograph 4.6. Rocky offshore area at profile 1, North Bay (taken 21/04/01 at low water +3 hrs)

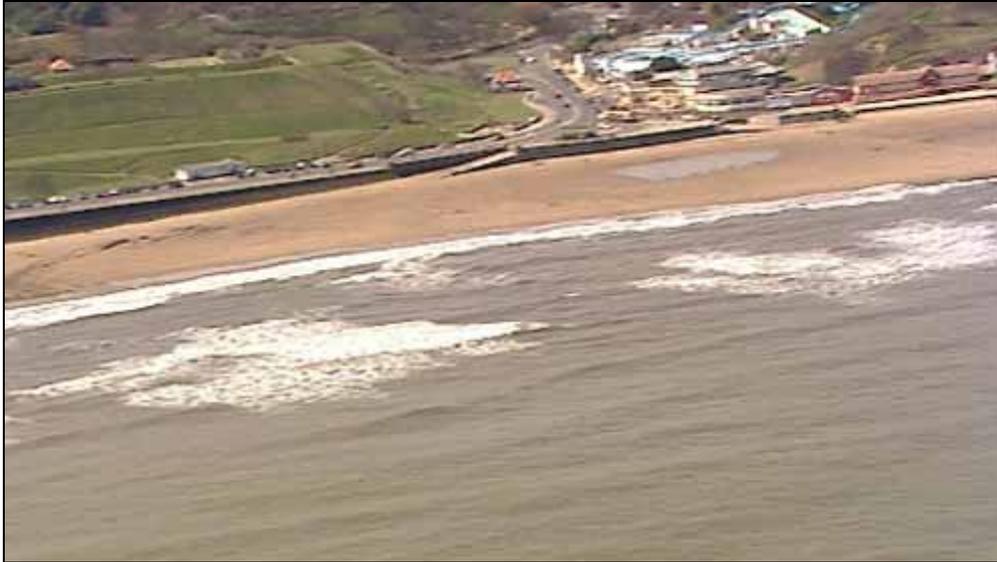
- A seawall extends along the entire length of North Bay from Scalby Mills to Castle Headland (see Photograph 4.6 and 4.7);
- Overall vertical **accretion** of 19,333m³ from Sept 01 – April 04. Beach profiles 1-4 generally remain consistent between survey periods, whilst profiles 5 and 6 demonstrate significant variations (characteristic of destructive storm waves). As such, beach profiles in the north of North Bay can be considered to fluctuate but **remain generally stable**, while profiles further south have the potential for **significant variations** of volume and gradient.
- It is anticipated that the southern part of the North Bay will continue to change as a consequence of construction activity.

Photograph 4.7.: A typical view of North Bay (taken at profile 4 on 21/04/01 at low water +3 hrs)

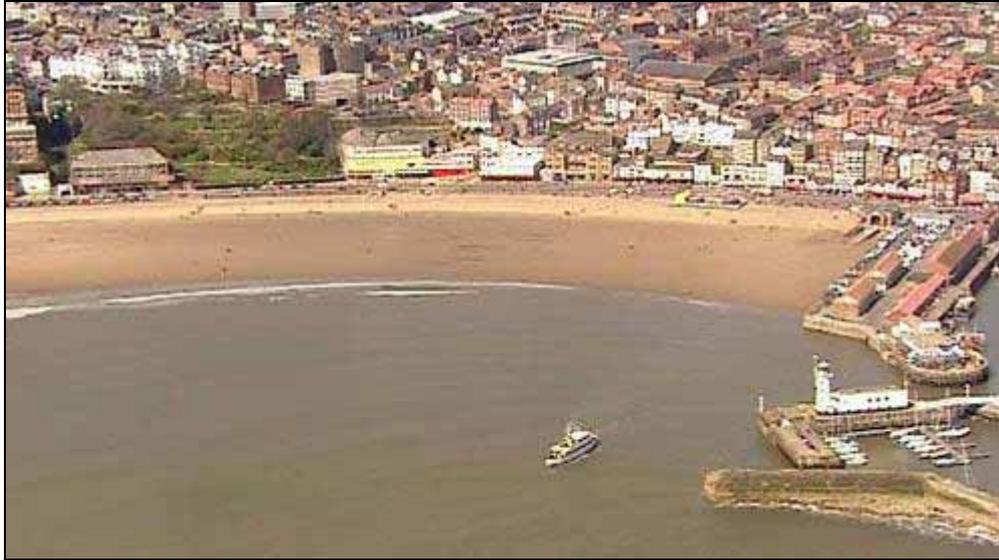
- A seawall is present along the entire length of South Bay (see Photographs 4.8 and 4.9). Beach reprofiling has also been carried out in the north (April 01 and March 02, 03 and 04), the location of which is evident in Photograph 4.8;
- Overall vertical **accretion** of 33,364m³ from Oct 01 – April 04. This encompasses almost the entire length of the beach. However, **erosion** is experienced in the southern half, predominantly at the southern tip.

Photograph 4.8.: The site of the beach re-profiling (at profiles 1 and 2 on 21/04/01 at low water +3 hrs)

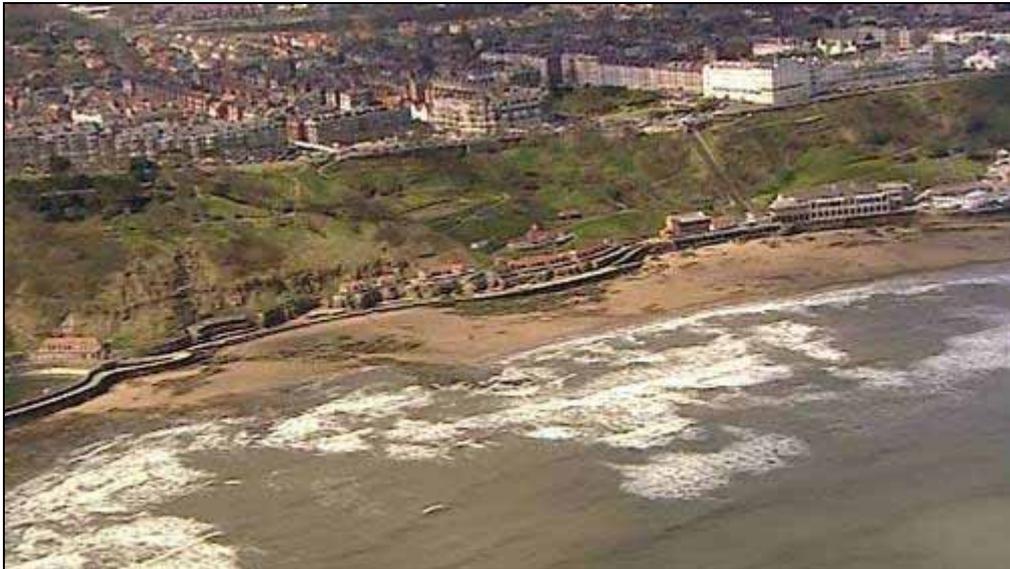
Photograph 4.9.: Profile 4, South Bay (taken at 21/04/01 at low water +3 hrs)

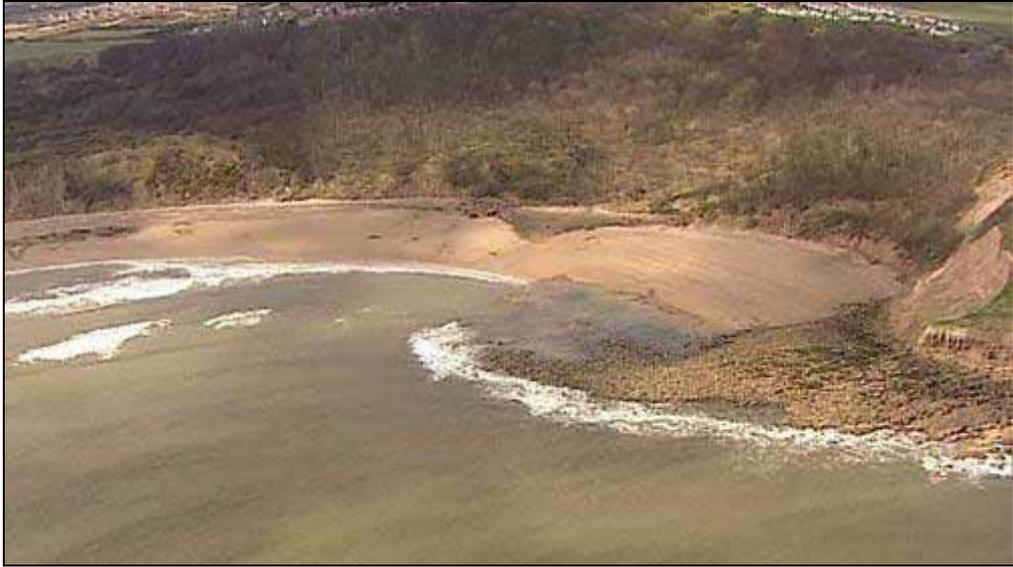
- This length of coastline is predominantly undefended, with a 60-70m seawall, located just updrift of profile 3, providing the only form of protection (see Photographs 4.10 and 4.11). As such, it is likely that fluctuations in **erosion/accretion** are predominately linked to natural processes and not the result of defence structures;
- Overall vertical **erosion** of 137,175m³ from March 02 – April 04. Whilst this is experienced along the entire length, there are isolated areas that have been consistently accreting throughout the study period (their size fluctuating over time).

Photograph 4.10.: Protection offered at profile 1 at Cayton Bay (taken 21/04/01 at low water +3 hrs)

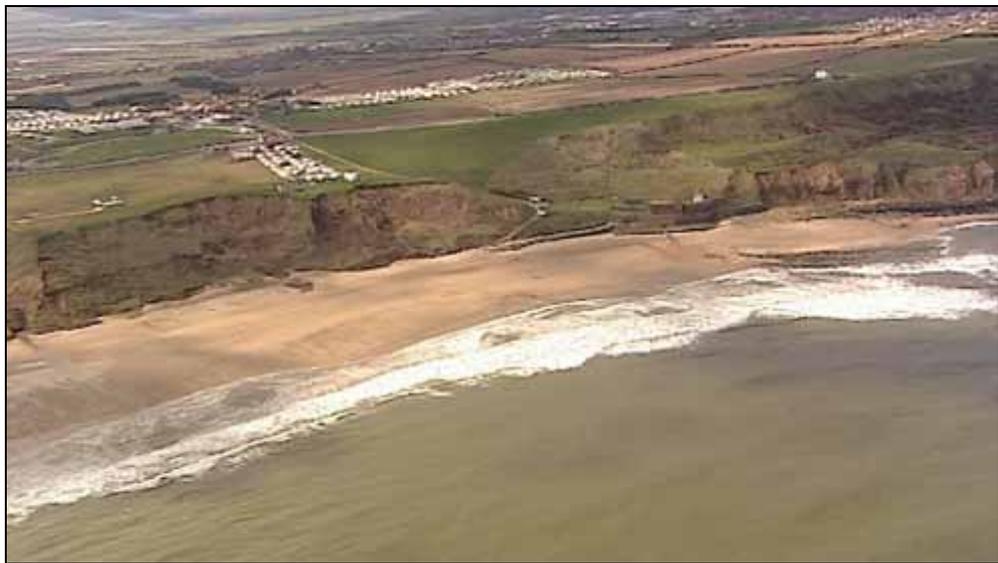
- Beach profile gradients remain **relatively constant** from March 02 – Apr 04. This is possibly due to the sheltering effect produced by the natural geography of the coastline. This will result in little reworking of sediment by wave action (see Photographs 4.10 and 4.11);

Photograph 4.11.: Central Cayton Bay and sea wall (taken at profile 4 on 21/04/01 at low water +3 hrs)

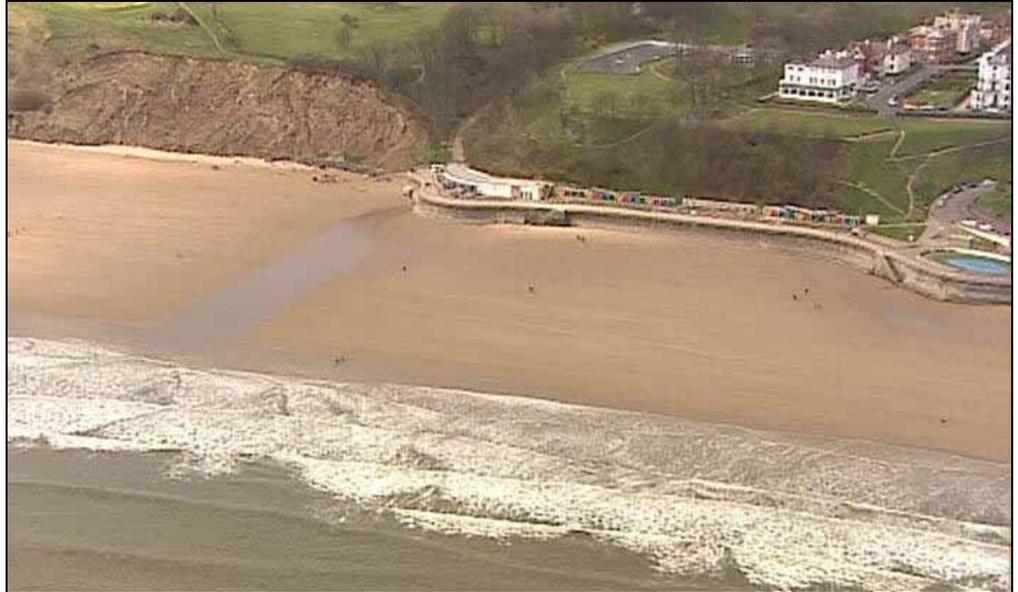
- Volumetric analysis highlights general upper/lower foreshore **erosion** and middle foreshore **accretion** at this profile over the study period. The section of **erosion** along the upper foreshore may be a result of wave scour in front of the seawall defences. This trend continues through to Profile 4 (photograph 4.12).

Photograph 4.12.: Defended Filey Bay coastline (taken at Profile 4 on 21/04/01 at low water +3 hours).

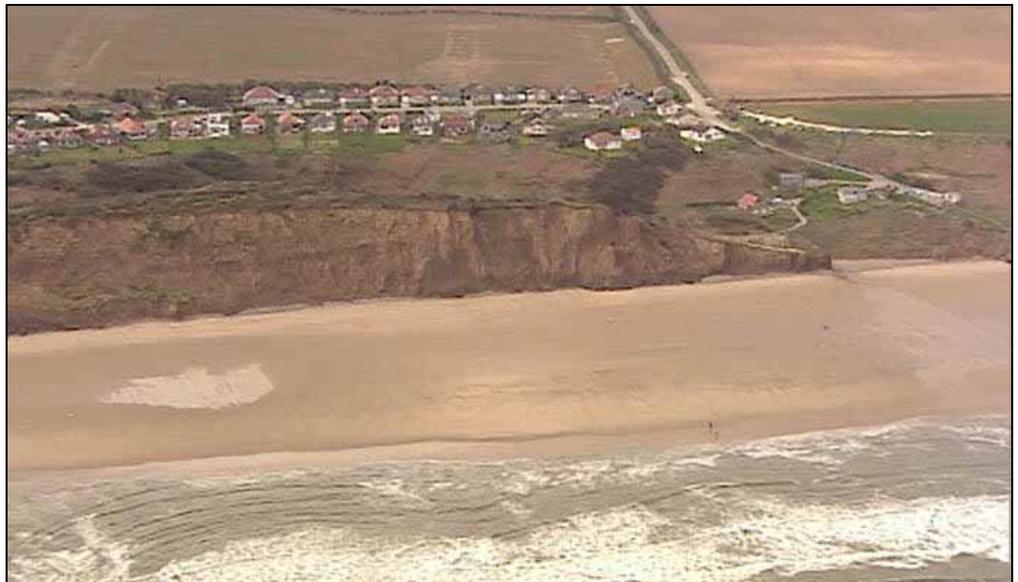
- Oct 02 – March 03: general **erosion** along the profile.
 - March 03 – April 04: vertical **erosion** along the length of the profile.
 - Volumetric analysis reveals general **erosion** of the profile throughout the study period at this undefended location (photograph 4.13).

Photograph 4.13.: Undefended Filey Bay coastline (taken at Profile 10 on 21/04/01 at low water +3 hours).
