Scarborough Borough Council
Strategic Coastal Monitoring Programme
2001 – 2006

Condition Analysis of Coast Protection Assets,
Cliffs and Beaches from Staithes to Speeton

November 2006

Halcrow Group Limited

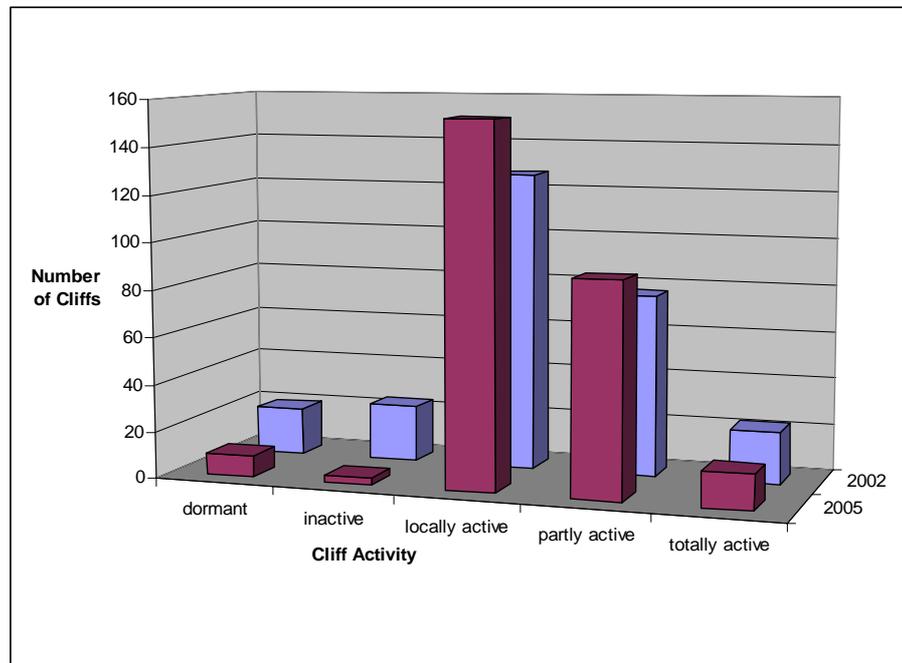
Figure 5.2. Distribution of cliff activity classification in 2002 and 2005.

The Figure shows that cliffs were predominantly classified as being locally active in both surveys. This suggests that shallow, small scale cliff failures are common along the whole coastline. Between 2002 and 2005, the number of partly active cliffs has increased slightly, while the number of totally active cliffs has decreased. This pattern suggests on-going episodic failure of cliffs through landsliding in a small number of cliffs. Because part of the 2002 survey was undertaken using a different classification scheme, subtle differences in the two annual surveys may not be significant.
