Coast Protection Assets and Coastal Slope Condition Analysis

**Scarborough Borough Council
Final Report**

March 2010

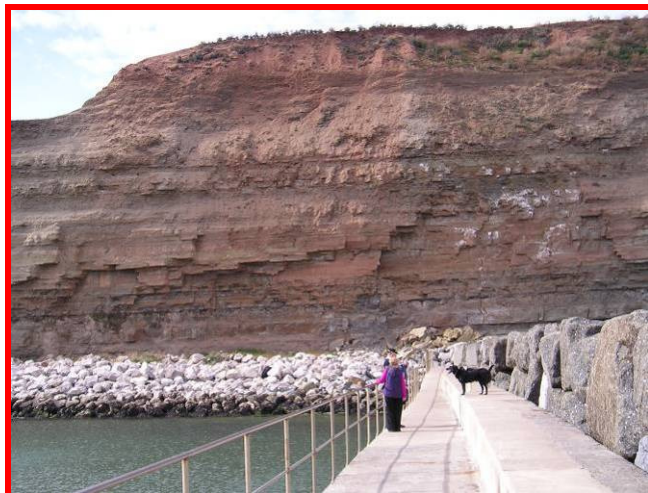
MU4/1a - Exposed and active eastward facing end of Cowbar Nab, Staithes (Totally Active)

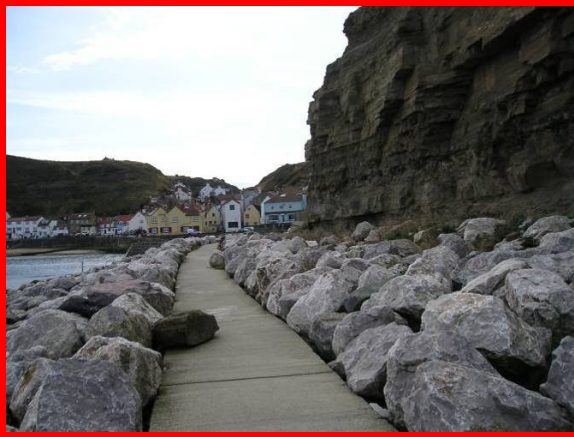
MU4/1a – Rockfall onto the walkway at the eastwards facing end of Cowbar Nab (Totally Active)

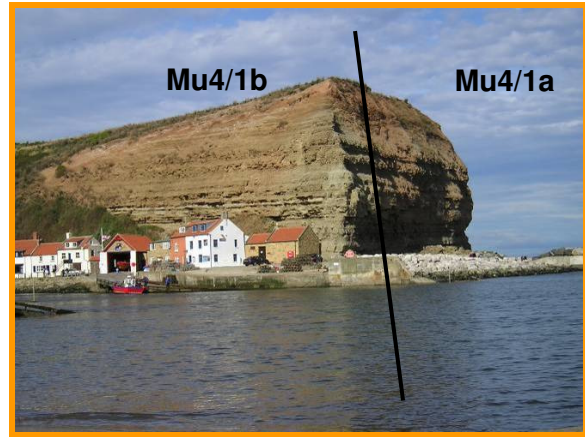
MU4/1a and MU4/1b – The end and side of Cowbar Nab (Totally and Partly Active respectively) (approx. extents shown)

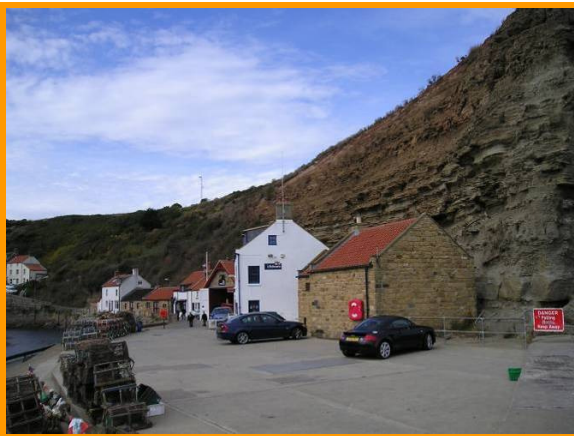
MU4/1b – The southwards facing side of Cowbar Nab which runs along Staithes Beck (Partly Active)

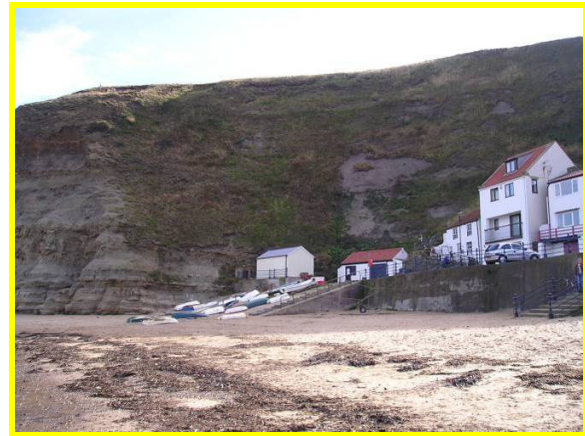
MU4/2 – Generally well vegetated cliff with localised erosion, behind Staithes harbour (Locally Active)

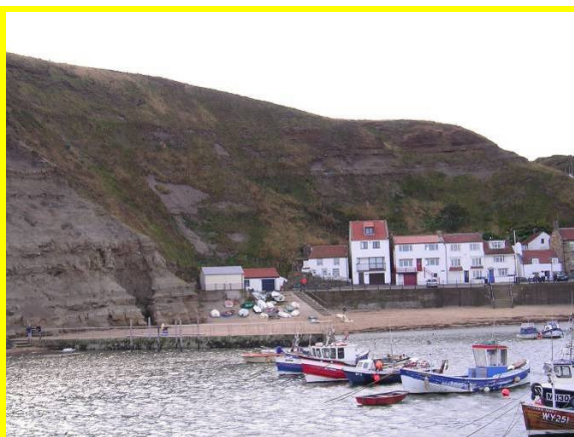
MU4/2 – More active eastern end of cliff unit behind Staithes harbour (Locally Active)

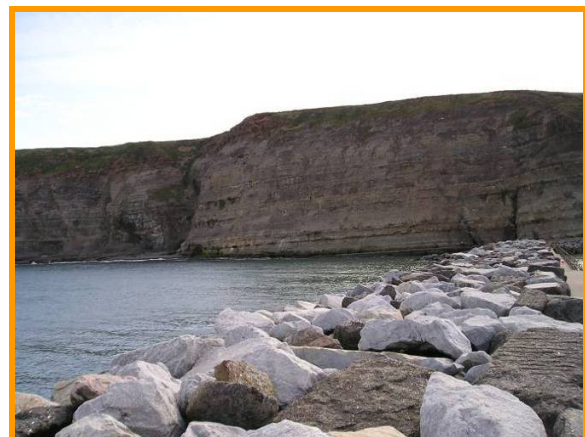
Further east, beyond the extent of Staithes harbour is **unit MU4/3**. The face of this unit is almost entirely exposed and showing signs of active erosion. Unlike any of the other cliffs within this Management Unit, this section is not protected at the toe and is therefore subject to marine erosion. This unit is classified as Partly Active.

MU4/3 – Exposed cliff, subject to marine erosion, eastwards of Staithes harbour (Partly Active)

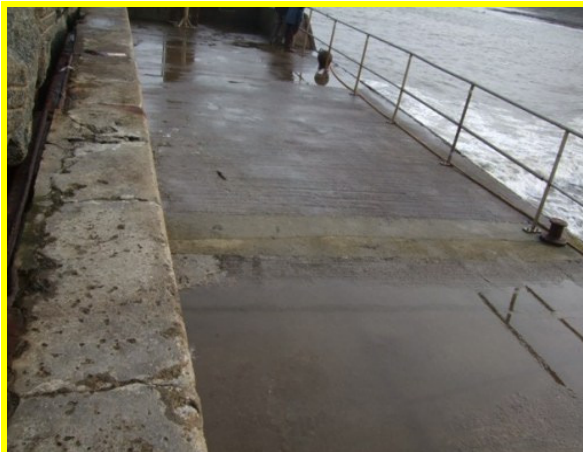
Cracking to beam next to rock armour
(Asset Ref. 1221D901D0402C01)

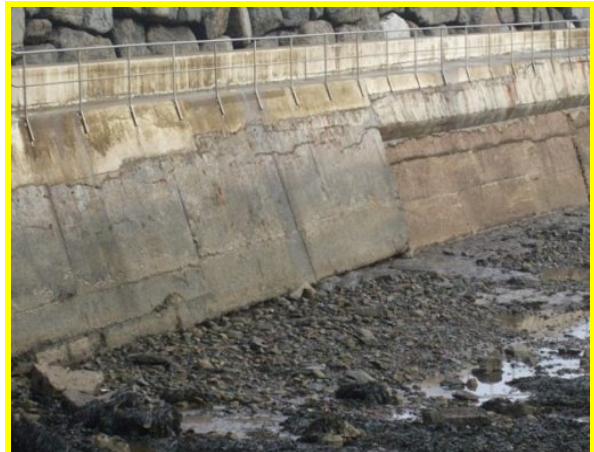
Undercutting occurring to inland part of wall
(Asset Ref. 1221D901D0402C01)

A number of the assets within the village of Staithes have been renewed or repaired in recent years. As noted in previous inspections, the most significant of these are the breakwater arms where 5-8 tonne rock armour has been placed on the seaward side. This acts to provide a greater defended height and to dissipate waves from the breakwater surface. New stainless steel handrails were added and a new concrete topping, cast over the original breakwater added further height to the defence. The sheet piling coping piece (horizontal) on the landward side of the breakwater still shows corrosion at fixing points and has failed. Undercutting continues to occur to the landward west breakwater wall, as well as corrosion to the sheet piling which has caused displacement of a pile. It is recommended that the sheet piling coping is replaced to prevent seawater intruding behind the pile and the undercutting repaired to prevent further damage to the wall. (Asset Ref. 1221D901D0402C01)

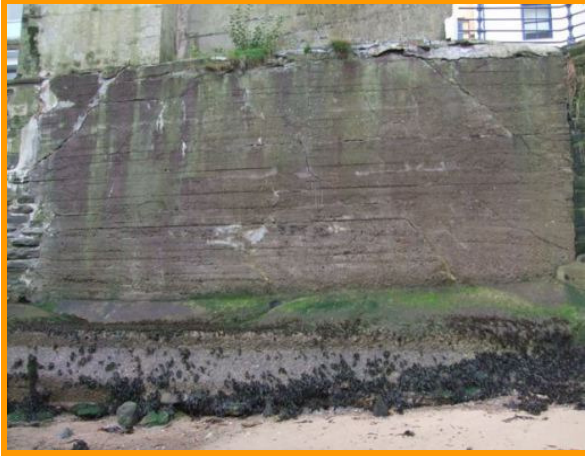
Cracks throughout wall and toe
(Asset Ref. 1221D901D0402C22)

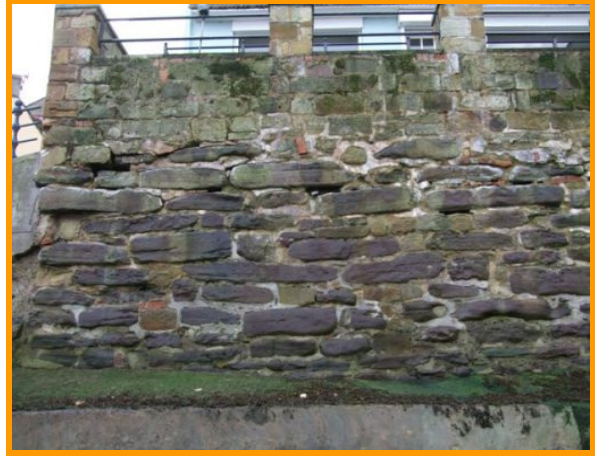
Older sections of the wall, towards the west side of the harbour, consist of masonry blockwork and are often exterior walls of private properties, these display visible loss of mortar and blocks. Although there is evidence of repair work, maintenance needs to be implemented at regular intervals (Asset Ref. 1221D901D0402C22). Should these repairs continue to fail, replacement of the assets should be considered.

Older sections of harbour wall in need of regular
maintenance
(Asset Ref. 1221D901D0402C22)

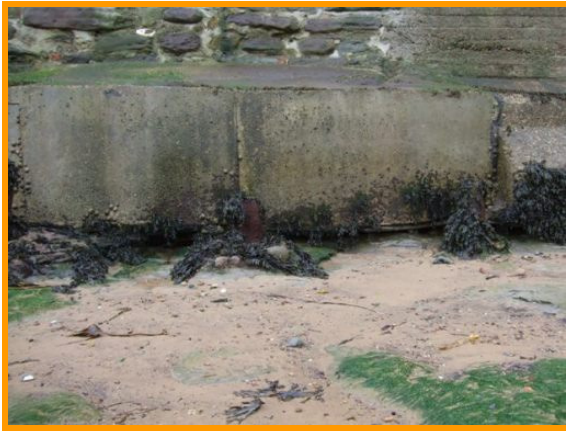
Some sections of the harbour wall also show evidence of undercutting at the toe. It is anticipated that this is due to the dynamic movement of sand, however further investigation would be necessary to establish this for certain (Asset Ref. 1221D901D0402C22).

Undercutting at the toe of some parts of the
harbour wall
(Asset Ref. 11221D901D0402C22)

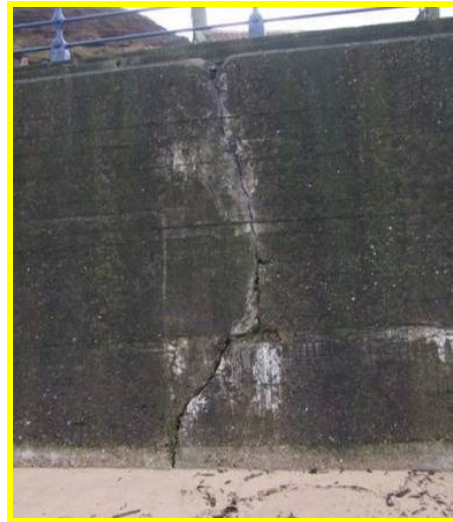
Vertical crack through wall
(Asset Ref. 1221D901D0403C01)

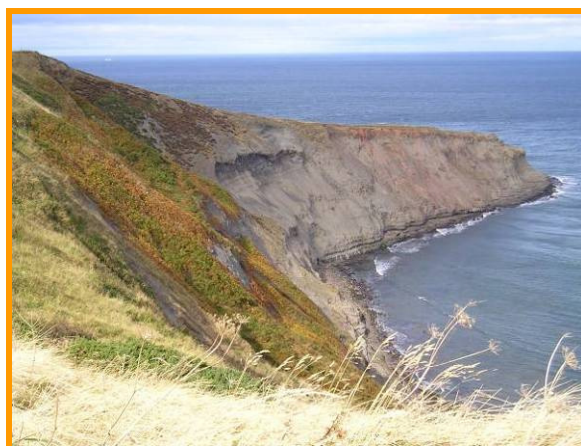
MU6/1 – The eroding shales of the east facing side of Old Nab (Partly Active)

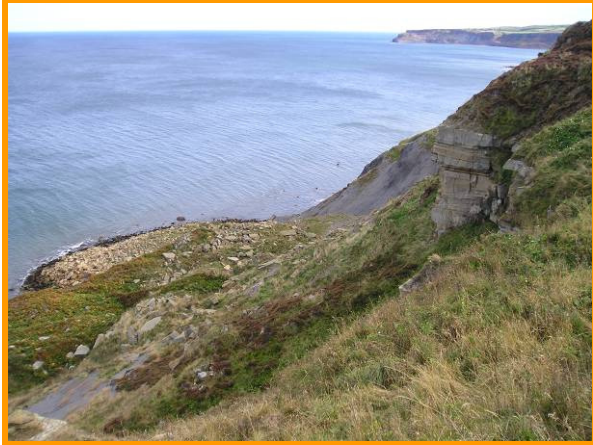
MU6/2 – Rockfall from upper slopes, weathering of lower slopes and lobe shaped unit toe, north of Port Mulgrave (Partly Active)

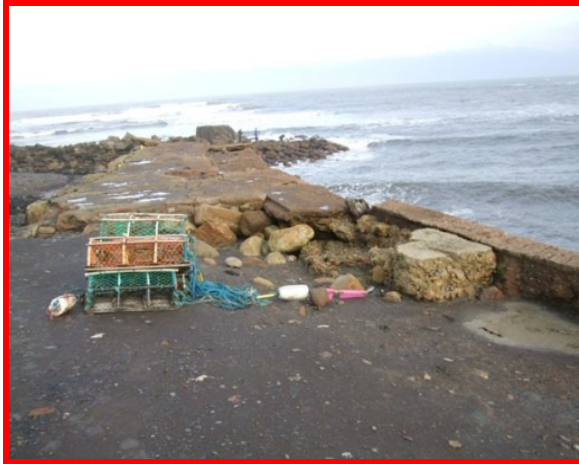
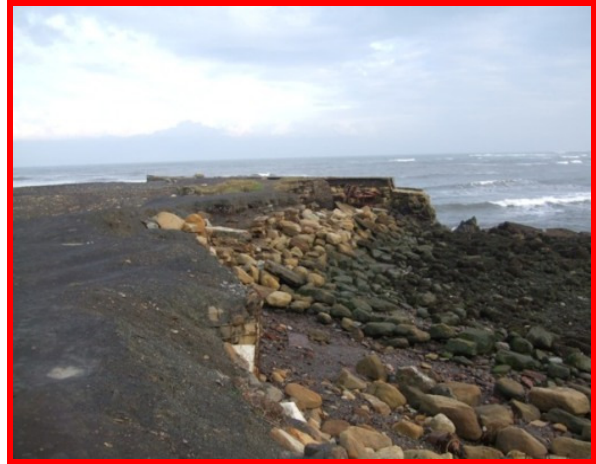
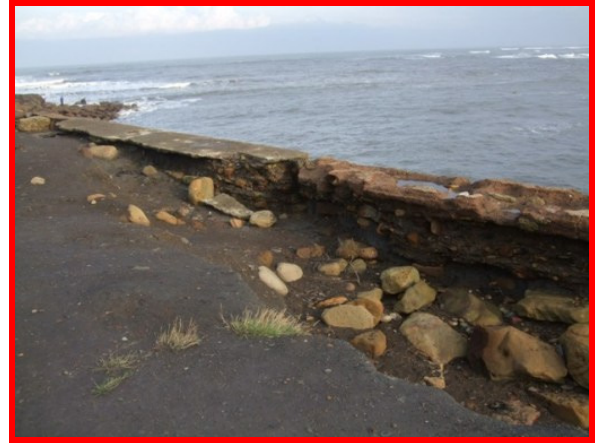
Sub-Management Unit 6B features relict assets at Port Mulgrave. As noted during the 2008 inspection, this is a former port and ironstone mine which has been derelict for 70 years. Virtually all coastal defences have been lost to the sea. What is left of the breakwater is undergoing large scale cracking, deformation, undercutting and outflanking. It is estimated that half of its original length has now been eroded (Asset Ref. 1221D901D0502C01). As a result, the launching and retrieval of boats would be difficult here. If regular access by sea was required, a regeneration project to remove the breakwater ruins and build a new access point would be of benefit. There has been no significant change since 2008.

Looking at the end of the breakwater with evidence of erosion and failure
(Asset Ref. 1221D901D0502C01)

Outflanking and erosion occurring behind the breakwater
(Asset Ref. 1221D901D0502C01)

Visible failure
(Asset Ref. 1221D901D0502C01)

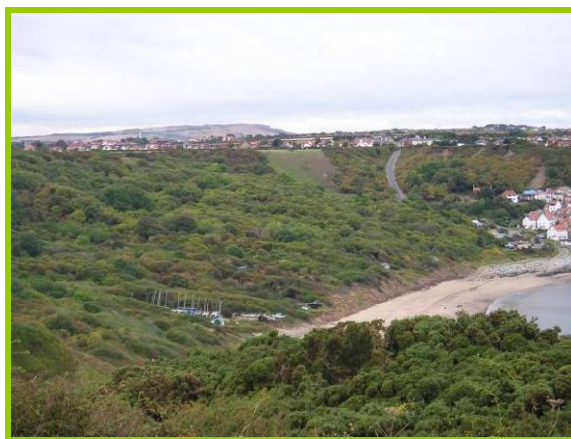
Unit MU7/2 is a narrow unit located to the south of Runswick Bay village. The slopes are relatively shallow and well vegetated. The only activity evident is at the unit toe, where the cliffs are subject to marine erosion in the absence of protection measures. This unit is also classified as Inactive.

MU7/2 – The well vegetated slopes and eroding toe adjacent to Runswick Bay village (Inactive)

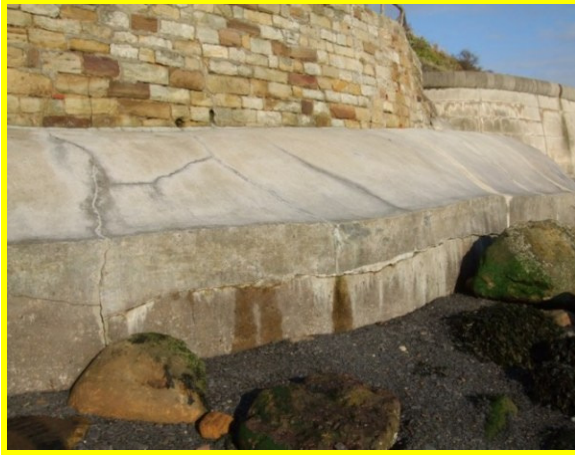
Beneath the northern properties, repair work to significant cracks at the toe of the wall is evident, although there are still unrepaired cracks to the second tiered wall behind. Although some vertical cracks to the toe have been recently repaired, horizontal cracks are appearing at the toe of the wall. This indicates that deformation is active. Installation of a tell tale would give precise levels of movement. Further studies are required (Asset Ref. 1221D901D0601C06).

Repaired vertical cracks to toe of wall, and recent horizontal cracks visible
(Asset Ref. 1221D901D0601C06)

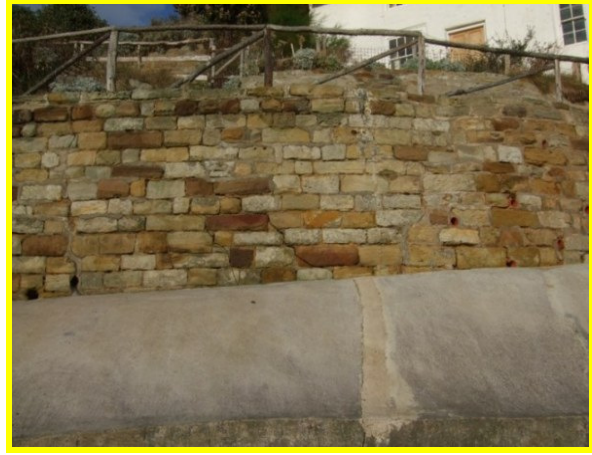
Repaired vertical crack to toe of wall and vertical cracks to second tiered wall
(Asset Ref. 1221D901D0601C06)

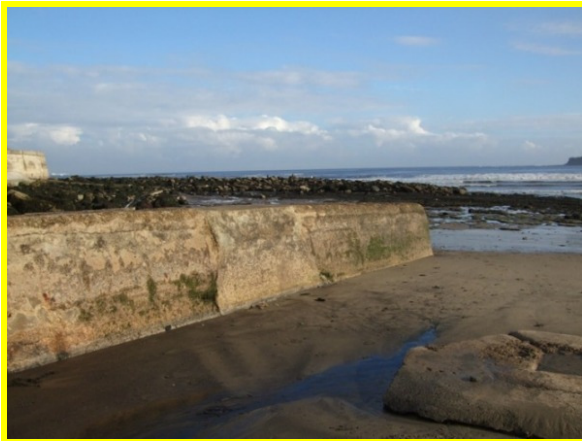
The breakwater north of the slipway is in need of repair with large horizontal and vertical cracks propagating through the defence. It is advised that urgent repair work is carried out to the asset (Asset Ref. 1221D901D0601C02).

Overview of breakwater
(Asset Ref. 1221D901D0601C02)

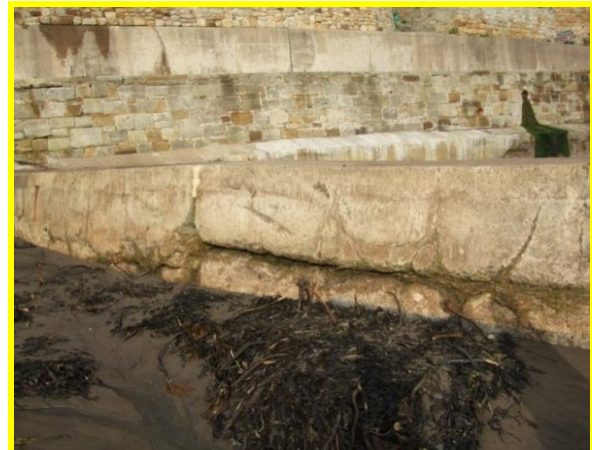
Large horizontal crack to breakwater
(Asset Ref. 1221D901D0601C02)

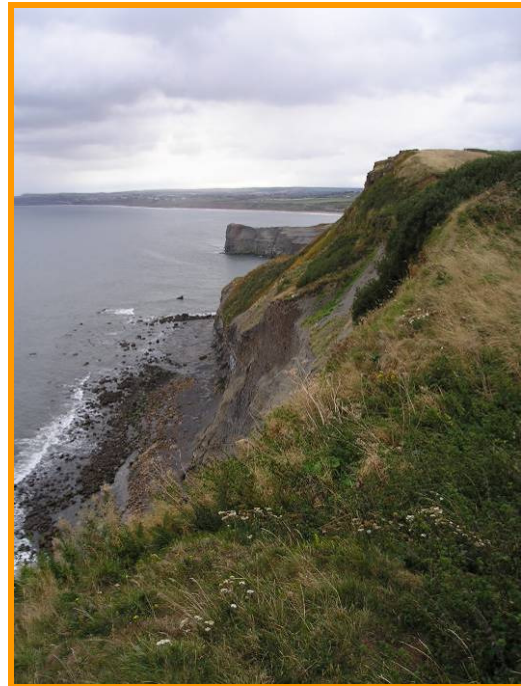
MU8/12 Steep, unvegetated lower slopes and shallower, partly vegetated upper section (Partly Active)

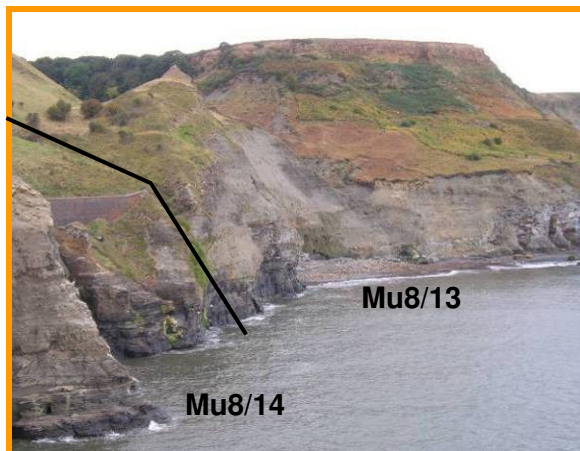
Units MU8/13, MU8/14 and MU8/15 form the headland of Sandsend Ness and the adjacent cliffs. All units are classified as Partly Active. The toes of these units are subject to continual marine action and are eroding accordingly. Some vegetation is supported on the upper slopes. The disintegration of relict sea defences within Unit MU8/15 are resulting in exposure and erosion of the lower cliff face.

MU8/13 and **MU8/14** Erosion at the toe of the units (Partly Active) (approx. extents shown)

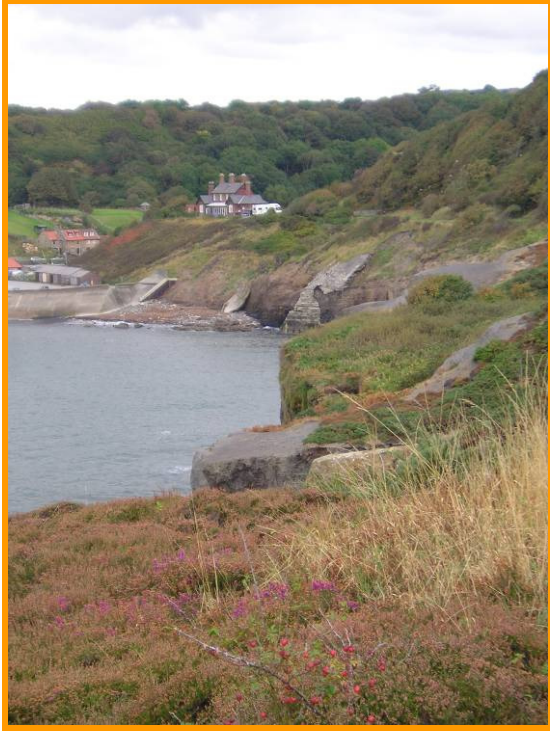
MU8/15 Erosion just north of Sandsend (Partly Active)

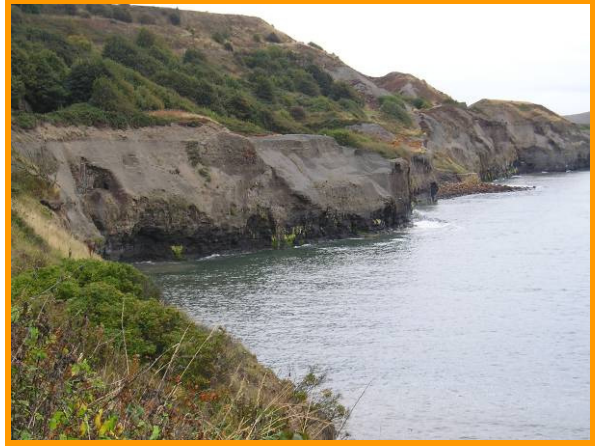
MU8/15 Marine erosion of lower part of this unit, just north of Sandsend (Partly Active)

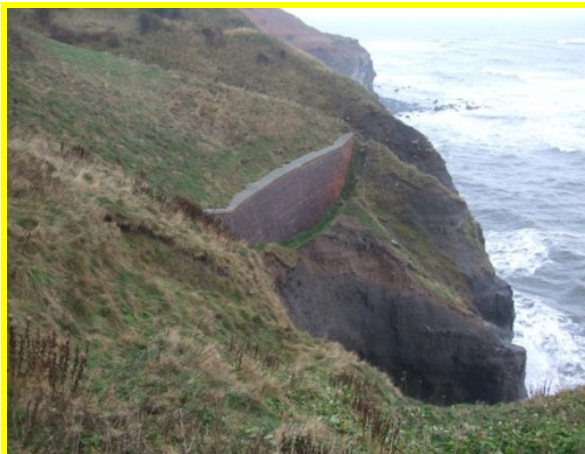
Two retaining walls believed to be used to protect and maintain stability of the disused railway line can be seen along the coast. The brickwork wall at Deepgrove Wyke appears to be in good condition, although was difficult to inspect, and appears to be preserving the stability of the embankment. The second wall South of The Scar has failed; most of the wall has now collapsed onto rocks below. This defence is now thought to be redundant, and as the wall is so short in extent, it has not been included in the asset inspection report.

Brickwork wall at Deepgrove Wyke
(Asset Ref. 1221D901D0603C01)

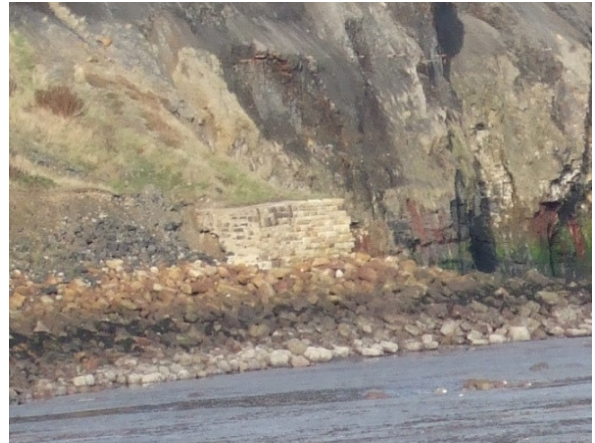
Failed masonry wall South of The Scar
(Asset Ref. 1221D901D0701C01)

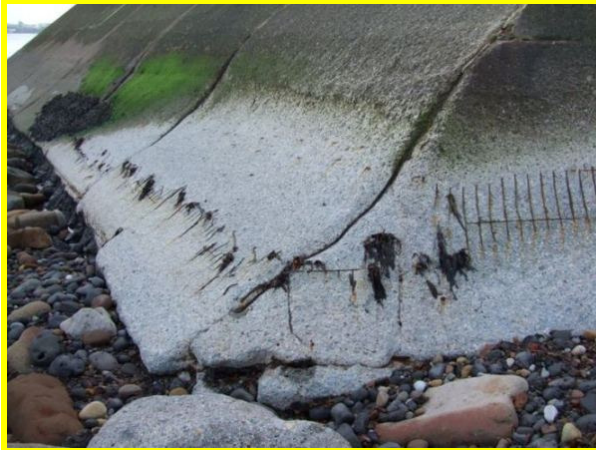
Coastal defences at Sandsend are in fair to poor condition. A concrete revetment, the most northerly defence (car park area), is in fair condition with minimal damage to the surface. There is some minor cracking and surface erosion which is typical of concrete defences such as this. The north end of the revetment has lost thickness of concrete at the base, with some reinforcement bars being exposed. Encasement of this reinforcement is advised from a structural perspective, as well as preventing any H&S accidents occurring due to sharp edges of the exposed bars. The toe of the revetment is exposed in places resulting in undercutting. This could be ameliorated by increasing the basal rock armour protection (Asset Ref No.1221D901D0701C02).

Exposed reinforcement bar and undercutting to concrete revetment
(Asset Ref No.1221D901D0701C02)

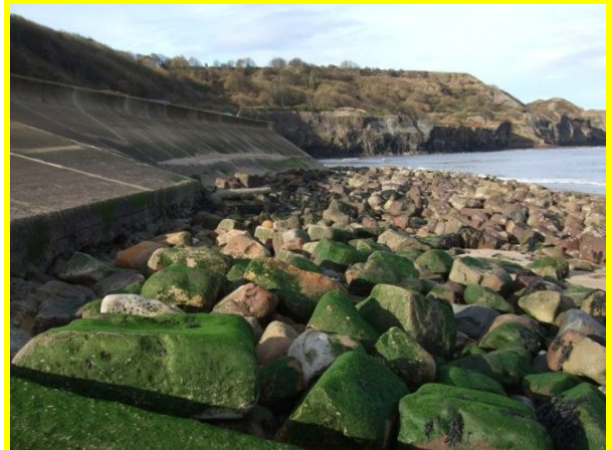
Concrete revetment located in the north of Sandsend
(Asset Ref No.1221D901D0701C02)

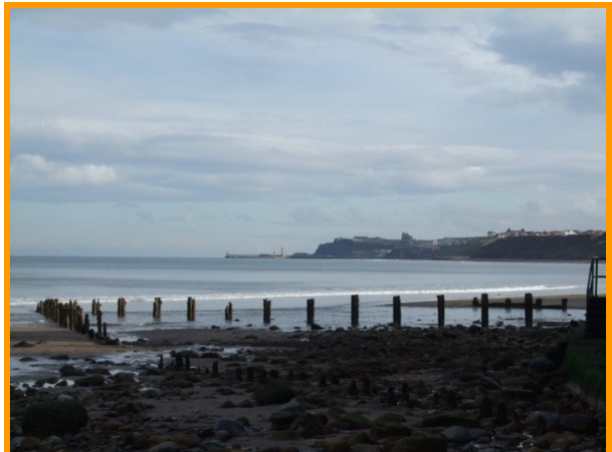
The remnants of timber groynes are visible in front of Sandsend village. These are in such a poor state that it is unlikely that they have a significant impact on sand movement. The toe of the seawall is also showing evidence of significant damage and movement although not yet affecting the structural stability of the sea wall (Asset Ref. 1221D901D0702C01).

Timber groynes in front of Sandsend (Asset Ref. 1221D901D0702C01)

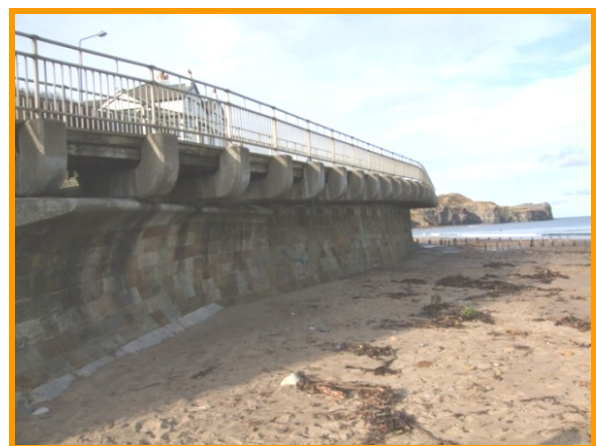
A fairly new short section of blockwork sea wall supports a cantilevered promenade along part of the Sandsend frontage. In the previous inspection undercutting of the toe of this structure revealed steel sheet piling in need of repair. Due to the beach height this was not visible on the current inspection therefore the only defects to the defence is a large vertical crack and minor erosion to the sea wall (Asset Ref. 1221D901D0702C04).

Relatively new blockwork sea wall with undercutting at the toe
(Asset Ref. 1221D901D0702C04)

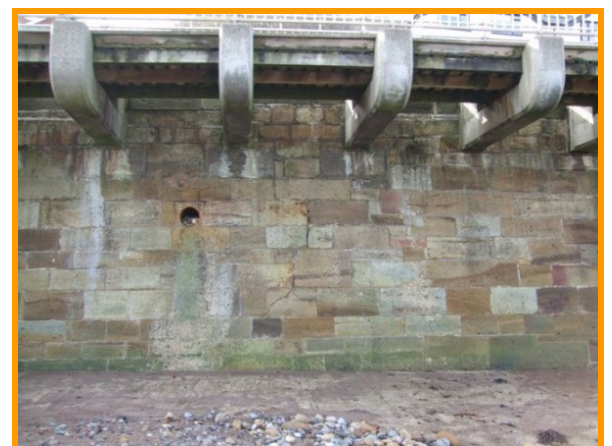
Undercutting and erosion of the concrete revetment backing Sandsend Beach
(Asset Ref. 1221D901D0702C04)

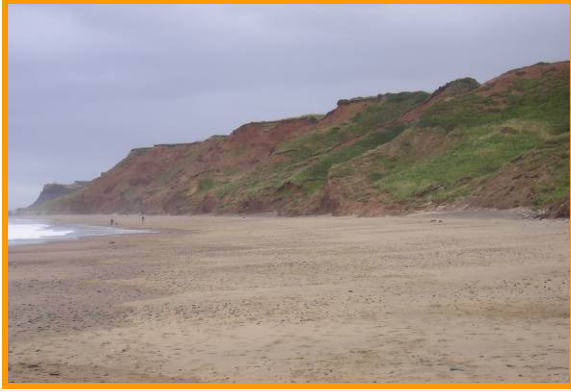
Unit MU10/2 comprises the glacial till cliffs behind Upgang Beach. These cliffs are prone to episodic failure in the form of localising mudsliding and block failure onto the beach. Vegetation cover is sporadic and is most likely related to the landslide cycles. This unit is classified as Partly Active.

MU10/2 The collapsing till cliffs at Upgang Beach
(Partly Active)

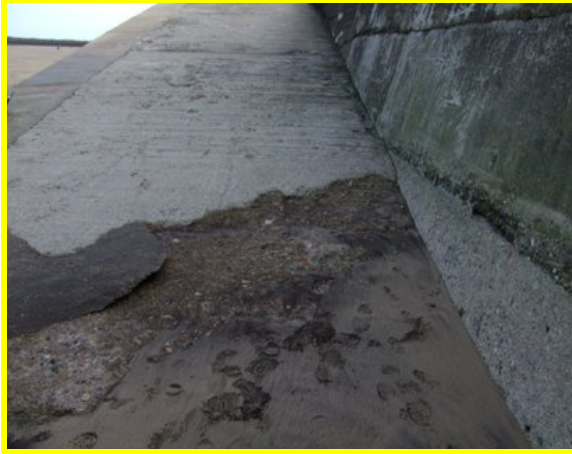
The slipway and stair structures were digitised for defences to the west of Whitby, these structures were all in poor condition. Defects such as undercutting, erosion, cracking, exposure of aggregate and rounding of step edges have occurred to most of these structures. Repair work is needed to some structures to prevent future failure. Undercutting and erosion is occurring to the side walls of the stairs along the West Cliff and are in need of repair (Asset Ref. 1221D901D0802C04001).

Erosion evident to slipway next to wall
(Asset Ref. 1221D901D0802C13002)

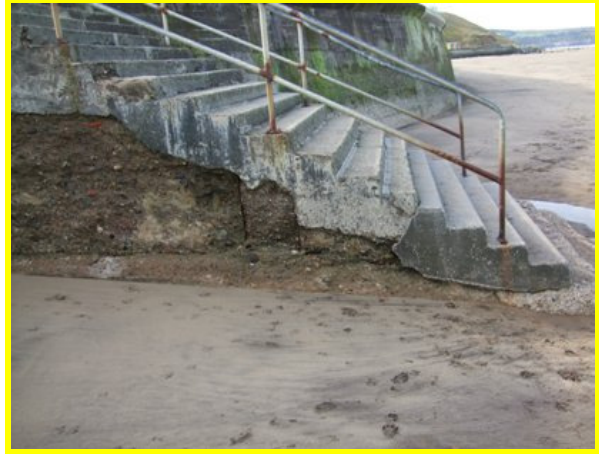
Erosion and cracking to stair side wall
(Asset Ref. 1221D901D0802C04001)

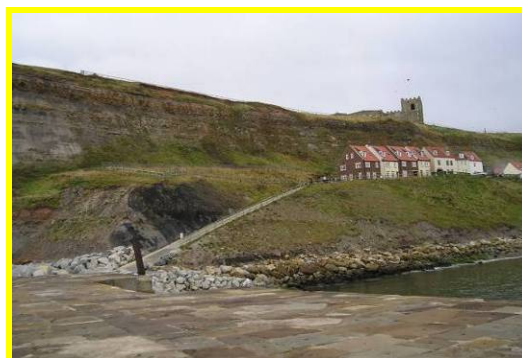
This Management Unit consists of **unit MU12/1** only and is situated below Whitby Abbey. The slopes are generally well vegetated with localised activity at the toe and headscarp. For example, there is some rock exposure just below the headscarp which is supported by wire netting. This unit is classified as Locally Active – this does not represent a change in activity class since the 2008 walkover survey.

MU12/1 Localised erosion at the toe and headscarp (Locally Active)

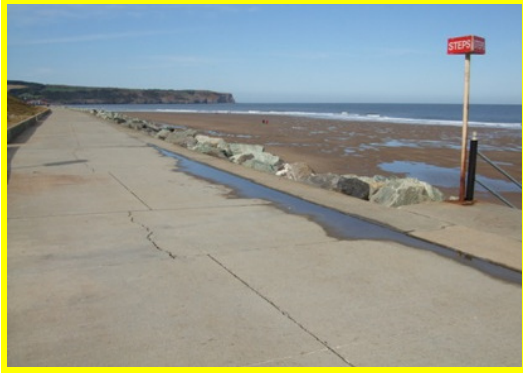
Rock armour defences along the promenade to the west of Whitby are in good condition with only minor movement visible in the armour. The promenade and low concrete retaining wall are in good condition with repaired and sealed lateral cracks along the promenade. Some planks along the promenade appear to be sinking with standing water, further investigation and monitoring is needed (Asset Ref. 1221D901D0801C01).

There is cracking to numerous concrete planks along the northern promenade. Spalling and cracking to the coping at top of sea wall is also visible along the length. This is the case in those sections protected with rock armour and those with no protection.

Cracking and settlement of promenade
(Asset Ref. 1221D901D0801C01)

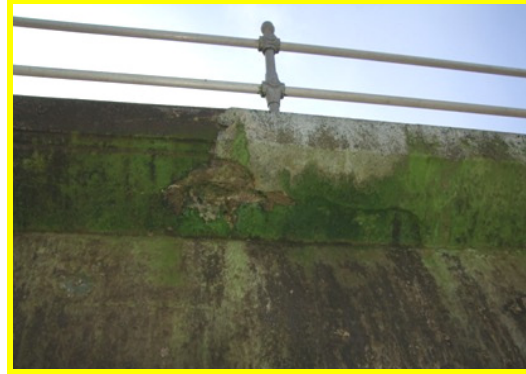
Damage and repair to coping
(Asset Ref. 1221D901D0802C01)

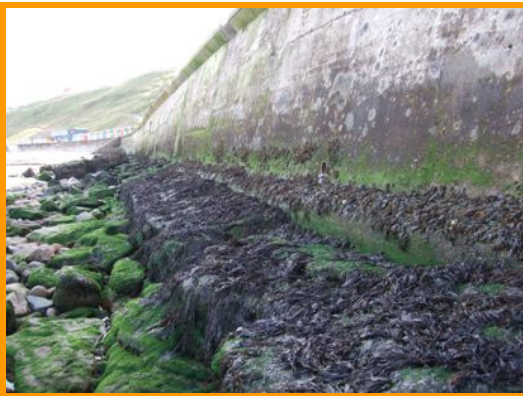
Further east, adjacent to North Promenade, a large concrete walls structure (Asset Ref. 1221D901D0802C03) is currently intact, but the toe is exposed and eroded along its length, leading to significant undercutting. This defence is currently in a poor condition. It is recommended that further studies are undertaken to investigate cause of degradation. Repairs to toe are required to prevent future instability of wall. Adjacent sections of wall show similar defects although toe is often less visible here

Overview of asset looking south, showing exposure of toe.
(Asset Ref. 1221D901D0802C03)

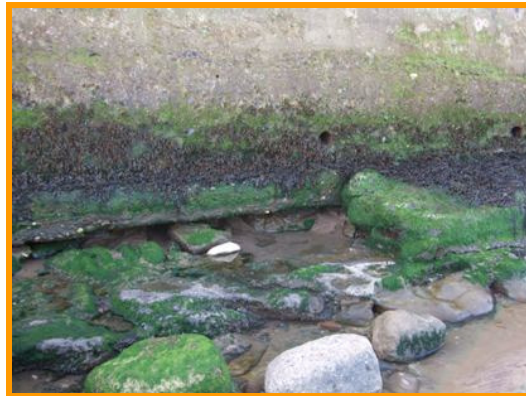
Erosion of toe near northern extent
(Asset Ref. 1221D901D0802C03)

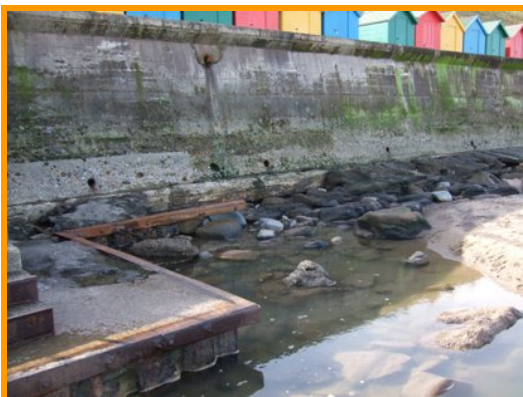
Erosion of toe and stair foundation
(Asset Ref. 1221D901D0802C03)

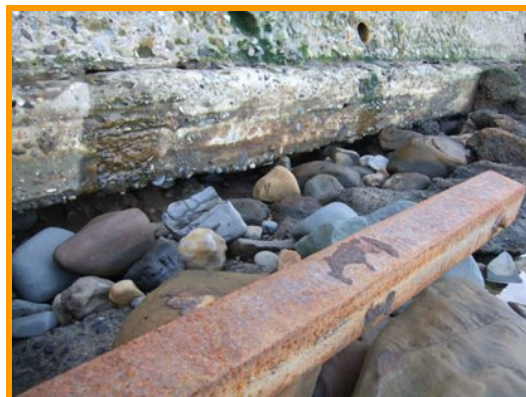
Significant undercutting to defence
(Asset Ref. 1221D901D0802C03)

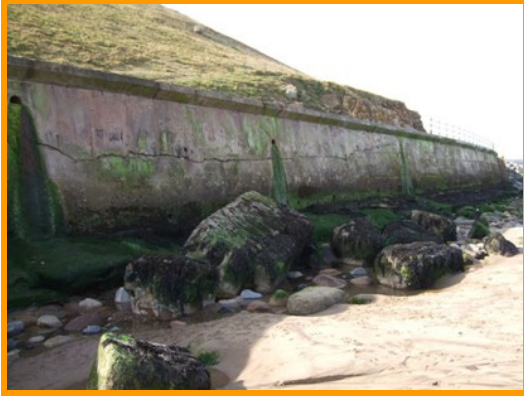
Cracking, repair work and exposed toe
(Asset Ref. 1221D901D0802C03)

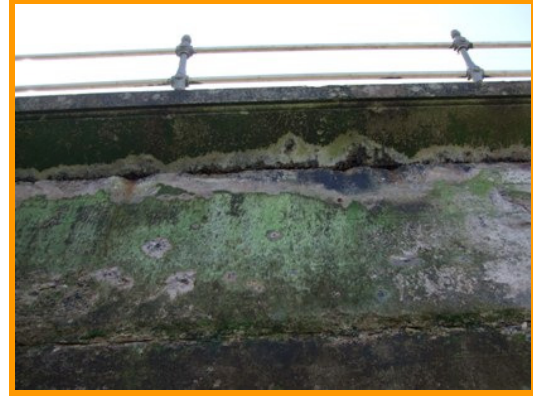
Exposure of rebar and cracking to underside of
capping
(Asset Ref. 1221D901D0802C03)

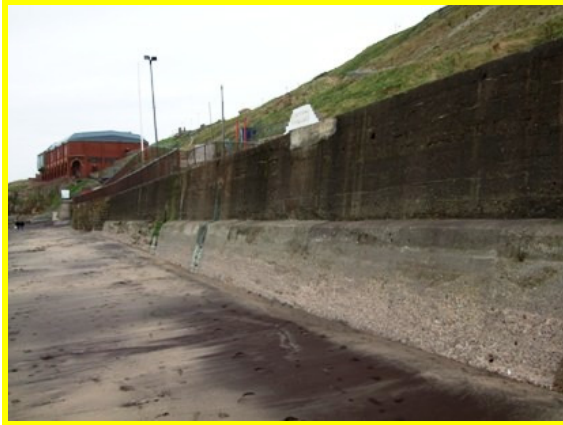
The wall adjacent to Argyle Road is in fair condition, and is intact with no toe exposed at the time of the site visit. However, the front face shows extensive abrasion and erosion and there are significant cracks both through the capping and directly beneath it. Although in some places patch repairs are visible, these defects should be monitored and repaired when possible to prevent further degradation in the future.

Overview of asset, looking south. Patchwork
repairs to capping visible.
(Asset Ref. 1221D901D0802C04)

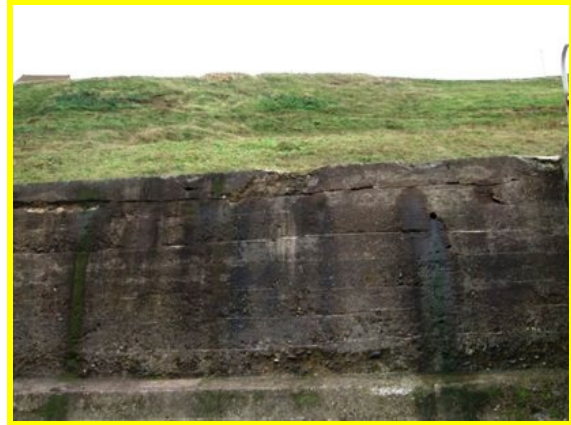
Significant damage to and cracking beneath
capping
(Asset Ref. 1221D901D0802C04)

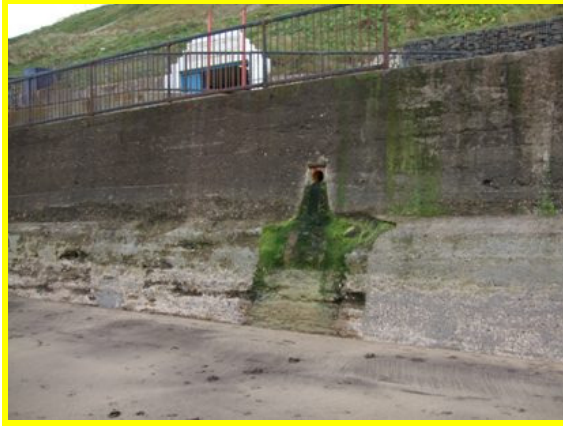
View near tunnel showing damage resulting from erosion and abrasion
(Asset Ref. 1221D901D0802C04)

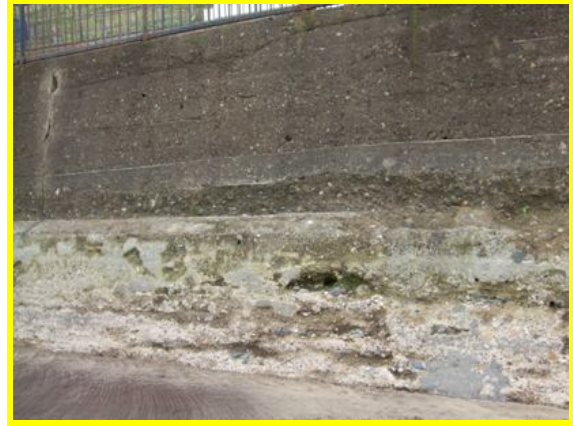
Close up view of eroded front face and significant vertical crack (to left of image)
(Asset Ref. 1221D901D0802C04)

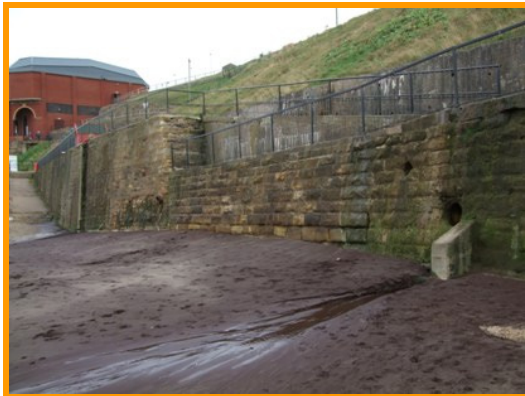
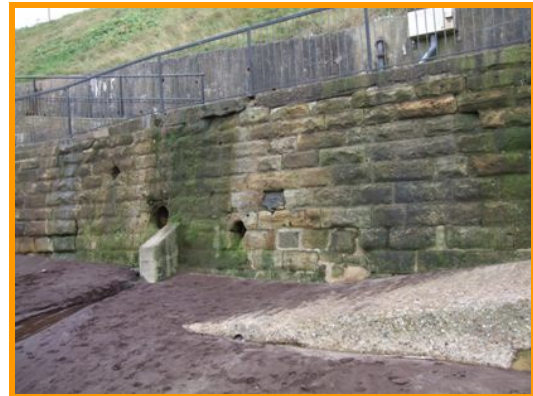
Between Argyle Road and the Royal Crescent, two sections of blockwork separated by a slipway show further defects. There are cracks through blocks, washout along joints and the capping shows significant damage which requires repair. Defence with Asset Ref. 1221D901D0802C07 is currently in poor condition and 1221D901D0802C06 is in fair condition. Both assets have pipes exiting through front face, seepage from which has attracted vegetation growth.

Cracking, mortar loss, damage to capping and localised repairs
(Asset Ref. 1221D901D0802C07)

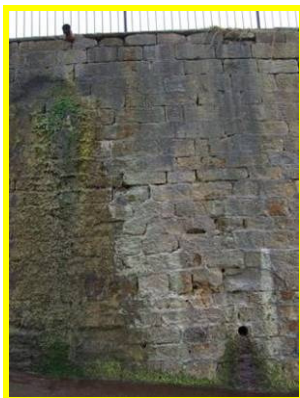
Visible joint washout and seepage
(Asset Ref. 1221D901D0802C06)

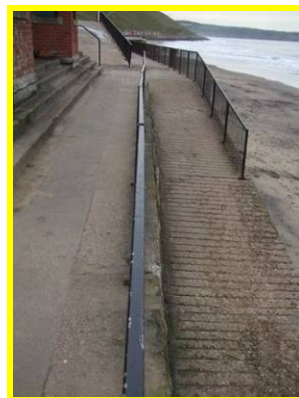
View of capping and promenade
(Asset Ref. 1221D901D0802C06)

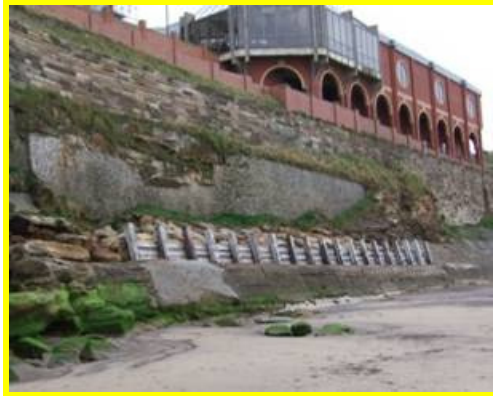
The area below the theatre consists of a variety of defences, which are formed in several vertical stages or layers, with concrete/stone on the beach and with cliff protection walls formed of timber breastwork, rock armour and vertical walls. Most require non-urgent repair works and are in fair condition. Typical defects here include cracking and washout at joints. It appears that there may be some movement in the vertical wall directly beneath the north corner of the theatre building/walkway. It is recommended that further investigations and monitoring are undertaken here, installation of tell tales and the setting up of a deformation survey may be appropriate.

Overview of assets
(Asset Refs. 1221D901D0802C05 and C15)

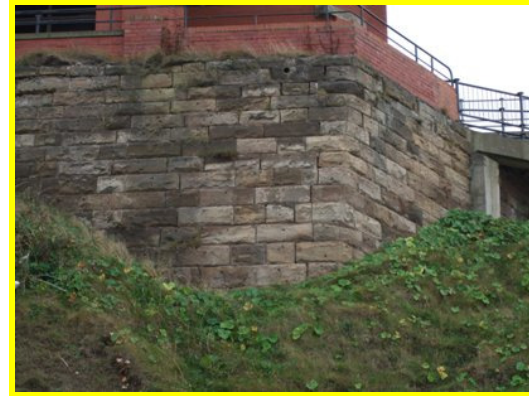
Mortar loss and surface erosion to wall
(Asset Ref. 1221D901D0802C15)

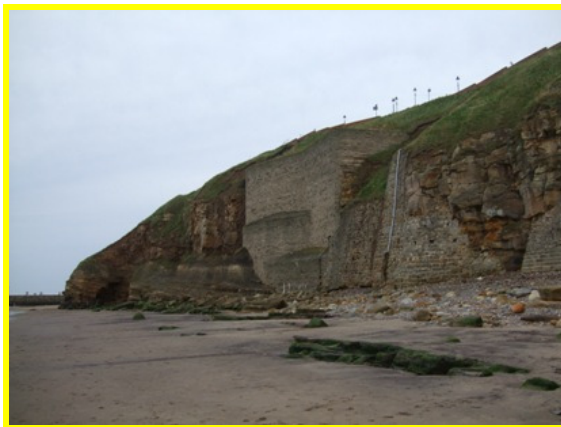
The natural cliff to the east of the theatre is additionally defended with a series of blockwork and brickwork sections. These vary in construction and are generally in good condition. However, one section shows some significant undercutting, which lowers the condition to a 'fair' grading. Although only localised, this area does require repair.

Natural cliff protected with block/brickwork
(Asset Refs. 1221D901D0802C09)

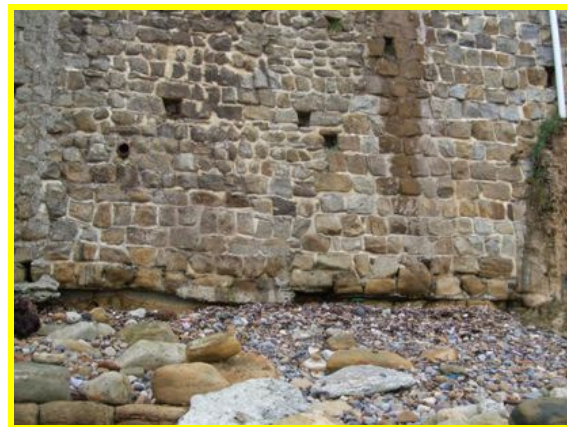
Undercutting to blockwork section, requires repair
(Asset Refs. 1221D901D0802C09)

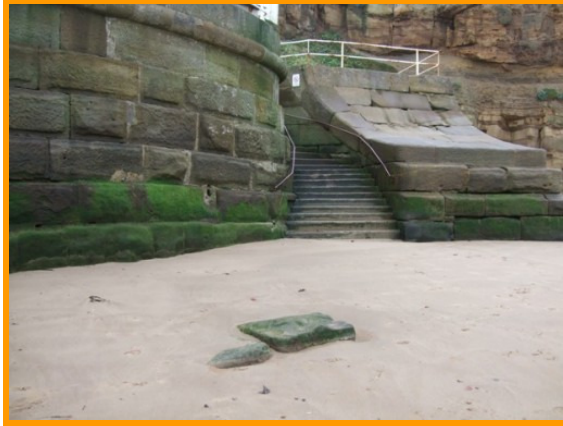
The area around First Nab just west of West Pier is formed of large stone blocks (Asset Ref. 1221D901D0802C12) and shows signs of movement, from numerous cracked blocks to large gaps at joints. Investigation is required as to the reason for this movement, and repairs are required to prevent further washout of fines which subsequently may lead to more significant damage. Repairs to some gaps are evident, but further repairs are deemed necessary.

Repairs visible, also voids and gaps
(Asset Refs. 1221D901D0802C12)

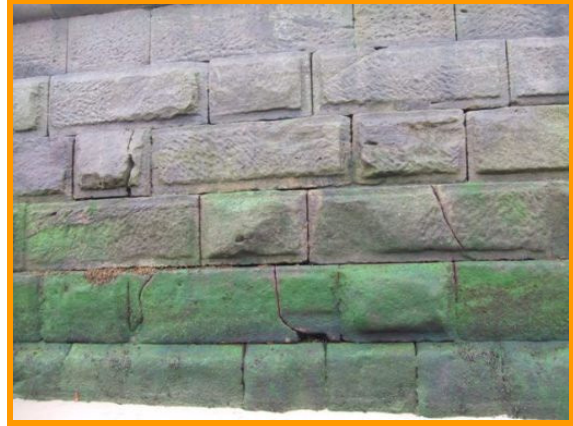
Cracking, gaps and joints and lateral movement
(Asset Refs. 1221D901D0802C12)

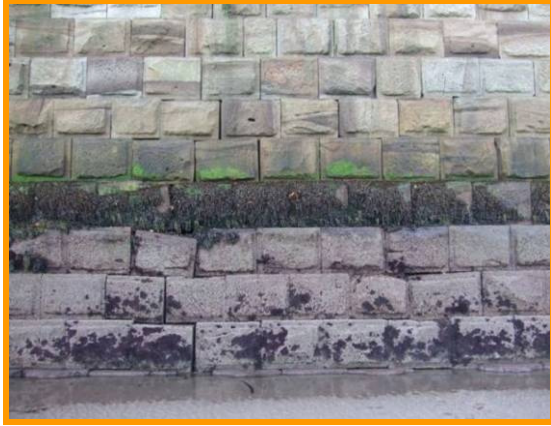
Displacement of blockwork to west side of the west harbour Pier
(Asset Ref. 1221D901D0803C02)

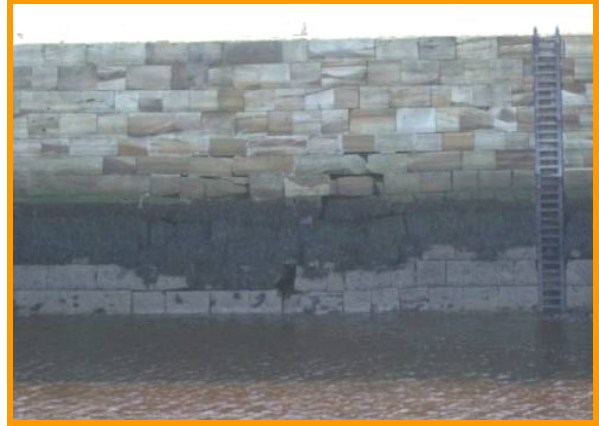
Crack and voids to east harbour pier (inspection below the water line is necessary before replacement of blocks)
(Asset Ref. 1221D901D0803C03)

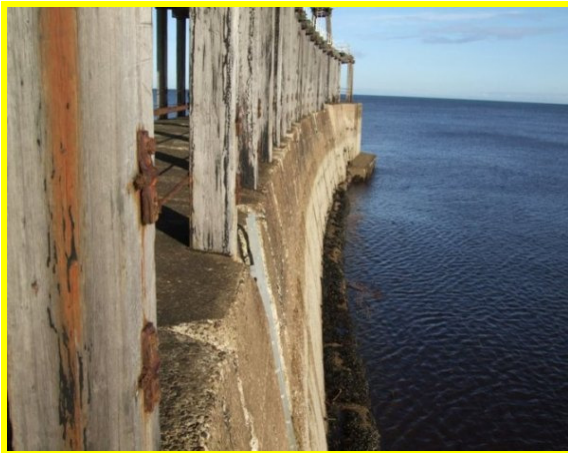
Close inspection of the breakwaters was not possible due to high tides. However, there were signs of recent concrete repair and replacement work. Erosion and cracks were visible at the top and edges of the concrete structure. The timber deck of the western breakwater is in a good condition, although slippery when wet and may present a possible H&S issue. Emergency works are currently being developed to repair voids and movement at the landward end of the eastern breakwater, with construction anticipated in summer 2010. The eastern breakwater has no access due to a bridge no longer being in service connecting the pier to the breakwater. This has given a limited visual inspection from the east harbour arm and will also need a full inspection by boat.

Erosion to edges of west concrete breakwater
(Asset Ref. 1221D901D0803C01)

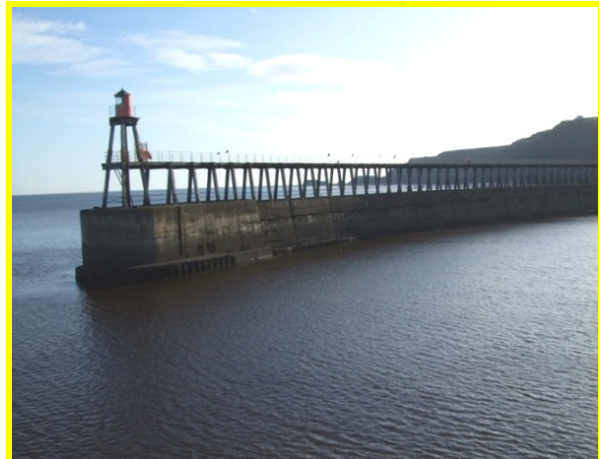
East breakwater
(Asset Ref. 1221D901D0803C04)

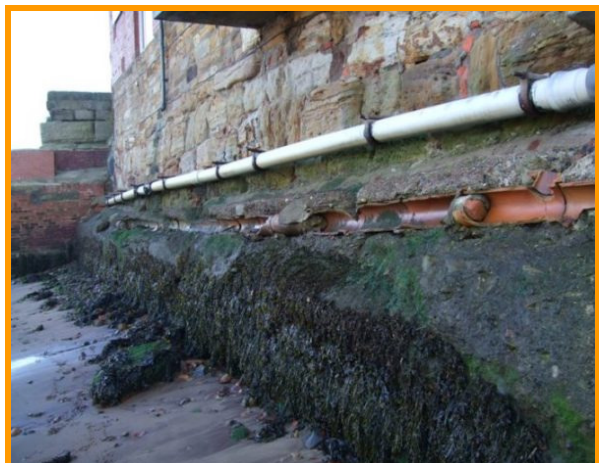
Cracking and erosion to east harbour wall next to breakwater
(Asset Ref. 1221D901D0803C08)

The east inner harbour walls are in poor condition although structurally sound at present. Missing and displaced blockwork, large horizontal cracking as well as erosion and voids are present throughout the wall (Asset Ref. 1221D901D0803C08 and 1221D901D0803C09). Previous repair work is visible throughout the wall, although more repair work is needed. A pontoon structure attached to end of the RNLI pier has missing and corroded bolts causing movement in the structure. A local resident describes visible movement while several pedestrians were standing on the platform. Due to the height of the tide at low tide there is limited access to the structure, therefore an inspection from a boat and further investigation into the structure is needed (Asset Ref. 1221D901D0803C08). An inspection via boat is also needed for a promenade extension on the West side of the harbour. Limited access is available under the extension giving limited visibility to the wall and supports and hindering a full inspection (Asset Ref. 1221D901D0803C06).

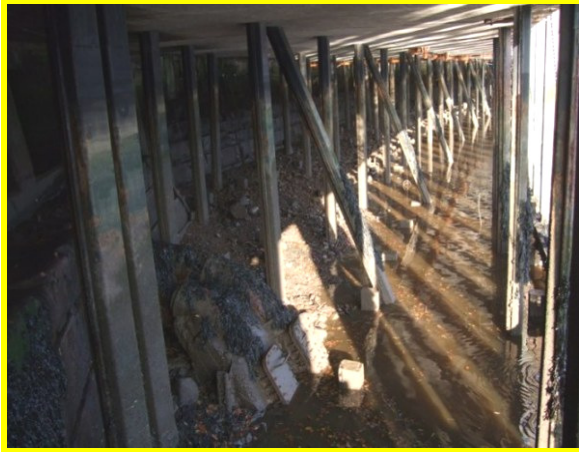
Concrete extension of promenade supports
(Asset Ref. 1221D901D0803C06)

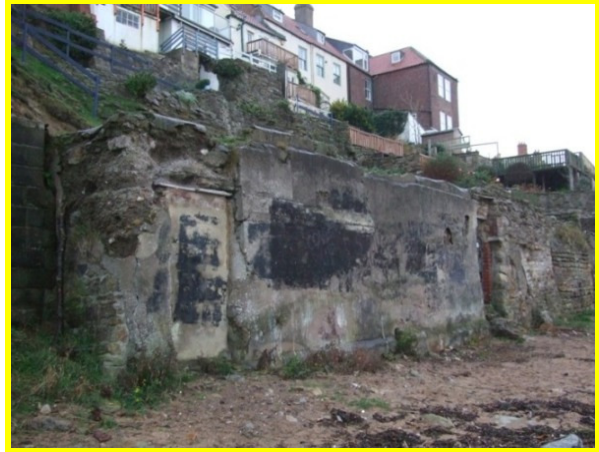
Wall at East side of harbour
(Asset Ref. 1221D901D0803C09)

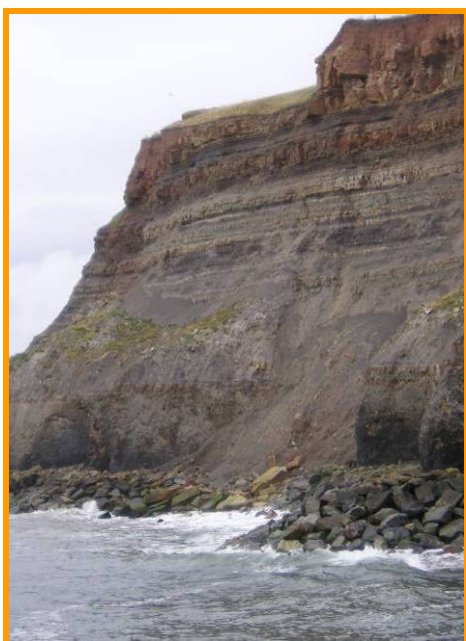
This Sub-Management Unit consists of **unit MU12/2** only. The high cliffs which comprise this unit are classified as Partly Active. There is evidence of a large recent rock fall from the upper part of the cliff and ongoing erosion at the headscarp. Almost the entire cliff face is exposed with very little vegetation cover. There is no change in activity level since 2008.

MU12/2 Recent rockfall evidence
(Partly Active)

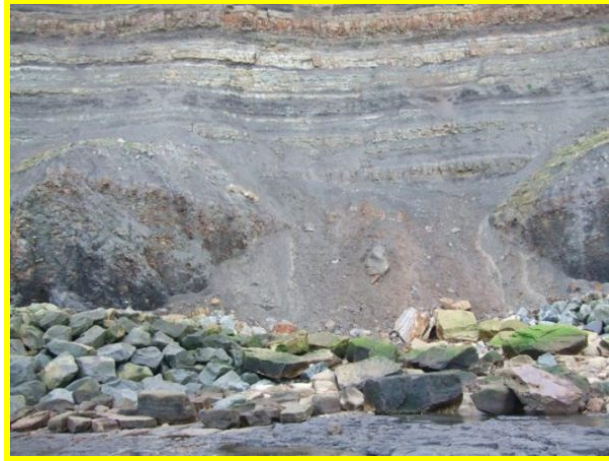
There is a section of rock armour protecting the eastern side of the harbour and toe of natural cliff directly to the east of Whitby. The rock armour varies in size from 1-4 tonnes to 5-8 tonnes. Rockfall as identified in previous inspection is still visible, either replenishment with larger rock armour or a larger scale repair is recommended if this can be justified (Asset Ref No.1221D901D0803C05).

Close up of the base of a rockfall over rock armour defences
(Asset Ref. 1221D901D0803C05)
