Coast Protection Assets and Coastal Slope Condition Analysis

**Scarborough Borough Council
Final Report**

March 2010

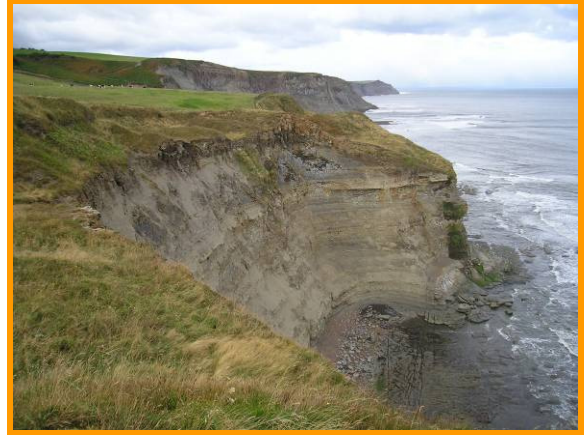
MU15/3 Ongoing erosion and evidence of small scale rockfall (Partly Active)

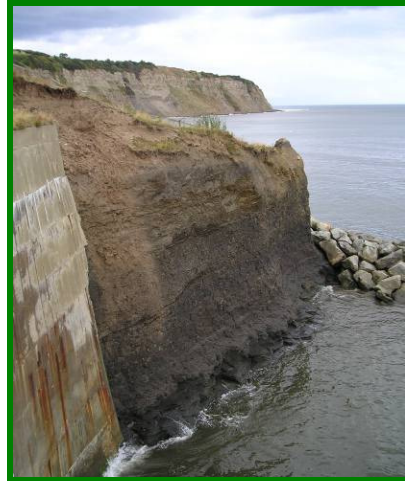
Units MU16/2 and Mu16/3 are located further south at Robin Hood’s Bay Village and are both classified as Dormant. The units are largely protected by sea defences and show no evidence of recent activity. There is however, a section of cliff which is not currently protected and is therefore subject to intense marine erosion. This should be addressed as soon as possible in order to prevent the development of instability in this area.

MU16/2 undefended section subject to marine action and potential instability if not addressed (Dormant)

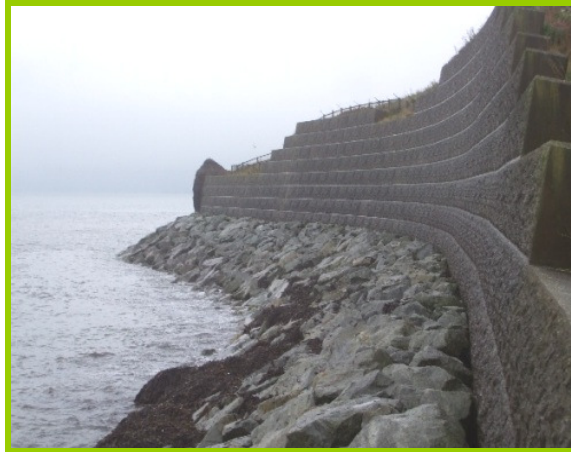
At the northern end of this Sub-Management Unit there is a newly built sea wall in very good condition. Joints and sealant show no signs of damage or minor defects. There is packing visible in some joints, possibly for resistance of movement. Rock armour protecting the toe of the wall is tightly packed with good coverage throughout. The northern slipway is supporting some vegetation growth but is overall in good condition (Asset Ref. 1221D901D1003C01).

Sea wall at the northern end of Mu16A
(Asset Ref. 1221D901D1003C01)

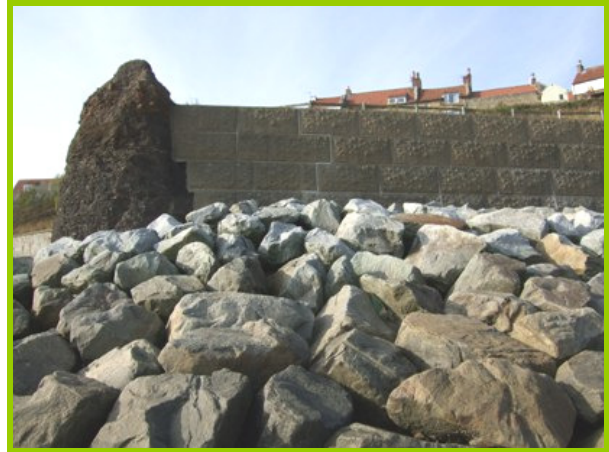
Joint between defended and undefended section.
Packing of joints between blocks also visible
(Asset Ref. 1221D901D1003C01)

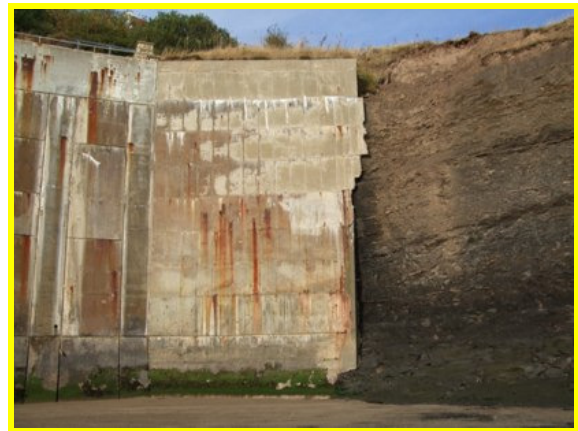
In between the two hard defences there is a short section of exposed cliff, which is exhibiting signs of erosion and threatens to undermine the western end of the vertical wall.

Joint between defended and undefended section
(Asset Ref. 1221D901D1003C02)

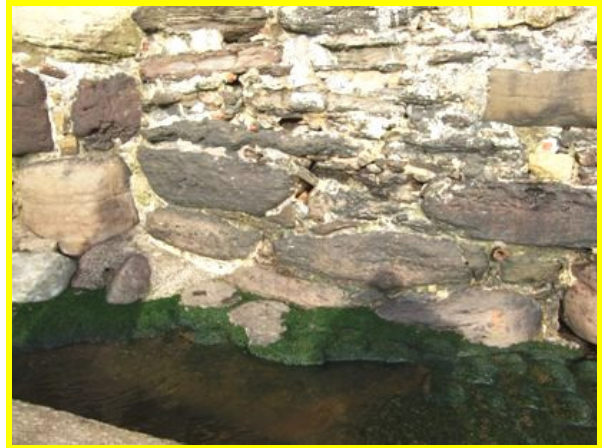
Open joints and voids visible in several places
(Asset Ref. 1221D901D1003C04)

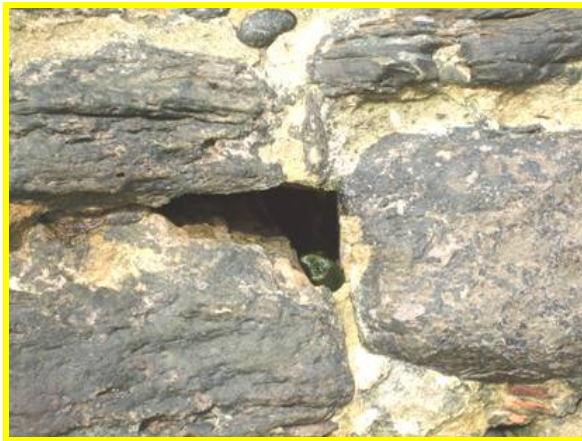
Close up of void
(Asset Ref. 1221D901D1003C04)

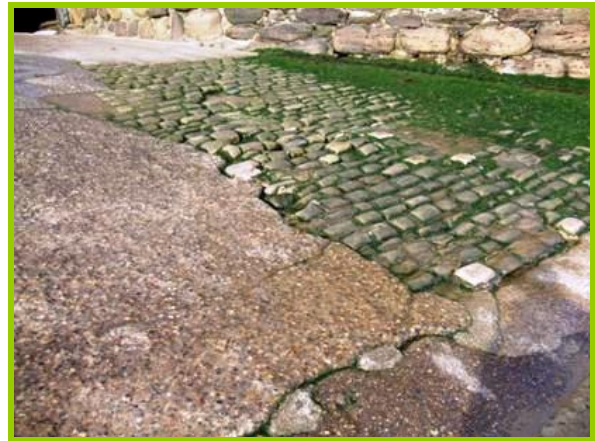
Slipway with missing cobbles and cladding
(Asset Ref. 1221D901D1003C05)

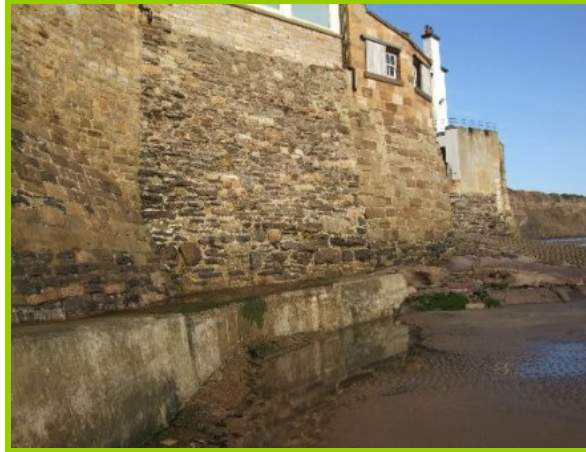
The mixed construction defence (Asset Ref. 1221D901D1003C06) on the opposite side of the slipway is formed of mass concrete at the base with stone and blockwork above. The most notable defects here are wide cracks in the concrete base, although these are currently no cause for concern.

Looking northwards at the short section of defence in the south of Robin Hood's Bay village (Asset Ref. 1221D901D1003C06)

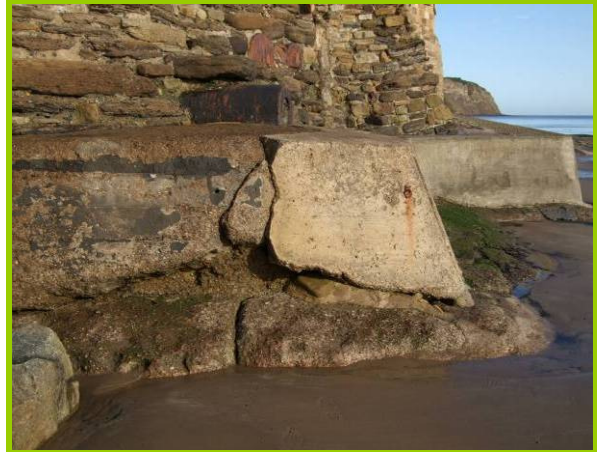
Wide cracks to toe of wall (Asset Ref. 1221D901D1003C06)

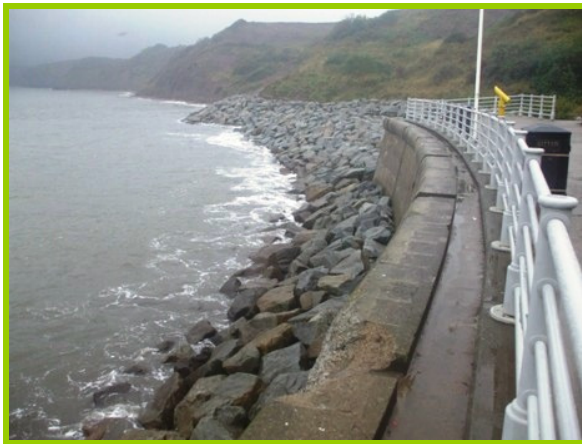
The southern-most defences in the village (Asset Refs. 1221D901D1003C09/C10) are formed of rock armour, together with a section of concrete sea wall. These defences are considered to be in a good condition. Rock armour is tightly packed and is providing good protection to the toe of the sea wall behind. The upper sections of the sea wall itself show some evidence of seepage through the blockwork joints, rather than visible cracking, as well as erosion to the capping beam and spalling. The promenade above the sea wall is in a good condition, with only minor defects present

The rock armour, sea wall and promenade above (Asset Ref. 1221D901D1003C10)

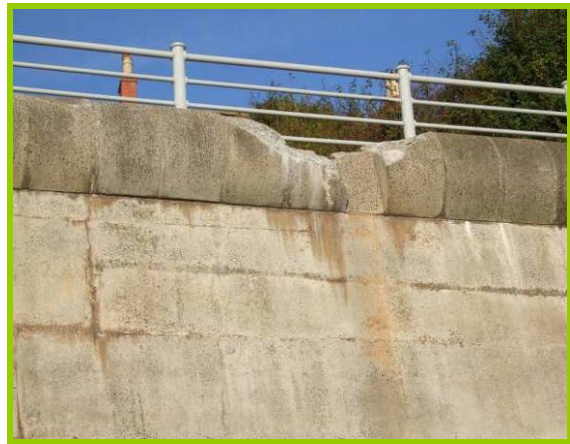
Sea wall with damaged capping beam (Asset Ref. 1221D901D1003C10)

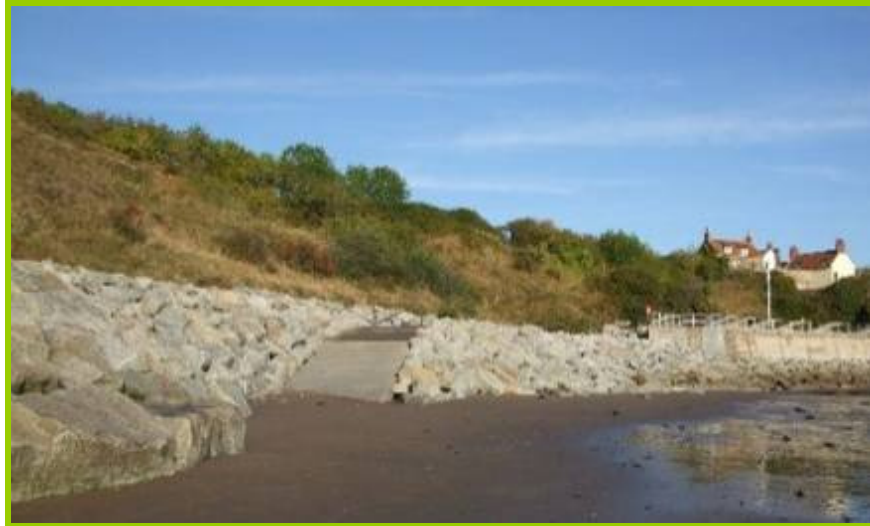
The rock armour described for Mu16B extends southwards into this Sub-Management Unit. There is also a section of newly installed rock armour which is in very good condition, is tightly packed and performing well (Asset Ref. 1221D901D1003C07). Vegetation is present on the defences in localised spots, however it is anticipated that this will die away in the winter months. As described in the Coastal Slope Condition Assessment, there is noticeably greater erosion of the natural cliffs where the rock revetment finishes to the south, which is a typical 'end effect' of linear coastal defences. The condition of these assets remains unchanged since previous inspection.

Looking northwards at the rock armour
(Asset Ref. 1221D901D1003C07)

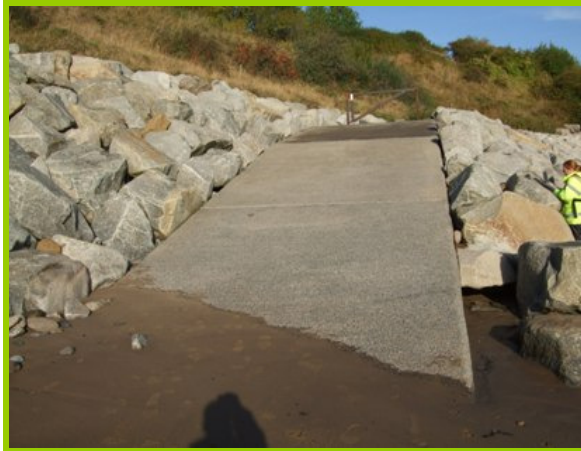
Individual slipway and stair structures were included in the inspection for the Robins Hood Bay stretch of defences. These structures were all in good condition with the residual life of

the assets ranging from 11-20 to over 20 years. None of the structures show any signs of defects and do not require any maintenance work, although continued monitoring of the structures is advised.

Slipway next to rock armour at south end of bay
(Asset Ref. 1221D901D1003C07001)

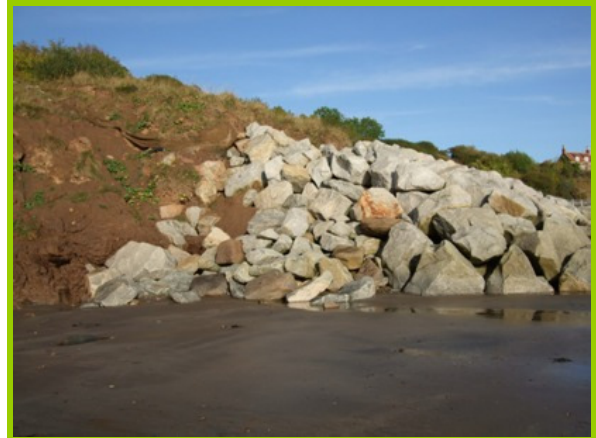
Extent of rock armour, showing 'end effect'
(Asset Ref. 1221D901D1003C07)

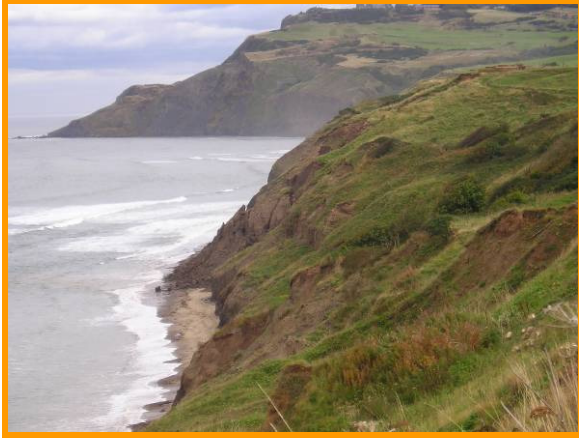
MU17/5 Recent failure onto the beach (Partly Active)

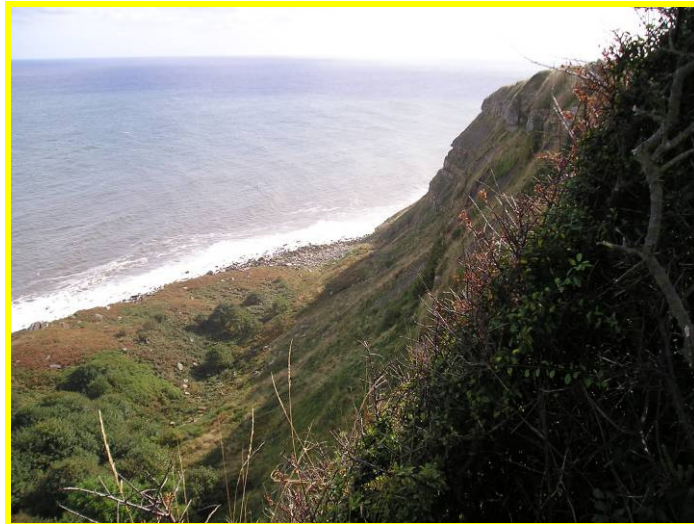
MU19/3 Showing localised erosion (Locally Active)

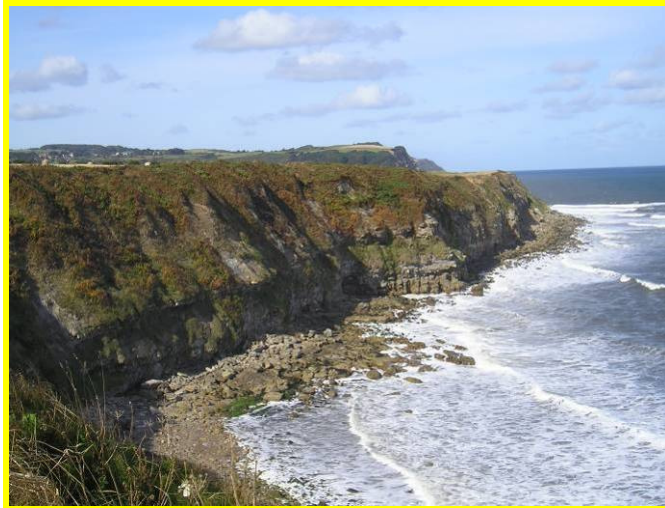
MU19/6 Well vegetated cliffs south of Cloughton Wyke (Locally Active)

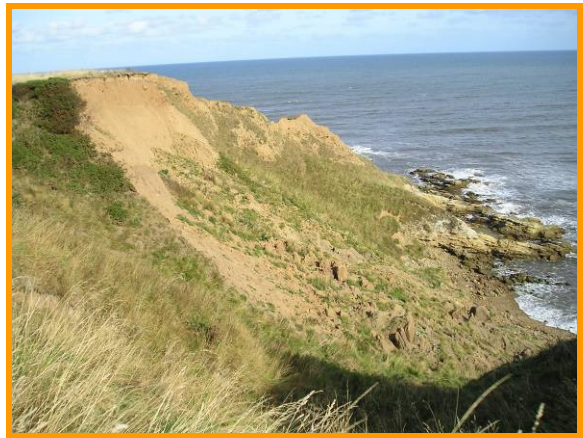
Units MU19/9 and MU19/10 are located between Cromer Point and Scalby Ness and are classified as Partly Active. The toe of these units is subject to continual marine action and is slumped in places. The headscarp is steep, exposed and actively receding over much of the unit lengths. Despite the vegetation cover, mid-slope there are very common tension cracks, slumping, sliding and gliding blocks indicating ongoing activity.

MU19/9 Headscarp erosion (Partly Active)

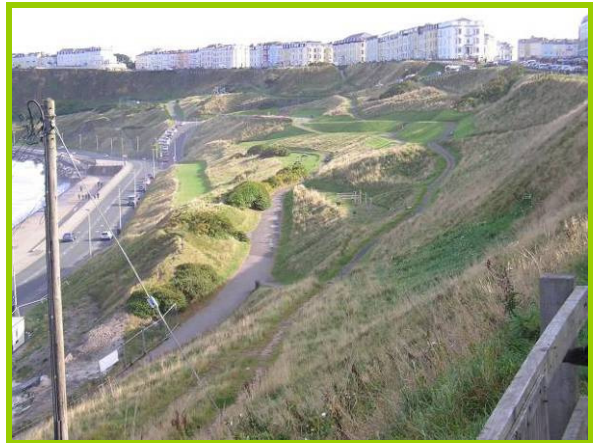
MU20/4a Relict slopes with localised activity (Inactive)

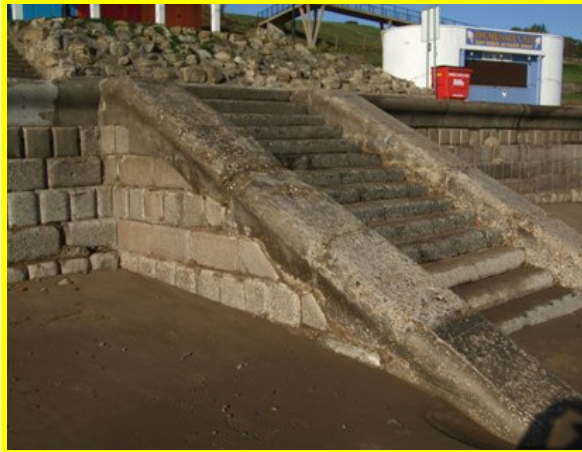
Mu20A and Mu20B – Northern North Bay and Southern North Bay
Individual slipway and stair structures were included in the inspection for the North Bay promenade. These structures ranged in condition with the residual life of the assets from 6-10 through to over 20 years. Due to a high beach level most of the structures were largely buried, and therefore full inspections of the assets were not possible. Erosion and cracks, as well as rounding of step edges have occurred to most of the structures. Erosion and cracks are occurring to the side walls of the stairs at the North end of the promenade and are in need of repair (Asset Ref. 1221D901D1201C26001).

Erosion evident to stairs and side walls
(Asset Ref. 1221D901D1201C26001)

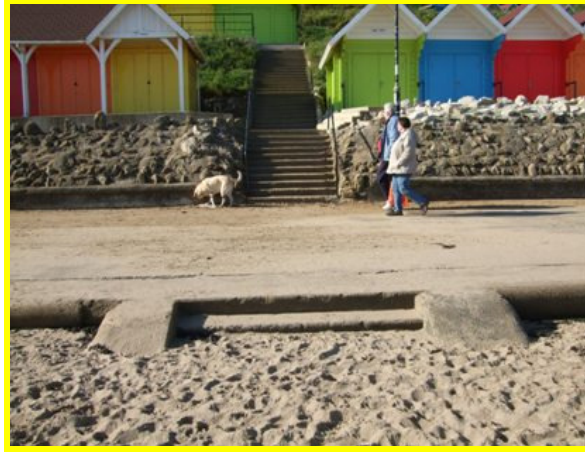
High beach level covering most of stairs
(Asset Ref. 1221D901D1201C12001)

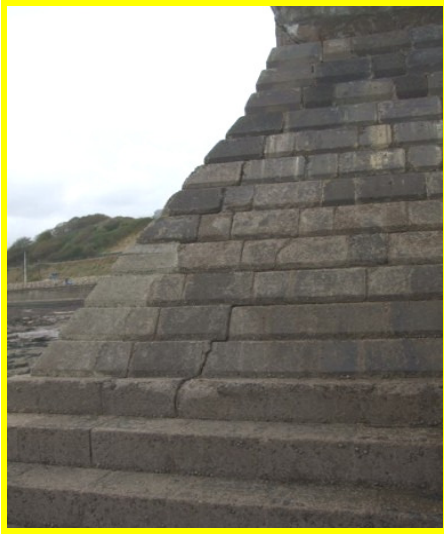
Sea walls (Asset Refs. 1221D901D1201C01, C02, C03, C04, C05, C06, C07, C08, C09, C10, C11, C12, C13, C14, C15, C16, C17, C18, C19, C24 and C25), are curved or vertical and formed of blockwork with a concrete crest wall with a promenade beyond. In many places large vertical cracks running the full height of the sea wall are evident, such as near the Sea Life Centre (Asset Refs. 1221D901D1201C02 and 1221D901D1201C03). Repair work is evident to some of these cracks, although additional repair work to remaining cracks and to the cracked crest wall is needed. These cracks are now more evident than in the previous survey. The front face of blockwork making up Asset Ref. 1221D901D1201C03 shows degradation and it appears that repairs to this face have failed, as reinforcement bars are exposed on the sea wall here. Beach erosion is evident in the north, where in places the sheet pile toe (Asset Ref. 1221D901D1201C02) or concrete toe (Asset Ref. 1221D901D1201C24) has been exposed and is corroded or eroded. This may present a risk to public health and safety due to the sharp edges present on the sheet piling along parts of the beach side.

North Bay sea wall and exposed toe
(Asset Ref. 1221D901D1201C02)

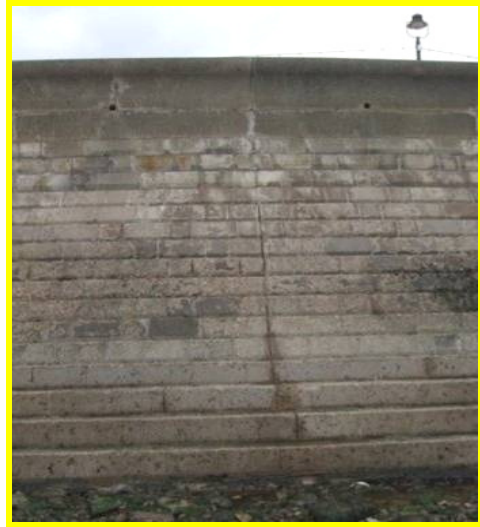
Full height vertical crack
(Asset Ref. 1221D901D1201C02)

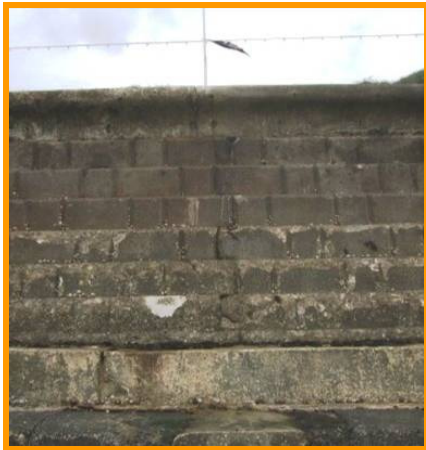
Full height vertical crack and exposed toe
(Asset Ref. 1221D901D1201C03)

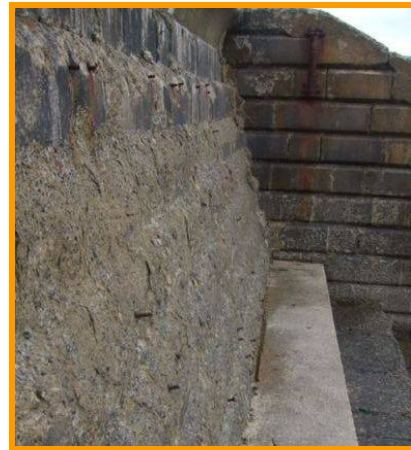
Eroded and abraded front face, exposed steel
(Asset Ref. 1221D901D1201C03)

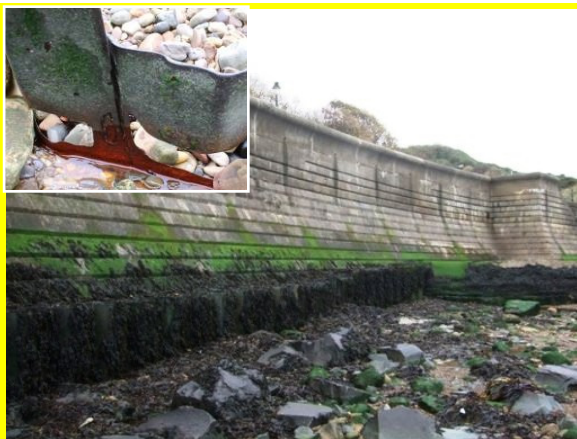
Exposed sheet pile toe
(Asset Ref. 1221D901D1201C02)

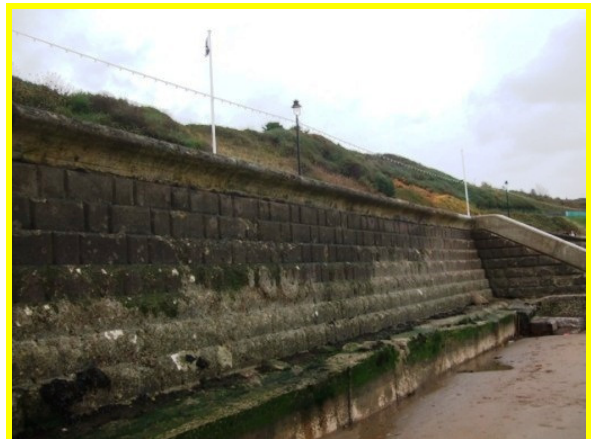
Exposed concrete toe
(Asset Ref. 1221D901D1201C24)

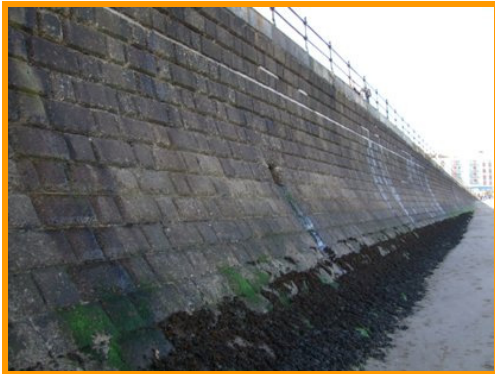
There is cracking along joints and loss of material in several parts of the sea wall, as well as vertical cracks the full height of the wall with some partly repaired (Asset Refs. 1221D901D1201C07 opposite Alexandra Gardens and 1221D901D1201C21 to the north of Clarence Gardens). The promenade also shows cracking in many places, with additional cracks between the coping stones and promenade in places. The slipway in the south also shows several structural cracks running the full height of the wall. These represent significant damage to the sea wall and threaten the integrity of the overall defence, and need to be addressed. Repair work to the vertical cracks is needed along with additional repair work to the cracks previously repaired, this is likely to require capital investment.

Looking northwards along wall, with filled lateral joints visible (Asset Ref. 1221D901D1201C07)

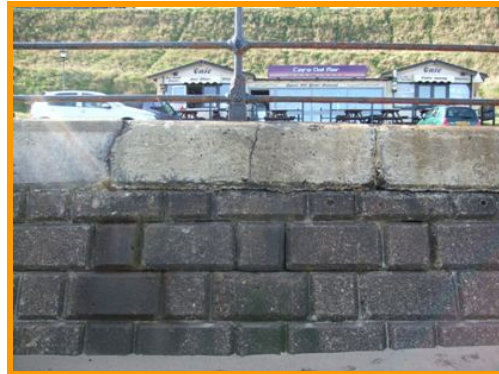
Cracking through and beneath capping, near southern end of defence (Asset Ref. 1221D901D1201C07)

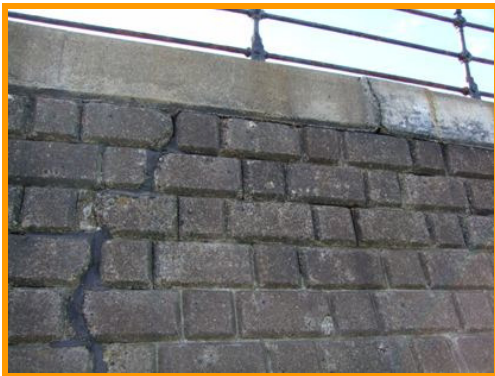
Example of repaired and re-opened crack (Asset Ref. 1221D901D1201C07)

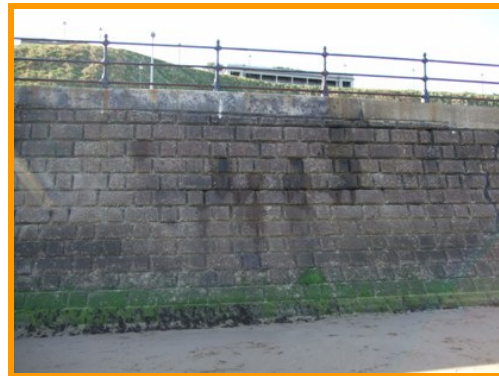
Seepage through wall and open joints (Asset Ref. 1221D901D1201C07)

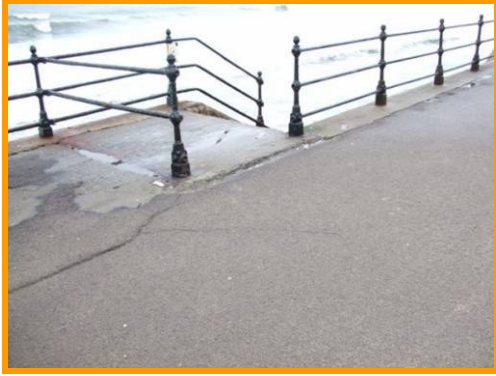
Erosion at joints and cracking to promenade
(Asset Ref. 1221D901D1201C07)

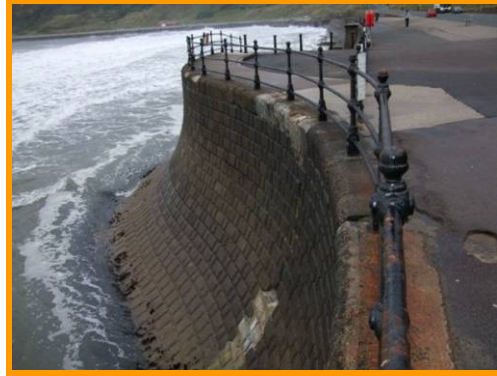
Erosion at joints and repairs to promenade, and
damaged coping
(Asset Ref. 1221D901D1201C21)

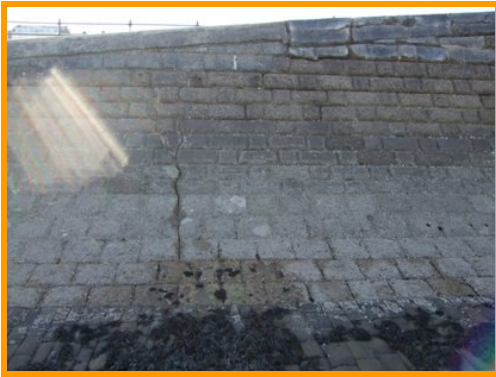
Vertical crack running the full height of the slipway
sea wall
(Asset Ref. 1221D901D1201C21)

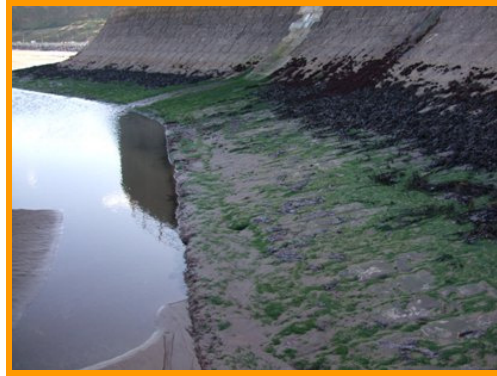
Exposed toe
(Asset Ref. 1221D901D1201C21)

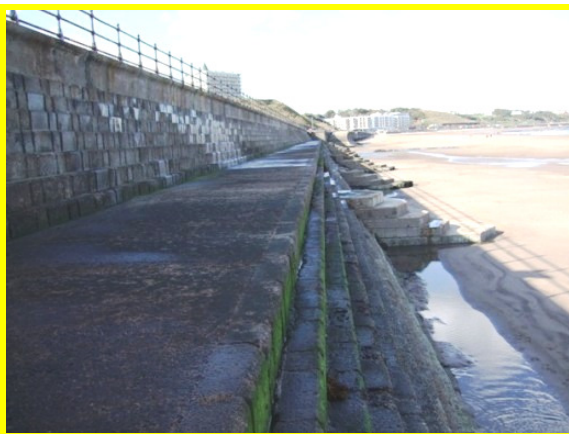
To the southern end of the North Bay there is a stepped concrete blockwork sea wall structure (Asset Ref. 1221D901D1201C08 – just north of Albert Road) constructed with numerous buttresses/bastions which protrude from land out onto the beach. The buttresses/bastions vary in height and length. The toe of the wall is severely eroded and there is severe cracking to outbuilt sections particularly at north end. There is a concrete berm above the buttresses, this is in good condition. Above this is the sea wall and promenade, and a second wall at the back of the promenade. Both the promenade and the second wall show cracking. There are localised signs of repair to eroded faces of blockwork and to buttresses, however, additional repairs are now required.

Looking north along berm from south end
(Asset Ref. 1221D901D1201C08)

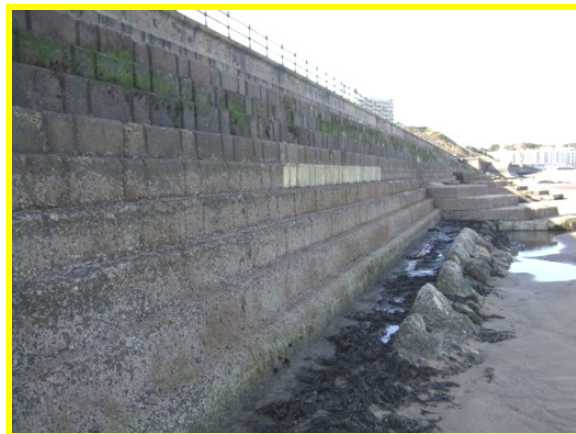
Looking north, showing eroded toe and repairs to blockwork face
(Asset Ref. 1221D901D1201C08)

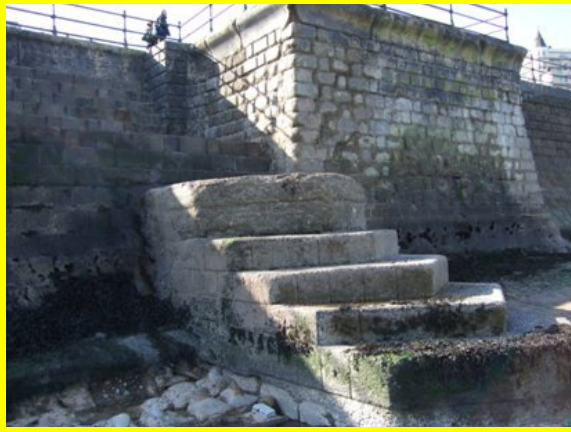
Cracking outbuilt section at north of defence.
(Asset Ref. 1221D901D1201C08)

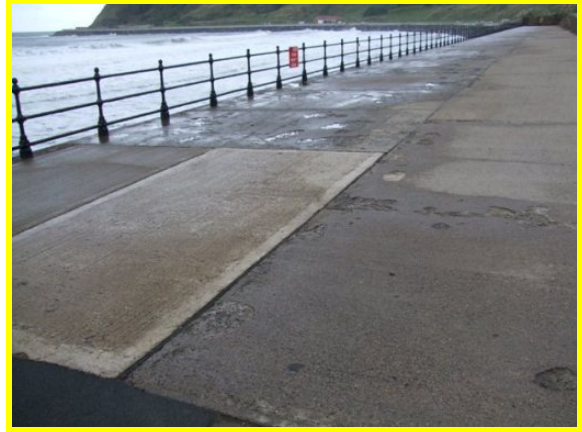
Repaired and damaged promenade, with cracking throughout
(Asset Ref. 1221D901D1201C08)

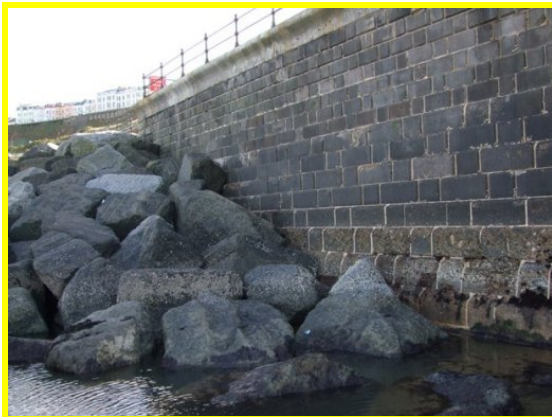
There is a short section of defence (Asset Ref. 1221D901D1202C23) between this wall and the rock armour section. This short wall is formed of stepped blockwork and shows two large vertical cracks with one crack extending through the capping beam. There is another crack extending half way up the wall. There is missing blockwork in localised areas and the lower part of wall is eroded with exposed aggregate. The secondary wall beyond the promenade and the promenade itself are also cracked.

Overview of construction
(Asset Ref. 1221D901D1202C23)

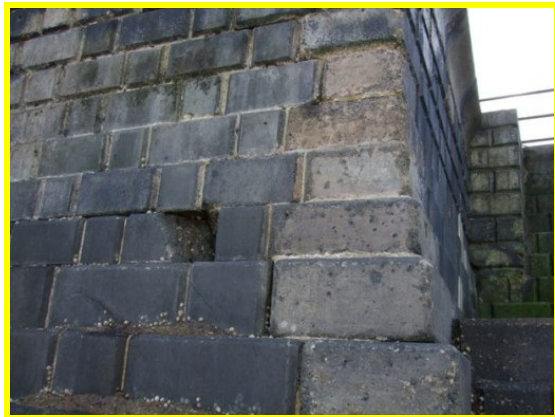
Missing blockwork and damage
(Asset Ref. 1221D901D1202C23)

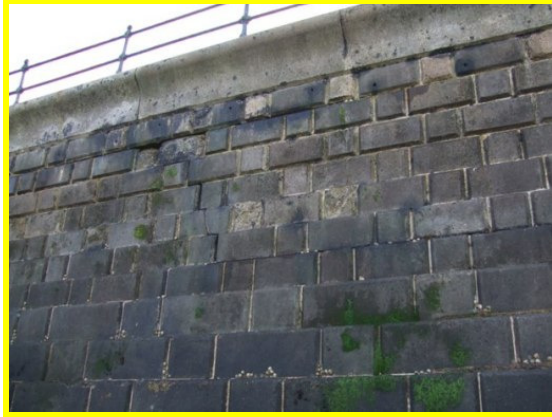
Example of cracking
(Asset Ref. 1221D901D1202C23)

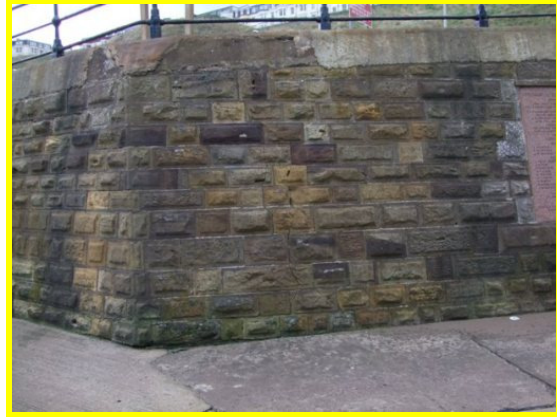
Full height cracks to left and right of corner of
secondary wall beyond promenade
(Asset Ref. 1221D901D1202C23)

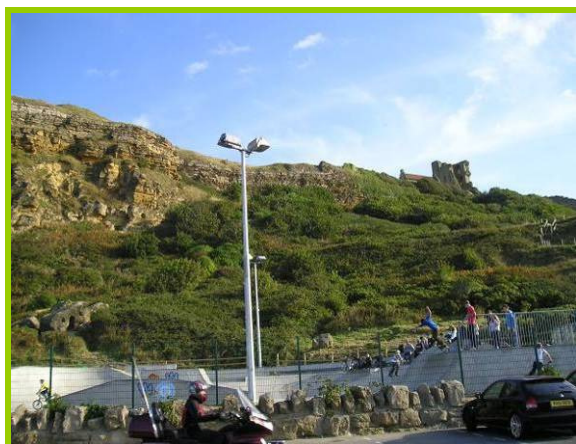
Unit MU21/1 is located at The Holms and is classified as Inactive. This represents a reduction in activity status since the 2008 walkover survey. This is mostly due to the lack of ongoing rockfall from the exposed, well jointed rock and because the rest of the unit is well vegetated with little evidence of recent activity. Despite this drop in classification it should be noted that there remains the potential for significant rockfalls at this location putting the road and skate park at risk.

MU21/1 Well jointed hard rock behind the skate park (location of former rockfall) (Inactive)

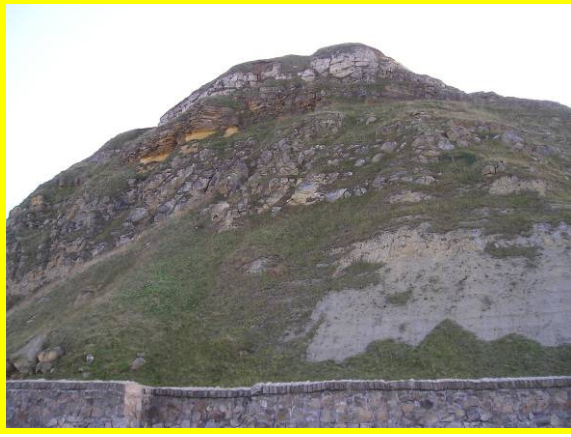
Unit MU21/2 comprises the area known as Castle Cliff and is classified as Locally Active as it was in 2008. The cliffs are steep with variable vegetation cover. Locally, the well jointed hard rock of which the cliffs are composed is exposed and subject to on-going weathering and erosion. Like unit MU21/1, there is the potential for significant rockfall within this unit although such activity is not currently being displayed.

MU21/2 Well jointed hard rock layer within this unit (Locally Active)

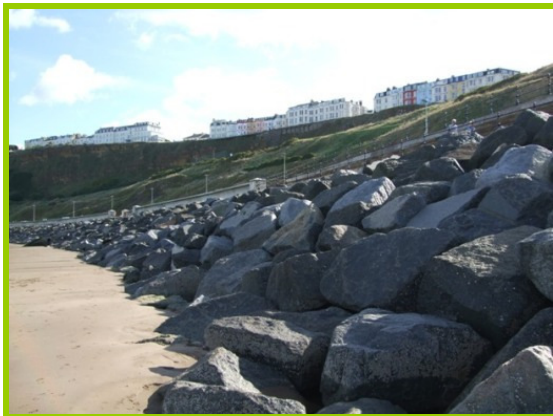
Overview of rock armour with raised crest wall
(Asset Refs. 1221D901D1202C01)

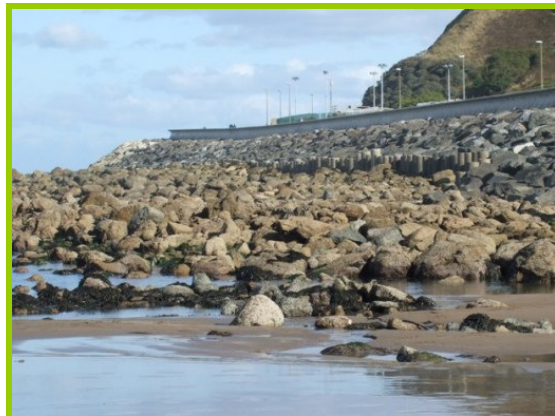
Overview of rock armour with concrete piles visible
(Asset Refs. 1221D901D1202C03)

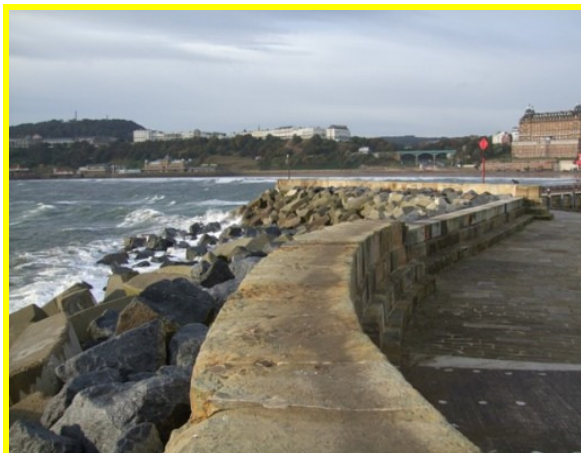
The harbour wall (Asset Ref. 1221D901D1301C01) is in very good condition, with only minor cracking to the crest wall and individual tetrapods. A raised section has recently been added to the top of the existing defence along almost the entire length with minor erosion and cracks present (see photo below, top left). At one point at the seaward end of the harbour arm the rock armour is less tightly packed than it is along the rest of the headland.

The new harbour wall with rock armour, tetrapods
and raised section
(Asset Ref. 1221D901D1301C01)

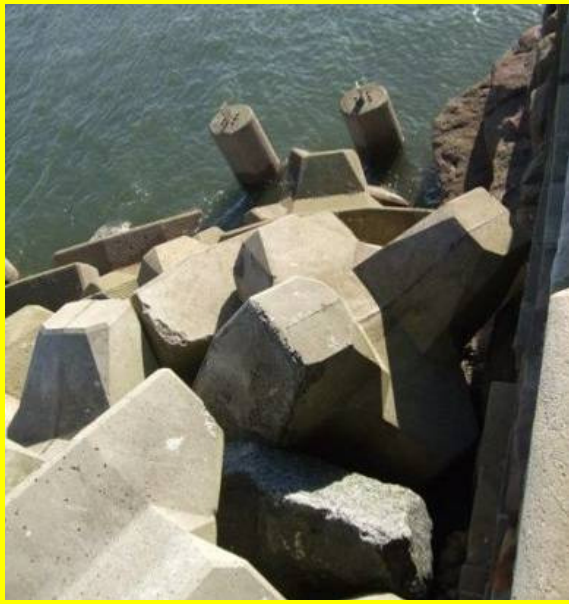
Far end of harbour arm showing potential lack of armour fill
(Asset Ref. 1221D901D1301C01)

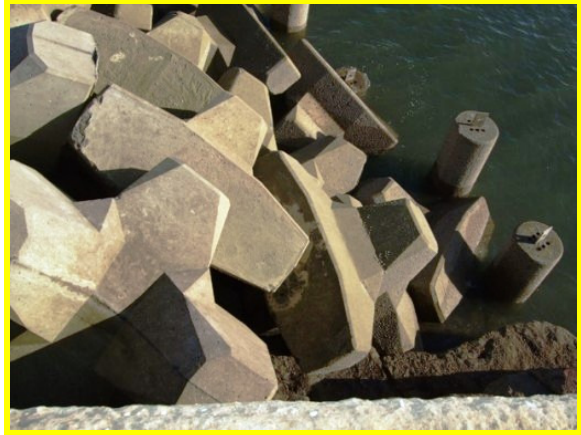
Far end of harbour arm showing potential lack of armour fill
(Asset Ref. 1221D901D1301C01)

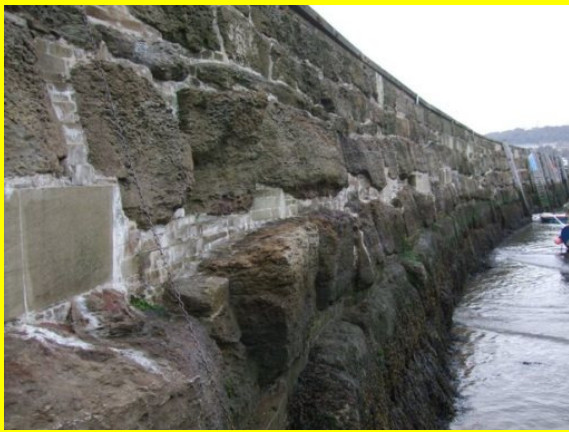
The faces of many blocks are missing or cracked at the seaward end of the original harbour wall, with cracks appearing throughout the top layer of concrete and the wall (Asset Ref. 1221D901D1301C16). Minor missing joints and cracks appear throughout the harbour masonry walls with recent maintenance work visible to the landward part of the harbour arms. The timber fenders also appear newer on the landward side of the arm than they do on the seaward side, with many of the seaward side fenders deteriorating. Stairs set into this defence should be monitored to ensure stability, as washout is visible in some places.

Filled and repaired wall
(Asset Ref. 1221D901D1301C16)

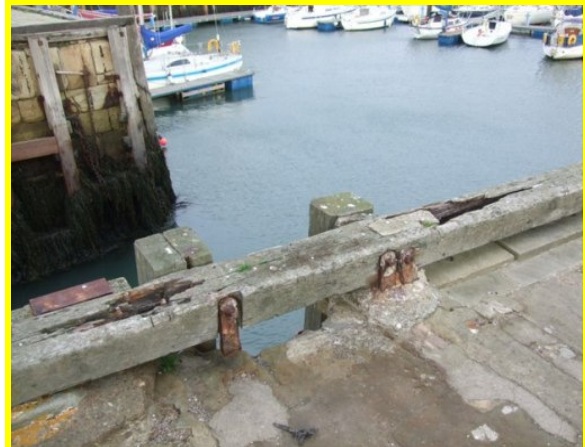
Deterioration of timber fenders throughout inner harbour
(Asset Ref. 1221D901D1301C16)

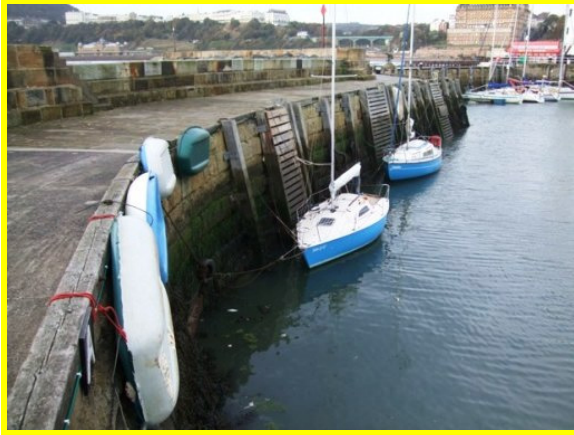
Overview of wall showing newer timber fenders
(Asset Ref. 1221D901D1301C16)

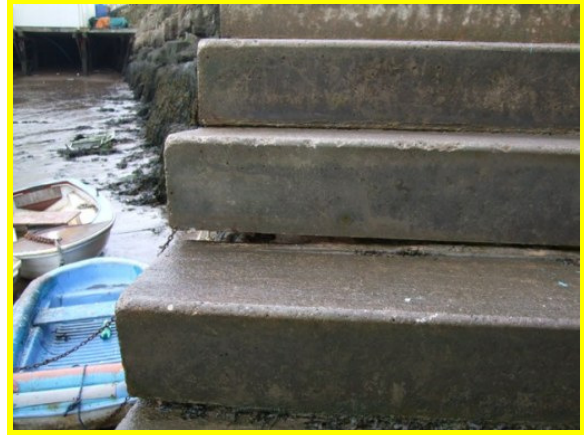
Washout behind steps
(Asset Ref. 1221D901D1301C16)

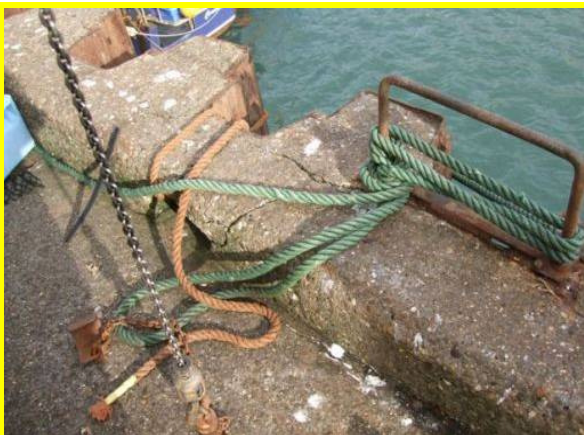
Cracking to concrete capping of sheet piling
(Asset Ref. 1221D901D1301C13)

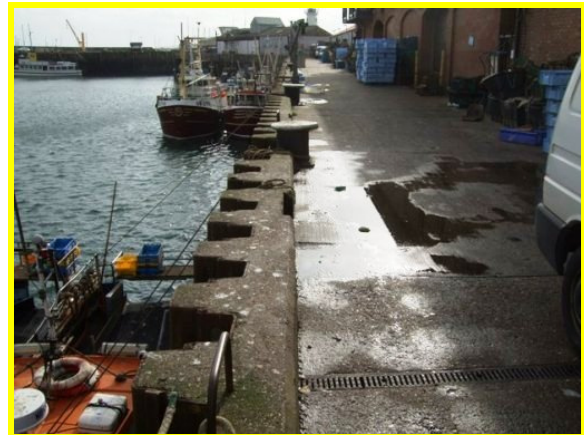
Overview of asset near the market on West Pier
(Asset Ref. 1221D901D1301C13)

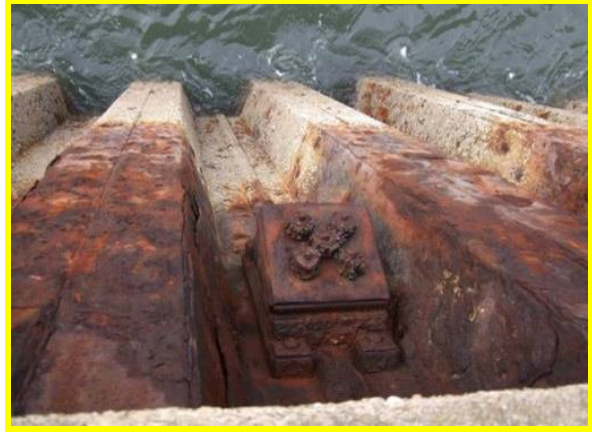
A number of defences in the harbour area show corrosion to the steel piling of varying degrees (Asset Ref. 1221D901D1301C13 and 1221D901D1301C17), as would be expected in an environment such as this. Locals report the piles to be up to 50 years old. Significant corrosion is evident in the photo below located on the harbour arm near the lighthouse. In parts of the piling the concrete capping is cracked in places (Asset Ref. 1221D901D1301C13).

Significant corrosion of steel piling
(Asset Ref. 1221D901D1301C17)

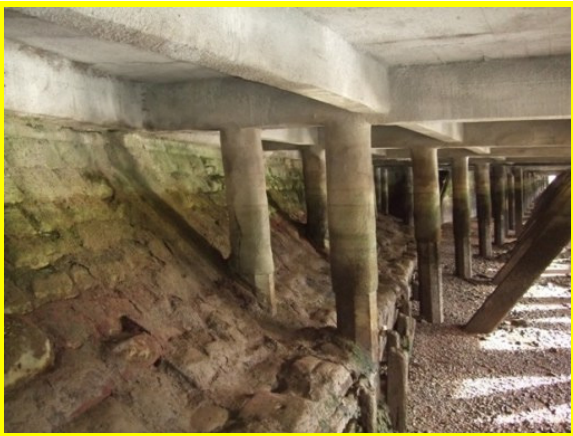
The original quay wall on Sandside (Asset Ref. 1221D901D1301C06) shows signs of deformation; missing joints and movement of blockwork. The newer concrete jetty which has been constructed above also shows signs of movement although still structurally sound. There are also cracks forming on the columns and beams to the underside of the extended jetty with exposed reinforcement bar in places.

The original quay wall beneath the newer
concrete jetty
(Asset Ref. 1221D901D1301C06)

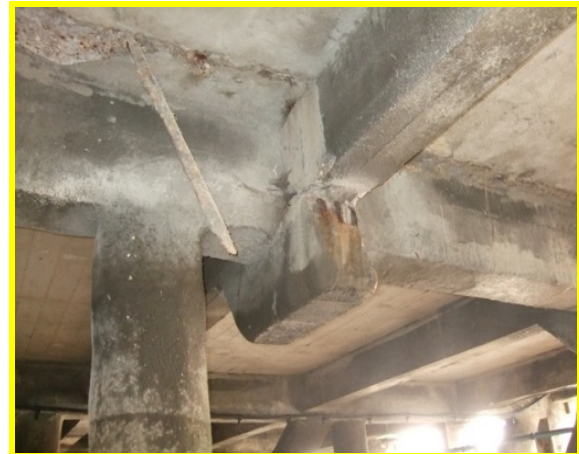
Exposed re bar and erosion to the concrete jetty
supports.
(Asset Ref. 1221D901D1301C06)

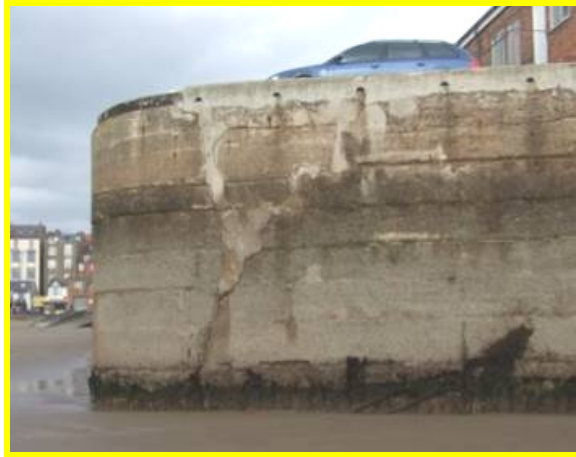
The west pier appears to be in fair condition, the sheet metal piling on the inner side of the harbour wall is corroded, although intact (Asset Ref. 1221D901D1301C13). The outer side (Asset Refs. 1221D901D1301C07 and Asset Ref. 1221D901D1301C19) shows several significant defects including large full height cracks and exposure of aggregates. During the inspection at low tide the toe was exposed, this shows potential undercutting. Erosion to the wall and minor cracks to the promenade were also noted during the inspection (Asset Ref. 1221D901D1301C19). These cracks require repair and monitoring to ensure that the structural integrity of the defence is maintained.

Significant cracking with exposed toe
(Asset Ref. 1221D901D1301C07)

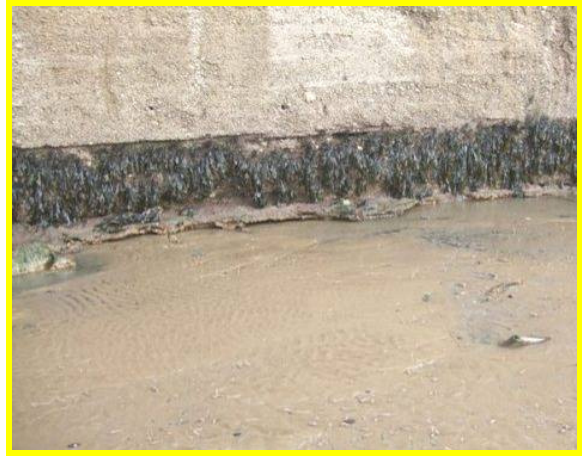
Exposed toe
(Asset Ref. 1221D901D1301C07)

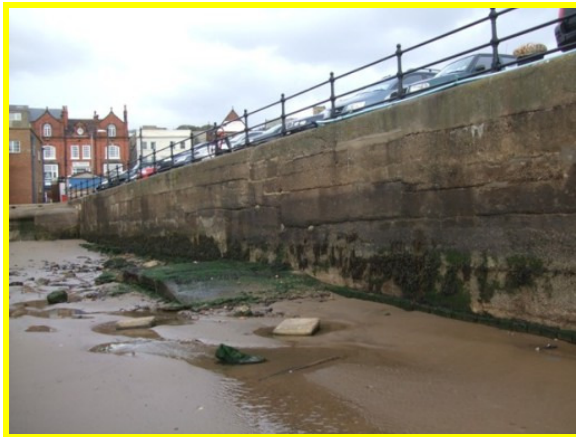
Overview of wall
(Asset Ref. 1221D901D1301C19)

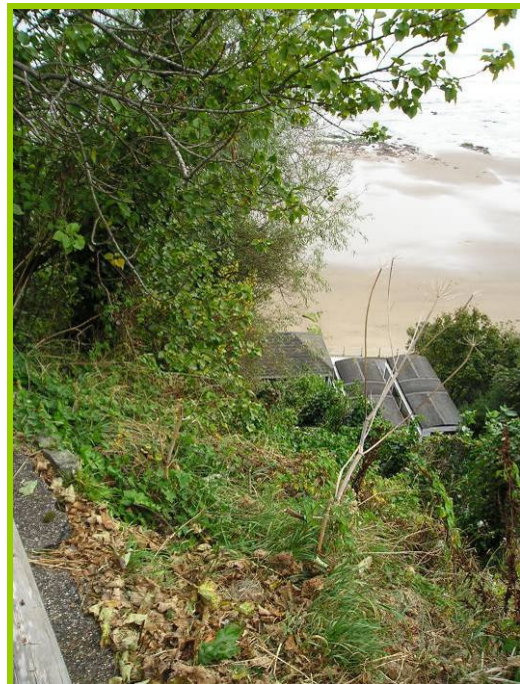
Unit MU22/3 is located just south of the Spa Complex in the vicinity of the cliff lift. The steep slopes of this unit are well vegetated with little evidence of instability apart from cracking to footpaths. Therefore, this unit is classified as Inactive.

MU22/3 Looking down towards the cliff lift (Inactive)

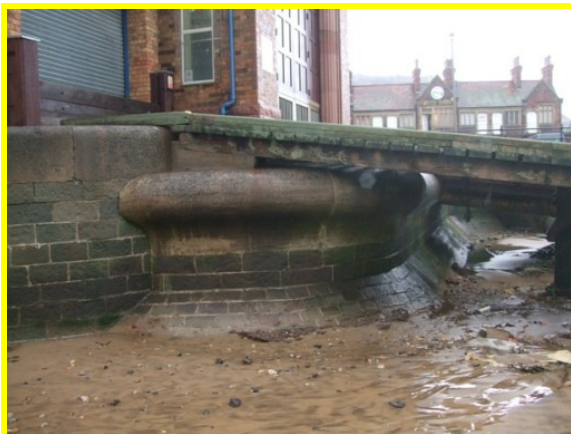
View of blockwork wall beneath life boat station
(Asset Ref. 1221D901D1301C08)

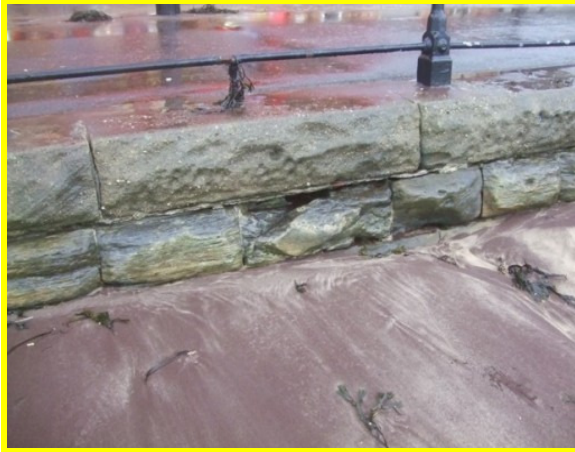
Missing joints and erosion to top part of wall
(Asset Ref. 1221D901D1301C15)

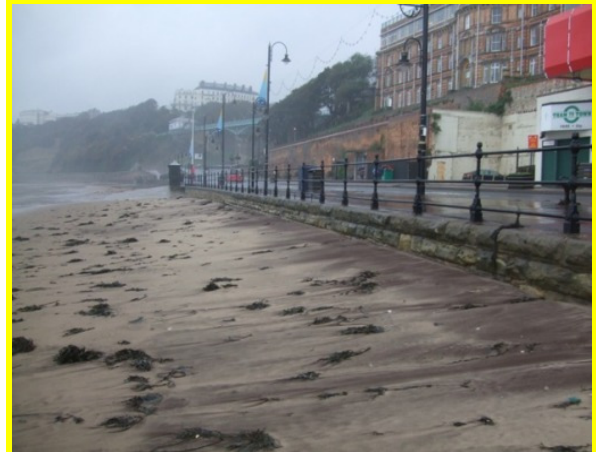
The sea wall runs in front of Foreshore Road, backing the beach at South Sands. Due to high beach levels only the top two courses of bricks are visible here. However, where visible, the sea wall is in good condition with only minor missing joints and erosion evident (Asset Ref. 1221D901D1301C15). The sea wall protecting the Lifeboat Station is also in good condition with minor mortar loss of joints and erosion (Asset Ref No.1221D901D1301C08).

High beach level along sea wall running in front of
Foreshore Road, South Bay
(Asset Ref. 1221D901D1301C15)

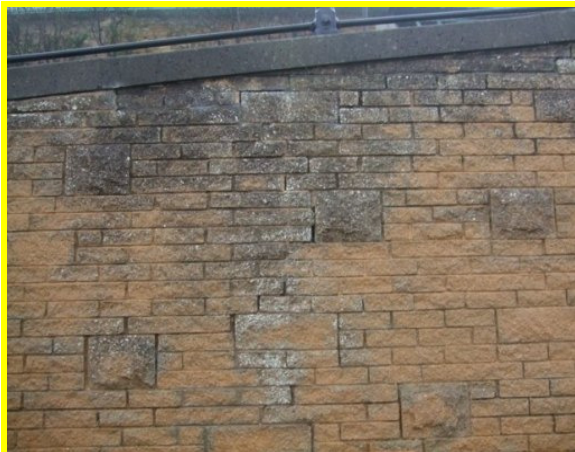
Vertical crack to second wall protecting road.
(Asset Ref. 1221D901D1301C09)

Large vertical cracks are evident in parts of the wall at the back of the promenade (Asset Ref. 1221D901D1301C09). Repair work to the vertical cracks is advised to prevent further cracking to the wall.

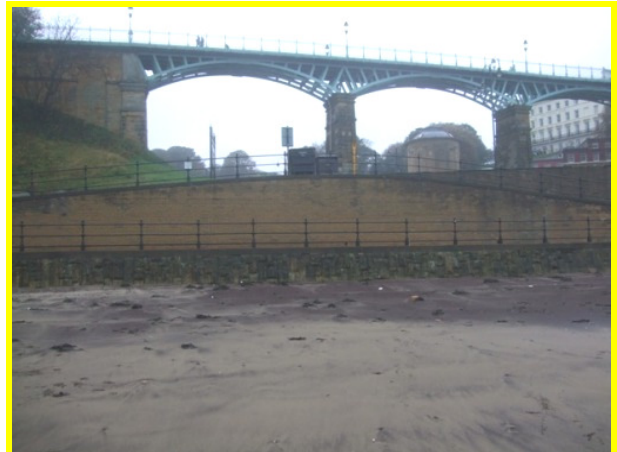
Second stage wall, sea wall and promenade at
end of Foreshore Road
(Asset Ref. 1221D901D1301C09)

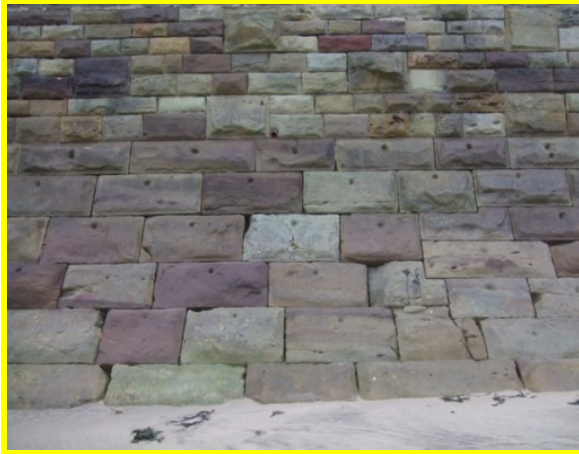
A sea wall and promenade runs the whole length of this section. The recurved sea wall (Asset Ref. 1221D901D1301C10) shows defects throughout, such as washout of joints and erosion to the blockwork surface is prevalent. It is recommended that repointing is undertaken to prevent future washout and further damage. The recurved sea wall at “The Spa” shows signs of undercutting, with an exposed apron as well as cracking to the capping beam in many places along length (Asset Ref. 1221D901D1301C28). Repair work to the capping beam and undercutting would be beneficial to the structural stability of the wall.

Missing joints throughout blockwork wall
(Asset Ref. 1221D901D1301C10)
