Coast Protection Assets and Coastal Slope Condition Analysis

**Scarborough Borough Council
Final Report**

March 2010

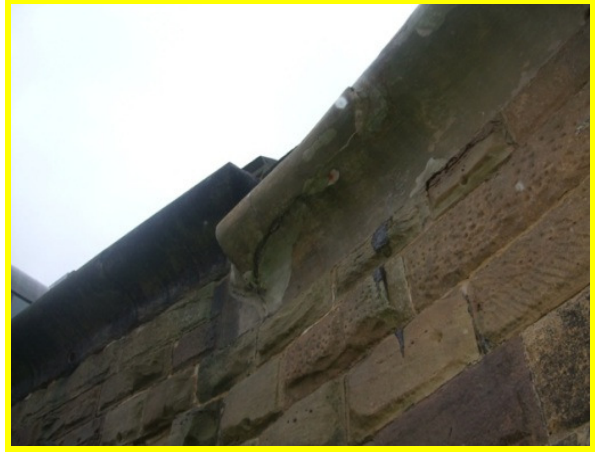
Cracking to the splash beam
(Asset Ref. 1221D901D1301C28)

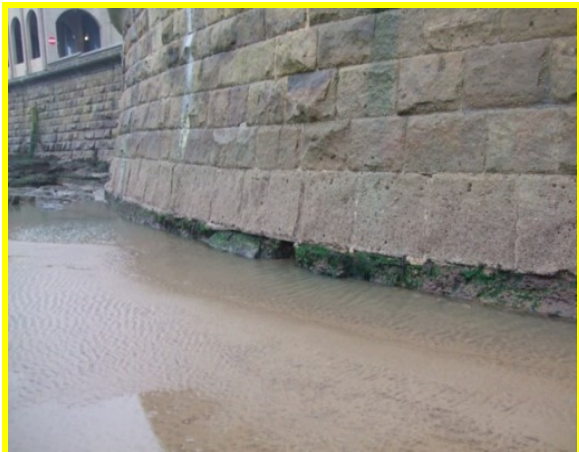
Undercutting to the sea wall
(Asset Ref. 1221D901D1301C28)

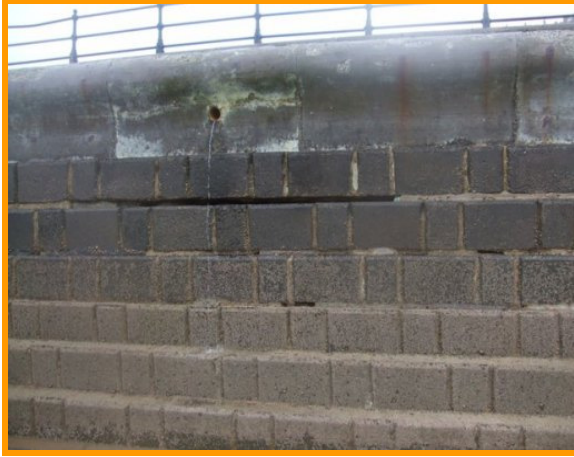
At the southern end of the sea wall the blockwork is in poor condition (Asset Ref. 1221D901D1303C02). Areas of the wall have deeply washed out joints horizontally along the wall. There is also a section of concrete where corroded rebar is exposed on the capping beam (Asset Ref. 1221D901D1304C02). Many large cracks and poor areas are evident in the back wall and the capping beam.

Large missing horizontal joints to wall
(Asset Ref. 1221D901D1303C02)

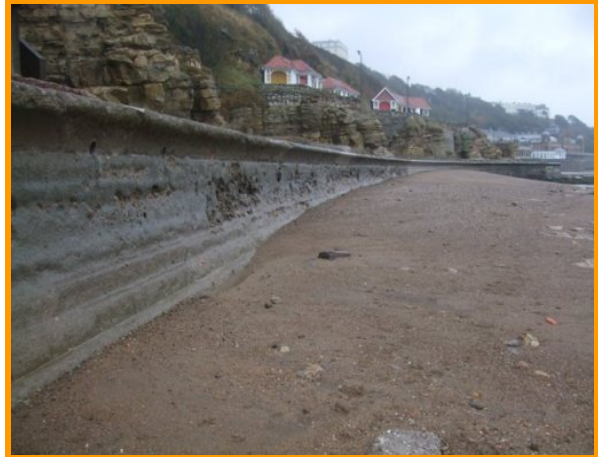
The lower section of the concrete wall and capping beam is showing evidence of significant surface erosion exposing aggregate throughout the defence. It is recommended that the wall needs re-surfacing in places. Replacement of the capping beam and wall is evident mid section of the wall.

Repaired wall eroded with sections of replaced
wall and capping beams
(Asset Ref. 1221D901D1302C02)

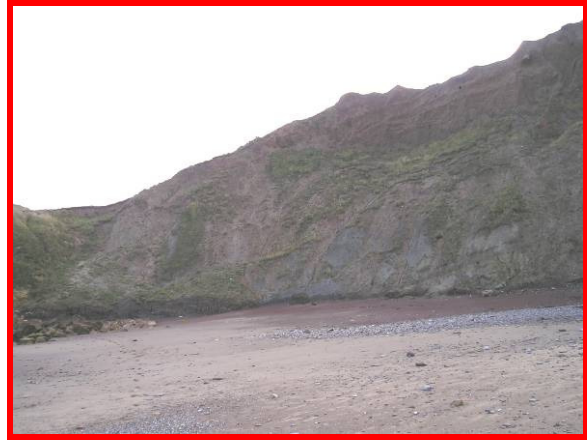
Unit MU23/I4 situated on the north side of Knipe Point is composed of soft glacial material and is classified as Totally Active. The retreating cliffs of this unit are almost entirely affected by intense erosion, with very little vegetative cover. Marine activity is eroding the toe, with slumping, sliding, rilling and gullying occurring down most of the unit length.

MU23/I4 Intense erosion of the north side of
Knipe Point (Totally Active)

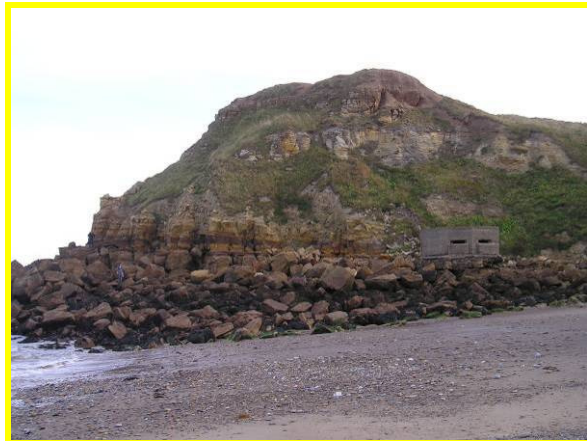
Unit MU23/J is also located on the north side of Knipe Point. This unit is composed of hard, well jointed rock and is classified as Locally Active. There is some recession at the headscarp and some evidence of past rockfall at the unit base.

MU23/J Rock face of the north side of Knipe
Point (Locally Active)

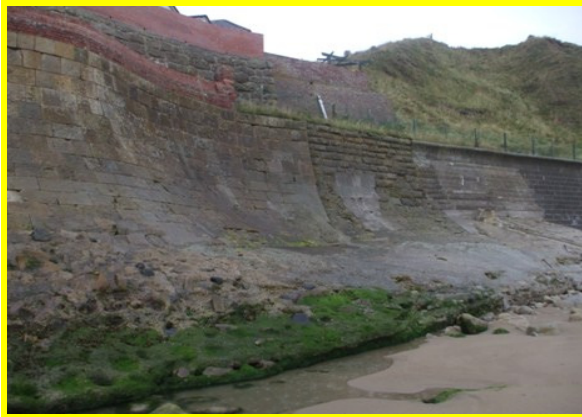
Cayton Bay is predominantly a natural bay free from coastal defences. Cayton pumping station, (located 506665,484520 OS Grid) is protected against wave attack by a series of blockwork and concrete sea walls (Asset Ref. 1221D901D1402C05). The condition of the defences varies from good to very poor and relates to the height from the high water mark. The higher, red brick walls are in a sound condition, displaying limited mortar washout (see photo below, top left). The lower, concrete and sandstone blockwork is of fair to poor condition with joint and minor blockwork washout and movement in the blockwork. Repair work is visible to the previous blockwork washout throughout the defence (see photo below, top right Asset Ref. 1221D901D1402C05). Joints require repointing to sections which are showing evidence of mortar loss. Access may be difficult as the pumping station is situated on private land.

High sea defences below the pumping station, including the upper tier of red brick walls (Asset Ref. 1221D901D1402C05)

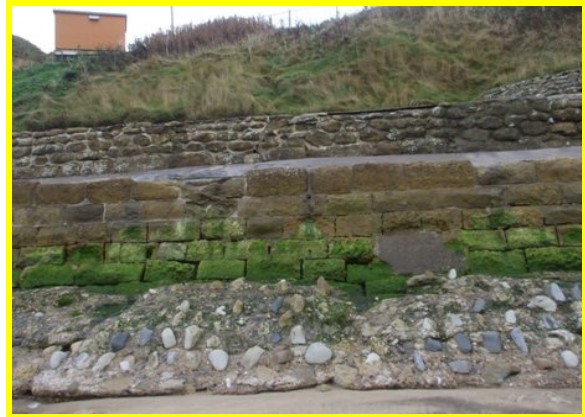
Lower section of concrete and sandstone, with joint wash out and repairs (Asset Ref. 1221D901D1402C05)

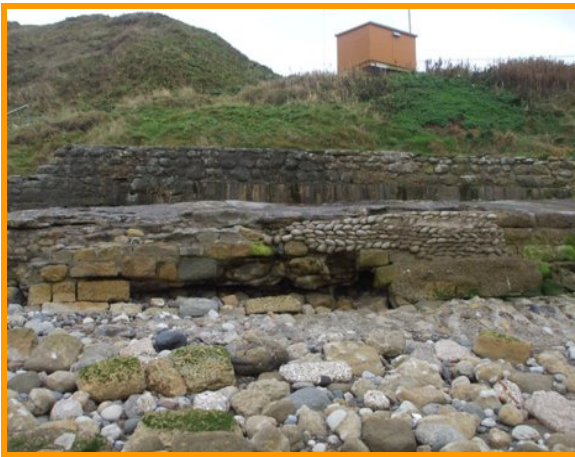
The southern end of the pumping station defences, consist of a patchwork of makeshift additions which lack unity (Asset Ref. 1221D901D1402C04, see photo below, bottom left). This has resulted in major undercutting, blockwork washout, parts of upper wall missing and significant damage. It is advised that the repair work for this asset is included in capital investment due to the amount of repair work needed. The last defence in the south is in fair to poor condition with large cracks and voids throughout the concrete apron (Asset Ref. 1221D901D1402C06). Repair work consisting of a concrete skim over the voids is apparent, although more repair work is needed to the voids. Any repairs here should be prioritised towards the area around the pumping station, where the defences are essential; however, public access to the beach is poor due to the condition of the defences.

Large voids to makeshift defences to the south of the pumping station (Asset Ref. 1221D901D1402C04)

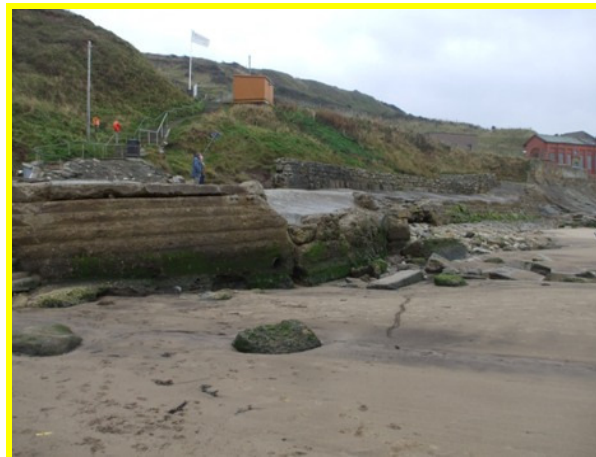
South end defence of the pumping station (Asset Ref. 1221D901D1402C06)

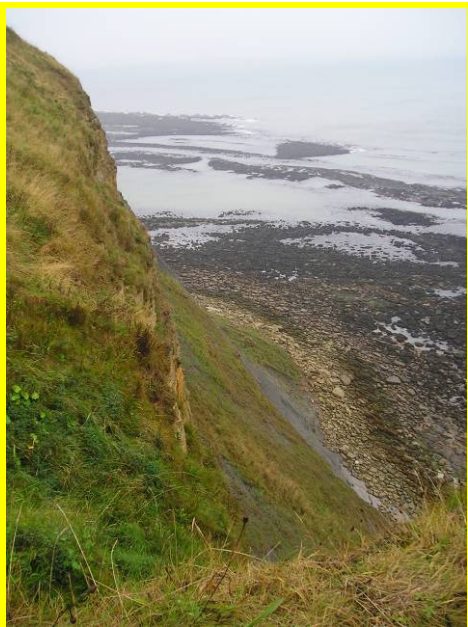
Units MU26/AF, MU26/AG and MU26/AH are located at The Wyke, to the west of Newbiggin Cliff and are all classified as Locally Active. These units are characterised by an upper layer composed of soft tills, a more resistant rock middle layer and a series of vegetated debris slumps at the unit toes. There is minor, localised activity within the upper layer including recession of the headscarp in places. The middle layer appears to be largely stable, albeit there is evidence of past rockfall at the cliff toe. The lower slopes are partly vegetated and subject to marine erosion.

MU26/AF Rockfall evidence at the unit toe
(Locally Active)

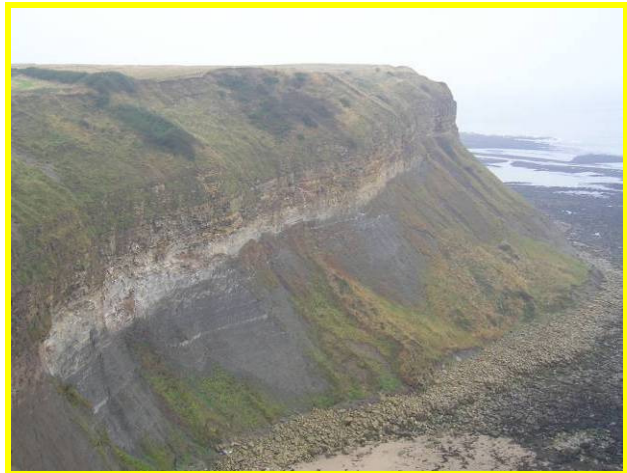
MU26/AG and MU26/AH Soft upper layer, resistant rock middle layer and debris cones at the toe
(Locally Active)

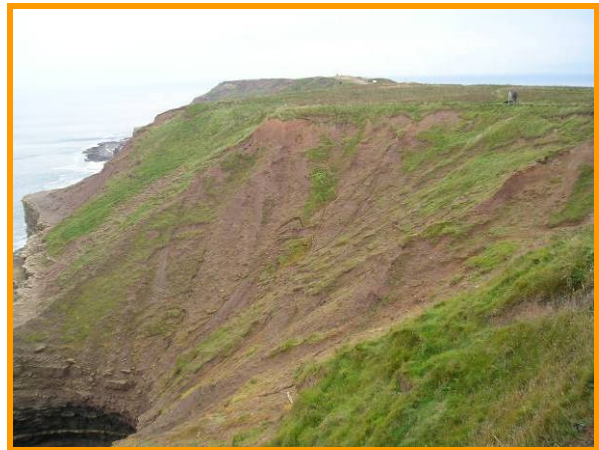
MU27/BC Slumping, sliding and rilling
(Partly Active)

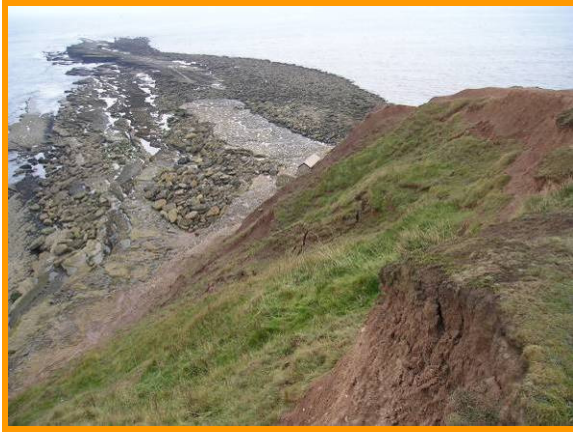
Units MU27/A to MU27/D, located around the end of Filey Brigg, are all classified as Partly Active. These units are composed entirely of the soft glacial material which particularly susceptible to erosion. Despite some vegetation cover, there is frequent cracking, slumping, sliding and toppling observed within these units.

MU27/B Cracking and slumping activity (Partly Active)

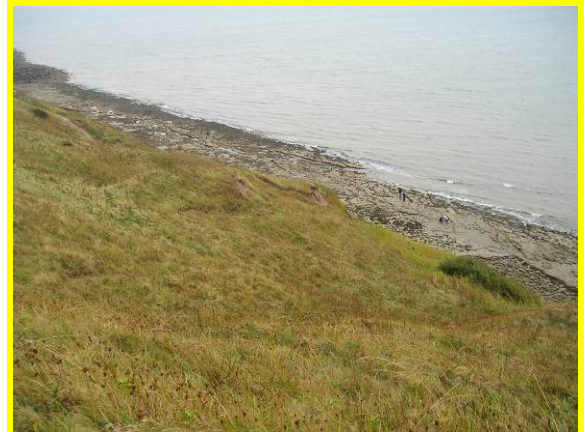
MU27/H Well vegetated slopes with localised erosion (Locally Active)

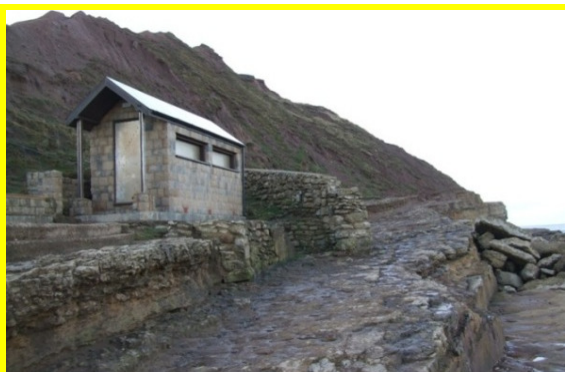
At the East end of Filey Brigg a cabin structure and wall exists tucked away against the cliffs. The structure comprises of a blockwork wall, poured concrete apron and blockwork cabin build onto the cliff strata. Undercutting is occurring to the apron as well as washout of the joints to the wall, the cabin is in structurally sound condition. Access is restricted due to the eroded path leading to the asset.

View of wall and cabin looking North West
(Asset Ref. 1221D901D1502C01001)

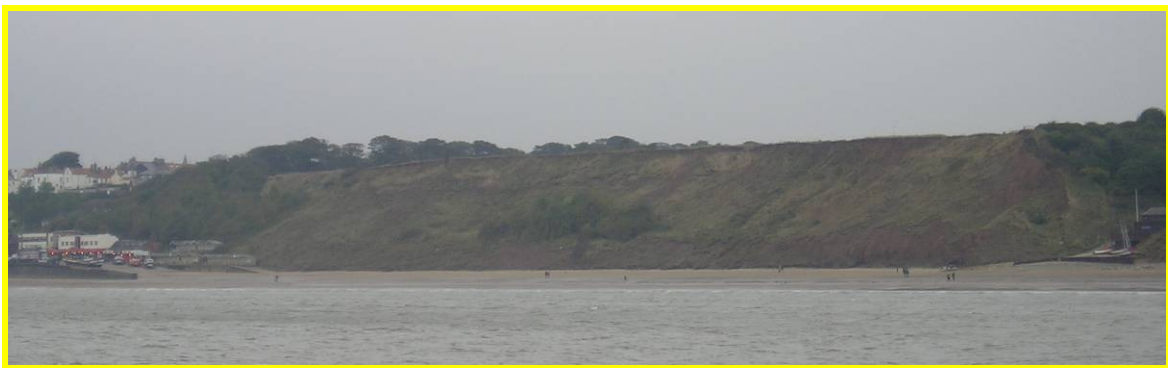
MU27/W and MU27/X Localised activity at the head and toe (Locally Active)

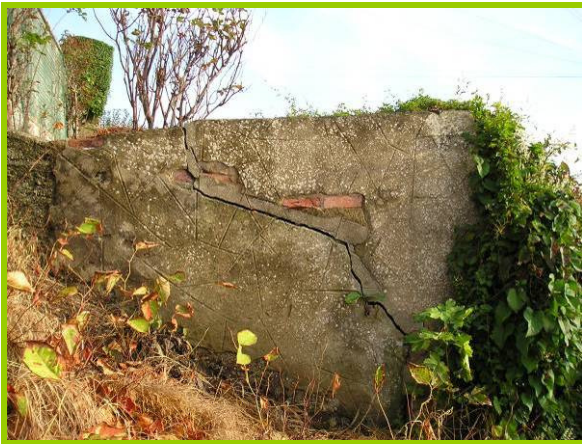
Much of the town frontage lies within **unit MU28/Y**. There is some evidence of minor instability, including cracks to footpaths, walls and other structures. Otherwise however, there are no obvious signs of activity on the coastal slopes. Therefore this unit is classified as Inactive, as it was in 2008.

MU28/Y Cracking to wall (Inactive)

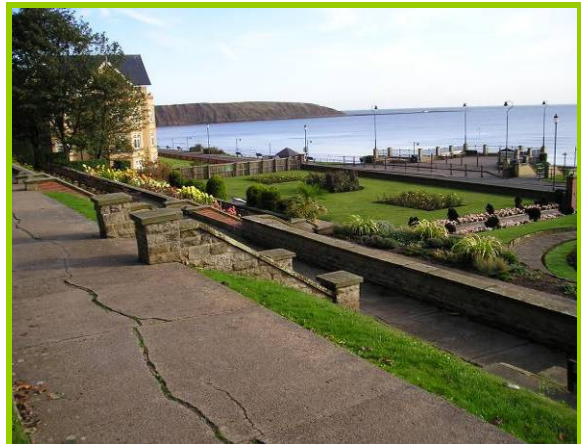
MU28/Y Repaired cracks to footpath (Inactive)

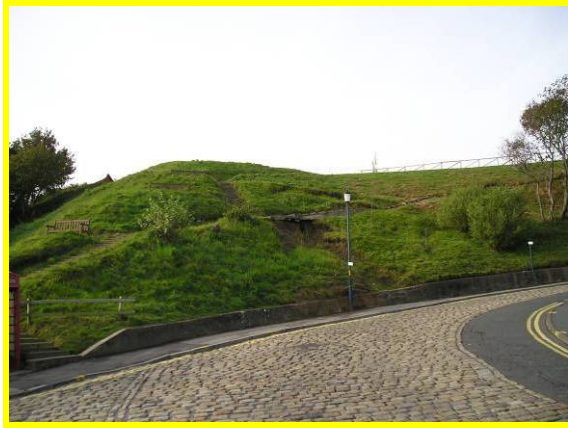
Unit MU28/Z is located at the southern end of Filey and is classified as Locally Active. There is evidence of ongoing minor instability in this area with the associated closure of footpaths; however this does not represent a change since 2008. Recently, significant slope stabilisation works have been undertaken within the ravine.

MU28/Z Recent landslide activity and footpath closure (Locally Active)

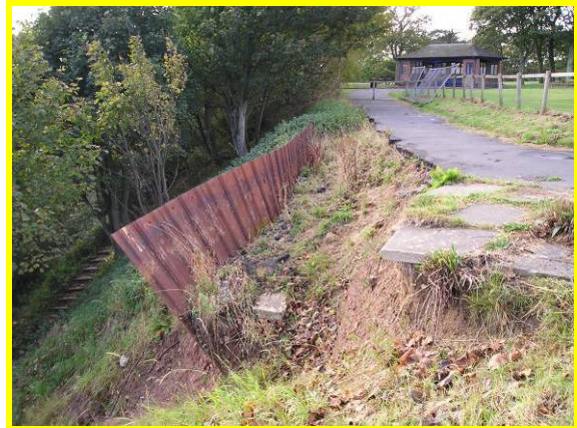
MU28/Z Ongoing slope instability and footpath closure (Locally Active)

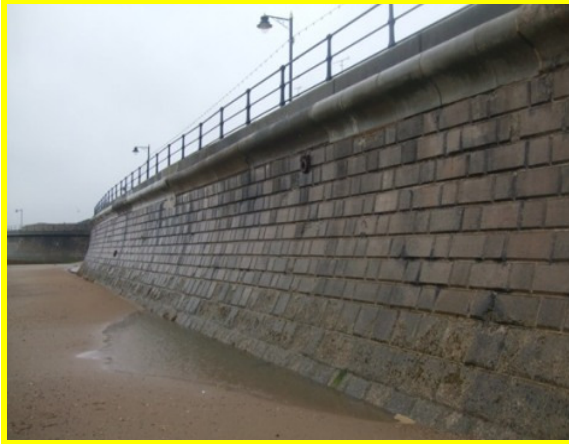
seen at the south section of The Beach Road (Asset Ref. 1221D901D1602C03). Although the overall condition is fair, some repair work is needed to the poor sections of the capping beam. Some urgent repair work is needed to the corroded and loose hand railing as this could pose a risk to public health and safety (Asset Ref. 1221D901D1602C03). Six access points (slipways) are built into the sea wall along with a number of outfalls or flap valves (200mm – 1500mm). Active repair work is also apparent. A short section of rock revetment is located at the southern end of the coastal defences, with gabion baskets beneath (Asset Ref. 1221D901D1602C02, see near Martin’s Gill). This defence extends into Sub-Management Unit Mu29A. The revetment does run through the whole defence, which may be the result of washout or on-going stability issues in the glacial sediments. An area of collapse has occurred at the north end of the defence where there is no apparent toe protection. The rock armour has degraded since the previous inspection. Improving compaction of armour and rebuilding south end would be beneficial to the defence.

Erosion to sea wall and replaced capping beam
(Asset Ref. 1221D901D1602C03)

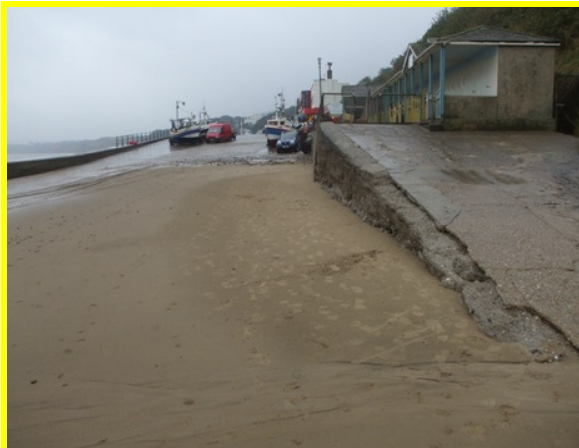
Individual slipway and stair structures were included in the inspection for the Filey stretch of defences. These structures were all in fair condition with the residual life of the assets ranging from 11-20 to over 20 years. Most of the slipways need some minor form of repair due to cracks appearing and joints needing re-pointing. Erosion to parts of the stair structures is evident with the edges of the stairs rounded and in need of re edging.

Erosion to the slipway wall
(Asset Ref. 1221D901D1602C09002)

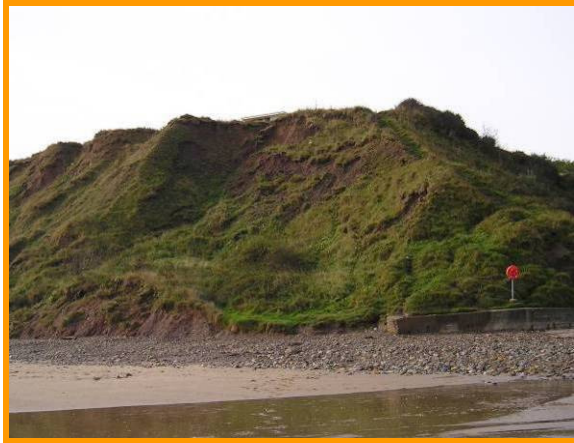
MU29/AJ Very common areas of intense erosion
(Partly Active)

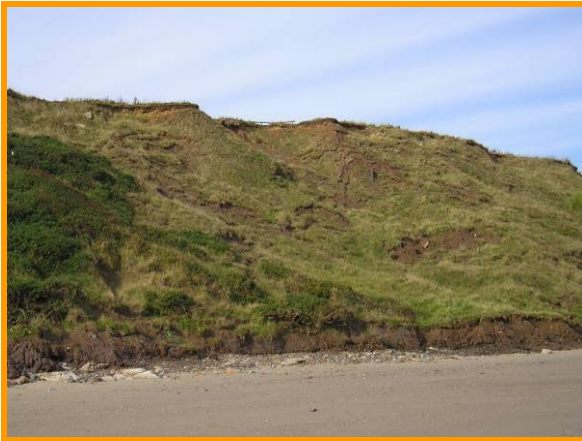
Unit MU29/AO is a small unit located just north of Flat Cliff. This unit is characterised by very common areas of intense erosion, sliding and cracking. There is recession at the headscarp and erosion at the unit toe. This unit has experienced a minor increase in activity since the 2008 walkover survey and is now classified as Partly Active.

MU29/AO Intense erosion at the toe and headscarp, sliding mid-slope (Partly Active)

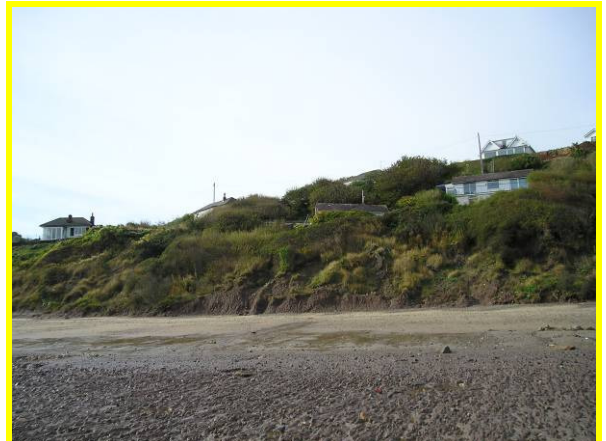
MU29/AR Toe erosion at Flat Cliff
(Locally Active)

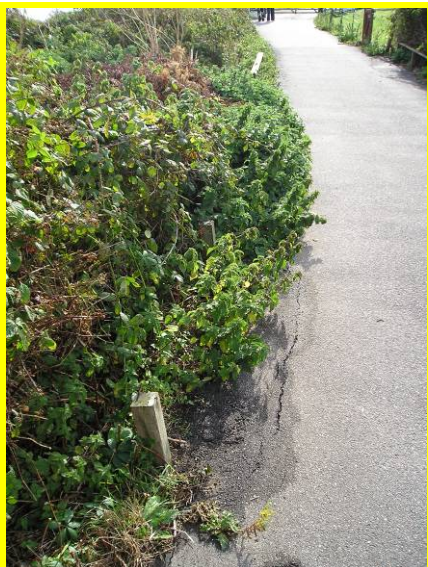
MU29/AS Minor cracks to the road at Flat Cliff
(Locally Active)

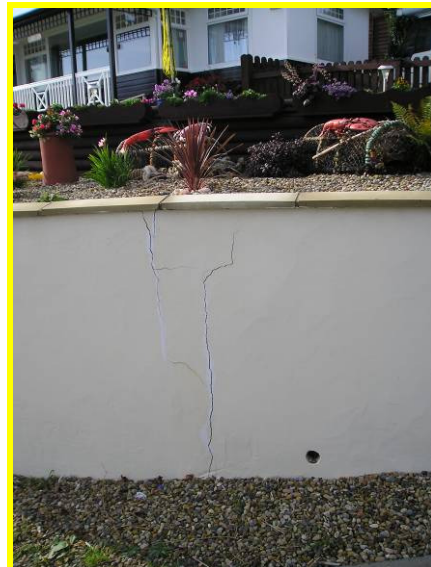
MU29/AS Cracking of a wall at Flat Cliff
(Locally Active)

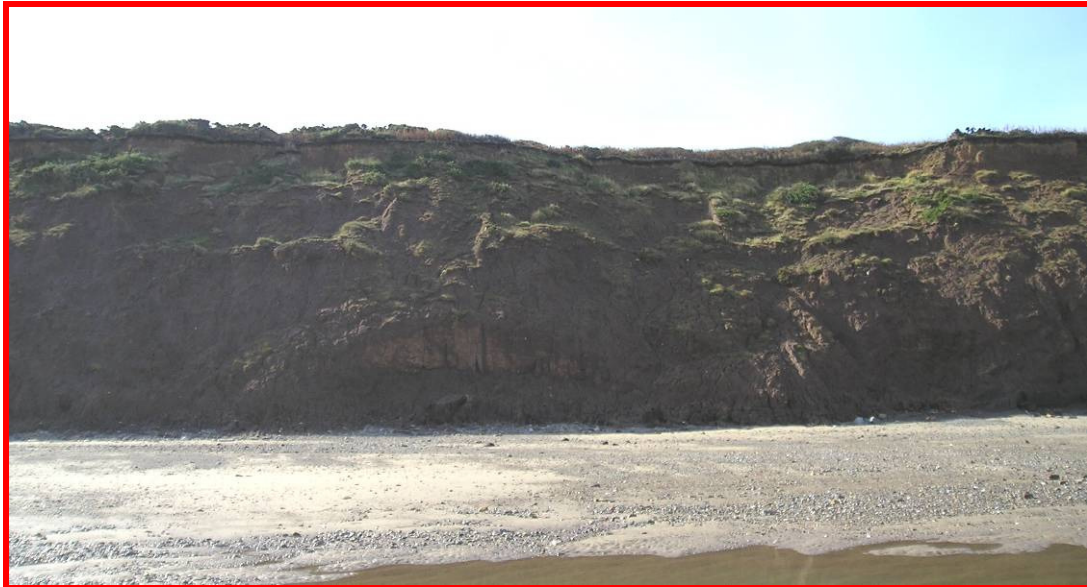
MU29/BH Headscarp recession and slumping of material onto the beach (Totally Active)

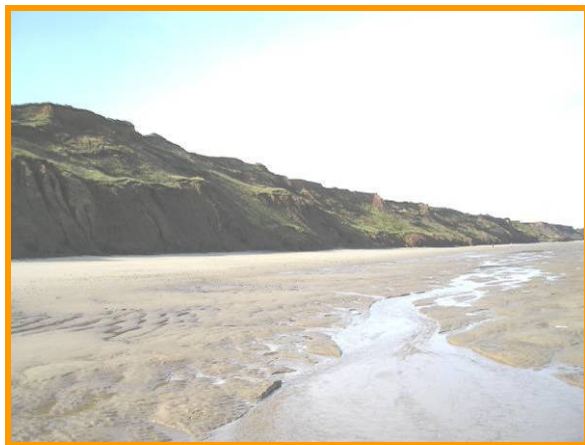
Further south, **units MU29/BI to MU29/BQ** are located above Reighton Sands and all classified as Partly Active. These units are characterised by steep slopes which support some vegetation cover. There is recession of the headscarp, common areas of intense erosion mid-slopes and a steep, eroding toe section.

MU29/BN to MU29/BQ (approx.) Intense erosion of the unit toes (Partly Active)

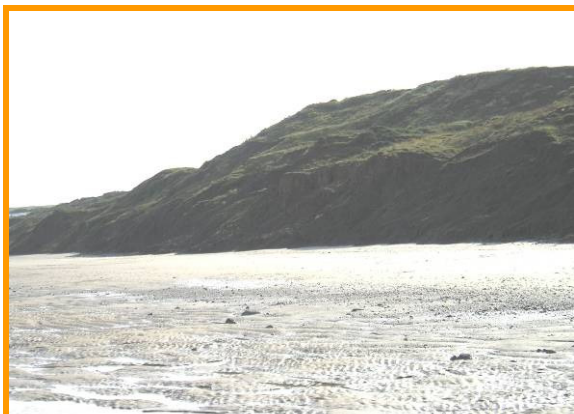
Units MU29/BR, MU29/BS and MU29/CA form the majority of this Sub-Management Unit and were all assigned the Partly Active classification during the 2009 walkover survey. These units support some vegetation cover, but are actively eroding at the head and toe with slumping onto the beach. Mid-slope there is also a fair amount of intense erosion in the form of cracking and mudsliding.

MU29/BR Active toe erosion (Partly Active)

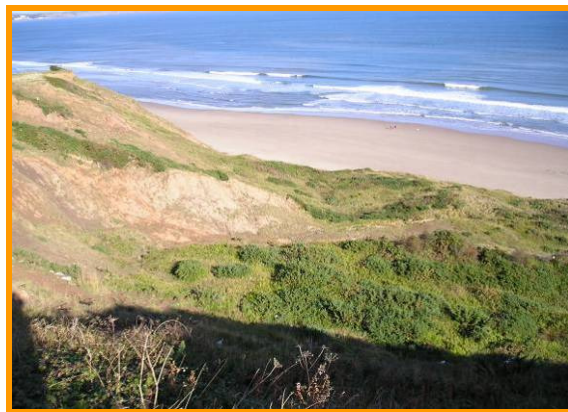
MU29/CA Intense erosion and mudsliding near unit head (Partly Active)

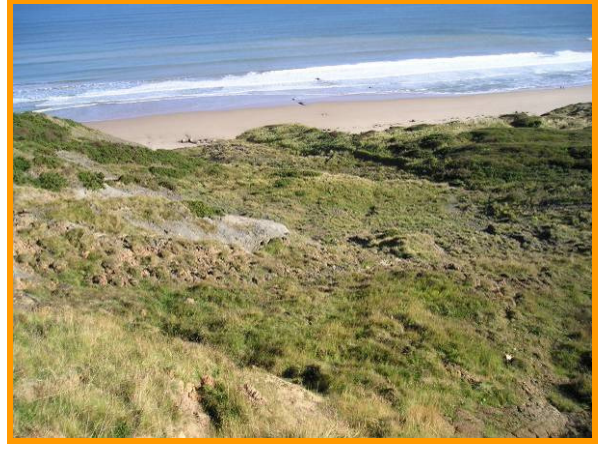
Unit MU29/CD forms another large shallow embayment which is also well vegetated. Despite this though, the slopes are almost entirely affected by activity in the form of cracking and sliding especially on the mid-slopes. As a result this unit is classified as Partly Active – this represents a minor increase in activity since the 2008 walkover survey.

MU29/CD Mid-slope cracking and sliding
(Partly Active)
