Walk-over Visual Inspections of Assets – Final Report

Prepared for
Scarborough Borough Council

July 2015

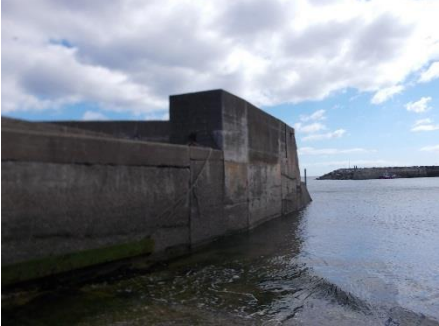
SBC Reference:	N/A		
NFCDD reference:	1221D901D0402C03

Asset Location:	NZ78251893, NZ78301893. RNLI slipway.	
	Asset Length:	55.3	
	Condition Assessment		
	Condition	Priority	Risk
	B	3	
	Brief Description		
	Exposed aggregate at the face of the wall, also horizontal cracks to wall. Slipway surface in good condition, but timber piles cracked and weathered. Gabion wall has presumably been replaced with a Conventional retaining wall with concrete capping. Guide rail to slipway corroded but in fair condition.		
	Recommendations		
	Monitoring and repairs cracks to wall.

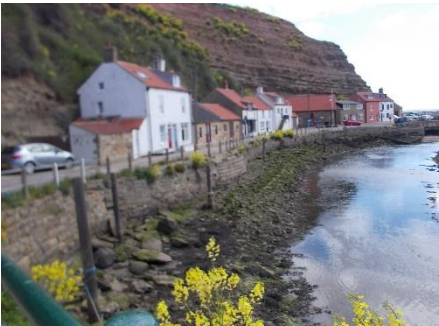
SBC Reference:	N/A		
NFCDD reference:	1221D901D0402C06

Asset Location:	Staithes, LB of River D/S of footbridge.	
	Asset Length:	100.3	
	Condition Assessment		
	Condition	Priority	Risk
	C	3	
	Brief Description		
	Promenade in fair condition. Wall has missing blocks and open joints. Toe armour, where present near ends not well packed. Vegetation at top of wall.		
	Recommendations		
	Replace missing blocks and grout open joints. Reinforce toe rock armour.

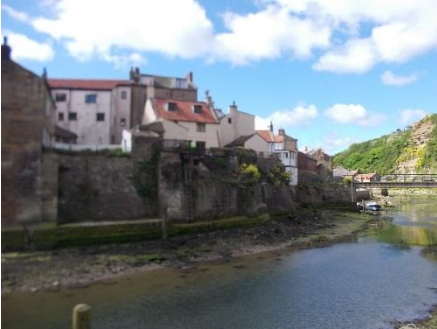
SBC Reference:	N/A		
NFCDD reference:	1221D901D0402C04

Asset Location:	NZ78261889, NZ78301886. South bank from bridge.	
	Asset Length:	117.1	
	Condition Assessment		
	Condition	Priority	Risk
	B	3	
	Brief Description		
	Repair work to parts of wall evident. Cracking in upper masonry sections but lower sections repaired. Vegetation re growing in parts of the wall. Minor cracks evident thought wall. New wire gabion wall & berm upstream from bridge. Riparian sea walls only visible from the bridge and from the opposite bank.		
	Recommendations		
Monitor, repair cracks fill voids

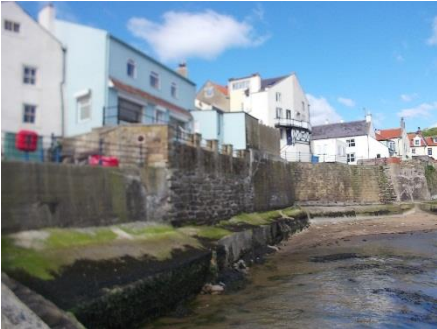
SBC Reference:	02-04-01		
NFCDD reference:	1221D901D0402C22

Asset Location:	Between slipway and groyne on South wall.	
	Asset Length:	47.7	
	Condition Assessment		
	Condition	Priority	Risk
	B	3	
	Brief Description		
	Repairs evident to cracks and missing blocks replaced. Undercutting of the toe in places. Groyne in good condition. Missing joints to slipway wall. Only visible from the adjacent slipway due to rising tides. No major damage apparent from a distance.		
	Recommendations		
Repairs to walls joints, cracks and toe.

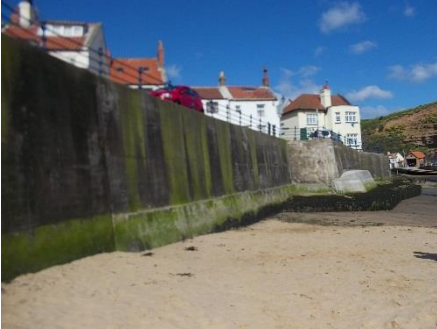
SBC Reference:	03-04-01		
NFCDD reference:	1221D901D0402C05

Asset Location:	NZ78301886, NZ78361882. Between East groyne and slipway.	
	Asset Length:	70.5	
	Condition Assessment		
	Condition	Priority	Risk
	B	3	
	Brief Description		
	Multiple cracks and spalling, but signs of multiple repair works. Void at root of slipway West side. Some loose blocks to slip walls. Cracks along promenade. Slipway very slippery. Additional toe berm placed along short length since 2012. Cope repair patches holding.		
	Recommendations		
	Continue to monitor and repair cracks and joints.

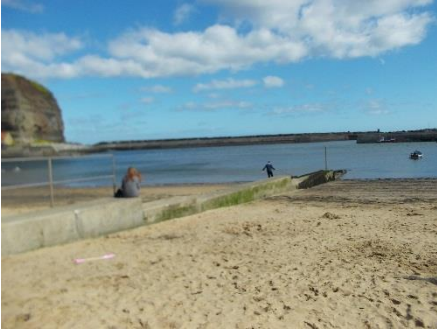
SBC Reference:	N/A		
NFCDD reference:	1221D901D0403C07

Asset Location:	NZ78361882, NZ78381885. In-between South slipways.	
	Asset Length:	32	
	Condition Assessment		
	Condition	Priority	Risk
	B	3	
	Brief Description		
	Horizontal cracking to second step, rest of groyne in good condition, minor vegetation growth at seaward end. Vertical crack between second and third step on inner side Top concrete revetment crumbling in places.		
	Recommendations		
	Continue to monitor

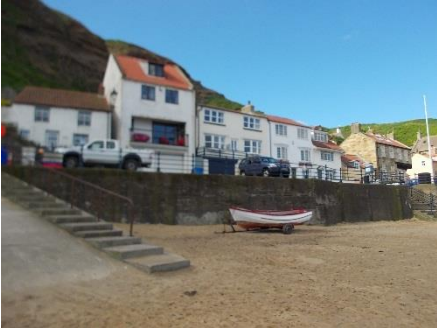
SBC Reference:	04-04-01		
NFCDD reference:	1221D901D0403C01

Asset Location:	NZ78361882, NZ78421880 South wall next to last slipway.	
	Asset Length:	73.1	
	Condition Assessment		
	Condition	Priority	Risk
	B	3	
	Brief Description		
	Vertical full height crack through the wall between stairs and groyne has been filled. Exposure of aggregate throughout wall. Vegetation re growing at top of wall. Cracking to promenade.		
	Recommendations		
Continue to monitor and repair crack to wall and promenade cracking

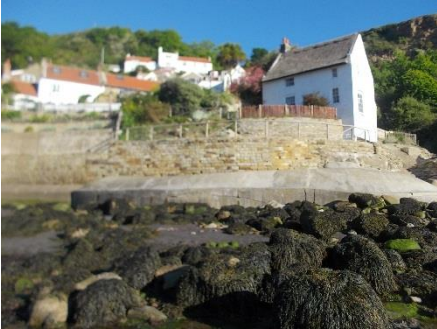
SBC Reference:	07-07A-03		
NFCDD reference:	1221D901D0601C06

Asset Location:	North side of Runswick Bay	
	Asset Length:	25.3	
	Condition Assessment		
	Condition	Priority	Risk
	B	3	
	Brief Description		
	Cracks to top of bagwork. Some horizontal cracks at base of toe. Repair work evident to large cracks. Cracks to wall, as well as repair work evident to previous cracks. Some missing masonry blocks.		
	Recommendations		
	Continue to monitor and repair cracks, replace blocks

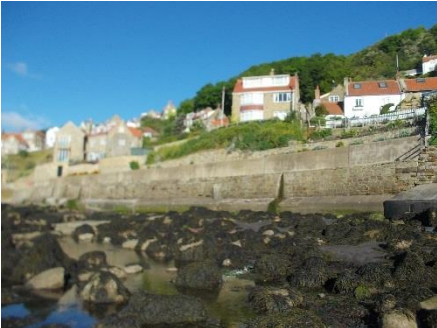
SBC Reference:	08-07A-01		
NFCDD reference:	1221D901D0601C03

Asset Location:	NZ81001604, NZ81081614. North of breakwater.	
	Asset Length:	91.3	
	Condition Assessment		
	Condition	Priority	Risk
	B	3	
	Brief Description		
	Washout of the joints to masonry block wall. Repairs to coping masonry and crest evident. Cracks to toe berm. Some cracks to promenade. Repairs to steps and toe being undercut. Beach low West of outfall exposing mudstone platform.		
	Recommendations		
	Repair cracks, voids and undercutting. Consider extending the rock scour protection.

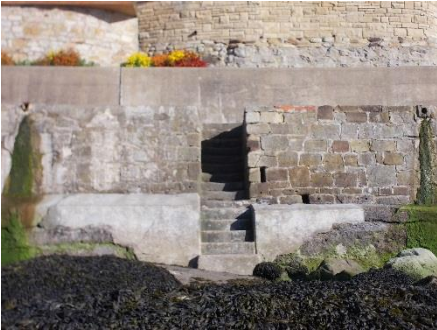
SBC Reference:	08-07A-02		
NFCDD reference:	1221D901D0601C03001

Asset Location:		
	Asset Length:	~7	
	Condition Assessment		
	Condition	Priority	Risk
	B	3	
	Brief Description		
	Steep and weathered stone block. Bottom half repaired with concrete. The last tread to the beach is noticeably high.		
	Recommendations		
	Continue to monitor

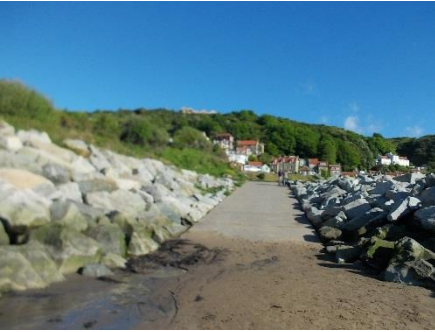
SBC Reference:	10-07B-01		
NFCDD reference:	1221D901D0602C01001

Asset Location:	NZ81051591, NZ81011601	
	Asset Length:	~50	
	Condition Assessment		
	Condition	Priority	Risk
	B	4	>5
	Brief Description		
	Slipway in good condition. Filler joints missing		
	Recommendations		
Continue to monitor

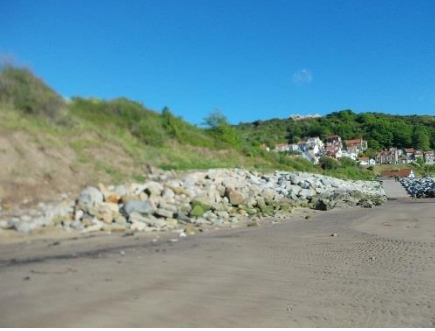
SBC Reference:	10-07B-02		
NFCDD reference:	1221D901D0602C01002

Asset Location:		
	Asset Length:	~48	
	Condition Assessment		
	Condition	Priority	Risk
	B	2	
	Brief Description		
	Rock armour mostly good condition but some movement / loose blocks at both ends by southern slipway. Cliff slumping and eroding to south.		
	Recommendations		
Continue to monitor

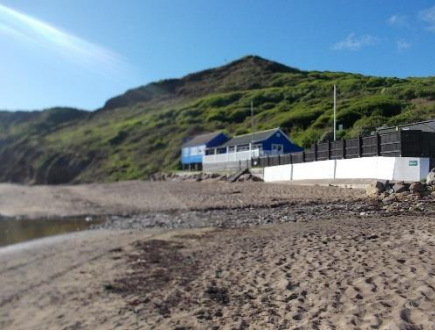
SBC Reference:	N/A		
NFCDD reference:	1221D901D0602C05

Asset Location:	South end of bay.	
	Asset Length:	56.2	
	Condition Assessment		
	Condition	Priority	Risk
	C	2	
	Brief Description		
	Wall concrete toe not visible due to high beach level. Timber sleeper retaining wall has been undercut. Cracks throughout concrete tank blocks at South end of wall. Timber toe exposed at North end. Planks rotten		
	Recommendations		
Continue to monitor and repair/replace timber

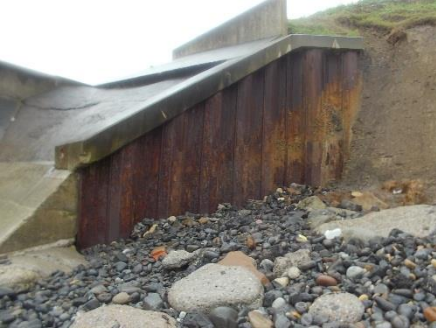
SBC Reference:	13-09A-01		
NFCDD reference:	1221D901D0701C02 001

Asset Location:	NZ86061286, NZ85981297. Wall protecting car park.	
	Asset Length:	~5	
	Condition Assessment		
	Condition	Priority	Risk
	C	3	
	Brief Description		
	Sheet piles retaining wall tied into the unprotected cliff. Remains of the mudrock can be seen on the sheet pile suggesting a possible erosion of the cliff and undermining of the sheet pile retaining wall. However no deflection / movement of the pile noticeable. Concrete capping appears in good condition.		
	Recommendations		
Continue to monitor

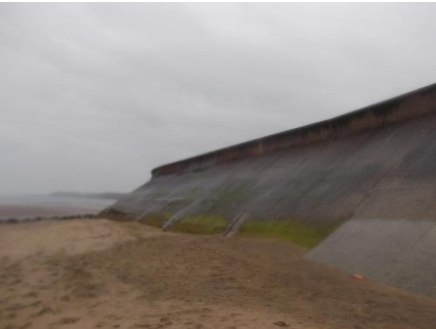
SBC Reference:	13-09A-02		
NFCDD reference:	1221D901D0701C02

Asset Location:	NZ86061286, NZ85981297. Wall protecting car park.	
	Asset Length:	174.5	
	Condition Assessment		
	Condition	Priority	Risk
	B	3	
	Brief Description		
	Toe of wall exposed and undercut in many places. Toe armor displaced. Exposure of rebar to bottom of wall at North end. Bottom part of wall abraded exposing rebar. No rebar exposure observed in 2015 as the toe was covered by sand during the inspection except at the South end. Horizontal joint (half way up the wall) opened widely.		
	Recommendations		
Repair toe armour/undercutting to toe and cover exposed re bar. Replace missing blocks.

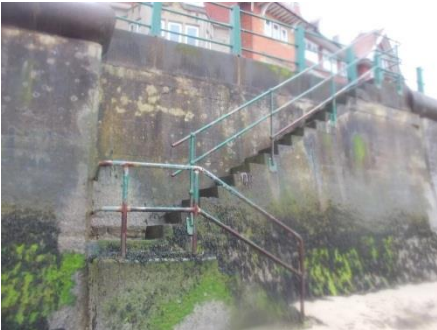
SBC Reference:	14-09B-02		
NFCDD reference:	1221D901D0702C01001

Asset Location:		
	Asset Length:	~4	
	Condition Assessment		
	Condition	Priority	Risk
	B	3	
	Brief Description		
	Steps covered by vegetation. Handrail corroded with missing bottom rail at lower end. Concrete weathered in places.		
	Recommendations		
Replace handrail

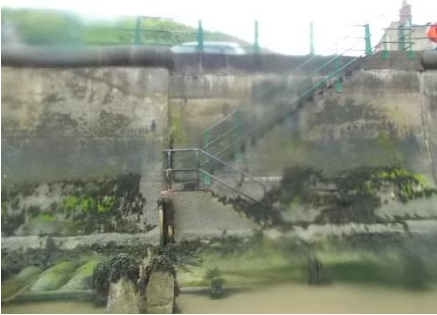
SBC Reference:	14-09B-04		
NFCDD reference:	1221D901D0702C01003

Asset Location:		
	Asset Length:	~4	
	Condition Assessment		
	Condition	Priority	Risk
	B	3	
	Brief Description		
	Steps in fair condition		
	Recommendations		
Continue to monitor

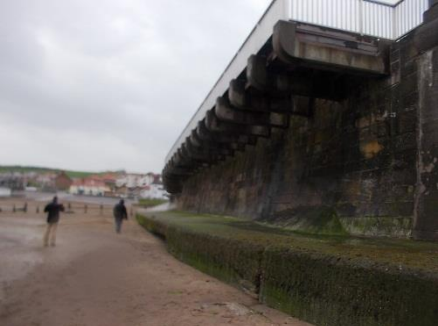
SBC Reference:	15-09B-01		
NFCDD reference:	1221D901D0702C04

Asset Location:	NZ86251264, NZ86241268. NE of East Row Bridge.	
	Asset Length:	42.1	
	Condition Assessment		
	Condition	Priority	Risk
	B	3	
	Brief Description		
	Beach higher than 2012 covering possible voids under apron. See 2012 insp. Toe piles exposed look very corroded. Groynes derelict. Vertical crack to masonry wall near pipe at centre of wall. Some mortar missing in some joints in masonry wall. Timber walkway being replaced.		
	Recommendations		
Expose and repair voids under toe apron.

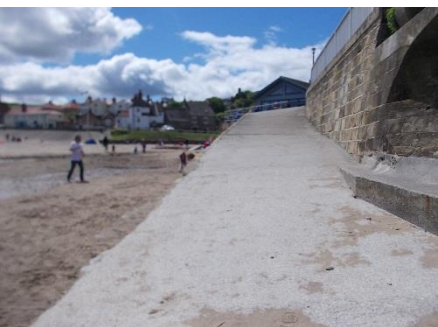
SBC Reference:	15-09B-02		
NFCDD reference:	1221D901D0702C03

Asset Location:		
	Asset Length:	~10	
	Condition Assessment		
	Condition	Priority	Risk
	B	3	
	Brief Description		
	Slipway in fair condition overall		
	Recommendations		
Continue to monitor

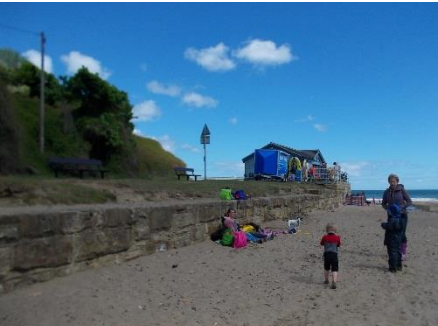
SBC Reference:	15-09B-03		
NFCDD reference:	1221D901D0702C03001

Asset Location:	NZ86211252, NZ86251264. Wall extending from East Row Bridge	
	Asset Length:	232.4 total (15-09b-03 to 15-09b-05)	
	Condition Assessment		
	Condition	Priority	Risk
	B	3	
	Brief Description		
	Masonry blockwork wall to channel sides in fair to good condition. Minor abrasion to a few blocks, missing mortar in joints near cafe.		
	Recommendations		
Repoint wall. Continue to monitor

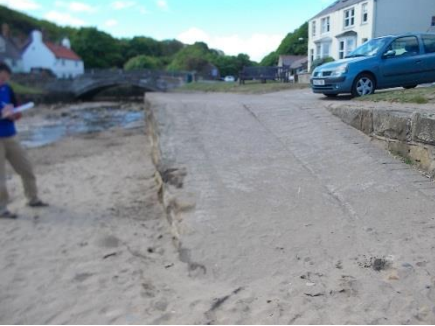
SBC Reference:	15-09B-04		
NFCDD reference:	1221D901D0702C03 002

Asset Location:		
	Asset Length:	~4	
	Condition Assessment		
	Condition	Priority	Risk
	B	3	
	Brief Description		
	Fair overall condition. Edge capping stone missing. Toe below beach level		
	Recommendations		
Repair capping edge

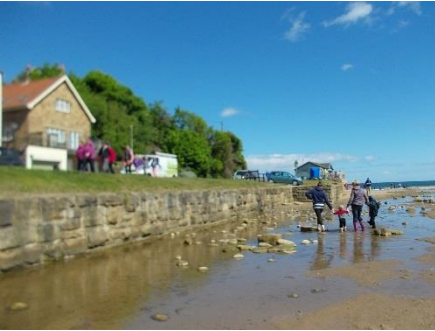
SBC Reference:	15-09B-05		
NFCDD reference:	1221D901D0702C03 003

Asset Location:		
	Asset Length:	232.4 total (15-09b-03 to 15-09b-05)	
	Condition Assessment		
	Condition	Priority	Risk
	B	3	
	Brief Description		
	Masonry blockwork wall to channel sides in fair to good condition. Low retaining stone wall is in a good condition on both banks.		
	Recommendations		
Continue to monitor

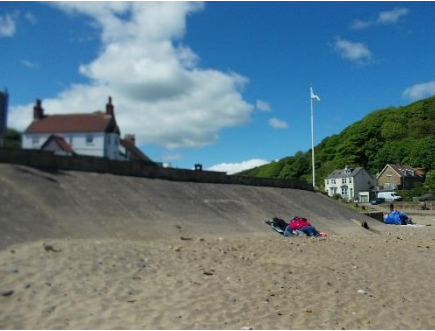
SBC Reference:	15-09B-06		
NFCDD reference:	1221D901D0702C02

Asset Location:	NZ86281257, NZ86981226. North of Raven Hill.	
	Asset Length:	774.5 total (15-09b-06 to 17-10-02)	
	Condition Assessment		
	Condition	Priority	Risk
	B	4	5
	Brief Description		
	Concrete revetment is in a fair condition with no particular defects observed. Toe covered by sand. Revetment material changes to masonry blockwork towards river crossing and is in good condition.		
	Recommendations		
Continue to monitor

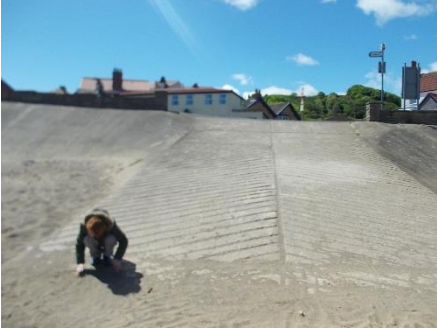
SBC Reference:	15-09B-07		
NFCDD reference:	1221D901D0702C02001

Asset Location:		
	Asset Length:	774.5 total (15-09b-06 to 17-10-02)	
	Condition Assessment		
	Condition	Priority	Risk
	B	4	>5
	Brief Description		
	Slipway in good condition - toe below beach level		
	Recommendations		
Continue to monitor

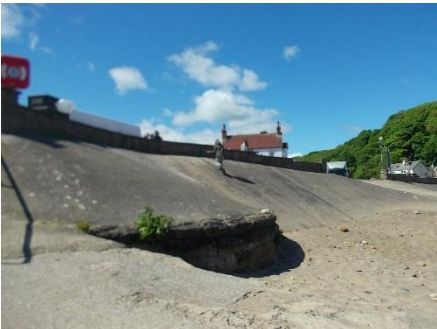
SBC Reference:	16-09C-01		
NFCDD reference:	1221D901D0702C02002

Asset Location:		
	Asset Length:	774.5 total (15-09b-06 to 17-10-02)	
	Condition Assessment		
	Condition	Priority	Risk
	B	4	5
	Brief Description		
	Good condition – Good revetment with toe below beach level		
	Recommendations		
Continue to monitor

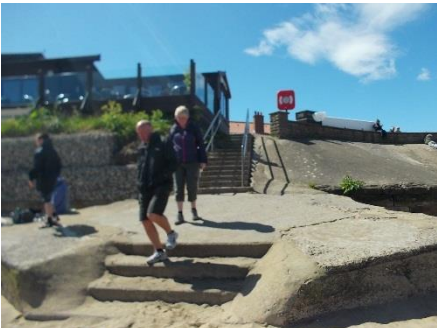
SBC Reference:	16-09C-02		
NFCDD reference:	1221D901D0702C02003

Asset Location:		
	Asset Length:	774.5 total (15-09b-06 to 17-10-02)	
	Condition Assessment		
	Condition	Priority	Risk
	B	3	
	Brief Description		
	Steps in good overall condition. Concrete revetment on the landing, weathered in places		
	Recommendations		
Continue to monitor

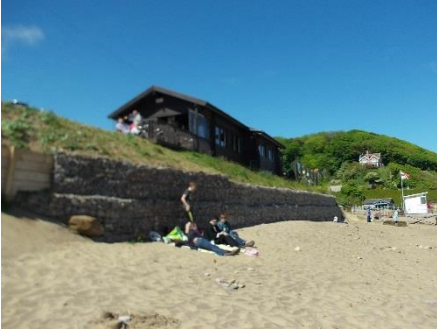
SBC Reference:	16-09C-03		
NFCDD reference:	1221D901D0702C02004

Asset Location:		
	Asset Length:	774.5 total (15-09b-06 to 17-10-02)	
	Condition Assessment		
	Condition	Priority	Risk
	B	2	
	Brief Description		
	The gabion baskets have not filled completely with visible sagging on the bottom row. The top row has remained vertical but suggest this is monitored. Seems to be holding at the moment. Baskets founded on stone blocks visible at Northern end.		
	Recommendations		
Continue to monitor

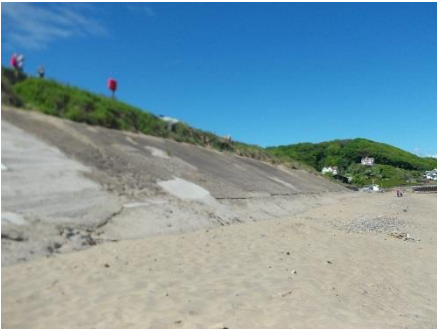
SBC Reference:	16-09C-04		
NFCDD reference:	1221D901D0702C02005

Asset Location:		
	Asset Length:	774.5 total (15-09b-06 to 17-10-02)	
	Condition Assessment		
	Condition	Priority	Risk
	C	2	
	Brief Description		
	Cracks throughout revetment and missing sections of concrete overlay exposing rubble and stone under layer and voids. Evidence of multiple repairs (presumably following surge in December 2013). Undercutting to bottom of revetment. Improvement scheme planned. Timber soldier piled wall (i.e. transition between the concrete revetment and the gabion baskets) appears in good condition.		
	Recommendations		
Keep patching up until scheme in place

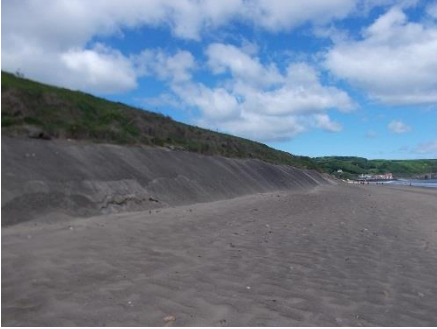
SBC Reference:	17-10-01		
NFCDD reference:	1221D901D0702C02009

Asset Location:		
	Asset Length:	774.5 total (15-09b-06 to 17-10-02)	
	Condition Assessment		
	Condition	Priority	Risk
	C	2	
	Brief Description		
	Cracks throughout revetment and missing sections of concrete overlay exposing rubble and stone under layer and voids. Evidence of multiple repairs (presumably following surge in December 2013) Improvement scheme planned. Toe below beach level but scour holes and undercutting present in many places.		
	Recommendations		
Continue patching up until scheme in place

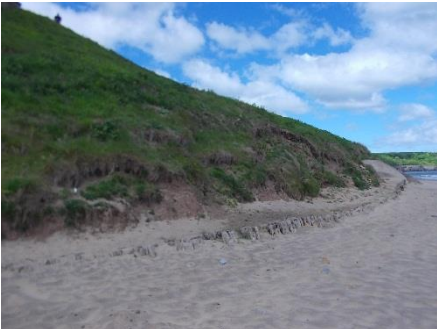
SBC Reference:	17-10-02		
NFCDD reference:	1221D901D0702C02010

Asset Location:		
	Asset Length:	774.5 total (15-09b-06 to 17-10-02)	
	Condition Assessment		
	Condition	Priority	Risk
	C	1	
	Brief Description		
	Timber toe exposed and rotten. Bank slip failure behind evident		
	Recommendations		
Incorporate into repair scheme for wall section 17-10-01

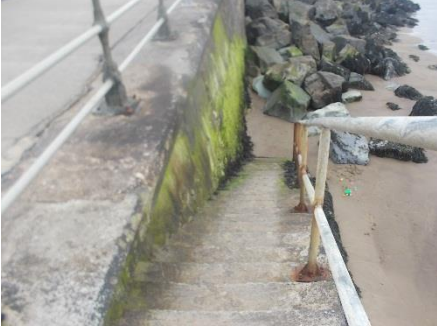
SBC Reference:	70-11A-04		
NFCDD reference:	1221D901D0802C02003

Asset Location:	Western promenade, Whitby	
	Asset Length:	216.1 (inc 70-11a-01 to 70-11a-04)	
	Condition Assessment		
	Condition	Priority	Risk
	C	3	
	Brief Description		
	Steps. Tread condition fair. Damaged capping and side wall corner - heavily abraded with missing blocks. Handrail corroded and loose fixing at the bottom		
	Recommendations		
	Treat or replace handrails. Repair capping and replace blocks

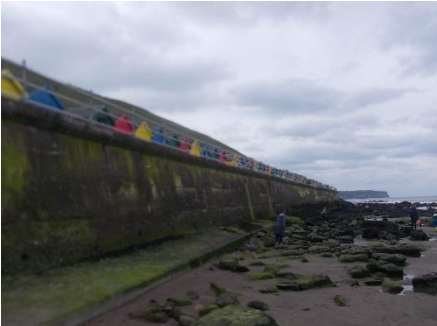
SBC Reference:	71-11A-01		
NFCDD reference:	1221D901D0802C03

Asset Location:	NZ88861170, NZ89231154	
	Asset Length:	166.8	
	Condition Assessment		
	Condition	Priority	Risk
	C	2	
	Brief Description		
	Lower half of wall abraded/eroded. Toe exposed along whole length due to low sand level - heavily undercut/eroded & missing in part. Apron missing locally and in poor condition. Prom fair, signs of wave overtopping causing damage. Handrails anchor bolts corroding. The concrete toe has been repaired at the southern end.		
	Recommendations		
	Consider extending rock armour along this section

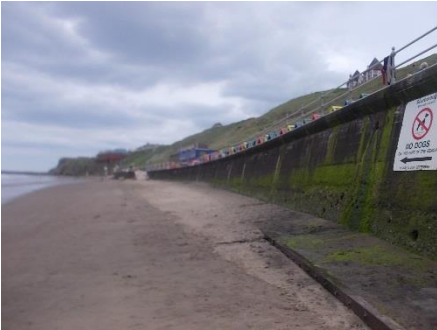
SBC Reference:	71-11A-03		
NFCDD reference:	1221D901D0802C13

Asset Location:	NZ88861170, NZ89231154	
	Asset Length:	158.4	
	Condition Assessment		
	Condition	Priority	Risk
	C	2	
	Brief Description		
	Horizontal cracks to wall visible near slipway East of beach cafe. Beach level higher than 2012, toe not exposed. Cracks in joint along prom 0.5m from edge. Handrail has been replaced. Some anchor bolts showing signs of corrosion. Concrete facing weathered with exposed aggregates near the toe of the wall.		
	Recommendations		
Repair cracks to wall near slipway. Fill/seal joint prom gaps. Repair Toe

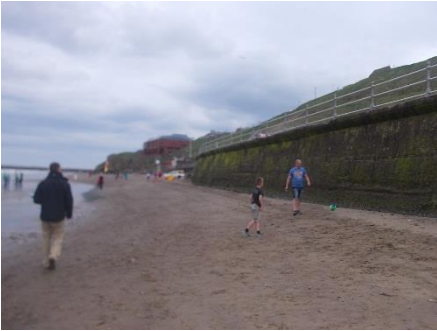
SBC Reference:	71-11A-05		
NFCDD reference:	1221D901D0802C14

Asset Location:	NZ88861170, NZ89231154	
	Asset Length:	86.2	
	Condition Assessment		
	Condition	Priority	Risk
	C	2	
	Brief Description		
	Erosion/abrasion to lower half of wall. Minor damage throughout. Apron not visible. Minor cracking to prom throughout. Areas of chipping/cracking along top edge. Handrails have been replaced.		
	Recommendations		
Repair chipped areas approx. 0.5m from edge throughout

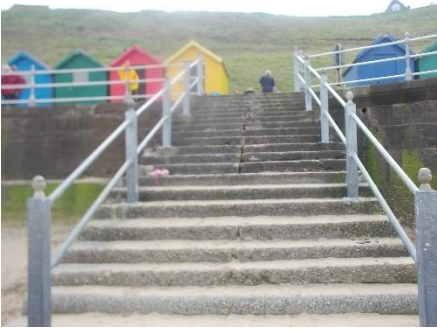
SBC Reference:	20-11A-01		
NFCDD reference:	1221D901D0802C04001

Asset Location:	Western promenade, Whitby	
	Asset Length:	~7	
	Condition Assessment		
	Condition	Priority	Risk
	C	3	
	Brief Description		
	Steps. Weathered concrete revetment with exposed aggregates. Abraded side walls with large cracks. Handrail in fair condition.		
	Recommendations		
Repair cracks. Continue to monitor

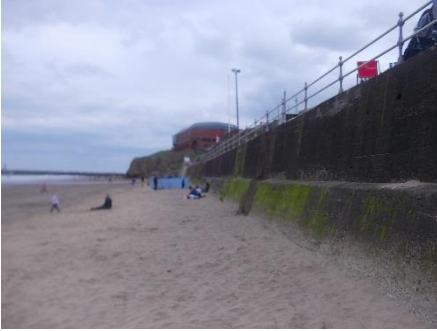
SBC Reference:	20-11A-02		
NFCDD reference:	1221D901D0802C04

Asset Location:	NZ89231154, NZ89291153	
	Asset Length:	65.4	
	Condition Assessment		
	Condition	Priority	Risk
	C	3	
	Brief Description		
	<p>Large horizontal crack below capping level at the northern end with concrete capping block missing locally and one vertical crack in southern third of wall. Erosion/abrasion to lower half of wall. Lower handrails have been replaced (set back from edge). Minor cracking to promenade.</p>		
	Recommendations		
	Repaint upper level hand rails, repair eroded front face. Repair cracks and replace blocks

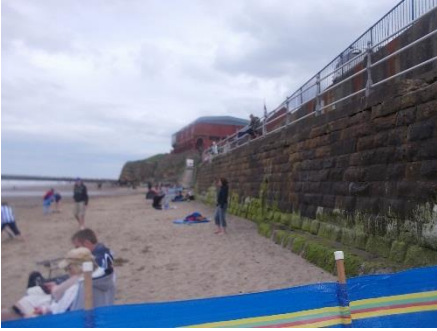
SBC Reference:	21-11A-01		
NFCDD reference:	1221D901D0802C07

Asset Location:	NZ89291153, NZ89361152	
	Asset Length:	71.9	
	Condition Assessment		
	Condition	Priority	Risk
	C	3	
	Brief Description		
	<p>Blockwork wall - cracking/loss of mortar and blocks in places locally poor. Joints and capping block missing locally. Generally stable although these points of weakness could cause failure. Higher concrete wall in a fair condition. Minor cracking in promenade. Corrosion to upper hand rails.</p>		
	Recommendations		
	Repair/replace damaged blocks and grout joints

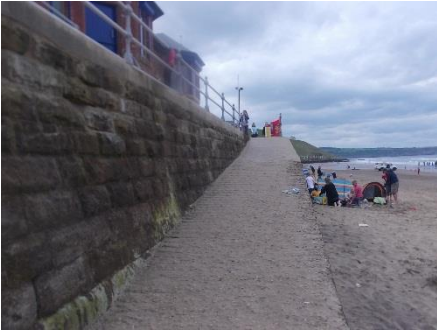
SBC Reference:	21-11A-02		
NFCDD reference:	1221D901D0802C07001

Asset Location:		
	Asset Length:	~30	
	Condition Assessment		
	Condition	Priority	Risk
	C	3	
	Brief Description		
	Slipway. Concrete deck replaced on the top half of the structure - bottom half abraded		
	Recommendations		
Continue to monitor

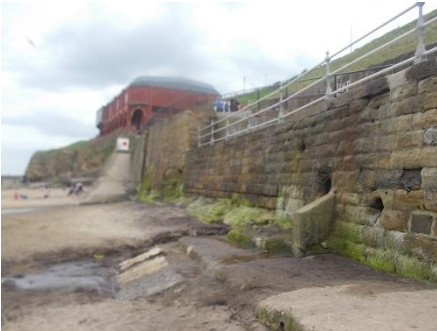
SBC Reference:	22-11A-01		
NFCDD reference:	1221D901D0802C06

Asset Location:	NZ89361152, NZ89401152	
	Asset Length:	37.5	
	Condition Assessment		
	Condition	Priority	Risk
	C	3	
	Brief Description		
	Blockwork wall with many open joints. Abrasion and loss of blocks and mortar in lower section and under ramp. Water seeping through wall and leaking pipe as in 2012. Beach lower exposing toe structure which is abraded.		
	Recommendations		
Repair or encase toe. Repair cracking in masonry wall. Repair pipe

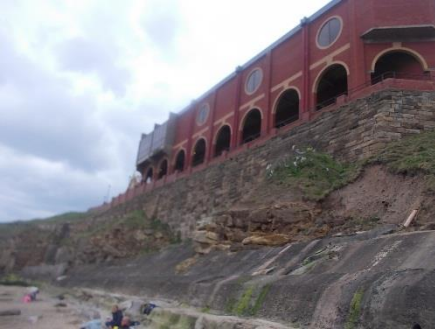
SBC Reference:	22-11A-03		
NFCDD reference:	1221D901D0802C15

Asset Location:	Beneath red brick building.	
	Asset Length:	71.8	
	Condition Assessment		
	Condition	Priority	Risk
	C	3	
	Brief Description		
	Concrete toe showing signs of cracking, abrasion and loss of concrete and undercutting. Blockwork walls appear sound but some loss of mortar. Slips in cliff between upper wall and toe structure.		
	Recommendations		
Stabilise and repair cliff. Repair toe

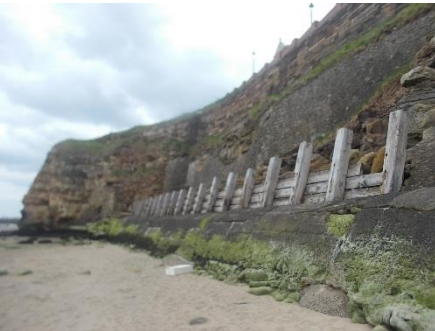
SBC Reference:	N/A		
NFCDD reference:	1221D901D0802C05

Asset Location:	NZ89401152, NZ89511152	
	Asset Length:	43.1	
	Condition Assessment		
	Condition	Priority	Risk
	C	3	
	Brief Description		
	Concrete toe seaward of timber breastwork is undercut with large voids beneath and breaking up. Blockwork walls above appear sound but slips / falls in cliff below and some loss of mortar.		
	Recommendations		
Urgent repairs to toe, more detailed survey to cliff and walls required

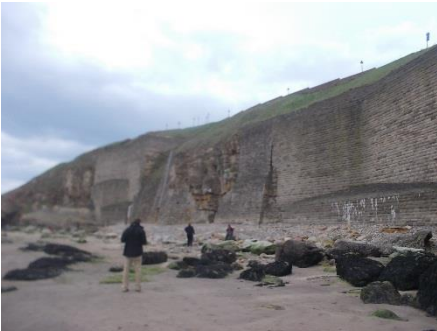
SBC Reference:	24-11B-01		
NFCDD reference:	1221D901D0802C09

Asset Location:	NZ89541152, NZ89651151	
	Asset Length:	115.8	
	Condition Assessment		
	Condition	Priority	Risk
	B	3	
	Brief Description		
	High sections of blockwork sea wall facing in between in-situ rock outcrops. Sections of masonry appear sound condition, some mortar loss, but worse than noted previously, in several locations tie in of edges to cliff getting outflanked / abraded.		
	Recommendations		
Repair edges of panels where tie in to cliff

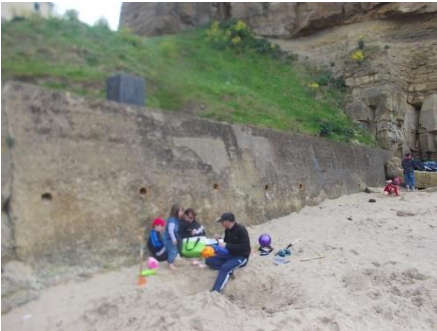
SBC Reference:	25-11B-01		
NFCDD reference:	1221D901D0802C10

Asset Location:	NZ89771147, NZ89781150. West side of West Pier.	
	Asset Length:	26.8	
	Condition Assessment		
	Condition	Priority	Risk
	B	3	
	Brief Description		
	In situ concrete retaining wall. Opened joints with exposed aggregates. Fair condition overall.		
	Recommendations		
Continue to monitor. Grout joints

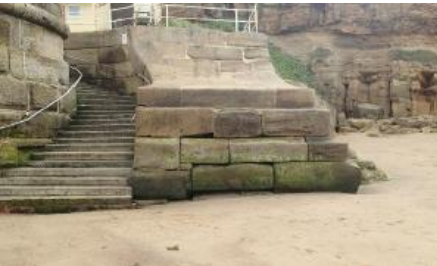
SBC Reference:	25-11B-02		
NFCDD reference:	1221D901D0802C12 002

Asset Location:	NZ89781150, NZ89861150	
	Asset Length:	~7	
	Condition Assessment		
	Condition	Priority	Risk
	B	3	
	Brief Description		
	Landing area has evidence of repairs and repointing to upper blocks		
	Recommendations		
Continue to monitor

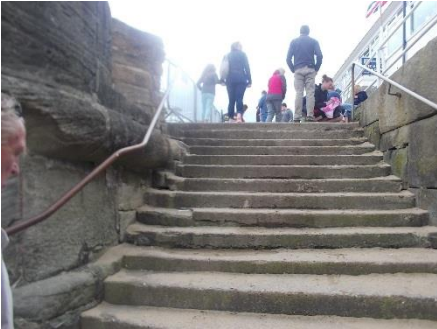
SBC Reference:	25-11B-03		
NFCDD reference:	1221D901D0802C12 003

Asset Location:	NZ89781150, NZ89861150	
	Asset Length:	~7	
	Condition Assessment		
	Condition	Priority	Risk
	B	3	
	Brief Description		
	Steps abraded and chipped on the top section with several horizontal cracks. Handrail corroded Wing wall in fair condition.		
	Recommendations		
Continue to monitor

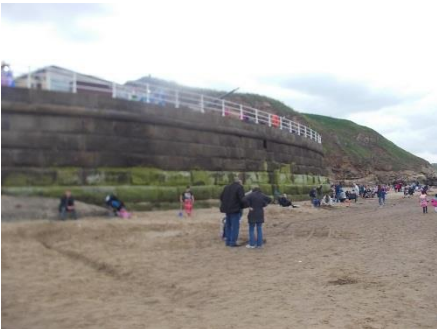
SBC Reference:	26-11B-01		
NFCDD reference:	1221D901D0802C12

Asset Location:	NZ89781150, NZ89861150 Start of west pier at slipway.	
	Asset Length:	87.7	
	Condition Assessment		
	Condition	Priority	Risk
	B	2	
	Brief Description		
	Battery wall. Deep voids between blockwork, few blocks vertically cracked. Voids between corners of blocks. Slipway wall capping beam and wall to W eroded, with displaced block. Prom in fair condition.		
	Recommendations		
Continue to monitor and repair deep voids, Cracks and monitor abrasion

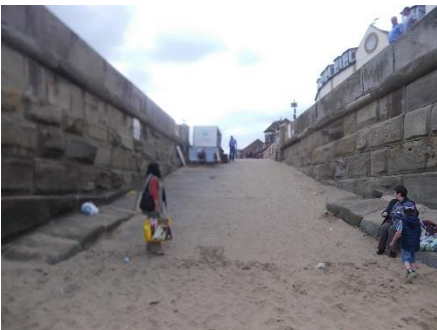
SBC Reference:	26-11B-02		
NFCDD reference:	1221D901D0802C12 001

Asset Location:	NZ89781150, NZ89861150	
	Asset Length:	~12	
	Condition Assessment		
	Condition	Priority	Risk
	B	3	
	Brief Description		
	Slipway in fair condition. Toe below beach level		
	Recommendations		
Continue to monitor

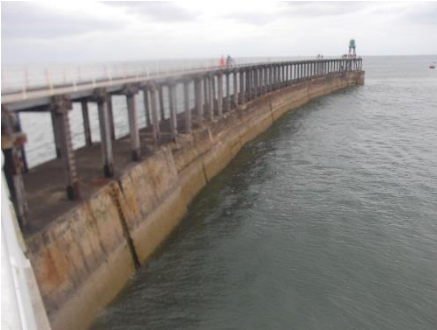
SBC Reference:	N/A		
NFCDD reference:	1221D901D0803C01

Asset Location:	NZ89921172, NZ89921187 West breakwater arm.	
	Asset Length:	315.5	
	Condition Assessment		
	Condition	Priority	Risk
	B	3	
	Brief Description		
	Limited inspection as toe covered in water at low tide. Rust to handrail. Some timber planks in prom have ends rotting. Abrasion to edges of concrete structure and exposure of aggregate. Timber supporting structure weathered.		
	Recommendations		
Continue to monitor and replace planks in prom as necessary. Detailed inspection required

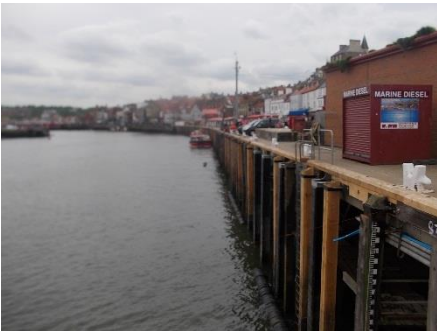
SBC Reference:	N/A		
NFCDD reference:	1221D901D0803C06

Asset Location:	West bank, Whitby Harbour	
	Asset Length:	215.4	
	Condition Assessment		
	Condition	Priority	Risk
	B	4	5
	Brief Description		
	Timber edge beam and fenders recently replaced. Deck support piles corroding. Original wall viewed from ends, looks fair. Some voids to blockwork. Deck support piles corroding.		
	Recommendations		
Detailed inspection of supporting piles to deck required

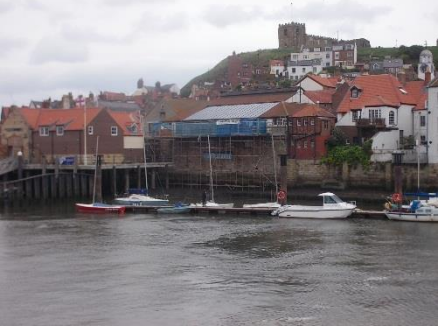
SBC Reference:	N/A		
NFCDD reference:	1221D901D0803C10

Asset Location:	West bank, Whitby Harbour	
	Asset Length:	157.4	
	Condition Assessment		
	Condition	Priority	Risk
	C	3	3
	Brief Description		
	Timber fenders along length, vegetation to upper part of wall. Promenade in good condition. Lower wall obscured by seaweed. Steps cracked and open joints at mid-length. Concrete steps repaired but cracking and abrasion still evident. No handrail. Corrosion to floating pontoon supports at steps.		
	Recommendations		
Repair and repoint joints at steps

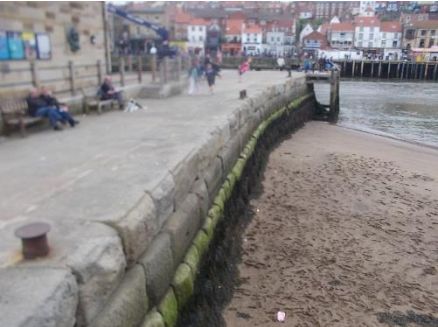
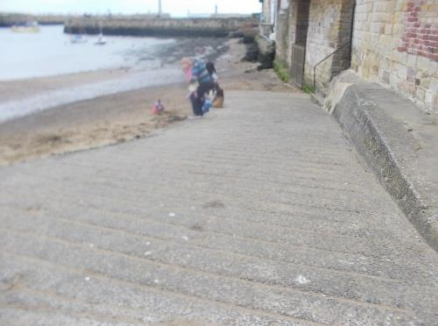
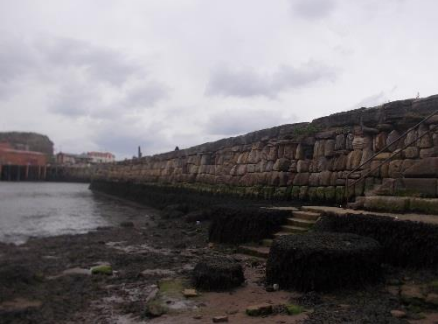
SBC Reference:	N/A		
NFCDD reference:	1221D901D0803C08

Asset Location:	East bank, D/S of Whitby Bridge	
	Asset Length:	135.2	
	Condition Assessment		
	Condition	Priority	Risk
	B	3	
	Brief Description		
	Looks fair - some joint washout to riparian walls. Area of damage to blocks 20m d/s of bridge. Limited access, visual inspection from RNLI and bridge. Concrete apron near to the bridge appears in fair condition including the sheet pile toe.		
	Recommendations		
	Continue to monitor – repair washed out joints to wall

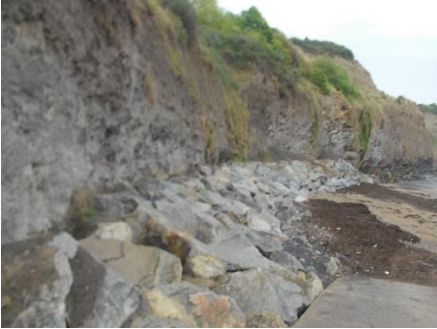
SBC Reference:	32-16A-01		
NFCDD reference:	1221D901D1002C02

Asset Location:	Robin Hood's Bay.	
	Asset Length:	59.4	
	Condition Assessment		
	Condition	Priority	Risk
	B	4	>5
	Brief Description		
	Rock armour remains tightly packed and in good condition. Installed in 2001.		
	Recommendations		
	Continue to monitor

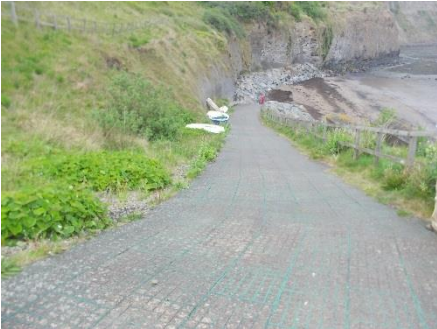
SBC Reference:	32-16A-02		
NFCDD reference:	1221D901D1003C01001

Asset Location:	Robin Hood's Bay.	
	Asset Length:	~70	
	Condition Assessment		
	Condition	Priority	Risk
	B	4	>5
	Brief Description		
	Slipway. Mixed construction in fair condition		
	Recommendations		
	Continue to monitor

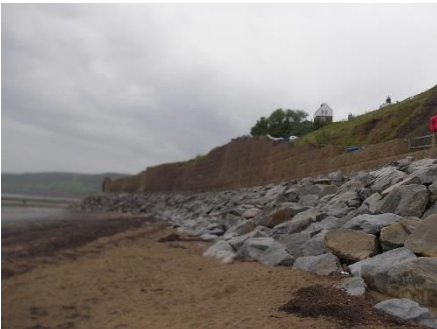
SBC Reference:	33-16A-01		
NFCDD reference:	1221D901D1003C01

Asset Location:	NZ95340504, NZ95270520	
	Asset Length:	183.4	
	Condition Assessment		
	Condition	Priority	Risk
	B	4	>5
	Brief Description		
	Wall was built in 2001. Rock armour in good condition with good coverage. Some movement of rocks near centre apparent. Slipway ramp in good condition, some abrasion to slab and joints near toe. Wall very good condition, although starting to become exposed at Southern end tie in.		
	Recommendations		
	Continue to monitor. Repair S end tie into undefended cliff

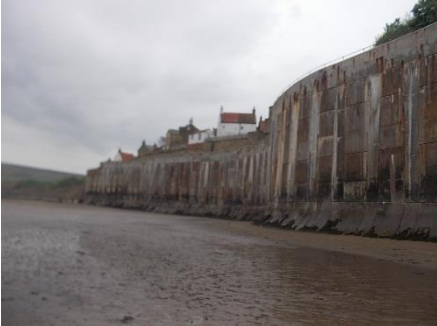
SBC Reference:	33-16A-02		
NFCDD reference:	1221D901D1003C02

Asset Location:	NZ95330488, NZ95310502	
	Asset Length:	150.5	
	Condition Assessment		
	Condition	Priority	Risk
	C	2	
	Brief Description		
	Toe not visible high beach levels. Concrete wall poor - displaying surface cracking, loss of surface, rust staining and mineral encrustation. Wall crest showing more cracking and repair work. Recent concrete spalling evident. Signs of recent repairs and repainting on crest wall. Prom fair.		
	Recommendations		
Continue to monitor. Undertake capital repairs

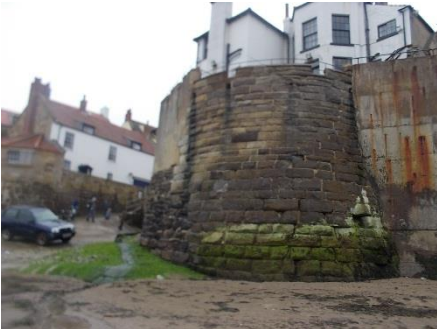
SBC Reference:	34-16A-01		
NFCDD reference:	1221D901D1003C04

Asset Location:	NZ95320486, NZ95330488	
	Asset Length:	29.3	
	Condition Assessment		
	Condition	Priority	Risk
	C	3	
	Brief Description		
	Wall displaying surface erosion and joint washout. Recent repairs evident. Voids and open joints in masonry near tie in to concrete wall. Loose render on upper wall.		
	Recommendations		
Grout voids, repair render, repoint joints, re-inspect toe when beach lower

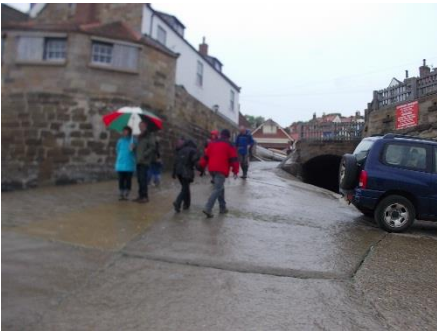
SBC Reference:	35-16B-01		
NFCDD reference:	1221D901D1003C05

Asset Location:	NZ95310485, NZ95320486	
	Asset Length:	15.6	
	Condition Assessment		
	Condition	Priority	Risk
	B	3	
	Brief Description		
	Slipway in gen good condition. Some cracking but appears stable at present. Several missing cobbles near to toe and stream outfall. Some cracks/ missing joints.		
	Recommendations		
Continue to monitor , investigate and fill voids, repoint as necessary

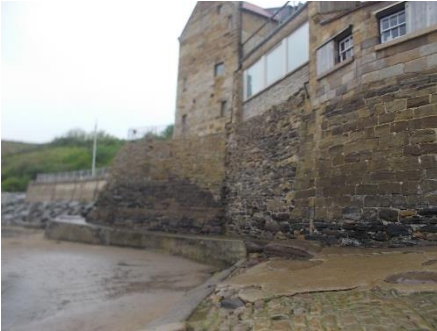
SBC Reference:	36-16B-01		
NFCDD reference:	1221D901D1003C06

Asset Location:	NZ95310481, NZ95310485	
	Asset Length:	51.9	
	Condition Assessment		
	Condition	Priority	Risk
	C	2	
	Brief Description		
	Patchwork of repairs/repointing throughout. Void / undercutting to S end of concrete toe. Some open joints and voids between blocks in south part near tie in. Deep horizontal cracks in low level berm with southern extremity previously repaired. Vertical crack in the repaired concrete section.		
	Recommendations		
Continue to monitor and repoint/repair

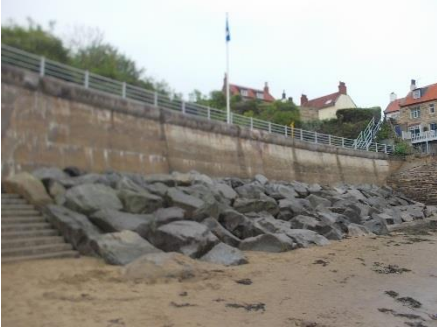
SBC Reference:	36-16B-02		
NFCDD reference:	1221D901D1003C10

Asset Location:	NZ95320468, NZ95310481	
	Asset Length:	29.2	
	Condition Assessment		
	Condition	Priority	Risk
	C	3	
	Brief Description		
	Cracks and spalling to capping beam. Damage to previous repairs to South end of wall. Rock armour at toe in good condition. Rust staining below capping beam. Rock armour tightly packed.		
	Recommendations		
Continue to monitor. Repair spalling and joints where necessary

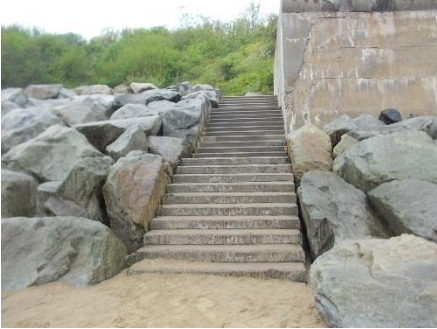
SBC Reference:	36-16B-03		
NFCDD reference:	1221D901D1003C09001

Asset Location:	NZ95320468, NZ95310481	
	Asset Length:	~10	
	Condition Assessment		
	Condition	Priority	Risk
	B	4	5
	Brief Description		
	Steps in good overall condition. No handrail.		
	Recommendations		
Continue to monitor

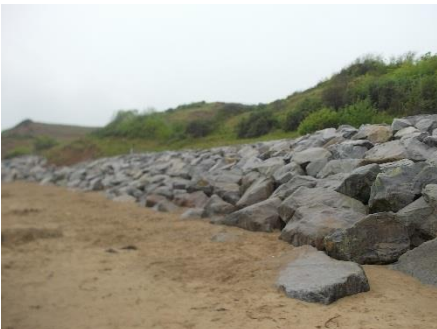
SBC Reference:	37-16C-01		
NFCDD reference:	1221D901D1003C09

Asset Location:	NZ95320468, NZ95310481	
	Asset Length:	62	
	Condition Assessment		
	Condition	Priority	Risk
	B	4	>5
	Brief Description		
	Rock armour is generally tightly packed and good cover. Some smaller rocks show signs of movement. Promenade in good condition. Overall good.		
	Recommendations		
Monitor armour for need to re-profile in future

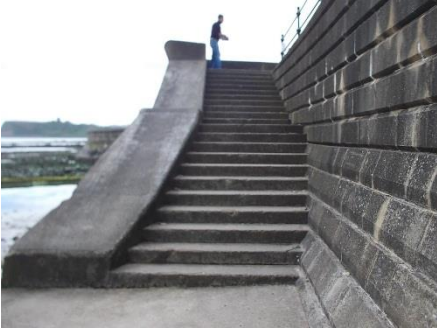
SBC Reference:	39-20A-01		
NFCDD reference:	1221D901D1201C02001

Asset Location:	TA03549057, TA03569082 next to Sea Life Centre.	
	Asset Length:	~10	
	Condition Assessment		
	Condition	Priority	Risk
	B	4	>5
	Brief Description		
	Steps. Localised concrete abrasion with chipped tread but overall fair condition		
	Recommendations		
Continue to monitor

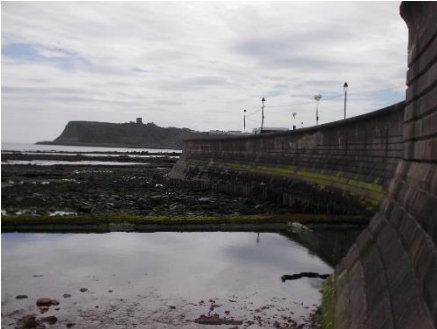
SBC Reference:	39-20A-02		
NFCDD reference:	1221D901D1201C02

Asset Location:	TA03549057, TA03569082. Wall and promenade next to Sea Life Centre. Extends to Southern steps (40-20a-01)	
	Asset Length:	327.2	
	Condition Assessment		
	Condition	Priority	Risk
	B	3	>5
	Brief Description		
	Vertical cracks either side of the 90deg corner at the slipway indicating movement. Spalling / damaged block facing and missing joints in places. Exposed aggregate in places to wall. Wall toe getting undercut to N & S. Sheet piling visible in places holes in piles where visible. Cracks to splash wall but looks sound. Prom good cond.		
	Recommendations		
Continue to monitor crack movement, refill joints

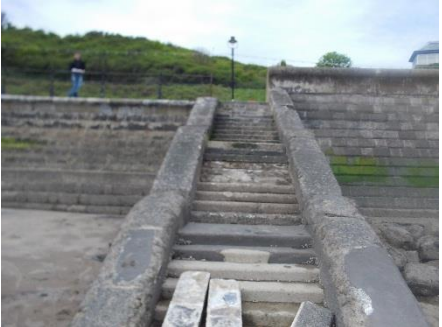
SBC Reference:	40-20A-01		
NFCDD reference:	1221D901D1201C02004

Asset Location:		
	Asset Length:	~5	
	Condition Assessment		
	Condition	Priority	Risk
	D	1	
	Brief Description		
	Very poor condition. Asset in needs of major repairs. To be closed off as hazardous to Public. Abutments and steps dilapidated. (I.e. Missing and broken steps, limited edge protection from prom). Toe piling only exposed at steps at N end.		
	Recommendations		
Close off to public. Consider removing completely

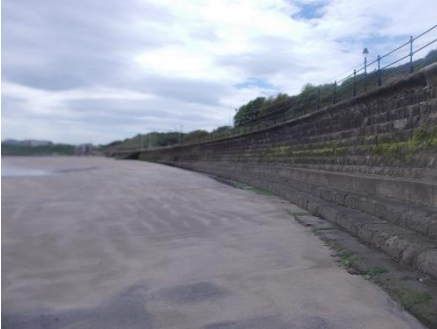
SBC Reference:	40-20A-02		
NFCDD reference:	1221D901D1201C03

Asset Location:	TA03589031, South of Sea Life Centre.	
	Asset Length:	120.6	
	Condition Assessment		
	Condition	Priority	Risk
	C	3	
	Brief Description		
	Erosion of external blockwork throughout sea wall. Vertical crack to sea wall at south end of stretch. Corroded handrails. Cracking and spalling to prom slabs and some missing sealant between slabs. Discontinuous handrail Damaged splash beam and significant spalling of concrete block facing.		
	Recommendations		
Continue to monitor and repair cracks to wall

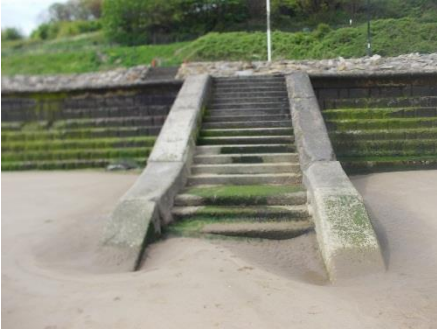
SBC Reference:	40-20A-03		
NFCDD reference:	1221D901D1201C03001

Asset Location:	TA03589031, South of Sea Life Centre.	
	Asset Length:	~5	
	Condition Assessment		
	Condition	Priority	Risk
	B	3	
	Brief Description		
	Weathered concrete revetment but fair condition overall. The South abutment wall has been repaired but the North wall would also need attention as damaged in places. Treads in fair condition		
	Recommendations		
Repair northern wall. Continue to monitor

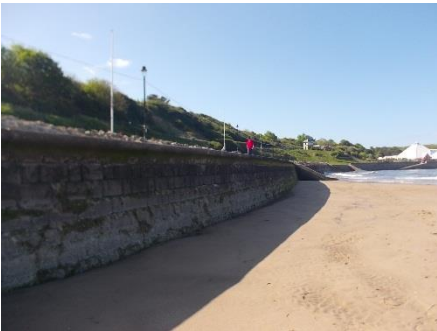
SBC Reference:	40-20A-04		
NFCDD reference:	1221D901D1201C24

Asset Location:	TA03589031, TA03549057	
	Asset Length:	65	
	Condition Assessment		
	Condition	Priority	Risk
	C	3	
	Brief Description		
	Exposed aggregate and erosion / spalling to capping beam and facing blockwork. Cracks throughout promenade. Repairs evident in rear revetment.		
	Recommendations		
Continue to monitor. Repair damaged capping beam and cracks in promenade

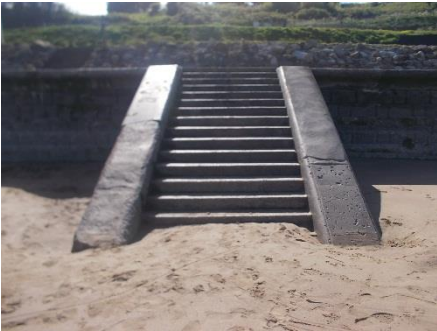
SBC Reference:	40-20A-05		
NFCDD reference:	1221D901D1201C24 ⁰⁰¹

Asset Location:		
	Asset Length:	~5	
	Condition Assessment		
	Condition	Priority	Risk
	B	4	>5
	Brief Description		
	Abutment wall abraded on one side (bottom half only) Steps in fair condition overall		
	Recommendations		
Continue to monitor

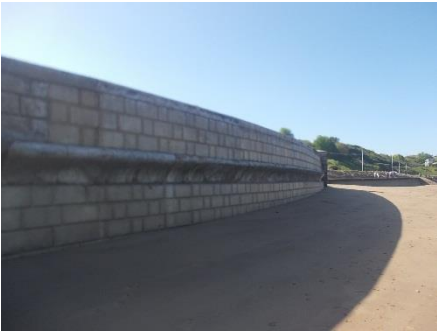
NFCDD reference:	1221D901D1201C04

Asset Location:	TA03599020, TA03589031 At North end of beach huts.	
	Asset Length:	99.1	
	Condition Assessment		
	Condition	Priority	Risk
	B	3	
	Brief Description		
	Repairs appear to be holding. Beach high covering lower wall. Promenade in good condition. Missing joints at the North end where not repaired.		
	Recommendations		
Continue to monitor repair cracks and coping

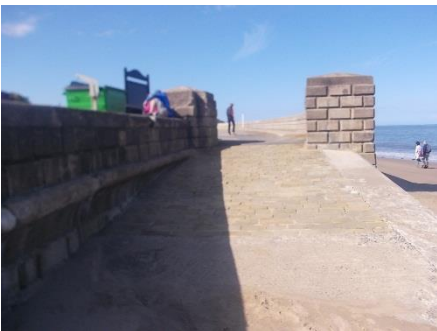
SBC Reference:	41-20A-03		
NFCDD reference:	1221D901D1201C10 001

Asset Location:	TA03599020, TA03589031	
	Asset Length:	~4	
	Condition Assessment		
	Condition	Priority	Risk
	B	3	
	Brief Description		
	Slipway. Joints to block paving missing Capping beam to side wall abraded and chipped		
	Recommendations		
Replace joints. Continue to monitor

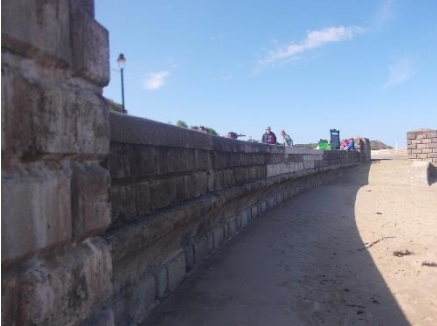
SBC Reference:	41-20A-04		
NFCDD reference:	1221D901D1201C10

Asset Location:	TA03599020, TA03589031	
	Asset Length:	13	
	Condition Assessment		
	Condition	Priority	Risk
	B	3	
	Brief Description		
	Few cracks appear on capping beam, adjacent to N ramp to prom. High beach level, toe not visible. Promenade in good condition. Visible repair to block facing and capping but localised spalling to splash wall in places.		
	Recommendations		
Repair spalling to splash wall

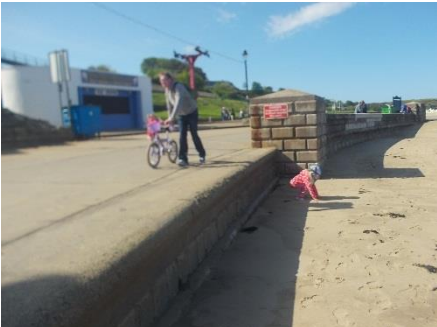
SBC Reference:	42-20A-02		
NFCDD reference:	1221D901D1201C26

Asset Location:	TA03758981, TA03599020	
	Asset Length:	13.7	
	Condition Assessment		
	Condition	Priority	Risk
	B	4	5
	Brief Description		
	Sea wall mostly buried by sand. Spalling in poured concrete capping to wall, promenade in fair condition.		
	Recommendations		
Continue to monitor and maintain

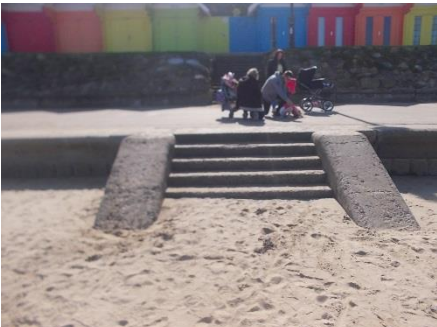
SBC Reference:	42-20A-03		
NFCDD reference:	1221D901D1201C26 ⁰⁰¹

Asset Location:		
	Asset Length:		
	Condition Assessment		
	Condition	Priority	Risk
	B	4	5
	Brief Description		
	Damaged abutment with exposed aggregates Rounded and chipped steps but fair condition overall.		
	Recommendations		
Continue to monitor

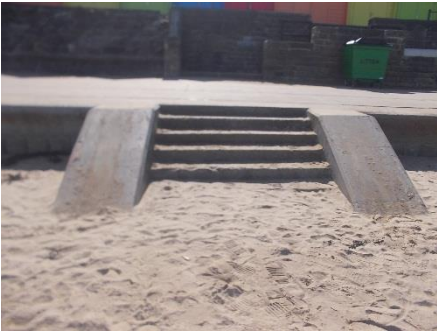
SBC Reference:	42-20A-05		
NFCDD reference:	1221D901D1201C11001

Asset Location:	TA03758981, TA03599020	
	Asset Length:	~3	
	Condition Assessment		
	Condition	Priority	Risk
	B	4	5
	Brief Description		
	New abutment walls either side. Steps in fair condition		
	Recommendations		
Continue to monitor

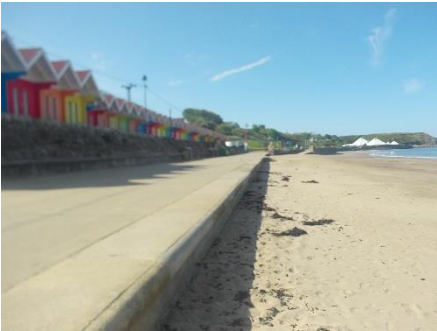
SBC Reference:	42-20A-06		
NFCDD reference:	1221D901D1201C12

Asset Location:	TA03758981, TA03599020	
	Asset Length:	58.4	
	Condition Assessment		
	Condition	Priority	Risk
	B	4	5
	Brief Description		
	Sea wall mostly buried by sand. Section of coping to wall have been repaired, promenade in good condition but some spalling adjacent to coping. Rear revetment in fair condition.		
	Recommendations		
Continue to monitor			
SBC Reference:	42-20A-07		
NFCDD reference:	1221D901D1201C12001

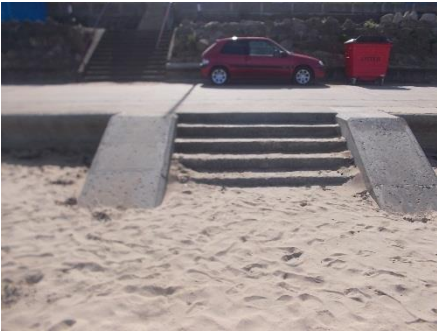
Asset Location:		TA03758981, TA03599020
	Asset Length:		~3
	Condition Assessment		
	Condition	Priority	Risk
	B	4	5
	Brief Description		
	Steps: Abutment rebuilt both sides Lower steps rounded but good condition overall		
	Recommendations		
Continue to monitor

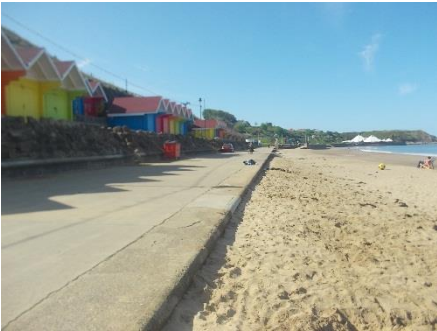
SBC Reference:	42-20A-08		
NFCDD reference:	1221D901D1201C13

Asset Location:		TA03758981, TA03599020
	Asset Length:		58.2
	Condition Assessment		
	Condition	Priority	Risk
	B	4	>5
	Brief Description		
	Beach high, only top row of blocks and capping visible. Some spalling to joints between sections of capping, erosion to capping exposing aggregate. Missing joints in grouted revetment to rear.		
	Recommendations		
Continue to monitor. Replace joints

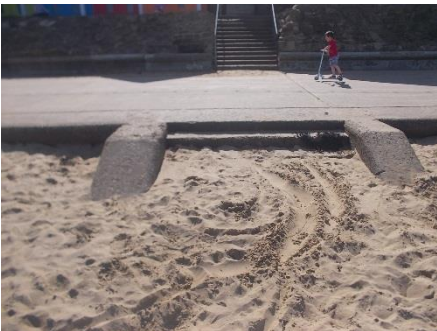
SBC Reference:	42-20A-09		
NFCDD reference:	1221D901D1201C13 ⁰⁰¹

Asset Location:		TA03758981, TA03599020
	Asset Length:		~3
	Condition Assessment		
	Condition	Priority	Risk
	B	4	>5
	Brief Description		
	Most steps below beach level. Rounded steps. Fair condition overall		
	Recommendations		
Continue to monitor

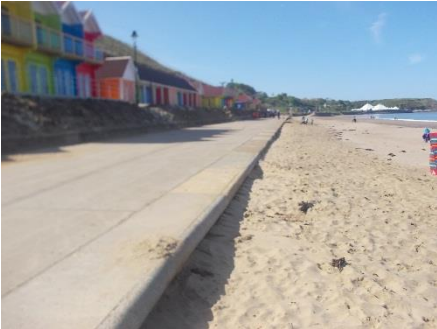
SBC Reference:	42-20A-10		
NFCDD reference:	1221D901D1201C14

Asset Location:	TA03758981, TA03599020	
	Asset Length:	58.4	
	Condition Assessment		
	Condition	Priority	Risk
	B	4	5
	Brief Description		
	Cracks to capping with some erosion exposing aggregate in places, Some capping slabs repaired, but remaining showing signs of damage. High beach at time of inspection. Rear revetment fair condition.		
	Recommendations		
Monitor and repair spalling to wall capping

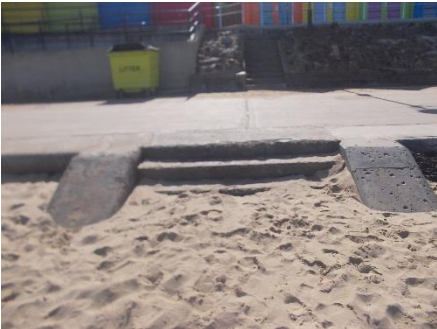
SBC Reference:	42-20A-11		
NFCDD reference:	1221D901D1201C14001

Asset Location:	TA03758981, TA03599020	
	Asset Length:	~3	
	Condition Assessment		
	Condition	Priority	Risk
	B	4	>5
	Brief Description		
	Most steps below beach level. Rounded and chipped steps. Abutments walls in good condition		
	Recommendations		
Continue to monitor

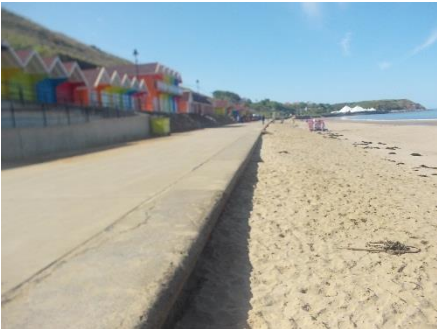
SBC Reference:	42-20A-12		
NFCDD reference:	1221D901D1201C15

Asset Location:	TA03758981, TA03599020	
	Asset Length:	31.9	
	Condition Assessment		
	Condition	Priority	Risk
	B	4	>5
	Brief Description		
	Only concrete capping of wall visible due to high beach, wall capping and promenade in good condition, no visible defects. Rear wall - ramp below beach management centre appears near new condition, some rust staining at fixings.		
	Recommendations		
Continue to monitor

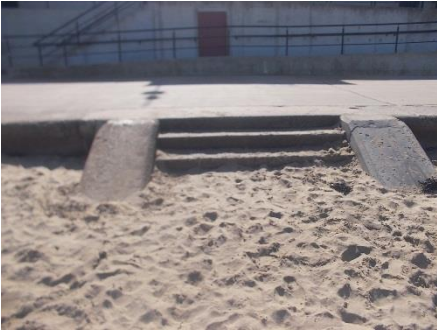
SBC Reference:	42-20A-13		
NFCDD reference:	1221D901D1201C15001

Asset Location:	TA03758981, TA03599020	
	Asset Length:	~3	
	Condition Assessment		
	Condition	Priority	Risk
	B	4	5
	Brief Description		
	Fair condition overall. Rounded steps and new abutment walls		
	Recommendations		
Continue to monitor
