Walk-over Visual Inspections of Assets – Final Report

Prepared for
Scarborough Borough Council

July 2015

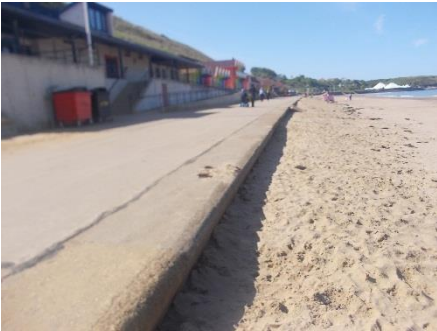
SBC Reference:	42-20A-14		
NFCDD reference:	1221D901D1201C16

Asset Location:	TA03758981, TA03599020. In front of Beach Management Centre.	
	Asset Length:	32	
	Condition Assessment		
	Condition	Priority	Risk
	B	4	5
	Brief Description		
	Only capping visible due to high beach. Some missing mortar to first (North) slab, cracking to capping at joints as well as the edges. Chipped capping at North end. Promenade in good condition. Rear revetment has been repaired		
	Recommendations		
Repair damage to capping and inspect at low beach height

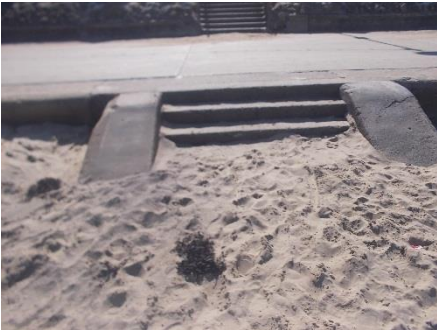
SBC Reference:	42-20A-15		
NFCDD reference:	1221D901D1201C16001

Asset Location:	TA03758981, TA03599020.	
	Asset Length:	~3	
	Condition Assessment		
	Condition	Priority	Risk
	B	4	5
	Brief Description		
	Steps: Fair overall condition		
	Recommendations		
Continue to monitor

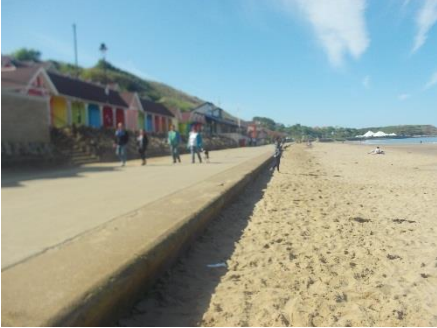
SBC Reference:	42-20A-16		
NFCDD reference:	1221D901D1201C05

Asset Location:	TA03758981, TA03599020	
	Asset Length:	55.6	
	Condition Assessment		
	Condition	Priority	Risk
	B	4	5
	Brief Description		
	High beach, capping & top row only visible. Exposed aggregate in localised places. Some chipped capping along length.		
	Recommendations		
Monitor and repair coping

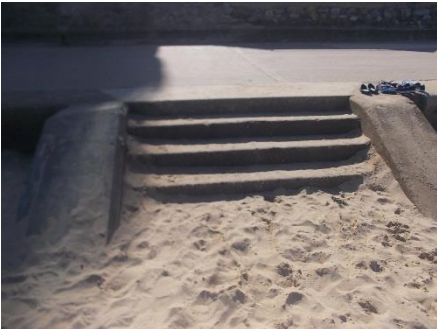
SBC Reference:	42-20A-17		
NFCDD reference:	1221D901D1201C05001

Asset Location:	TA03758981, TA03599020	
	Asset Length:	~3	
	Condition Assessment		
	Condition	Priority	Risk
	A	4	5
	Brief Description		
	Fair condition overall		
	Recommendations		
Continue to monitor

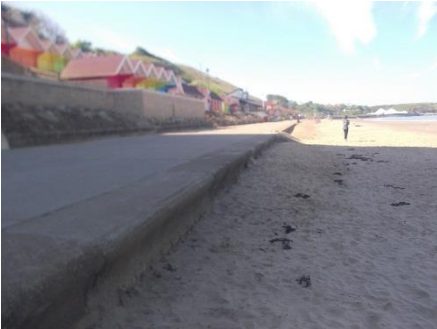
SBC Reference:	42-20A-18		
NFCDD reference:	1221D901D1201C17

Asset Location:	In front on new apartments.	
	Asset Length:	22.8	
	Condition Assessment		
	Condition	Priority	Risk
	B	4	5
	Brief Description		
	Only capping and top row visible. Localised gapping at joint, in centre of defence. New wall to rear has replaced most of rock revetment. Some voids evident in rear revetment. Some chips to rear of capping on prom.		
	Recommendations		
Repair defects to coping/prom edge and rear revetment

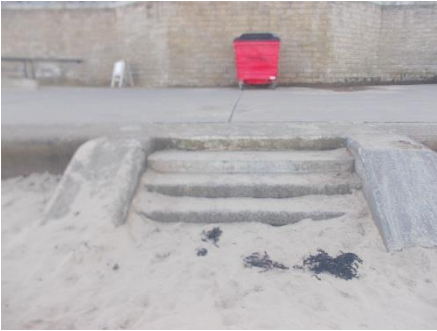
SBC Reference:	42-20A-19		
NFCDD reference:	1221D901D1201C17001

Asset Location:		
	Asset Length:	~3	
	Condition Assessment		
	Condition	Priority	Risk
	B	4	5
	Brief Description		
	Steps: Fair overall condition Penultimate step replaced from the top		
	Recommendations		
	Continue to monitor

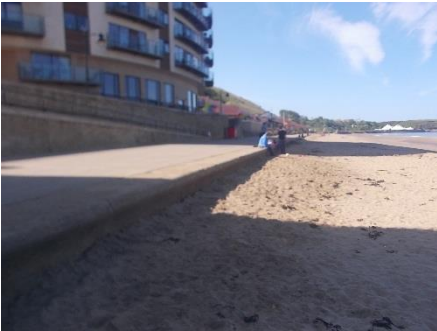
SBC Reference:	42-20A-20		
NFCDD reference:	1221D901D1201C18

Asset Location:	In front of new apartments.	
	Asset Length:	43	
	Condition Assessment		
	Condition	Priority	Risk
	B	4	5
	Brief Description		
	Cracking and spalling to wall capping. Beach high covering most of wall. Promenade in good condition. Rear wall remains as new.		
	Recommendations		
	Repair/replace damaged capping/coping beams

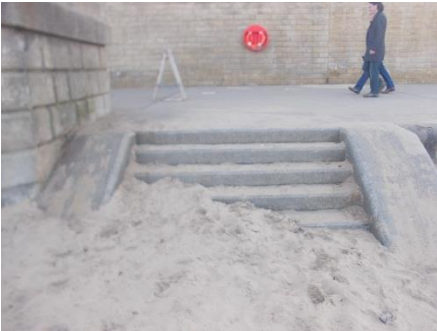
SBC Reference:	42-20A-21		
NFCDD reference:	1221D901D1201C18001

Asset Location:		
	Asset Length:	~3	
	Condition Assessment		
	Condition	Priority	Risk
	B	4	5
	Brief Description		
	Steps: Fair condition -partly buried in sand		
	Recommendations		
	Continue to monitor

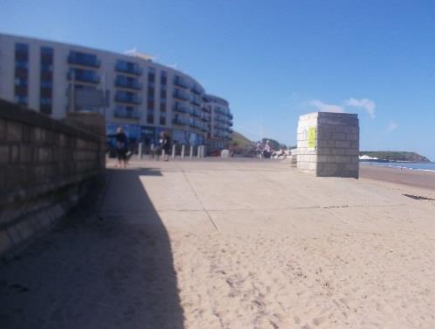
SBC Reference:	43-20B-04		
NFCDD reference:	1221D901D1201C20001

Asset Location:		
	Asset Length:	~10	
	Condition Assessment		
	Condition	Priority	Risk
	B	3	
	Brief Description		
	Broken edge to construction joints. Missing sealant. Overall Fair condition. Toe below beach level		
	Recommendations		
Replace sealant in joints. Continue to monitor

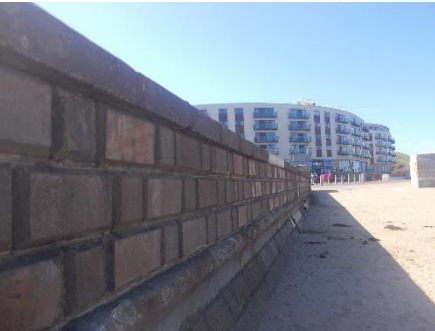
SBC Reference:	44-20B-01		
NFCDD reference:	1221D901D1201C20

Asset Location:	South of new development.	
	Asset Length:	40.8	
	Condition Assessment		
	Condition	Priority	Risk
	B	3	
	Brief Description		
	Section of coping recently repaired. Cracking / missing joints below coping in several places. Missing block at toe level. Cracking in prom.		
	Recommendations		
Seal joints and repair cracks in coping. Continue to monitor

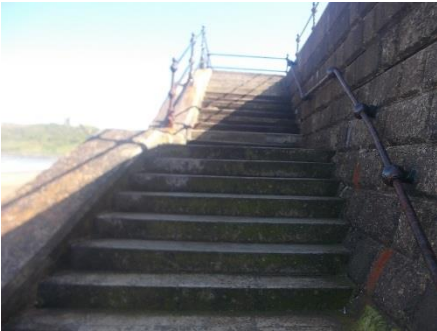
SBC Reference:	44-20B-04		
NFCDD reference:	1221D901D1201C07002

Asset Location:		
	Asset Length:	~7	
	Condition Assessment		
	Condition	Priority	Risk
	B	3	
	Brief Description		
	Fair condition Corroded handrail and discontinuous seaward.		
	Recommendations		
Treat corroded handrail. Continue to monitor

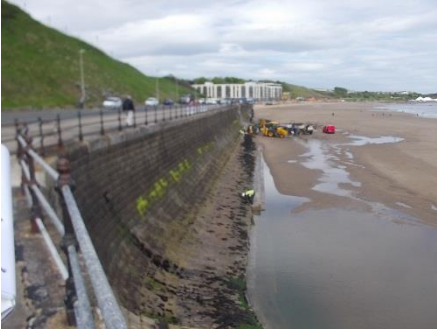
SBC Reference:	44-20B-05		
NFCDD reference:	1221D901D1201C21

Asset Location:	TA03818971, TA04078946 East of Alexandra Gardens.	
	Asset Length:	211.1	
	Condition Assessment		
	Condition	Priority	Risk
	C	3	
	Brief Description		
	Erosion to capping at edge of prom. Cracks and holes between capping and prom. Prom surface replaced in 2012 at N and S ends, but centre still to do. Apron toe slab being repaired whilst undertaking the survey. Concrete block missing at Northern end. Vertical crack through the concrete repair already carried out.		
	Recommendations		
Repairs appeared to be being carried out in area. Continue to monitor

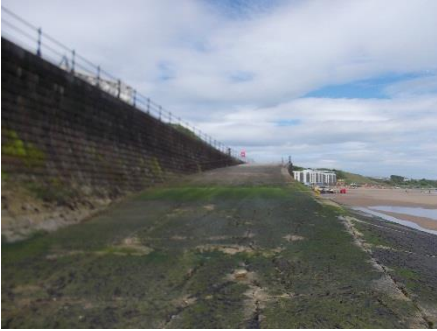
SBC Reference:	45-20B-01		
NFCDD reference:	1221D901D1201C08001

Asset Location:	Part of 45-20B-02	
	Asset Length:	25	
	Condition Assessment		
	Condition	Priority	Risk
	C	2	
	Brief Description		
	Slipway fenced off to prevent access. Significant settlement (i.e. depression in the tarmac revetment at the top). Concrete block facing replacement at rear of slipway. Large crack at the bottom Block revetment with mass concrete repair but missing joints		
	Recommendations		
	Carry out repairs to make slipway safe or fence off at bottom as well as top

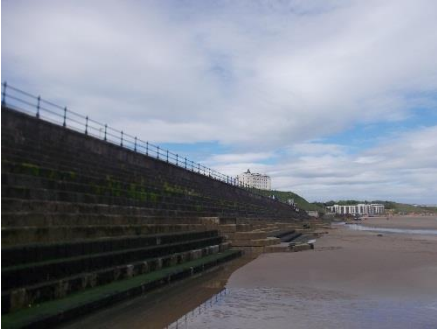
SBC Reference:	45-20B-02		
NFCDD reference:	1221D901D1201C08

Asset Location:	TA04078945, TA04288930	
	Asset Length:	206.9	
	Condition Assessment		
	Condition	Priority	Risk
	B	3	
	Brief Description		
	Cracks & open joints to prom slabs and loss of surface. Some prom slabs have been replaced / repaired recently. Recent repair / replacement work on some of the steps / toe, but some horizontal cracks in original blocks remain. Lower wall not visible.		
	Recommendations		
	Continue to monitor and repair cracks and resurface rest of prom

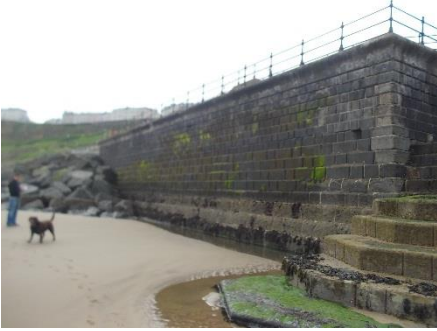
SBC Reference:	45-20B-03		
NFCDD reference:	1221D901D1202C23

Asset Location:	North of Albert Road.	
	Asset Length:	31.5	
	Condition Assessment		
	Condition	Priority	Risk
	C	3	
	Brief Description		
	2 large vertical cracks extending through wall. Damaged blockwork and lower part of wall eroded and exposed aggregate. Cracks to promenade. Handrails corroding.		
	Recommendations		
Continue to monitor, seal cracks, repair damage

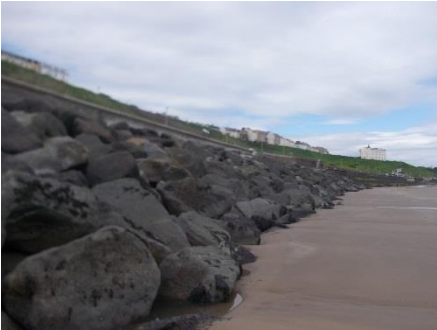
SBC Reference:	46-20B-01		
NFCDD reference:	1221D901D1202C01

Asset Location:	TA04288929, TA0493895. East of Albert Road.	
	Asset Length:	124.8	
	Condition Assessment		
	Condition	Priority	Risk
	B	4	>5
	Brief Description		
	Original wall hidden by rock armour, splash wall seems to be in good condition. Tightly packed rock armour with good coverage. Some smaller rock loose on crest.		
	Recommendations		
Continue to monitor

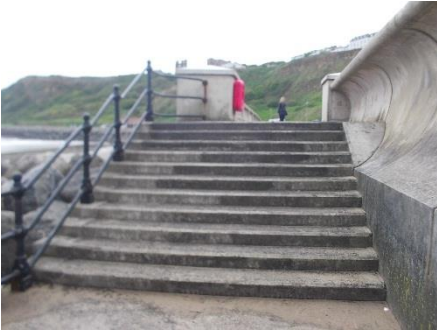
SBC Reference:	46-20B-03		
NFCDD reference:	1221D901D1202C03 003

Asset Location:	Part of 46-20b-04	
	Asset Length:	~3	
	Condition Assessment		
	Condition	Priority	Risk
	B	4	>5
	Brief Description		
	Good condition throughout. Steps combine with SBC Ref: 46-20B-02 with single flight to beach level		
	Recommendations		
Continue to monitor

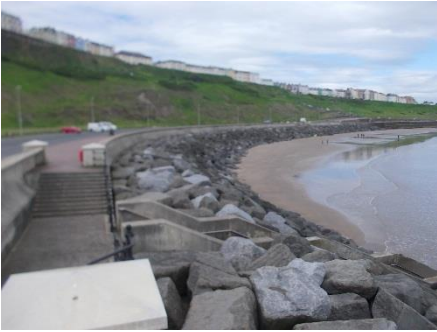
SBC Reference:	46-20B-04		
NFCDD reference:	1221D901D1202C03

Asset Location:		
	Asset Length:	429.2	
	Condition Assessment		
	Condition	Priority	Risk
	B	4	>5
	Brief Description		
	The Holms. Prom & Splash wall in good condition. Some of prom surfacing damaged locally. Armour well packed and good cover. Original wall not visible.		
	Recommendations		
Continue to monitor

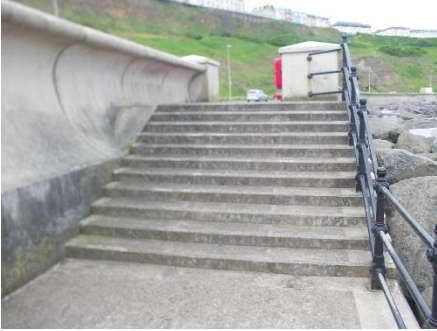
SBC Reference:	46-20B-05		
NFCDD reference:	1221D901D1202C03 002

Asset Location:	Part of 46-20B-04	
	Asset Length:	~4	
	Condition Assessment		
	Condition	Priority	Risk
	A	4	>5
	Brief Description		
	Steps in good condition throughout		
	Recommendations		
Continue to monitor

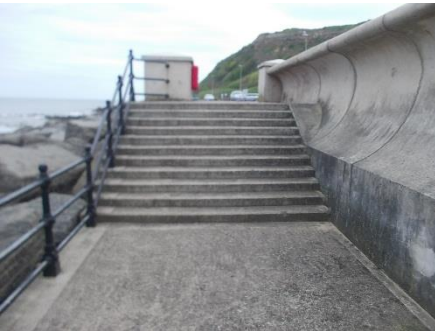
SBC Reference:	46-20B-06		
NFCDD reference:	1221D901D1202C03001

Asset Location:	Part of 46-20B-04	
	Asset Length:	~4	
	Condition Assessment		
	Condition	Priority	Risk
	A	4	
	Brief Description		
	Steps in good condition throughout. Steps combine with SBC Ref: 46-20B-05 with single flight to beach level		
	Recommendations		
Continue to monitor

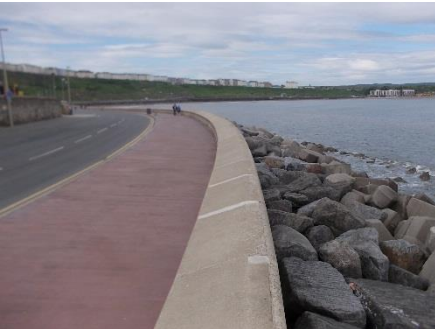
SBC Reference:	46-20B-07		
NFCDD reference:	1221D901D1202C04

Asset Location:		
	Asset Length:	219.9	
	Condition Assessment		
	Condition	Priority	Risk
	B	4	>5
	Brief Description		
	Original wall hidden by armour, splash wall seems to be in good condition. Tightly packed rock armour appears stable, no loose rocks. Toe piling working well, some natural rock against piling. Prom good condition.		
	Recommendations		
Continue to monitor

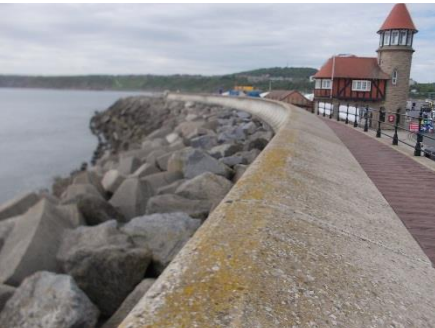
SBC Reference:	N/A		
NFCDD reference:	1221D901D1202C02

Asset Location:	TA05178883, TA04988952. East of Scarborough Castle.	
	Asset Length:	886.7	
	Condition Assessment		
	Condition	Priority	Risk
	B	4	>5
	Brief Description		
	Vertical cracks on some of the splash wall modules, some chipping at joints, Accropodes slightly eroded and chipped throughout. No concern at present. Promenade slab sound. Piling not all visible, inspection only from crest.		
	Recommendations		
Continue to monitor. Repair cracks and joints to splash walls

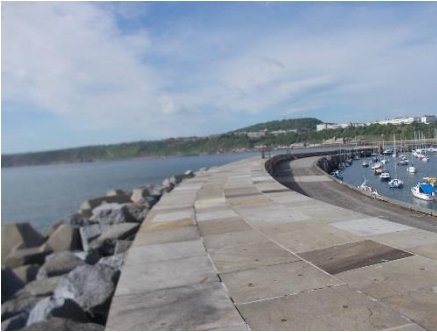
SBC Reference:	N/A		
NFCDD reference:	1221D901D1301C01

Asset Location:	TA04958849, TA05178883 North Harbour Breakwater.	
	Asset Length:	444.9	
	Condition Assessment		
	Condition	Priority	Risk
	B	4	5
	Brief Description		
	Crest wall good. Rock armour & accropodes in generally good condition, well packed. Less tightly packed or missing armour units at south end of wall. Several cracked pieces of armour. Possible settlement of crest adjacent to area with rock toe apron.		
	Recommendations		
Continue to monitor

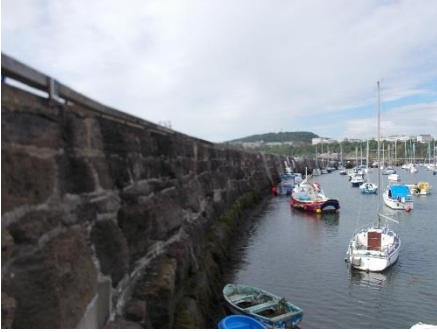
SBC Reference:	N/A		
NFCDD reference:	1221D901D1301C16

Asset Location:	Scarborough Harbour. North breakwater inner wall.	
	Asset Length:	362.1	
	Condition Assessment		
	Condition	Priority	Risk
	B	3	3
	Brief Description		
	Vegetation at bottom half of wall. Wall repointed and gap filled. Repairs holding, but some voids at toe. Some cracks to promenade. Timber edge beams have been replaced. Steps have been repaired since 2012.		
	Recommendations		
Continue to monitor. Repair toe voids

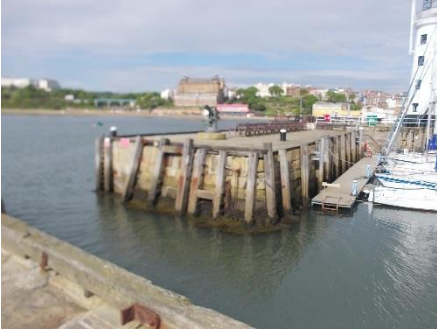
SBC Reference:	N/A		
NFCDD reference:	1221D901D1301C03

Asset Location:	TA04948860, TA05088877. Old pier	
	Asset Length:	463.1	
	Condition Assessment		
	Condition	Priority	Risk
	B	3	
	Brief Description		
	Appears fair. Missing fill between blocks throughout wall, fenders, vegetation and boats obscuring the lower parts of wall on old harbor side. Promenade in good condition.		
	Recommendations		
Continue to monitor and repoint cracks and missing joints

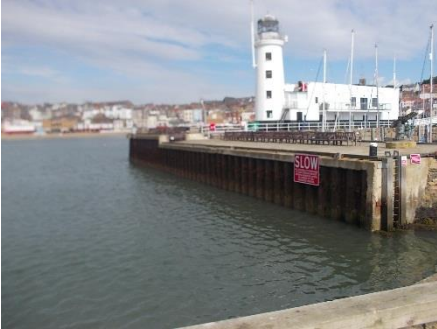
SBC Reference:	N/A		
NFCDD reference:	1221D901D1301C17

Asset Location:	TA04958853, TA04938860. Lighthouse island.	
	Asset Length:	83.5	
	Condition Assessment		
	Condition	Priority	Risk
	C	3	
	Brief Description		
	Inner wall at entrance breakwater. Numerous cracks to blocks and missing mortar in joints. Vegetation and fenders obscuring most of walls. Only inspected from distance.		
	Recommendations		
Continue to monitor and repoint cracks and joints

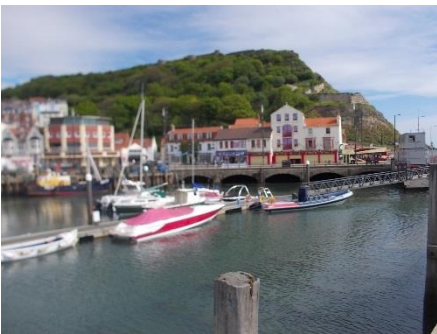
SBC Reference:	N/A		
NFCDD reference:	1221D901D1301C05

Asset Location:	TA04958853, TA04938860. Wall at south side of Lighthouse island	
	Asset Length:	97	
	Condition Assessment		
	Condition	Priority	Risk
	B	3	
	Brief Description		
	Outer face. Sheet piles heavily corroded, although obscured by vegetation growing on the bottom of the piling. Void seen under southern corner in 2012, has been repaired. Only visible from a distance.		
	Recommendations		
Full structural assessment of sheet piles required

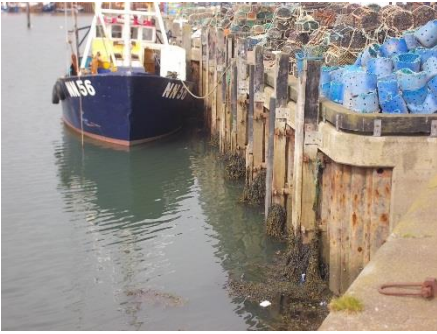
SBC Reference:	N/A		
NFCDD reference:	1221D901D1301C12

Asset Location:	TA05048878, TA05088877. South of roundabout opposite arcade.	
	Asset Length:	43.2	
	Condition Assessment		
	Condition	Priority	Risk
	B	3	
	Brief Description		
	Cracking and missing joints to top of capping, arches look structurally sound, access ladder has been renewed. Promenade in good condition. Slipway partly obstructed by portacabins but seems in good condition.		
	Recommendations		
	Repair cracks and damage to coping. Grout slipway blocks

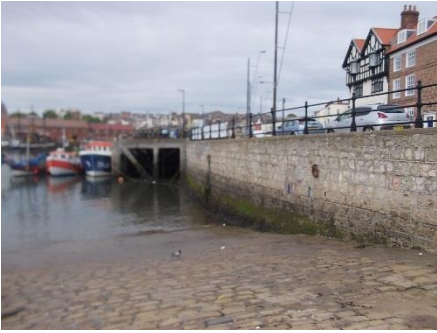
SBC Reference:	N/A		
NFCDD reference:	1221D901D1301C11

Asset Location:	TA04998877, TA05048878. West of masonry arches.	
	Asset Length:	51.7	
	Condition Assessment		
	Condition	Priority	Risk
	C	3	
	Brief Description		
	Corrosion evident sheet piles, especially lower part, but appear stable. Promenade in good condition. Some timber fenders replaced with GRP. Missing mortar in joints in slipway surfacing at western end.		
	Recommendations		
	Continue to monitor. Repair joints in slipway

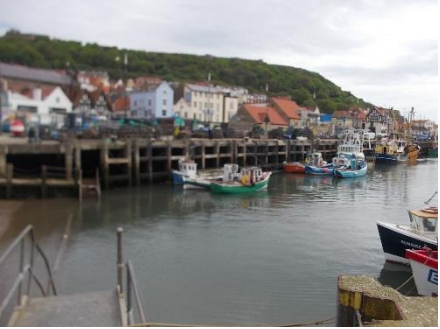
SBC Reference:	N/A		
NFCDD reference:	1221D901D1301C06

Asset Location:	TA04958876, TA04998877, Opposite Subway restaurant.	
	Asset Length:	47	
	Condition Assessment		
	Condition	Priority	Risk
	B	3	
	Brief Description		
	Few minor cracks to wall, spalling to capping. Promenade in good condition. Upper wall good. Slipway blocks missing mortar joints in places. Concrete piles at lower wall appear stable.		
	Recommendations		
	Continue monitoring, repair cracks/joints

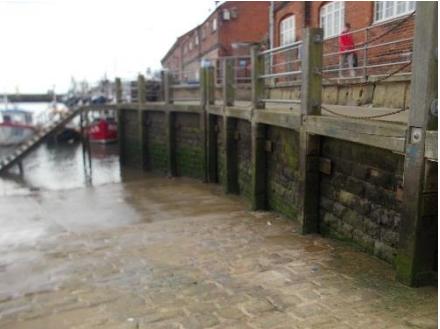
SBC Reference:	N/A		
NFCDD reference:	1221D901D1301C14

Asset Location:	TA04768876, TA04958876. Opposite Information centre.	
	Asset Length:	195.8	
	Condition Assessment		
	Condition	Priority	Risk
	B	2	
	Brief Description		
	Back wall appears to be fair to good, where visible although cracks and missing joints in places. Suspended quay appears to be fair condition, some cracks in protective coating. Concrete spray lining on roof seems in good condition. Exposed rebars and concrete spalling noted on structural beams at east end where accessible. Prom good. Timber edging rail decaying.		
	Recommendations		
	Monitor cracks to wall. Repair spalling

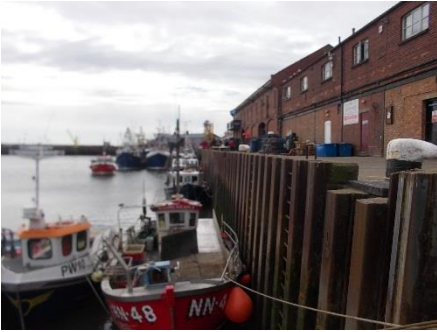
SBC Reference:	N/A		
NFCDD reference:	1221D901D1301C13

Asset Location:	TA04758875, TA04768876. West of Information centre.	
	Asset Length:	19.5	
	Condition Assessment		
	Condition	Priority	Risk
	B	3	
	Brief Description		
	Missing mortar in wall at top. Gaps in between blocks in slipway missing mortar.		
	Recommendations		
	Continue monitoring. Repoint missing joints

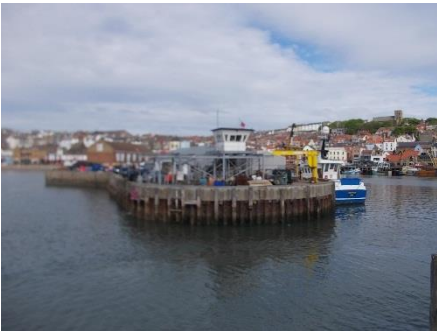
SBC Reference:	N/A		
NFCDD reference:	1221D901D1301C18

Asset Location:	TA04758875, TA04908862. West pier wall.	
	Asset Length:	140.2	
	Condition Assessment		
	Condition	Priority	Risk
	B	3	
	Brief Description		
	Sheet piles appear fair where visible, but only inspected from distance at low water. Cracks in concrete capping and prom. Missing mortar between blocks in slipway.		
	Recommendations		
Consider future inspection of quay from boat. Grout slipway joints

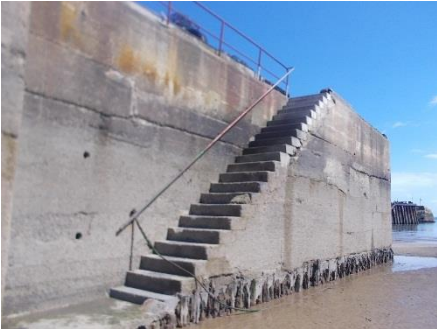
SBC Reference:	49-21B-03		
NFCDD reference:	1221D901D1301C07001

Asset Location:	TA04738870, TA04908862. Beach end of West Pier, between stairs.	
	Asset Length:	58.7	
	Condition Assessment		
	Condition	Priority	Risk
	C	2	
	Brief Description		
	Scour apron not visible due to beach level. Horizontal and vertical cracking at bend of wall, repair work failing. Exposed aggregate throughout wall. Numerous cracks throughout wall. Exposed timber toe piles rotten with scoured concrete wall behind.		
	Recommendations		
	Continue to monitor and repair cracks, voids and damaged apron. Improve toe protection

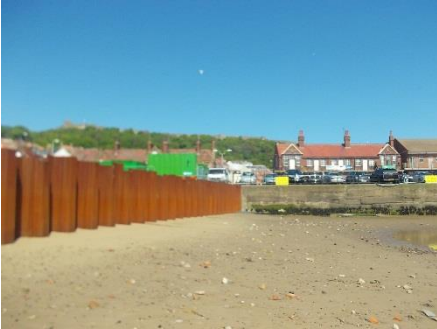
SBC Reference:	49-21B-01		
NFCDD reference:	1221D901D1301C08

Asset Location:	TA04738870, TA04908862. Shore end of West Pier.	
	Asset Length:	110.4	
	Condition Assessment		
	Condition	Priority	Risk
	C	3	
	Brief Description		
	Toe piles not visible. Vertical crack from top to bottom of wall at middle section of length, appears same as last inspection. Horizontal and vertical cracks and exposed aggregate throughout wall. Rotten timber toe piles exposed at deeper end. Scour hole developing behind the timber piles. Few minor cracks to promenade.		
	Recommendations		
	Continue to monitor and repair cracks. Repair scour holes.

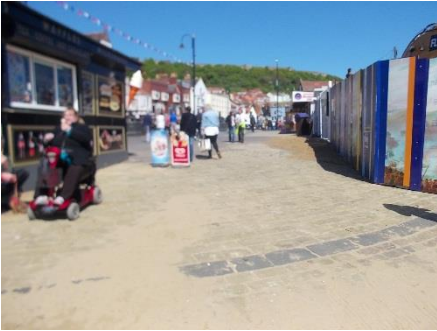
SBC Reference:	51-22A-01		
NFCDD reference:	1221D901D1301C20

Asset Location:	TA04708872, TA04738870	
	Asset Length:	69.2	
	Condition Assessment		
	Condition	Priority	Risk
	B	3	
	Brief Description		
	Majority of the wall now made redundant as incorporated in new development site. Some mortar loss to joints in remainder of wall, some minor erosion to capping beam, as well as minor mortar loss of joints to toe.		
	Recommendations		
	Continue monitoring, repair joints. Redefine extent of asset because of construction works

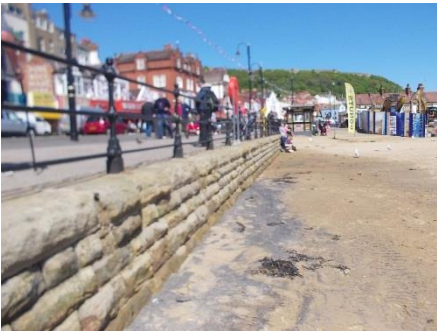
SBC Reference:	51-22A-02		
NFCDD reference:	1221D901D1301C15

Asset Location:	Next to Life boat house.	
	Asset Length:	28.5	
	Condition Assessment		
	Condition	Priority	Risk
	B	3	
	Brief Description		
	Majority of asset hidden within construction site		
	Recommendations		
	Repair missing joints and cracks. Redefine extent of asset after construction works

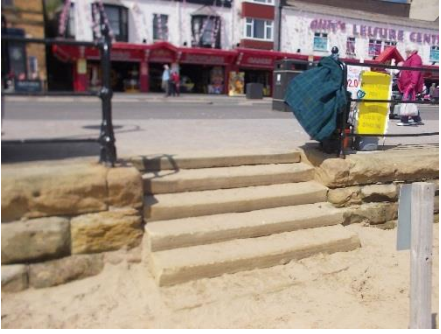
SBC Reference:	51-22A-05		
NFCDD reference:	1221D901D1301C21001

Asset Location:	TA04538856, TA04698873	
	Asset Length:	57.8	
	Condition Assessment		
	Condition	Priority	Risk
	B	3	
	Brief Description		
	Wall in fair condition, missing mortar between blocks, especially below coping. Prom good. Beach quite high, only top of wall visible. Rusting coming through on several areas of handrails.		
	Recommendations		
Repoint when necessary. Treat handrails

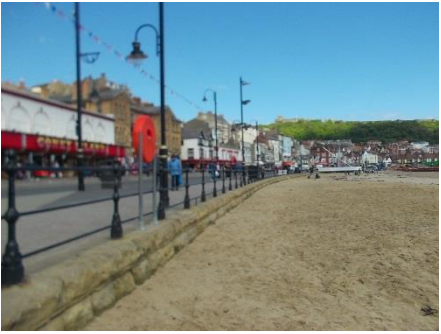
SBC Reference:	51-22A-06		
NFCDD reference:	1221D901D1301C22

Asset Location:	TA04538856, TA04698873	
	Asset Length:	~3	
	Condition Assessment		
	Condition	Priority	Risk
	B	4	5
	Brief Description		
	Fair condition overall		
	Recommendations		
Continue to monitor

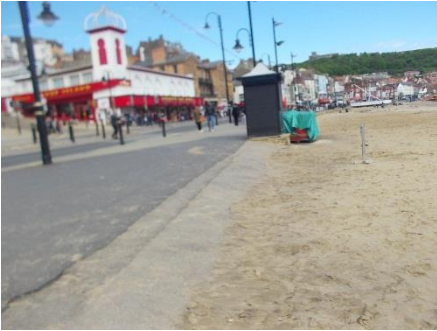
SBC Reference:	51-22A-07		
NFCDD reference:	1221D901D1301C22 001

Asset Location:	TA04538856, TA04698873	
	Asset Length:	114.9	
	Condition Assessment		
	Condition	Priority	Risk
	B	3	
	Brief Description		
	Beach high so only upper wall visible. Broken section of lower handrail at mid length. Some missing mortar between top row of blocks. Prom good.		
	Recommendations		
Repair handrails. Repoint blocks

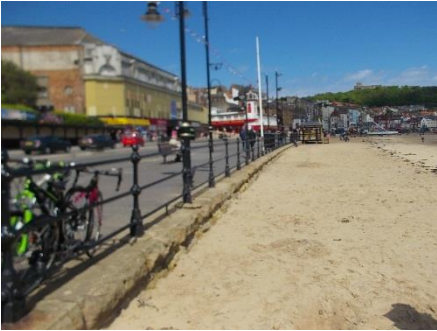
SBC Reference:	51-22A-08		
NFCDD reference:	1221D901D1301C23

Asset Location:	TA04538856, TA04698873	
	Asset Length:	~10	
	Condition Assessment		
	Condition	Priority	Risk
	B	3	
	Brief Description		
	Small access ramp covered by the beach. Exposed surface looks in fair condition.		
	Recommendations		
Continue to monitor

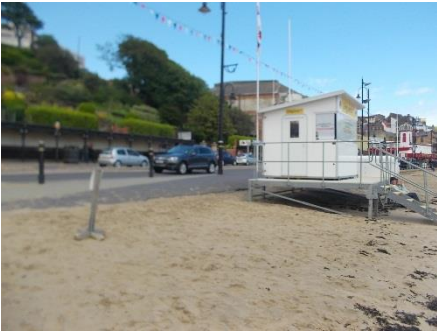
SBC Reference:	51-22A-09		
NFCDD reference:	1221D901D1301C23 001

Asset Location:	TA04538856, TA04698873	
	Asset Length:	101.8	
	Condition Assessment		
	Condition	Priority	Risk
	B	3	
	Brief Description		
	Beach high so only upper wall inspected. Wall appears in fair to good condition although missing joints in places. Some loss of material at road / slipway junction in south.		
	Recommendations		
Repair edge of road at slipway

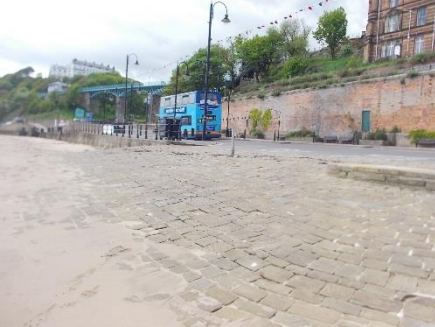
SBC Reference:	51-22A-11		
NFCDD reference:	1221D901D1301C24 ⁰⁰¹

Asset Location:	TA04538856, TA04698873	
	Asset Length:	109.7	
	Condition Assessment		
	Condition	Priority	Risk
	B	3	
	Brief Description		
	Southern section face of masonry abraded. Some missing mortar between blocks. Prom good.		
	Recommendations		
	Monitor and repoint when necessary

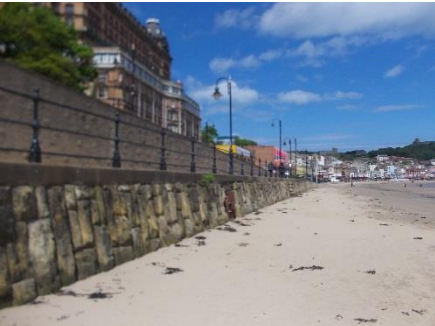
SBC Reference:	51-22A-12		
NFCDD reference:	1221D901D1301C25

Asset Location:		
	Asset Length:	~10	
	Condition Assessment		
	Condition	Priority	Risk
	B	3	
	Brief Description		
	Slipway. Missing mortar in gaps between blocks.		
	Recommendations		
	Fill gaps between blocks. Continue to monitor

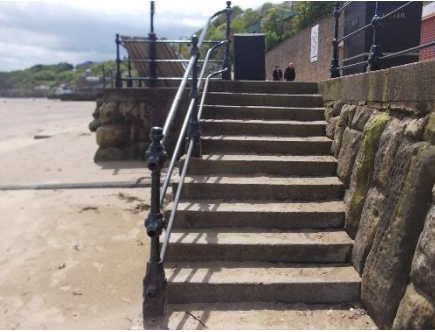
SBC Reference:	52-22A-01		
NFCDD reference:	1221D901D1301C09 001

Asset Location:	TA04538856, TA04698873. In front of Hotel.	
	Asset Length:	99.1	
	Condition Assessment		
	Condition	Priority	Risk
	B	3	
	Brief Description		
	Missing mortar in joints in places and signs of abrasion, but no cause for concern. Promenade in good condition.		
	Recommendations		
	Continue to monitor and repair joints

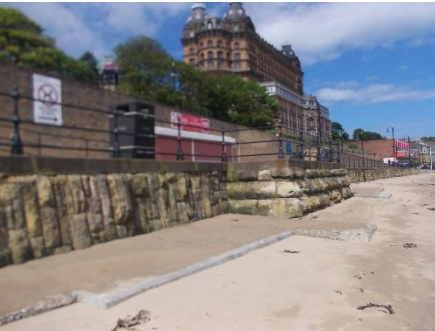
SBC Reference:	52-22A-02		
NFCDD reference:	1221D901D1301C09

Asset Location:		
	Asset Length:	~4	
	Condition Assessment		
	Condition	Priority	Risk
	B	4	5
	Brief Description		
	Fair condition overall		
	Recommendations		
	Continue to monitor

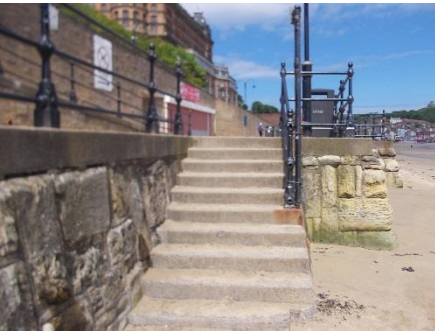
SBC Reference:	52-22A-03		
NFCDD reference:	1221D901D1301C09 002

Asset Location:	TA04428822, TA04438827. Wall at underground tunnel entrance.	
	Asset Length:	41.5	
	Condition Assessment		
	Condition	Priority	Risk
	B	3	5
	Brief Description		
	Toe apron has been repaired / overlaid. Localised missing mortar in joints to wall and signs of abrasion. Several full height vertical cracks to upper road wall. Promenade in good condition.		
	Recommendations		
	Continue to monitor and repair joints and cracks

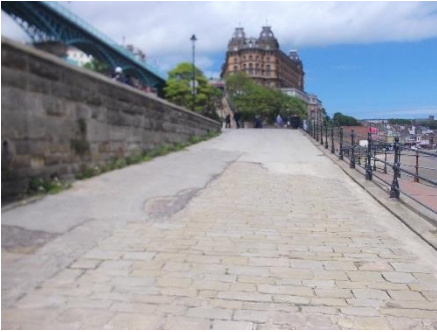
SBC Reference:	53-22B-01		
NFCDD reference:	1221D901D1301C10001

Asset Location:	South of 52-22A-04	
	Asset Length:	~12	
	Condition Assessment		
	Condition	Priority	Risk
	B	3	
	Brief Description		
	Repairs to slipway toe holding, but more open joints require filling. Mixed revetment construction testimony of previous repairs undertaken.		
	Recommendations		
Continue monitoring, repair joints

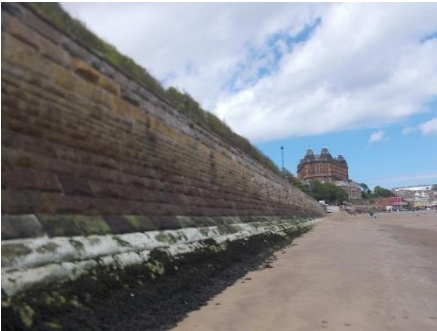
SBC Reference:	53-22B-02		
NFCDD reference:	1221D901D1301C26

Asset Location:	TA04508772, TA04428822. South of slipway.	
	Asset Length:	162.1	
	Condition Assessment		
	Condition	Priority	Risk
	B	3	
	Brief Description		
	Wall in fair. Some cracked blocks but seem stable. Missing mortar / open joints here and there. Crest wall repairs evident with some sections of coping repaired after storm damage. Some coping blocks very weathered.		
	Recommendations		
Grout joints. Continue to monitor

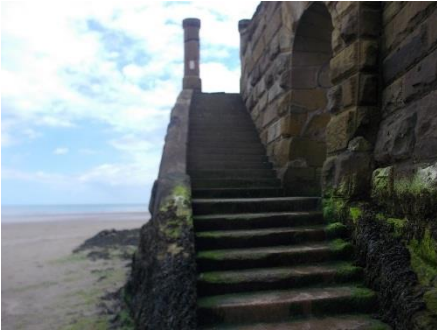
SBC Reference:	53-22B-04		
NFCDD reference:	1221D901D1301C26001

Asset Location:	Part of 53-22b-02	
	Asset Length:	~5	
	Condition Assessment		
	Condition	Priority	Risk
	B	3	
	Brief Description		
	Fair overall condition with bottom steps damaged in places		
	Recommendations		
	Repair damaged steps. Continue to monitor

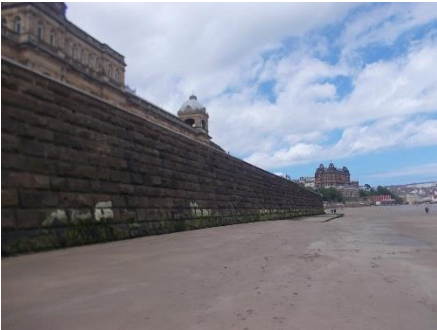
SBC Reference:	53-22B-05		
NFCDD reference:	1221D901D1301C27

Asset Location:	TA04508772, TA04428822. North of The Spa.	
	Asset Length:	158.1	
	Condition Assessment		
	Condition	Priority	Risk
	B	2	
	Brief Description		
	Toe piling corroding. Multiple repairs, some not holding well. Section of crest wall has been rebuilt after Dec 13 storm, but still poor elsewhere. Horizontal cracks in the upper section of the walls more apparent (3 blocks from top). Many cracks, open joints and displaced blocks in main wall. Recent joint repair carried out		
	Recommendations		
	Repair cracks and joints

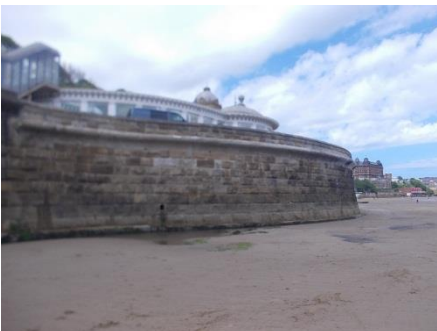
SBC Reference:	53-22B-06		
NFCDD reference:	1221D901D1301C28

Asset Location:	TA04508772, TA04428822 Opposite The Spa	
	Asset Length:	76.4	
	Condition Assessment		
	Condition	Priority	Risk
	B	3	
	Brief Description		
	Open joints and cracked blocks throughout, cracking to splash beam especially in south. Erosion / scour at toe along southern section of wall.		
	Recommendations		
	Monitor and patch up

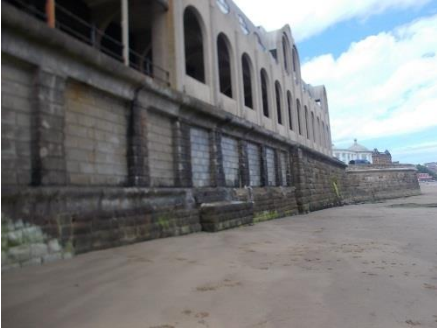
SBC Reference:	53-22B-07		
NFCDD reference:	1221D901D1301C29

Asset Location:	TA04508772, TA04428822. South of The Spa.	
	Asset Length:	57.4	
	Condition Assessment		
	Condition	Priority	Risk
	B	3	
	Brief Description		
	Beach high at time of inspection. Open joints in main wall. Major spalling and loss of concrete to lower splash beam below infilled openings. Promenade in good condition.		
	Recommendations		
Continue repair joints and monitor erosion

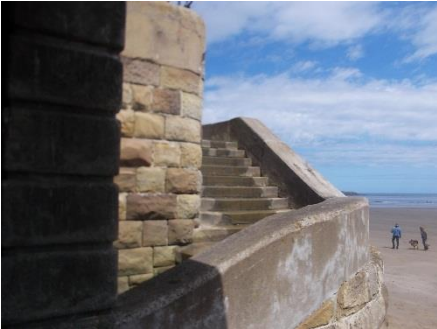
SBC Reference:	53-22B-08		
NFCDD reference:	1221D901D1302C01001

Asset Location:		
	Asset Length:	~4	
	Condition Assessment		
	Condition	Priority	Risk
	B	3	
	Brief Description		
	Side wall capping cracked but steps in fair condition		
	Recommendations		
Continue to monitor

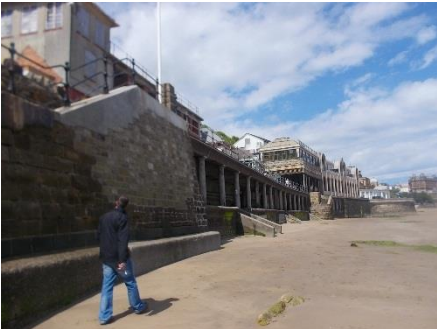
SBC Reference:	54-22B-01		
NFCDD reference:	1221D901D1302C01

Asset Location:	TA04538765, TA04508772. Next to cliff railway.	
	Asset Length:	77.5	
	Condition Assessment		
	Condition	Priority	Risk
	B	3	
	Brief Description		
	Capping beam repair and repointing carried out recently. Lower wall between the 2 set of stairs has been refaced. Steps to beach weathered and cracked. Abutment walls cracking and spalling. Tread missing at Northern end. Cracking and corrosion /rust staining to beams supporting upper prom near stairs. Major weathering loss of stone blocks in rear splash wall.		
	Recommendations		
Continue to monitor

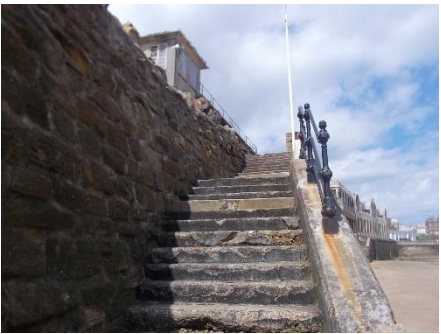
SBC Reference:	54-22B-02		
NFCDD reference:	1221D901D1302C01002

Asset Location:		
	Asset Length:	~4	
	Condition Assessment		
	Condition	Priority	Risk
	C	2	
	Brief Description		
	Steps worn out. Cracks visible across a number of steps. Some have already been repaired.		
	Recommendations		
Repair steps. Continue to monitor

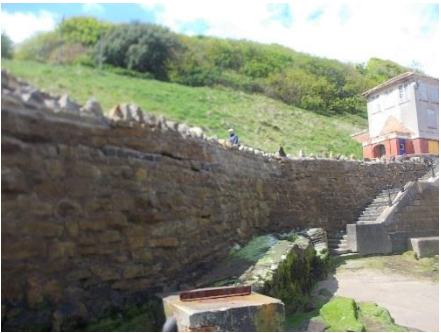
SBC Reference:	54-22B-03		
NFCDD reference:	1221D901D1302C03

Asset Location:	TA04628752, TA04538765. South of cliff railway.	
	Asset Length:	19.2	
	Condition Assessment		
	Condition	Priority	Risk
	B	3	
	Brief Description		
	Major repairs evident with blocks replaced and joints filled. However, in other areas still joint mortar loss evident in places. Cracks, and open joints in stairs. Repair work to prom visible and crack across full width.		
	Recommendations		
Replace damaged and missing joints. Repair Cracks

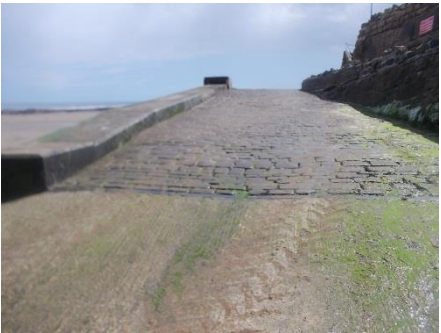
SBC Reference:	56-22B-04		
NFCDD reference:	1221D901D1302C02001

Asset Location:		
	Asset Length:	~10	
	Condition Assessment		
	Condition	Priority	Risk
	B	3	
	Brief Description		
	Fair overall condition. Uneven cobbles which need repointing in places.		
	Recommendations		
Repoint joints. Continue to monitor

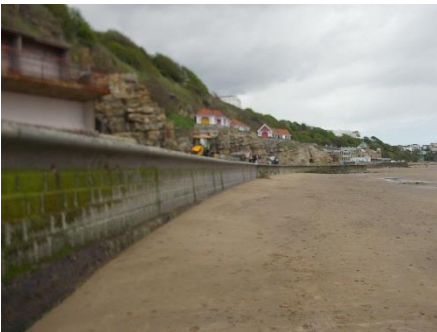
SBC Reference:	55-22B-01		
NFCDD reference:	1221D901D1302C02

Asset Location:	TA04628752, TA04538765. In front of Beach Chalets.	
	Asset Length:	231.8	
	Condition Assessment		
	Condition	Priority	Risk
	C	2	
	Brief Description		
	Repairs evident. Several sections rebuilt facing and prom slabs have been replaced. However, large areas of missing joints in prom slabs, particularly at north end. Scour of the toe with deep holes over a 20m section. Repair of concrete prom were being carried out during the inspection.		
	Recommendations		
Continue with any outstanding repair work

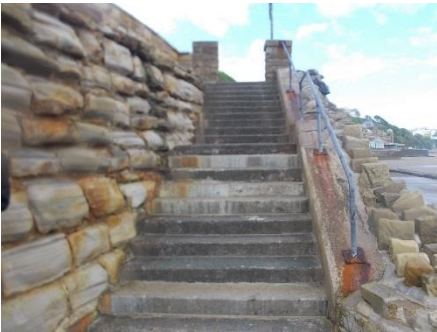
SBC Reference:	56-22B-02		
NFCDD reference:	1221D901D1302C02002

Asset Location:		
	Asset Length:	~4	
	Condition Assessment		
	Condition	Priority	Risk
	B	3	
	Brief Description		
	Cracks between the capping beam and the steps. Some steps have been recently been refurbished. Fixings to handrail corroded. Overall fair condition.		
	Recommendations		
Treat handrail fixings. Continue to monitor.

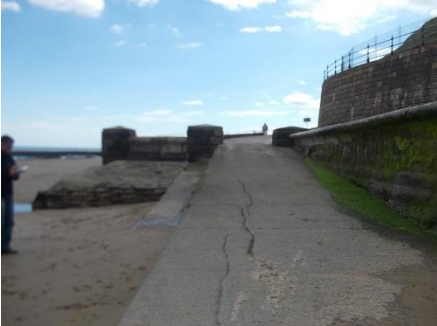
SBC Reference:	56-22B-04		
NFCDD reference:	1221D901D1302C02 004

Asset Location:		
	Asset Length:	~5	
	Condition Assessment		
	Condition	Priority	Risk
	B	3	
	Brief Description		
	Top section behind defence wall has been re-built although cracks have started to appear. Slipway leading to beach - large cracks with damaged side walls (especially the concrete bagwork and mass concrete screed)		
	Recommendations		
Repair cracks and screed.

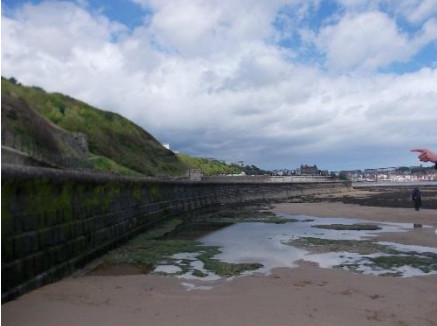
SBC Reference:	56-22B-05		
NFCDD reference:	1221D901D1303C02

Asset Location:	TA04828723, TA04668746.Wall at Dickinsons Point.	
	Asset Length:	308.2	
	Condition Assessment		
	Condition	Priority	Risk
	B	2	
	Brief Description		
	Deep voids/ missing joints in blockwork in lower wall need further attention. Loss of facing to second wall, cracks/spalling to splash beam. Abrasion / spalling throughout. Many open joints between concrete slabs in lower prom. Cracks on top deck repaired with flexible asphalt filler.		
	Recommendations		
Repair voids in joints in lower wall and open joints in lower prom. Continue to monitor

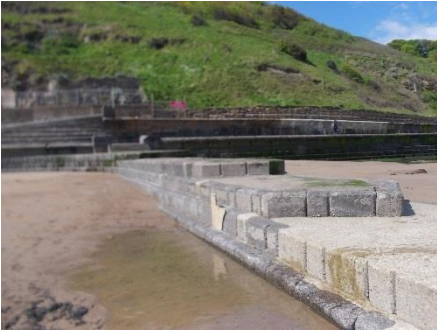
SBC Reference:	56-22B-06		
NFCDD reference:	1221D901D1303C02001

Asset Location:		
	Asset Length:	~12	
	Condition Assessment		
	Condition	Priority	Risk
	B	3	
	Brief Description		
	Groyne in fair condition with visible repairs works Ramp - Visible resin repair to side wall Concrete slab revetment repaired with flexible asphalt filler but repairs have failed and need redoing		
	Recommendations		
Replace asphalt filler

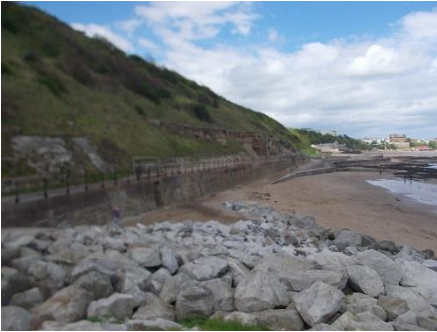
SBC Reference:	56-22B-07		
NFCDD reference:	1221D901D1304C02

Asset Location:	TA04868713, TA04828723. East of Holbeck Gardens.	
	Asset Length:	112.5	
	Condition Assessment		
	Condition	Priority	Risk
	C	3	
	Brief Description		
	Cracks to bastion throughout. Missing pointing / open joints and damaged parts of upper and lower capping beam. Unable to inspect lower wall due to high beach level. Corroded handrail with missing sections. Upper prom has been fenced off.		
	Recommendations		
Repair facing and copings. Replace broken handrails

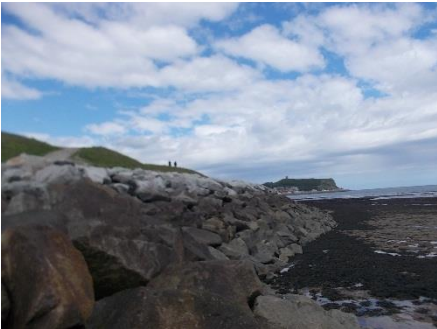
SBC Reference:	56-22B-08		
NFCDD reference:	1221D901D1304C01

Asset Location:	TA05038695, TA04868713. Land slip.	
	Asset Length:	294.7	
	Condition Assessment		
	Condition	Priority	Risk
	B	4	>5
	Brief Description		
	Rock armour tightly packed, good cover and looks in good condition. Toe in good condition, rock socketed into wave cut platform of soft rock. Exposed woven geotextile with localised ground settlement behind the rock revetment		
	Recommendations		
Continue to monitor, monitor stability of cliffs

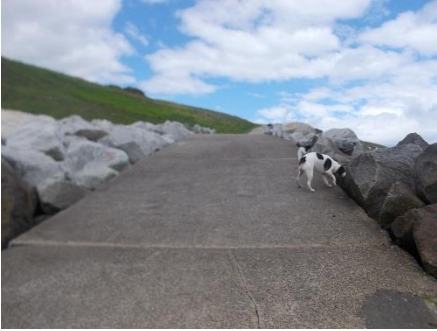
SBC Reference:	56-22B-09		
NFCDD reference:	1221D901D1304C01001

Asset Location:	Part of 56-22b-08	
	Asset Length:	~10	
	Condition Assessment		
	Condition	Priority	Risk
	B	4	>5
	Brief Description		
	Southern ramp has vertical drop to rocks and crack in bottom slab		
	Recommendations		
Repair cracks. Continue to monitor

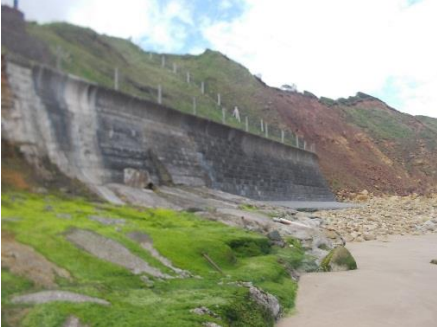
SBC Reference:	58-24B-01		
NFCDD reference:	1221D901D1402C02

Asset Location:	TA06618455, TA06648454	
	Asset Length:	34	
	Condition Assessment		
	Condition	Priority	Risk
	B	4	>5
	Brief Description		
	North of old PS. Poured concrete and concrete blockwork toe below a stepped seawall with curved coping stone. More recent construction than adjacent walls. Cliff cutting back adjacent to North. Wall generally fair, but toe undercut at South.		
	Recommendations		
Repair to voids. Monitor for outflanking

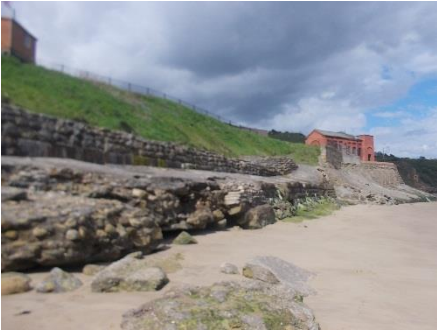
SBC Reference:	59-24B-01		
NFCDD reference:	1221D901D1402C05

Asset Location:	TA06698449, TA06658454	
	Asset Length:	67.3	
	Condition Assessment		
	Condition	Priority	Risk
	C	3	3
	Brief Description		
	Private wall to old PS. Lower apron has multiple patch repairs with poured concrete, but has cracks. Recent pointing to main wall joints. Higher wall slightly better than lower. Beach high, but toe may be undercut. Slip failure behind higher wall with access steps consolidated with trench sheets. Large voids in the lower wall at beach level		
	Recommendations		
Private maintenance

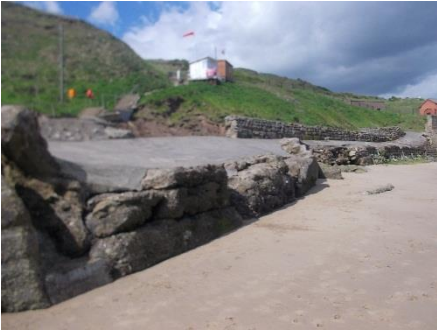
SBC Reference:	60-24B-01		
NFCDD reference:	1221D901D1402C04

Asset Location:	TA06698449, TA06758445	
	Asset Length:	32.6	
	Condition Assessment		
	Condition	Priority	Risk
	C	3	
	Brief Description		
	Southern section of apron is missing, lower sea wall has been undercut and failed. Blockwork missing and displaced. Some repairs to deck with concrete. Upper wall missing southern section. Toe undermined. Crest breaking up.		
	Recommendations		
Repair or remove/make safe

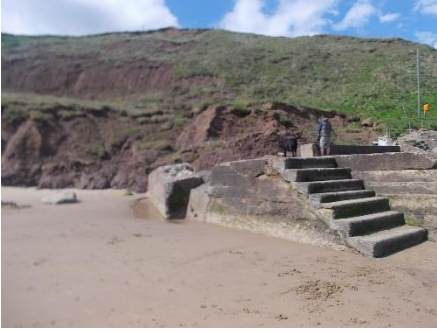
SBC Reference:	60-24B-01		
NFCDD reference:	1221D901D1402C06

Asset Location:	Nr Pumping Station in Cayton Bay.	
	Asset Length:	19.9	
	Condition Assessment		
	Condition	Priority	Risk
	C	3	
	Brief Description		
	Mass concrete wall has failed and is breaking up. More patch repair work has been done to make safer for pedestrians. Large voids beneath. Needs removing and replacing with safer beach pedestrian access.		
	Recommendations		
Demolish and remove and construct safer beach access ramp

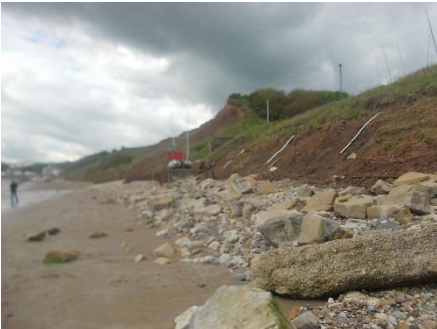
SBC Reference:	N/A		
NFCDD reference:	1221D901D1601C01

Asset Location:	TA12248126, TA12278130	
	Asset Length:	18.3	
	Condition Assessment		
	Condition	Priority	Risk
	D	4	
	Brief Description		
	Rock armour scattered and totally ineffective. Timber breastwork no longer evident. Coastal slope appears to be actively eroding. Rock armour originally placed in failed breastwork.		
	Recommendations		
Consider reprofiling rock to slow erosion at boat club

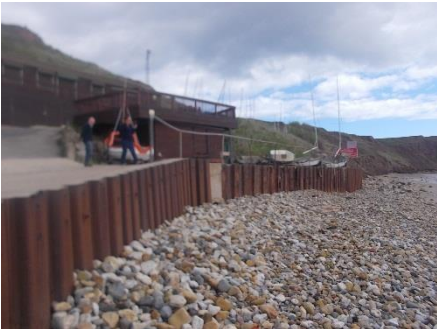
SBC Reference:	64-28A-02		
NFCDD reference:	1221D901D1601C03

Asset Location:	TA12228121, TA12248126	
	Asset Length:	55.8	
	Condition Assessment		
	Condition	Priority	Risk
	D	1	
	Brief Description		
	Sheet piling heavily corroded with very large holes within sheet piles & large voids under prom in front of club and P/S. Piles adjacent to slip and at North end appear new, but are corroding.		
	Recommendations		
Replace central section of sheet piling

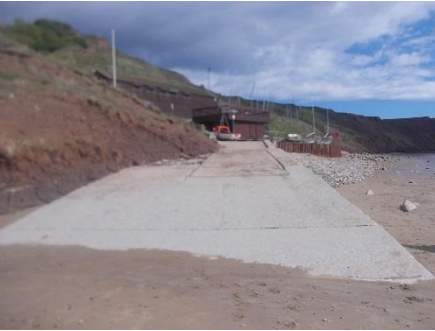
SBC Reference:	64-28A-01		
NFCDD reference:	1221D901D1601C03001

Asset Location:	TA12228121, TA12248126	
	Asset Length:	~15	
	Condition Assessment		
	Condition	Priority	Risk
	B	3	
	Brief Description		
	Good condition at the lower end but cracks in the middle part with patch repairs carried out. Upper section in fair condition. Noticeable movement of the earth slope which is encroaching on the slipway and slowly narrowing the access		
	Recommendations		
Reprofile bank at edge of slipway to maintain access and secure cliff erosion

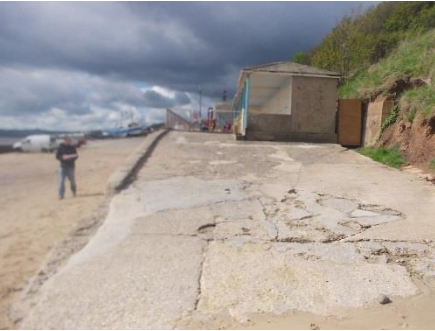
SBC Reference:	N/A		
NFCDD reference:	1221D901D1602C09002

Asset Location:	TA12118095, TA12128100	
	Asset Length:	~10	
	Condition Assessment		
	Condition	Priority	Risk
	C	2	
	Brief Description		
	Wing wall badly eroded at base. Capping failed with large section missing. Ramp revetment is a mixture of concrete repairs with large cracks and voids. Poor state overall		
	Recommendations		
Repair deck of slipway. Rebuild wingwall. Continue to monitor

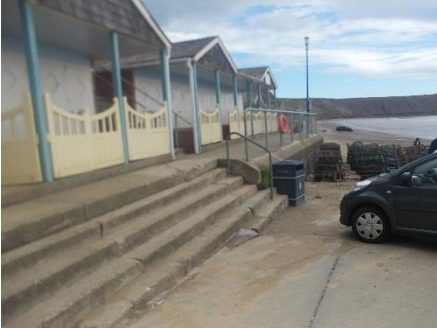
SBC Reference:	N/A		
NFCDD reference:	1221D901D1602C09

Asset Location:	North of promenade, Filey.	
	Asset Length:	38.8	
	Condition Assessment		
	Condition	Priority	Risk
	B	3	
	Brief Description		
	Crest section repaired since 2012, looks to be holding well. Some horizontal cracks and open joints. Degradation of front faces of blocks and capping. including steps on upper side of the slipway Steps chipped with one vertical crack but fair condition overall		
	Recommendations		
Monitor and repair damage as necessary

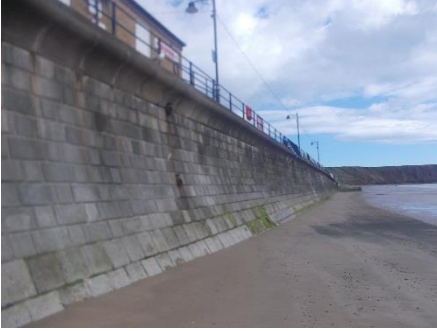
SBC Reference:	67-28B-01		
NFCDD reference:	1221D901D1602C06

Asset Location:	TA12118095, TA12128100	
	Asset Length:	49.6	
	Condition Assessment		
	Condition	Priority	Risk
	B	2	
	Brief Description		
	Mass concrete wall abraded with exposed aggregates. Construction joints chipped with missing sealant. Top handrail corroding		
	Recommendations		
Repair damaged wall. Treat handrailing

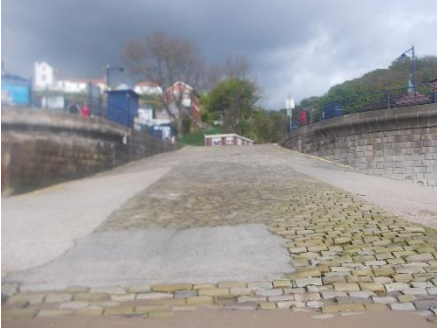
SBC Reference:	67-28B-02		
NFCDD reference:	1221D901D1602C08001

Asset Location:	North of promenade	
	Asset Length:	109.8	
	Condition Assessment		
	Condition	Priority	Risk
	B	2	
	Brief Description		
	Missing pointing between blocks on wall. Damage to front face of several blocks. Repairs have been undertaken to one area. Cracks to wing wall of Southern slipway (67-28B-02). Large crack throughout the wing wall (7m from the extremity of the wall) indicating GEO and STR failure.		
	Recommendations		
Repointing. Seal cracks below coping. Monitor large crack for movement

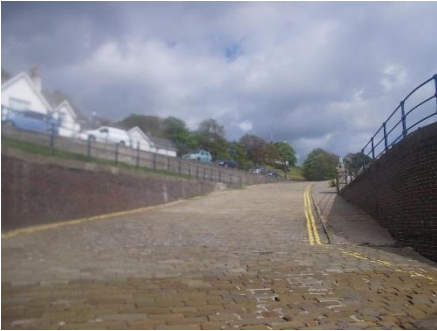
SBC Reference:	67-28B-04		
NFCDD reference:	1221D901D1602C03002

Asset Location:	TA11978020, TA12068082	
	Asset Length:	301.6	
	Condition Assessment		
	Condition	Priority	Risk
	B	3	
	Brief Description		
	Abrasion to front face, particularly just above beach level. Many bullnose splash blocks have been repaired, but others are cracked and require attention. Missing joints in slipway ramp at South. Handrails corroded.		
	Recommendations		
Replace/repair cracked coping and repair damaged blocks. Replace handrails

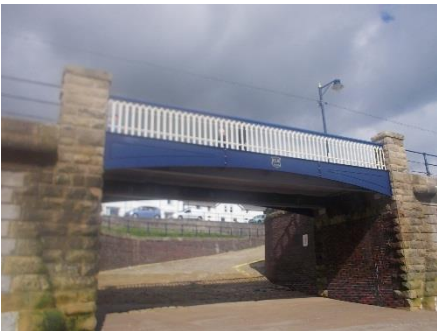
SBC Reference:	67-28B-04		
NFCDD reference:	1221D901D1602C03003

Asset Location:		
	Asset Length:	12	
	Condition Assessment		
	Condition	Priority	Risk
	B	3	
	Brief Description		
	Missing joints in slipway ramp at South .Handrails corroded. Missing joints in places particularly at the lower end, one block missing. Flexible asphalt repair to joints Missing brickwork and mortar joints on abutment walls		
	Recommendations		
Replace block and missing joints. Treat handrail or replace

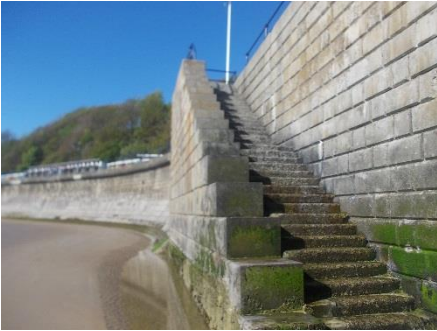
SBC Reference:	67-28B-08		
NFCDD reference:	1221D901D1602C04 001

SBC Reference:	67-28B-07		
NFCDD reference:	1221D901D1602C04		
 	Asset Location:	TA11968012, TA11978020	
	Asset Length:	91.8	
	Condition Assessment		
	Condition	Priority	Risk
	B	3	
	Brief Description		
	Evidence of repair to cracks/joints with mastic. Faces of some blocks missing, but overall fair. Missing joints between a few blocks. Prom fair. Crack on bullnose.		
	Recommendations		
Seal cracks. Repair missing block faces

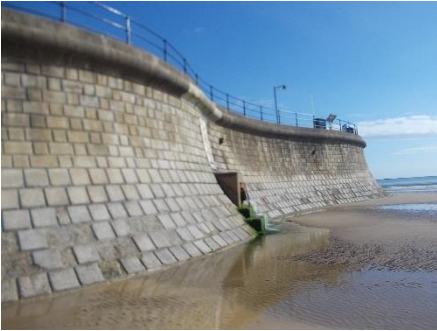
SBC Reference:	67-28B-11		
NFCDD reference:	1221D901D1602C05

Asset Location:		
	Asset Length:	10	
	Condition Assessment		
	Condition	Priority	Risk
	B	3	
	Brief Description		
	Spalling, abrasion to concrete blocks on seaward side with missing joints in places. Steps in fair condition		
	Recommendations		
Replace missing joints. Continue to monitor

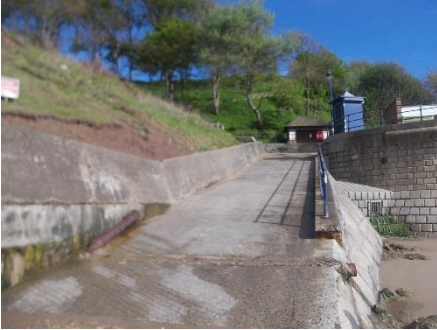
SBC Reference:	67-28B-12		
NFCDD reference:	1221D901D1602C02 001

Asset Location:	TA11957997, TA11968012	
	Asset Length:	103.9	
	Condition Assessment		
	Condition	Priority	Risk
	B	3	
	Brief Description		
	Some damage to seaward edge of prom. Repairs to splash beam by outfall holding. Numerous lower blocks from beach level to 2m damaged on front face. Beach higher than in 2012. Horizontal crack on seaward section as 2012. Cracks in retaining wall to slipway		
	Recommendations		
Monitor damage to blocks and repair where necessary. Patch repair prom surfacing. Treat/replace handrailing
