Asset Inspection Document

Walk-over Visual Inspections of Assets

Scarborough Borough Council

September 2016

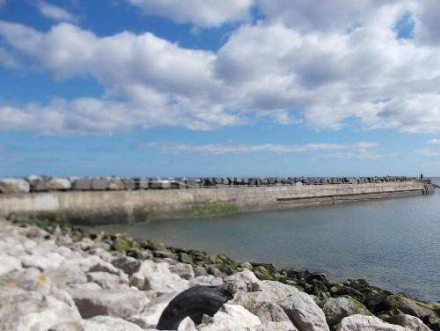
SBC Reference:	N/A		
NFCDD reference:	1221D901D0402C01

Asset Location:	NZ78271901, NZ78441906. North breakwater.	
	Asset Length:	370.8	
	Condition Assessment		
	Condition	Priority	Risk
	C	2	
	Brief Description		
	Rock tightly packed. Heavily corroded sheet piling. Cracking to promenade. Cracking to promenade and crest wall.		
	Recommendations		
	Replace sheet piles; grout voids in structure.

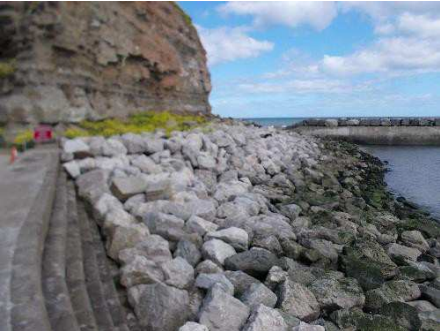
SBC Reference:	N/A		
NFCDD reference:	1221D901D0402C02

Asset Location:	NZ78301893, NZ78271901. South of Northern breakwater.	
	Asset Length:	91.4	
	Condition Assessment		
	Condition	Priority	Risk
	B	3	
	Brief Description		
	Rock armour in generally good condition, undercutting at toe.		
	Recommendations		
	Continue to monitor.

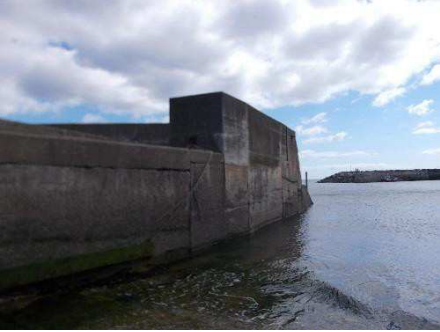
SBC Reference:	N/A		
NFCDD reference:	1221D901D0402C03

Asset Location:	NZ78251893, NZ78301893. RNLI slipway.	
	Asset Length:	55.3	
	Condition Assessment		
	Condition	Priority	Risk
	C	3	
	Brief Description		
	Horizontal cracks to wall. Slipway surface in good condition, but timber piles cracked and weathered. Gabion generally in good condition, but one section settled.		
	Recommendations		
Monitoring and repair cracks to wall.

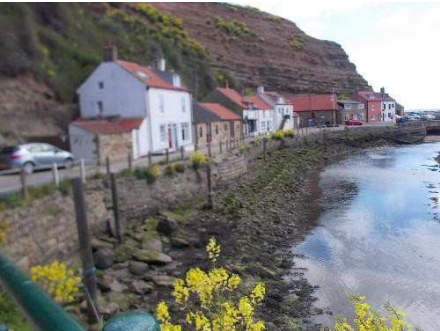
SBC Reference:	N/A		
NFCDD reference:	1221D901D0402C06

Asset Location:	Staithes, LB of River D/S of footbridge.	
	Asset Length:	100.3	
	Condition Assessment		
	Condition	Priority	Risk
	C	3	
	Brief Description		
	Promenade in fair condition. Wall has missing blocks and open joints. Vegetation at top of wall.		
	Recommendations		
Replace missing blocks and grout open joints.

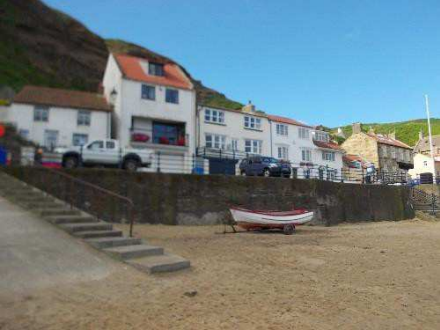
SBC Reference:	04-04-01		
NFCDD reference:	1221D901D0403C01

Asset Location:	NZ78361882, NZ78421880 South wall next to last slipway.	
	Asset Length:	73.1	
	Condition Assessment		
	Condition	Priority	Risk
	B	3	
	Brief Description		
	Vertical full height crack through the wall between stairs and groyne has been filled. Exposure of aggregate throughout wall. Vegetation re-growing at top of wall. Cracking to promenade. Steps in fair condition. New full height vertical crack.		
	Recommendations		
	Continue to monitor and repair crack to wall and promenade cracking.

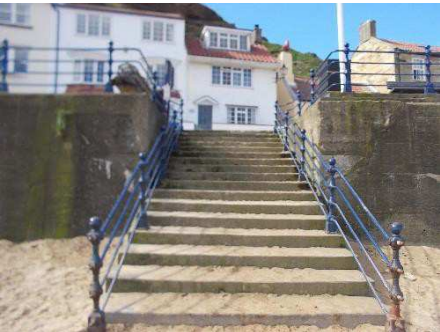
SBC Reference:	N/A		
NFCDD reference:	1221D901D0403C02

Asset Location:		
	Asset Length:	~5	
	Condition Assessment		
	Condition	Priority	Risk
	B	3	
	Brief Description		
	Steps in fair condition.		
	Recommendations		
	Continue to monitor

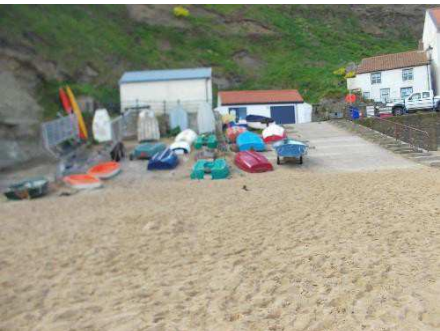
SBC Reference:	N/A		
NFCDD reference:	1221D901D0403C05

Asset Location:	NZ78421881, NZ78441881 Next to cliff.	
	Asset Length:	26.8	
	Condition Assessment		
	Condition	Priority	Risk
	B	4	>5
	Brief Description		
	Good condition no sign of defects visible.		
	Recommendations		
	Continue to monitor.

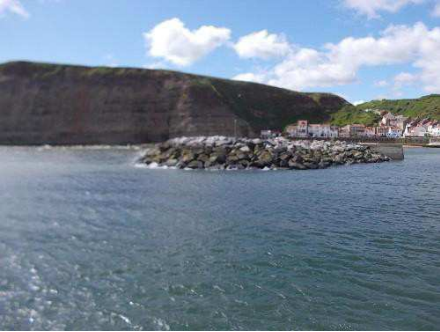
SBC Reference:	N/A		
NFCDD reference:	1221D901D0403C03

Asset Location:	NZ78491884, South Breakwater.	
	Asset Length:	327.5	
	Condition Assessment		
	Condition	Priority	Risk
	B	3	
	Brief Description		
	Concrete crest cracked in the middle of the length. Rock armour mostly tightly packed. Opening of construction joints to the old part of the wall (inner face).		
	Recommendations		
Continue to monitor.

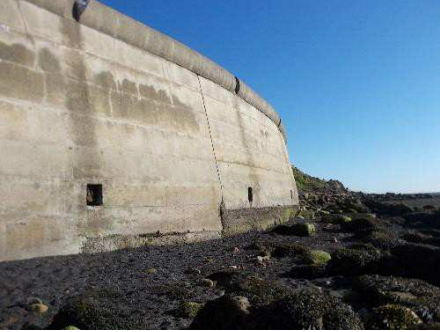
SBC Reference:	07-07A-01		
NFCDD reference:	1221D901D0601C01

Asset Location:	NZ81081614, NZ81111619. Next to Upgarth Hill	
	Asset Length:	72.4	
	Condition Assessment		
	Condition	Priority	Risk
	C	2	
	Brief Description		
	Erosion and abrasion & undercutting to the wall toe in the mudstone. Cracks, erosion and spalling to capping beam. Wash out of the joints under the capping beam. Missing joints and filler joints in places on wall and prom. Prom slabs have dropped /moved		
	Recommendations		
Repair joints, cracks and undercutting as well as the voids to wall

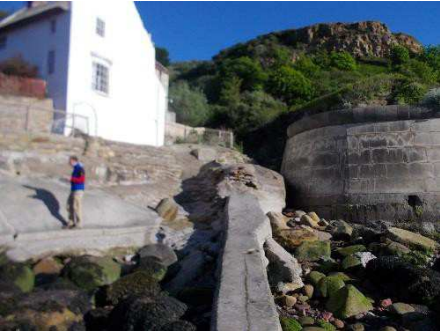
SBC Reference:	07-07A-02		
NFCDD reference:	1221D901D0601C01 001

Asset Location:		
	Asset Length:	2	
	Condition Assessment		
	Condition	Priority	Risk
	B	4	>5
	Brief Description		
	2015: Function unknown - might be sewer outfall with protective concrete encasing. 2016: Not inspected in detail.		
	Recommendations		
Continue to monitor

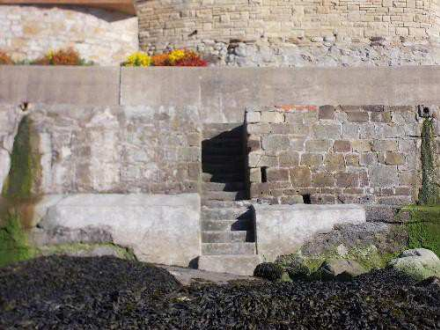
SBC Reference:	08-07A-02		
NFCDD reference:	1221D901D0601C03001

Asset Location:		
	Asset Length:	~7	
	Condition Assessment		
	Condition	Priority	Risk
	B	3	
	Brief Description		
	2015: Steep and weathered stone block. Bottom half repaired with concrete. The last tread to the beach is noticeably high. 2016: Not inspected in detail.		
	Recommendations		
	Continue to monitor

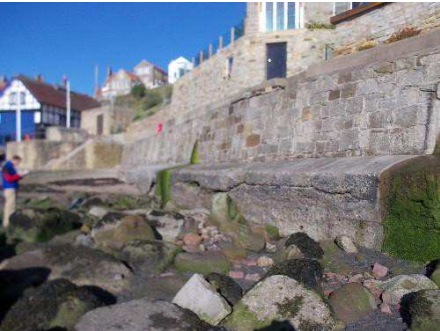
SBC Reference:	08-07A-03		
NFCDD reference:	1221D901D0601C03002

Asset Location:		
	Asset Length:	~35	
	Condition Assessment		
	Condition	Priority	Risk
	C	2	
	Brief Description		
	2015: Evident scattered concrete repairs to the stepped berm but deep horizontal cracks still remain with significant voids in places. Cracking to the repaired concrete section observed. 2016: Not inspected in detail.		
	Recommendations		
	Repair cracks, voids and undercutting. Consider extending the rock scour protection

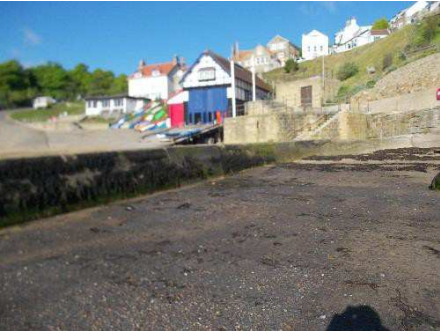
SBC Reference:	08-07A-04		
NFCDD reference:	1221D901D0601C02

Asset Location:	NZ81011606, NZ81031605.	
	Asset Length:	26.1	
	Condition Assessment		
	Condition	Priority	Risk
	C	2	
	Brief Description		
	Breakwater / groyne. Large deep horizontal cracks through breakwater have worsened since 2012. Crest slab may have moved. Multiple patches and cracks. Smaller vertical cracks to breakwater at sea end. Poor condition overall.		
	Recommendations		
Consider removal or incorporation in new revetment scheme.

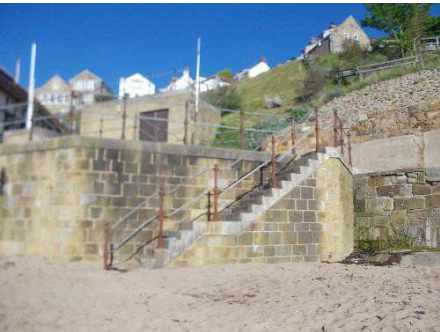
SBC Reference:	08-07A-05		
NFCDD reference:	1221D901D0601C07001

Asset Location:		
	Asset Length:	7	
	Condition Assessment		
	Condition	Priority	Risk
	B	4	>5
	Brief Description		
	2015: Corrosion to handrail standards, especially on steps. Minor surface damage to steps. 2016: Not inspected in detail.		
	Recommendations		
Continue to monitor.

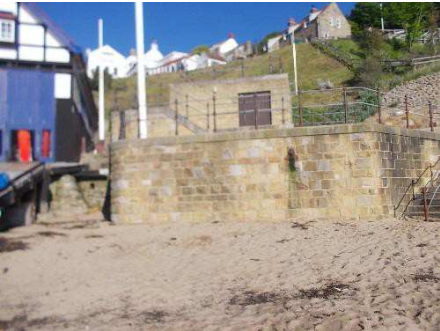
SBC Reference:	08-07A-06		
NFCDD reference:	1221D901D0601C07

Asset Location:	Runswick Bay. Pumping station.	
	Asset Length:	33.3	
	Condition Assessment		
	Condition	Priority	Risk
	B	4	>5
	Brief Description		
	Pumping station and associated sea wall and berm. Wall and berm in good condition.		
	Recommendations		
Continue to monitor.

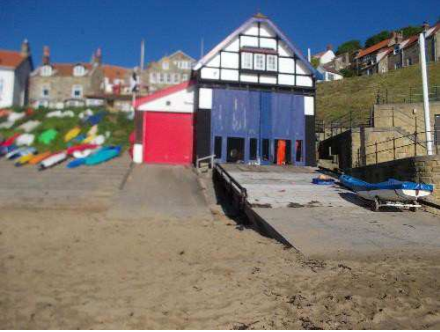
SBC Reference:	09-07A-01		
NFCDD reference:	1221D901D0601C04

Asset Location:	NZ81011601. Lifeboat slipway.	
	Asset Length:	43.8	
	Condition Assessment		
	Condition	Priority	Risk
	B	3	
	Brief Description		
	Rotting timber supports to disused timber slipway - some planks recently replaced in deck. Cracks to side walls of smaller slipway. Southern slipway / ramp in good condition. Concrete revetment including timber grippers in good condition with joints recently repaired.		
	Recommendations		
Repair cracks to slipway, replace rotten/missing timbers.

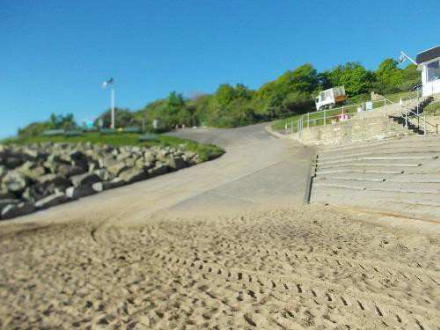
SBC Reference:	09-07A-02		
NFCDD reference:	1221D901D0601C04001

Asset Location:		
	Asset Length:	~30	
	Condition Assessment		
	Condition	Priority	Risk
	B	4	>5
	Brief Description		
	2015: Southern slipway / ramp in good condition. 2016: Not inspected in detail.		
	Recommendations		
Continue to monitor.

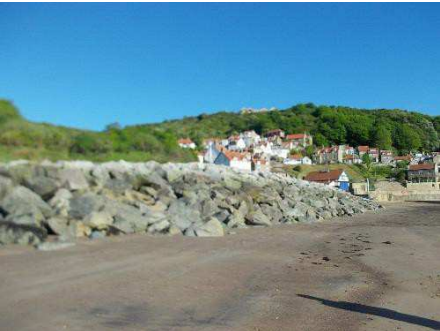
SBC Reference:	10-07A-01		
NFCDD reference:	1221D901D0602C01

Asset Location:	NZ81051591, NZ81011601	
	Asset Length:	290	
	Condition Assessment		
	Condition	Priority	Risk
	B	4	>5
	Brief Description		
	Rock armour mostly in very good condition, well and tightly packed.		
	Recommendations		
Continue to monitor.

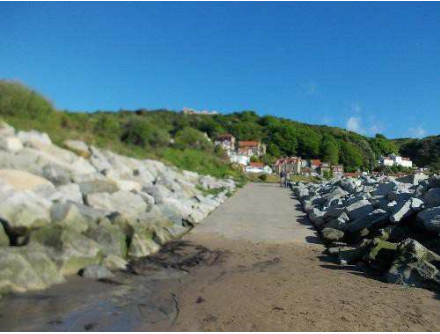
SBC Reference:	10-07B-01		
NFCDD reference:	1221D901D0602C01 001

Asset Location:	NZ81051591, NZ81011601	
	Asset Length:	~50	
	Condition Assessment		
	Condition	Priority	Risk
	B	4	>5
	Brief Description		
	2015: Slipway in good condition. 2016: Not inspected in detail.		
	Recommendations		
	Continue to monitor.

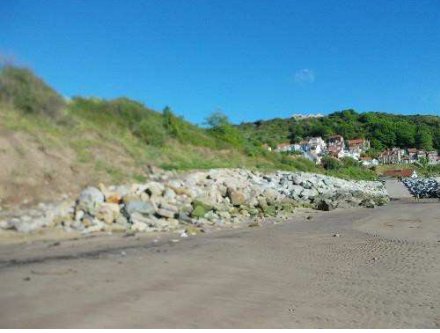
SBC Reference:	10-07B-02		
NFCDD reference:	1221D901D0602C01 002

Asset Location:		
	Asset Length:	~48	
	Condition Assessment		
	Condition	Priority	Risk
	B	2	
	Brief Description		
	2015: Rock armour mostly good condition but some movement / loose blocks at both ends by southern slipway. Cliff slumping and eroding to south. 2016: Not inspected in detail.		
	Recommendations		
	Continue to monitor

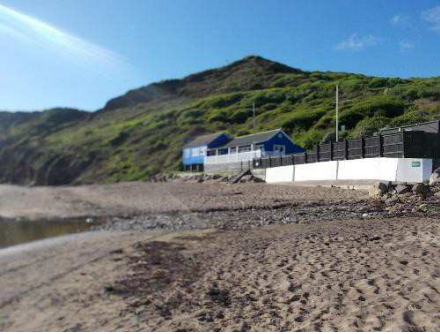
SBC Reference:	N/A		
NFCDD reference:	1221D901D0602C05

Asset Location:	South end of bay.	
	Asset Length:	56.2	
	Condition Assessment		
	Condition	Priority	Risk
	B	3	
	Brief Description		
	Boulders and concrete blocks placed at toe of timber sleeper retaining wall.		
	Recommendations		
	Continue to monitor and repair/replace rock.

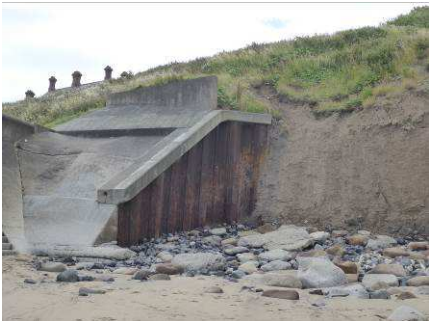
SBC Reference:	13-09A-01		
NFCDD reference:	1221D901D0701C02001

Asset Location:	NZ86061286, NZ85981297. Wall protecting car park.	
	Asset Length:	~5	
	Condition Assessment		
	Condition	Priority	Risk
	C	3	
	Brief Description		
	Heavily corroded sheet pile retaining wall tied into the unprotected cliff. No deflection / movement of the pile noticeable. Concrete capping appears in good condition.		
	Recommendations		
	Continue to monitor corrosion of piles and erosion of undefended cliff at tie-in.

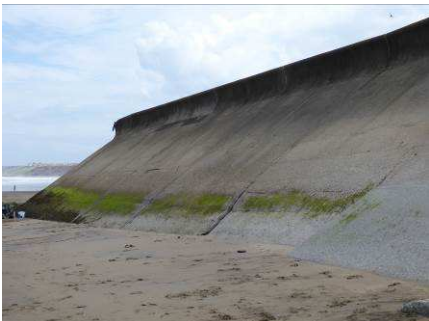
SBC Reference:	13-09A-02		
NFCDD reference:	1221D901D0701C02

Asset Location:	NZ86061286, NZ85981297. Wall protecting car park.	
	Asset Length:	174.5	
	Condition Assessment		
	Condition	Priority	Risk
	B	3	
	Brief Description		
	Sloping concrete revetment with a recurve crest wall. The concrete wall remains in fair condition with minimal damage to the surface, however the revetment has lost thickness of concrete at the base through abrasion, with exposure of reinforcement bars.		
	Recommendations		
	Encasement of this reinforcement is advised from a structural perspective, as well as preventing any Health & Safety incidents occurring due to sharp edges of the exposed bars on this popular amenity beach. Cracks towards southern end need filling.

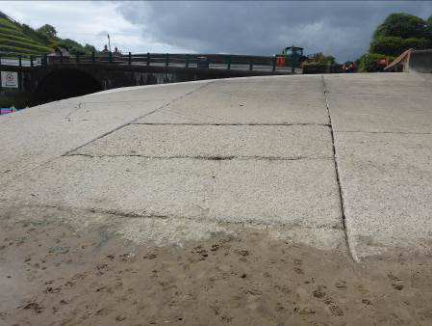
SBC Reference:	13-09A-03		
NFCDD reference:	1221D901D0701C02002

Asset Location:		
	Asset Length:	~15	
	Condition Assessment		
	Condition	Priority	Risk
	B	3	
	Brief Description		
	Missing filler in joints to slipway. Toe at interface of slipway and adjacent seawall is locally poor.		
	Recommendations		
Continue to monitor and fill gaps in joints.

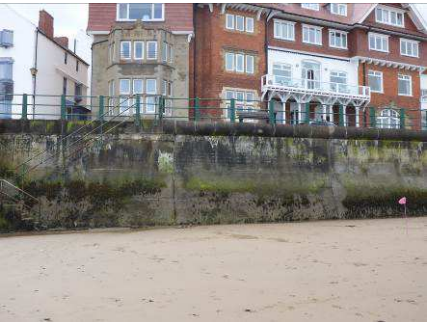
SBC Reference:	14-09B-01		
NFCDD reference:	1221D901D0702C01

Asset Location:	NZ86061286, NZ86241268	
	Asset Length:	259.1	
	Condition Assessment		
	Condition	Priority	Risk
	C	2	
	Brief Description		
	Groynes derelict. Apron part buried, assume still very poor. Timber planks & stakes next to apron missing and rotten. Missing joints filler under capping beam. Missing sealant in most joints in wall, with abrasion around joints.		
	Recommendations		
Re-seal joints between poured sections of sea wall, and replace apron. Whilst not yet 'urgent' the structure would benefit from works with 2 years.

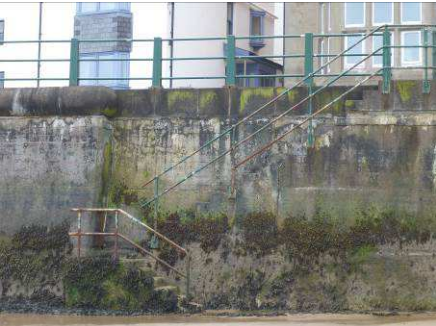
SBC Reference:	14-09B-02		
NFCDD reference:	1221D901D0702C01001

Asset Location:		
	Asset Length:	~4	
	Condition Assessment		
	Condition	Priority	Risk
	B	3	
	Brief Description		
	Steps covered by vegetation. Handrail corroded with missing bottom rail at lower end. Concrete weathered in places.		
	Recommendations		
Replace handrail

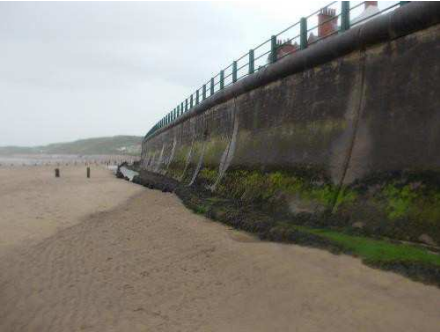
SBC Reference:	14-09B-03		
NFCDD reference:	1221D901D0702C01002

Asset Location:	Same as 14-09B-01	
	Asset Length:	Incl. in 14-09B-01	
	Condition Assessment		
	Condition	Priority	Risk
	C	2	
	Brief Description		
	Groynes derelict. Apron part buried, assume still very poor. Timber planks & stakes next to apron missing and rotten. Missing joints filler under capping beam. Missing sealant in most joints in wall, with abrasion around joints.		
	Recommendations		
Re-seal joints between poured sections of sea wall, and replace apron. Whilst not yet 'urgent' the structure would benefit from works with 2 years.

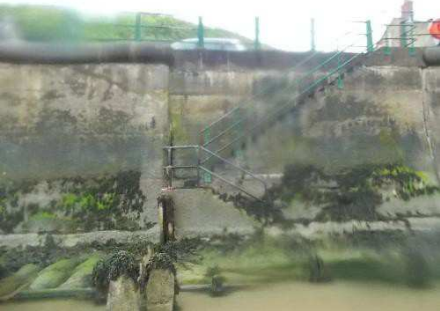
SBC Reference:	14-09B-04		
NFCDD reference:	1221D901D0702C01003

Asset Location:		
	Asset Length:	~4	
	Condition Assessment		
	Condition	Priority	Risk
	B	3	
	Brief Description		
	Steps in fair condition		
	Recommendations		
Continue to monitor

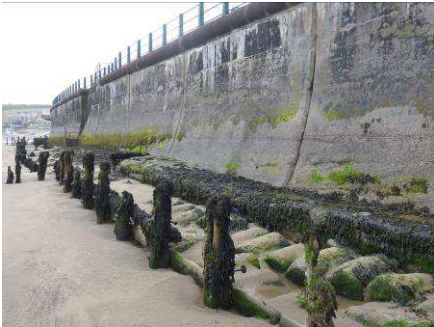
SBC Reference:	14-09B-05		
NFCDD reference:	1221D901D0702C01004

Asset Location:	Same as 14-09B-01	
	Asset Length:	Incl. in 14-09B-01	
	Condition Assessment		
	Condition	Priority	Risk
	C	2	
	Brief Description		
	Groynes derelict. Apron still very poor. Timber planks & stakes next to apron missing and rotten. Missing joints filler under capping beam. Missing sealant in most joints in wall, with abrasion around joints.		
	Recommendations		
Re-seal joint between poured sections of sea wall, and replace apron. Whilst not yet 'urgent' the structure would benefit from works with 2 years.

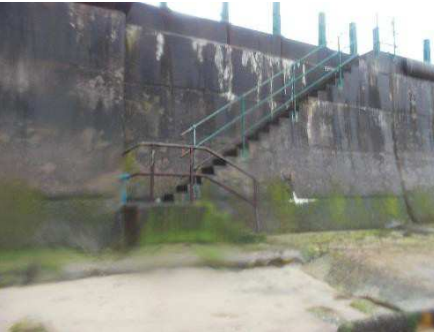
SBC Reference:	14-09B-06		
NFCDD reference:	1221D901D0702C01005

Asset Location:		
	Asset Length:	~4	
	Condition Assessment		
	Condition	Priority	Risk
	B	3	
	Brief Description		
	Fair condition with localised damage to concrete facing. Handrail corroded		
	Recommendations		
Replace handrail			
SBC Reference:	14-09B-07

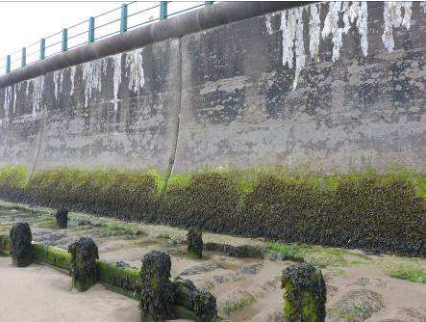
NFCDD reference:	1221D901D0702C01006

Asset Location:	Same as 14-09B-01	
	Asset Length:	Incl. in 14-09B-01	
	Condition Assessment		
	Condition	Priority	Risk
	C	2	
	Brief Description		
	Groynes derelict. Apron part buried, assume still very poor. Timber planks & stakes next to apron missing and rotten. Missing joints filler under capping beam. Missing sealant in most very joints in wall, with abrasion around joints.		
	Recommendations		
Re-seal joints between poured sections of sea wall, and replace apron. Whilst not yet 'urgent' the structure would benefit from works with 2 years.

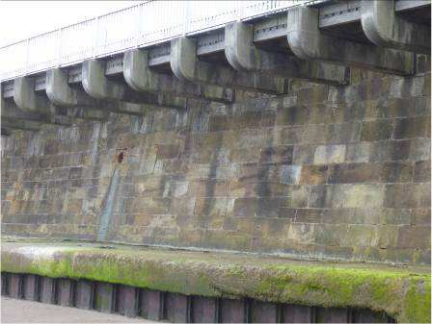
SBC Reference:	15-09B-01		
NFCDD reference:	1221D901D0702C04

Asset Location:	NZ86251264, NZ86241268. NE of East Row Bridge.	
	Asset Length:	42.1	
	Condition Assessment		
	Condition	Priority	Risk
	B	3	
	Brief Description		
	Steel toe piles exposed and look very corroded. Groynes derelict. Vertical crack to masonry wall near pipe at centre of wall. Some mortar missing in some joints in masonry wall. Timber walkway replaced.		
	Recommendations		
Expose and repair voids under toe apron.

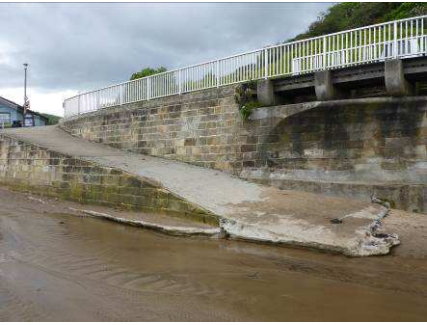
SBC Reference:	15-09B-02		
NFCDD reference:	1221D901D0702C03

Asset Location:		
	Asset Length:	~10	
	Condition Assessment		
	Condition	Priority	Risk
	B	3	
	Brief Description		
	Slipway in fair condition overall, but with one or two gaps in the blockwork wing wall.		
	Recommendations		
Continue to monitor

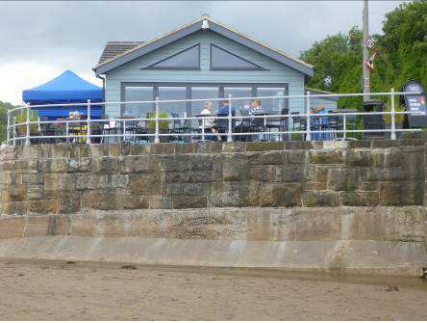
SBC Reference:	15-09B-03		
NFCDD reference:	1221D901D0702C03001

Asset Location:	NZ86211252, NZ86251264. Wall extending from East Row Bridge	
	Asset Length:	232.4 total (15-09b-03 to 15-09b-05)	
	Condition Assessment		
	Condition	Priority	Risk
	B	3	
	Brief Description		
	Masonry blockwork wall to channel sides in fair to good condition. Minor abrasion to a few blocks, missing mortar in joints near cafe.		
	Recommendations		
Repoint wall. Continue to monitor

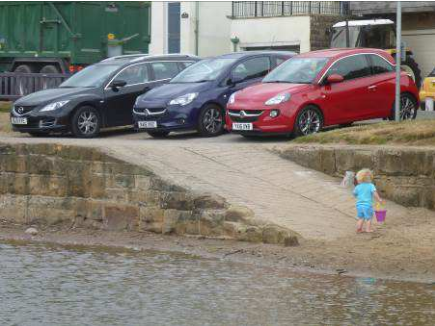
SBC Reference:	15-09B-04		
NFCDD reference:	1221D901D0702C03002

Asset Location:		
	Asset Length:	~4	
	Condition Assessment		
	Condition	Priority	Risk
	B	3	
	Brief Description		
	Fair overall condition. Edge capping stone missing. Toe below beach level		
	Recommendations		
Repair capping edge

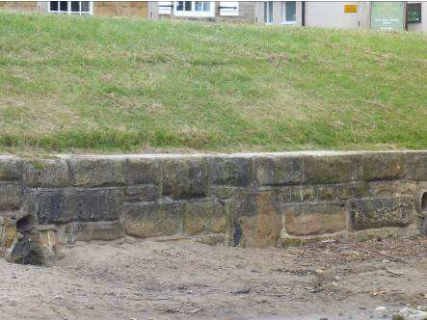
SBC Reference:	15-09B-05		
NFCDD reference:	1221D901D0702C03003

Asset Location:		
	Asset Length:	232.4 total (15-09b-03 to 15-09b-05)	
	Condition Assessment		
	Condition	Priority	Risk
	B	3	
	Brief Description		
	Masonry blockwork wall to channel sides in fair to good condition. Low retaining stone wall is in a good condition on both banks.		
	Recommendations		
Continue to monitor

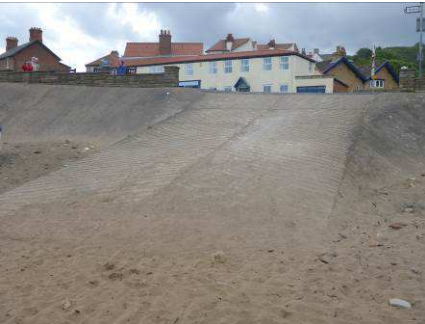
SBC Reference:	15-09B-07		
NFCDD reference:	1221D901D0702C02 001

Asset Location:		
	Asset Length:	774.5 total (15-09b-06 to 17-10-02)	
	Condition Assessment		
	Condition	Priority	Risk
	B	4	>5
	Brief Description		
	Slipway in good condition - toe below beach level		
	Recommendations		
Continue to monitor

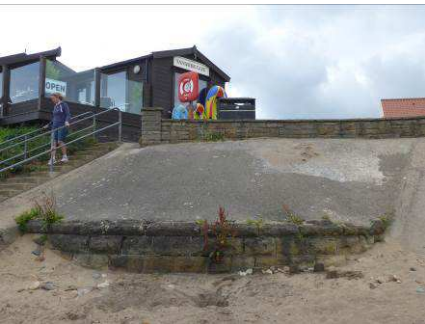
SBC Reference:	16-09C-01		
NFCDD reference:	1221D901D0702C02 002

Asset Location:		
	Asset Length:	774.5 total (15-09b-06 to 17-10-02)	
	Condition Assessment		
	Condition	Priority	Risk
	B	4	5
	Brief Description		
	Good condition – Good revetment with toe below beach level but some open joints		
	Recommendations		
Repoint joints

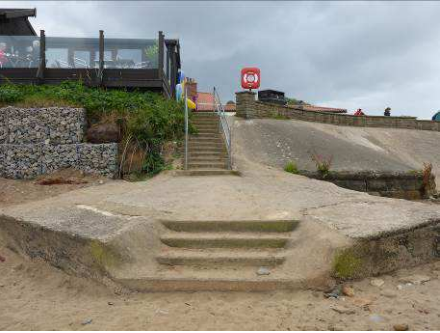
SBC Reference:	16-09C-02		
NFCDD reference:	1221D901D0702C02 003

Asset Location:		
	Asset Length:	774.5 total (15-09b-06 to 17-10-02)	
	Condition Assessment		
	Condition	Priority	Risk
	B	3	
	Brief Description		
	Steps in good overall condition. Concrete revetment on the landing, weathered in places		
	Recommendations		
Continue to monitor

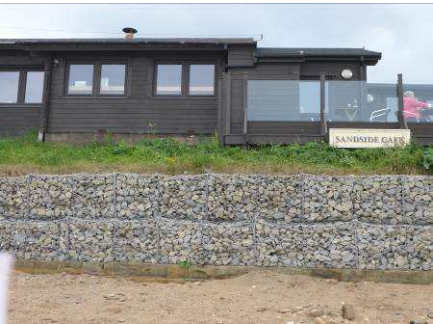
SBC Reference:	16-09C-04 to 17-10-02		
NFCDD reference:

Asset Location:		
	Asset Length:		
	Condition Assessment		
	Condition	Priority	Risk
	B	2	
	Brief Description		
	The gabion baskets have not filled completely with visible sagging on the bottom row. The top row has remained vertical. Seems to be holding at the moment. Baskets founded on stone blocks visible at northern end.		
	Recommendations		
Continue to monitor

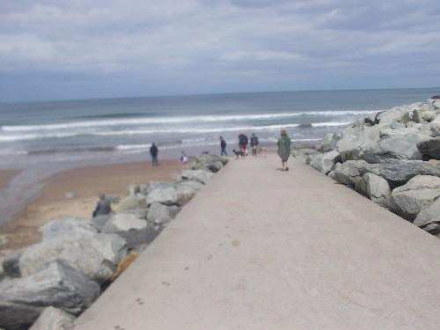
SBC Reference:	18-11A-01		
NFCDD reference:	1221D901D0801C01001

Asset Location:	NZ88161194, NZ88541185	
	Asset Length:	~10	
	Condition Assessment		
	Condition	Priority	Risk
	B	4	>5
	Brief Description		
	Concrete edge of slipway chipped at construction joint. Overall good condition. Toe below beach level. Rock armour both sides tightly packed.		
	Recommendations		
Continue to monitor

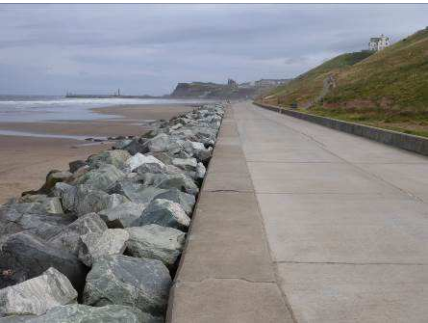
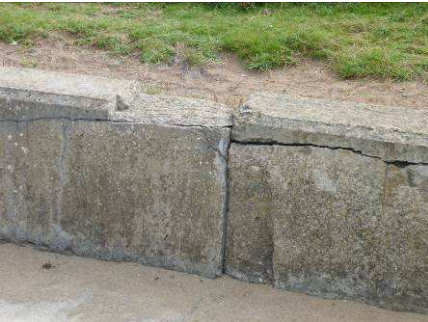
SBC Reference:	18-11A-02		
NFCDD reference:	1221D901D0801C01

Asset Location:	NZ88161194, NZ88541185	
	Asset Length:	439.3	
	Condition Assessment		
	Condition	Priority	Risk
	B	3	3
	Brief Description		
	Rock armour generally good, well packed but movement in several local areas. Some smaller armour loosely packed on crest. Prom as in 2012, some slabs have settled.		
	Localised damages to prom capping and rear 'splash' wall observed. Large crack on prom at mid-section left opened. Previous repairs to cracks in prom deck re-opening.		
Recommendations			
Continue to monitor surface cracking in promenade

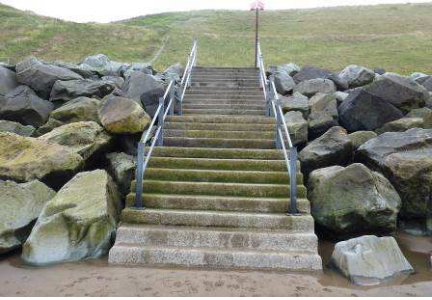
SBC Reference:	18-11A-03		
NFCDD reference:	1221D901D0801C01 002

Asset Location:		
	Asset Length:	~5	
	Condition Assessment		
	Condition	Priority	Risk
	C	3	
	Brief Description		
	Steps covered by vegetation (i.e. slippery). Heavy abrasion on lower sections of steps.		
	Recommendations		
Continue to monitor

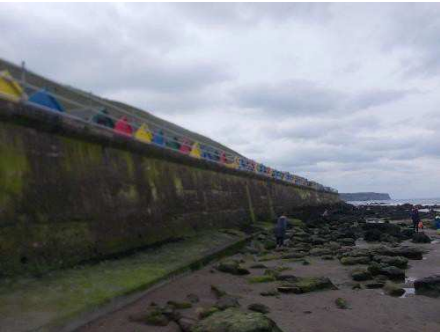
SBC Reference:	71-11A-01		
NFCDD reference:	1221D901D0802C03

Asset Location:	NZ88861170, NZ89231154	
	Asset Length:	166.8	
	Condition Assessment		
	Condition	Priority	Risk
	C	2	
	Brief Description		
	Lower half of wall abraded/eroded. Toe exposed along whole length due to low sand level - heavily undercut/eroded & missing in part. Apron missing locally and in poor condition. Prom fair, signs of wave overtopping causing damage. Handrails anchor bolts corroding. The concrete toe has been repaired at the southern end.		
	Recommendations		
Consider extending rock armour along this section

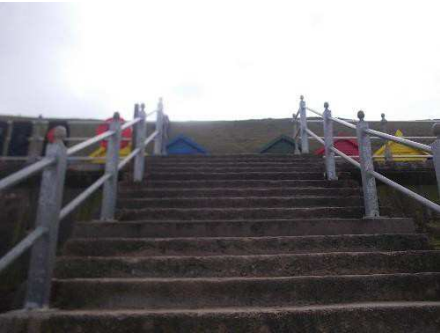
SBC Reference:	71-11A-02		
NFCDD reference:	1221D901D0802C13 001

Asset Location:	Western promenade, Whitby	
	Asset Length:	~ 4	
	Condition Assessment		
	Condition	Priority	Risk
	B	3	
	Brief Description		
	Tread repaired half way up the steps. Sheet pile toe is exposed with steel capping. The steel rise 'facing' on the bottom step has moved seaward. Handrail in generally good condition. Heavy abrasion on lower sections of steps.		
	Recommendations		
Continue to monitor

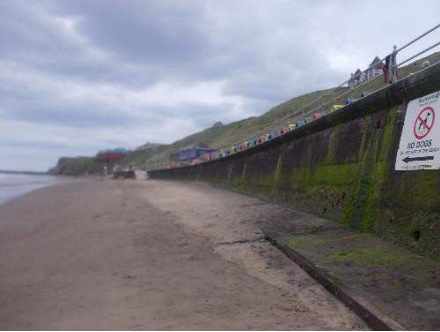
SBC Reference:	71-11A-03		
NFCDD reference:	1221D901D0802C13

Asset Location:	NZ88861170, NZ89231154	
	Asset Length:	158.4	
	Condition Assessment		
	Condition	Priority	Risk
	C	2	
	Brief Description		
	Horizontal cracks to wall visible near slipway East of beach cafe. Beach level higher than 2012, toe not exposed. Cracks in joint along prom 0.5m from edge. Handrail has been replaced. Some anchor bolts showing signs of corrosion. Concrete facing weathered with exposed aggregates near the toe of the wall.		
	Recommendations		
Repair cracks to wall near slipway. Fill/seal joint prom gaps. Repair Toe

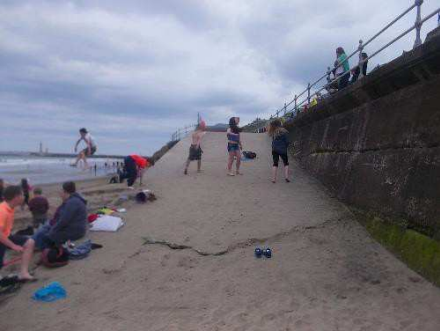
SBC Reference:	71-11A-04		
NFCDD reference:	1221D901D0802C13002

Asset Location:	Western promenade, Whitby	
	Asset Length:	~12	
	Condition Assessment		
	Condition	Priority	Risk
	C	2	
	Brief Description		
	Slipway. Loss of section of render on wing wall. Lower concrete revetment broken / missing. Toe below beach level.		
	Recommendations		
Continue to monitor

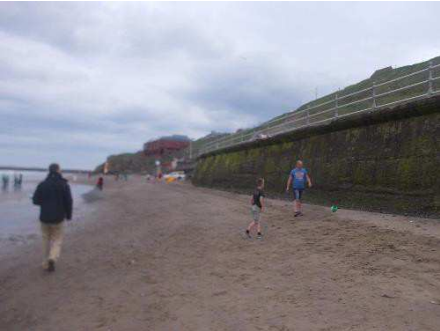
SBC Reference:	71-11A-05		
NFCDD reference:	1221D901D0802C14

Asset Location:	NZ88861170, NZ89231154	
	Asset Length:	86.2	
	Condition Assessment		
	Condition	Priority	Risk
	C	2	
	Brief Description		
	Erosion/abrasion to lower half of wall. Minor damage throughout. Apron not visible. Minor cracking to prom throughout. Areas of chipping/cracking along top edge. Handrails have been replaced.		
	Recommendations		
Repair chipped areas approx. 0.5m from edge throughout

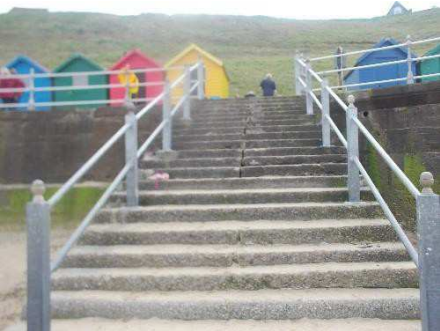
SBC Reference:	20-11A-01		
NFCDD reference:	1221D901D0802C04001

Asset Location:	Western promenade, Whitby	
	Asset Length:	~7	
	Condition Assessment		
	Condition	Priority	Risk
	C	3	
	Brief Description		
	Steps. Weathered concrete revetment with exposed aggregates. Abraded side walls with large cracks. Handrail in fair condition. Heavy abrasion on lower sections of steps.		
	Recommendations		
Repair cracks. Continue to monitor

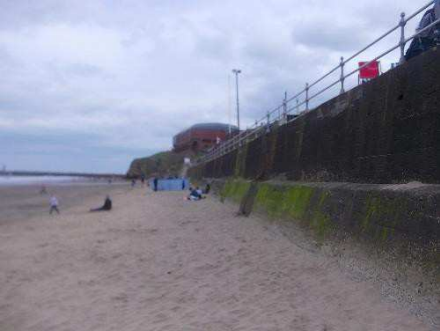
SBC Reference:	20-11A-02		
NFCDD reference:	1221D901D0802C04

Asset Location:	NZ89231154, NZ89291153	
	Asset Length:	65.4	
	Condition Assessment		
	Condition	Priority	Risk
	C	3	
	Brief Description		
	<p>Large horizontal crack below capping level at the northern end with concrete capping block missing locally and one vertical crack in southern third of wall. Erosion/abrasion to lower half of wall. Lower handrails have been replaced (set back from edge). Minor cracking to promenade.</p>		
	Recommendations		
Repair eroded front face. Repair cracks and replace blocks

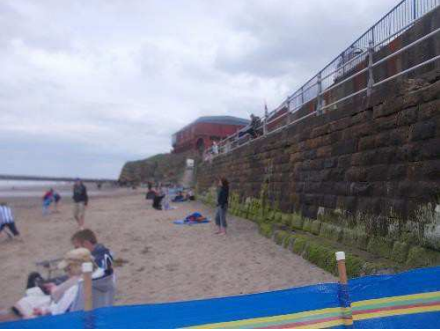
SBC Reference:	21-11A-01		
NFCDD reference:	1221D901D0802C07

Asset Location:	NZ89291153, NZ89361152	
	Asset Length:	71.9	
	Condition Assessment		
	Condition	Priority	Risk
	C	3	
	Brief Description		
	<p>Blockwork wall - cracking/loss of mortar and blocks in places locally poor. Joints and capping block missing locally. Generally stable although these points of weakness could cause failure. Higher concrete wall in a fair condition. Minor cracking in promenade. Corrosion to upper hand rails. New coping beam since 2014.</p>		
	Recommendations		
Repair/replace damaged blocks and grout joints

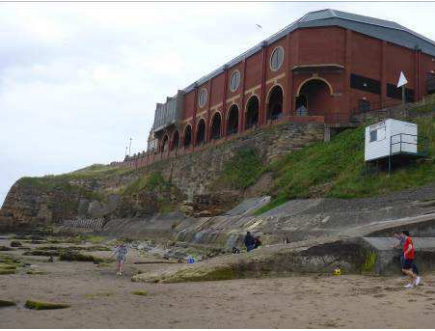
SBC Reference:	22-11A-03		
NFCDD reference:	1221D901D0802C15

Asset Location:	Beneath red brick building.	
	Asset Length:	71.8	
	Condition Assessment		
	Condition	Priority	Risk
	C	3	
	Brief Description		
	Concrete toe showing signs of cracking, abrasion and loss of concrete and undercutting. Blockwork walls appear sound but some loss of mortar. Slips in cliff between upper wall and toe structure.		
	Recommendations		
Stabilise and repair cliff. Repair toe

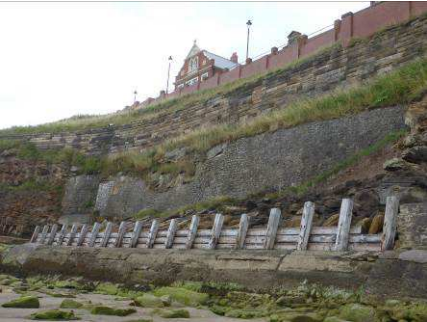
SBC Reference:	N/A		
NFCDD reference:	1221D901D0802C05

Asset Location:	NZ89401152, NZ89511152	
	Asset Length:	43.1	
	Condition Assessment		
	Condition	Priority	Risk
	C	3	
	Brief Description		
	Concrete toe seaward of timber breastwork is undercut with large voids beneath and breaking up. Blockwork walls above appear sound but slips / falls in cliff below and some loss of mortar.		
	Recommendations		
Repairs to toe, more detailed survey to cliff and walls required

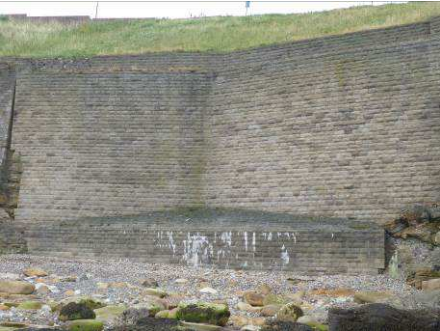
SBC Reference:	24-11B-01		
NFCDD reference:	1221D901D0802C09

Asset Location:	NZ89541152, NZ89651151	
	Asset Length:	115.8	
	Condition Assessment		
	Condition	Priority	Risk
	B	3	
	Brief Description		
	High sections of blockwork sea wall facing in between in-situ rock outcrops. Sections of masonry appear sound condition, some mortar loss, but worse than noted previously, in several locations tie in of edges to cliff getting outflanked / abraded.		
	Recommendations		
Repair edges of panels where tie in to cliff

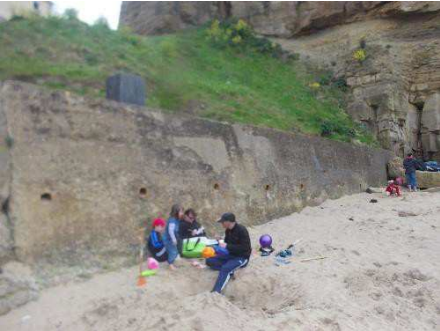
SBC Reference:	25-11B-01		
NFCDD reference:	1221D901D0802C10

Asset Location:	NZ89771147, NZ89781150. West side of West Pier.	
	Asset Length:	26.8	
	Condition Assessment		
	Condition	Priority	Risk
	B	3	
	Brief Description		
	In situ concrete retaining wall. Opened joints with exposed aggregates. Fair condition overall despite abraded face.		
	Recommendations		
Continue to monitor. Grout joints

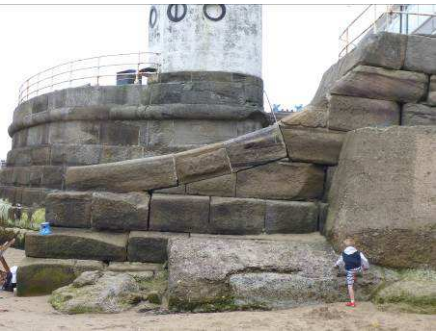
SBC Reference:	25-11B-02		
NFCDD reference:	1221D901D0802C12002

Asset Location:	NZ89781150, NZ89861150	
	Asset Length:	~7	
	Condition Assessment		
	Condition	Priority	Risk
	B	3	
	Brief Description		
	Landing area has evidence of repairs and repointing to upper blocks. Open gaps between blocks on wing wall.		
	Recommendations		
Continue to monitor

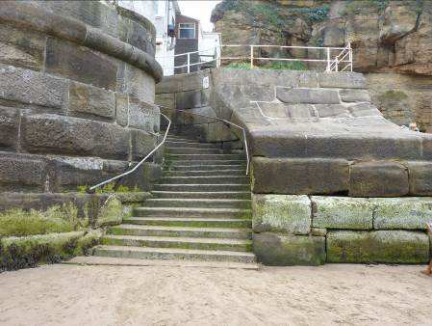
SBC Reference:	25-11B-03		
NFCDD reference:	1221D901D0802C12 003

Asset Location:	NZ89781150, NZ89861150	
	Asset Length:	~7	
	Condition Assessment		
	Condition	Priority	Risk
	B	3	
	Brief Description		
	Steps abraded and chipped on the top section with several horizontal cracks. Handrail corroded Wing wall in fair condition.		
	Recommendations		
Continue to monitor

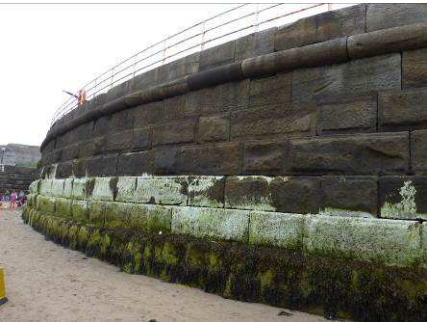
SBC Reference:	26-11B-01		
NFCDD reference:	1221D901D0802C12

Asset Location:	NZ89781150, NZ89861150 Start of west pier at slipway.	
	Asset Length:	87.7	
	Condition Assessment		
	Condition	Priority	Risk
	B	2	
	Brief Description		
	Battery wall. Deep voids between blockwork, few blocks vertically cracked. Voids between corners of blocks. Slipway wall capping beam and wall to W eroded, with displaced block. Damaged apron. Prom in fair condition.		
	Recommendations		
Continue to monitor and repair deep voids, Cracks and monitor abrasion

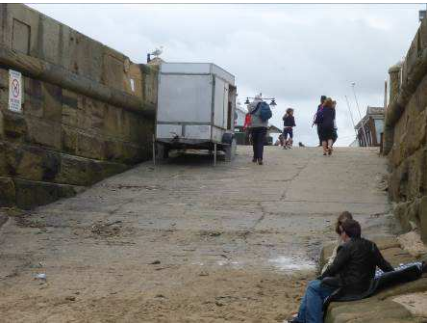
SBC Reference:	26-11B-02		
NFCDD reference:	1221D901D0802C12 001

Asset Location:	NZ89781150, NZ89861150	
	Asset Length:	~12	
	Condition Assessment		
	Condition	Priority	Risk
	B	3	
	Brief Description		
	Slipway in fair condition. Toe below beach level		
	Recommendations		
Continue to monitor

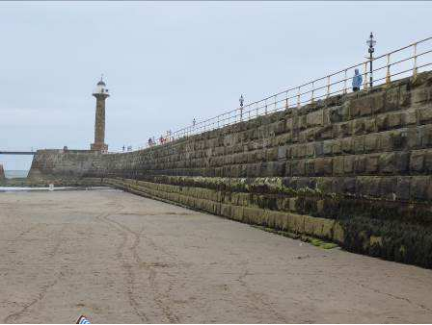
SBC Reference:	27-11B-01		
NFCDD reference:	1221D901D0803C02

Asset Location:	NZ89861145, NZ89931173 West pier.	
	Asset Length:	639.7	
	Condition Assessment		
	Condition	Priority	Risk
	B	3	
	Brief Description		
	Inspection from crest side in generally fair condition. Some local movement and cracking of blocks. Prom has cracking between slabs. Handrails showing rust stains but intact. Where visible inner toe OK.		
	Recommendations		
Investigate and repair displaced/missing blocks

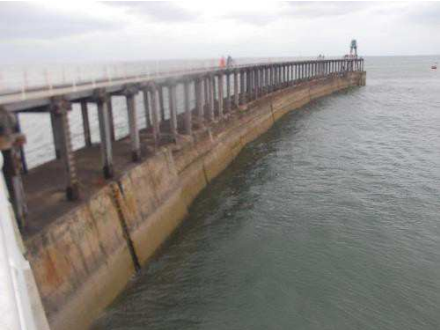
SBC Reference:	N/A		
NFCDD reference:	1221D901D0803C01

Asset Location:	NZ89921172, NZ89921187 West breakwater arm.	
	Asset Length:	315.5	
	Condition Assessment		
	Condition	Priority	Risk
	B	3	
	Brief Description		
	Limited inspection as toe covered in water at low tide. Rust to handrail. Some timber planks in prom have ends rotting. Abrasion to edges of concrete structure and exposure of aggregate. Timber supporting structure weathered.		
	Recommendations		
Continue to monitor and replace planks in prom as necessary. Detailed inspection required

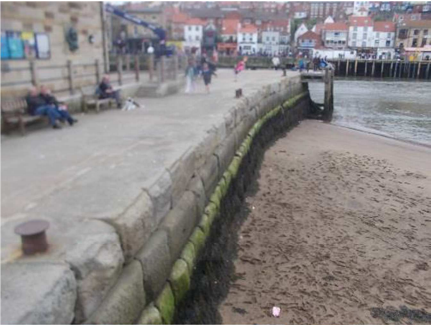
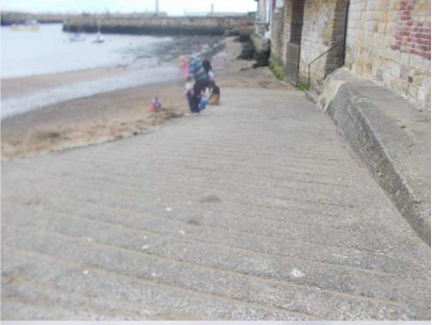
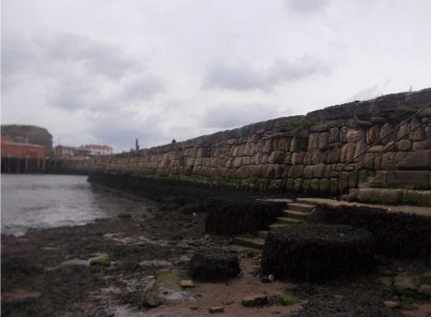
SBC Reference:	N/A		
NFCDD reference:	1221D901D0803C08

Asset Location:	West bank, Whitby Harbour RNLI Station and Pier.	
	Asset Length:	391.3	
	Condition Assessment		
	Condition	Priority	Risk
	B	3	
	Brief Description		
	Very weathered blocks with gaps on South side of old RNLI pier and displacement of facing/crack to deck slab at end. Void under SW corner.		
	Capping block missing on the slipway but fair overall condition.		
	Walls between piers of mixed construction, fair to poor condition. Missing mortar between blocks and cracked blocks.		
Breakwater wall with deep joints and block eroding. Steps weathered with corroding handrail. Top revetment in fair condition			
Recommendations			
Fill voids, cracks and open joints

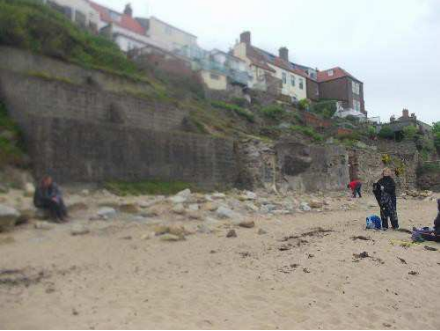
SBC Reference:	N/A		
NFCDD reference:	1221D901D0803C09

Asset Location:	South of Collier Hope and Mussel Beds	
	Asset Length:	154.9	
	Condition Assessment		
	Condition	Priority	Risk
	C	3	
	Brief Description		
	Riparian walls in various conditions, some quite poor. Protected by sand and cobble beach. Spalling to the render and exposure of the aggregate. Slipway and steps weathered with missing joints.		
	Recommendations		
Continue to monitor, repoint where needed. Replace missing blocks

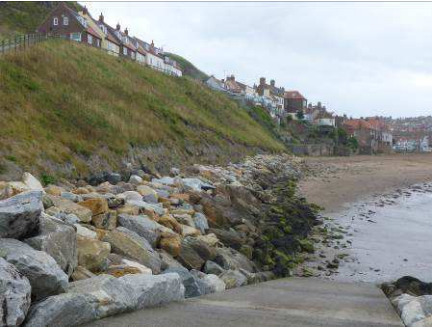
SBC Reference:	N/A		
NFCDD reference:	1221D901D0803C05

Asset Location:	NZ90171146, NZ90421143. East side of pier.	
	Asset Length:	420.7	
	Condition Assessment		
	Condition	Priority	Risk
	B	3	
	Brief Description		
	Rock armour previously described as very poor, but appears generally fair on present inspection.		
	Recommendations		
Continue to monitor

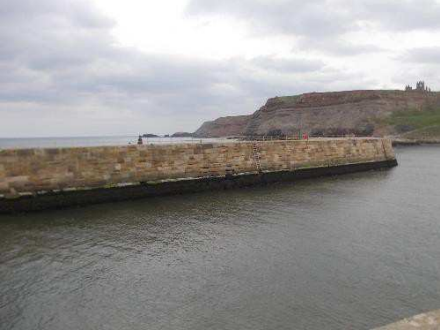
SBC Reference:	N/A		
NFCDD reference:	1221D901D0803C03

Asset Location:	NZ90161146, NZ90001174. East Pier.	
	Asset Length:	637	
	Condition Assessment		
	Condition	Priority	Risk
	B	3	
	Brief Description		
	Signs of many repairs to deck, but some open joints seen. Erosion to capping beams. Voids & settled blockwork at NE bend, inside face. Large cracks at several locations. Loose blocks at S end by rock armour. Toe piles corroded. Settled blocks on E face. Timber edge protection at Eastern end rotten.		
	Recommendations Continue to monitor and patch up pending capital repair scheme

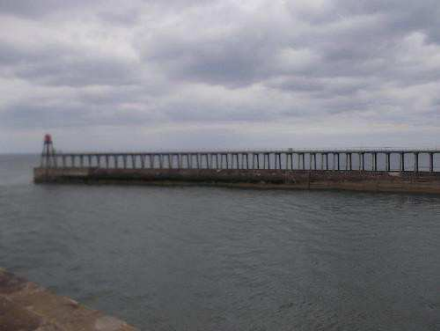
SBC Reference:	N/A		
NFCDD reference:	1221D901D0803C04

Asset Location:	NZ90041172, NZ89971186. East breakwater.	
	Asset Length:	330.9	
	Condition Assessment		
	Condition	Priority	Risk
	C	3	
	Brief Description		
	Limited visibility due to tide level and no access. Eroded joints and gaps in wall. Timber structure in poor condition. Corroded toe piles. Repair completed in 2012, more needed.		
	Recommendations Repair further sections of toe pile. Detailed inspection required

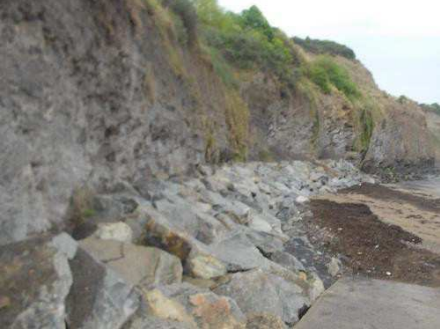
SBC Reference:	32-16A-01		
NFCDD reference:	1221D901D1002C02

Asset Location:	Robin Hood's Bay.	
	Asset Length:	59.4	
	Condition Assessment		
	Condition	Priority	Risk
	B	4	>5
	Brief Description		
	Rock armour remains tightly packed and in good condition. Installed in 2001.		
	Recommendations		
Continue to monitor.

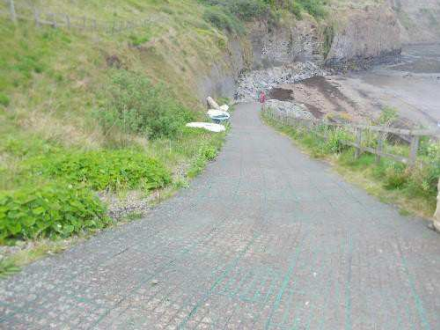
SBC Reference:	32-16A-02		
NFCDD reference:	1221D901D1003C01001

Asset Location:	Robin Hood's Bay.	
	Asset Length:	~70	
	Condition Assessment		
	Condition	Priority	Risk
	B	4	>5
	Brief Description		
	2015: Slipway. Mixed construction in fair condition 2016: Not inspected in detail.		
	Recommendations		
Continue to monitor.

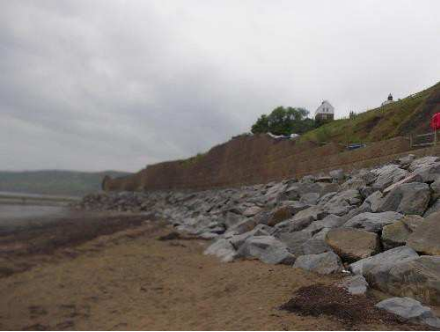
SBC Reference:	33-16A-01		
NFCDD reference:	1221D901D1003C01

Asset Location:	NZ95340504, NZ95270520	
	Asset Length:	183.4	
	Condition Assessment		
	Condition	Priority	Risk
	B	4	>5
	Brief Description		
	Wall was built in 2001. Rock armour in good condition with good coverage. Slipway ramp in good condition, some abrasion to slab and joints near toe. Wall very good condition.		
	Recommendations		
Continue to monitor.

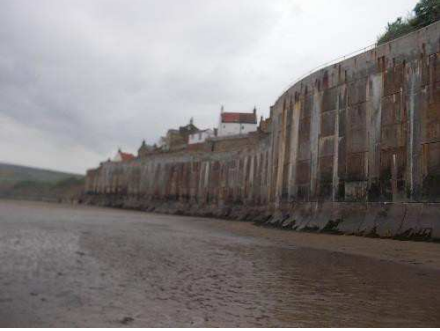
SBC Reference:	33-16A-02		
NFCDD reference:	1221D901D1003C02

Asset Location:	NZ95330488, NZ95310502	
	Asset Length:	150.5	
	Condition Assessment		
	Condition	Priority	Risk
	C	2	
	Brief Description		
	Toe not visible high beach levels. Concrete wall poor - displaying surface cracking, loss of surface, rust staining and mineral encrustation. Wall crest showing more cracking and repair work. Recent concrete spalling evident. Signs of recent repairs and repainting on crest wall. Prom fair.		
	Recommendations		
Continue to monitor. Undertake capital repairs.

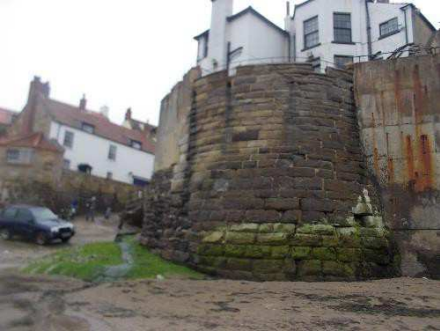
SBC Reference:	34-16A-01		
NFCDD reference:	1221D901D1003C04

Asset Location:	NZ95320486, NZ95330488	
	Asset Length:	29.3	
	Condition Assessment		
	Condition	Priority	Risk
	C	2	
	Brief Description		
	Wall displaying surface erosion and joint washout. Voids and open joints in masonry near tie in to concrete wall. Loose render on upper wall. Toe not visible.		
	Recommendations		
Grout voids, repair render, repoint joints, re-inspect toe when beach lower.

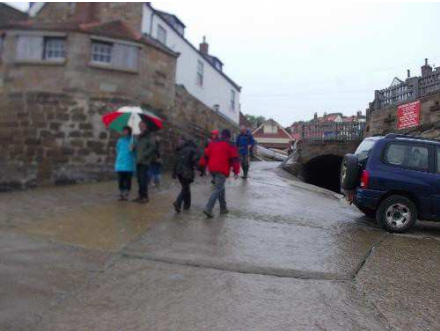
SBC Reference:	35-16B-01		
NFCDD reference:	1221D901D1003C05

Asset Location:	NZ95310485, NZ95320486	
	Asset Length:	15.6	
	Condition Assessment		
	Condition	Priority	Risk
	B	3	
	Brief Description		
	Slipway in gen fair condition. Some cracking but appears stable at present.		
	Recommendations		
Continue to monitor , investigate and fill voids, repoint as necessary.

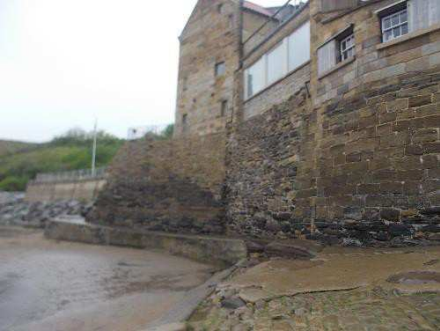
SBC Reference:	36-16B-01		
NFCDD reference:	1221D901D1003C06

Asset Location:	NZ95310481, NZ95310485	
	Asset Length:	51.9	
	Condition Assessment		
	Condition	Priority	Risk
	B	3	
	Brief Description		
	Patchwork of repairs/repointing throughout. Void / undercutting to S end of concrete toe.		
	Recommendations		
Continue to monitor and repoint/repair.

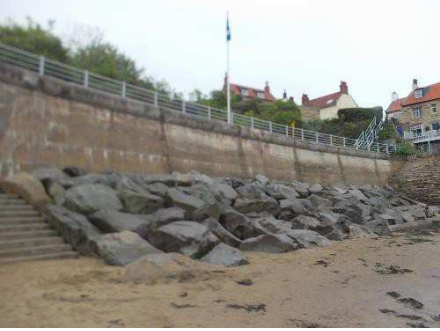
SBC Reference:	36-16B-02		
NFCDD reference:	1221D901D1003C10

Asset Location:	NZ95320468, NZ95310481	
	Asset Length:	29.2	
	Condition Assessment		
	Condition	Priority	Risk
	B	3	
	Brief Description		
	Cracks and spalling to capping beam. Damage to previous repairs to South end of wall. Rock armour at toe in good condition.		
	Recommendations		
Continue to monitor. Repair spalling and joints where necessary.

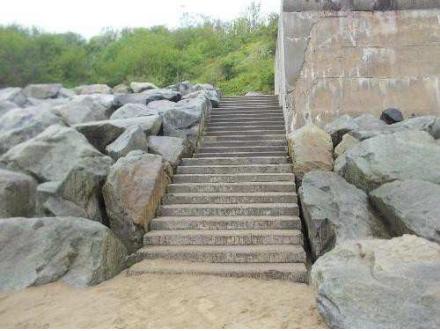
SBC Reference:	36-16B-03		
NFCDD reference:	1221D901D1003C09 ⁰⁰¹

Asset Location:	NZ95320468, NZ95310481	
	Asset Length:	~10	
	Condition Assessment		
	Condition	Priority	Risk
	B	4	5
	Brief Description		
	2015: Steps in good overall condition. No handrail. 2016: Steps in fair overall condition. No handrail.		
	Recommendations		
Continue to monitor

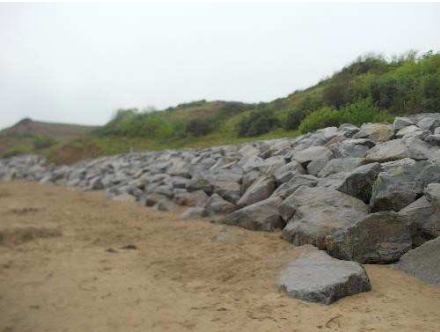
SBC Reference:	37-16C-01		
NFCDD reference:	1221D901D1003C09

Asset Location:	NZ95320468, NZ95310481	
	Asset Length:	62	
	Condition Assessment		
	Condition	Priority	Risk
	B	4	>5
	Brief Description		
	Rock armour is generally tightly packed and good cover. Some smaller rocks show signs of movement. Promenade in good condition. Overall good.		
	Recommendations		
Repaint gate. Monitor armour for need to re-profile in future.

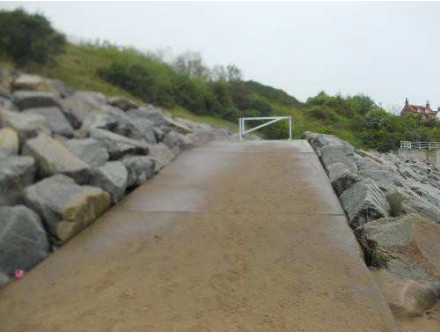
SBC Reference:	37-16C-02		
NFCDD reference:	1221D901D1003C07 001

Asset Location:	NZ95320468, NZ95310481	
	Asset Length:	~20	
	Condition Assessment		
	Condition	Priority	Risk
	B	4	>5
	Brief Description		
	2015: Slipway in good condition. 2016: Not inspected in detail.		
	Recommendations		
	Continue to monitor

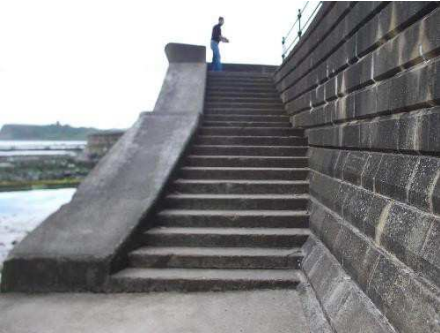
SBC Reference:	39-20A-01		
NFCDD reference:	1221D901D1201C02001

Asset Location:	TA03549057, TA03569082 next to Sea Life Centre.	
	Asset Length:	~10	
	Condition Assessment		
	Condition	Priority	Risk
	B	4	>5
	Brief Description		
	2015: Steps. Localised concrete abrasion with chipped tread but overall fair condition. 2016: Not inspected in detail.		
	Recommendations		
Continue to monitor.

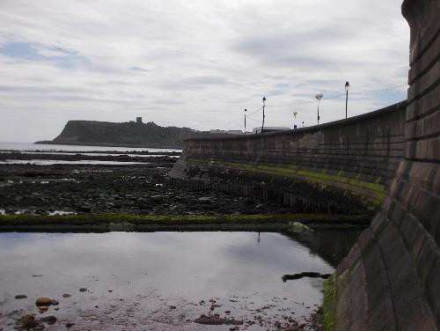
SBC Reference:	39-20A-02		
NFCDD reference:	1221D901D1201C02

Asset Location:	TA03549057, TA03569082. Wall and promenade next to Sea Life Centre. Extends to Southern steps (40-20a-01)	
	Asset Length:	327.2	
	Condition Assessment		
	Condition	Priority	Risk
	B	3	
	Brief Description		
	Cracks to splash wall but looks sound. Prom good condition. Wall in fair condition.		
	Recommendations		
Continue to monitor, refill joints and repair cracks.

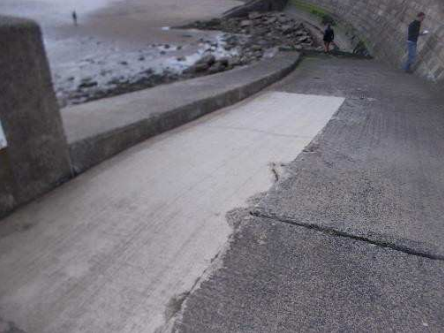
SBC Reference:	39-20A-03		
NFCDD reference:	1221D901D1201C02 ⁰⁰²

Asset Location:	TA03549057, TA03569082. Wall and promenade next to Sea Life Centre.	
	Asset Length:	~15	
	Condition Assessment		
	Condition	Priority	Risk
	B	3	
	Brief Description		
	2015: Slipway at S not usable due to toe erosion. Evident revetment repairs seaward on the top half. 2016: Not inspected in detail.		
	Recommendations		
Continue to monitor

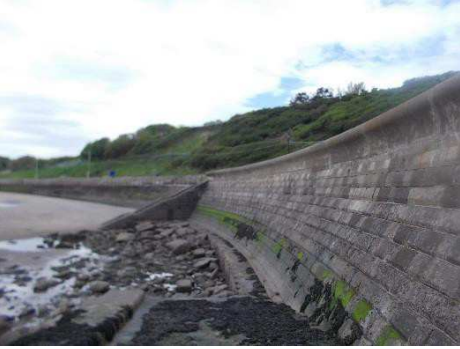
SBC Reference:	39-20A-04		
NFCDD reference:	1221D901D1201C02003

Asset Location:	Between slipway and steps	
	Asset Length:	Part of overall wall length (327.2)	
	Condition Assessment		
	Condition	Priority	Risk
	B	3	
	Brief Description		
	2015: Blockwork in fair condition. 2016: Not inspected in detail.		
	Recommendations		
	Continue to monitor

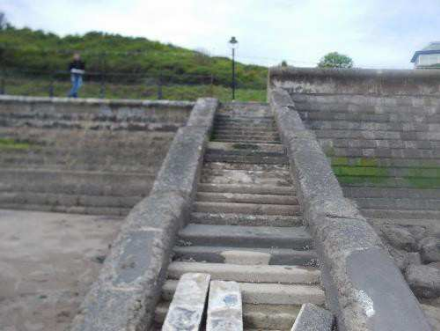
SBC Reference:	40-20A-01		
NFCDD reference:	1221D901D1201C02004

<p>Above: Condition in 2015 (now rebuilt)</p>	Asset Location:		
	Asset Length:	~5	
	Condition Assessment		
	Condition	Priority	Risk
	B	4	
	Brief Description		
	2015: Very poor condition. Asset in needs of major repairs. To be closed off as hazardous to Public. Abutments and steps dilapidated. (I.e. Missing and broken steps, limited edge protection from prom). Toe piling only exposed at steps at N end. 2016: Rebuilt steps.		
	Recommendations		
	Continue to monitor
