Asset Inspection Document

Walk-over Visual Inspections of Assets

Scarborough Borough Council

September 2016

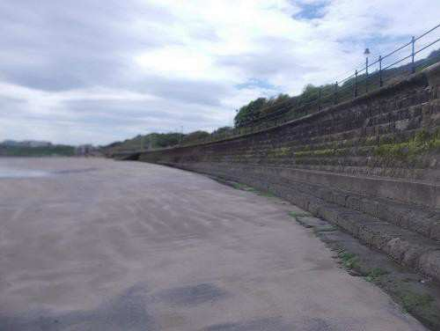
SBC Reference:	40-20A-02		
NFCDD reference:	1221D901D1201C03

Asset Location:	TA03589031, South of Sea Life Centre.	
	Asset Length:	120.6	
	Condition Assessment		
	Condition	Priority	Risk
	C	3	
	Brief Description		
	Abrasion of external blockwork throughout sea wall. Corroded handrails. Cracking and spalling to prom slabs and some missing sealant between slabs.		
	Recommendations		
Continue to monitor and repair cracks to wall and handrail.

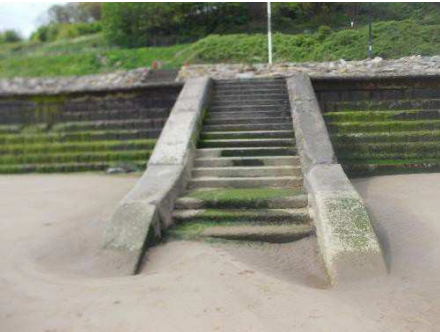
SBC Reference:	40-20A-03		
NFCDD reference:	1221D901D1201C03001

Asset Location:	TA03589031, South of Sea Life Centre.	
	Asset Length:	~5	
	Condition Assessment		
	Condition	Priority	Risk
	B	3	
	Brief Description		
	Weathered concrete revetment but fair condition overall. The South abutment wall has been repaired but the North wall would also need attention as damaged in places. Treads in fair condition		
	Recommendations		
Repair northern wall. Continue to monitor

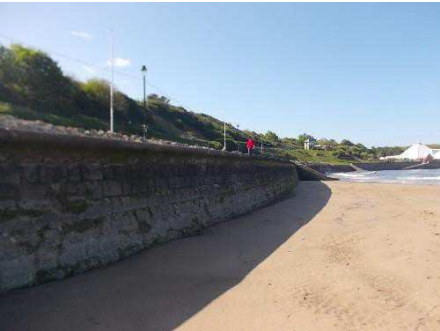
SBC Reference:	40-20A-04		
NFCDD reference:	1221D901D1201C24

Asset Location:	TA03589031, TA03549057	
	Asset Length:	65	
	Condition Assessment		
	Condition	Priority	Risk
	C	3	
	Brief Description		
	Exposed aggregate and abrasion / spalling to capping beam and facing blockwork. Cracks throughout promenade. Repairs evident in rear revetment.		
	Recommendations		
Continue to monitor. Repair damaged capping beam and cracks in promenade.

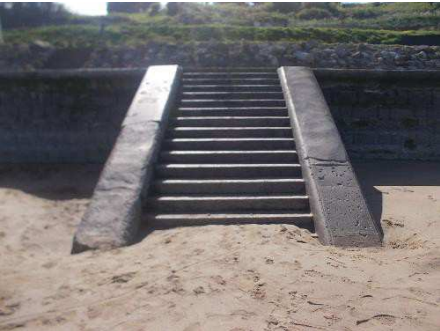
SBC Reference:	40-20A-05		
NFCDD reference:	1221D901D1201C24001

Asset Location:		
	Asset Length:	~5	
	Condition Assessment		
	Condition	Priority	Risk
	B	4	>5
	Brief Description		
	2015: Abutment wall abraded on one side (bottom half only) Steps in fair condition overall 2016: Not inspected in detail.		
	Recommendations		
Continue to monitor

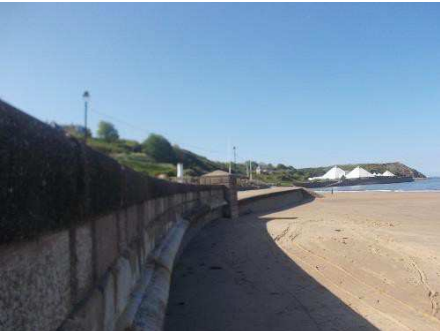
SBC Reference:	40-20A-06		
NFCDD reference:	1221D901D1201C25

Asset Location:	TA0357690349 North of slipway and beach huts.	
	Asset Length:	73.8	
	Condition Assessment		
	Condition	Priority	Risk
	C	3	
	Brief Description		
	Face loss with exposed aggregates. Cracking to parts of promenade. Revetment to rear of prom appears in good condition, recently repaired.		
	Recommendations		
Continue to monitor and repair cracks.

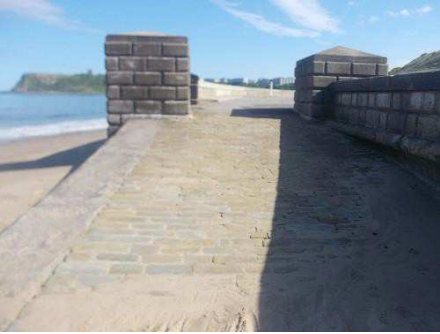
SBC Reference:	41-20A-01		
NFCDD reference:	1221D901D1201C04 001

Asset Location:		
	Asset Length:	~6	
	Condition Assessment		
	Condition	Priority	Risk
	B	3	
	Brief Description		
	2015: Slipway. Spalling coping on side wall. Missing joints on revetment. 2016: Not inspected in detail.		
	Recommendations		
Replace missing joints.			
SBC Reference:	41-20A-02

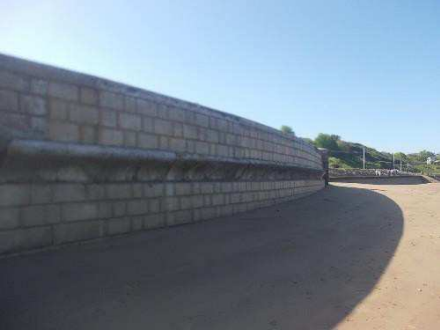
NFCDD reference:	1221D901D1201C04

Asset Location:	TA03599020, TA03589031 At North end of beach huts.	
	Asset Length:	99.1	
	Condition Assessment		
	Condition	Priority	Risk
	B	3	
	Brief Description		
	Repairs appear to be holding. Spalling coping next to southern ramp. Promenade in good condition. Heavily abrasion to unrepaired lower sections.		
	Recommendations		
Continue to monitor repair cracks and coping.

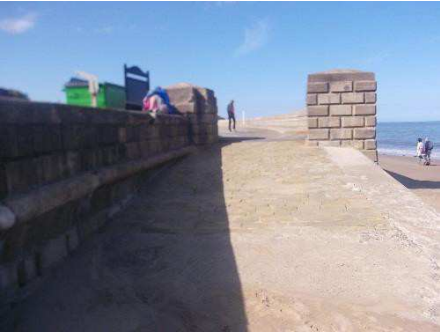
SBC Reference:	41-20A-03 CONTINUE		
NFCDD reference:	1221D901D1201C10 001

Asset Location:	TA03599020, TA03589031	
	Asset Length:	~4	
	Condition Assessment		
	Condition	Priority	Risk
	B	3	
	Brief Description		
	2015: Slipway. Joints to block paving missing Capping beam to side wall abraded and chipped 2016: Not inspected in detail.		
	Recommendations		
Replace joints. Continue to monitor.

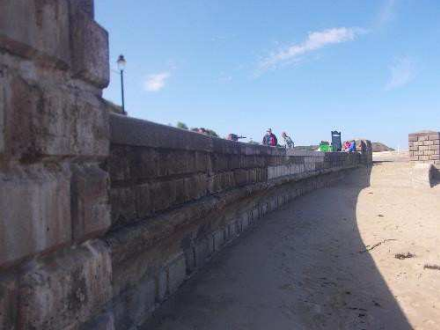
SBC Reference:	41-20A-04		
NFCDD reference:	1221D901D1201C10

Asset Location:	TA03599020, TA03589031	
	Asset Length:	13	
	Condition Assessment		
	Condition	Priority	Risk
	B	3	
	Brief Description		
	Few cracks appear on capping beam, adjacent to N ramp to prom. High beach level, toe not visible. Promenade in good condition.		
	Recommendations		
Repoint missing mortar to sea wall.

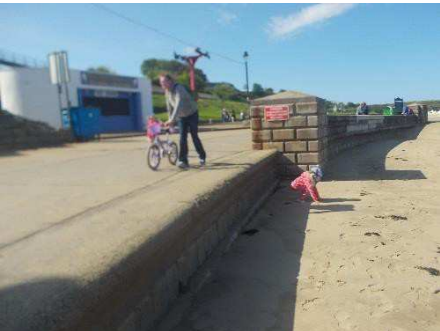
SBC Reference:	42-20A-02		
NFCDD reference:	1221D901D1201C26

Asset Location:	TA03758981, TA03599020	
	Asset Length:	13.7	
	Condition Assessment		
	Condition	Priority	Risk
	B	4	5
	Brief Description		
	Sea wall mostly buried by sand. Spalling in poured concrete capping to wall, promenade in fair condition.		
	Recommendations		
Continue to monitor and maintain.

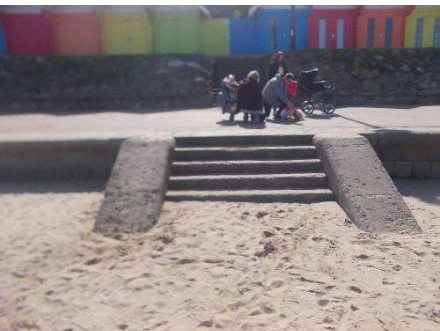
SBC Reference:	42-20A-03		
NFCDD reference:	1221D901D1201C26001

Asset Location:		
	Asset Length:		
	Condition Assessment		
	Condition	Priority	Risk
	B	4	5
	Brief Description		
	2015: Damaged abutment with exposed aggregates Rounded and chipped steps but fair condition overall. 2016: Not inspected in detail.		
	Recommendations		
Continue to monitor

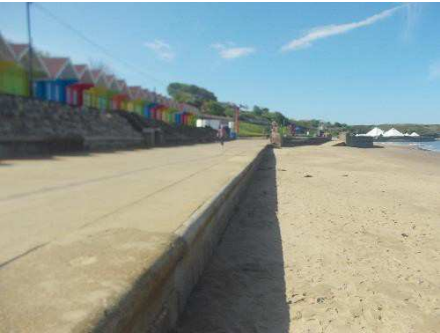
SBC Reference:	42-20A-04		
NFCDD reference:	1221D901D1201C11

Asset Location:	TA03758981, TA03599020	
	Asset Length:	58.7	
	Condition Assessment		
	Condition	Priority	Risk
	B	4	5
	Brief Description		
	Beach high. Evidence of repairs to capping. Abrasion to wall blocks and steps rounded. Cracks in poured concrete capping to wall, promenade in good condition. Rear revetment looks fair. Some sections of capping repaired since 2012.		
	Recommendations		
Continue to monitor.

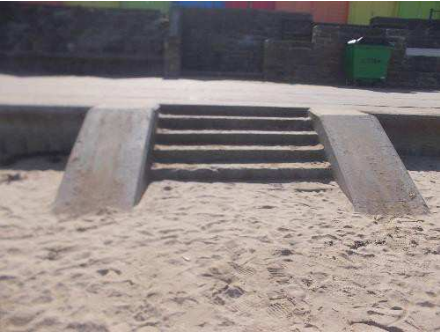
SBC Reference:	42-20A-05		
NFCDD reference:	1221D901D1201C11001

Asset Location:	TA03758981, TA03599020	
	Asset Length:	~3	
	Condition Assessment		
	Condition	Priority	Risk
	B	4	5
	Brief Description		
	2015: New abutment walls either side. Steps in fair condition 2016: Not inspected in detail.		
	Recommendations		
Continue to monitor.

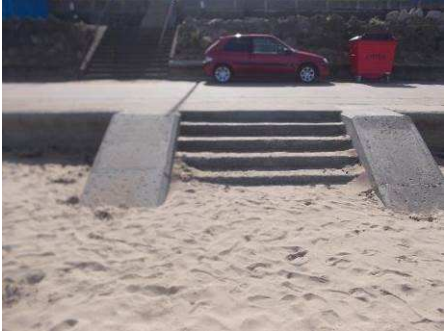
SBC Reference:	42-20A-07		
NFCDD reference:	1221D901D1201C12001

Asset Location:	TA03758981, TA03599020	
	Asset Length:	~3	
	Condition Assessment		
	Condition	Priority	Risk
	B	4	5
	Brief Description		
	2015: Steps: Abutment rebuilt both sides Lower steps rounded but good condition overall 2016: Not inspected in detail.		
	Recommendations		
Continue to monitor.

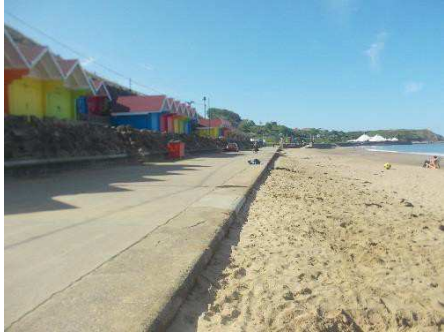
SBC Reference:	42-20A-08		
NFCDD reference:	1221D901D1201C13

Asset Location:	TA03758981, TA03599020	
	Asset Length:	58.2	
	Condition Assessment		
	Condition	Priority	Risk
	B	4	>5
	Brief Description		
	Beach high, only top row of blocks and capping visible. Some spalling to joints between sections of capping, erosion to capping exposing aggregate.		
	Recommendations		
Repair cracks to capping and inspect when blockwork visible.

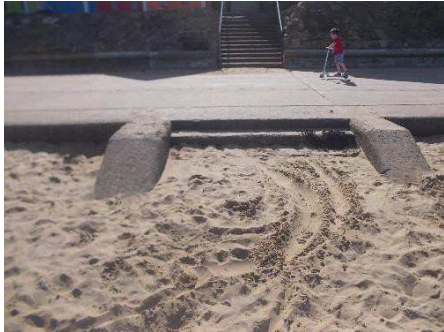
SBC Reference:	42-20A-09		
NFCDD reference:	1221D901D1201C13001

Asset Location:	TA03758981, TA03599020	
	Asset Length:	~3	
	Condition Assessment		
	Condition	Priority	Risk
	B	4	>5
	Brief Description		
	2015: Most steps below beach level. Rounded steps. Fair condition overall 2016: Not inspected in detail.		
	Recommendations		
Continue to monitor

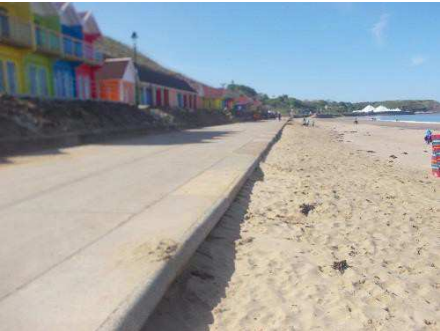
SBC Reference:	42-20A-10		
NFCDD reference:	1221D901D1201C14

Asset Location:	TA03758981, TA03599020	
	Asset Length:	58.4	
	Condition Assessment		
	Condition	Priority	Risk
	B	4	5
	Brief Description		
	Cracks to capping with some erosion exposing aggregate in places, Some capping slabs repaired, but remaining showing signs of damage. High beach at time of inspection. Rear revetment fair condition with recent repairs.		
	Recommendations		
Monitor and repair spalling to wall capping.

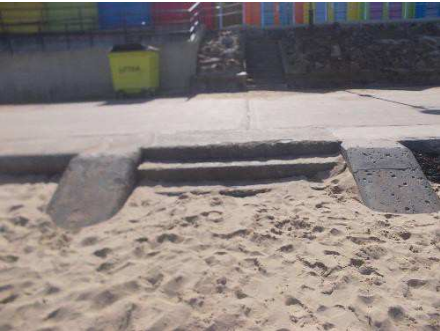
SBC Reference:	42-20A-11		
NFCDD reference:	1221D901D1201C14001

Asset Location:	TA03758981, TA03599020	
	Asset Length:	~3	
	Condition Assessment		
	Condition	Priority	Risk
	B	4	>5
	Brief Description		
	2015: Most steps below beach level. Rounded and chipped steps. Abutments walls in good condition 2016: Not inspected in detail.		
	Recommendations		
Continue to monitor.

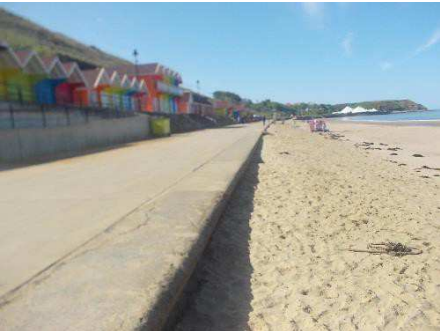
SBC Reference:	42-20A-12		
NFCDD reference:	1221D901D1201C15

Asset Location:	TA03758981, TA03599020	
	Asset Length:	31.9	
	Condition Assessment		
	Condition	Priority	Risk
	B	4	>5
	Brief Description		
	Only concrete capping of wall visible due to high beach, wall capping and promenade in good condition, no visible defects.		
	Recommendations		
Continue to monitor.

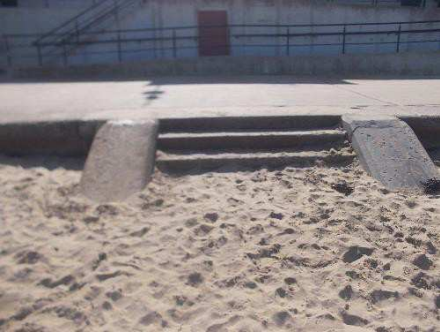
SBC Reference:	42-20A-13		
NFCDD reference:	1221D901D1201C15 001

Asset Location:	TA03758981, TA03599020	
	Asset Length:	~3	
	Condition Assessment		
	Condition	Priority	Risk
	B	4	5
	Brief Description		
	2015: Fair condition overall. Rounded steps and new abutment walls. 2016: Not inspected in detail.		
	Recommendations		
Continue to monitor

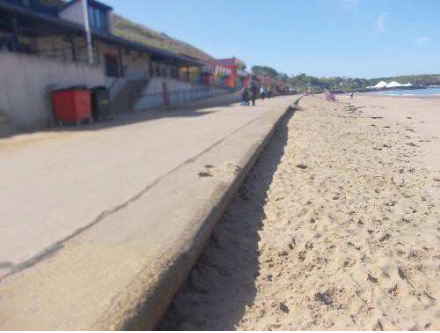
SBC Reference:	42-20A-14		
NFCDD reference:	1221D901D1201C16

Asset Location:	TA03758981, TA03599020. In front of Beach Management Centre.	
	Asset Length:	32	
	Condition Assessment		
	Condition	Priority	Risk
	B	4	5
	Brief Description		
	Only capping visible due to high beach. Promenade in good condition. Rear revetment has been repaired		
	Recommendations		
Repair cracks to capping and inspect at low beach height.

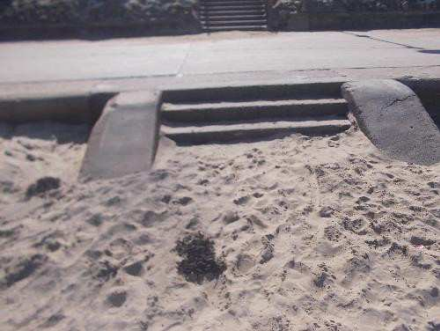
SBC Reference:	42-20A-15		
NFCDD reference:	1221D901D1201C16 001

Asset Location:	TA03758981, TA03599020.	
	Asset Length:	~3	
	Condition Assessment		
	Condition	Priority	Risk
	B	4	5
	Brief Description		
	2015: Steps: Fair overall condition. 2016: Not inspected in detail.		
	Recommendations		
Continue to monitor.

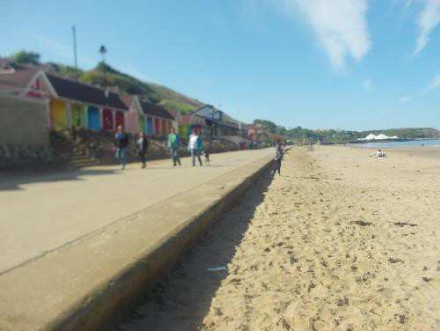
SBC Reference:	42-20A-16		
NFCDD reference:	1221D901D1201C05

Asset Location:	TA03758981, TA03599020	
	Asset Length:	55.6	
	Condition Assessment		
	Condition	Priority	Risk
	B	4	5
	Brief Description		
	High beach, capping & top row only visible. Exposed aggregate in localised places. Some chipped capping along length.		
	Recommendations		
Monitor and repair coping.

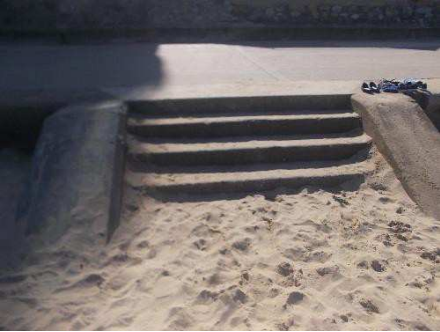
SBC Reference:	42-20A-17		
NFCDD reference:	1221D901D1201C05001

Asset Location:	TA03758981, TA03599020	
	Asset Length:	~3	
	Condition Assessment		
	Condition	Priority	Risk
	A	4	5
	Brief Description		
	2015: Fair condition overall. 2016: Not inspected in detail.		
	Recommendations		
Continue to monitor

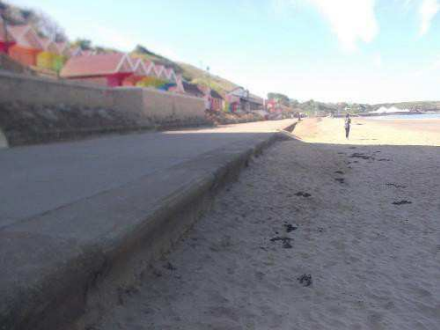
SBC Reference:	42-20A-18		
NFCDD reference:	1221D901D1201C17

Asset Location:	In front on new apartments.	
	Asset Length:	22.8	
	Condition Assessment		
	Condition	Priority	Risk
	B	4	5
	Brief Description		
	Only capping and top row visible.		
	Recommendations		
Repair defects to coping/prom edge and rear revetment.

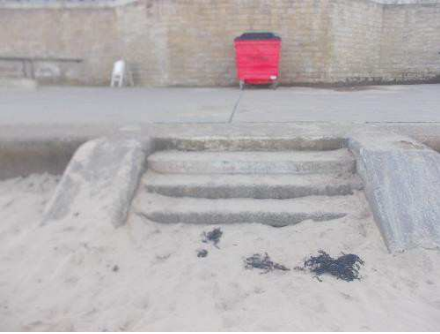
SBC Reference:	42-20A-19		
NFCDD reference:	1221D901D1201C17001

Asset Location:		
	Asset Length:	~3	
	Condition Assessment		
	Condition	Priority	Risk
	B	4	5
	Brief Description		
	2015: Steps: Fair overall condition Penultimate step replaced from the top. 2016: Not inspected in detail.		
	Recommendations		
Continue to monitor.

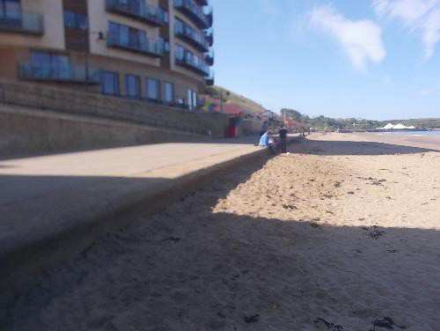
SBC Reference:	42-20A-20		
NFCDD reference:	1221D901D1201C18

Asset Location:	In front of new apartments.	
	Asset Length:	43	
	Condition Assessment		
	Condition	Priority	Risk
	B	4	5
	Brief Description		
	Cracking and spalling to wall capping. Beach high covering most of wall. Promenade in good condition.		
	Recommendations		
Repair/replace damaged capping/coping beams.

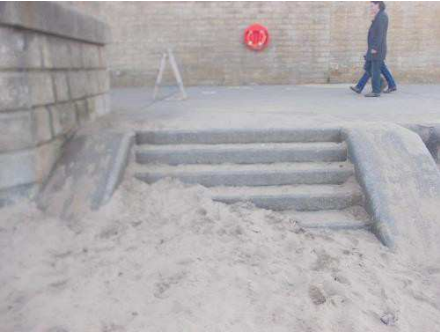
SBC Reference:	42-20A-21		
NFCDD reference:	1221D901D1201C18001

Asset Location:		
	Asset Length:	~3	
	Condition Assessment		
	Condition	Priority	Risk
	B	4	5
	Brief Description		
	2015: Steps: Fair condition -partly buried in sand 2016: Not inspected in detail.		
	Recommendations		
Continue to monitor.

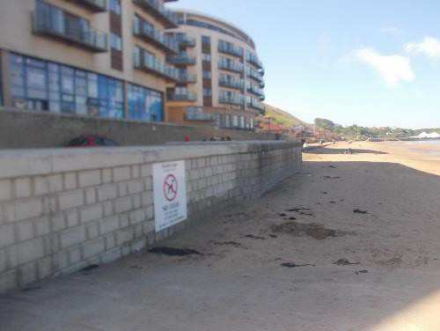
SBC Reference:	43-20B-01		
NFCDD reference:	1221D901D1201C06

Asset Location:	TA03818971, TA03758981	
	Asset Length:	34.2	
	Condition Assessment		
	Condition	Priority	Risk
	B	3	
	Brief Description		
	Wall has been repaired since 2012. South section rebuilt / overlaid. Cracking still evident at N end.		
	Recommendations		
Monitor and repair cracks.

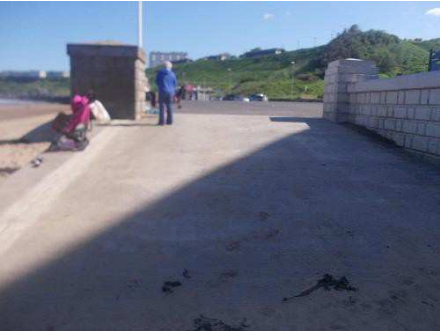
SBC Reference:	43-20B-02		
NFCDD reference:	1221D901D1201C06001

Asset Location:		
	Asset Length:		
	Condition Assessment		
	Condition	Priority	Risk
	A	4	5
	Brief Description		
	2015: Slipway in good condition – As new 2016: Not inspected in detail.		
	Recommendations		
No issues.

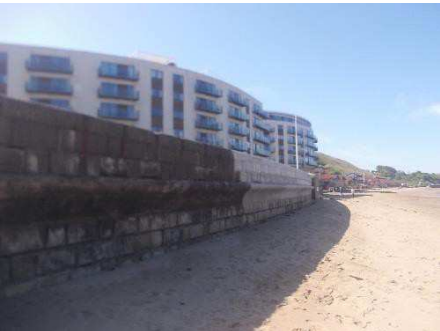
SBC Reference:	43-20B-03		
NFCDD reference:	1221D901D1201C19

Asset Location:	TA03818971, TA03758981. In front of new development.	
	Asset Length:	93.2	
	Condition Assessment		
	Condition	Priority	Risk
	B	3	
	Brief Description		
	Upper wall has been rebuilt at North end.		
	Recommendations		
Repair missing joints and chipped parts of capping and splash beams.

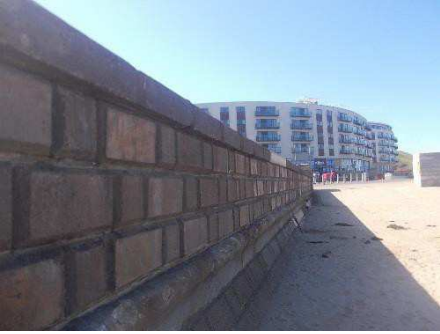
SBC Reference:	44-20B-01		
NFCDD reference:	1221D901D1201C20

Asset Location:	South of new development.	
	Asset Length:	40.8	
	Condition Assessment		
	Condition	Priority	Risk
	B	3	
	Brief Description		
	Section of coping recently repaired.		
	Recommendations		
Seal joints and repair cracks in coping. Continue to monitor.

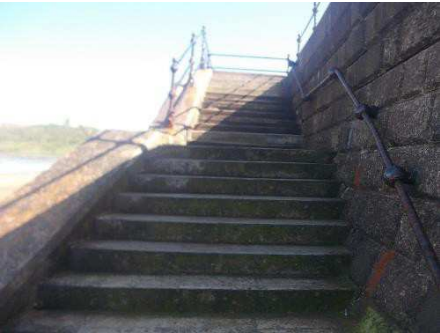
SBC Reference:	44-20B-04		
NFCDD reference:	1221D901D1201C07002

Asset Location:		
	Asset Length:	~7	
	Condition Assessment		
	Condition	Priority	Risk
	B	3	
	Brief Description		
	2015: Fair condition Corroded handrail and discontinuous seaward. 2016: Not inspected in detail.		
	Recommendations		
Treat corroded handrail. Continue to monitor

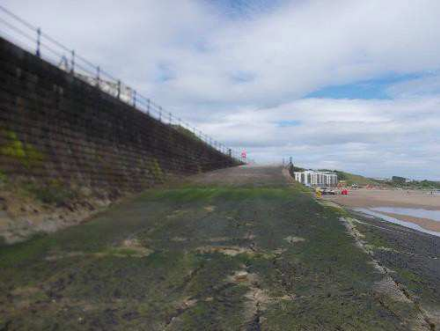
SBC Reference:	45-20B-01		
NFCDD reference:	1221D901D1201C08 001

Asset Location:	Part of 45-20B-02	
	Asset Length:	25	
	Condition Assessment		
	Condition	Priority	Risk
	C	2	
	Brief Description		
	2015: Slipway fenced off to prevent access. Significant settlement (i.e. depression in the tarmac revetment at the top). Concrete block facing replacement at rear of slipway. Large crack at the bottom Block revetment with mass concrete repair but missing joints 2016: Not inspected in detail.		
	Recommendations		
Carry out repairs to make slipway safe or fence off at bottom as well as top

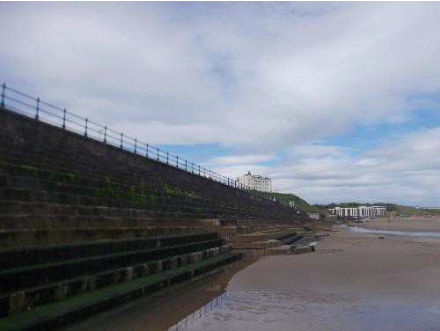
SBC Reference:	45-20B-02		
NFCDD reference:	1221D901D1201C08

Asset Location:	TA04078945, TA04288930	
	Asset Length:	206.9	
	Condition Assessment		
	Condition	Priority	Risk
	B	3	
	Brief Description		
	Some prom slabs have been replaced / repaired recently. Recent 2012/13 repair / replacement work on some of the steps / toe, but some horizontal cracks in original blocks remain.		
	Recommendations		
Continue to monitor and repair cracks and resurface rest of prom.

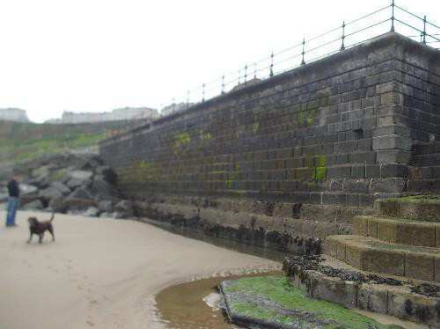
SBC Reference:	45-20B-03		
NFCDD reference:	1221D901D1202C23

Asset Location:	North of Albert Road.	
	Asset Length:	31.5	
	Condition Assessment		
	Condition	Priority	Risk
	C	3	
	Brief Description		
	Fair condition.		
	Recommendations		
Continue to monitor.

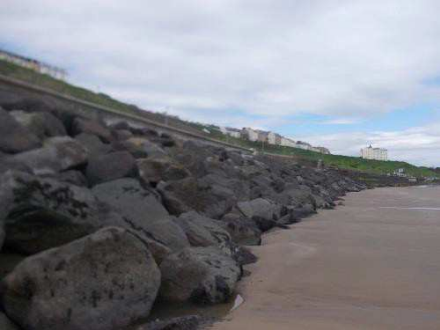
SBC Reference:	46-20B-01		
NFCDD reference:	1221D901D1202C01

Asset Location:	TA04288929, TA0493895. East of Albert Road.	
	Asset Length:	124.8	
	Condition Assessment		
	Condition	Priority	Risk
	B	4	>5
	Brief Description		
	Original wall hidden by rock armour, splash wall seems to be in good condition. Tightly packed rock armour with good coverage. Scour pool at toe of steps prevents use at low tide.		
	Recommendations		
Continue to monitor.

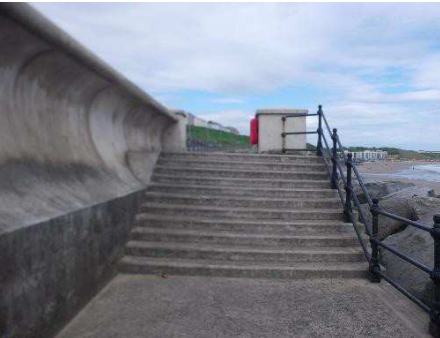
SBC Reference:	46-20B-02		
NFCDD reference:	1221D901D1202C01001

Asset Location:		
	Asset Length:	~5	
	Condition Assessment		
	Condition	Priority	Risk
	B	4	>5
	Brief Description		
	2015: Steps: Good condition throughout. 2016: Not inspected in detail.		
	Recommendations		
Continue to monitor.

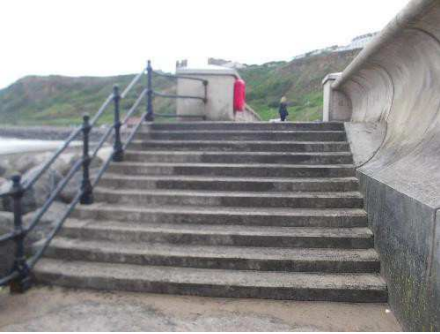
SBC Reference:	46-20B-03		
NFCDD reference:	1221D901D1202C03 003

Asset Location:	Part of 46-20b-04	
	Asset Length:	~3	
	Condition Assessment		
	Condition	Priority	Risk
	B	4	>5
	Brief Description		
	2015: Good condition throughout. Steps combine with SBC Ref: 46-20B-02 with single flight to beach level 2016: Not inspected in detail.		
	Recommendations		
Continue to monitor

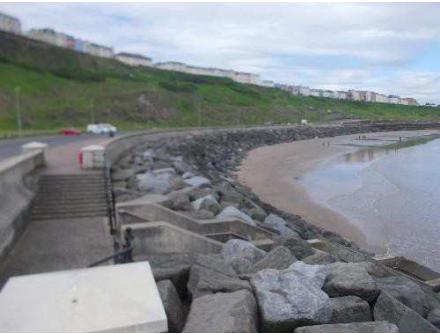
SBC Reference:	46-20B-04		
NFCDD reference:	1221D901D1202C03

Asset Location:		
	Asset Length:	429.2	
	Condition Assessment		
	Condition	Priority	Risk
	B	4	>5
	Brief Description		
	Constructed 2003ish. The Holms. Prom & Splash wall in good condition. Armour well packed and good cover. Original wall not visible.		
	Recommendations		
Continue to monitor.

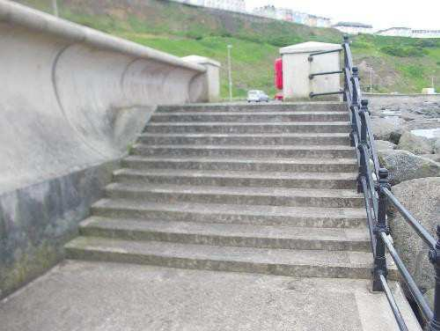
SBC Reference:	46-20B-05		
NFCDD reference:	1221D901D1202C03 002

Asset Location:	Part of 46-20B-04	
	Asset Length:	~4	
	Condition Assessment		
	Condition	Priority	Risk
	A	4	>5
	Brief Description		
	2015: Steps in good condition throughout 2016: Not inspected in detail.		
	Recommendations		
Continue to monitor.

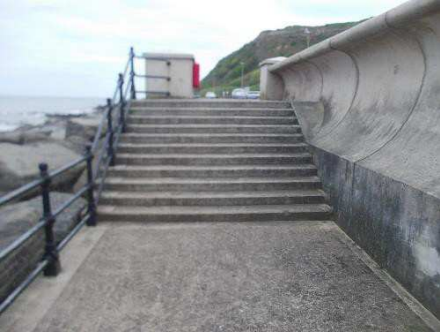
SBC Reference:	46-20B-06		
NFCDD reference:	1221D901D1202C03001

Asset Location:	Part of 46-20B-04	
	Asset Length:	~4	
	Condition Assessment		
	Condition	Priority	Risk
	A	4	
	Brief Description		
	2015: Steps in good condition throughout. Steps combine with SBC Ref: 46-20B-05 with single flight to beach level. 2016: Not inspected in detail.		
	Recommendations		
Continue to monitor.

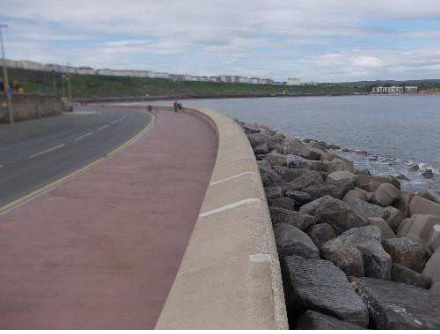
SBC Reference:	46-20B-07		
NFCDD reference:	1221D901D1202C04

Asset Location:		
	Asset Length:	219.9	
	Condition Assessment		
	Condition	Priority	Risk
	B	4	>5
	Brief Description		
	Original wall hidden by armour, splash wall seems to be in good condition. Tightly packed rock armour appears stable, no loose rocks. Toe piling working well, some natural rock against piling. Prom good condition.		
	Recommendations		
Continue to monitor.

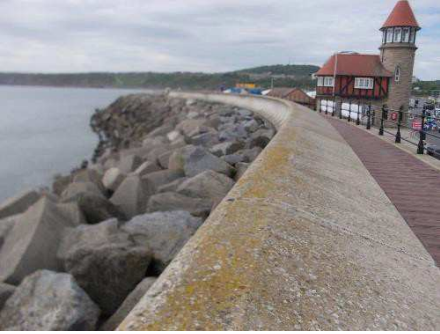
SBC Reference:	N/A		
NFCDD reference:	1221D901D1202C02

Asset Location:	TA05178883, TA04988952. East of Scarborough Castle.	
	Asset Length:	886.7	
	Condition Assessment		
	Condition	Priority	Risk
	B	4	>5
	Brief Description		
	Accropodes slightly abraded and chipped throughout. No concern at present.		
	Recommendations		
Continue to monitor.

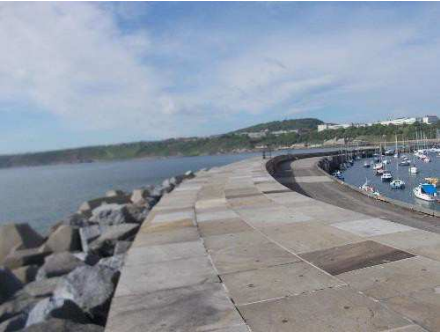
SBC Reference:	N/A		
NFCDD reference:	1221D901D1301C01

Asset Location:	TA04958849, TA05178883 North Harbour Breakwater.	
	Asset Length:	444.9	
	Condition Assessment		
	Condition	Priority	Risk
	B	4	5
	Brief Description		
	Crest wall good. Rock armour & accropodes generally in good condition, well packed. Less tightly packed or missing armour units at south end of wall. Several cracked pieces of armour.		
	Recommendations		
Continue to monitor.

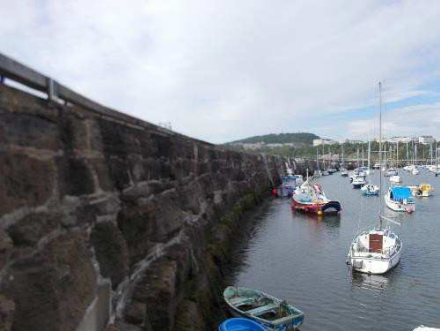
SBC Reference:	N/A		
NFCDD reference:	1221D901D1301C16

Asset Location:	Scarborough Harbour. North breakwater inner wall.	
	Asset Length:	362.1	
	Condition Assessment		
	Condition	Priority	Risk
	B	3	3
	Brief Description		
	Vegetation at bottom half of wall. Wall was repaired 2004/5. Generally repairs holding, but some voids at toe. Some cracks to promenade.		
	Recommendations		
Continue to monitor. Repair toe voids.

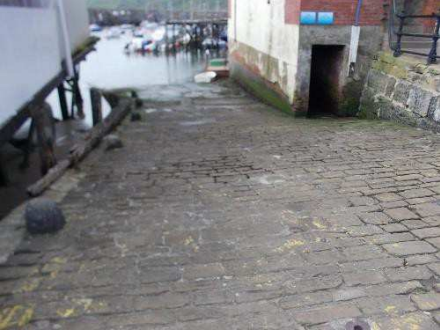
SBC Reference:	N/A		
NFCDD reference:	1221D901D1301C02

Asset Location:	TA05108874, TA05148874. Next to and under fairground.	
	Asset Length:	77.9	
	Condition Assessment		
	Condition	Priority	Risk
	B	3	
	Brief Description		
	Wall unable to be inspected due to fair ground. Render breaking away.		
	Recommendations		
Report missing joints to spillway wall and repair slipway surfacing.

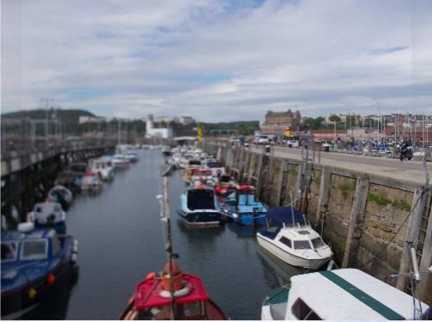
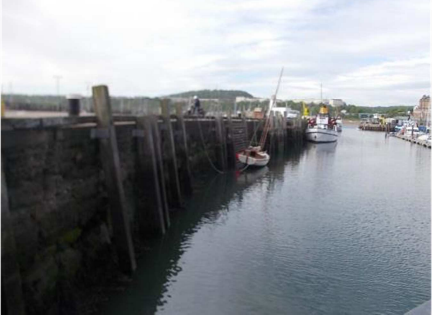
SBC Reference:	N/A		
NFCDD reference:	1221D901D1301C04

Asset Location:	TA04948860, TA05088877. Old pier	
	Asset Length:	463.1	
	Condition Assessment		
	Condition	Priority	Risk
	B	3	
	Brief Description		
	Appears fair. Missing fill between blocks throughout wall, fenders, vegetation and boats obscuring the lower parts of wall on old harbour side. Promenade in good condition.		
	Recommendations		
Continue to monitor and repoint cracks and missing joints.

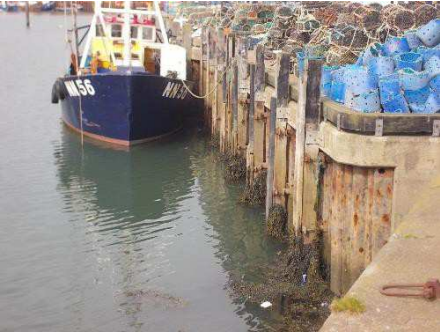
SBC Reference:	N/A		
NFCDD reference:	1221D901D1301C12

Asset Location:	TA04998877, TA05048878. West of masonry arches.	
	Asset Length:	51.7	
	Condition Assessment		
	Condition	Priority	Risk
	C	3	
	Brief Description		
	Corrosion evident sheet piles, especially lower part, but appear fair. Promenade in good condition.		
	Recommendations		
Continue to monitor.

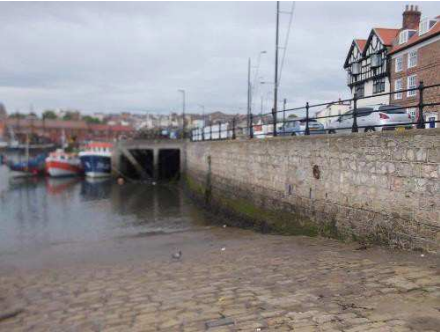
SBC Reference:	N/A		
NFCDD reference:	1221D901D1301C11

Asset Location:	TA04958876, TA04998877, Opposite Subway restaurant.	
	Asset Length:	47	
	Condition Assessment		
	Condition	Priority	Risk
	B	3	
	Brief Description		
	Few minor cracks to wall, spalling to capping. Promenade in good condition. Upper wall good. Slipway fair. Concrete piles at lower wall appear to have rotated in past but appear to be stable.		
	Recommendations		
Continue monitoring, repair cracks/joints

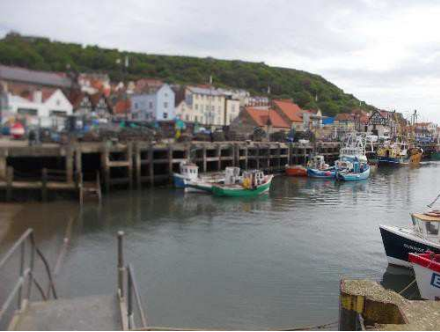
SBC Reference:	N/A		
NFCDD reference:	1221D901D1301C06

Asset Location:	TA04768876, TA04958876. Opposite Information centre.	
	Asset Length:	195.8	
	Condition Assessment		
	Condition	Priority	Risk
	B	3	
	Brief Description		
	Back wall appears to be fair to good, where visible although cracks and missing joints in places. Suspended quay appears to be fair condition, some cracks in protective coating. Promenade good. Timber edging rail decaying.		
	Recommendations		
	Monitor cracks to wall.

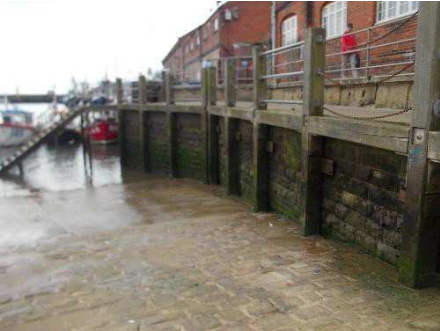
SBC Reference:	N/A		
NFCDD reference:	1221D901D1301C14

Asset Location:	TA04758875, TA04768876. West of Information centre.	
	Asset Length:	19.5	
	Condition Assessment		
	Condition	Priority	Risk
	B	3	
	Brief Description		
	Fair overall, only minor gaps.		
	Recommendations		
	Continue active monitoring. Repoint missing joints.

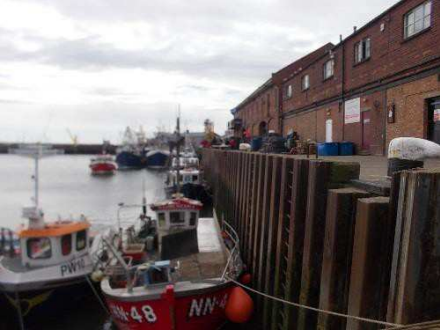
SBC Reference:	N/A		
NFCDD reference:	1221D901D1301C13

Asset Location:	TA04758875, TA04908862. West pier wall.	
	Asset Length:	140.2	
	Condition Assessment		
	Condition	Priority	Risk
	B	3	
	Brief Description		
	Sheet piles appear fair where visible, but only inspected from distance at low water. Promenade in good condition.		
	Recommendations		
Consider future inspection of quay from boat.

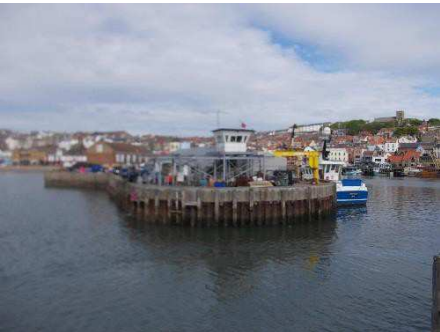
SBC Reference:	N/A		
NFCDD reference:	1221D901D1301C18

Asset Location:	West Pier, Scarborough South Bay.	
	Asset Length:	115.6	
	Condition Assessment		
	Condition	Priority	Risk
	C	2	
	Brief Description		
	Downgraded to poor. Heavily corroded piles throughout. Cracking coping beam.		
	Recommendations		
Continue to monitor. Inspect piles, repair cracks.

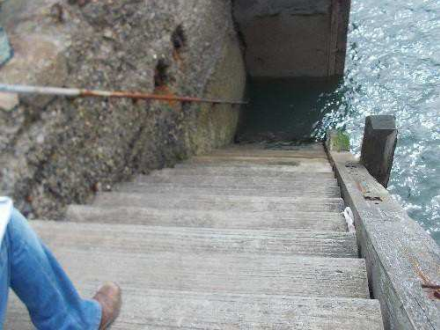
SBC Reference:	49-21B-05		
NFCDD reference:	1221D901D1301C18001

Asset Location:	West Pier, Scarborough South Bay.	
	Asset Length:	~5	
	Condition Assessment		
	Condition	Priority	Risk
	C	2	
	Brief Description		
	2015: Cracking and missing render at steps. Treads in good condition. Back wall heavily abraded with exposed aggregates and missing capping block in places. Heavily corroded handrail. 2016: Not inspected in detail.		
	Recommendations		
Treat or replace handrail. Replace missing capping block and concrete skim the back wall.

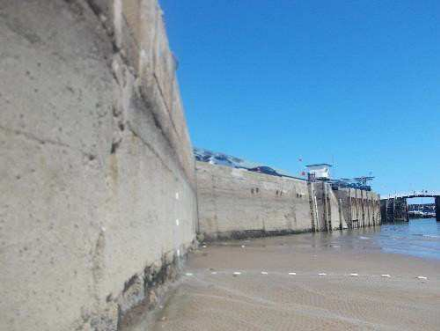
SBC Reference:	49-21B-04		
NFCDD reference:	1221D901D1301C07

Asset Location:	TA04738870, TA04908862. Beach end of West Pier, between stairs.	
	Asset Length:	58.7	
	Condition Assessment		
	Condition	Priority	Risk
	C	2	
	Brief Description		
	Scour apron not visible due to beach level. Horizontal and vertical cracking at bend of wall, repair work failing. Exposed aggregate throughout wall. Numerous cracks throughout wall. Exposed timber toe piles rotten with scoured concrete wall behind.		
	Recommendations		
Continue to monitor and repair cracks, voids and damaged apron. Improve toe protection.

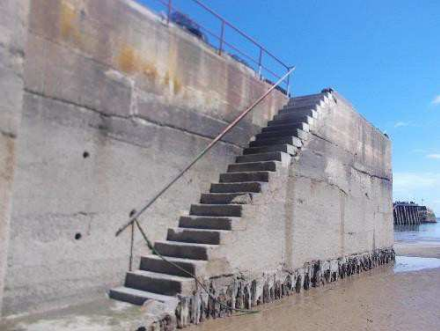
SBC Reference:	49-21B-03		
NFCDD reference:	1221D901D1301C07001

Asset Location:	TA04738870, TA04908862. Beach end of West Pier, between stairs.	
	Asset Length:	~5	
	Condition Assessment		
	Condition	Priority	Risk
	B	3	
	Brief Description		
	2015: Precast steps exposed on seaward side - needs repointing. No edge / toe protection seaward. 2016: Not inspected in detail.		
	Recommendations		
Repoint steps. Continue to monitor.

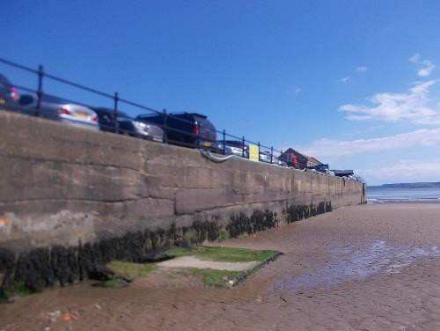
SBC Reference:	49-21B-02		
NFCDD reference:	1221D901D1301C19

Asset Location:	TA04738870, TA04908862. Shore end of West Pier.	
	Asset Length:	110.4	
	Condition Assessment		
	Condition	Priority	Risk
	-	-	
	Brief Description		
	2015: Toe piles not visible. Vertical crack from top to bottom of wall at middle section of length, appears same as last inspection. Horizontal and vertical cracks and exposed aggregate throughout wall. Rotten timber toe piles exposed at deeper end. Scour hole developing behind the timber piles. Few minor cracks to promenade. 2016: Not inspected because RNLI Lifeboat Station is being built.		
	Recommendations		
-

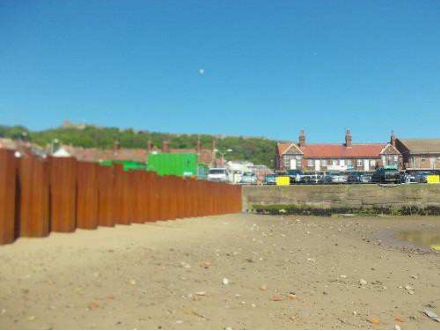
SBC Reference:	49-21B-01		
NFCDD reference:	1221D901D1301C08

Asset Location:	TA04708872, TA04738870	
	Asset Length:	69.2	
	Condition Assessment		
	Condition	Priority	Risk
	-	-	
	Brief Description		
	2015: Majority of the wall now made redundant as incorporated in new development site. Some mortar loss to joints in remainder of wall, some minor erosion to capping beam, as well as minor mortar loss of joints to toe. 2016: Not inspected because RNLI Lifeboat Station is being built.		
	Recommendations		
-

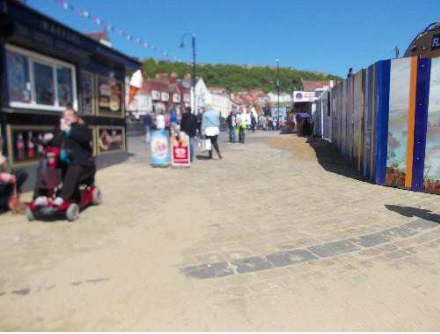
SBC Reference:	51-22A-01		
NFCDD reference:	1221D901D1301C20

Asset Location:	Next to Life boat house.	
	Asset Length:	28.5	
	Condition Assessment		
	Condition	Priority	Risk
	-	-	
	Brief Description		
	2015: Majority of asset hidden within construction site. 2016: Not inspected because RNLI Lifeboat Station and slipway are being built.		
	Recommendations		
-

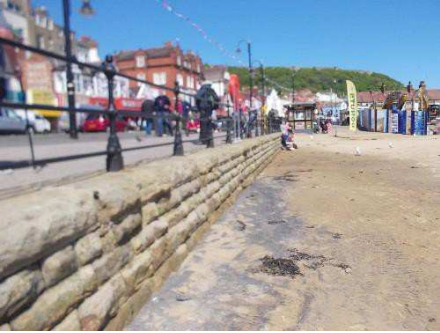
SBC Reference:	51-22A-02		
NFCDD reference:	1221D901D1301C15

Asset Location:	TA04538856, TA04698873	
	Asset Length:	40.3	
	Condition Assessment		
	Condition	Priority	Risk
	B	3	
	Brief Description		
	High beach levels cover wall.		
	Recommendations		
Repair joints between blocks.

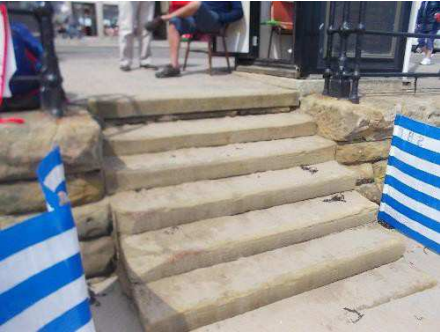
SBC Reference:	51-22A-03		
NFCDD reference:	1221D901D1301C15001

Asset Location:	TA04538856, TA04698873	
	Asset Length:	~3	
	Condition Assessment		
	Condition	Priority	Risk
	B	4	5
	Brief Description		
	2015: Fair condition overall. Chipped concrete steps. 2016: Not inspected in detail.		
	Recommendations		
Continue to monitor.

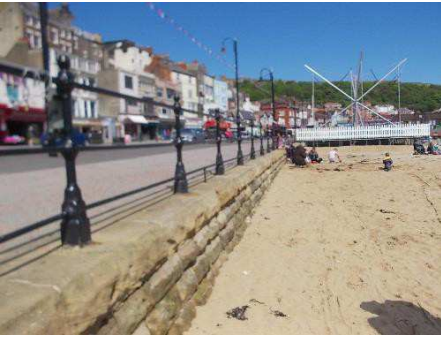
SBC Reference:	51-22A-04		
NFCDD reference:	1221D901D1301C21

Asset Location:	TA04538856, TA04698873	
	Asset Length:	57.8	
	Condition Assessment		
	Condition	Priority	Risk
	B	3	
	Brief Description		
	High beach levels cover wall.		
	Recommendations		
Repoint when necessary.

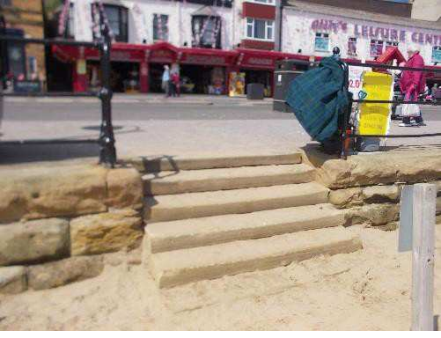
SBC Reference:	51-22A-05		
NFCDD reference:	1221D901D1301C21001

Asset Location:	TA04538856, TA04698873	
	Asset Length:	~3	
	Condition Assessment		
	Condition	Priority	Risk
	B	4	5
	Brief Description		
	2015: Fair condition overall 2016: Not inspected in detail.		
	Recommendations		
Continue to monitor

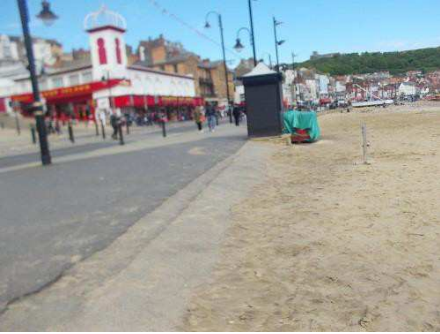
SBC Reference:	51-22A-07		
NFCDD reference:	1221D901D1301C22 001

Asset Location:	TA04538856, TA04698873	
	Asset Length:	~10	
	Condition Assessment		
	Condition	Priority	Risk
	B	3	
	Brief Description		
	2015: Small access ramp covered by the beach. Exposed surface looks in fair condition. 2016: Not inspected in detail.		
	Recommendations		
Continue to monitor.

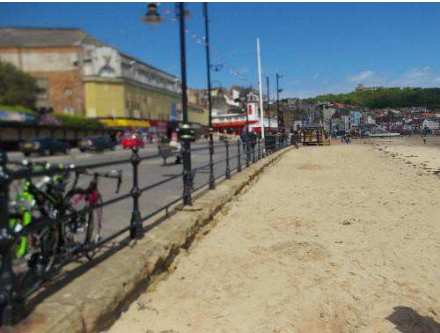
SBC Reference:	51-22A-08		
NFCDD reference:	1221D901D1301C23

Asset Location:	TA04538856, TA04698873	
	Asset Length:	101.8	
	Condition Assessment		
	Condition	Priority	Risk
	B	3	
	Brief Description		
	Beach high so only upper wall inspected. Wall appears in fair to good condition although missing joints in places. Some loss of material at road / slipway junction in south.		
	Recommendations		
Repair edge of road at slipway.

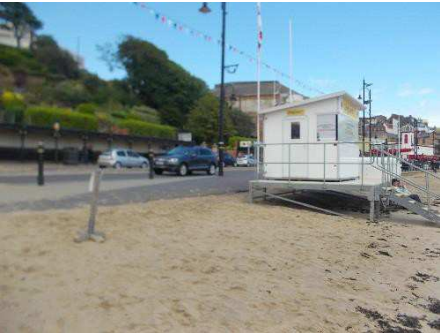
SBC Reference:	51-22A-09		
NFCDD reference:	1221D901D1301C23 001

Asset Location:	TA04538856, TA04698873	
	Asset Length:	~10	
	Condition Assessment		
	Condition	Priority	Risk
	B	4	5
	Brief Description		
	2015: Covered by sand and by the lifeguard station. 2016: Not inspected in detail.		
	Recommendations		
Continue to monitor.

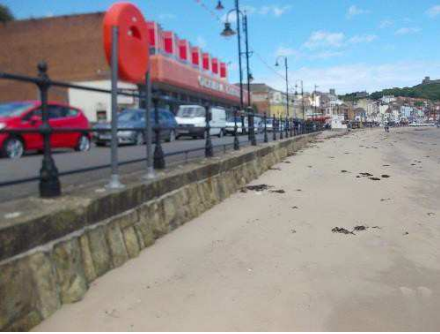
SBC Reference:	51-22A-10		
NFCDD reference:	1221D901D1301C24

Asset Location:	TA04538856, TA04698873	
	Asset Length:	109.7	
	Condition Assessment		
	Condition	Priority	Risk
	B	3	
	Brief Description		
	Some missing mortar between blocks. Promenade good.		
	Recommendations		
	Monitor and repoint when necessary.

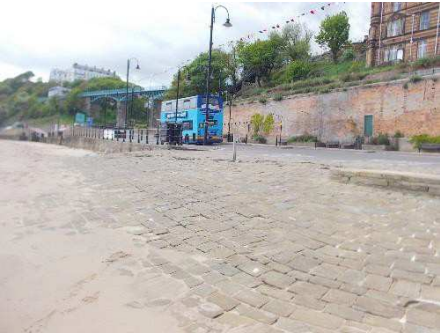
SBC Reference:	51-22A-11		
NFCDD reference:	1221D901D1301C24 ⁰⁰¹

Asset Location:		
	Asset Length:	~10	
	Condition Assessment		
	Condition	Priority	Risk
	B	3	
	Brief Description		
	2015: Slipway. Missing mortar in gaps between blocks. 2016: Not inspected in detail.		
	Recommendations		
	Fill gaps between blocks. Continue to monitor.

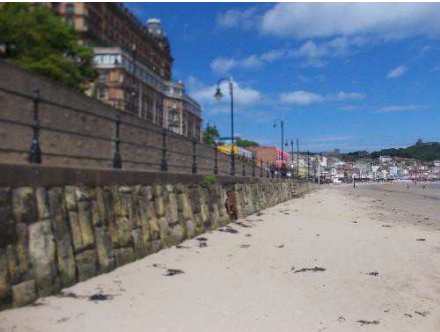
SBC Reference:	51-22A-12		
NFCDD reference:	1221D901D1301C25

Asset Location:	TA04538856, TA04698873. In front of Hotel.	
	Asset Length:	99.1	
	Condition Assessment		
	Condition	Priority	Risk
	B	2	
	Brief Description		
	Missing mortar in joints in places and signs of abrasion. Repairs suggested.		
	Recommendations		
	Continue to monitor and repair joints, inspect at low beach level.

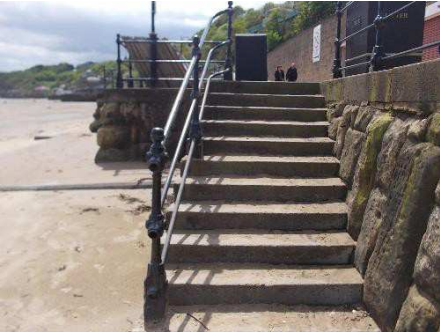
SBC Reference:	52-22A-01		
NFCDD reference:	1221D901D1301C09 001

Asset Location:		
	Asset Length:	~4	
	Condition Assessment		
	Condition	Priority	Risk
	B	4	5
	Brief Description		
	2015: Fair condition overall. 2016: Not inspected in detail.		
	Recommendations		
	Continue to monitor.

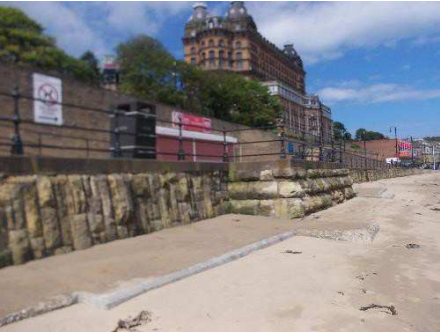
SBC Reference:	52-22A-02		
NFCDD reference:	1221D901D1301C09

Asset Location:	TA04428822, TA04438827. Wall at underground tunnel entrance.	
	Asset Length:	41.5	
	Condition Assessment		
	Condition	Priority	Risk
	B	3	5
	Brief Description		
	Toe apron has been repaired / overlaid in places, but further repairs needed. Localised missing mortar in joints to wall and signs of abrasion. Several full height vertical cracks to upper road wall. Promenade in good condition.		
	Recommendations		
	Continue to monitor and repair joints and cracks.

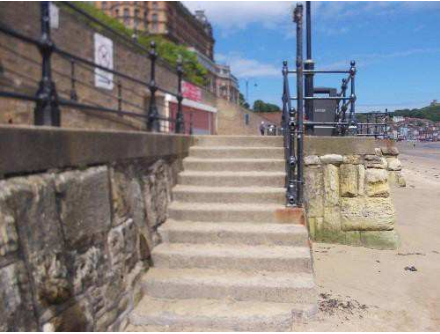
SBC Reference:	52-22A-03		
NFCDD reference:	1221D901D1301C09 002

Asset Location:		
	Asset Length:	~4	
	Condition Assessment		
	Condition	Priority	Risk
	B	4	5
	Brief Description		
	2015: Fair condition overall. 2016: Not inspected in detail.		
	Recommendations		
	Continue to monitor.

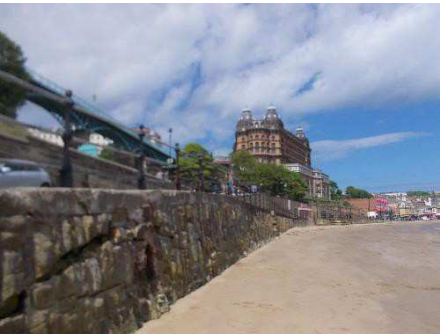
SBC Reference:	52-22A-04		
NFCDD reference:	1221D901D1301C10

Asset Location:	TA04508772, TA04428822. North of slipway.	
	Asset Length:	100.7	
	Condition Assessment		
	Condition	Priority	Risk
	C	1	
	Brief Description		
	Missing mortar joints to wall, occasional cracked blockwork to lower part of wall, vegetation near slipway. Cracking in upper retaining wall between prom and slipway. Repairs to slipway toe holding, but more open joints require filling, especially around Spa		
	Recommendations		
Continue to monitor, repair cracks and joints.

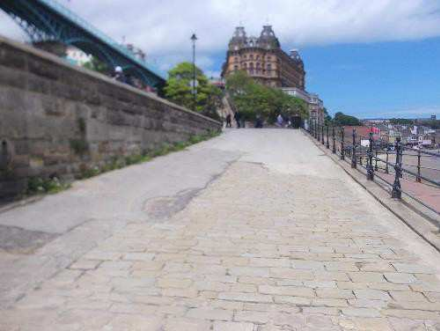
SBC Reference:	53-22B-01		
NFCDD reference:	1221D901D1301C10001

Asset Location:	South of 52-22A-04	
	Asset Length:	~12	
	Condition Assessment		
	Condition	Priority	Risk
	B	3	
	Brief Description		
	2015: Repairs to slipway toe holding, but more open joints require filling. Mixed revetment construction testimony of previous repairs undertaken. 2016: Not inspected in detail.		
	Recommendations		
Continue monitoring, repair joints.

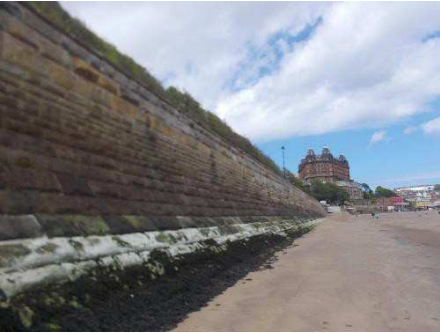
SBC Reference:	53-22B-02		
NFCDD reference:	1221D901D1301C26

Asset Location:	TA04508772, TA04428822. South of slipway.	
	Asset Length:	162.1	
	Condition Assessment		
	Condition	Priority	Risk
	B	3	
	Brief Description		
	Wall in fair condition. Some cracked blocks, but seem stable. Missing mortar / open joints here and there. Crest wall repairs evident with some sections of coping repaired but others abraded.		
	Recommendations		
Grout joints. Continue to monitor.

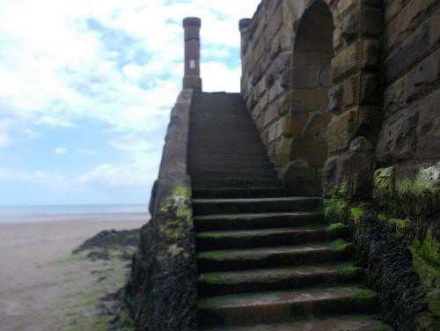
SBC Reference:	53-22B-04		
NFCDD reference:	1221D901D1301C26001

Asset Location:	Part of 53-22b-02	
	Asset Length:	~5	
	Condition Assessment		
	Condition	Priority	Risk
	B	3	
	Brief Description		
	2015: Fair overall condition with bottom steps damaged in places. 2016: Not inspected in detail.		
	Recommendations		
Repair damaged steps. Continue to monitor.

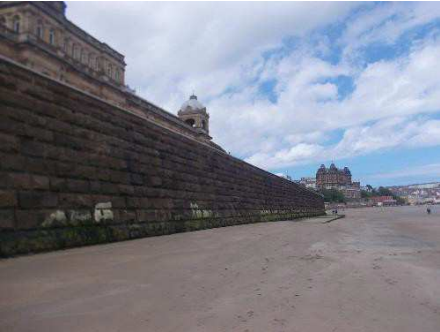
SBC Reference:	53-22B-05		
NFCDD reference:	1221D901D1301C27

Asset Location:	TA04508772, TA04428822. North of The Spa.	
	Asset Length:	158.1	
	Condition Assessment		
	Condition	Priority	Risk
	B	2	
	Brief Description		
	Multiple repairs. Section of crest wall has been rebuilt after Dec 13 storm, but still poor elsewhere. Many cracks, open joints and displaced blocks in main wall.		
	Recommendations		
Develop improvement scheme. Repair cracks and joints to hold wall until scheme. Works scheduled for 2017.

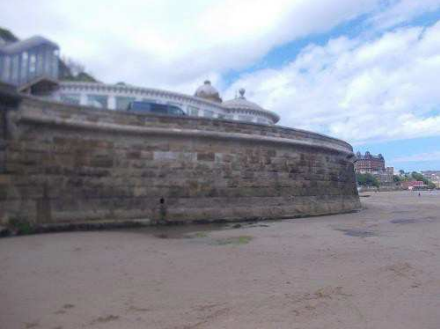
SBC Reference:	53-22B-06		
NFCDD reference:	1221D901D1301C28

Asset Location:	TA04508772, TA04428822 Opposite The Spa	
	Asset Length:	76.4	
	Condition Assessment		
	Condition	Priority	Risk
	B	3	
	Brief Description		
	Open joints and cracked blocks throughout.		
	Recommendations		
Monitor and patch up until improvement scheme implemented. Works scheduled for 2017.

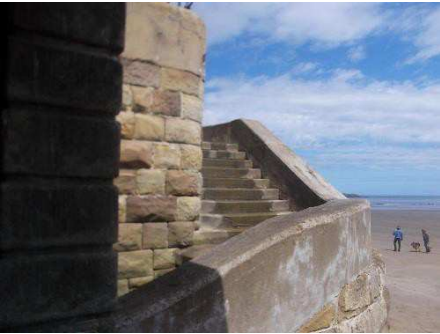
SBC Reference:	53-22B-08		
NFCDD reference:	1221D901D1302C01001

Asset Location:		
	Asset Length:	~4	
	Condition Assessment		
	Condition	Priority	Risk
	B	3	
	Brief Description		
	2015: Side wall capping cracked but steps in fair condition. 2016: Not inspected in detail.		
	Recommendations		
Continue to monitor.

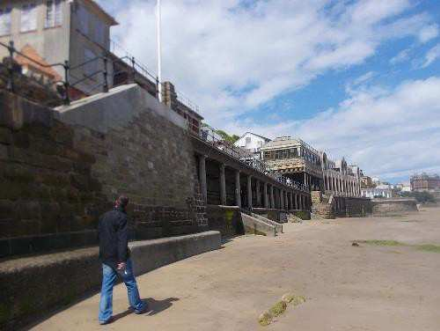
SBC Reference:	54-22B-01		
NFCDD reference:	1221D901D1302C01

Asset Location:	TA04538765, TA04508772. Next to cliff railway.	
	Asset Length:	77.5	
	Condition Assessment		
	Condition	Priority	Risk
	C	2	
	Brief Description		
	Lower wall has repairs to 2 large areas. Cracking and corrosion/rust staining to beams supporting upper prom near stairs. Cracking & rust staining to cols. Major weathering loss of stone blocks in rear splash wall.		
	Recommendations		
Patch up until scheme can be implemented.

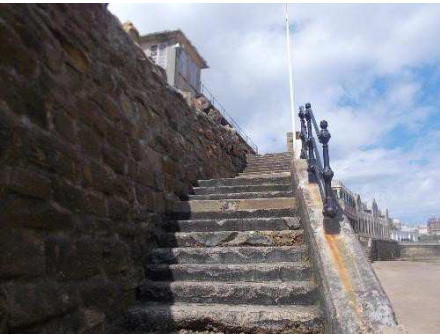
SBC Reference:	54-22B-02		
NFCDD reference:	1221D901D1302C01002

Asset Location:		
	Asset Length:	~4	
	Condition Assessment		
	Condition	Priority	Risk
	C	2	
	Brief Description		
	2015: Steps worn out. Cracks visible across a number of steps. Some have already been repaired. 2016: Not inspected in detail.		
	Recommendations		
Repair steps. Continue to monitor.

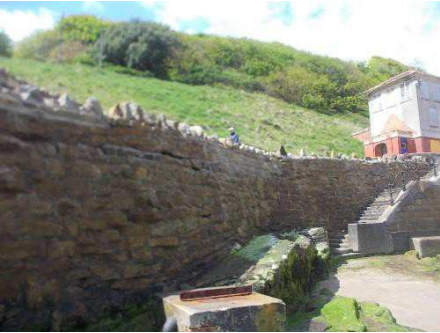
SBC Reference:	54-22B-03		
NFCDD reference:	1221D901D1302C03

Asset Location:	TA04628752, TA04538765. South of cliff railway.	
	Asset Length:	19.2	
	Condition Assessment		
	Condition	Priority	Risk
	B	3	
	Brief Description		
	Major repairs evident with blocks replaced and joints filled. However, in other areas still joint mortar loss and cracks evident in places.		
	Recommendations		
Regular repair to joints, particularly on steps.

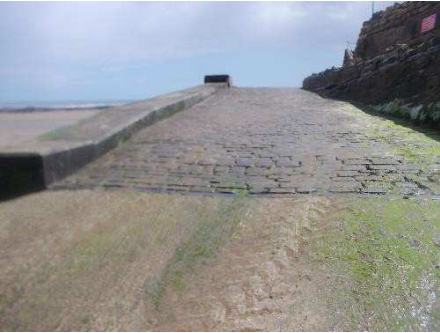
SBC Reference:	56-22B-04		
NFCDD reference:	1221D901D1302C02001

Asset Location:		
	Asset Length:	~10	
	Condition Assessment		
	Condition	Priority	Risk
	B	3	
	Brief Description		
	2015: Fair overall condition. Uneven cobbles which need repointing in places. 2016: Not inspected in detail.		
	Recommendations		
Repoint joints. Continue to monitor

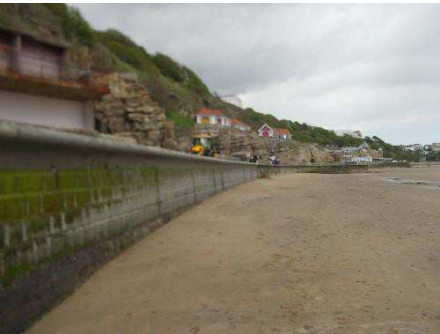
SBC Reference:	55-22B-01		
NFCDD reference:	1221D901D1302C02

Asset Location:	TA04628752, TA04538765. In front of Beach Chalets.	
	Asset Length:	231.8	
	Condition Assessment		
	Condition	Priority	Risk
	C	2	
	Brief Description		
	Repairs evident. Several sections rebuilt facing and wave wall. Repairs to wall and prom evident, and prom slabs have been replaced. However one section of missing blockwork and one section of missing bagwork.		
	Recommendations		
Replace missing filler in joints in promenade. Replace missing blocks / bagwork. (Note: Repairs undertaken in July 2016.)

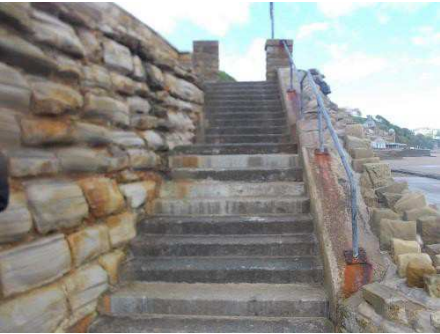
SBC Reference:	56-22B-02		
NFCDD reference:	1221D901D1302C02002

Asset Location:		
	Asset Length:	~4	
	Condition Assessment		
	Condition	Priority	Risk
	B	3	
	Brief Description		
	2015: Cracks between the capping beam and the steps. Some steps have been recently been refurbished. Fixings to handrail corroded. Overall fair condition. 2016: Not inspected in detail.		
	Recommendations		
Treat handrail fixings. Continue to monitor.
