Asset Inspection Document

Walk-over Visual Inspections of Assets

Scarborough Borough Council

September 2016

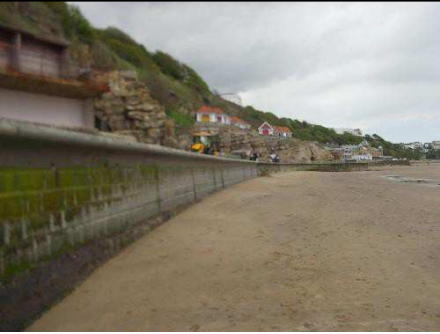
SBC Reference:	56-22B-03		
NFCDD reference:	1221D901D1302C02003

Asset Location:	Wall south of steps	
	Asset Length:	231.8 (with 55-22b-01)	
	Condition Assessment		
	Condition	Priority	Risk
	C	2	
	Brief Description		
	2015: Repairs evident. Several sections rebuilt facing and prom slabs have been replaced. However, large areas of missing joints in prom slabs, particularly at north end. Scour of the toe with deep holes over a 20m section. Repair of concrete prom were being carried out during the inspection. 2016: Not inspected in detail.		
	Recommendations		
Continue with any outstanding repair work.

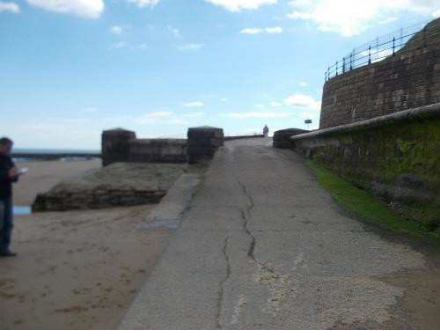
SBC Reference:	56-22B-04		
NFCDD reference:	1221D901D1302C02004

Asset Location:		
	Asset Length:	~5	
	Condition Assessment		
	Condition	Priority	Risk
	B	3	
	Brief Description		
	2015: Top section behind defence wall has been re-built although cracks have started to appear. Slipway leading to beach - large cracks with damaged side walls (especially the concrete bagwork and mass concrete screed) 2016: Not inspected in detail.		
	Recommendations		
Repair cracks and screed.

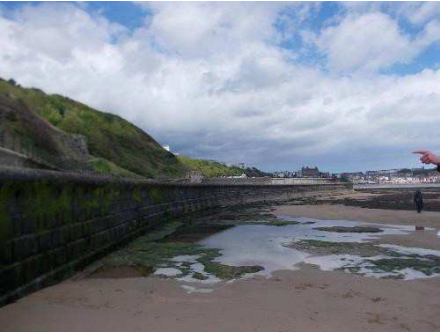
SBC Reference:	56-22B-05		
NFCDD reference:	1221D901D1303C02

Asset Location:	TA04828723, TA04668746.Wall at Dickinsons Point.	
	Asset Length:	308.2	
	Condition Assessment		
	Condition	Priority	Risk
	C	2	
	Brief Description		
	Deep voids/ missing joints in blockwork in lower wall need further attention. Beach higher than in 2012 covering toe. Many open joints between concrete slabs in lower prom. Loss of facing to second wall, cracks/spalling to splash beam.		
	Recommendations		
Urgently repair voids in joints in lower wall, and open joints in lower prom. Continue to monitor.

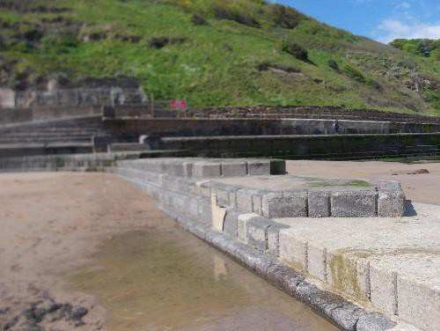
SBC Reference:	56-22B-06		
NFCDD reference:	1221D901D1303C02001

Asset Location:		
	Asset Length:	~12	
	Condition Assessment		
	Condition	Priority	Risk
	B	3	
	Brief Description		
	2015: Groyne in fair condition with visible repairs works Ramp - Visible resin repair to side wall Concrete slab revetment repaired with flexible asphalt filler but repairs have failed and need redoing 2016: Not inspected in detail.		
	Recommendations		
Replace asphalt filler.

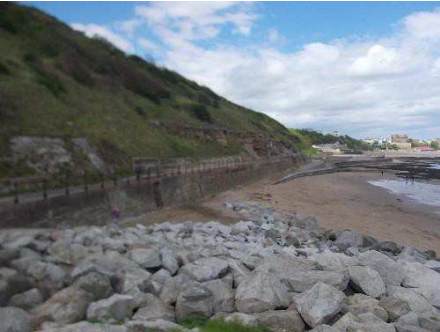
SBC Reference:	56-22B-07		
NFCDD reference:	1221D901D1304C02

Asset Location:	TA04868713, TA04828723. East of Holbeck Gardens.	
	Asset Length:	112.5	
	Condition Assessment		
	Condition	Priority	Risk
	C	3	
	Brief Description		
	Cracks to bastion throughout. Missing pointing / open joints and damaged parts of upper and lower capping beam. Unable to inspect lower wall due to high beach level. Corroded handrail with missing sections. Upper prom has been fenced off.		
	Recommendations		
Repair facing and copings. Replace broken handrails.

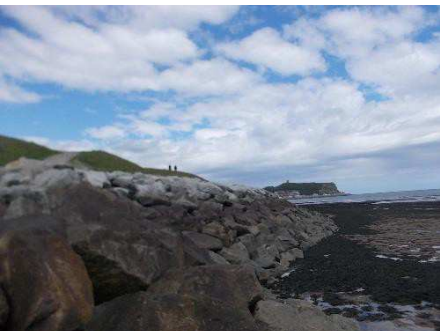
SBC Reference:	56-22B-08		
NFCDD reference:	1221D901D1304C01

Asset Location:	TA05038695, TA04868713. Land slip.	
	Asset Length:	294.7	
	Condition Assessment		
	Condition	Priority	Risk
	B	4	>5
	Brief Description		
	Rock armour tightly packed, good cover and looks in good condition. Toe in good condition, rock socketed into wave cut platform of soft rock.		
	Recommendations		
Continue to monitor, monitor stability of cliffs.

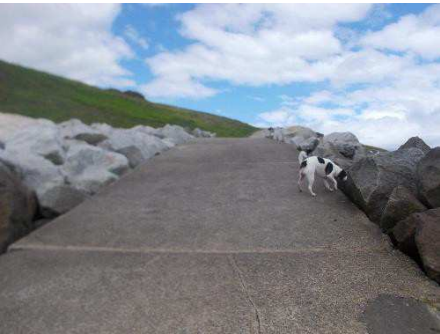
SBC Reference:	56-22B-09		
NFCDD reference:	1221D901D1304C01001

Asset Location:	Part of 56-22b-08	
	Asset Length:	~10	
	Condition Assessment		
	Condition	Priority	Risk
	B	4	>5
	Brief Description		
	2015: Southern ramp has vertical drop to rocks and crack in bottom slab. 2016: Not inspected in detail.		
	Recommendations		
	Repair cracks. Continue to monitor.

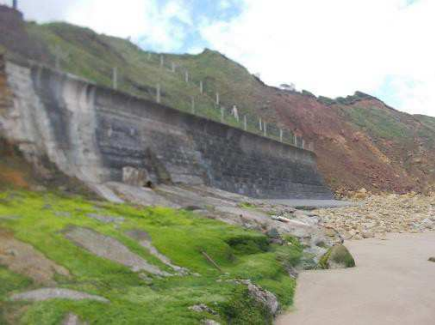
SBC Reference:	58-24B-01		
NFCDD reference:	1221D901D1402C02

Asset Location:	TA06618455, TA06648454	
	Asset Length:	34	
	Condition Assessment		
	Condition	Priority	Risk
	B	4	>5
	Brief Description		
	North of old PS. Poured concrete and concrete blockwork toe below a stepped seawall with curved coping stone. More recent construction than adjacent walls. Cliff cutting back adjacent to North. Wall generally fair, but toe undercut at South.		
	Recommendations		
Repair to voids. Monitor for outflanking.

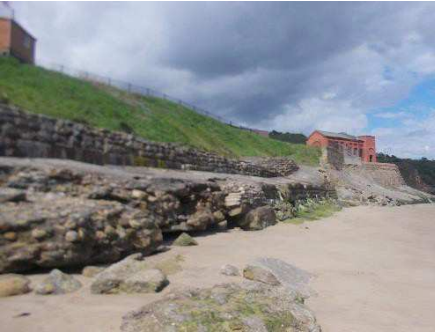
SBC Reference:	59-24B-01		
NFCDD reference:	1221D901D1402C05

Asset Location:	TA06698449, TA06658454	
	Asset Length:	67.3	
	Condition Assessment		
	Condition	Priority	Risk
	C	3	
	Brief Description		
	Private wall to old PS. Lower apron has multiple patch repairs with poured concrete, but has cracks. Recent pointing to main wall joints. Higher wall slightly better than lower. Beach high, but toe may be undercut. Slip failure behind higher wall with access steps consolidated with trench sheets. Large voids in the lower wall at beach level.		
	Recommendations		
Private maintenance.

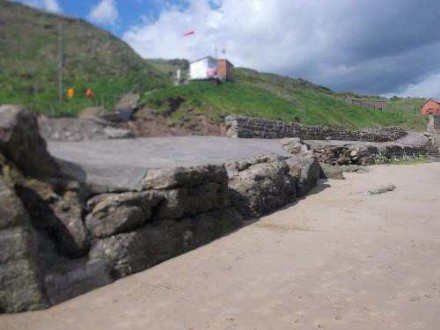
SBC Reference:	60-24B-01		
NFCDD reference:	1221D901D1402C04

Asset Location:	TA06698449, TA06758445	
	Asset Length:	32.6	
	Condition Assessment		
	Condition	Priority	Risk
	D	1	
	Brief Description		
	Southern section of apron is missing, lower sea wall has been undercut and failed. Blockwork missing and displaced. Some repairs to deck with concrete. Upper wall missing southern section. Toe undermined. Crest breaking up.		
	Recommendations		
Repair or remove/make safe. (Note: Repairs undertaken to make safe in July 2016.)

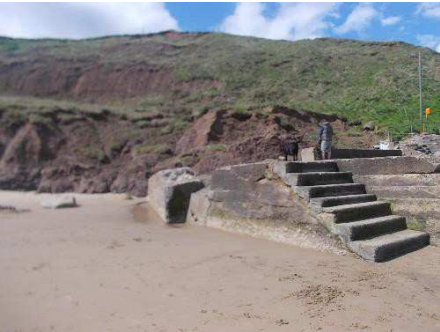
SBC Reference:	60-24B-01		
NFCDD reference:	1221D901D1402C06

Asset Location:	Nr Pumping Station in Cayton Bay.	
	Asset Length:	19.9	
	Condition Assessment		
	Condition	Priority	Risk
	D	2	
	Brief Description		
	Mass concrete wall has failed and is breaking up. More patch repair work has been done to make safer for pedestrians. Large voids beneath. Needs removing and replacing with safer beach pedestrian access.		
	Recommendations		
Demolish and remove and construct safer beach access. (Note: Repairs undertaken to make safe in July 2016.)

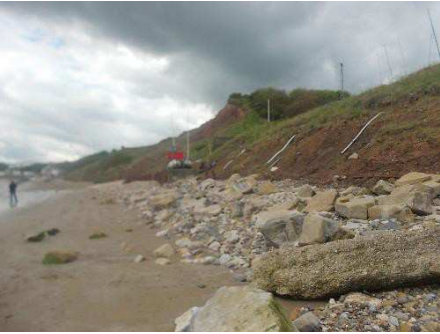
SBC Reference:	N/A		
NFCDD reference:	1221D901D1601C02

Asset Location:	TA12248126, TA12278130	
	Asset Length:	18.3	
	Condition Assessment		
	Condition	Priority	Risk
	D	4	
	Brief Description		
	Rock armour scattered and totally ineffective. Timber breastwork no longer evident. Coastal slope appears to be actively eroding. Rock armour originally placed in failed breastwork.		
	Recommendations		
Consider reprofiling rock to slow erosion at boat club.

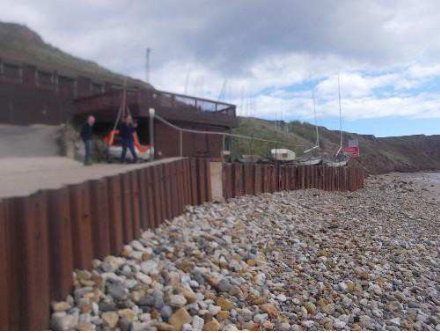
SBC Reference:	64-28A-02		
NFCDD reference:	1221D901D1601C03

Asset Location:	TA12228121, TA12248126	
	Asset Length:	55.8	
	Condition Assessment		
	Condition	Priority	Risk
	B	4	
	Brief Description		
	Sheet piling repaired to good condition.		
	Recommendations		
Inspections every 2 years.

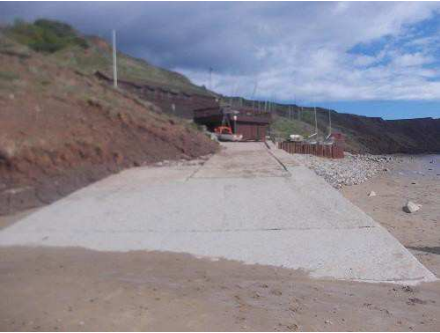
SBC Reference:	64-28A-01		
NFCDD reference:	1221D901D1601C03 001

Asset Location:	TA12228121, TA12248126	
	Asset Length:	~15	
	Condition Assessment		
	Condition	Priority	Risk
	B	3	
	Brief Description		
	2015: Good condition at the lower end but cracks in the middle part with patch repairs carried out. Upper section in fair condition. Noticeable movement of the earth slope which is encroaching on the slipway and slowly narrowing the access. 2016: Not inspected in detail.		
	Recommendations		
Reprofile bank at edge of slipway to maintain access and secure cliff erosion.

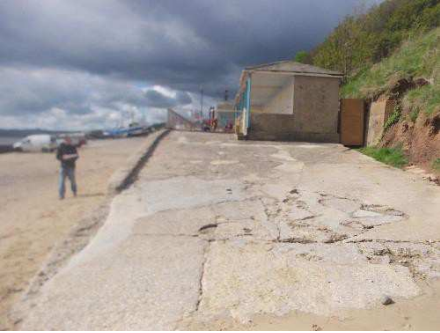
SBC Reference:	N/A		
NFCDD reference:	1221D901D1602C09 002

Asset Location:	TA12118095, TA12128100	
	Asset Length:	~10	
	Condition Assessment		
	Condition	Priority	Risk
	C	2	
	Brief Description		
	2015: Wing wall badly eroded at base. Capping failed with large section missing. Ramp revetment is a mixture of concrete repairs with large cracks and voids. Poor state overall. 2016: Not inspected in detail.		
	Recommendations		
Repair deck of slipway. Rebuild wingwall. Continue to monitor.

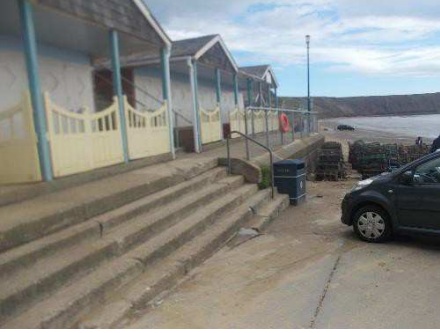
SBC Reference:	N/A		
NFCDD reference:	1221D901D1602C09

Asset Location:	North of promenade, Filey.	
	Asset Length:	38.8	
	Condition Assessment		
	Condition	Priority	Risk
	B	3	
	Brief Description		
	Crest section repaired since 2012, looks to be holding well. Some horizontal cracks and open joints. Degradation of front faces of blocks and capping.		
	Recommendations		
Monitor and repair damage as necessary.

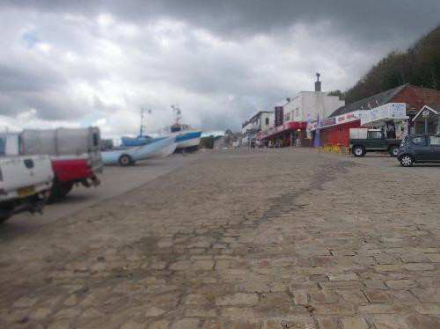
SBC Reference:	N/A		
NFCDD reference:	1221D901D1602C09001

Asset Location:	North of promenade, Filey.	
	Asset Length:	10	
	Condition Assessment		
	Condition	Priority	Risk
	B	4	>5
	Brief Description		
	2015: Slipway in good condition. 2016: Not inspected in detail.		
	Recommendations		
Continue to monitor

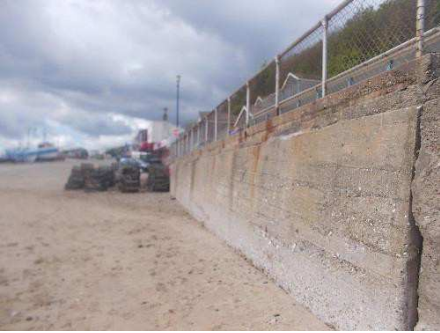
SBC Reference:	N/A		
NFCDD reference:	1221D901D1602C01

Asset Location:	TA12118095, TA12128100	
	Asset Length:	49.6	
	Condition Assessment		
	Condition	Priority	Risk
	B	2	
	Brief Description		
	Slipway blockwork looks in good condition. Horizontal crack in wall at rear. Abrasion and surface erosion to rest of wall visible.		
	Recommendations		
Repair damaged wall.

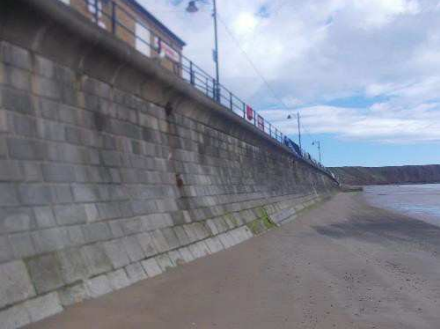
SBC Reference:	67-28B-01		
NFCDD reference:	1221D901D1602C06

Asset Location:	North of promenade	
	Asset Length:	109.8	
	Condition Assessment		
	Condition	Priority	Risk
	B	2	
	Brief Description		
	Missing pointing between blocks on wall. Damage to front face of several blocks. Repairs have been undertaken to one area. Cracks to wing wall of Southern slipway (67-28B-02). Large crack throughout the wing wall (7m from the extremity of the wall) indicating GEO and STR failure.		
	Recommendations		
Repointing. Seal cracks below coping. Monitor large crack for movement.

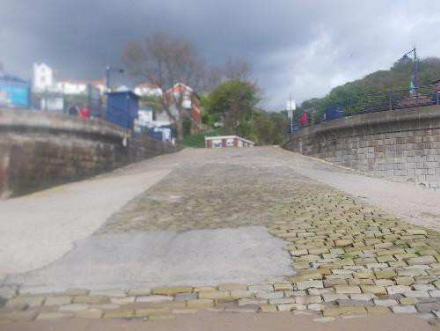
SBC Reference:	67-28B-02		
NFCDD reference:	1221D901D1602C08001

Asset Location:		
	Asset Length:	~6	
	Condition Assessment		
	Condition	Priority	Risk
	B	3	
	Brief Description		
	2015: Mixed construction. Joints missing between paving blocks Cracks on concrete revetment. Patch repair (i.e. mass concrete infill) evident on the bottom part. 2016: Not inspected in detail.		
	Recommendations		
Replace missing joints. Repair cracks. Continue to monitor.

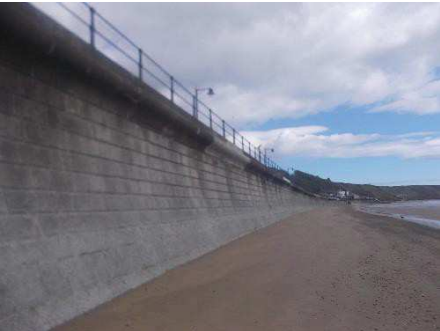
SBC Reference:	67-28B-03		
NFCDD reference:	1221D901D1602C08

Asset Location:	TA11978020, TA12068082	
	Asset Length:	301.6	
	Condition Assessment		
	Condition	Priority	Risk
	B	3	
	Brief Description		
	Abrasion to front face, particularly just above beach level. Many bullnose splash blocks have been repaired, but others are cracked and require attention. Missing joints in slipway ramp at South. Handrails corroded.		
	Recommendations		
Replace/repair cracked coping and repair damaged blocks. Replace handrails.

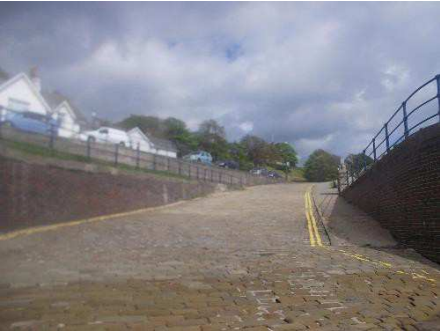
SBC Reference:	67-28B-04		
NFCDD reference:	1221D901D1602C03002

Asset Location:		
	Asset Length:	12	
	Condition Assessment		
	Condition	Priority	Risk
	B	3	
	Brief Description		
	2015: Missing joints in slipway ramp at South. Handrails corroded. Missing joints in places particularly at the lower end, one block missing. Flexible asphalt repair to joints. Missing brickwork and mortar joints on abutment walls. 2016: Not inspected in detail.		
	Recommendations		
Replace block and missing joints. Treat handrail or replace

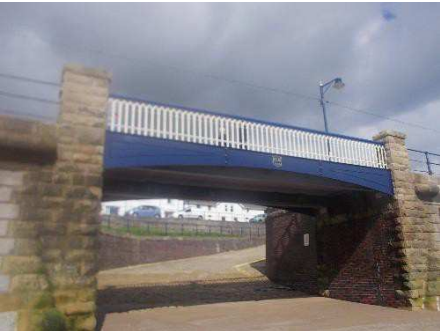
SBC Reference:	67-28B-04		
NFCDD reference:	1221D901D1602C03003

Asset Location:		
	Asset Length:	6	
	Condition Assessment		
	Condition	Priority	Risk
	B	3	
	Brief Description		
	2015: Bridge in excellent condition - recently refurbished. Crack on abutment wall repaired but requires further refurbishment. 2016: Not inspected in detail.		
	Recommendations		
Repair cracks in abutment wall.

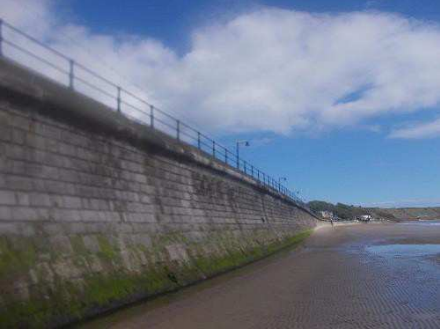
SBC Reference:	67-28B-05		
NFCDD reference:	1221D901D1602C03

Asset Location:	TA11978020, TA12068082	
	Asset Length:	318.8	
	Condition Assessment		
	Condition	Priority	Risk
	B	3	
	Brief Description		
	Chipped / abraded areas of blocks. Loss of face to many blocks throughout, particularly at lower levels at South end. Several new / repaired coping blocks. South slip has missing pointing in some joints and veg growing. Hand rails corroding at many joints, one broken. Cracked splash beam and missing joints in several places.		
	Recommendations		
Monitor abrasion and reface in blocks. Repair/replace handrails. Repair missing joints.

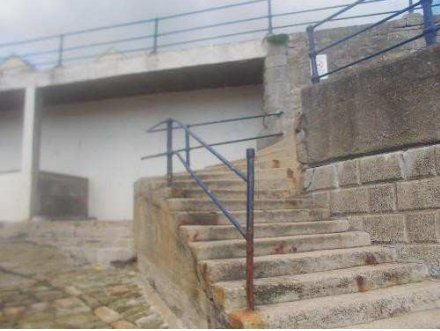
SBC Reference:	N/A		
NFCDD reference:	1221D901D1602C03 001

Asset Location:		
	Asset Length:	5	
	Condition Assessment		
	Condition	Priority	Risk
	B	3	
	Brief Description		
	2015: Corroded handrail and cracking joints below treads on side wall. 2016: Not inspected in detail.		
	Recommendations		
Repair joints. Treat handrails. Continue to monitor.

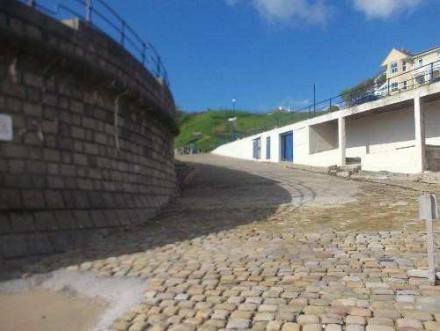
SBC Reference:	67-28B-06		
NFCDD reference:	1221D901D1602C04 002

Asset Location:	TA11968012, TA11978020	
	Asset Length:	20	
	Condition Assessment		
	Condition	Priority	Risk
	B	3	
	Brief Description		
	2015: Scour hole near the toe stabilized with mass concrete infill but still depressed. Missing joints throughout between stone block paving. 2016: Not inspected in detail.		
	Recommendations		
Replace missing joints. Continue to monitor.

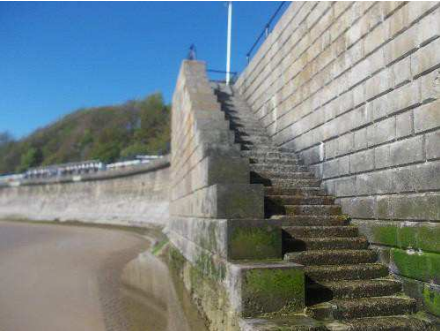
SBC Reference:	67-28B-08		
NFCDD reference:	1221D901D1602C04001

Asset Location:		
	Asset Length:	~6	
	Condition Assessment		
	Condition	Priority	Risk
	B	3	
	Brief Description		
	2015: Abrasion / chipping to steps. 2016: Not inspected in detail.		
	Recommendations		
Continue to monitor.

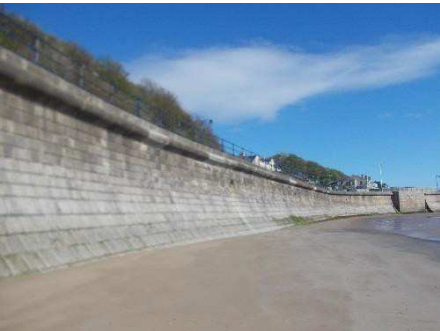
SBC Reference:	67-28B-09		
NFCDD reference:	1221D901D1602C07

Asset Location:		
	Asset Length:	98	
	Condition Assessment		
	Condition	Priority	Risk
	B	3	
	Brief Description		
	Cracking to splash beam in a few places, other areas have been repaired. Numerous chipped / damaged blocks, but overall fair. Cracks and open joints in blockwork of Southern steps buttress. Promenade fair to good.		
	Recommendations		
Repair cracks and loose blocks. Fill joints. Continue to monitor.

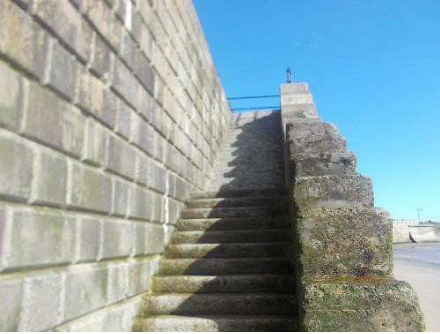
SBC Reference:	67-28B-10		
NFCDD reference:	1221D901D1602C05 001

Asset Location:		
	Asset Length:	10	
	Condition Assessment		
	Condition	Priority	Risk
	B	3	
	Brief Description		
	2015: Spalling, abrasion to concrete blocks on seaward side with missing joints in places. Steps in fair condition. 2016: Not inspected in detail.		
	Recommendations		
Replace missing joints. Continue to monitor

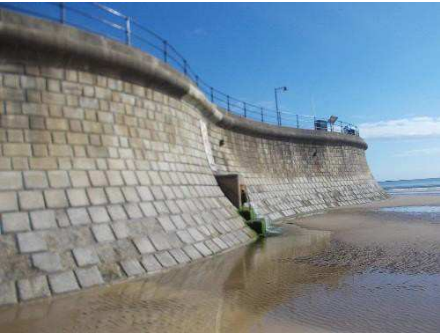
SBC Reference:	67-28B-11		
NFCDD reference:	1221D901D1602C05

Asset Location:	TA11957997, TA11968012	
	Asset Length:	103.9	
	Condition Assessment		
	Condition	Priority	Risk
	B	3	
	Brief Description		
	Some damage to seaward edge of prom. Repairs to splash beam by outfall holding. Numerous lower blocks from beach level to 2m damaged on front face. Beach higher than in 2012. Horizontal crack on seaward section as 2012. Cracks in retaining wall to slipway.		
	Recommendations		
Monitor damage to blocks and repair where necessary. Patch repair prom surfacing. Treat/replace handrailing.

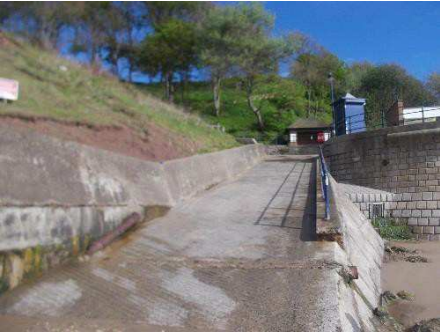
SBC Reference:	67-28B-12		
NFCDD reference:	1221D901D1602C02 001

Asset Location:	TA12248126, TA12278130	
	Asset Length:	15	
	Condition Assessment		
	Condition	Priority	Risk
	B	4	>5
	Brief Description		
	2015: Spalling to concrete near base. Crack on side wall at mid- section. Fair condition overall. Handrail need repainting. 2016: Not inspected in detail.		
	Recommendations		
Repair spalling and crack. Repaint handrails.

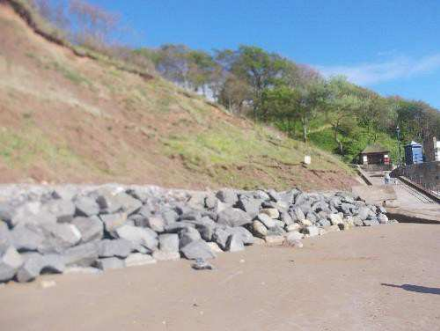
SBC Reference:	67-28B-13		
NFCDD reference:	1221D901D1602C02

Asset Location:	TA12068082, TA12118035	
	Asset Length:	18.3	
	Condition Assessment		
	Condition	Priority	Risk
	C	2	
	Brief Description		
	Gabions covered in small rock armour which has been improved since 2012. Slumping cliffs behind may be pushing rock over. Needs additional rock and re profiling to stable slope.		
	Gabions covered in concrete with eroding cliff behind.		
	Recommendations		
Re-profile and top up rock armour.
