Ongoing Analysis and Interpretation of Coastal Monitoring Data

Second Review of Restricted Suite Monitoring

Geotechnical Interpretative Report

Document Ref. No. 721229/002/GIR/004/Final

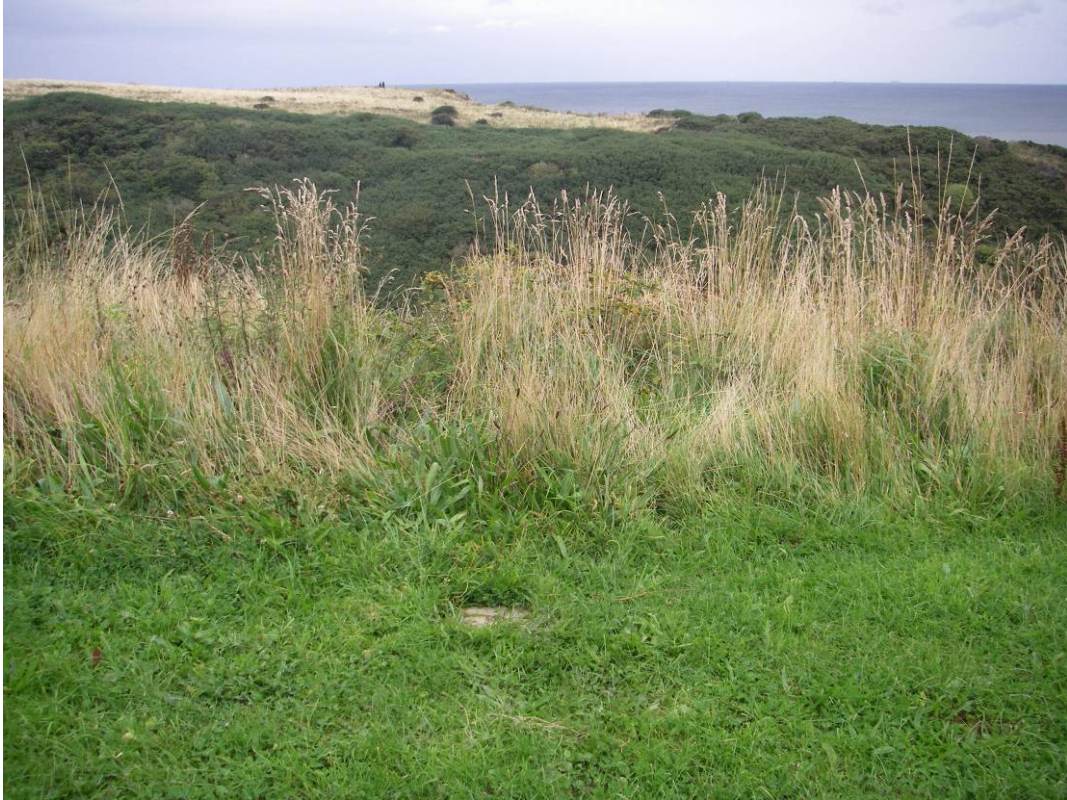
Plate 4 Scalby Ness MP3

The survey pins were measured in July and August, a comparison of measurements taken from these stations (MP1, MP2, MP3 and MP4) showed zero cliff recession rates had occurred during this period. During the proceeding months period, a cliff recession rate of 10mm was noted at MP3 though zero at other points.
