Ongoing Analysis and Interpretation of Coastal Monitoring Data

Review of Second Additional Suite Monitoring

Geotechnical Interpretative Report

Document Ref. No. 721229/021/GIR/002/Final

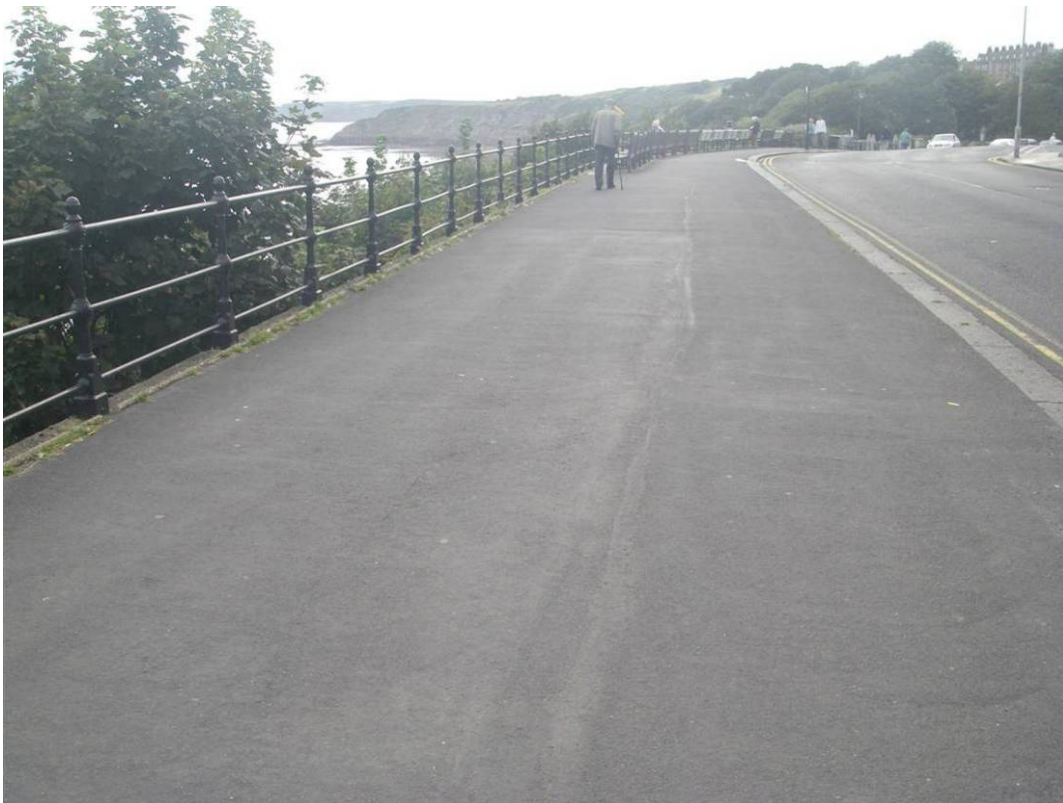
Ground movements are evidently on-going within the slopes of South Cliff gardens although the amount of movement recorded to date is minimal as demonstrated from the results of inclinometer monitoring. At Spa Cliff, Plates 77 and 78 (Appendix F) illustrate the effects of ground subsidence where cracking has occurred in the pavement along the promenade to the south of BH01 Prom. This part of the cliff top is immediately above an arcuate embayment formed from a past deep-seated retrogressive rotational failure. This has left mid-slope benches with a steep rear scarp up to the promenade. At other locations within the gardens, there is clear evidence of slope movements as observed in hummocky ground on slope surfaces, collapsed edging stones to pavements and pavement cracking (Plate 85, Appendix F). Tarmac surfaced pavements behind the Clock Café (Plates 79-83, Appendix F) display evidence of slope instability where cracked pavements are present below which the slopes display bulging with a hummocky ground appearance. These areas continue to be observed for signs of ground movements and any acceleration of such movements that may occur.

Plate 77 Scarborough South Cliff. Promenade showing signs of subsidence.

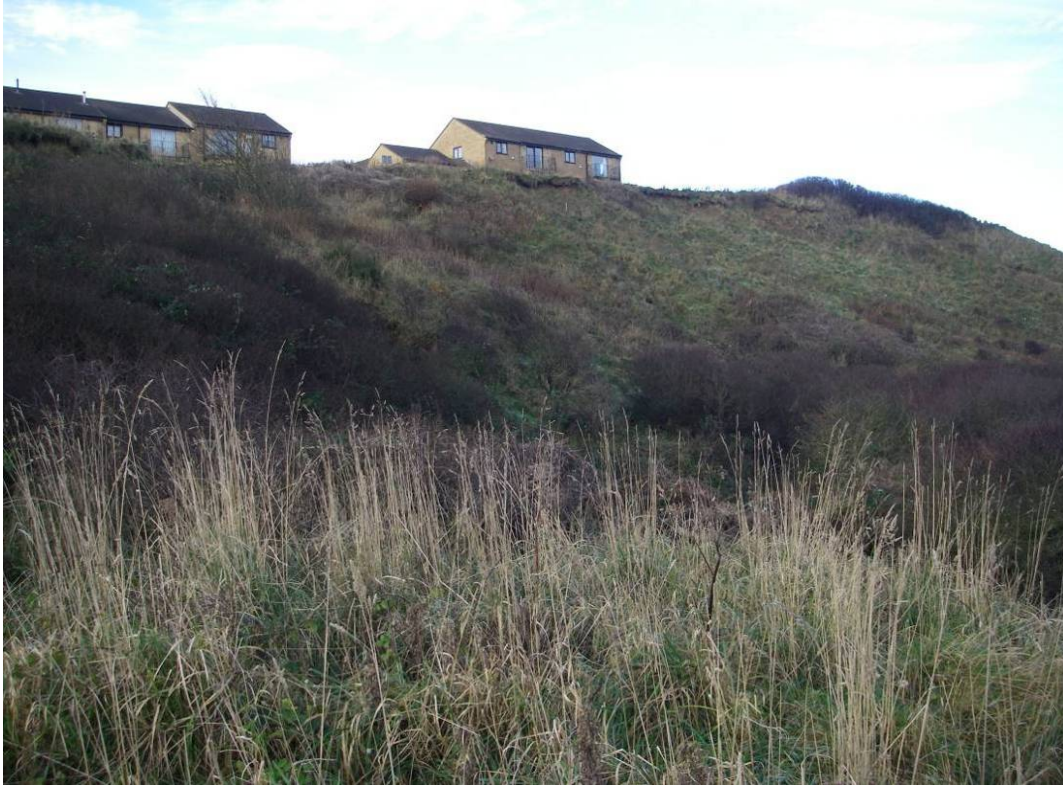
Plate 7 Site view of Behaviour Unit II showing over steepened back-scarp below Upper Plateau (November 2008).

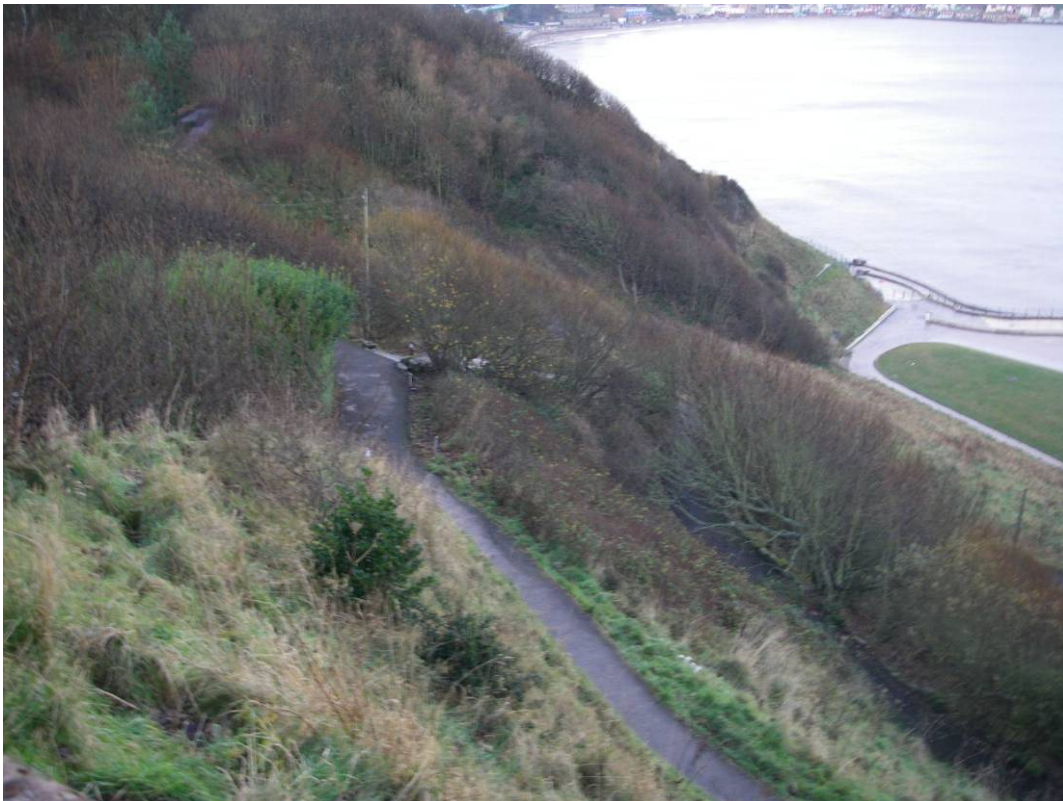
Plate 17 Site view showing steep slope angles above South Bay Pool Cliff.

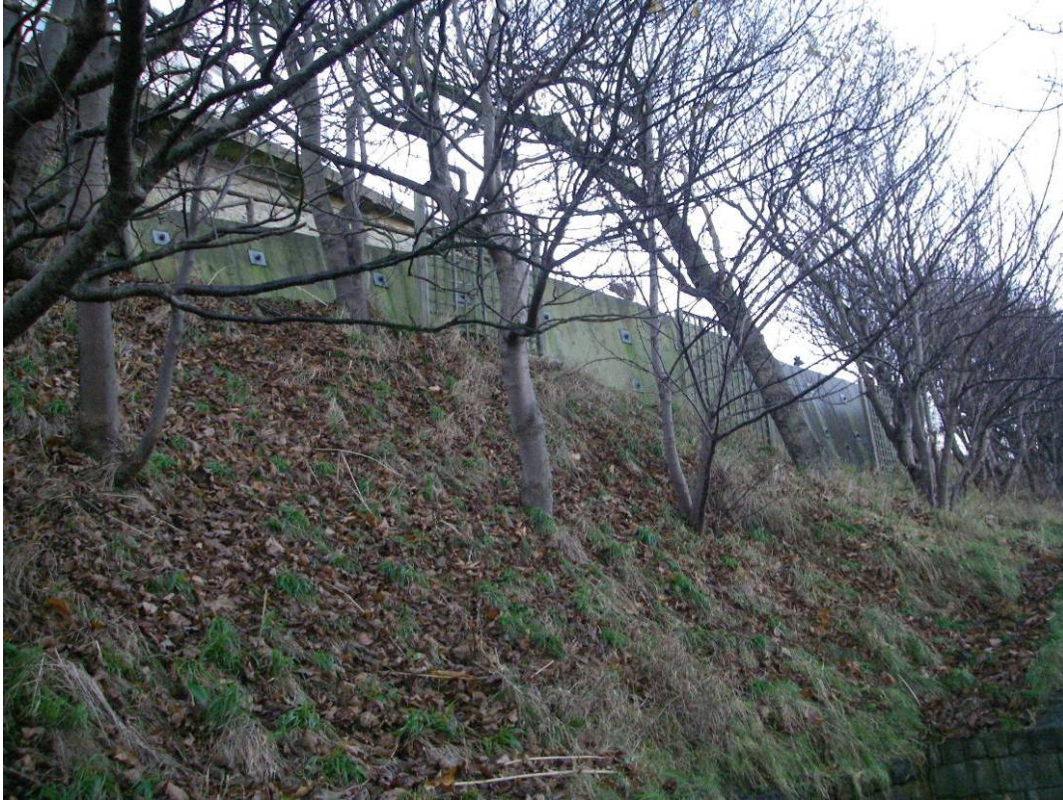
Plate 20 Site view of slope crest retaining walls at Prince of Wales Cliff.

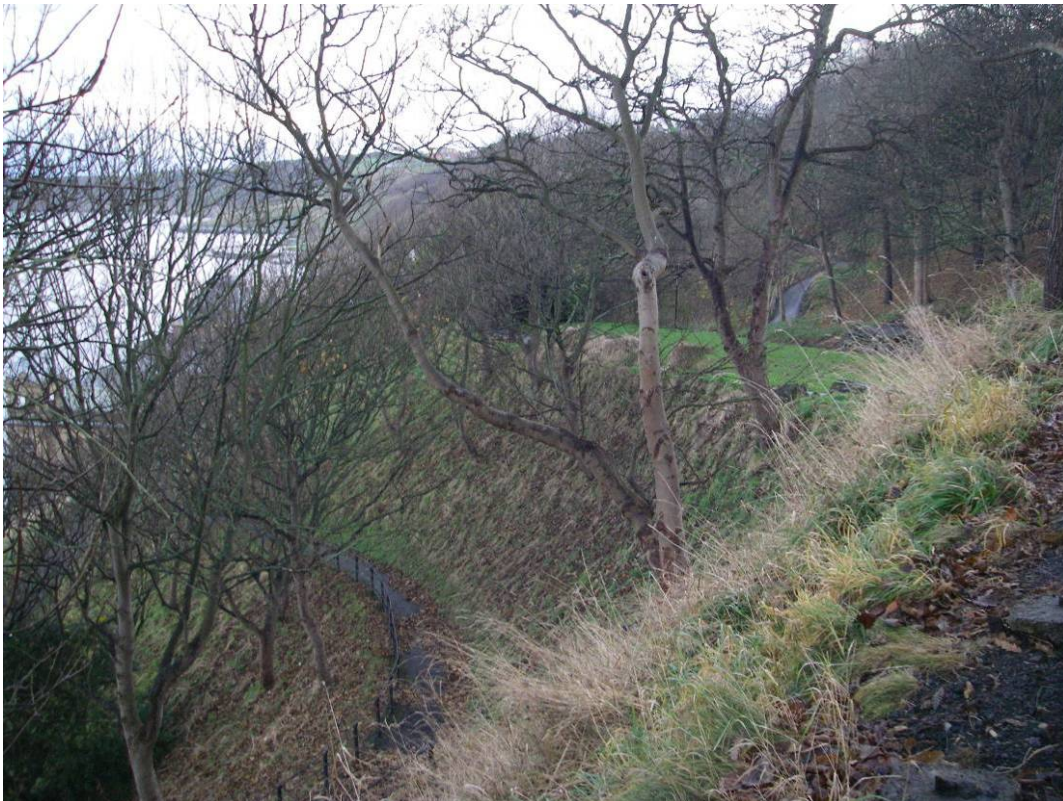
Plate 21 Site view looking south across Spa Cliff showing steep slope angles and bench-cut paths.

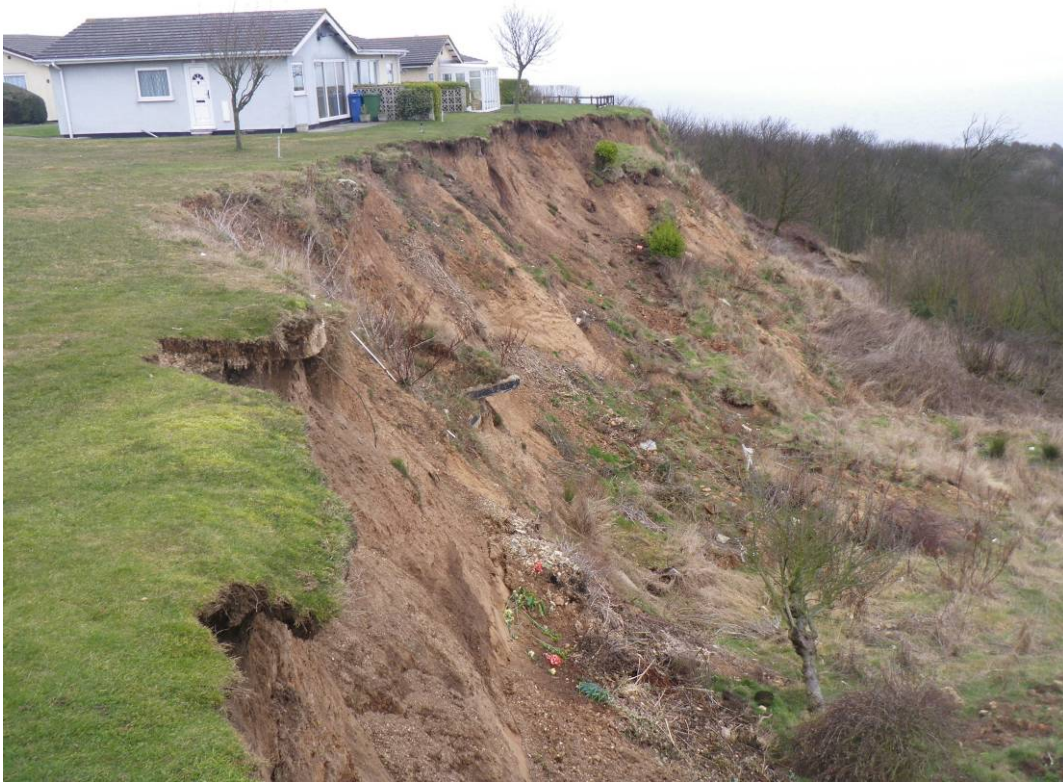
Plate 28 Cliff recession at Knipe Point Headland (8th March 2010) looking east

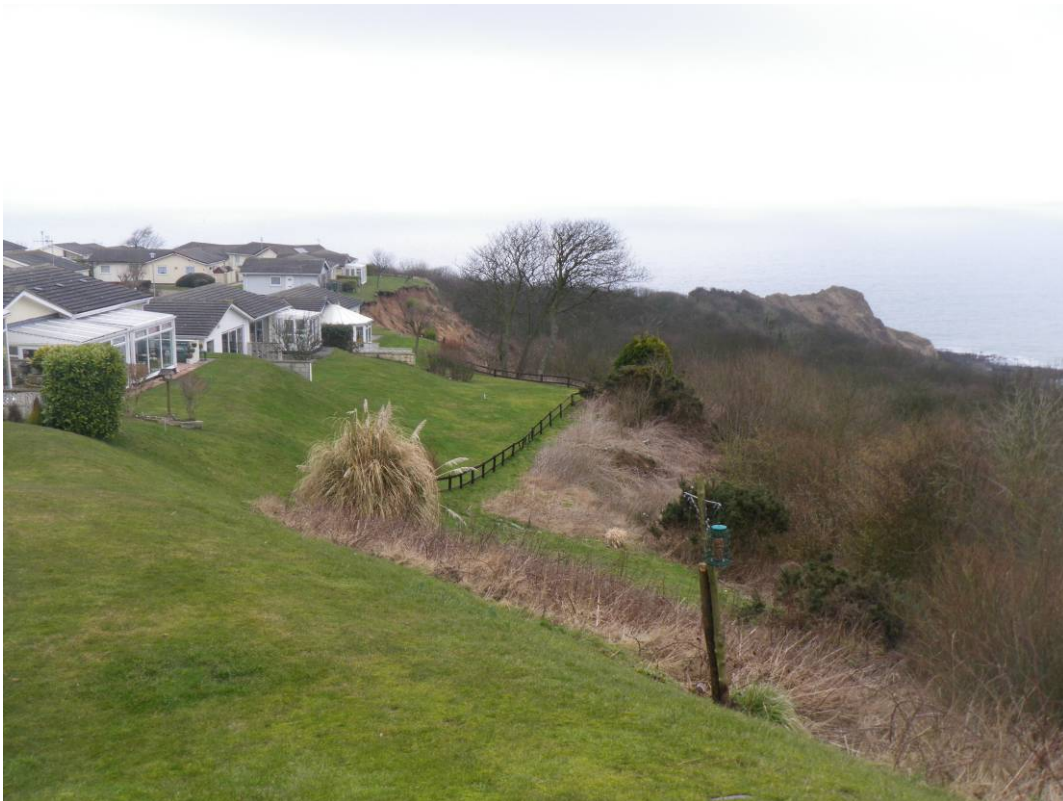
Plate 29 Cliff recession at Knipe Point Headland (8th March 2010) looking east

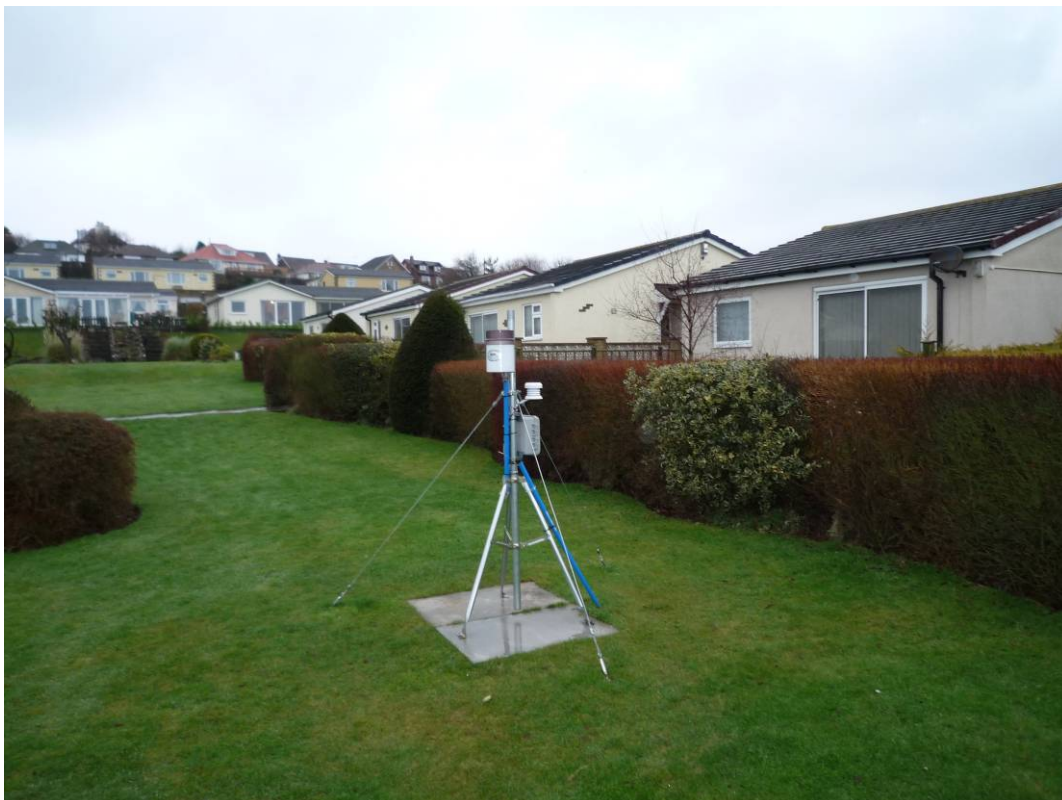
Continuous rainfall, air and ground temperatures are recorded on site by an automatic weather station located within the residential area of the site. Data from this is to be downloaded in April 2010 following a hand-over meeting with The National Trust and SBC. A photograph of this equipment is presented in Appendix L, Plate 31.

Plate 31 Knipe Point Weather Station with Chalet No. 50 behind.

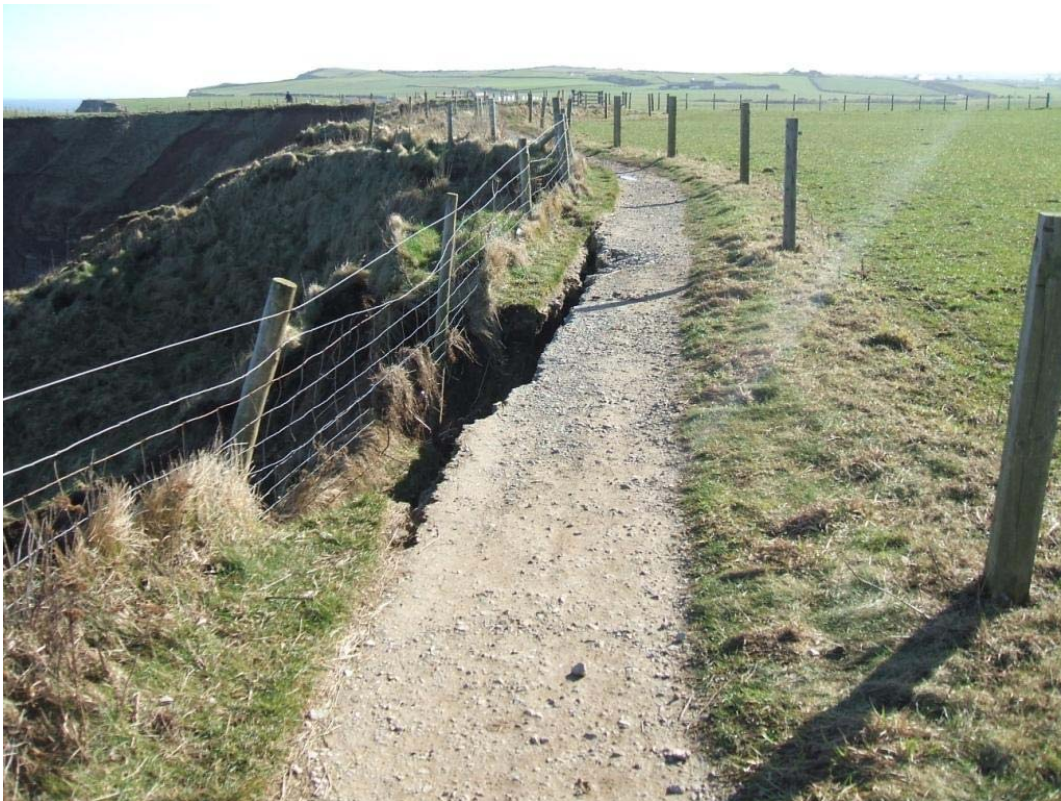
Plate 2 Cliff erosion at Saltwick

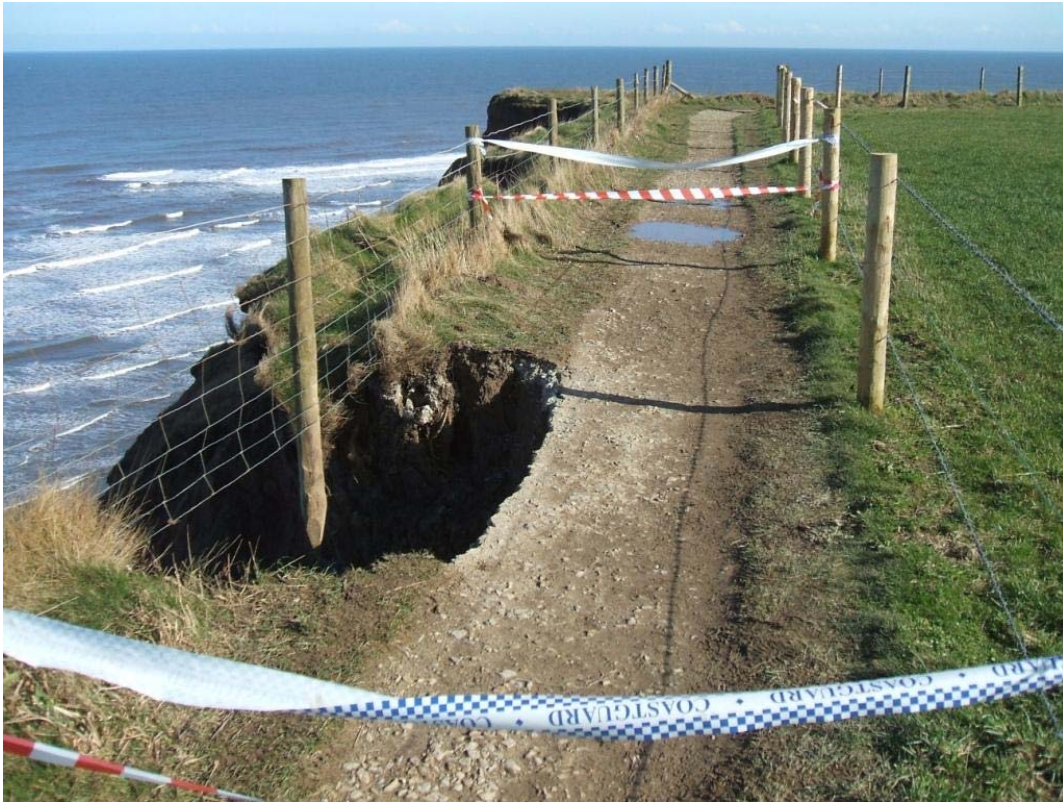
Plate 3 Cliff erosion at Saltwick

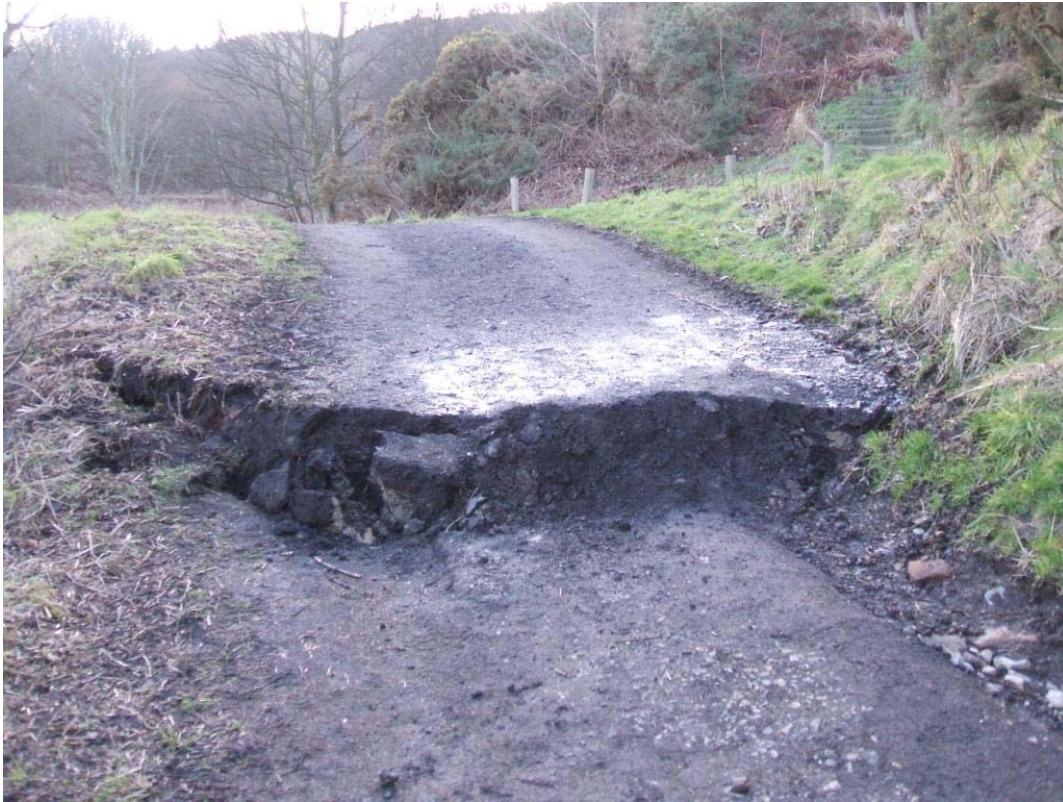
Plate 5 Slip in railway path at Sandsend

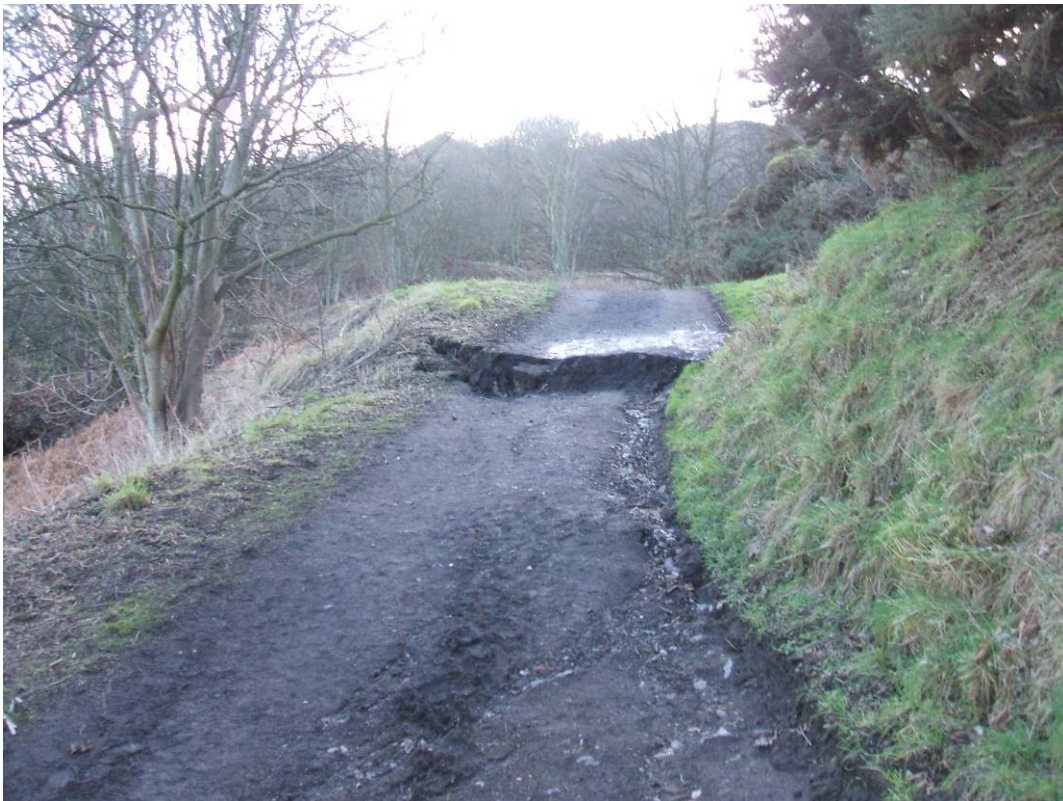
Plate 6 Slip in railway path at Sandsend

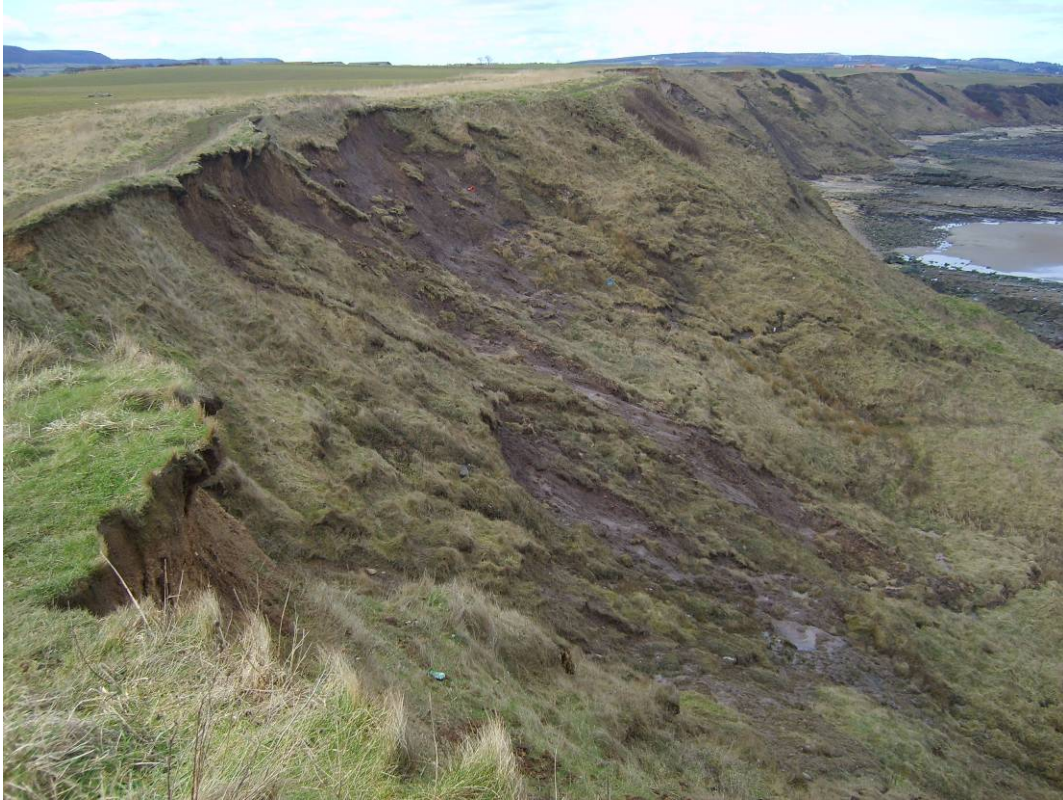
Plate 9 Slope erosion at Scalby Mills

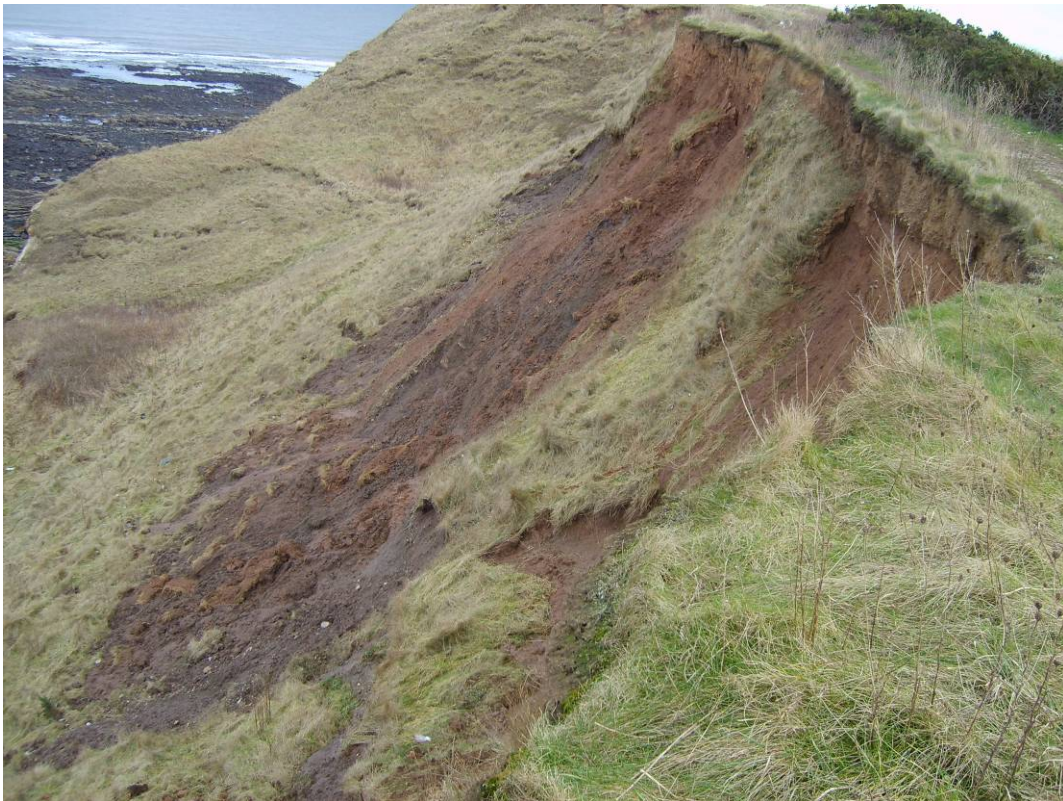
Plate 10 Slope erosion at Scalby Mills
