Ongoing Analysis and Interpretation of Coastal Monitoring Data

Fourth Review of Full Suite Monitoring

Geotechnical Interpretative Report

Document Ref. No. 721229/002/GIR/011/Final

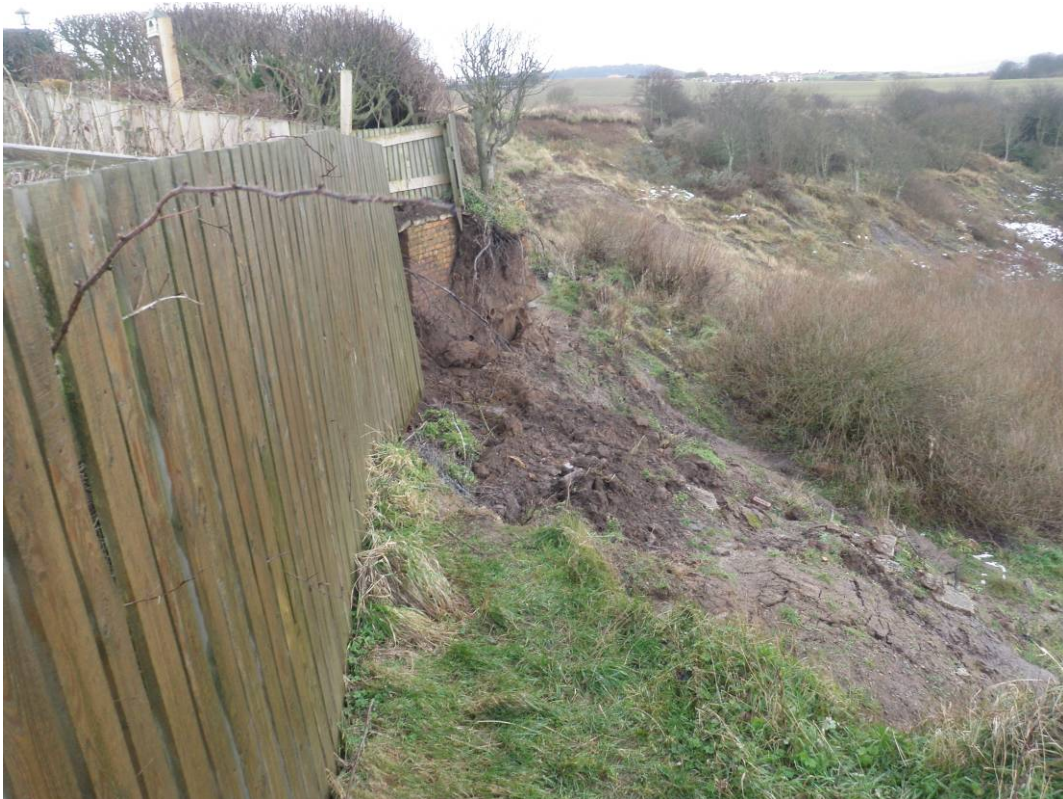
A photographic record of the site, presented in Appendix J, shows the degradation of the headscarps under observation particularly the areas around monitoring points C01 to 08 and H04 to 11. At Cornelian headland most of the original monitoring points have been lost to cliff recession, C01 and C04 are still used although C08 has been repositioned inland and measurements are taken in a northerly and easterly direction. Recession at C08 continues in a northerly direction although eastwards, recession rates have significantly accelerated since June 2010 with approximately 2.0 metres of land being lost to cliff recession (see Plates 1 to 4, Appendix J).

Plate 2 Cornelian Bay side of Knipe Point looking northwest (13th December 2010)

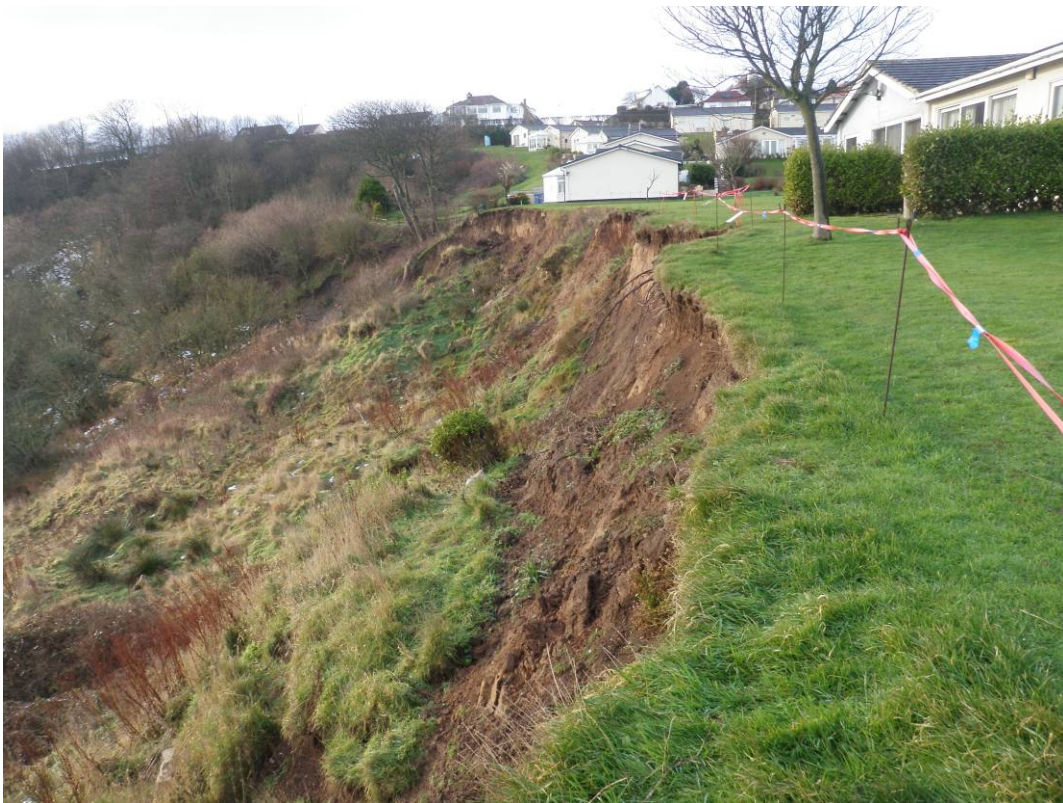
Plate 6 Cliff recession at Knipe Point Headscarp (13th December 2010)

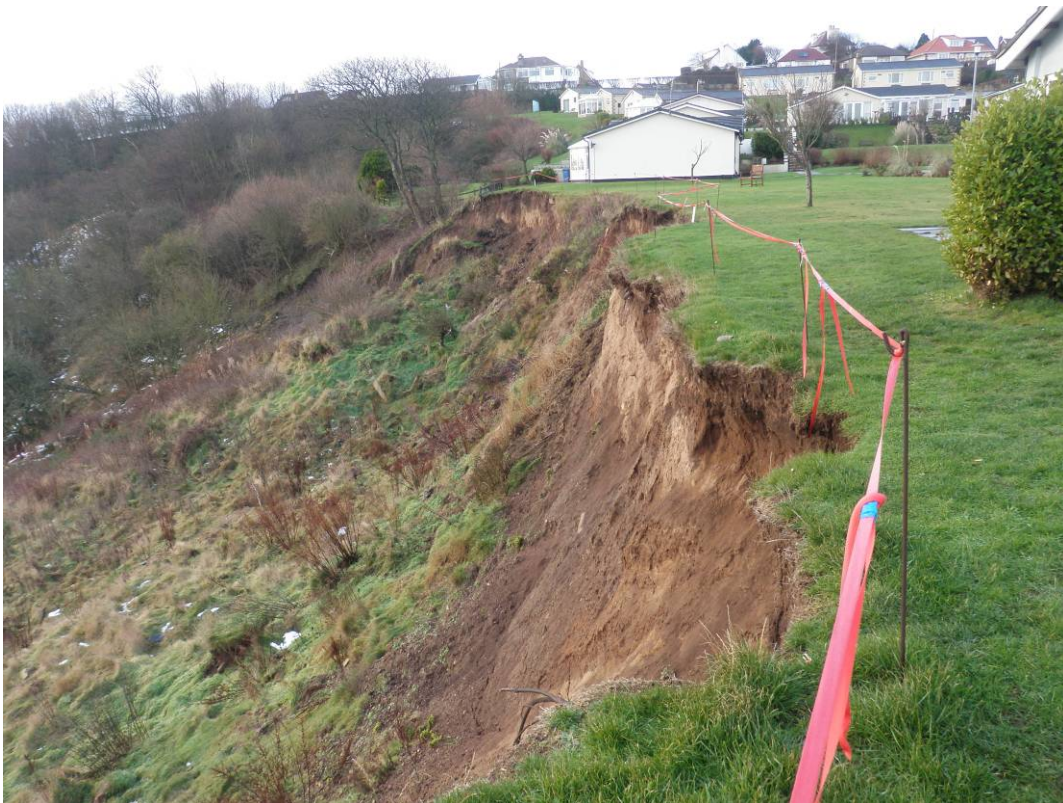
Plate 8 Cliff recession at Knipe Point Headscarp (13th December 2010)

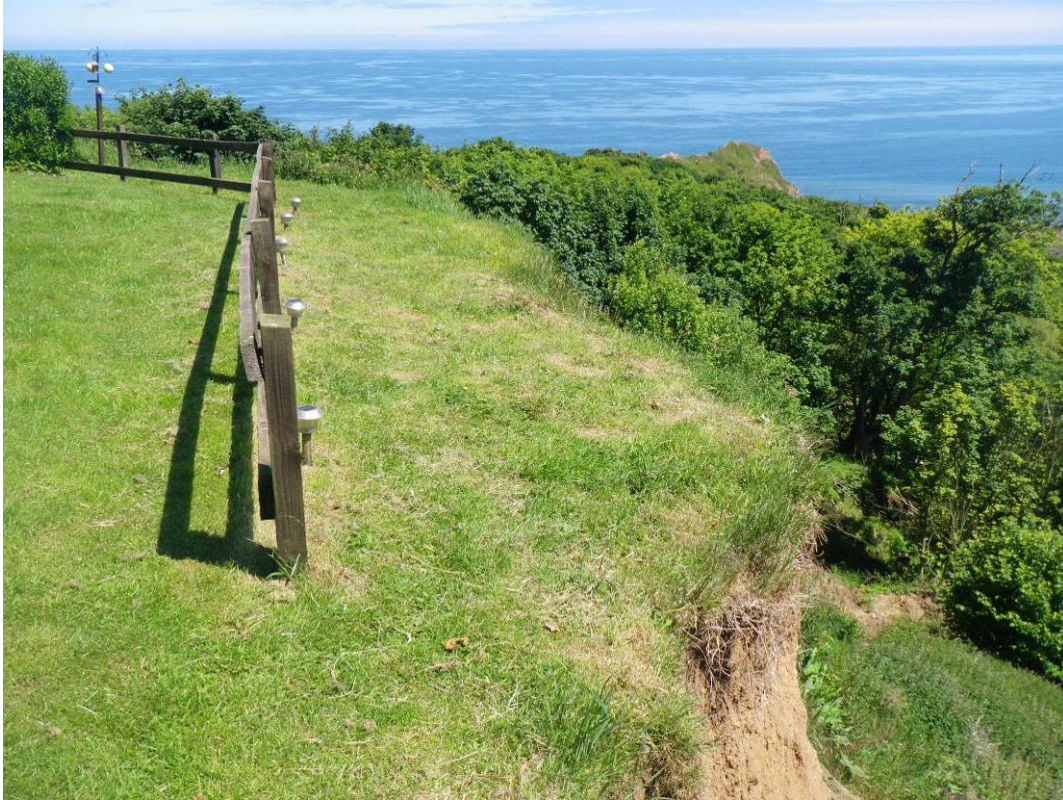
Plate 9 Cliff recession at Knipe Point Headscarp looking east (17th June 2010)

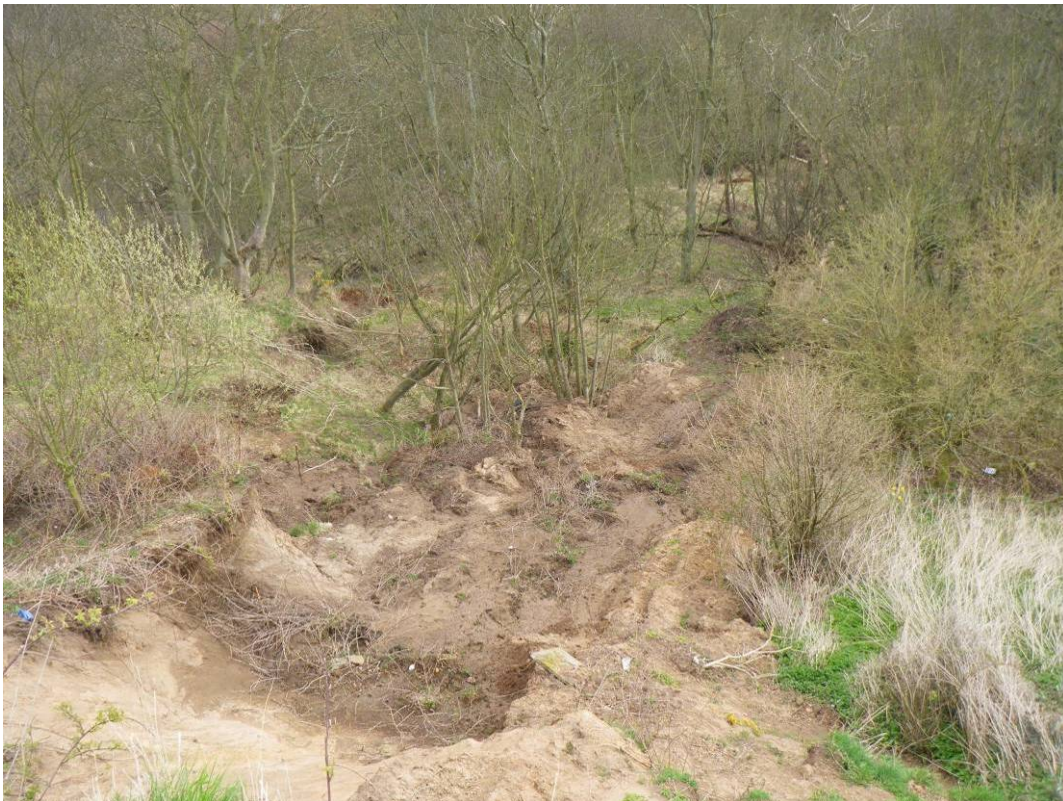
During the survey of April 2010 a 'fresh' mudslide with failure run-out and rafted trees was observed on the slopes of Knipe Point immediately below monitoring point H06. During the site monitoring of December 2010, this mudslide was observed to have developed further and was approximately 10 metres below cliff crest level and extending further down the slopes (Plate 10 and 11, Appendix J). Ground water seepages were observed to be active (free flowing

Plate 10 View of 'fresh' mudslide on Knipe Point Headscarp below survey pin H06 (14th April 2010)
