# Ongoing Analysis and Interpretation of Coastal Monitoring Data

Fifth Review of Full Suite Monitoring

## Geotechnical Interpretative Report

Document Ref. No. 721229/002/GIR/012/Final

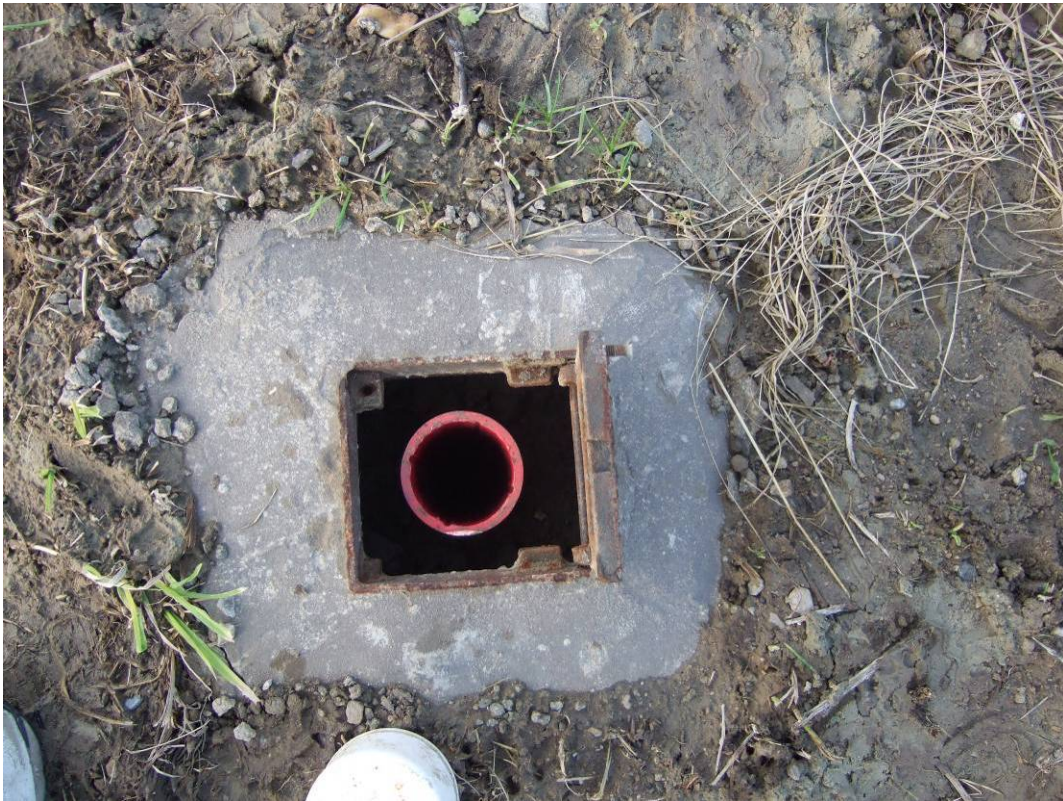
Plate 20 BH21 located mid-slope at Wheatcroft Cliff

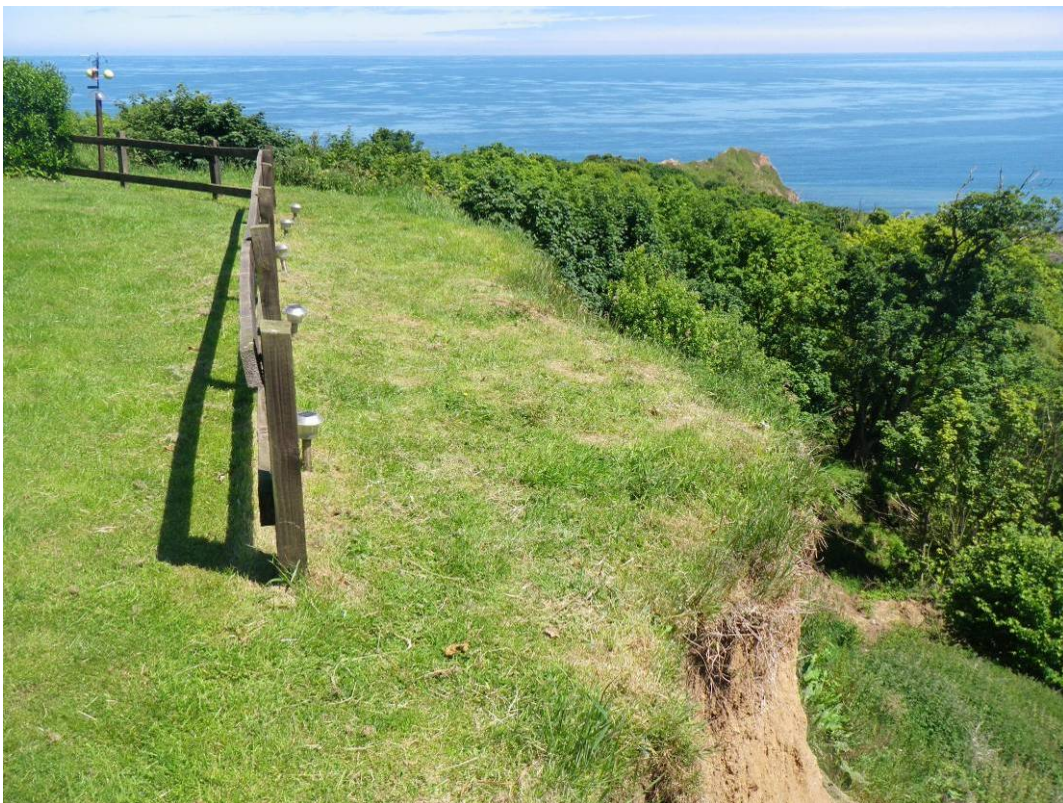
Plate 10 Cliff recession at Knipe Point Headscarp looking east (17<sup>th</sup> June 2010)

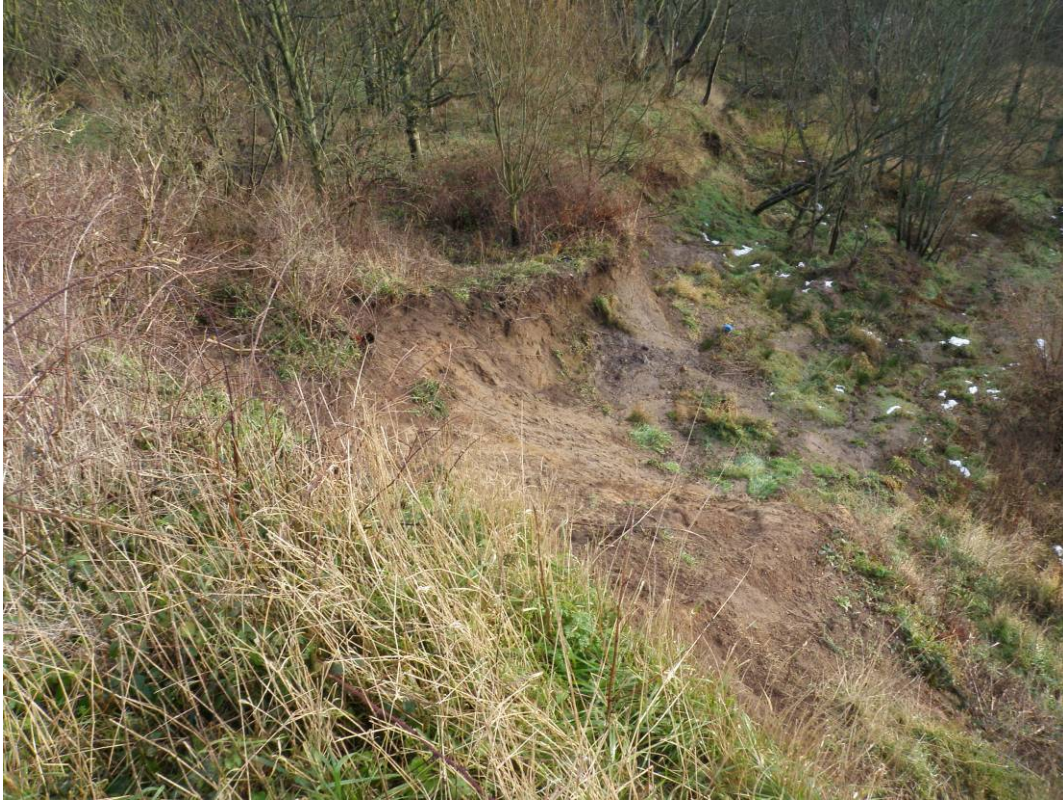
During a survey carried out in April 2010 a 'fresh' mudslide with failure run-out and rafted trees was observed on the slopes of Knipe Point immediately below monitoring point H06. During the site monitoring of December 2010, this mudslide was observed to have developed further and was approximately 10 metres below cliff crest level and extending further down the slopes (Plate 11, Appendix J). Ground water seepages were observed to be active (free flowing ground water was observed) from this point in the slope and continue to be coincident with the mudslide. Immediately above the mudslide on the slope

Plate 11 View of mudslide on Knipe Point Headscarp, below survey pin H06 (13<sup>th</sup> December 2010))

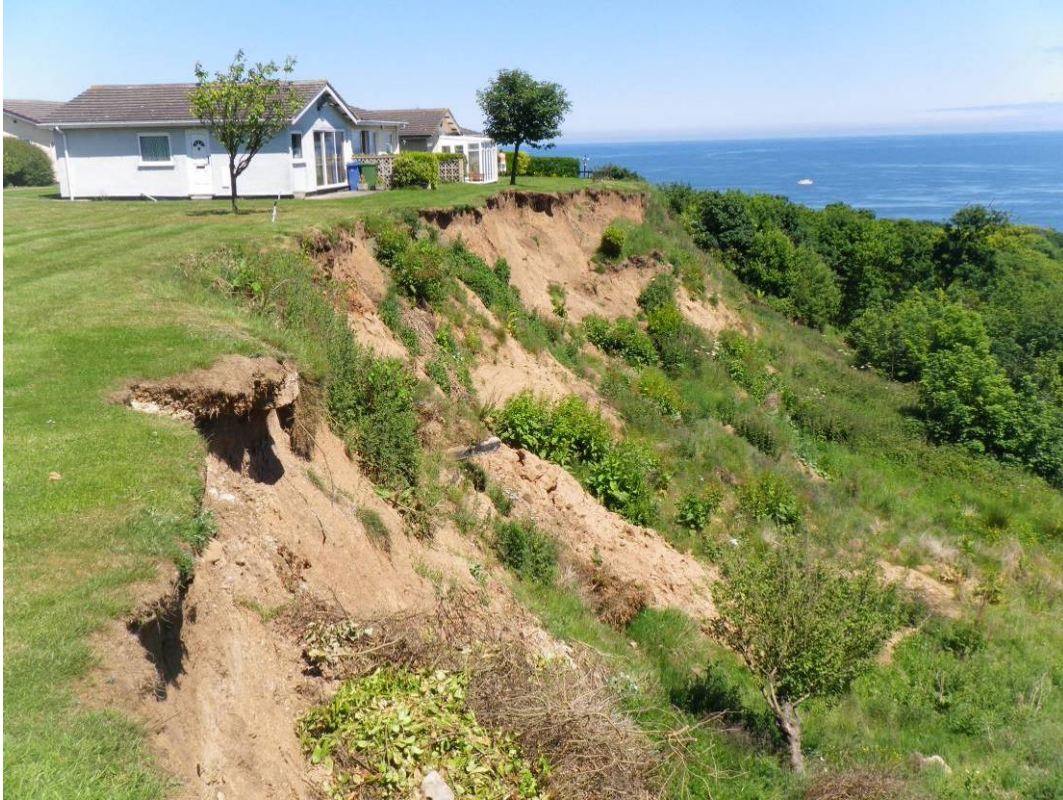
Plate 15 Cliff recession at Knipe Point Headland looking east (17<sup>th</sup> June 2010)

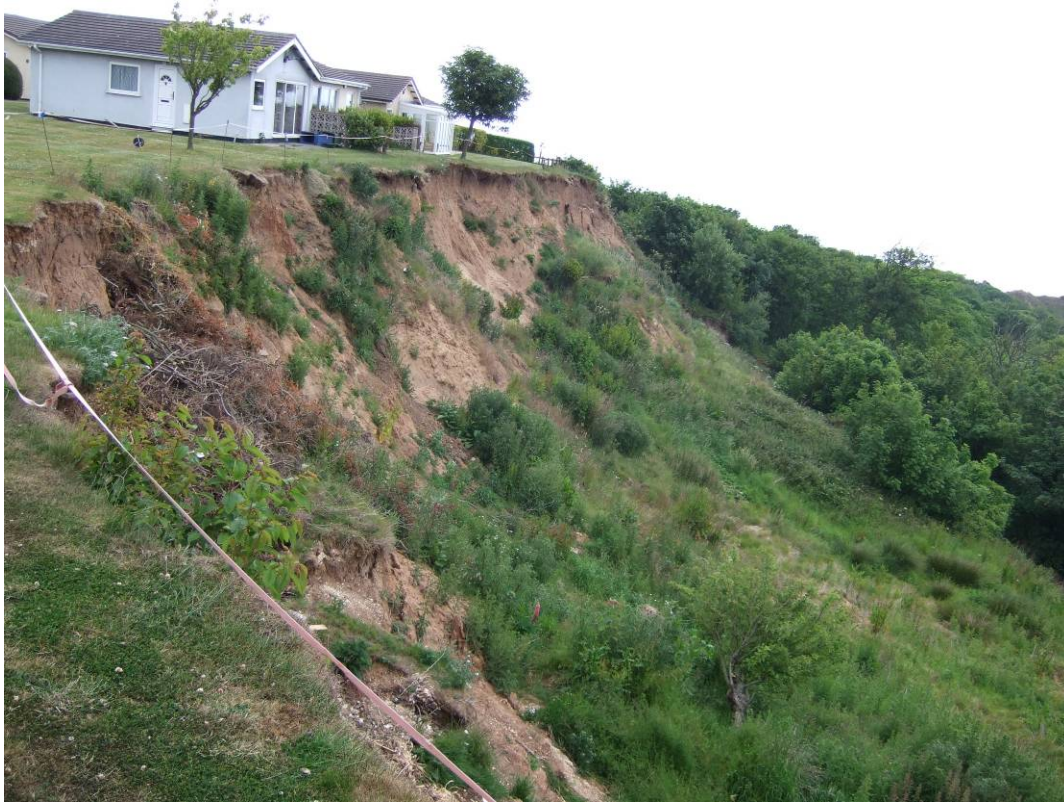
Plate 17 Cliff recession at Knipe Point Headland looking east (17<sup>th</sup> June 2011)

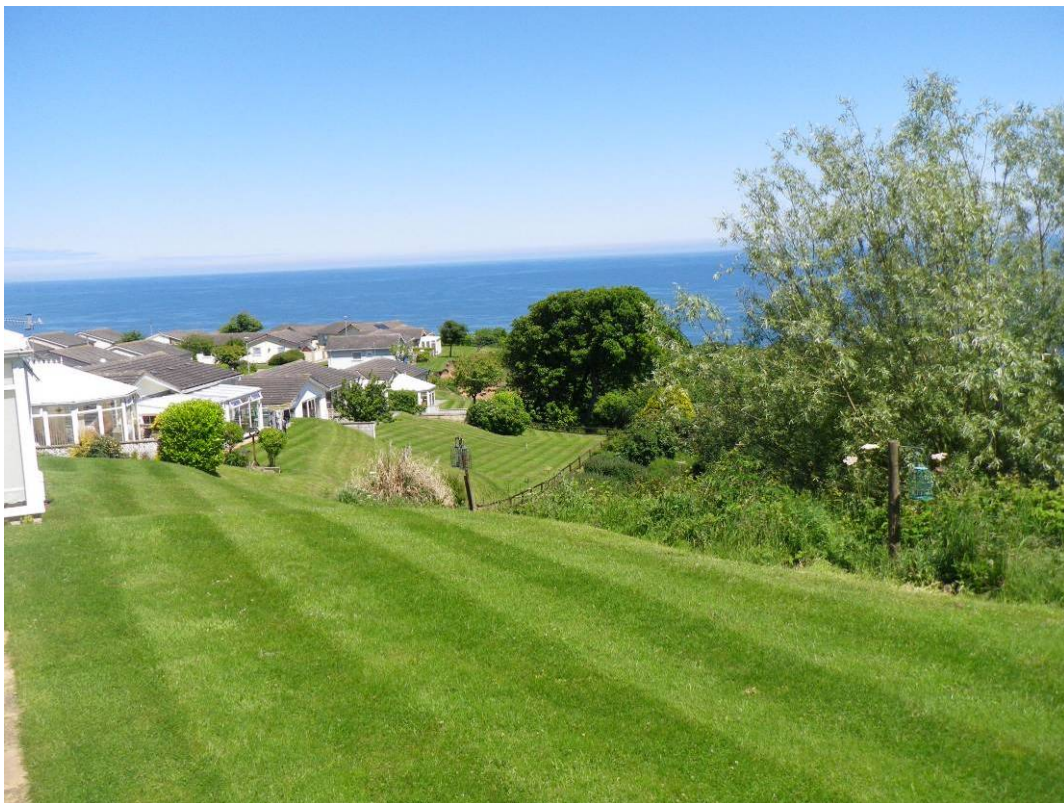
Plate 18 Cliff recession at Knipe Point Headland looking east (17<sup>th</sup> June 2010)
