Interpretation Report 14: December 2019 to July 2020

Prepared for
Scarborough
Borough Council

October 2020

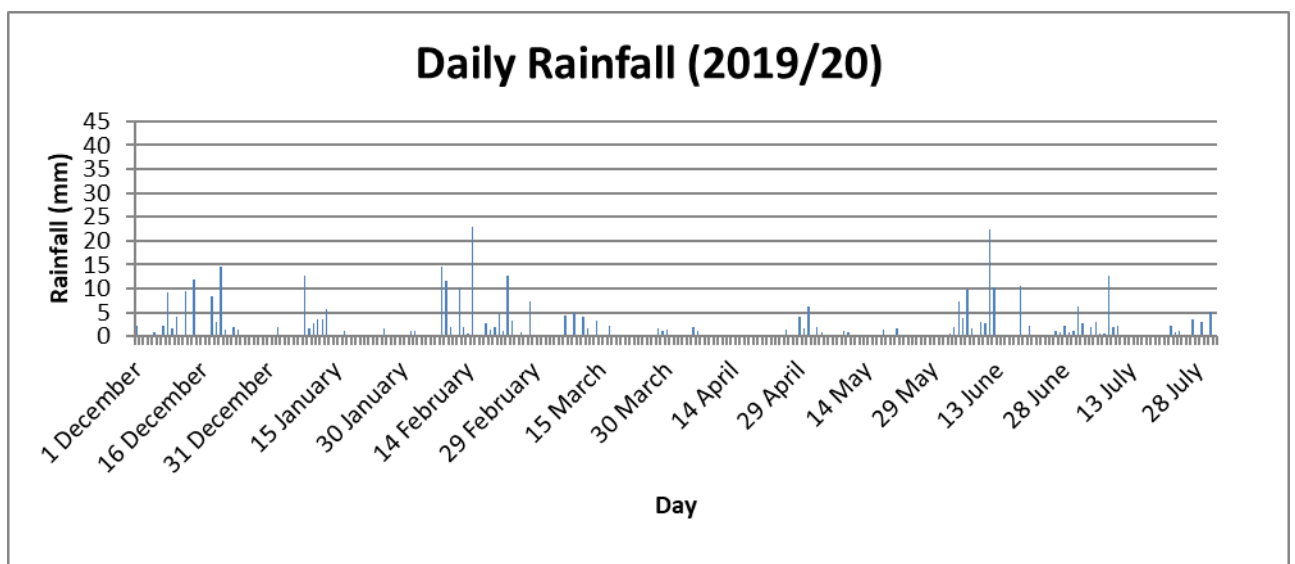
Figure 2.2 Daily rainfall recorded at Scarborough Spa from December 2019 to July 2020.

Daily rainfall totals recorded by the Scarborough Spa weather station are presented in Figure 2.2, which shows twelve peaks in daily rainfall over 10 mm, mainly occurring in February. Rainfall peaked between 20 to 25 mm on 15 February and 11 June. The highest daily rainfall total over this monitoring period was 22.8 mm on 15 February.

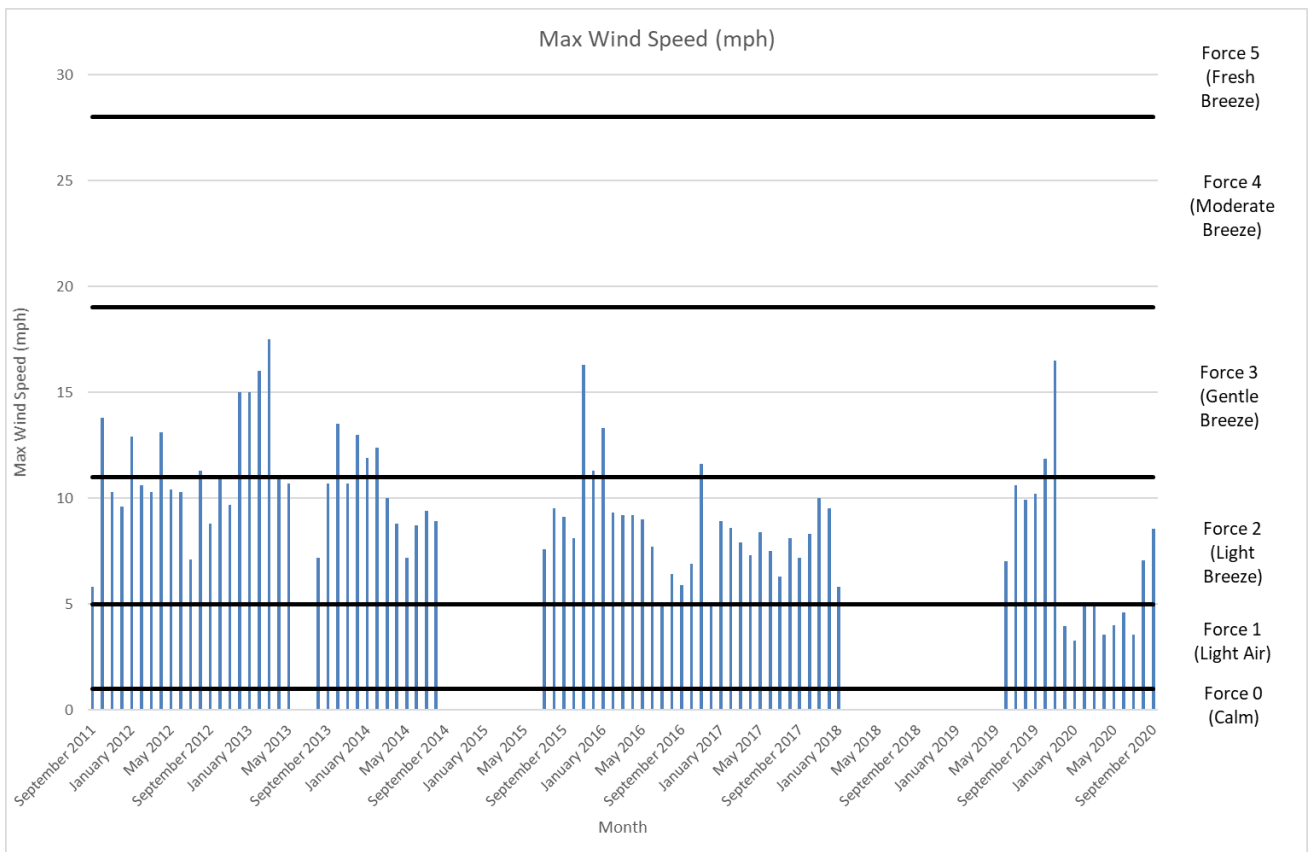
Figure 2.4 Maximum daily wind speed (2011 to 2020).

Wind speed and air temperature records are presented in Figures 2.4 and 2.5. In both cases, the failure of the Scarborough Spa met station means there are no data for the previous monitoring periods.
