Interpretation Report 19: June 2022 to November 2022

Document no: B2431200-19
Revision no: 0

Scarborough Borough Council

Local Coastal Slope Geotechnical Monitoring Analysis
27 January 2023

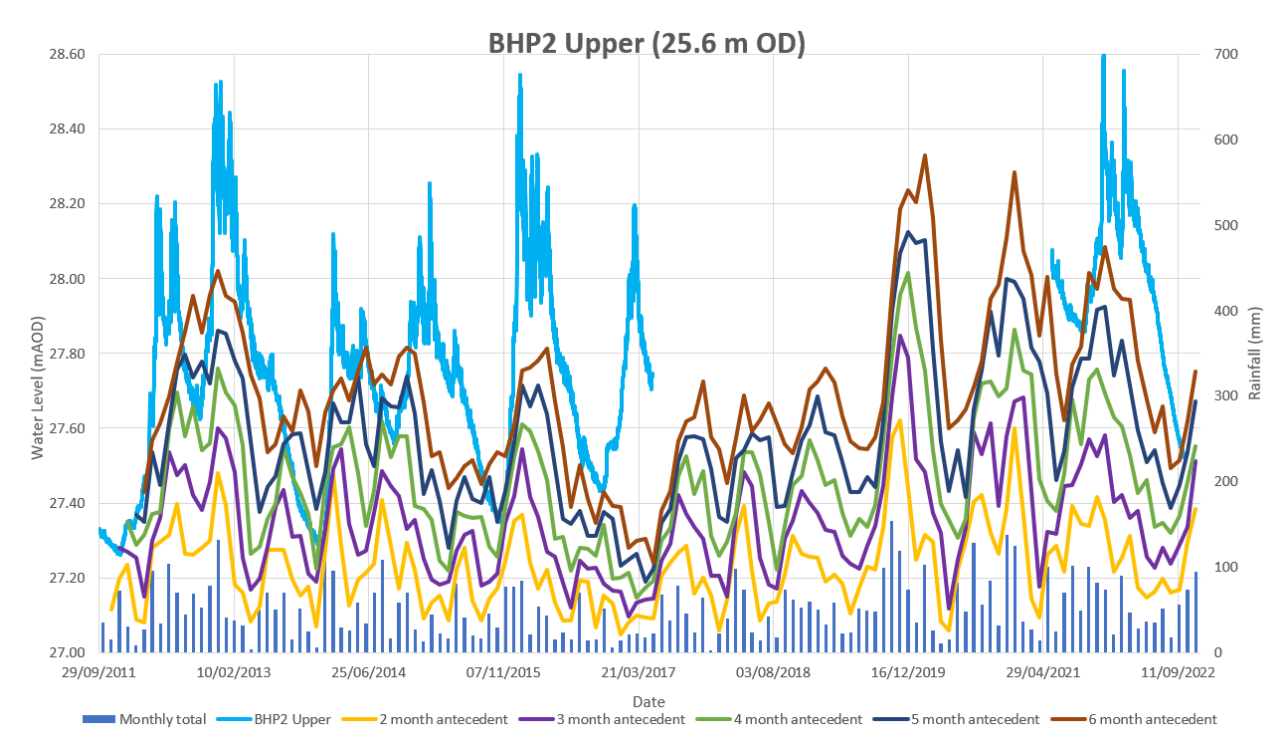
With the collection of 10 years of data it is possible to examine relationships between rainfall and groundwater response. An example from Scalby Ness is presented below, which illustrates groundwater levels (m OD) recorded by piezometer BHP2 Upper and antecedent rainfall (mm) over the periods September 2011 to 2022. Ground elevation at this location is 37.7m OD and the piezometer tip is at an elevation of 25.6m OD. The data reveal groundwater responses correlate best to the 4 to 5 month antecedent rainfall total and also to intense rainstorms, both of which are known to trigger ground movement and landslides.

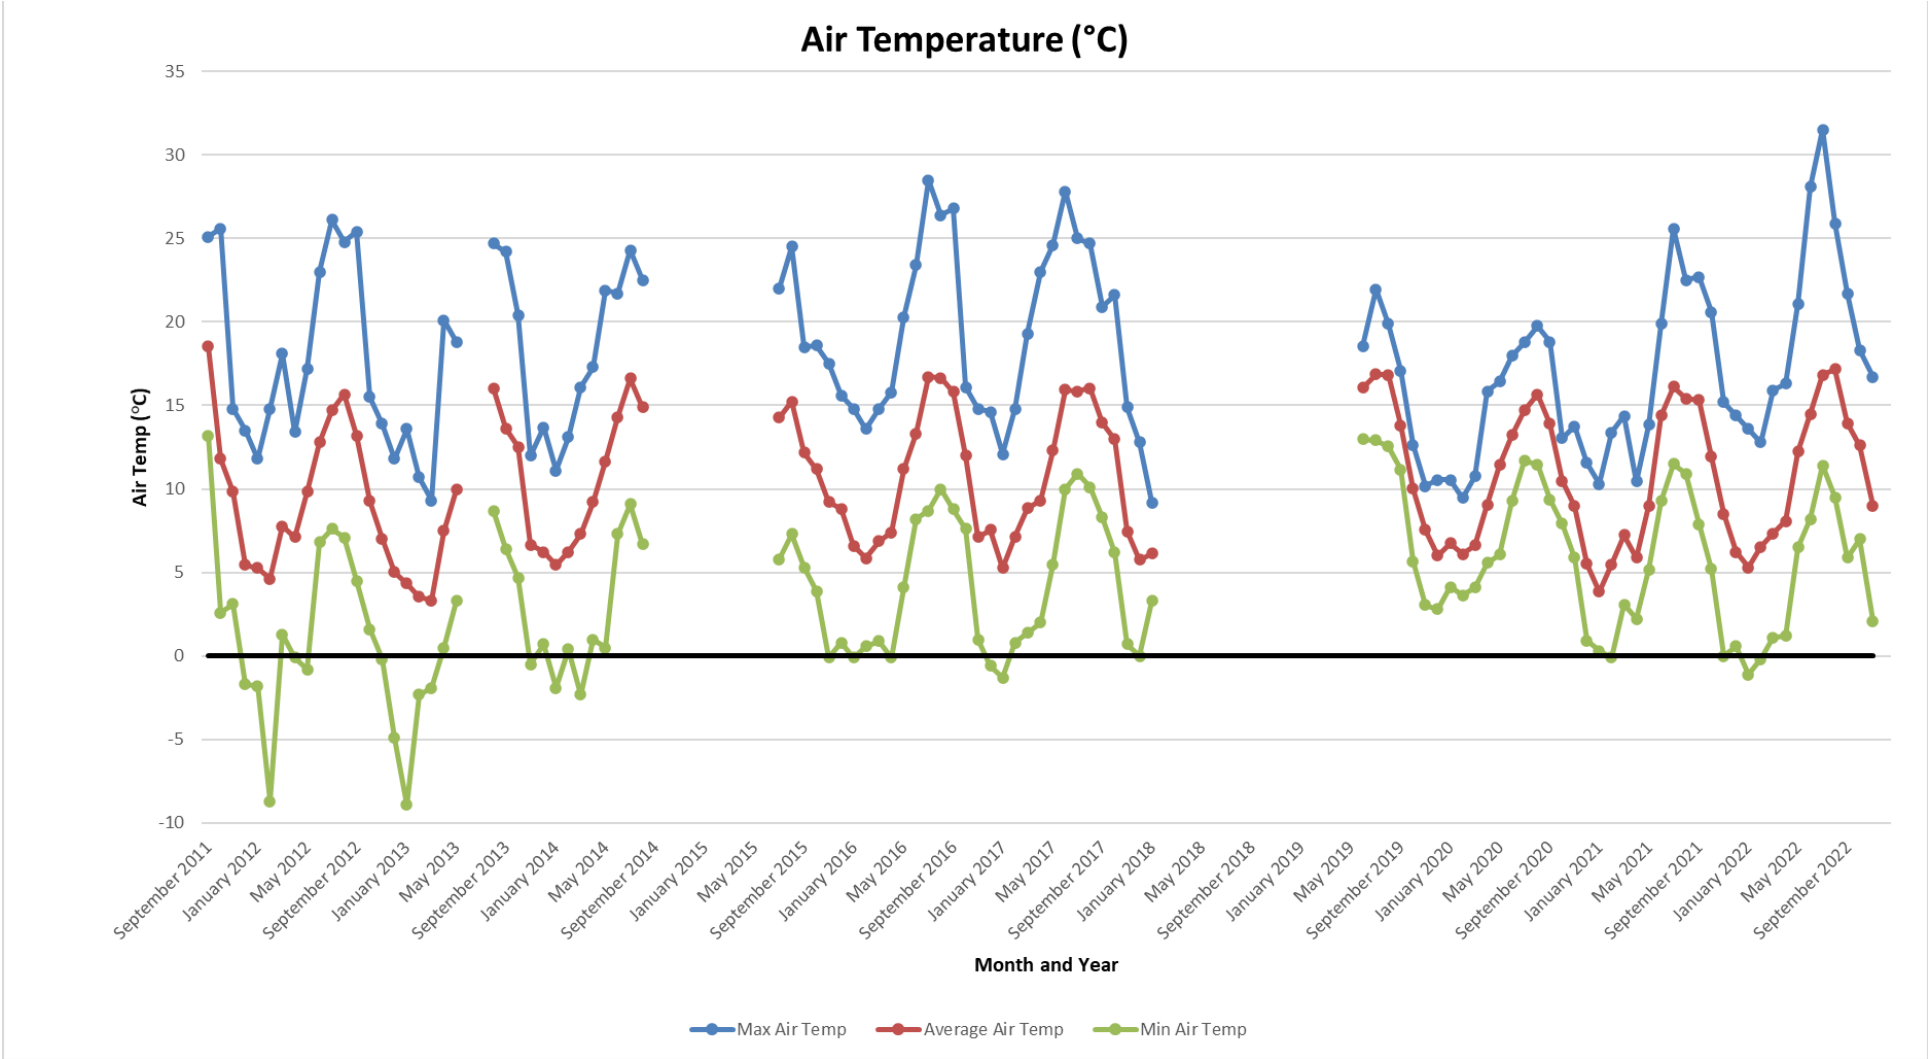
Figure 4: Maximum daily wind speed (2011 to 2022).

Wind speed and air temperature records are presented in Figure 4 and Figure 5. December 2021 had the highest wind speed on record since 2011 at 21.6 mph, equalling a Force 5 on the Beaufort Wind Scale. This event relates to Storm Barra.
