Interpretation Report 6: December 2015 to May 2016

Prepared for
Scarborough
Borough Council

August 2016

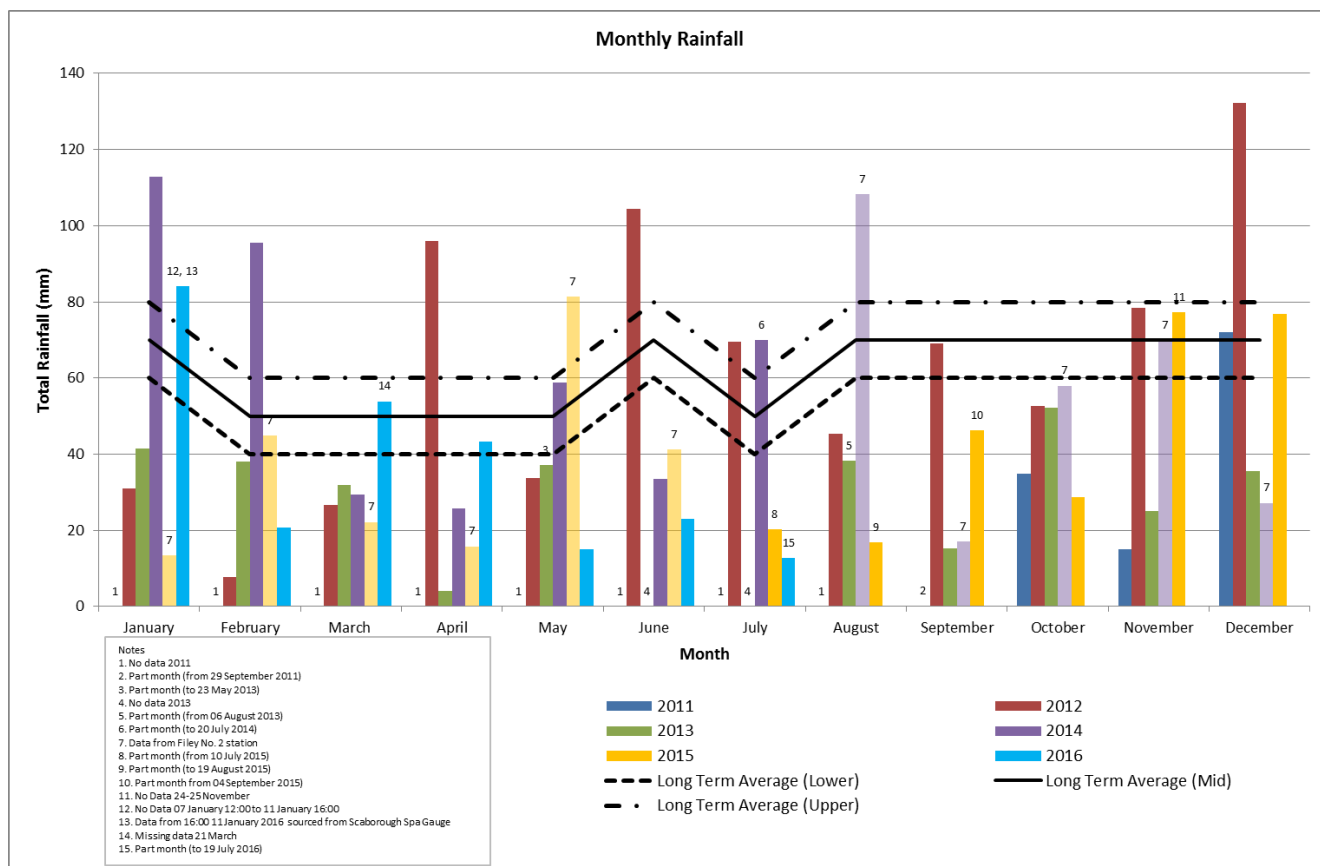
Figure 2.1 Comparison of monthly rainfall records (2011 to 2016).

A meteorological station that records wind speed and direction, air temperature, humidity, air pressure, rainfall and rainfall intensity every 15 minutes has been in place at Flat Cliffs, central Filey Bay, since 29 September 2011. The device was inoperative from September 2014 to July 2015 and additional MetOffice rainfall data were therefore acquired from recording station Filey No 2 (54.20395, -0.30127), c. 3km north-northwest of Flat Cliffs. The Flat Cliffs weather station recorded erroneous data in the period March to May 2016, however at this time a new weather station at Scarborough Spa had become operational and therefore data from that site has been used from 11 January 2016 onwards. Data from all three weather stations are summarised in Table 2.1 and Figure 2.1, which show that January, March and April 2016 were particularly wet when compared to past records.

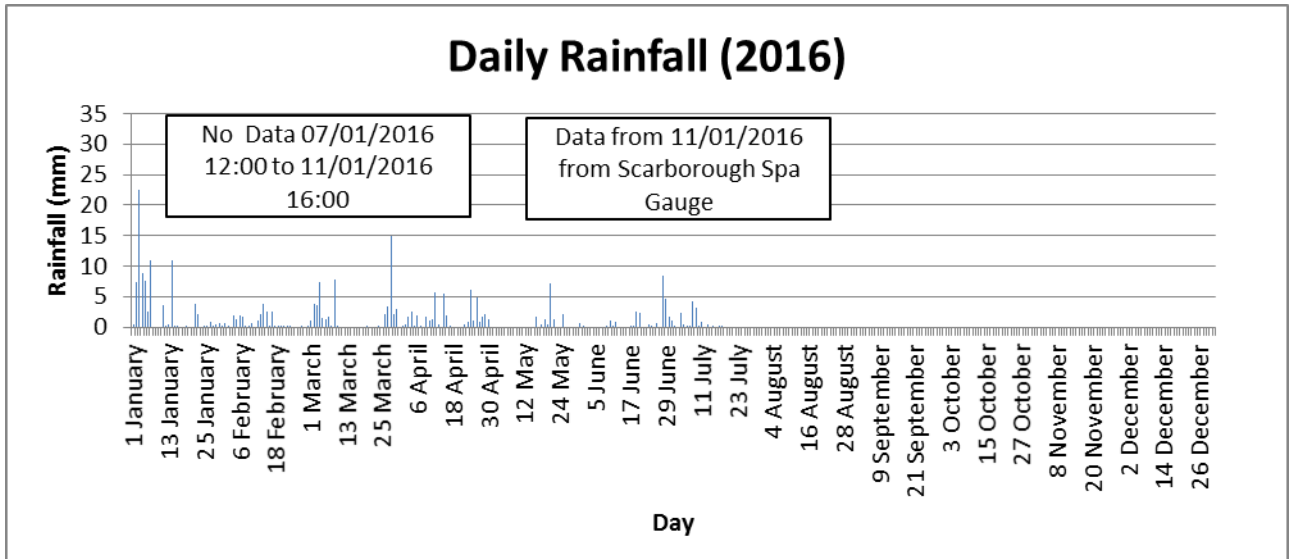
Figure 2.2 Daily rainfall recorded at Flat Cliffs during 2016

Daily rainfall totals recorded by the Scarborough Spa weather station are presented in Figure 2.2, which shows peaks on 3 January and 28 March. The combined dataset has been used for comparison with all coastal slope monitoring data in order to identify relationships. The data are taken to be representative of the whole Scarborough Borough Council frontage, but it is accepted that micro-climate effects may lead to local variations.

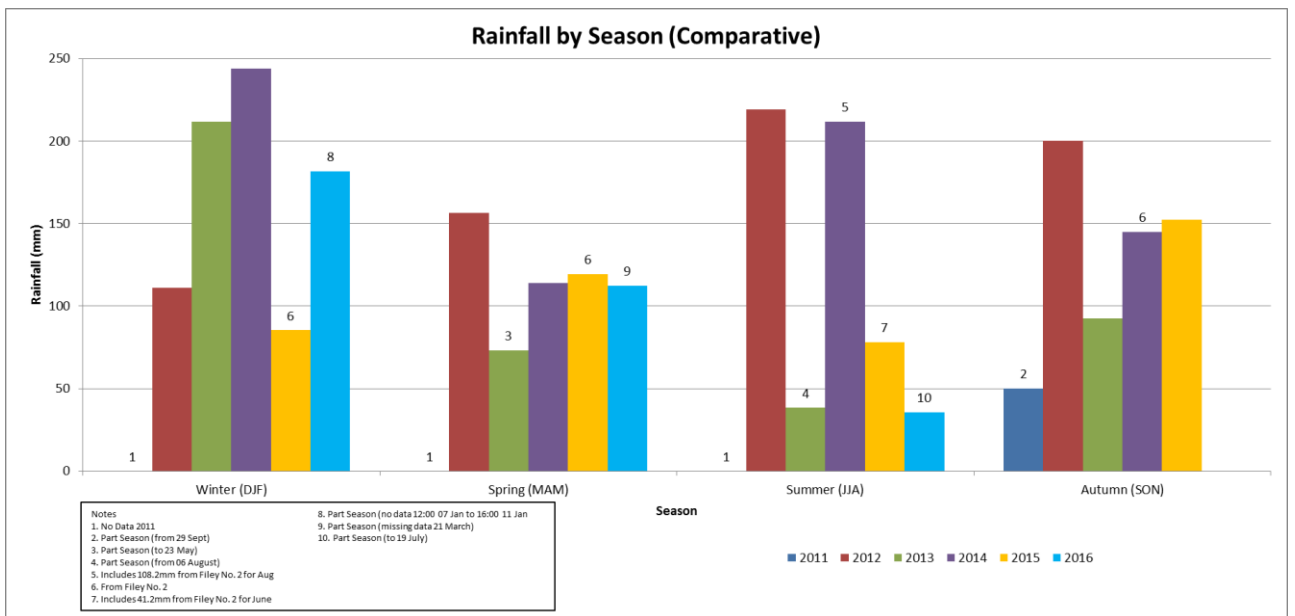
Figure 2.3 Seasonal rainfall comparison (2011-2016)

Seasonal totals are shown in Figure 2.3, which shows that the wettest seasons tend to be winter and summer and that the spring is the driest. The wettest season on record was winter of 2013/14 (i.e. December 2013, January and February 2014) that received a total of 244mm rainfall. The summers of 2012 and 2014 were also very wet, receiving 219mm and 211mm respectively. The winter of 2015/16 received around double the rainfall of 2014/5, but the spring was marginally drier.

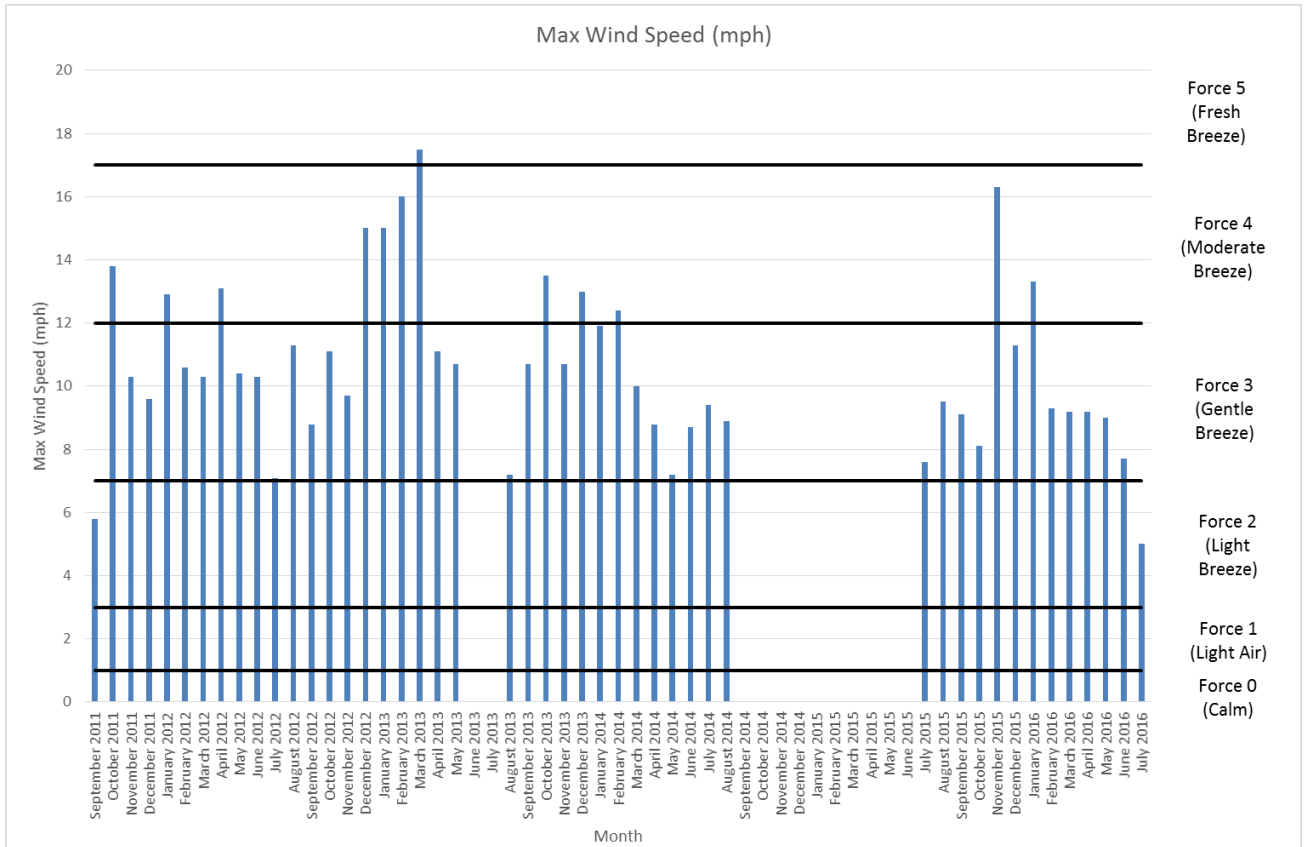
Figure 2.4 Maximum daily wind speed (2011 to 2016)

Wind speed and air temperature records from Flat Cliffs are presented in Figures 2.4 and 2.5. The data shows January 2016 as the windiest month in the monitoring period and relatively gentle conditions persisted into mid-2016. Recorded temperatures during 2016 are average, except for the relatively mild winter of 2015/2016.
