Robin Hood's Bay Coastal Defence Condition Survey

May 2014
Scarborough Borough Council

A condition assessment of the coastal defences along the Robin Hood's Bay sea wall, which forms part of the '2007, River Tyne to Flanborough Head Shoreline Management Plan (SMP2)' was carried out by representatives of Mott MacDonald on behalf of Scarborough Borough Council on 10th April 2014.

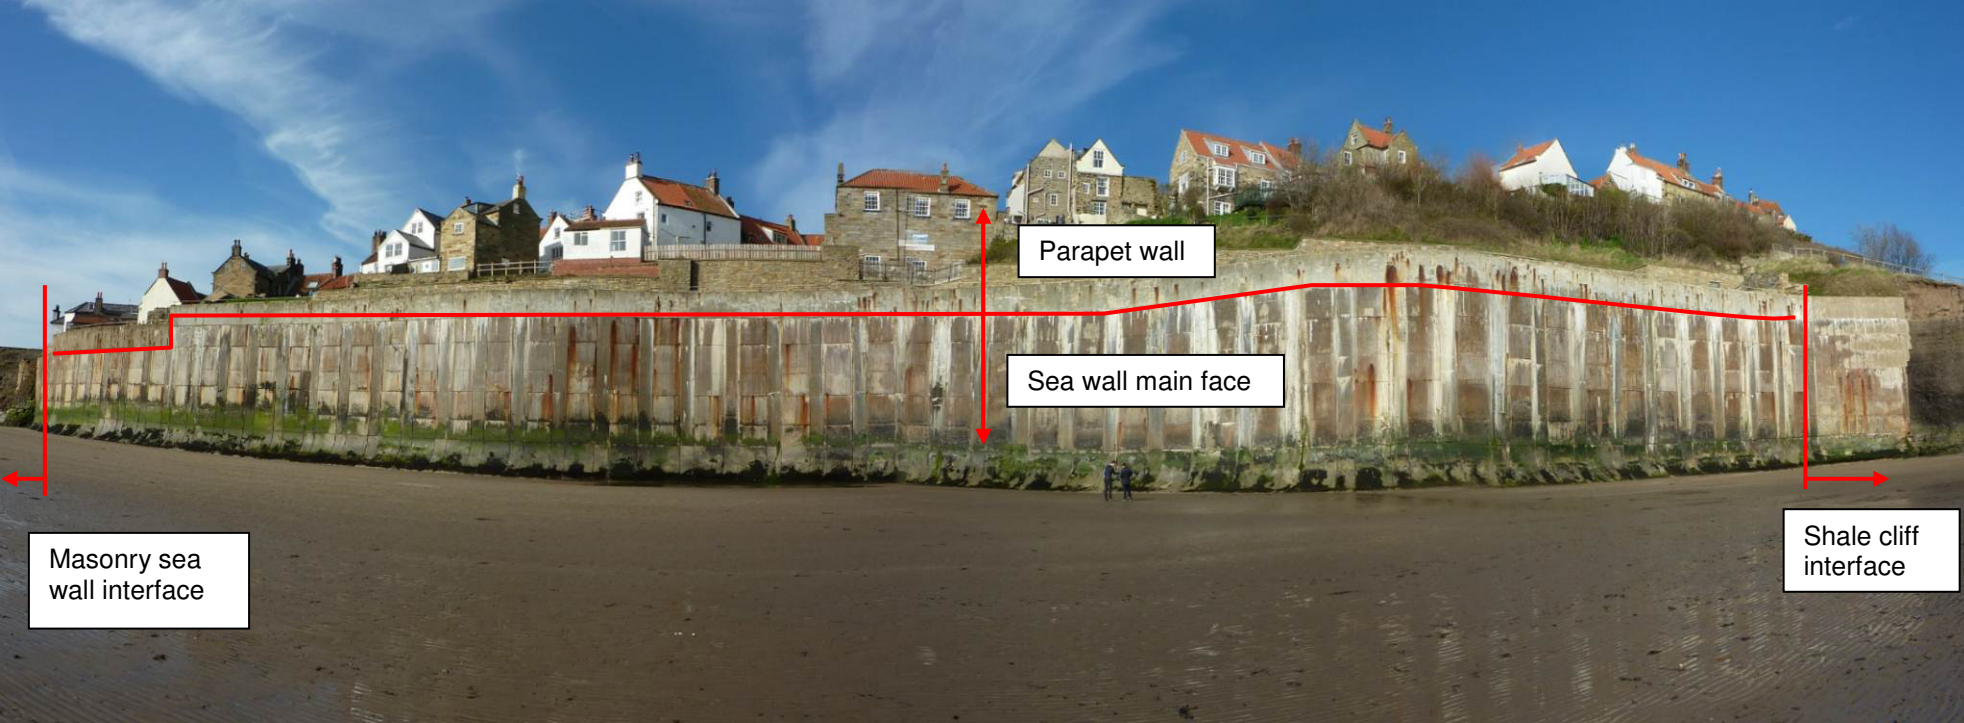
Figure 2.1: Panoramic view and survey sections

The bay has been broken up into four sections: the interface between the masonry and concrete sea walls, the main face of sea wall, the parapet wall and promenade and the interface between the sea wall and the cliff. The survey sections are presented in Figure 2.1.

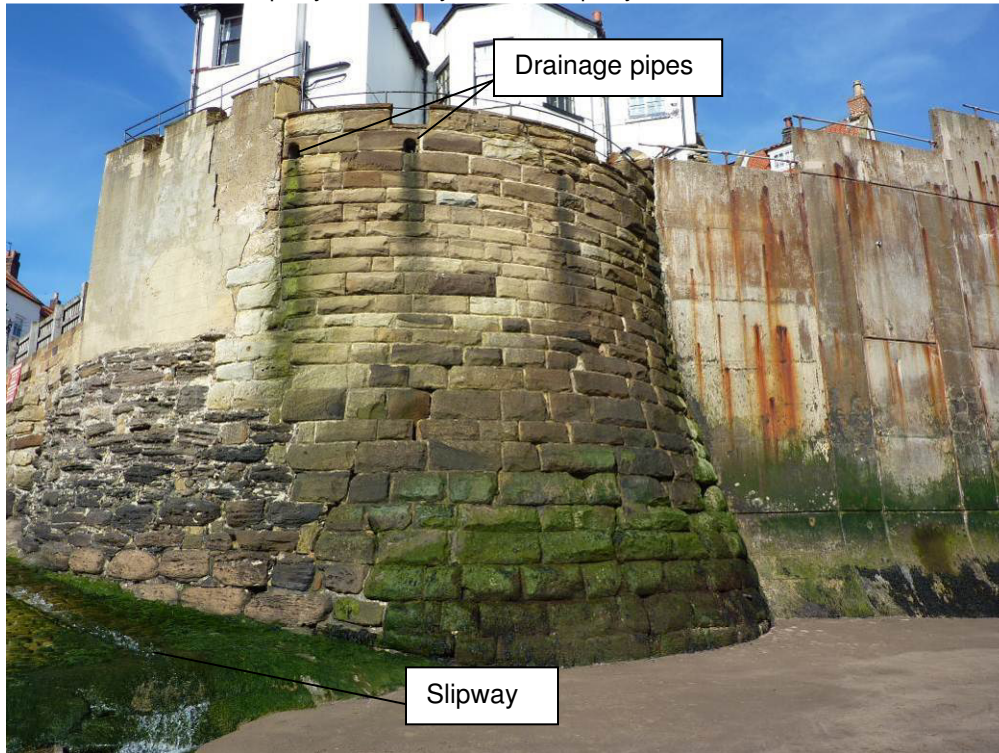
Figure 2.5: View from end of the slipway of masonry sea wall, slipway and concrete sea wall

The crest of the masonry sea wall is lower than the main crest of the concrete sea wall. The masonry blocks are irregular in size but generally reduce in size higher up the wall. There is minimal drainage provided in the wall; the only drainage which is visible is at promenade level (see Figure 2.5). During the start-up meeting representatives from SBC commented that following heavy rainfall water can be seen running through the structure between the blocks. SBC also stated that regular maintenance is done on the wall filling voids that appear between the blocks.

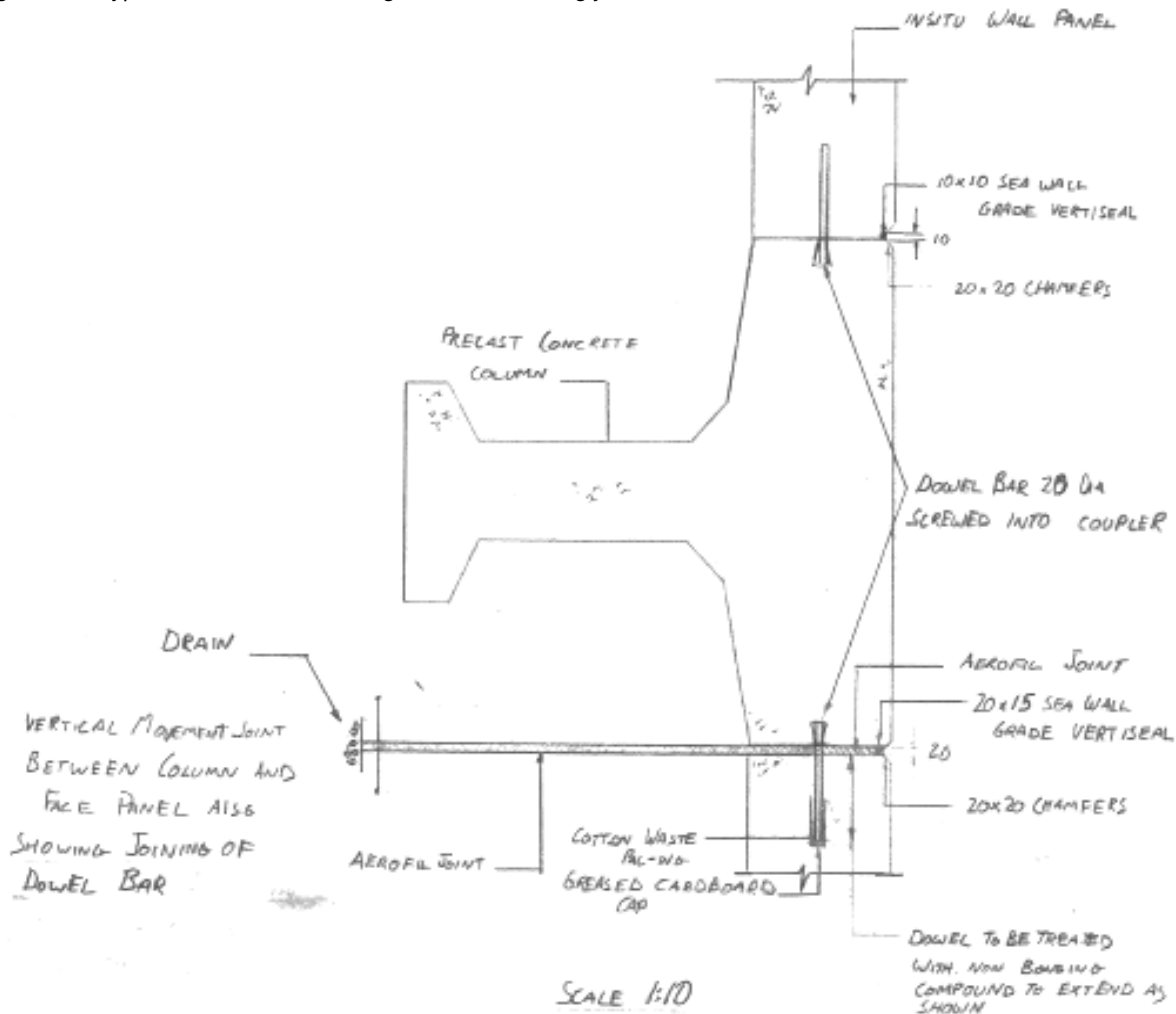
Figure 3.2: Typical cross-section through column showing joint details

The sea wall is founded on precast concrete base units the toe of which is buried in the beach. These base units have a curved seaward face. The top edge of these base units is the same width as the face panels. I-beam shaped precast concrete columns are slotted into the top of the base units. The columns are single span sections are run from the base units to the bottom of a parapet wall. These columns are tied to cast in situ reinforced concrete face panels with 20mm diameter dowel bars (see Figure 3.2 and Figure 3.3). The precast columns and cast in place panels form the face of the sea wall.
