**CONDITION ASSESSMENT
OF
ROBIN HOOD'S BAY SEA WALL
FOR
SCARBOROUGH BOROUGH
COUNCIL**

www.concrete-repairs.co.uk email: sbladon@concrete-repairs.co.uk		
CONTRACT DETAILS				
Contract No.:	SUR07605			
Site:	Sea Wall, Robin Hood's Bay			
Client:	Scarborough Borough Council Technical Services Town Hall St. Nicolas Street Scarborough North Yorkshire YO11 2HG For the attention of: Mr. Martin Lloyd			
FOR CONCRETE REPAIRS LIMITED				
Authors:	Simon Bladon BSc., MSc. Survey Division Manager	Approved:	Simon Bladon BSc., MSc. Survey Division Manager	
	Grzegorz Nowakowski Survey Division Area Manager (UK North)	Signed:

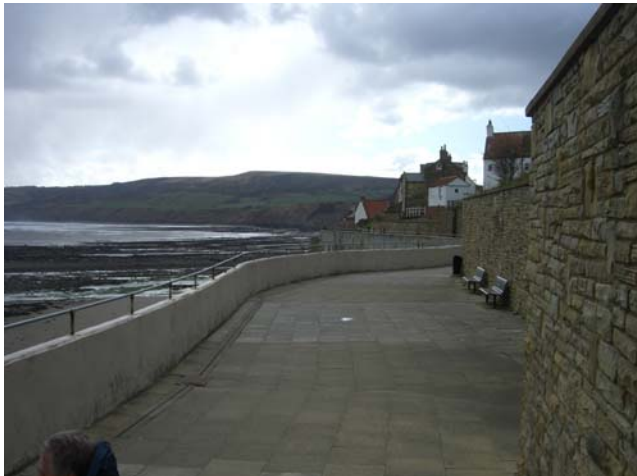
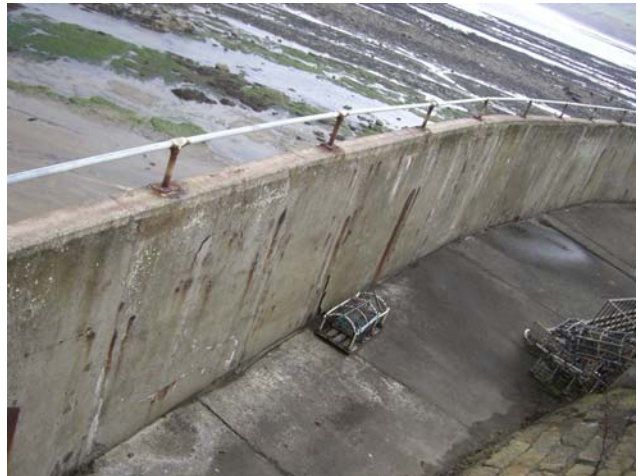
Plates T4: Views at the top of the wall, showing a small parapet, with handrail and paved walkway of extremely variable width.

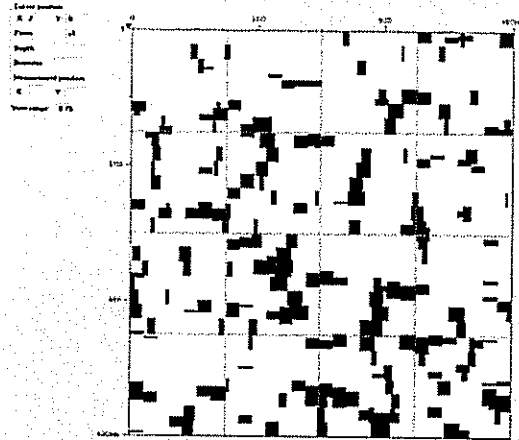
This view reduces the range to 75mm. This has removed a great deal of 'noise' from the scan (See Notes Section of Report). One of the objectives of the survey was to determine the cause of the rust staining on the surface of the concrete. Close visual inspection showed 'eruptions' on the surface of the concrete. When investigated by removing the surface of the concrete, there were two causes.

The cover to the steel measured by Ferroskan and cover meter was in the order of 70mm to 80mm in the areas tested. This was confirmed by physical measurements in the holes drilled to connect the half cell. A full cover survey was not carried out due to time constraints. Visual examination of the reinforcement in the areas broken out did not show any signs of bar corrosion or wasting.

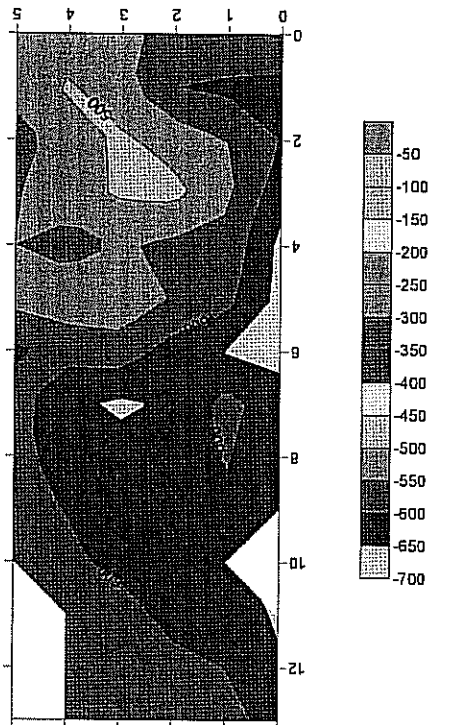
Half Cell Potential
 Contour Map and Half Cell Values for Panel 1

-521	-523	-538	-567	-554	-547
-524	-494	-537	-599	-610	-618
-574	-519	-493	-520	-551	-601
-554	-519	-493	-487	-537	-632
-549	-573	-544	-561	-572	-663
-531	-516	-519	-554	-580	-666
-608	-582	-569	-622	-654	-660
-582	-637	-658	-643	-581	-635
-573	-638	-633	-626	-596	-635
-583	-602	-636	-636	-611	-612
	-577	-587	-616	-604	-634
	-567	-568	-620	-612	-658
	-565	-567	-578	-600	-641
	-584	-563	-568	-572	-627

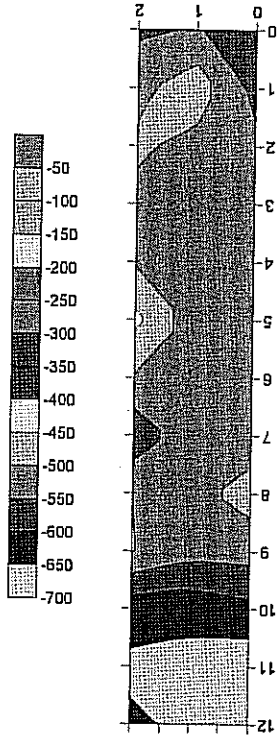
Half Cell Potential
 Contour Map and Half Cell Values for Column 2

-599	-545	-559
-567	-469	-513
-537	-517	-492
-546	-514	-512
-551	-509	-506
-532	-516	-438
-535	-524	-504
-527	-517	-590
-478	-516	-500
-531	-533	-498
-615	-636	-630
-684	-665	-659
-700	-659	-642

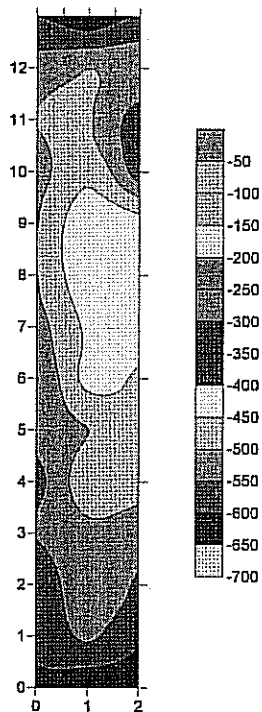
Half Cell Potential
 Contour Map and Half Cell Values for Column 3

-646	-404	-521
-600	-646	-596
-523	-497	-496
-496	-495	-589
-527	-453	-586
-504	-404	-424
-502	-407	-417
-522	-441	-433
-556	-424	459
-537	-504	-462
-571	-460	-474
-545	-511	-540
-602	-505	-558
-586	-536	-593
-612	-635	-627

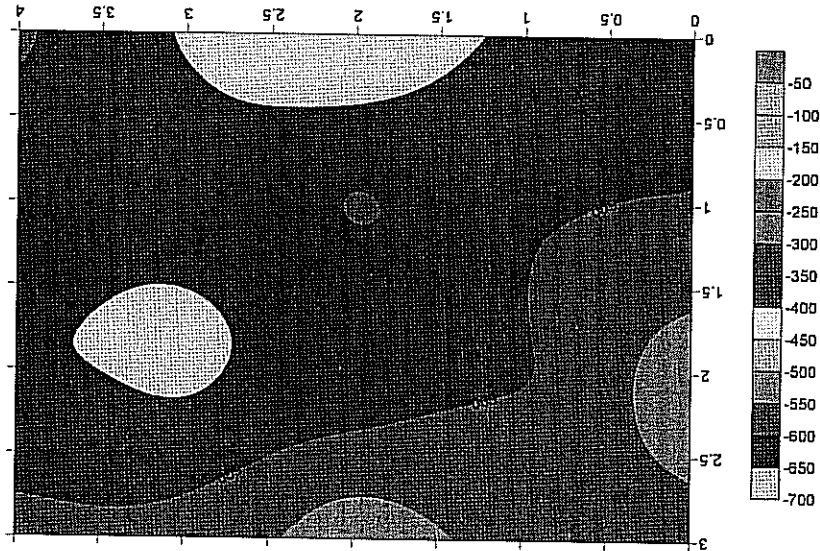
Parapet RHS Column 5

**Half Cell Potential
 Contour Map and Half Cell Values for
 Parapet Wall above and right Column 5**

-641	-692	-655	-593	-558
-597	-605	-593	-637	-619
-517	-605	-637	-664	-648
-564	-565	-513	-582	-581

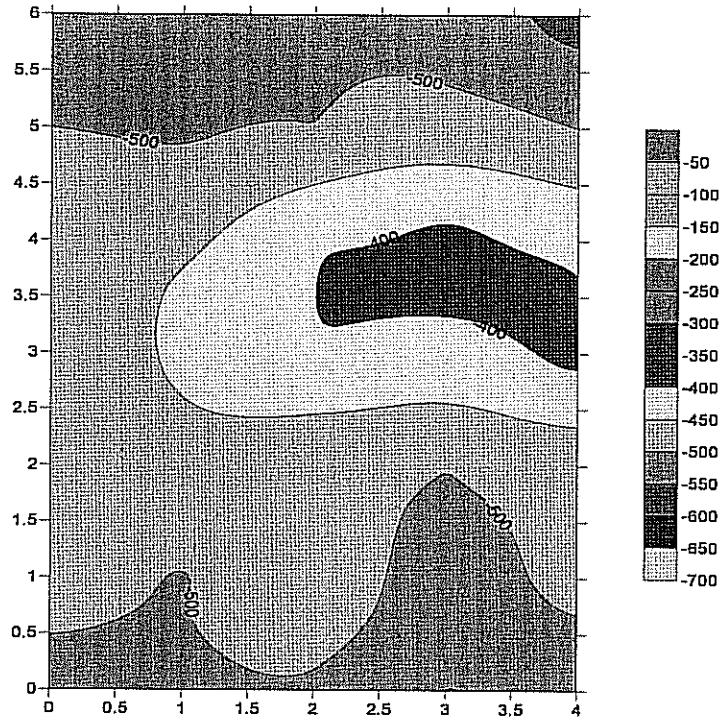
Bottom Panel RHS Col 5

Half Cell Potential
 Contour Map and Half Cell Values for
 Bottom Panel to RHS of Column 5

-519	-511	-505	-551	-542
-477	-503	-452	-530	-474
-468	-464	-486	-499	-400
-490	-441	-403	-420	-386
-462	-460	-404	-387	-411
-500	-509	-499	-479	-501
-539	-533	-507	-519	-571

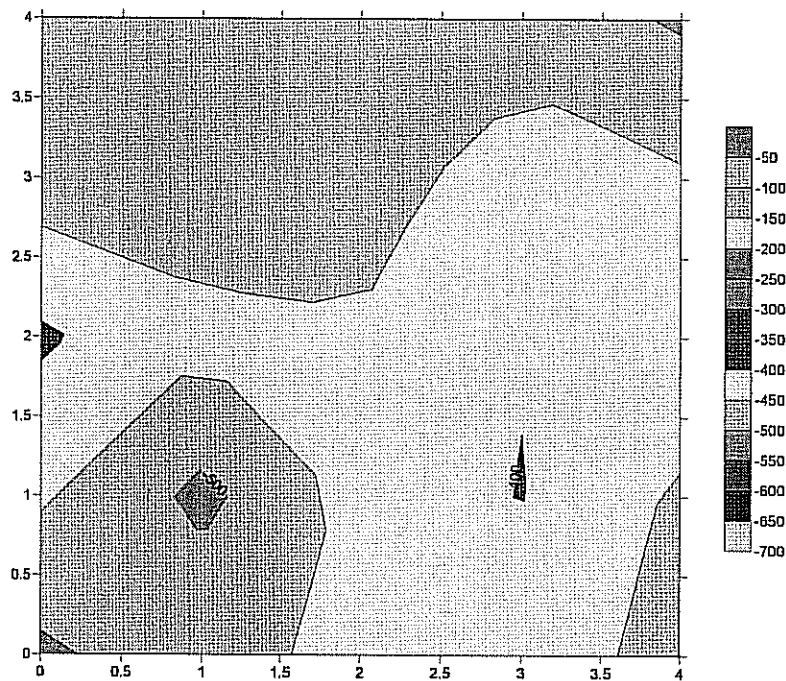
Half Cell Potential
 Contour Map and Half Cell Values for
 Parapet Wall left of Column 23

-510	-466	-438	-436	-459
-443	-512	-438	-398	-458
-392	-441	-445	-403	-405
-476	-470	-472	-423	-444
-487	-470	-499	-473	-506

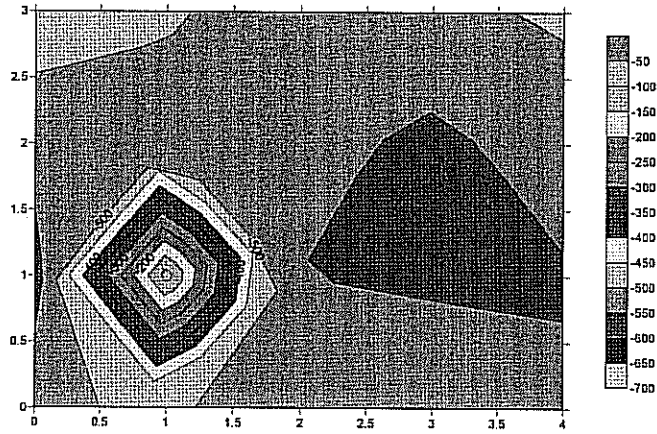
Top Half of Panel left of Column 23

**Half Cell Potential
 Contour Map and Half Cell Values for
 Top half of first Panel left of Column 23**

-507	-493	-526	-527	-540
-583	-78	-550	-555	-555
-519	-514	-533	-563	-526
-483	-496	-518	-512	-493

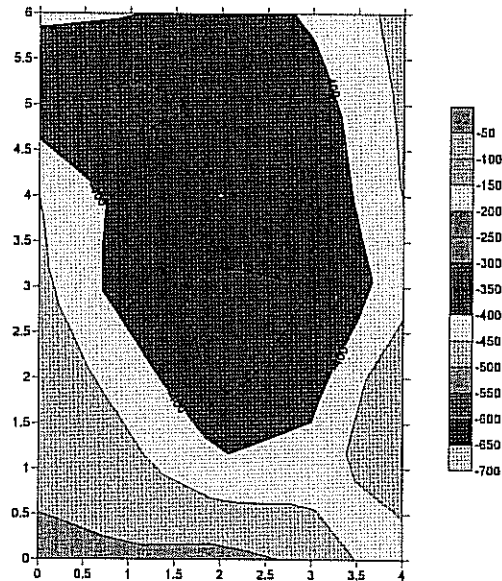
Middle Panel Left of Column 23

**Half Cell Potential
 Contour Map and Half Cell Values for
 Middle Panel left of Column 23**

-512	-507	-519	-490	-408
-489	-464	-410	-424	-501
-479	-431	-335	-378	-499
-462	-370	-334	-350	-424
-452	-382	-401	-358	-453
-367	-330	-359	-375	-459
-406	-403	-369	-408	-467

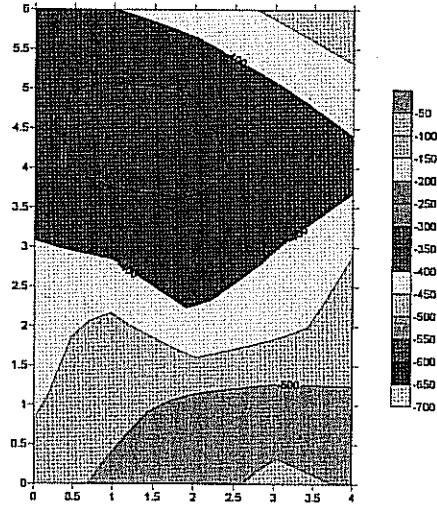
Lower Panel Left of Column 23

Half Cell Potential
 Contour Map and Half Cell Values for
 Lower Panel left of Column 23

-472	-513	-518	-488	-504
-445	-483	-516	-524	-510
-435	-463	-406	-435	-469
-404	-388	-372	-397	-448
-357	-337	-336	-366	-378
-353	-346	-351	-394	-432
-388	-399	-424	-458	-489

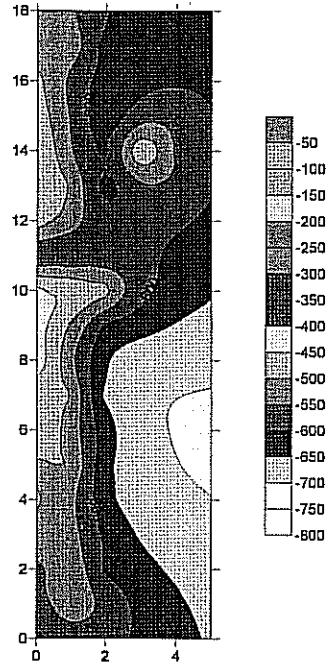
Half Cell Potential
 Contour Map and Half Cell Values for
 Column 37

-613	-572	-582
-569	-516	-561
-567	-514	-607
-505	-529	-610
-510	-501	-637
-497	-536	-637
-421	-539	-645
-479	-499	-620
-434	-509	-611
-435	-595	-594
-471	-519	-594
-454	-506	-619
-454	-547	-607
-444	-560	-589
-474	-555	-640
-489	-563	-621
-527	-519	-617
-499	-545	-597

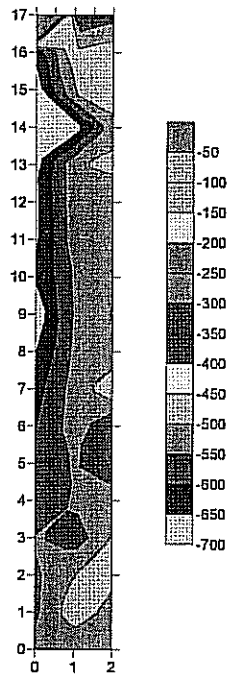
Half Cell Potential
 Contour Map and Half Cell Values for
 Column 41

-536	-547	-549
-561	-463	-521
-559	-501	-483
-545	-580	-499
-604	-546	-511
-589	-547	-602
-603	-524	-602
-618	-529	-457
-652	-541	-539
-687	-544	-497
-643	-545	-513
-664	-517	-521
-658	-523	-539
-656	-504	-487
-671	-683	-520
-679	-482	-463
-636	-483	-469
314	-595	-570

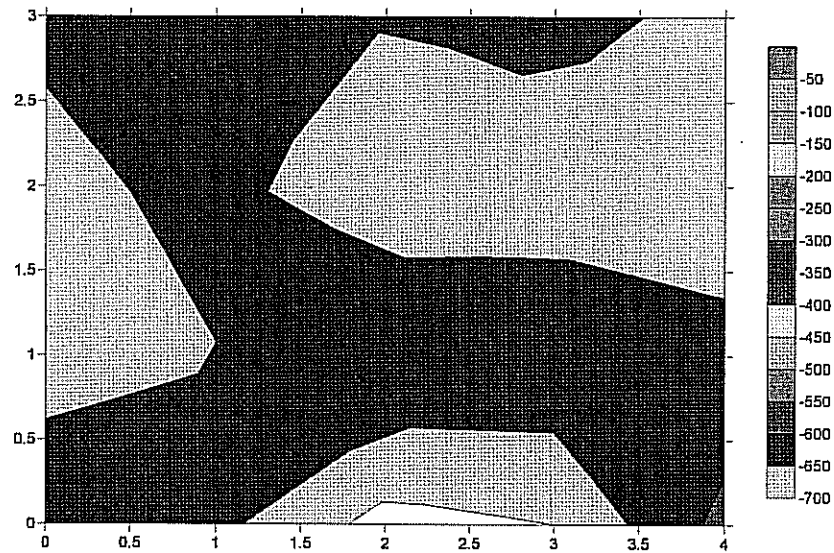
Parapet to right of Column 41

Half Cell Potential
 Contour Map and Half Cell Values for
 Parapet to Top Panel right of Column 41

-619	-637	-717	-700	-586
-669	-651	-600	-608	-638
-661	-638	-686	-679	-673
-642	-649	-648	-630	-668

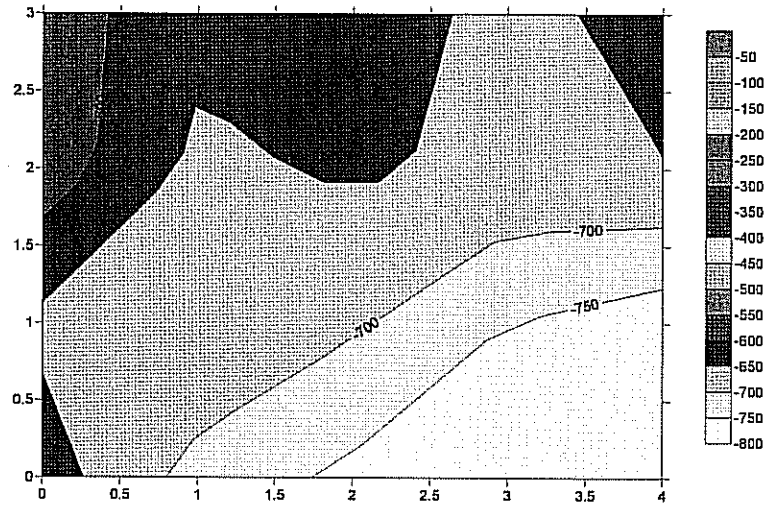
Half Cell Potential
 Contour Map and Half Cell Values for
 Top Panel right of Column 41

-625	-719	-761	-785	-800
-662	-651	-693	-750	-779
-570	-661	-642	-664	-653
-573	-637	-602	-677	-616

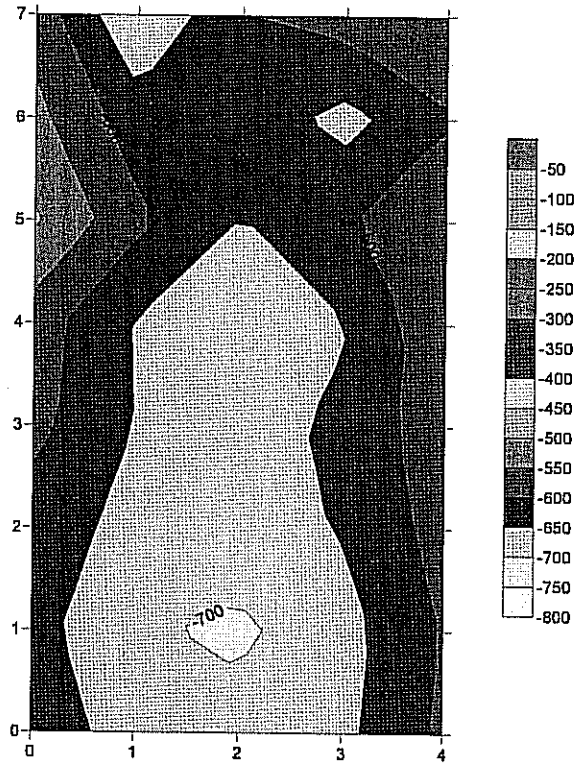
Centre Panel Right of Column 41

Half Cell Potential
 Contour Map and Half Cell Values for
 Centre Panel right of Column 41

-600	-684	-684	-663	-591
-632	-693	-709	-670	-597
-626	-664	-676	-646	-581
-584	-651	-661	-644	-561
-575	-653	-689	-652	-566
-494	-588	-653	-603	-573
-537	-628	-622	-666	-603
-571	-701	-601	-579	-574

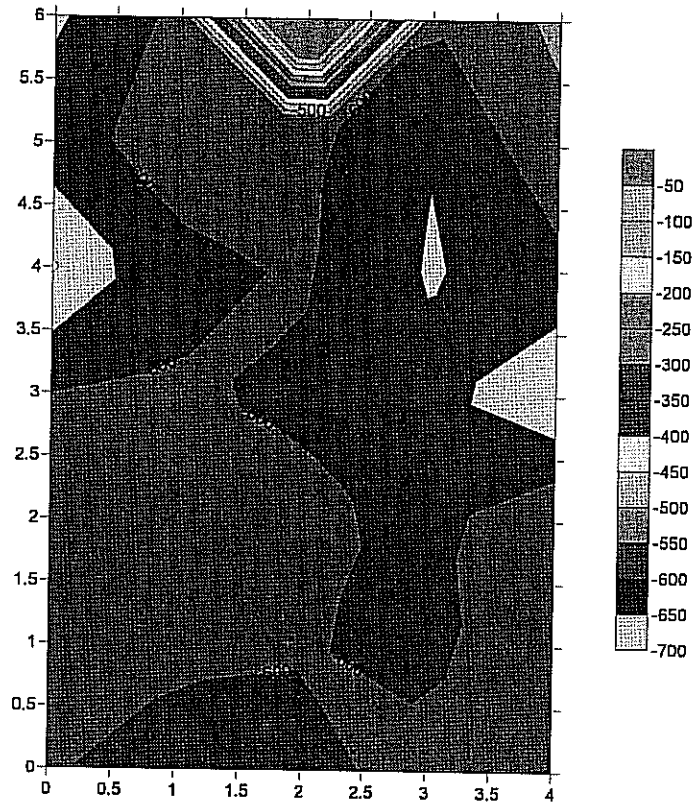
Bottom Panel Right of Column 41

Half Cell Potential
 Contour Map and Half Cell Values for
 Bottom Panel right of Column 41

-658	-586	299	-598	-538
-620	-575	-592	-647	-565
-705	-614	-594	-655	-614
-600	-596	-609	-638	-698
-567	-571	-585	-612	-550
-564	-576	-596	-619	-555
-588	-649	-616	-582	-587

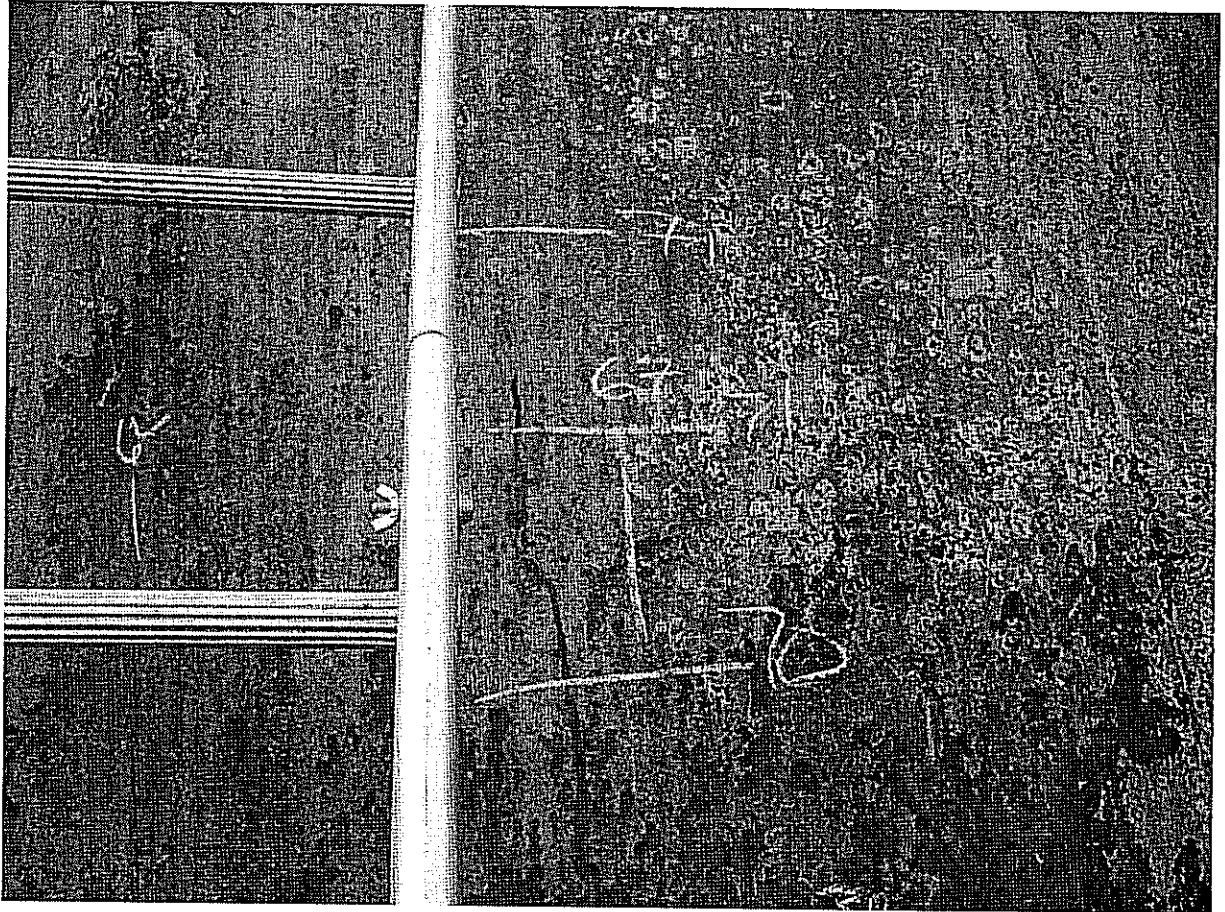
Another example of iron inclusions within the aggregate
