Historic Trend Analysis and Geomorphological Review -Crimdon Beck, Hartlepool

Client: North East Coastal Observatory (on behalf of Hartlepool Borough Council)

Reference: PC1950-IB-RP-230911

Status: Draft/P01

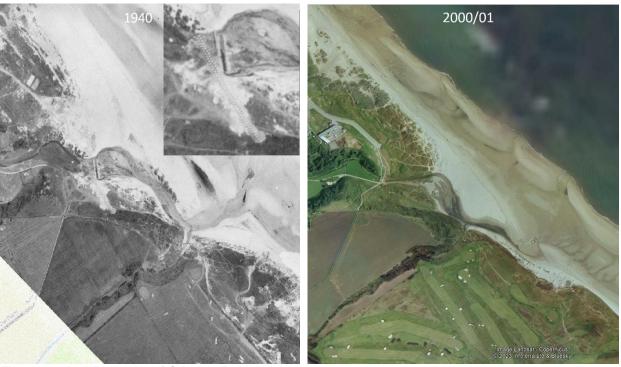
The first available imagery of this location from 1940 (**Figure 2.1**) is from a similar period as the OS 1:25,000 1937-61 & OS 1:10,000/1:10,560, 1949 – 1972 mapping, described in **Section 2.1.1**. Anti-tank blocks are visible across the mouth of the beck (see inset in **Figure 2.1**). The dunes to the immediate north and south of where the beck meets the beach are in poor condition, showing large blowouts and large trails/paths through the dunes (**Figure 2.1**). The beck is in a similar orientation as mapping from 1949 – 1972, running south for a short extent before discharging to the sea. Hart Warren dunes adjacent to the golf course show large blowouts.

Figure 2.1 Aerial imagery of Crimdon Beck in 1940, with inset showing anti-tank blocks (NECO, 2023)

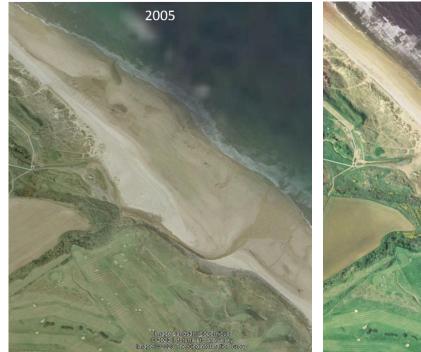
Aerial imagery from 2005 – 2007 (**Figure 2.3 – 2.5**) shows dune vegetation has continued to recover since the blowouts observed in the 1940 imagery to the immediate north of the beck outfall and in the lee of the meander as it discharges onto the beach. The beck continues south (approximately 70m further than in 2001) and has moved inland to run directly along the toe of the dunes. The dunes adjacent to this channel show minor erosion since 2000/01. A defence asset survey (originally called the North East Coastal Authorities Group (NECAG) Coast Protection Assets and Coastal Slope Condition Analysis) carried out by Royal Haskoning in 2008 noted that a principal area of concern was the dune erosion at the southern side of the south of the beck (Royal Haskoning, 2008). The report notes the dunes at the southern side of the mouth of the beck are high, steep and bare of vegetation with cliffing occurring at the toe of the dunes caused by the proximity of the channel of the beck (Royal Haskoning, 2008).

Figure 2.3 Aerial imagery of Crimdon Beck in 2005 (Google Earth, 2023)

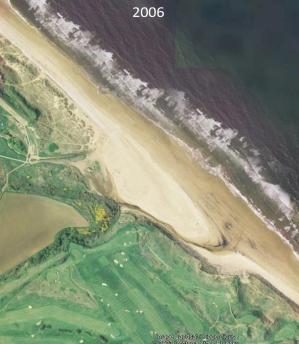
Figure 2.4 Aerial imagery of Crimdon Beck in 2006 (Google Earth, 2023)

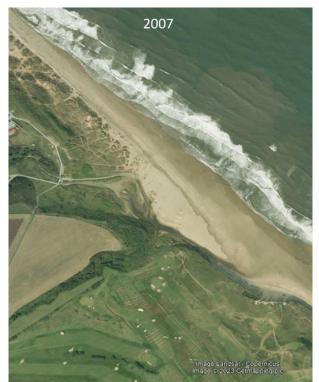
Figure 2.5 Aerial imagery of Crimdon Beck in 2007 (Google Earth, 2023)

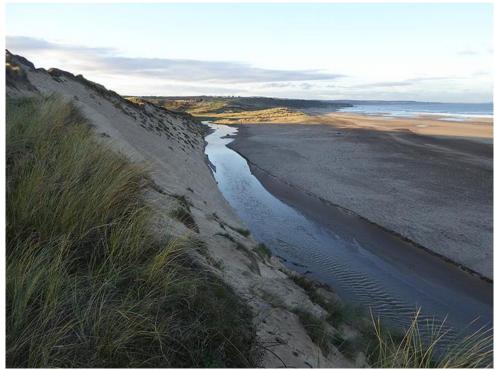
Two images published on Geograph.co.uk in 2015 show the deflection of Crimdon Beck to the south by a barrier of well vegetated dunes (**Figure 2.6**) and the position of the beck relative to the steep Hart Warren dunes (**Figure 2.7**) (Geograph.co.uk, 2015a,b). The walkover inspection report from 2016 notes that the profiles of the dunes fronting the golf course remain similar to that of 2014, suggesting they have been relatively inactive, with only evidence of small-scale local erosion evident at the toe of the slope adjacent to Crimdon Dene (Royal HaskoningDHV, 2016). The report notes that there has been a lowering of the dune crest and lack of vegetation caused by trampling at informal access points along this frontage (Royal HaskoningDHV, 2016).

Figure 2.7 Crimdon Beck and Hart Warren Dunes, image taken on 19th November 2015 by Oliver Dixon (Geograph.org.uk, 2015b). The photo is copyrighted but also licensed for further reuse.

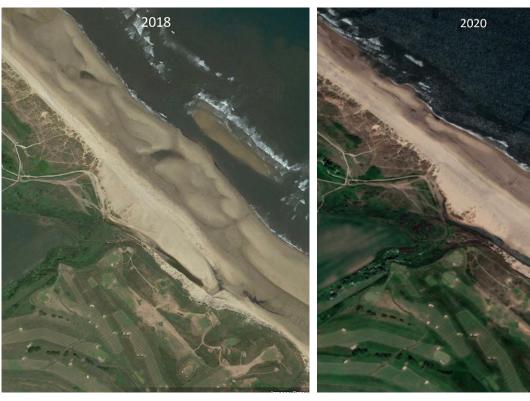
Aerial imagery from 2017/18 (**Figure 2.8**) shows the vegetation to the north of the beck outfall in a similar position as previous imagery. The beck continues to run along the toe of the dunes, diverting north towards the sea approximately 124m further south than previous imagery in 2005-2007. The coastal inspection report from 2018 notes that dunes remain in a relatively similar position as 2016, with evidence of small-scale local erosion evident at the toe of the slope adjacent to Crimdon Dene.

Figure 2.8 Aerial imagery of Crimdon Beck in 2018 (Google Earth, 2023)

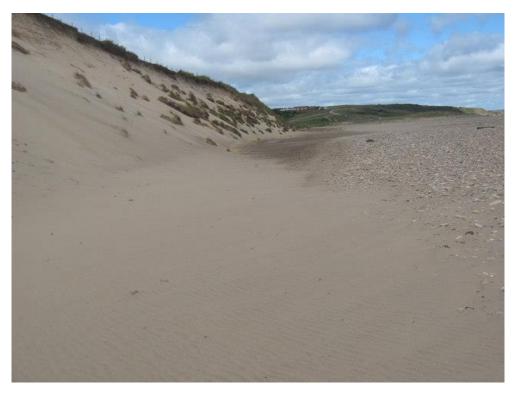
Aerial imagery from 2020 (**Figure 2.9**) is relatively similar to 2017/18. The beck continues to run along the toe of the dunes but does not flow across the beach, possibly due to a long dry period leading up to the image being taken (image taken on 20th May 2020). This is corroborated by an image taken on 11th July 2020 by Peter Robinson (**Figure 2.10**) showing a very low volume, in which the beck apparently reaches the sea under the sands. A photograph taken on the 1st November 2021 (**Figure 2.11**) shows the beck back to discharging across the open beach. The coastal inspection report for 2020 noted signs of small-scale local erosion of the dunes and that the wooden sand fence at the crest of the dune had been bypassed by the retreating crest (Royal HaskoningDHV, 2020).

Figure 2.10 Crimdon Beck dried up during a dry spell, image taken by Peter Robinson on 11th July 2020 (Geograph.org.uk, 2020). The photo is copyrighted but also licensed for further reuse.

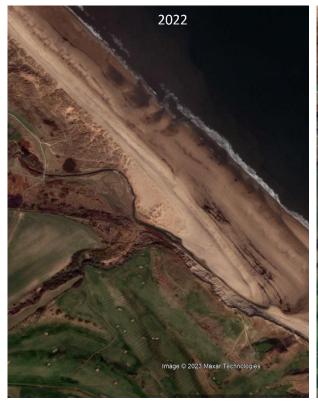
Aerial imagery from 2022 shows the beck discharging further to the south (**Figure 2.12**). The coastal inspection report from 2022 notes minor cliffing at the crest of the dunes, showing signs of local erosion (Royal HaskoningDHV, 2022). The wooden sand fence which was once at the crest of the dune was noted to be on the face. The dunes to the south of this were noted as well vegetated and showing a similar position compared to the last inspection.

Figure 2.12 Aerial imagery of Crimdon Beck in 2022 (Google Earth, 2023)

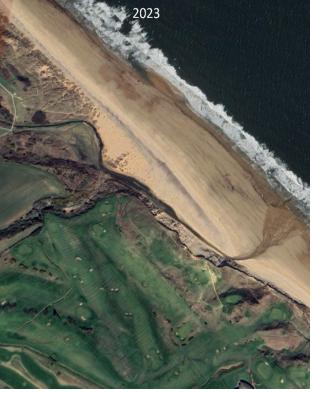
The latest aerial imagery of the area was taken on 3rd April 2023 (**Figure 2.13**) and this shows that the beck is generally at its most southerly position since records began.

Figure 2.13 Aerial imagery of Crimdon Beck in 2023 (Google Earth, 2023)

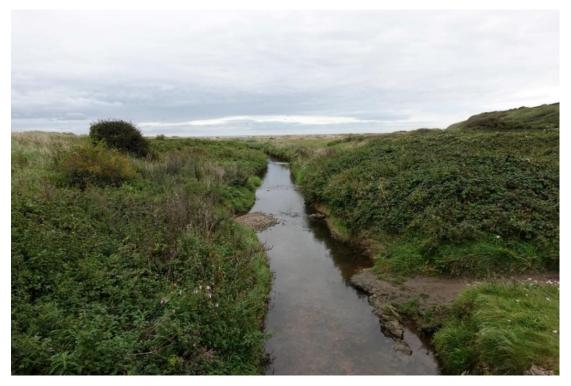
The inspection continued south over the bridge towards the golf course, showing the southerly deflection of the beck (Figure 3.4 – Figure 3.5). Figure 3.6 shows the view of the beck towards the north, with the low dunes visible on the upper beach.

Figure 3.4 View to the east from a bridge crossing Crimdon Beck

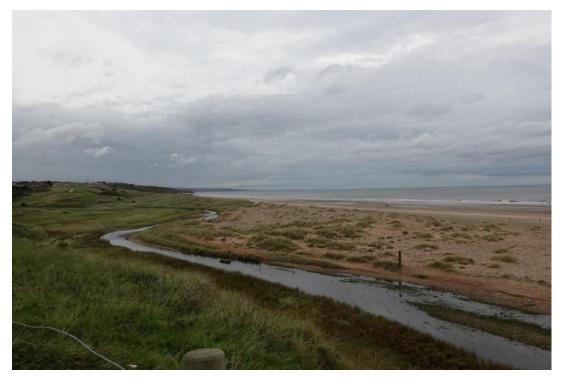
Figure 3.6 View to the north of the beck routing south along the upper beach

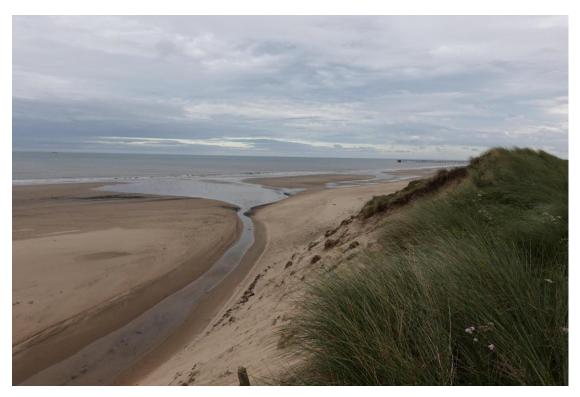
The inspection continued along the top of the dunes adjacent to the golf course, where the sand fence once at the crest of the dunes was visible on the face of the dunes (**Figure 3.7**). The crest of the dunes has eroded close to the fence bordering the golf course (**Figure 3.8**). The beck cuts along the toe of the dunes before discharging to the sea (**Figure 3.9**).

Figure 3.9 View to the south of the beck along the toe of the dunes and discharging to the sea

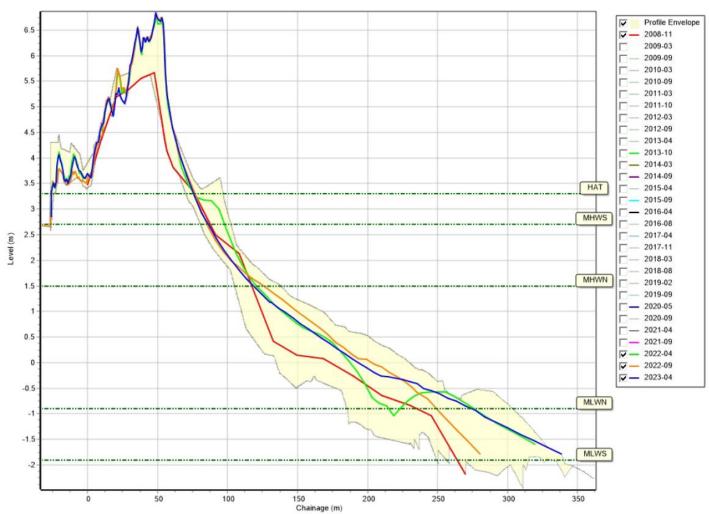
Profiles: 1cHN1

The beginning of profile 1cHN1, between chainages 0m and 70m, covers the dune system that generally have remained stable. Minor erosion of up to 0.3m in level is observed to the crests of the rear dunes. The upper beach up until chainage 105m is unchanged. Between chainage 105m and 224m the beach has dropped in level by 0.2m. Seawards of 224m, the lower beach profile has slackened significant resulting in an increase in level at the end of the previous profile of 0.8m in level. Overall, the beach is at a medium level compared to the range recorded in previous surveys.

Figure 3.13 Profile 1cHN1 envelope between 2008 - 2023 (SANDS)

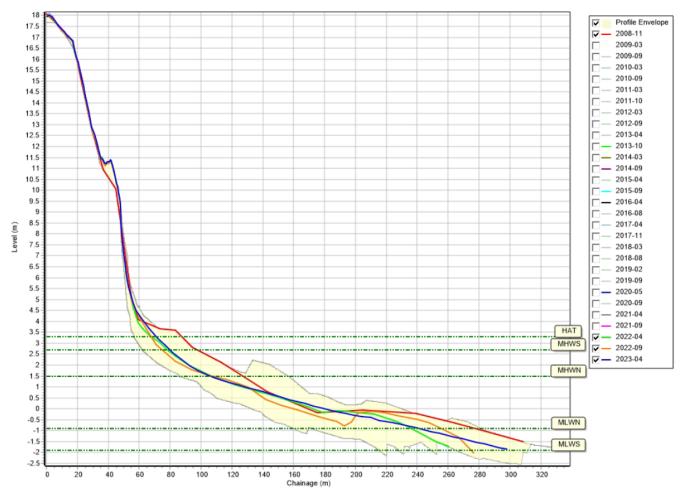
Profiles: 1cHN2

At profile 1cHN2, the dunes between chainage 0 and 48m, have remained stable since the previous survey. At the toe of the foredune until chainage 52m, accretion of up to 0.3m in level has occurred. Seawards of chainage 100m the undulating profile observed previously has become more uniform resulting in alternating lengths of erosion and accretion. The magnitude of change is limited to $\pm 0.6m$. Overall, the beach is at a medium level compared to the range recorded in previous surveys.

Figure 3.14 Profile 1cHN2 envelope between 2008 - 2023 (SANDS)

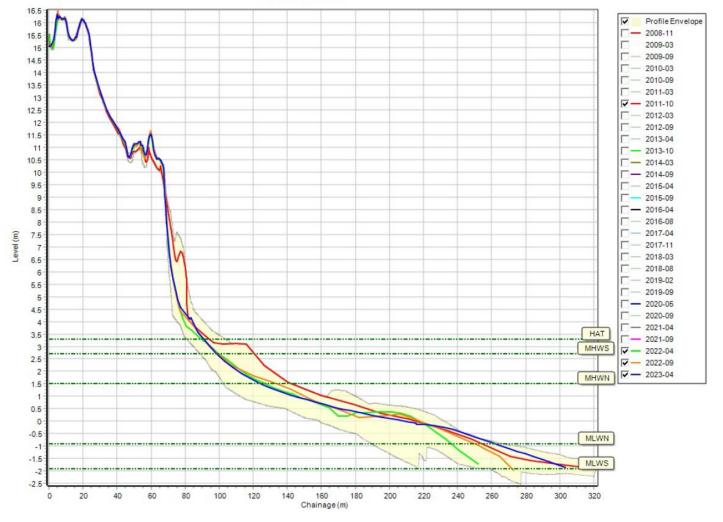
Profiles: 1cHN2A

Figure 3.15 Profile 1cHN2A envelope between 2008 - 2023 (SANDS)

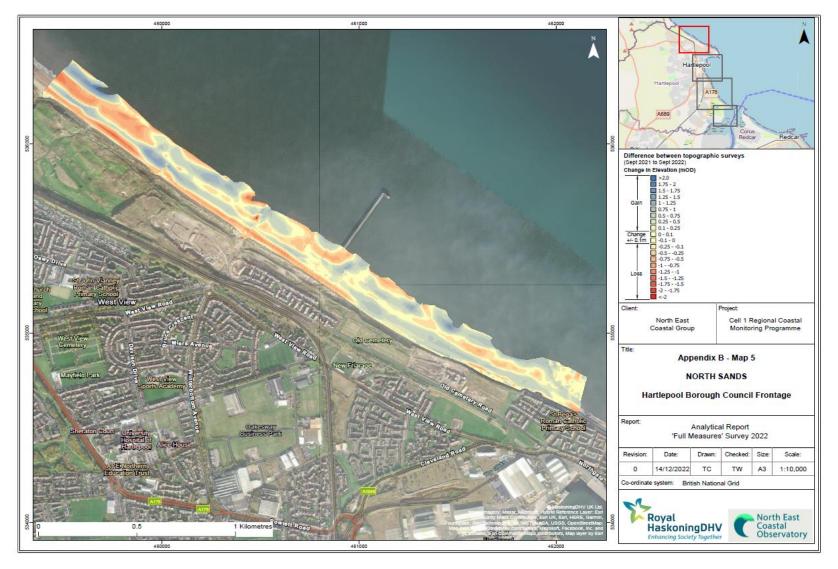
Data from the most recent topographic survey (2022 Full Measures survey) have been used to create a DGM (**Figure 3.16**) using a GIS package. The majority of the frontage is characterised by shore-parallel contours, except in the vicinity of outfalls, groynes, and the pier where contours change direction. The GIS has also been used to calculate the differences between the September 2021 and September 2022 topographic surveys to identify areas of net erosion and accretion (**Figure 3.16**). The difference plot at North Sands shows alternating bands of erosion and accretion running parallel to the shoreline associated with shifting sandbars – a pattern typical for this frontage.

Figure 3.16 Difference between topographic surveys at North Sands, Hartlepool September 2021 - September 2022 (Royal HaskoningDHV, 2022)
