Interpretation Report 13: June 2019 to November 2019

Prepared for
Scarborough
Borough Council

February 2020

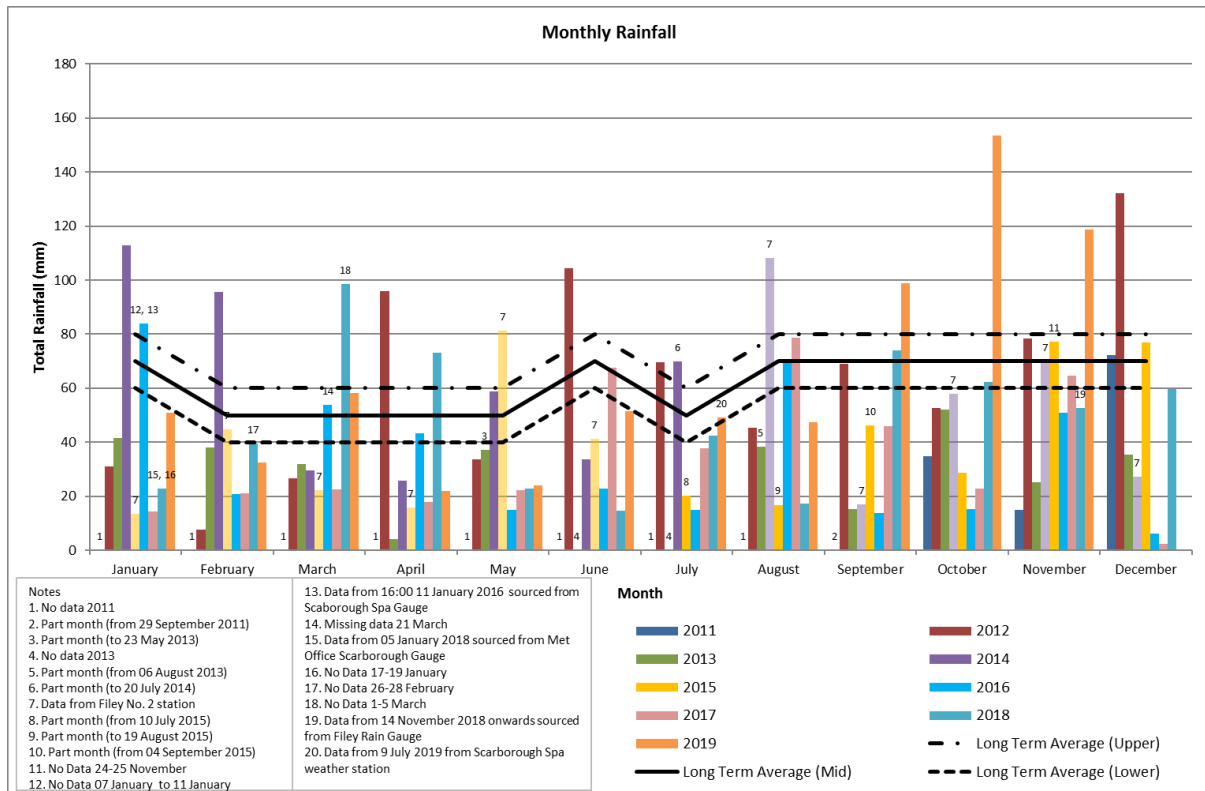
Figure 2.1 Comparison of monthly rainfall records (2011 to 2019).

Data from all sources are summarised in Table 2.1 and Figure 2.1. The records for the last six months show that summer 2019 was marginally wetter when compared to past records, but that autumn 2019 was exceptionally wet. Rainfall totals for the months September to November all exceed records since 2011, with October rainfall totals reaching 154 mm. This is the wettest month recorded since 2011.

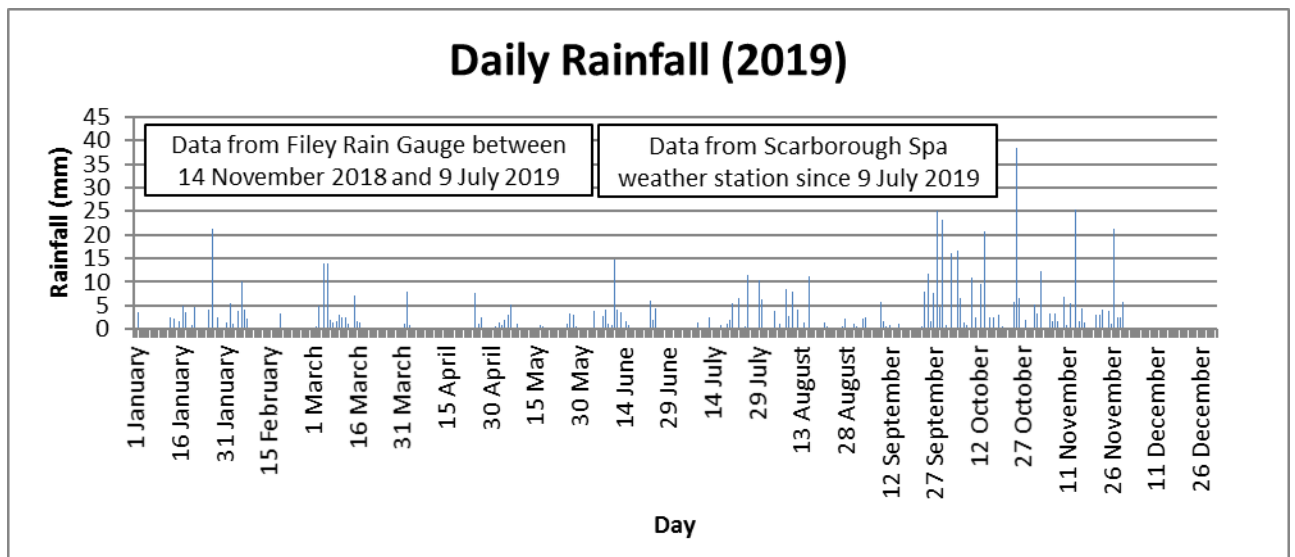
Figure 2.2 Daily rainfall recorded at Scarborough Spa during 2019.

Daily rainfall totals recorded by the Scarborough Spa weather station are presented in Figure 2.2, which shows eleven peaks in daily rainfall over 10 mm, mainly occurring in late September to mid-October. Rainfall peaked between 20 to 25 mm on 28 and 30 September, 14 October, and 14 and 27 November. The highest daily rainfall total over this monitoring period was 38.4 mm on 25 October.

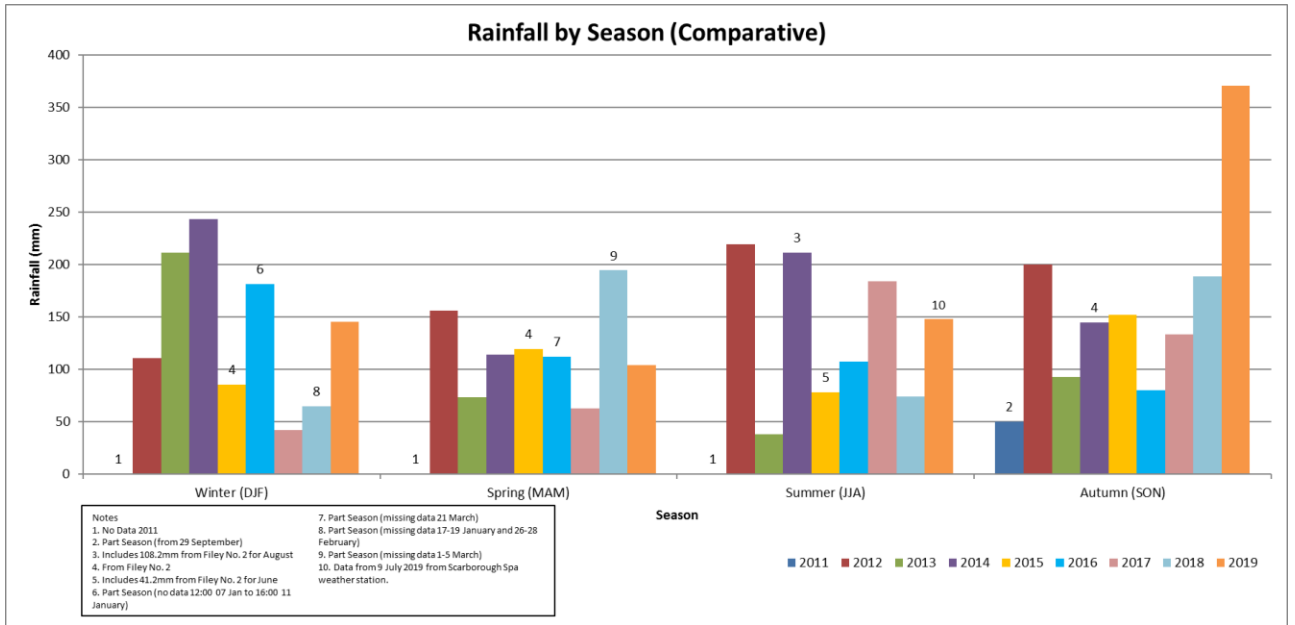
Figure 2.3 Seasonal rainfall comparison (2011-2019)

Seasonal totals are shown in Figure 2.3, which shows that the wettest season tends to be autumn, and that the spring is the driest. The wettest season on record was autumn of 2019 (i.e. September, October and November) that received a total of 371mm rainfall, which is exceptional when compared to previous years. The next wettest season was the winter of 2013/14, with 244mm of rainfall. The winter of 2016/17 and summer 2013 have been the driest on record.

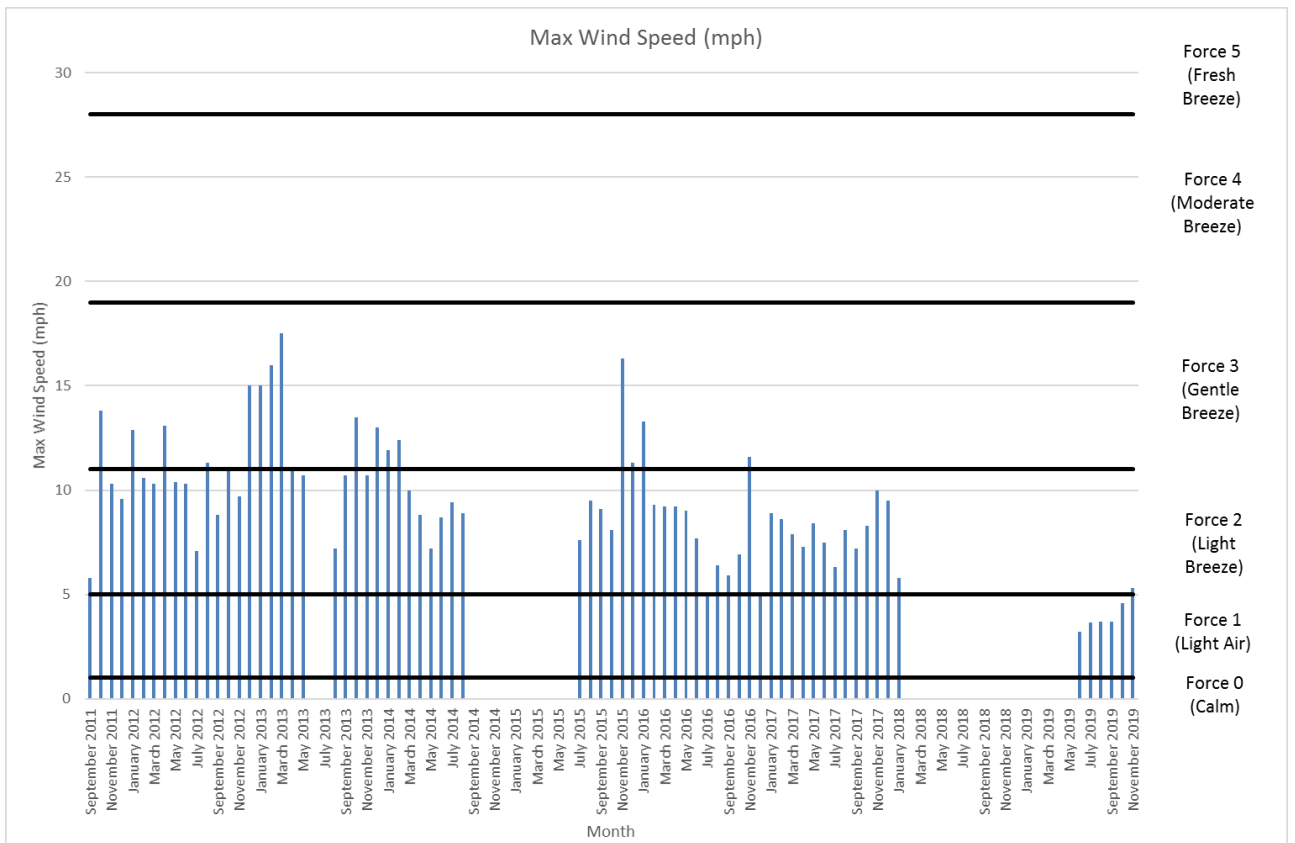
Figure 2.4 Maximum daily wind speed (2011 to 2019).

Wind speed and air temperature records are presented in Figures 2.4 and 2.5. In both cases, the failure of the Scarborough Spa met station means there are no data for the previous monitoring periods.

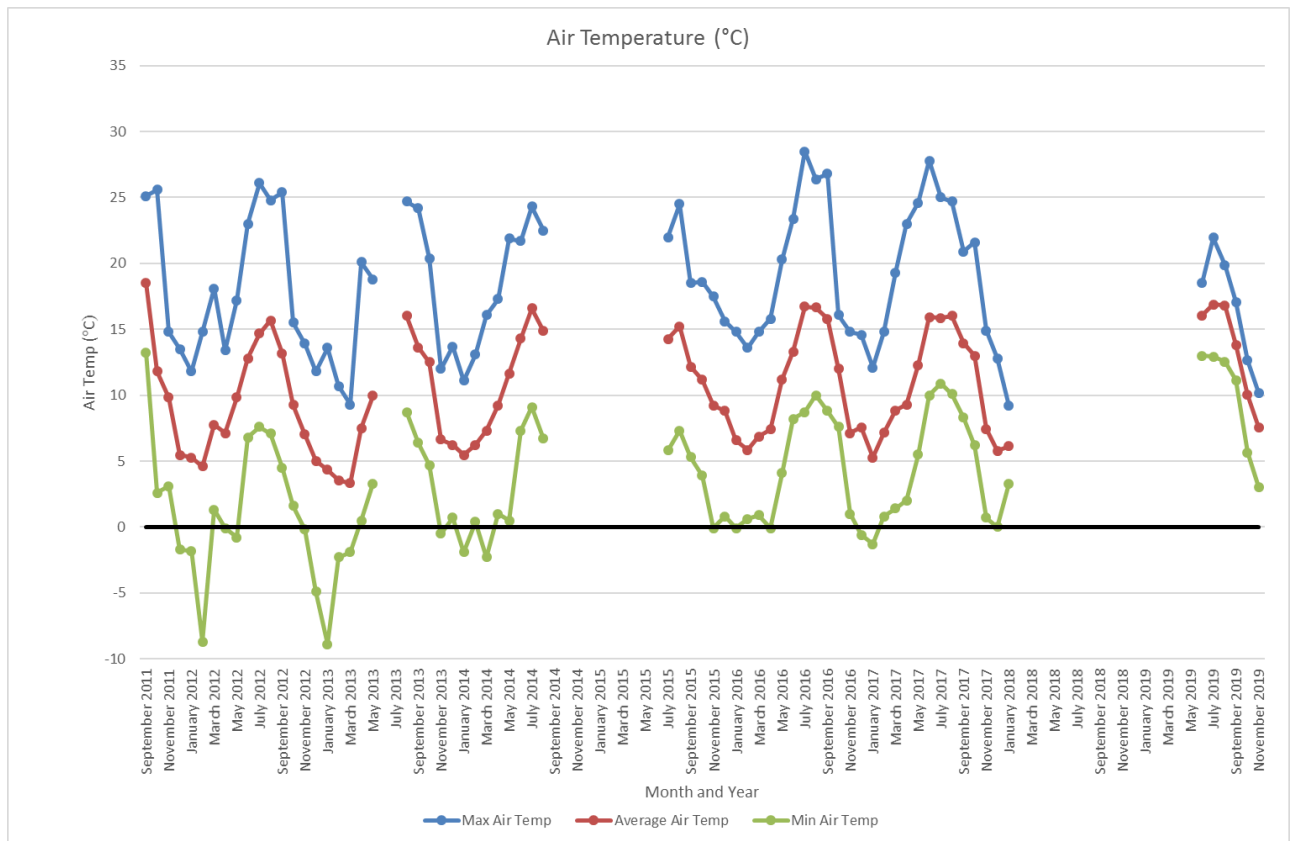
Figure 2.5 Air temperature variation (2011 to 2019).

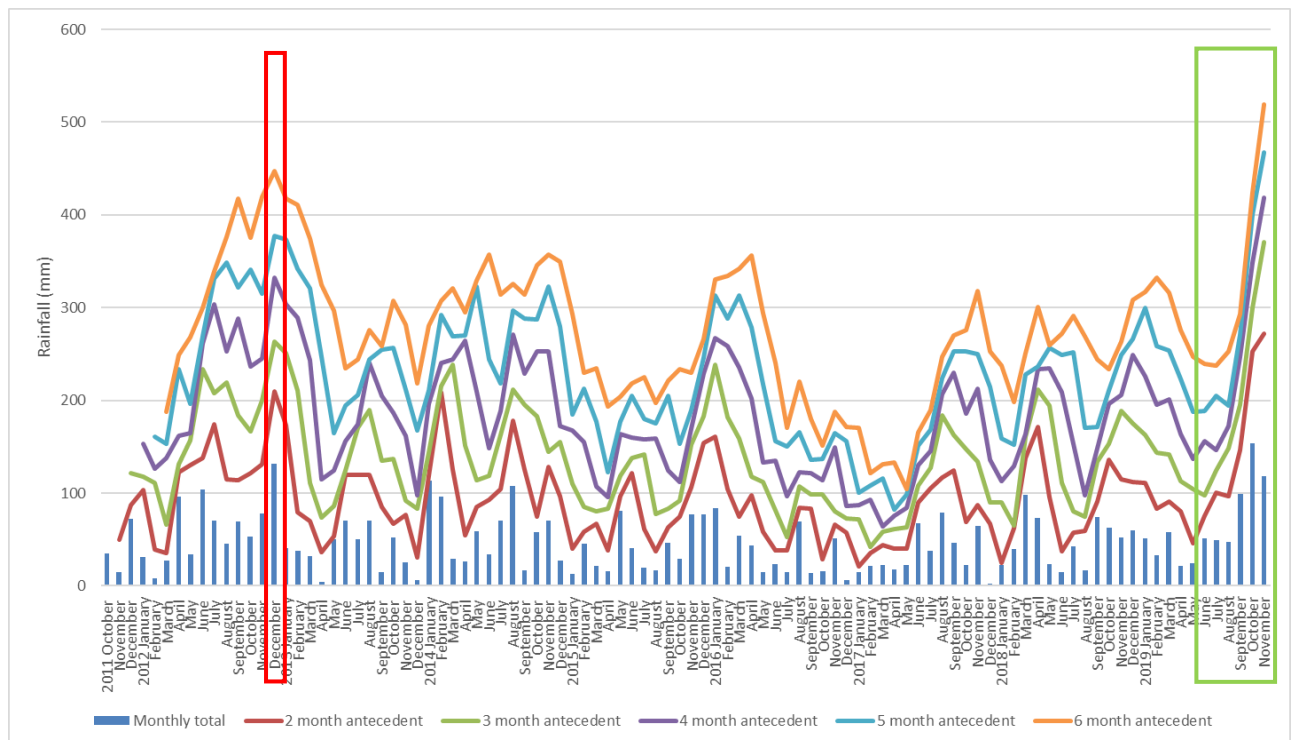
Figure 2.6. Monthly rainfall and two to six-month antecedent totals (2011 to 2019). Ground movements were recorded at Scalby Mills during December 2012 (red box). Current monitoring period shown by green box.

Antecedent rainfall over the current June-November 2019 monitoring period show peaks that are higher than that seen in December 2012. Antecedent rainfall conditions during this monitoring period increase rapidly from September 2019 and continues to rise through the autumn.

Antecedent rainfall totals significantly surpass those seen in December 2012 and it is concluded there is a high likelihood of rainfall-induced landslides occurring during the period Autumn-Winter 2019/2020.

Groundwater levels in South Cliff tend to show a decrease in groundwater levels or remain steady since reaching historical high levels during previous monitoring periods. Some piezometers with data loggers show a response to the peak rainfall events in December, January and March, however, the most common response is for steady or falling groundwater levels, which suggests a lagged response to the drier conditions over spring, and/or a relationship to the 5 or 6-month antecedent rainfall (Figure 2.6).
