Cell 1 Regional Coastal Monitoring Programme Update Report 14: 'Partial Measures' Survey 2022

Scarborough Borough Council August 2022

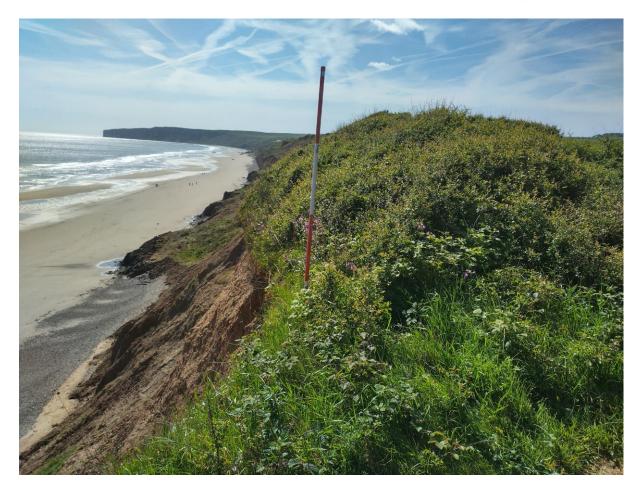
Figure 1 Sediment Cells in England and Wales

The Cell 1 Regional Coastal Monitoring Programme covers approximately 300km of the north east coastline, from the Scottish Border (just south of St. Abb's Head) to Flamborough Head in East Yorkshire. This coastline is often referred to as 'Coastal Sediment Cell 1' in England and Wales (Figure 1). Within this frontage the coastal landforms vary considerably, comprising low-lying tidal flats with fringing salt marshes, hard rock cliffs that are mantled with glacial sediment to varying thicknesses, softer rock cliffs and extensive landslide complexes.

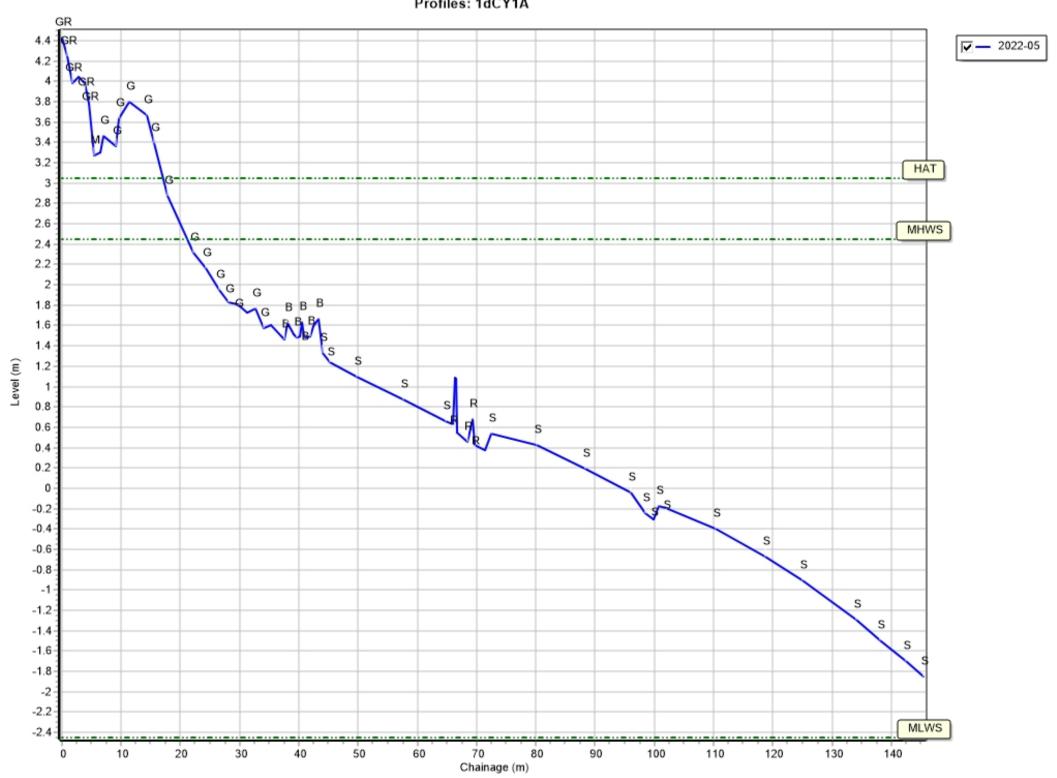
Profiles: 1dCY1

The following sediment feature codes are used on some profile plots:
