Cell 1 Regional Coastal Monitoring Programme: Walk-over Visual Inspections of Assets

Northumberland County Council Final Report

November 2012

Walkover Visual Inspection of Assets

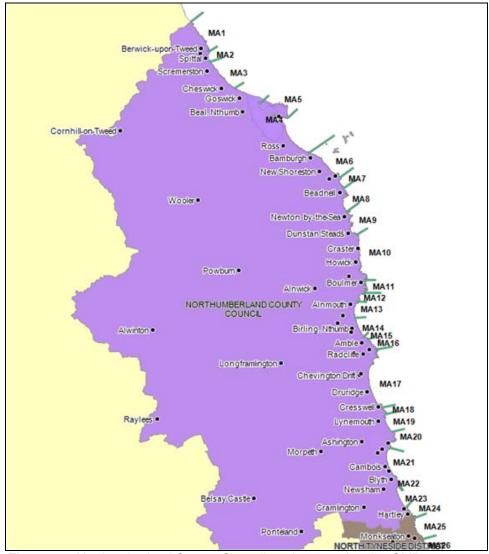
Figure 1-1: Northumberland County Council study area, showing SMP2 Management Units.

Northumberland County Council's coastal frontage is approximately 100km in length extending from Scottish Border in the north to Hartley in the South as shown in **Figure 1-1**. In accordance with previous coastal inspection surveys, this frontage is sub-divided into approximately 146 built asset lengths and 203 natural asset lengths (349 total assets). Detailed maps showing the location of each of these assets are presented in **Appendix A**.
