# Ongoing Analysis and Interpretation of Coastal Monitoring Data

Seventh Review of Full Suite Monitoring

## Geotechnical Interpretative Report

Document Ref. No. 721229/002/GIR/014/Final

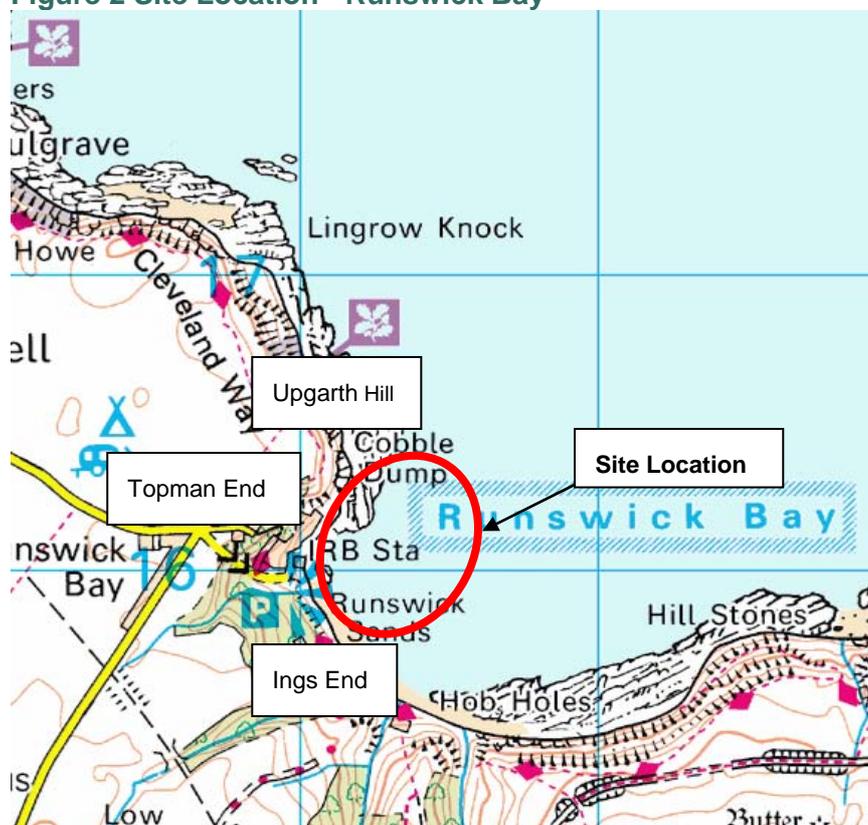
Figure 2 Site Location - Runswick Bay

Three areas of slope instability have been identified within Runswick Bay which have influenced the failure of the previous sea-wall and other sea defences and are still having an effect. These areas are identified in Figure 2 and are described as being:

- Upgarth Hill – The Upper Lias shales and sandstones of the Saltwick Formation forming the cliffs below Upgarth Hill are covered by a thin mantle of glacial clay. Intact cliffs stand at angles of 50 to 70 degrees whereas previous failures have led to slopes of talus debris standing at 20 to 30 degrees with light vegetation cover. The toe of the east facing slopes are protected by a concrete sea-wall and the toe of the south facing slopes are continually being undercut by Runswick Beck which forms an incised valley with over steepened sides to the north east of Runswick village.

- Topman End – is located immediately north of the village, with heavily vegetated, glacial slopes characterised by a network of scarps and transverse tension cracks behind small superficial failures. Slope angles vary between 30 and 40 degrees, decreasing to 5 to 10 degrees mid-slope. These superficial failures are caused by the entrapment of excessive ground water.

- Ings End – this area extends from south of Nettledale Beck to Limekiln Beck a distance of approximately 500 metres over an area known as Dother Pits. Sub-vertical headscarps, formed in glacial tills, are present below the cliff tops between the two becks. Below this scarp are a series of undulating slopes formed by the retrogressive failure of deep seated basal shear planes along the shale bedrock. The slopes can be divided into three distinct zones characterised by uneven ground, ponding water, irregular springs and streams and dense vegetation. Slope angles vary between 15 and 20 degrees with the crests of individual landslide blocks well defined by breaks of slope at lesser angles of between 5 and 10 degrees. Subsequent failures have been triggered by the destabilising effect of an initial failure caused by undercutting of the leading block by progressive coastal erosion. The back scarp areas of the landslip complex has been found to contain saturated sand layers and lenses which are thought to be supplied by a sandstone aquifer (Saltwick Formation) present further inland. Groundwater seepages have been experienced, during ground investigations, from the basal backscarp areas and from within disturbed shales immediately below the glacial tills some distance from the slope toe.

Runswick Bay is situated on the north east coast of England some 16 km north west of Whitby town at NGR NZ 800 160. It is formed between the headlands of Caldron Cliff to the north and Kettleness to the south and comprises a deeply indented sandy bay approximately 2 km in length. The bay is backed mostly by cliffs and steep glacial till coastal slopes. The village of Runswick Bay is developed within the general valley formed by the Runswick and Nettle Dale Becks. The village straddles the boundary between the glacial till slopes which occupy most of the bay and the Jurassic shale and sandstone cliffs to the north. Most of the village is founded on weathered shale but properties near the southern edge and the access road (Runswick Bank) and car parks are founded on glacial till landslide debris. The village is fronted by four separate sea defences, of varying age and construction, which stretch from Runswick Beck north of Caldron Cliff around to Nettle Dale Beck to the south.

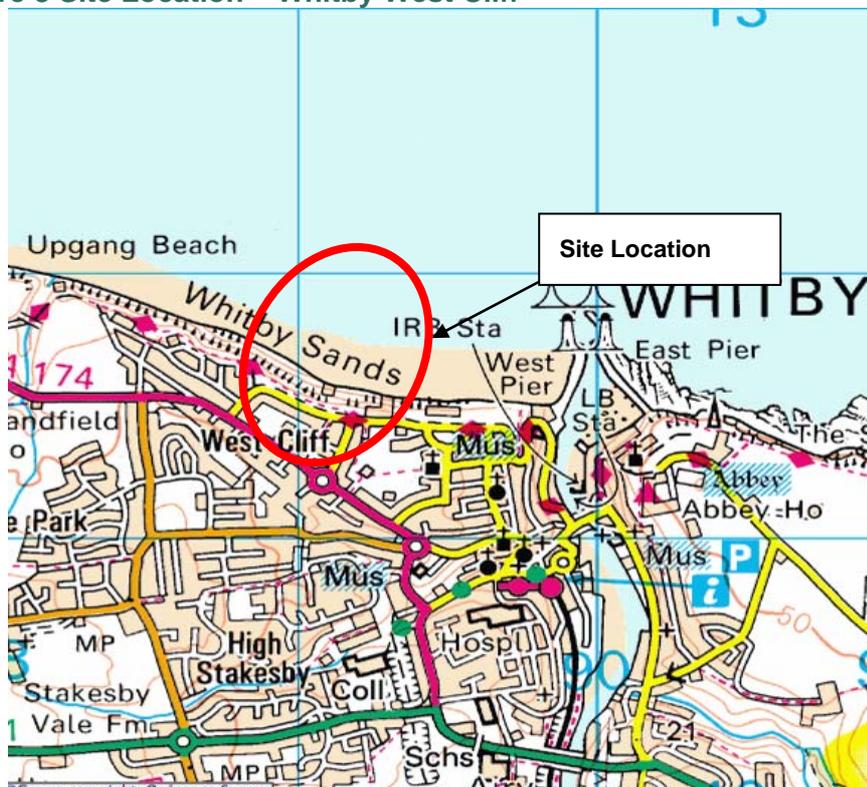
Figure 3 Site Location – Whitby West Cliff

Whitby is located on the north east coast of England approximately 30 miles south of the industrial town of Middlesbrough and 20 miles north of Scarborough. West Cliff is part of a long stretch of exposed cliffs running west-east forming soft, glacial till cliffs to the west of Whitby harbour, see Figure 3. The West Cliff site is bounded by The Spa complex to the east and the Cliff Lift towards the west.

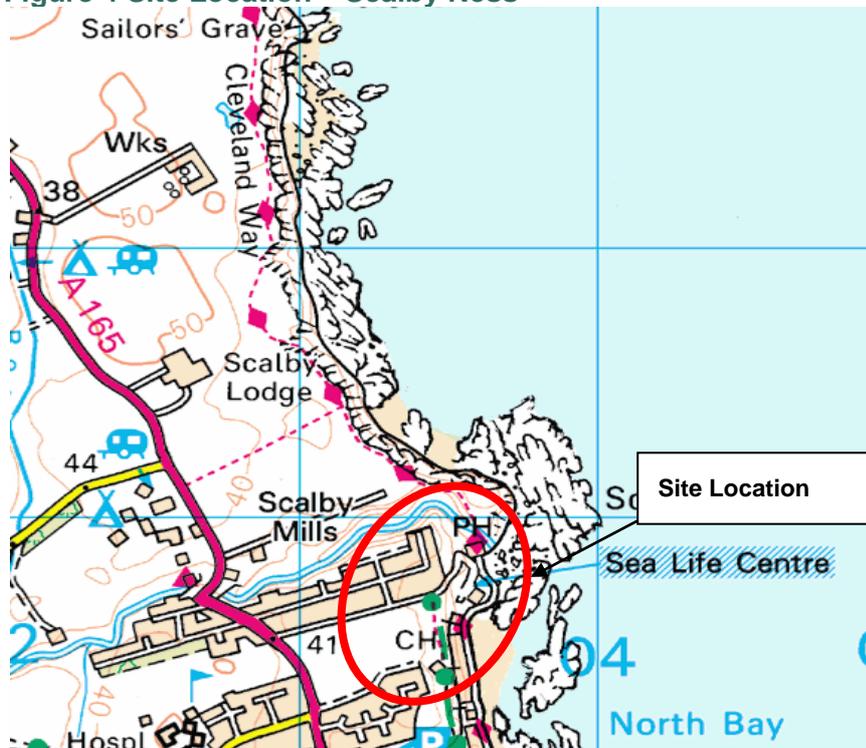
Figure 4 Site Location – Scalby Ness

Scalby Ness forms a broad promontory to the north of Scarborough North Bay, approximately 3 km north of Scarborough. The headland is incised by Scalby Beck which acts as an overflow from the River Derwent when in flood. The beck flows in an east-north easterly direction through Scalby, where at Scalby Mills it changes direction sharply through 90 degrees to flow south easterly at Scalby Ness and outfalls to the sea between Scalby Ness headland and the Sea Life Centre (See Figure 4).

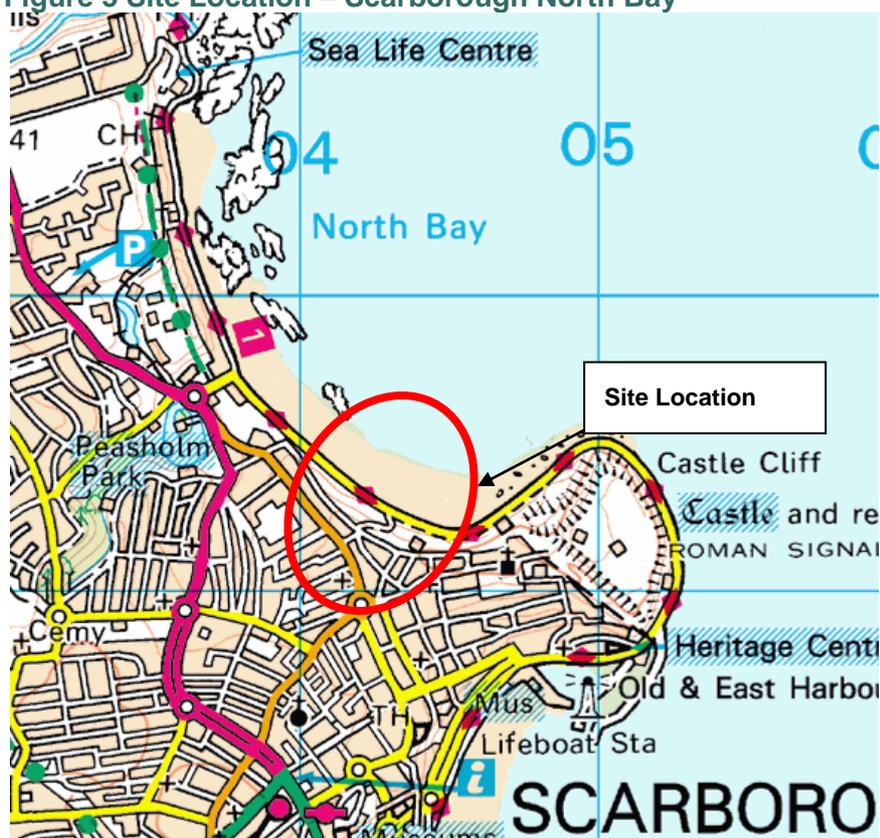
Figure 5 Site Location – Scarborough North Bay

Scarborough North Bay is one of two bays either side of a headland around which the town of Scarborough has developed on the north east coast of Yorkshire. Scarborough North Bay extends from Castle Cliff northwards to Scalby Ness. The site is known as The Holms, an area of sloping, open parkland between the Castle above and Royal Albert Drive (Marine Drive) along the coast. The parkland consists of open grassed areas with groups of semi-mature trees and shrubs and, meandering tarmac footpaths which increase in steepness from the sea front leading up to the south western flanks of Castle Headland. Discrete rock outcrops are clearly visible across the slopes, see Figure 5.

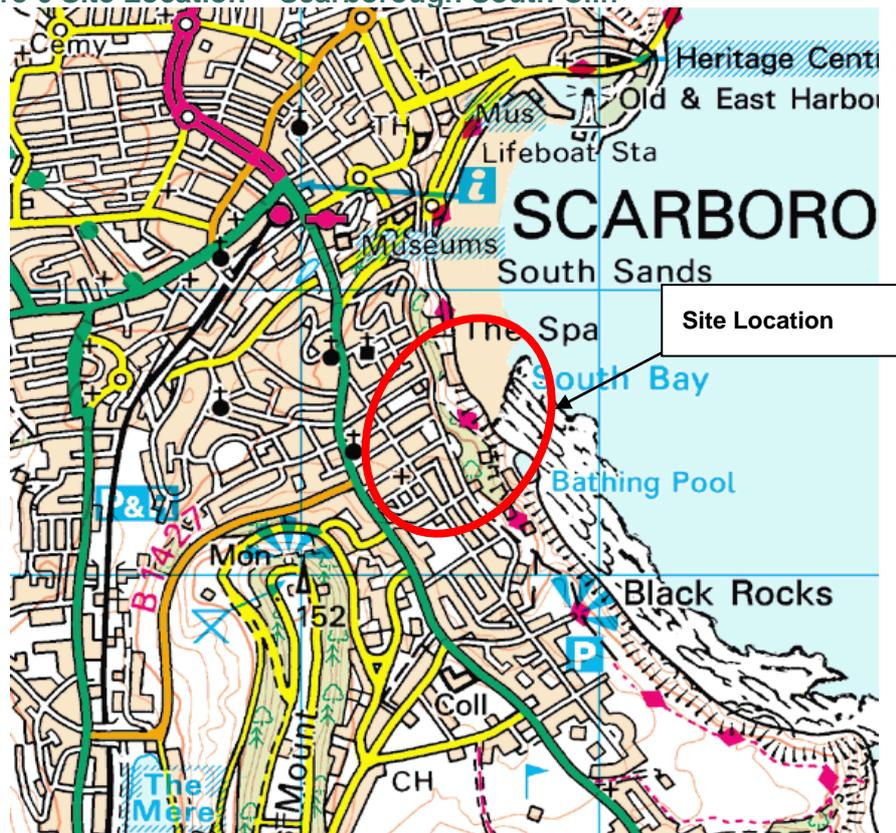
Figure 6 Site Location – Scarborough South Cliff

Scarborough is a popular sea-side resort located on the north east coast of England. The South Cliff occupies the southern bay of Scarborough town with a gently sweeping coastline from the northern promontory of Castle Hill to the Black Rocks some 2km southwards, see Figure 6. The South Cliff site comprises a variety of landscaped gardens stretching from north to south in the following order: Spa Chalet Cliff, Spa Cliff, Prince of Wales Cliff, South Cliff Gardens, Rose Gardens, South Bay Pool Cliff, Holbeck Gardens, Holbeck Cliff and Wheatcroft Cliff. The cliff top is a gently undulating plateau surface with a road, Esplanade Crescent, running parallel to the cliff line. Large houses and hotels line the landward side of the road, set-back generally 30metres, but up to 100metres in places, from the cliff edge.

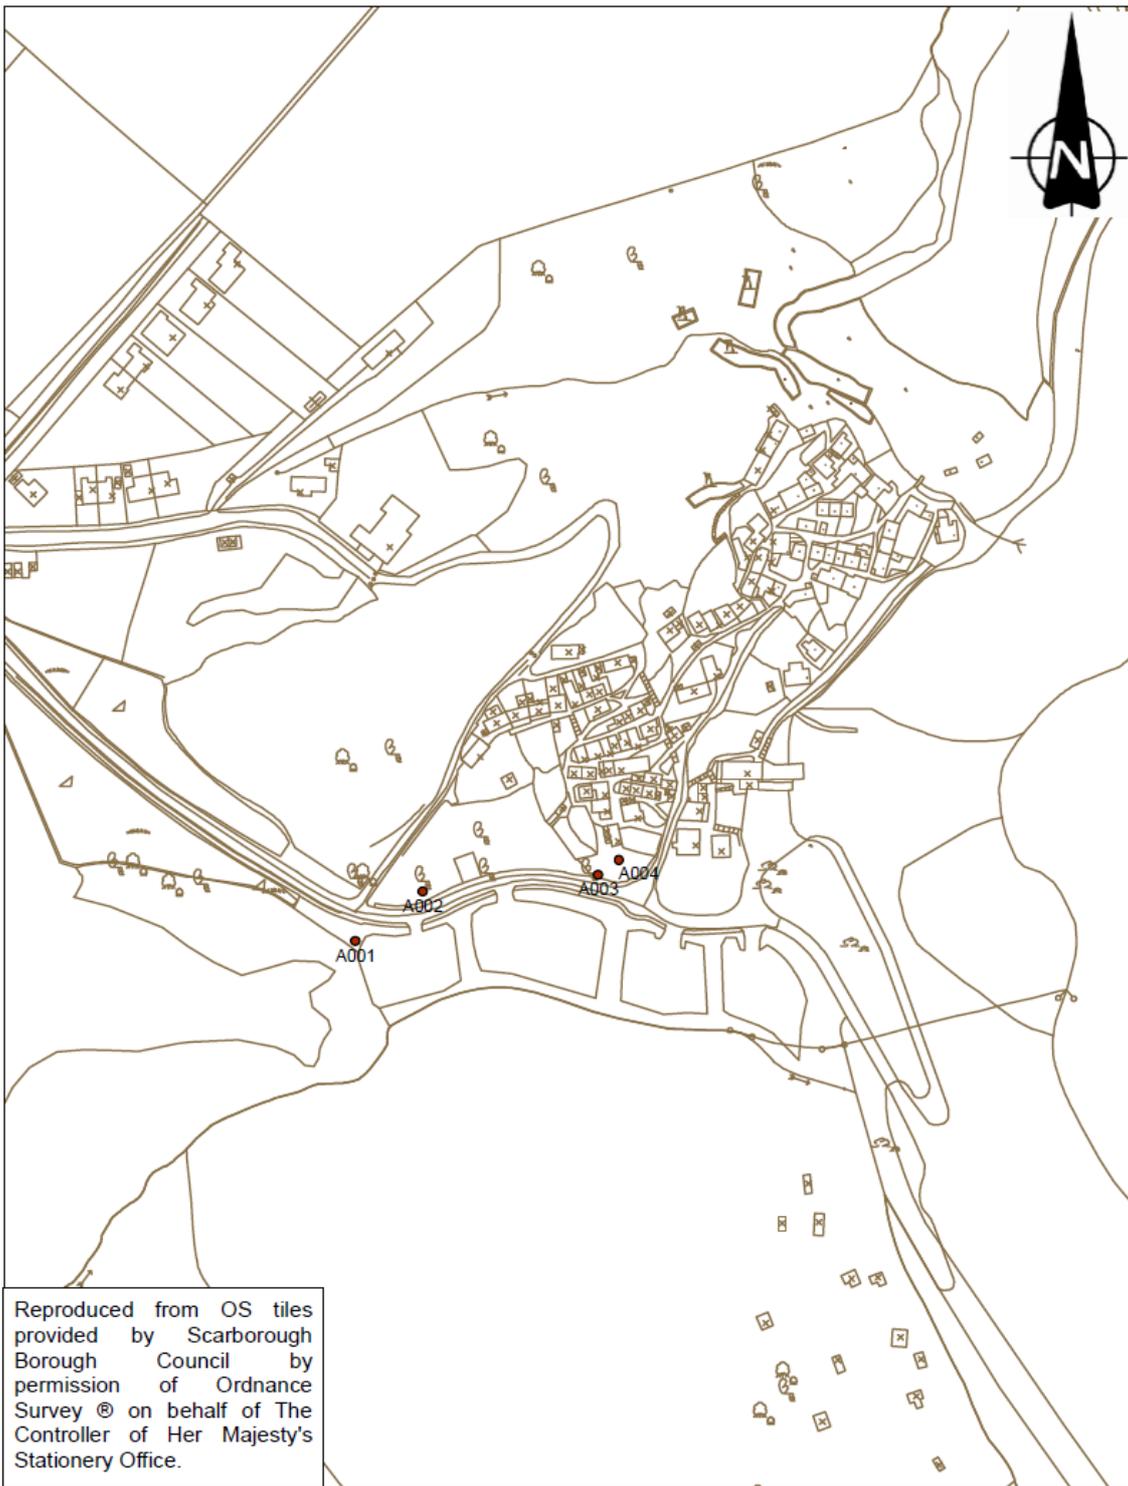
Drawing No. 1 Location Plan of Runswick Bay

Runswick Bay Inclinometer Location Plan	Scale: 1:2,500

The ongoing monitoring regime was initialised in July 2009 and follows that detailed in Section 2.5.1, above. Following on from the findings of the *Condition Survey Report*, the monitoring regime consists of existing inclinometers (A001, A002, A003 and A004) located along the edge of the main access road leading down into Runswick village (See Appendix A, Drawing 1). Groundwater was measured in the inclinometer tubes with a dip meter.

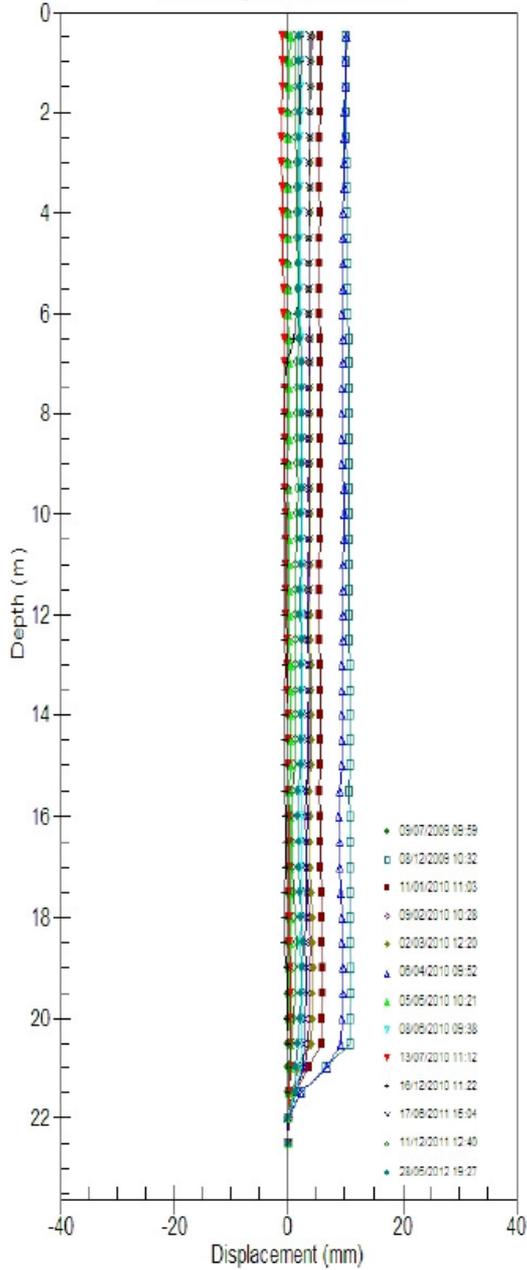
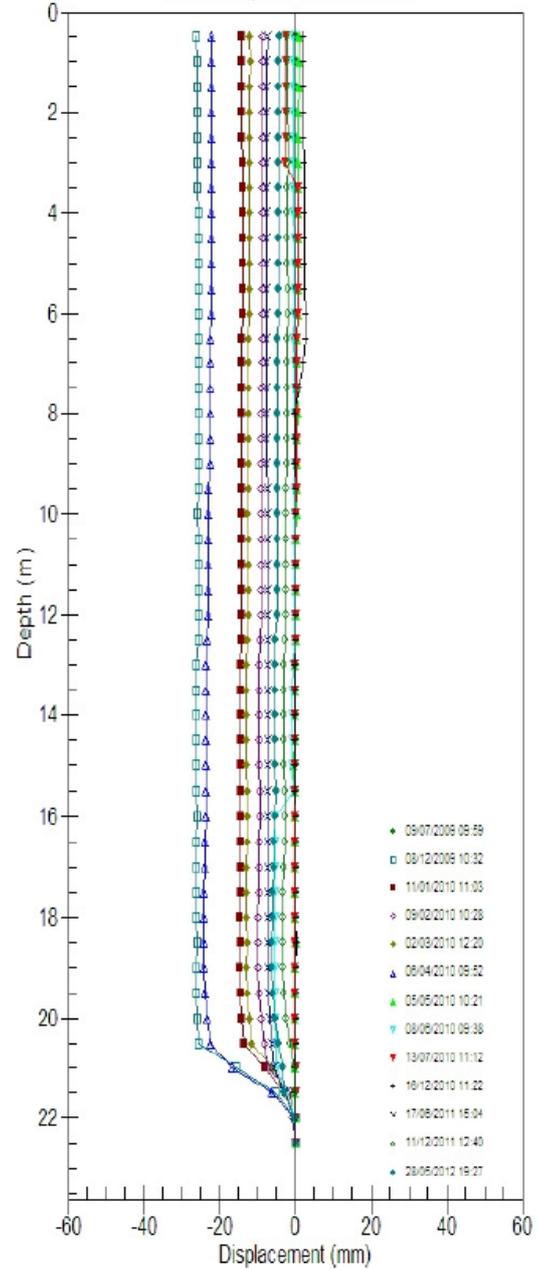
### RB:A001 - A Axis Cumulative

### RB:A001 - B Axis Cumulative

PROJECT: 1022971 Ongoing Analysis of Coastal Monitoring Data

SITE: Runswick Bay

In addition to the monitoring frequency undertaken at the sites stated above, monitoring at Runswick Bay was increased to monthly intervals from February 2010 extending through to July 2010 due to suspected ground movements observed within inclinometers A001 and A004 in December 2009.

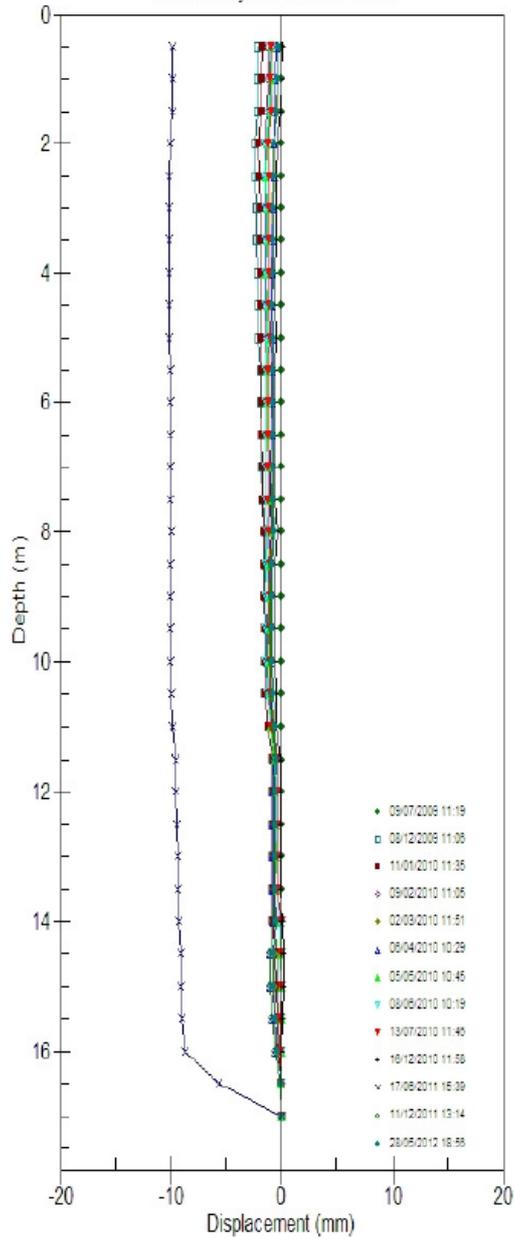
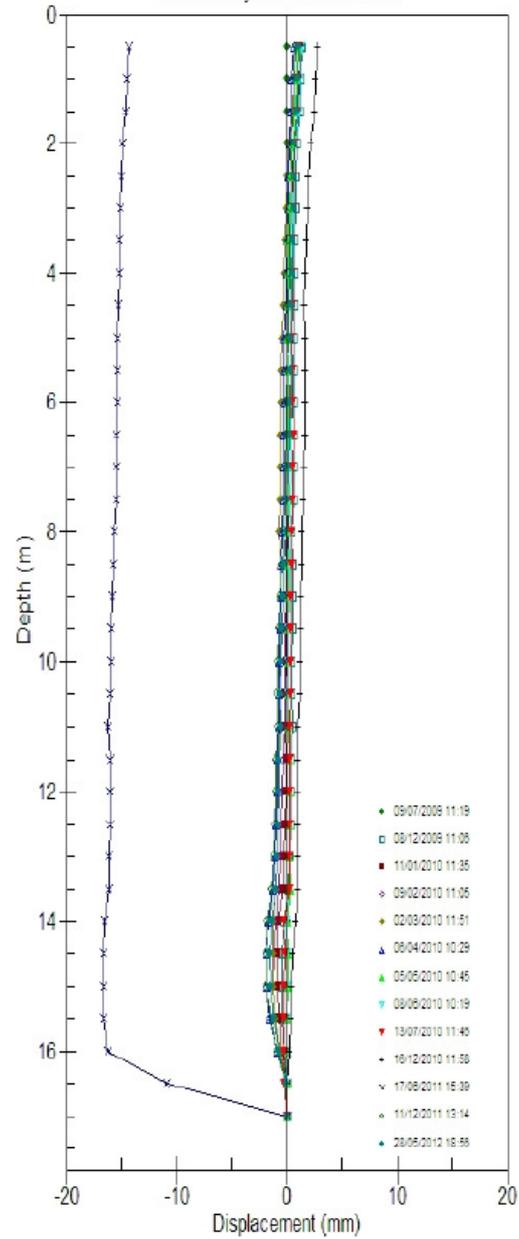
### RB:A002 - A Axis Cumulative

### RB:A002 - B Axis Cumulative

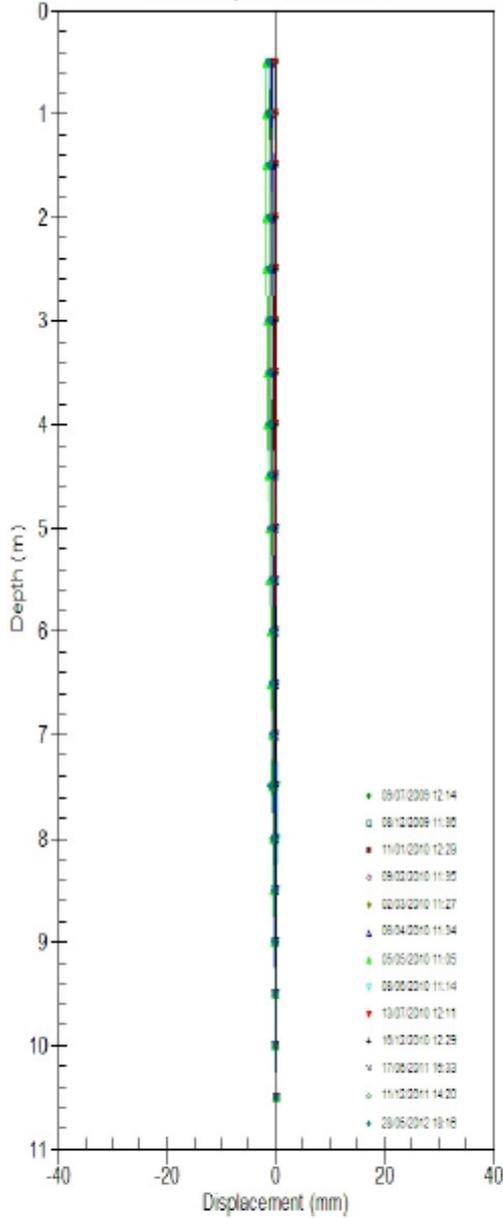
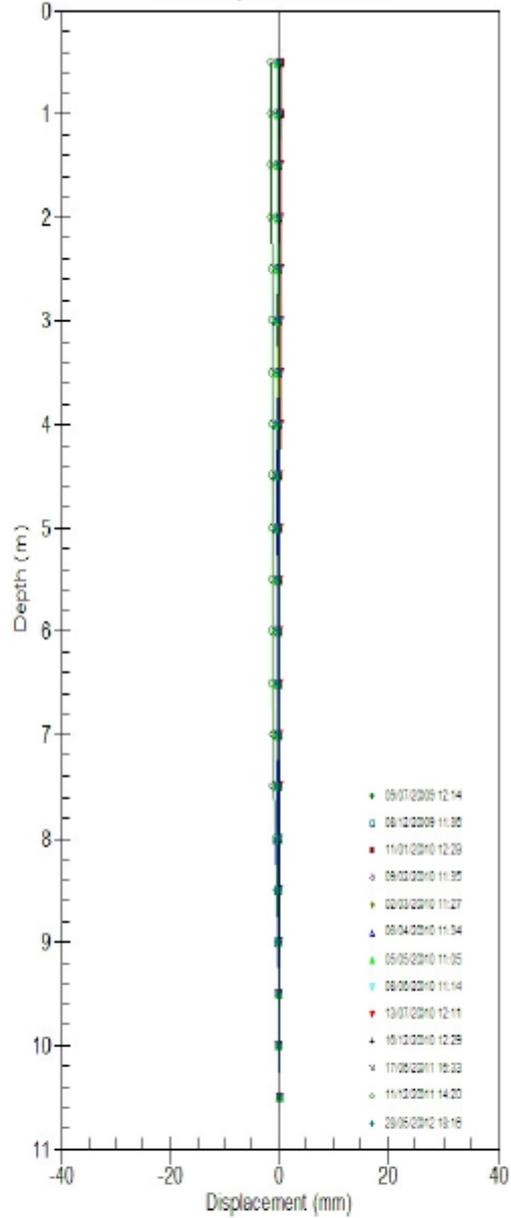
### RB:A003 - A Axis Cumulative

### RB:A003 - B Axis Cumulative

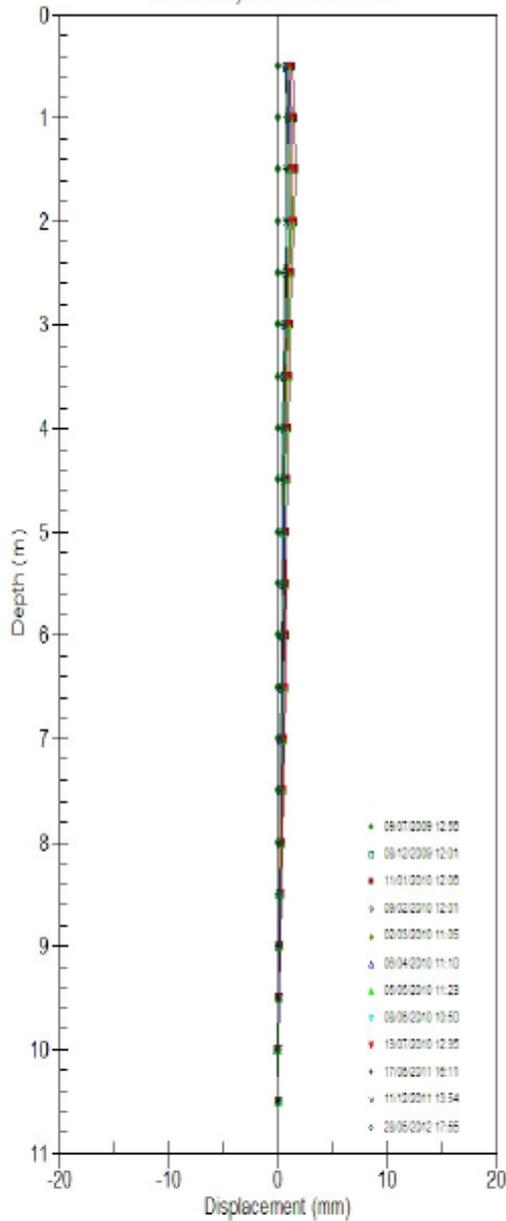
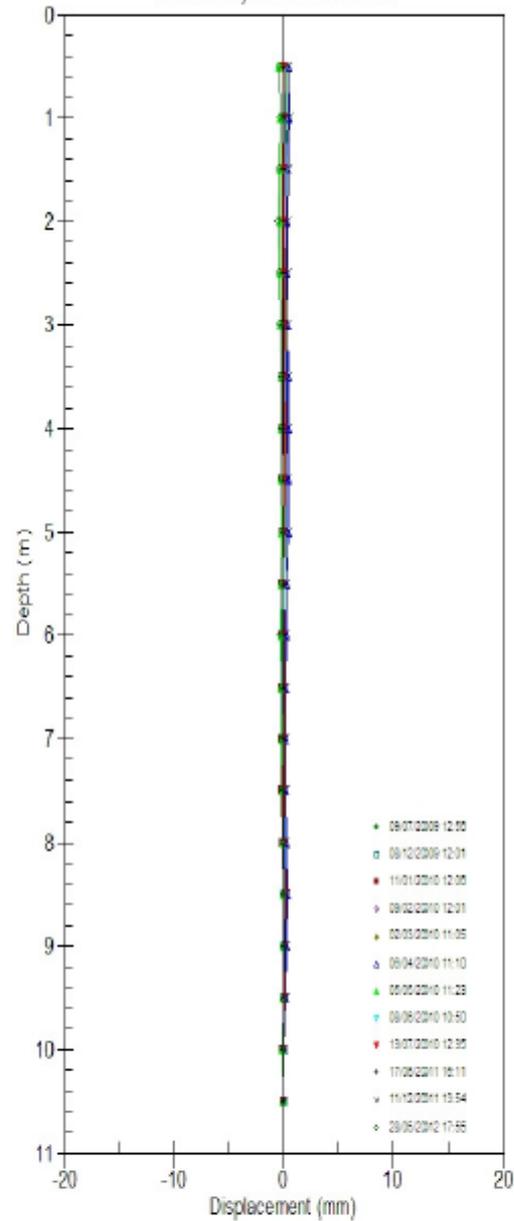
### RB:A004 - A Axis Cumulative

### RB:A004 - B Axis Cumulative

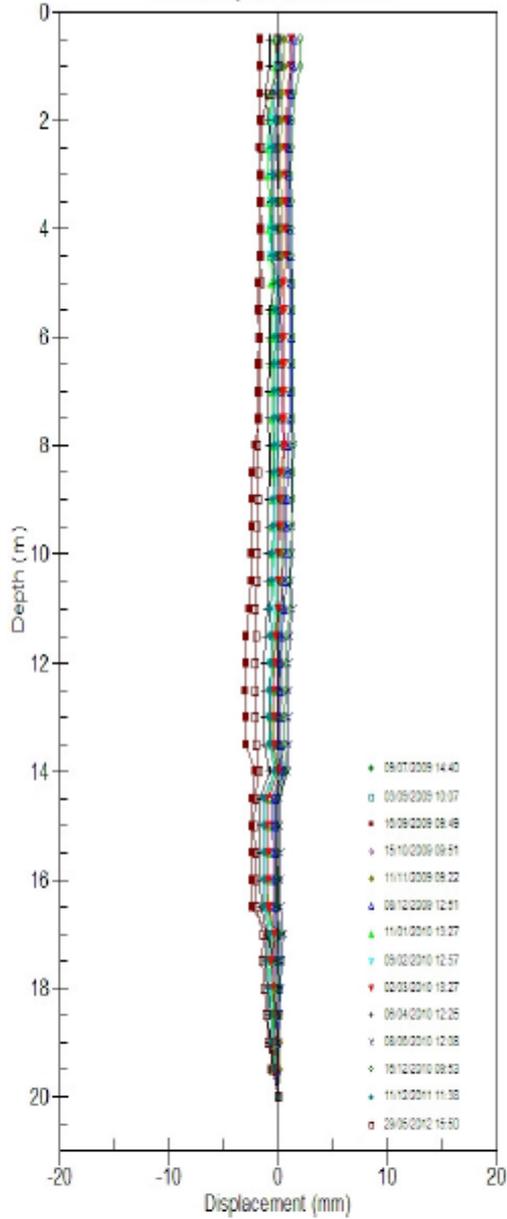
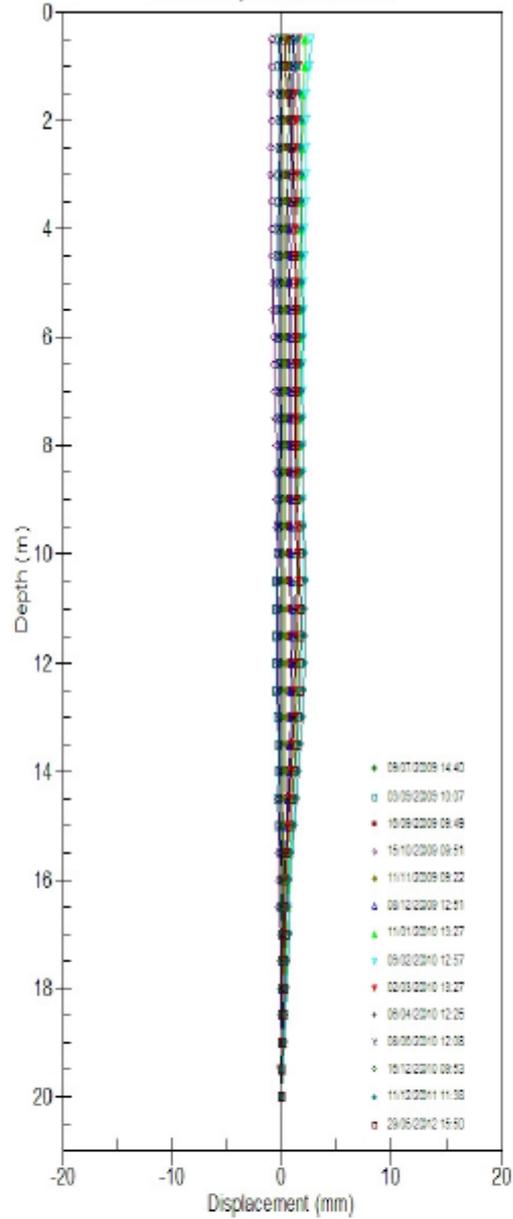
### WWC:BH2 - A Axis Cumulative

### WWC:BH2 - B Axis Cumulative

PROJECT: 1022971 Ongoing Analysis of Coastal Monitoring Data  
SITE: Whitby West Cliff  
INSTALLATION: BH2  
COMPANY: Mouchel Ltd  
CLIENT: Scarborough Borough Council  
NOTE: A0 Direction = North

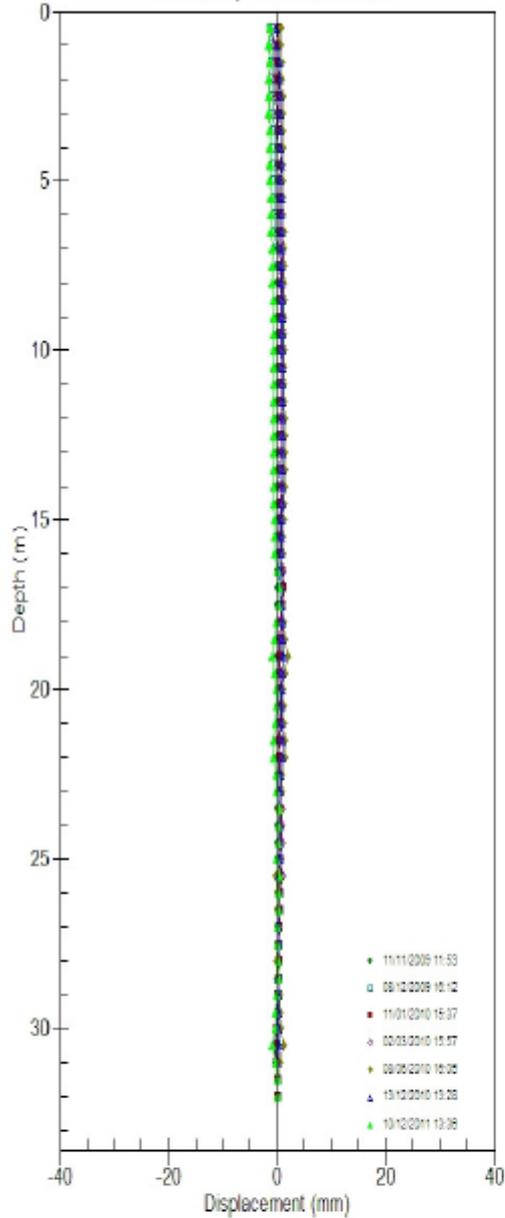
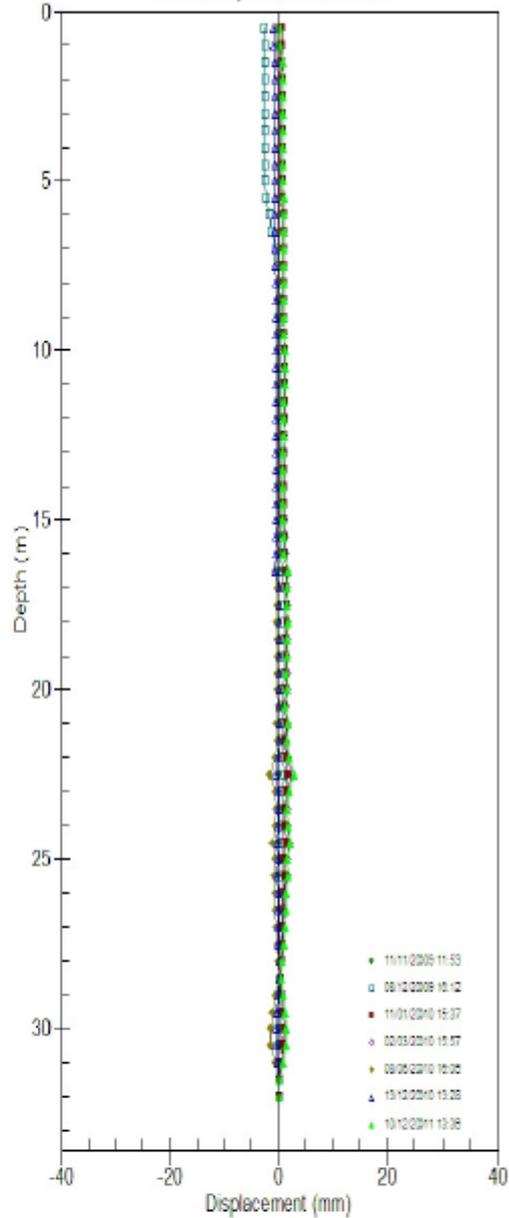
### SN:I1 - A Axis Cumulative

### SN:I1 - B Axis Cumulative

PROJECT: 1022971 Ongoing Analysis of Coastal Monitoring Data

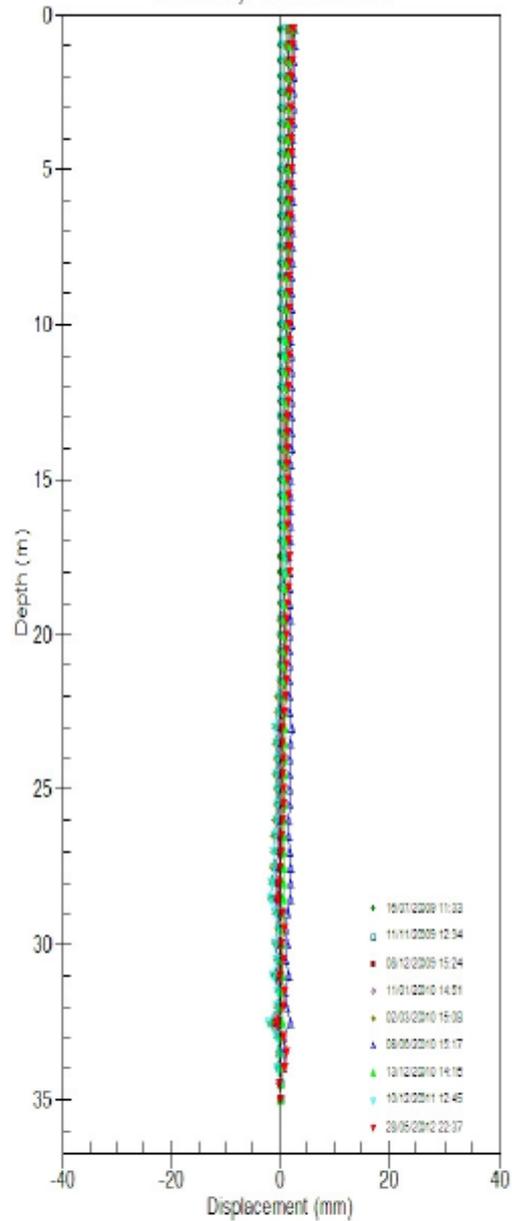
### SN:I2 - B Axis Cumulative

Initial survey: 16/07/2009 11:33

PROJECT: 1022971 Ongoing Analysis of Coastal Monitoring Data

SITE: Scalby Ness

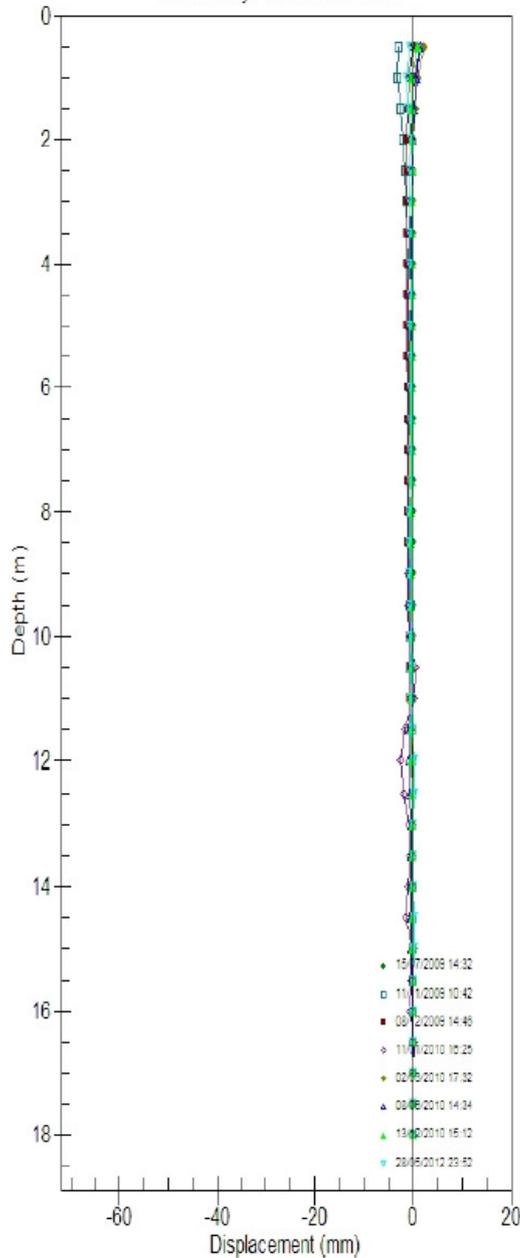
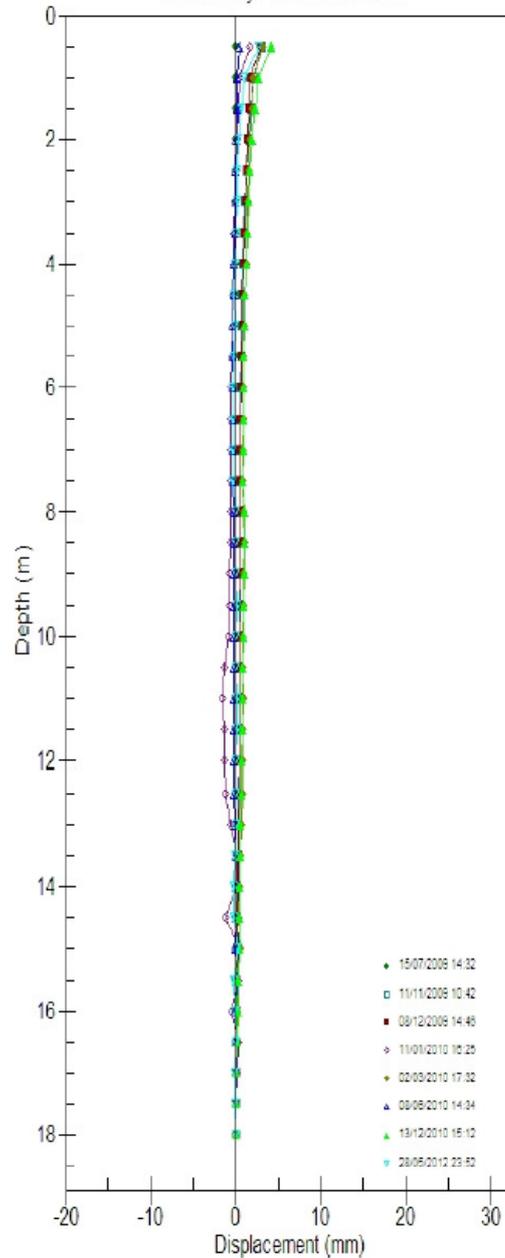
### SN:I3 - A Axis Cumulative

Initial survey: 15/07/2009 14:32

### SN:I3 - B Axis Cumulative

PROJECT: 1022971 Ongoing Analysis of Coastal Monitoring Data

SITE: Scalby Ness

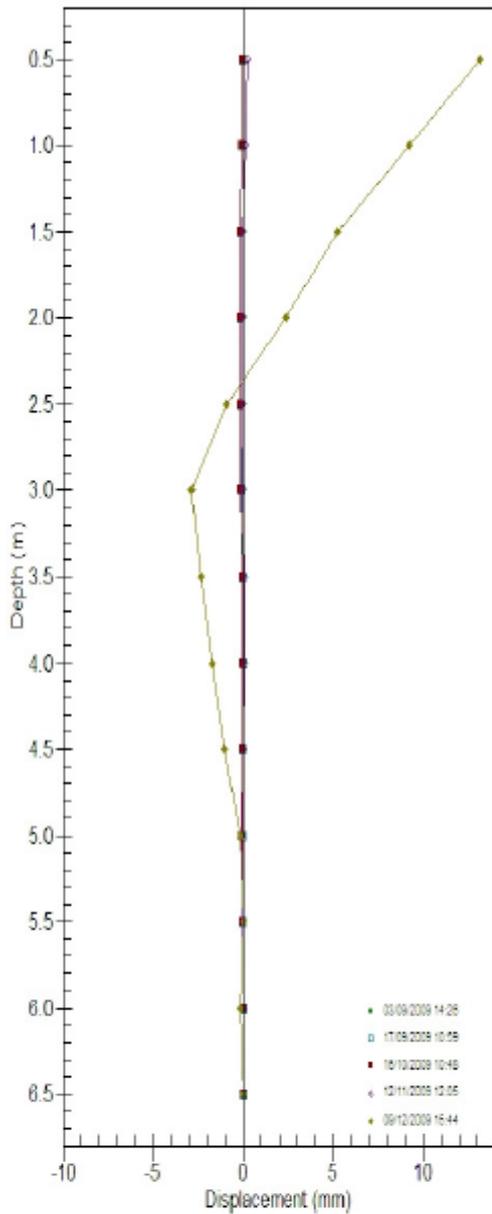
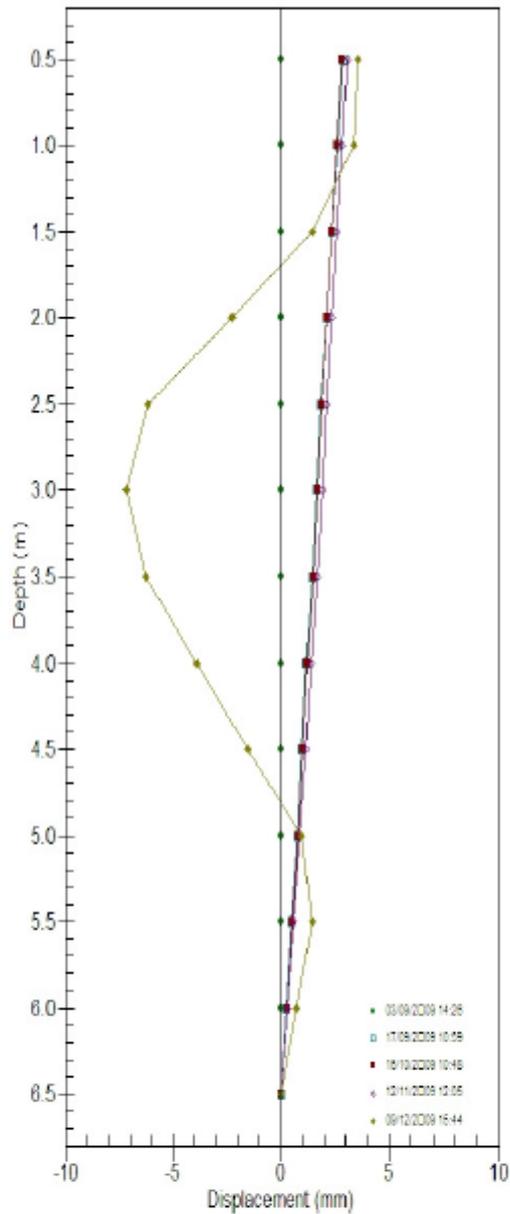
### OASIS:BH1 - A Axis Cumulative

Initial survey: 03/09/2009 14:26

### OASIS:BH1 - B Axis Cumulative

PROJECT: 1022971 Ongoing Analysis of Coastal Monitoring Data  
SITE: OASIS CAFE  
INSTALLATION: BH1  
COMPANY: Mouchel Ltd  
CLIENT: Scarborough Borough Council  
NOTE: A0 Direction = East

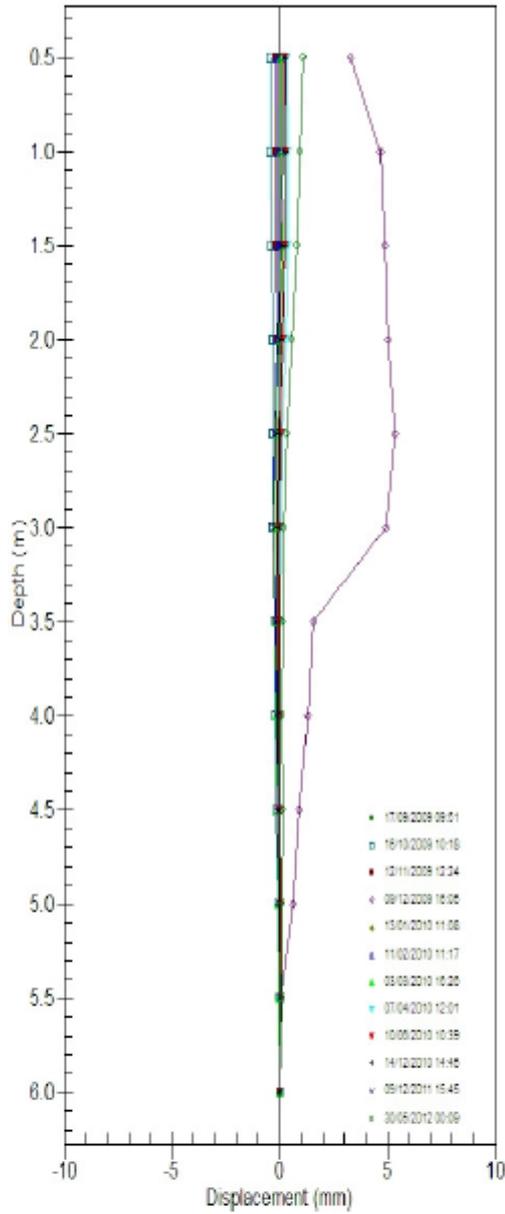
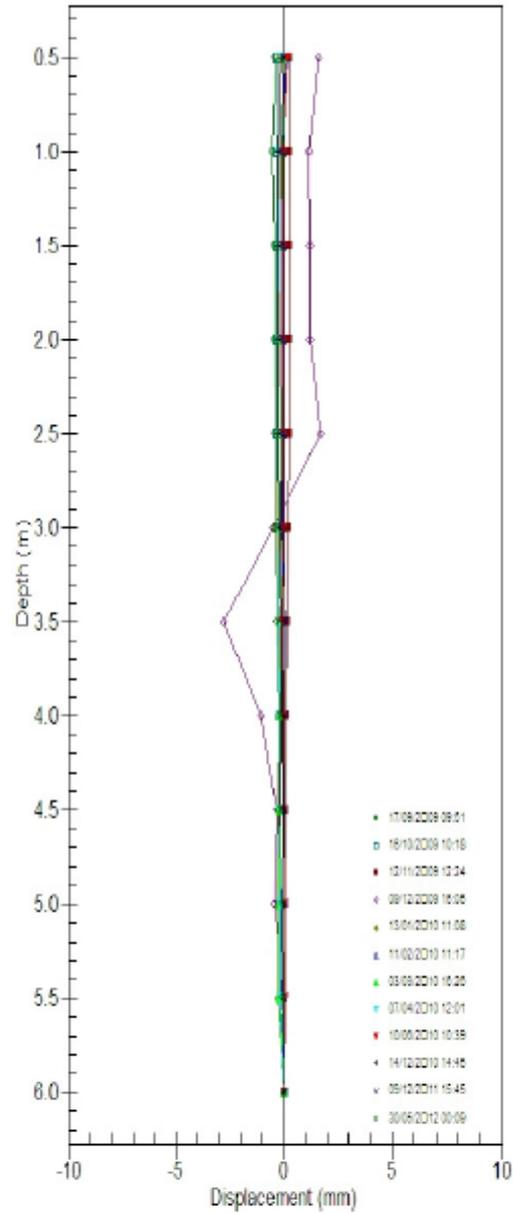
### OASIS:BH3 - A Axis Cumulative

Initial survey: 17/09/2009 09:51

### OASIS:BH3 - B Axis Cumulative

PROJECT: 1022971 Ongoing Analysis of Coastal Monitoring Data

SITE: OASIS CAFE

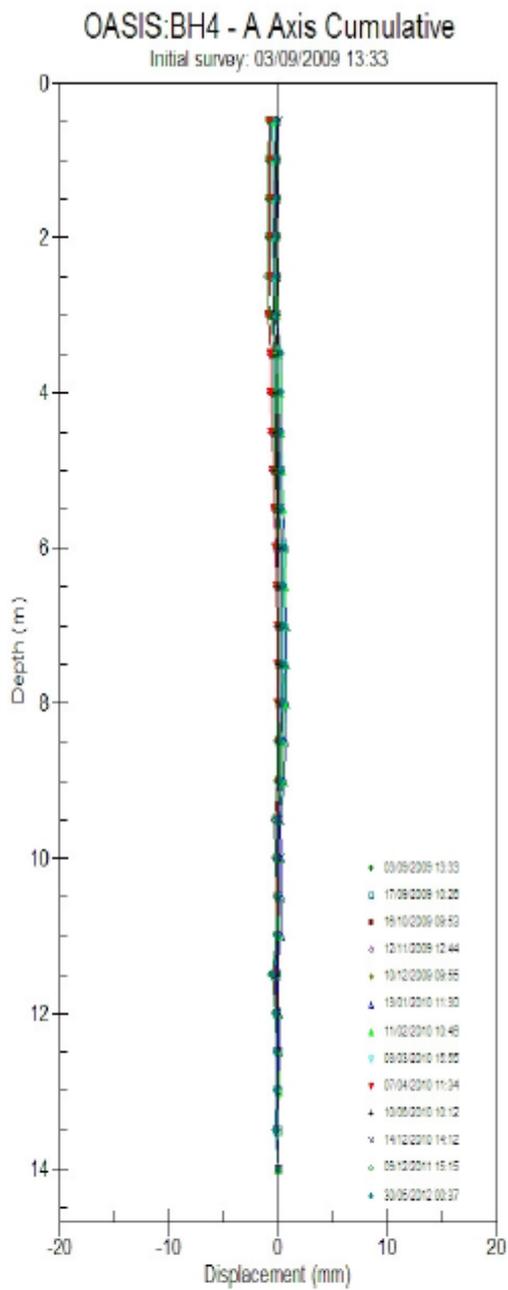
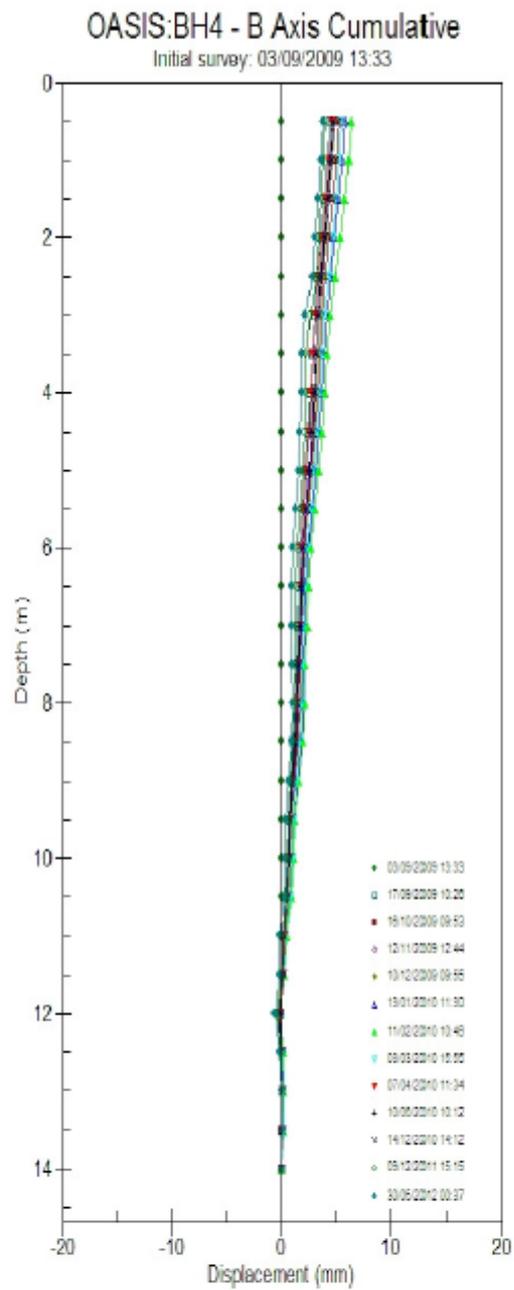
PROJECT: 1022971 Ongoing Analysis of Coastal Monitoring Data  
 SITE: OASIS CAFE  
 INSTALLATION: BH4  
 COMPANY: Mouchel Ltd  
 CLIENT: Scarborough Borough Council  
 NOTE: A0 Direction = East

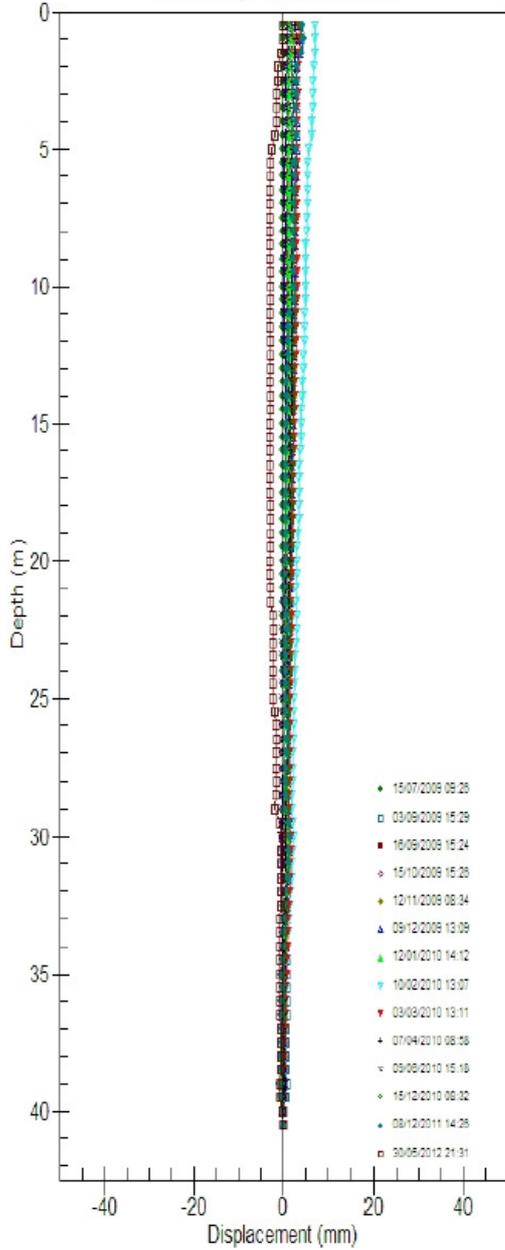
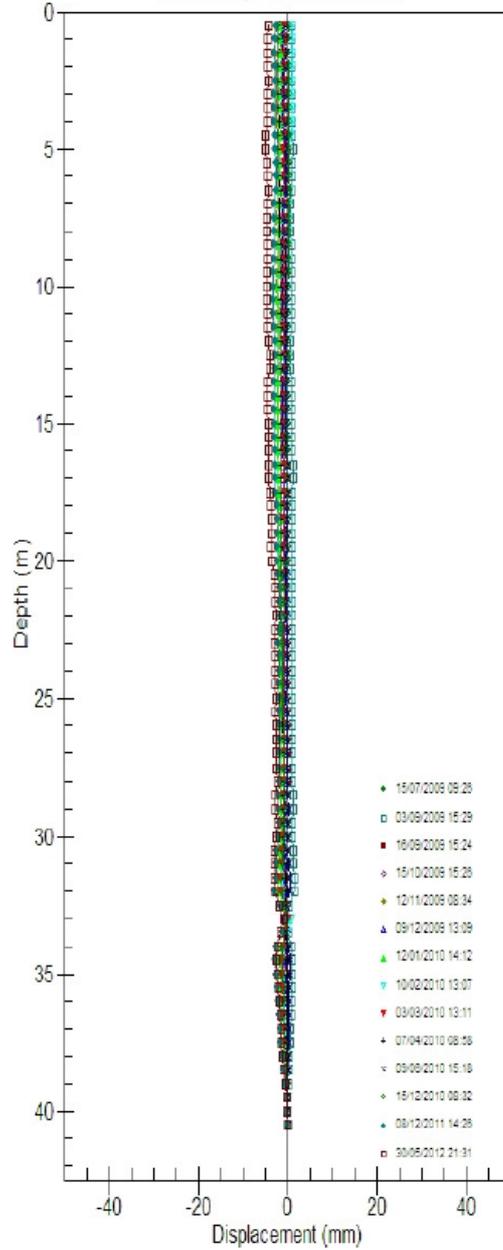
### SSC:AA04 - A Axis Cumulative

Initial survey: 15/07/2009 09:26

### SSC:AA04 - B Axis Cumulative

PROJECT: 1022971 Ongoing Analysis of Coastal Monitoring Data

SITE: Scarborough South Cliffs
