# Ongoing Analysis and Interpretation of Coastal Monitoring Data

Seventh Review of Full Suite Monitoring

## Geotechnical Interpretative Report

Document Ref. No. 721229/002/GIR/014/Final

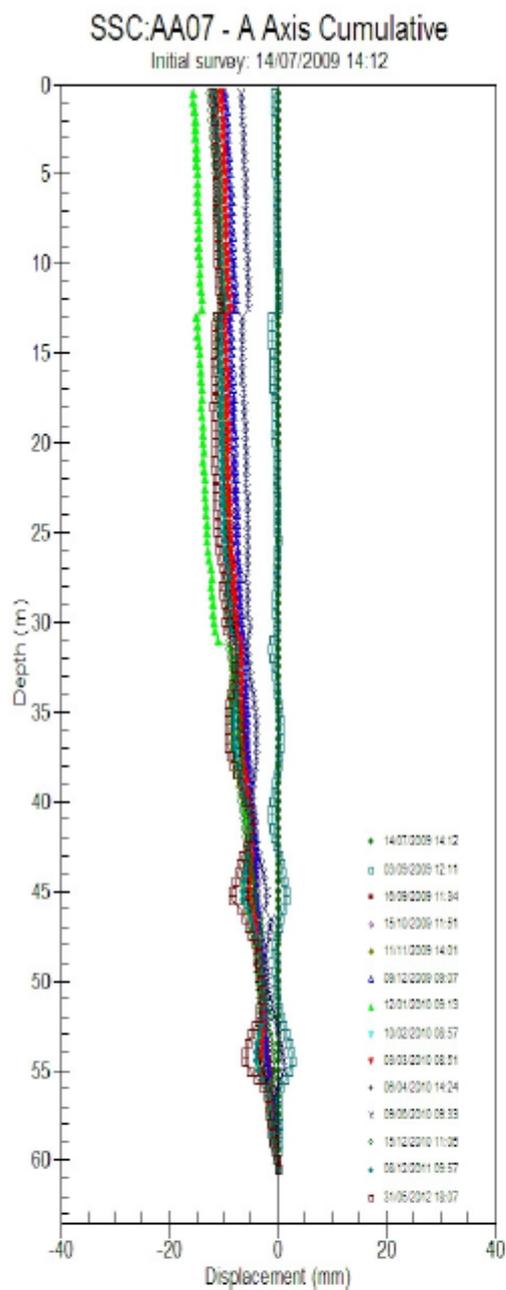
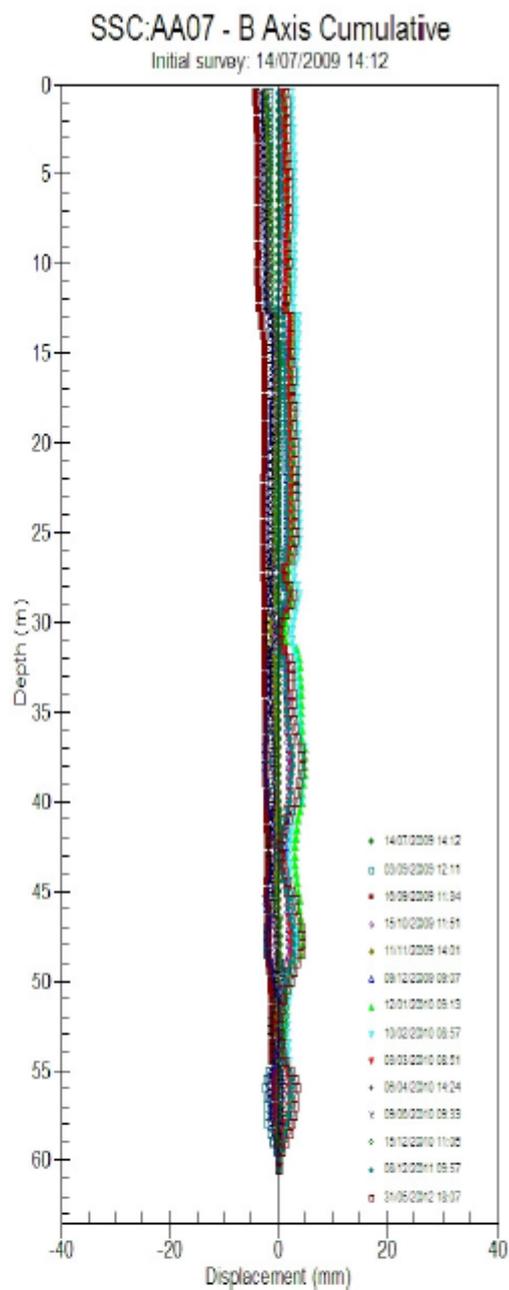
PROJECT: 1022971 Ongoing Analysis of Coastal Monitoring Data  
 SITE: Scarborough South Cliffs  
 INSTALLATION: AA07 (BH2)  
 COMPANY: Mouchel Ltd  
 CLIENT: Scarborough Borough Council  
 NOTE: A0 Direction = North East

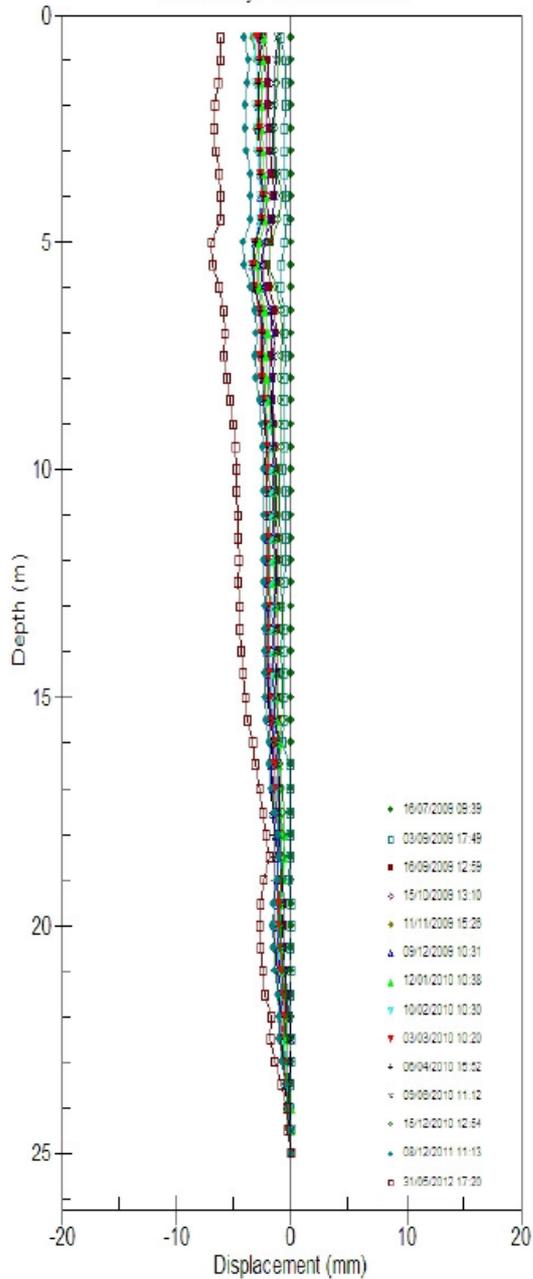
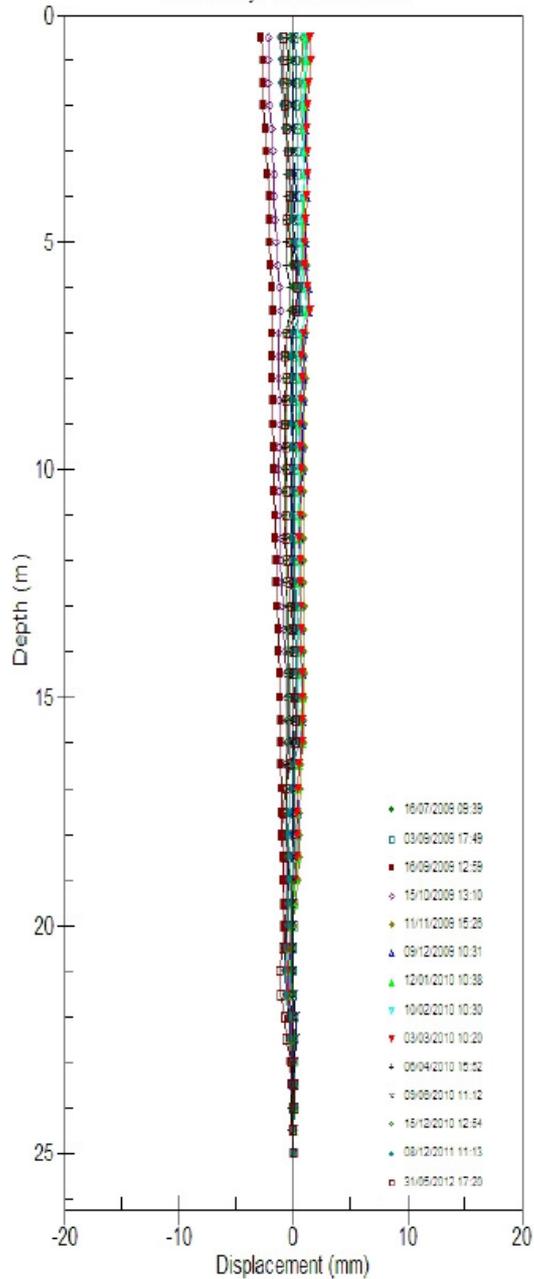
### SSC:AA08 - A Axis Cumulative

Initial survey: 16/07/2009 09:39

### SSC:AA08 - B Axis Cumulative

PROJECT: 1022971 Ongoing Analysis of Coastal Monitoring Data

SITE: Scarborough South Cliffs

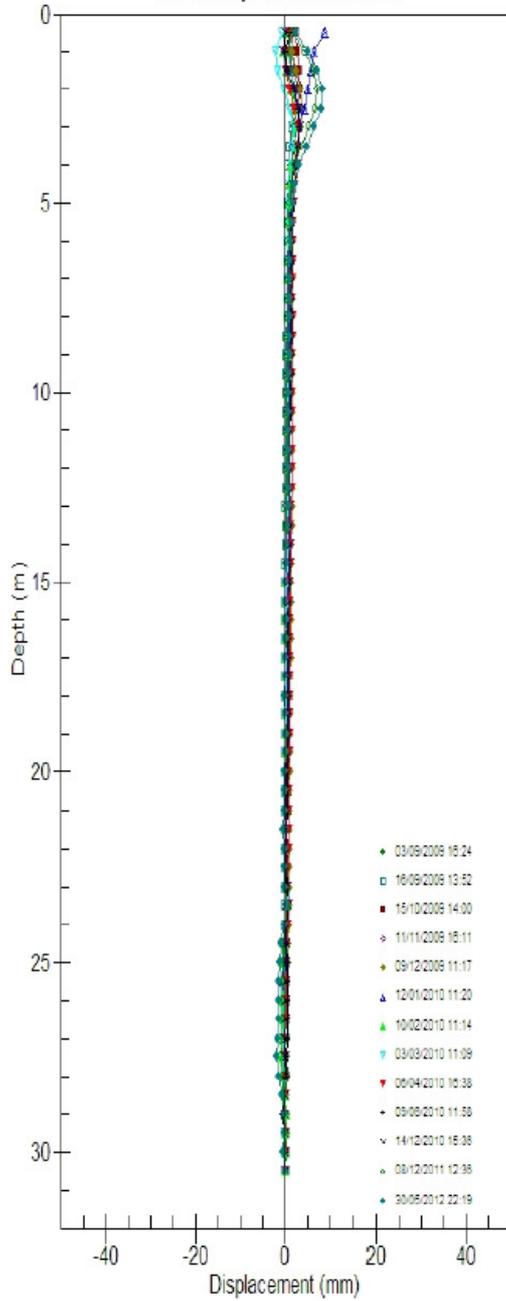
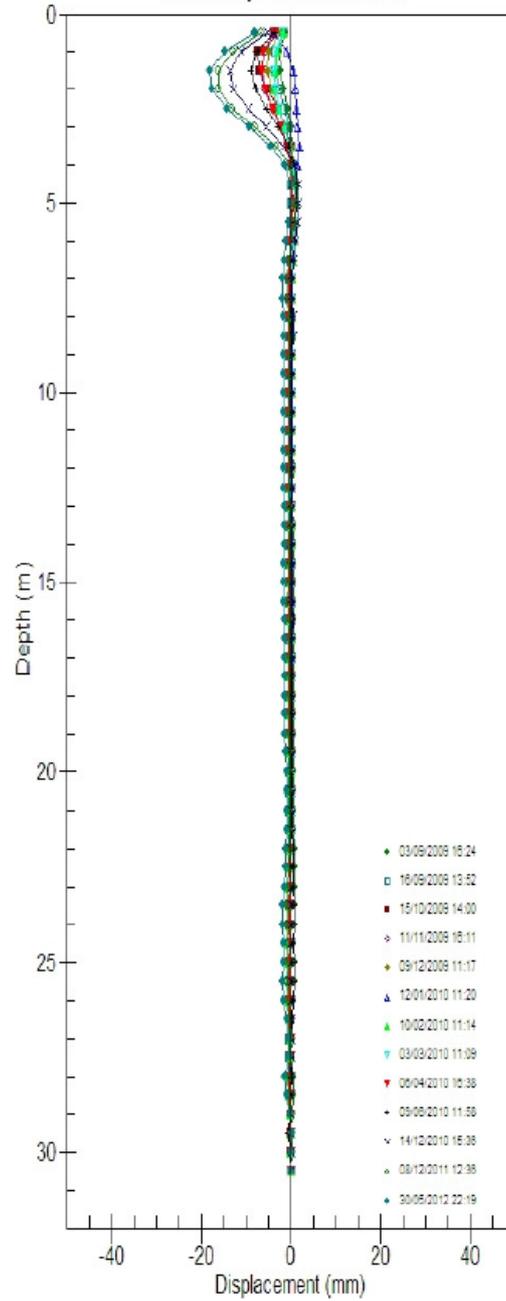
### SSC:AA10 - A Axis Cumulative

Initial survey: 15/07/2009 11:20

### SSC:AA10 - B Axis Cumulative

PROJECT: 1022971 Ongoing Analysis of Coastal Monitoring Data

SITE: Scarborough South Cliffs

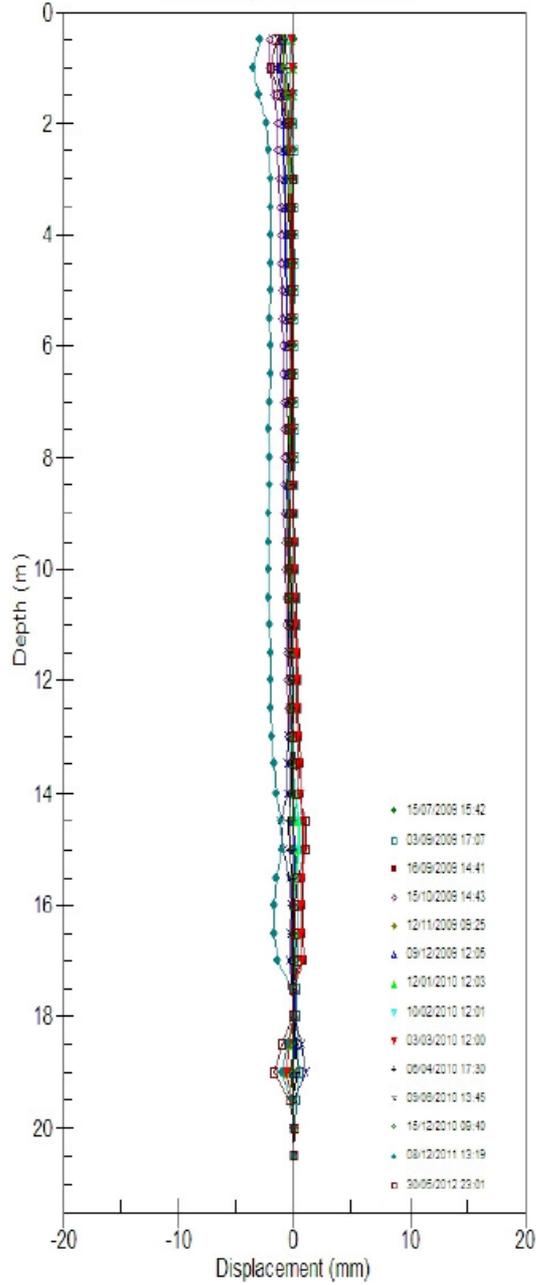
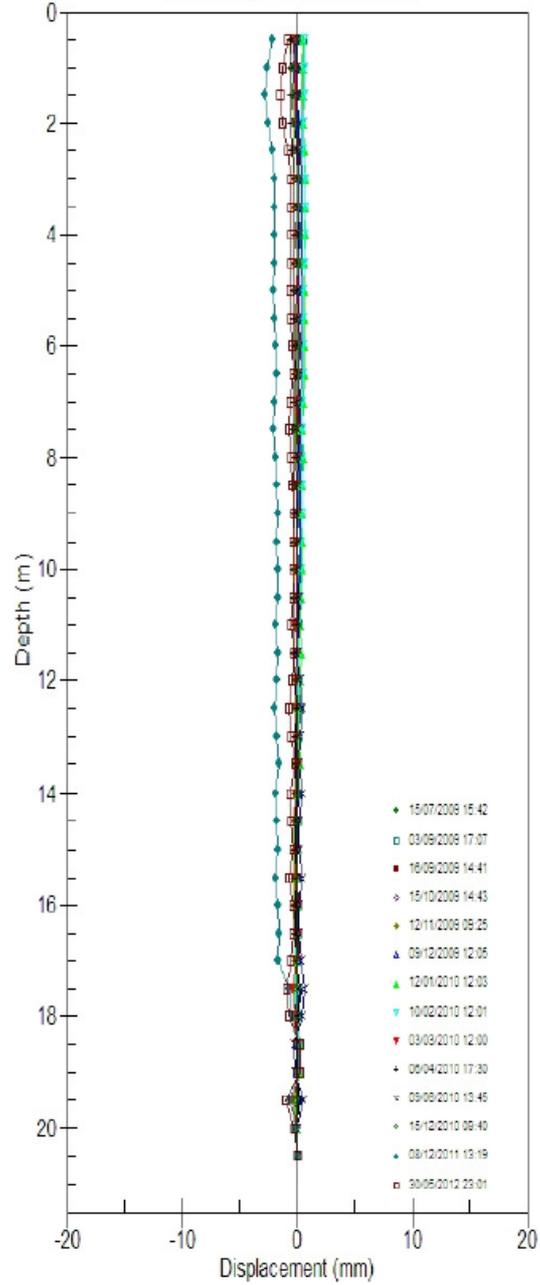
### SSC:AA11 - A Axis Cumulative

Initial survey: 15/07/2009 15:42

### SSC:AA11 - B Axis Cumulative

PROJECT: 1022971 Ongoing Analysis of Coastal Monitoring Data

SITE: Scarborough South Cliffs

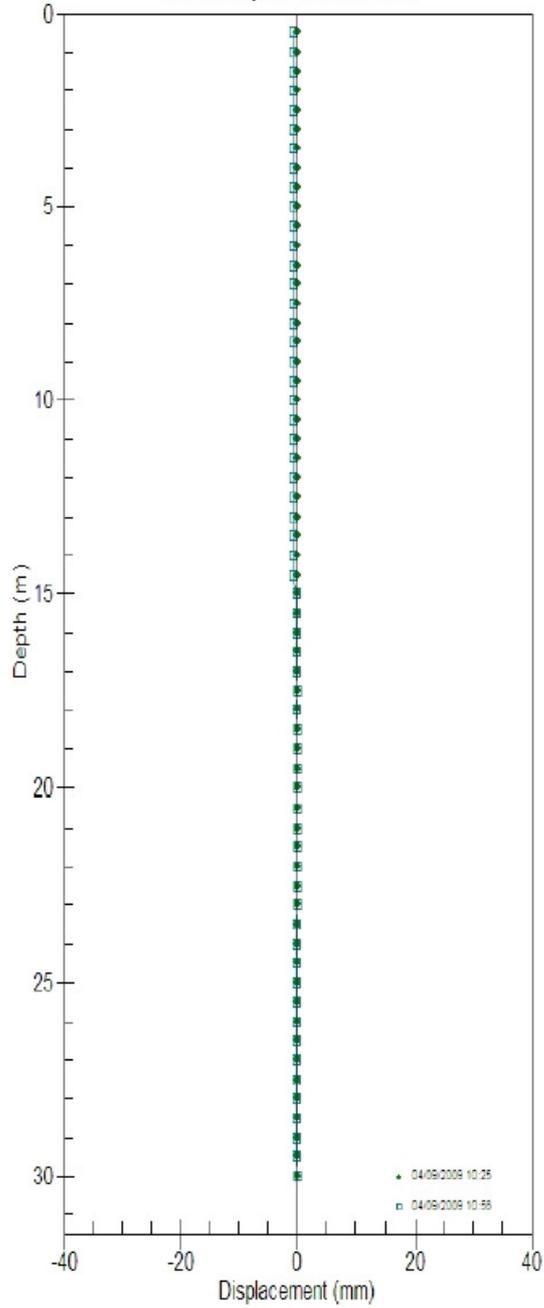
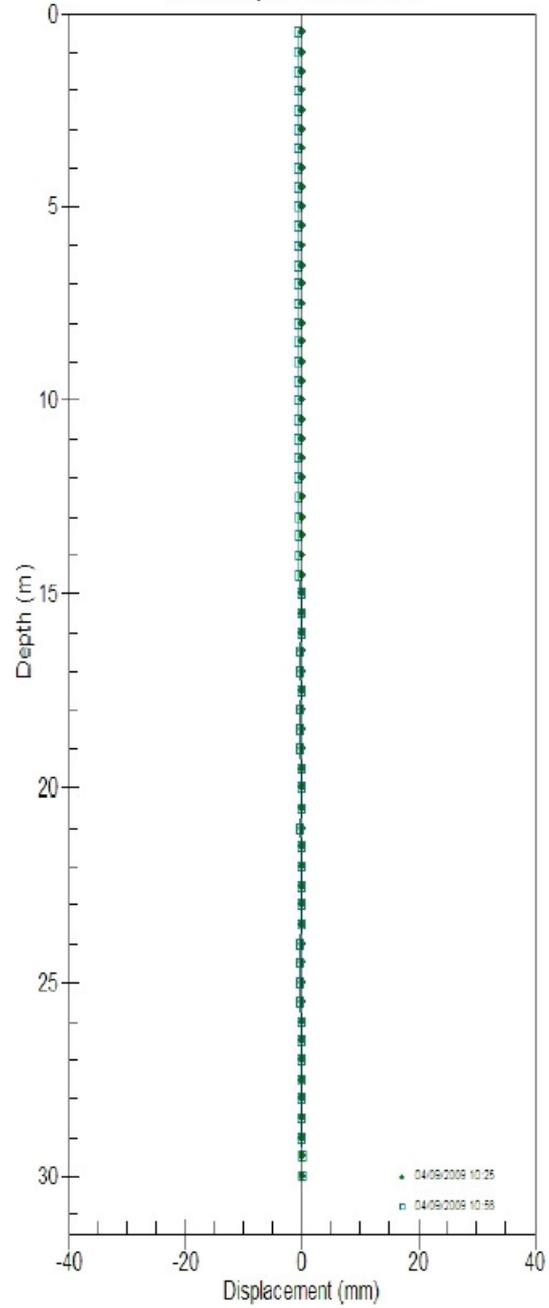
### FILEY: BH3 - A Axis Cumulative

Initial survey: 04/09/2009 10:25

### FILEY: BH3 - B Axis Cumulative

PROJECT: 1022971 Ongoing Analysis of Coastal Monitoring Data

SITE: FILEY

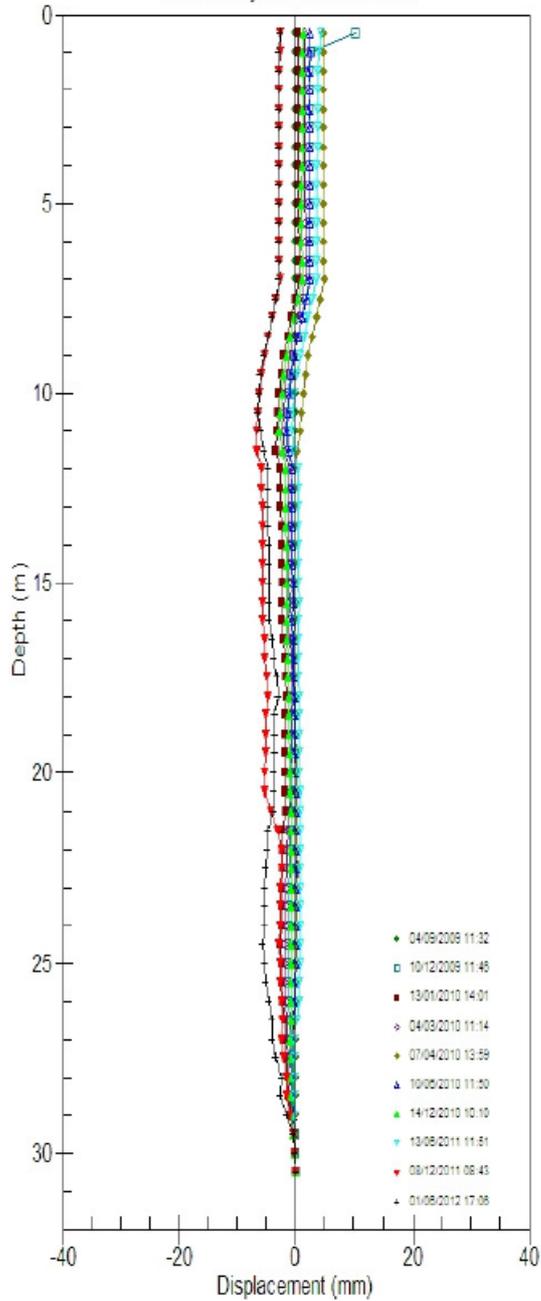
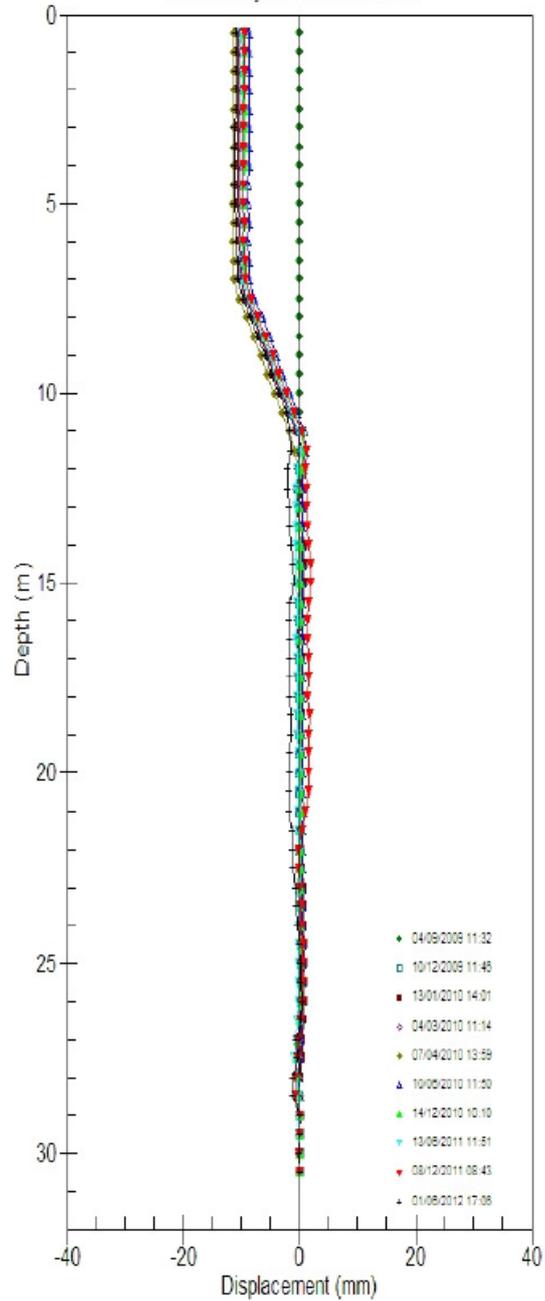
### FILEY: BH6 - A Axis Cumulative

Initial survey: 04/09/2009 11:32

### FILEY: BH6 - B Axis Cumulative

PROJECT: 1022971 Ongoing Analysis of Coastal Monitoring Data

SITE: FILEY

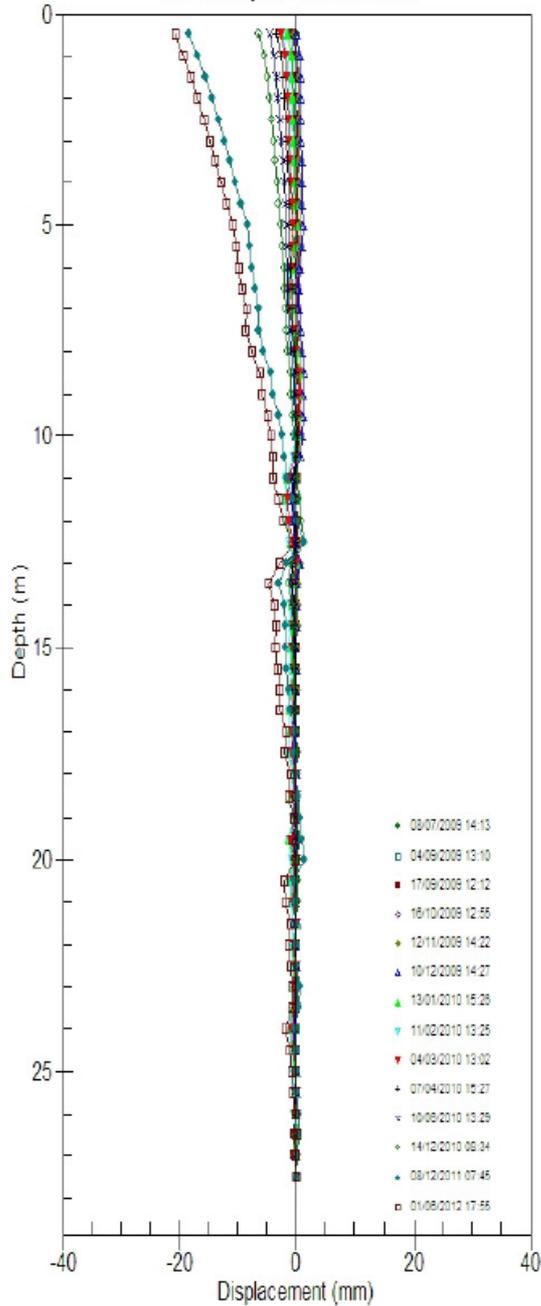
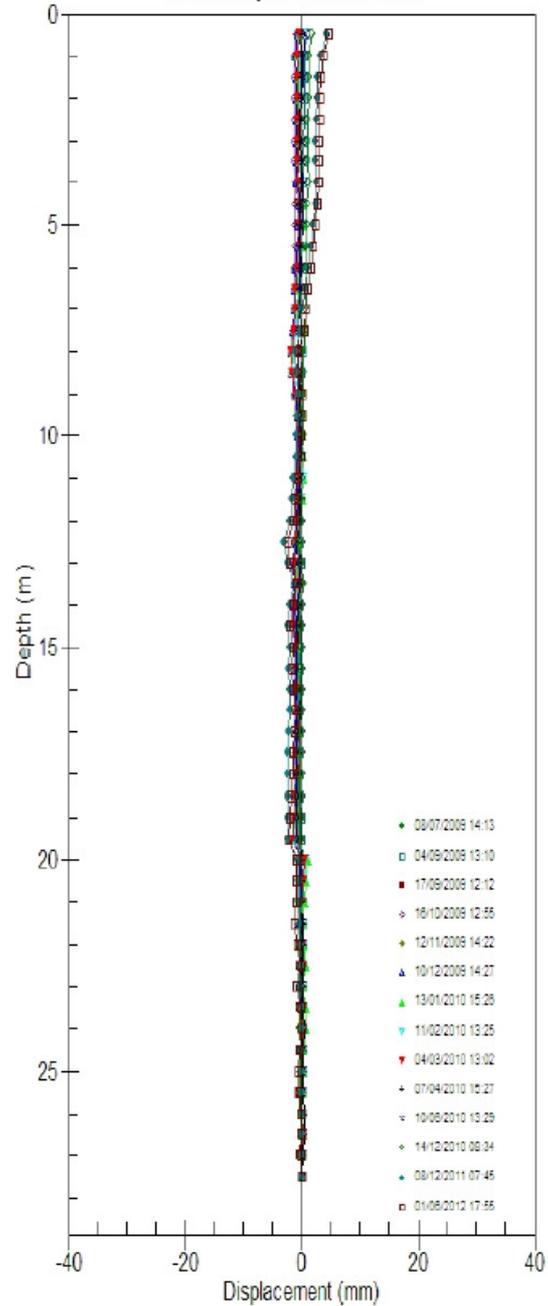
### FFC:BB02 - A Axis Cumulative

Initial survey: 08/07/2009 14:13

### FFC:BB02 - B Axis Cumulative

PROJECT: 1022971 Ongoing Analysis of Coastal Monitoring Data

SITE: Filey Flat Cliffs

The ongoing monitoring regime was initialised in July 2009 and follows that detailed in Section 9.5.1, above. Following on from the findings of the *Condition Survey Report*, monitoring consists of a single inclinometer BB02 (A2) located on the landside of the main access road down through Filey Flat Cliffs and 3 no. piezometers (A3, B1 and D1), one located within Filey Flat Cliffs and the remainder located above the village beyond the cliff crest, see Appendix A, Drawing 11.

The single inclinometer offers very limited coverage at Filey Flat Cliffs and there is the distinct possibility of undetected ground movements occurring elsewhere at this site. Previous interpretative reports (provided by SBC) have drawn attention to the fact that there is a lack of valid geotechnical data retrieved from this area with which to build a meaningful geotechnical model and to also carry out slope stability analyses. It is understood from SBC that additional instrumentation has been installed at this site and also the inclinometer BB01 has been repaired and upgraded to provide readings remotely.

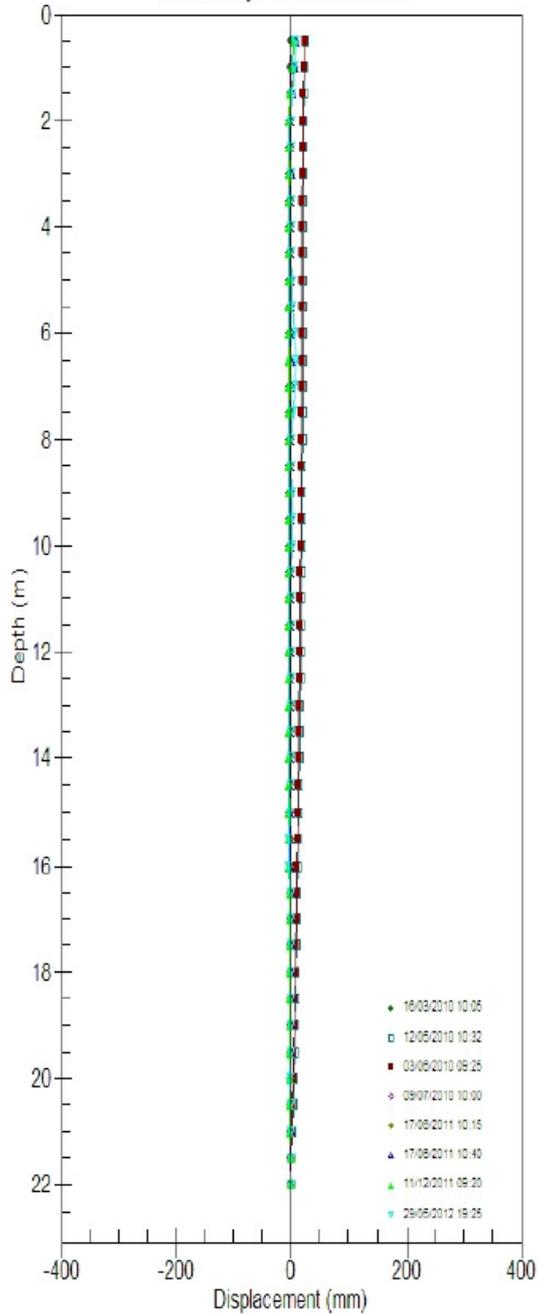
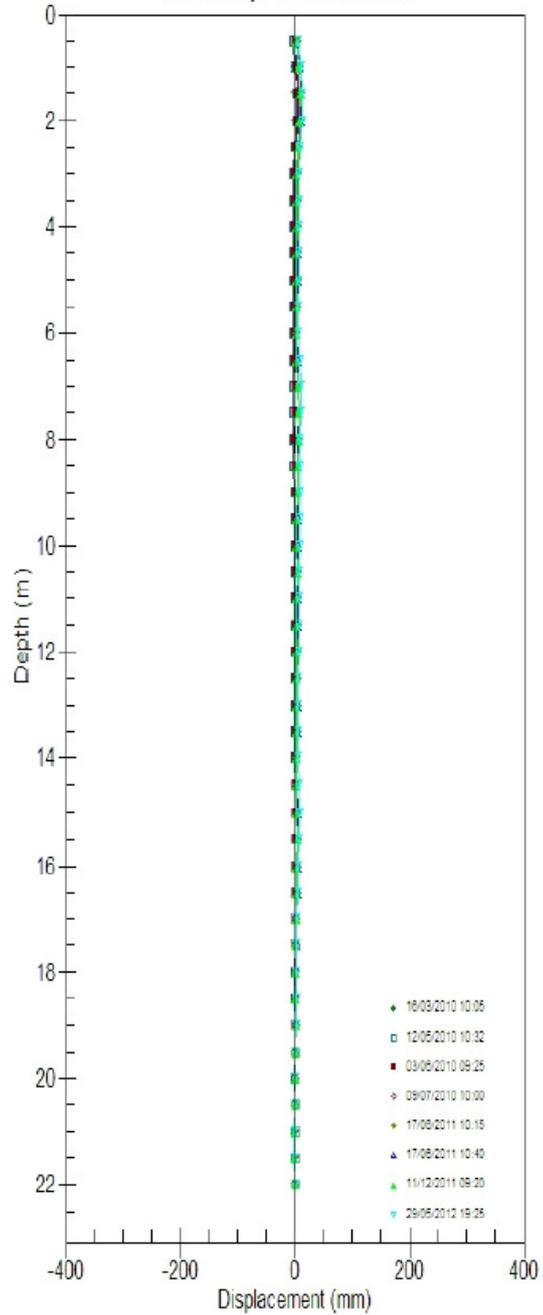
### RHB:BH2 - A Axis Cumulative

Initial survey: 16/03/2010 10:05

### RHB:BH2 - B Axis Cumulative

PROJECT: 1022971 Ongoing Analysis of Coastal Monitoring Data

SITE: Robin Hood's Bay

Inclinometer readings for BH2 and BH4 have been recorded in accordance with the procedures detailed in Section 1.2 of this report and are presented in Appendix C. Since installation in late February 2010, BH2 inclinometer has displayed ground movements of up to 35 mm at a depth of between 26 and 29 metres bgl. This movement was recorded by SBC staff during monitoring events following the completion of site works (in February 2010) from March to August 2010. This period was noted as being ‘unseasonally dry’ in comparison to previous years whereby the recorded monthly rainfall for March, April, May, July and August 2010 was lower than the average monthly rainfall recorded from the previous fifteen years.

BH2 inclinometer had previously displayed ground movements of up to 35 mm at a depth of between 26 and 29 metres bgl. This movement was recorded by SBC staff during monitoring events following the completion of site works (in February 2010) from March to August 2010. Although this amount of recorded movement is not considered to be “catastrophic”, continued monitoring on a monthly basis, and after prolonged periods of rainfall was strongly recommended to determine whether the movement is accelerating or reaching a critical point. The inclinometer installed in BH4 has so far indicated no ground movements.

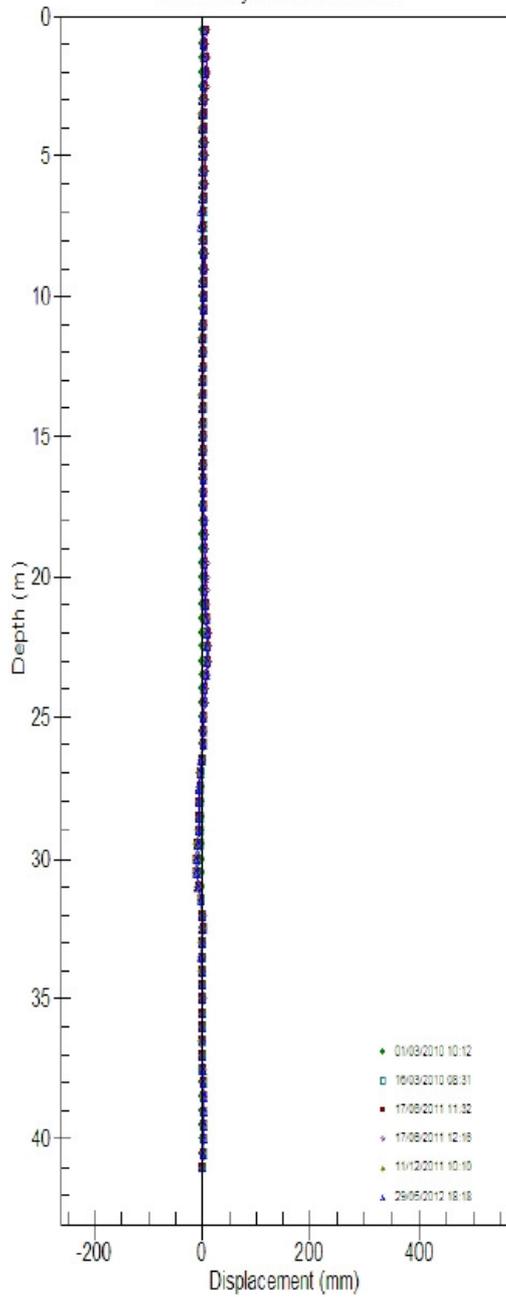
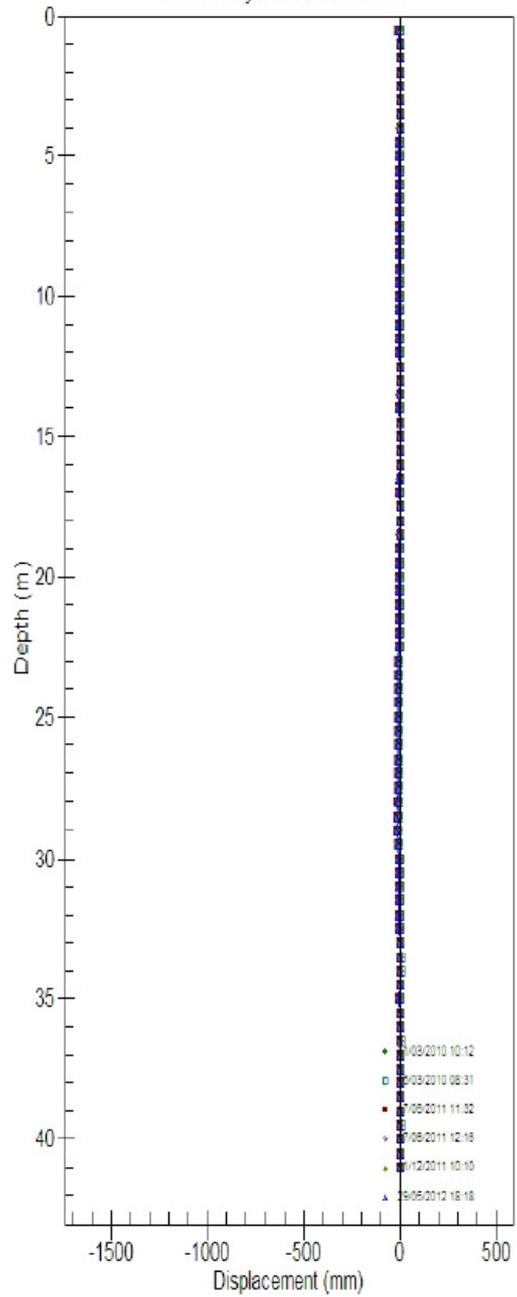
### RHB:BH4 - A Axis Cumulative

Initial survey: 01/03/2010 10:12

### RHB:BH4 - B Axis Cumulative

PROJECT: 1022971 Ongoing Analysis of Coastal Monitoring Data

SITE: Robin Hood's Bay

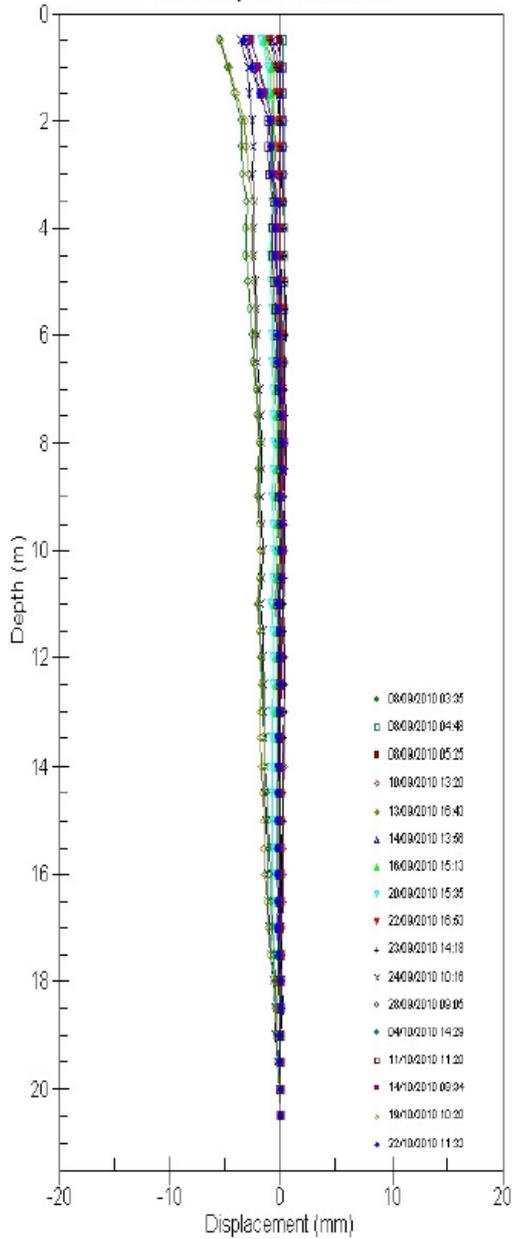
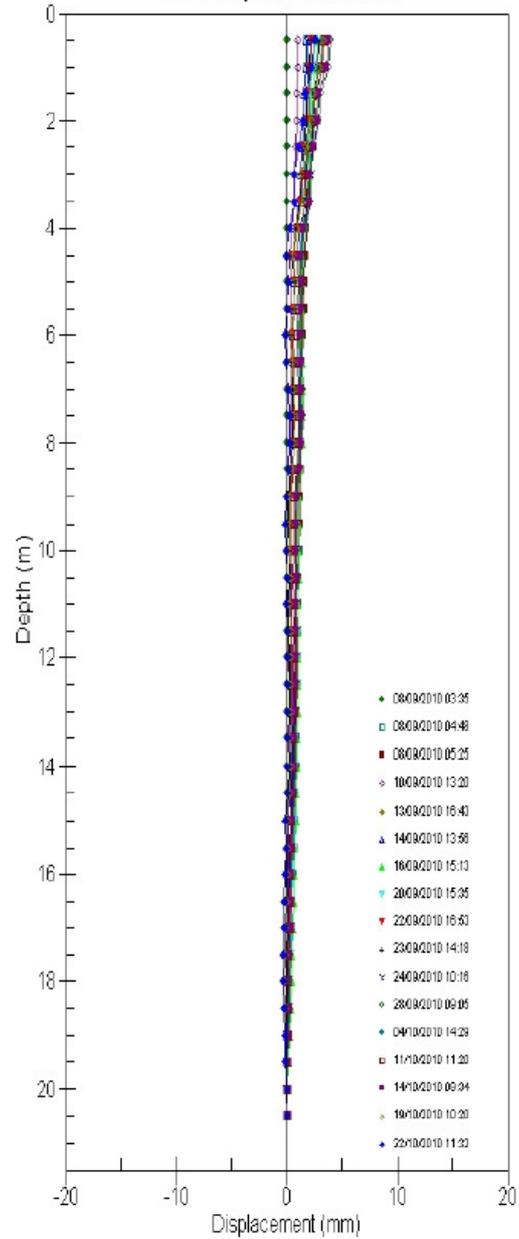
### A64274:BH7 - A Axis Cumulative

Initial survey: 08/09/2010 03:35

### A64274:BH7 - B Axis Cumulative

PROJECT: SCARBOROUGH BOREHOLE REPLACEMENT PROGRAMME  
SITE: A64274  
INSTALLATION: BH7  
COMPANY: WYG  
CLIENT: SCARBOROUGH BOROUGH COUNCIL

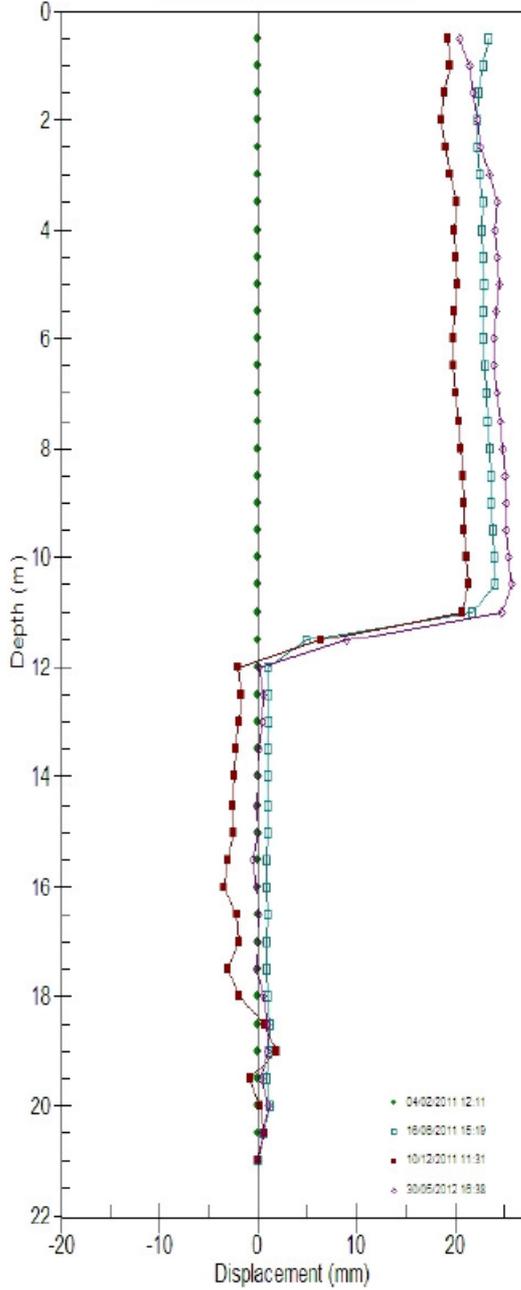
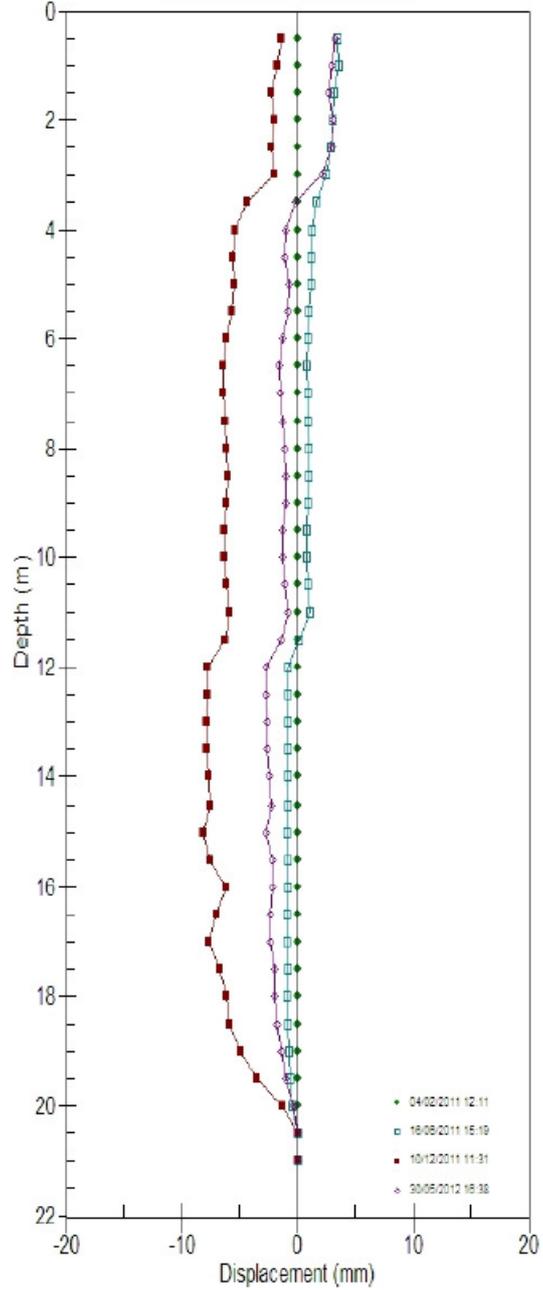
### SN:BH07 - A Axis Cumulative

Initial survey: 04/02/2011 12:11

### SN:BH07 - B Axis Cumulative

PROJECT: 1022971 Ongoing Analysis of Coastal Monitoring Data

SITE: Scalby Ness

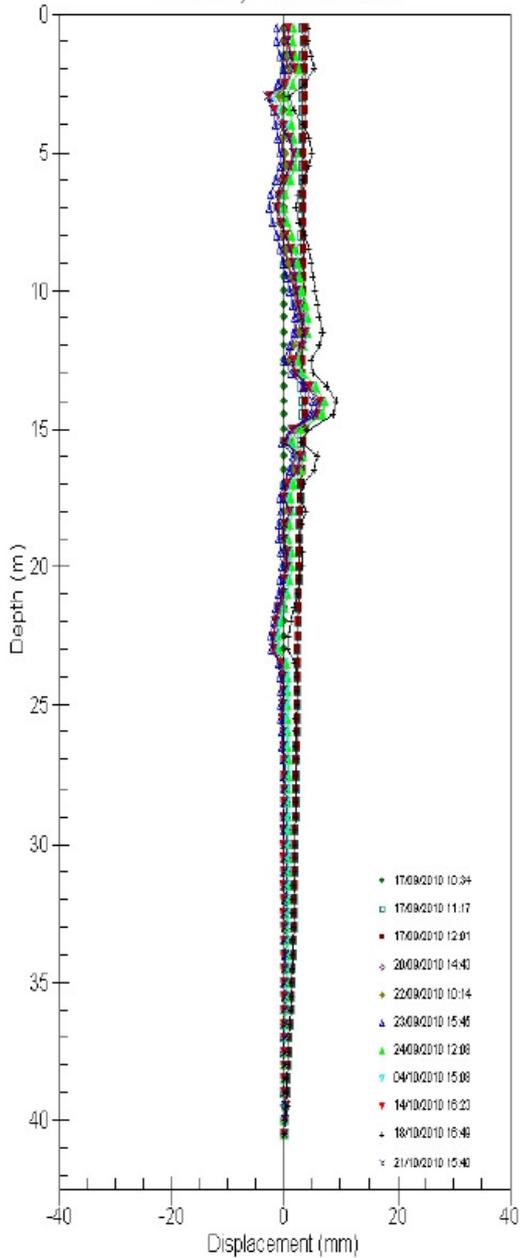
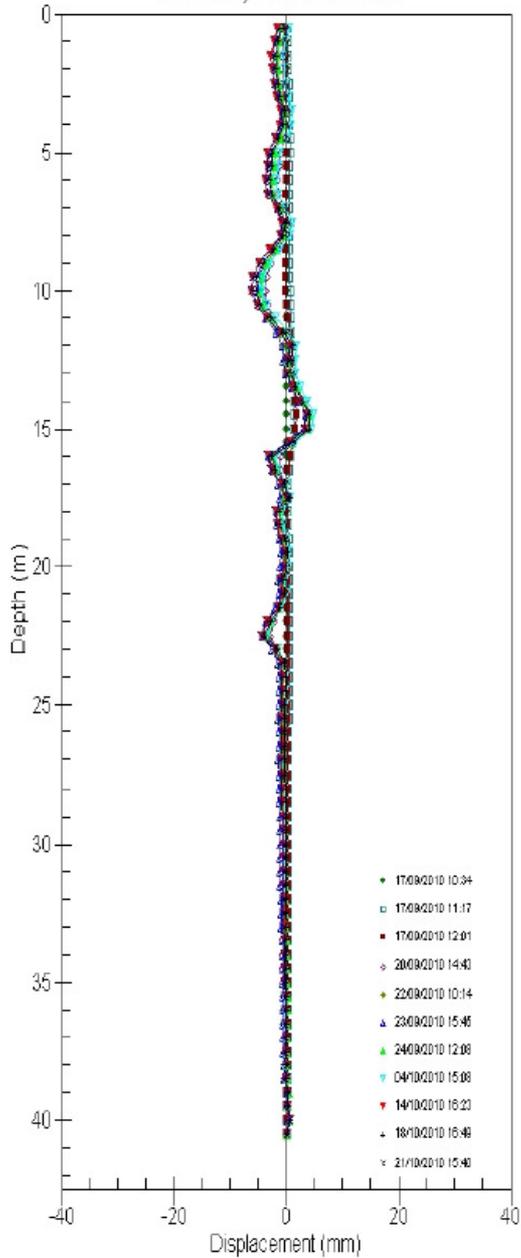
### A64274: BH10A - A Axis Cumulative

Initial survey: 17/09/2010 10:34

### A64274: BH10A - B Axis Cumulative

PROJECT: SCARBOROUGH BOREHOLE REPLACEMENT SCHEME

SITE: A64274

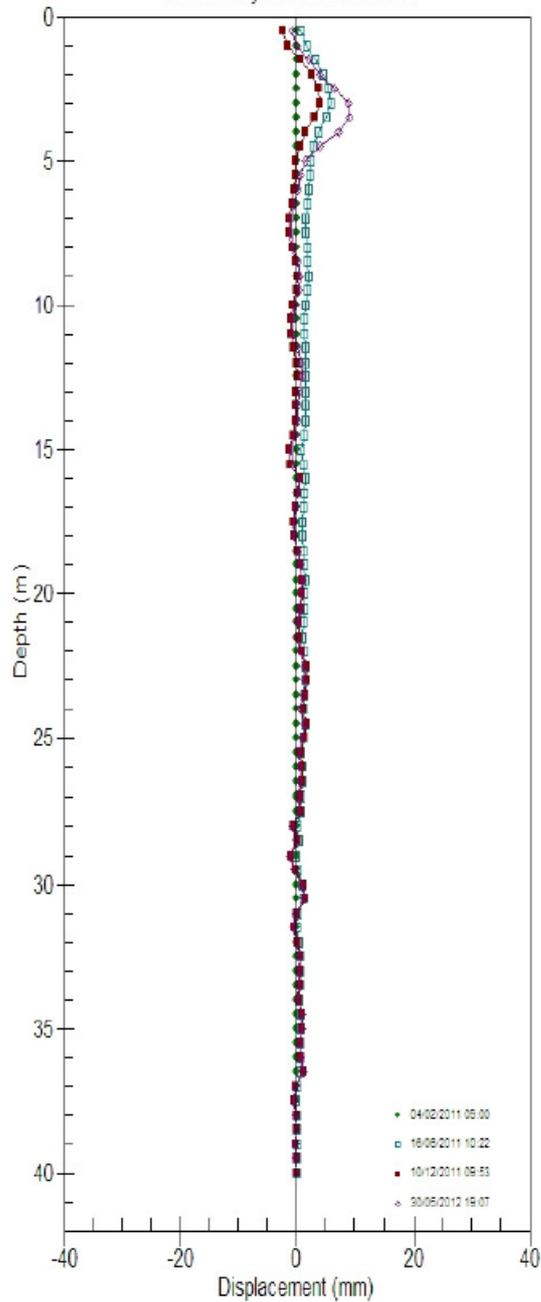
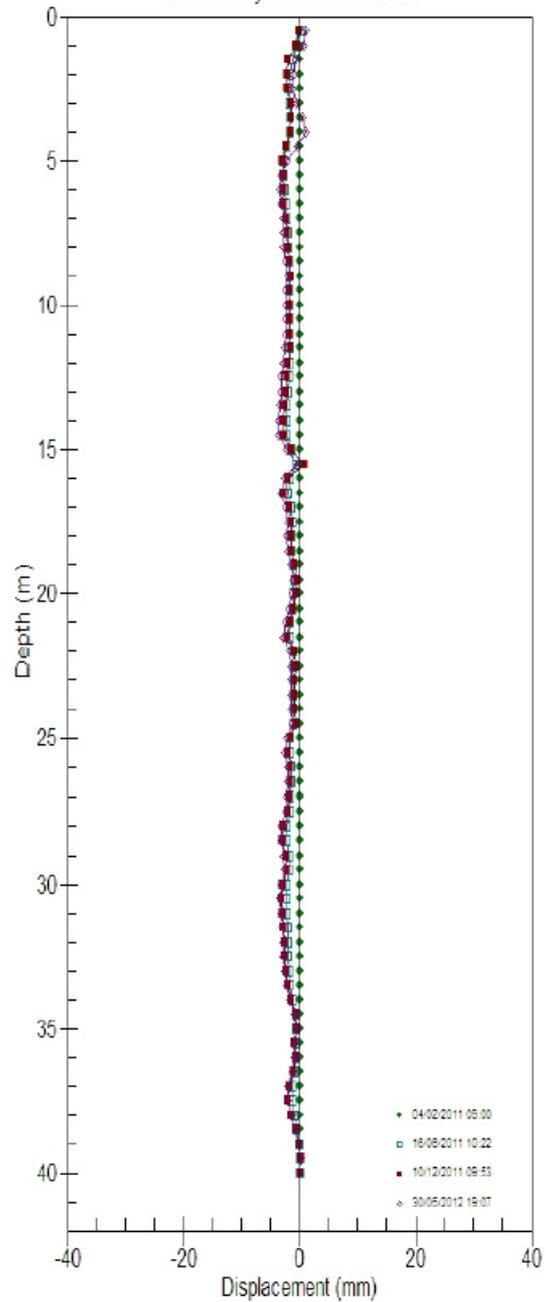
### SNB:BH10A - A Axis Cumulative

Initial survey: 04/02/2011 09:00

### SNB:BH10A - B Axis Cumulative

PROJECT: 1022971 Ongoing Analysis of Coastal Monitoring Data

SITE: Scarborough North Bay

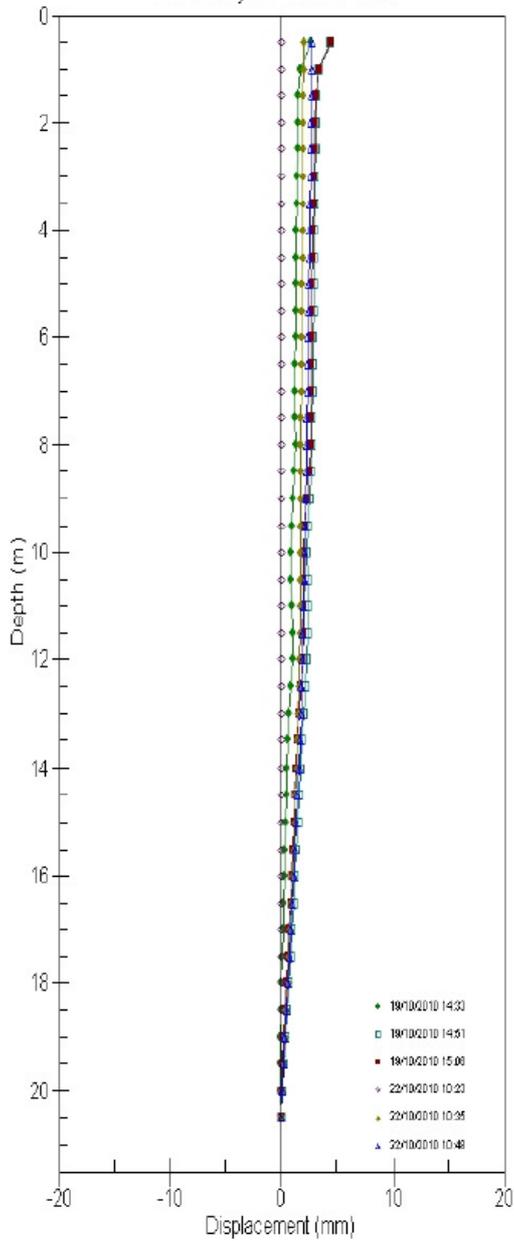
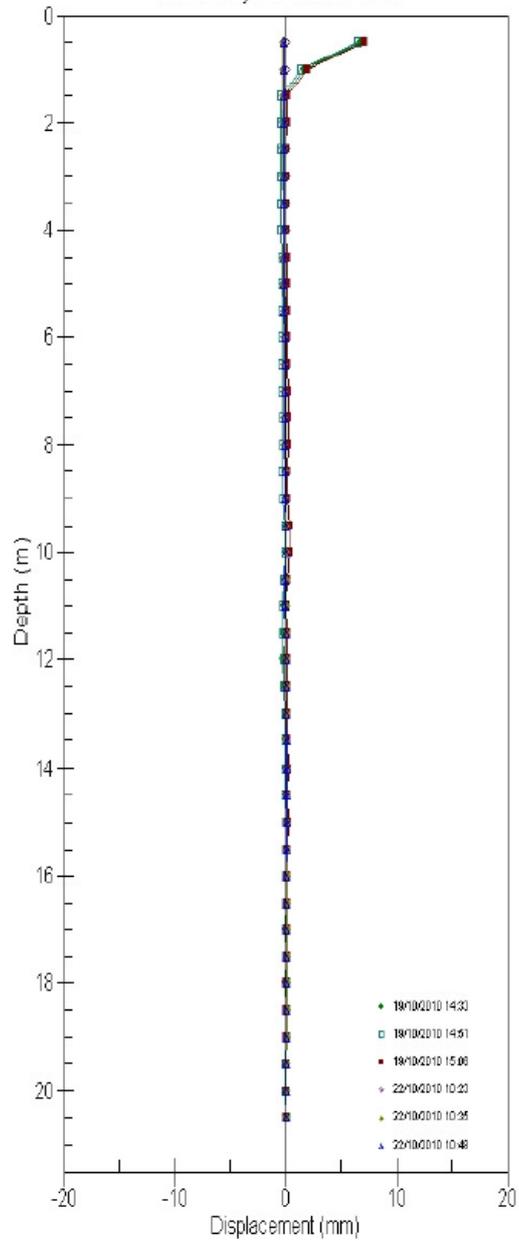
### A64274: BH11 - A Axis Cumulative

Initial survey: 22/10/2010 10:23

### A64274: BH11 - B Axis Cumulative

PROJECT: SCARBOROUGH BOREHOLE REPLACEMENT  
SITE: A64274  
INSTALLATION: BH11  
COMPANY: WYG  
CLIENT: SCARBOROUGH BOROUGH COUNCIL

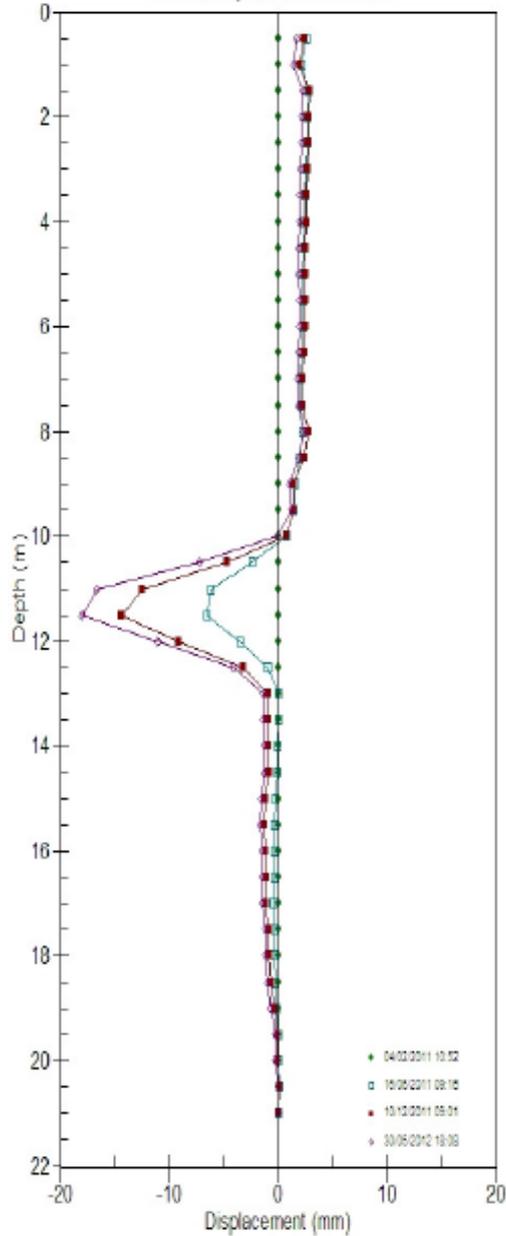
### SNB:BH11 - A Axis Cumulative

Initial survey: 04/02/2011 10:52

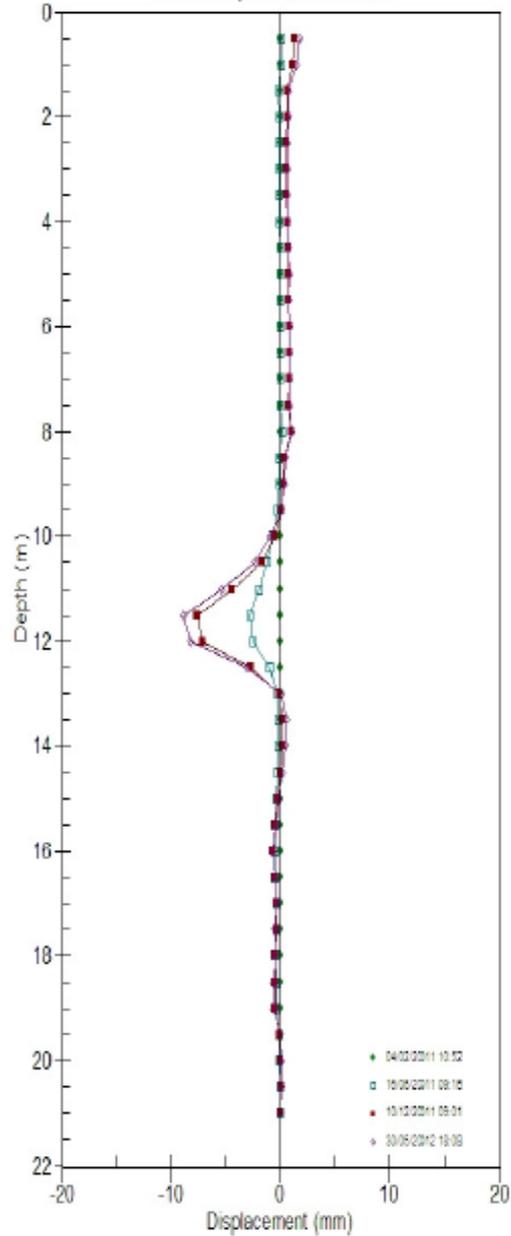
### SNB:BH11 - B Axis Cumulative

Initial survey: 04/02/2011 10:52

PROJECT: 1022971 Ongoing Analysis of Coastal Monitoring Data  
SITE: Scarborough North Bay  
INSTALLATION: BH11  
COMPANY: Mouchel Ltd  
CLIENT: Scarborough Borough Council  
NOTE: A0 Direction = North

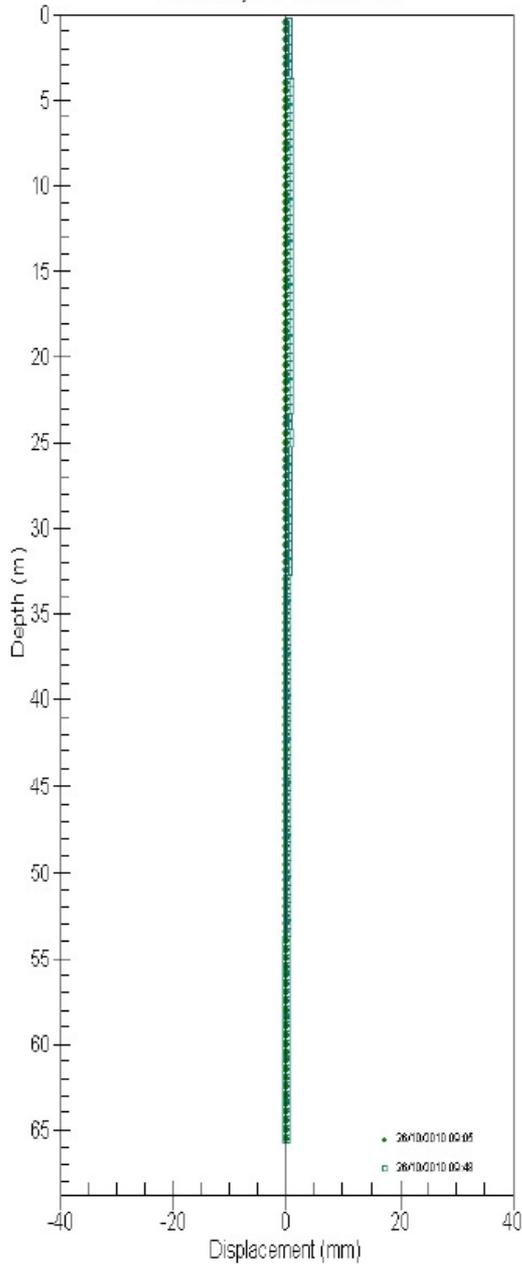
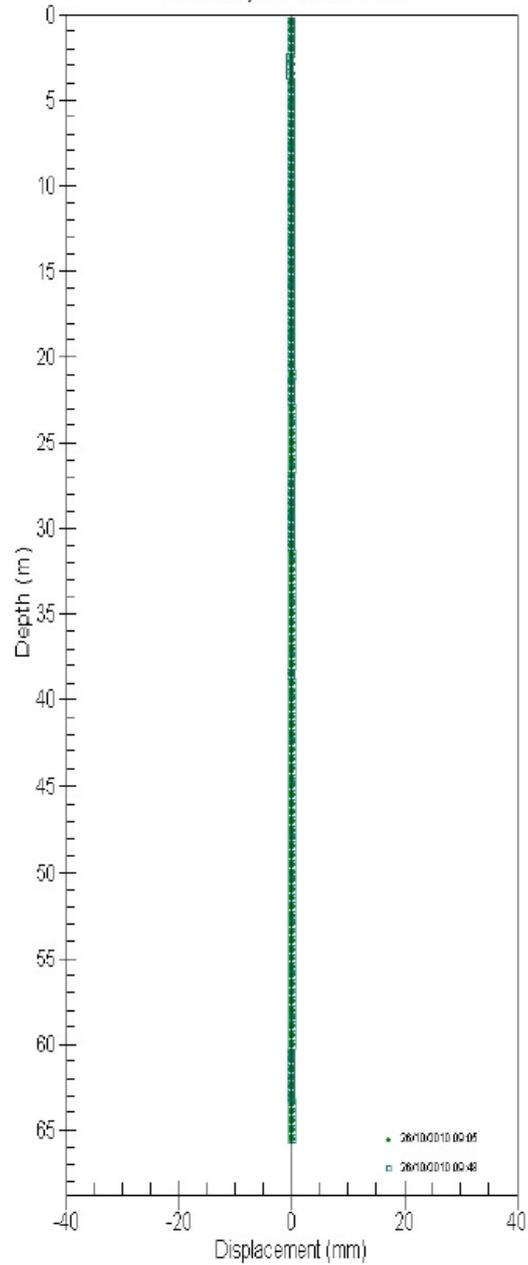
### A64274: BH12 - A Axis Cumulative

### A64274: BH12 - B Axis Cumulative

PROJECT: SCARBOROUGH BOREHOLE REPLACEMENT  
SITE: A64274  
INSTALLATION: BH12  
COMPANY: WYG  
CLIENT: SCARBOROUGH BOROUGH COUNCIL
