# Ongoing Analysis and Interpretation of Coastal Monitoring Data

Seventh Review of Full Suite Monitoring

## Geotechnical Interpretative Report

Document Ref. No. 721229/002/GIR/014/Final

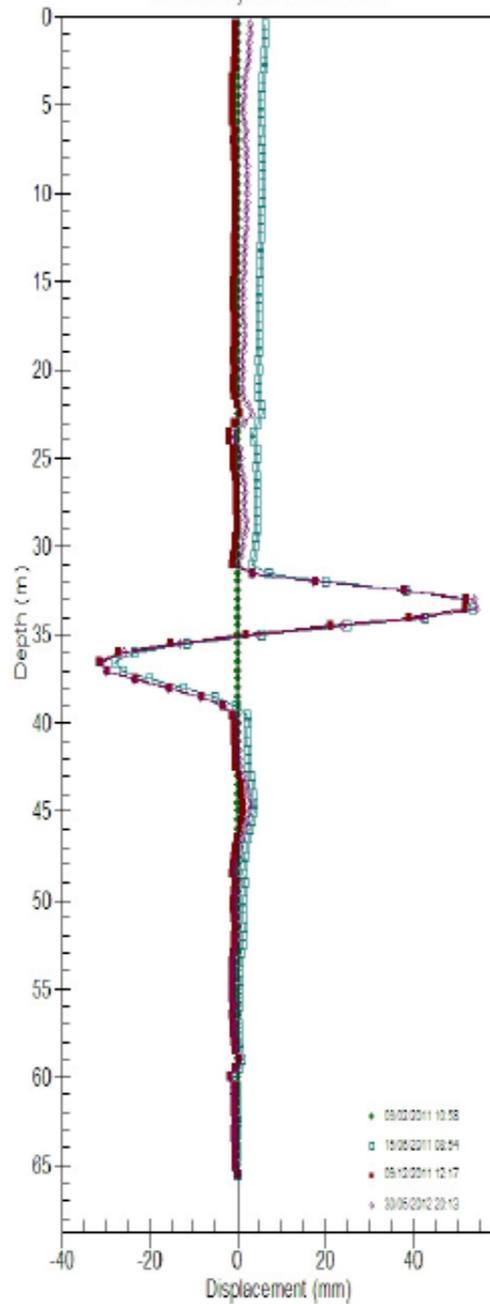
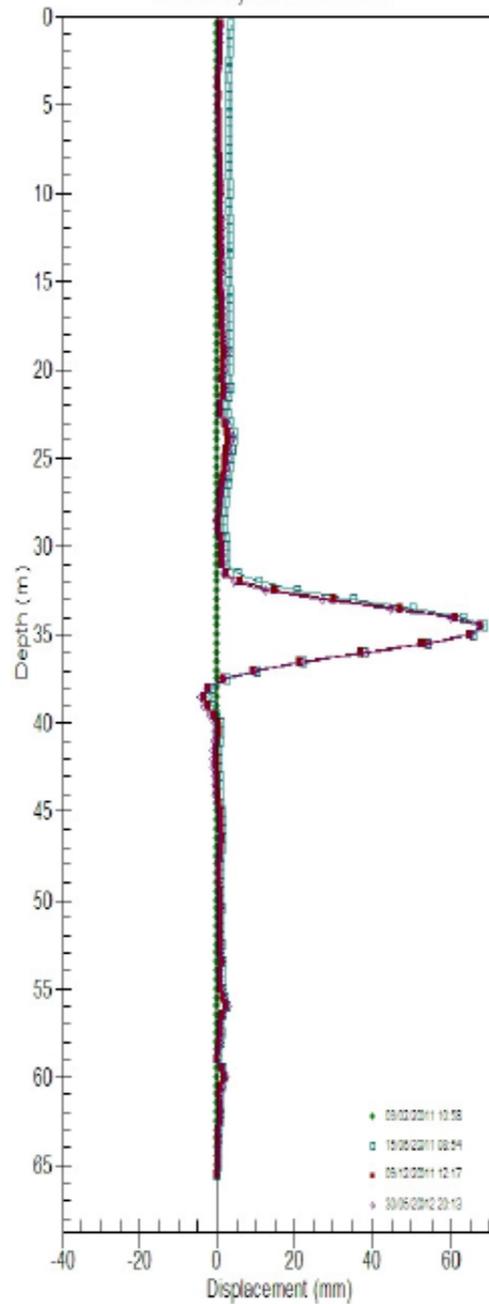
### SSC: BH12 - A Axis Cumulative

### SSC: BH12 - B Axis Cumulative

PROJECT: 1022971 Ongoing Analysis of Coastal Monitoring Data  
SITE: Scarborough South Cliffs  
INSTALLATION: BH12  
COMPANY: Mouchel Ltd  
CLIENT: Scarborough Borough Council  
NOTE: A0 Direction = East

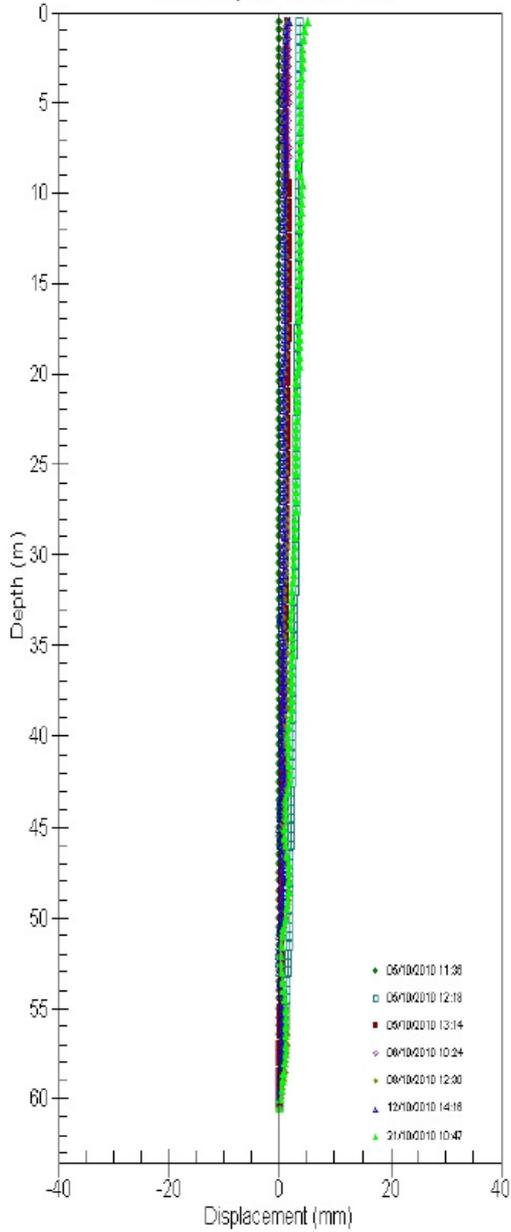
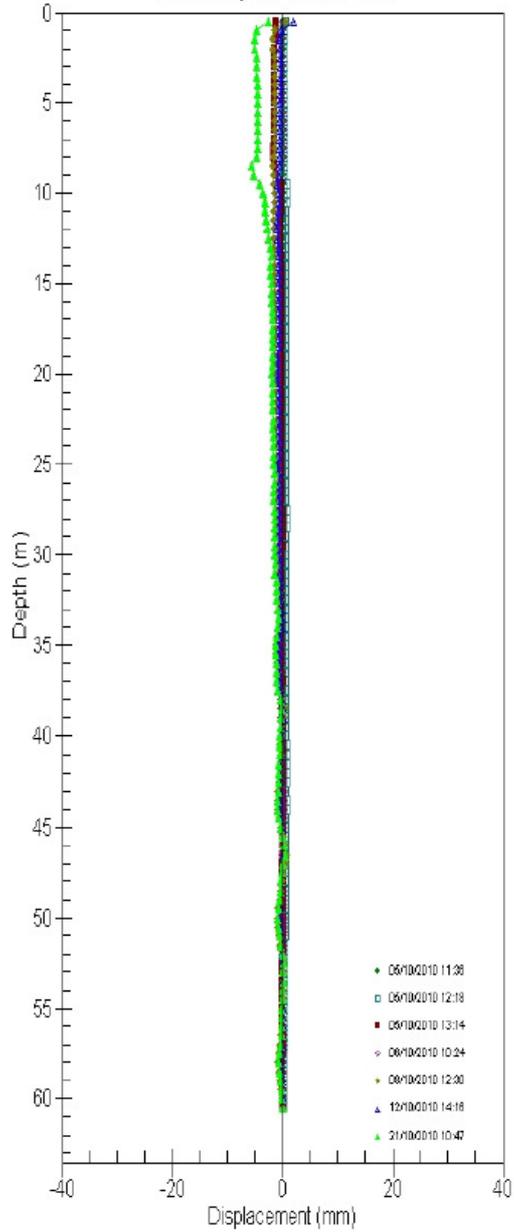
### A64274:BH13 - A Axis Cumulative

### A64274:BH13 - B Axis Cumulative

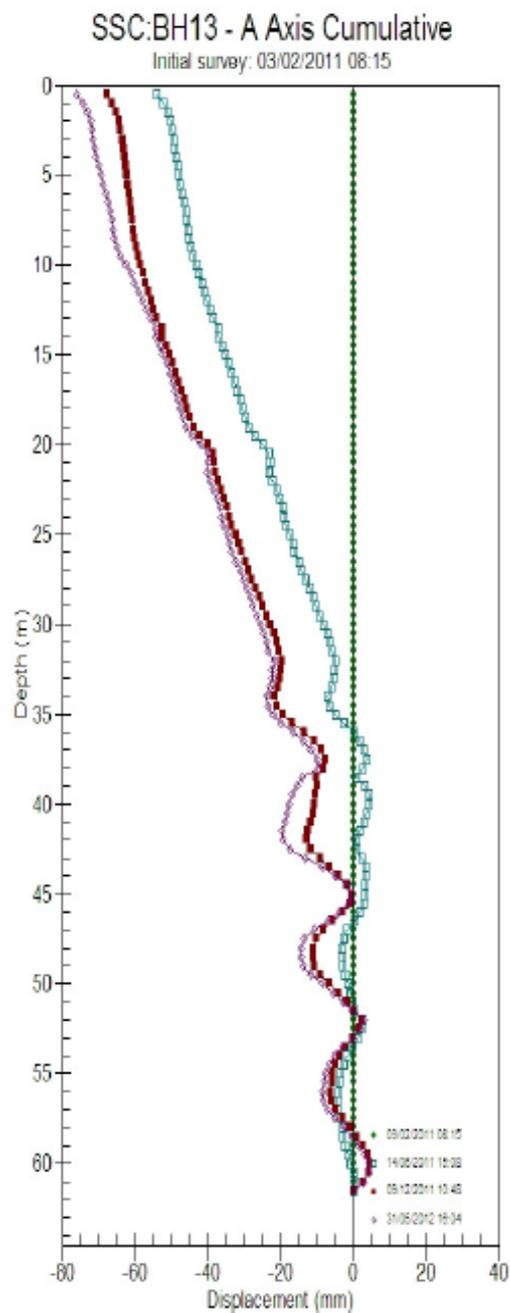
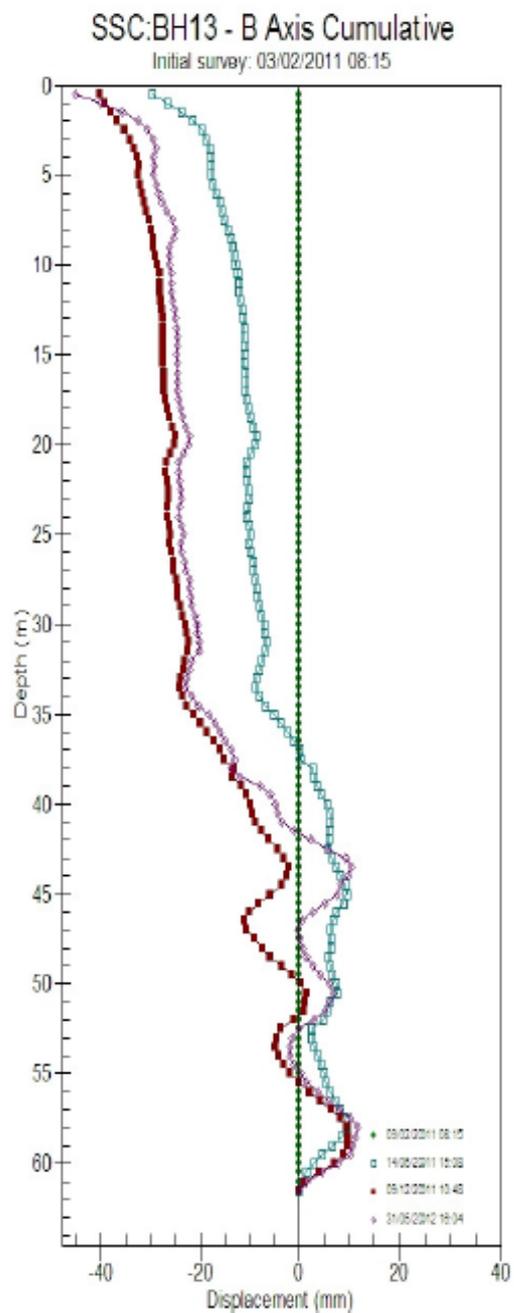
PROJECT: 1022971 Ongoing Analysis of Coastal Monitoring Data  
 SITE: Scarborough South Cliffs  
 INSTALLATION: BH13  
 COMPANY: Mouchel Ltd  
 CLIENT: Scarborough Borough Council  
 NOTE: A0 Direction = East

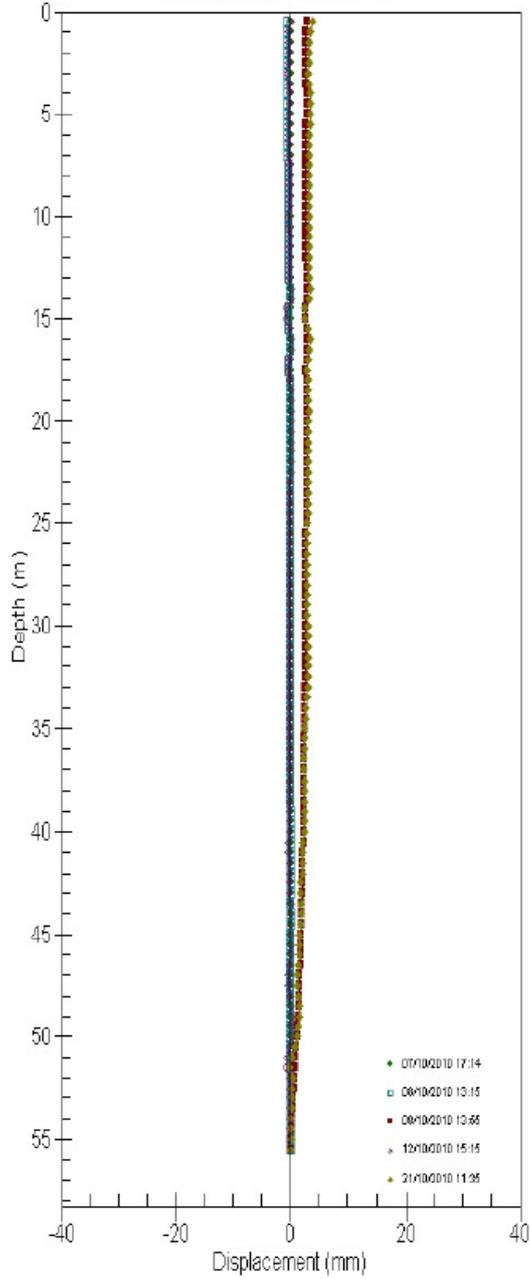
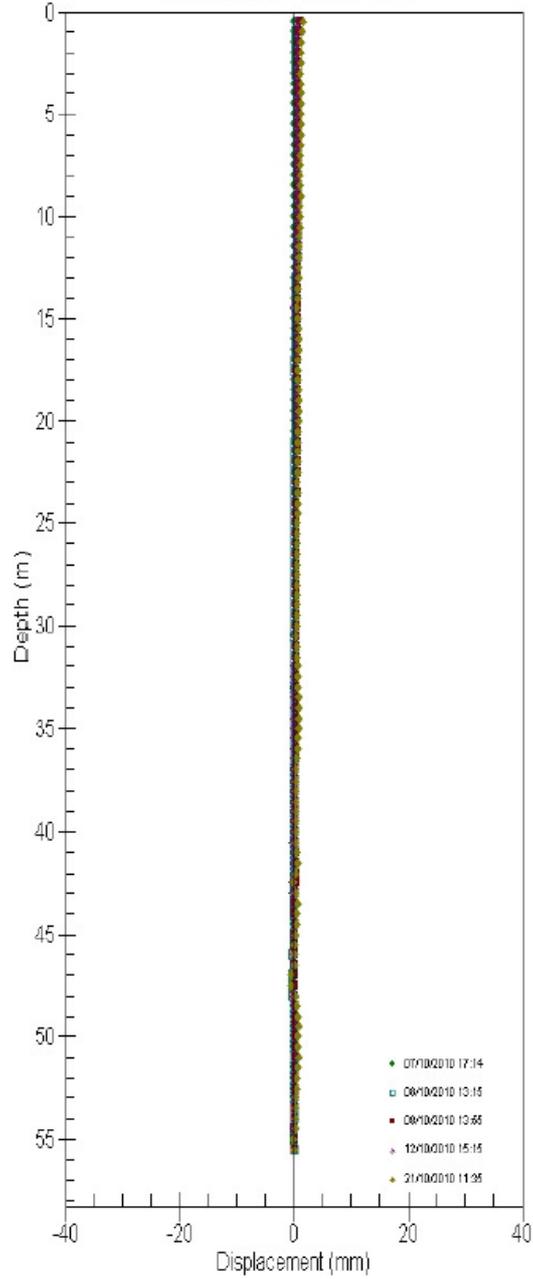
### A64274: BH14 - A Axis Cumulative

### A64274: BH14 - B Axis Cumulative

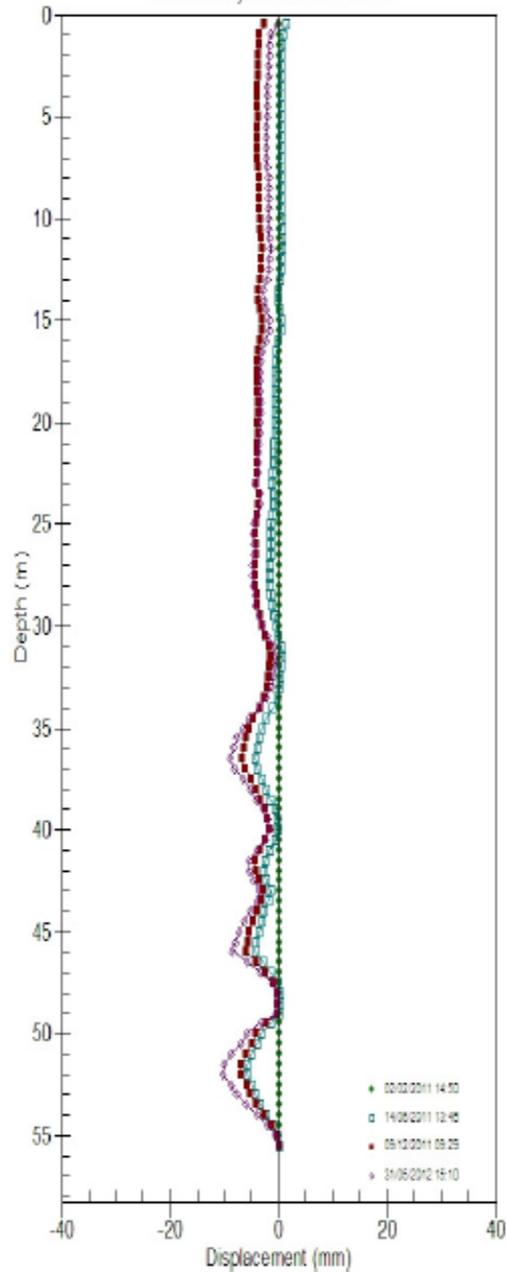
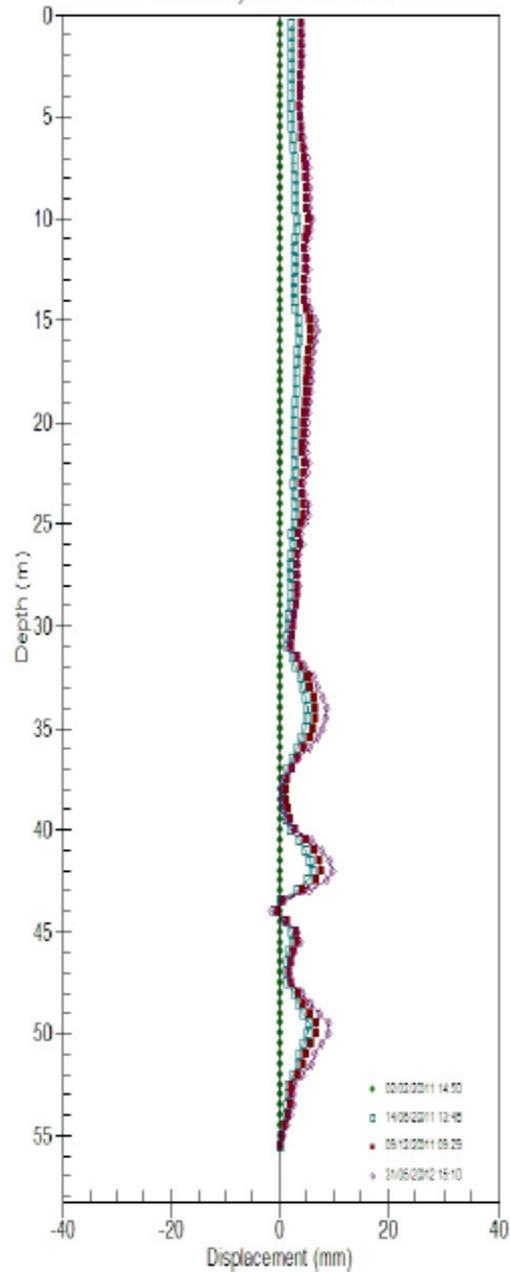
### SSC: BH14 - A Axis Cumulative

### SSC: BH14 - B Axis Cumulative

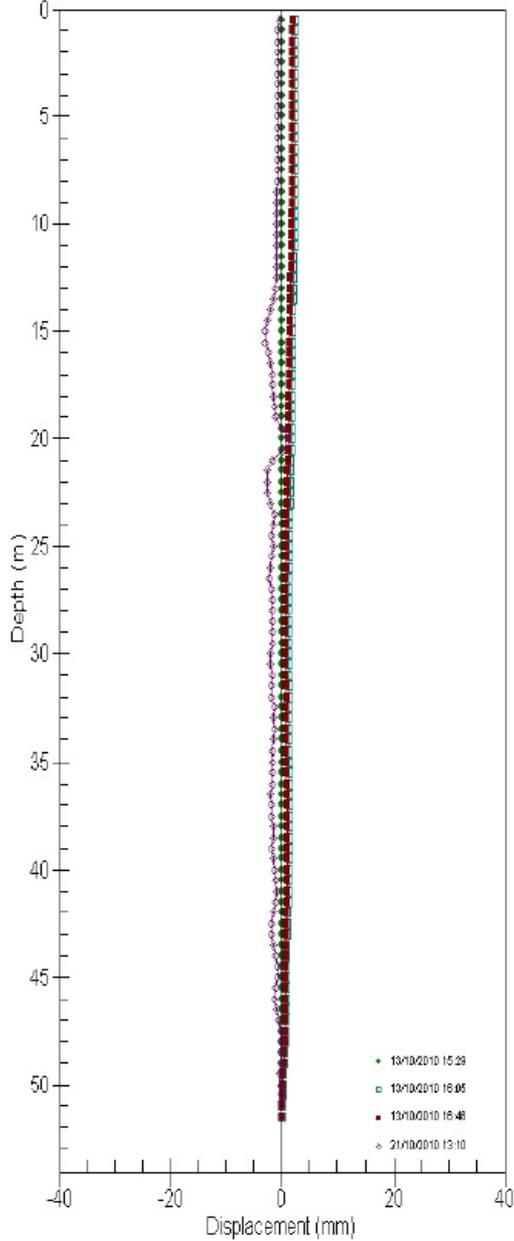
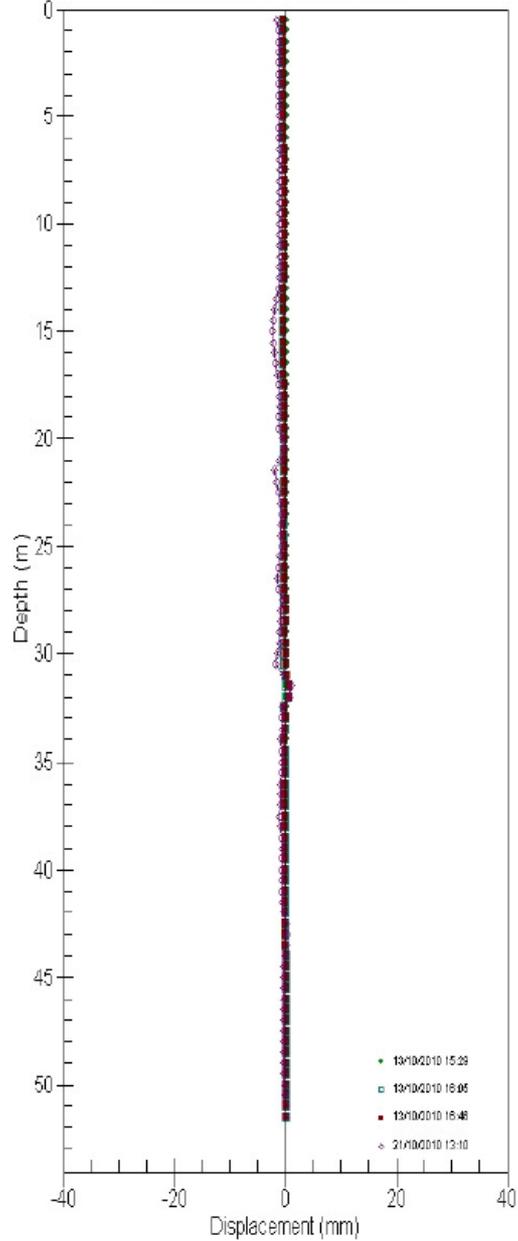
### A64274: BH16A - A Axis Cumulative

### A64274: BH16A - B Axis Cumulative

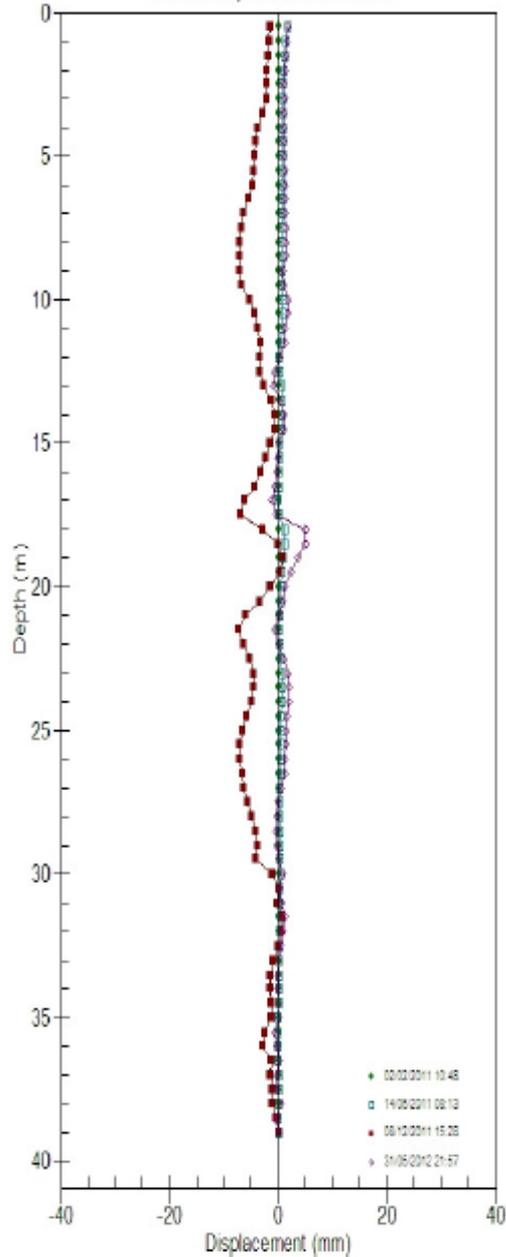
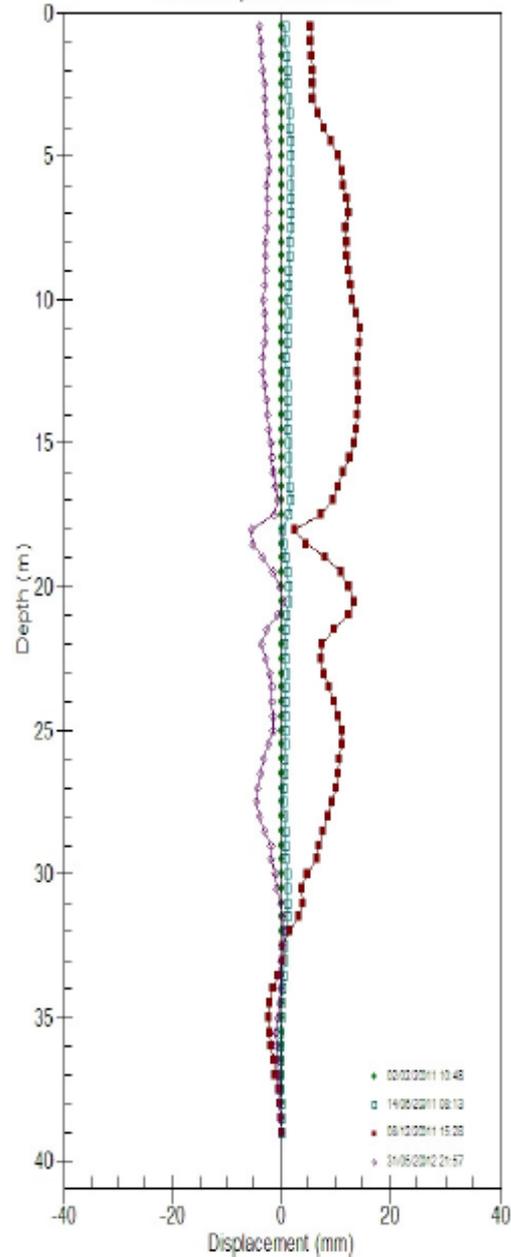
### SSC: BH16A - A Axis Cumulative

### SSC: BH16A - B Axis Cumulative

PROJECT: 1022971 Ongoing Analysis of Coastal Monitoring Data  
SITE: Scarborough South Cliffs  
INSTALLATION: BH16A  
COMPANY: Mouchel Ltd  
CLIENT: Scarborough Borough Council  
NOTE: A0 Direction = East

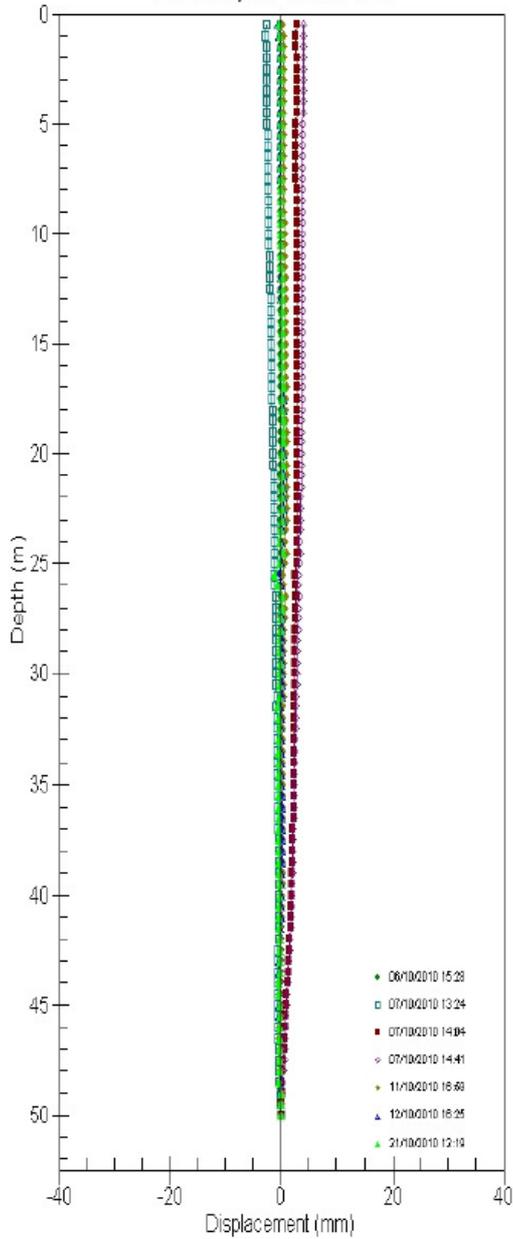
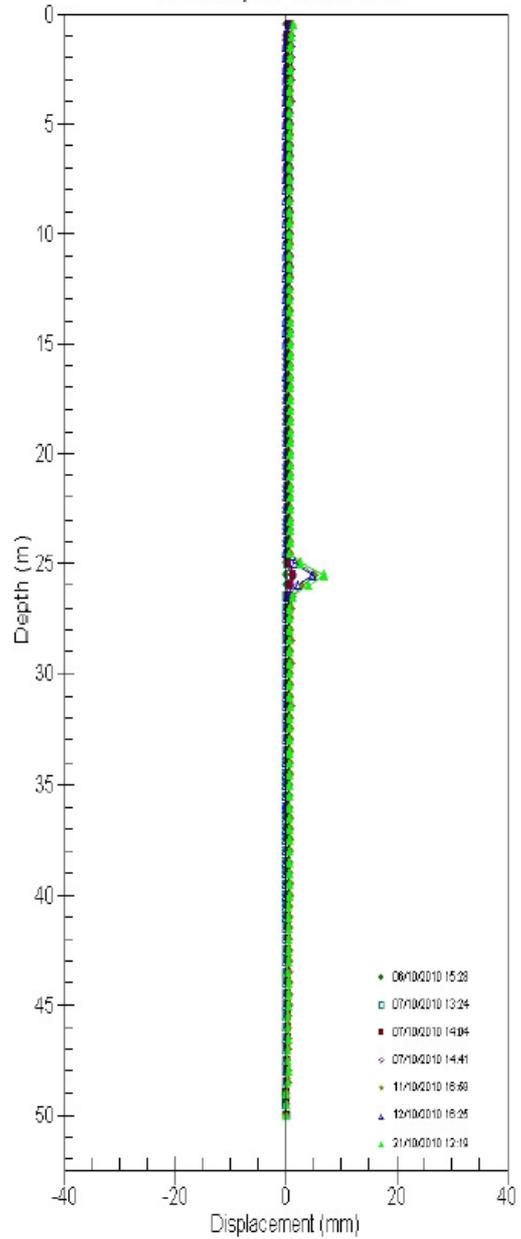
### A64274: BH17 - A Axis Cumulative

### A64274: BH17 - B Axis Cumulative

PROJECT: SCARBOROUGH BOREHOLE REPLACEMENT PROGRAMME  
SITE: A64274  
INSTALLATION: BH17  
COMPANY: WYG  
CLIENT: SCARBOROUGH BOROUGH COUNCIL

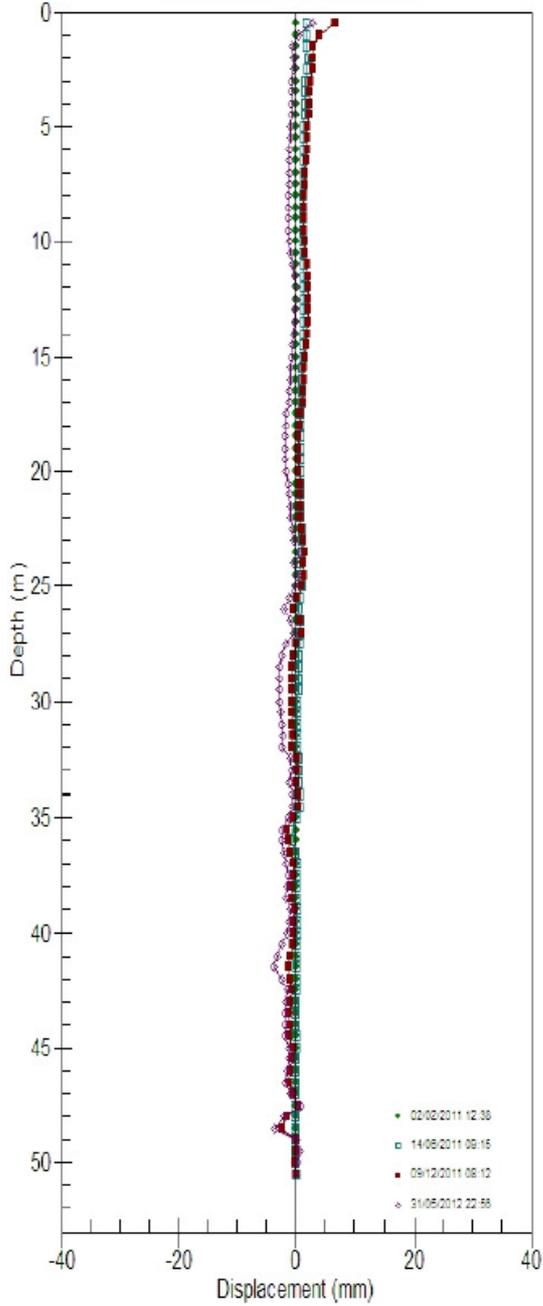
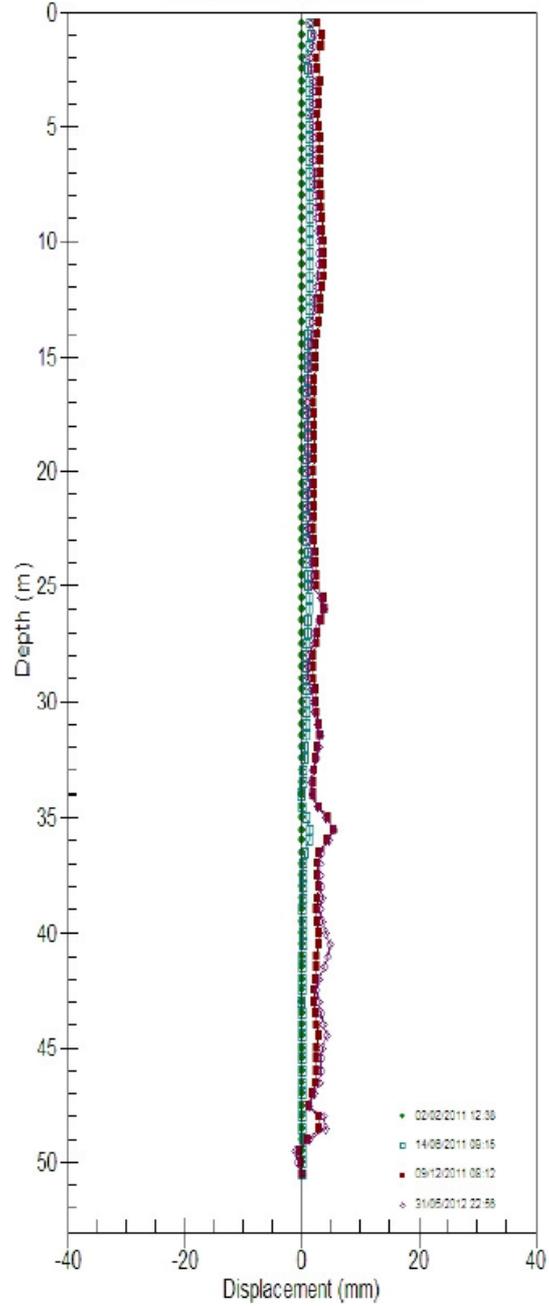
### SSC:BH17 - A Axis Cumulative

### SSC:BH17 - B Axis Cumulative

PROJECT: 1022971 Ongoing Analysis of Coastal Monitoring Data  
SITE: Scarborough South Cliff  
INSTALLATION: BH17  
COMPANY: Mouchel Ltd  
CLIENT: Scarborough Borough Council  
NOTE: A0 Direction = East

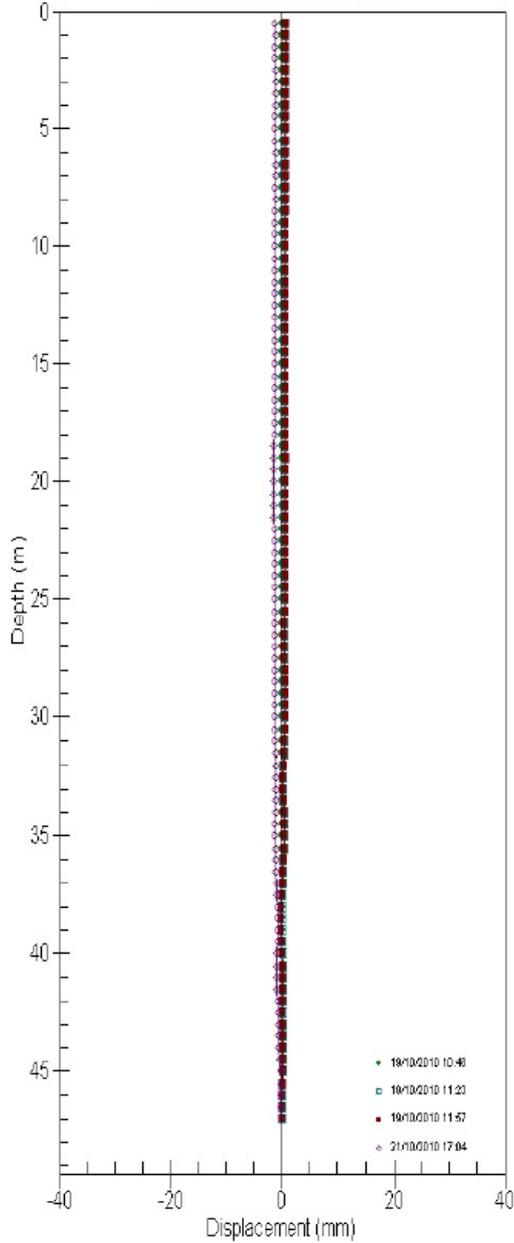
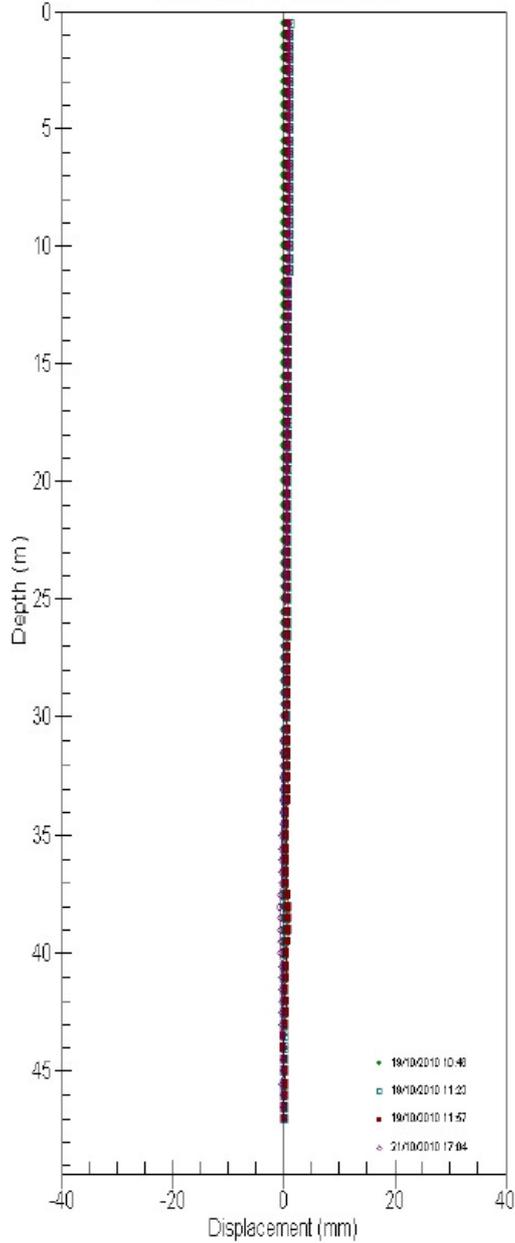
### A64274: BH20 - A Axis Cumulative

### A64274: BH20 - B Axis Cumulative

PROJECT: SCARBOROUGH BOREHOLE REPLACEMENT  
SITE: A64274  
INSTALLATION: BH20  
COMPANY: WYG  
CLIENT: SCARBOROUGH BOROUGH COUNCIL

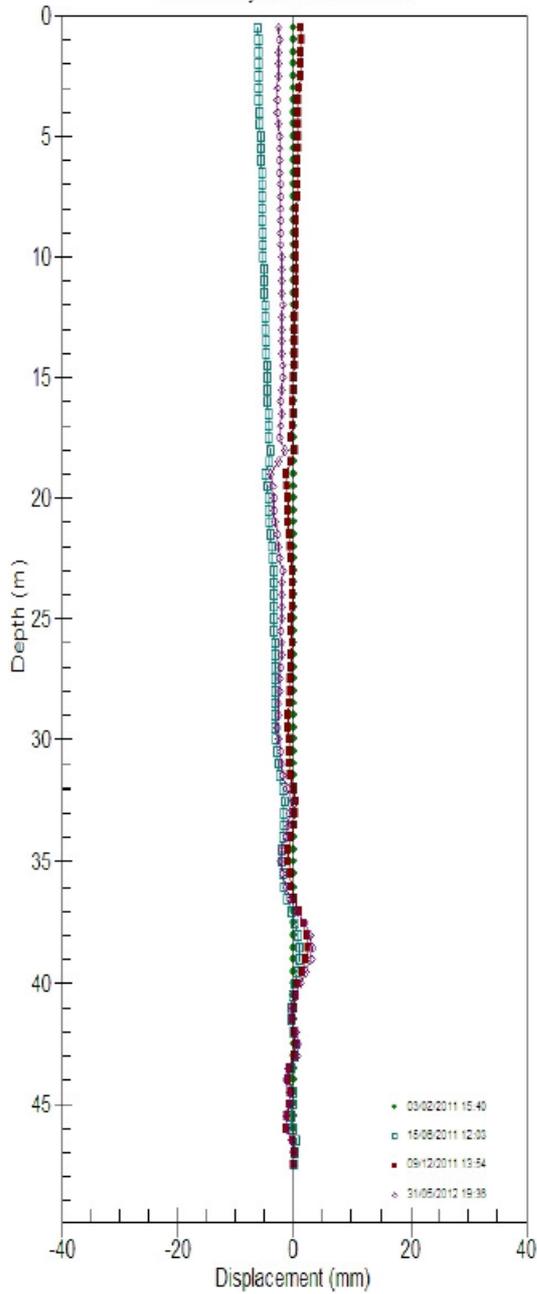
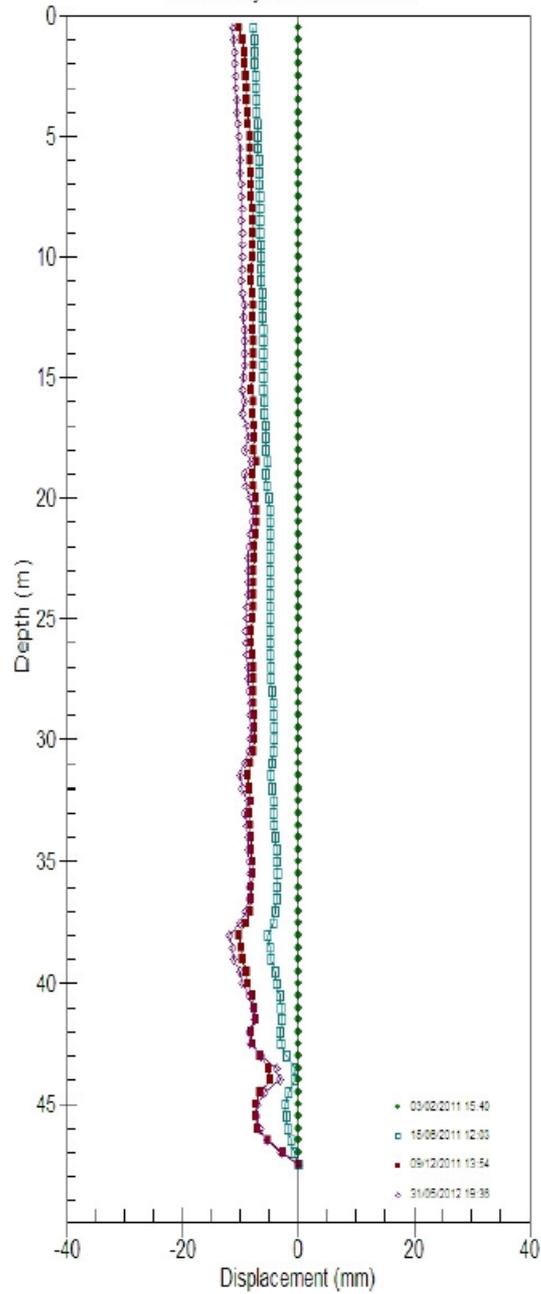
### SSC:BH20 - A Axis Cumulative

### SSC:BH20 - B Axis Cumulative

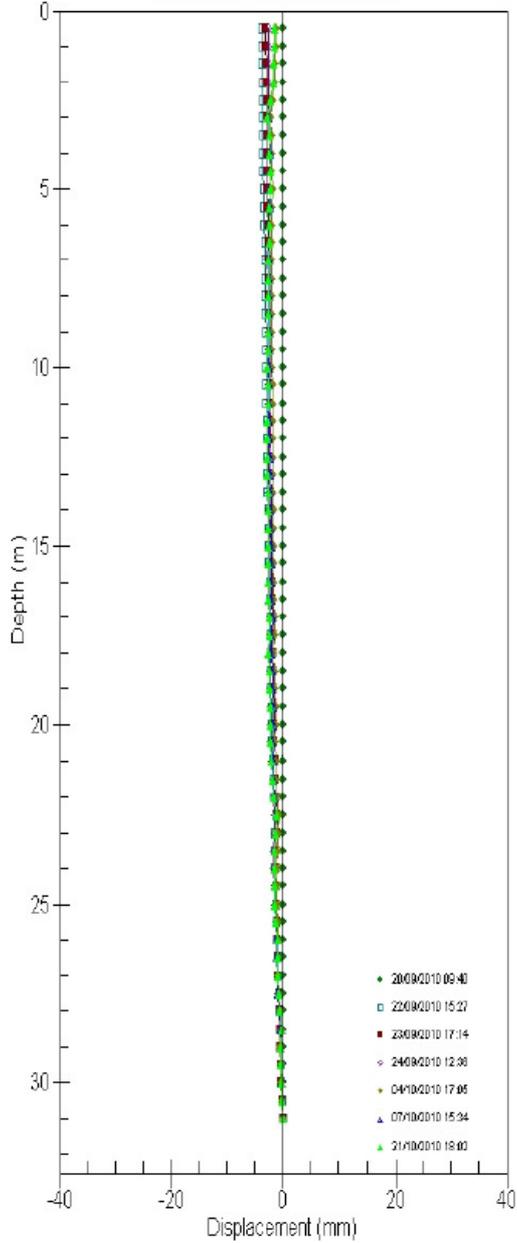
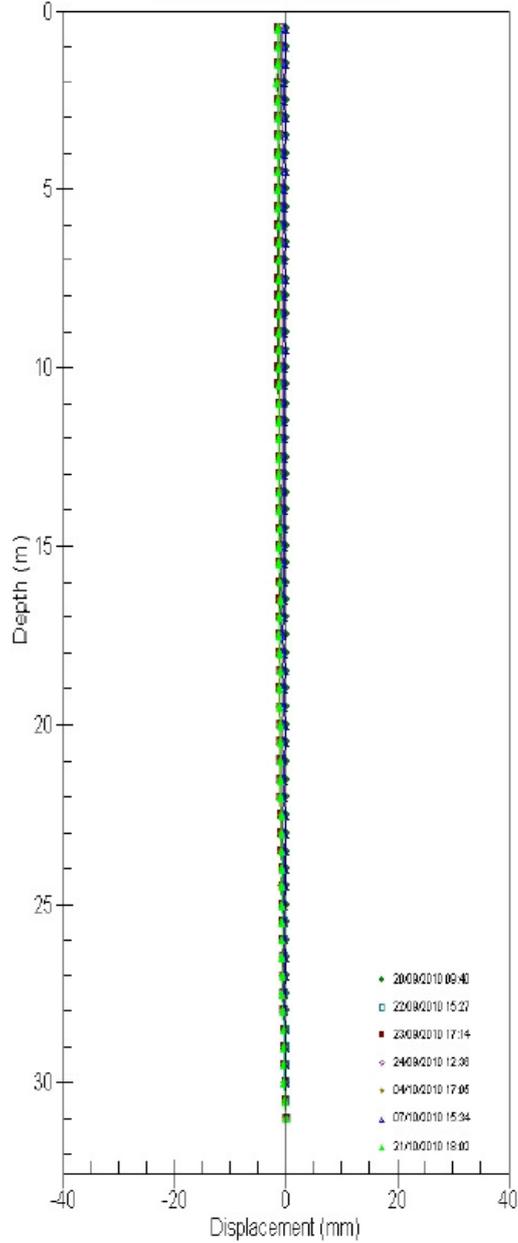
### A64274:BH21 - A Axis Cumulative

### A64274:BH21 - B Axis Cumulative

PROJECT: SCARBOROUGH BOREHOLE REPLACEMENT PROGRAMME  
SITE: A64274  
INSTALLATION: BH21  
COMPANY: WYG  
CLIENT: SCARBOROUGH BOROUGH COUNCIL

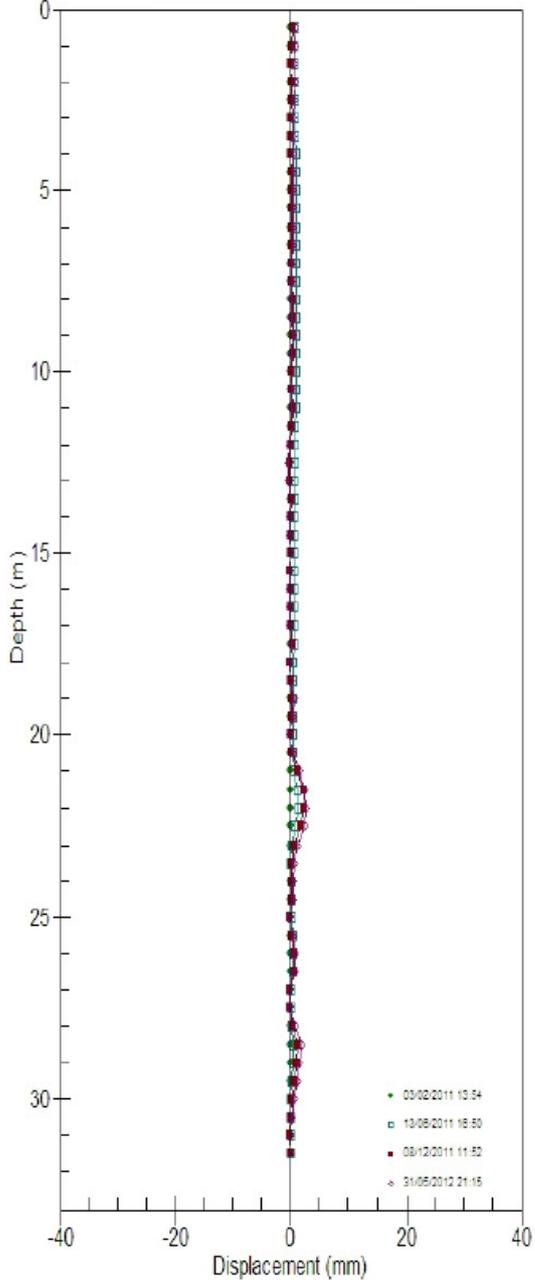
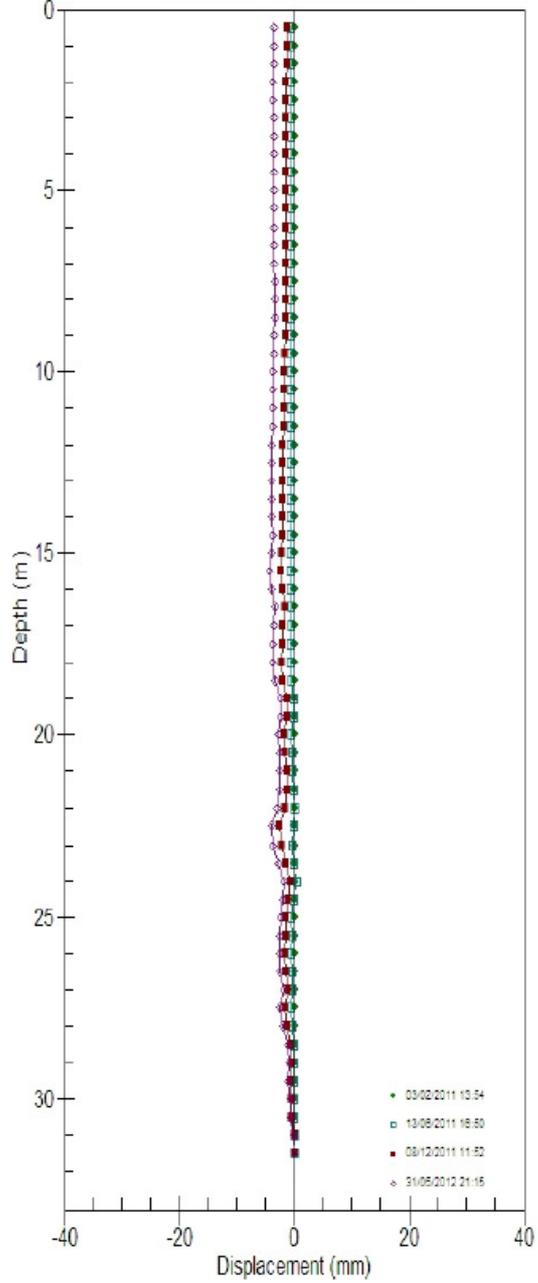
### SSC: BH21 - A Axis Cumulative

### SSC: BH21 - B Axis Cumulative

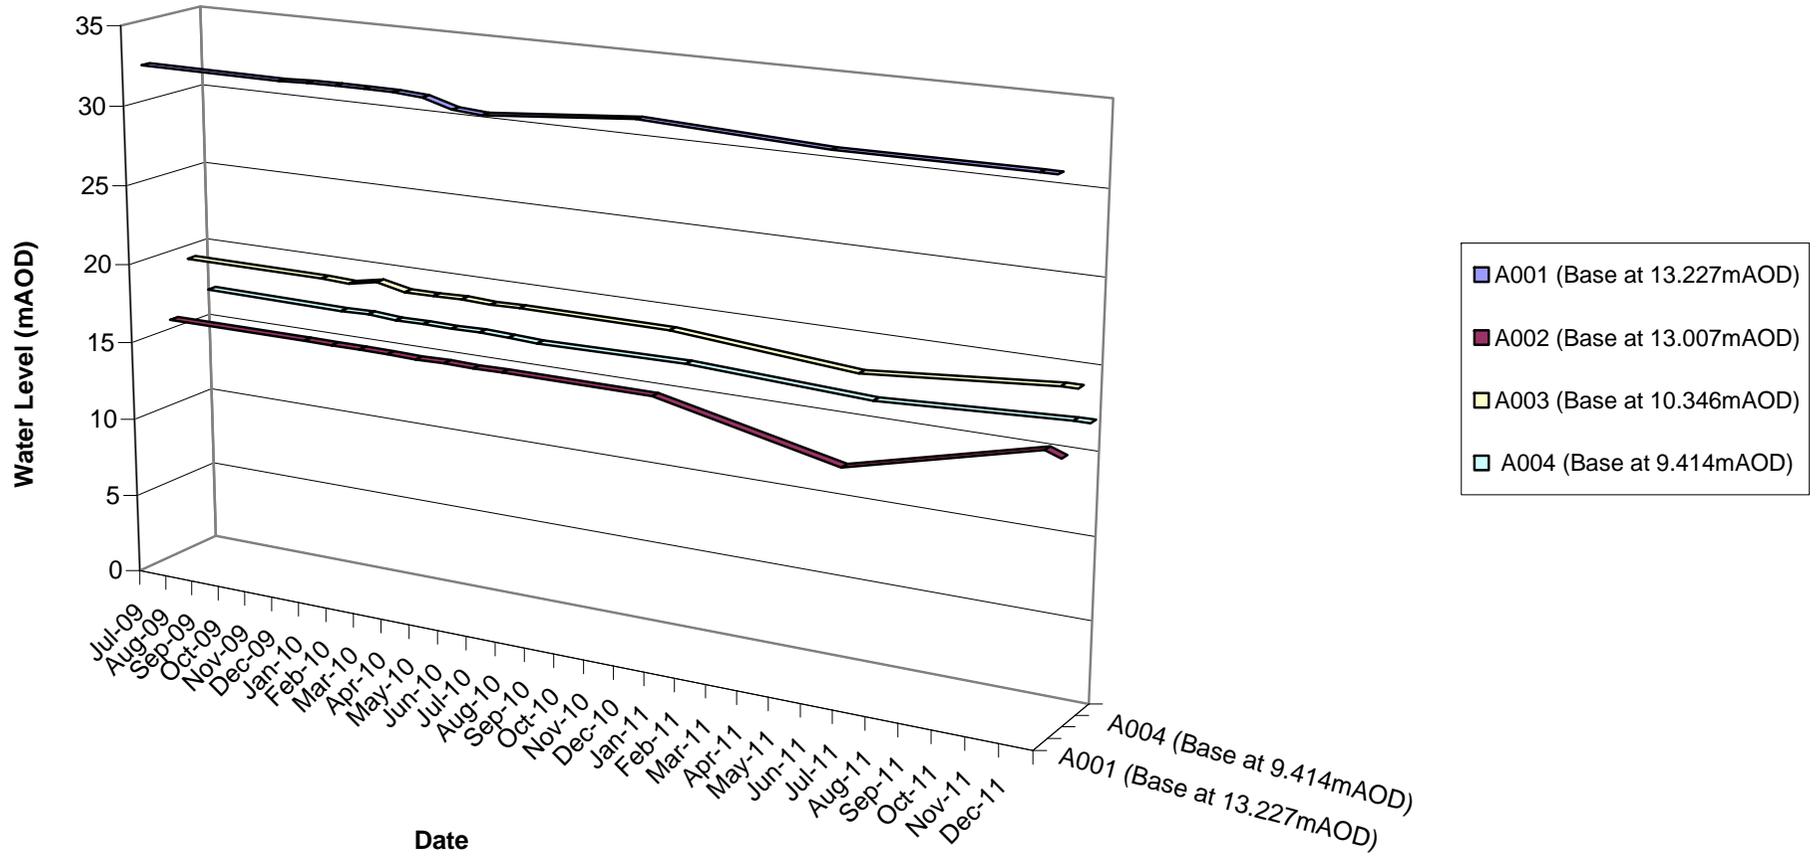
# RUNSWICK BAY GROUNDWATER LEVELS

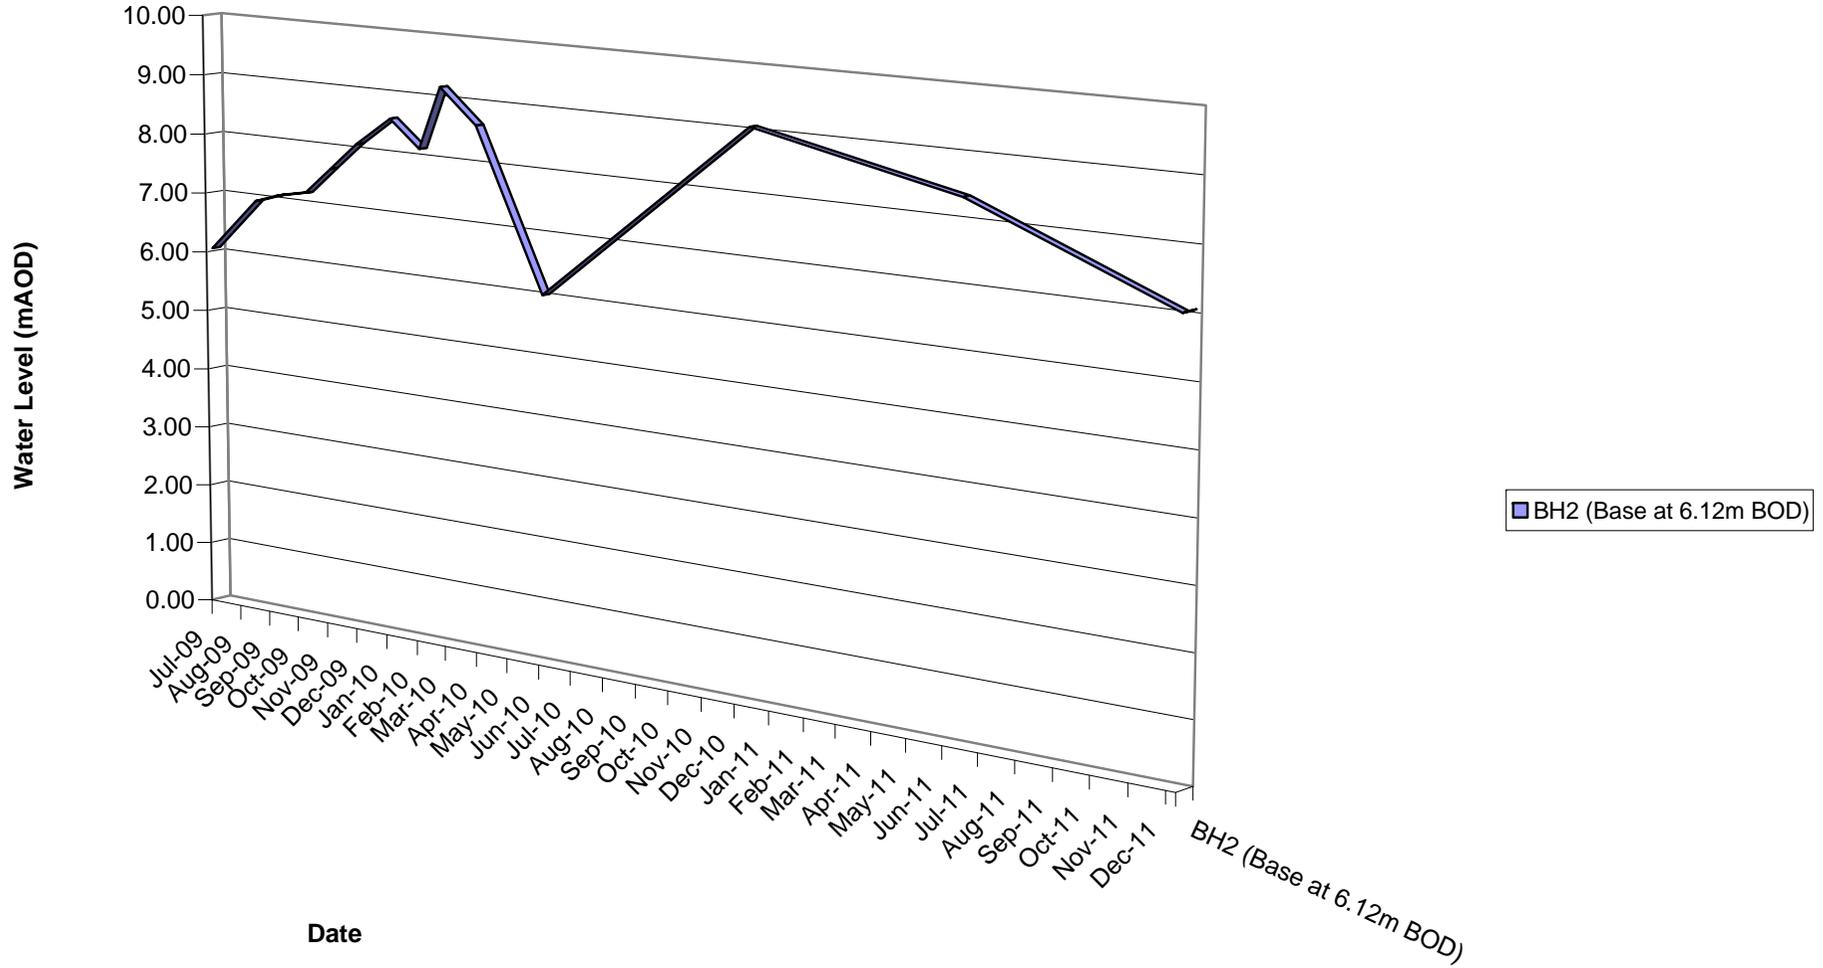
# WHITBY WEST CLIFF GROUNDWATER LEVELS

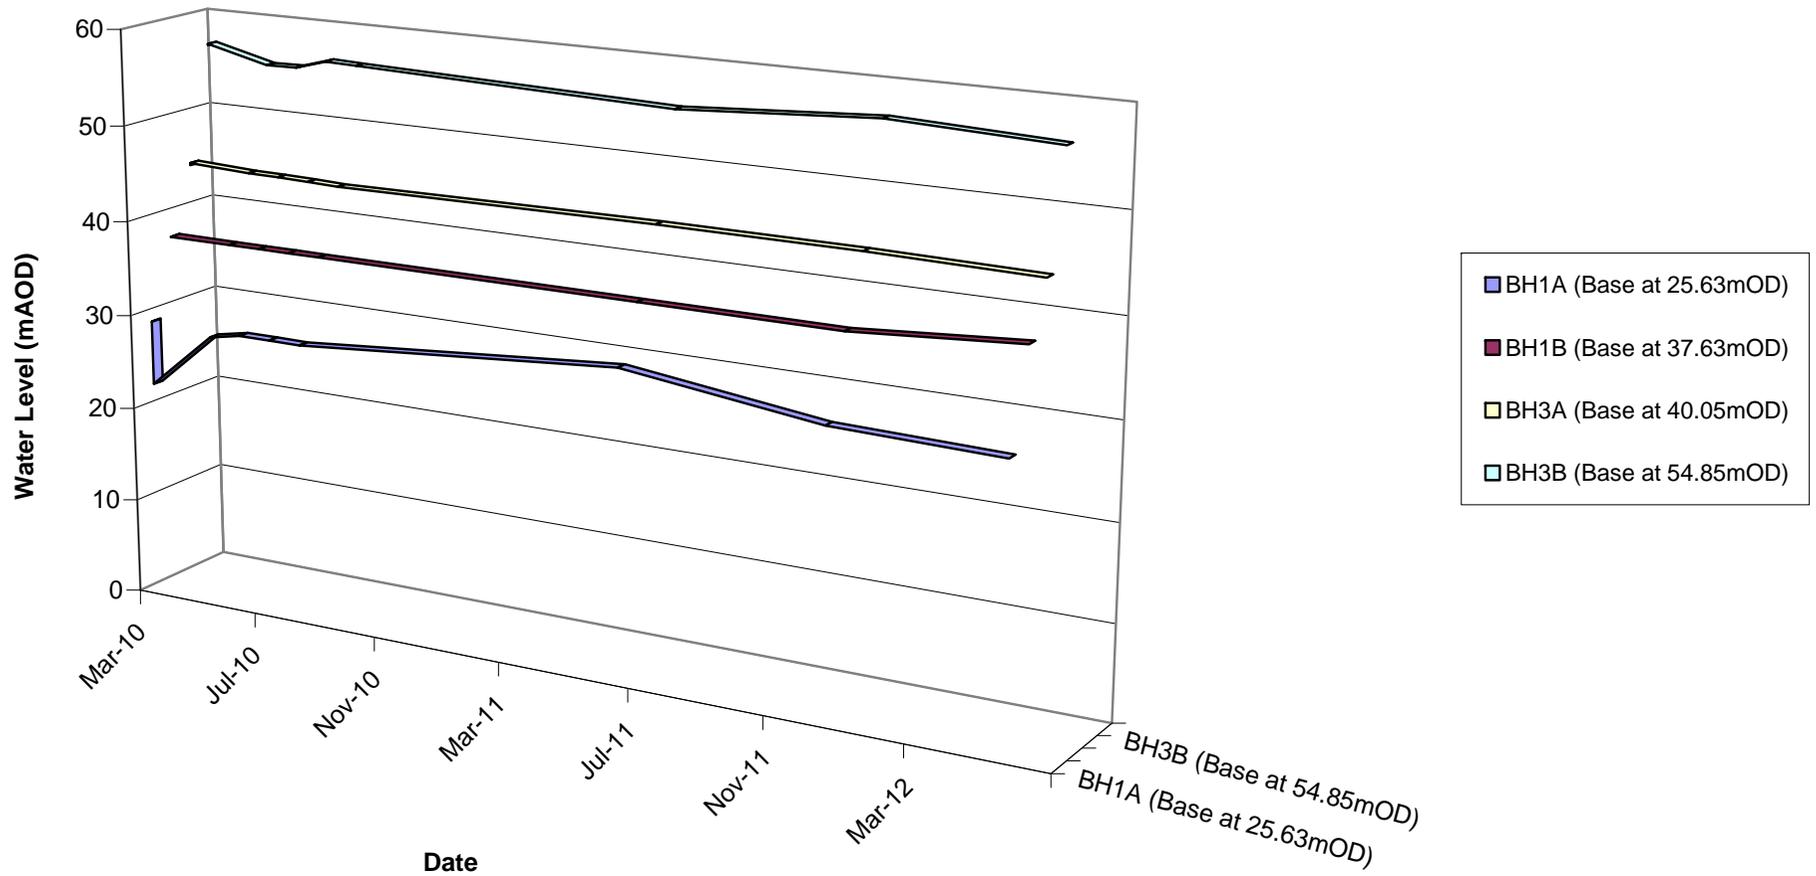
# ROBIN HOOD'S BAY GROUNDWATER LEVELS
