# Ongoing Analysis and Interpretation of Coastal Monitoring Data

Seventh Review of Full Suite Monitoring

## Geotechnical Interpretative Report

Document Ref. No. 721229/002/GIR/014/Final

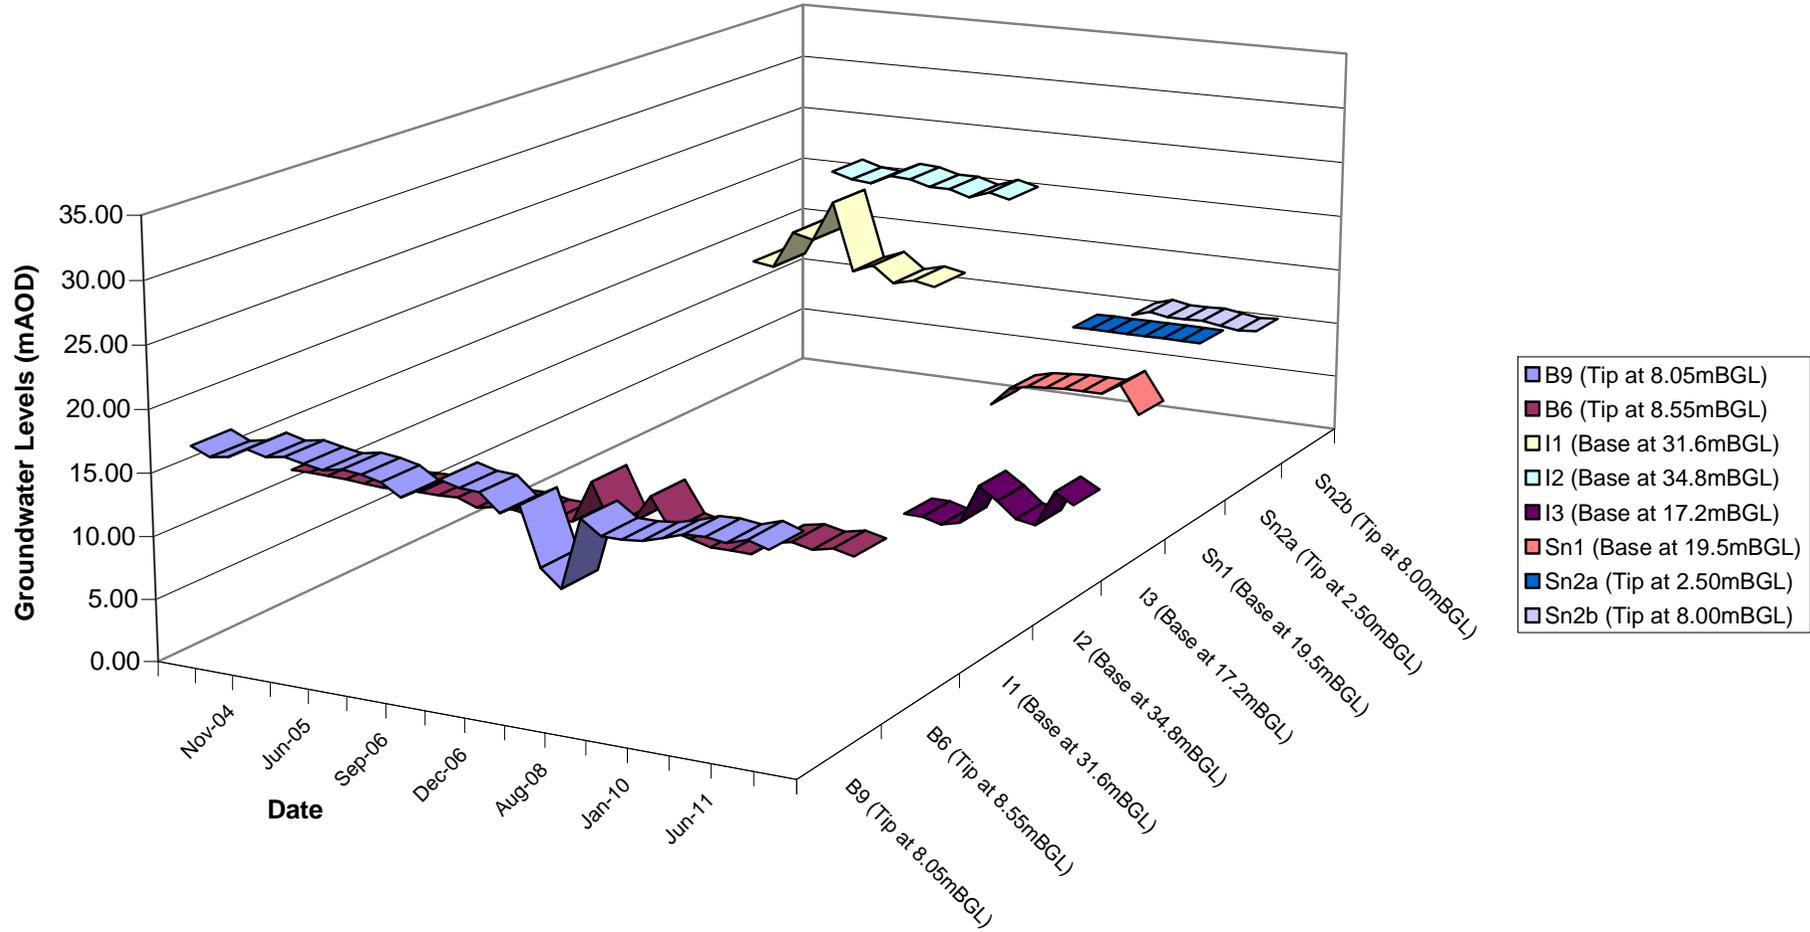
### SCALBY NESS GROUNDWATER LEVELS

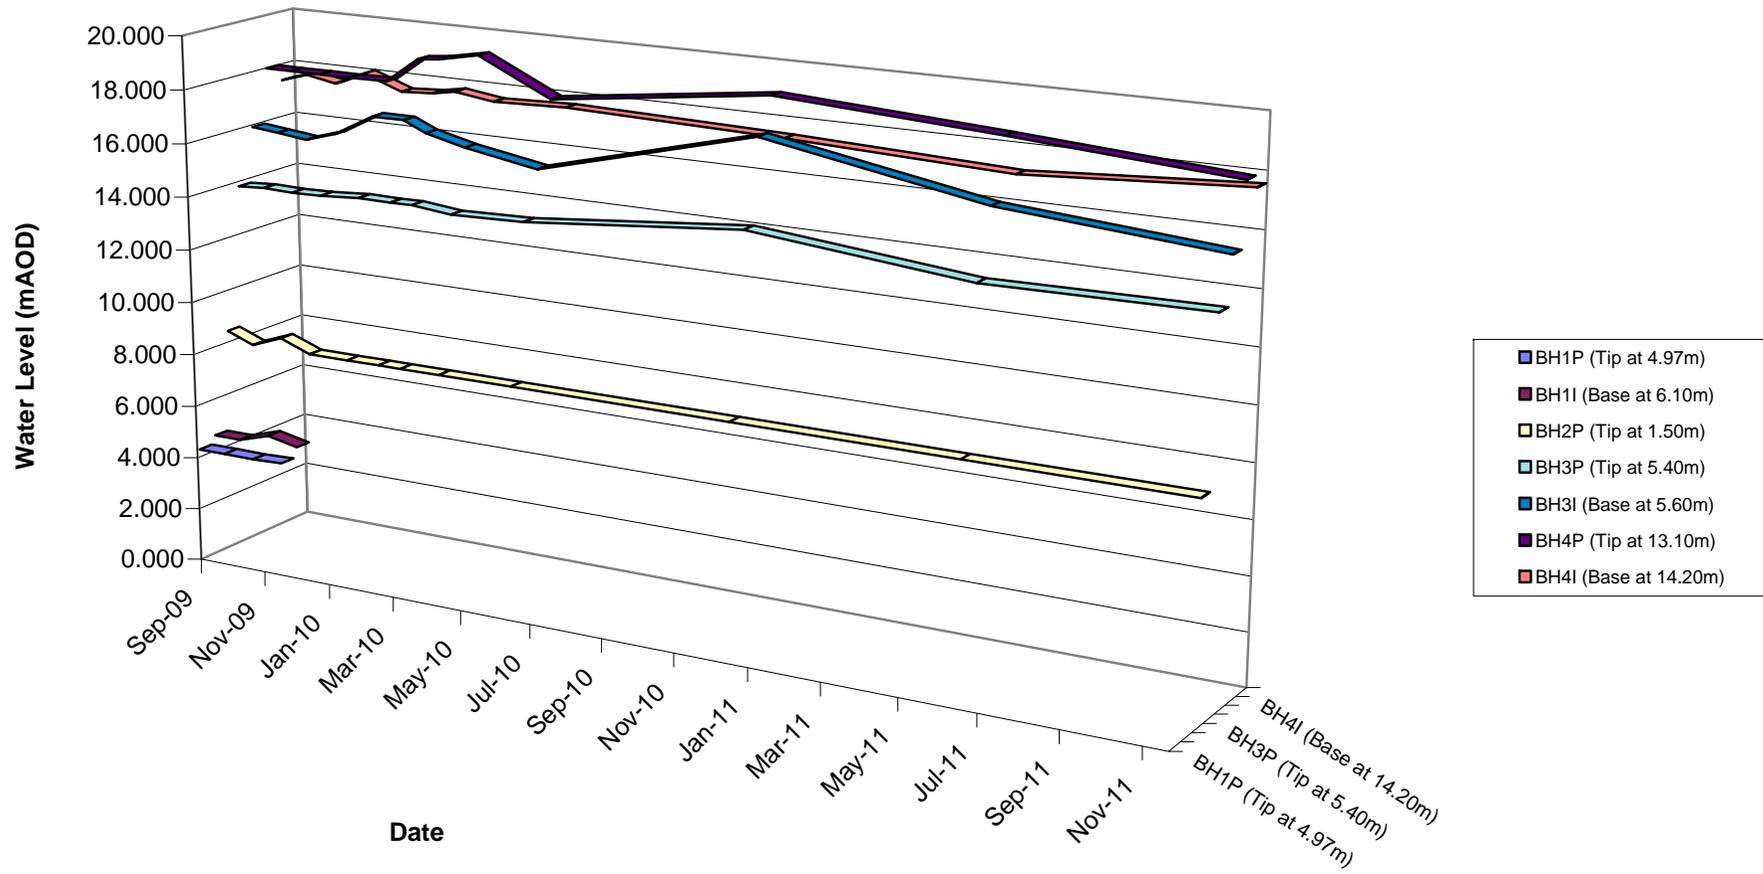
# OASIS CAFÉ GROUNDWATER LEVELS

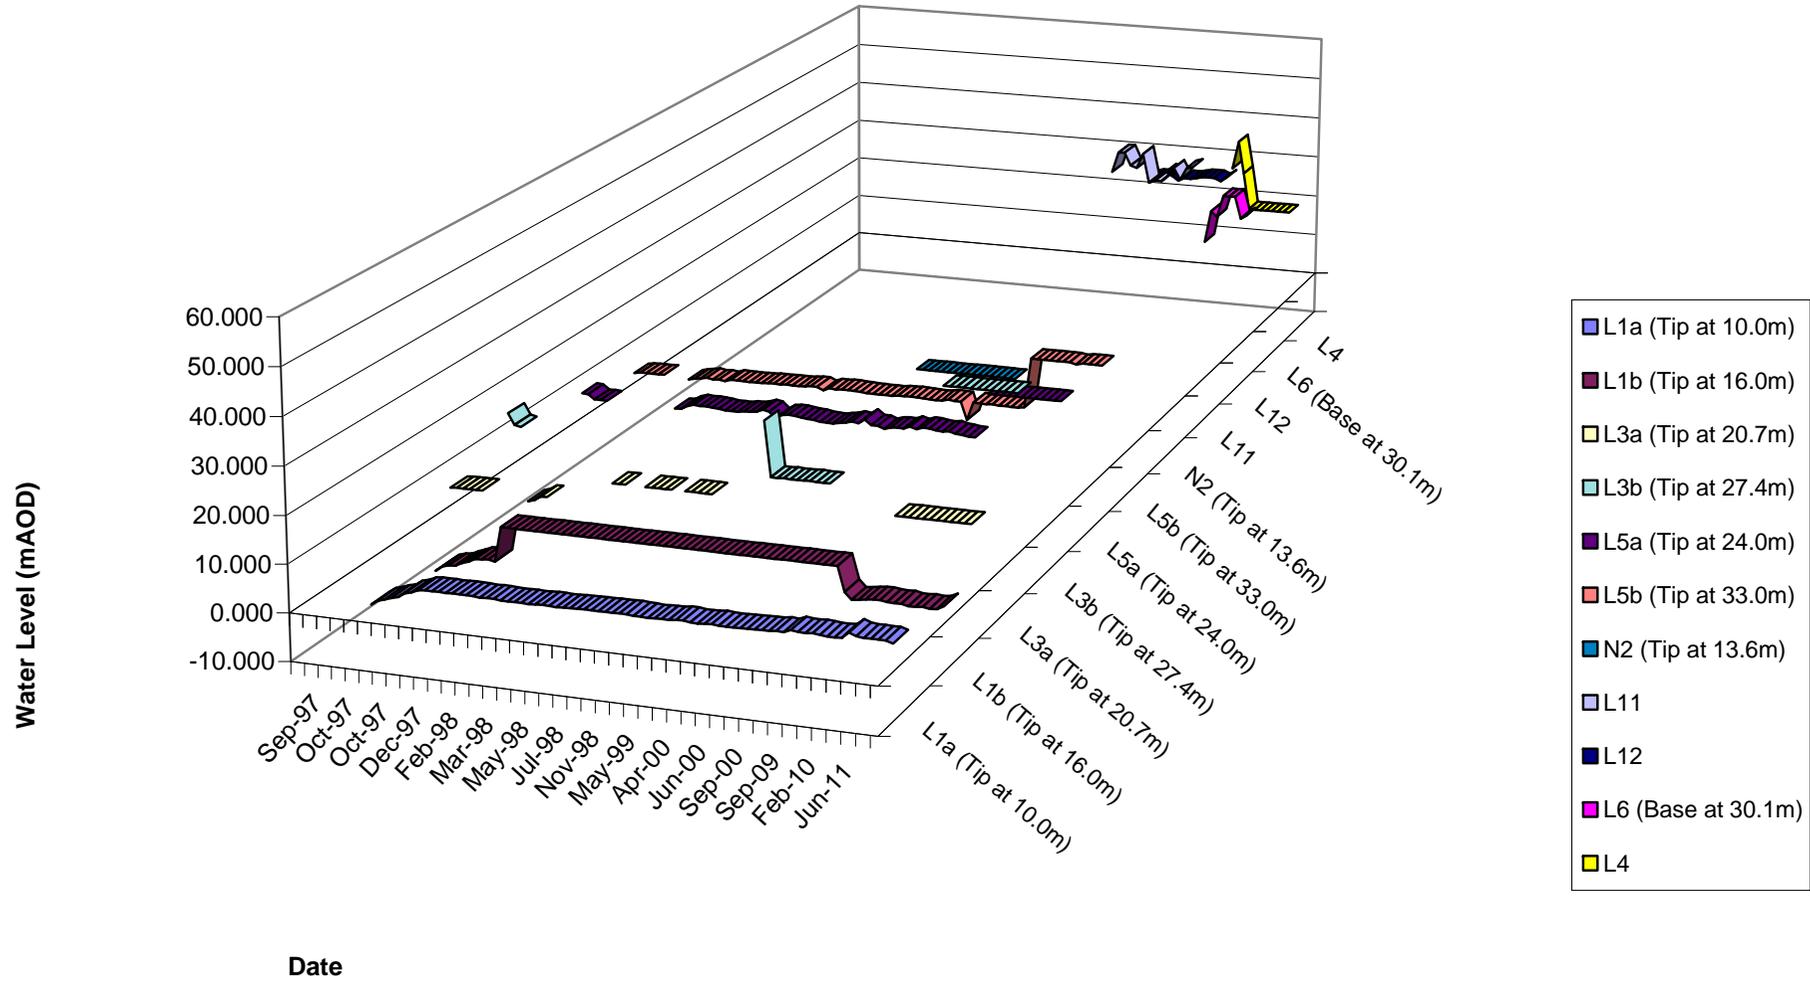
### SCARBOROUGH NORTH BAY GROUNDWATER LEVELS

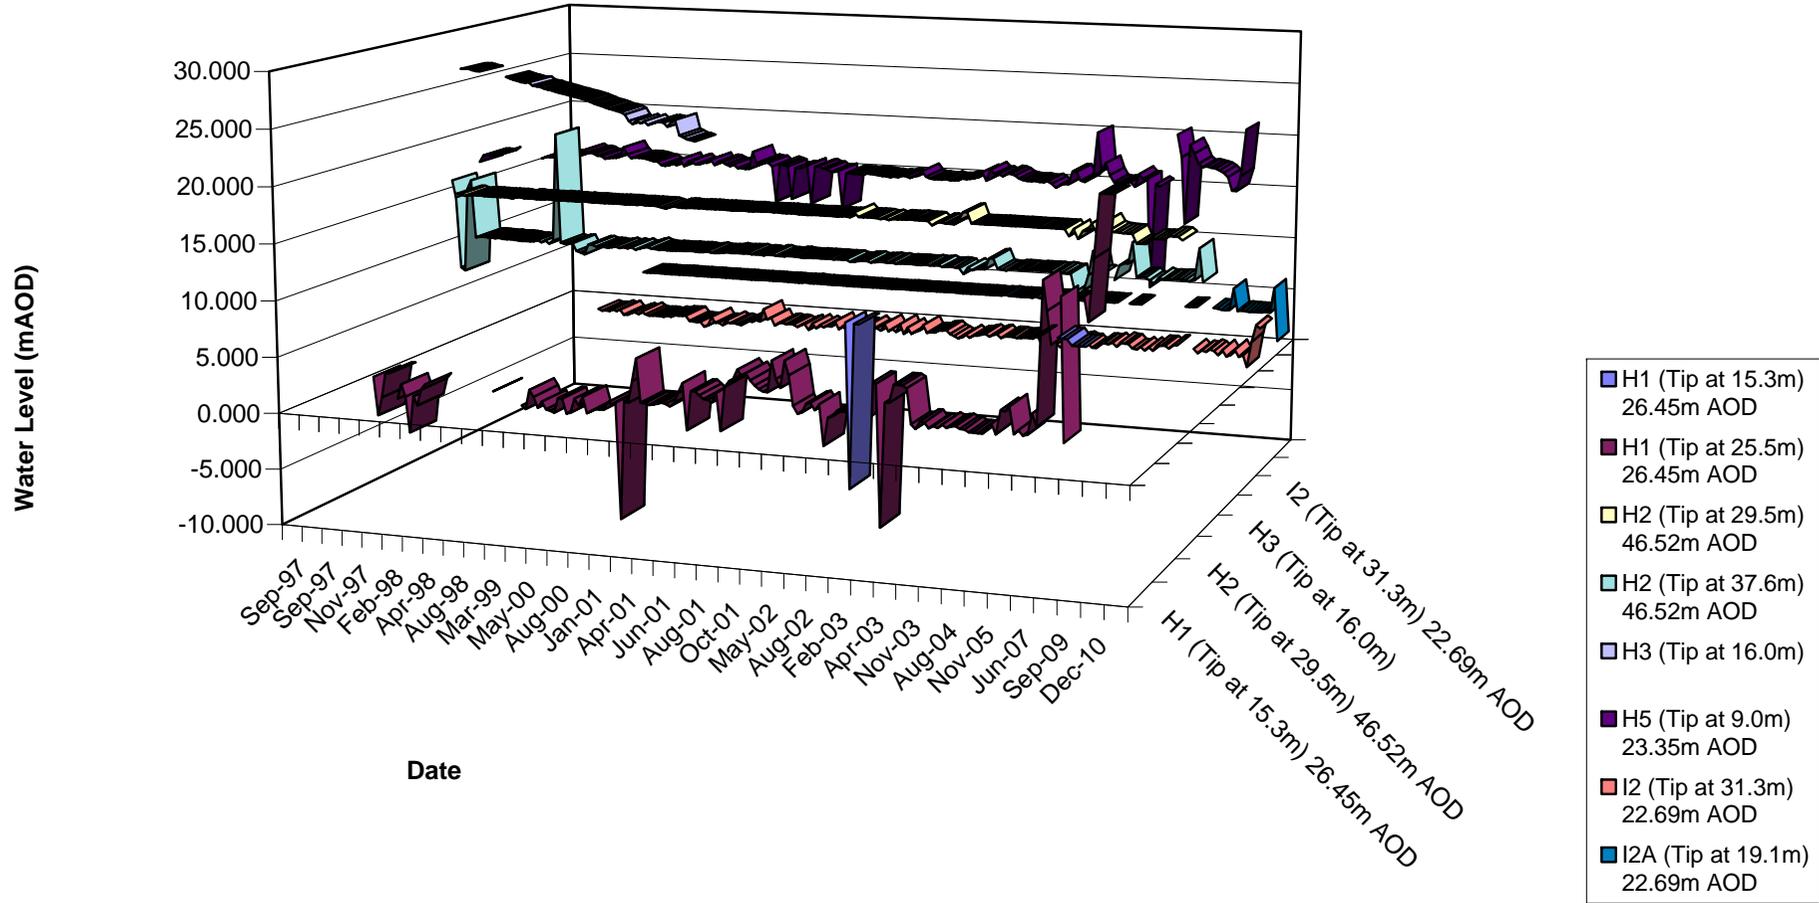
### SCARBOROUGH SOUTH CLIFF (NORTH) GROUNDWATER LEVELS

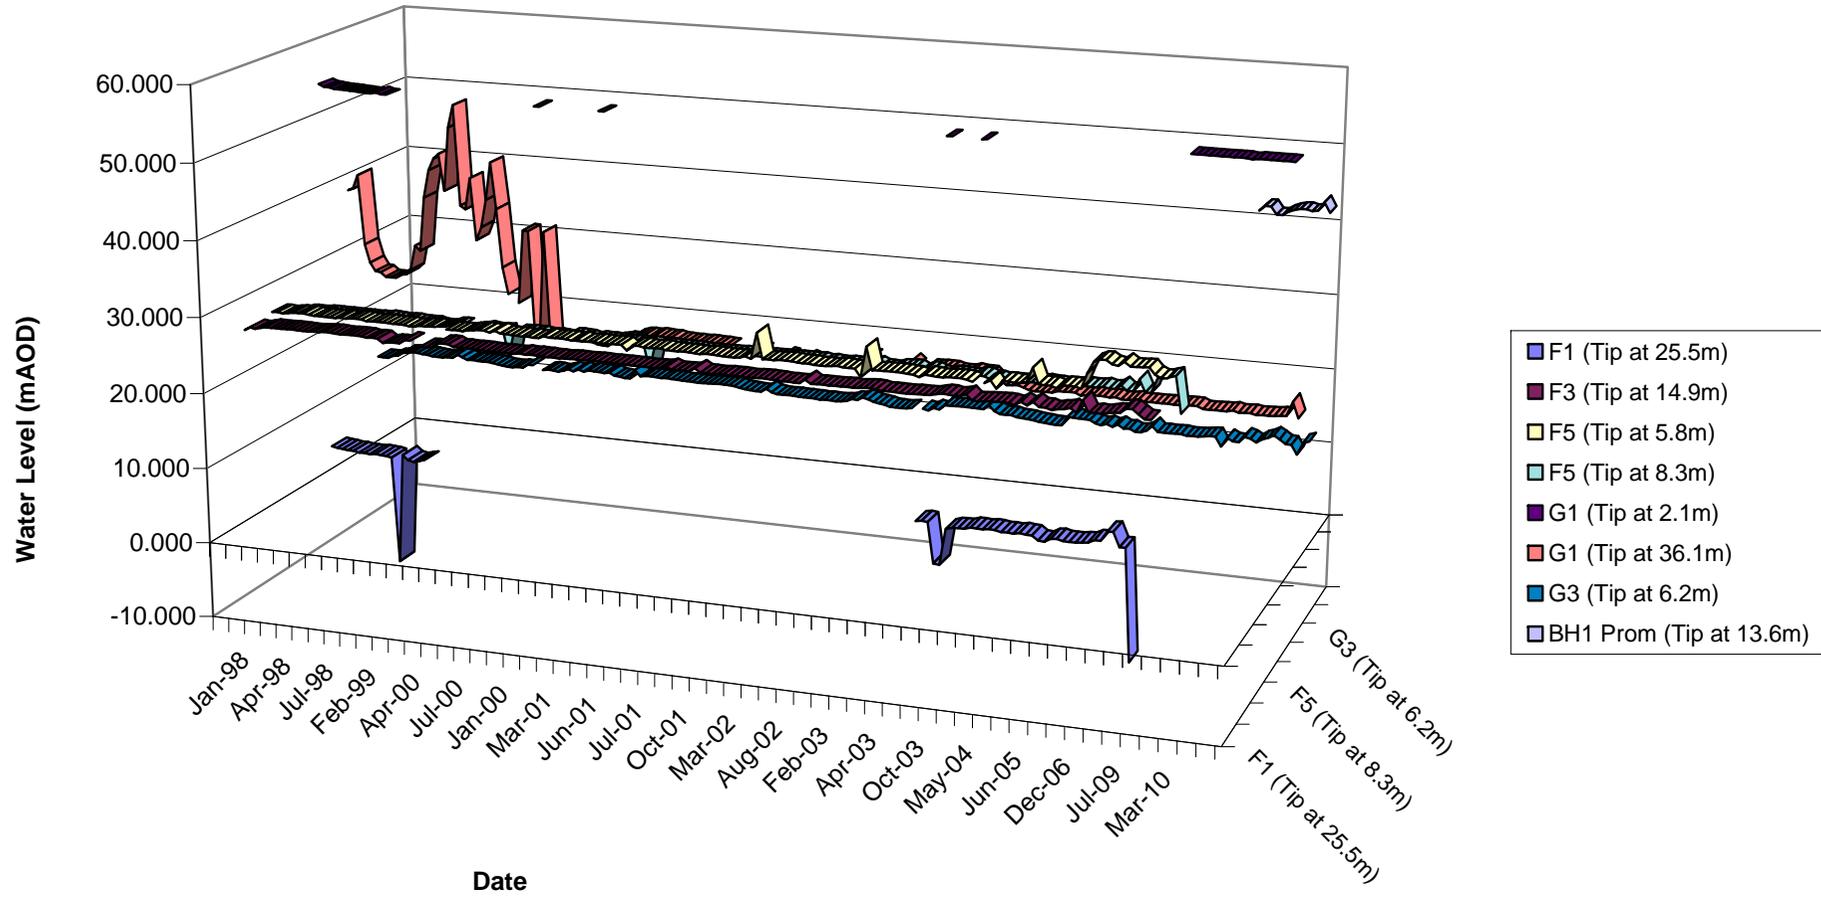
### SCARBOROUGH SOUTH CLIFF (MIDDLE) GROUNDWATER LEVELS

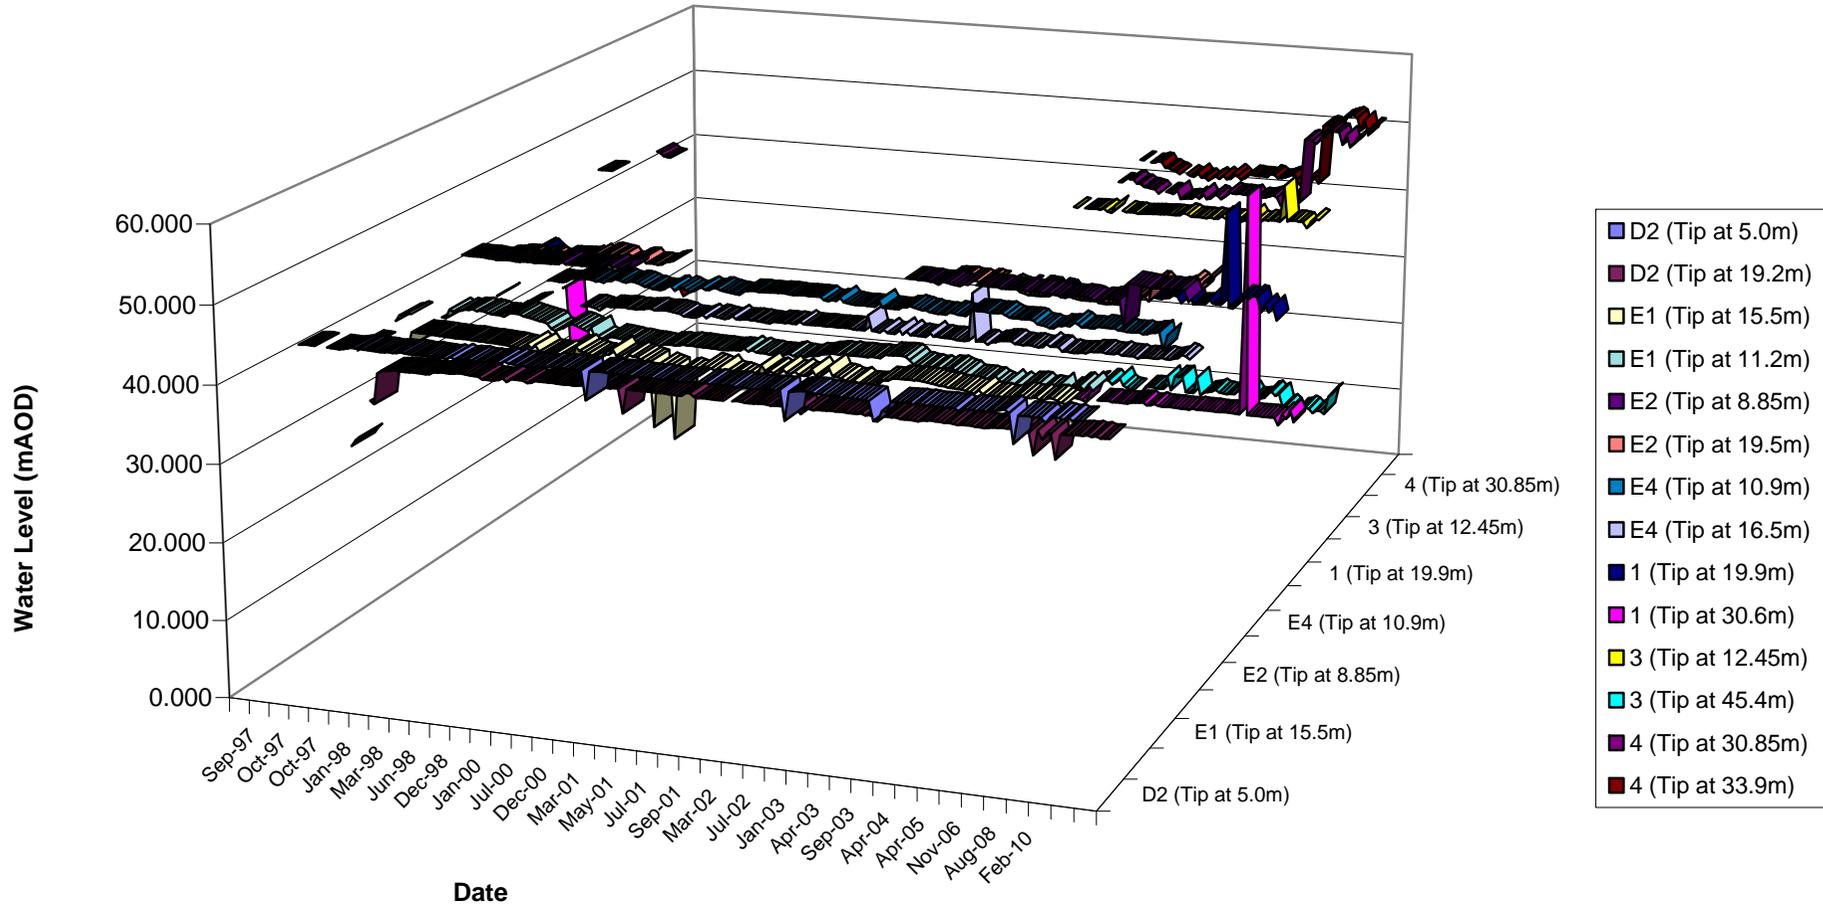
## SCARBOROUGH SOUTH CLIFF (SOUTH) GROUNDWATER LEVELS

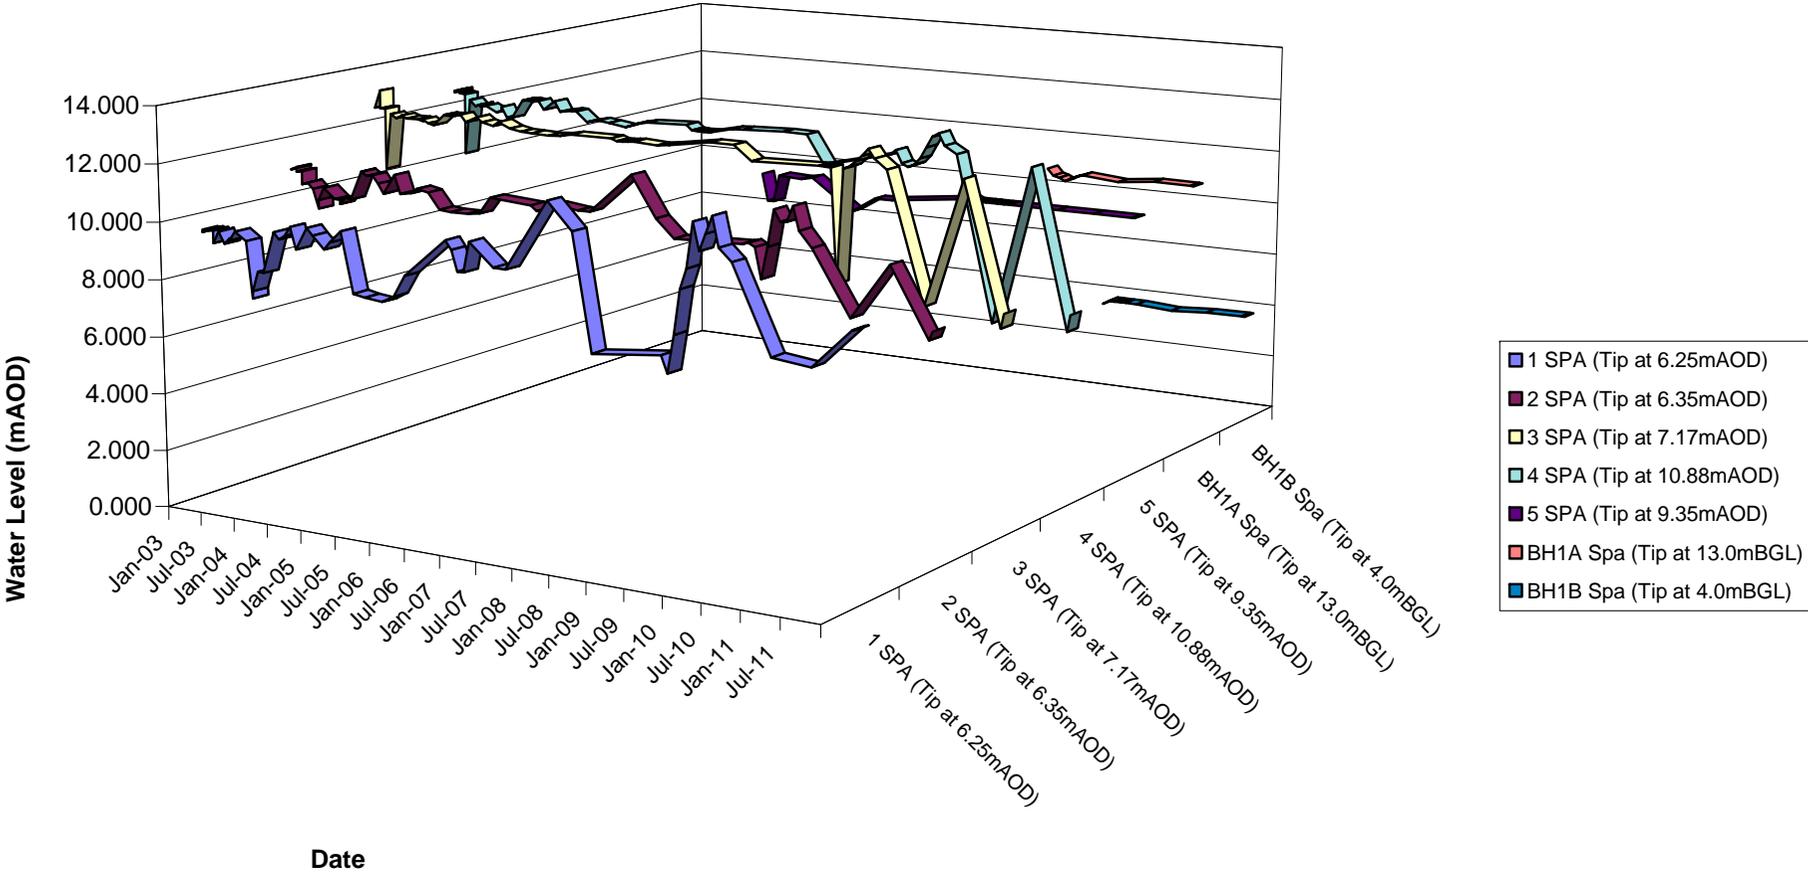
# SCARBOROUGH SPA GROUNDWATER LEVELS

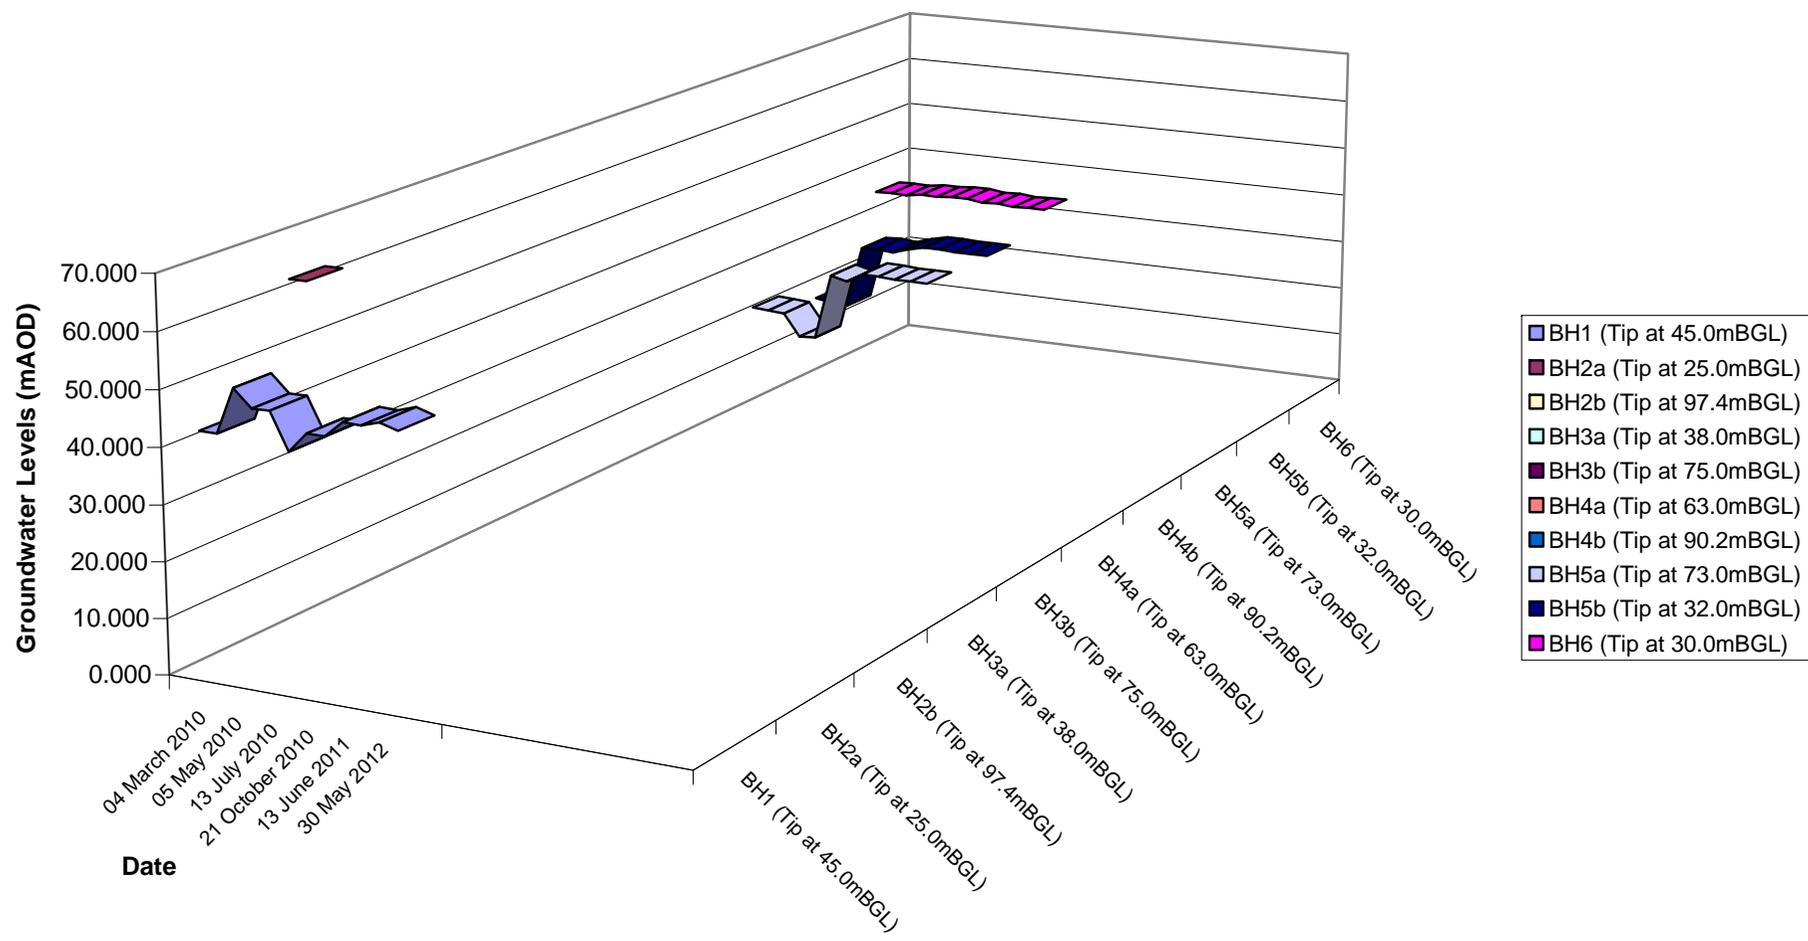
## KNIPE POINT GROUNDWATER LEVELS

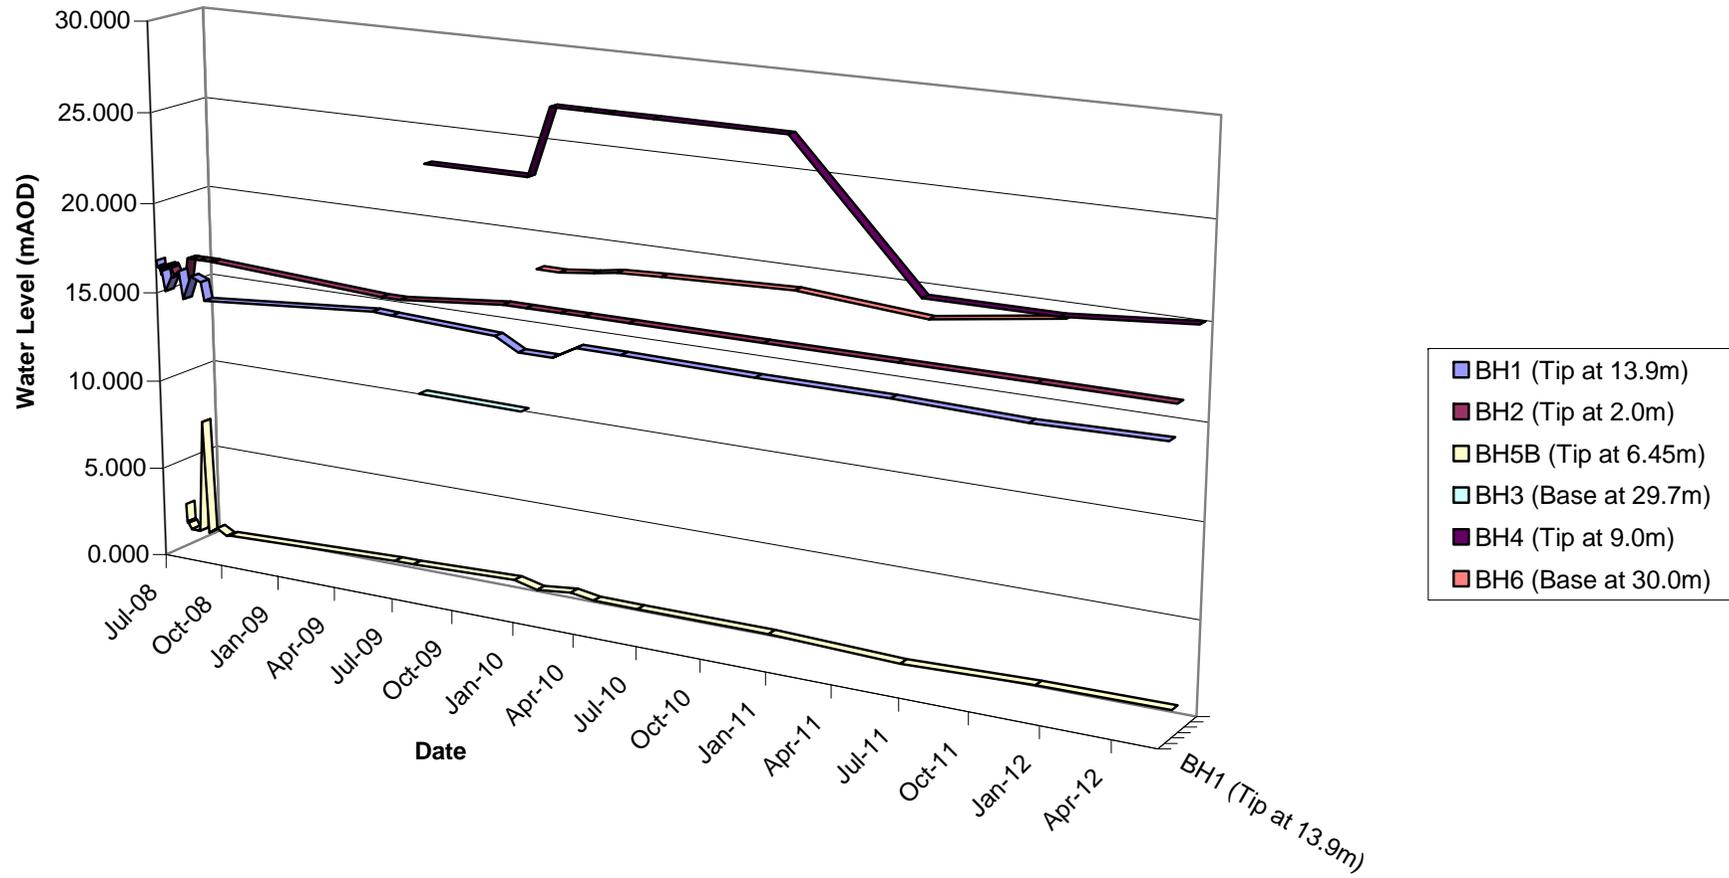
### FILEY TOWN GROUNDWATER LEVELS

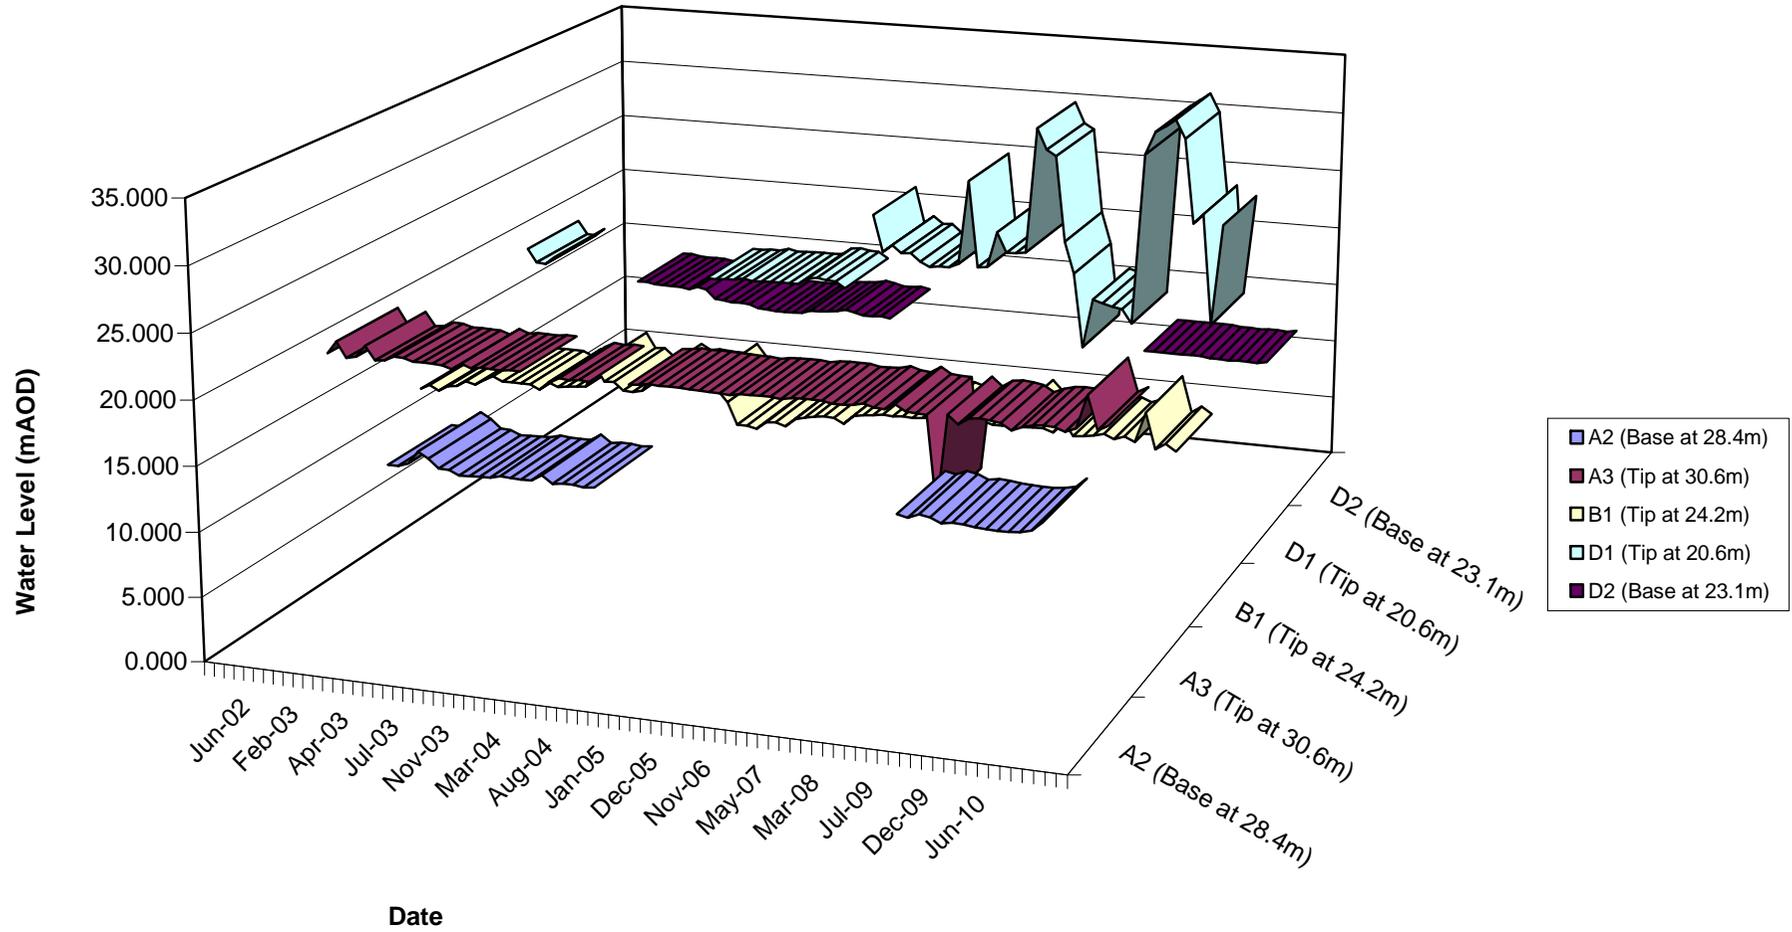
### FILEY FLAT CLIFFS GROUNDWATER LEVELS

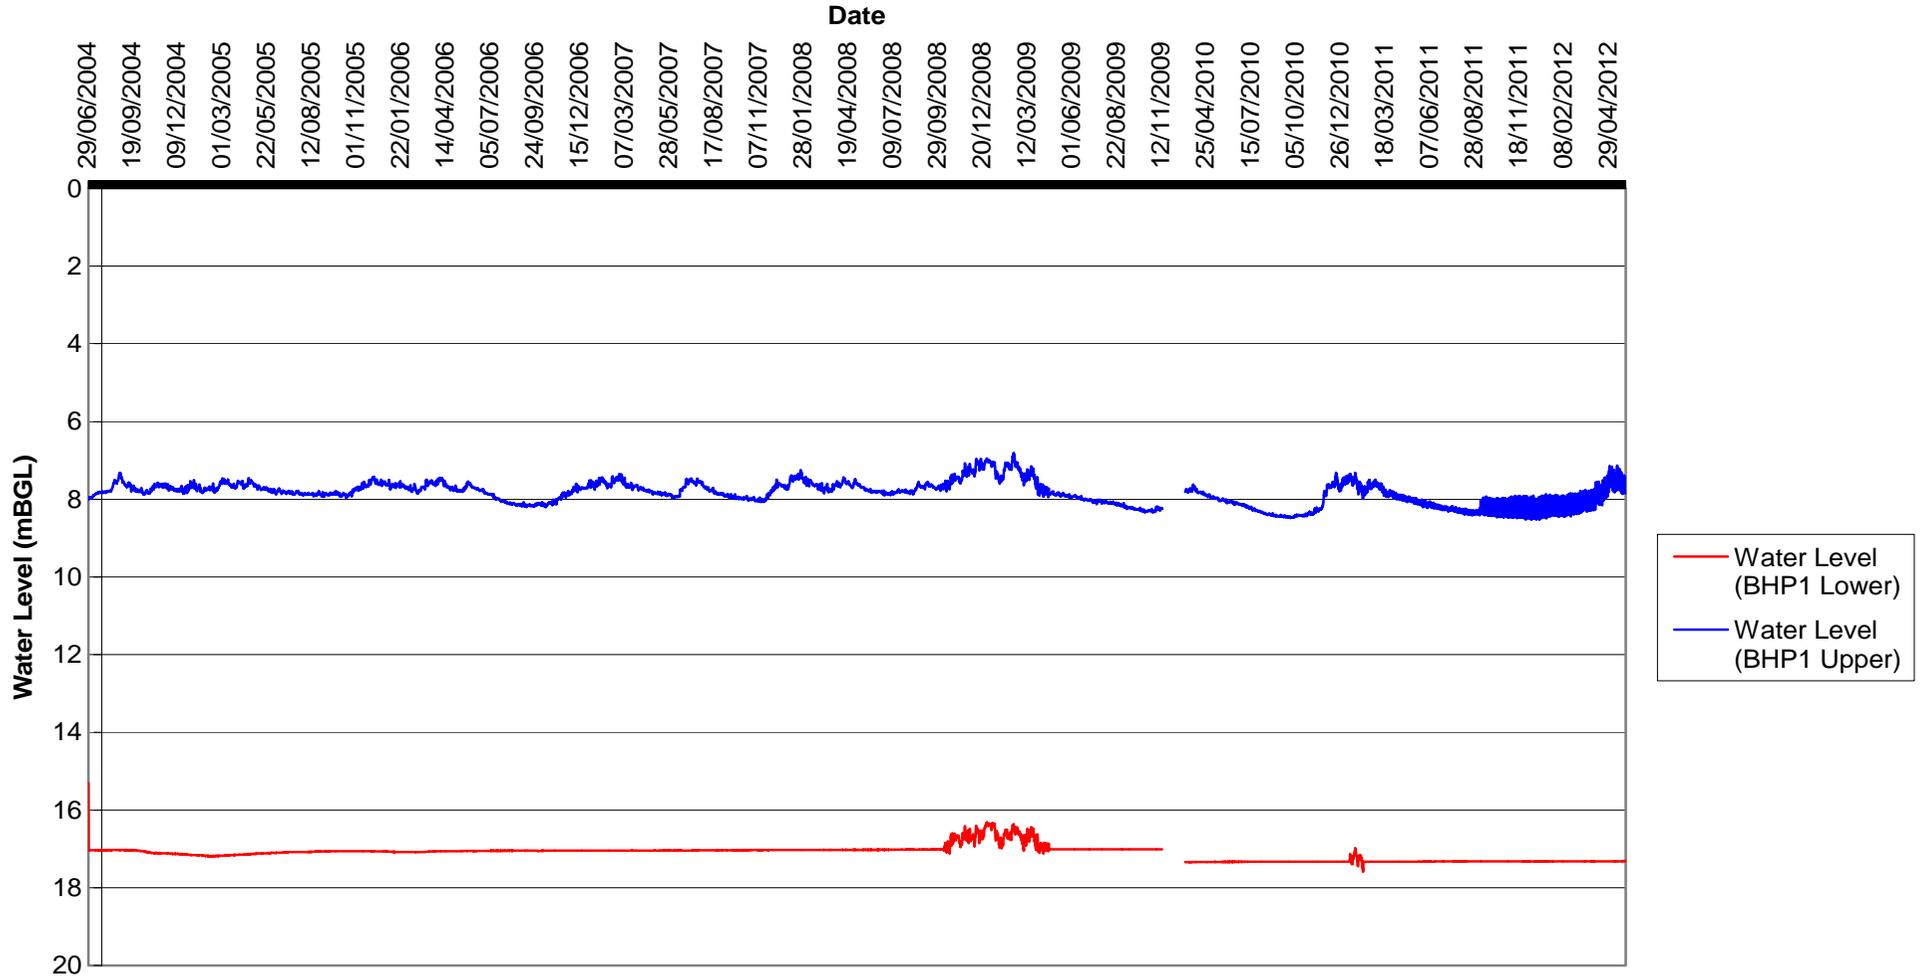
**Automated Piezometer Groundwater Monitoring  
Readings from Scalby Ness**

# SCALBY NESS (AUTOMATED) GROUNDWATER LEVELS

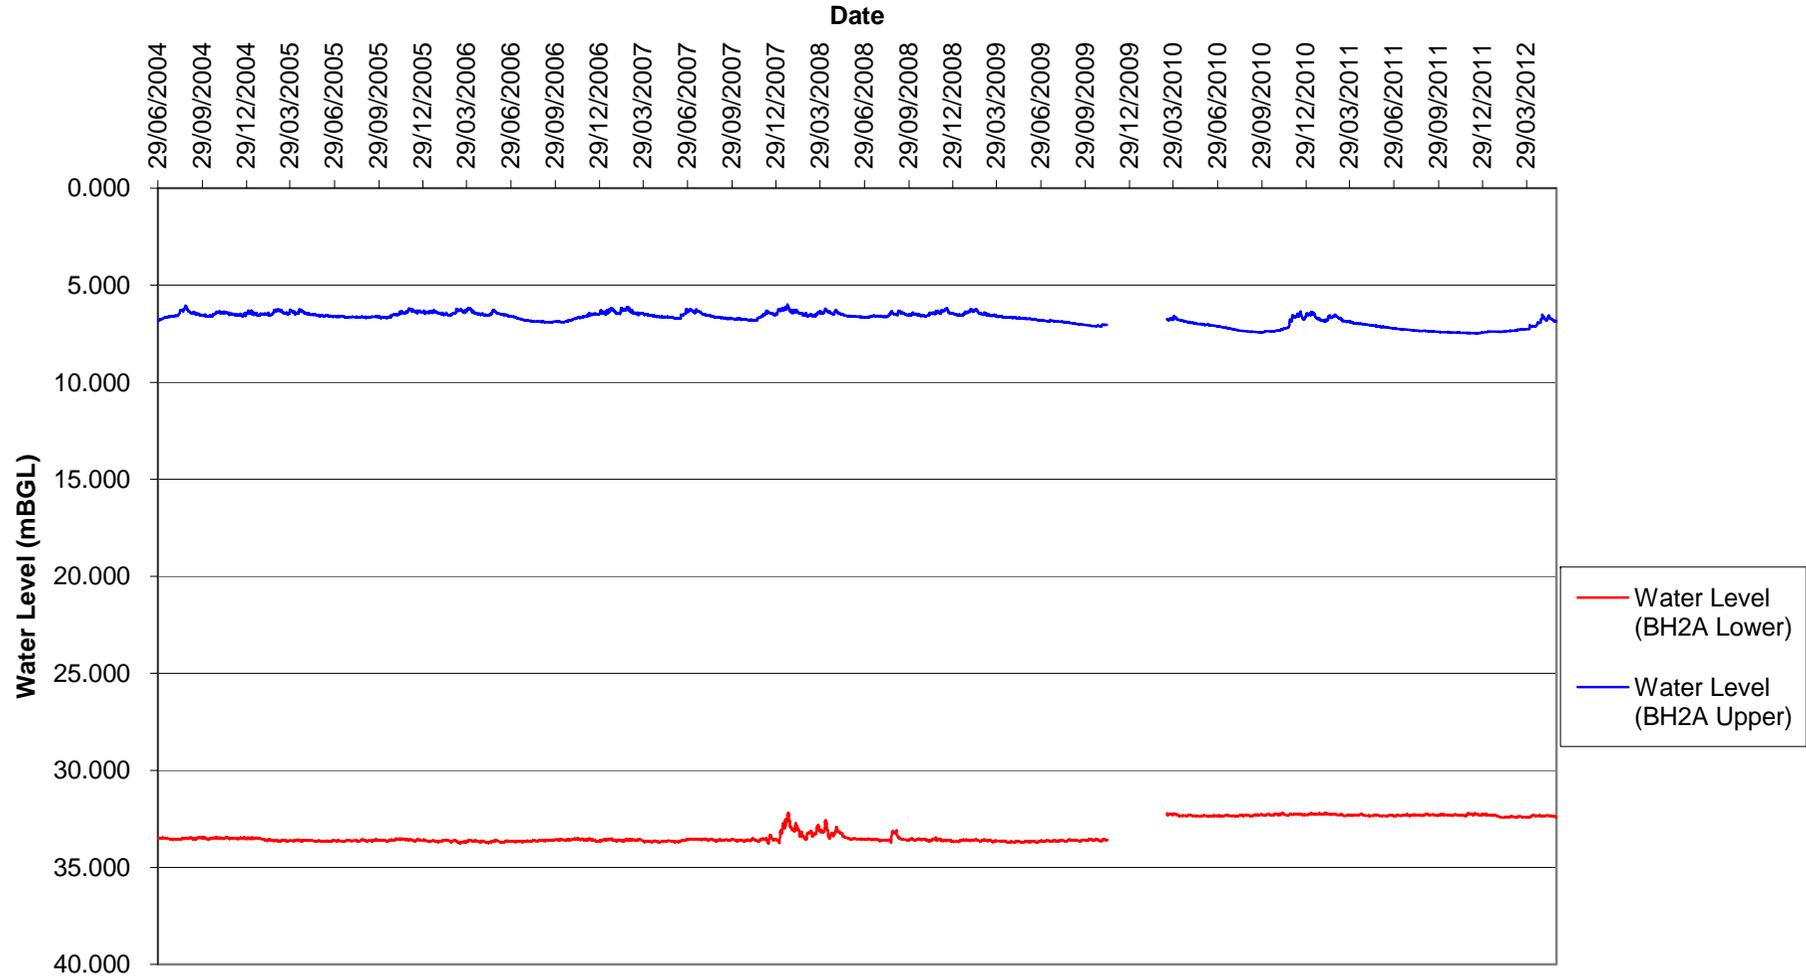
# SCALBY NESS (AUTOMATED) GROUNDWATER LEVELS

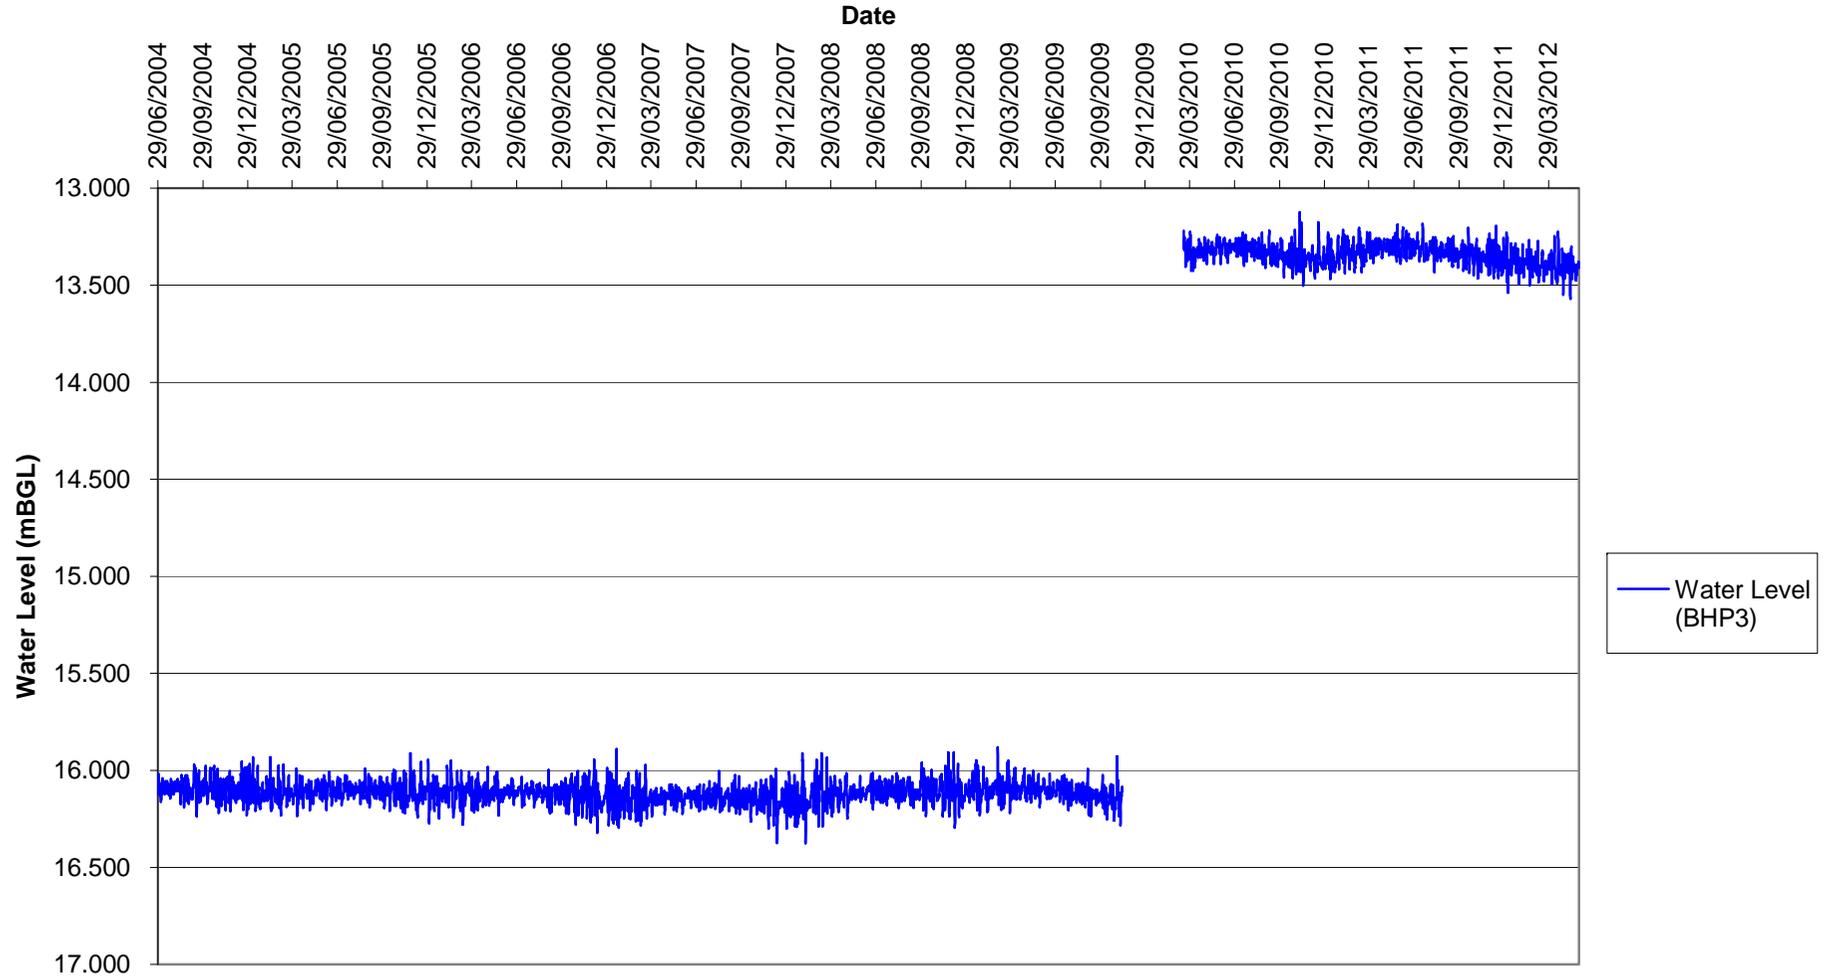
# SCALBY NESS (AUTOMATED) GROUNDWATER LEVELS
