# Ongoing Analysis and Interpretation of Coastal Monitoring Data

Seventh Review of Full Suite Monitoring

## Geotechnical Interpretative Report

Document Ref. No. 721229/002/GIR/014/Final

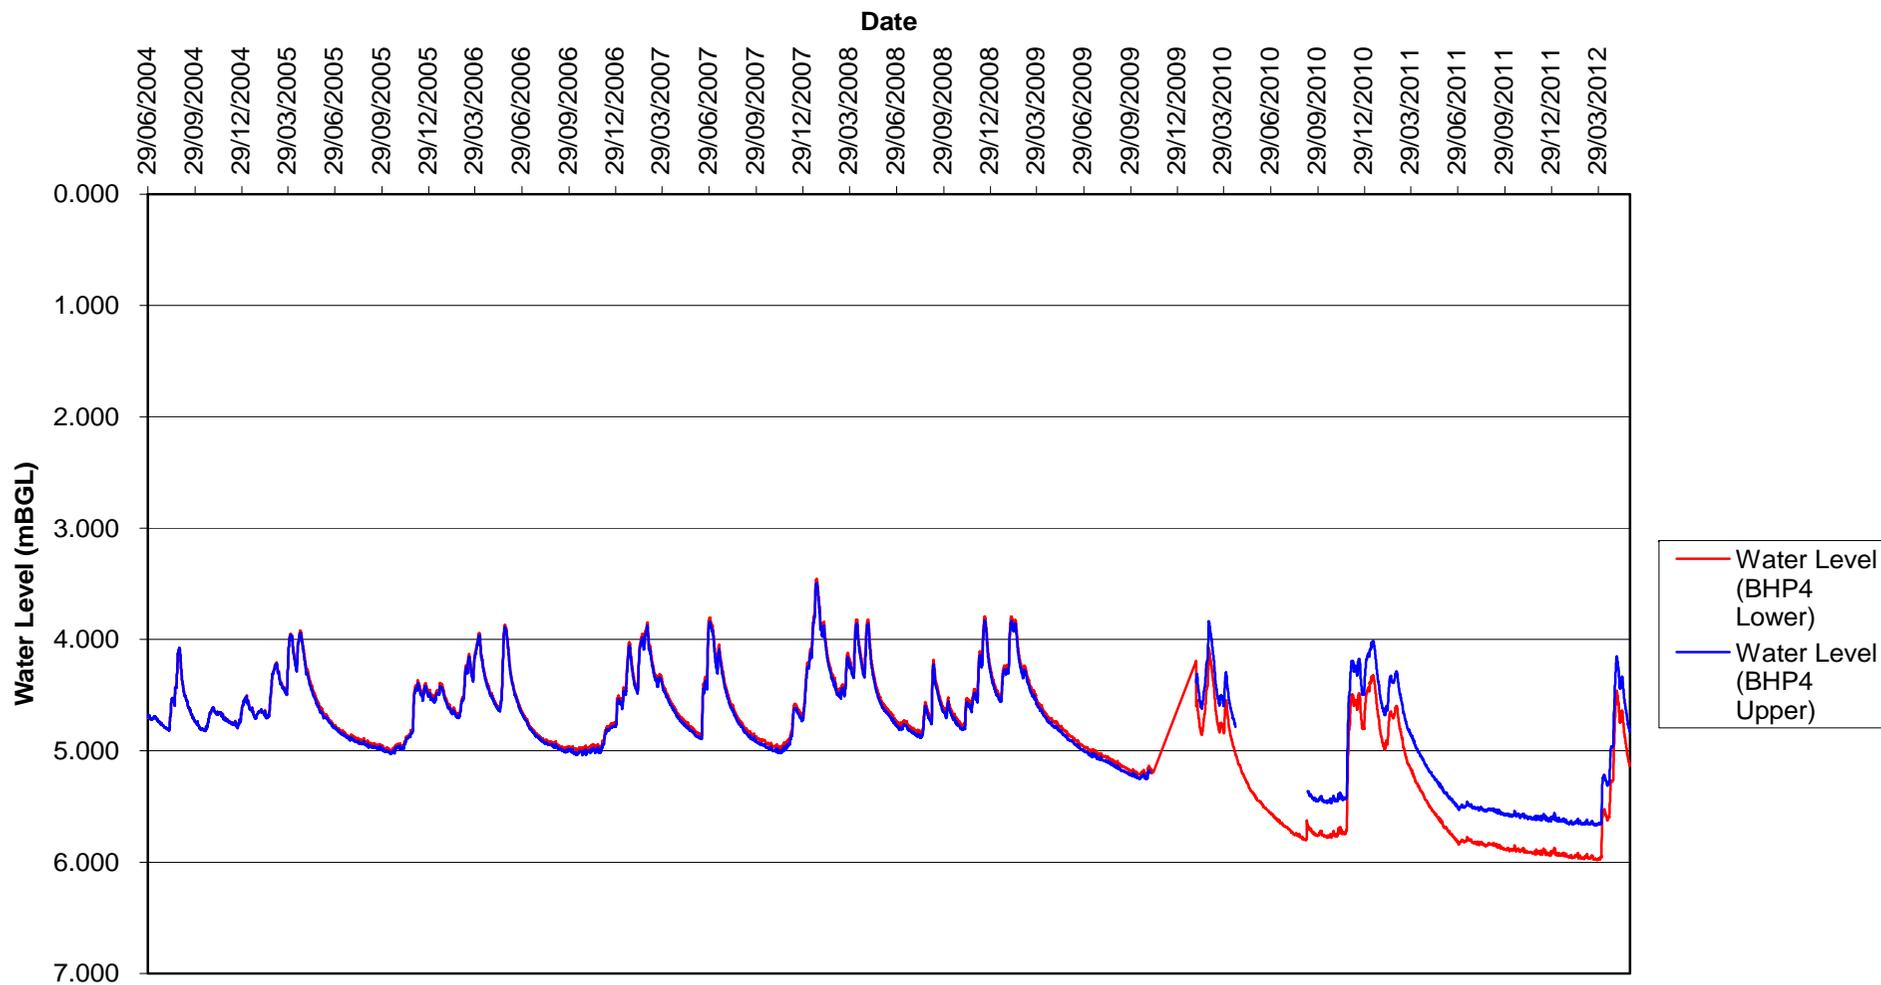
# SCALBY NESS (AUTOMATED) GROUNDWATER LEVELS

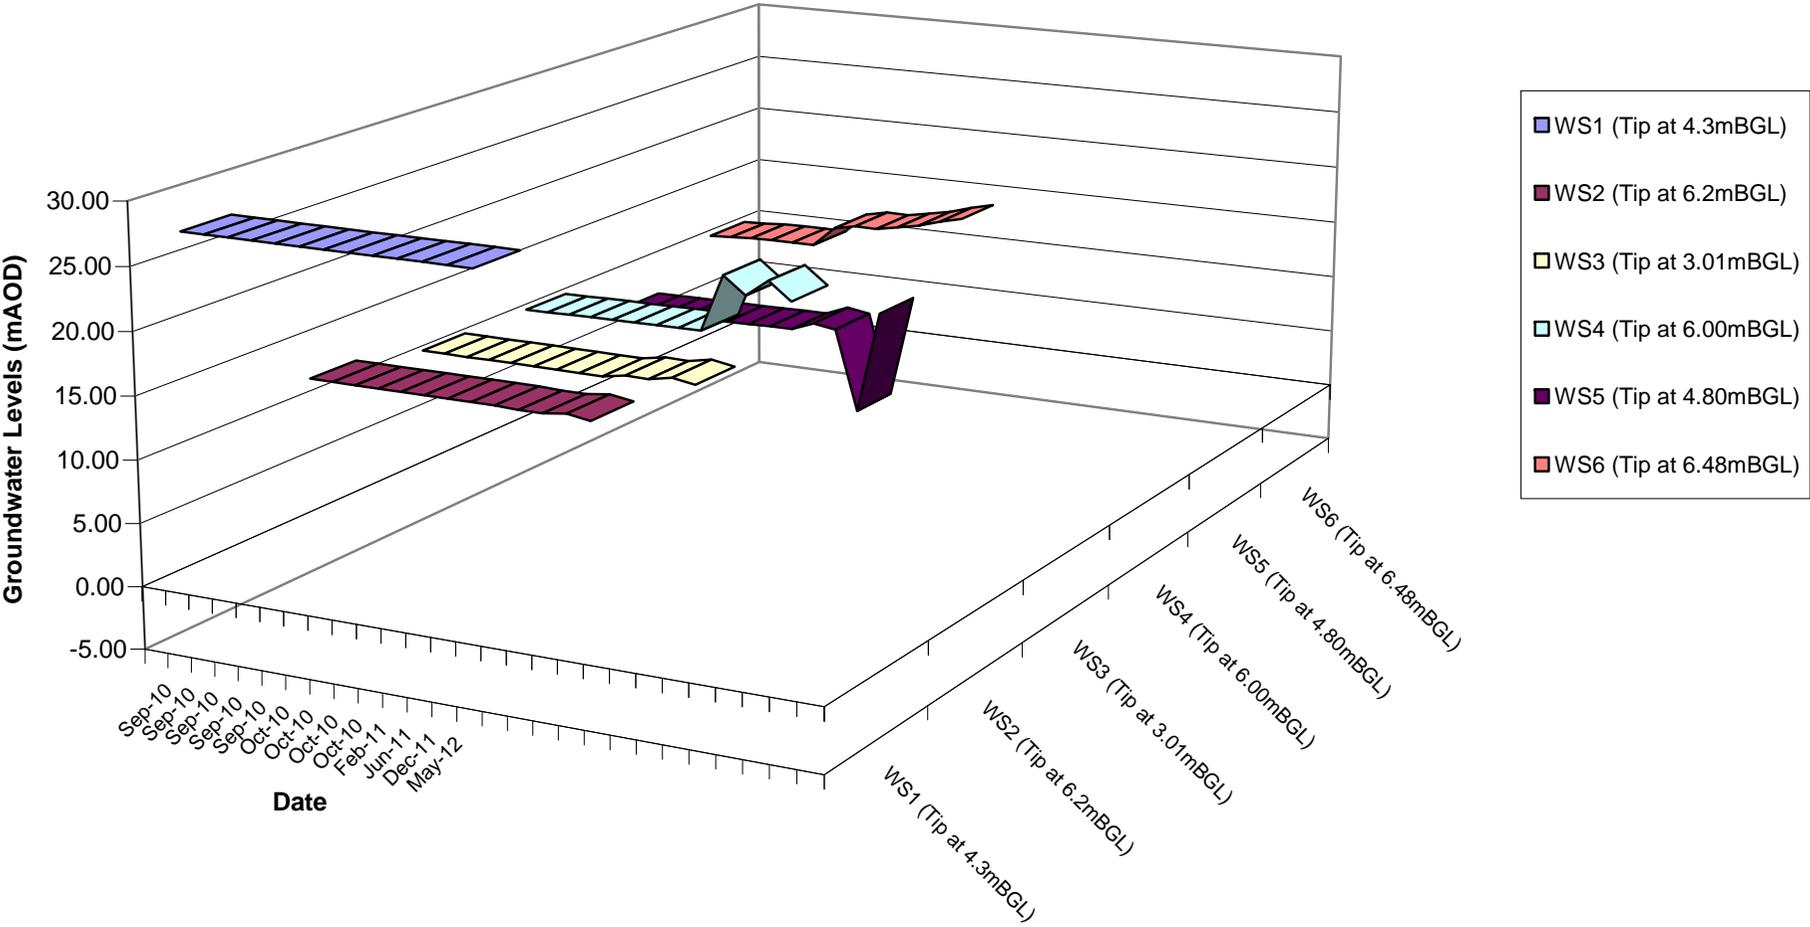
### SCALBY NESS REPLACEMENT INSTALLATION GROUNDWATER LEVELS

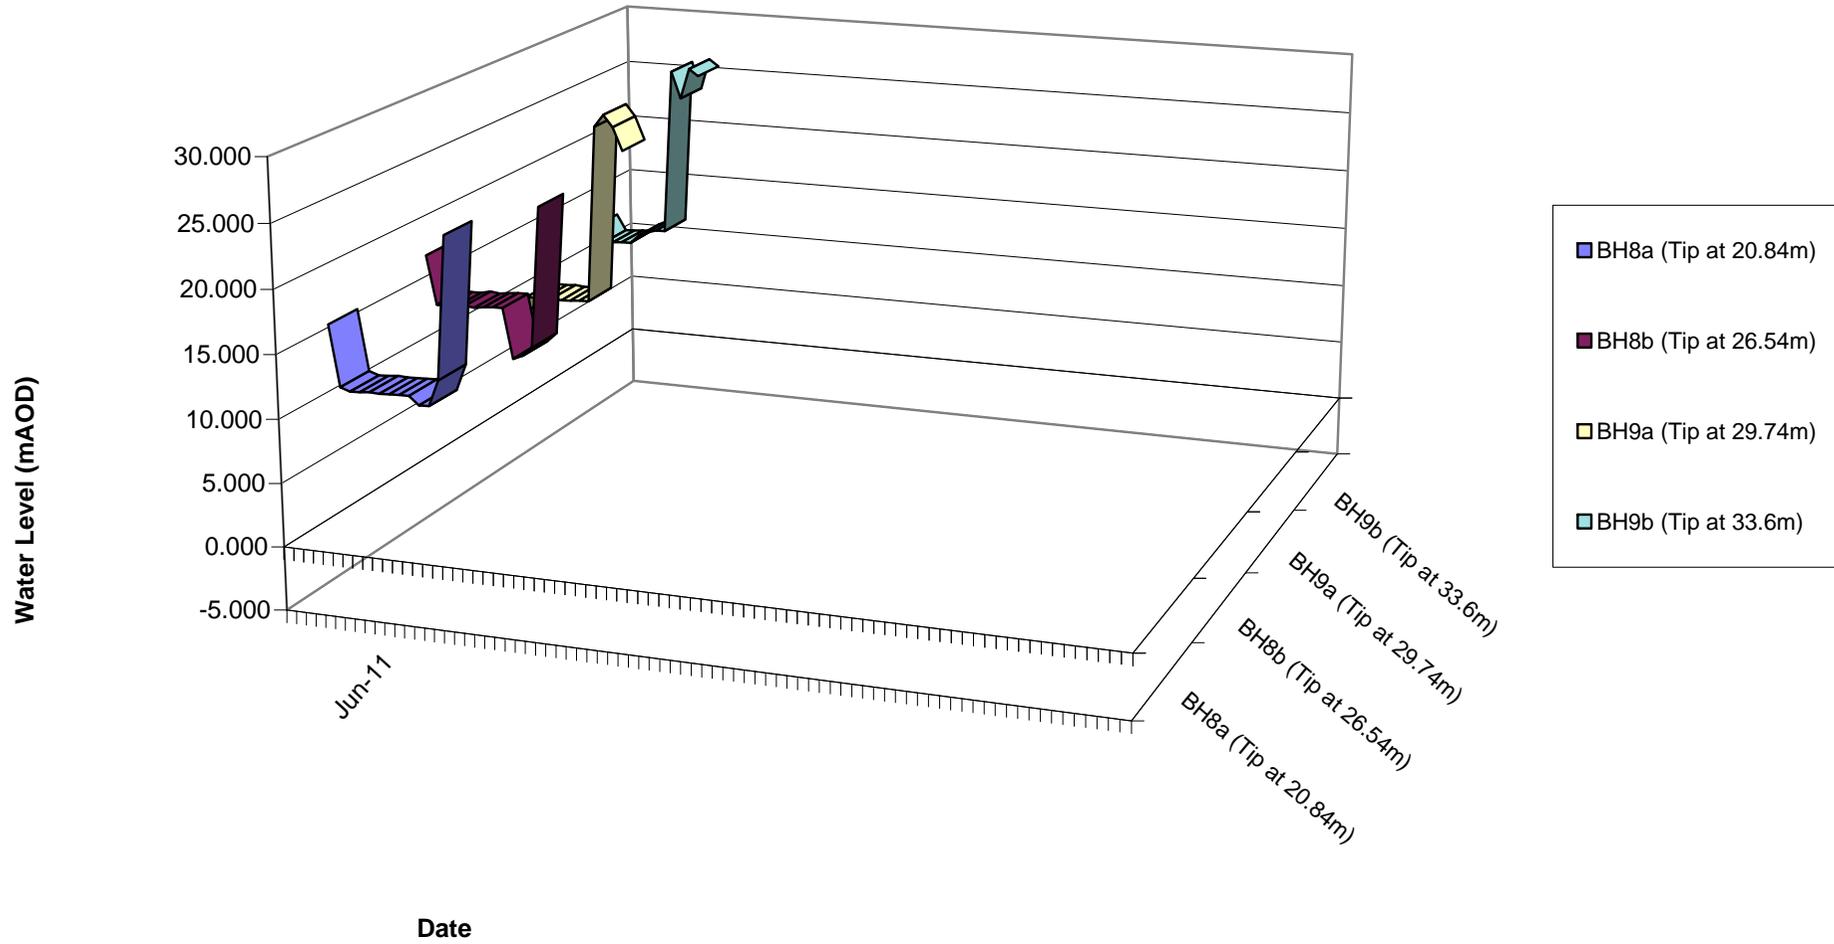
# THE HOLMS, SCARBOROUGH REPLACEMENT INSTALLATION GROUNDWATER LEVELS

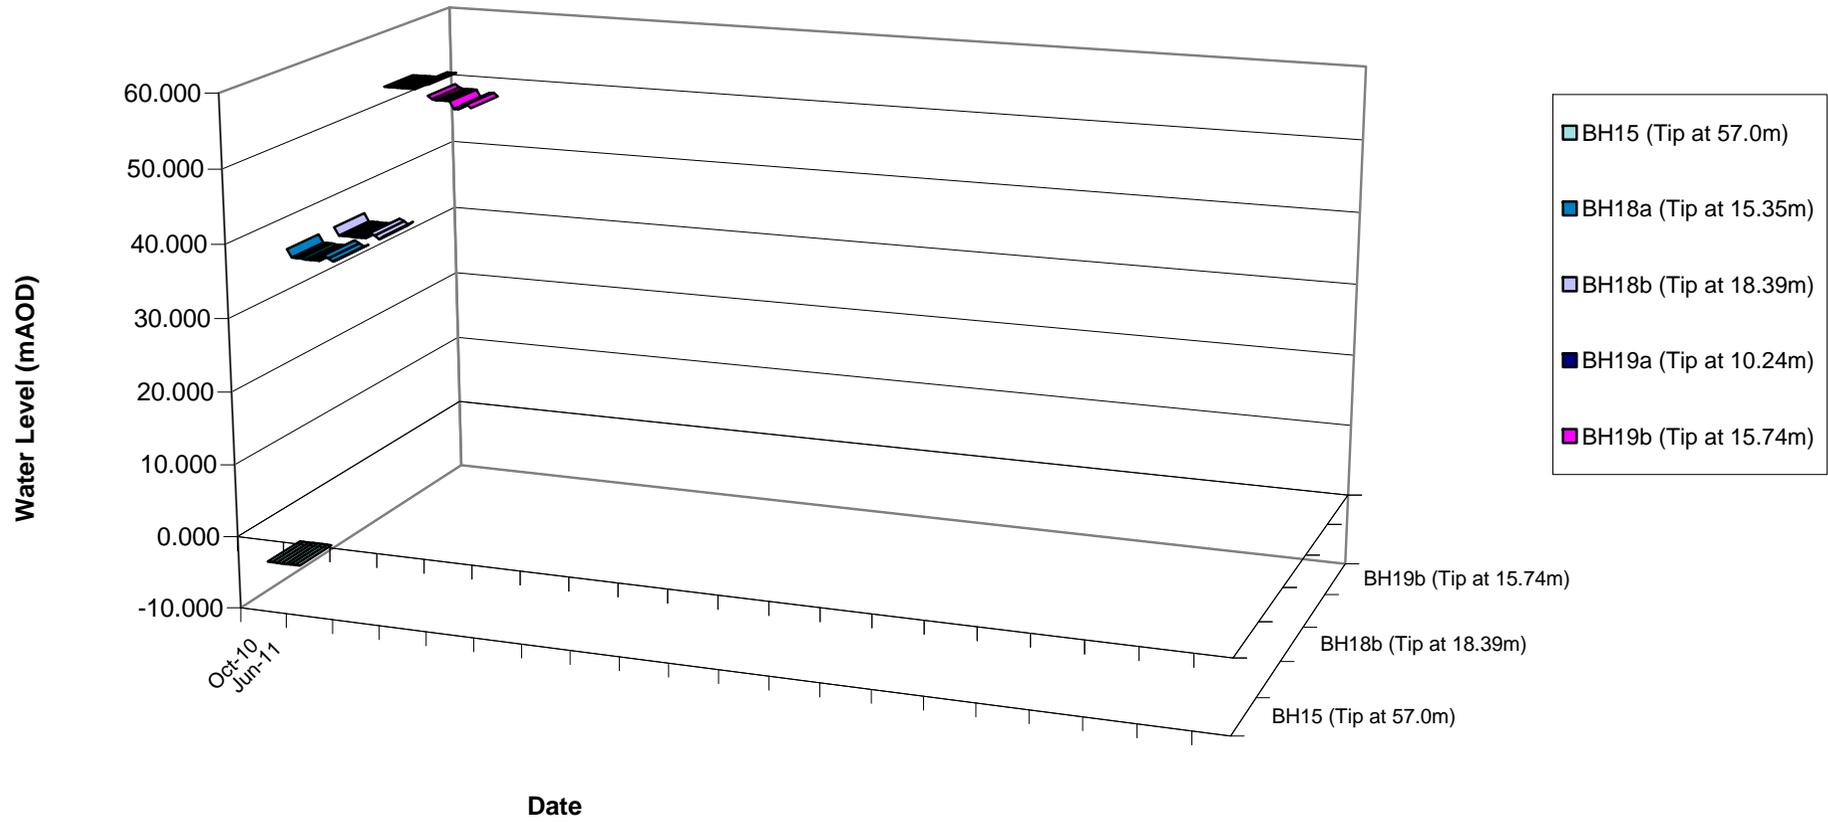
# SCARBOROUGH SOUTH CLIFF REPLACEMENT INSTALLATION GROUNDWATER LEVELS

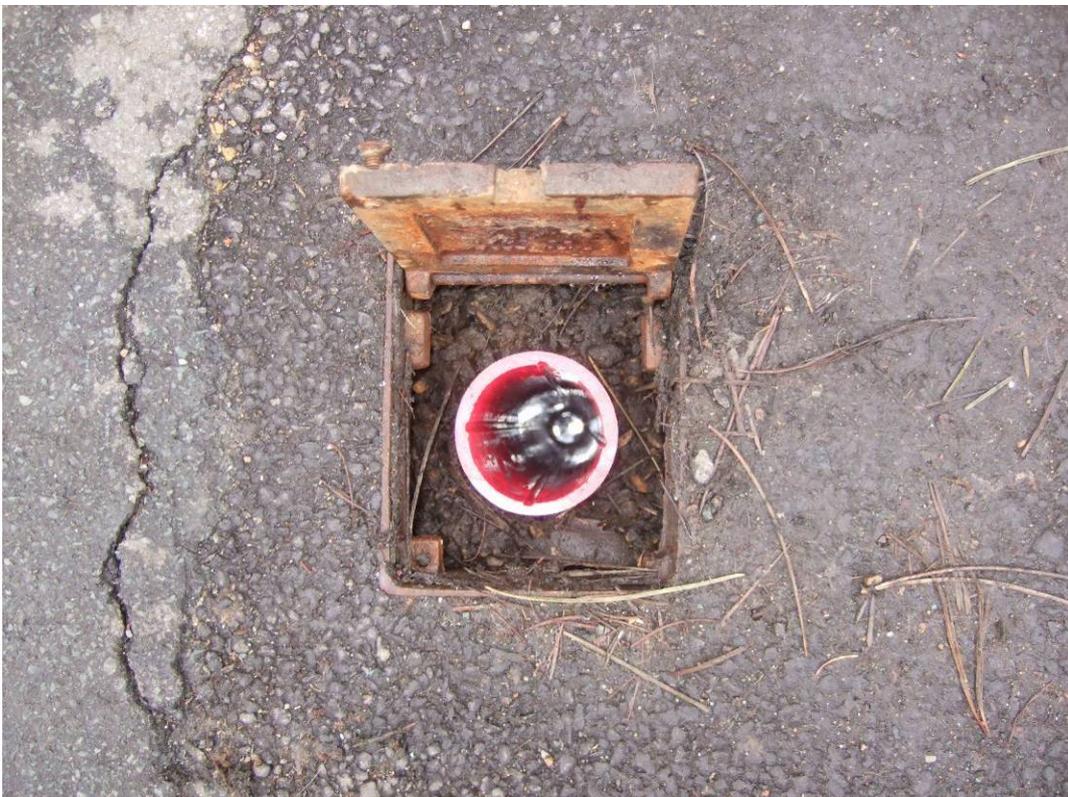
Plate 16 BH17 located on The Promenade north of The Rose Gardens

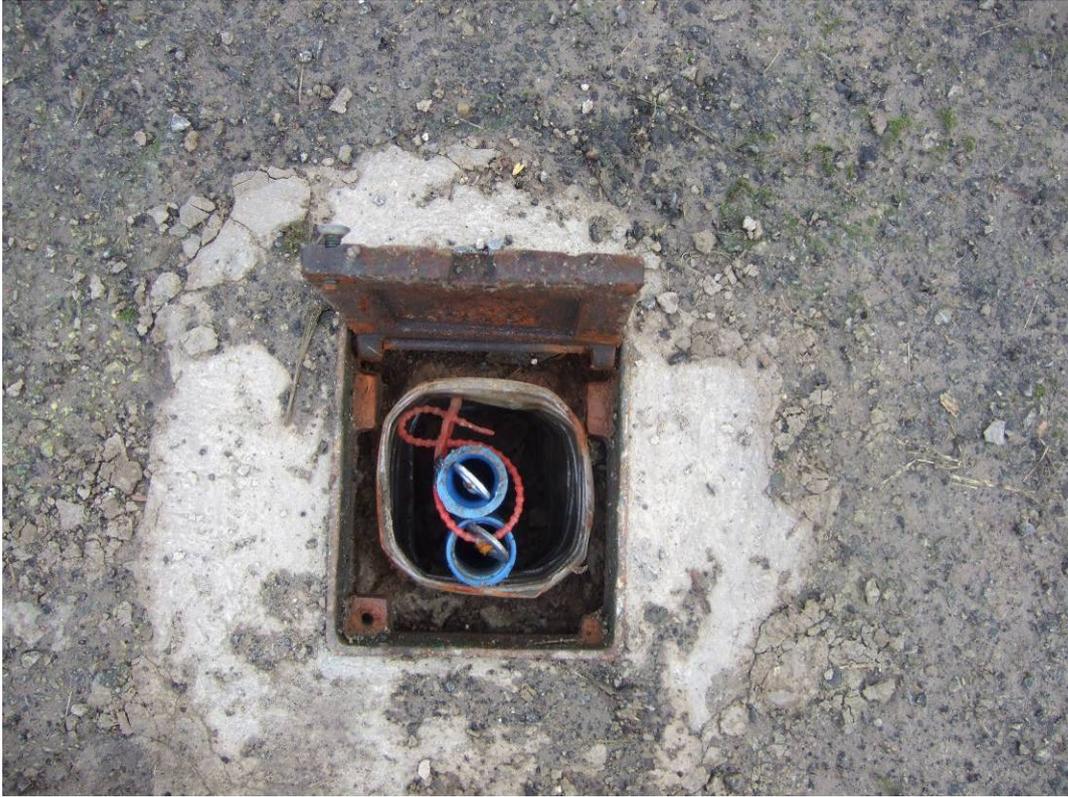
Plate 17 BH18 located mid-slope below The Rose Gardens

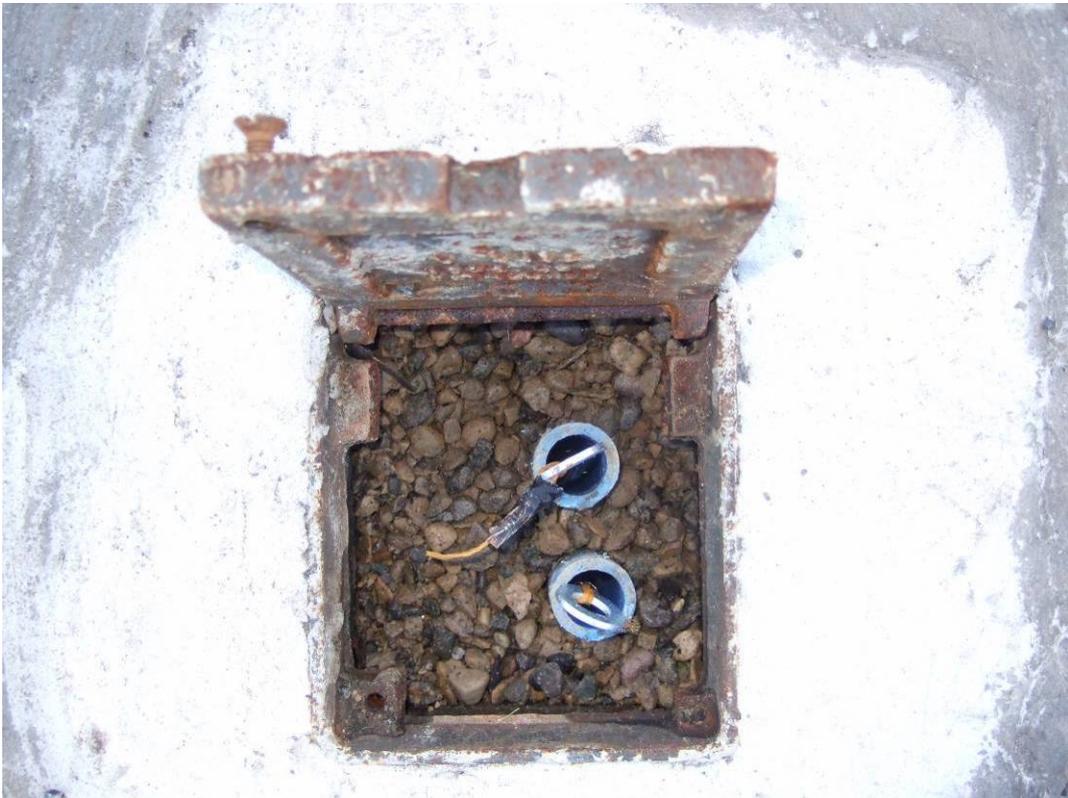
Plate 18 BH19 located on The Promenade above The Italian Garden

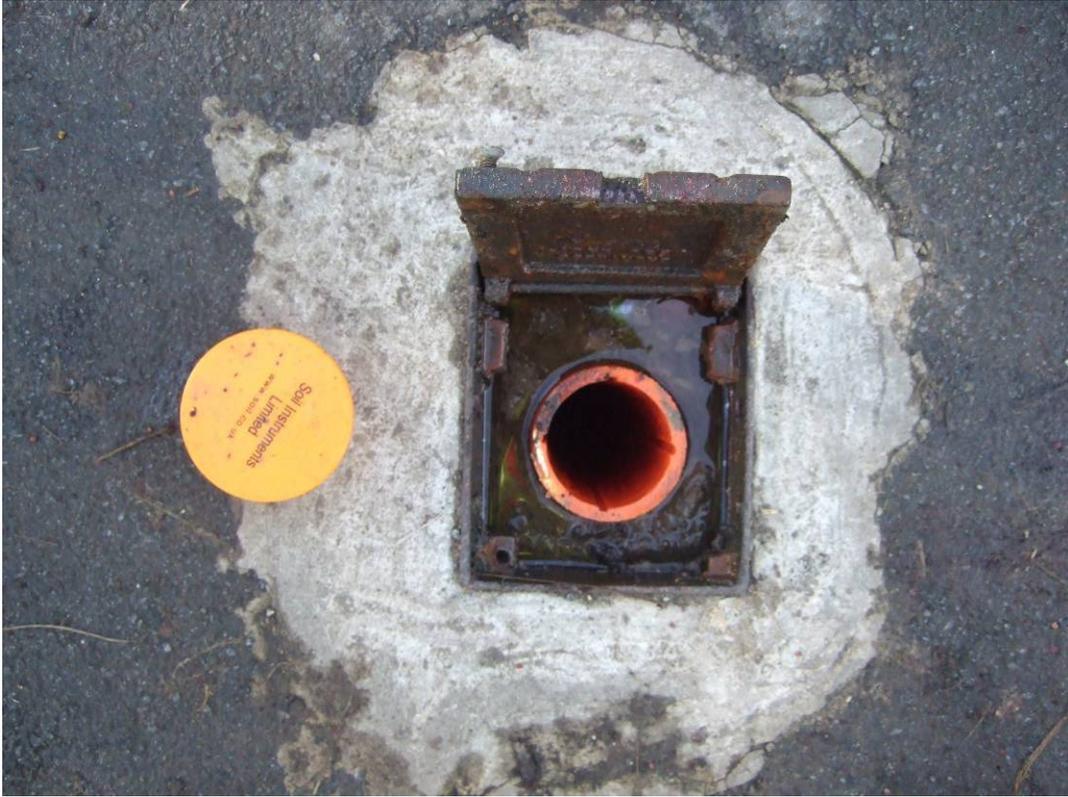
Plate 19 BH20 located mid-slope below The Rose Gardens

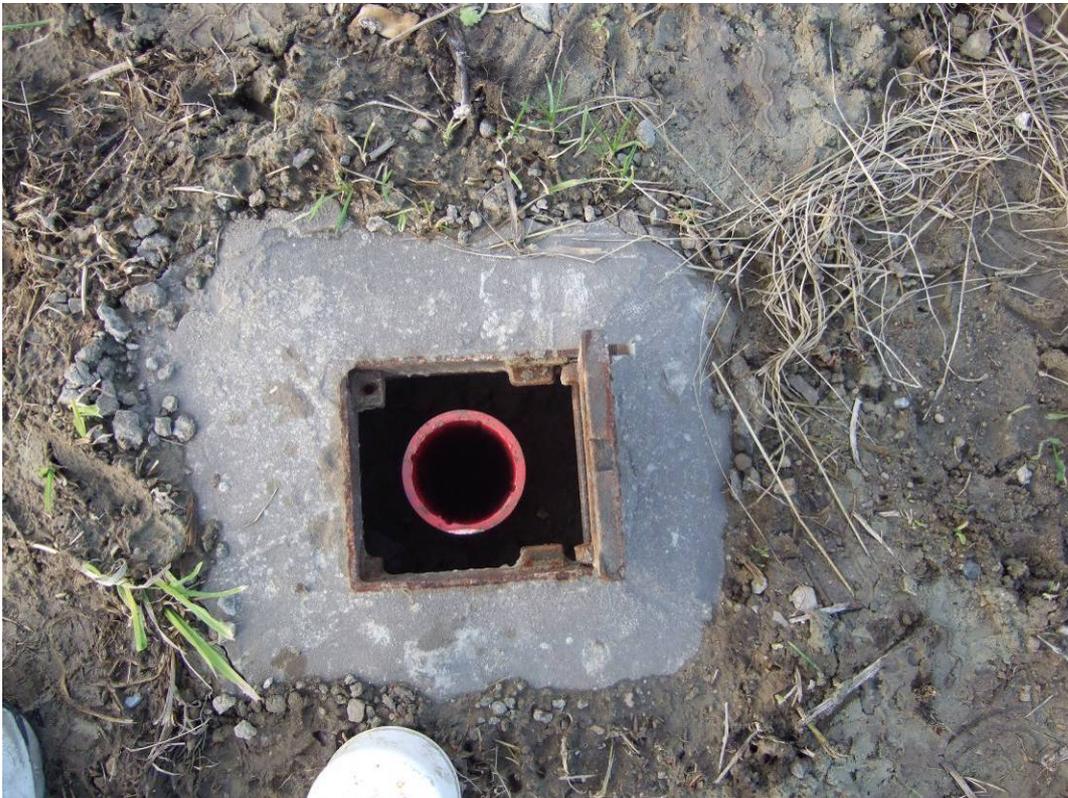
Plate 20 BH21 located mid-slope at Wheatcroft Cliff

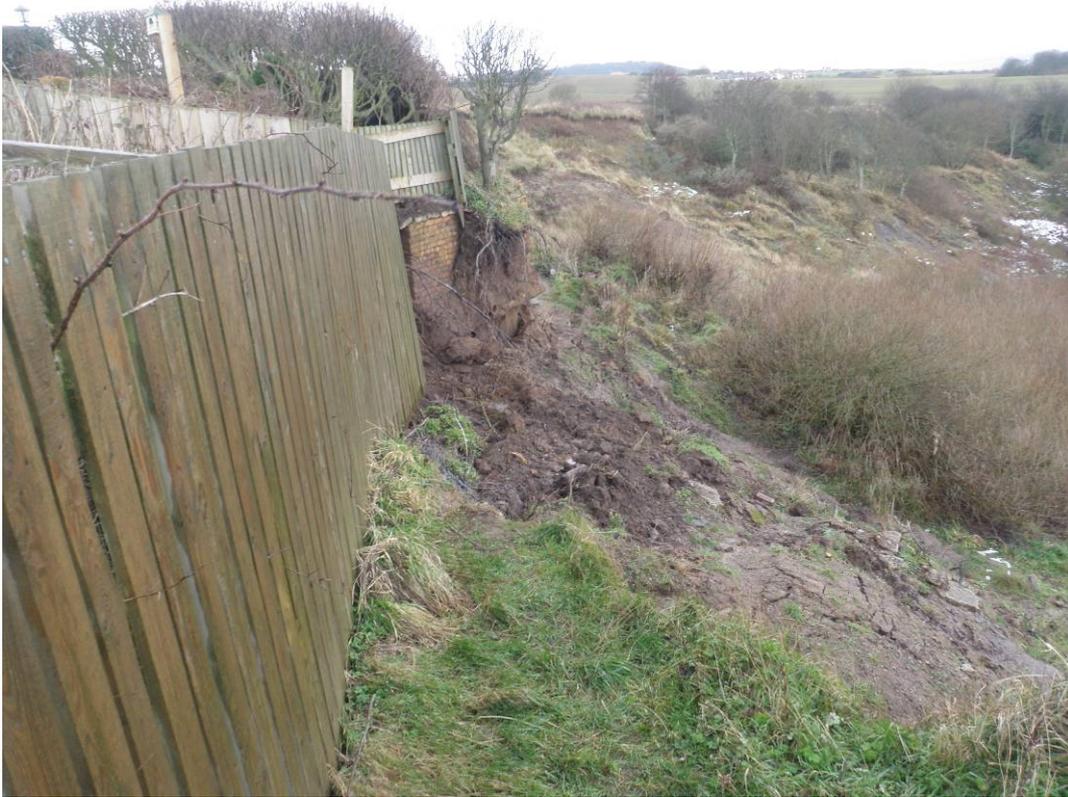
Plate 1 Cornelian Bay side of Knipe Point looking northwest (13<sup>th</sup> December 2010)

A photographic record of the site, presented in Appendix J, shows the degradation of the headscarps under observation particularly that of Cornelian Bay headland. Recession at survey point C08 had previously been noted to continue in a northerly direction and eastwards, recession rates had significantly accelerated since June 2010 with approximately 2.0 metres of land being lost to cliff recession (see Plates 1 to 6, Appendix J). This rapid rate of recession has continued with more than 5

metres of the headland being lost to recession since December 2010. Plates 1 to 6 clearly show the extent of this land loss, particularly since December 2011. From the most recent photographs (June 2012) a manhole, previously seen *in situ* in the glacial till cliffs, can be viewed partly down slope of it's original position and, the fencing and garden borders of properties 5 and 6 have almost entirely collapsed and disappeared down slope.

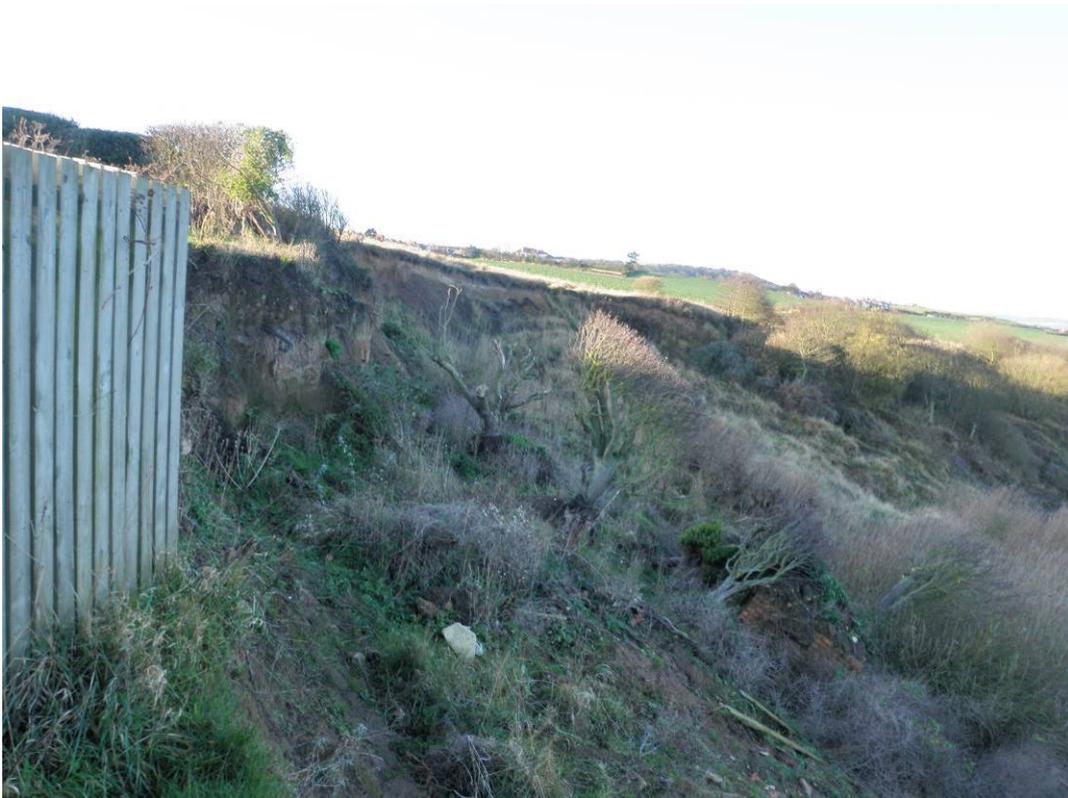
Plate 2 Cornelian Bay side of Knipe Point looking northwest (7<sup>th</sup> December 2011)

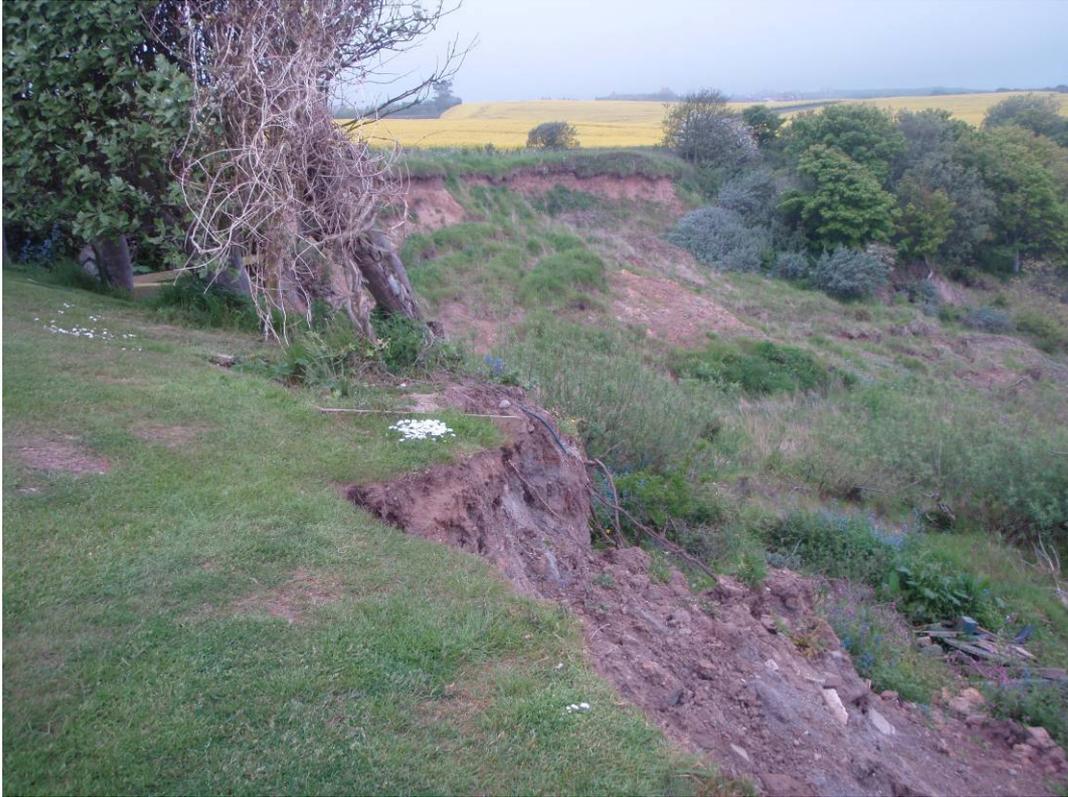
Plate 3 Cornelian Bay side of Knipe Point looking northwest (30<sup>th</sup> May 2012)

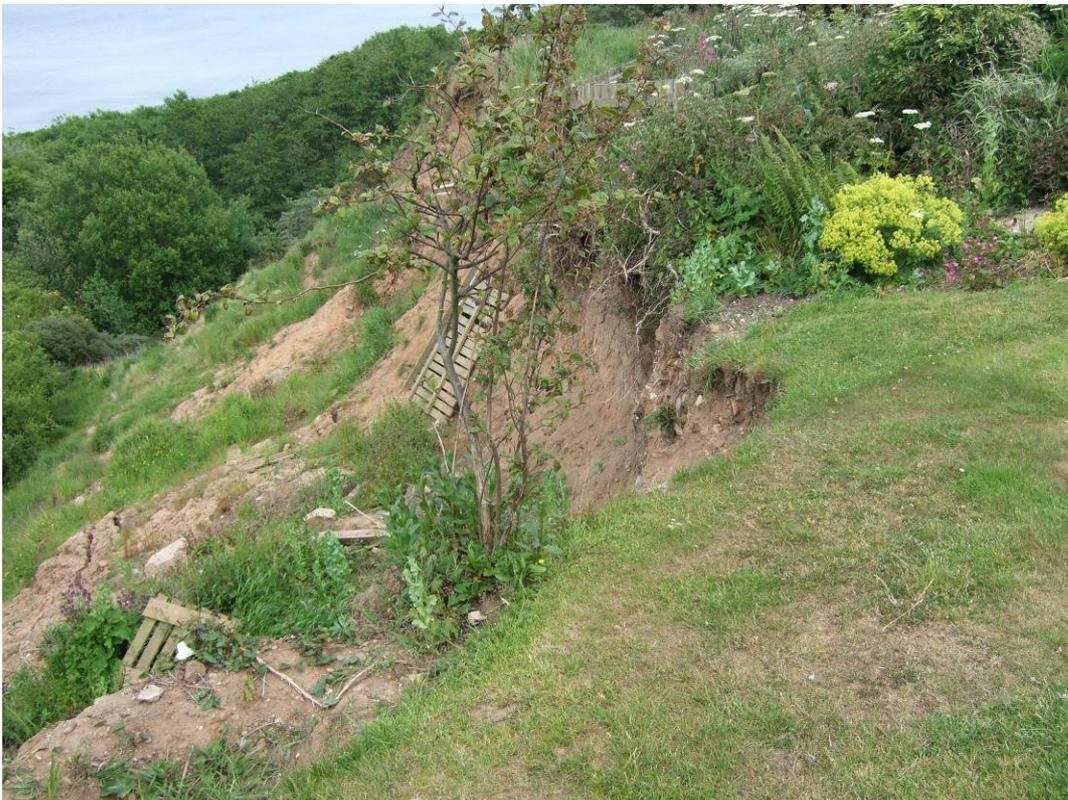
Plate 4 Cornelian Bay side of Knipe Point looking east (17<sup>th</sup> June 2011)

*(Note loss of survey pins C08 & C04 and boundary fence since last site visit of December 2011)*

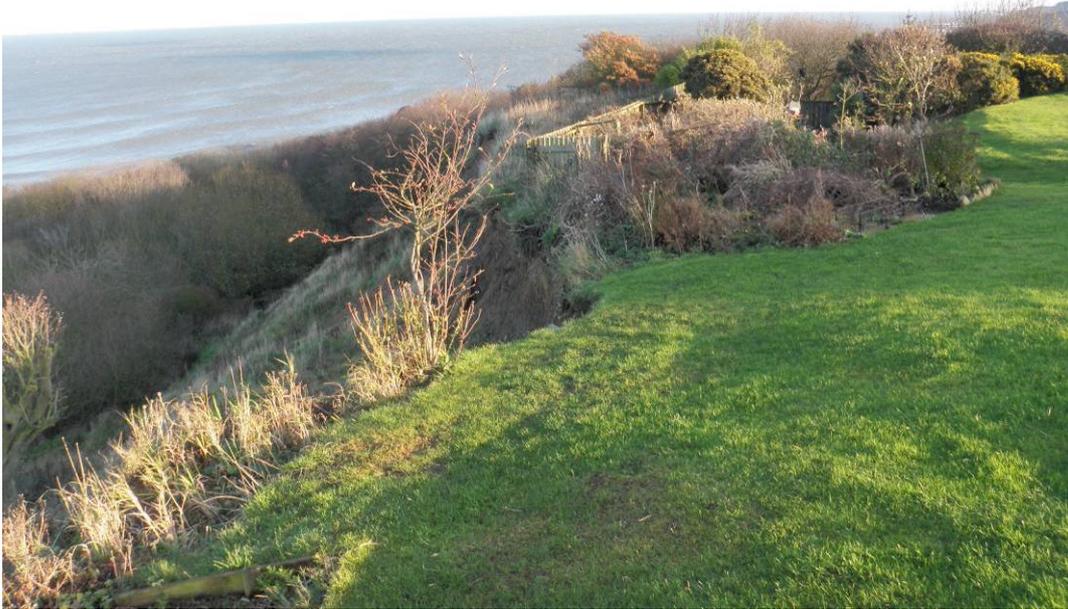
Plate 5 Cornelian Bay side of Knipe Point looking east (7<sup>th</sup> December 2011)

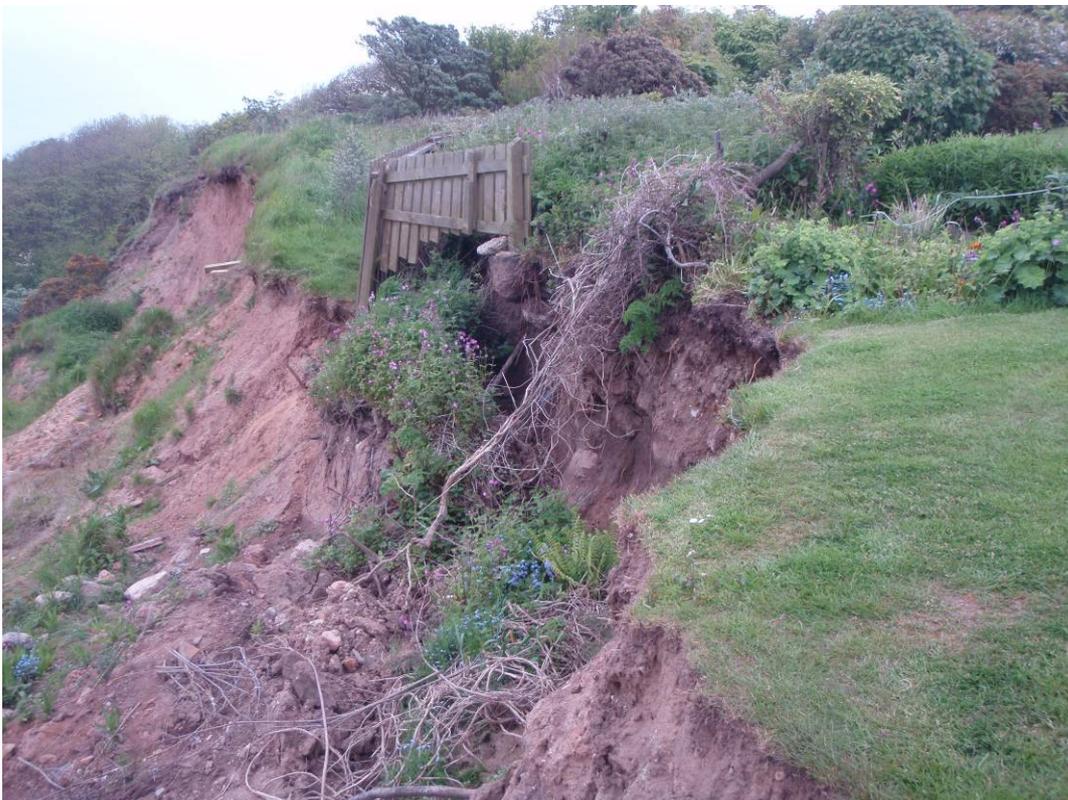
Plate 6 Cornelian Bay side of Knipe Point looking east (30<sup>th</sup> May 2012)

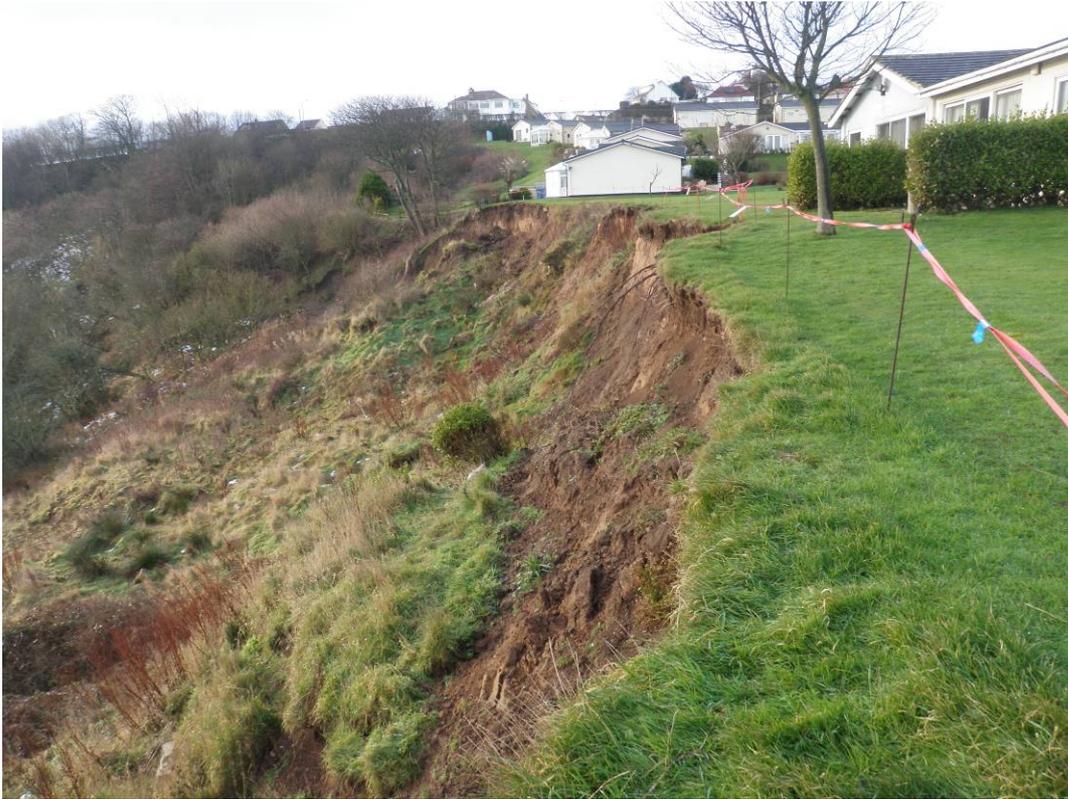
Plate 7 Cliff recession at Knipe Point Headscarp (13<sup>th</sup> December 2010)

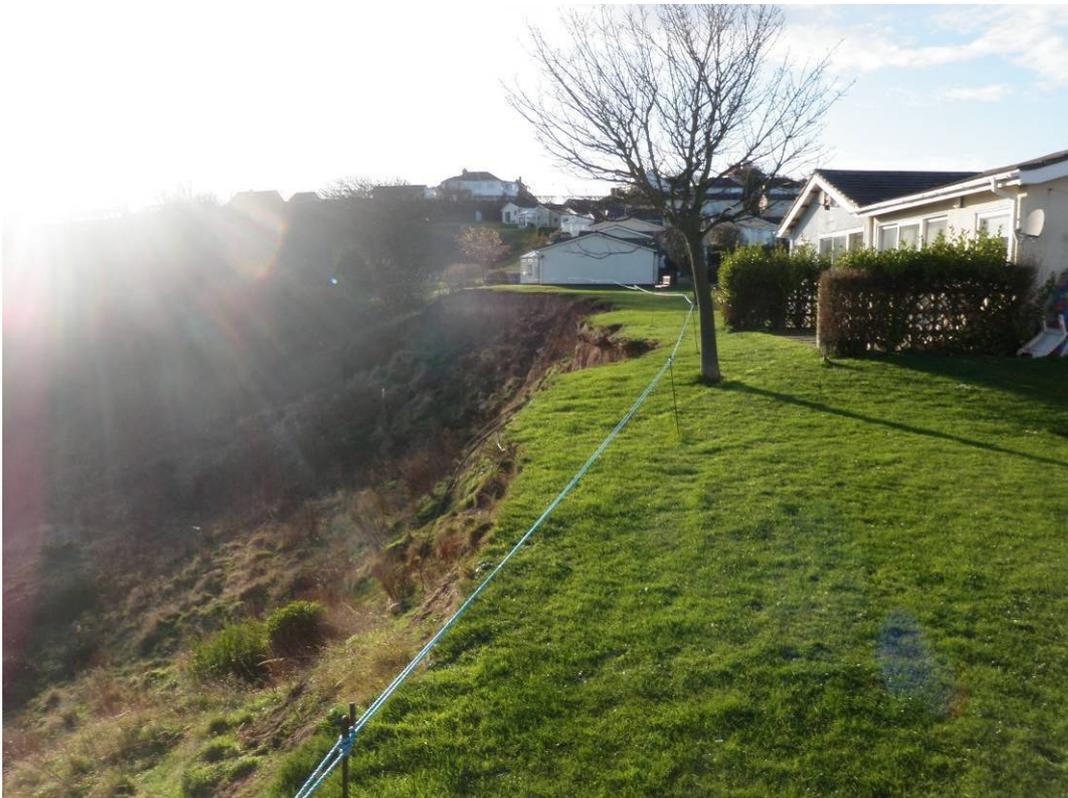
Plate 8 Cliff recession at Knipe Point Headscarp (7<sup>th</sup> December 2011)

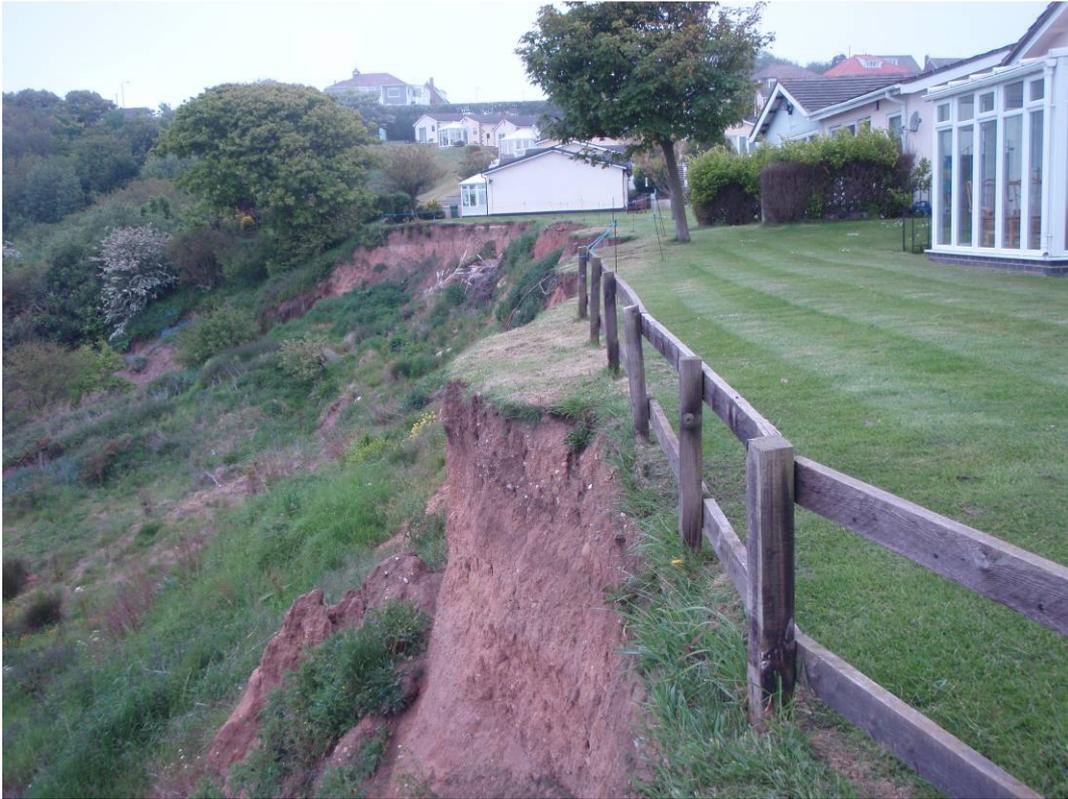
Plate 9 Cliff recession at Knipe Point Headscarp (30<sup>th</sup> May 2012)

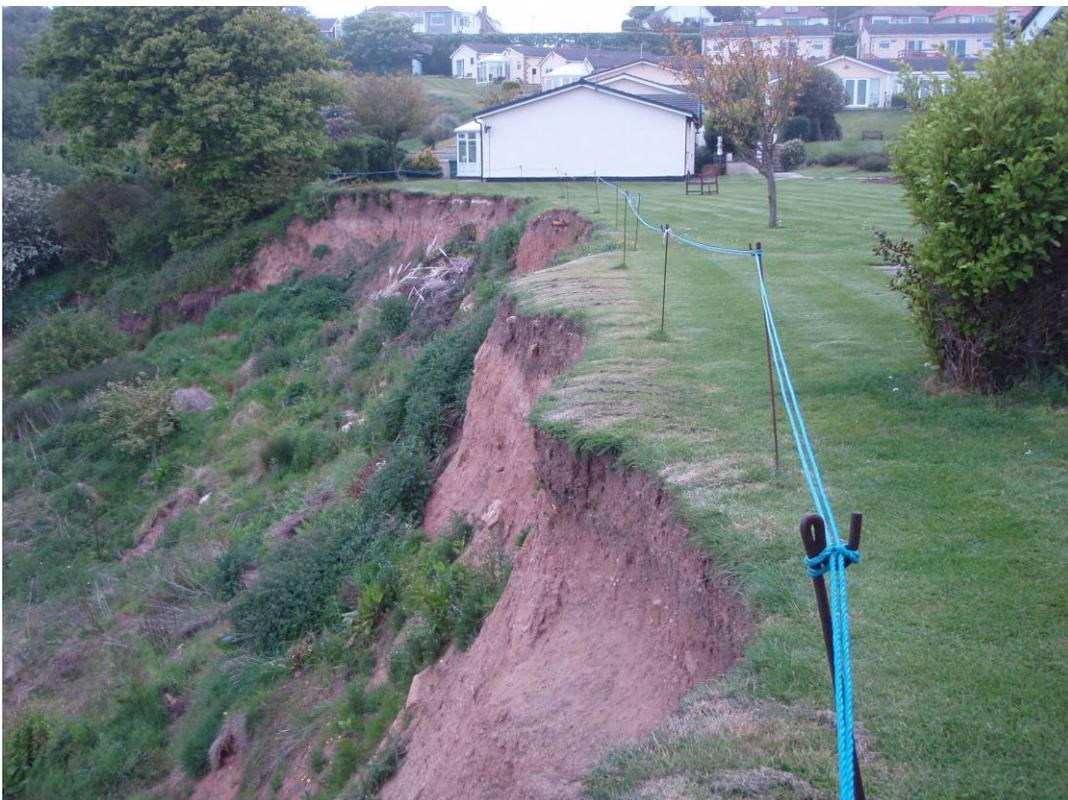
Plate 10 Cliff recession at Knipe Point Headscarp (30<sup>th</sup> May 2012)

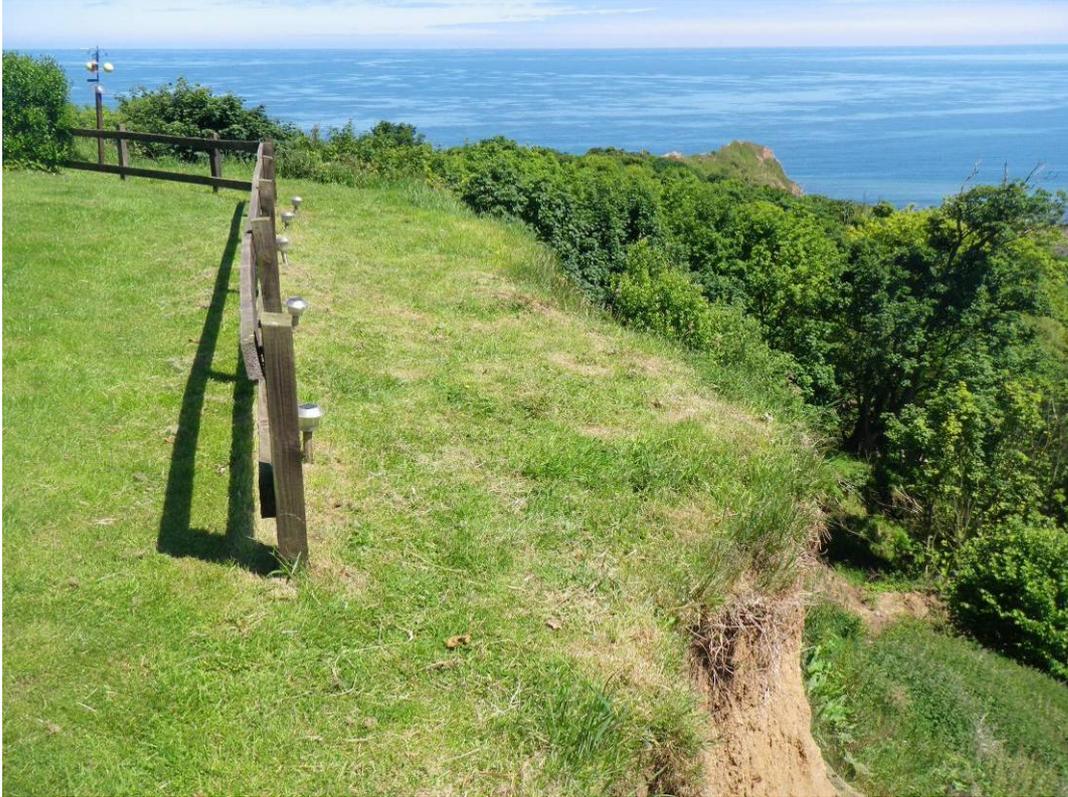
Plate 11 Cliff recession at Knipe Point Headscarp looking east (17<sup>th</sup> June 2010)

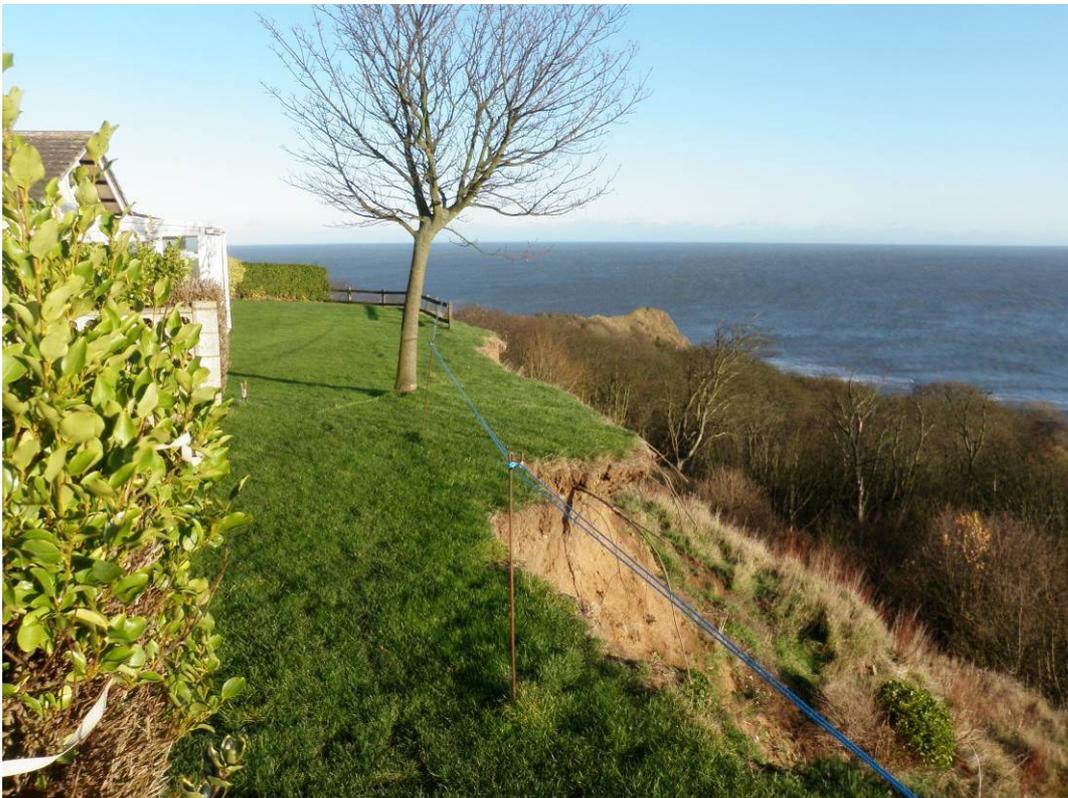
Plate 12 Cliff recession at Knipe Point Headscarp looking east (7<sup>th</sup> December 2011))

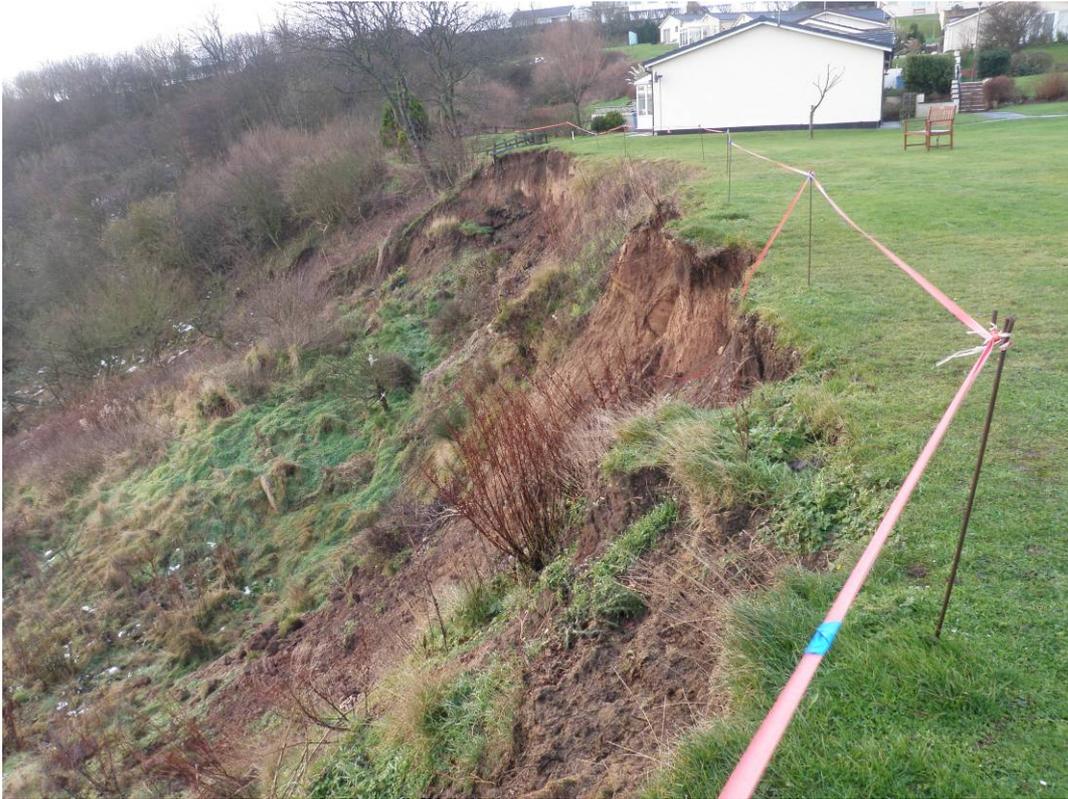
Plate 13 Cliff recession at Knipe Point Headland (13<sup>th</sup> December 2010)
