# Ongoing Analysis and Interpretation of Coastal Monitoring Data

Seventh Review of Full Suite Monitoring

## Geotechnical Interpretative Report

Document Ref. No. 721229/002/GIR/014/Final

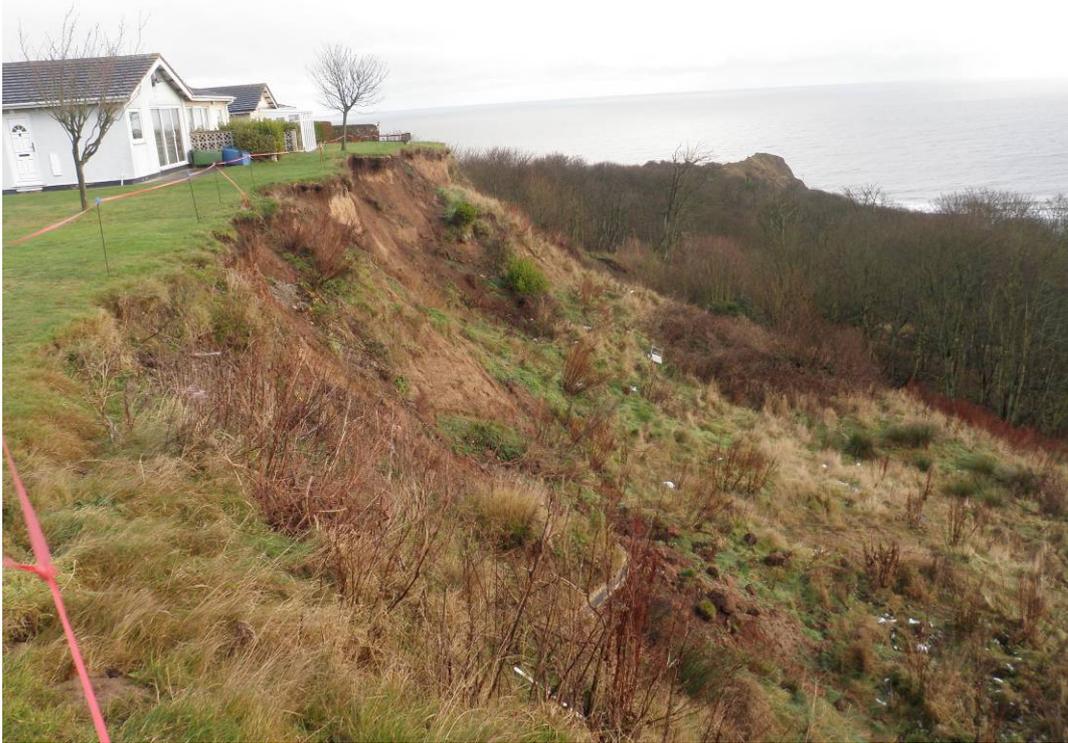
Plate 15 Cliff recession at Knipe Point Headland looking east (13<sup>th</sup> December 2010)

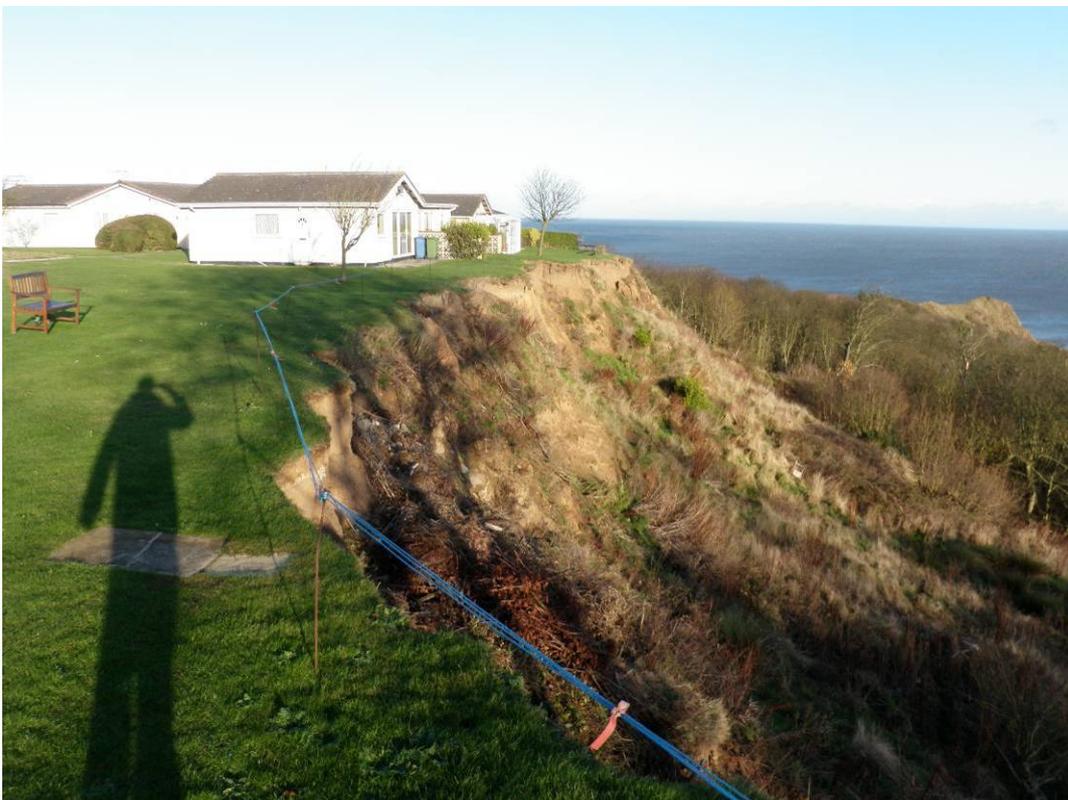
Plate 16 Cliff recession at Knipe Point Headland looking east (7<sup>th</sup> December 2011)

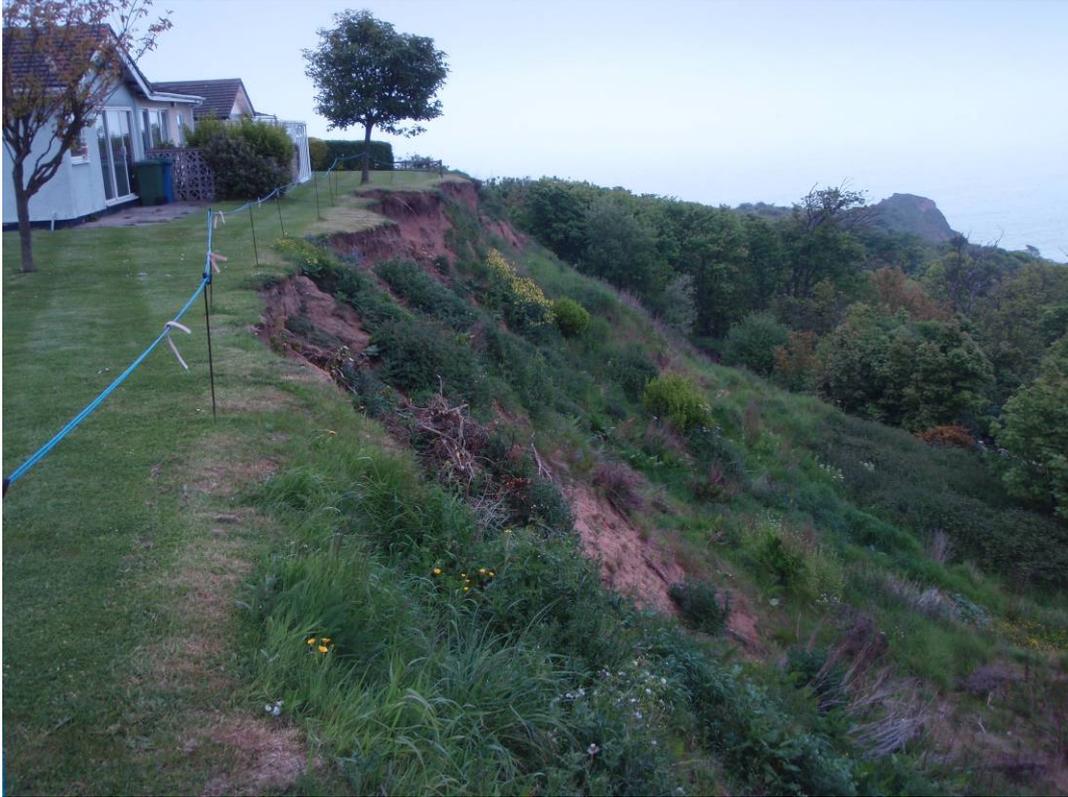
Plate 17 Cliff recession at Knipe Point Headland looking east (30<sup>th</sup> May 2012)

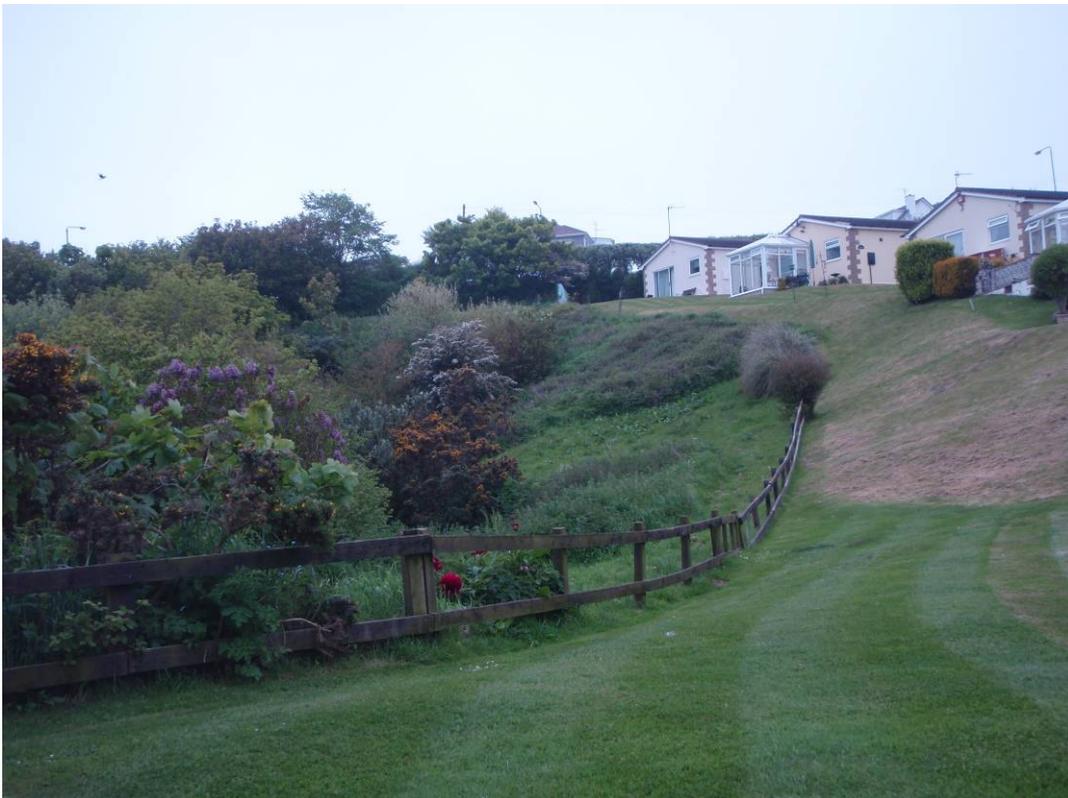
Plate 18 Cliff recession at Knipe Point Headland looking west (30<sup>th</sup> May 2012)

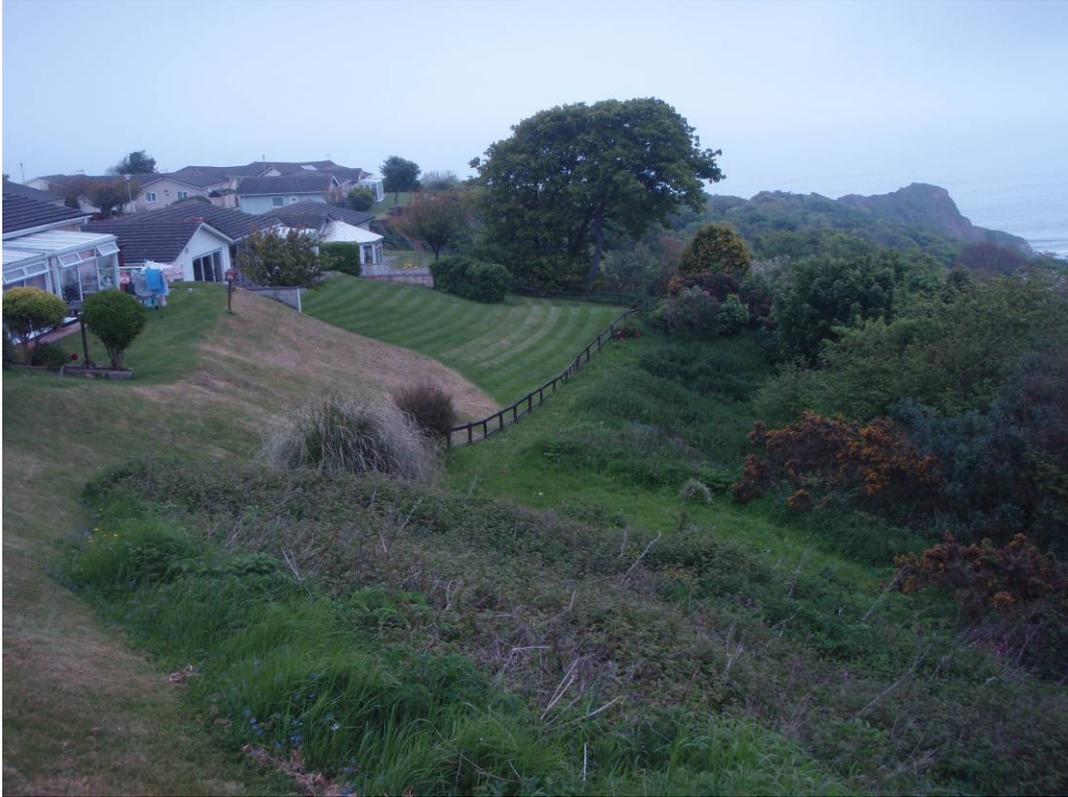
Plate 19 Cliff recession at Knipe Point Headland looking east (30<sup>th</sup> May 2012)

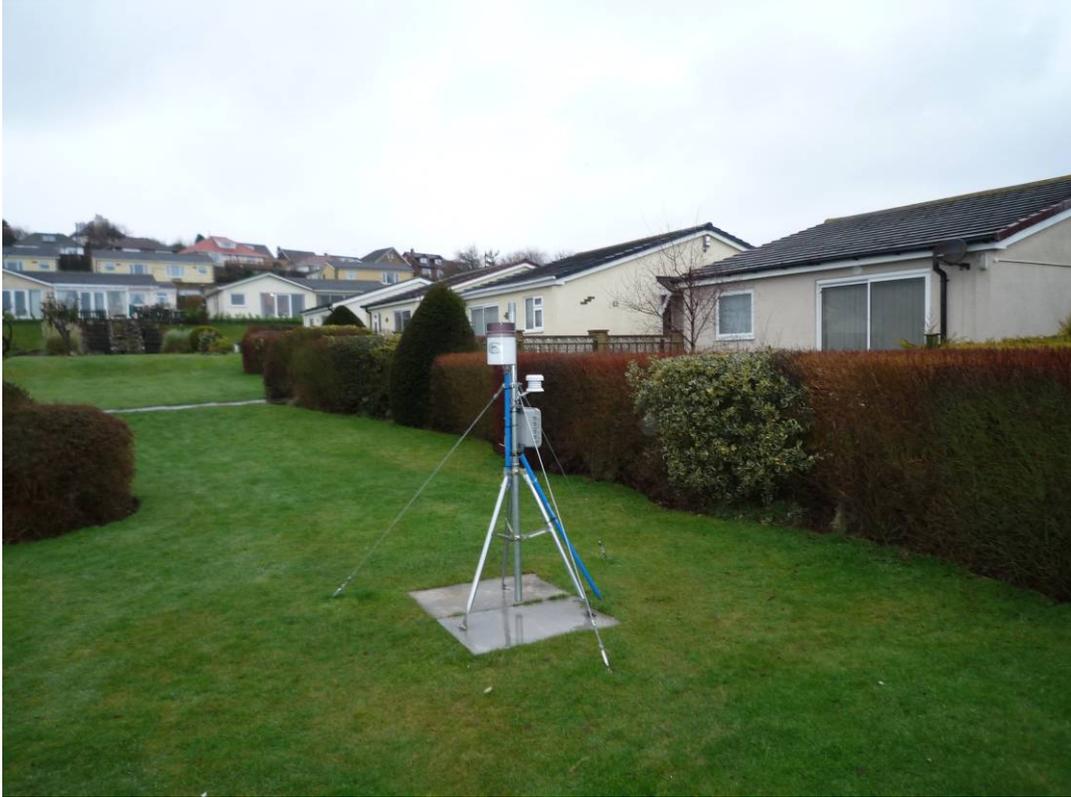
Plate 21 Knipe Point Weather Station with Chalet No. 50 behind.

Continuous rainfall, air and ground temperatures are recorded on site by an automatic weather station located within the residential area of the site. A photograph of this equipment is presented in Plate 21, Appendix J.

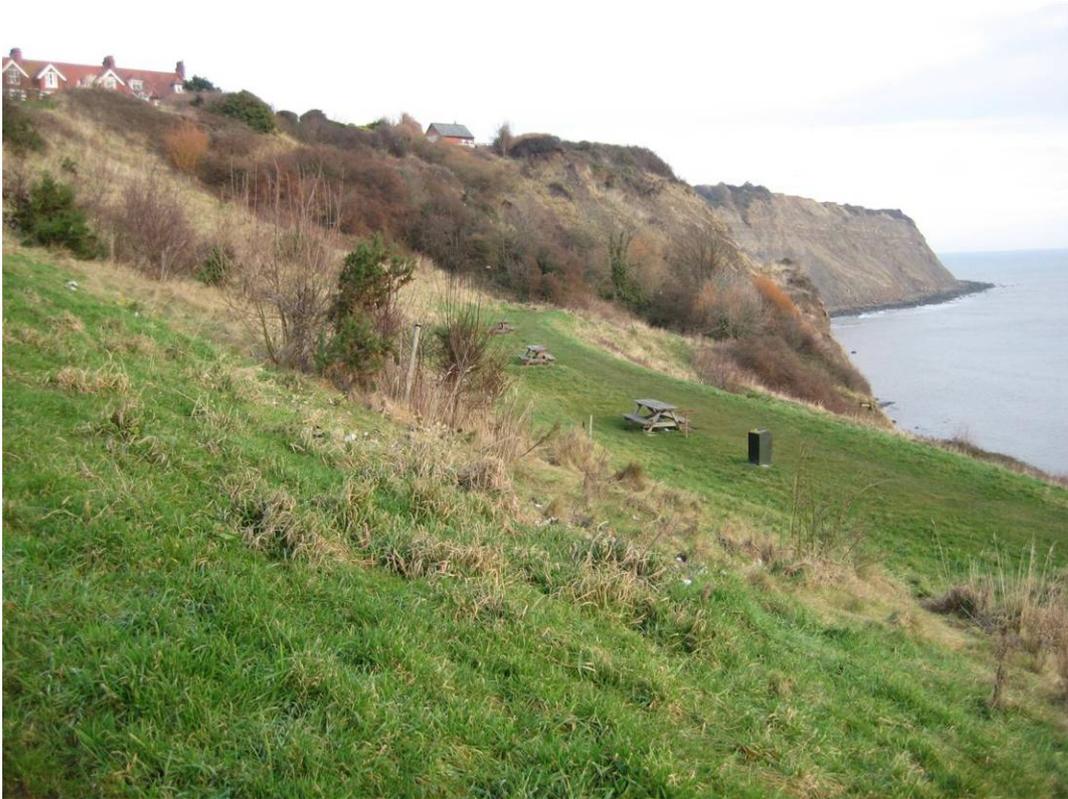
Plate 1 View of Robin Hood's Bay with the Rocket House in background and remediated coastal slopes below in foreground.

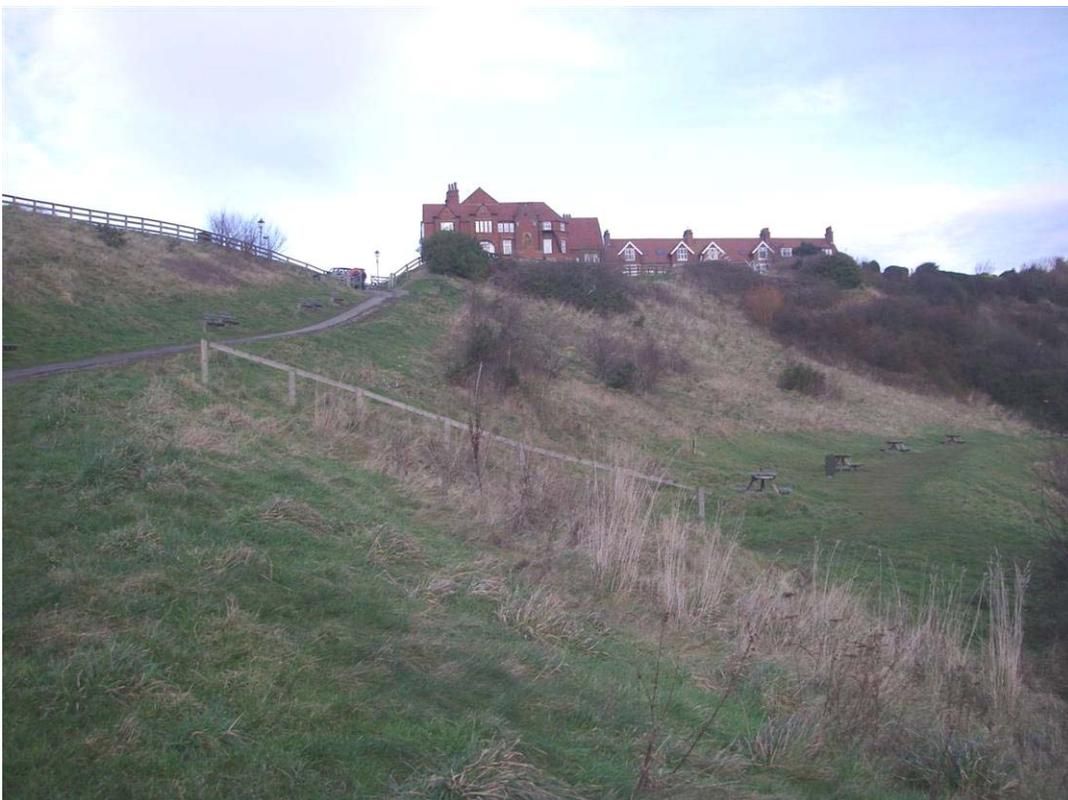
Plate 2 View looking north towards Victoria Hotel from remediated coastal slopes
