Note / Memo

HaskoningDHV UK Ltd.
Water

Subject: Runswick Bay Coastal Protection Scheme - Ecological Enhancement

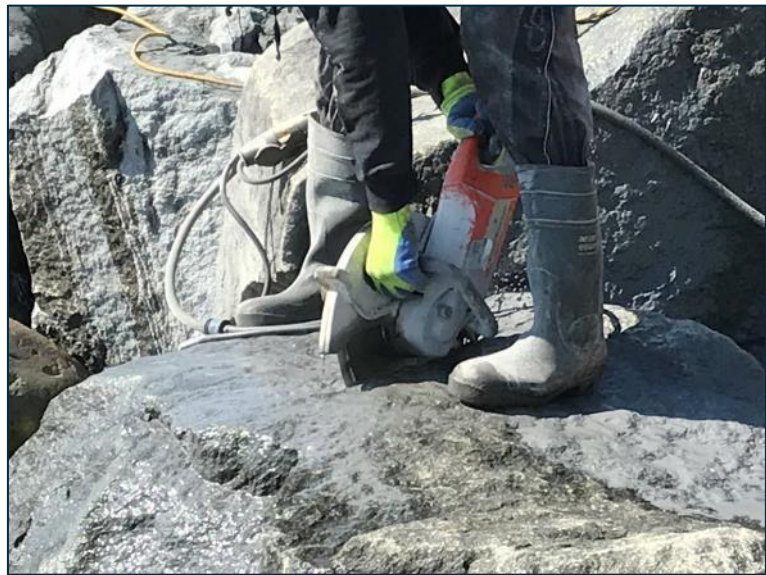
1. Circular saw used to make a series of parallel cuts (typically at 50mm centres).

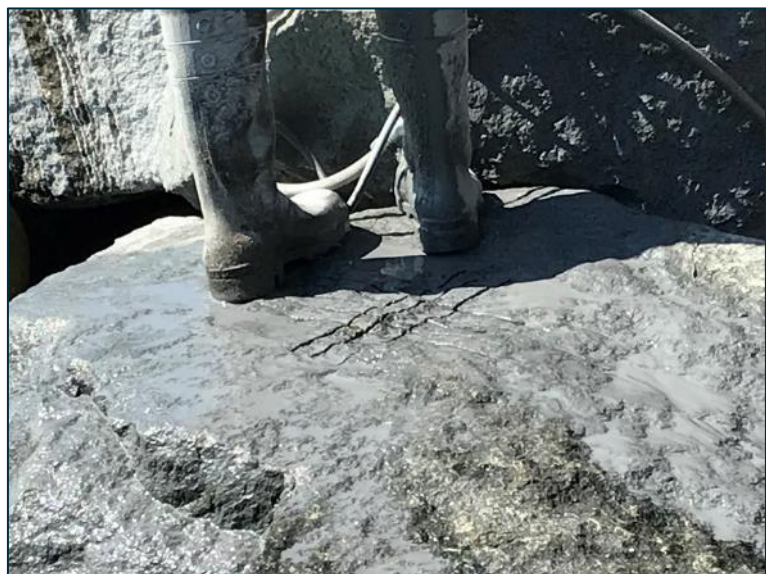
2. Circular saw used to make a second series of cuts perpendicular to first cuts (typically at 50mm centres).

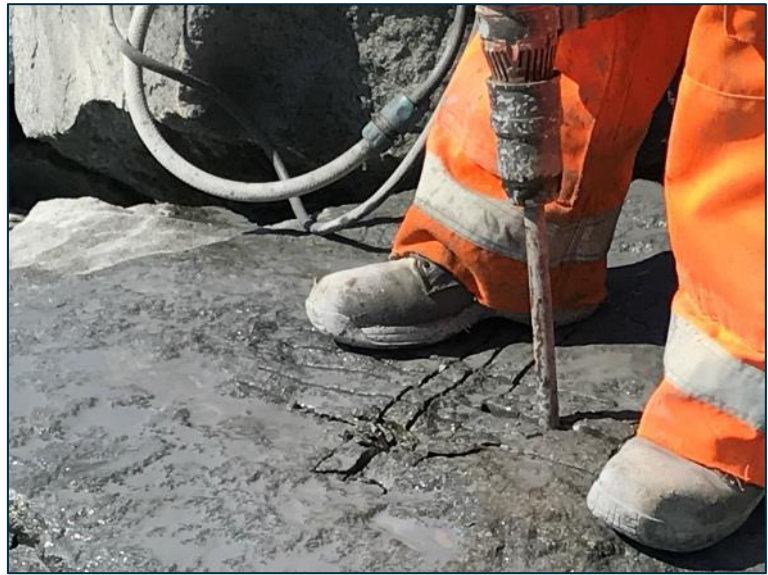
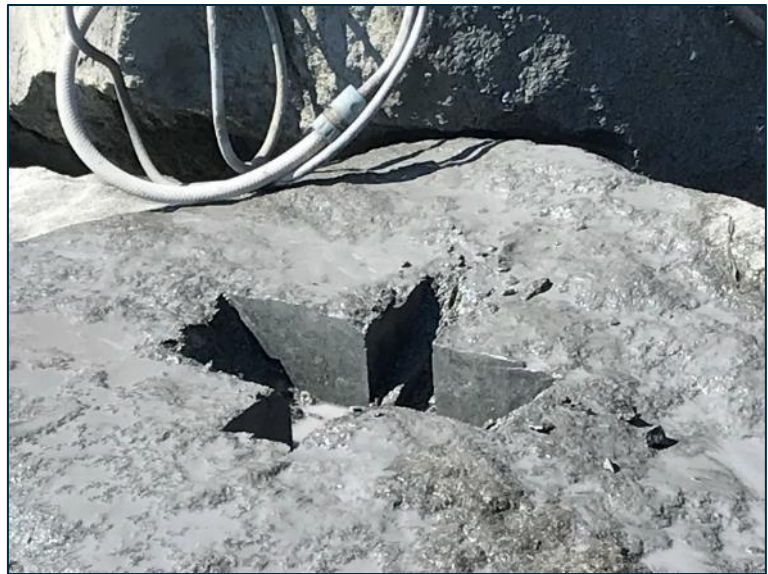
3. Breaker used to break out loose rock fragments, resulting in “cross” shaped pool.

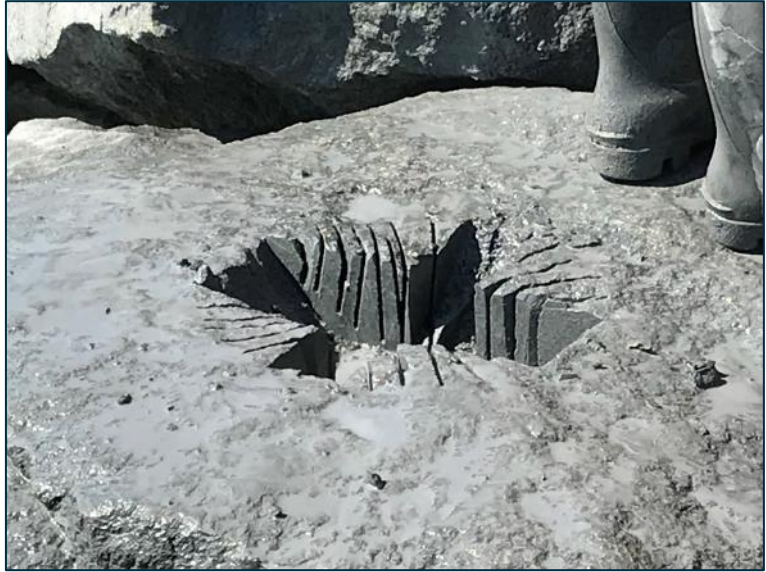
4. Circular saw used to make a series of “diagonal cuts” through corners.

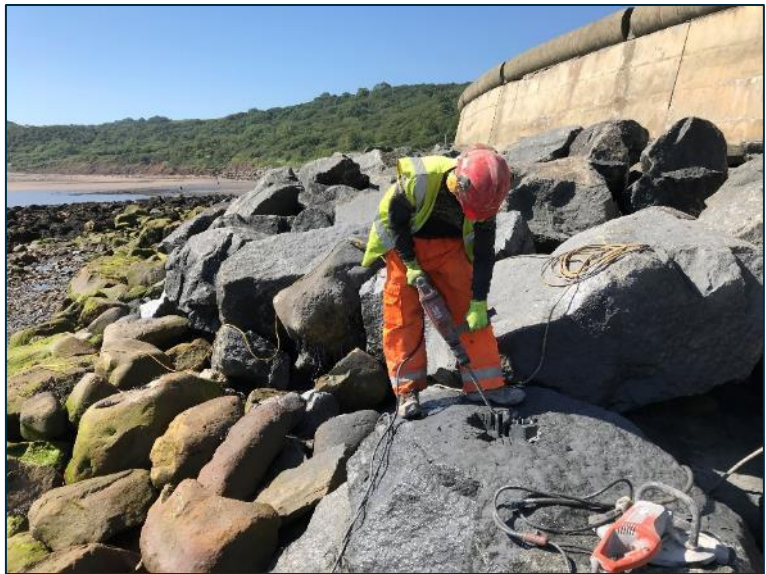
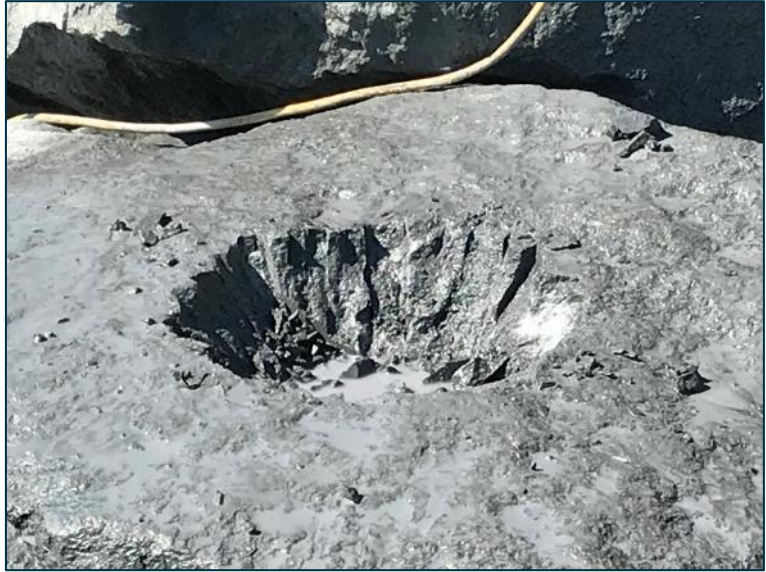
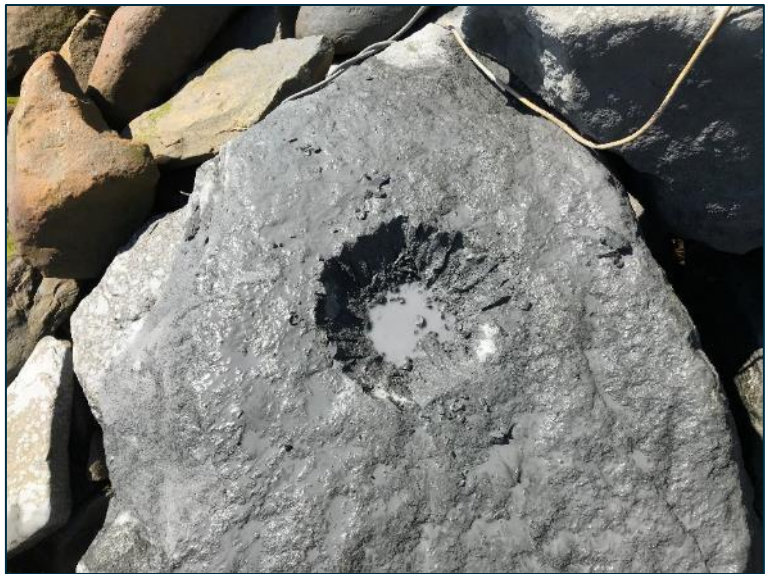
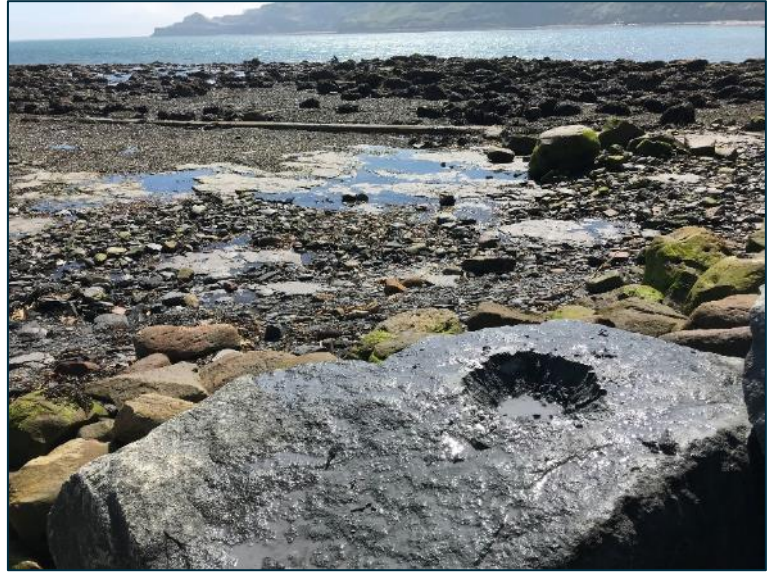
5. Breaker used to break out loose rock fragments and form dish/bowl shape approximately 300mm diameter with depth of approximately 150mm in centre.

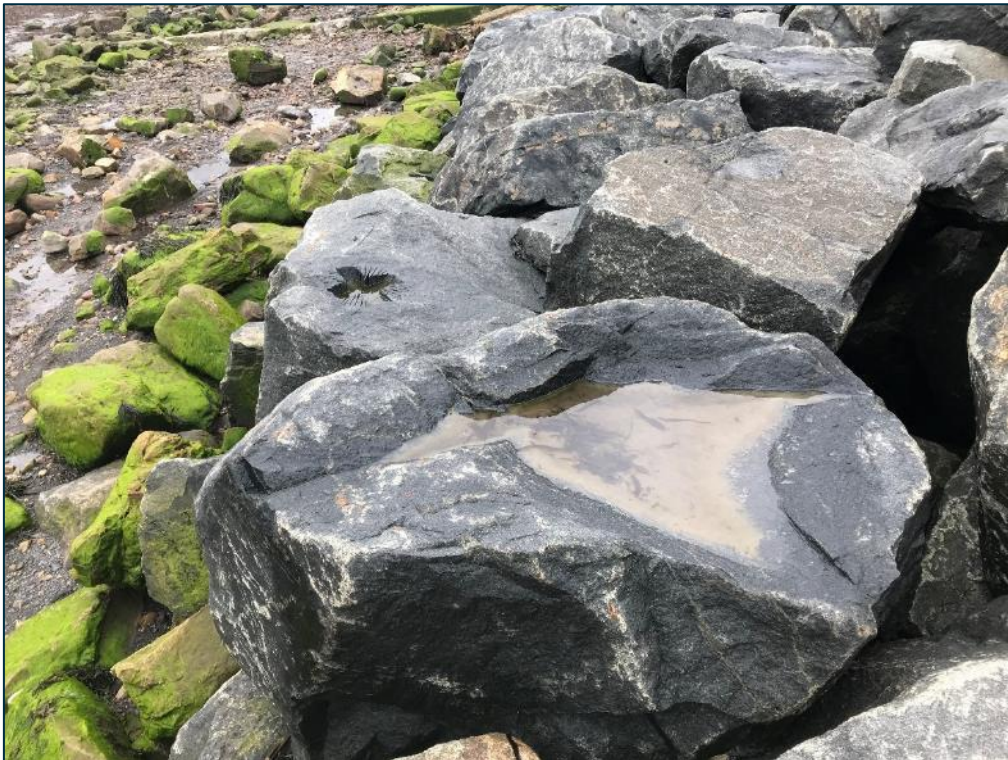
Where practicable, the position and orientation of rock armour blocks was selected to enable retention of water to mimic rock pools.

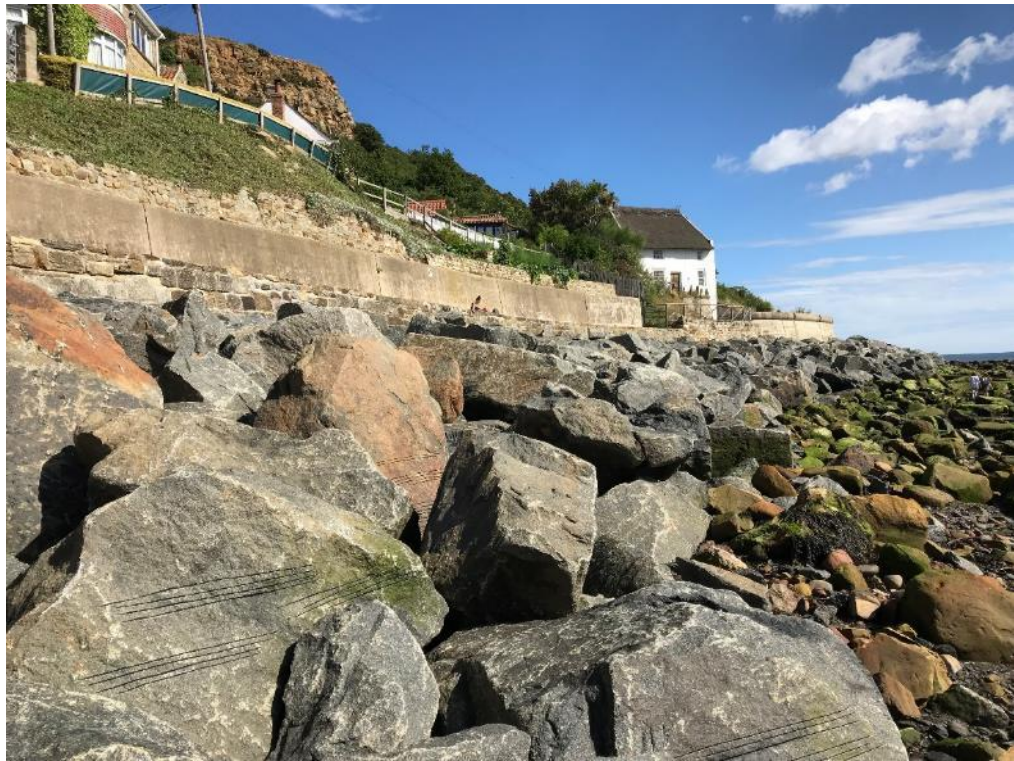
1. Circular saw used to make a series of parallel cuts (approximately 10mm deep) in the face of the armour rock.

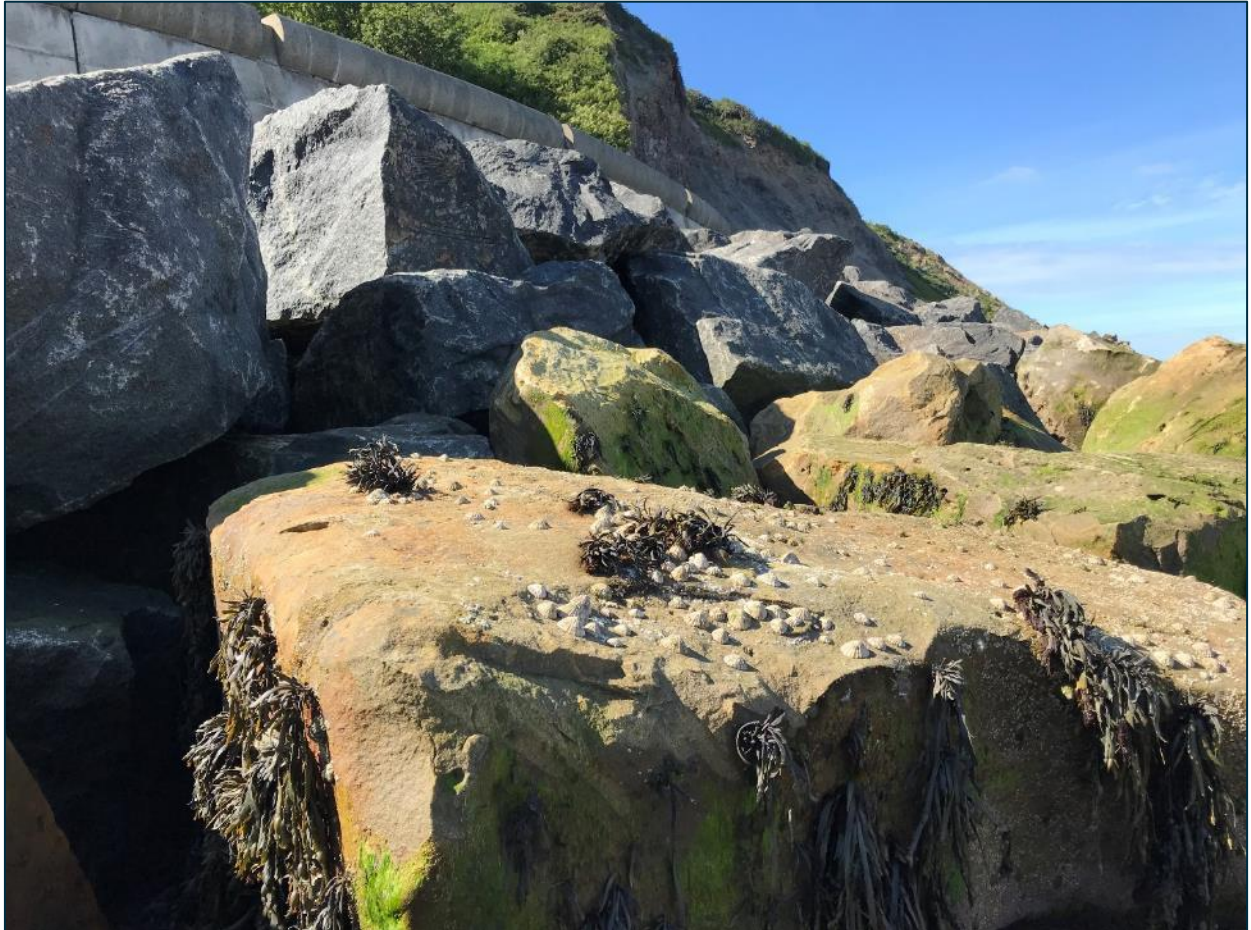
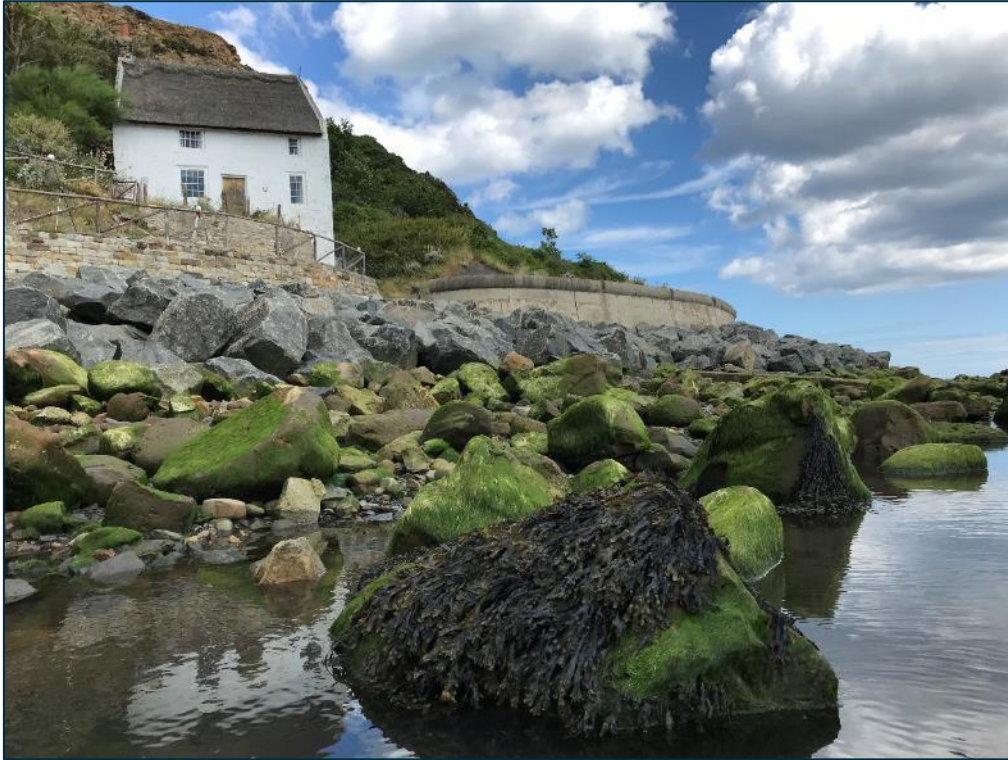
Existing boulders on the foreshore which were heavily colonised with vegetation / fauna were carefully set aside as required during construction. On completion of rock armour placement, the existing rocks were placed against the toe rocks of the new structure to allow seeding of the new rock armour and to encourage fast colonisation of the new material.

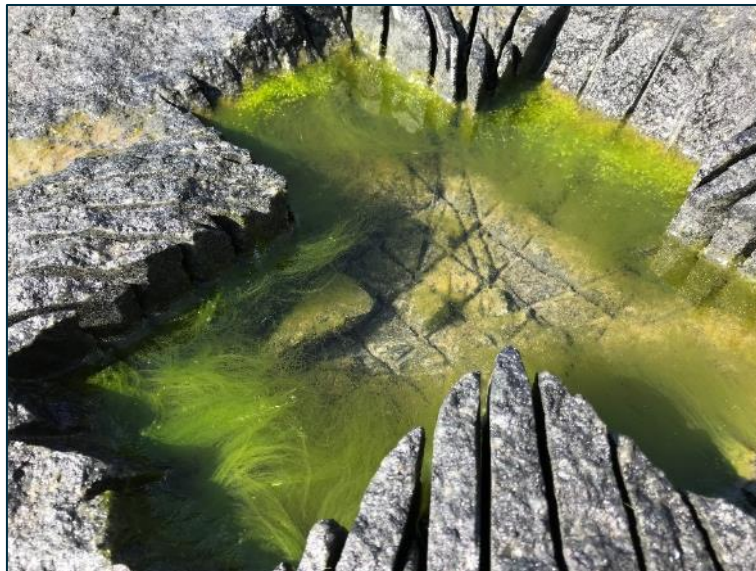
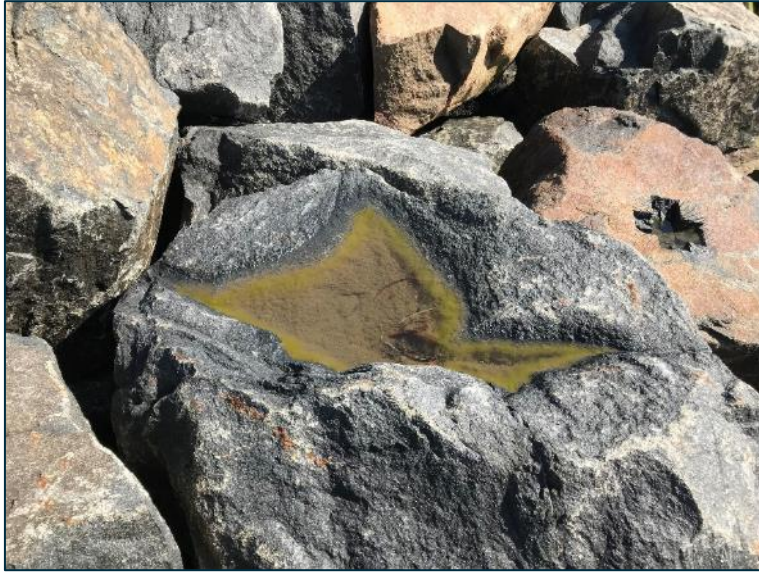
Within two months, vegetation establishment was evident within the artificial rock pools (including incomplete) and in the “natural” rock pools.
