FINAL REPORT

Runswick Bay artificial rock pool monitoring: 2019 results

DATE: February 2020
VERSION: Final v1.0
BUG REFERENCE: BUG2810
PROJECT MANAGER: Dr Andrew Harrison
REPORT AUTHOR(s): Dr Alice Hall, Dr Susan Hull, Dr Roger Herbert

Client:
Scarborough Borough Council
Town Hall
St Nicholas Street
Scarborough
YO11 2HG

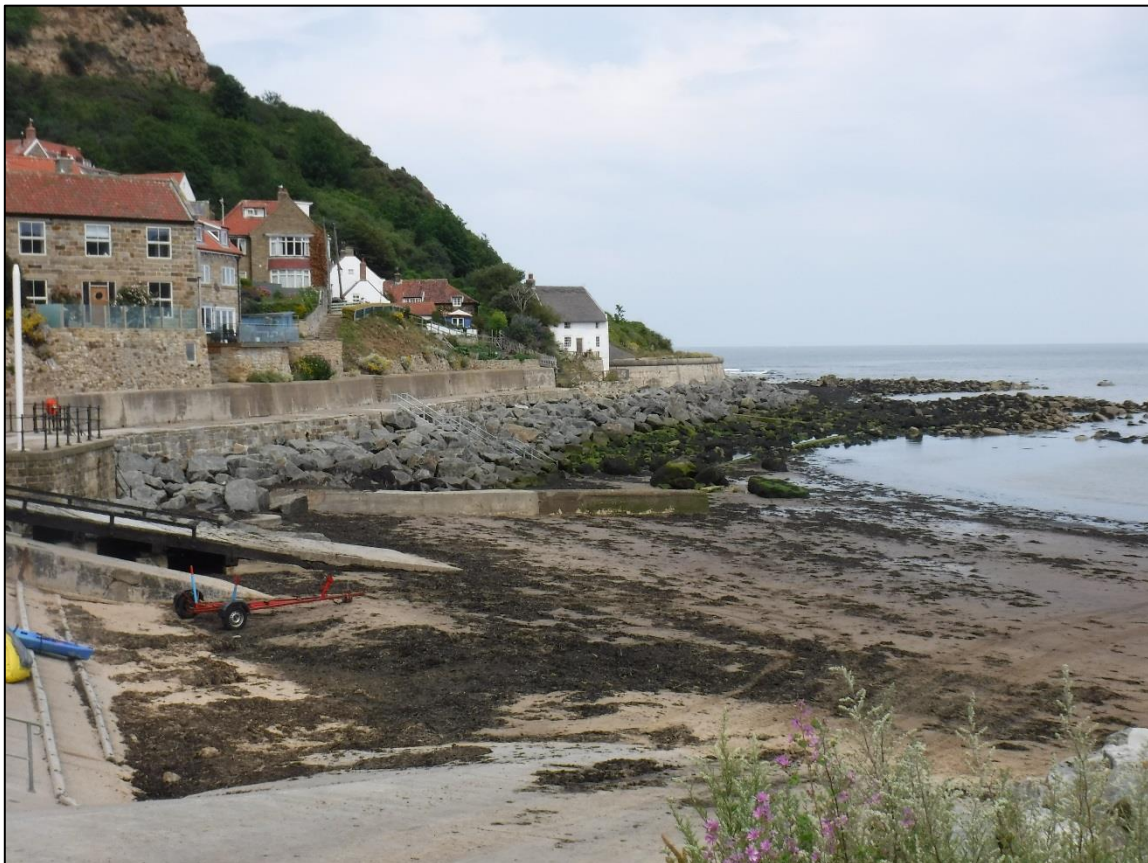
Runswick Bay is a moderately exposed sandy shore with large shale bedrock platforms. It has an easterly prevailing wind direction and the tidal range is 5.6 m during spring tides and 4.2 m during neap tides. The new rock armour was placed on top of the shale bedrock at the foot of the seawall (Figure 2.1). Existing boulders were moved during construction and replaced in front of the granite rock armour to test if “seeding” would increase colonisation rates.

Figure 2.1. Location of new granite rock armour at the foot of the seawall, note the green (colonised) natural boulders which have been placed in front of the granite rock (July 2019).

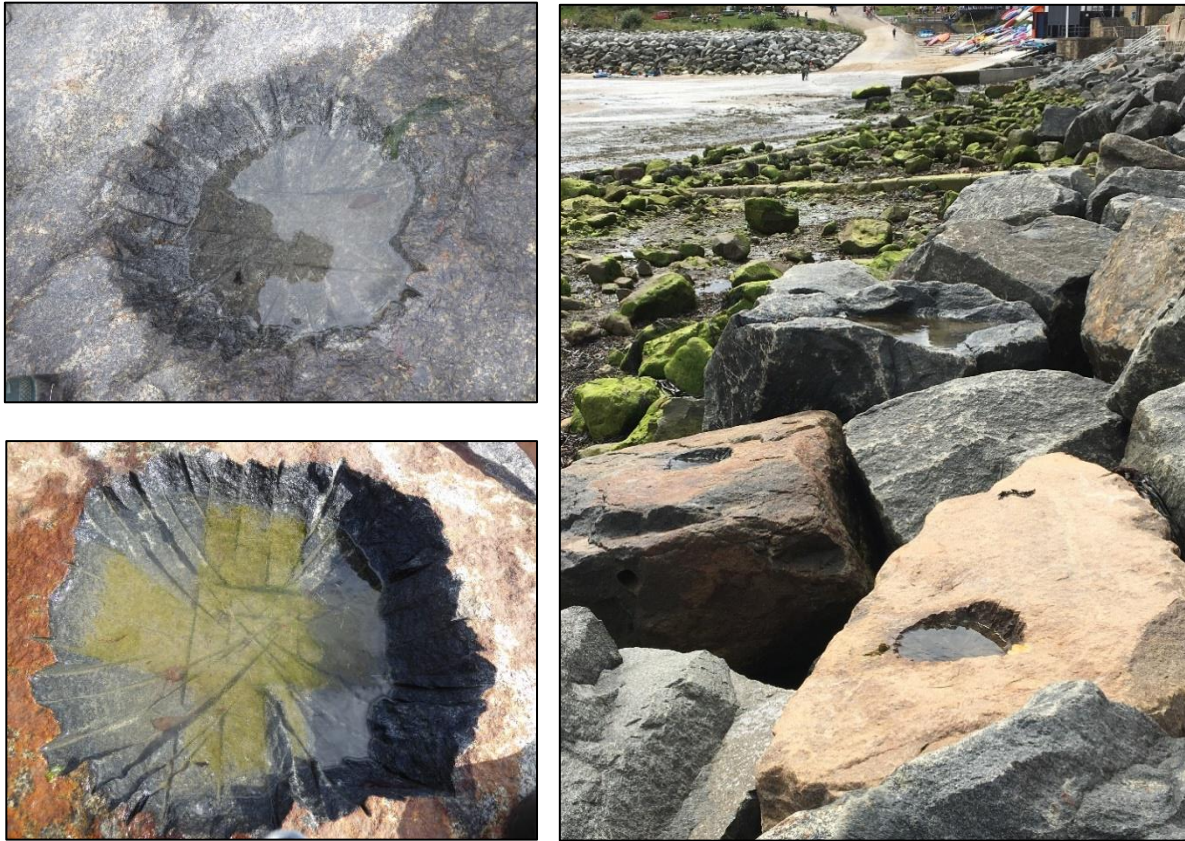
The 70 artificial rock pools were installed using a circular saw and breaker. The circular saw was used to make two sets of parallel cuts which were perpendicular to each other to form a cross shape. A breaker was then used to break up the cuts and form pools of approximately 300 mm diameter and 150 mm depth (Figure 2.2).

Figure 2.2. Examples of saw cut artificial rock pools roughly 300 mm diameter x 150 mm deep.

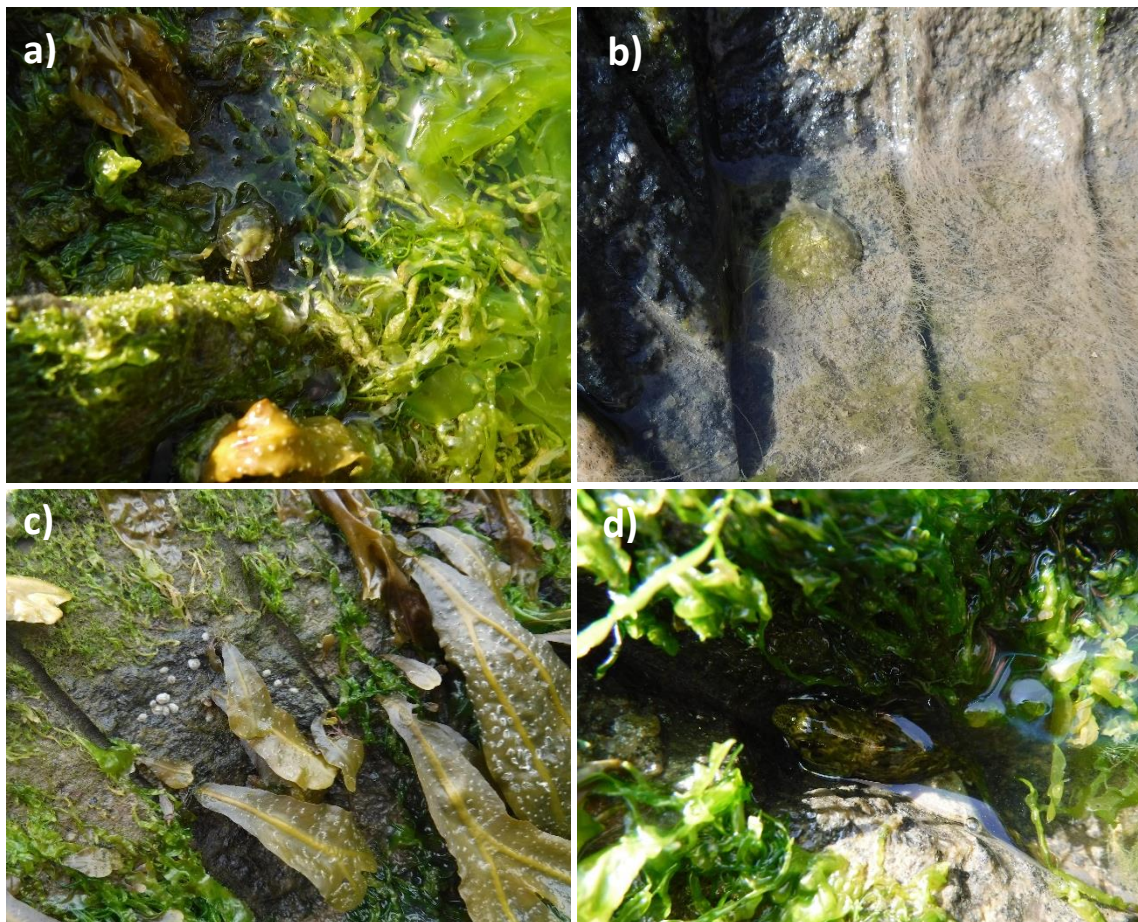
A total of twenty-two species were recorded within the artificial rock pools, compared with eleven species recorded on the adjacent control rock faces. Six of the additional species present within the rock pools were mobile species, including the intertidal fish Shanny (*Lipophrys pholis*), the intertidal crab (*Carcinus maenas*) and three intertidal snail species (*Littorina littorea*, *Littorina saxatilis* and *Melarhaphé neritoides*) (Figure 3.1). Results indicate that the artificial rock pools supported significantly greater species richness, species diversity and total abundance than the adjacent rock face controls (Figure 3.2, Table 3.1). The results also show that there was a significant increase in species richness, species diversity, % cover of algae and total abundance of animals between 2018 and 2019, both in the rock pools and control sites (Figure 3.2, Table 3.1).

Figure 3.1. a) Green shore crab (*Carcinus maenas*), b) Common limpet (*Patella vulgata*), c) Acorn barnacles (*Semibalanus balanoides*) and d) Shanny (*Lipophrys pholis*). Images from July 2019.
