**Walk-over Visual Inspections of Selected Assets  
following Storm Surge of  
5<sup>th</sup> December 2013**

**Scarborough Borough Council  
Supplementary Report**

**December 2013**

### Walk-over Visual Inspections of Selected Assets following Storm Surge of 5th December 2013

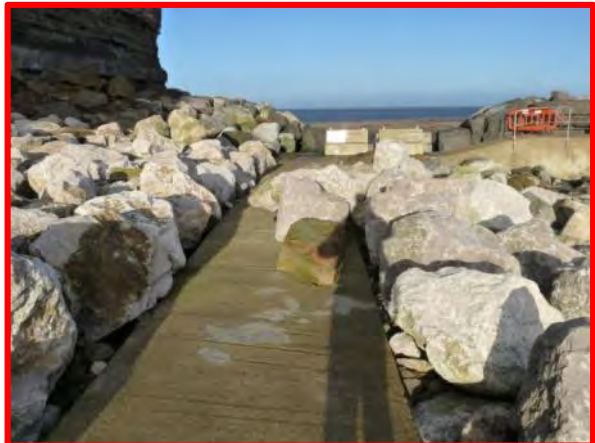
**During the post-surge inspection in December 2013, it was noted that in these units there had been relatively recent rockfalls and that there were significant talus deposits. Displaced rock armour and a rockfall block was noted on the path beneath these units,**

**MU4/1a** Displaced rock armour and rockfall block on path after the December 2013 surge. (Totally Active)

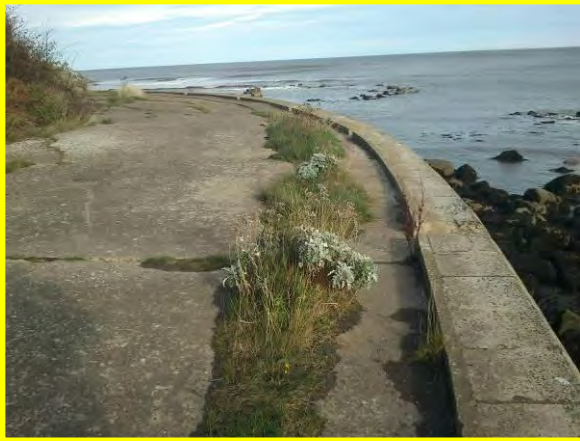
Promenade on top of northern seawall, 30/10/2012  
(Asset Ref. 1221D901D0601C01)

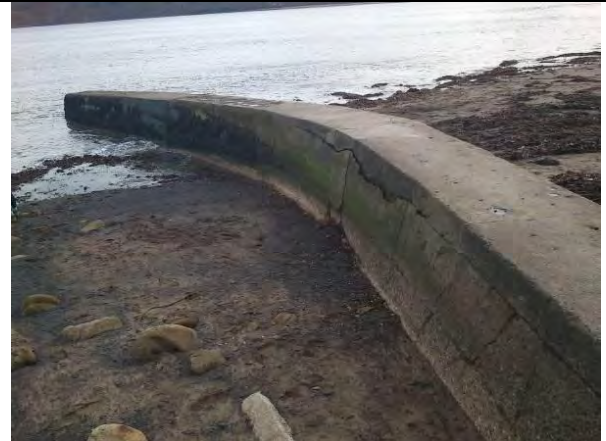
Oct 2012 (Asset Ref. 1221D901D0601C02)

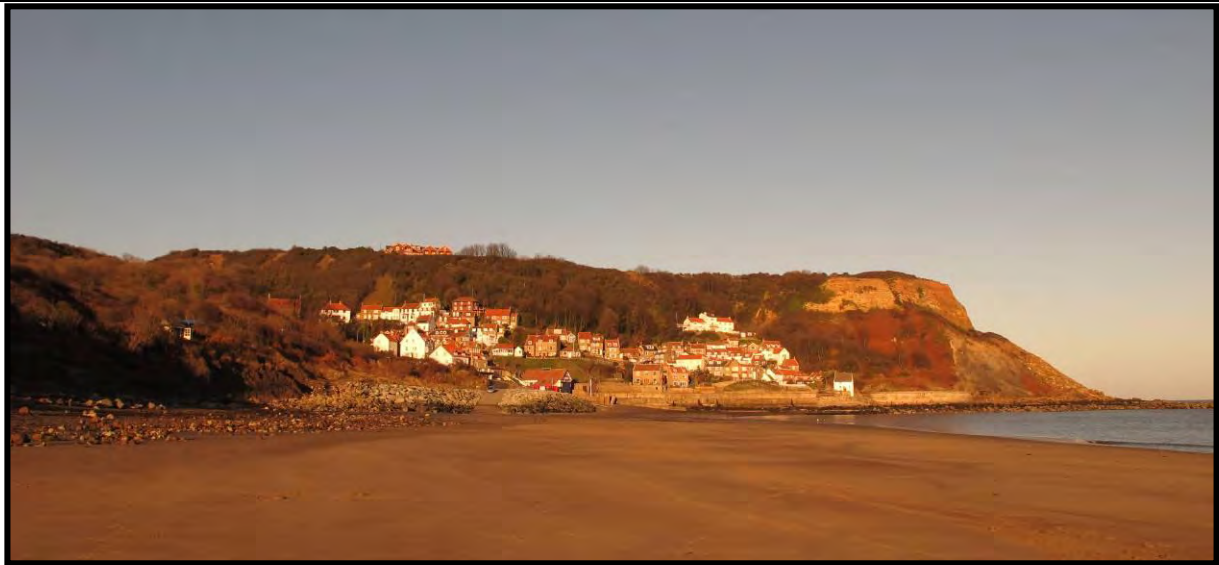
Runswick Bay's beach levels on 17<sup>th</sup> December 2013. (Asset Ref. 1221D901D0602C01-7)

***The observed changes were modest, apart from in the southern part of the bay, where up to 1m of erosion had occurred. The changes in beach level are not consistent with a large storm with large destructive waves. Thus it is considered that Runswick Bay was sheltered from the worst of the storm. The southern extent of the survey, which showed 1m of erosion may have been the most exposed area in the monitored part of the Bay. The storm data shows that the storm had a mean vector of 70°, as a result the changes to the beach must have been due to the refraction of the waves into Runswick Bay.***

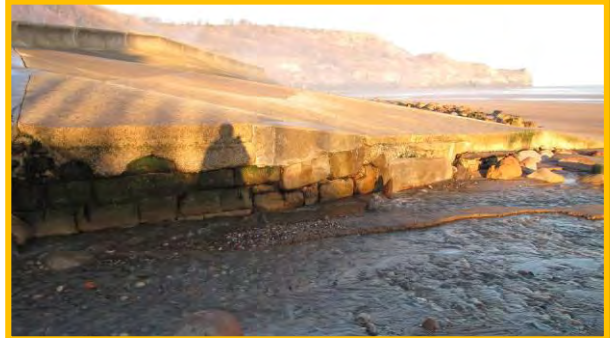
Slipway at the north of Sandsend, 17<sup>th</sup> December 2013. (Asset Ref No.1221D901D0701C02)

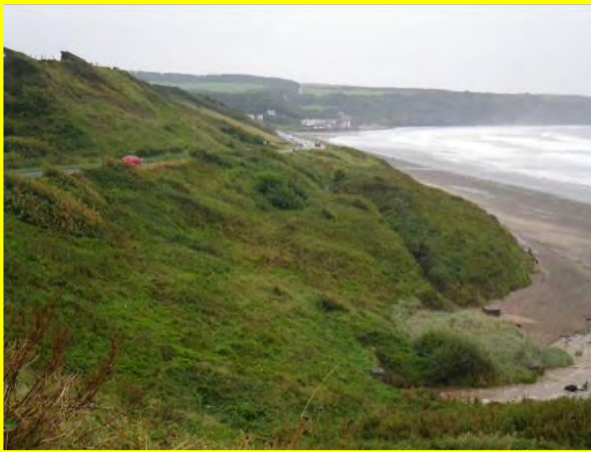
**MU9/4** (Locally Active) Sept 2013

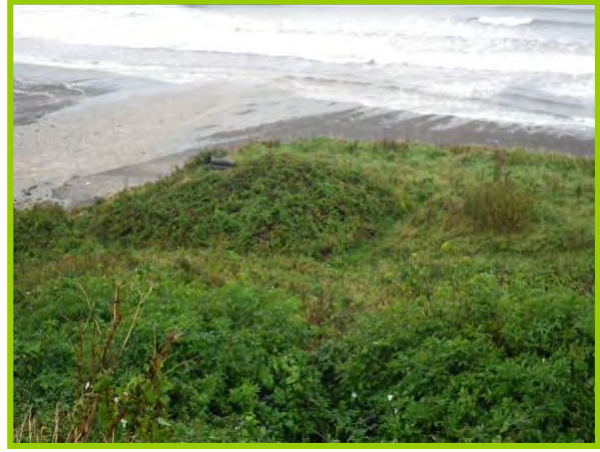
**MU10/1** Well vegetated slopes (Inactive) Sept 2013

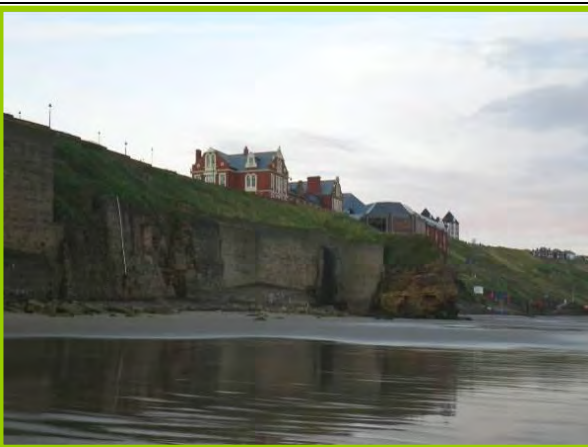
**MU11/3** Defended slopes with little evidence of recent activity (Inactive)

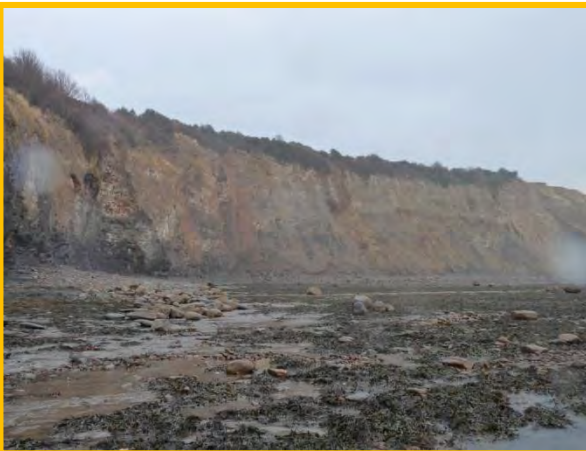
During the post-December 2013 storm surge inspection, MU16/1 was noted to still be very active with recent erosion and accumulation of coarse, angular debris at the cliff toe. The substantial notch at the cliff toe indicating undercutting of the cliff in the northern third of unit MU16/2 continued to be present, and failures in the bedrock cliff, beyond the end of the rock armour toe defences were noted here. Previously, unit had been assessed as ‘Dormant’. However, during this inspection because of the activity in the northern third of the unit, its activity status has been elevated to ‘Locally Active’. There were also several failures of the cliff behind the rock armour.

**MU16/1 – Partly Active, December 2013.**

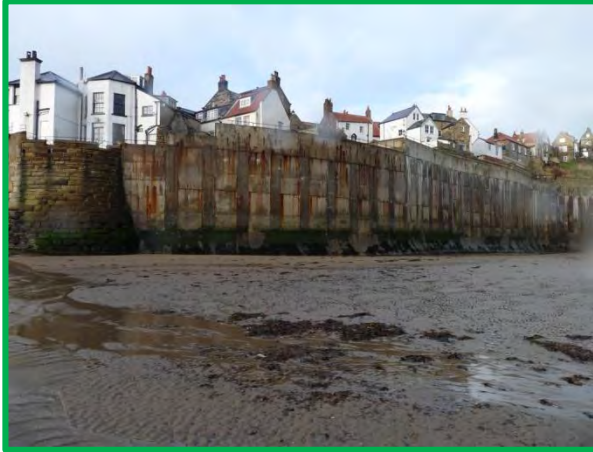
**MU16/3 – Robin Hood's Bay Village, December 2013 (Dormant)**

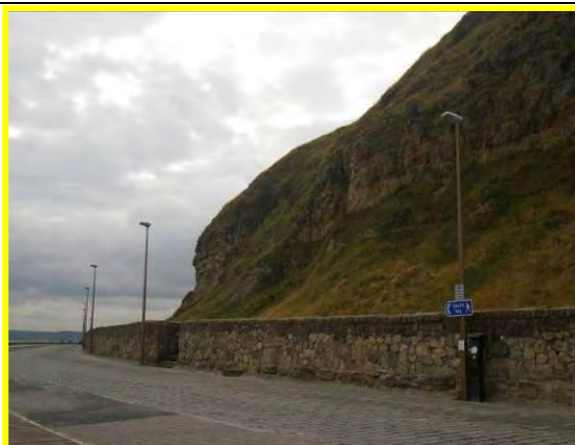
**MU21/2** Well jointed hard rock (Locally Active)  
Sept 2012

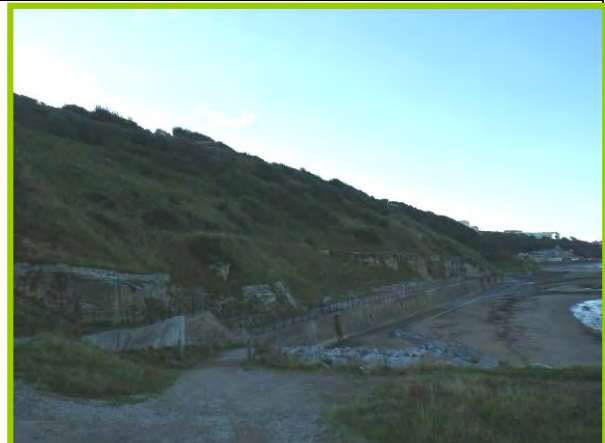
**MU22/7** The cliff face shows stability overall (Inactive). Sept 2012

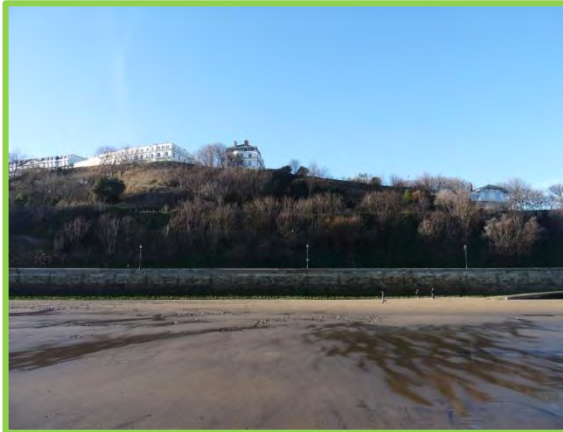
**MU22/1** – December 2013 (Inactive)

**Unit MU22/1** is the most northerly unit located in Scarborough's South Bay and is classified as Inactive. It is well vegetated with only minor, localised activity evident as footpath cracks.

**No new activity was noted in this unit following the storm surge in 2013.**

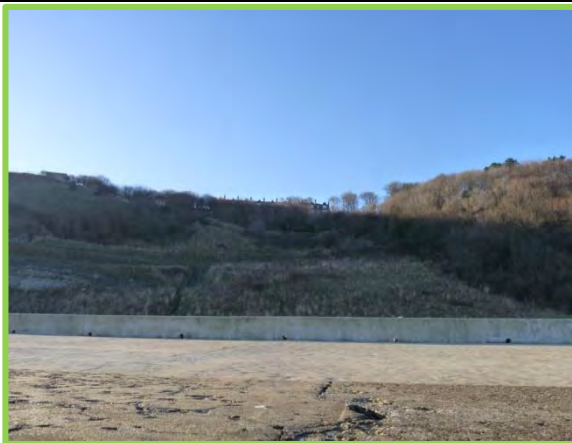
**MU22/6 – December 2013. (Inactive).**

**Unit Mu22/6** is located behind the former bathing pool and is classified as Inactive. The slopes of this unit are well vegetated although there are some signs of very localised rockfall near the unit toe. The unit was classified as Locally Active in 2009 due to more widespread activity. **Small areas of localised activity were noted in this unit but were not sufficiently significant to change the status of the unit.**

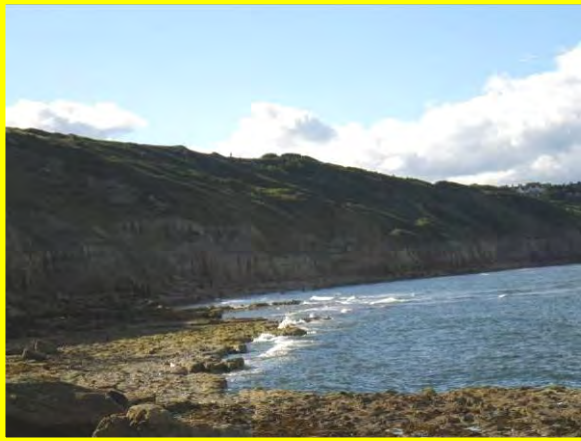
**During the post-December 2013 storm surge inspection recent activity was observed in units MU23/A, MU23B and MU23/C, with the most activity being apparent in MU23/A. Therefore the previous activity statuses of these units have been retained.**

**MU23/A – Continued toe erosion and failures of the sea cliff. December 2013 (Partly Active).**

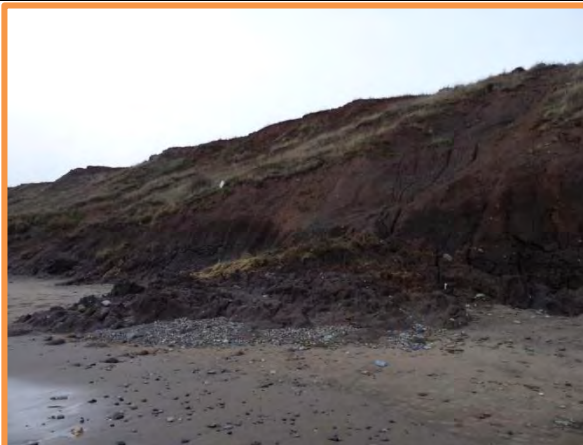
**MU27/V – Close up of mudslide lobe. December 2013 (Partly Active)**

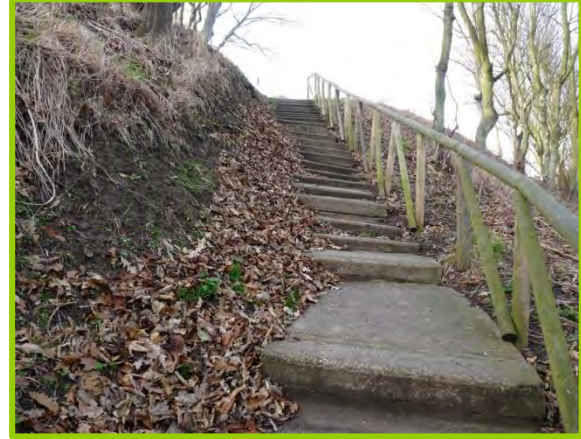
**MU27/Z – Off-horizotnal steps in woodland gardens. December 2013 (Inactive).**

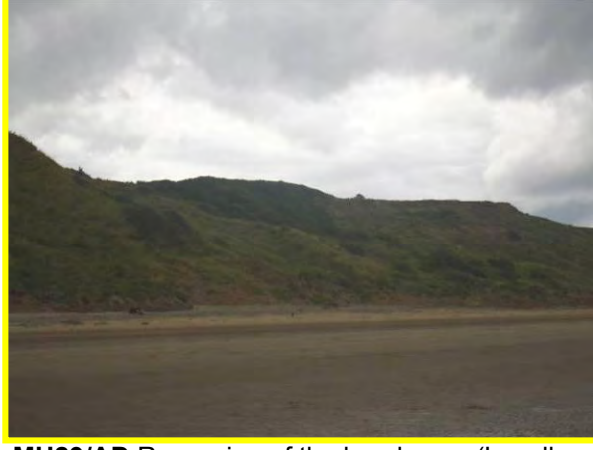
**MU29/AD** Recession of the headscarp (Locally Active) Sept 2012

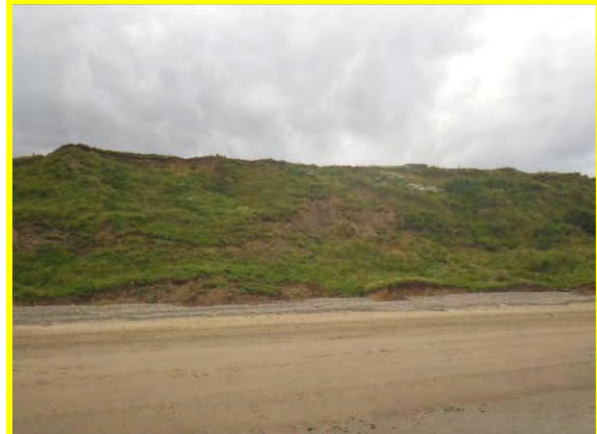
MU29/AK Well-vegetated low lying cliffs (Locally Active). Sept 2012

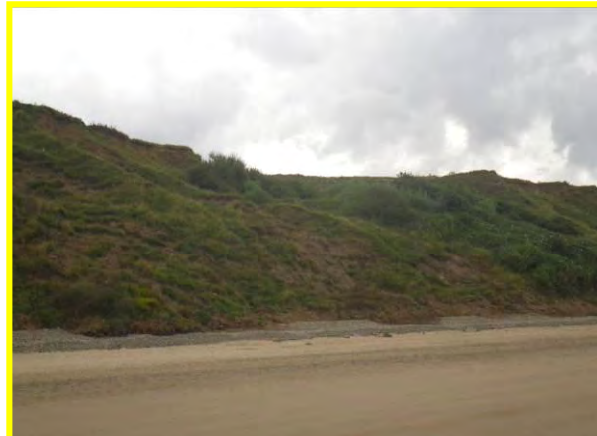
MU29/AN Toe erosion on an otherwise vegetated slope (Locally Active).

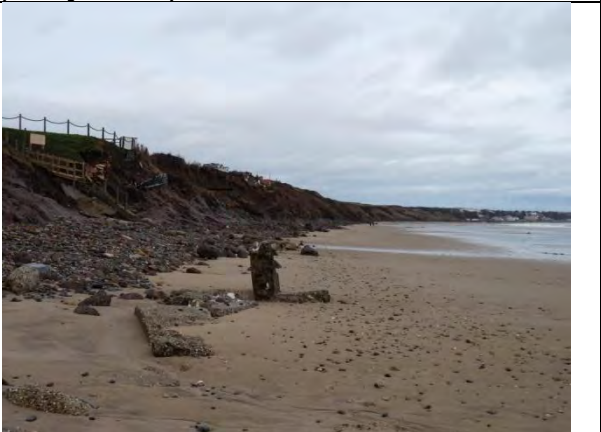
**MU29/AS and AR** – Beach condition. December 2013 (Partly Active)

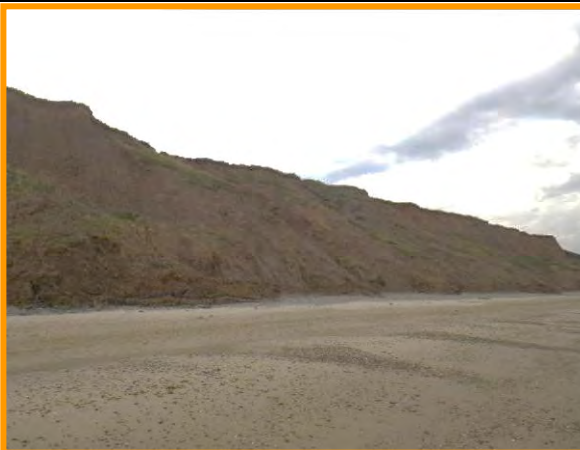
**MU29/BD** Slumping and sliding on the beach (Partly Active). Sept 2012

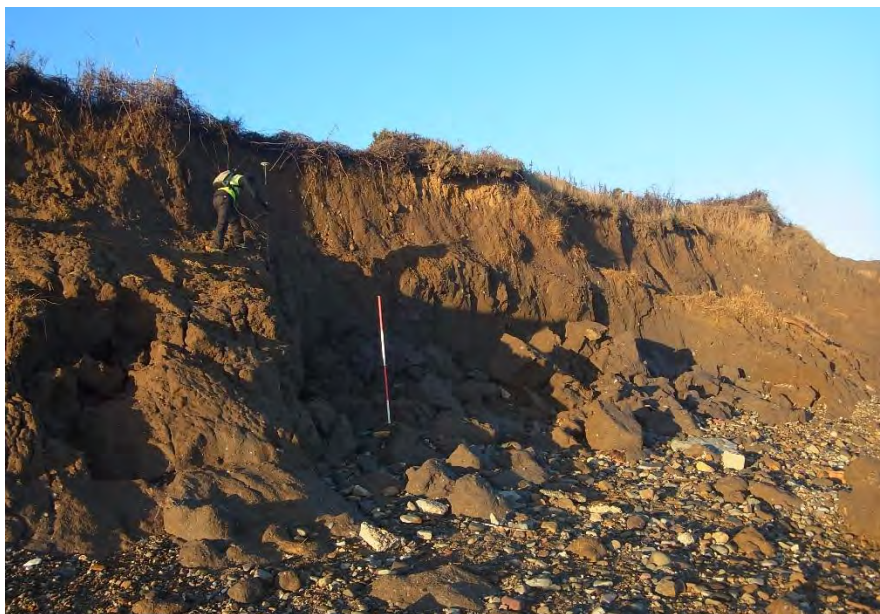
The following description of the changes to Filey Beach from the post storm surge beach profile surveys covers the north, centre and south of Filey Bay. Profiles FB1 to FB4 in the north and centre of the bay are all in the middle of the range of results. Profile FB5, near Reighton Gap, is low but not the lowest survey recorded. Between September and December 2013 the profiles have flattened although the beach level has remained similar.

At Profile FB3, close to Flat Cliffs the cliff line had eroded due to the December 2013 storm.
