Ongoing Analysis and Interpretation of Coastal Monitoring Data

Second Review of Full Suite Monitoring

Geotechnical Interpretative Report

Document Ref. No. 721229/002/GIR/007/Final

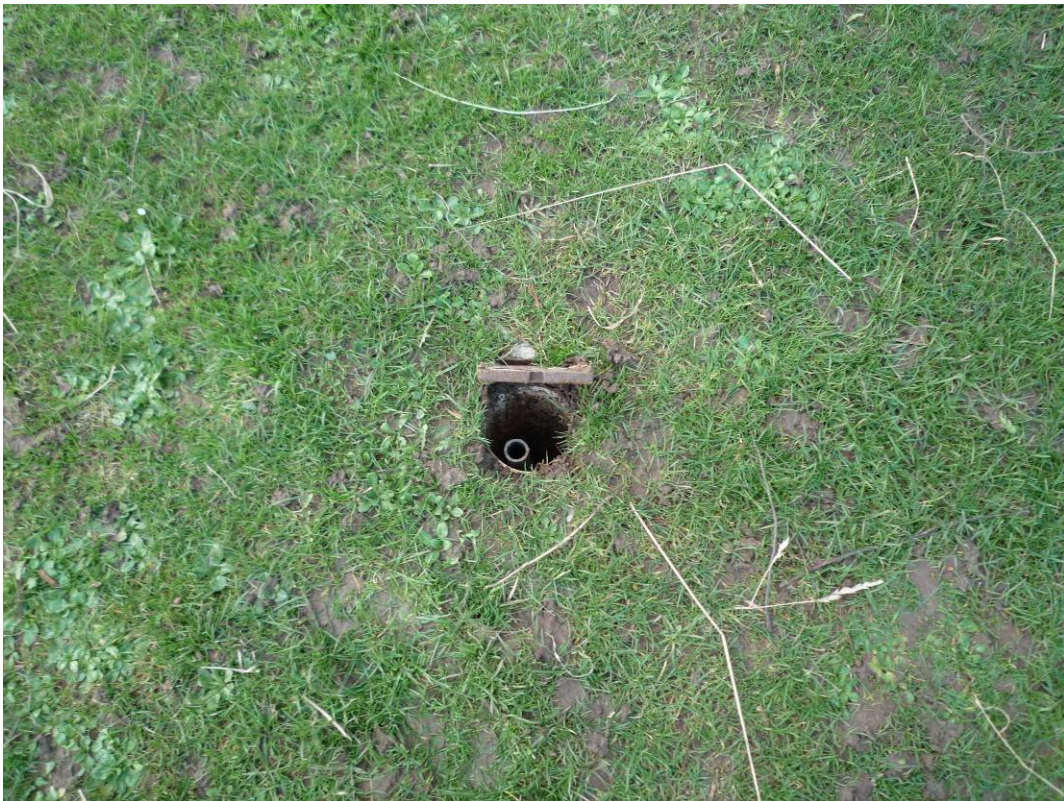
Plate 69 Scarborough South Cliff Promenade showing signs of subsidence.

Plates 68 and 69 (Appendix E) illustrate the effects of ground subsidence in the pavement along the promenade.

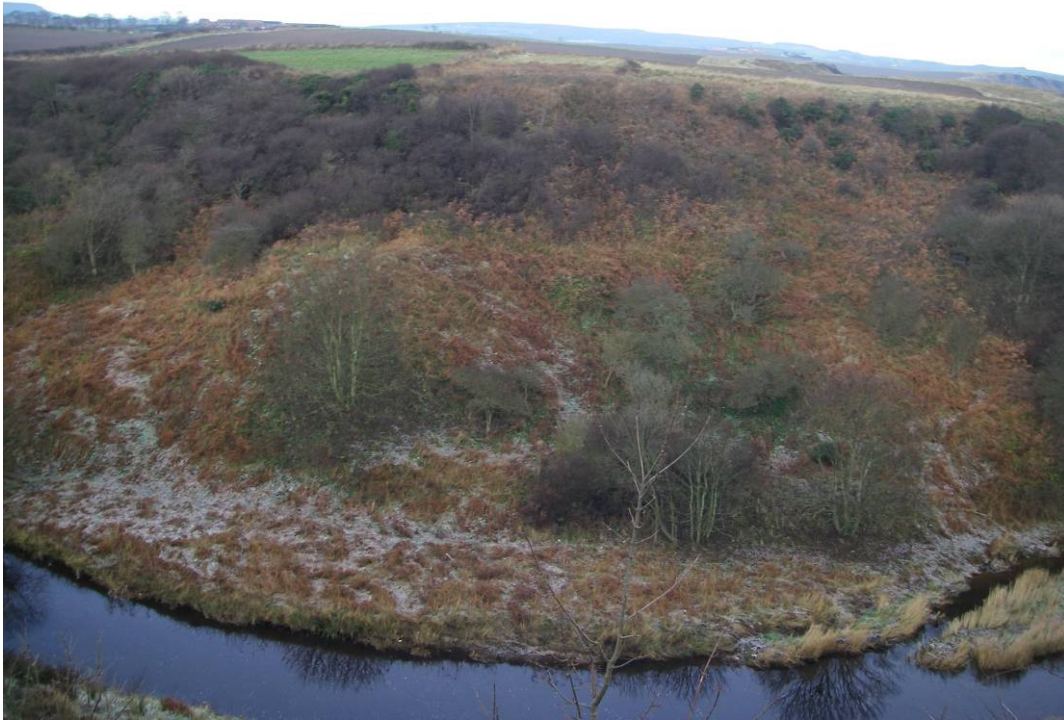
Plate 9 Site view looking north across Scalby Beck from the Upper Plateau.

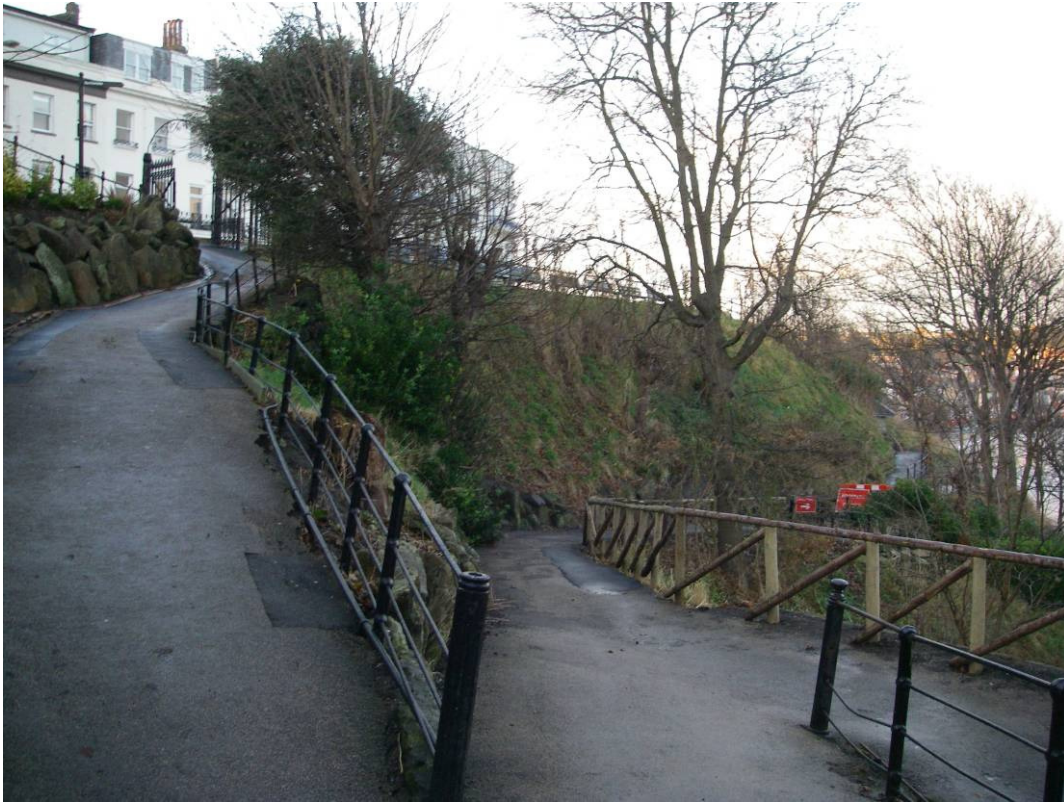
Plate 29 Site view looking north across Spa Chalet Cliff showing steep slope angles and bench-cut paths.

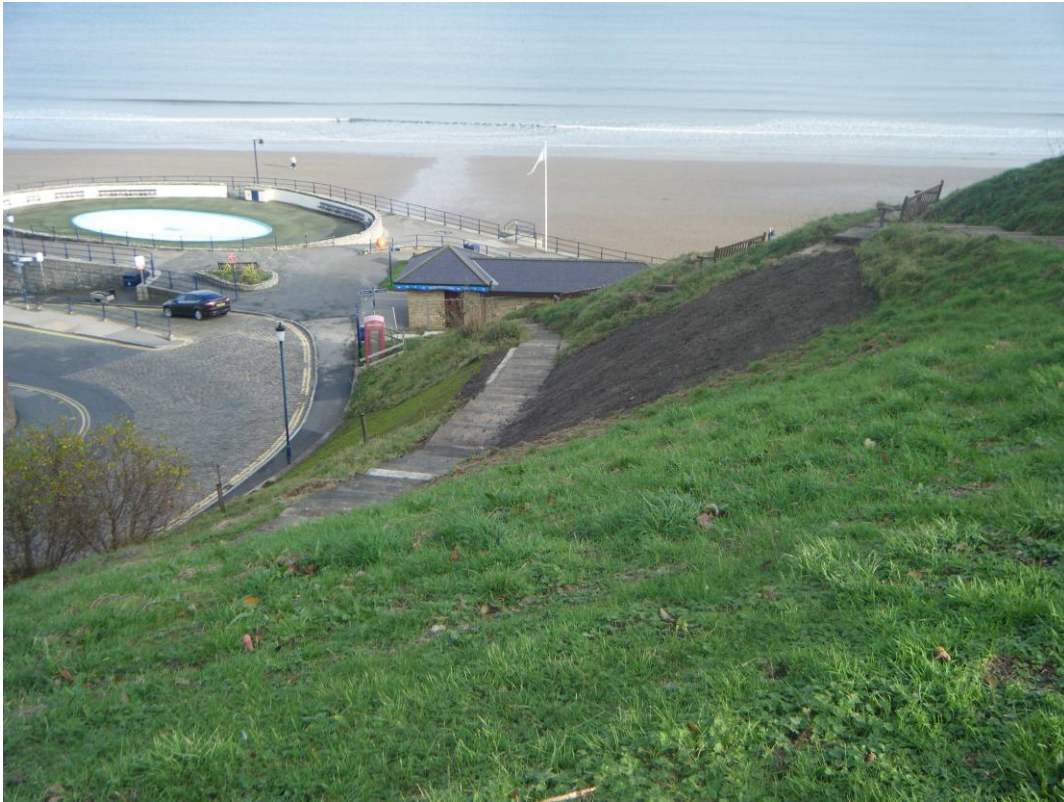
Plate 42 Site view of Crescent Hill from Glen Gardens.

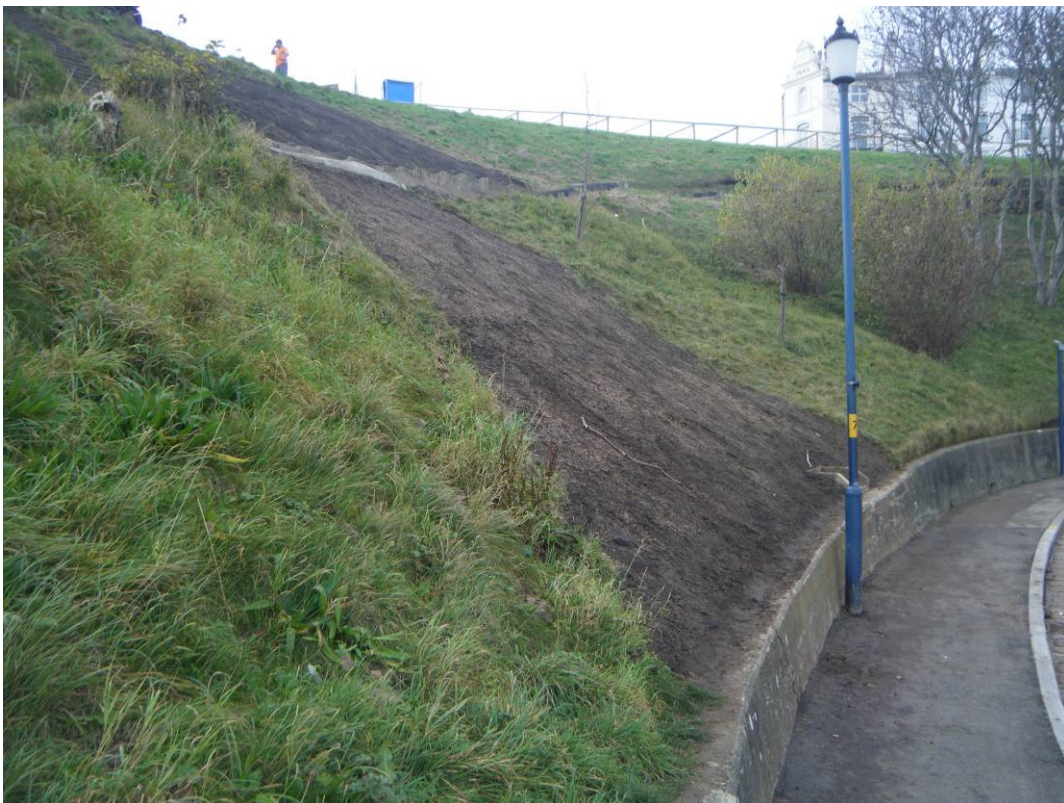
Plate 31 Site view of slopes at Crescent Hill.

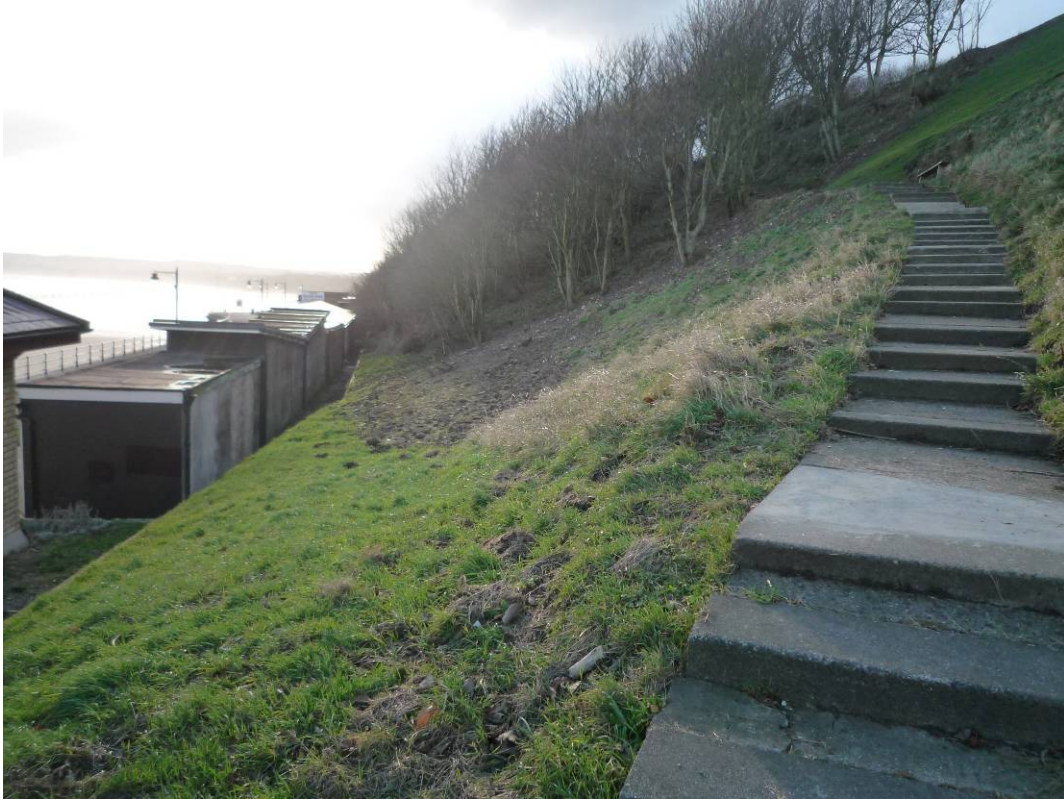
Plate 32 Site view of slopes behind chalets on Royal Parade.

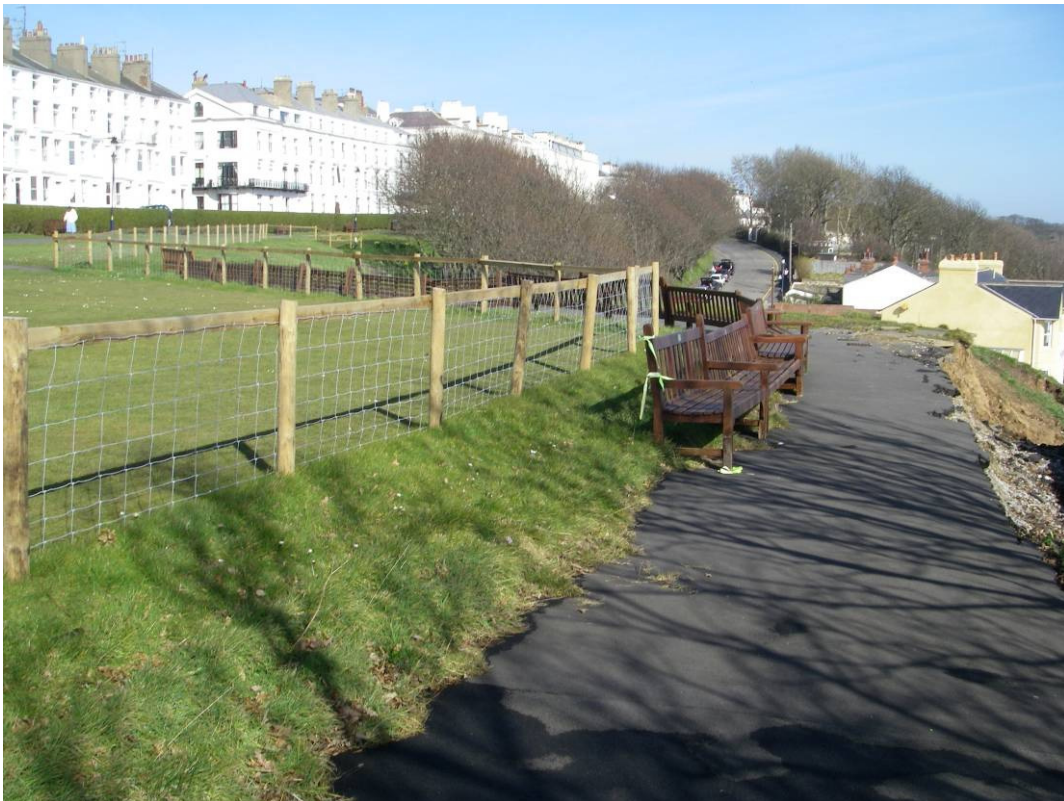
Plate 33 Site view looking north across Glen Gardens.

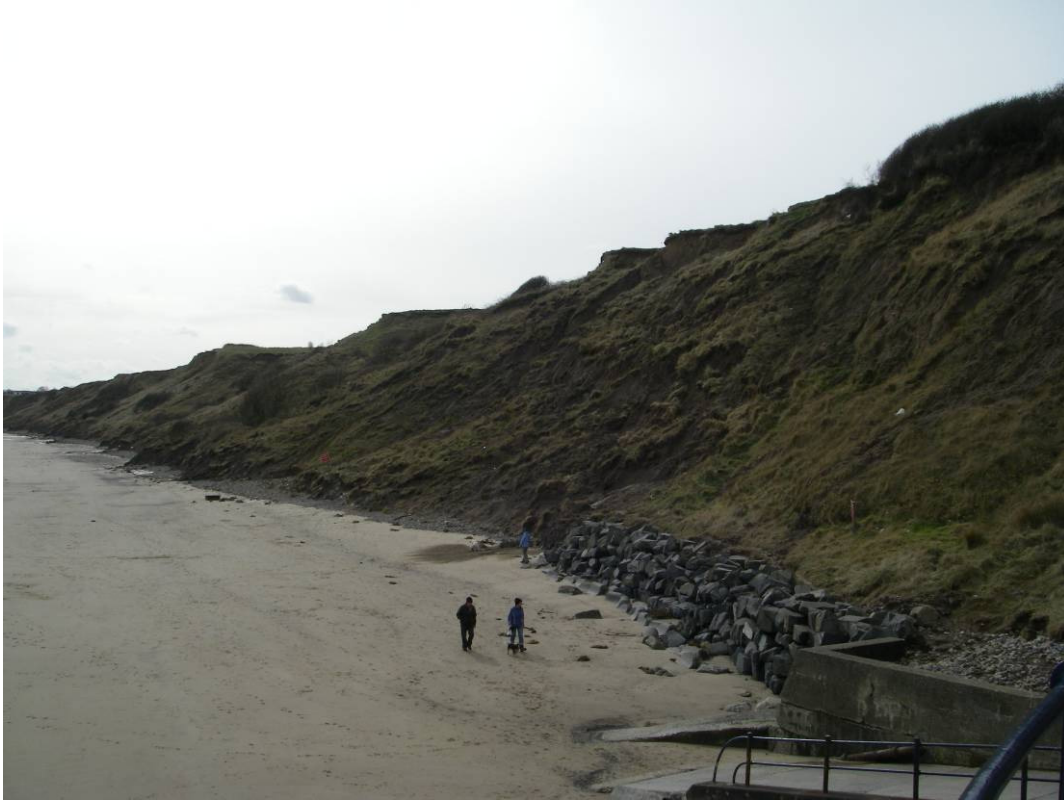
Plate 36 Site view of coastal slopes immediately south of Martin's Ravine.

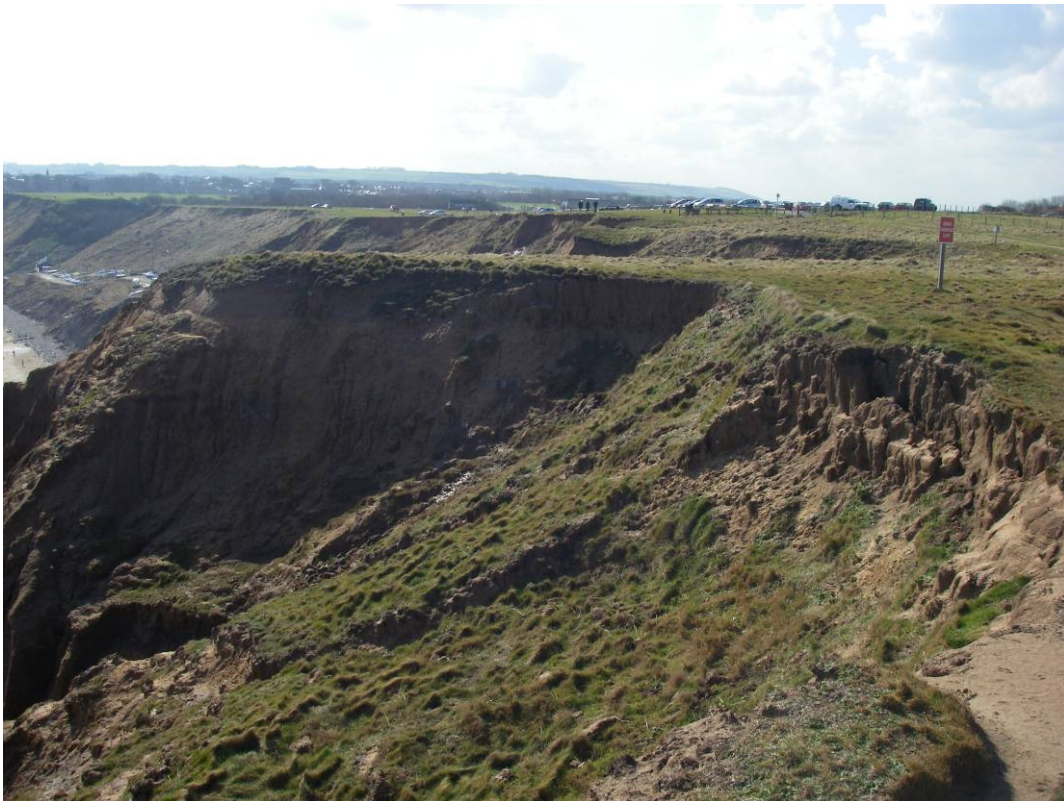
Plate 37 Site view of Filey Brigg looking west.

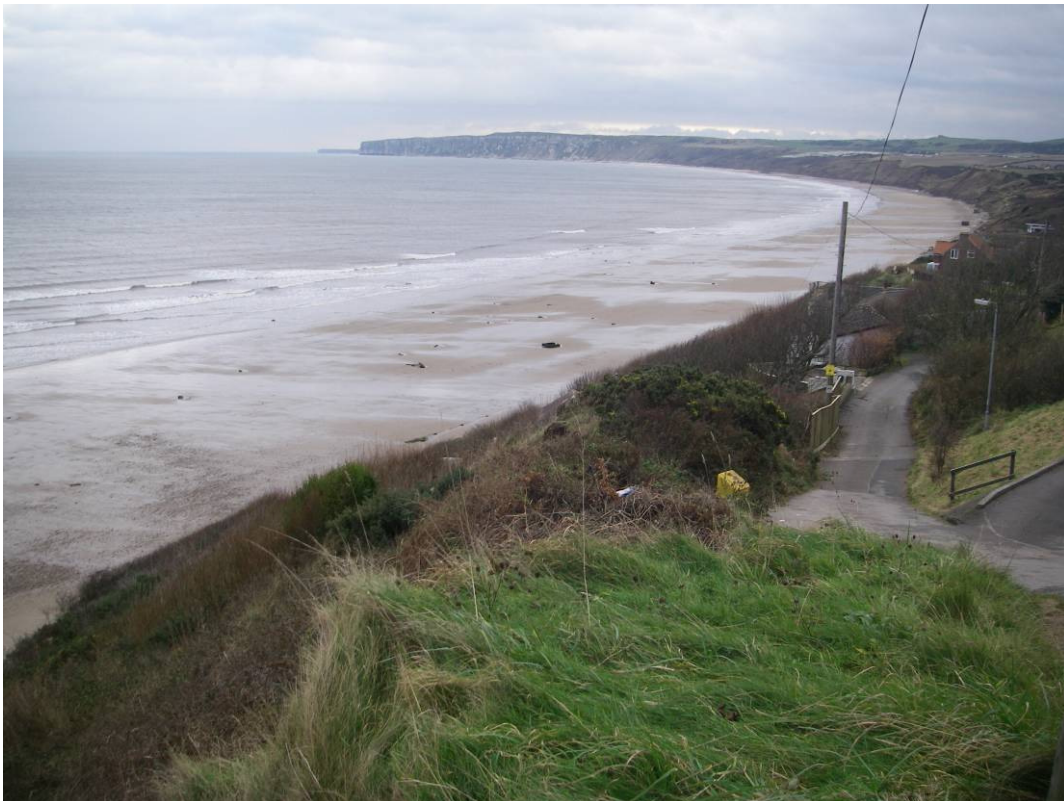
Plate 41 Site view looking south across Filey Bay towards Flamborough Head.

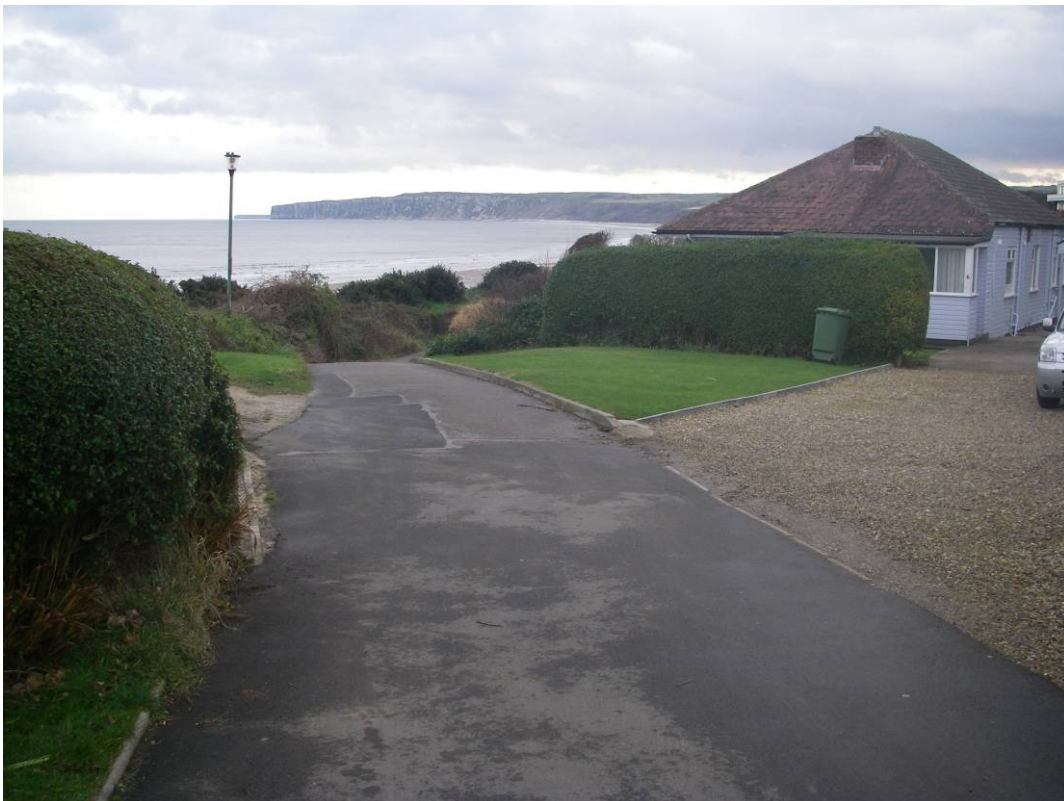
Plate 45 Site view looking down slope from 'level' mid-slope bench.
