**Cell 1 Regional Coastal Monitoring Programme:
Walk-over Visual Inspections of Assets**

Northumberland County Council

Walkover Visual Inspection of Assets

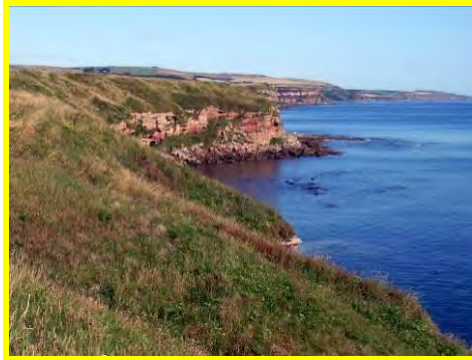
The cliffs along St John's Haven and Singing Cove continue to appear highly stable as they are fronted by a wide rock platform. This rock platform narrows to the south and the occurrence of caves and arches increases.

Cliffs at Singing Cove fronted by rock platform (/601c05).

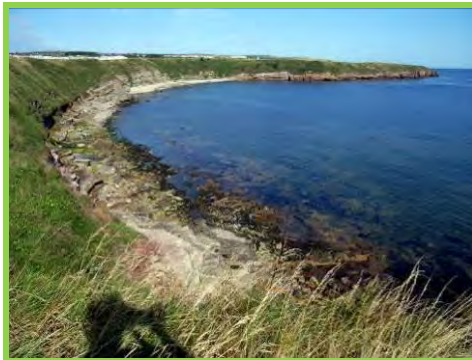
Between Burgess' Cove and Sharpers' Head the hard rock base is highly fissured and further areas of partial slumping have occurred in the overlying softer cliff material, cutting the cliff top back to the fence line in some locations. There is a concrete pavilion and access steps located at the centre of the bay which are in generally in fair/poor condition with signs of abrasion around the waterline. South of Sharpers' Head the cliffs continue to be characterised by large vertical fissures, caves along the base and local slumps in the overlying softer material.

Partial slips in upper soft cliffs north of Sharpers' Head (/701c02).

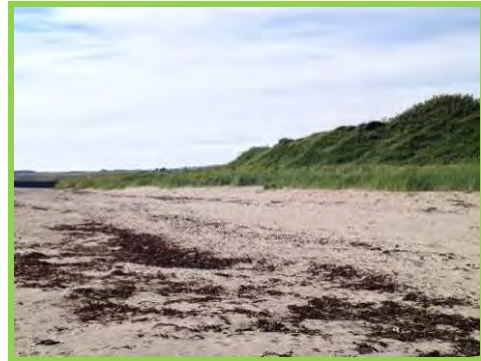
Wide stable dunes at Meadow Haven, north of Berwick Pier (/701c13).

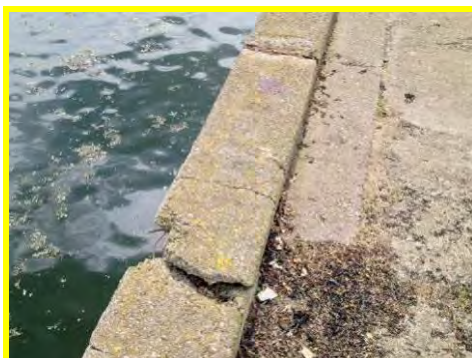
At Spittal Pier the masonry quay walls are heavily abraded with some localised cracking of blocks and exposure of steel reinforcement along the cope.

Exposed reinforcement in cope (/901C06).

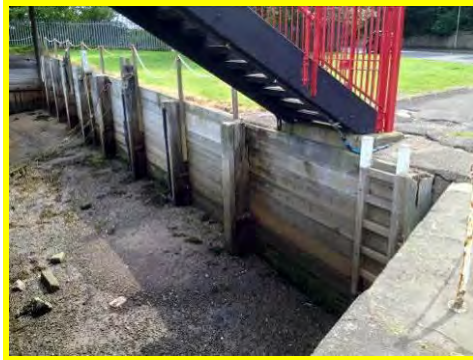
Low beach levels fronting Spittal Quay exposing masonry toe (/901C07).

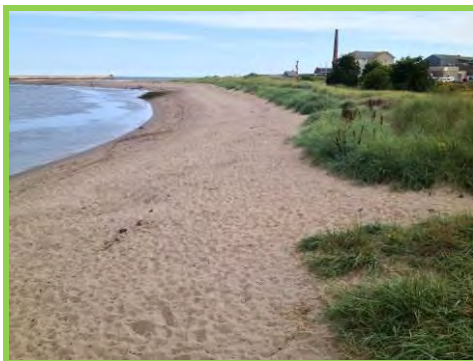
The dunes to the west of Sandstell Point appear relatively healthy with continued vegetation growth in front of an apparent historic erosion line. Cliffling of beach material identified in 2012 was not apparent. The previous inspection in 2010 reported active erosion of the dunes however this seems to have stabilised in recent years, possibly due to the presents of a large sand bar across the estuary mouth.

Dunes to the south of Sandstell Point appear stable (/901C08).

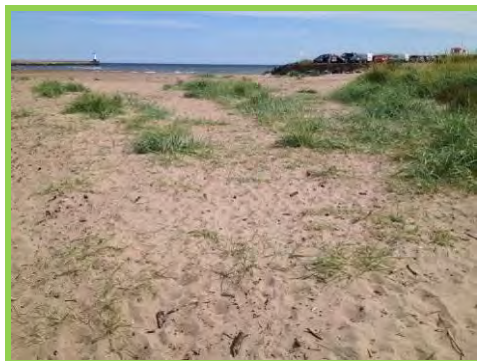
New vegetation growth in front of a historic erosion line (/901C08).

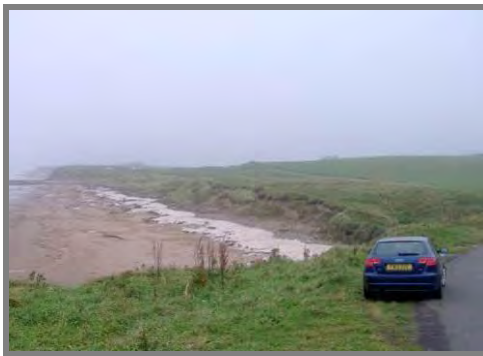
Dunes at Salt Pan Rocks in 2012.

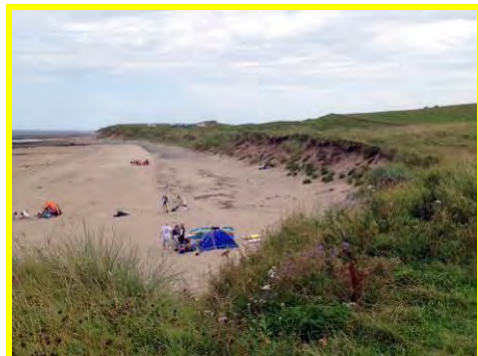
At the northern end of the dunes at Salt Pan Rocks there is evidence of continued erosion of the dunes from the previous inspection in 2012 with some re-growth of vegetation on the dune face.

Dunes at Salt Pan Rocks in 2014 (/1201c01).

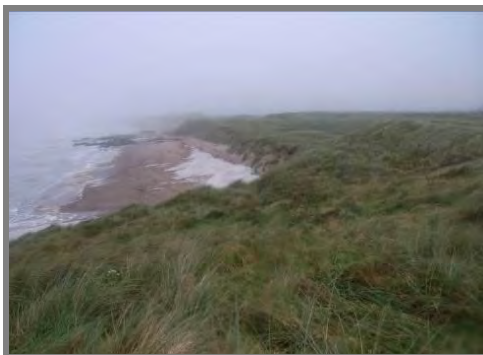
Dunes at Far Skerr in 2012

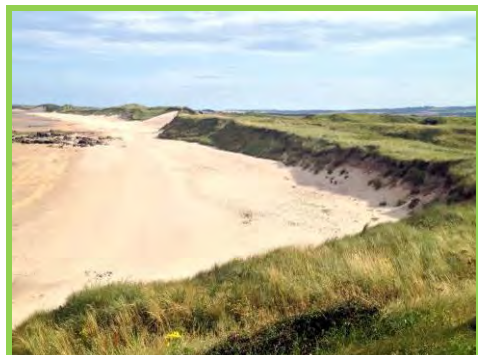
The condition of the dunes at Middle Skerr and Far Skerr do not appear to have significantly worsened since the previous inspection in 2012 however erosion to the dune face appears to be continuing.

Dunes at Far Skerr in 2014 (/1202c02)

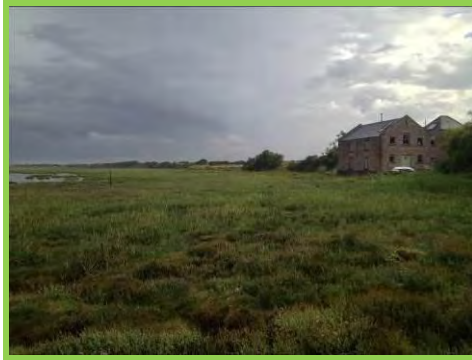
Narrow but healthy salt marsh at Fenham Mill (/1401c23).

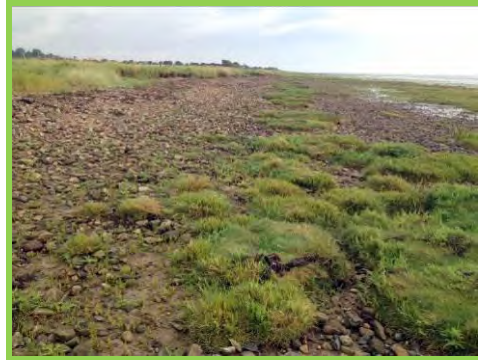
Salt marsh wider but more patchy near Fenham-le-Moor (/1401c23).

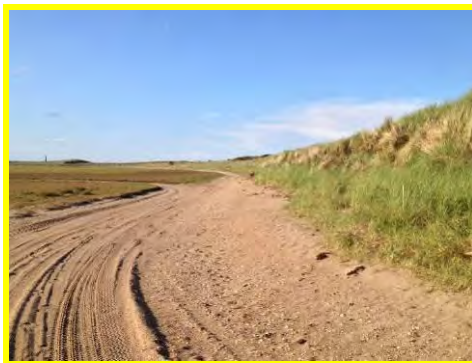
Landward side of Old Law dunes appear stable (/1401c99).

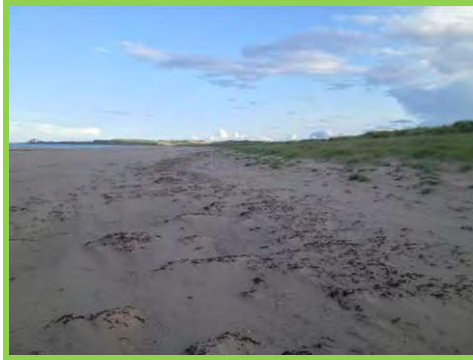
Embryo dune growth at north end of Ross Back Sands (/1401c06).

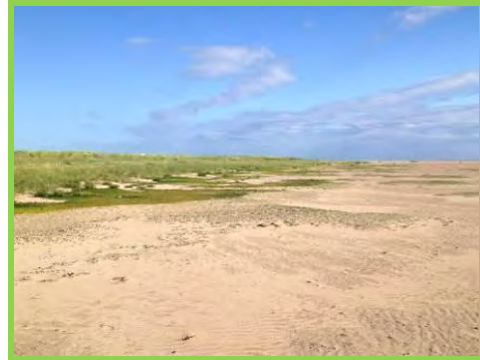
Embryo dune growth at south end of Ross Back Sands (/1401c06).

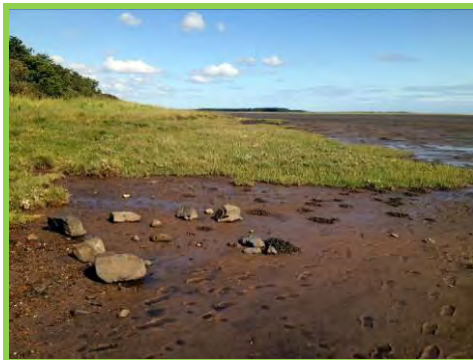
Along the Chesterhill Slakes in Budle Bay the salt marsh remains generally in a healthy condition with little change evident since the previous inspection. Some salt pans were evident although marsh edge erosion as reported in the previous inspection was not observed. The 2010 inspection noted Chord Grass (*Spartina*) growth on the foreshore.

Generally healthy salt marsh at Chesterhill Slakes (/1501c08).

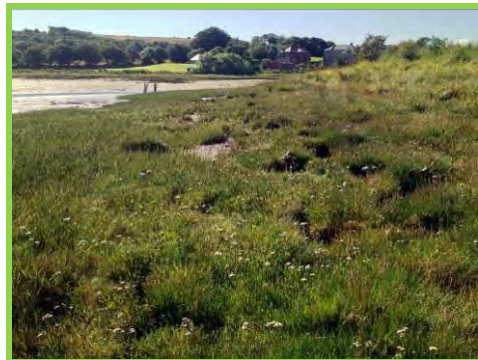
Some salt pans evident in salt marsh (/1501c08).

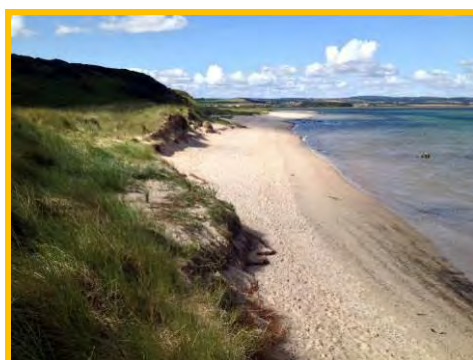
The dunes along the south side of Budle Bay are relatively healthy however continued erosion and cliffing of the dune face and pedestrian erosion of vegetation was evident near Heather Cottages.

Continued erosion and cliffing of dune face in 2014 (1501c06).

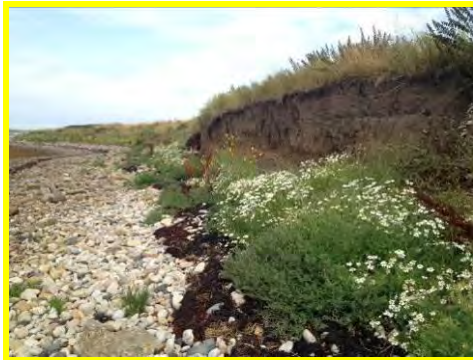
At The Basin, the low cliffs are locally active with several lengths bare of vegetation and occasional sumps. However, this does not appear to have worsened since the previous inspection. As noted in the 2012 inspection, holes from Sand Martins are still present in the exposed section of cliff.

Erosion and cliffing of low earth cliffs at The Basin (/4901c03).

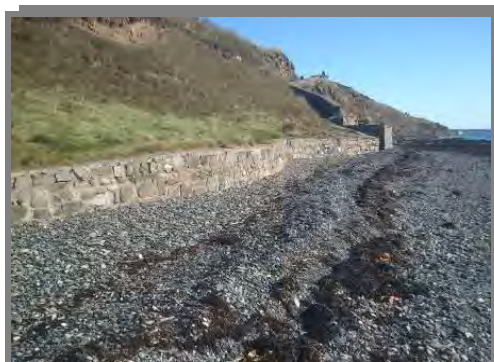
Higher beach levels obscure wall toe in 2012

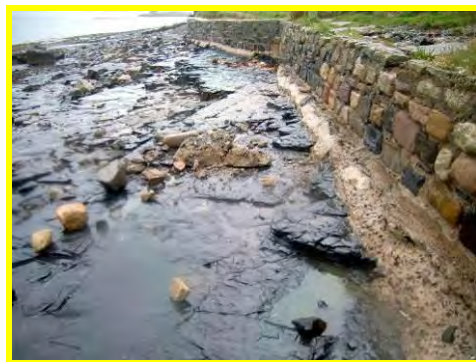
The previously noted shingle beach fronting the low masonry wall has been completely removed exposing the rock foreshore. This has re-exposed the toe of the wall showing the undermining as noted during the 2010 inspection. The concrete apron along the top of the wall is showing signs of damage with some loose fill material evident on the foreshore. Slumps in the softer cliff material above the wall identified during the previous inspection remain visible but do not appear to have worsened.

Shingle beach completely removed exposing rock foreshore in 2014 (/4901c06).

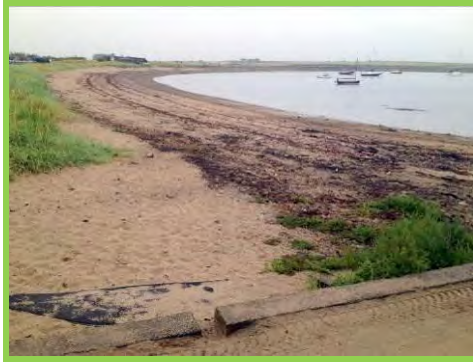
Beach within Harbour bay (The Ouse) remains stable (4901c10).

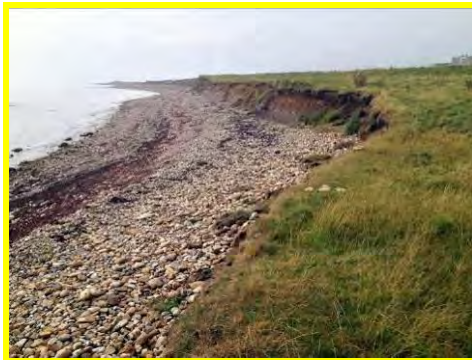
Eroding shingle cliff north of Castle Point (/5001c01).

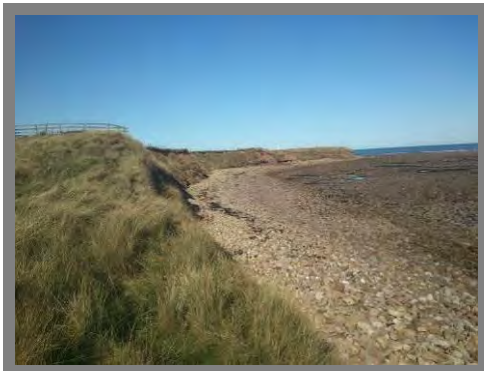
View to Emmanuel Head in 2012.

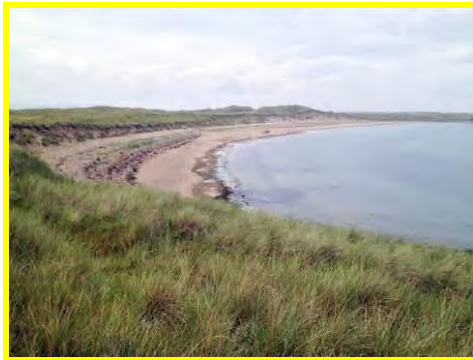
View of Sandham Bay from Emanuel Head (/5001c06).

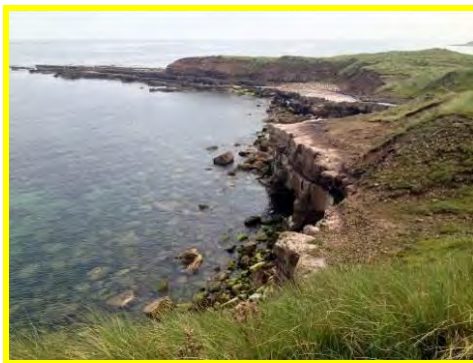
There is continued evidence of local rockfalls along with erosion and cliffing of the softer material in the cliffs at Nessend. However this is localised and does not represent significant concern. The caves and overhangs at Nessend continue to show signs of ongoing rock falls which would be a danger to members of the public. The 2012 inspection noted sand accretion on the dune ridge in Coves Have. However this was not observed and instead evidence of loss of vegetation on the face and undercutting at the crest was apparent.

Locally active cliff falls at Nessend (/5001c07).

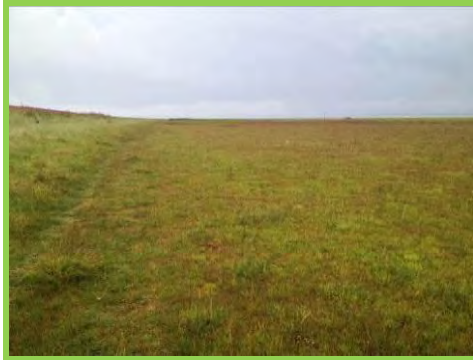
Vegetated dunes and foreshore north of causeway road (/5001c10).

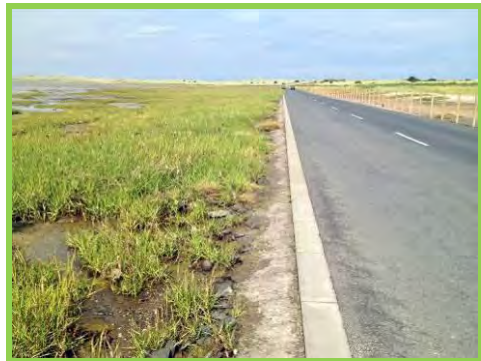
Causeway road at Chare End looking west (/5001c11).

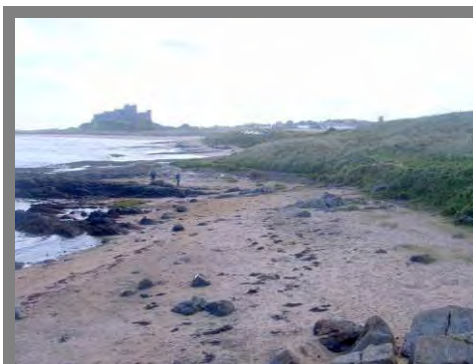
Low beach levels over rock foreshore north of Bamburgh in 2012.

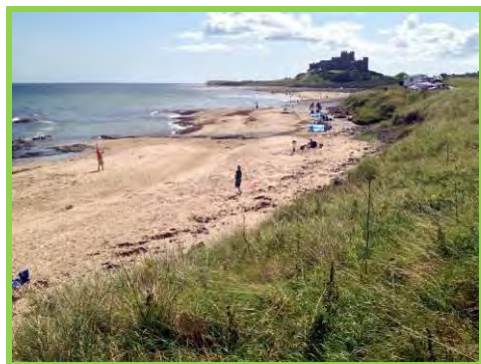
Beach levels accreting in 2014 (/1501c07).

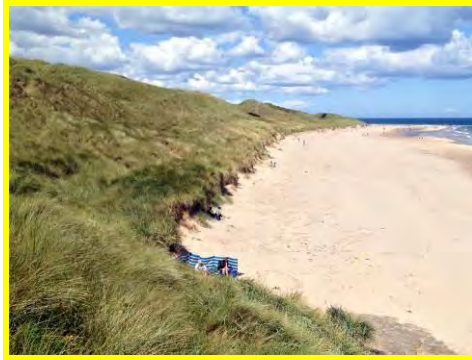
Wide, healthy and well vegetated dunes south of Bamburgh Castle (/1601c05).

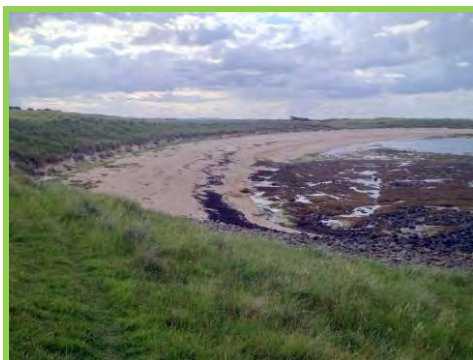
Vegetated dunes and sandy foreshore at Football Hole (/1901c02).

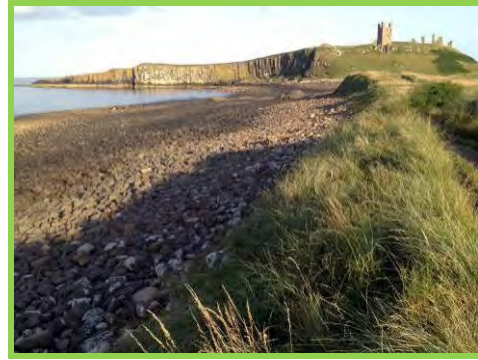
Low natural coastal slopes and shingle beach at Dunstanburgh Castle (/2001c05).

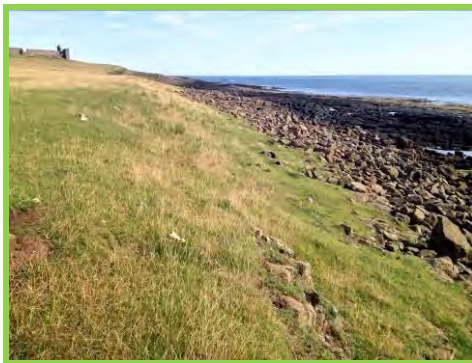
The gentle coastal slopes from Dunstanburgh Castle to Craster Harbour are well protected by a shingle/ boulder foreshore and generally in good condition.

Gentle coastal slopes south of Dunstanburgh Castle (/2101c01).

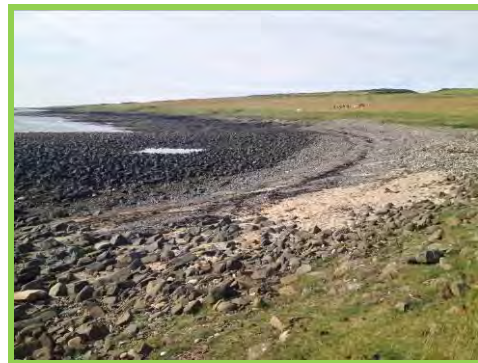
Gentle coastal slopes south of Dunstanburgh Castle (/2101c02).

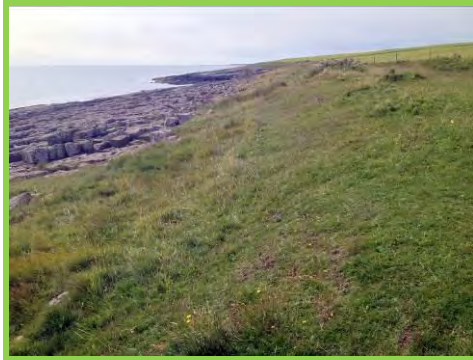
Rock slabs and vegetated upper slopes at Black Hole (/2301c01).

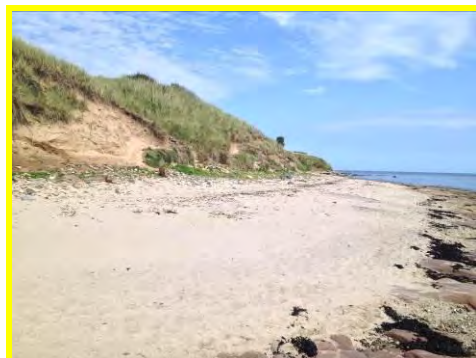
Localised erosion of low vegetated coastal slopes at Seaton Point (I2601c07).

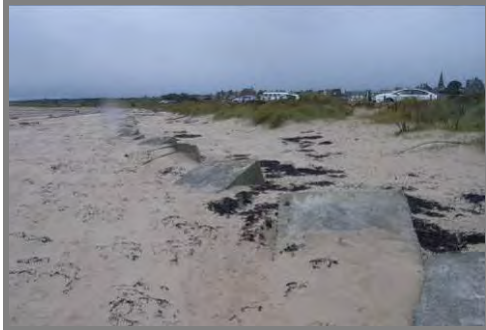
Beach levels fronting car park north of River Aln estuary in 2012.

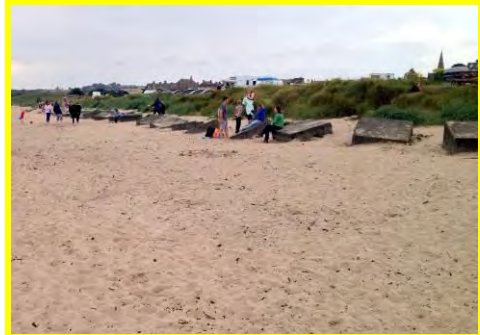
To the north of the River Aln estuary, beach levels in front of the car park appear relatively stable with only a slight lowering apparent since the previous inspection. The low earth slopes along this frontage are in good condition with no signs of recent erosion and some evidence of embryo dune on the foreshore. However, where the concrete blocks end in front of Marine Road some erosion and cliffing of the dunes is apparent.

Beach levels slightly lower in 2014 (/20701c07).

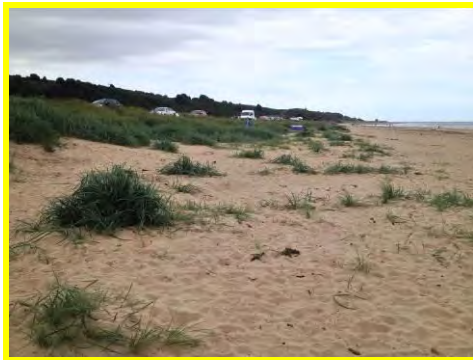
Embryo dune growth on the foreshore fronting the car park (/20701c07).

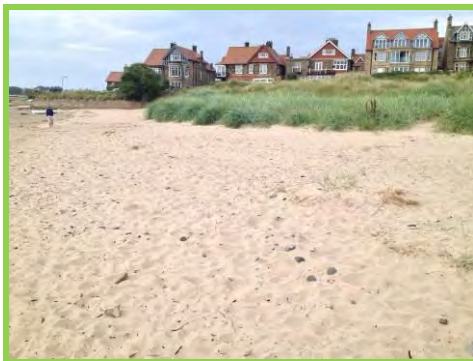
The dunes on the north side of the estuary are wide and well vegetated and appear stable with no signs of erosion. Some embryo dune growth was apparent.

No recent erosion of dunes north of River Aln estuary (/2801c01).

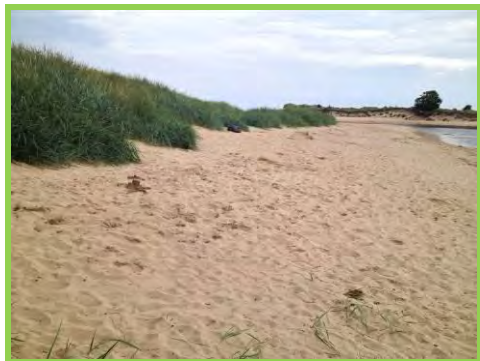
Some embryo dune growth north of River Aln estuary (/2801c01).

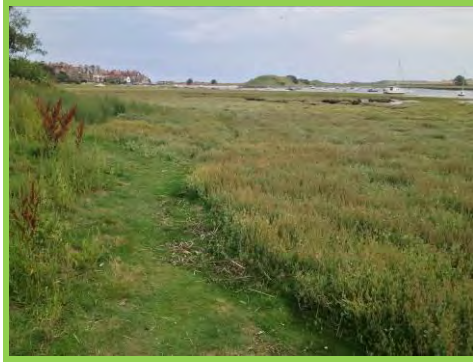
The downstream side of the low earth banks along the spit of land south of the river Aln road bridge is fronted by wide healthy salt marsh. Some erosion is evident on the edge of this marsh. The upstream bank of this spit is in poor condition with significant erosion, undercutting and collapse of the earth bank along most of its length.

Generally wide healthy salt marsh on downstream side of spit (/2801c08)t.

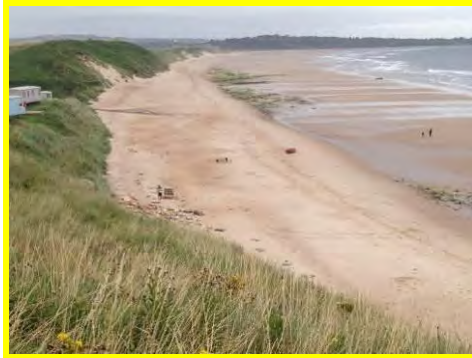
The dunes north of the rocky outcrop of Birling Carrs are stable although the hard rock base has suffered from local undermining and rock falls. However, the Warkworth Dunes to the south are in worse condition with partial erosion and slips continuing along much of the frontage.

Stable dunes north of Birling Carrs (/2901c02).

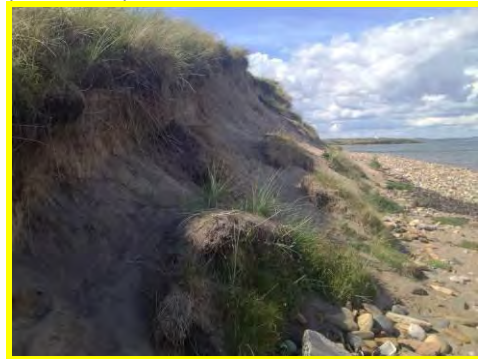
Erosion and collapse of dune face south of Wellhaugh Point (/3101c12).

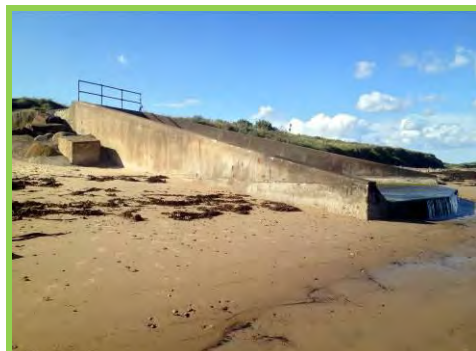
The large outfall structure adjacent to the Hadston Scaurs Boat Club remains largely in good condition with minor cracking to the wing walls. Undermining, settlement and cracking of the concrete apron reported in 2012 is now buried by high beach levels.

Higher beach levels in 2014 burying apron (/3201c12).

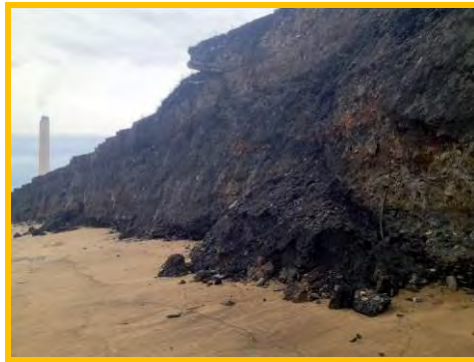
South of the River Lyne the high vertical colliery spoil 'cliff' formed by historic waste tipping over the coastal slope continues to be actively eroding. Waste of various descriptions continues to be released onto the foreshore. The land behind this actively eroding frontage is effectively a colliery spoil yard with no built assets at risk. However consideration should be given to the environmental impact of the continued release of waste from this eroding frontage and the safety implications to the members of public walking on the foreshore.

Actively eroding colliery spoil cliff south of the River Lyne (/3401c06).

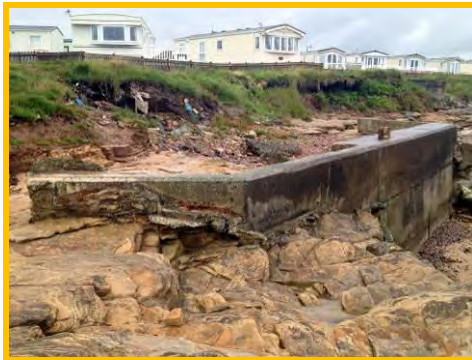
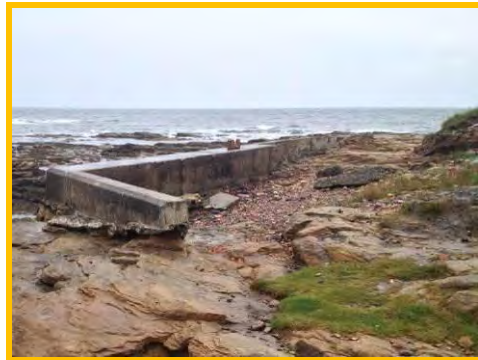
Extending between Newbiggin Point and Church Point is a continuation of the rock ledge, with overlaying softer material, interspersed with a series of ad-hoc defences to 'patch' local areas. At Beacon End a short length of concrete seawall is present which appears in fair condition on the seaward face. However abrasion and initial undermining of the toe was observed as well as undermining of the south return wall. Active erosion, cliffing and slumping of the soft cliff material behind the structure has continued since the previous inspection.

Outflanking and erosion behind the crest of the concrete wall at Newbiggin Point (/3501C08).

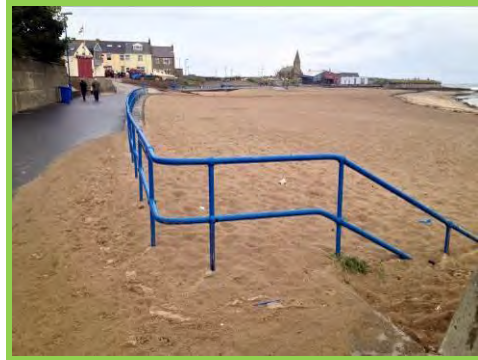
Windblown sand on the promenade (/3601c06).

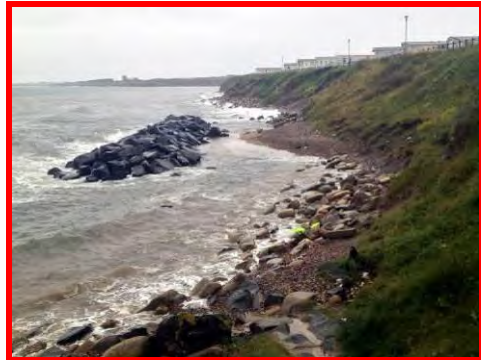
Accumulation of sand in lee of breakwaters but erosion continues (/3701c03).

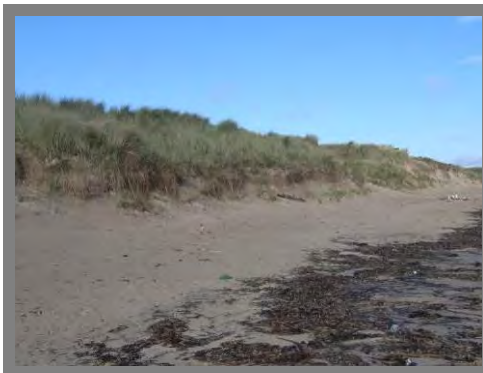
High beach levels and relatively stable dunes in 2012.

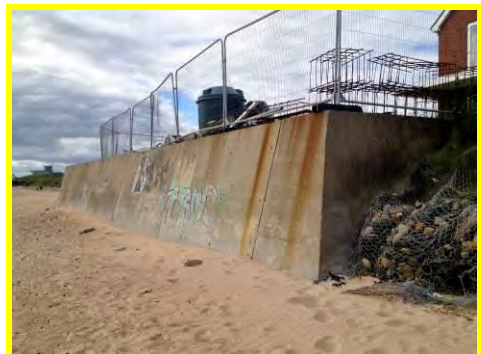
Higher beach levels burying toe in 2014 (/4201c04).
