Cell 1 Regional Coastal Monitoring Programme Walkover Inspection Surveys 2016

Northumberland County Council

Walkover Inspection Surveys 2016

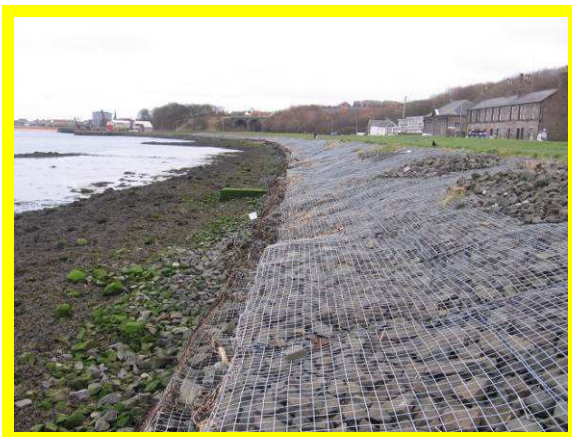
901c04 in 2006 showing small out fall.

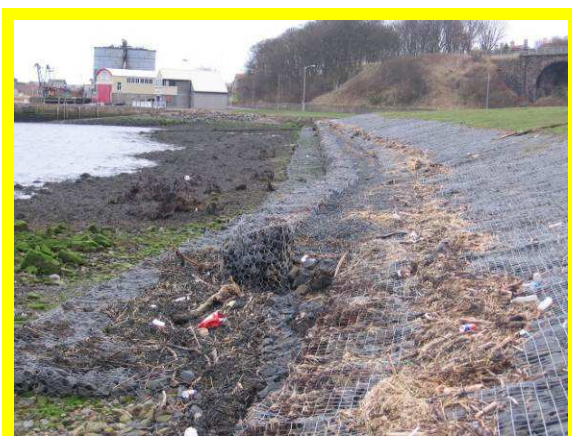
At the southern end of defence 901/ C04 a different type of mesh has been used (constructed by 2006), using a wrapped wire basket as opposed to a square welded mesh. This change in baskets has survived 10 years without major failure but is now showing local corrosion of the wire.

901c04 in 2006 showing change in mesh.

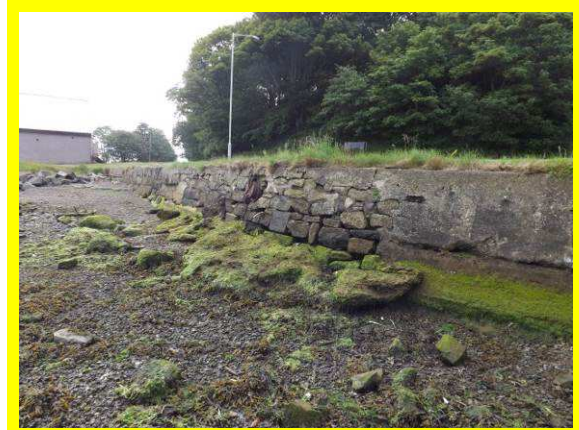
Defence lengths 121AA901A0901/ C05, and C06 comprise a section of masonry / concrete wall linking through to the Spital Pier. Previous reports highlight the main risk being the condition of the masonry and gaps between masonry. These are old structures and can only really be assessed in term of change rather than in terms of immediate condition.

In both cases there has been little change and while both structures show significant gaps and cracking, neither structure appears to have deteriorated further. Part of the upper surface of the pier has been resurfaced with tarmac improving previous concerns over surface deterioration.

901c06 in 2008 showing toe level and condition of masonry.

901c06 in 2016 showing little change compared to 2008.

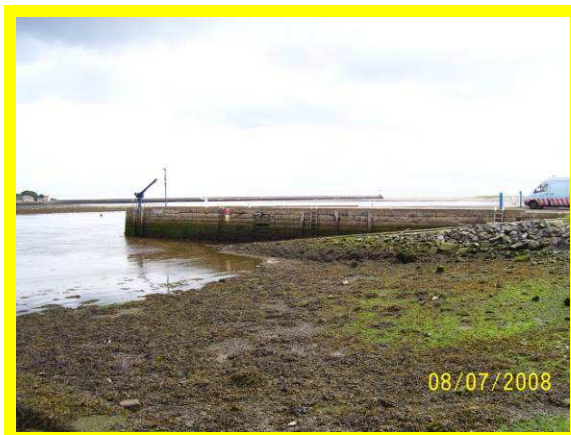
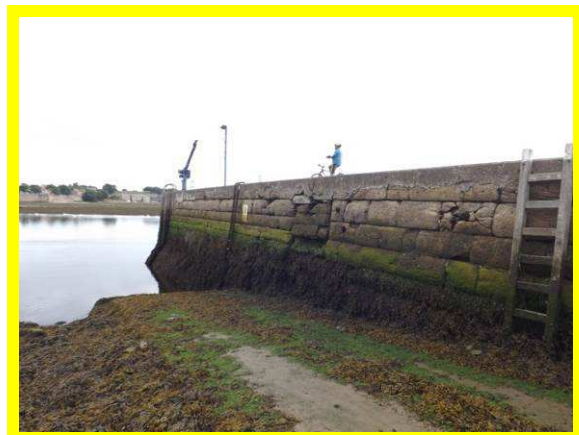
901c06 in 2008.

901c06 - 2016, Little change since 2008

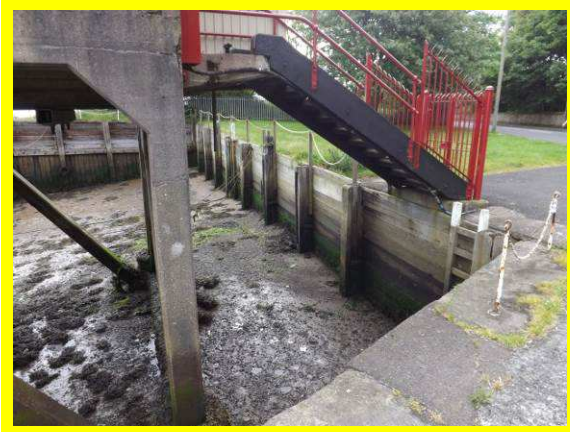
The open piled timber jetty remains in a dilapidated condition. The section behind the RNLI section is in fair condition. There appears to be some spalling of the concrete support structure to the RNLI Station and this possibly need further investigation.

901c07 no substantial change since 2014.

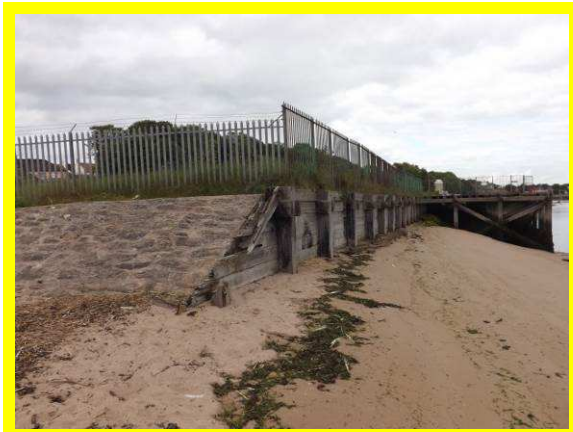
The general beach level to the eastern end of the main jetty section remains high (as identified in 2012 and 2014 compared to 2008). However, the open masonry revetment beneath the jetty continues to deteriorate. The change along this section has been linked to behaviour of Spital Point.

901c07 continuing high sand levels.

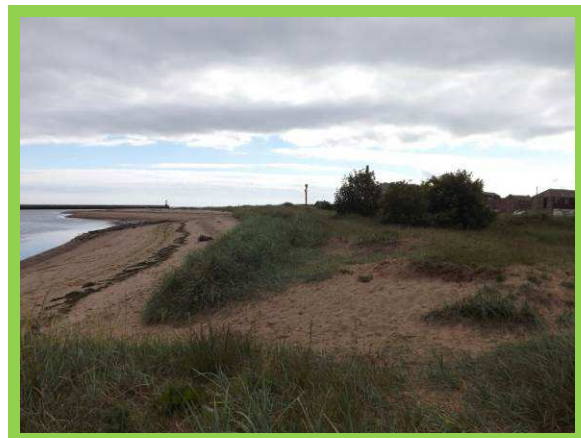
901c08 – substantial accretion 2016

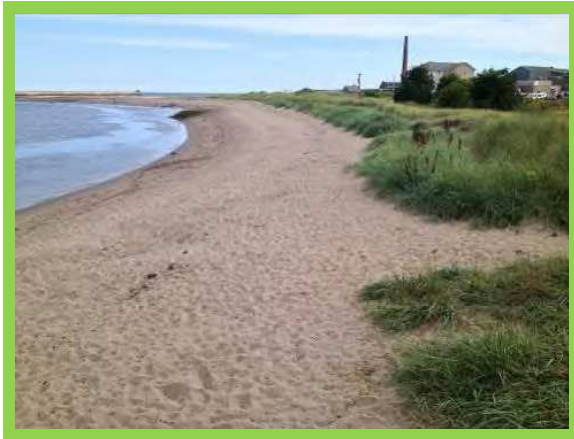
901c08 - developed front dune 2014

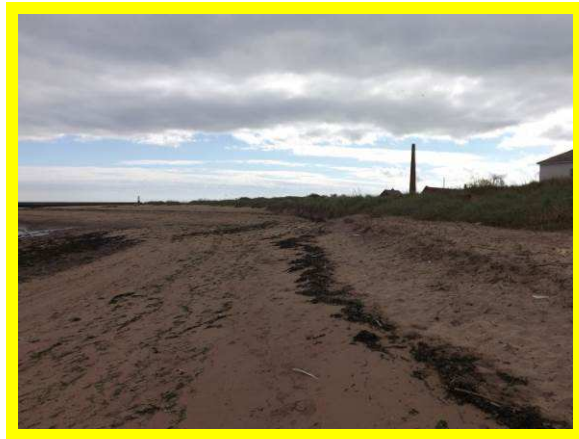
901c08 – cliffing and erosion 2016.

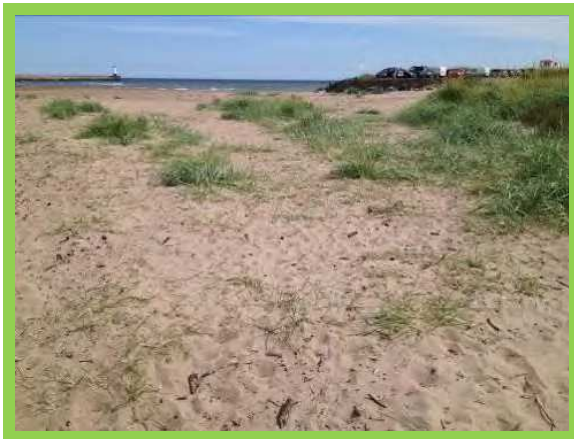
901c08 – developing embryo dune ridges 2014.

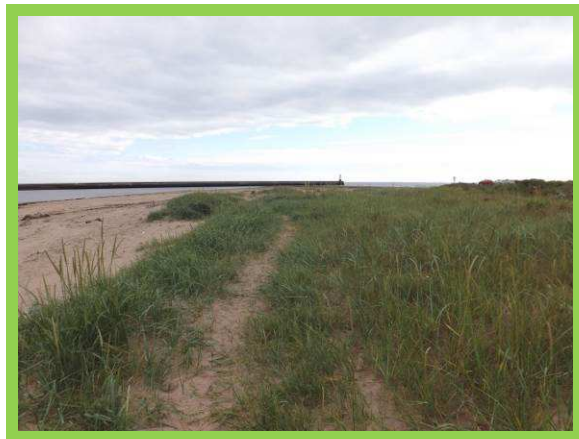
901c08 – fully developed front dune 2016.

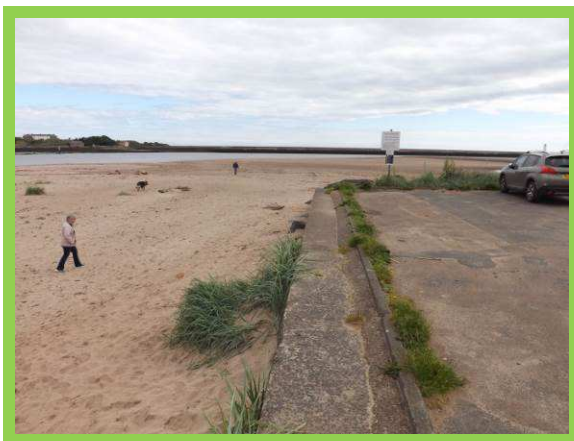
The accretion at the northern end of the dune system continues around the headland, although there are signs of cliffing of the upper beach on the open coast, demonstrating the continued variability associated with the estuary sand bar.

901c09 – high beach levels.

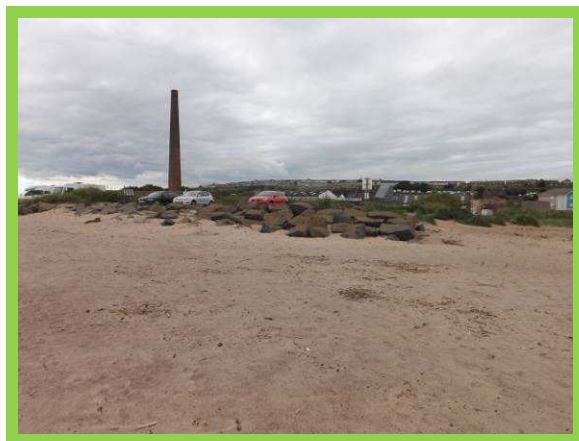
901c10 – high beach levels.

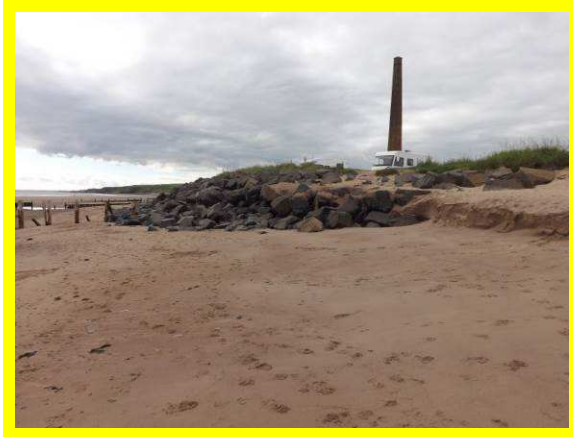
Beach levels along the northern section of the open coast 121AA901A1001/ C01 remain relatively high, there has been some erosion since 2014 but no worsening of erosion at crest (2014).

1001 c01 – Northern end, showing cliffing of beach around headland.

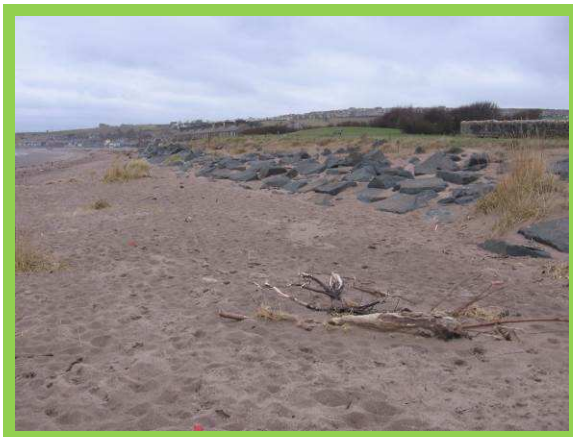
1001 c01 – 2006 showing very high beach levels.

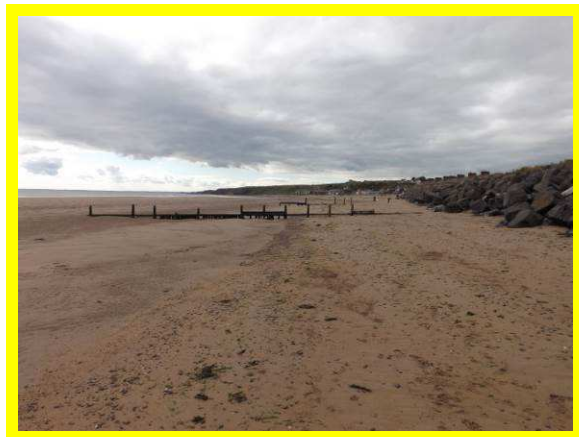
1001 c01 – 2016 showing reduced beach levels.

Beach levels and hence the pressure on this frontage was identified in the SMP as being closely associated with the position and shape of the sand bar and channels at Sandstell Point. The monitoring certainly seems to confirm this. This suggests that the frontage (and the area to the south) is dependent on broader scale change rather than purely on-going trends of beach loss.

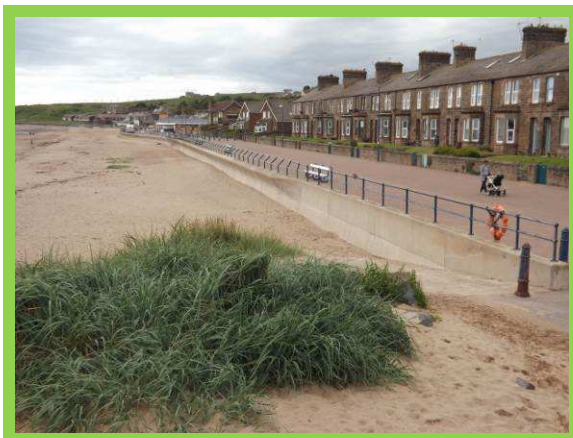
Beach levels remain high over defence length 121AA901A1001/ C02 with no deterioration from 2014.

1001 c02 – high beach levels with good crest width.

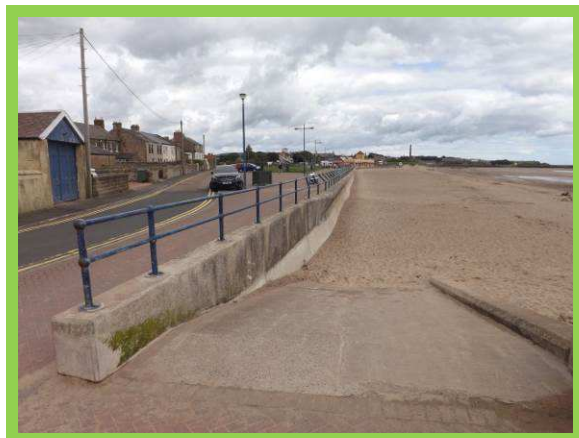
1001 c02 – high beach levels with good crest width..

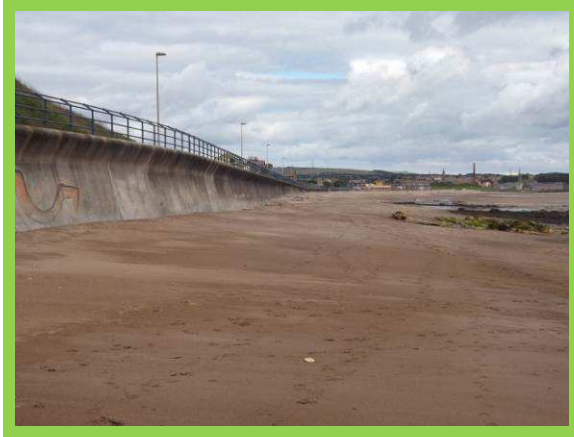
Beach levels to 121AA901A1001/ C03 remain high. The missing paving block in 2014 has not been repaired. The crack or failed repair identified in 2014 remains in the same condition. Further investigation of this shows that this crack was present in 2010 and does not appear to have deteriorated. There is significant loss of joint sealant as previously indicated but overall the defence appears in good condition.

1001 c03 – relatively high beach levels.

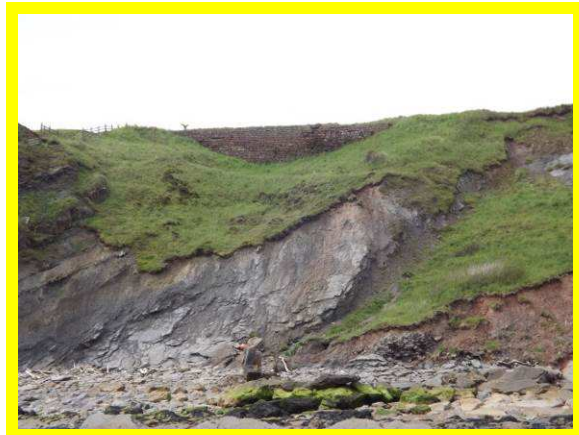
In particular, there is no obvious fresh slippage of the area below the masonry wall at the crest of the slope and no loss of fence posts further to the south. As such, although there is longer term concern for this section, in general at present the condition is assessed as fair.

No substantial change to upper slope of 1001/ C05

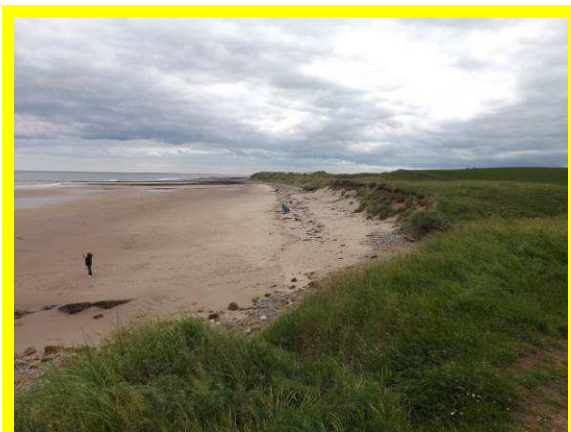
The dune frontages to the south of this section continue to erode but at the time of this inspection (2016) there is some indication that the previously eroded face has revegetated. Within the centre of the frontage there are healthy embryo dunes. To the southern end, beyond Far Skerr there is some regrowth of vegetation despite the beach being lower than 2014, re-exposing a backshore shingle bank.

1202/c01 north, continuing eroding dune edge but

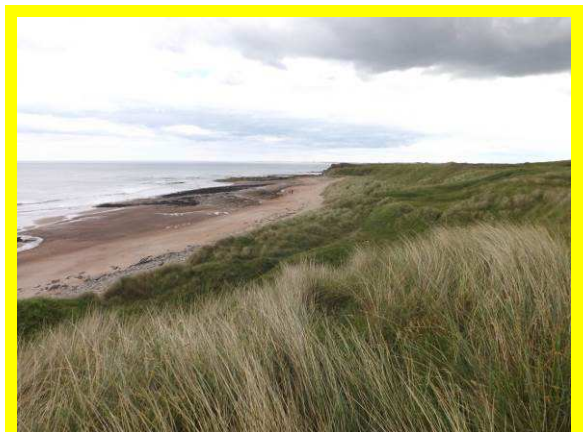
1202/c05 central to Far Skerr. Dune growth.

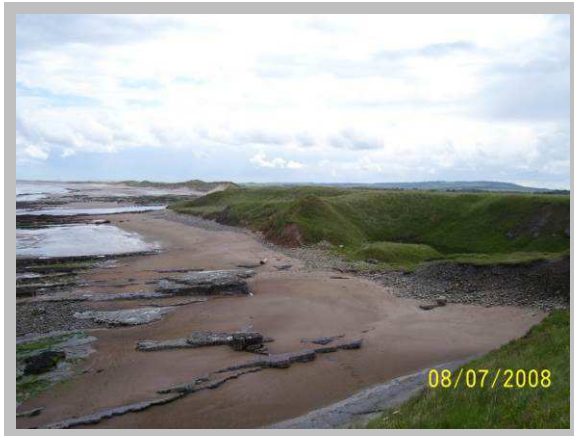
1202/c05 south of Far Skerr. 2008

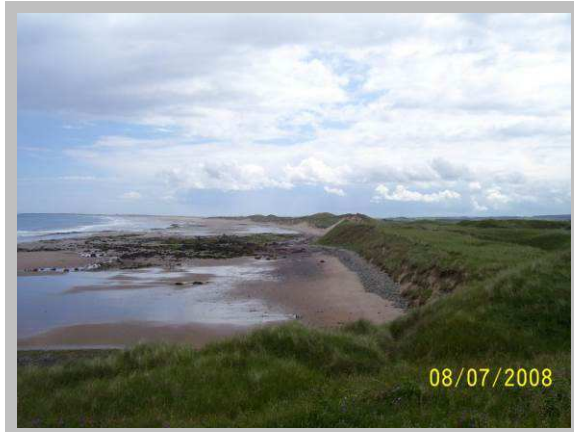
1201/ C02 – 2008 showing lower beach levels than present day.

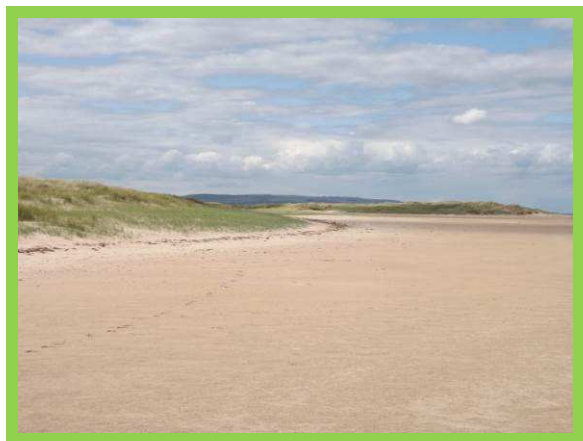
1301/ C01, 2016 at Beachcomber access showing continued dune development.

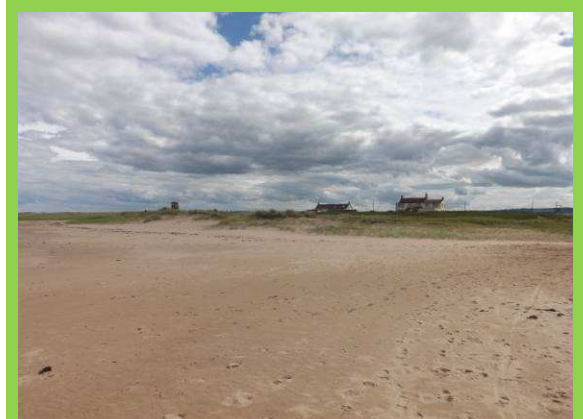
1401/ C31, 2016 north of beachcomber access

To the south of the Beachcomber access the dunes appear to have continued to develop. There has been some slight erosion over the central section of defence length 121AA901A1401C31 but in general there appears to be continuing development of the dune toe. The upper grass flats to the south potentially stop accumulation of dune growth in this area.

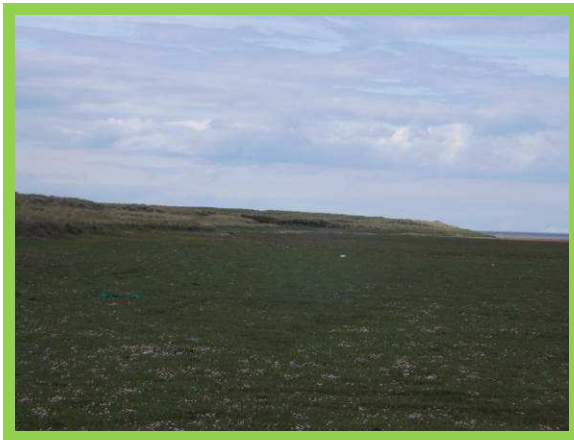
1401/C31 – grass flats potentially limiting sediment supply to dunes.

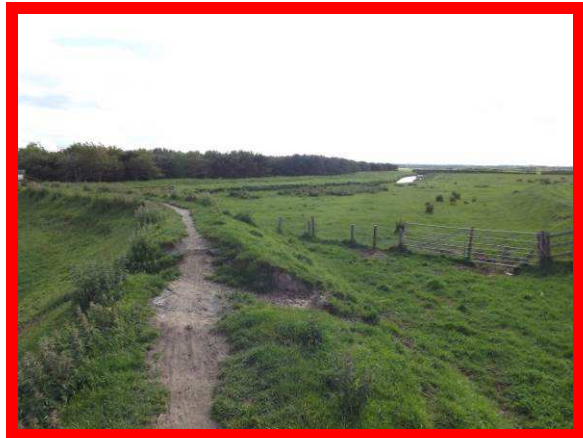
1401/ C31, Bank failure to area of South Low.

The new sluice as part of the Northumberland 4shores project allows saline intrusion to the area behind. The development of vegetation is presumably being monitored. Between the new sluice and the main Beal Sluice (121AA901A1401C01) there has been a bank failure. This needs to be reinstated.

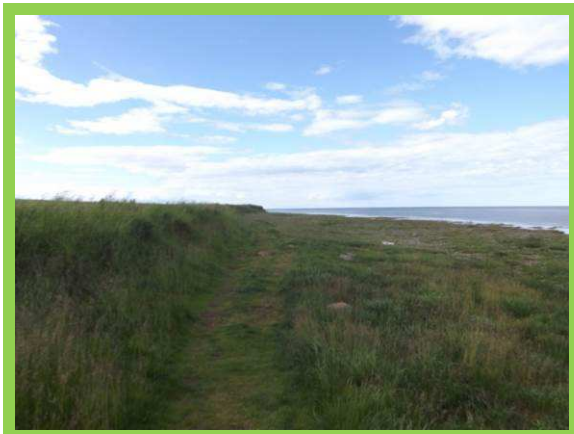
1401/C02 – Good vegetation to Beal Point .

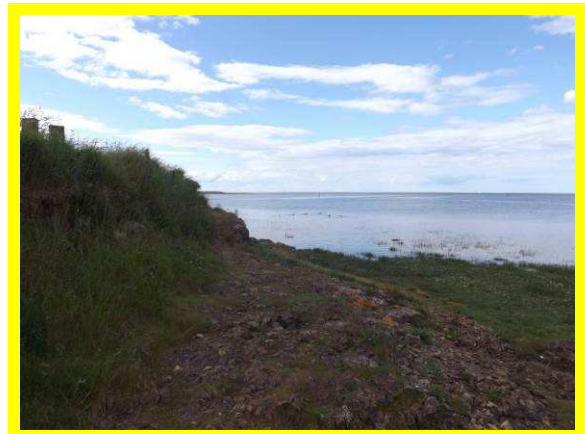
The frontage between Beal Sluice and the Holy Island causeway remains generally healthy with good vegetation growth. The coastal path, however, is tidally constrained around the headland Beal Point and there is the need to climb over the bank which is difficult.

1401/ C02, access issues around Beal Point. .

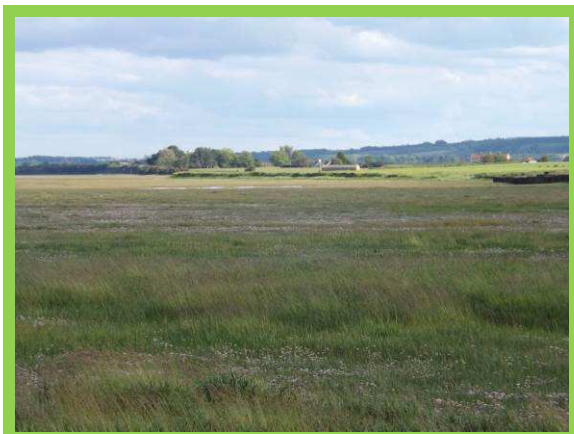
1401/C23 – wide vegetation looking from causeway.

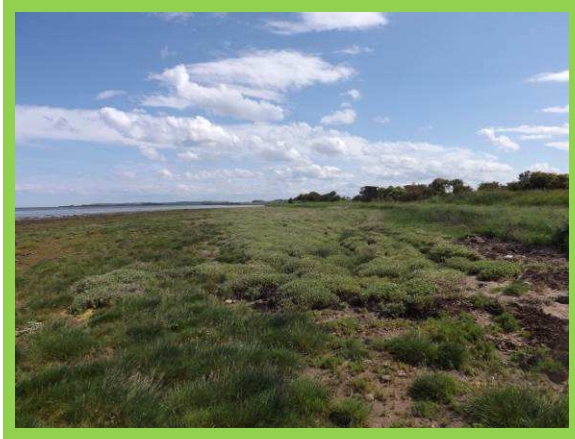
1401/C23 – relatively wide vegetation around Lowmoor.

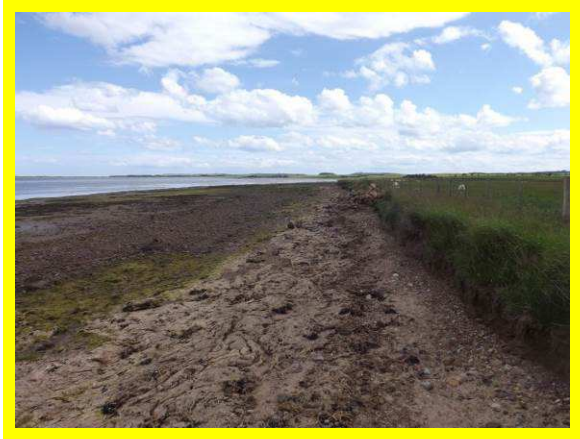
1401/ C23 Narrowing vegetation looking towards Tealhole Point.

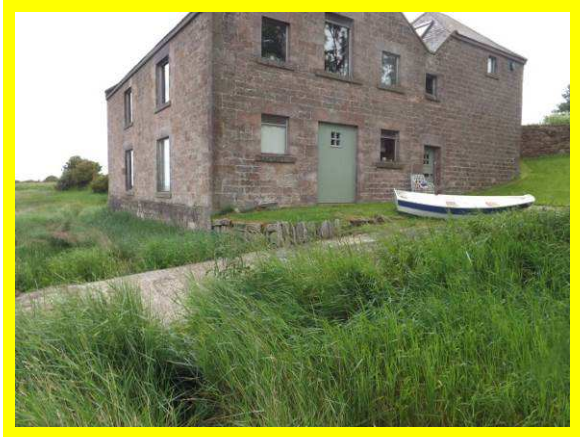
1401/ C23, Slipway.

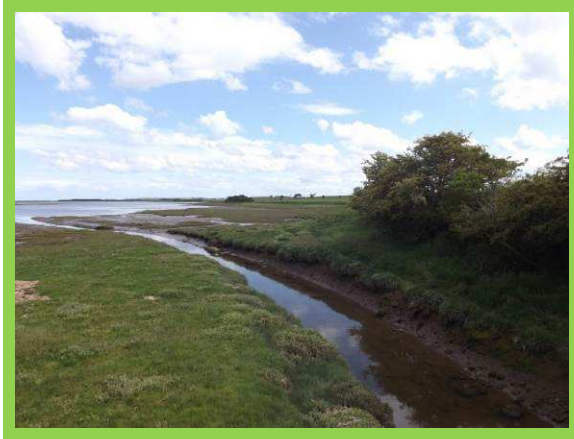
1401/C24 – Fenham Burn.

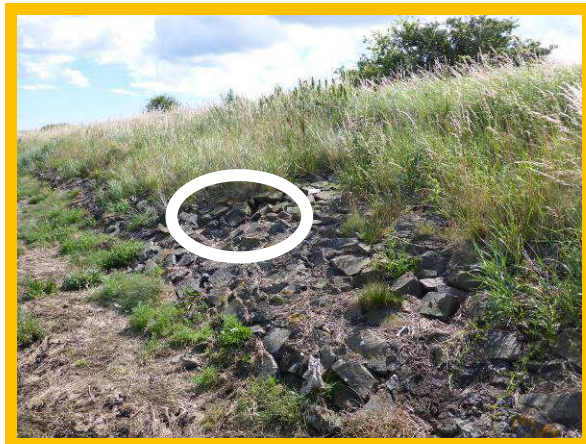
East of the bird hide at Elwick there is a flood embankment fronted by salt marsh. The embankment is protected by an asphalt and stone revetment which is generally in good condition despite being largely overgrown but locally is in poor condition where voids have opened due to loose or sunken stones. Despite this, the structure appears to continue to be effective in preventing sea flooding to a local low-lying bank of farmland across Ross. However a few areas would benefit from routine maintenance by the local landowner to infill gaps in the stones.

1401C98 – generally fair but locally poor stone-revetted embankment.

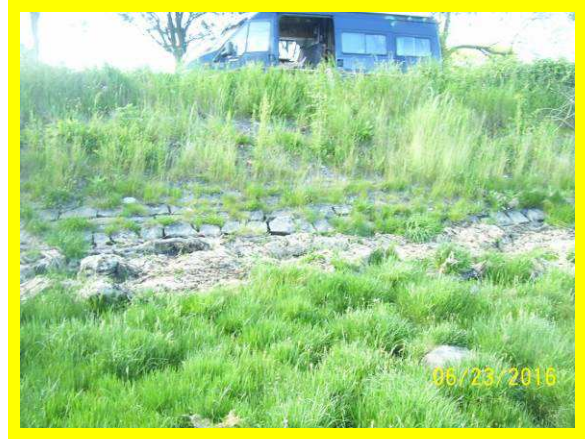
1501/C04 – gaps and local movement of stone to revetment.

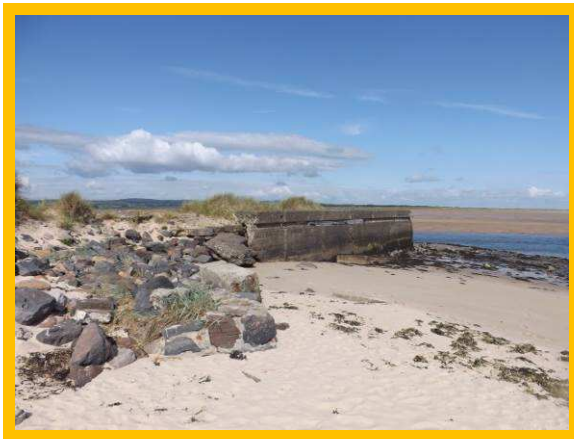
There was concern over safety with respect to the old Jetty at Heather Cottages within section 121AA901A1501C06 reported in the 2014 inspection. This has not substantially deteriorated but still might be considered a public safety hazard. There has been significant erosion to the south of the jetty, although at present this only cuts back as far as the second dune ridge shown in 2008. This is considered to be associated with the growth of the spit across Budle Bay, changing the position of the channel. The jetty does strongly influence the ability of the channel to cut further to the south.

1501/C06 – Partial collapse of northern wall to jetty

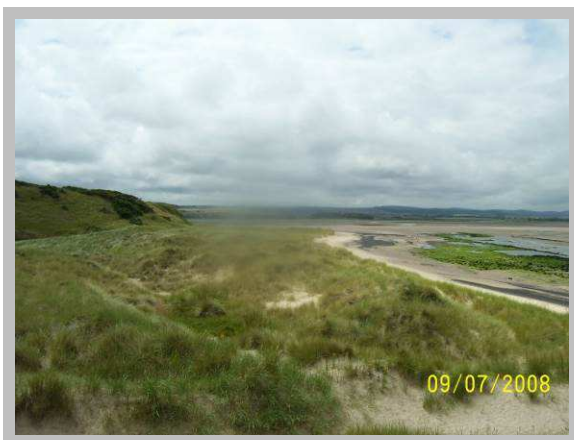
1501/C06 – 2008 major area of dune to south of jetty

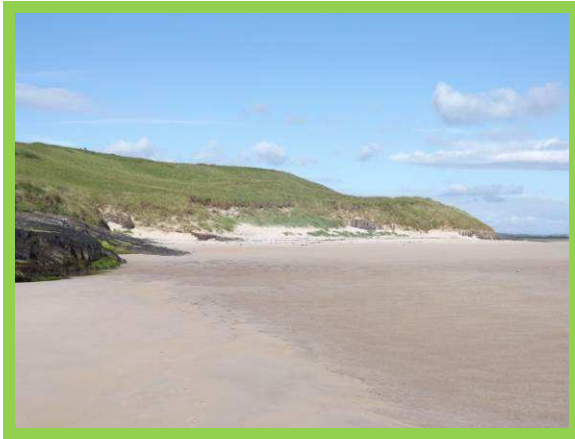
1501/C07 – areas of dune lower dune growth

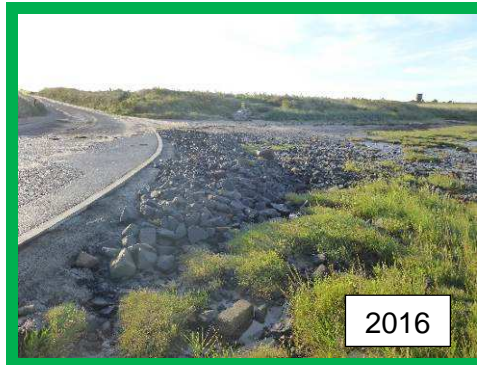
The damage to the causeway road at Chare Ends reported during the 2012 and 2014 inspections has now been repaired with resurfacing, a new kerb and adjacent stone armouring.

Repaired road surface and kerb at Chare Ends in 2016 (4901c01)

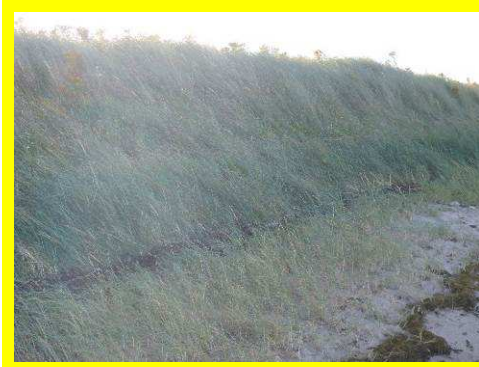
Stable dunes approaching The Basin (/4901c03).

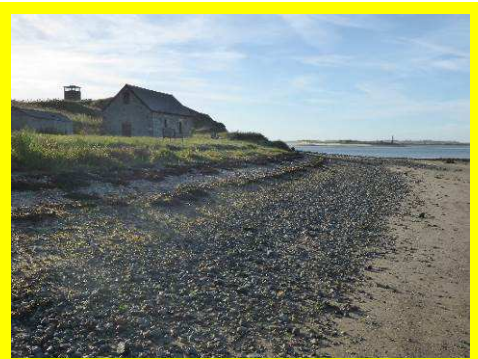
Beach in shelter of St. Cuthbert's Isle (/4901c04).

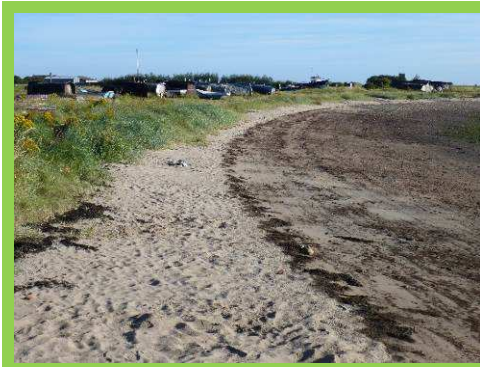
Beach within Harbour bay (The Ouse) remains sable (4901c10).

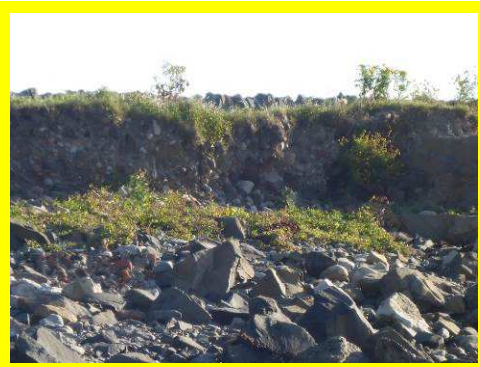
Active but localised erosion and cliffing of earth slopes around the north side of the bay (4901c11).

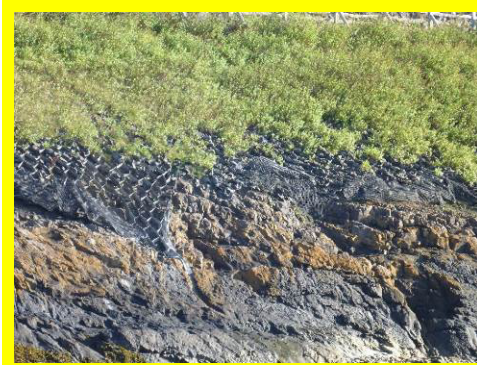
At Lindisfarne Castle, damage to the hexagonal netting and stone fill placed to stabilise the soft material covering the harder rock base below the castle does not appear to have worsened. However, this still ideally requires repair and refilling to help delay further slumps. Erosion of the upper soft earth cliffs at the east end of the erosion control matting appears to be continuing. The 2010 inspection also recommended extending the erosion control matting further east but this still needs to be undertaken.

Hexagonal erosion control matting below castle in fair condition (/4901c12).

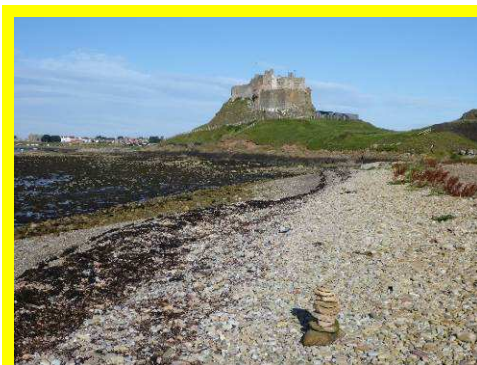
Shingle ness at Castle Point remains in a healthy condition (/4901c014)

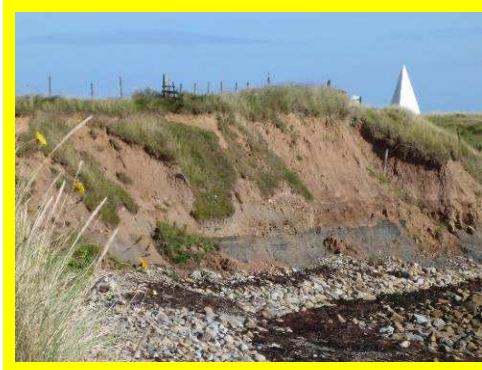
Erosion of soft cliffs remains an ongoing process (/5001c04).

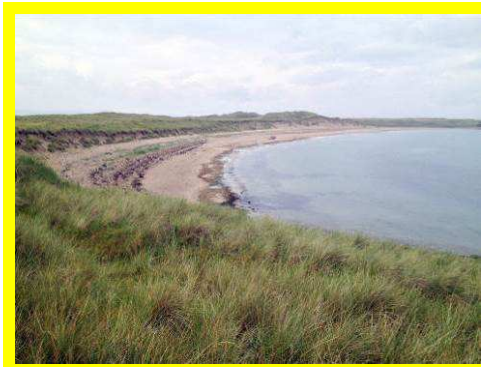
View of Sandham Bay from Emanuel Head (/5001c06).

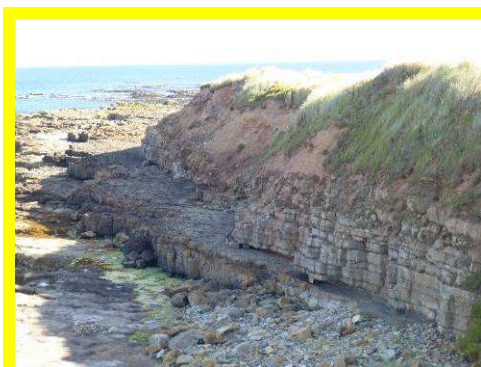
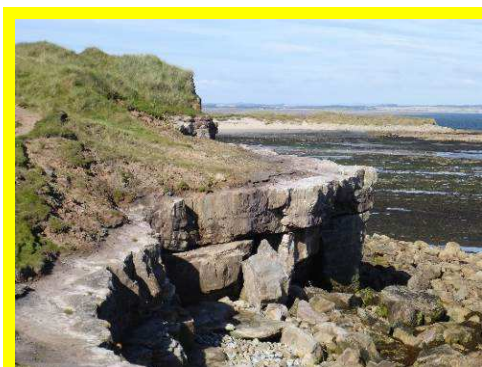
There is continued evidence of local rockfalls along with erosion and cliffing of the softer material in the cliffs at Nessend. However this is localised and does not represent significant concern.

Locally active cliffs at Nessend (/5001c07).

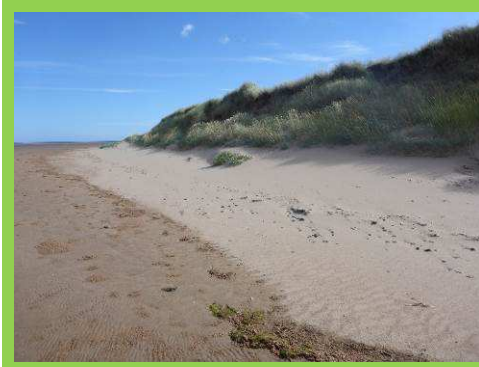
*Well vegetated dunes at Snook Point
(/5001c10).*

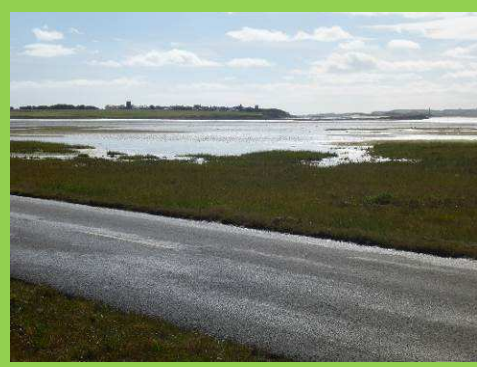
*Causeway road and salt marsh
(/5001c011).*

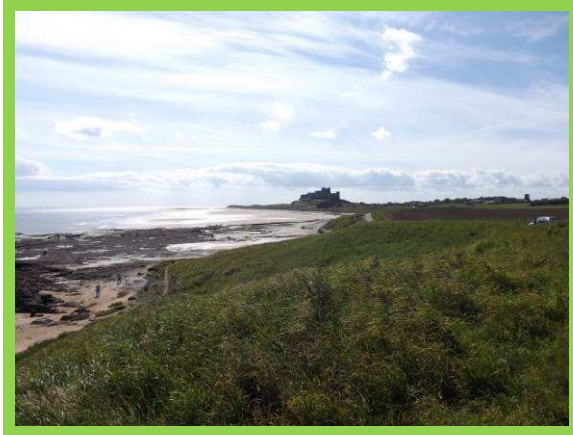
Despite relatively low foreshore levels, evidenced by exposure of the rock platform, there has been little evidence of significant erosion of the dune /coastal slope north of Bamburgh compared to 2014.

General view showing exposed rock platform north of Bamburgh.

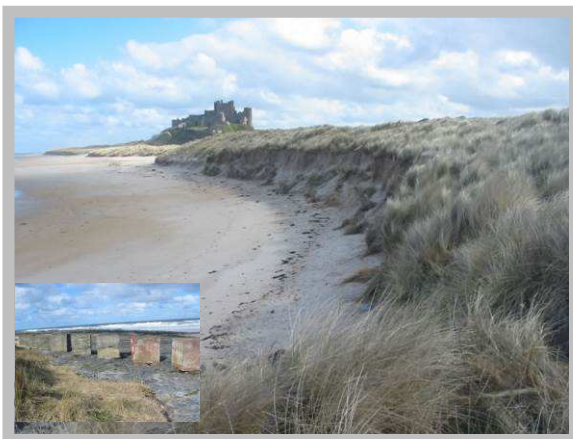
“The Dice” provide a useful reference point for this frontage and as shown below highlight: the steep cliffing in 2006, the slight growth of the dune immediately to the Dice in 2008, slight improvement generally to the dunes in 2010 and the significant growth of embryo dunes behind and to the south of the Dice in 2016.

View of the dune at “the Dice” 2006

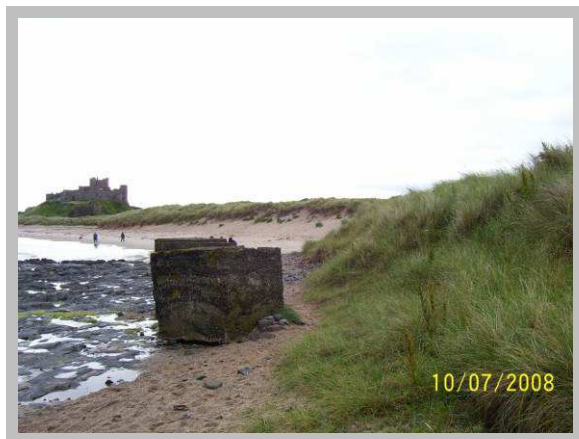
View of the dunes at “the Dice” 2008

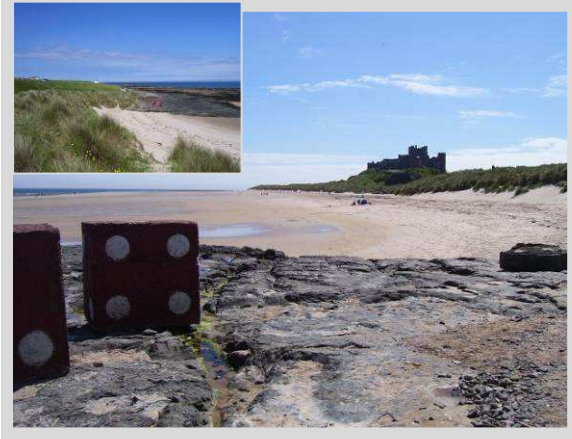
View at "the Dice" 2010.

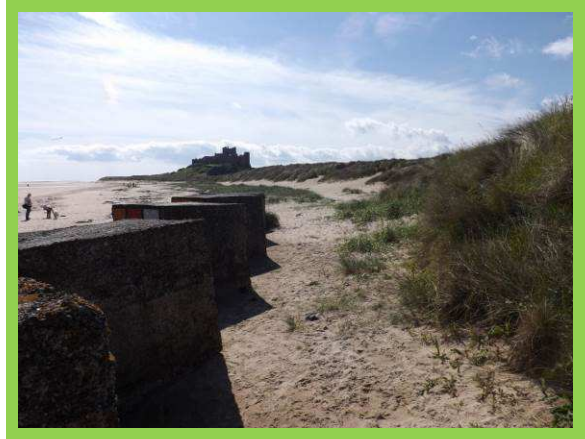
View at "the Dice" 2016, 1601/ C05

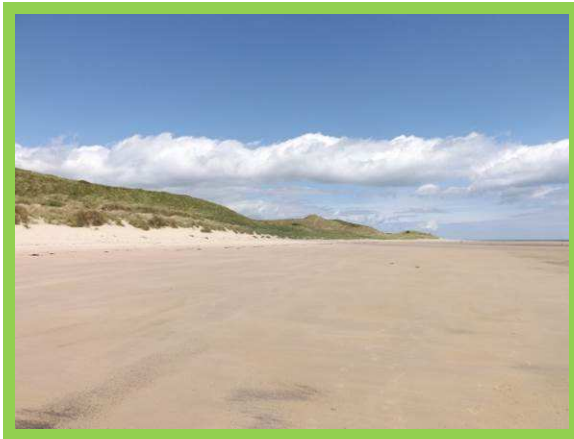
Beyond Islestone Rocks, the dune systems show a trend of recovery with in some areas build-up of sand at the toe of the dune and embryo dune development in other areas.

General improvement in dune toe 1601/ C02.

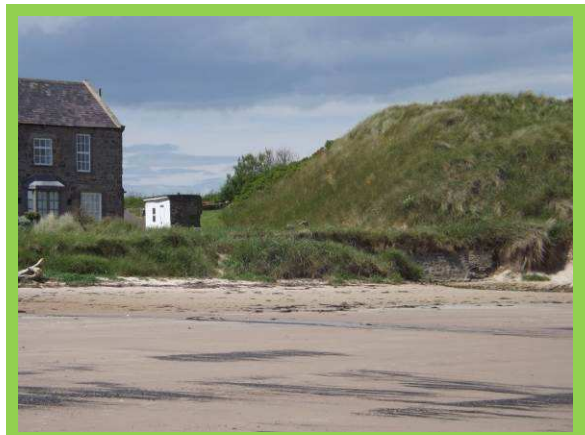
Embryo dune growth in front of Monk's House 1601/ C03

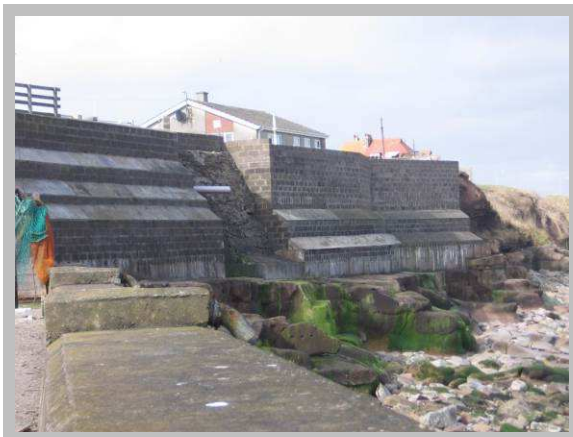
1701/C02 to 04 - 2006

The defences immediately to the north of Seahouses harbour (121AA901A1701C02 to C04) remain in fair condition. Some minor damage has occurred since 2006 as shown below.

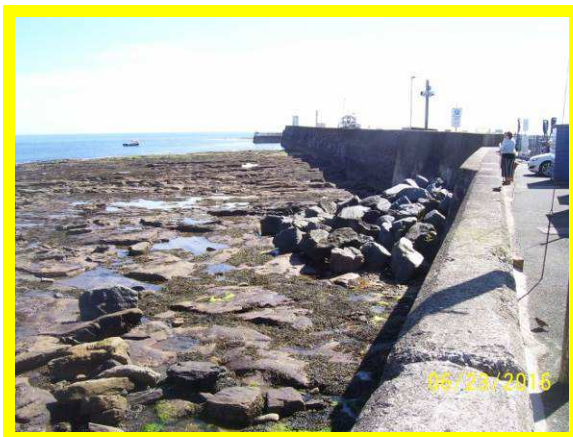
There has possibly been some further flattening of the wave reduction rock feature. However, this may be achieving stability. The need for any improvement should be reviewed against whether the structure still reduces wave impact.

Rock armour wave reduction 1701/C06 – C07

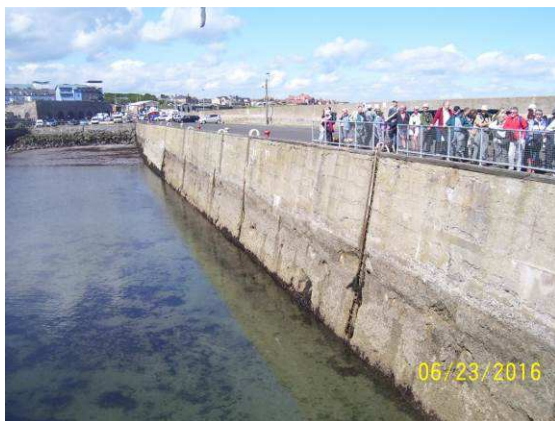
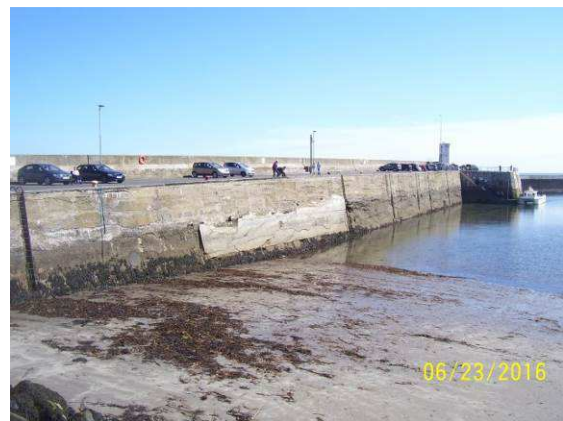
No obvious worsening of abrasion areas 1701/C09

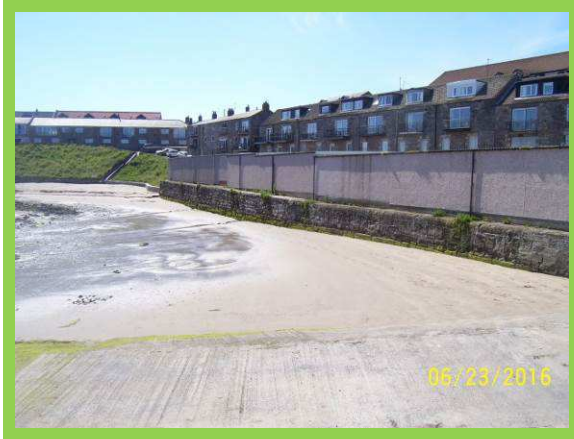
1701/C15 Good condition

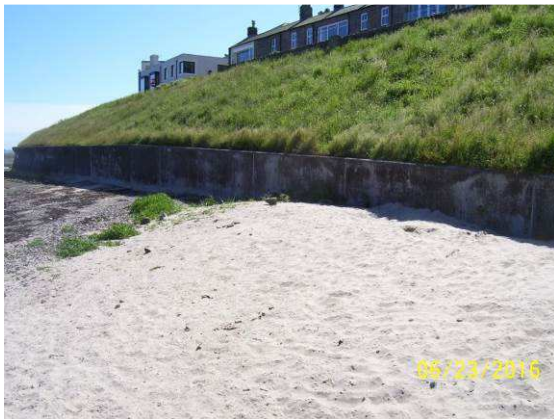
1701/C17 Good condition

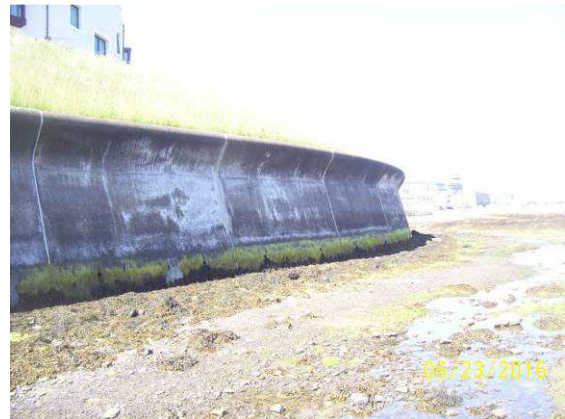
1701/C18 Good condition

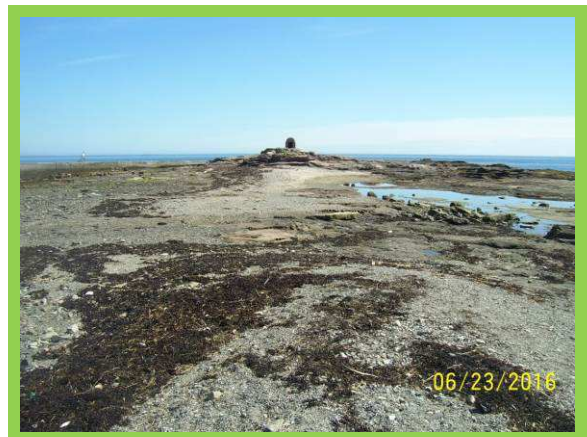
1701/C19 ridge to back of harbour.

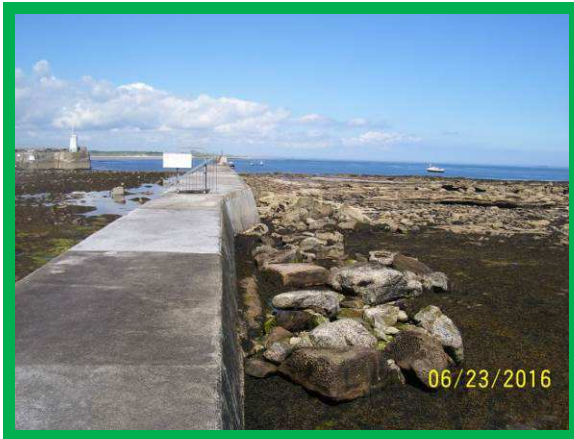
The Outer Breakwater was reinforced and encased in 2008. This structure has suffered no significant damage and remains in good condition.

1701/C20 No signs of damage

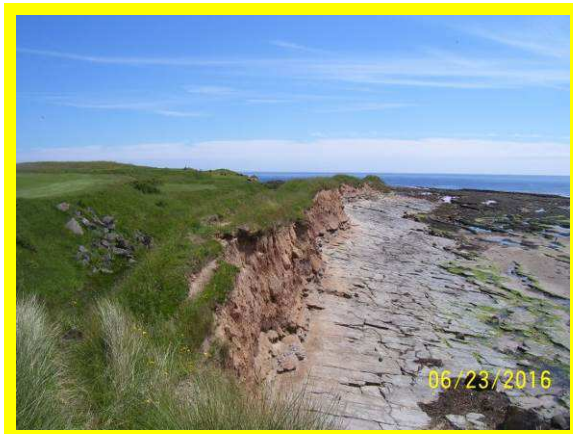
Beyond North Sunderland Point erosion continues to the thin boulder clay ridge, running along the seaward face of the golf course to the Annstead Burn. Access along the ridge has been closed off and the ridge is no longer possible. There is limited erosion to the north bank of the Annstead Burn but also areas where the toe to the dune has recovered. This poses no significant risk.

1701/C23 Narrowing ridge

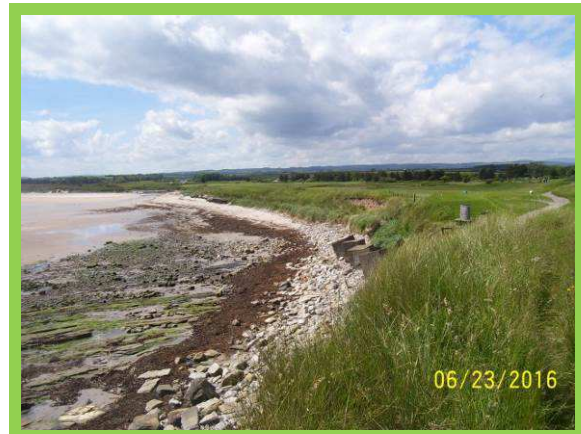
1701/C23 limited erosion to golf course

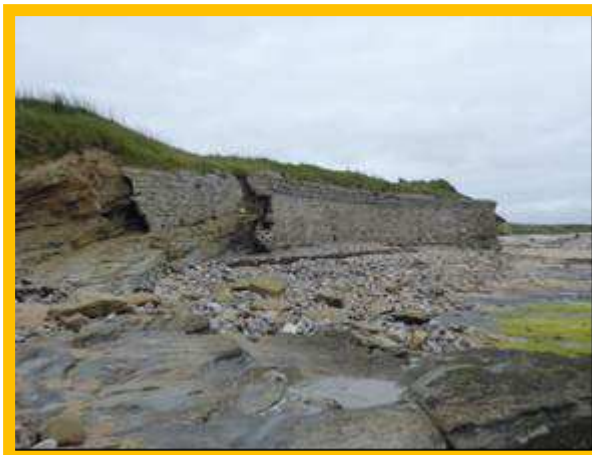
The masonry and concrete seawalls to the north of Dell Point (Red Brae) are generally in fair condition with some cracks and loss of mortar evident, but the outflanking issues warrant a poor overall classification. The soft earth cliffs around Dell Point (Red Brae) have previously experienced erosion along most of their length but presently have not significantly deteriorated. The concrete seawall fronting the property at the north end of the main Beadnell North bay is in good condition with only minor signs of cracking and rust staining.

Poor overall classification of walls north of Dell Point (/1701C25)

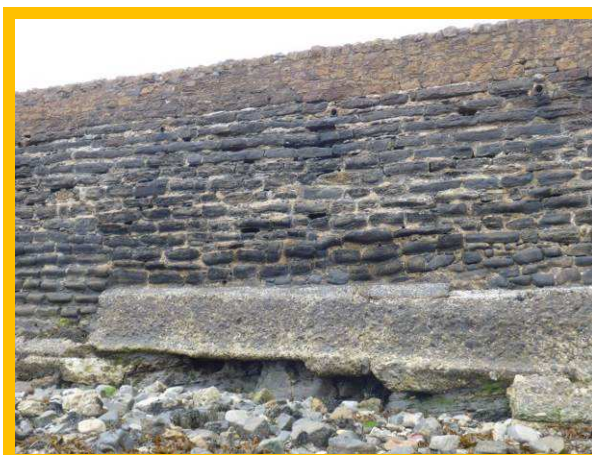
The various masonry seawalls at Nacker's Hole remain generally in poor condition with significant abrasion and gaps between blocks. In one area missing blocks has resulted in a sizable void. Undermining and voids are prevalent along much of the length. There appears no overtopping damage since the previous repairs c2011. It is recommended that the improvement works proposed in the Beadnell North PAR (also covering Lady's Hole) be implemented as soon as funding becomes available to prevent failure of this seawall.

Undermining of seawall at Beadnell North (Nacker's Hole) (/1701C36)

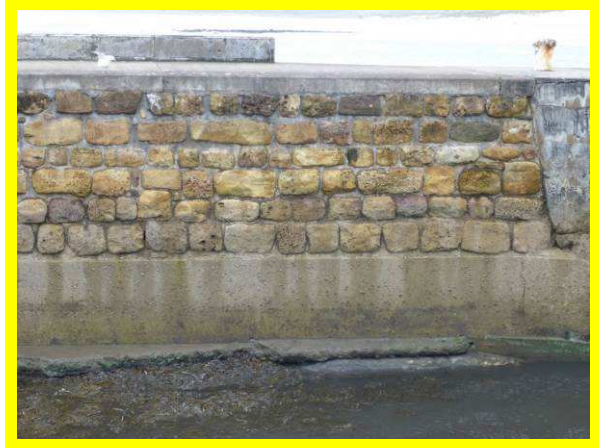
Undermining of Beadnell Harbour wall (inner face of southern wall) (/1701C51)

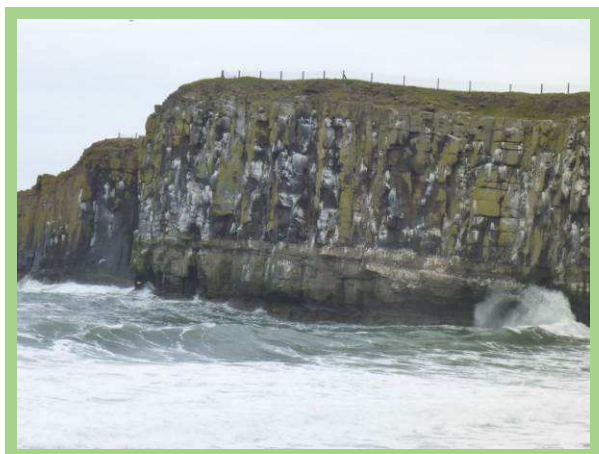
Hard rock cliffs at Castle Point (/2001C05)

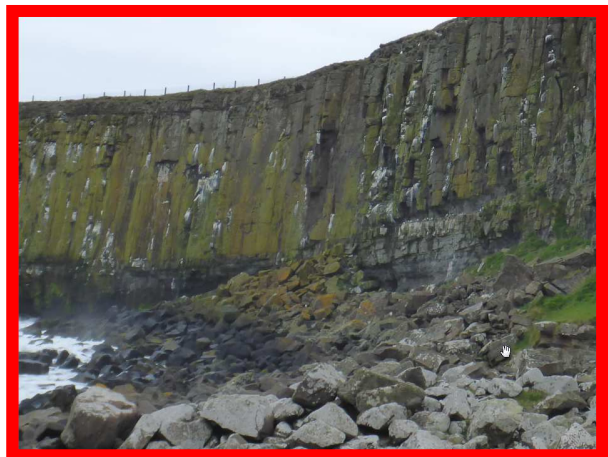
The hard rock cliffs at Dunstanburgh Castle are highly stable, aside from one local area of rockfall.

Localised rock fall at Castle Point (/2001C05)

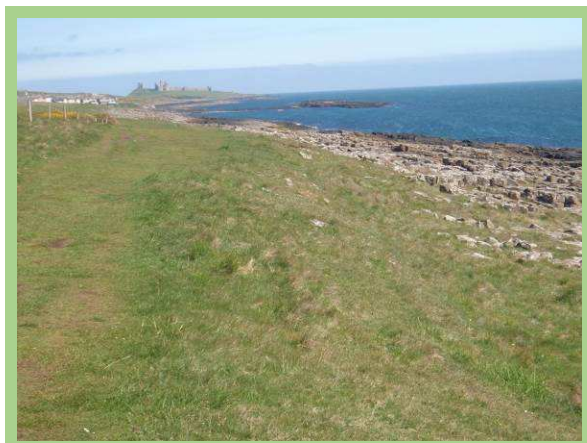
Stable gentle slopes and rocky foreshore south of Dunstanburgh Castle (/2101C02)

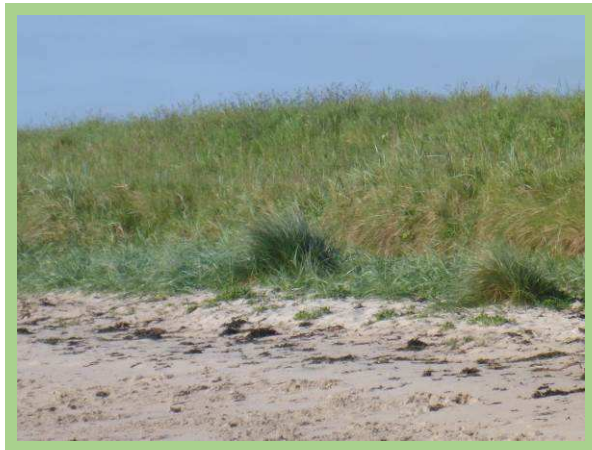
The dunes and low vegetated coastal slopes at Boulmer Haven are in good condition with accretion and embryo vegetation, but around Seaton Point the dunes reduce to generally fair condition due to some localised slumping.

Stable dunes around Boulmer Haven (/2601C06)
