Cell 1 Regional Coastal Monitoring Programme Walkover Inspection Surveys 2016

Northumberland County Council

Walkover Inspection Surveys 2016

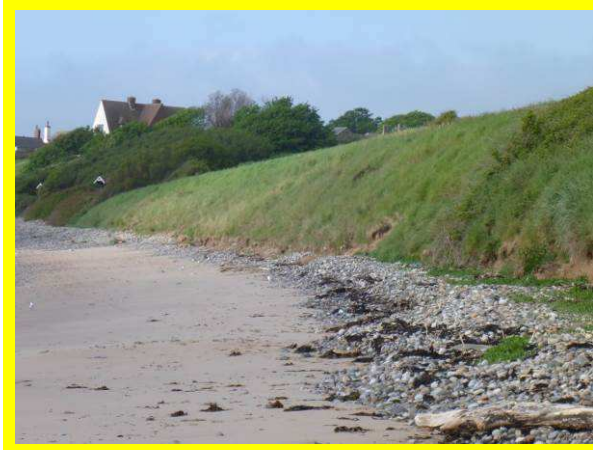
At Foxtton Hall, the eroding cliffs reduce to stable and well vegetated earth slopes that are protected by a shingle and cobble berm. In front of the properties there is localised timber breastwork. Remnants of an earlier concrete structure remain on the shore.

Stable and well vegetated slopes near Foxton Hall (/2701C02)

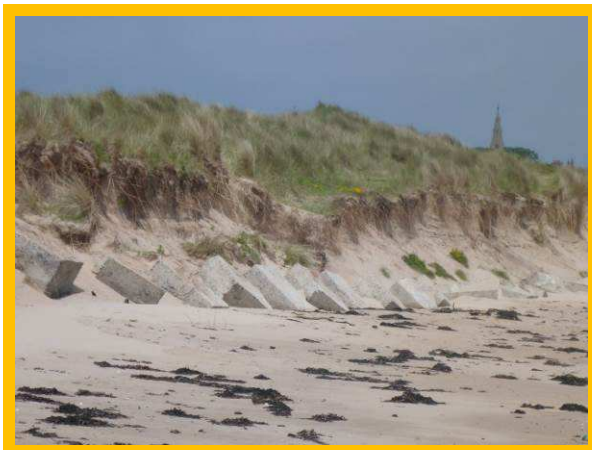
The high dunes along the south bank of the River Aln and further south towards Birling Carrs are in variable condition. There is slumping along dunes at the channel edge of the Aln estuary (including one location where a mature tree will be lost imminently to erosion) but some stable or accreting dunes further south as they extend round to the main coastal frontage. However the first 50m or so south of the estuary, the erosion is quite notable and concrete blocks have been placed in attempt to arrest this. For a further 150m the erosion continues, but is less severe, and then the dunes become considerably more stable to Birling Carrs.

Eroding dunes at northern end of Birling Carrs frontage (/2901C01)

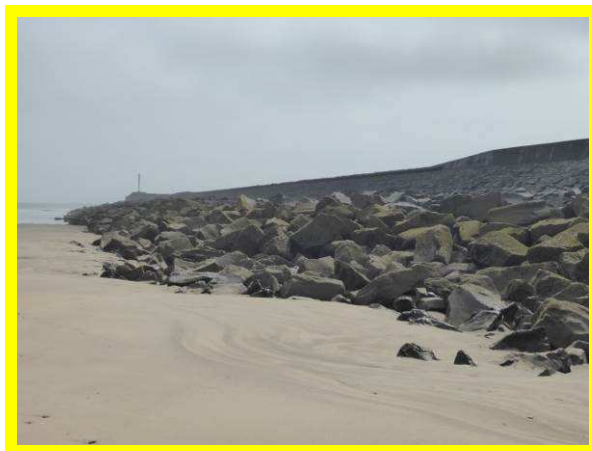
The large armourstones along the exposed north face of the North Pier continue to appear in fair condition. The masonry blockwork at the seaward end is also in fair condition with no obvious gaps or cracks. The revetment on the south face of the Pier is also in fair condition as is the concrete deck. However, the seaward end of the North Pier remains in very poor condition with extensive abrasion of the concrete and a missing section of deck. The large crack (~1m wide) and rotation of the tip of the pier identified during the previous inspections is still a cause of concern although no further movement appears to have occurred. It is understood that this crack and rotation occurred in the end of the structure soon after its construction. Although not formally defined as a coastal defence asset, the North Jetty is in a largely dilapidated condition.

Rock armourstones on north face of North Pier (/3001C01)

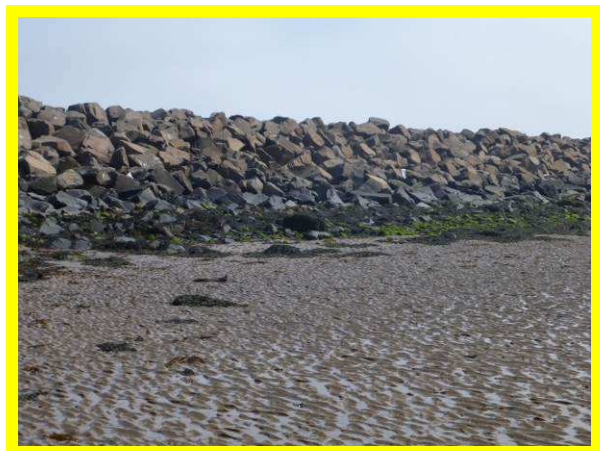
Rock armourstones on south face of North Pier (/3001C03)

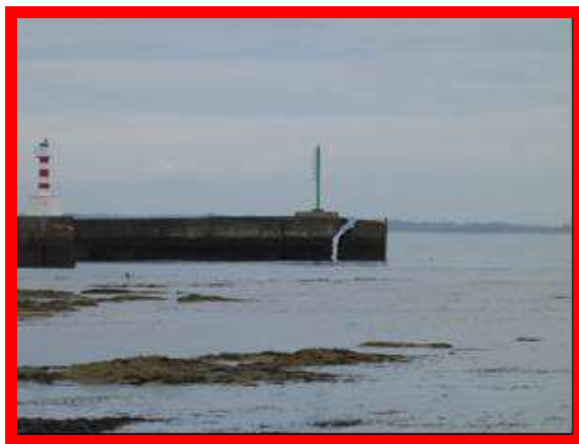
Seaward end of North Pier in very poor condition (/3001C02)

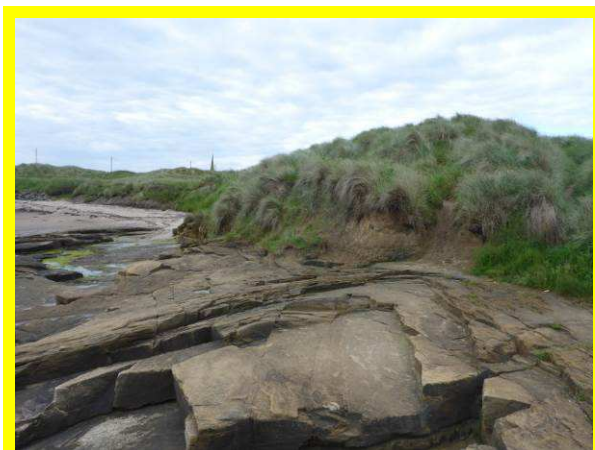
The earth slopes and dunes along Amble Links (/3101C06) have previously been reported as showing signs of erosion, with cliffing along much of the frontage. However, at the time of the present inspections the earth slopes and dunes appeared generally stable with only local areas of very minor slumping. Rock armourstone has been placed at the centre of the embayment and adjacent to the seawall at the south end.

Dunes and low slopes above rock ledge (/3101C06)

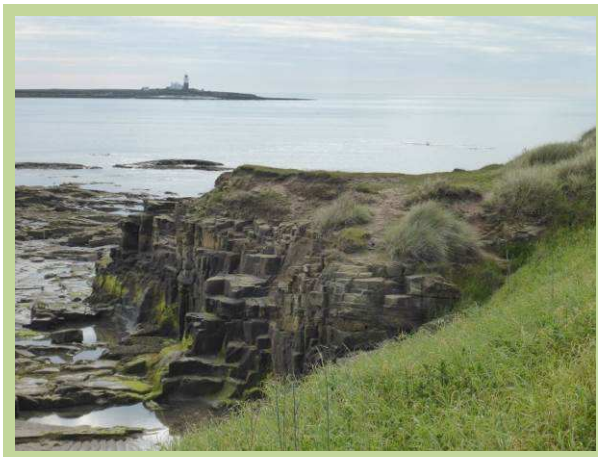
The rocky cliffed headland around Wellhaugh Point (/3101C11) is stable and protected by a wide rock shore platform. As the cliffs blend into low dunes, a rock ledge is present at the base and the frontage remains relatively stable. In one location a set of timber steps has been provided to enable access to the foreshore through the low dunes.

Cliffed headland around Wellhaugh Point (/3101C11)

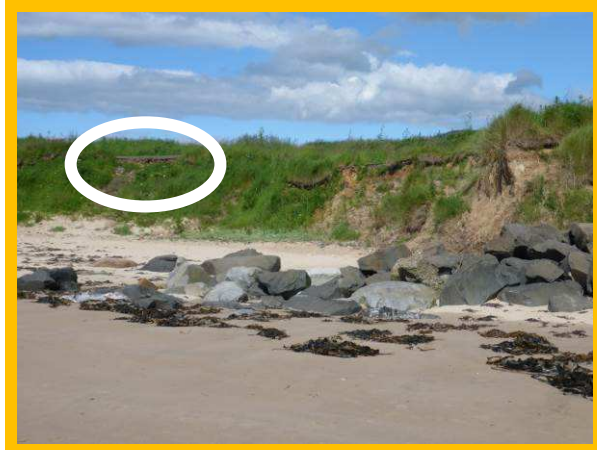
The large structure at the outfall to Ladyburn Lake remains in good condition. The adjacent slipway belonging to the Hadston Scaurs Boat Club remains in fair condition, as does its protective rock revetment. However, the revetment continues to be actively outflanked at the northern end resulting in unravelling of the structure with some rocks displaced across the foreshore and severe cut-back terminal erosion of the low vegetated earth cliffs to the south. These cliffs are in poor condition with recent erosion impinging on the flanks of the road carriageway.

Erosion of low cliffs (/3201C14) at terminal end of rock revetment

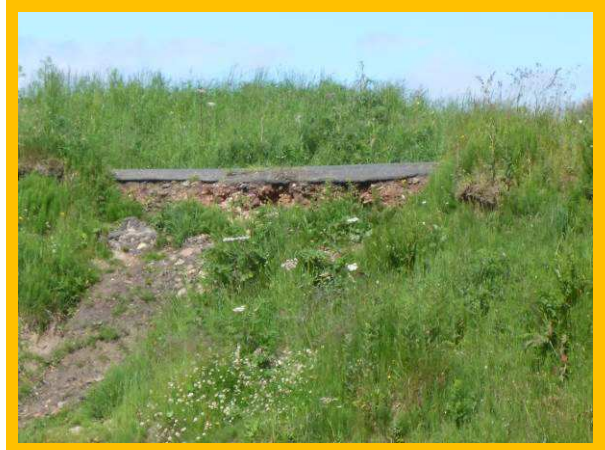
Erosion of low cliffs exposing carriage way of access road (/3201C14)

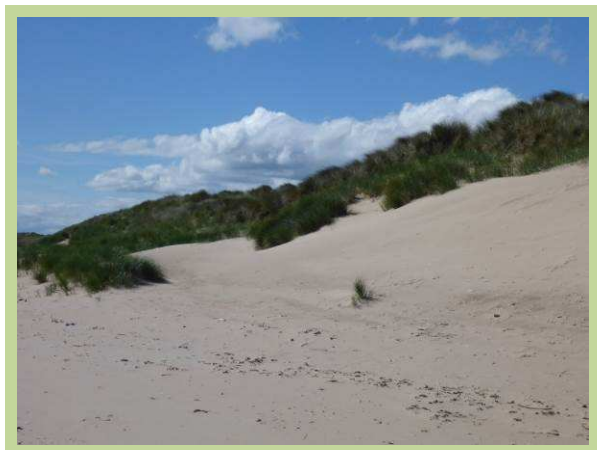
Around 100m south of the rock revetment, the wide vegetated dunes become less active and are protected by a cobble berm along the toe. Where the berm ends the protection is provided instead by concrete blocks. Generally throughout Druridge Bay, the dunes were stable and healthy at the time of the inspections and upper beach levels were notably high and wide. Towards the south of the beach there are outfall pipes in two different locations which have collapsed but are still discharging. It is notable that several of the natural discharge outlets were running dry at the time of the inspections.

Healthy dunes in Druridge Bay (/3201C15 & C16)

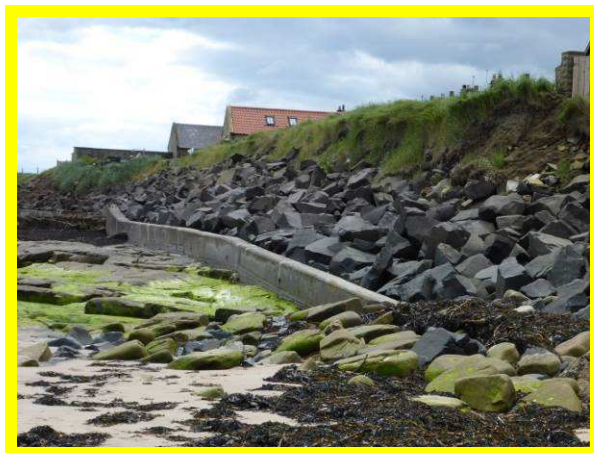
The revetment in the lee of the Scars blends into a low concrete wall built at the back of the rocky foreshore with rock armour continuing behind the wall to protect the vegetated earth cliffs. The wall is generally well founded on the rock foreshore and in fair condition with minor cracking and staining. However, there are local areas of more significant defects such as undermining, crest abrasion and break-up of some of the numerous previous patch repairs. The earth face along the upper slope continues to show signs of ongoing slumping.

Low concrete wall and rock revetment at Cresswell (/3201C18)

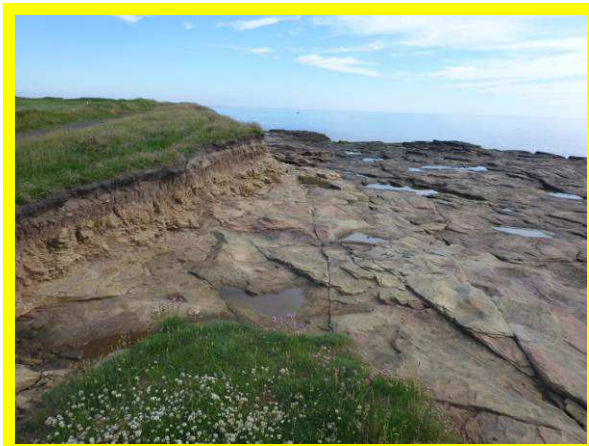
The cliffs leading around the headland to Beacon Point comprise of a hard rock base and a thin overlying layer of softer material. The typical tendency is for small-scale rock falls and occasional local slumps in the soft material but this was not prevalent at the time of the inspections and the cliffs were relatively stable. Further around Beacon Point the previous slumps in the upper cliff have cut the cliff top back to the footpath in a number of areas although there is sufficient space to realign the path landwards should this be necessary and at present there appear to be no recent episodes of failure. The cliffs here are fronted by an extensive rock ledge and therefore the recession rates are low and the events are highly localised.

Currently stable cliffs around Beacon Point (/3501C03)

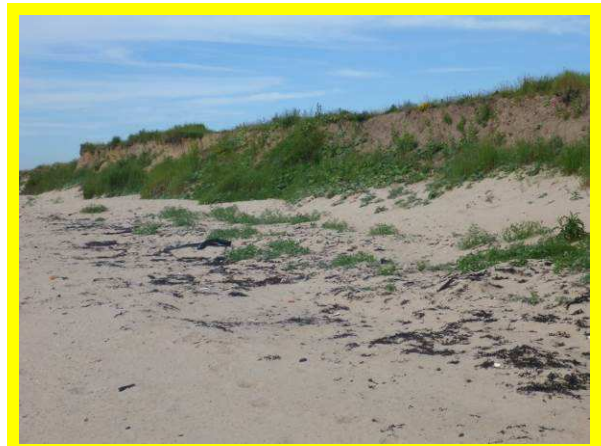
At Newbiggin Moor, within the shallow bay fronting the golf course, the cliffs are unprotected by rock platform and have no rock base. At present, the cliffs are recovering from historic erosion which has occurred, with sand accumulation and embryo dune vegetation growth at the toe.

Recovering cliffs/dunes at Newbiggin Moor golf course (/3501C04)

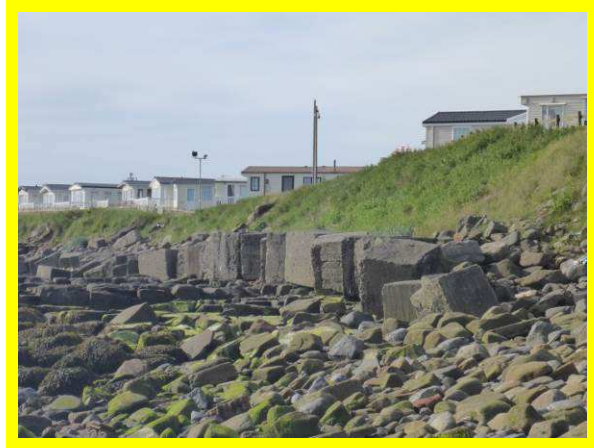
In both the central and southern sections, rubble has been tipped down the cliff face.

More stable central section fronting caravan park (/3501C06)

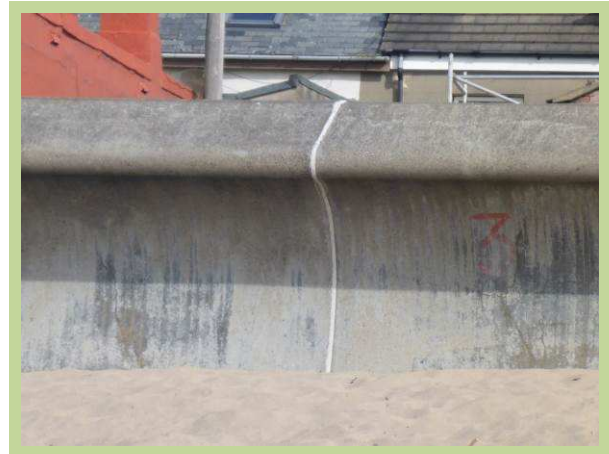
The high recurved seawall and promenade at the centre of the bay are in good condition. High beach levels mean the lower stepped seawall and piled toe which was previously identified as being vulnerable to erosion and undermining was completely buried. All joints appear well sealed.

High beach levels and well-sealed joints in central sections of Newbiggin Bay (/3601C07)

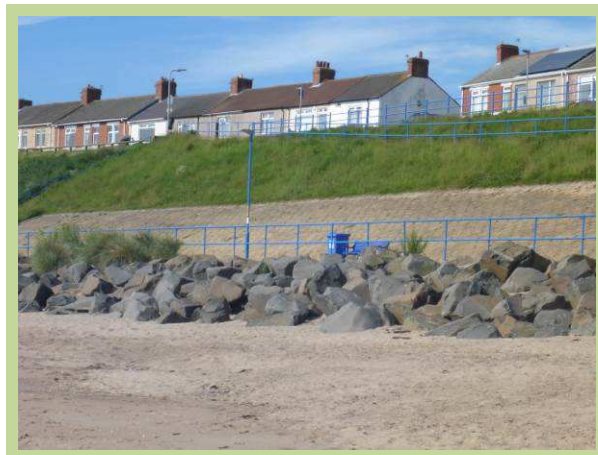
High beach levels fronting rock revetment (/3601C08)

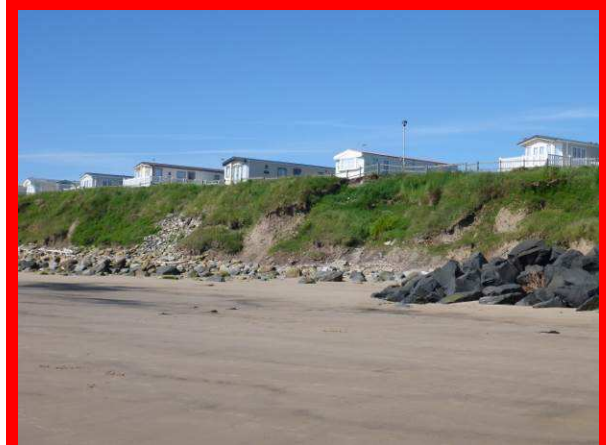
Erosion recommences to immediate south of rock berms (/3701C03)

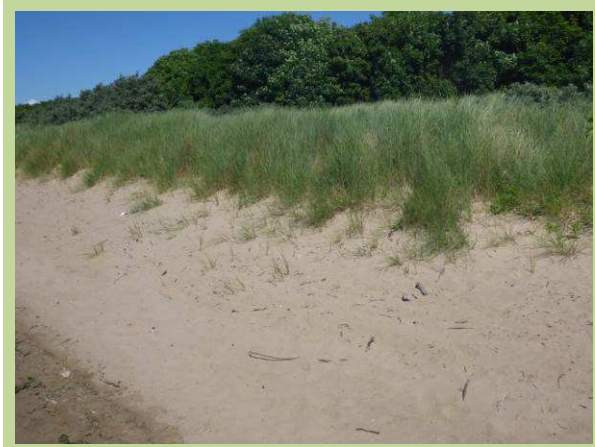
The undefended section of cliff within the estuary mouth is very stable with no visible signs of erosion or slippage and with the face being densely vegetated. Progressing from the sheltered estuarine frontage with its stable cliffs to the more active open coastline of Cambois Bay there is a transitional section of cliff fronting Cambois House. These cliffs are in poor condition with slips along the entire frontage and more significant erosion and cliffing of the upper slope further south. Whilst episodes of erosion have happened historically, there does not seem to be significant worsening since the last inspection. North of the access ramp the rock armour and some dumped concrete rubble continues to partially stabilise the outflanking problem of the ramp.

Stable dunes within estuary mouth (/3801C02)

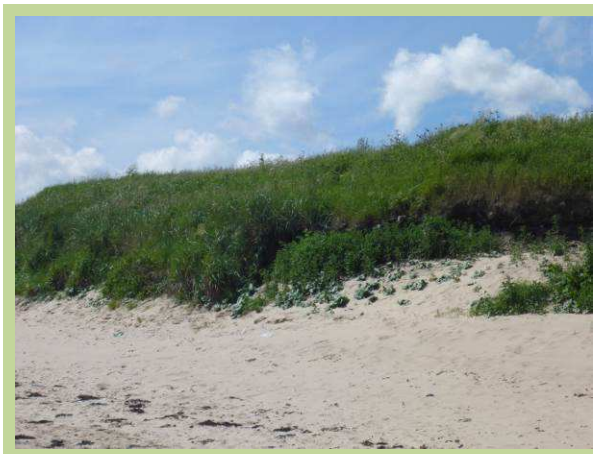
Further south of the zone of terminal erosion, there are wide, stable and well vegetated dunes. These appear to have suffered a previous erosion episode leading to cliffing, but subsequently are experiencing accretion of sand and growth of embryo dune vegetation. A set of timber access steps constructed in 2012 adjacent to the southern car park remains in good condition.

Stable and well vegetated dunes (/3901C04)

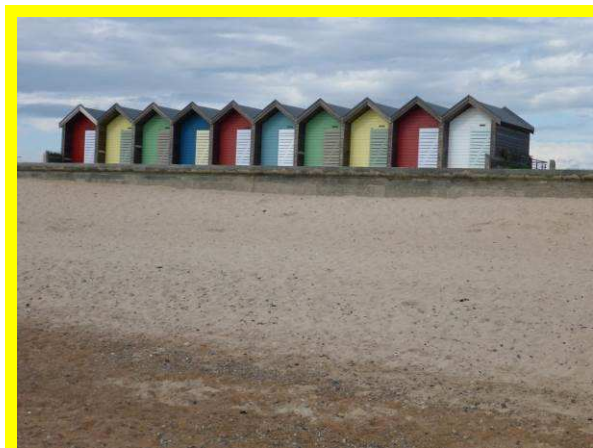
The wall merges seamlessly into the main promenade and setback amenity area towards the north of Blyth South Beach which underwent notable regeneration in 2009/10. The new promenade decking, is faring well and the sea wall fronting the promenade continues to be largely buried by high beach levels. The visible parts of the wall remained largely in good condition with some minor cracks and gaps at construction joints as well as a few areas of abrasion leading to exposed and corroded reinforcement bars.

Healthy beach fronting sea wall and promenade (/4201C07)
