## **Cell 1 Regional Coastal Monitoring Programme Walkover Inspection Surveys 2020**

**Northumberland County  
Council**

## Walkover Inspection Surveys 2020

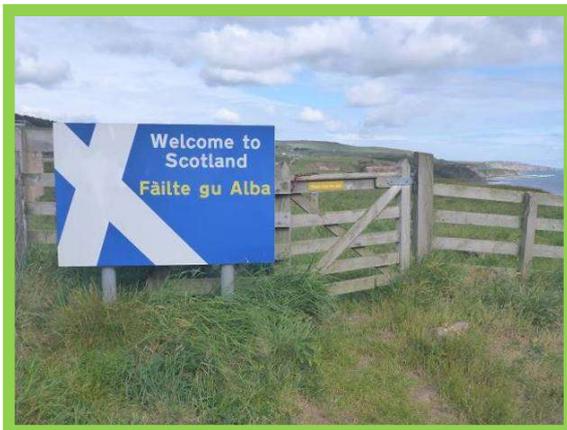
*Start of inspection at Scottish Border (/0601C01)*

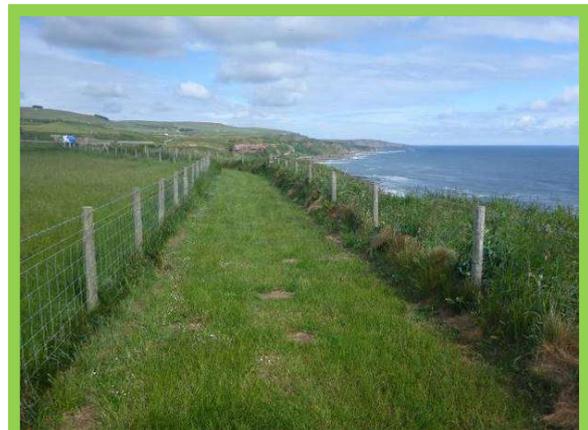
*Wide, well maintained footpath set back from the cliff edge (/0601C01)*

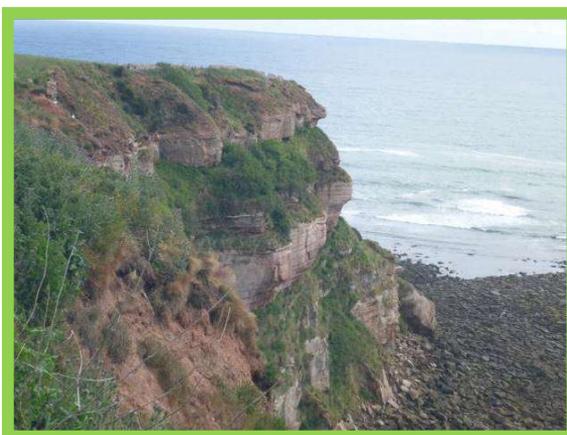
*High stable cliffs (/0601C01)*

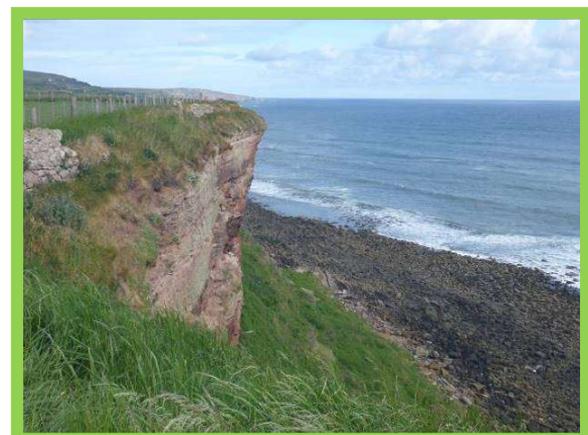
*High stable cliffs (/0601C01)*

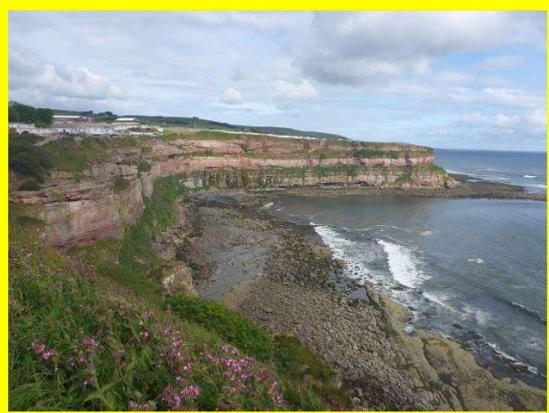
The cliffs at Marshall Meadows Bay are fractured in places adjacent to the caravan park but have been in this condition for some time with no apparent signs of collapse between subsequent inspections. At the time of the inspections, no recent movement was observed in terms of either rock falls in the harder rock base or slumping in the overlying softer material, although both processes remain the characteristic behaviour of these cliffs. There is one area of large overhang, but this has not collapsed for some time.

*Cliffs in front of the holiday park at Marshall Meadows Bay (/0601C02)*

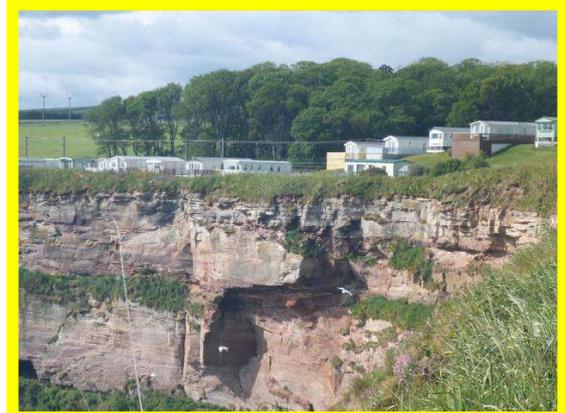
*Rock overhang in cliffs at Marshall Meadows Bay (/0601C02)*

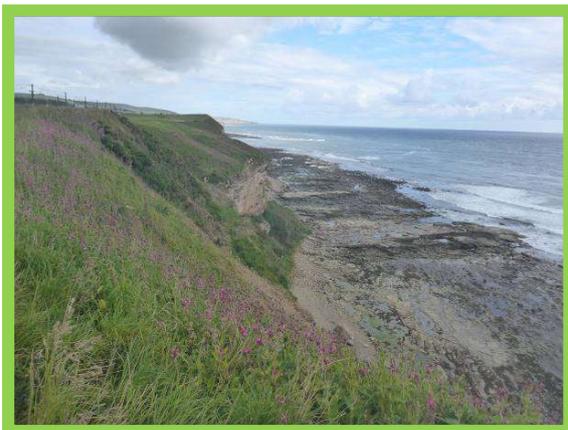
The cliffs along St John's Haven continue to appear highly stable as they are fronted by a wide rock platform. This rock platform narrows to the south and the occurrence of caves and arches increases. The arch of Needle's Eye remains a prominent feature along this stretch. The East Coast Main Line runs between Berwick and Edinburgh, close to the cliff top along this section.

*Stable cliffs at St. John's Haven (/0601C04)*

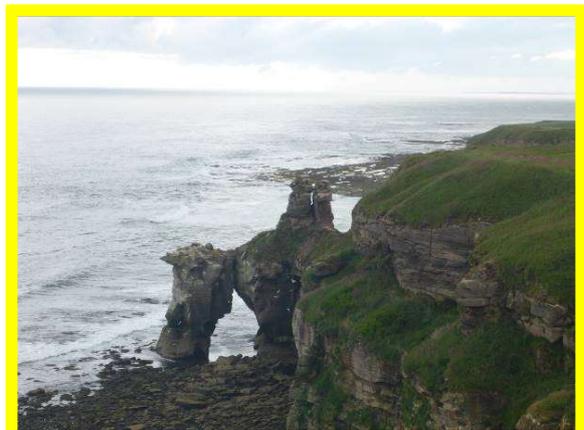
*Needle's Eye (/0601C05)*

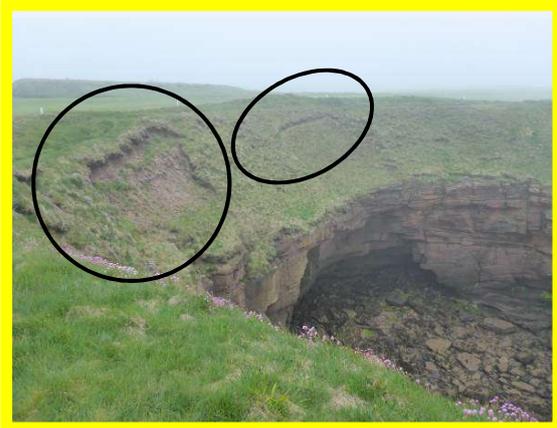
The cliffs at the northern section of Magdalene Fields (along the agricultural land north of the golf course) have previously been affected by a local rock fall and the debris from this remains on the foreshore. There is cracking along a measurable section of footpath at the cliff top indicating a slump in the overlying softer material may occur in the future as a consequence of the rock fall. Elsewhere along this section, the cliffs continue to be susceptible to local and occasional slumping in the upper soft material. Slumps previously noted at Brotherston's Hole were not as visible during the 2020 survey due to vegetation growth. Previous slumps have cut the cliff top back to the footpath in places at the Golf Course. In the harder rock base, there are numerous caves, fissures and rock overhangs.

*Localised slumping at Brotherston's Hole reported in 2018 (/0701C01)*

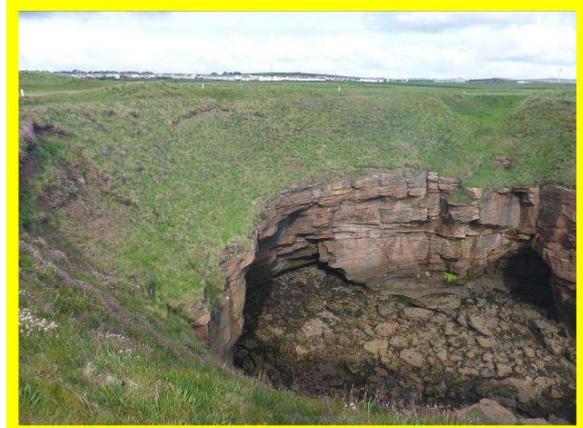
*Localised slumping at Brotherston's Hole less visible in 2020 (/0701C01)*

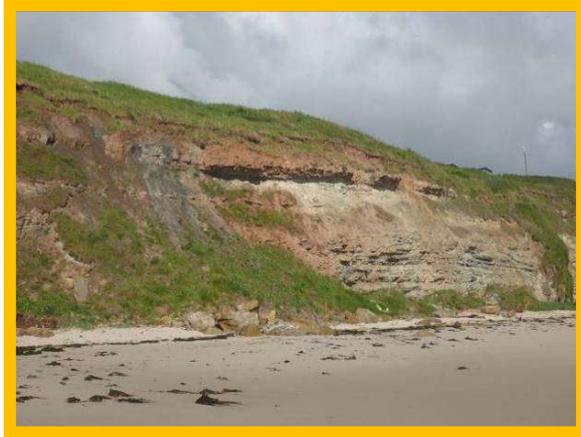
Between Burgess' Cove and Sharpers' Head the hard rock base is highly fissured and areas of partial slumping have occurred in the overlying softer cliff material, cutting the cliff top back to the fence line in some locations. Previous observations of a large overhanging section of cliff face left after a rock fall were

*Cliff face overhang (/0701C02)*

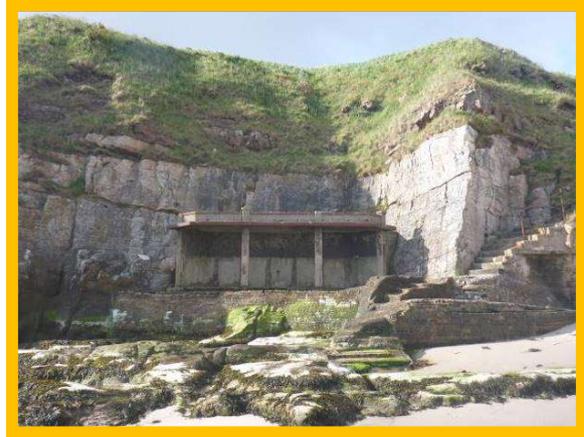
also observed during the 2020 inspection. There is a concrete pavilion and access steps located towards the south of the bay which are in generally in poor condition with signs of abrasion around the waterline. It appears that the fronting brickwork reported as being lost between 2018 and 2020 has not been repaired and there is some undercutting of the Northumbrian Water sewage treatment works outfall pipe across the foreshore.

*Concrete pavilion structure in fair/poor condition, missing brickwork from fronting wall (/0701C02)*

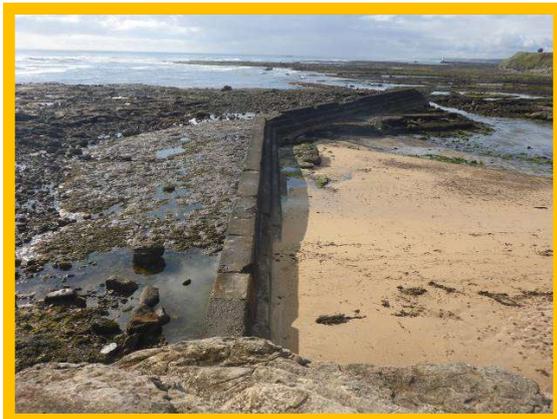
Green's Haven (also known as Fisherman's Haven) Breakwater remains in poor condition but there has been no significant further deterioration since the previous survey. The structure continues to show signs of heavy abrasion along most of its length with loss of the upper section of crest at two locations. Ongoing horizontal cracking and spalling along much of the rest of its length is likely to lead to further damage of the crest. Whilst the structure is well founded on rock, this is being undercut. Although the structure is in poor condition it is still performing the function of retaining sand within the bay. There remains embryo dune vegetation growing on the accumulated sand in the inner lee of the structure.

*Green's Haven Breakwater remains in poor condition but still retains beach sand (/0701C04)*

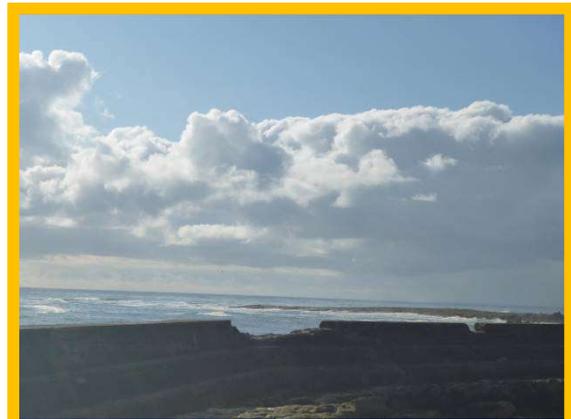
*Damaged section on breakwater crest (/0701C04)*

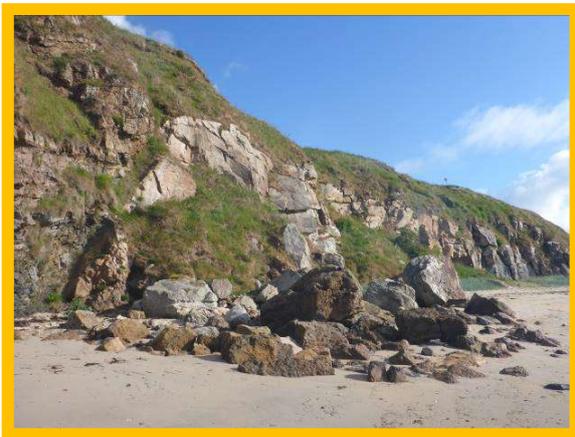
The cliffs around Green's Haven show fairly frequent activity in terms of slippages and rock falls. Signs are erected warning holiday makers at the caravan park of unstable cliffs. One slippage, just to the north of the southern access steps, has left a length of fencing suspended in mid-air (unchanged since 2016), whilst the backing land has been fenced off to ensure that visitors stay well away from the cliff edge.

*Past rock fall in cliffs at Green's Haven (/0701C06)*

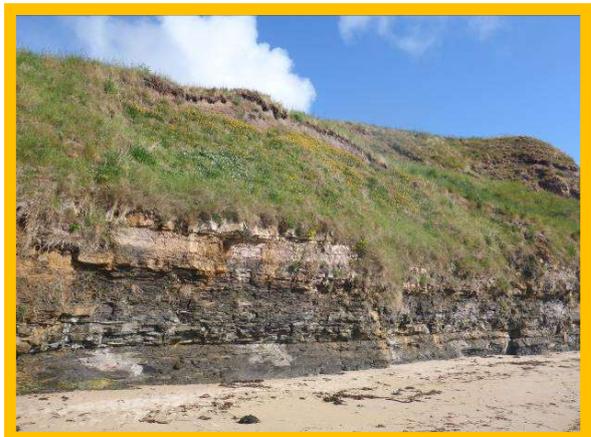
*Slumping in cliffs at Greens' Haven (/0701C06)*

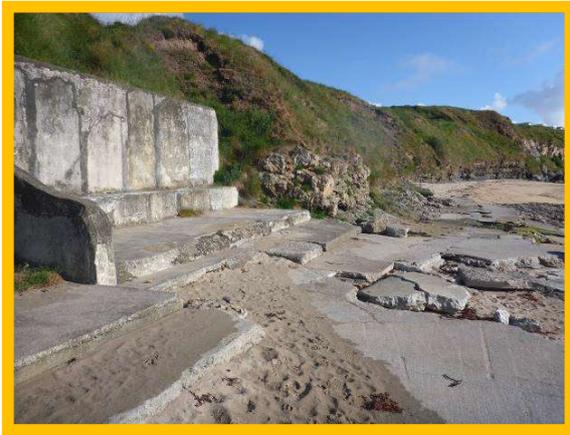
Various lengths of concrete apron and walls extending around the centre of the bay remain in poor condition and provide limited protection to the soft cliffs behind. One short section of wall in particular has

outflanking due to slope slippages and the toe apron is actively breaking-up. Concrete access steps at the centre of the bay and the concrete steps at the south end of the bay remain in fair condition but the adjacent ramp at the southern steps is in poor condition and a void has been filled with rock and rubble, but requires further work.

*Short seawall with active breaking-up apron (/0701C07)*

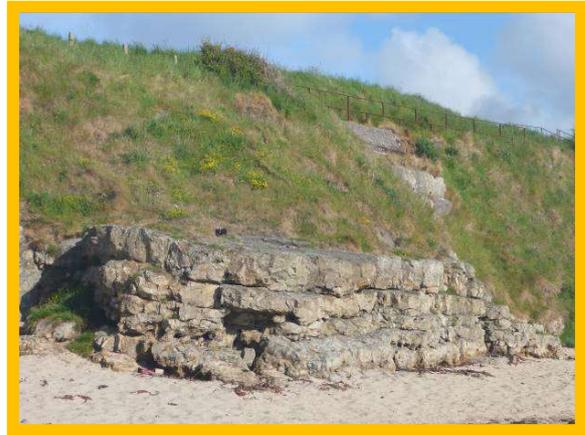
*Poor section of wall in front of cliffs at Greens' Haven (/0701C07)*

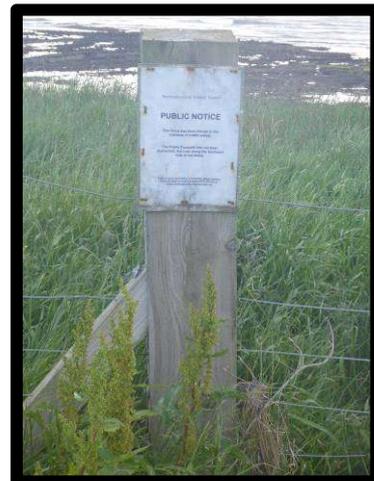
The cliffs along the southern part of Magdalene Fields are actively slumping and the fence and footpath have been moved away from the edge in response. There are signs of tension cracks in the cliff top path, suggesting the slumping remains ongoing. The foreshore is characterised by impressive rock platform.

*Relocation of fencing and footpath due to slumping cliffs along Magdalene Fields (/0701C12)*

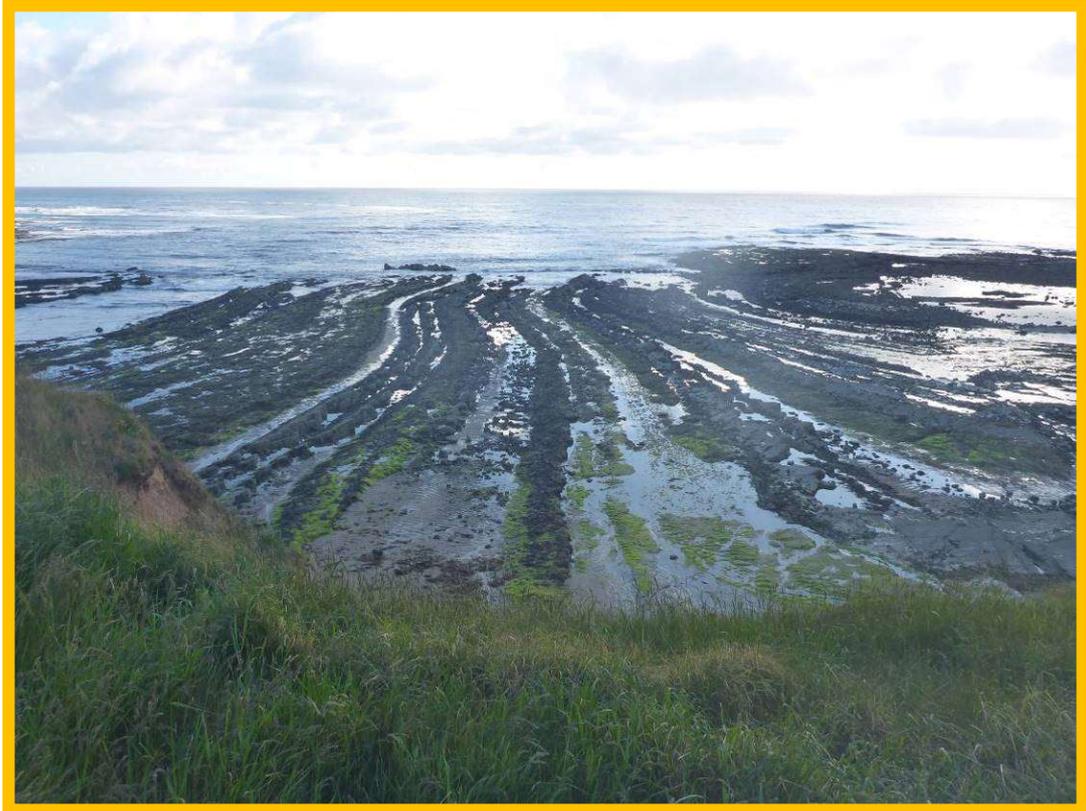
Impressive rock platform fronting cliffs (0701C12).

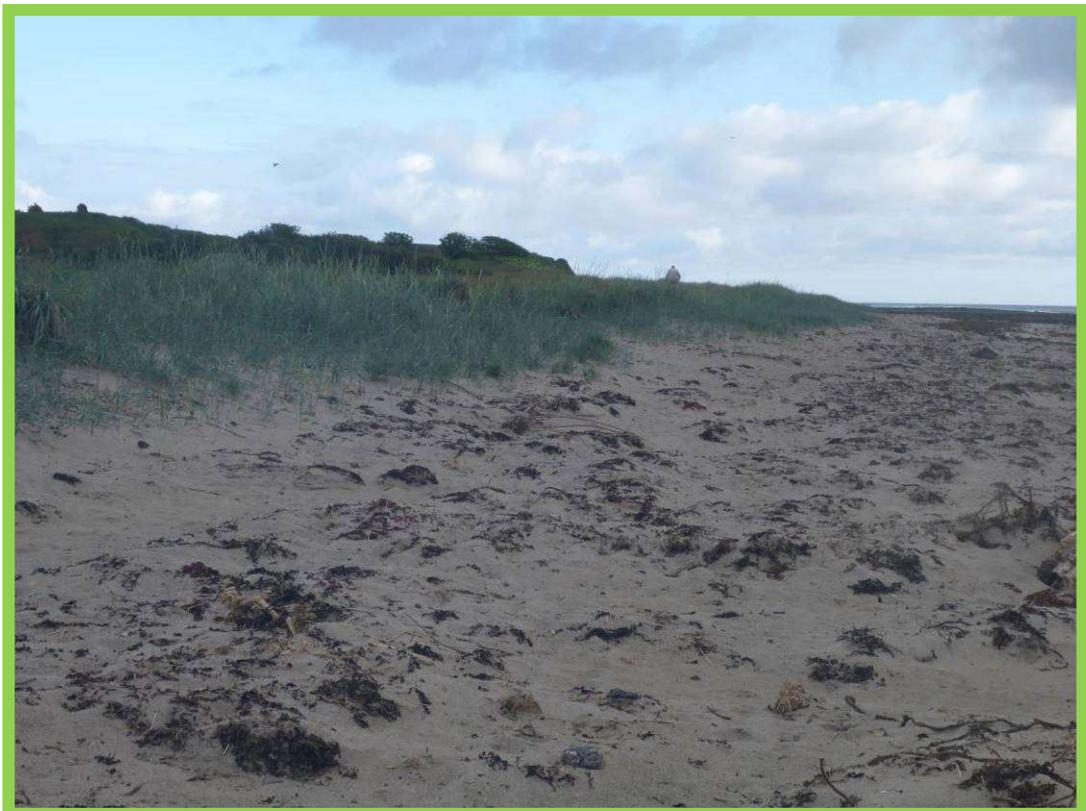
Sand beach and dunes along Little Beach (0701C13)

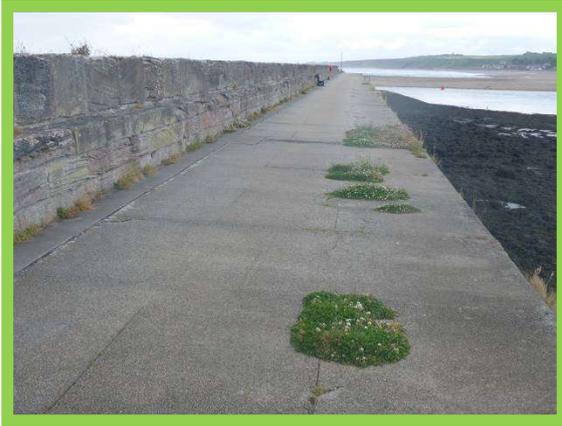
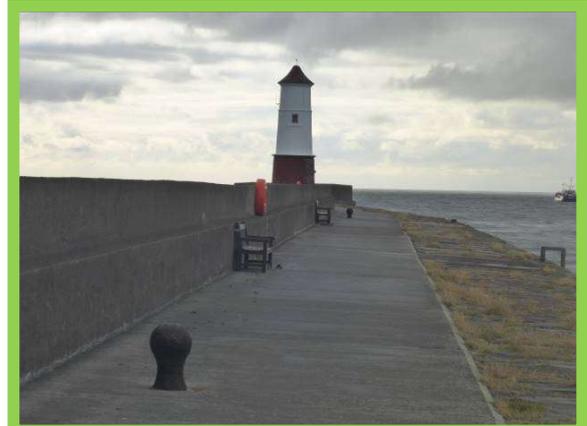
The new repairs remain in good condition, but some minor cracking, which does not seem to have worsened since the previous inspections, is evident in the older (inland section) deck. Vegetation growth is occurring in some of these cracks. In addition, some of the concrete render on the crest of the outer wave wall is spalling along the seaward sections and the older, inner section of this wave wall is heavily abraded on its landward face.

*Older (inland) sections of cracked deck and Repairs to deck of Berwick Pier (/0701C14/15)  
abraded wave wall on Berwick Pier (/0701C14)*

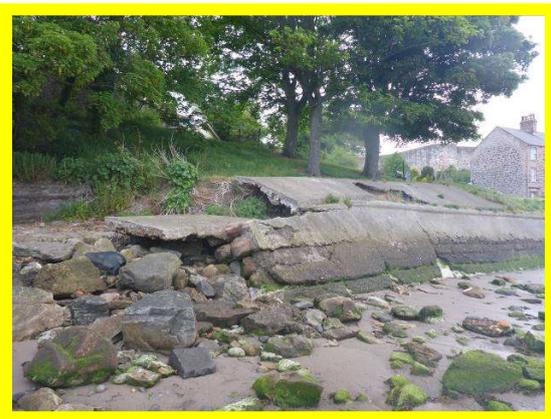
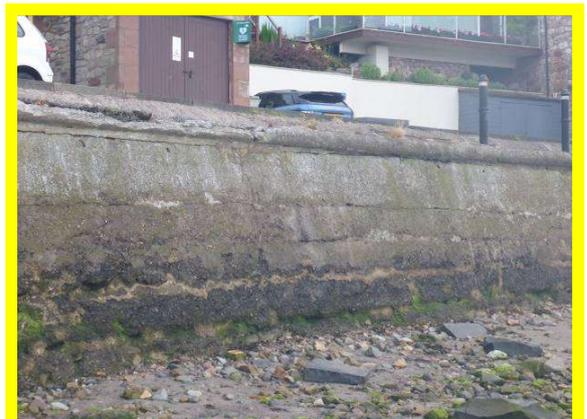
The masonry seawall along Pier Road remains in fair condition overall, with occasional minor cracking and frequent spalling of the concrete coping. However, as previously reported, there is outflanking and localised collapse of the wall at its western end, although this does not appear to have worsened since the previous inspection and appears to have changed little since first reported in 2004. An old cobble slipway which crosses an outfall pipe midway along the wall continues to be in poor condition with blocks continuing to be displaced across the foreshore. The nearshore section of the outfall is encased in concrete which has cracked notably.

*Local failed section of river slope revetment/wall Local damage to wall coping (/0801C07)  
(/0801C07)*

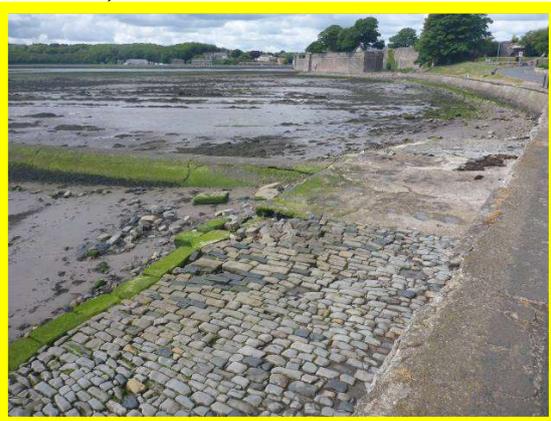
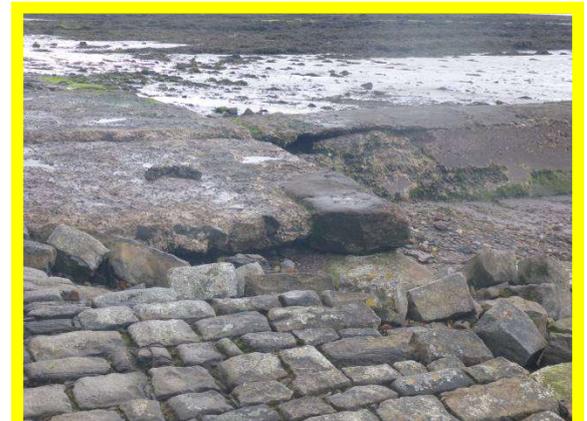
*Local failed section of slipway over foreshore Local failed section of slipway over foreshore  
outfall (/0801C07) outfall (/0801C07)*

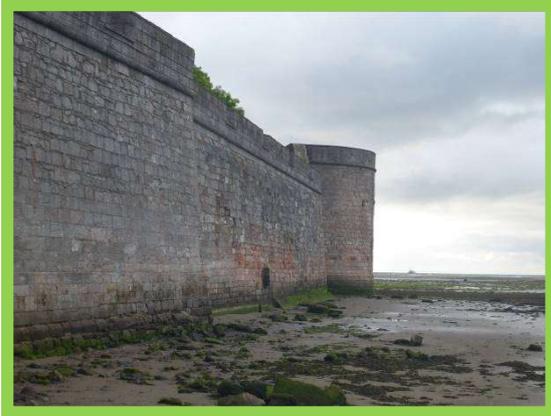
The historic masonry wall of Fisher's Fort remains in relatively good condition although some local areas would benefit from re-pointing. Previous repairs have been made at the junction of the wall and the roundhead. Where the wall has a toe apron several of the blocks in the apron are heavily abraded. There is a large vertical crack in the wall at the roundhead. The tidal flap valve in the wall is operational.

*Berwick's historic town walls in good overall condition (/0801C06)*

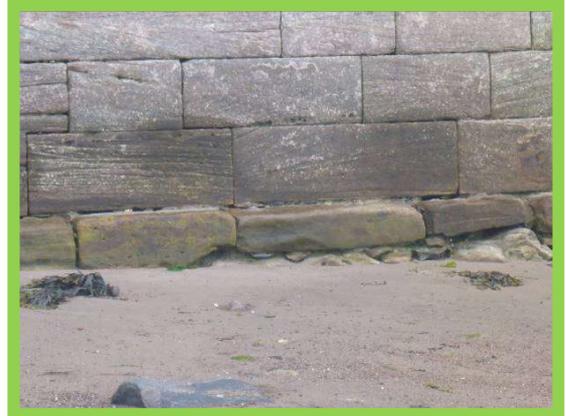
*Abrasion to toe (/0801C06)*

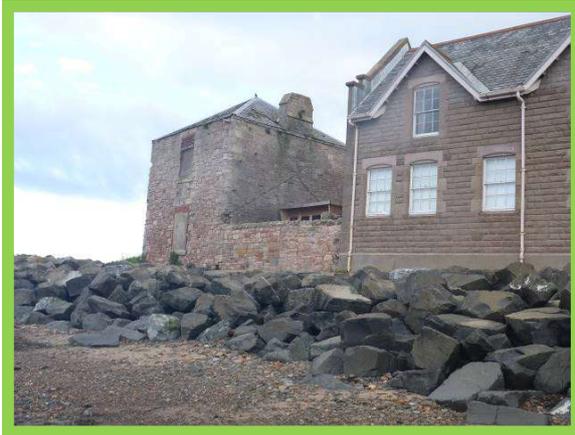
The short sections of masonry seawall (with concrete deck) fronting the properties at Gardo's Battery are in fair condition and where fronted by a rock revetment this remains in good condition with armour well packed. The timber slipway at this location is obsolete.

*Rock revetment in good overall condition (/0801C04)*

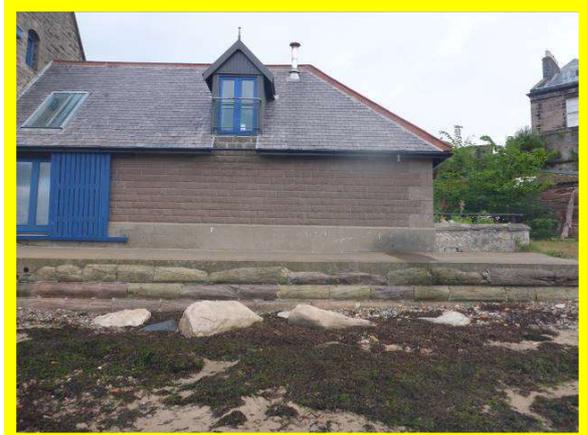
*Wall in fair overall condition (/0801C05)*

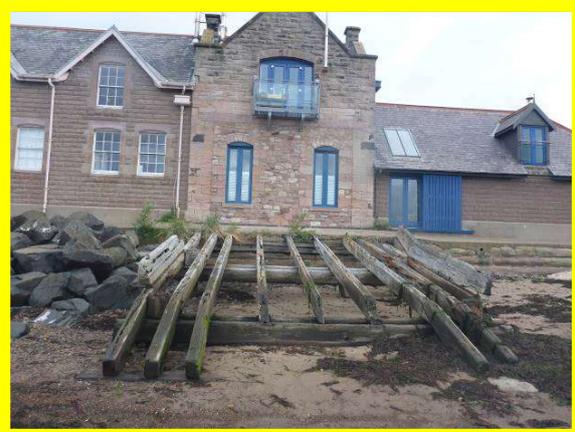
*Obsolete timber slipway (/0801C05)*

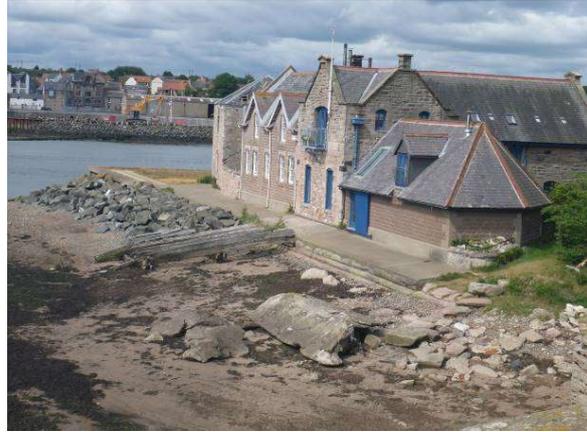
*Revetment and wall at Gardo's Battery (/0801C04 & C05)*

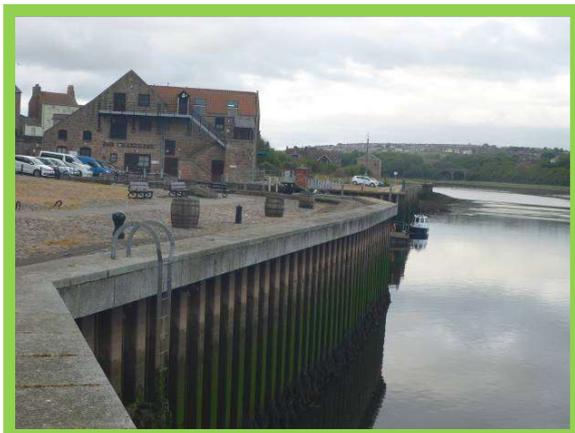
The Berwick quayside (north bank) consist mostly of sheet piled walls, with a short masonry wall extending around the dock area. The steel piles, concrete capping beam, ladders and timber fenders are all in good condition. The masonry wall in the small dock is in fair condition with some blocks broken and abraded and a number of open joints evident that would benefit from re-pointing. There is one crack to the coping near The Chandlery and voids are appearing at the blockwork access steps to the small dock.

*Steel sheet piled quay walls in good overall condition (/0801C03)*

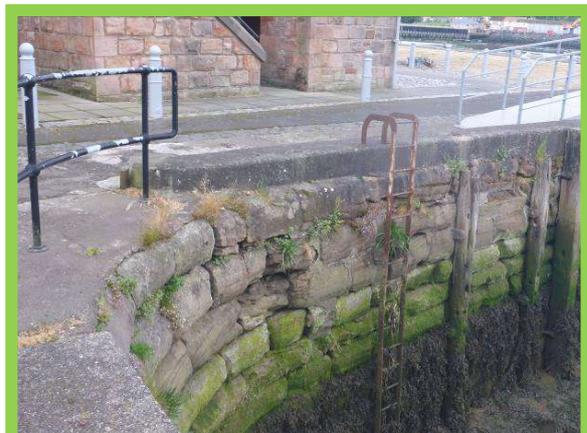
*Masonry quay walls in dock area in fair overall condition with some open joints, cracks and abrasion (/0801C03)*

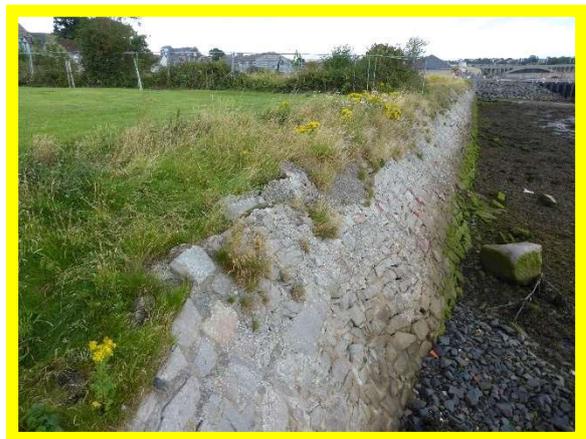
Defence length 121AA901A0901/ C04 runs from the southern jetty at the entrance of the Berwick Dock through to the area of the Pier and IRB Station at Carr Rock. The defence comprises two sections, the first being a masonry revetment protecting land formerly occupied by sheds (removed between 2006 and 2008). This section has undergone previous repairs and despite minor loss of pointing is generally in fair condition.

*Minor loss of pointing 2020*

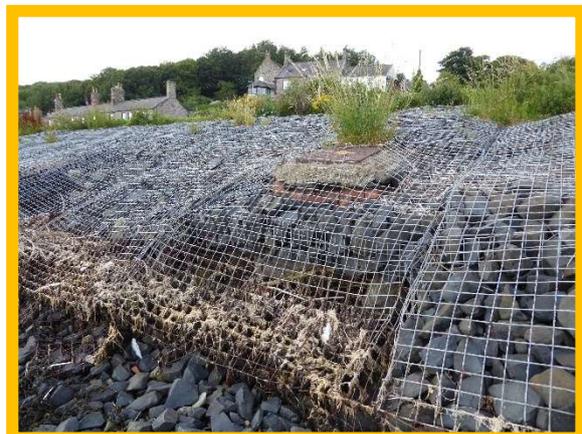
The main section of defence, protecting the open grass area in front of Dock Road, comprises gabion (Reno- mattress) defence. Much of the exposed original square mesh baskets have failed along the toe and continues to deteriorate. The small infill stone has formed a wedge at the toe of the structure. A new upper layer of mattress was constructed by 2006. At the southern end of defence 901/ C04 a different type of mesh has been used (constructed by 2006), using a wrapped wire basket as opposed to a square welded mesh. There now is general corrosion of the wire.

*901c04 continued damage 2020.*

This defence seems unlikely to suffer catastrophic failure. However, the SMP2, calls into question the benefits associated with continued defence of this area. Before investing further repairs, the need for which in areas are becoming urgent, as a safety issue, the need for defence needs to be reviewed.

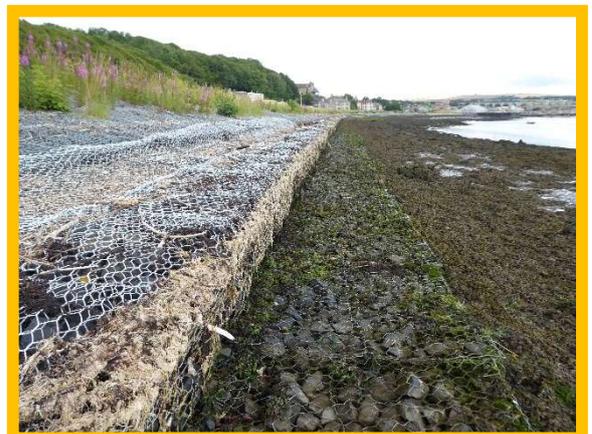
*General view of 901c04 -2020.*

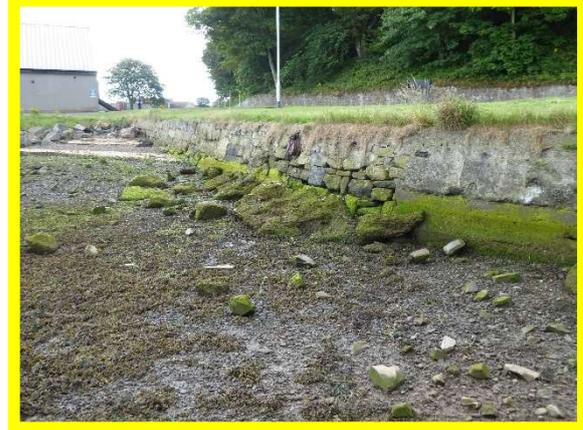
In both cases there has been little change and while both structures show significant gaps and cracking, in 2020 neither structure appears to have deteriorated further.

901c05/06 little change to 2020.

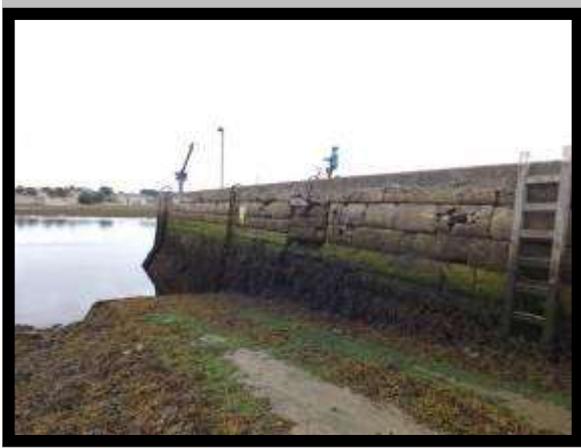
901c06 in 2008.

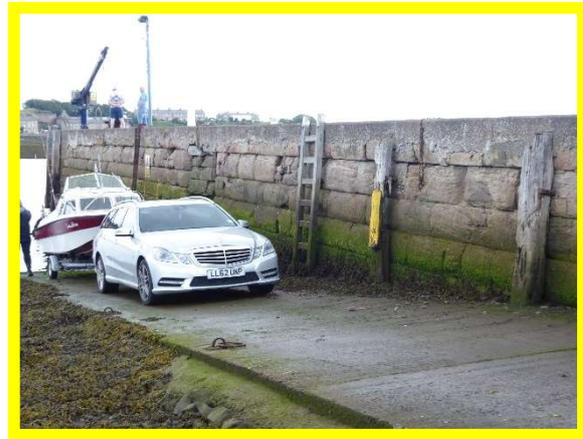
901c06 - 2020. Little change since 2008

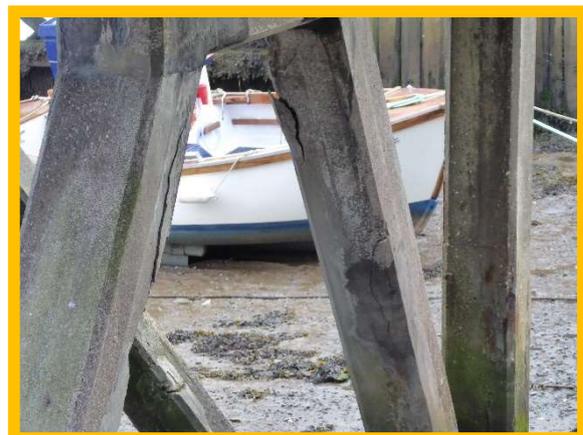
The open piled timber jetty remains in a dilapidated condition. The section behind the RNLI section is in fair condition. Despite some repairs spalling of the concrete support structure to the RNLI Station continues.

901c06 – 2020 spalling to RNLI structure.

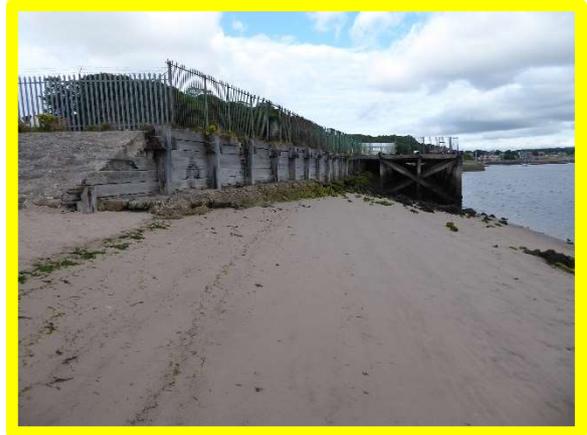
The beach level to the eastern end of the main jetty were noted to have reduced in 2018 compared to 2016, but only to the same extent as in 2008. Beach levels have changed little in 2020. The change along this section has been linked to behaviour of Sandstell Point (discussed later).

*901c07 – reduced beach levels 2020, similar to 2018.*

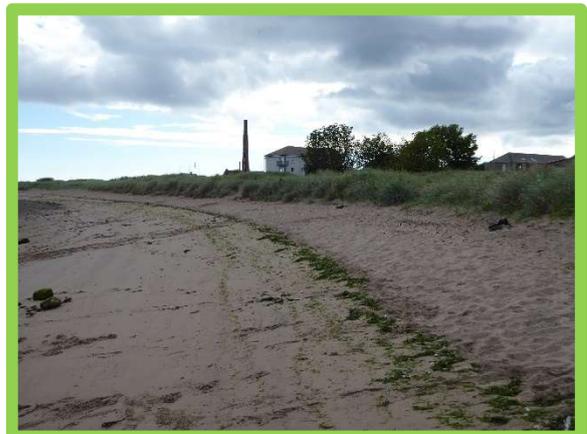
Beach levels along the 901c08 frontage, through to Sandstell Point remain stable compared to 2018; the beach face has improved compared to the condition in 2016 and back to 2012. These changes are linked to the change in the Sandstell Point bank across the mouth of the estuary and the associated movement of the channel. A comparison of this change based on lidar images from 2012, 2015, 2017 and 2018. (More recent Lidar is not available). The SMP recommends that a buffer zone is recognised to allow for change.

*901c08 – 2020, stable since 2017*

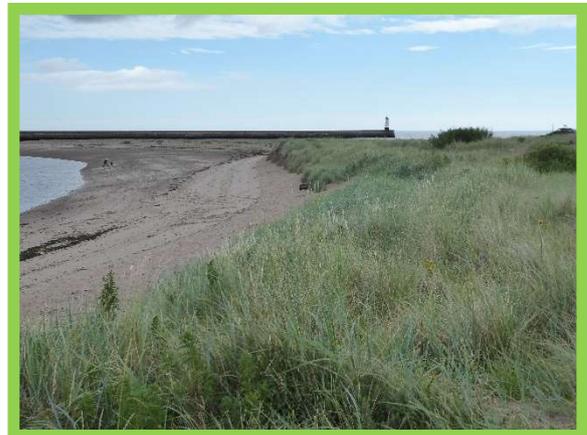
901c08 – fully developed front dune 2016.

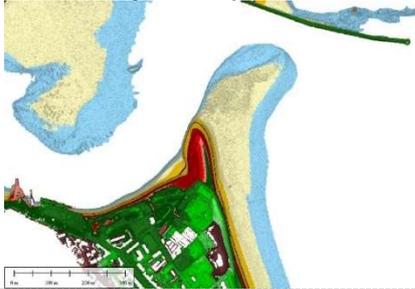
901c08 – change but still healthy in 2020.

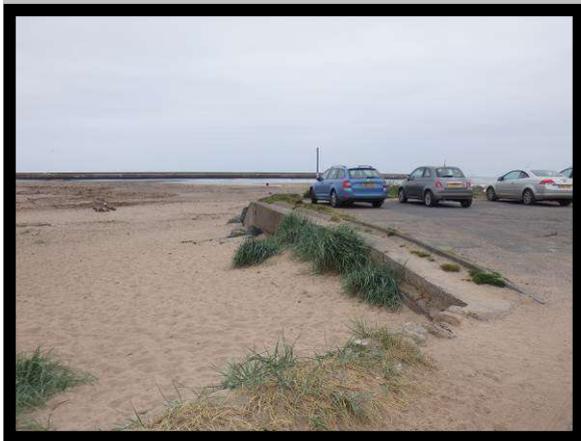
The beach levels around defence lengths 121AA901A0901/ C09 and C10 remain high and both defences remain in good condition. The general change in the position of the dune crest associated with Sandstell Point provides additional protection to these defences. This suggests a further westward movement of the spit since the Lidar image shown in 2018 above.

901c09 – high beach levels 2018.

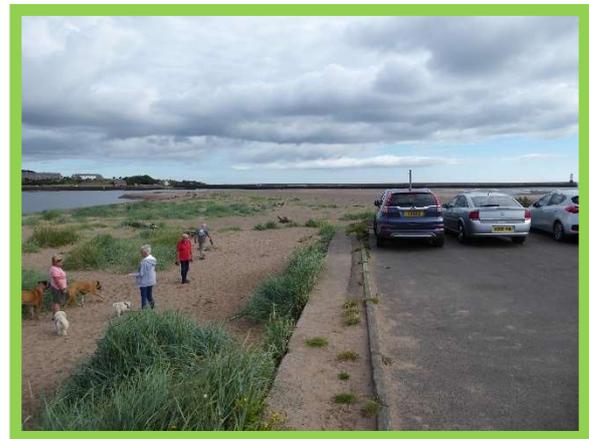
901c09 – growth of dune to estuary side of Sandstell Point 2020.

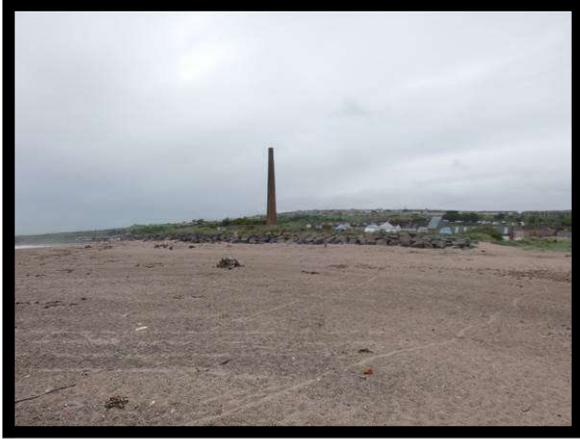
*901c10 – high beach levels 2018.*

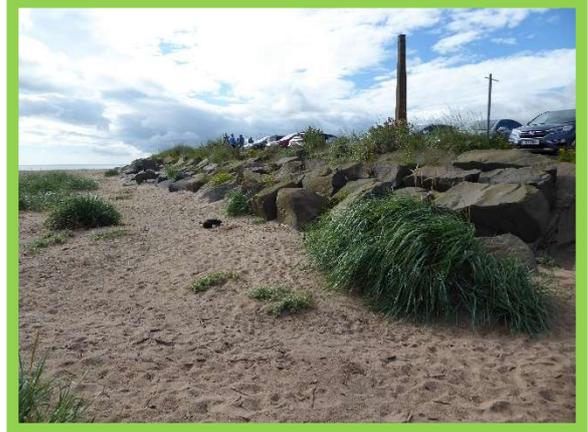
*901c10 – high beach levels 2020.*

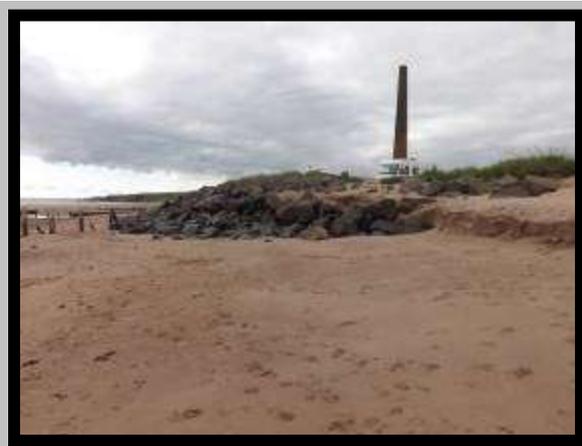
*1001 c01 – Northern end, showing cliffing of beach around headland 2016.*

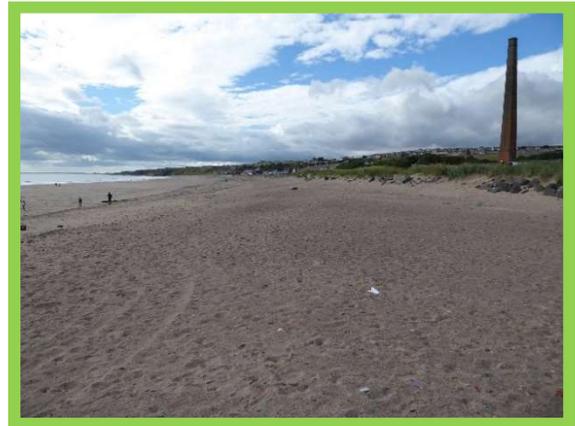
Beach levels along the northern section of the open coast 121AA901A1001/ C01 continue to be high, with groyne substantially buried. In particular there is significant increase in beach width to the south.

*1001 c01 – showing high beach levels 2020*

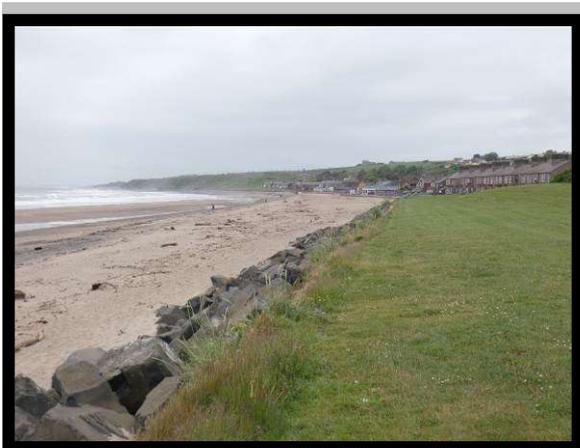
*1001 c01 – 2018 showing increased beach width with groyne buried.*

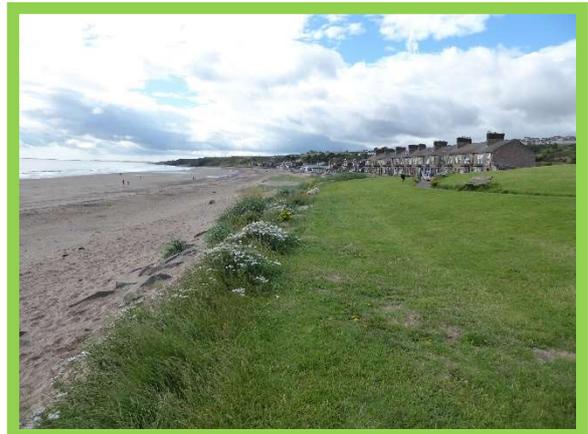
*1001 c01 – 2020 further increased beach width particularly to the south.*

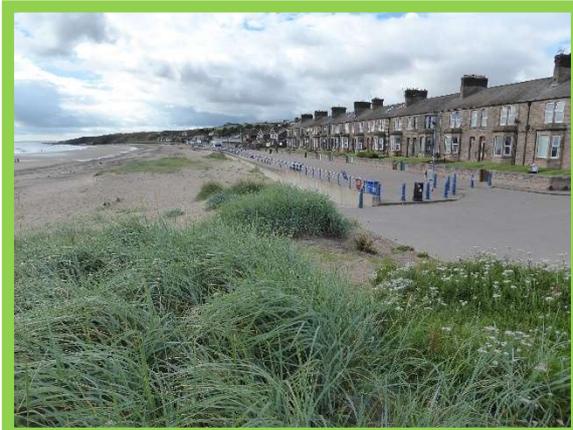
Beach levels remain relatively high over defence length 121AA901A1001/ C02 with no deterioration in the defence. Associated with changes further to the north the beach crest has realigned.

*1001 c02 – 2020 development of embryo dune .*

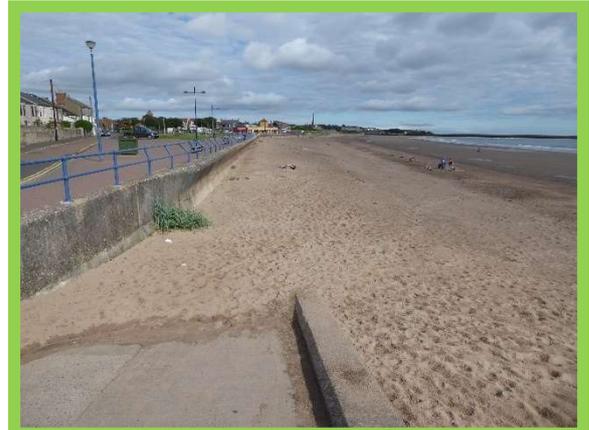
*1001 c02 – 2020 growth of upper beach width*

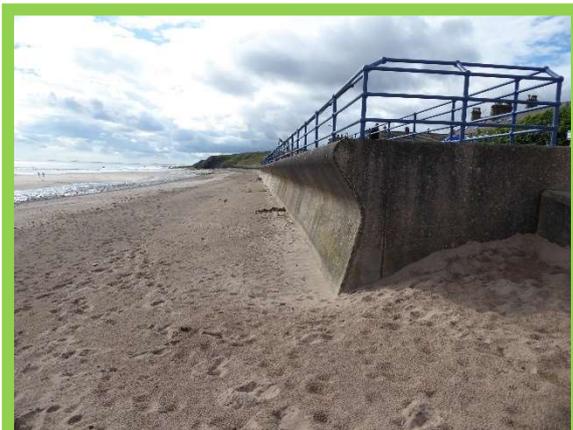
Beach levels to 121AA901A1001/ C03 have increased since 2018, to a similar level to 2016, particularly over the norther section. The crack or failed repair identified in 2014 remains in the same condition (this crack has remained the same since 2010). There is some general loss of joint sealant but this does not appear to be detrimental to the performance of the wall.

*1001 c03 – 2020 increased beach level*

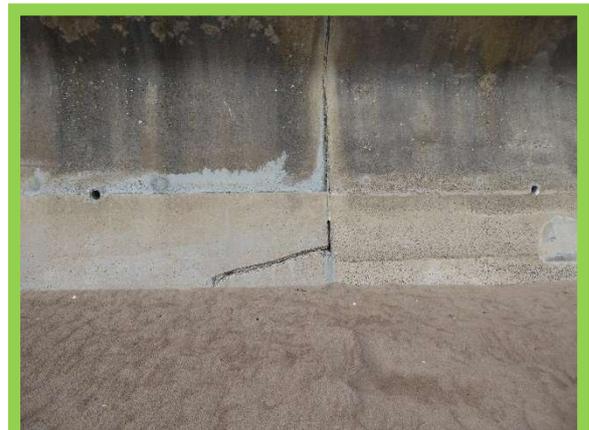
*1001 c03 – 2020 no change in crack*

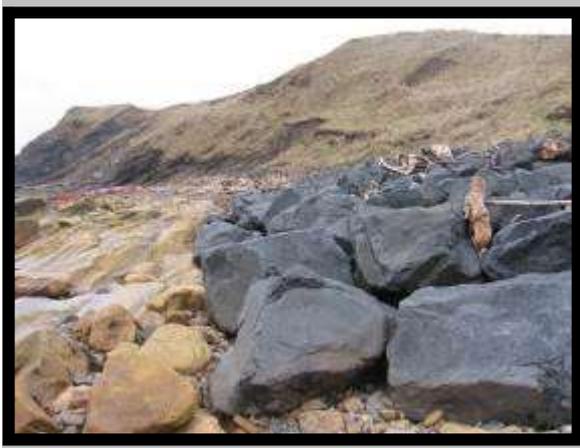
The beach levels in front of the rock revetment 121AA901A1001/ C04 remain high with a slightly increased crest width. beach levels are substantially higher than 2006.

*1001 c04/ 05 – low foreshore levels in 2006.*

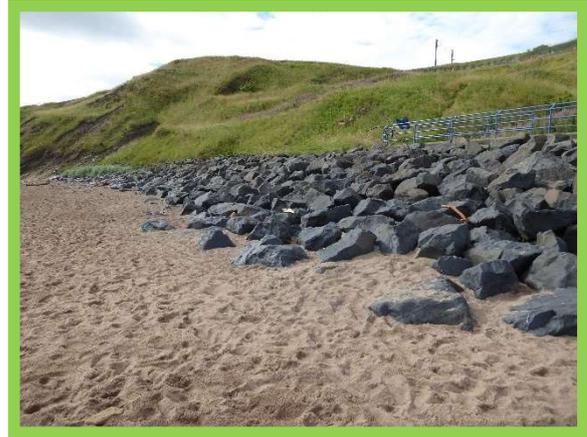
*1001 c04/ 05 – 2020 increased crest width.*

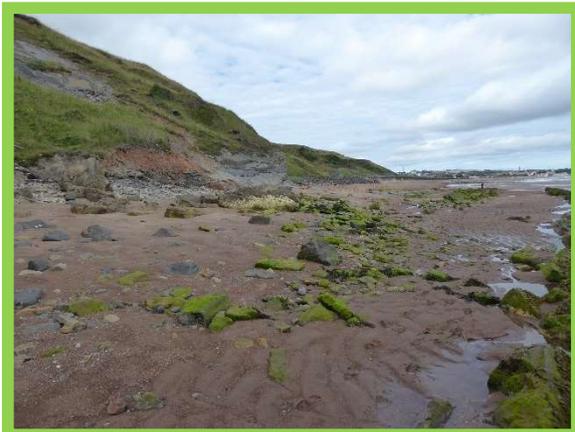
Since the slight additional slippage to the coastal slope at the southern end of 1001 c05 noted in 2018, there has been no further change in the coastal slope. Slippage here appears to be of the lower soils resting above the sloping rock and does not appear to affect the upper slope. There is no obvious deterioration of the retaining wall above the slippage area.

*1001 c05 – 2020 no change, slightly higher beach levels*

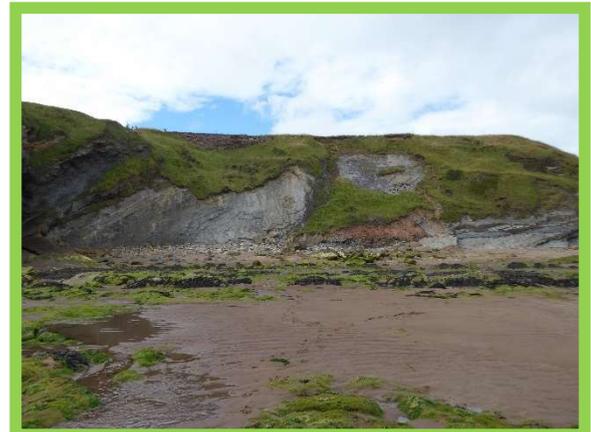
*1001 c05 – 2020 no change in coastal slope.*

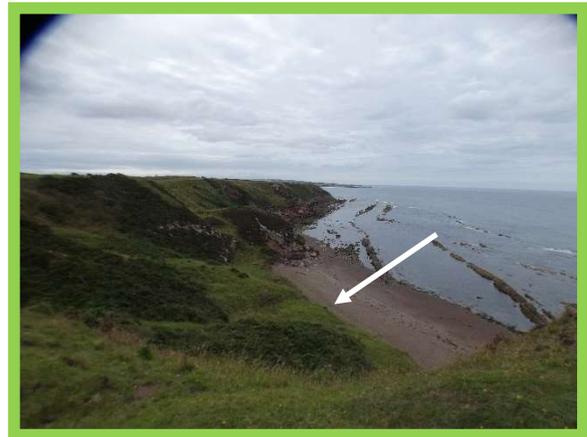
1101/c01 general view of cliffs and beach to north of Sea House 2020.

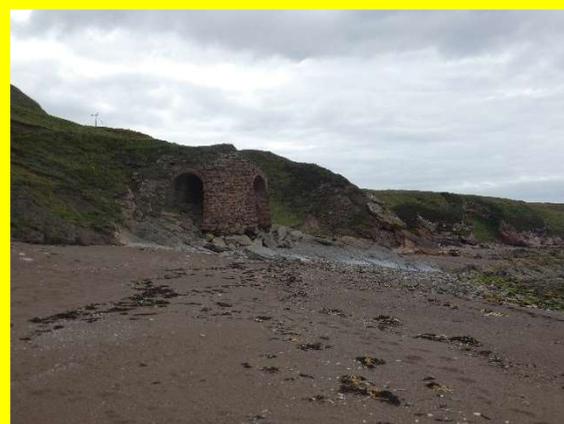
Between Spittal and Sea House farm (Scremerston) the high cliffs continue to exhibit slow erosion but with no assets at risk. Beach levels appear not to have changed since 2018 and there is a small area of embryo dunes (shown on image) that has changed very little since 2016. Beach levels and coastal slope have changed little over 121AA901A1101/ C02 and C03. The old lime kiln in C02 continues to deteriorate slowly.

1101/c02 2020 coastal slope and historic structure.

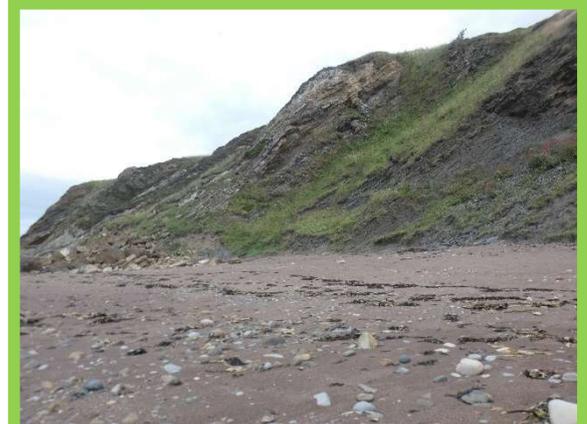
1101/c03 2020 coastal slope

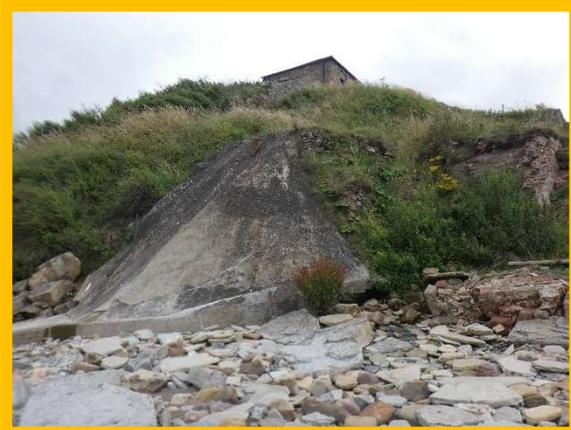
Sea House Farm (1101/c04) is possibly founded to the underlying rock rather than being reliant on the eroding vegetated surface cover. There is little change to the concrete protection around the outfall. It remains cracked with areas of local undermining but there seems to be not immediate risk. There is no change to the coastal slope compared to 2018.

*1101/c04 2020 Outfall and concrete slope protection, cracked and minor undermining.*

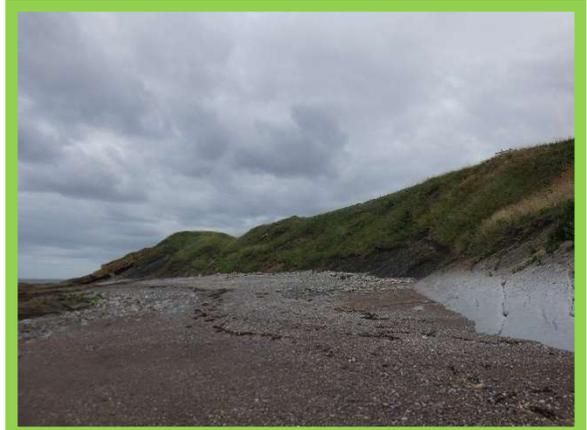
*1101/c04 2020 general slope, no change.*

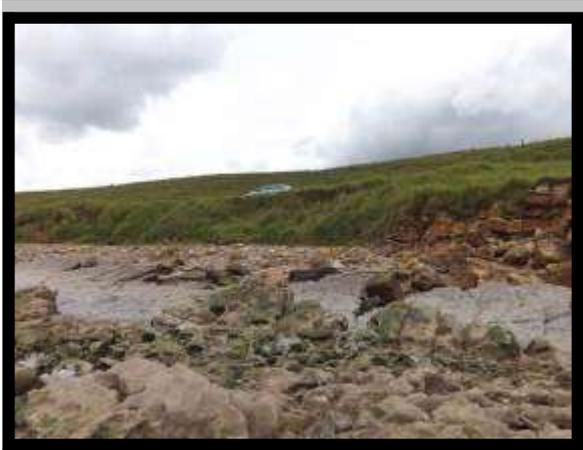
Further south of Sea House Farm, (1101/c05) the shoreline reverts to a generally hard rock basal cliff with varying thickness of surface deposits. Some sections continue to erode but where the road comes down to the Cocklawburn beach the cliff remains relatively stable, with little change since 2018.

*1101/c05 Critical section of frontage closest to road 2016*

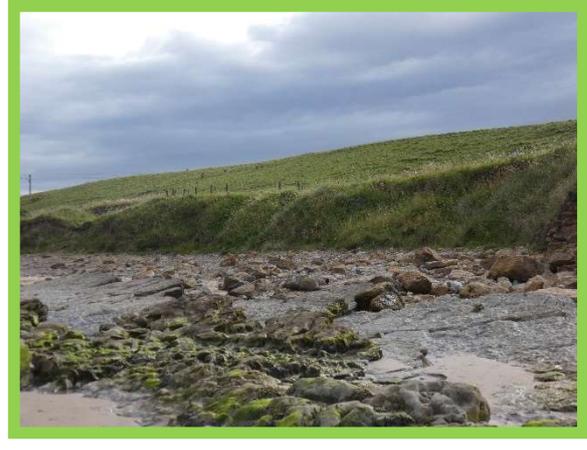
*1101/c05 2020 Critical section of frontage closest to road. No change.*
