## **Cell 1 Regional Coastal Monitoring Programme Walkover Inspection Surveys 2020**

**Northumberland County  
Council**

## Walkover Inspection Surveys 2020

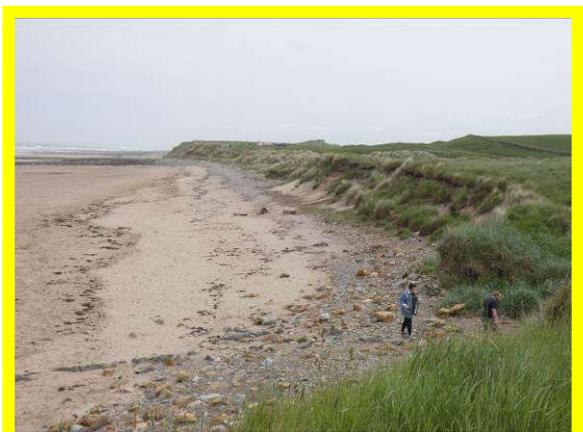
There has been a significant increase in beach levels since 2018 over the dune frontages 121AA901A1201 / C01, C02 and C03 since 2018, particularly over the upper beach. Previous years have however shown that beaches and the dune face can be subject to periods of erosion. Over the northern part of 1201/C01, in 2020, there is recovery of the upper beach compared to 2018, but little dune growth.

*1202/c01 northern end 2018*

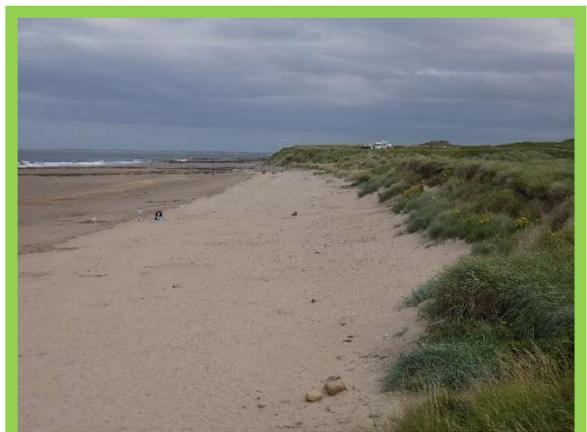
*1202/c01 northern end 2020*

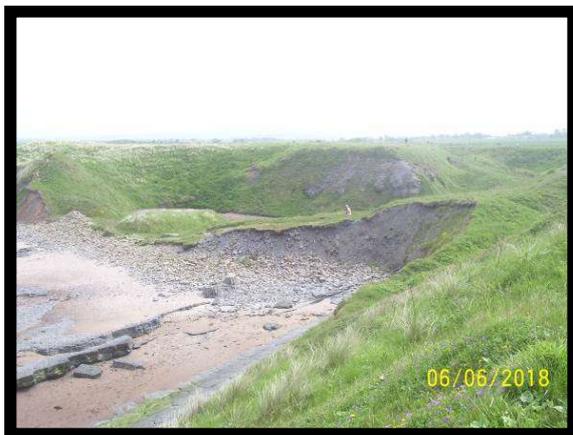
There is no evidence of further erosion of the back face of the dune in the bay to the south of Far Skerr. Beach levels have built between 2018 and 2020. The main pathway leading down into the this bay is still at risk.

1201/c01 south of Far Skerr. 2018

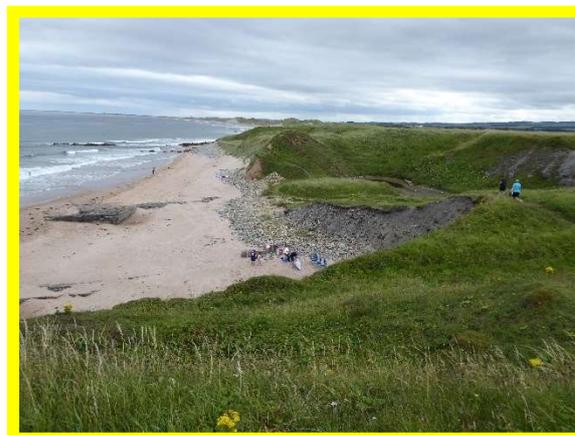
1201/c01 south of Far Skerr 2020.

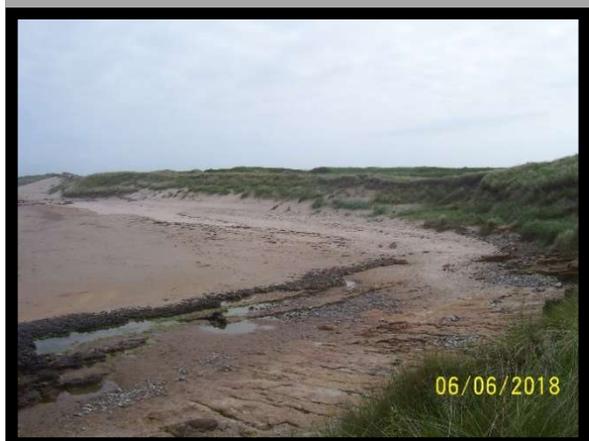
In the area around Cheswick Rocks there was erosion prior to the 2018 inspection and the area was recovering slightly. In 2020, this recovery has continued with some evidence of slight dune growth.

1201/C02 Cheswick Rocks 2018

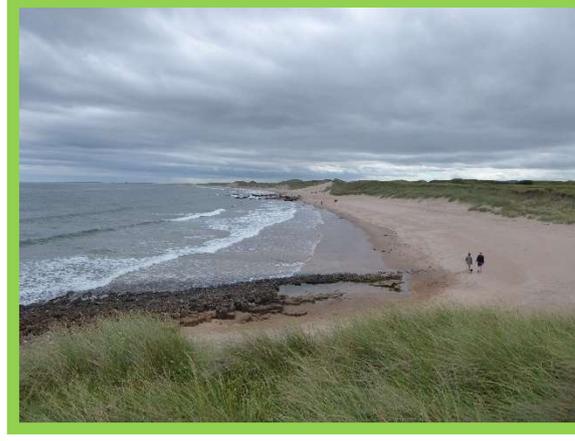
1201/C02 Cheswick Rocks 2020

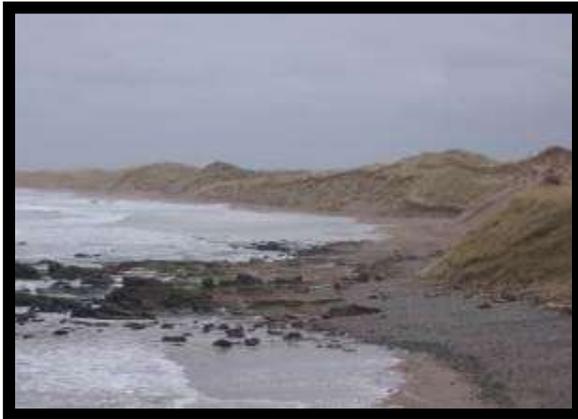
*1201/ C02, C03 – 2006 showing erosion but dune system further forward than present day*

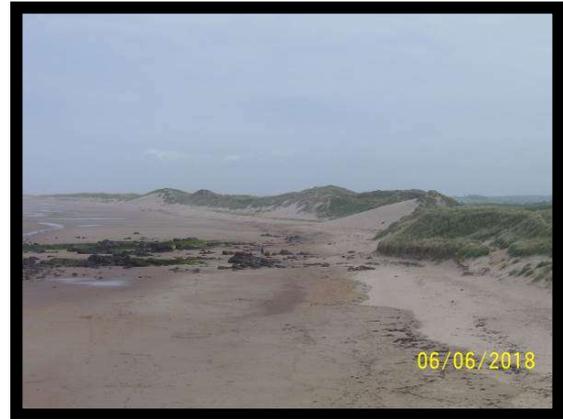
*1201/ C02, C03 – 2018 showing set back of frontage but some re-vegetation.*

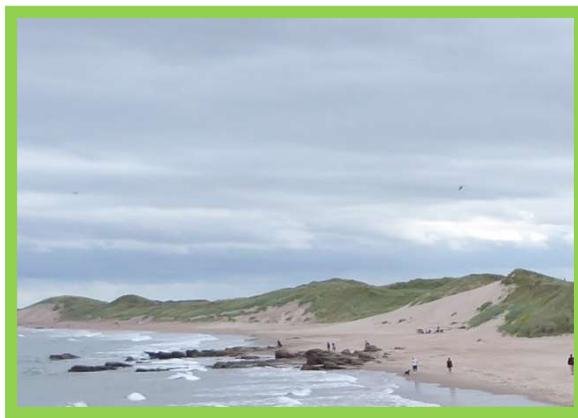
*1201/ C02, C03 – 2020 showing no significant change since 2018 but with further re-vegetation.*

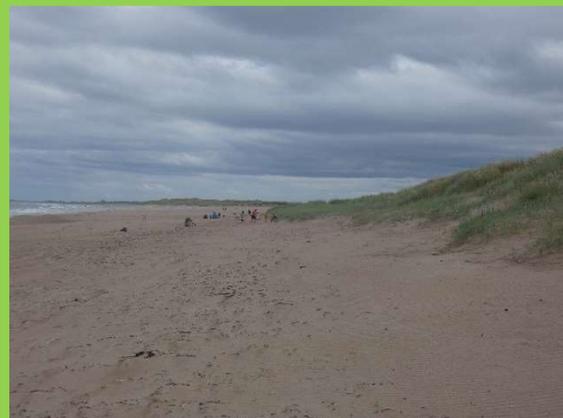
*1201/ C03 – 2020 embryo dune growth at southern end.*

While there are major changes in the position of the lower shore bar (tending to have been pushed back in line with the small island) there is noted to have been substantial growth of the southern part of length 1201/C03, which appears to have continued in 2020 with the growth of embryo dunes as shown in the picture above. This would support previous observation of southerly sediment transport.

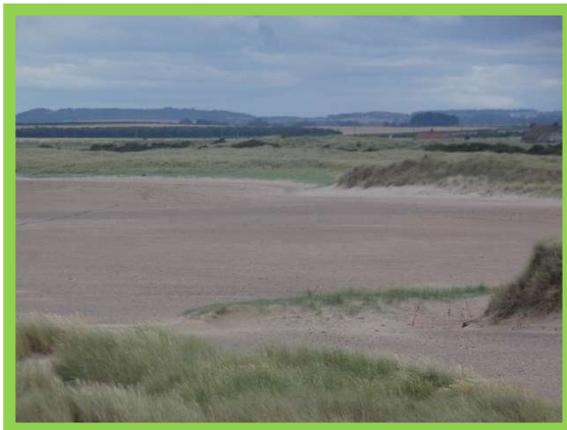
1301/C01 – general continued development of embryo dunes 2020.

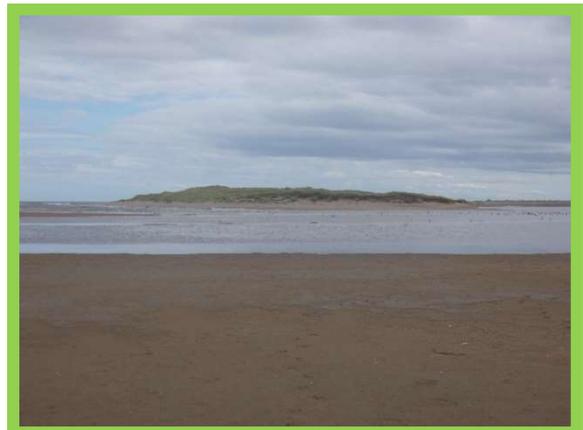
With this southerly growth of 1201/C03, there has been a narrowing of the North Low outlet channel to the south of the dune island, creating a wide flat lagoon area behind the lower shoreline. The dunes to the back of this area have advanced, with a general width of embryo dune along this length in 2020.

1301/ C01, Narrow channel and lagoon, with flow erosion to north edge of dune island

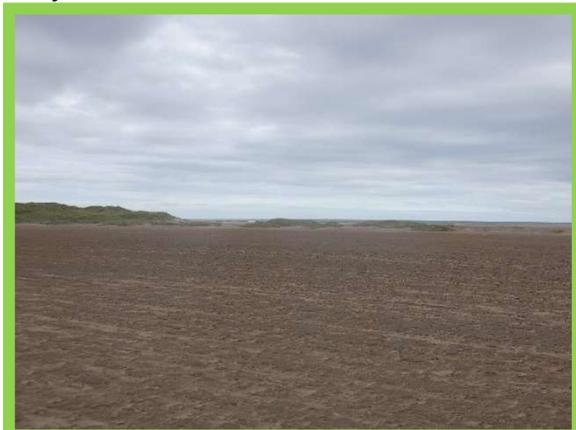
To the south of the dune island there was noted to be the growth of a ridge of low dune starting to develop in the 2018 inspection. This is shown in the 2018 Lidar, with these low dunes consolidating even further by 2020. Overall, the indications appear to be one of accretion with the development of a higher beach and dune vegetation between the island dune and the main dune face of the North Low. Uncertainty over future development of this area in response to beach levels and sea level rise was highlighted in the SMP.

1301/C01 – Dune ridge growth from south of Dune Island

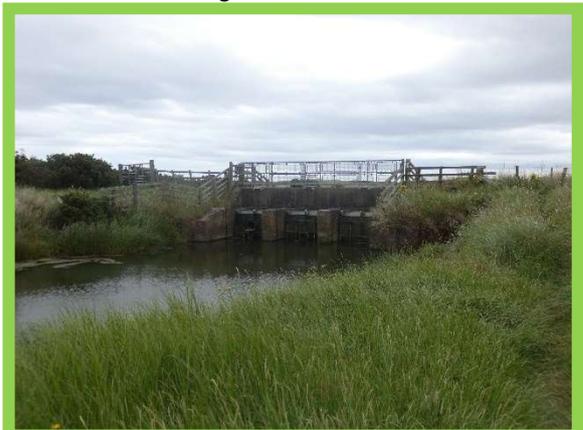
1301/ C01, 2020 North Low sluice

The north Low Sluice appears in fair condition.

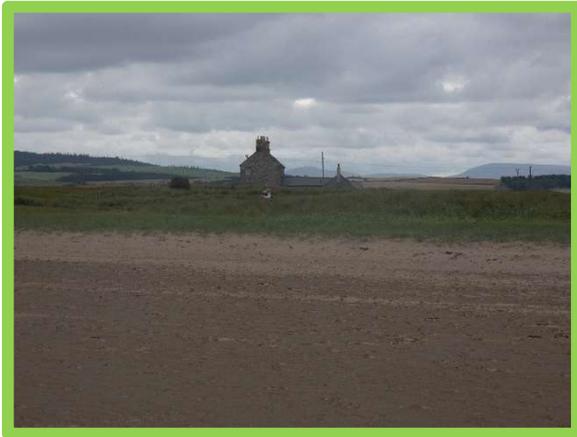
Further south there continues to be slight growth along the toe of the dune through to the Beachcomber access.

*1301/C01 – 2020 at Beachcomber access showing continued dune development.*

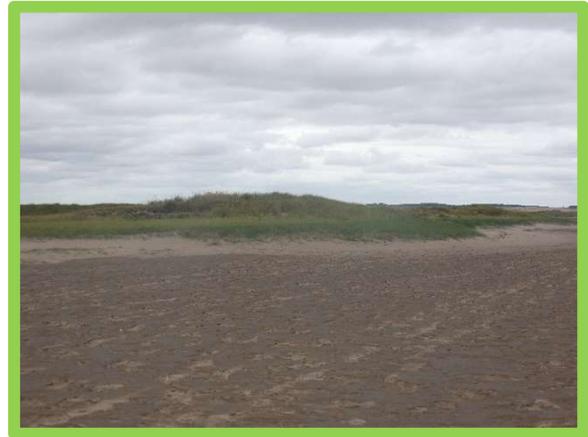
*1301/ C01, 2020 north of Beachcomber access.*

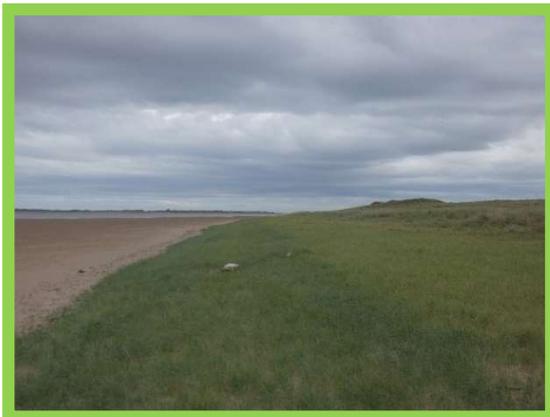
To the south of the Beachcomber access the dunes continued to develop forward with only local areas where there is no growth (particularly around the apex of the curving shoreline).

*1401/C31 – 2020 north of Beachcomber access showing continued dune development.*

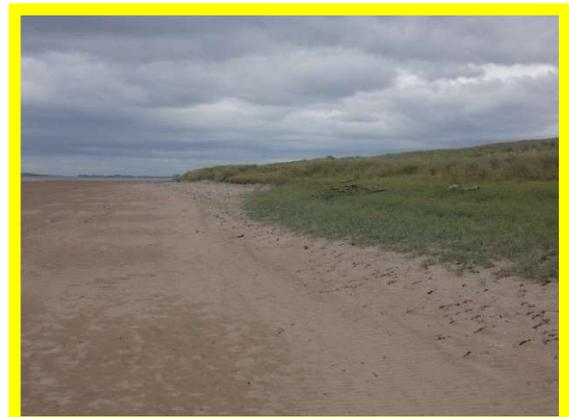
*1401/ C31, 2020 local area where there is little recovery from previous erosion.*

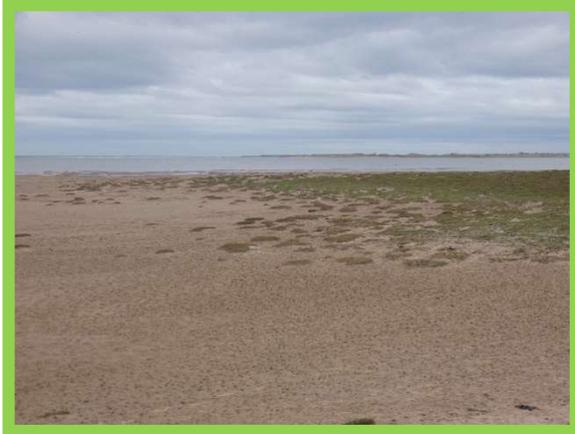
*1401/C31 – 2020 developing salt marsh edge.*

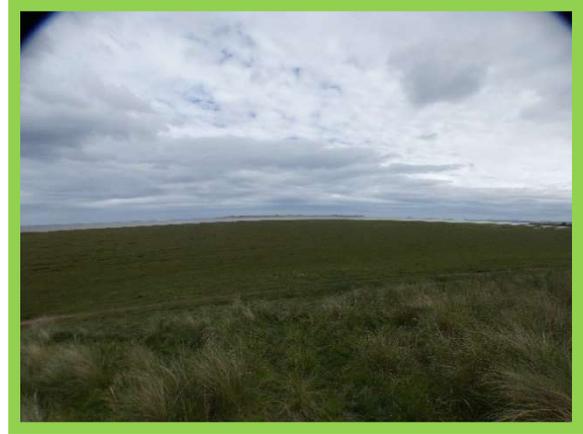
*1401/ C31, 2020 saltmarsh development*

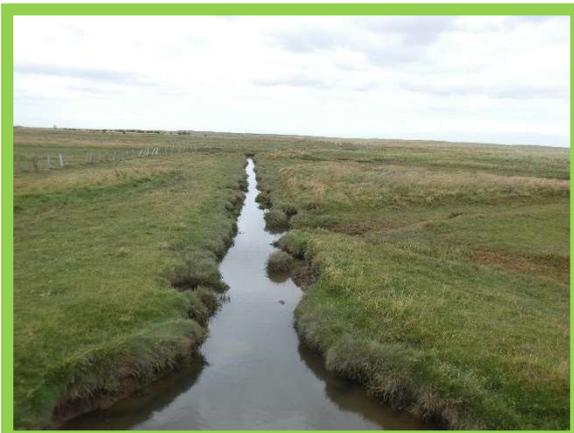
*1401/C31 – 2020 little change in area landward of new sluice.*

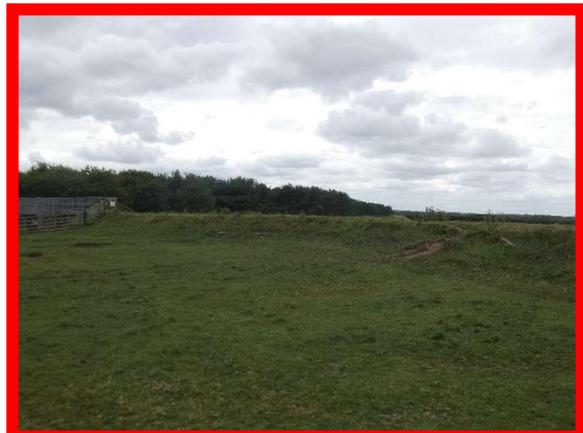
The area behind the new sluice, constructed as part of the Northumberland 4shores project shows little change. Between the new sluice and the main Beal Sluice (121AA901A1401C01) there is still a low point in the bank. This was previously highlighted and poses a threat to the area beyond the main Beal Sluice. The bank needs to be reinstated.

*1401/ C31, 2020 no improvement to low area of the bank to area of South Low.*

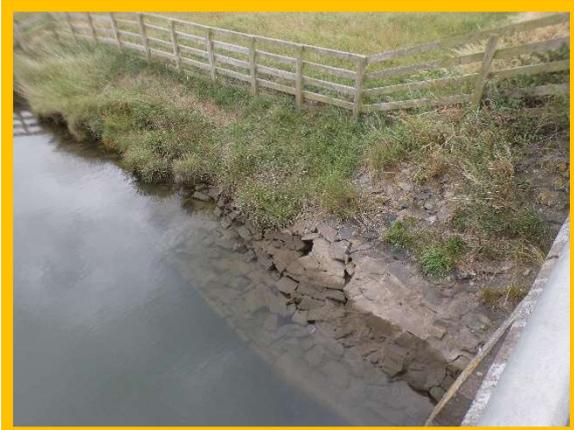
There is minor damage / undercutting to edge bank protection either side of main Beal Sluice. This appears to have worsened on the right hand side of the sluice (looking seaward).

*1401/C01 – 2020 undermining of edge protection.*

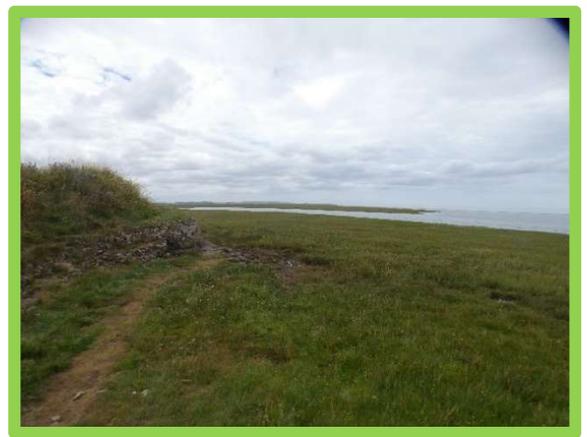
The frontage between Beal Sluice and the Holy Island causeway remains generally healthy with good vegetation growth. This is highlighted below in comparison to 2016.

*1401/ C02, 2020 indication of saltmarsh growth. .*

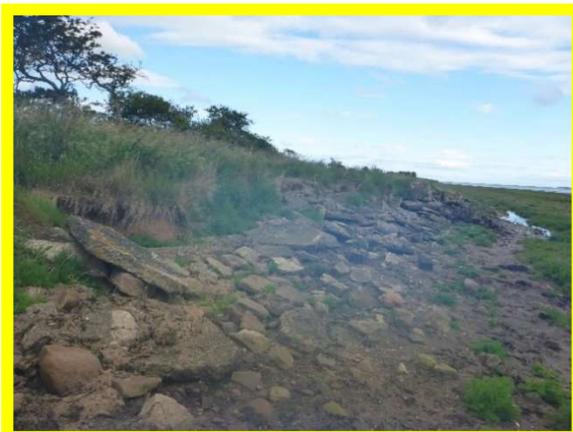
*1401/C23 – Localised informal rock pile to mitigate erosion*

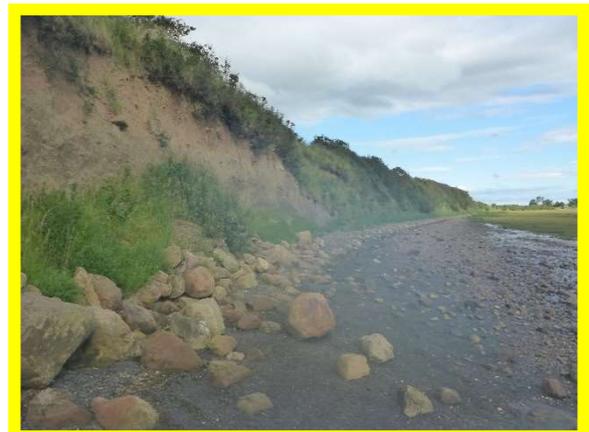
*1401/ C23 Actively eroding sandstone escarpment along Common Slap*

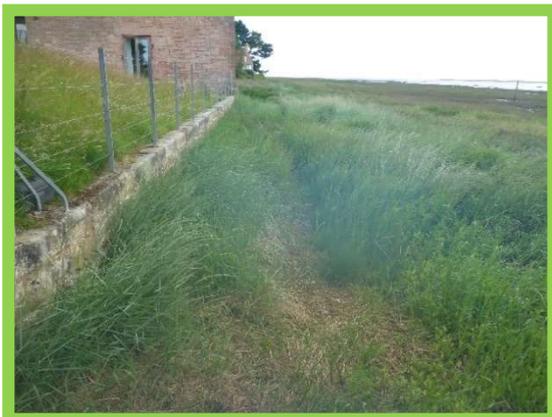
*1401/C23 – local defence north of slipway.*

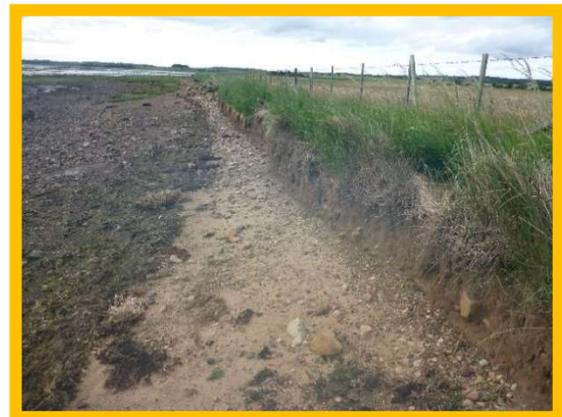
*1401/ C23 –Eroding bank nearing the field boundary at Tealhole Point*

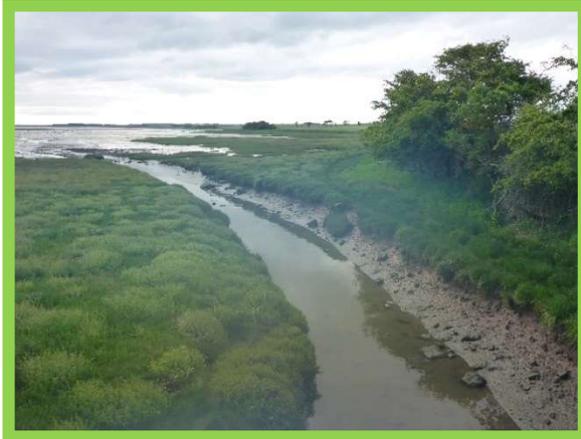
The timber bridge over the Fenham Burn is in fair condition, however one tread has been displaced and requires attention. Beyond the Fenham Burn the width of saltmarsh tends to reduce, before widening again past the windmill at Whitelee Letch. There has been minor erosion in places and again, possibly some local piling of rocks to mitigate this.

*1401/ C24 Healthy, but narrowing, marshland beyond Fenham burn*

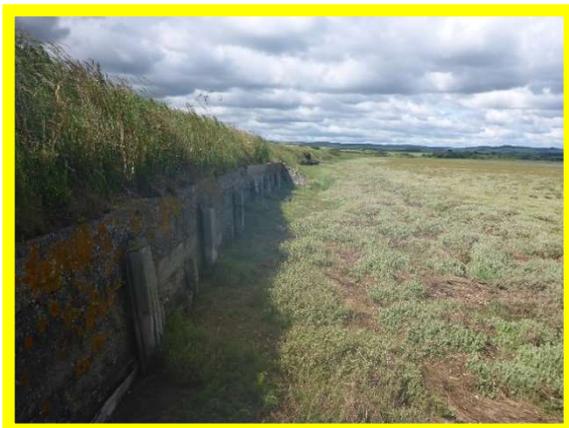
East of the bird hide at Elwick there is a flood embankment fronted by salt marsh. The embankment is protected by an asphalt and stone revetment which remains in a good general condition despite being largely overgrown. As noted in previous inspections, locally there are some areas of the embankment in poor condition, due to the presence of voids and loose or missing stones. The retaining structure on the seaward face of the embankment, approximately 500m east Elwick bird hide, is in poor condition. The timber support posts have rotted away, potentially resulting in the minor rotational movement that can be observed. The overall structure appears to continue to be effective in preventing sea flooding to a local low-lying bank of farmland across Ross. However, a few areas would benefit from routine maintenance by the local landowner to infill gaps in the stones. The rotational movement in the retaining structure should be monitored.

*1401C98 – retaining structure in fair condition. Rotten timber support posts and minor rotational movement.*

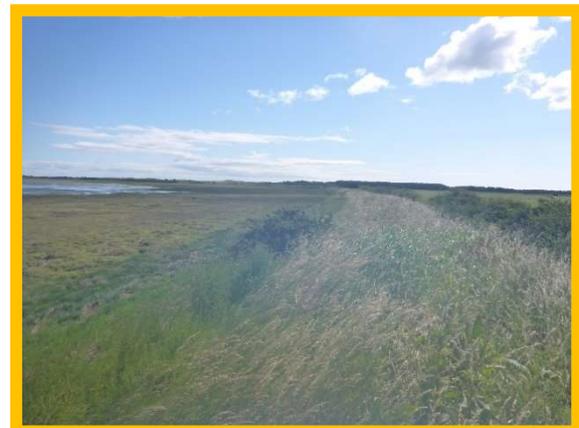
*1401C98 – Densely vegetated embankment.*

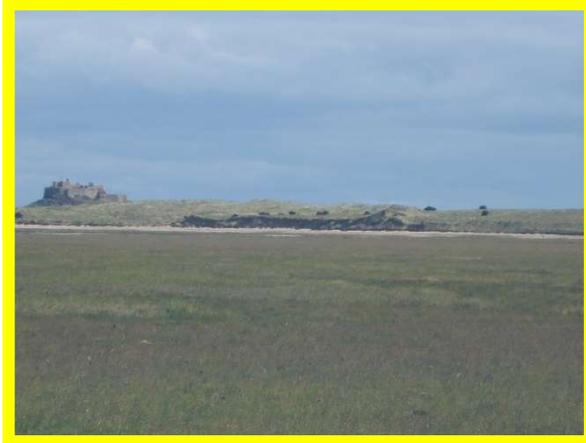
1401C99 – some evidence of erosion to dune toe

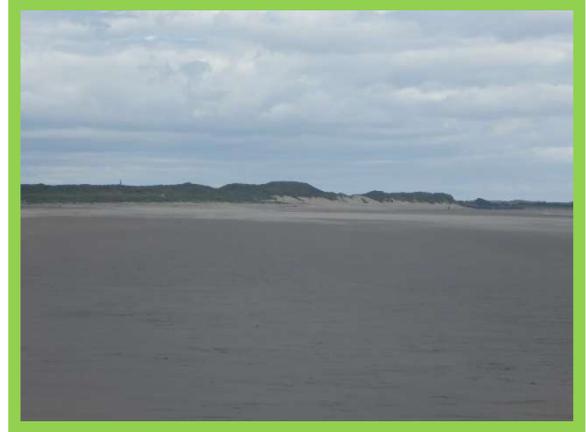
1401C99 –Embryo dune fronting southern end of the asset

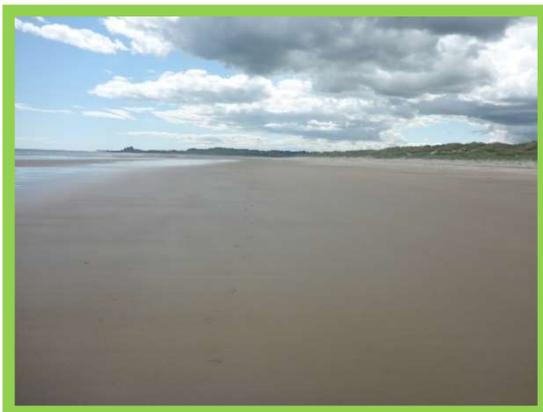
1401C06 – Wide healthy beach fronting well vegetated dunes

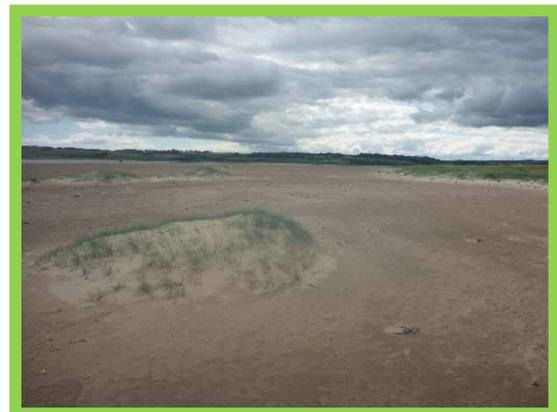
1401C06 – Embryo dunes observed to the south of Ross Back Sands

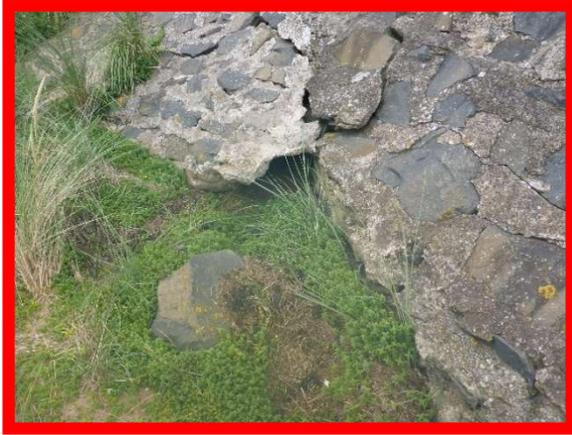
Various walls and grouted stone revetments, riprap and concrete retaining walls extend around Links End towards the sluice at Ross Low channel. Overall, the assets remain in fair to good condition with some notable areas of concern being the extensive cracking and lifting to the grouted stone revetments and localised cracking to concrete retaining walls. Ongoing lowering of the foreshore in localised areas is causing undermining of the mortared revetment. Washout of material behind the structure is evident causing some horizontal cracking and localised broken sections along the toe.

1401C27 – Localised section to the north of mortared revetment failed. Extensive cracking and washout of material.

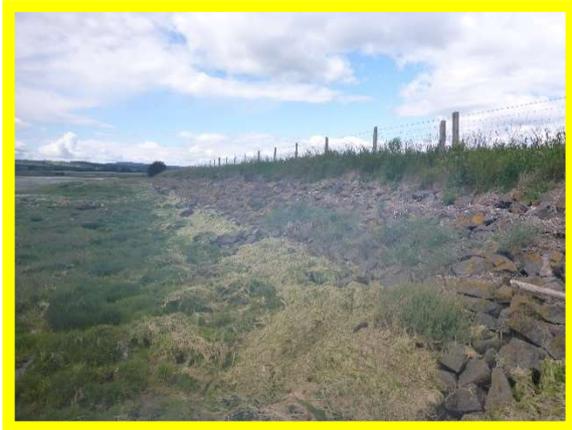
1401C22 – Section of evenly profiled, well graded revetment

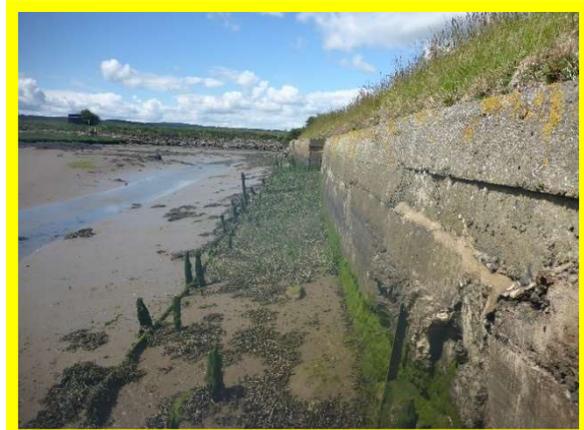
1401C14 – Concrete wall in fair condition. Timber toe erosion protection in poor condition.

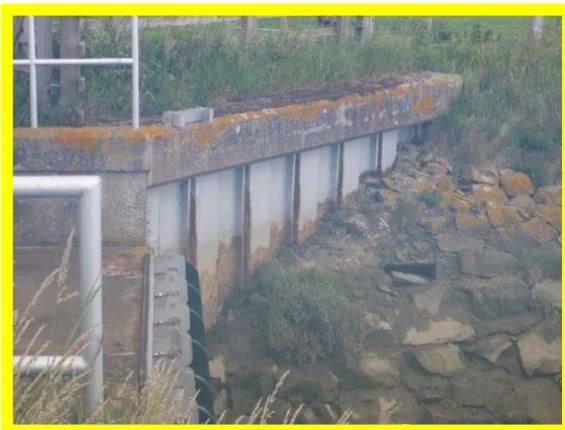
The sluice at Ross Low channel continues to be in a good state of repair with capping beams, hand-railings and ladders also in good condition. The steel sheet pile walls on either side of the structure show signs of corrosion. The extent of which is unknown due to the difficulty in accessing the sheet piles. There is no sign of vertical or lateral movement. It is recommended that a more detailed inspection is undertaken, and the level of corrosion monitored. It may be necessary to retreat the piles as was done in 2008.

1401C17 – Corrosion and marine growth evident on sheet piles at Ross Low sluice

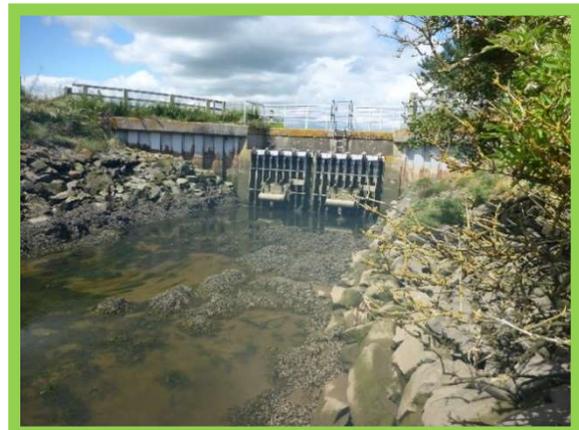
1401C18 – Good condition sluice at Ross Low channel

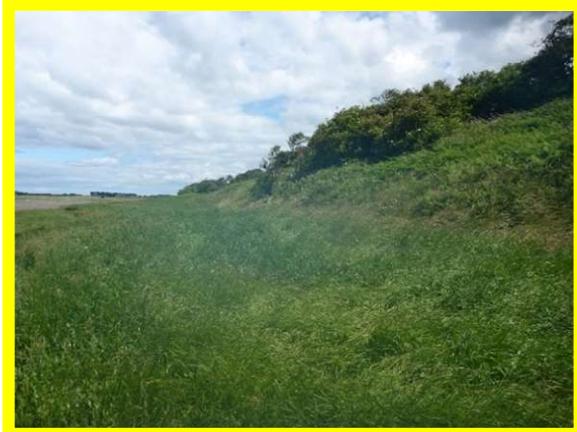
1401C21 – Heavily overgrown embankment to rear of saltmarsh

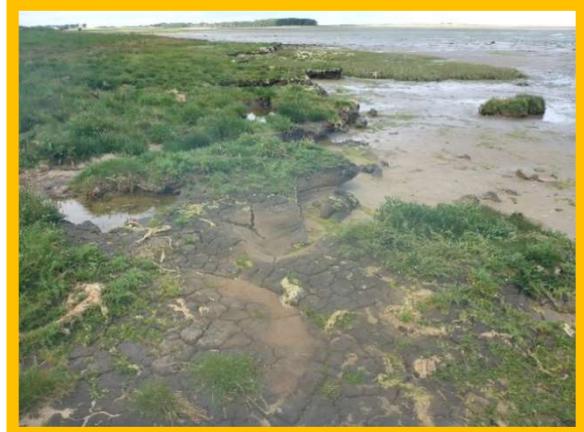
Along the Chesterhill Slakes in Budle Bay the salt marsh overall is in a fair condition, with salt pans evident in several locations. Not seen since the 2012, marsh edge erosion was again observed in the 2020 inspection. It is particularly apparent to the south of the marsh towards Warren Mill. In some places, there is Chord Grass (*Spartina*) growth on the foreshore.

1401C21 – Evidence of salt marsh erosion in in Budle Bay

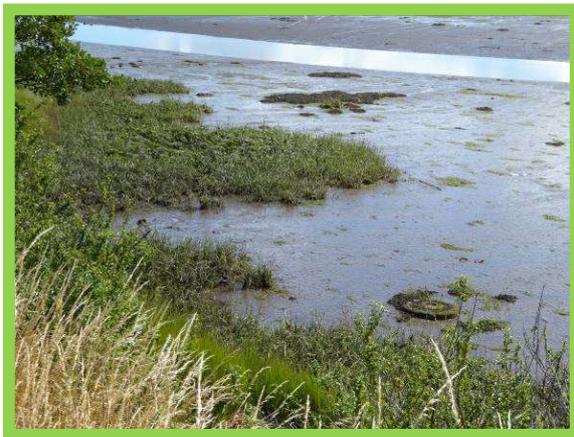
To the western side of Warren Mill there is still slow erosion of the back upper marsh to frontage 1501/C08 but with lower growth of spartina over the mud flats.

1501/C08 – lower spartina growth in front of eroding back marsh.

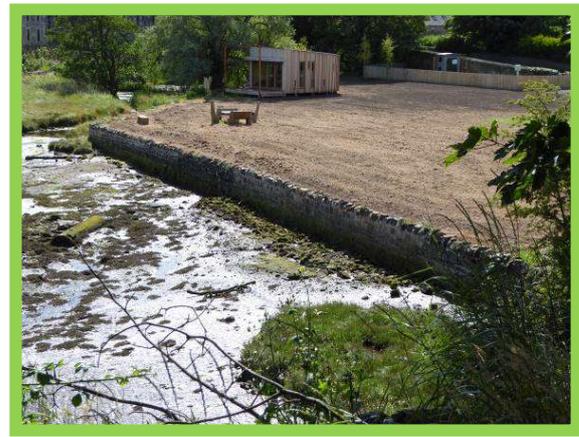
At Warren Mill, the wall fronting the private land at the head of the bay has been repaired as part of redeveloping the land behind as an open grassed area.

1501/C02 – Wall repaired to new development.

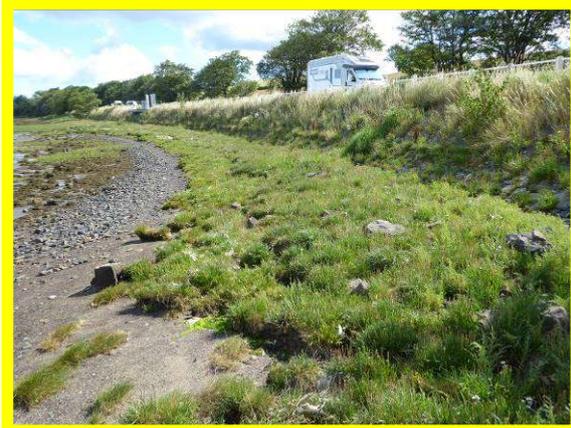
The revetment fronting the B1342 appears in fair condition although somewhat overgrown and in need of repointing. The upper marsh continues to erode slowly with the development of local creek systems. In places these small creeks, where they occur at the toe of the revetment cause very local undermining. To the front of the well-established upper marsh there is spartina growth over the mud flat.

*1501/C04 – heavily vegetated revetment*

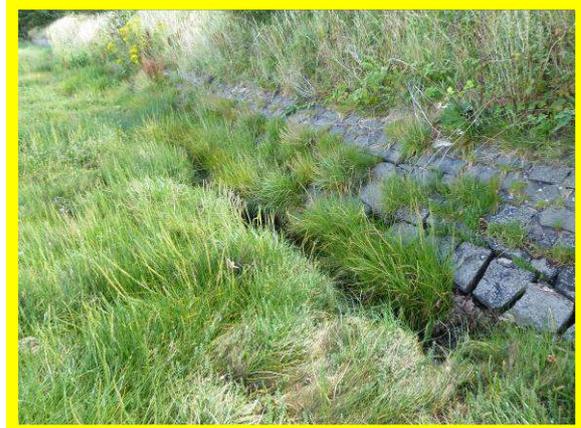
*1501/C04 – very local undermining due to back creek development.*

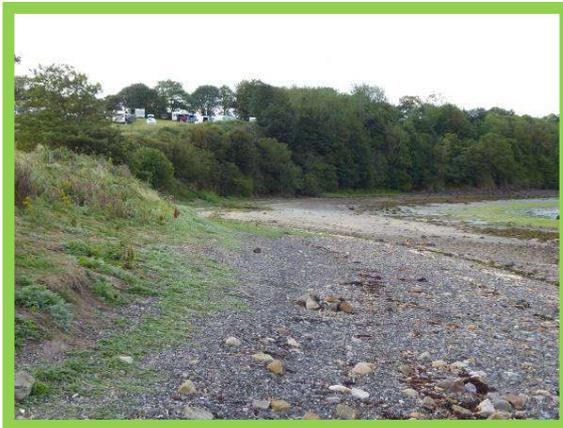
*1501/C05 – natural bank running to heavily wooded section.*

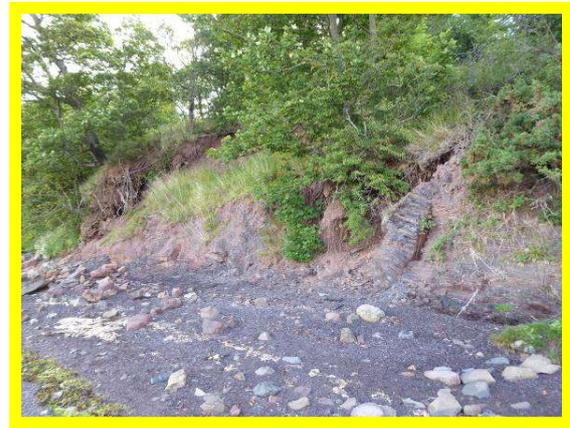
Frontage 1501/05 changes from a heavily wooded coastal slope changing to a shingle bank backed by a low bank to raising land. There is local erosion at the toe of the slope, with local failure associated, generally with trees. The road in this area is set back and there is no apparent risk from erosion.

*1501/C05 – local bank failure but no apparent risk to road.*

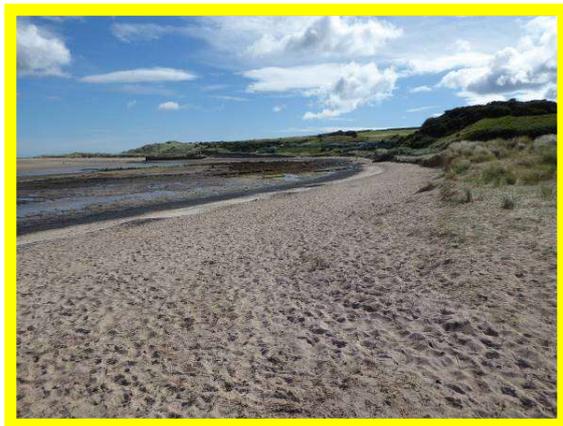
The frontage to the south of the jetty (1501/C06 south) continues to show signs of erosion, with exposure of peat on the lower foreshore. A sand spit has developed (noted in previous inspections) out into the estuary. As with the continued erosion closer to the jetty, this developing situation seems to be determined by the change in the channel position (held by the jetty and areas of harder substrate), the loop of channel pushing up against the end of the jetty.

*1501/C06 – erosion down to peat on foreshore south of Jetty*

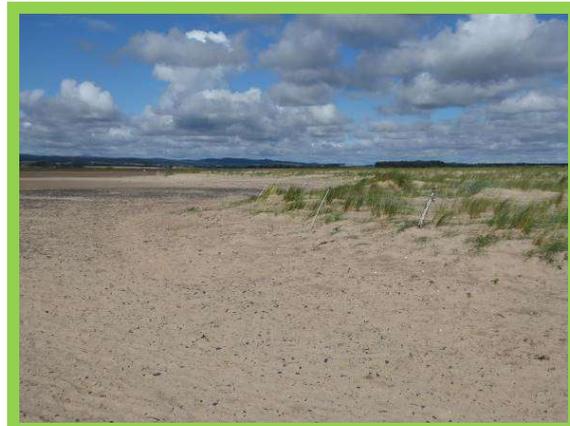
*1501/C06 – development of sand spit to south of frontage.*

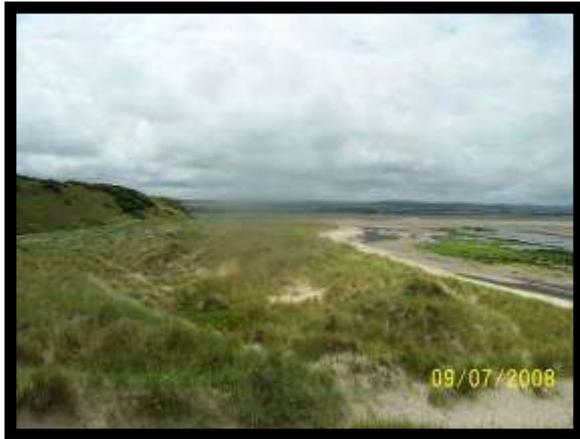
1501/C06 – Wide dune south of jetty 2008

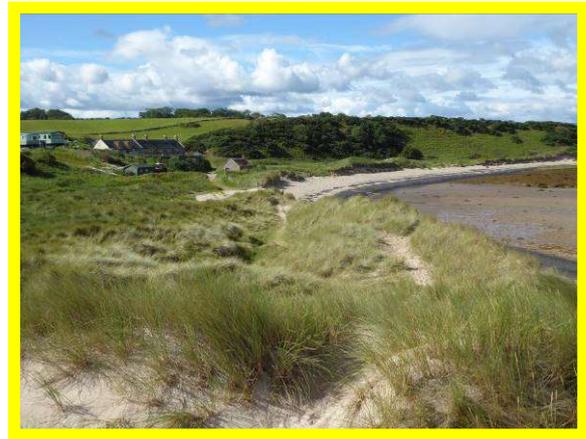
1501/C06 – continued erosion of dune 2020

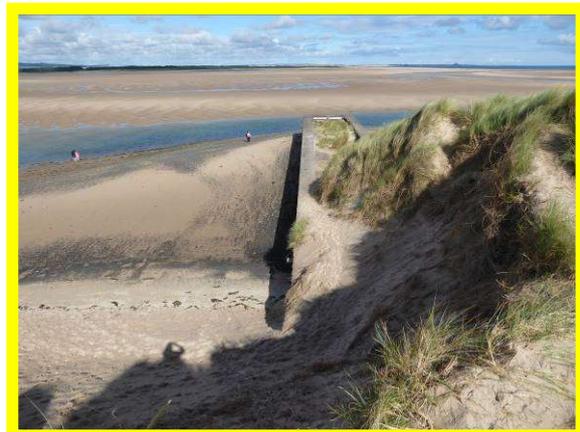
The old Jetty at Heather Cottages within section 121AA901A1501C06 remains in poor condition but has not significantly deteriorated since 2018.

1501/C06 – South face and core of Jetty

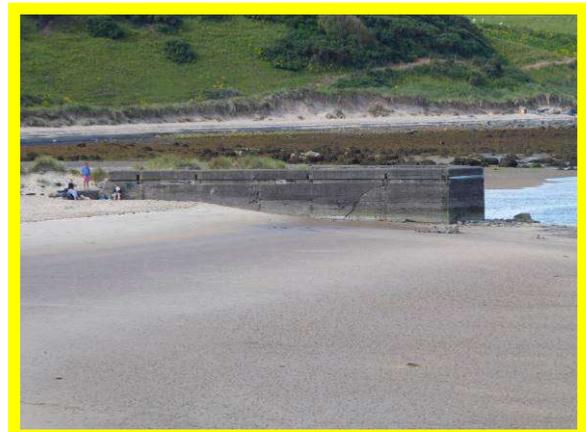
1501/C06 – view of jetty from the north

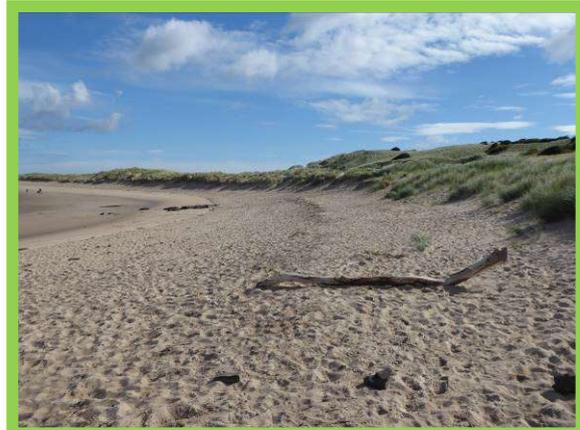
1501/C06 – Upper beach north of Jetty

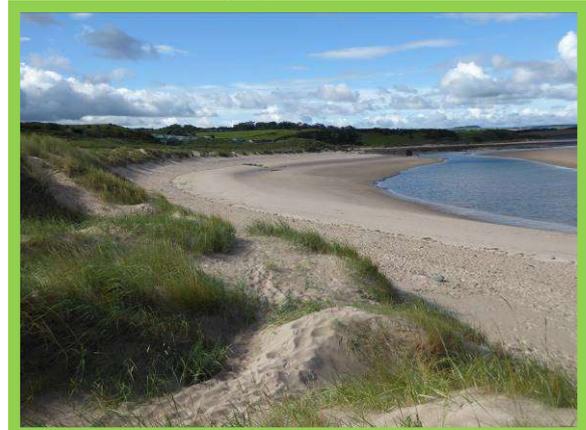
1501/C06 – general view north of jetty with limited growth at toe of dune.

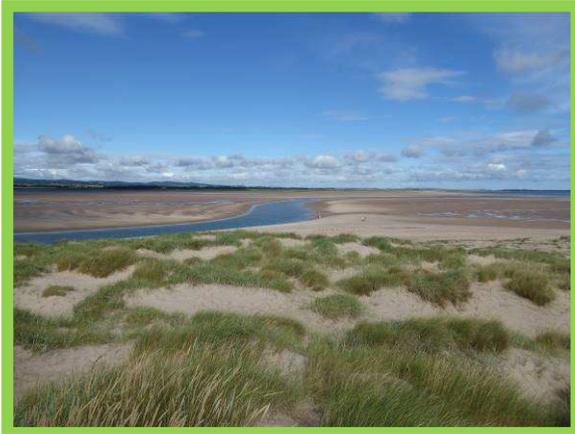
Budle Point remains relatively unchanged with some embryo dune growth to the north face.

1501/C06 – Budle Point 2020

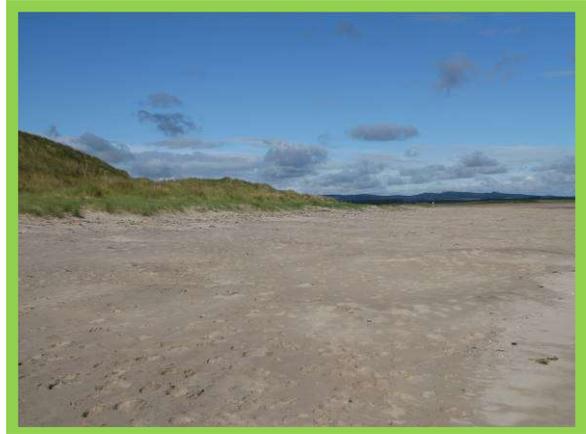
1501/C06 – Growth of embryo dunes to north face.

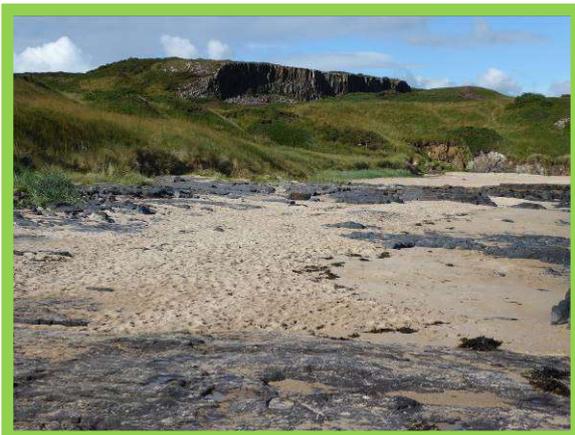
1501/C07 – areas of dune toe growth

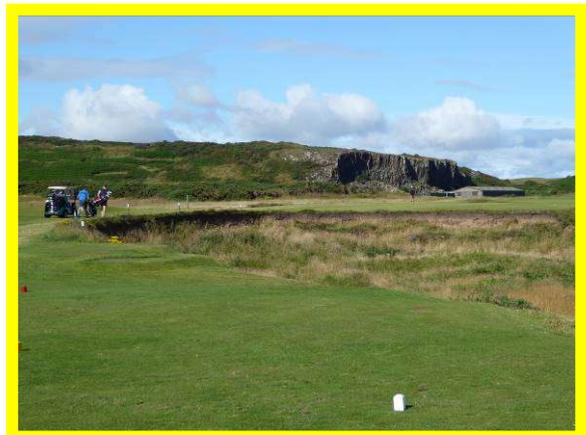
There has been some local dune toe growth between Budle Point and Harkness Point, improving the situation from 2018. There is an area of significant land slip at the crest of the coastal slope close to the lookout point and golf club. This continues develop slowly. There is no significant change since 2018. The slip is considered to be due to ground water and slope instability, rather than triggered by persistent erosion of the toe..

1501/C07 – slow continued slippage at crest of coastal slope.

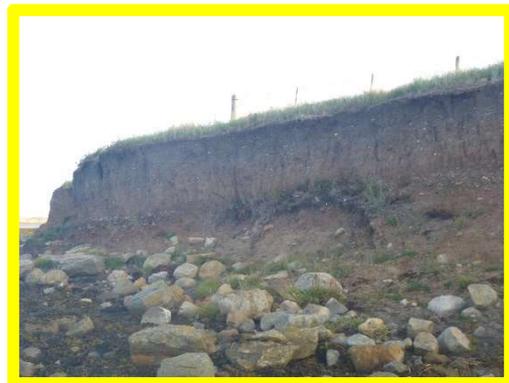
At The Basin, the dunes make way to gentle coastal slopes and then low cliffs which are fronted by a gravel and cobble ridge. The low cliffs are locally active with several lengths bare of vegetation and occasional sumps. However, this does not appear to have worsened since the previous inspections.

*Low cliffs at The Basin (4901c03).*

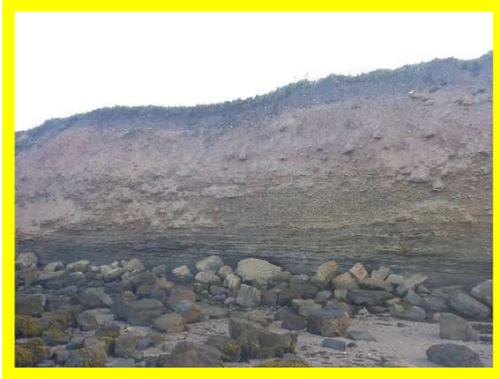
*Eroding section of higher cliff (/4901c03).*

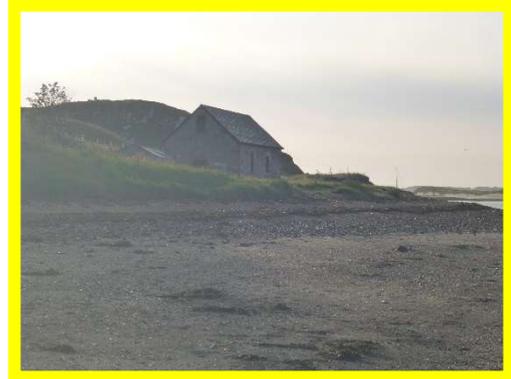
*Beach in shelter of St. Cuthbert's Isle (/4901c04).*

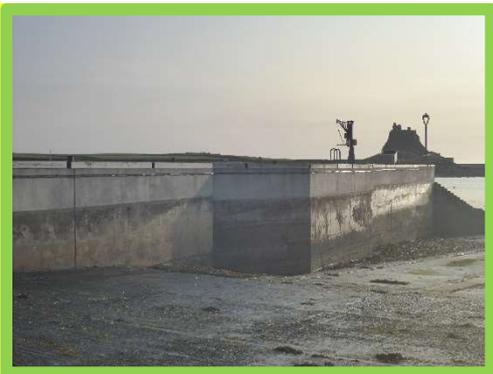
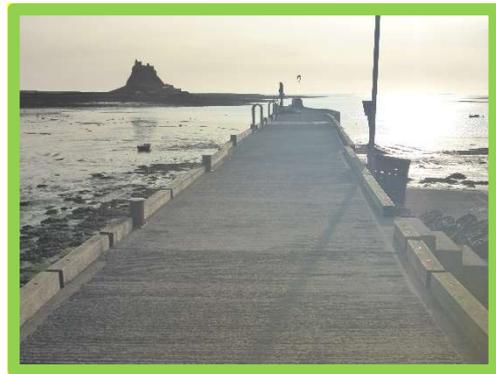
The highly fissured hard rock outcrop of Steel End provides natural sheltering to the harbour and bay to the north. Following successive inspections from 2008 onwards which reported several defects with the harbour pier, a major repair of the structure was undertaken prior to the 2016 inspections, with concrete encasement of upper sections. This has improved the condition of the pier to good and the repairs remain effective. Problems previously noted, associated with undermining were not observed due to high beach levels at the toe.

*Improvement works to harbour pier (/4901c09)*

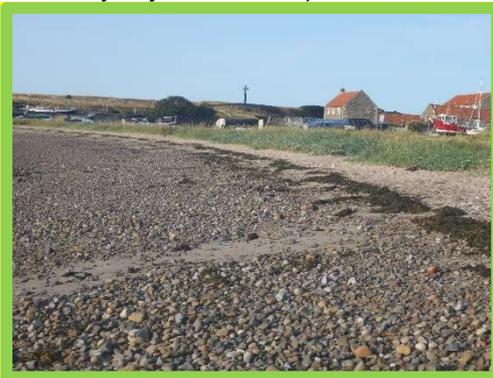
*Beach within Harbour bay (The Ouse) remains sable (4901c10).*

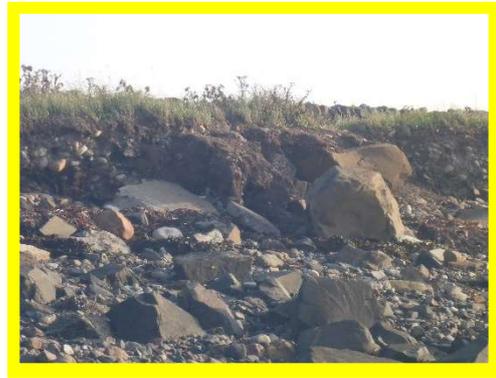
Within the harbour bay (The Ouse), the sand and gravel beach appears stable with little change evident over a number of recent inspections. Erosion and cliffing of the soft earth embankment around the north side of the bay adjacent to the path out to Lindisfarne Castle was noticeable.

*Slopes around the north side of the bay (4901c11).*

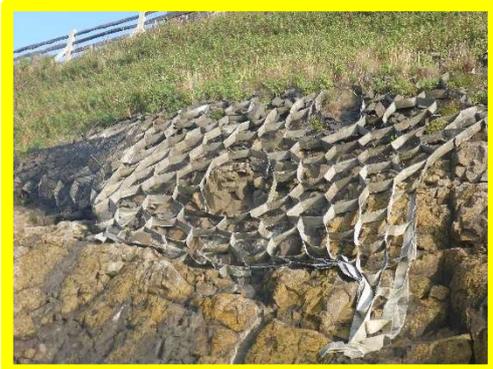
At Lindisfarne Castle, damage to the hexagonal netting and stone fill placed to stabilise the soft material covering the harder rock base below the castle does appear to have worsened (this is a general ongoing worsening trend over several recent inspections), with some totally empty hexagons. However, there does not appear to have been any further notable slumping in the soft earth slopes.

*Hexagonal erosion control matting below castle in fair condition but locally with absent rocks (/4901c12).*

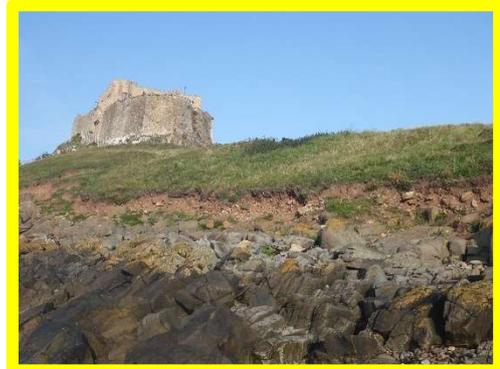
*Cliff below castle east of erosion matting (/4901c12).*

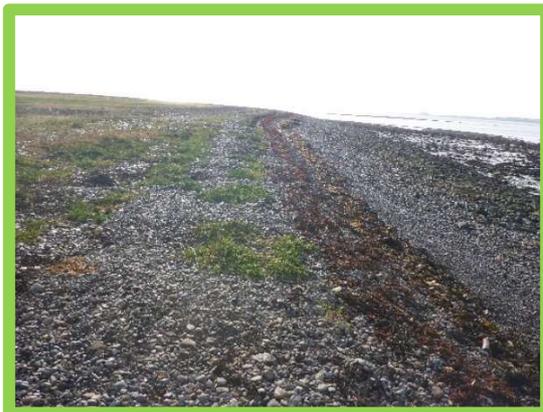
The shingle ness at Castle Point remains in a healthy condition over almost all of its extent, but there is minor erosion and cliffing of the grassed low cliffs on the north face where it nears the path.

*Shingle ness at Castle Point remains in a healthy condition – south face (/4901c014)*

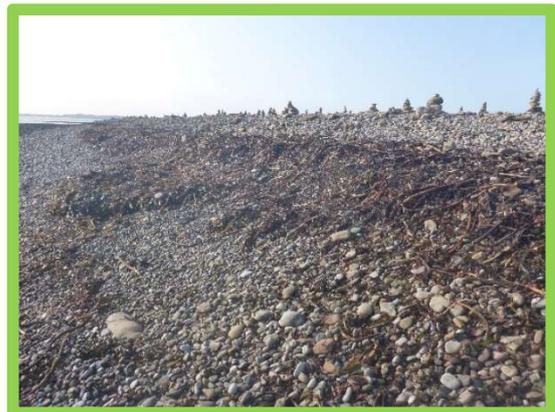
*Shingle ness at Castle Point remains in a healthy condition – north face (/4901c014)*

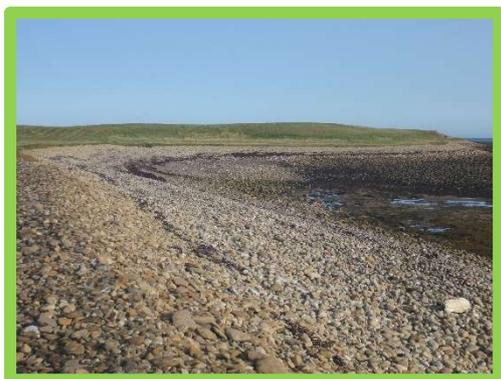
The low coastal slopes between Castle Point and Emmanuel Head are fronted by wide and high shingle berms and are relatively stable and in good condition. There is some evidence of shingle ‘washover’ during storms in the form of washover fans deposited above the crest. North of Brides Hole, cliffs become higher and these continue to show ongoing intermittent erosion and slumps. Since the last inspections two warning signs have been erected where the path is close to the cliff top, warning of the “high eroding cliff edge”. The cliff toe is mostly protected by a cobble berm, with some sections fronted by low rock platform.

*Relatively stable shingle bay near Sheldrake Pool with washover fans (/5001c03)*

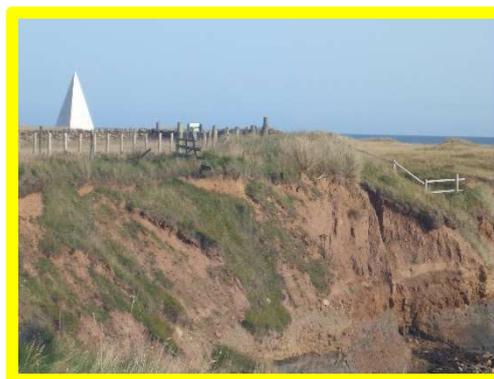
*Erosion of soft cliffs remains an ongoing process (/5001c04).*

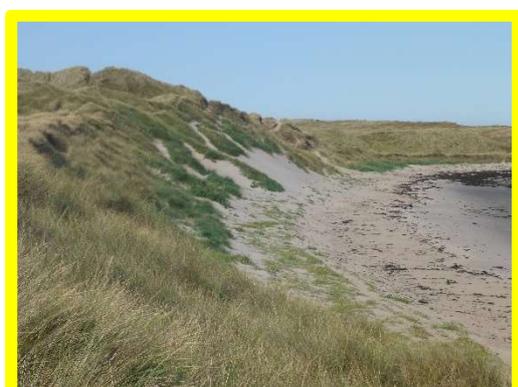
In Sandham Bay, west of Emmanuel Head, the dunes to the west and east of the bay are stable where they are protected by the cobble spit and rocky reefs of Castle Head Rocks. However, the higher dunes in the centre of the bay were also stable (in contrast to 2018 inspections), despite being largely bare of vegetation.

*View of Sandham Bay from Emanuel Head (/5001c06).*

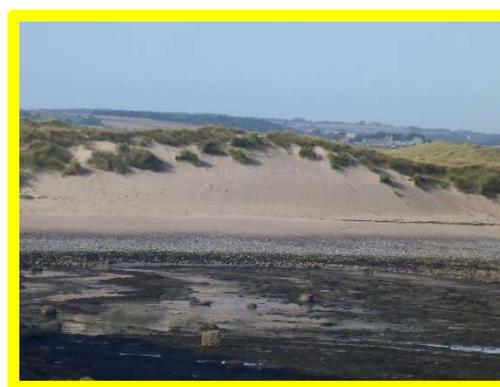
*Dunes in centre of Sandham Bay (/5001c06).*

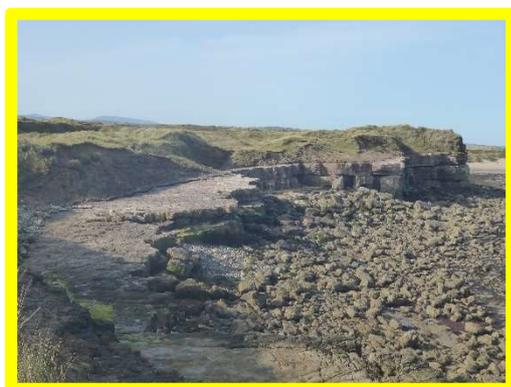
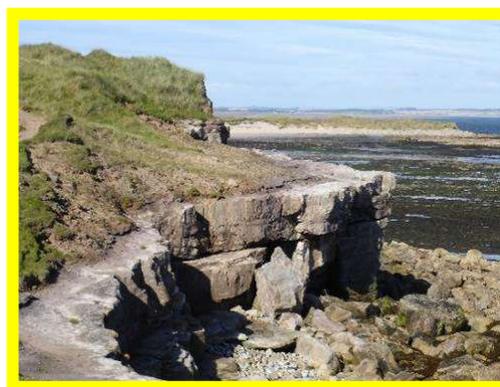
There is continued evidence of local rockfalls along with erosion and cliffing of the softer material in the cliffs at Nessend. However, this is localised and does not represent significant concern.

*Locally active cliffs at Nessend (/5001c07).*

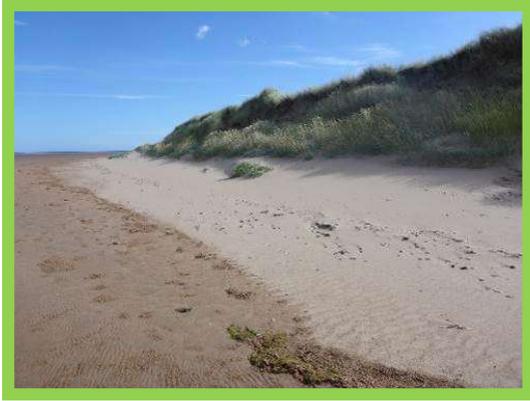
The dunes at The Links, in the shelter of Back Skerrs rocks appear very stable, with minimal change since the walk over inspections began in 2004. The dunes between Back Skerrs and the causeway road to the mainland are well vegetated with only localised evidence of erosion from previous storms. The very wide and flat sandy beach appears stable or accreting. Between where the causeway meets the island and

*Well vegetated dunes at Snook Point (/5001c10).*
